MISSOURI DEPARTMENT OF NATURAL RESOURCES
STATE HISTORIC PRESERVATION OFFICE, P.O. Box 176, Jefferson City, MO 65102
ARCHITECTURAL/HISTORIC INVENTORY FORM

1. Survey No. BO-AS-011-0087		2. Survey name: North Central Columbia Survey Phase II	
3. County: Boone		4. Address (Street No.) 902	Street (name) N. Seventh Street
5. City: Columbia	Vicinity: <input type="checkbox"/>	6. Geographical Reference:	7. Township/Range/Section: T: R: S:
8. Historic name (if known):		9. Present/other name (if known):	
10. Ownership: <input checked="" type="checkbox"/> Private <input type="checkbox"/> Public		11a. Historic use (if known): Domestic/single dwelling	11b. Current use: Domestic/single dwelling

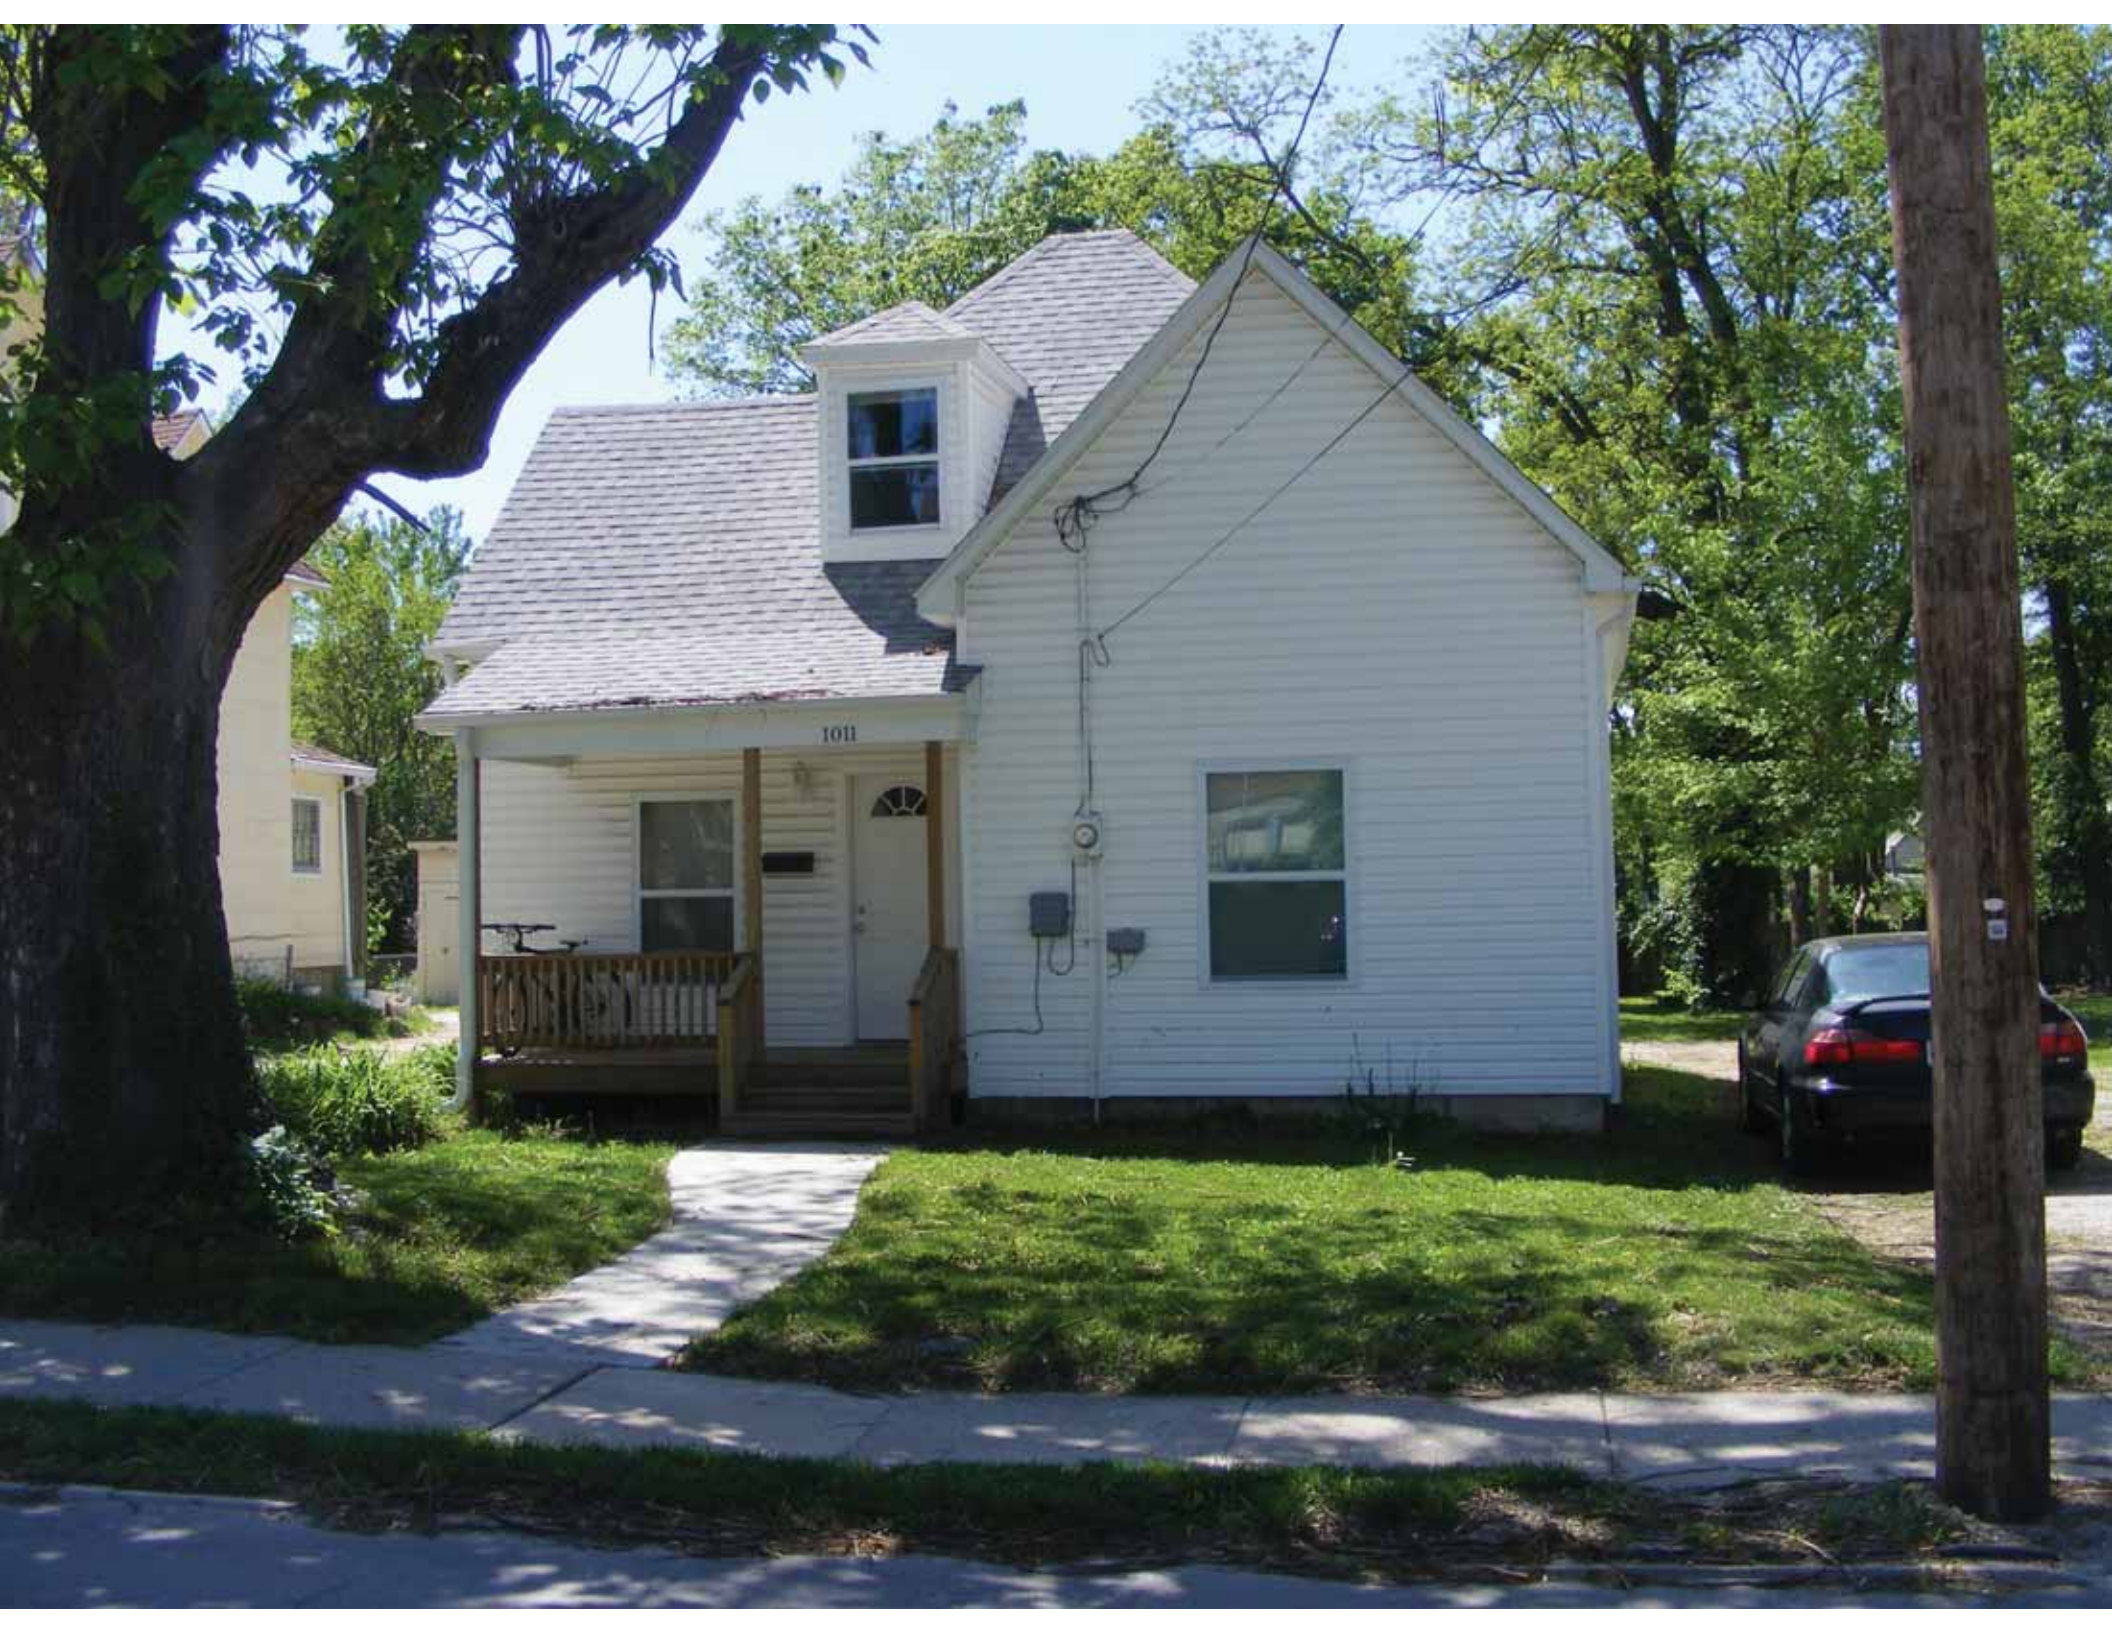
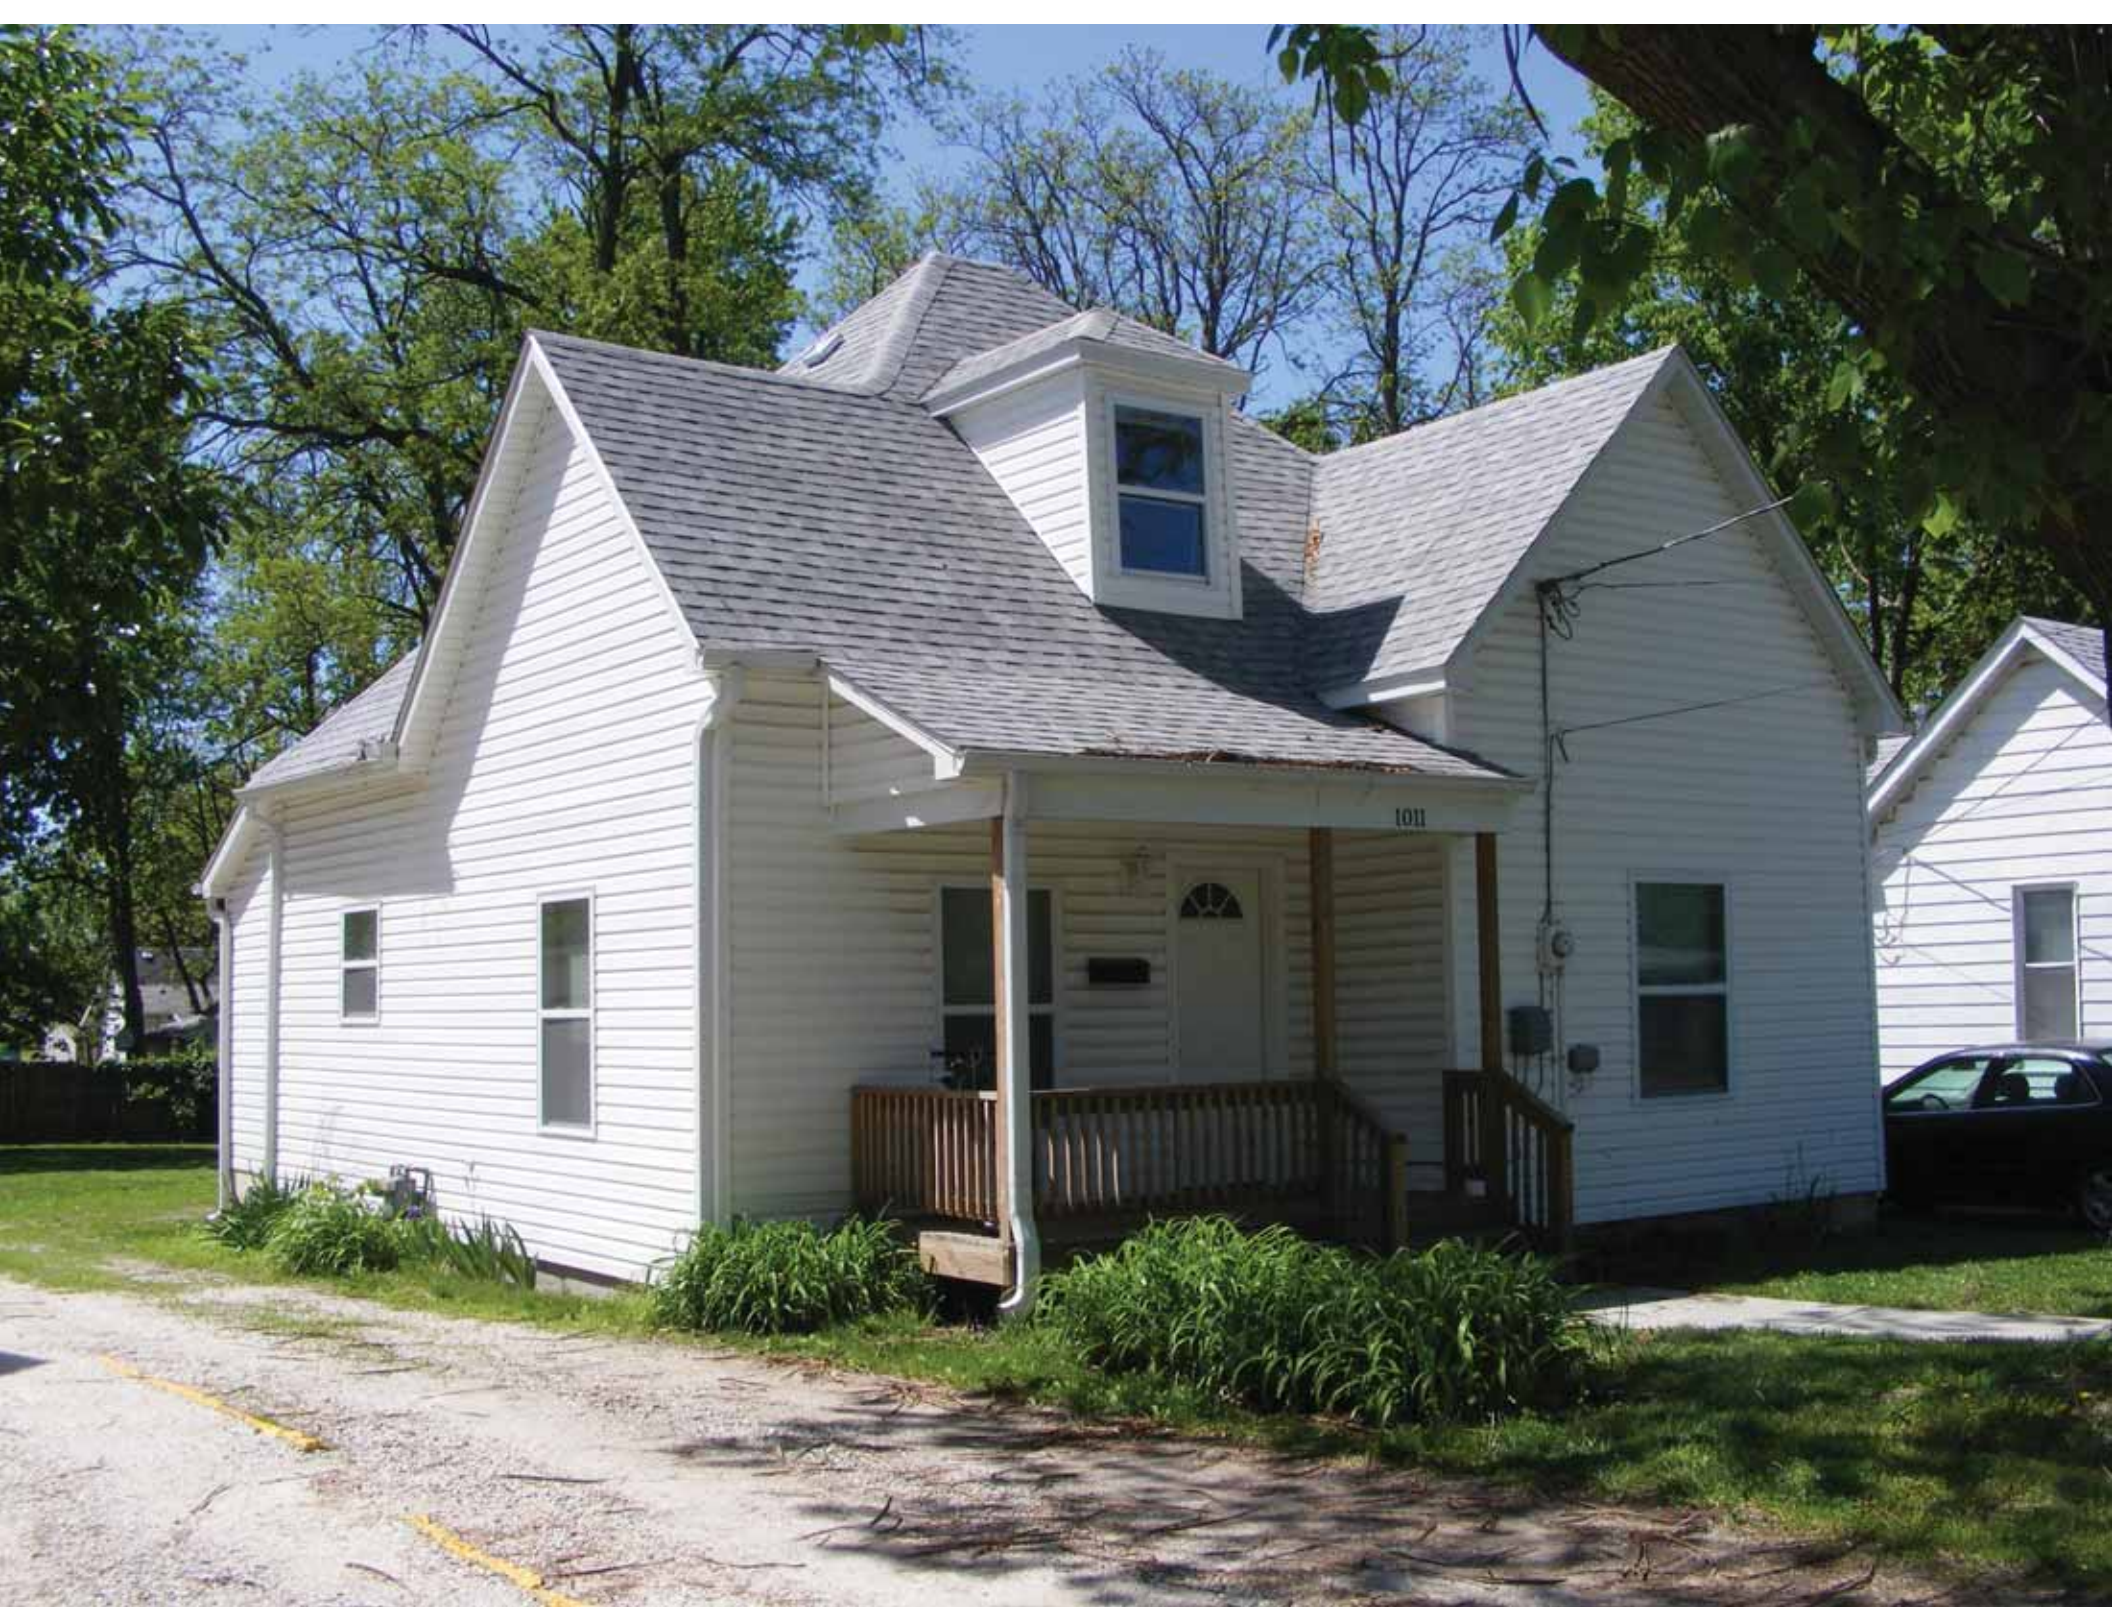
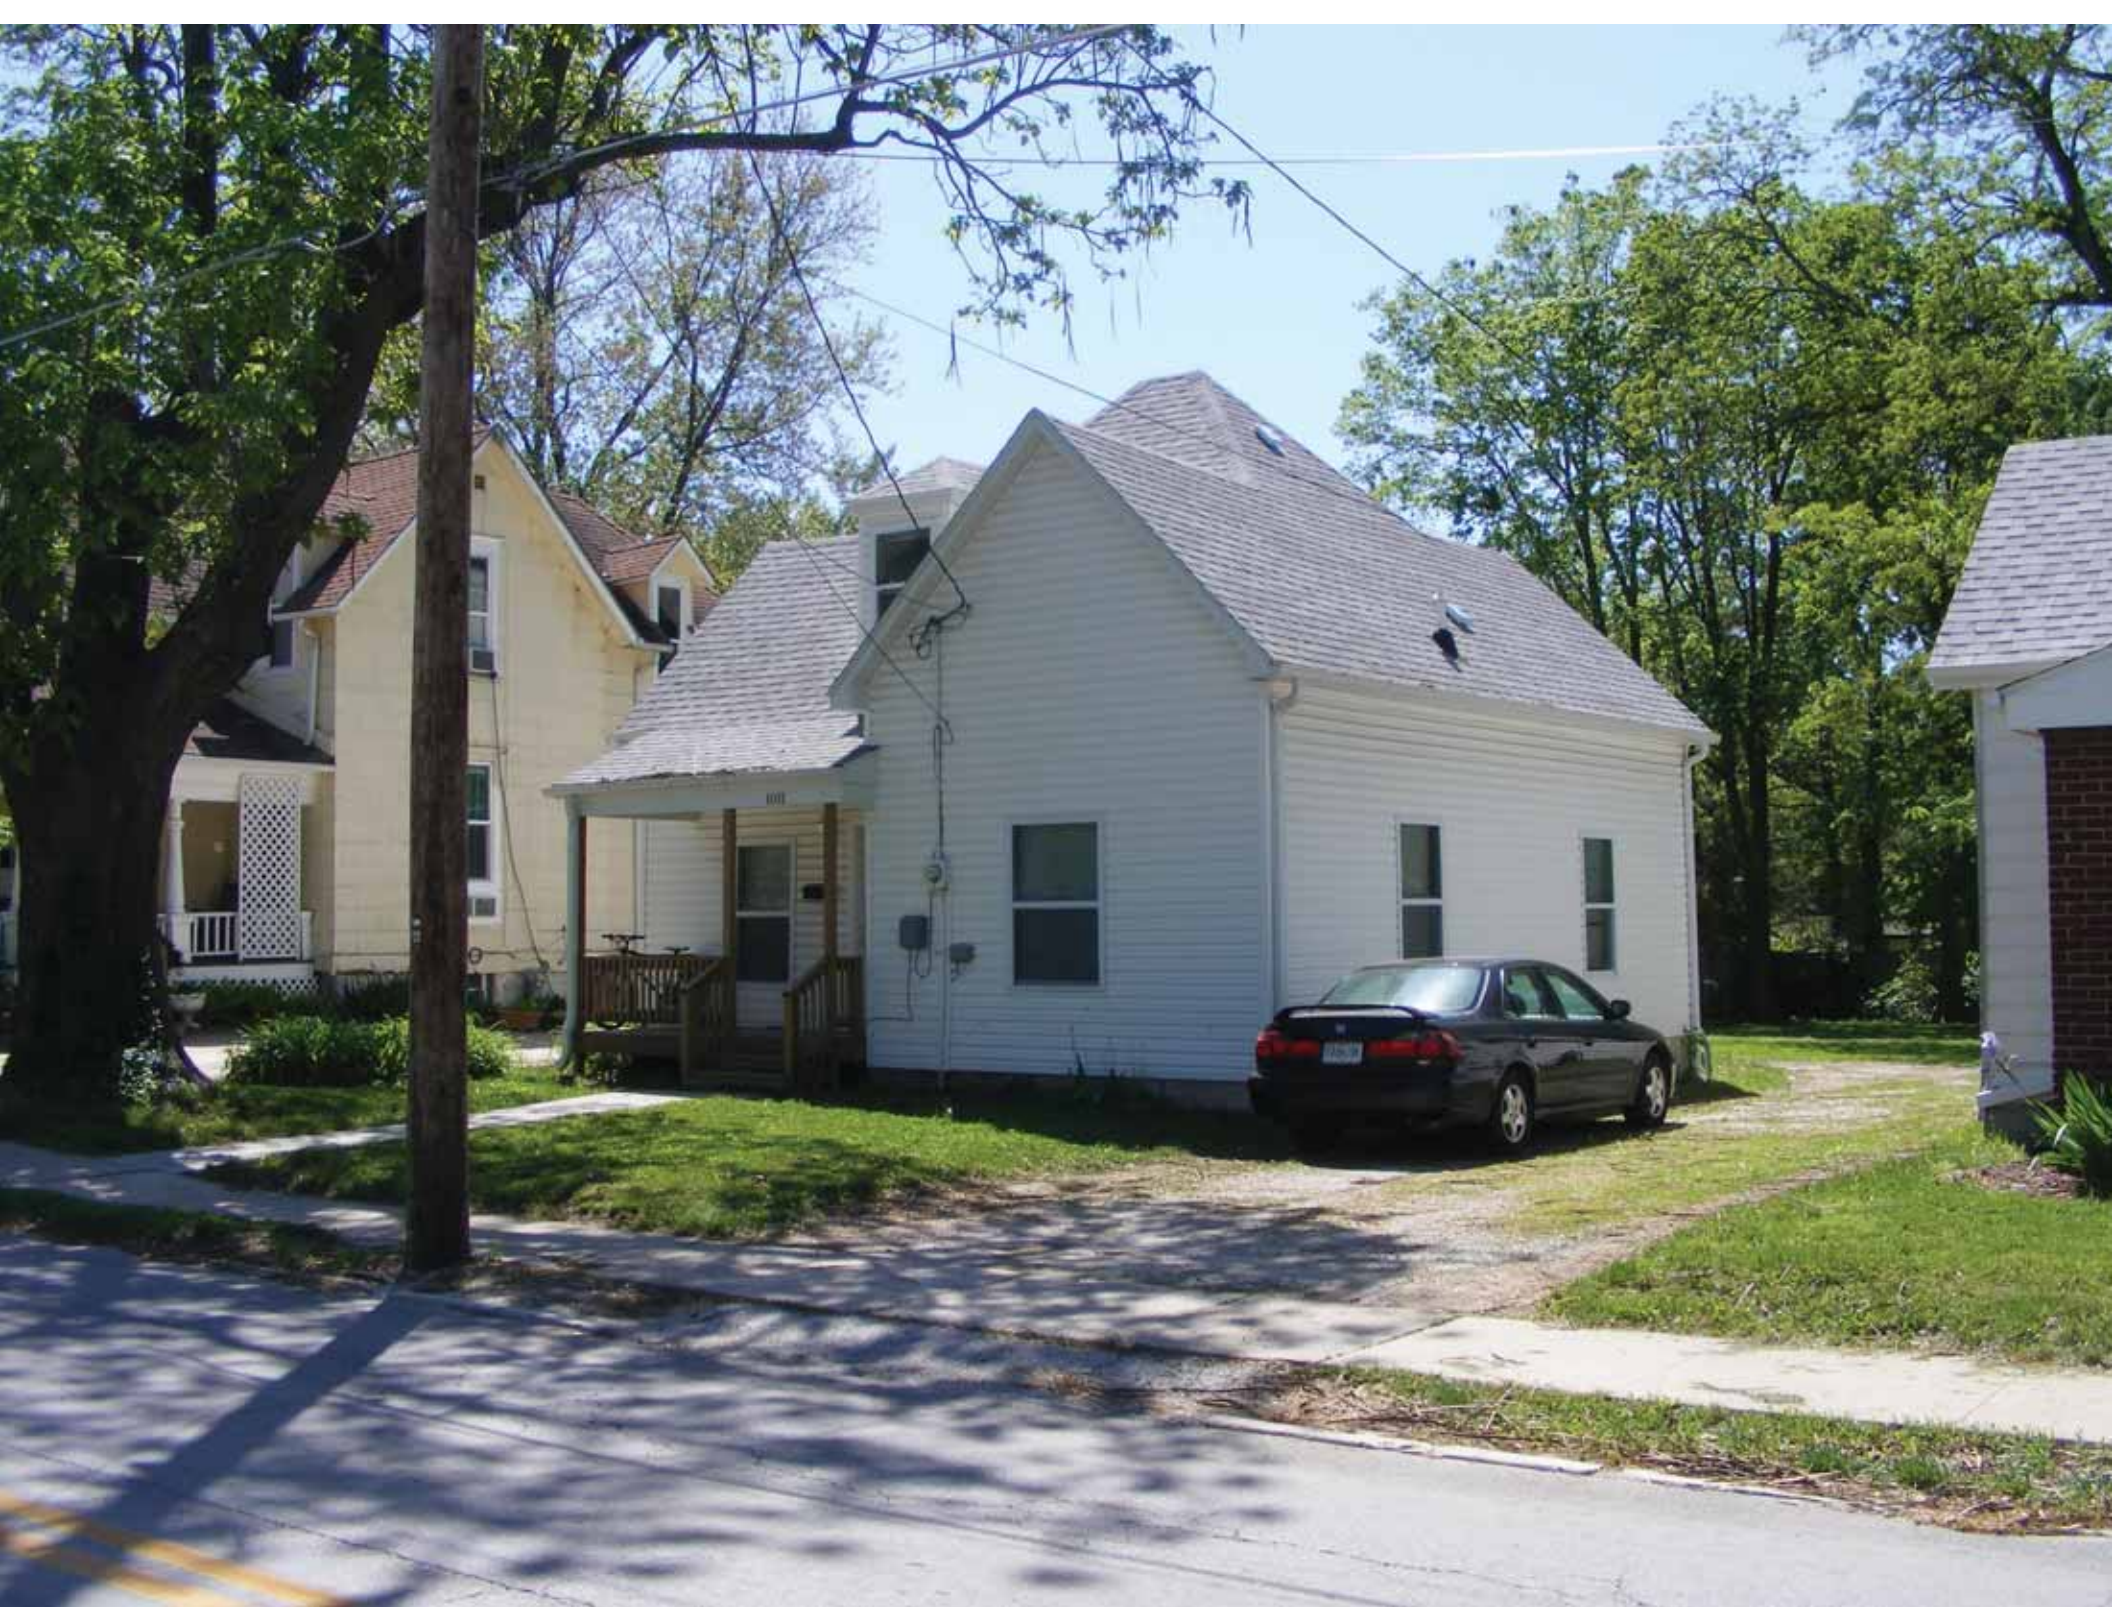
The dwelling has an asphalt shingled hip on gable roof, exterior vinyl siding and a concrete foundation. The primary (east) elevation has a half-width shed porch supported by wood replacement columns. A non-original balustrade surrounds the porch and extends along the steps as handrails. Within the porch bay (façade, east elevation) is a replacement paneled door with an upper fanlight. Offsetting the entry by on the south is a replacement one-over-one window. Remaining windows are of similar configuration. Above the porch is a hipped dormer with a one-over-one window. Flanking the north end of the porch is the dwelling's front-gabled wing. The east elevation of the wing holds a one-over-one window.

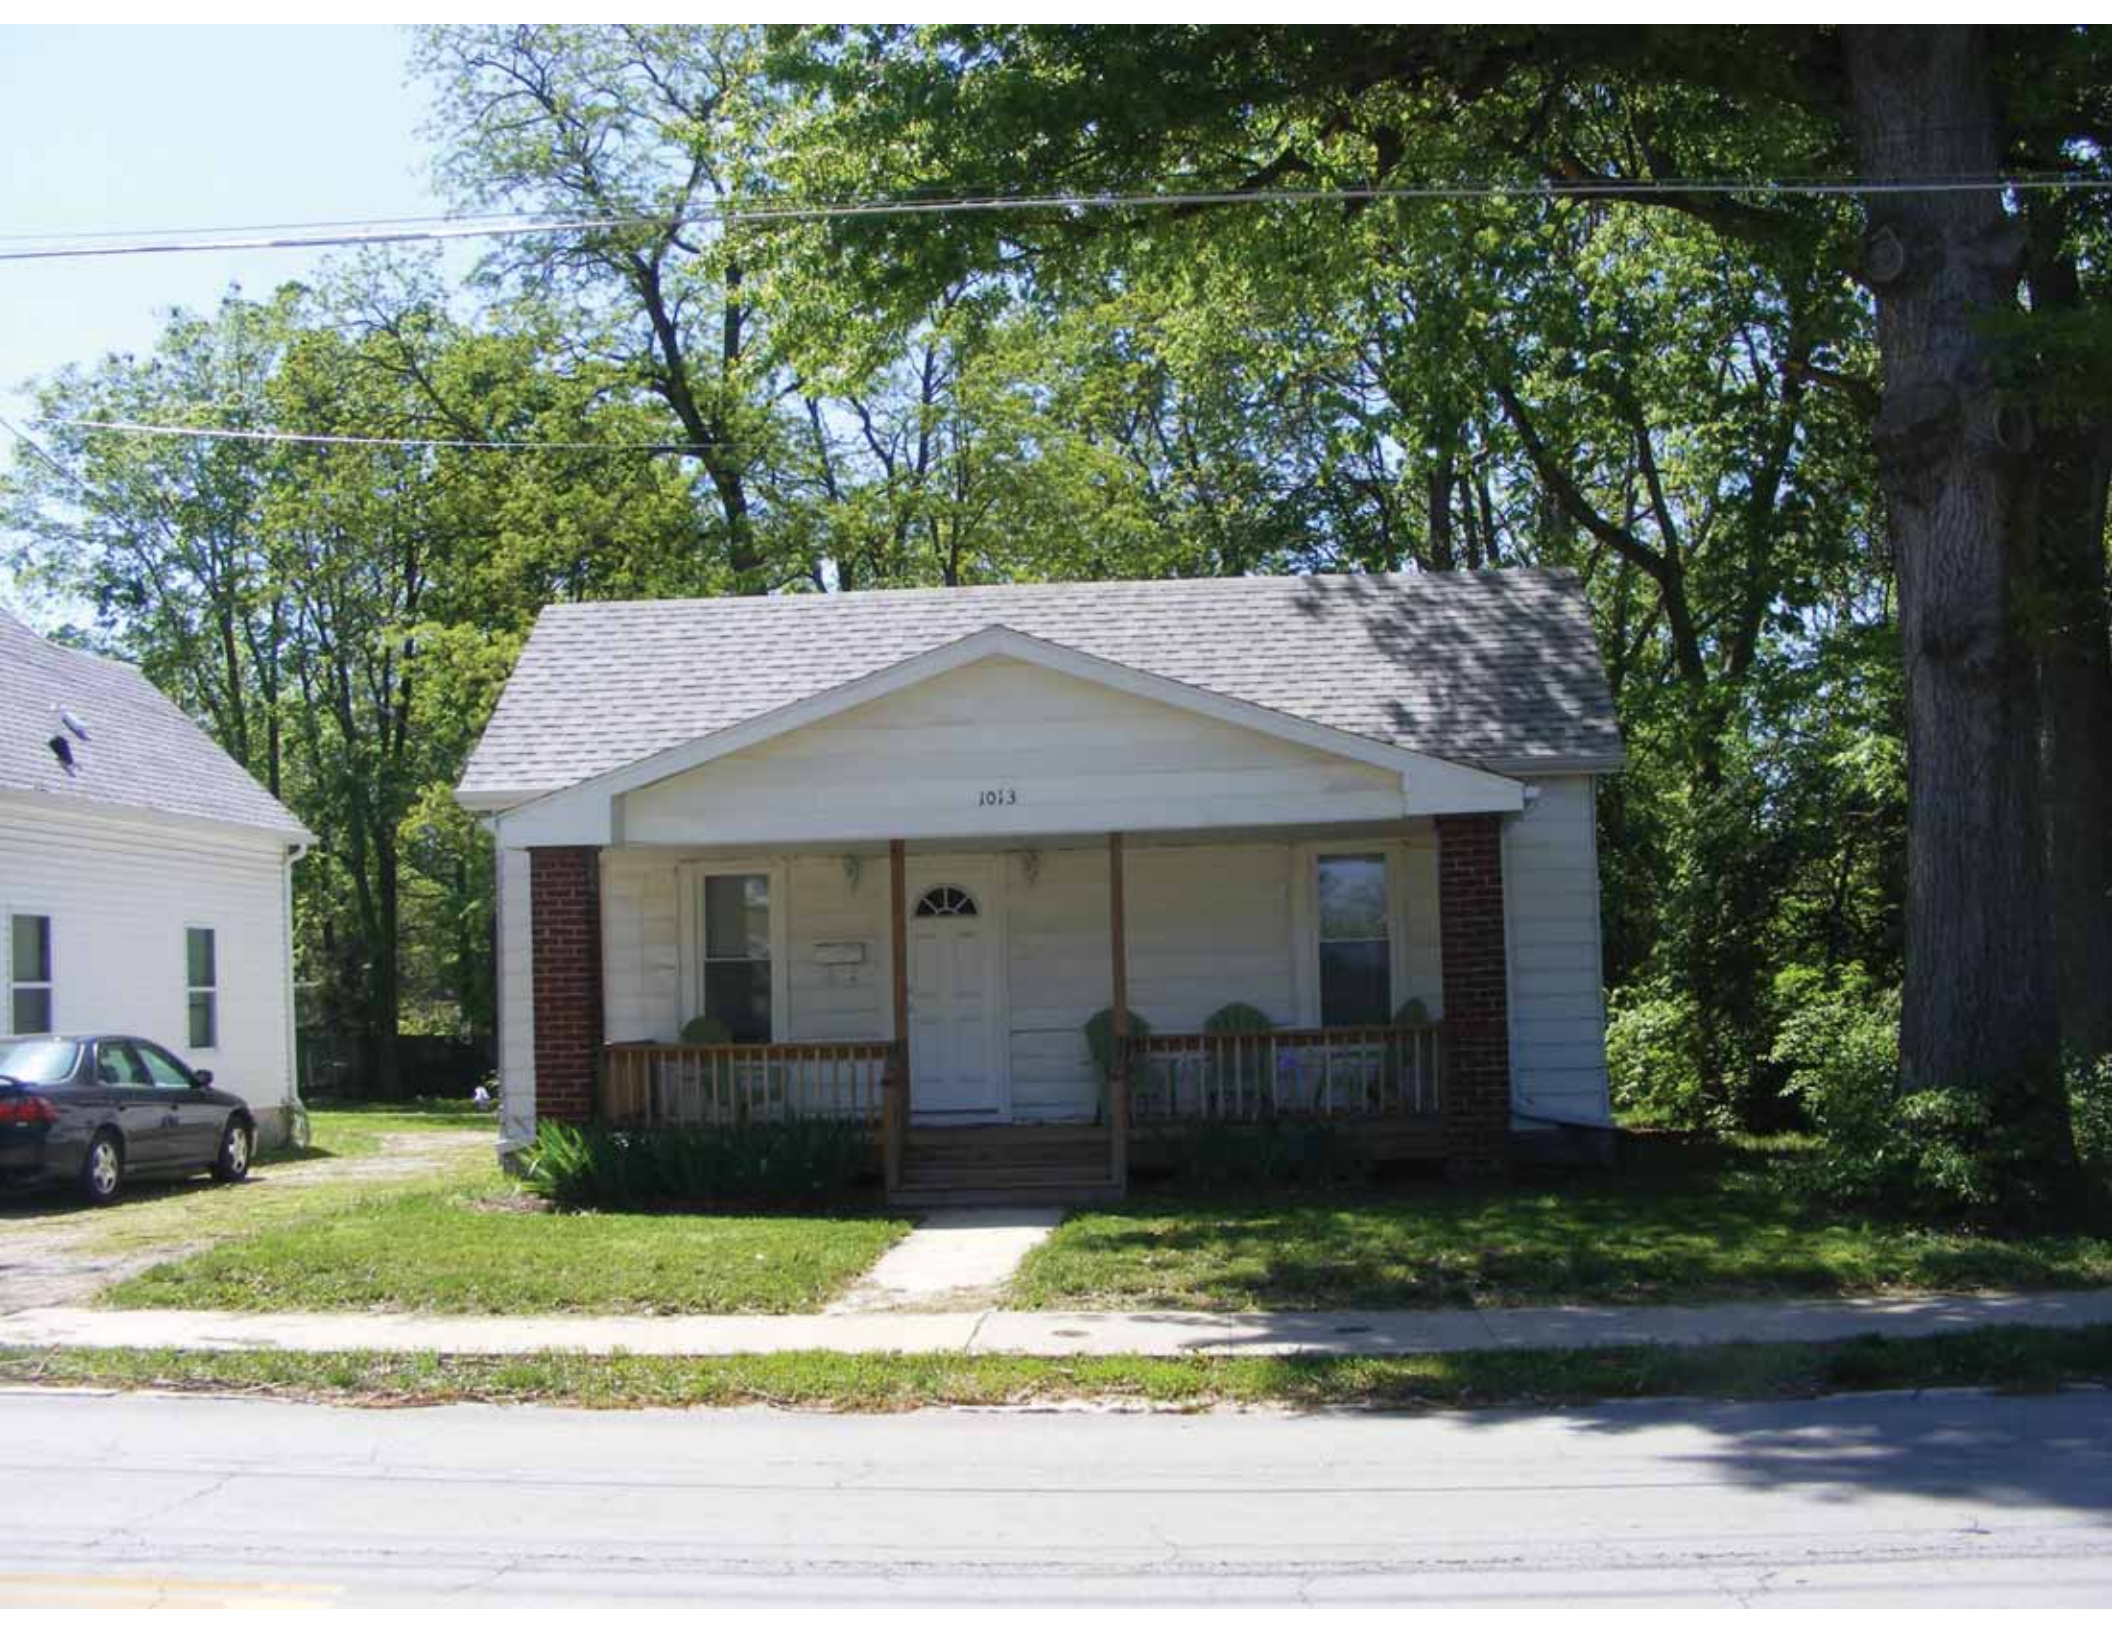
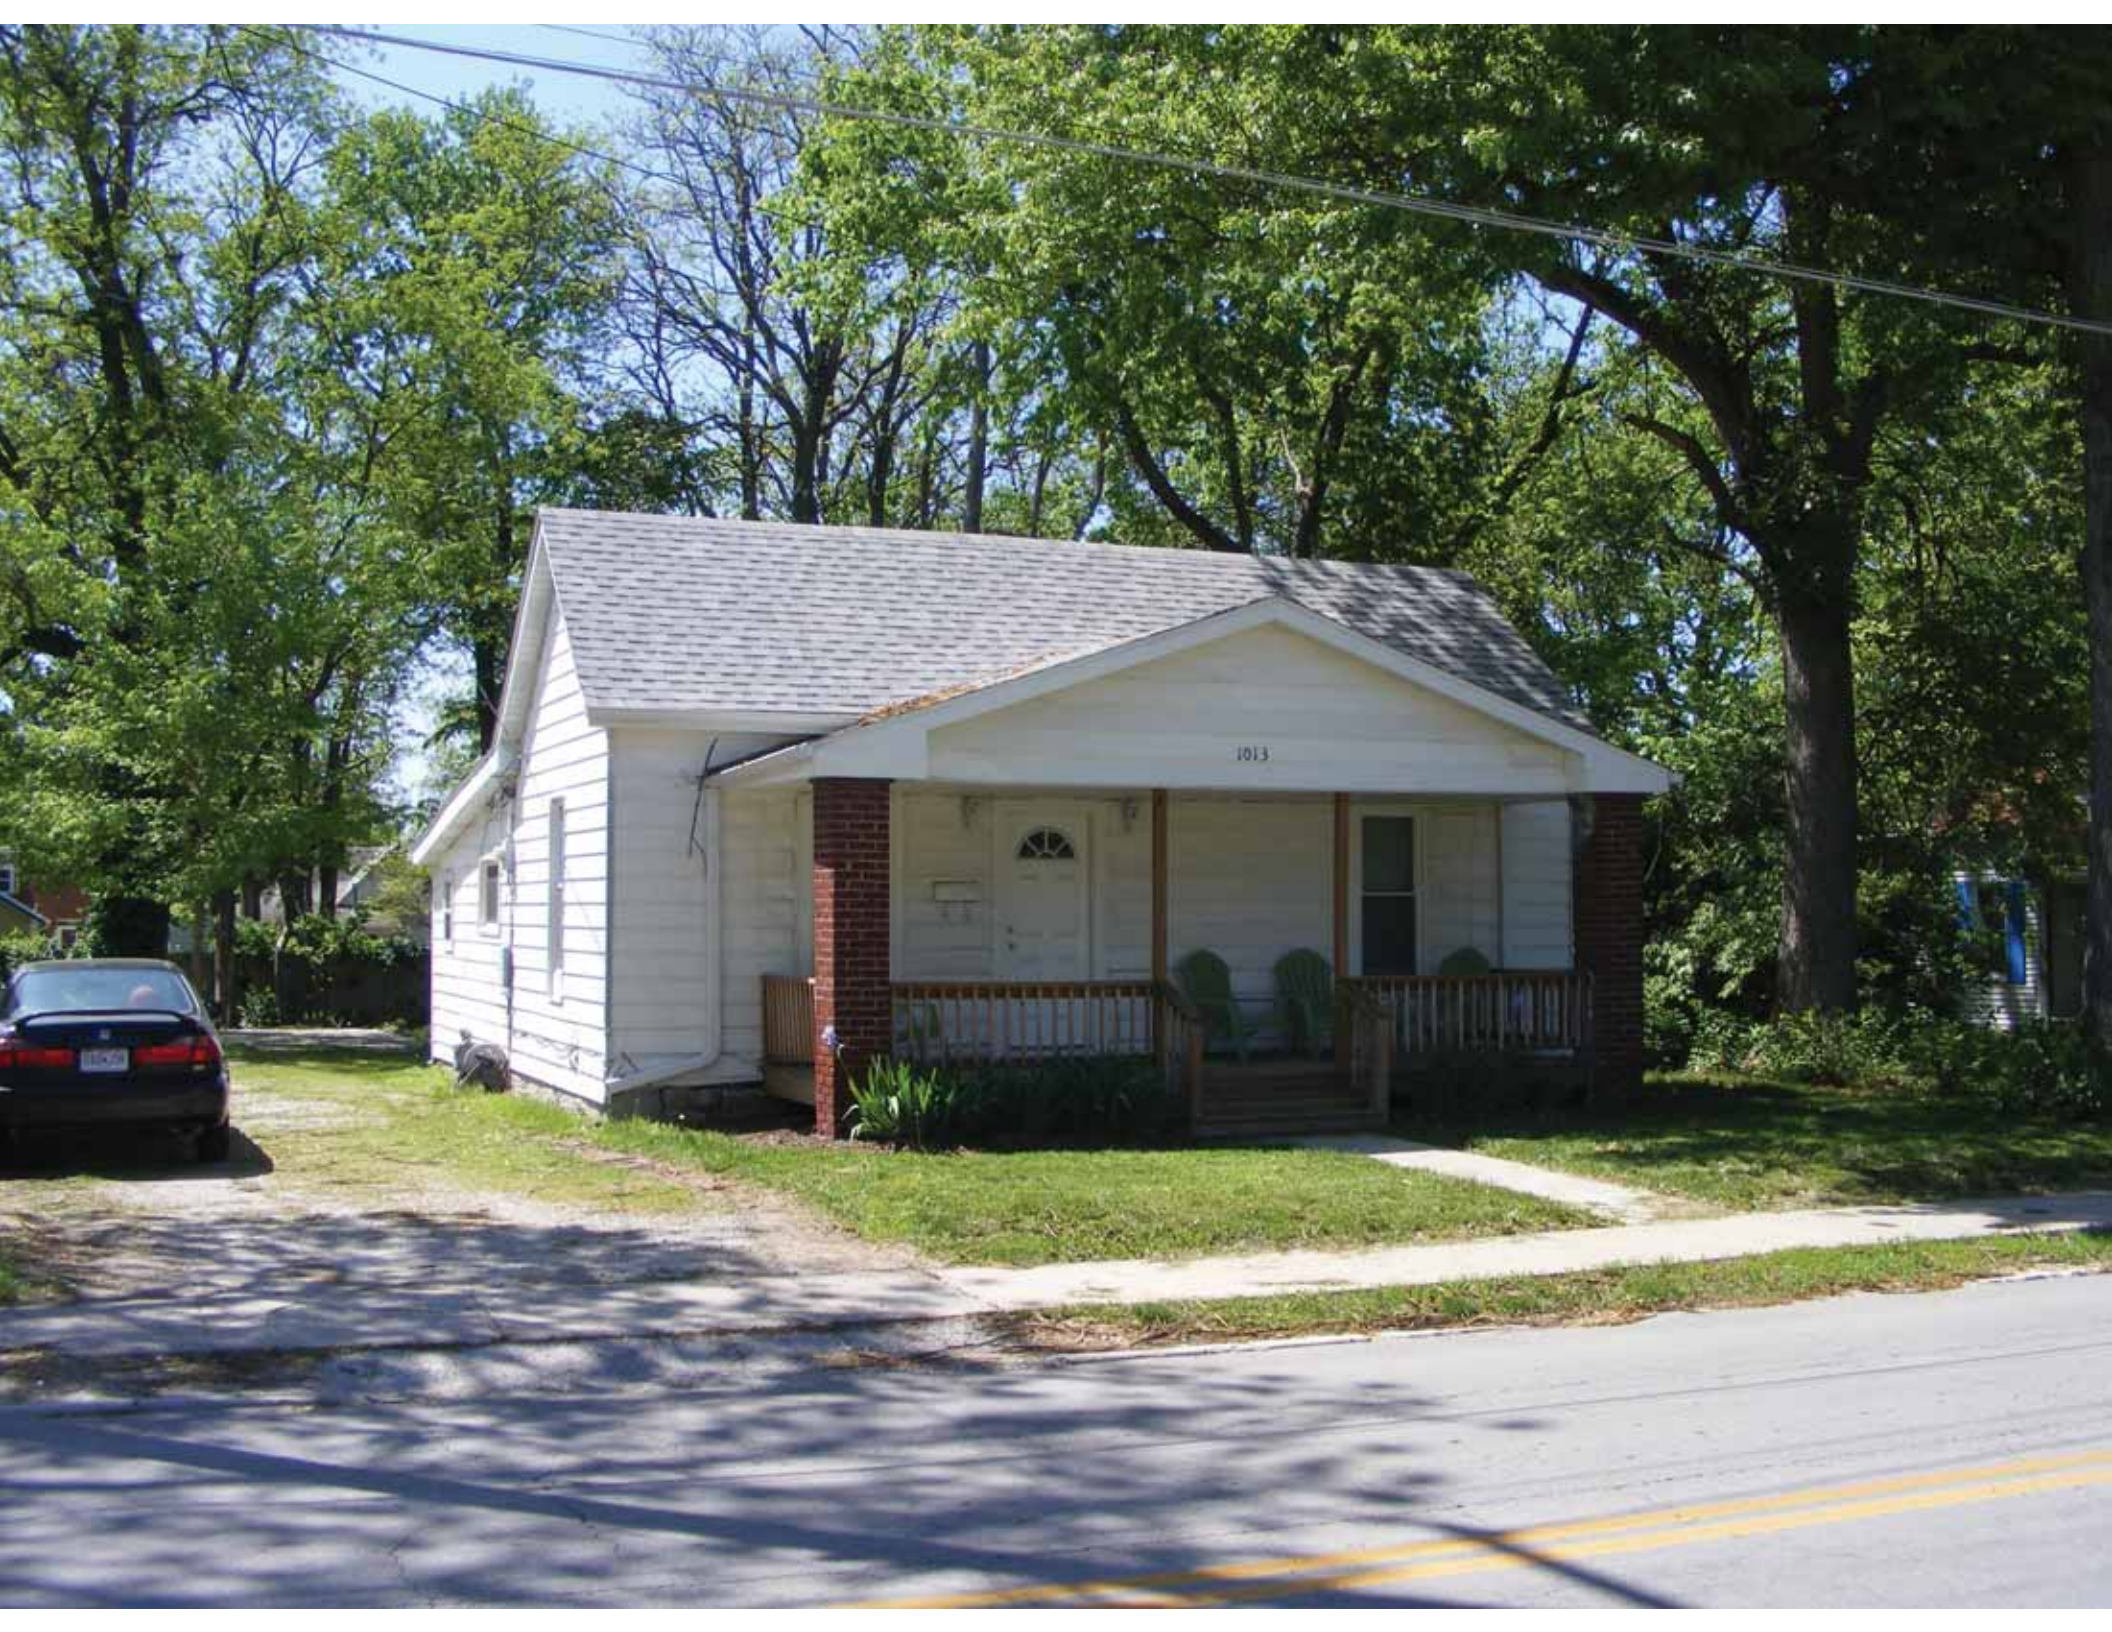
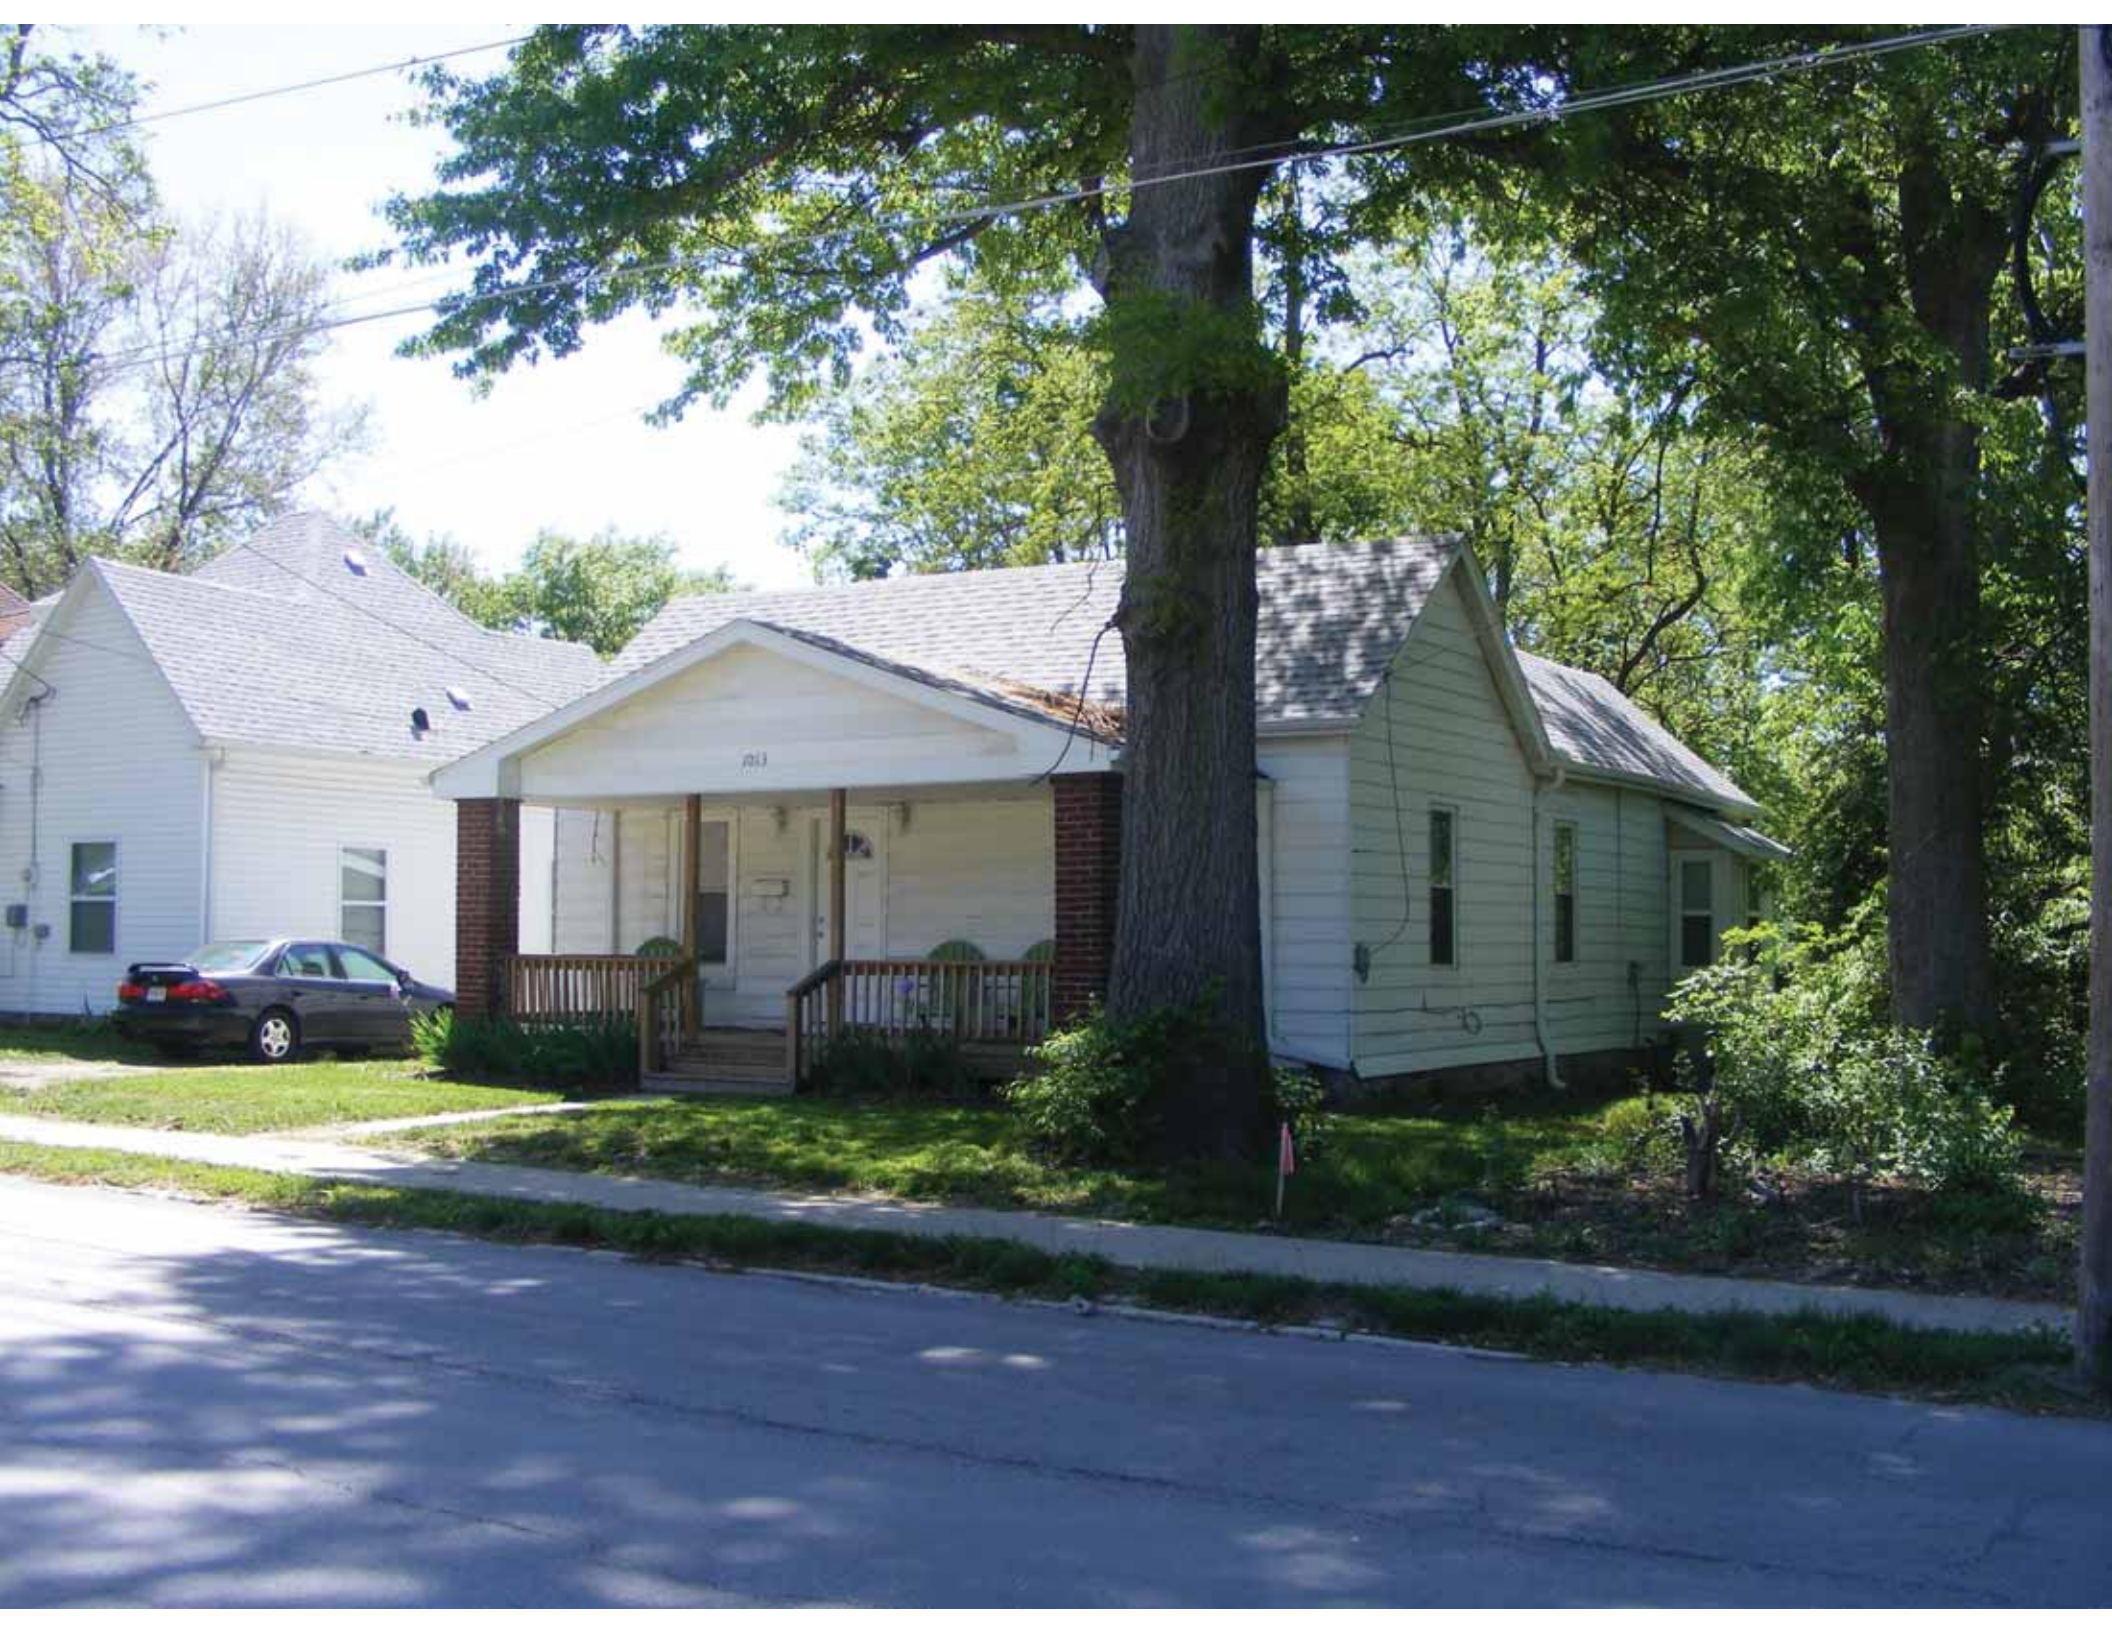
1013

The end gable plan dwelling has a rear intersecting gabled wing and shed wing at the west end of the house. The roof is clad with asphalt shingles. The exterior is clad with synthetic siding. The foundation is limestone partially covered with concrete. The primary (east) elevation supports a three-quarters width gabled porch supported by two large brick columns. A c. 1995 balustrade surrounds the porch. Two square wood columns flank the balustrade at the steps. Within the porch bay, the entry is slightly off center and filled with a c. 1995 paneled door with a fanlight. One-over-one replacement windows are situated on either side of the door. Remaining windows are of similar configuration.
