MISSOURI DEPARTMENT OF NATURAL RESOURCES
STATE HISTORIC PRESERVATION OFFICE, P.O. Box 176, Jefferson City, MO 65102
ARCHITECTURAL/HISTORIC INVENTORY FORM

1. Survey No. BO-AS-011-0087		2. Survey name: North Central Columbia Survey Phase II	
3. County: Boone		4. Address (Street No.) 902	Street (name) N. Seventh Street
5. City: Columbia	Vicinity: <input type="checkbox"/>	6. Geographical Reference:	7. Township/Range/Section: T: R: S:
8. Historic name (if known):		9. Present/other name (if known):	
10. Ownership: <input checked="" type="checkbox"/> Private <input type="checkbox"/> Public		11a. Historic use (if known): Domestic/single dwelling	11b. Current use: Domestic/single dwelling

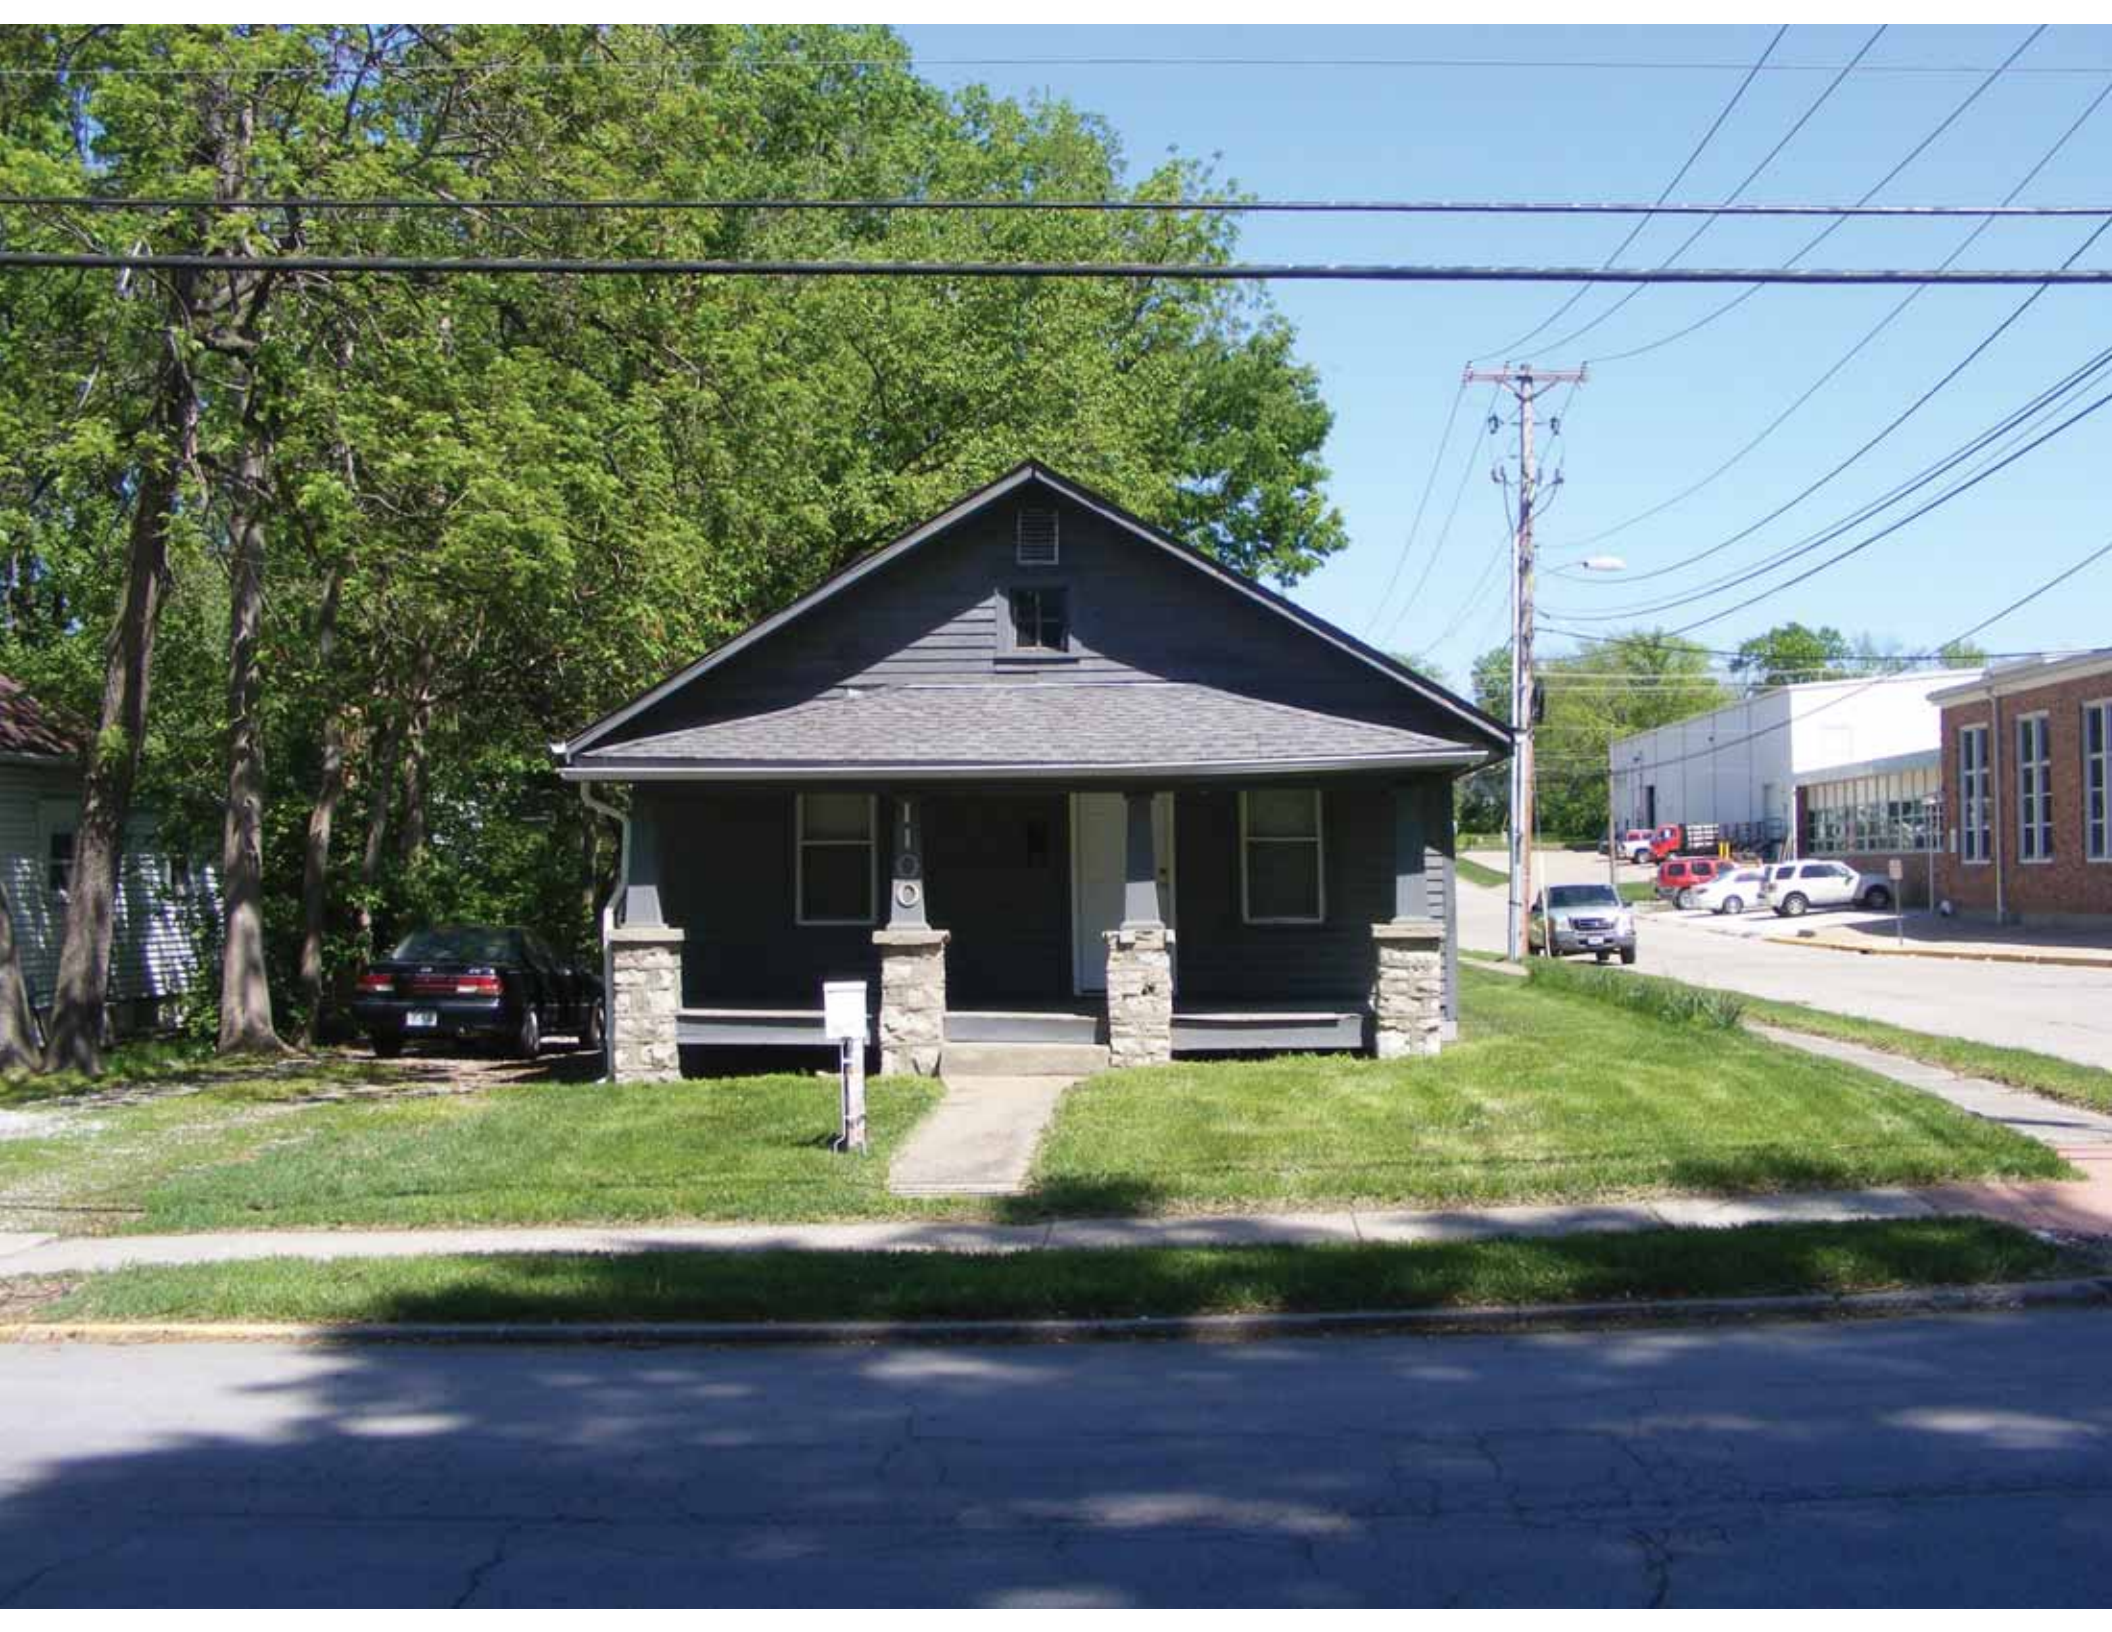
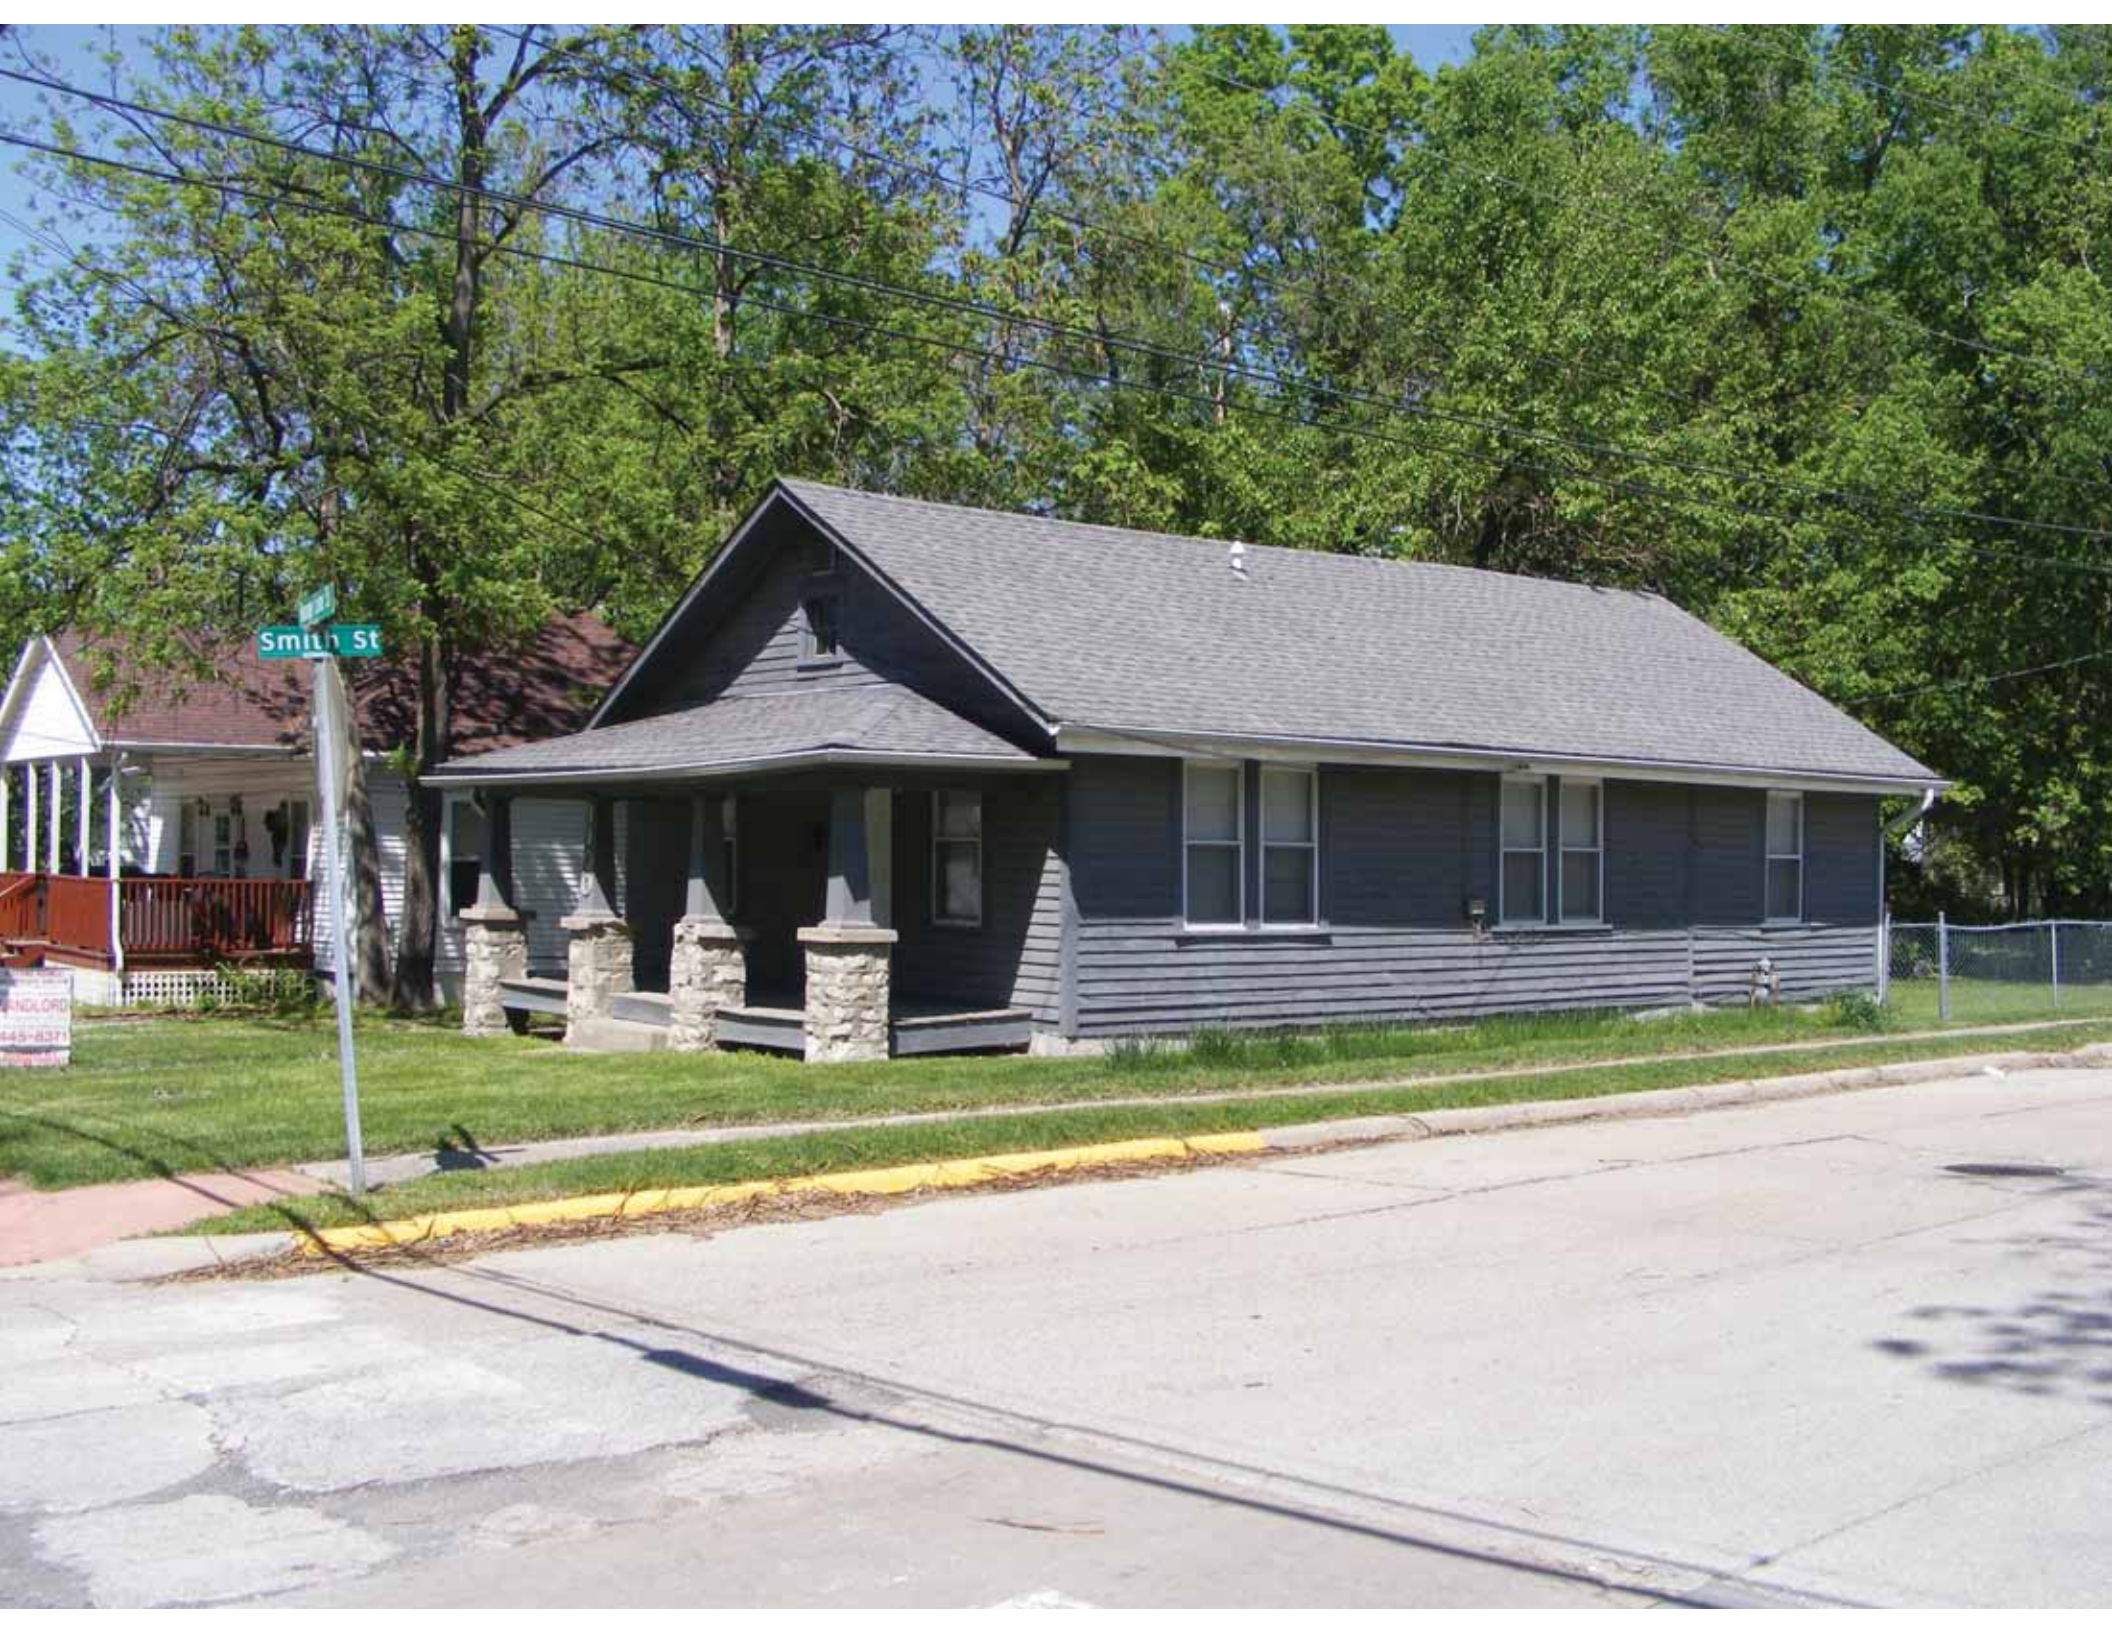
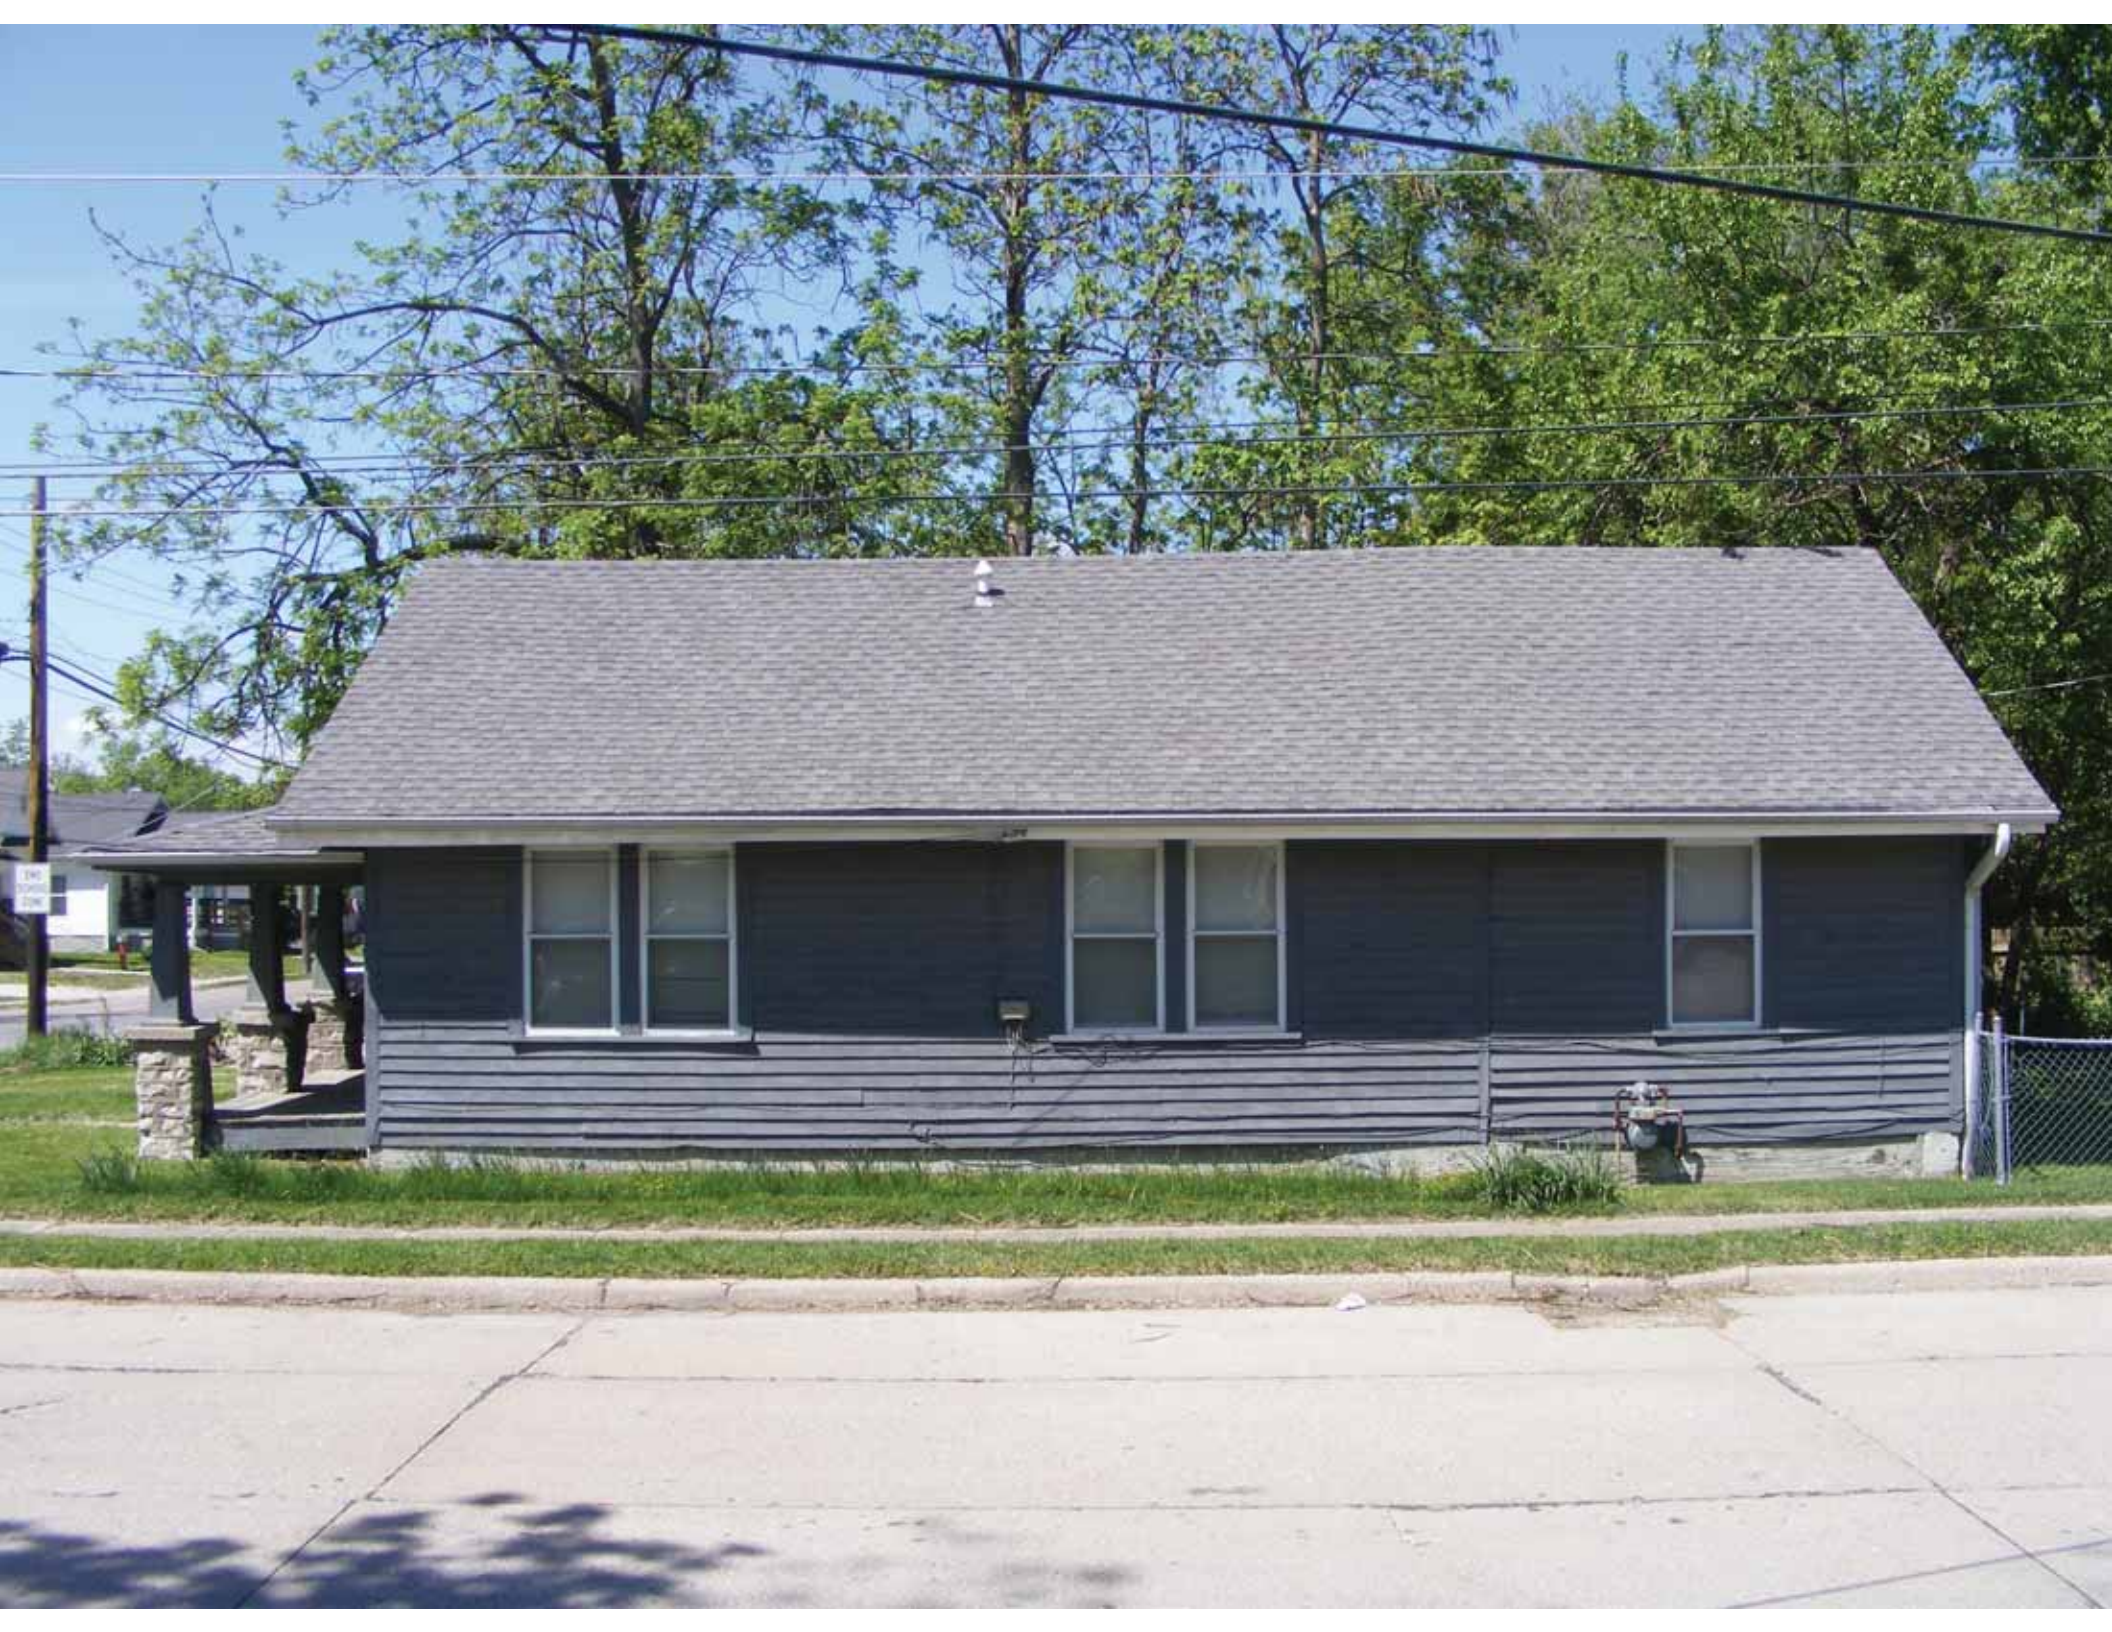
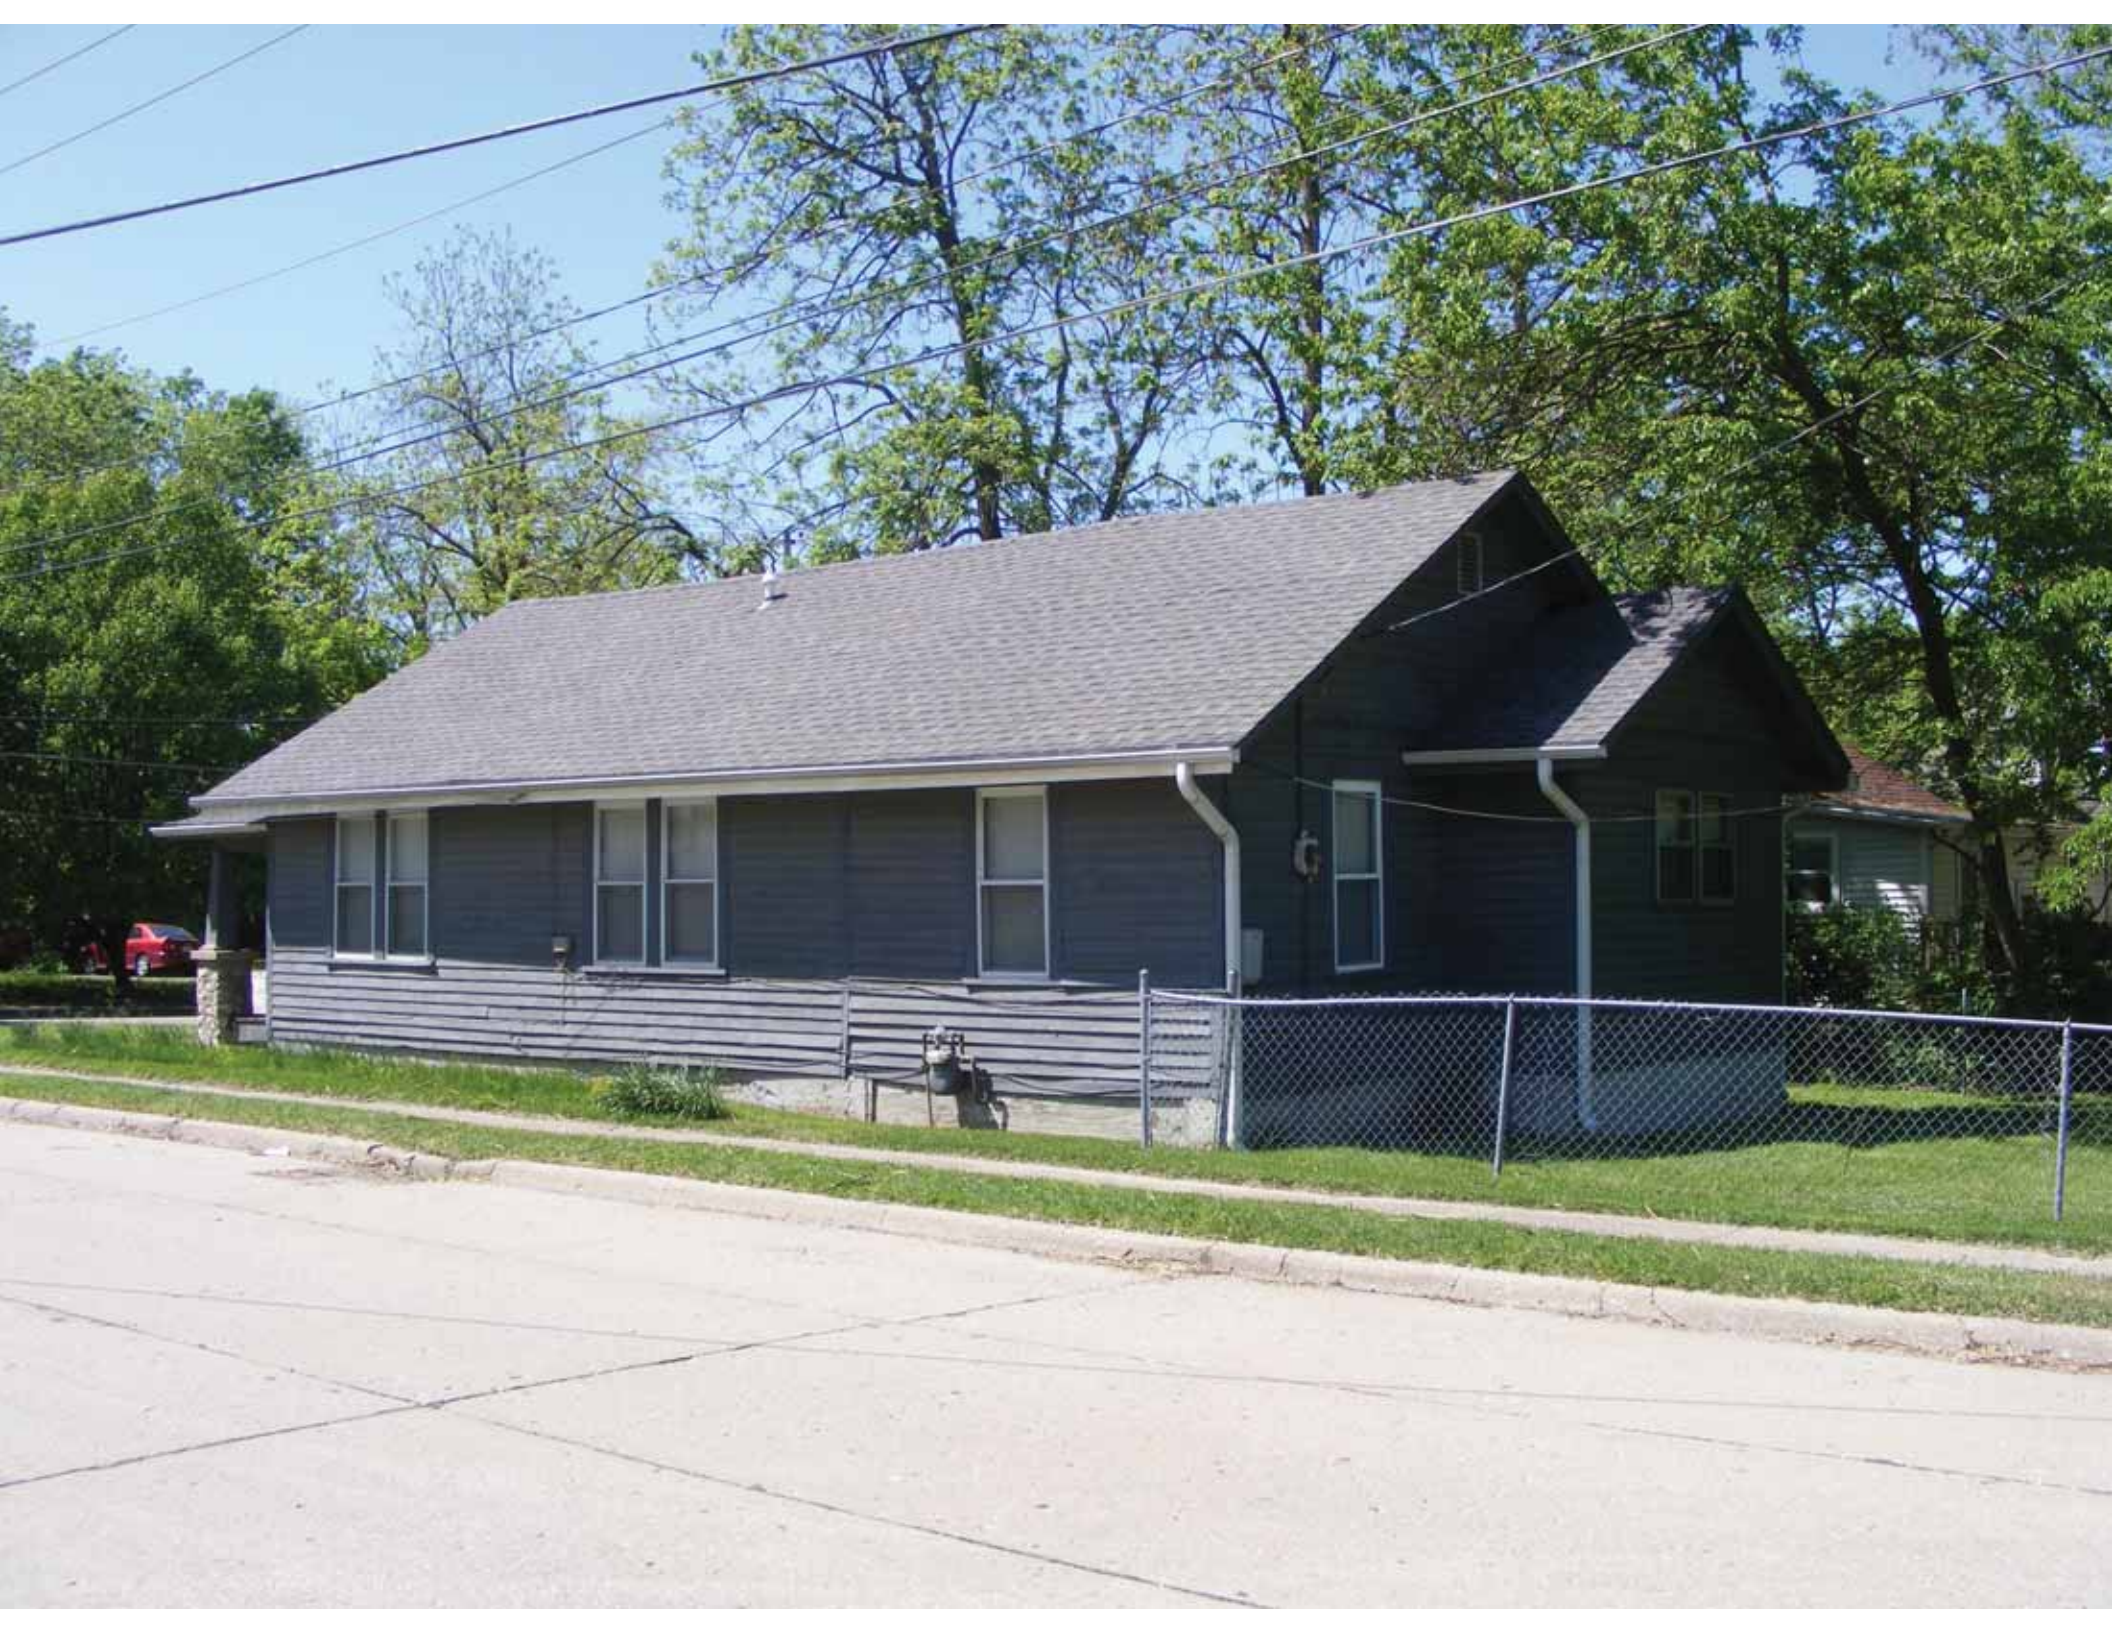
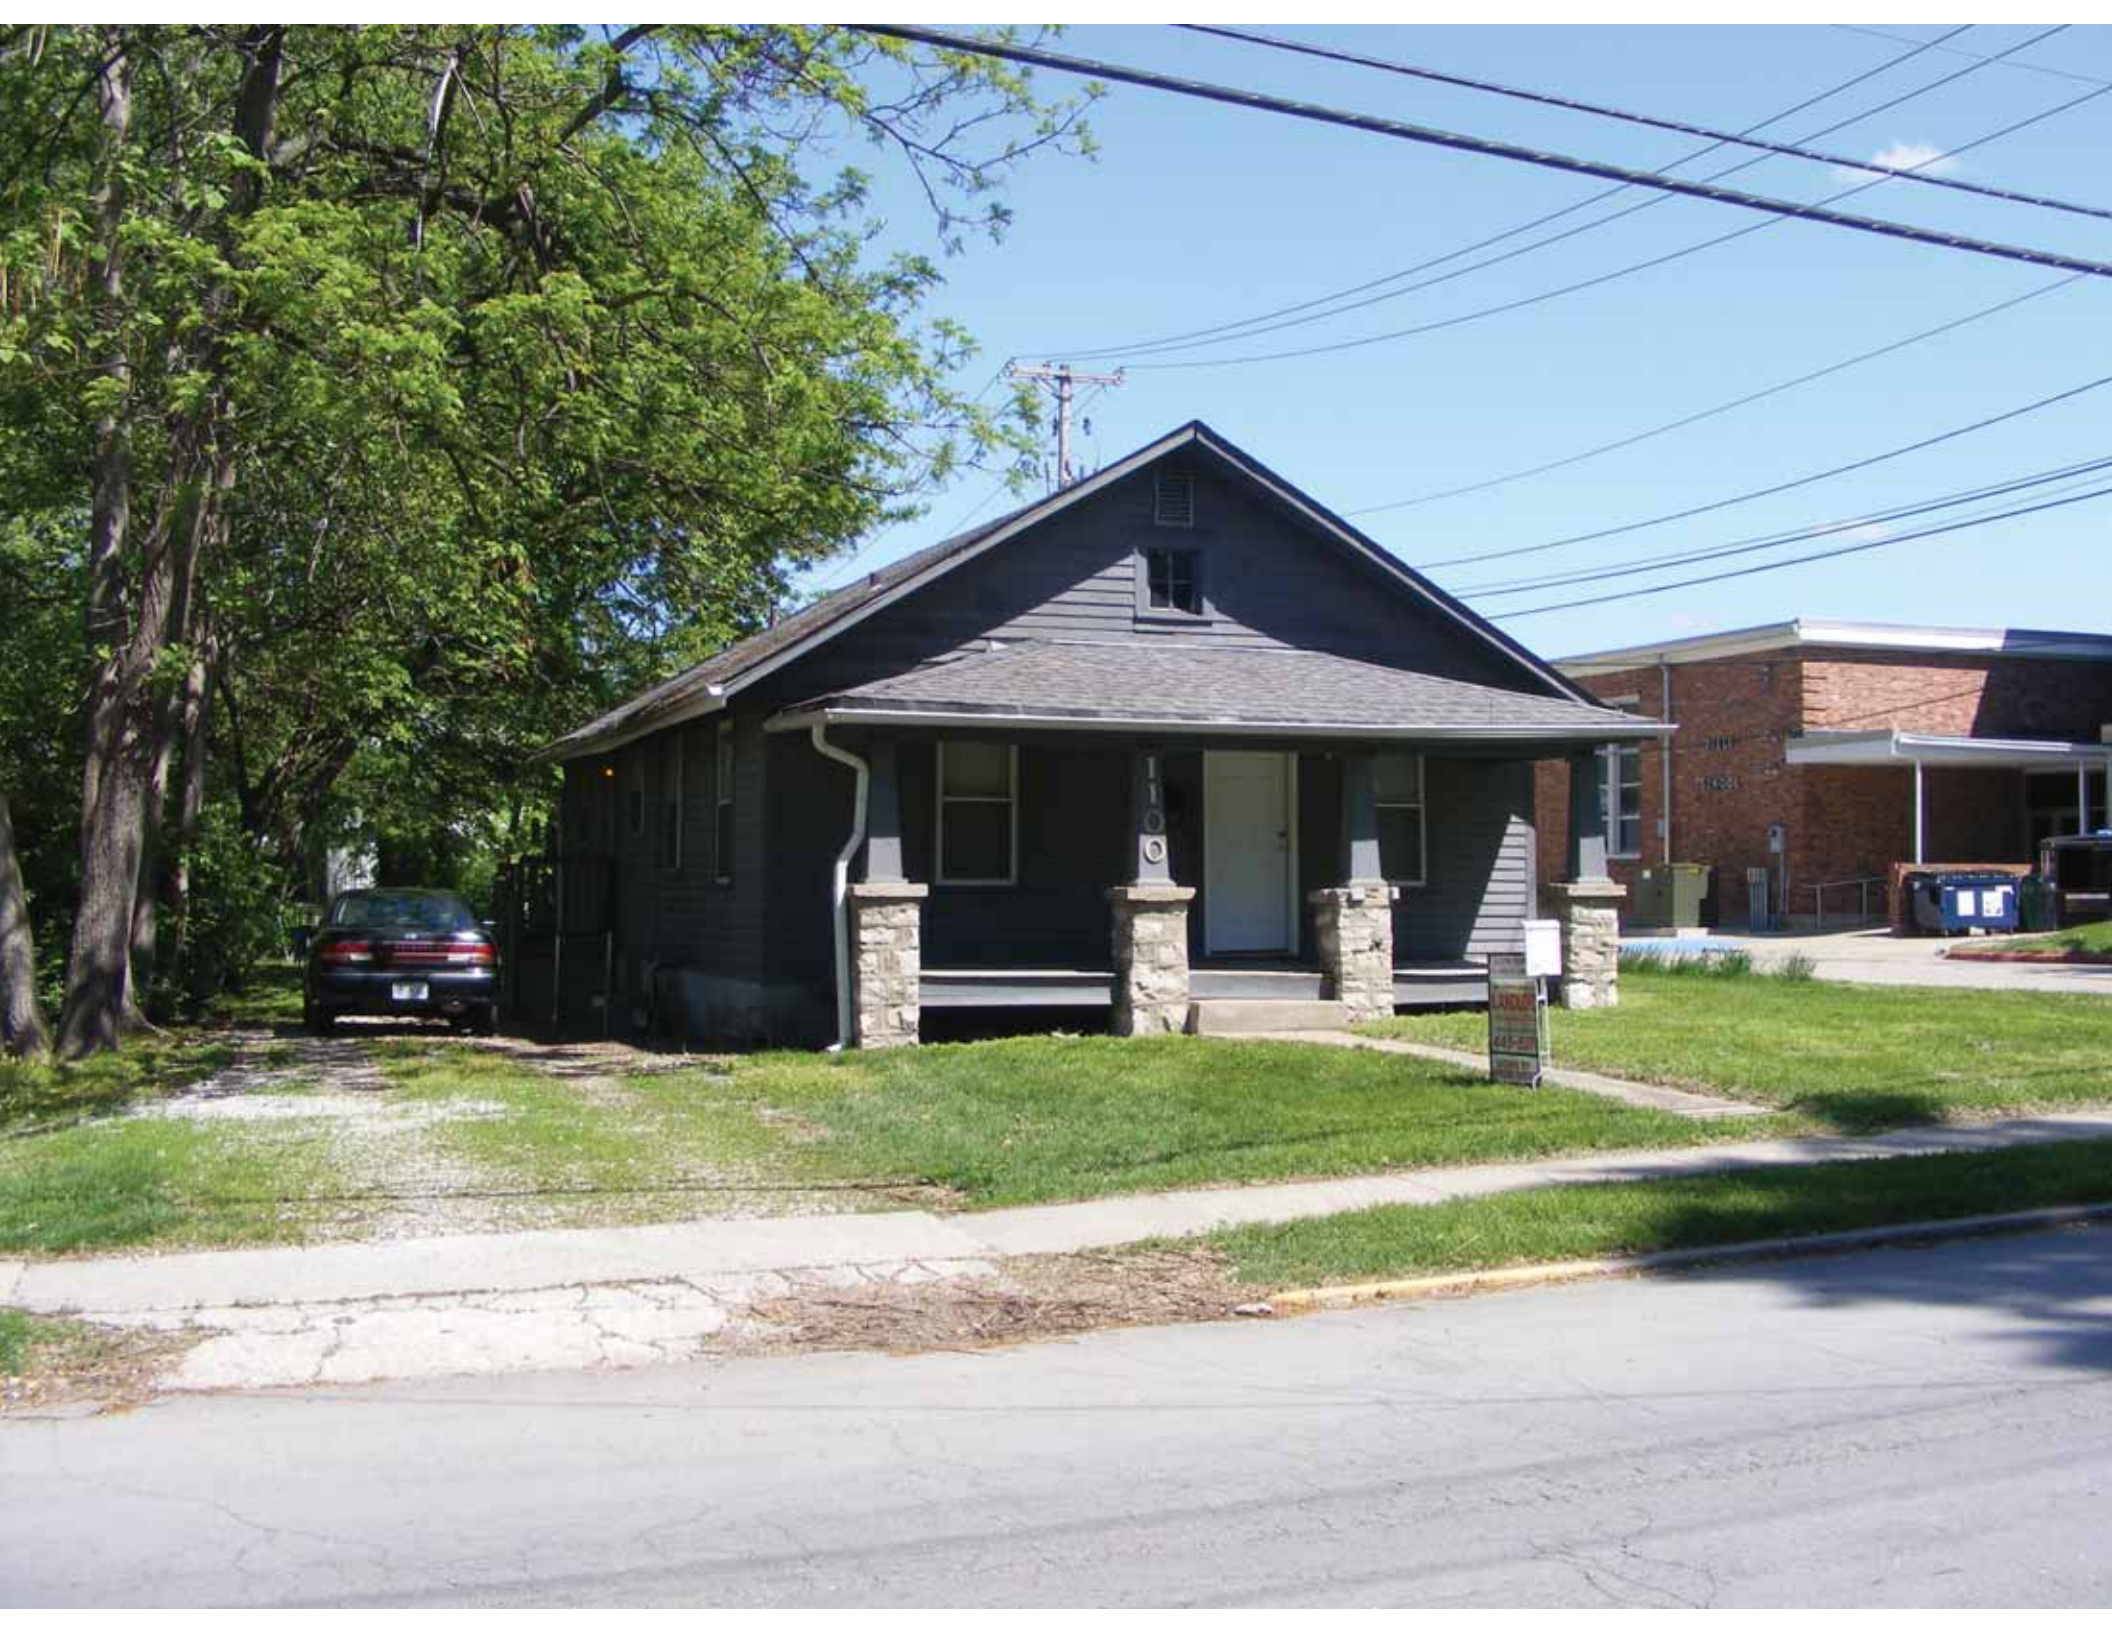
40. (cont.) Description of environment and outbuildings. Expand box as necessary, or add continuation pages.
The property is located on the northeast corner of Range Line Street and Smith Street. The dwelling is situated on the western portion of the property on a grass covered residential lot in an urban setting. A concrete public sidewalk runs adjacent to the western and southern edges of the property. The property has mature trees located in the eastern portion of the property. A chain link fence runs along the south east edge of the property. A gravel driveway is present on the north side of the dwelling.

41. (cont.) Description of primary resource. Expand box as necessary, or add continuation pages.
A wood sided one-story dwelling with an asphalt shingled front gable and a concrete foundation. The façade holds a hipped full-width porch supported by tapered wood columns on stone block piers. Porch is open with wood decking. Entrance is off-centered flanked by one-over-one windows. The gable end holds a four light fixed window and a vent. Side elevations hold one-over-one windows. The rear elevation features a small projecting gable wing with paired one-over-one windows offset to left by a one-over-one window.
