MISSOURI DEPARTMENT OF NATURAL RESOURCES
STATE HISTORIC PRESERVATION OFFICE, P.O. Box 176, Jefferson City, MO 65102
ARCHITECTURAL/HISTORIC INVENTORY FORM

1. Survey No. BO-AS-011-0087		2. Survey name: North Central Columbia Survey Phase II	
3. County: Boone		4. Address (Street No.) 902	Street (name) N. Seventh Street
5. City: Columbia	Vicinity: <input type="checkbox"/>	6. Geographical Reference:	7. Township/Range/Section: T: R: S:
8. Historic name (if known):		9. Present/other name (if known):	
10. Ownership: <input checked="" type="checkbox"/> Private <input type="checkbox"/> Public		11a. Historic use (if known): Domestic/single dwelling	11b. Current use: Domestic/single dwelling

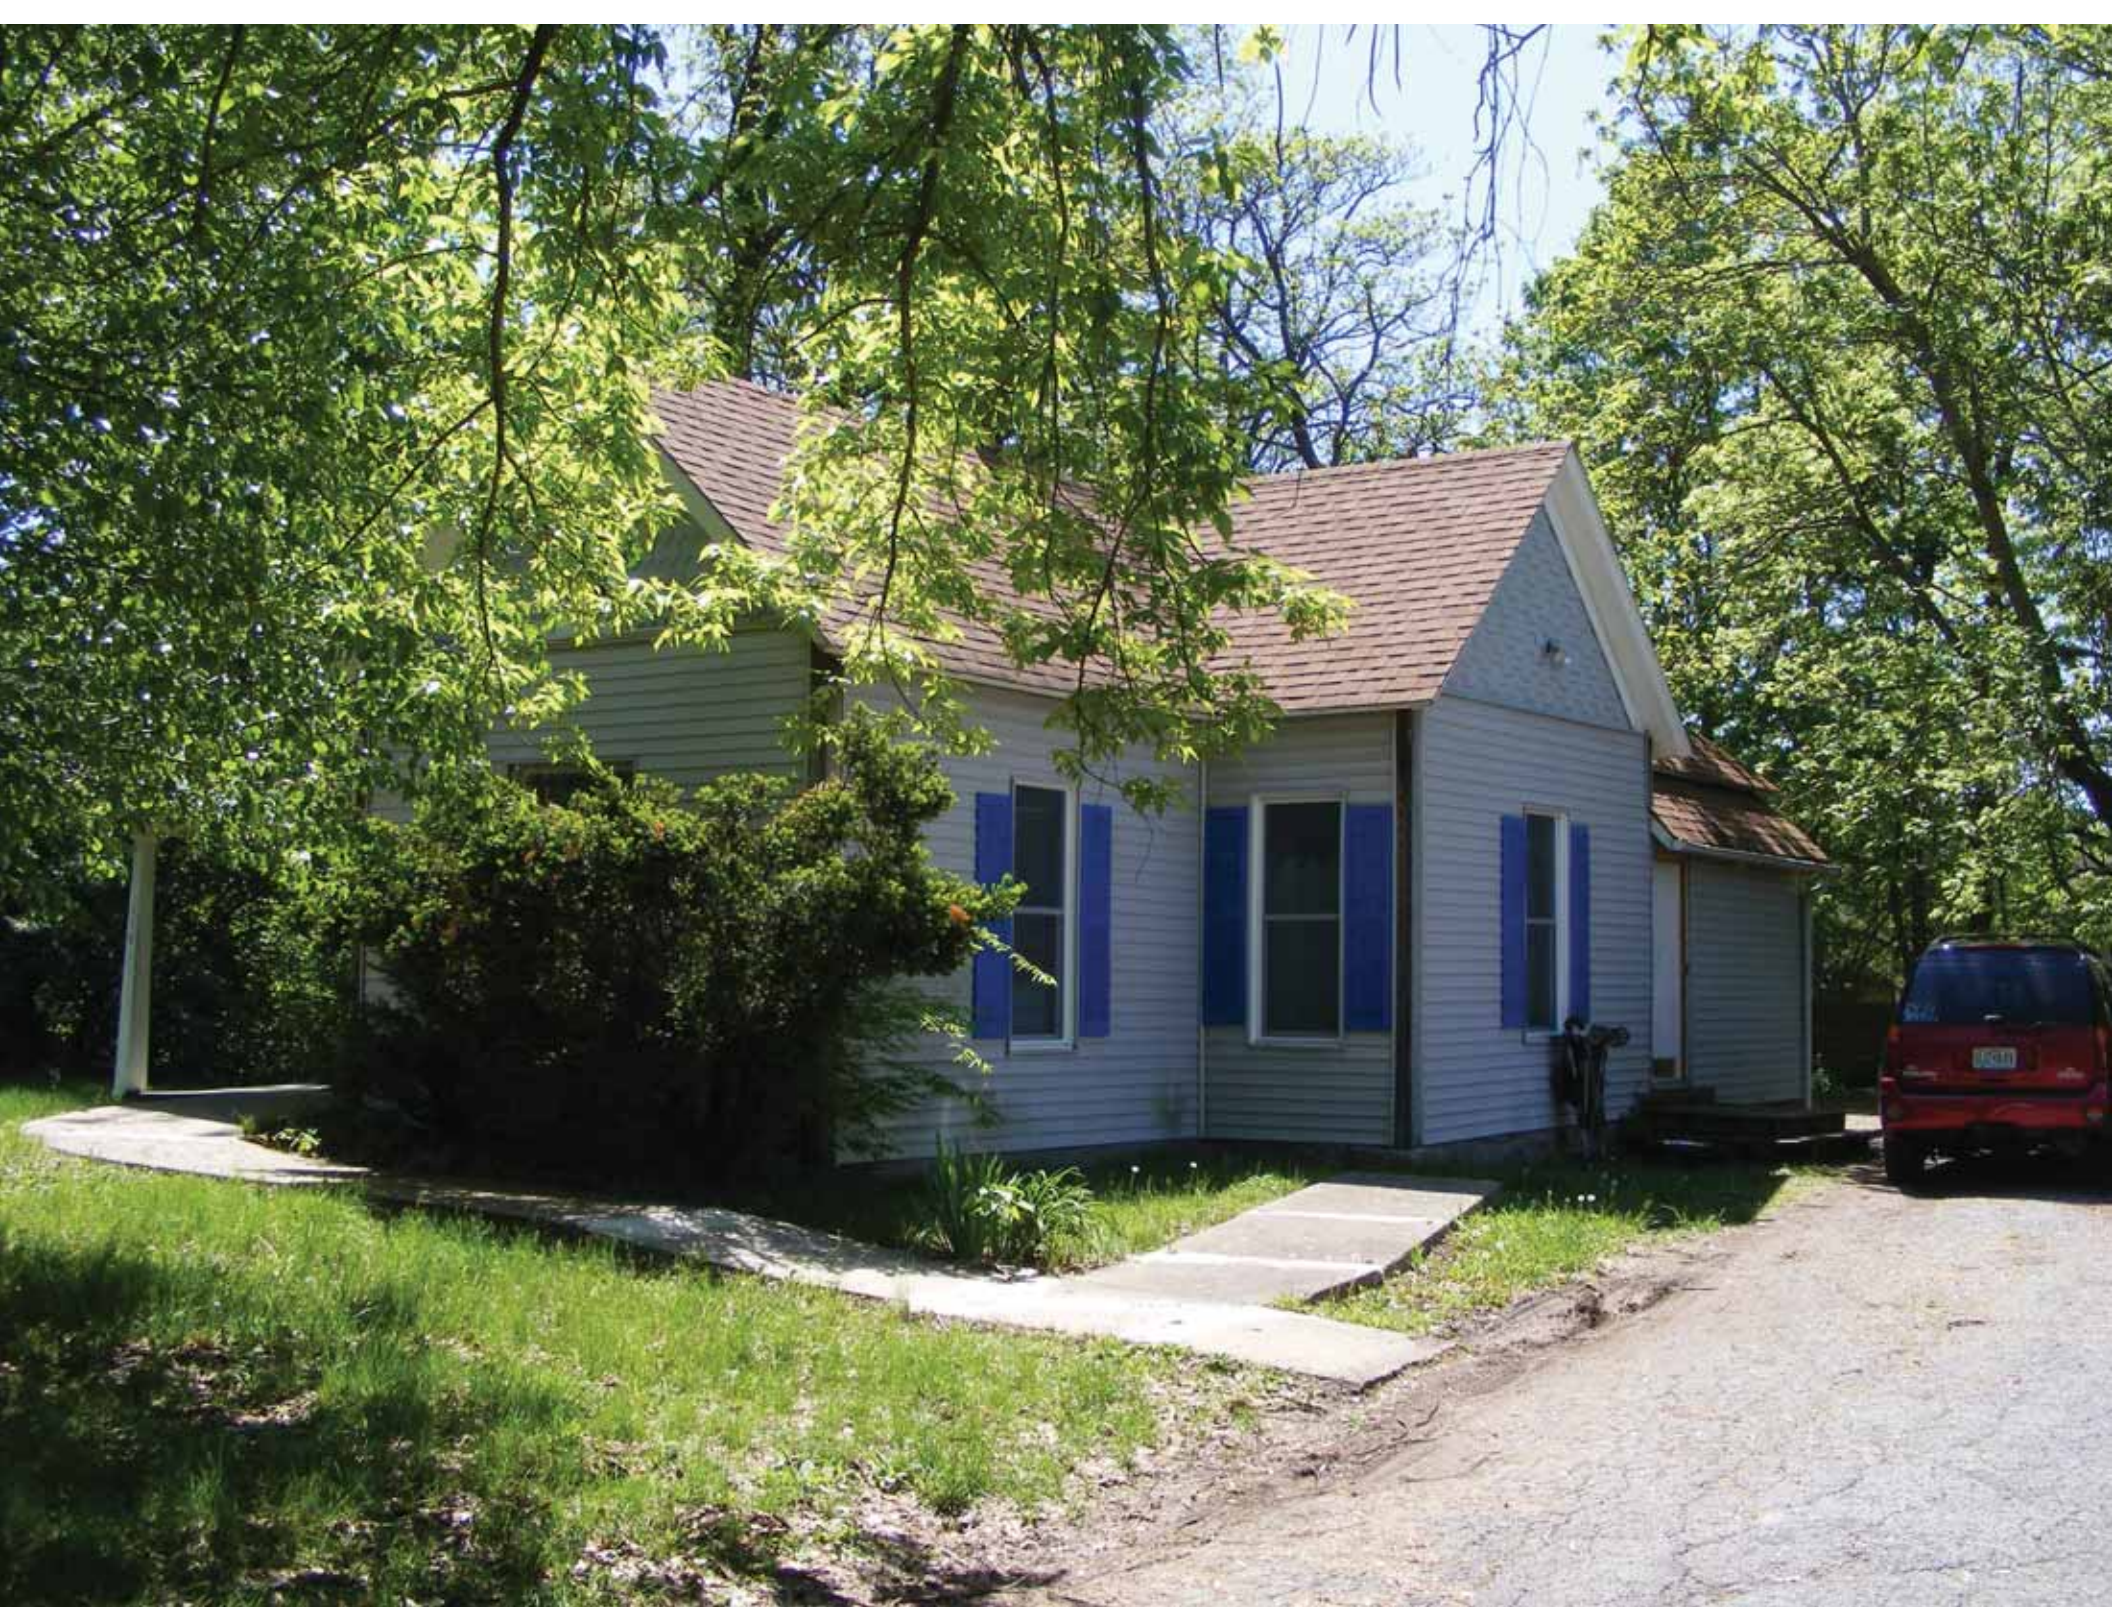
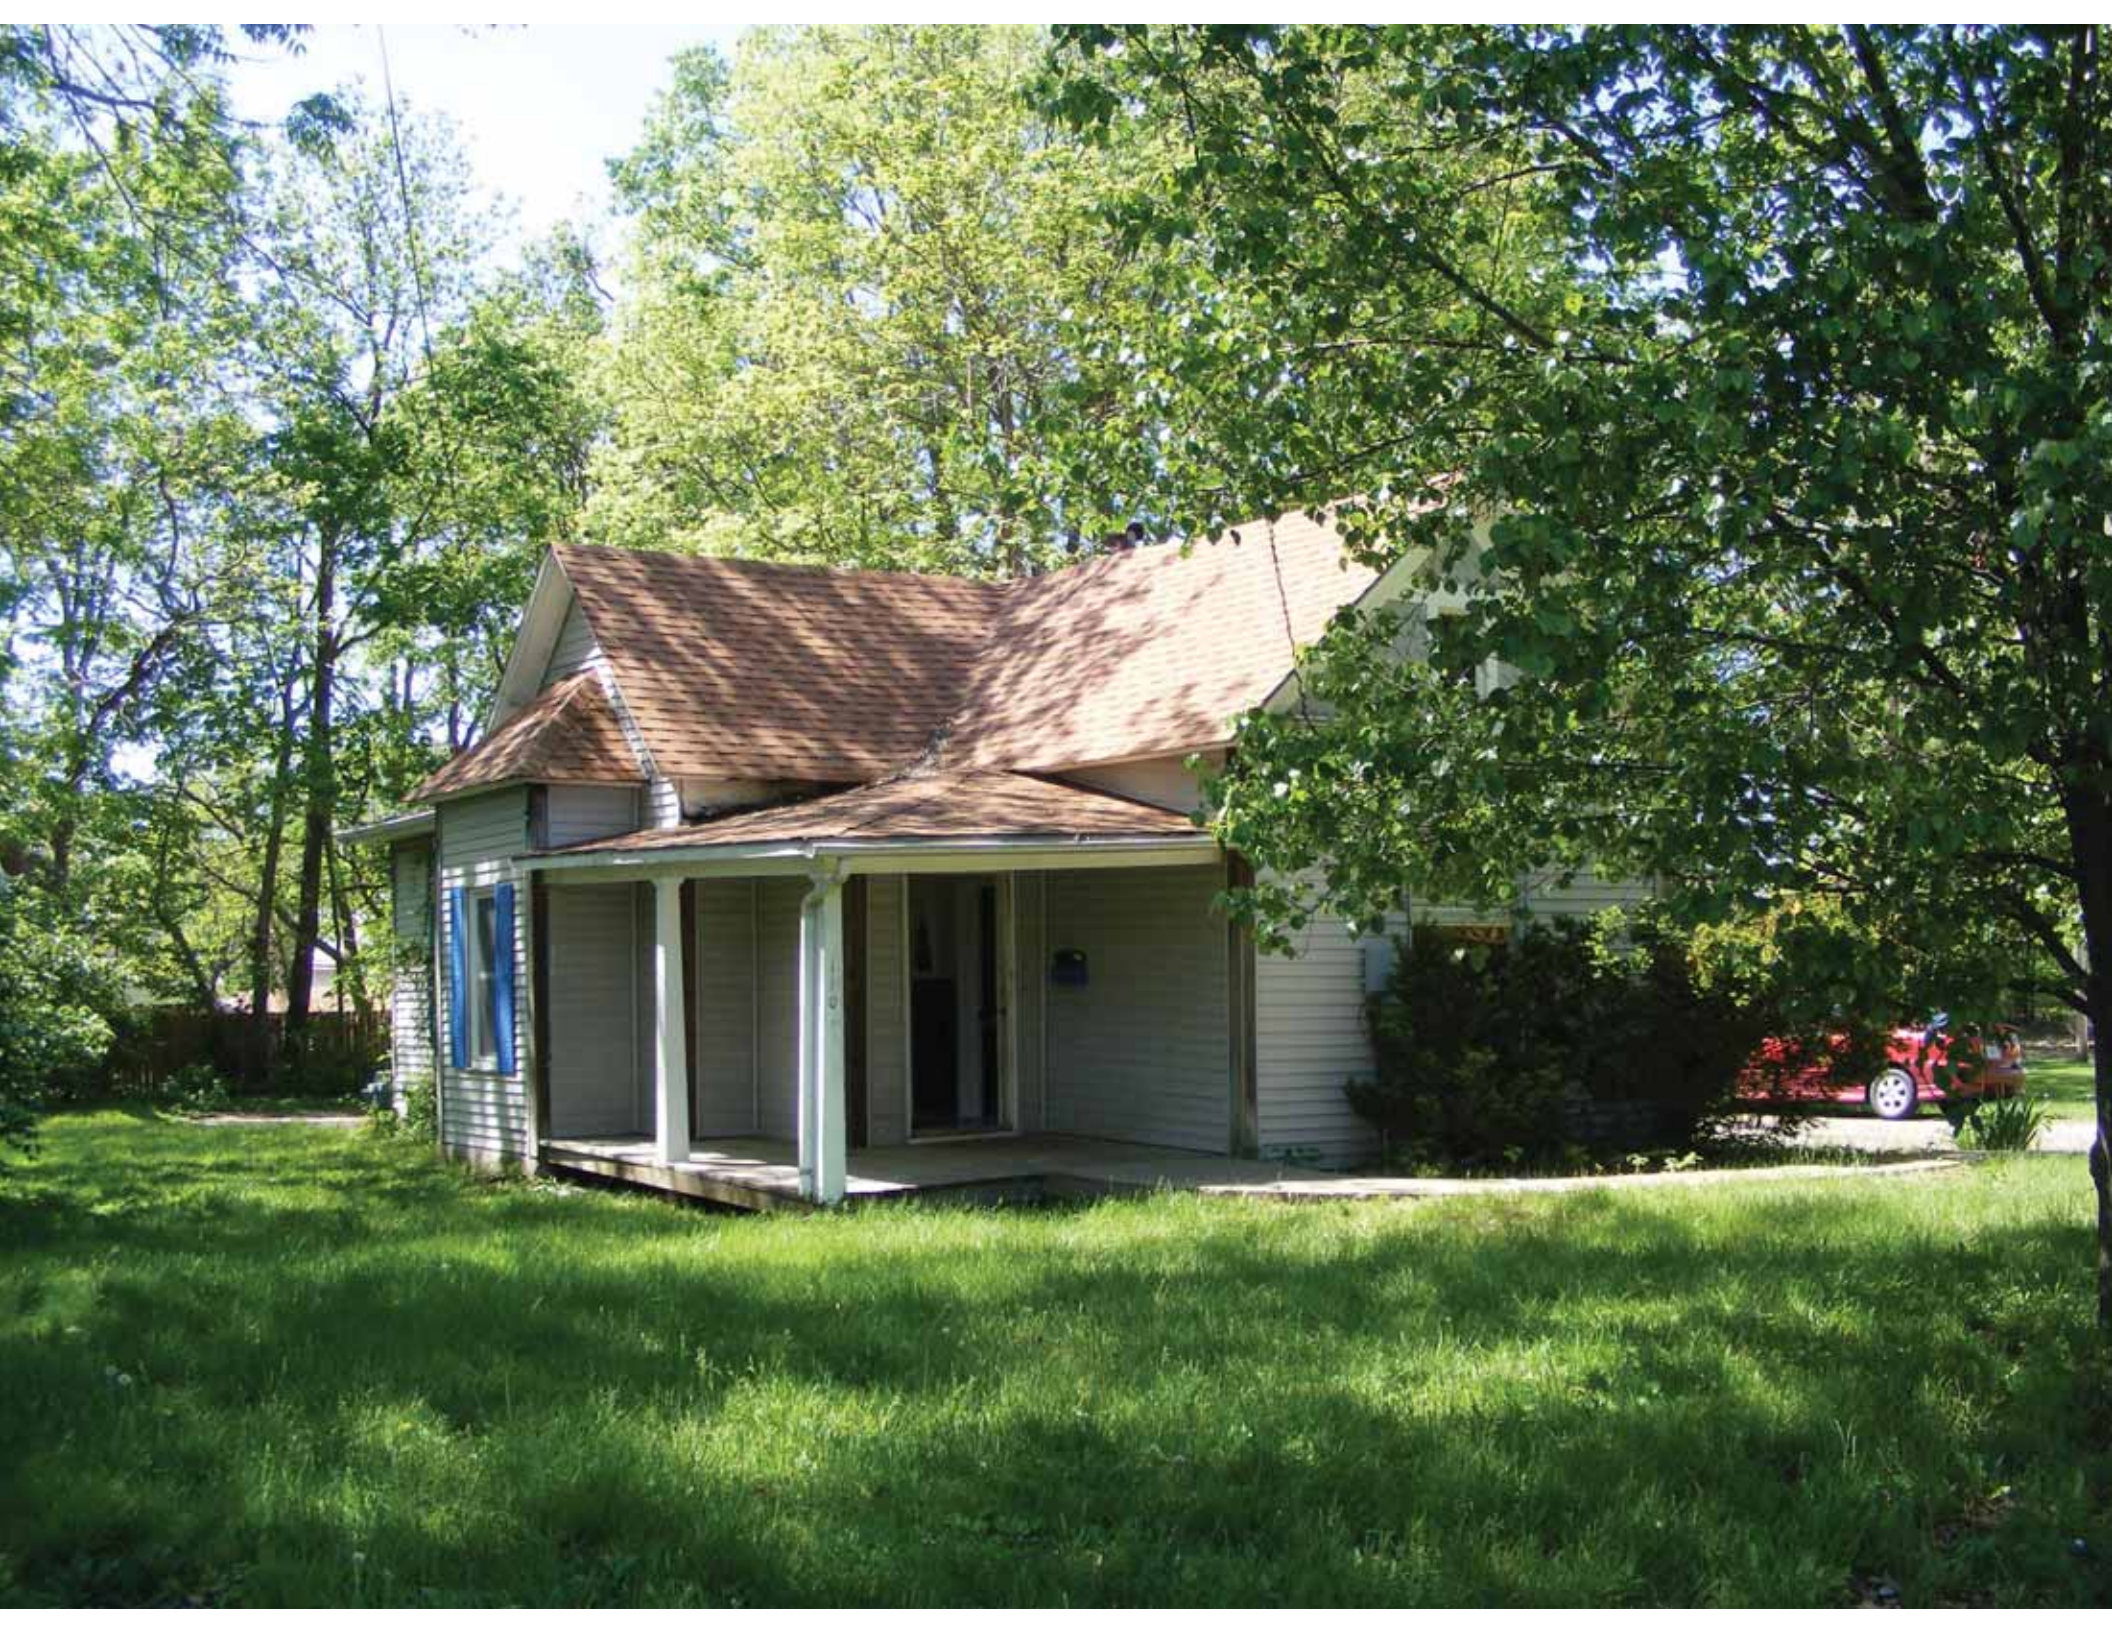
The dwelling has a cross-gabled asphalt shingled roof, exterior synthetic siding and a concrete foundation. The porch has a pier foundation. The primary (east) elevation has a front-facing gable with a wide one-over-one window with faux shutters on the first story and a smaller one-over-one window in the gable field. Windows are replacement. Offsetting the gabled wing on the south is a hipped porch supported by tapered columns. Within the porch bay is a single door facing east. The entry bay retains an original single-light wood paneled door. A projecting hipped window bay extends at the south elevation, supporting a one-over-one window with faux shutters. The north elevation has a cross-gabled wing with a one-over-one window on each of the exposed walls (east, north, and west). Gable fields are filled with square butt wood shingle siding.

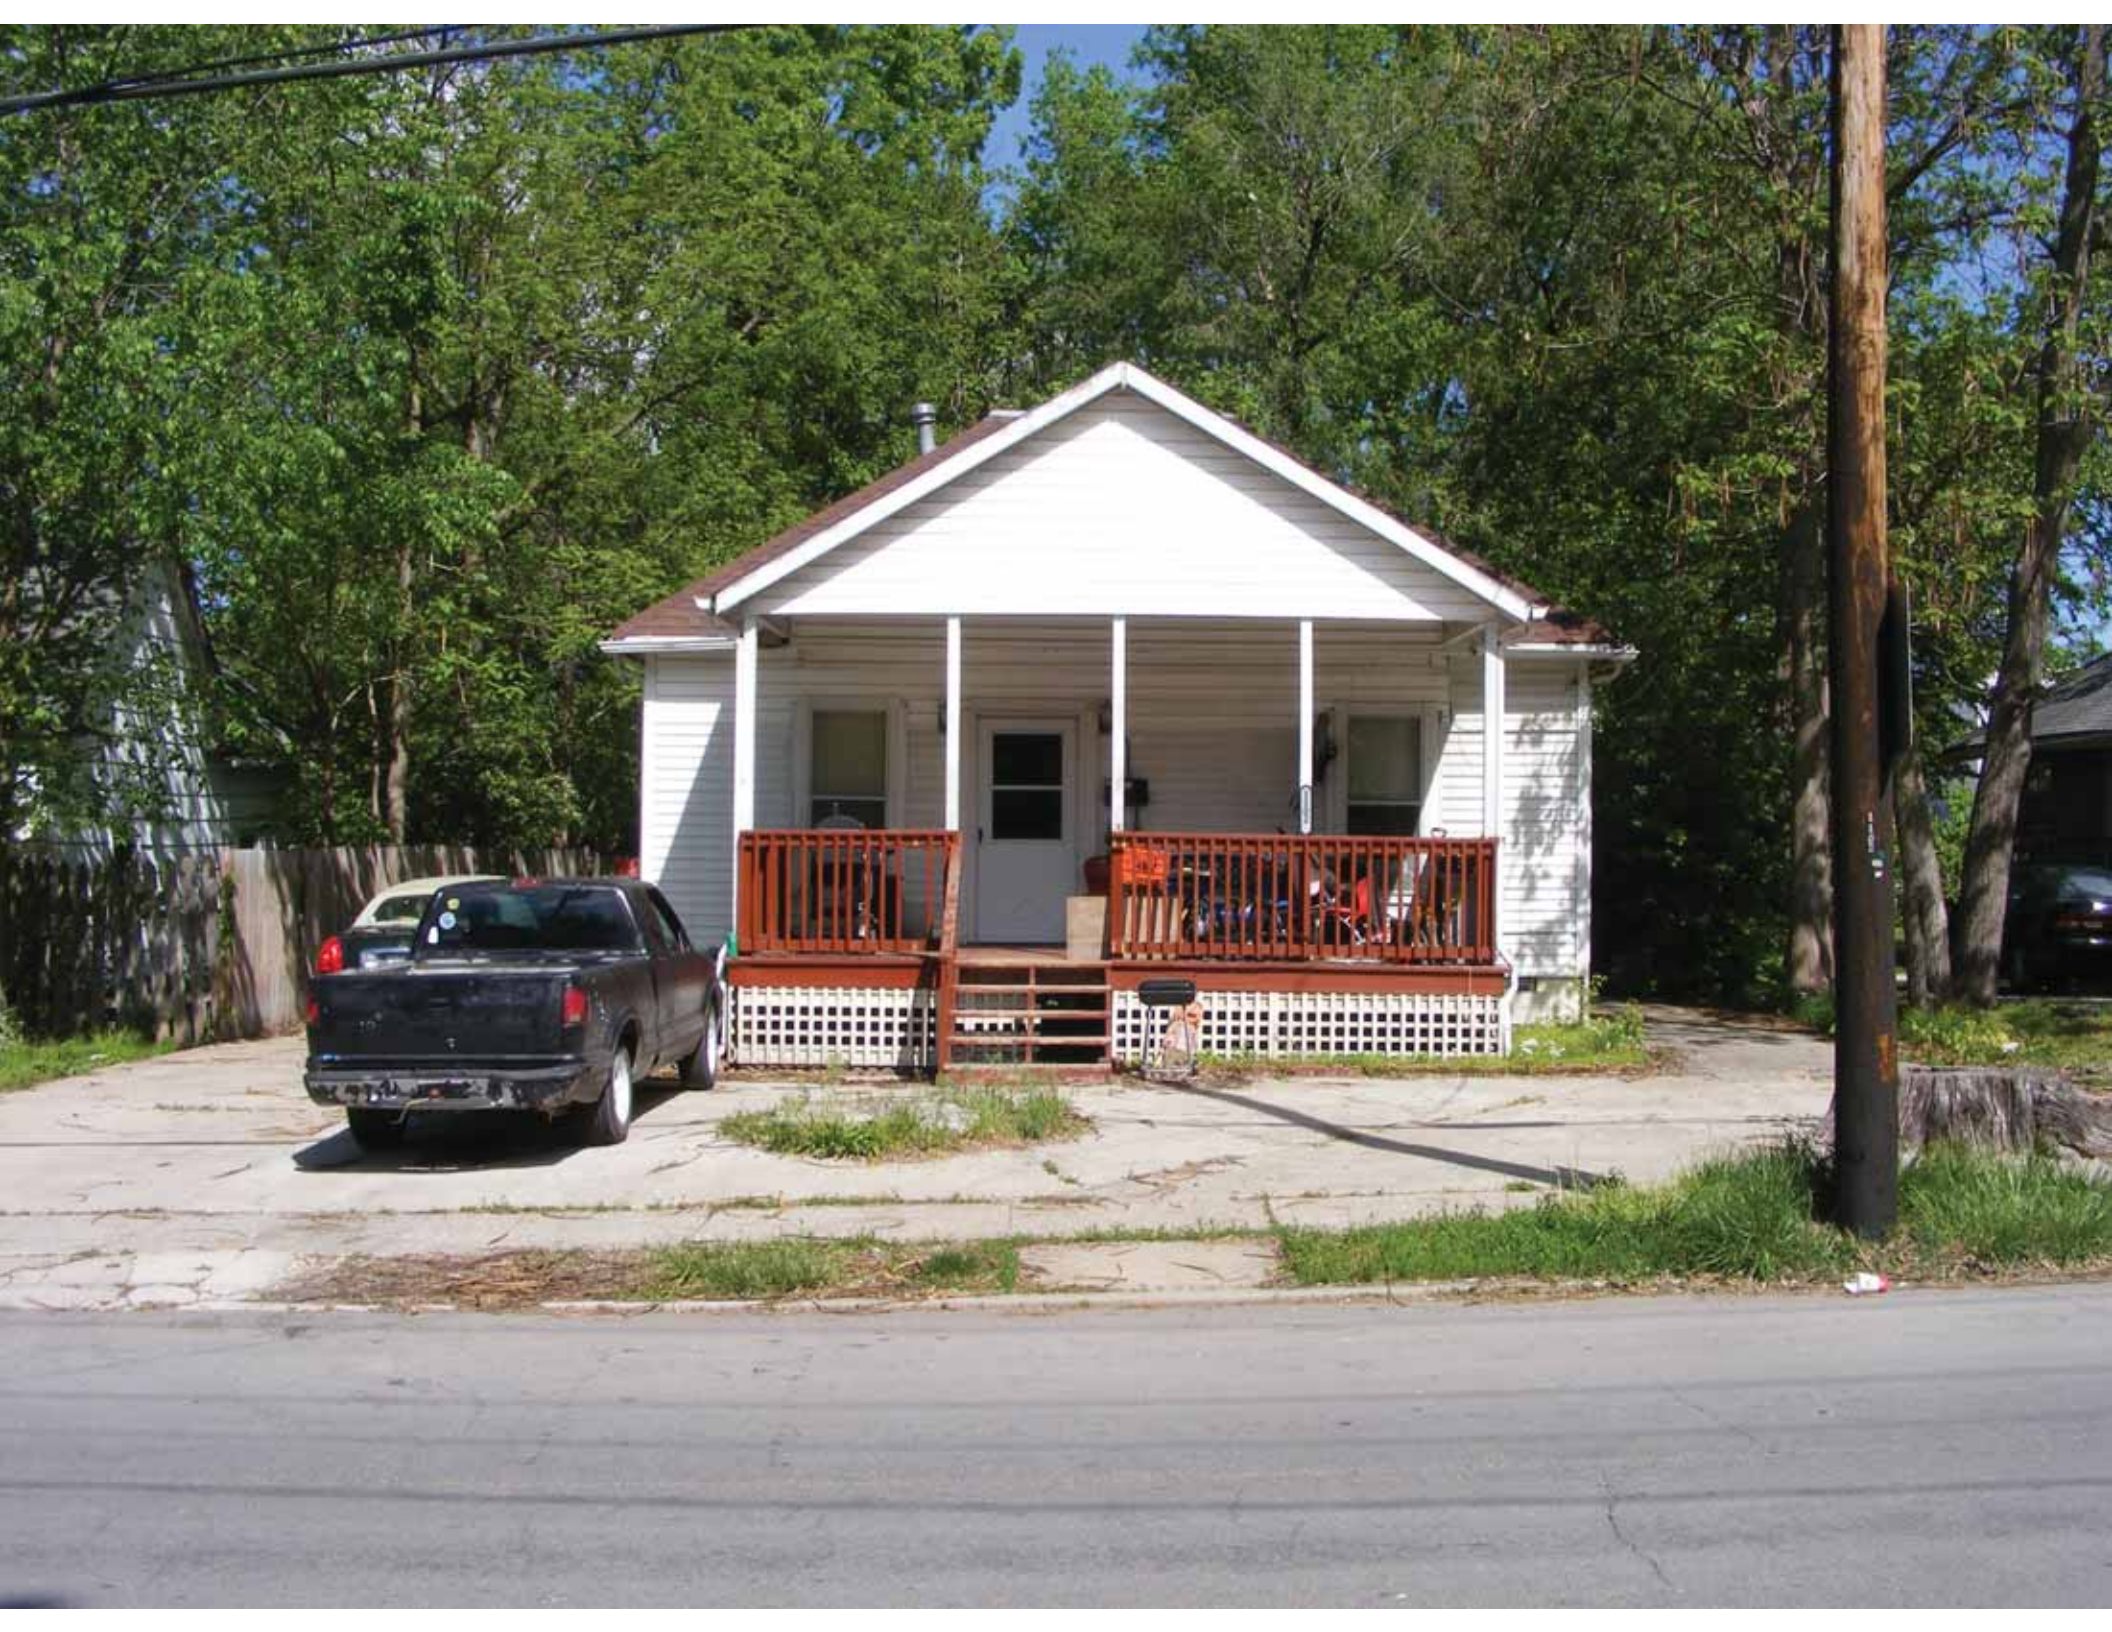
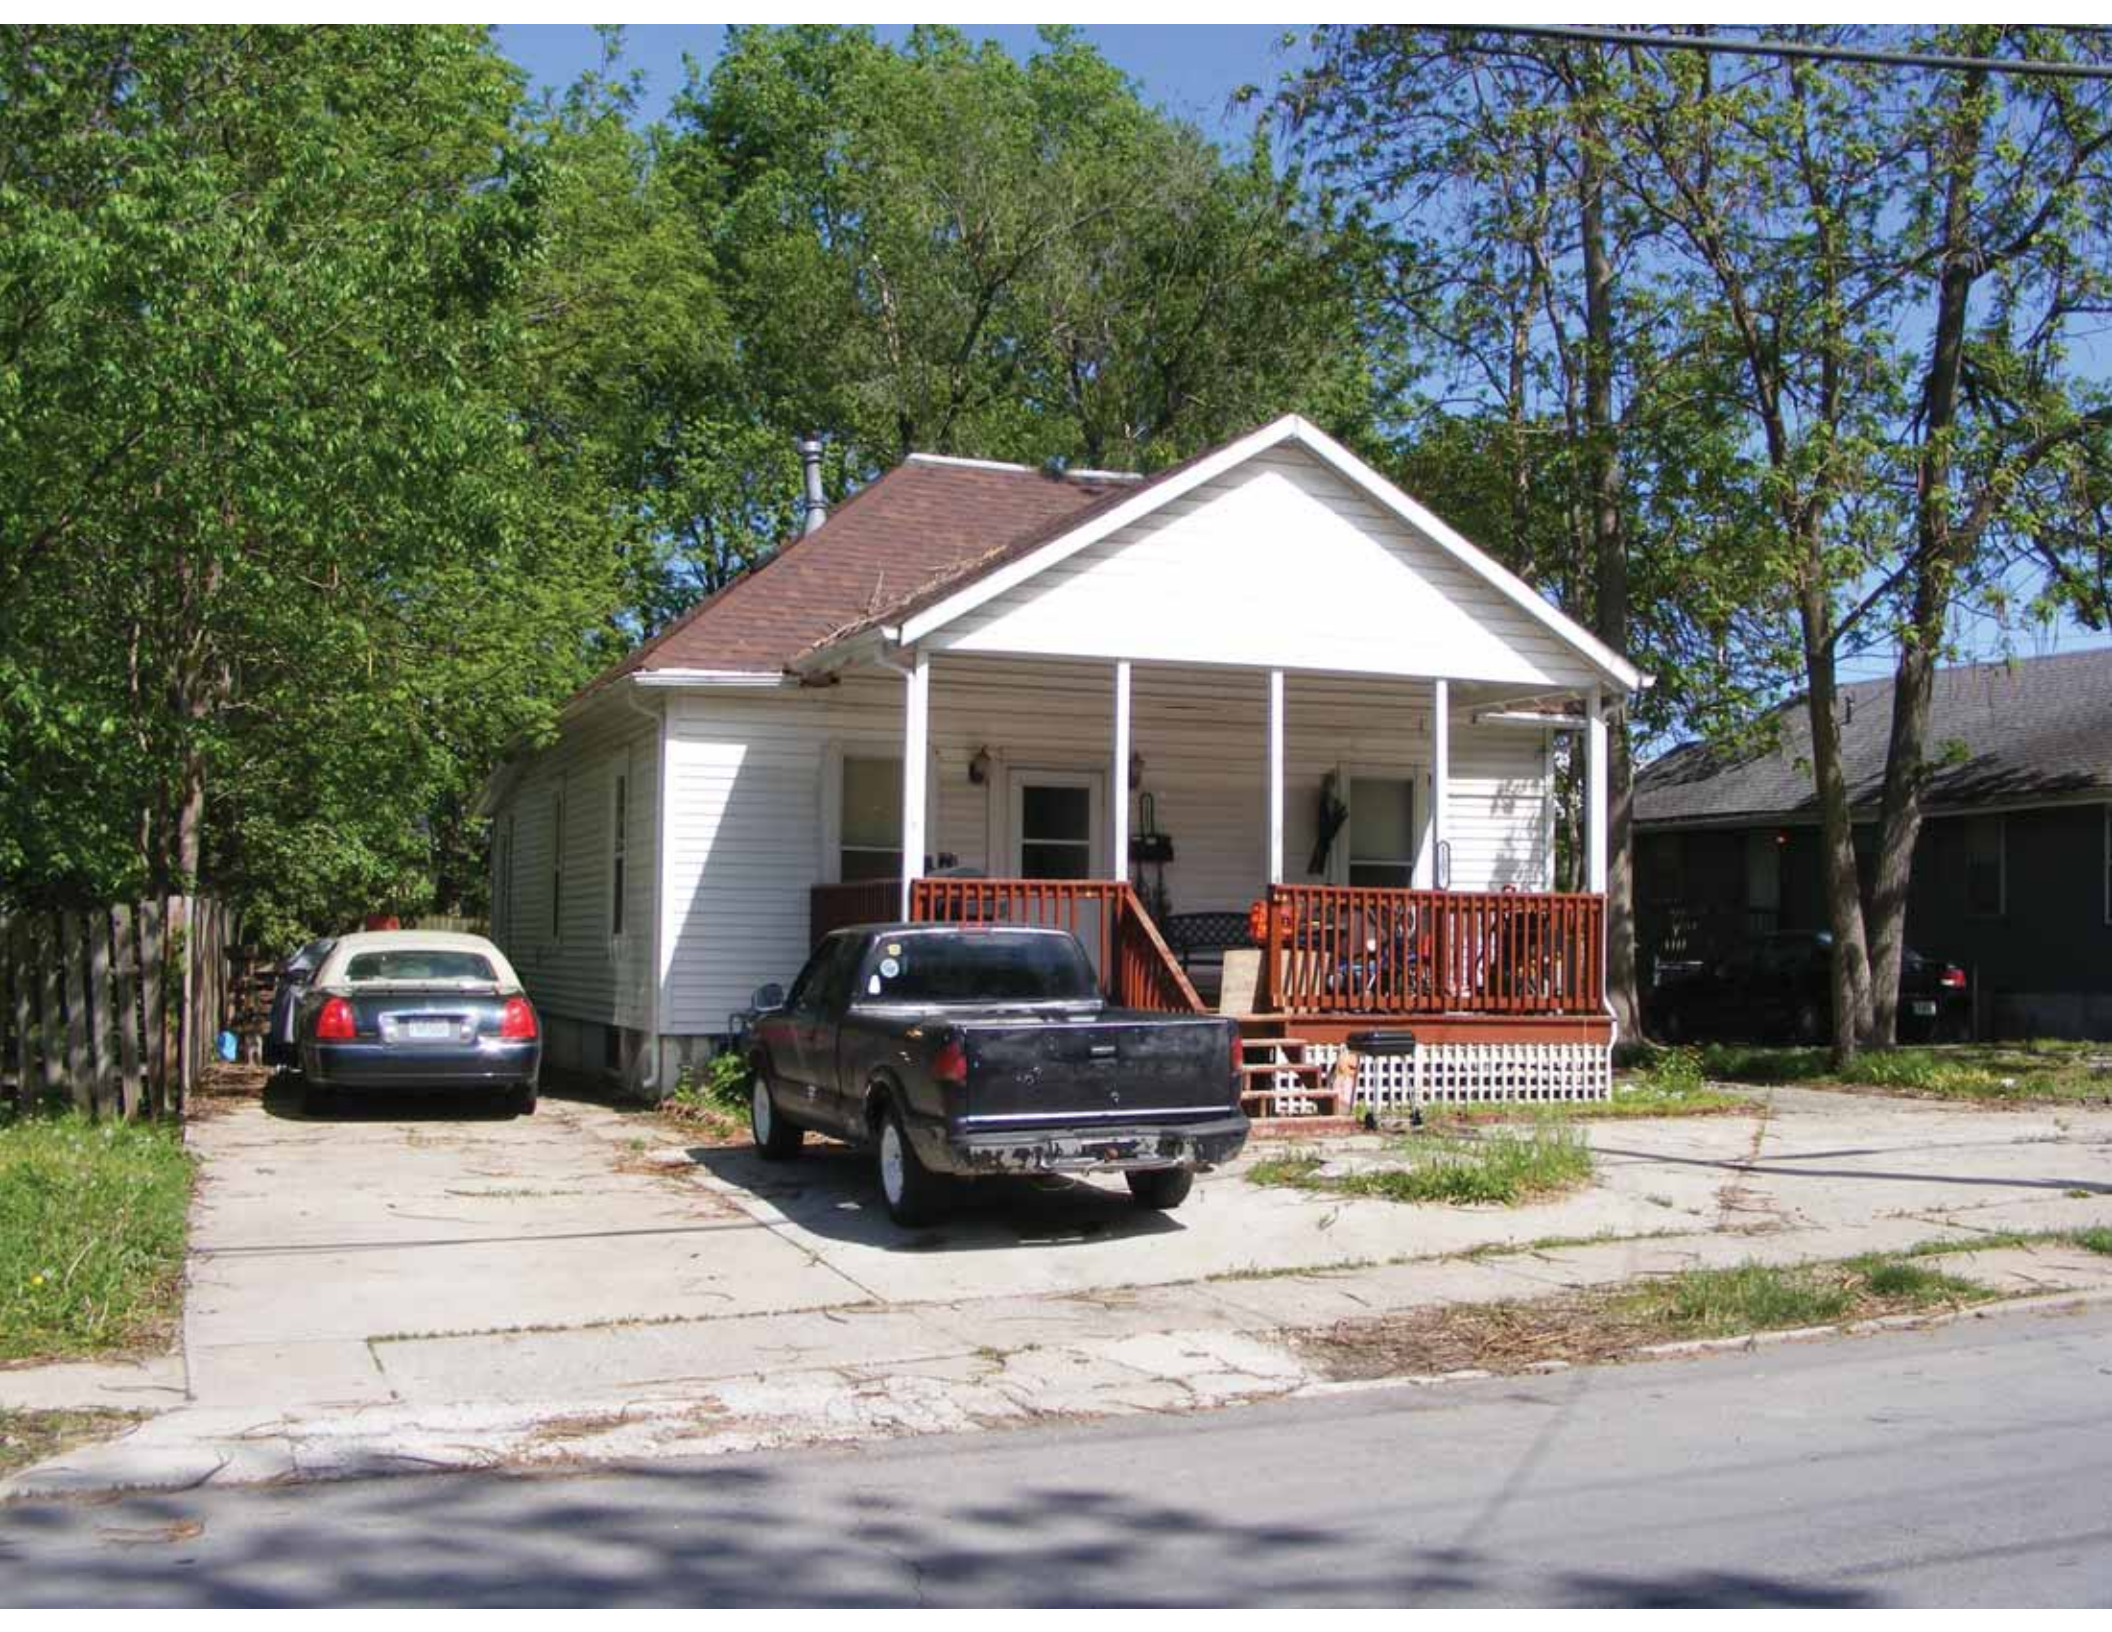
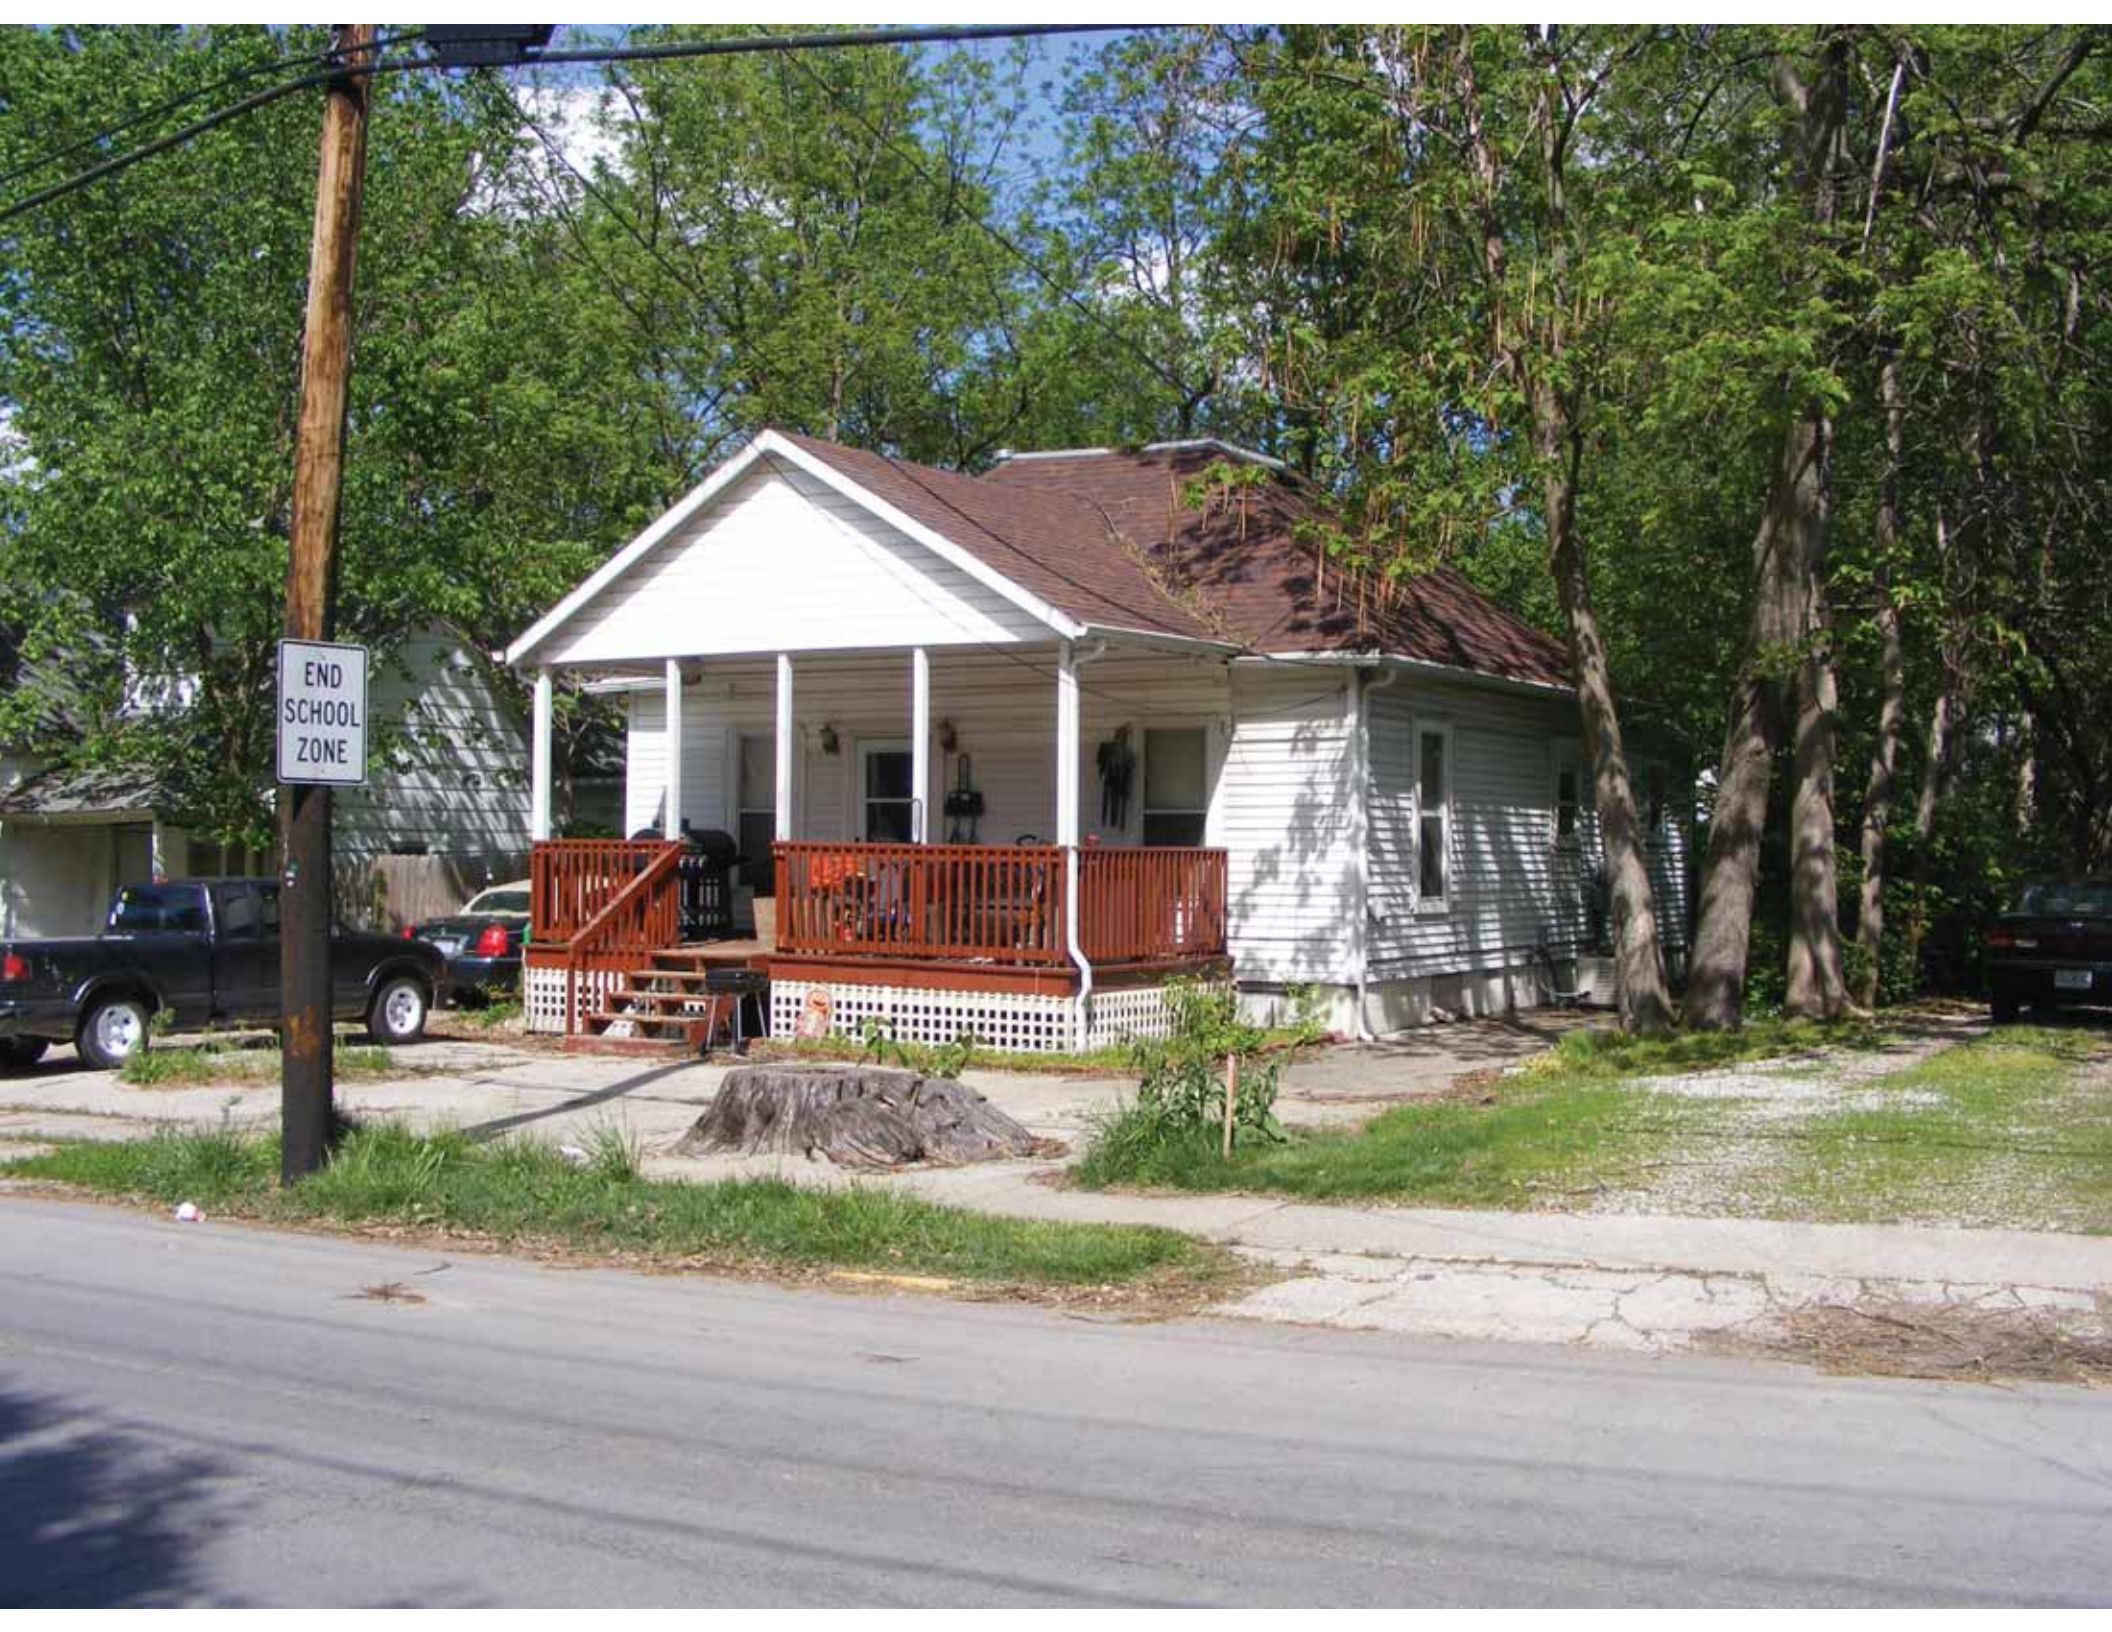
41. (cont.) Description of primary resource. Expand box as necessary, or add continuation pages.
The vinyl sided dwelling is a single-story with an asphalt-shingled truncated hipped roof to front gable and concrete foundation. The façade holds a full-width porch under the front gable supported by narrow square posts and has wood railings and decking. Entrance is off-centered flanked by one-over-one windows. Side elevations holds one-over-one windows.
