MISSOURI DEPARTMENT OF NATURAL RESOURCES
STATE HISTORIC PRESERVATION OFFICE, P.O. Box 176, Jefferson City, MO 65102
ARCHITECTURAL/HISTORIC INVENTORY FORM

1. Survey No. BO-AS-011-0087		2. Survey name: North Central Columbia Survey Phase II	
3. County: Boone		4. Address (Street No.) 902	Street (name) N. Seventh Street
5. City: Columbia	Vicinity: <input type="checkbox"/>	6. Geographical Reference:	7. Township/Range/Section: T: R: S:
8. Historic name (if known):		9. Present/other name (if known):	
10. Ownership: <input checked="" type="checkbox"/> Private <input type="checkbox"/> Public		11a. Historic use (if known): Domestic/single dwelling	11b. Current use: Domestic/single dwelling

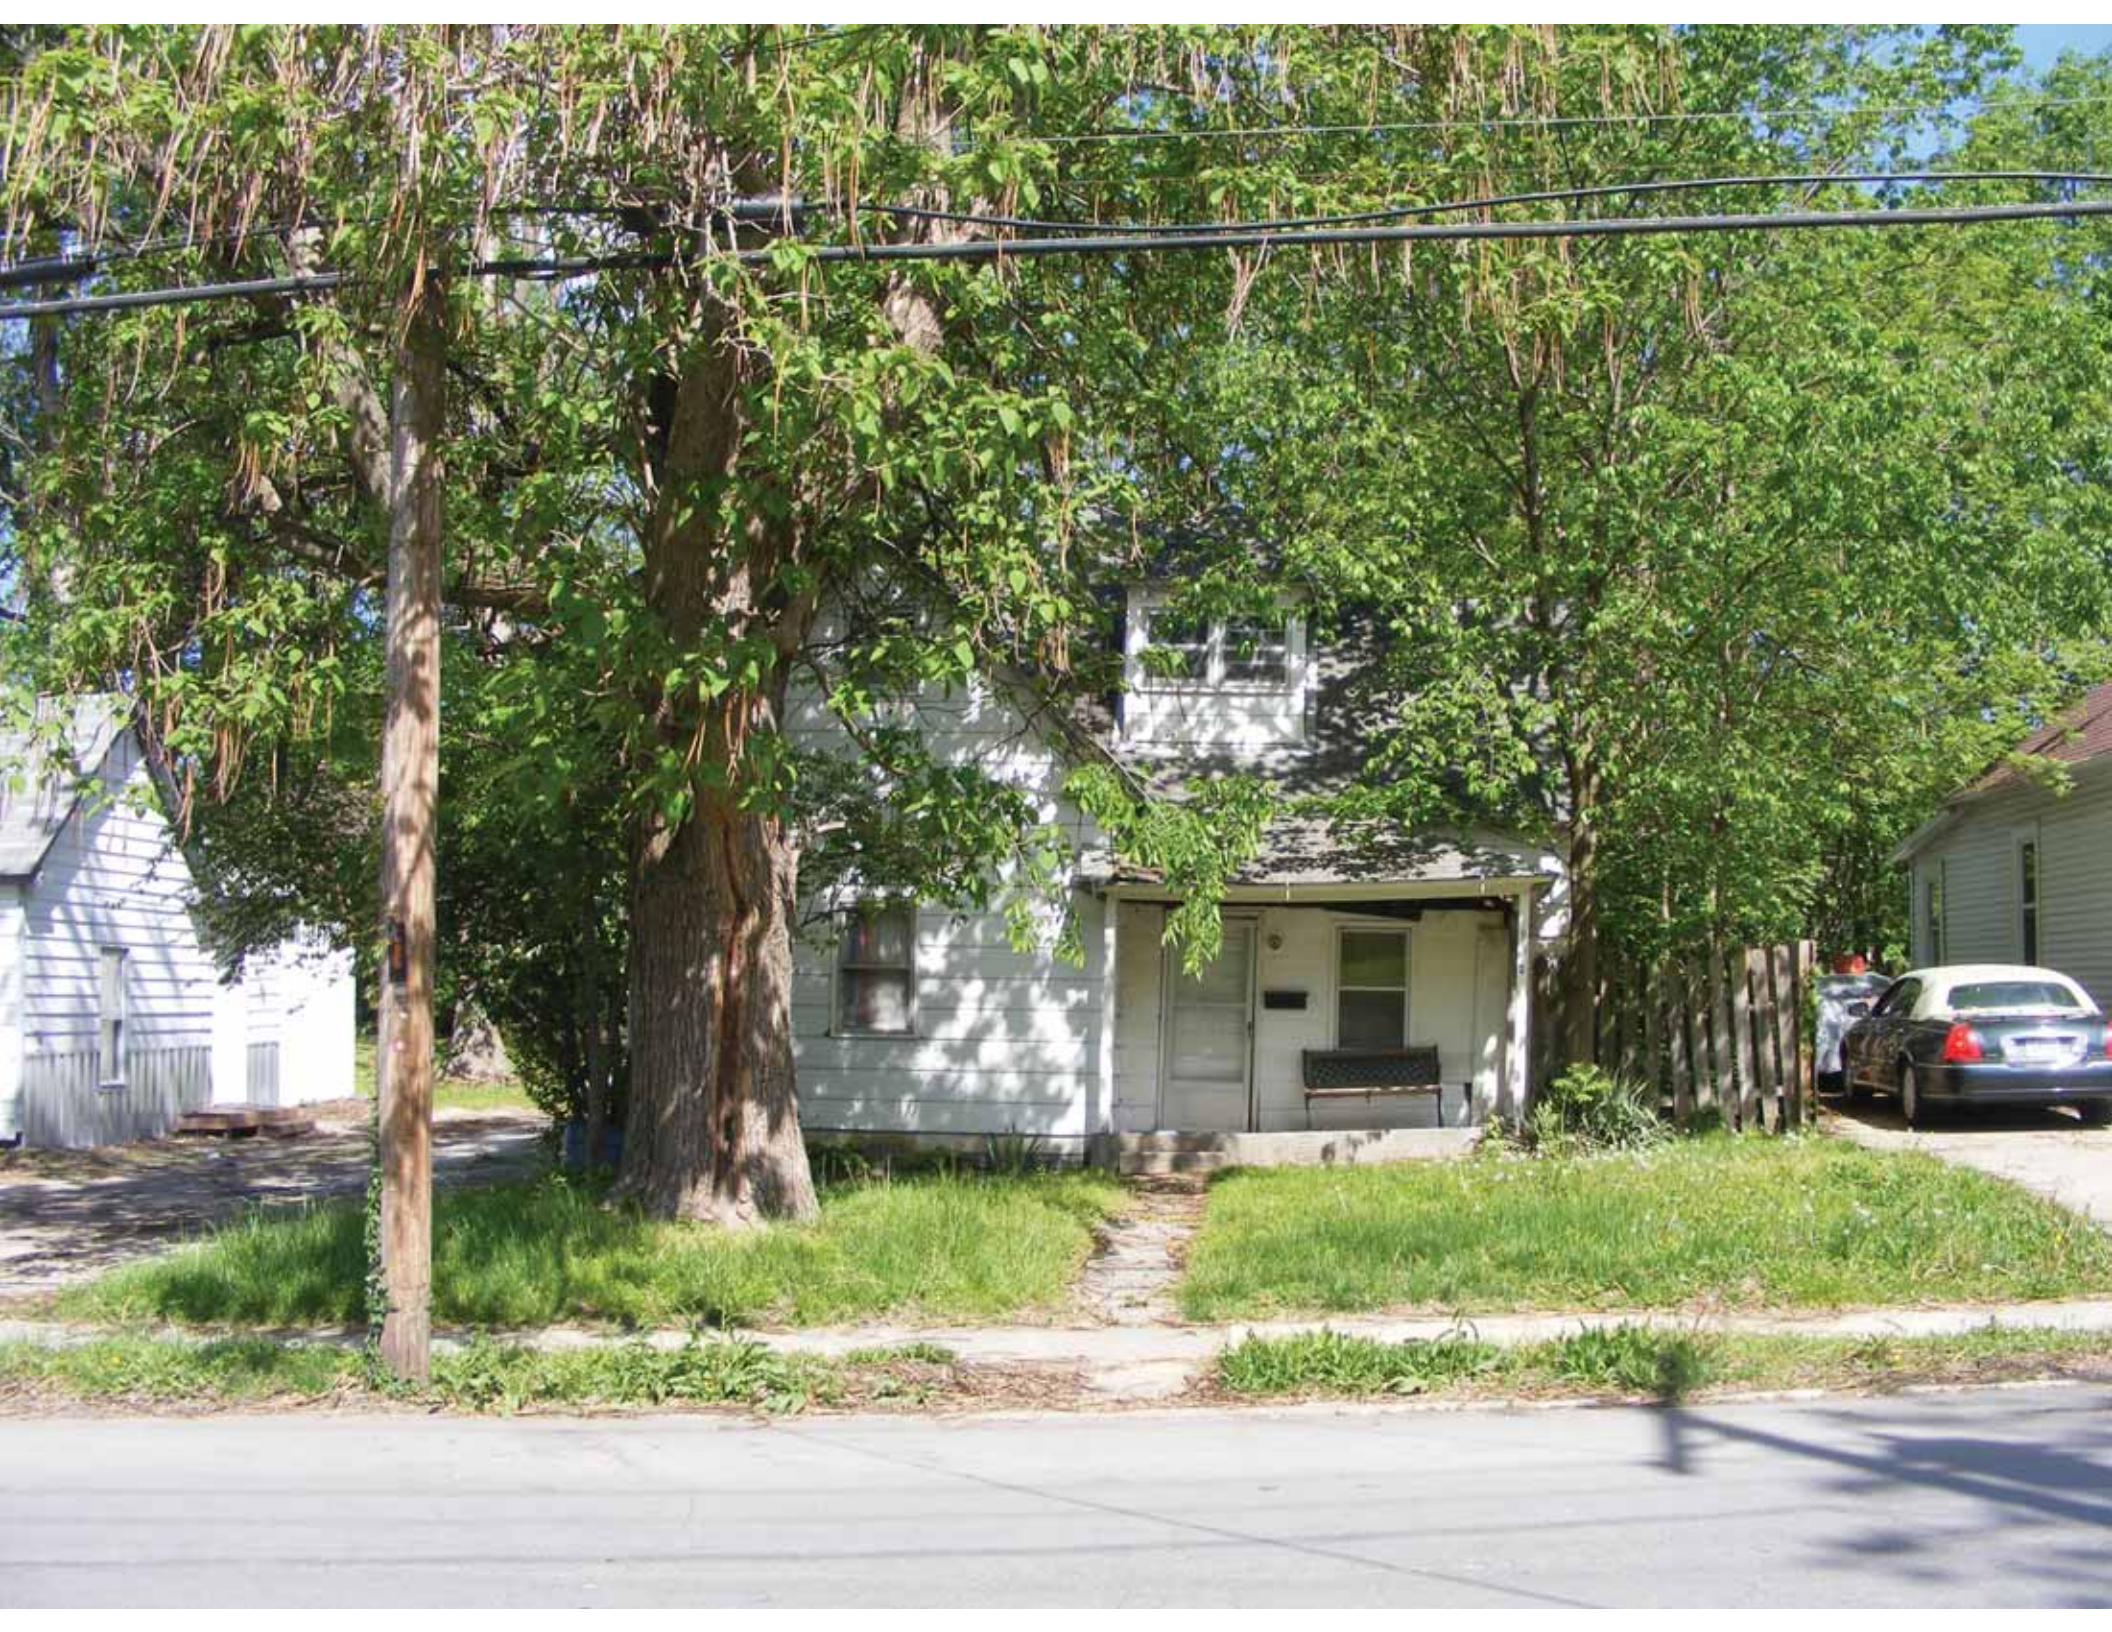
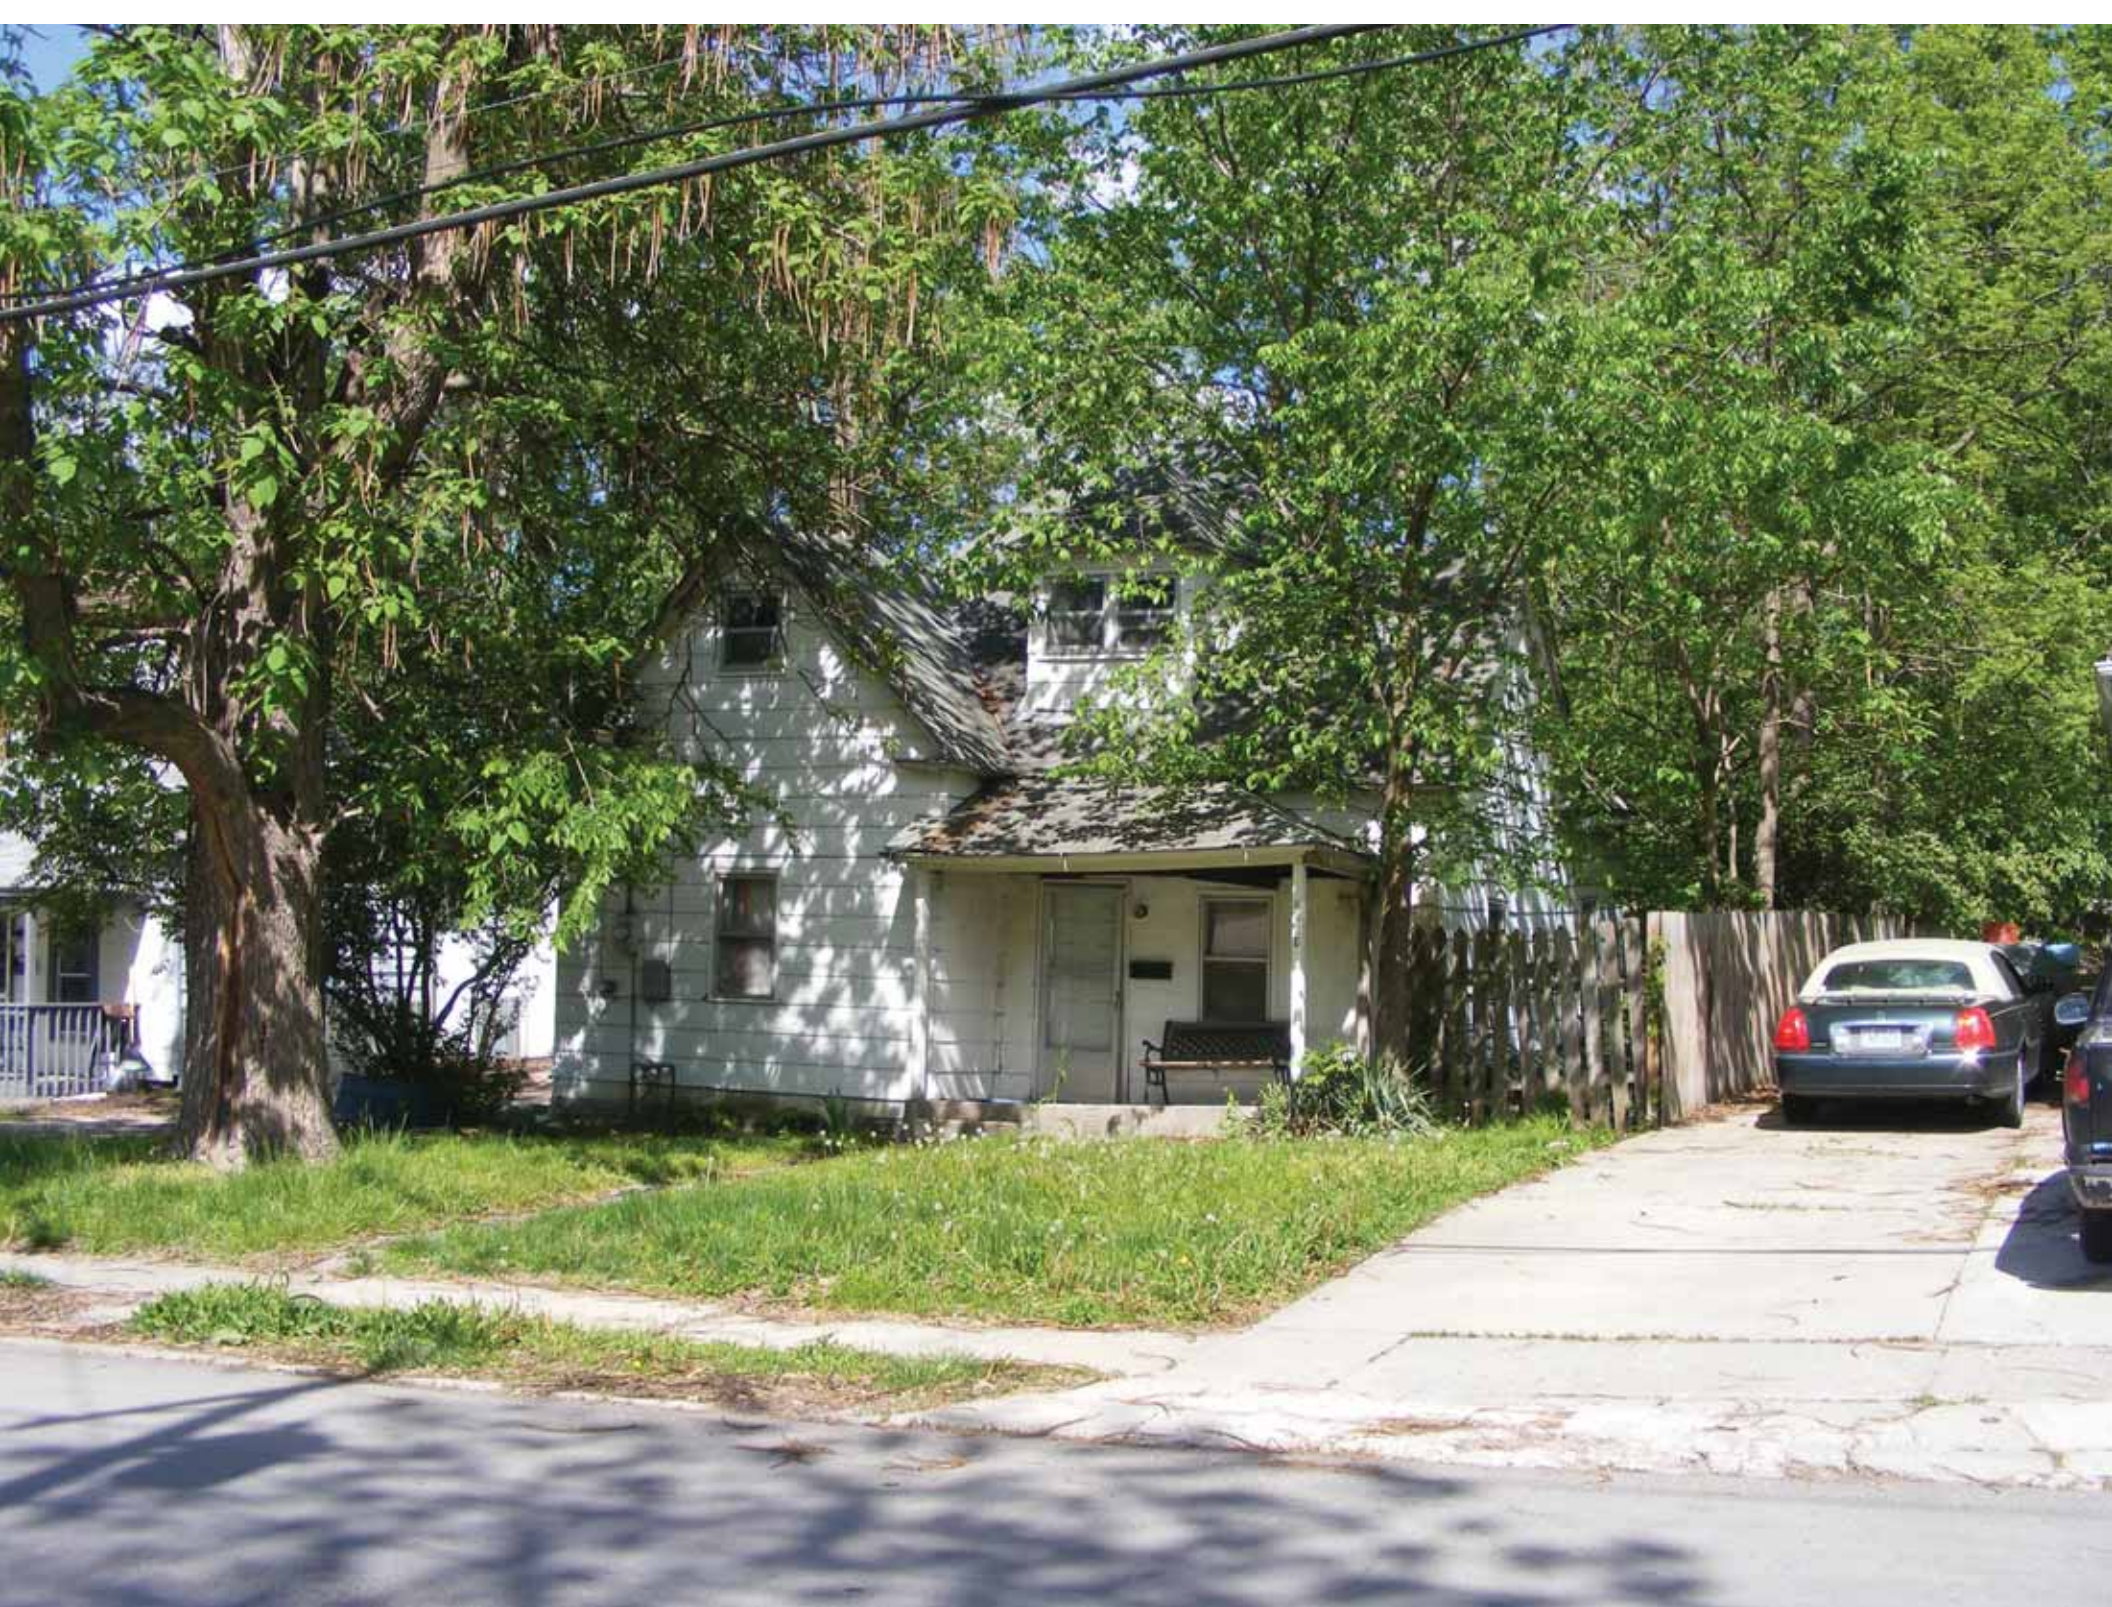
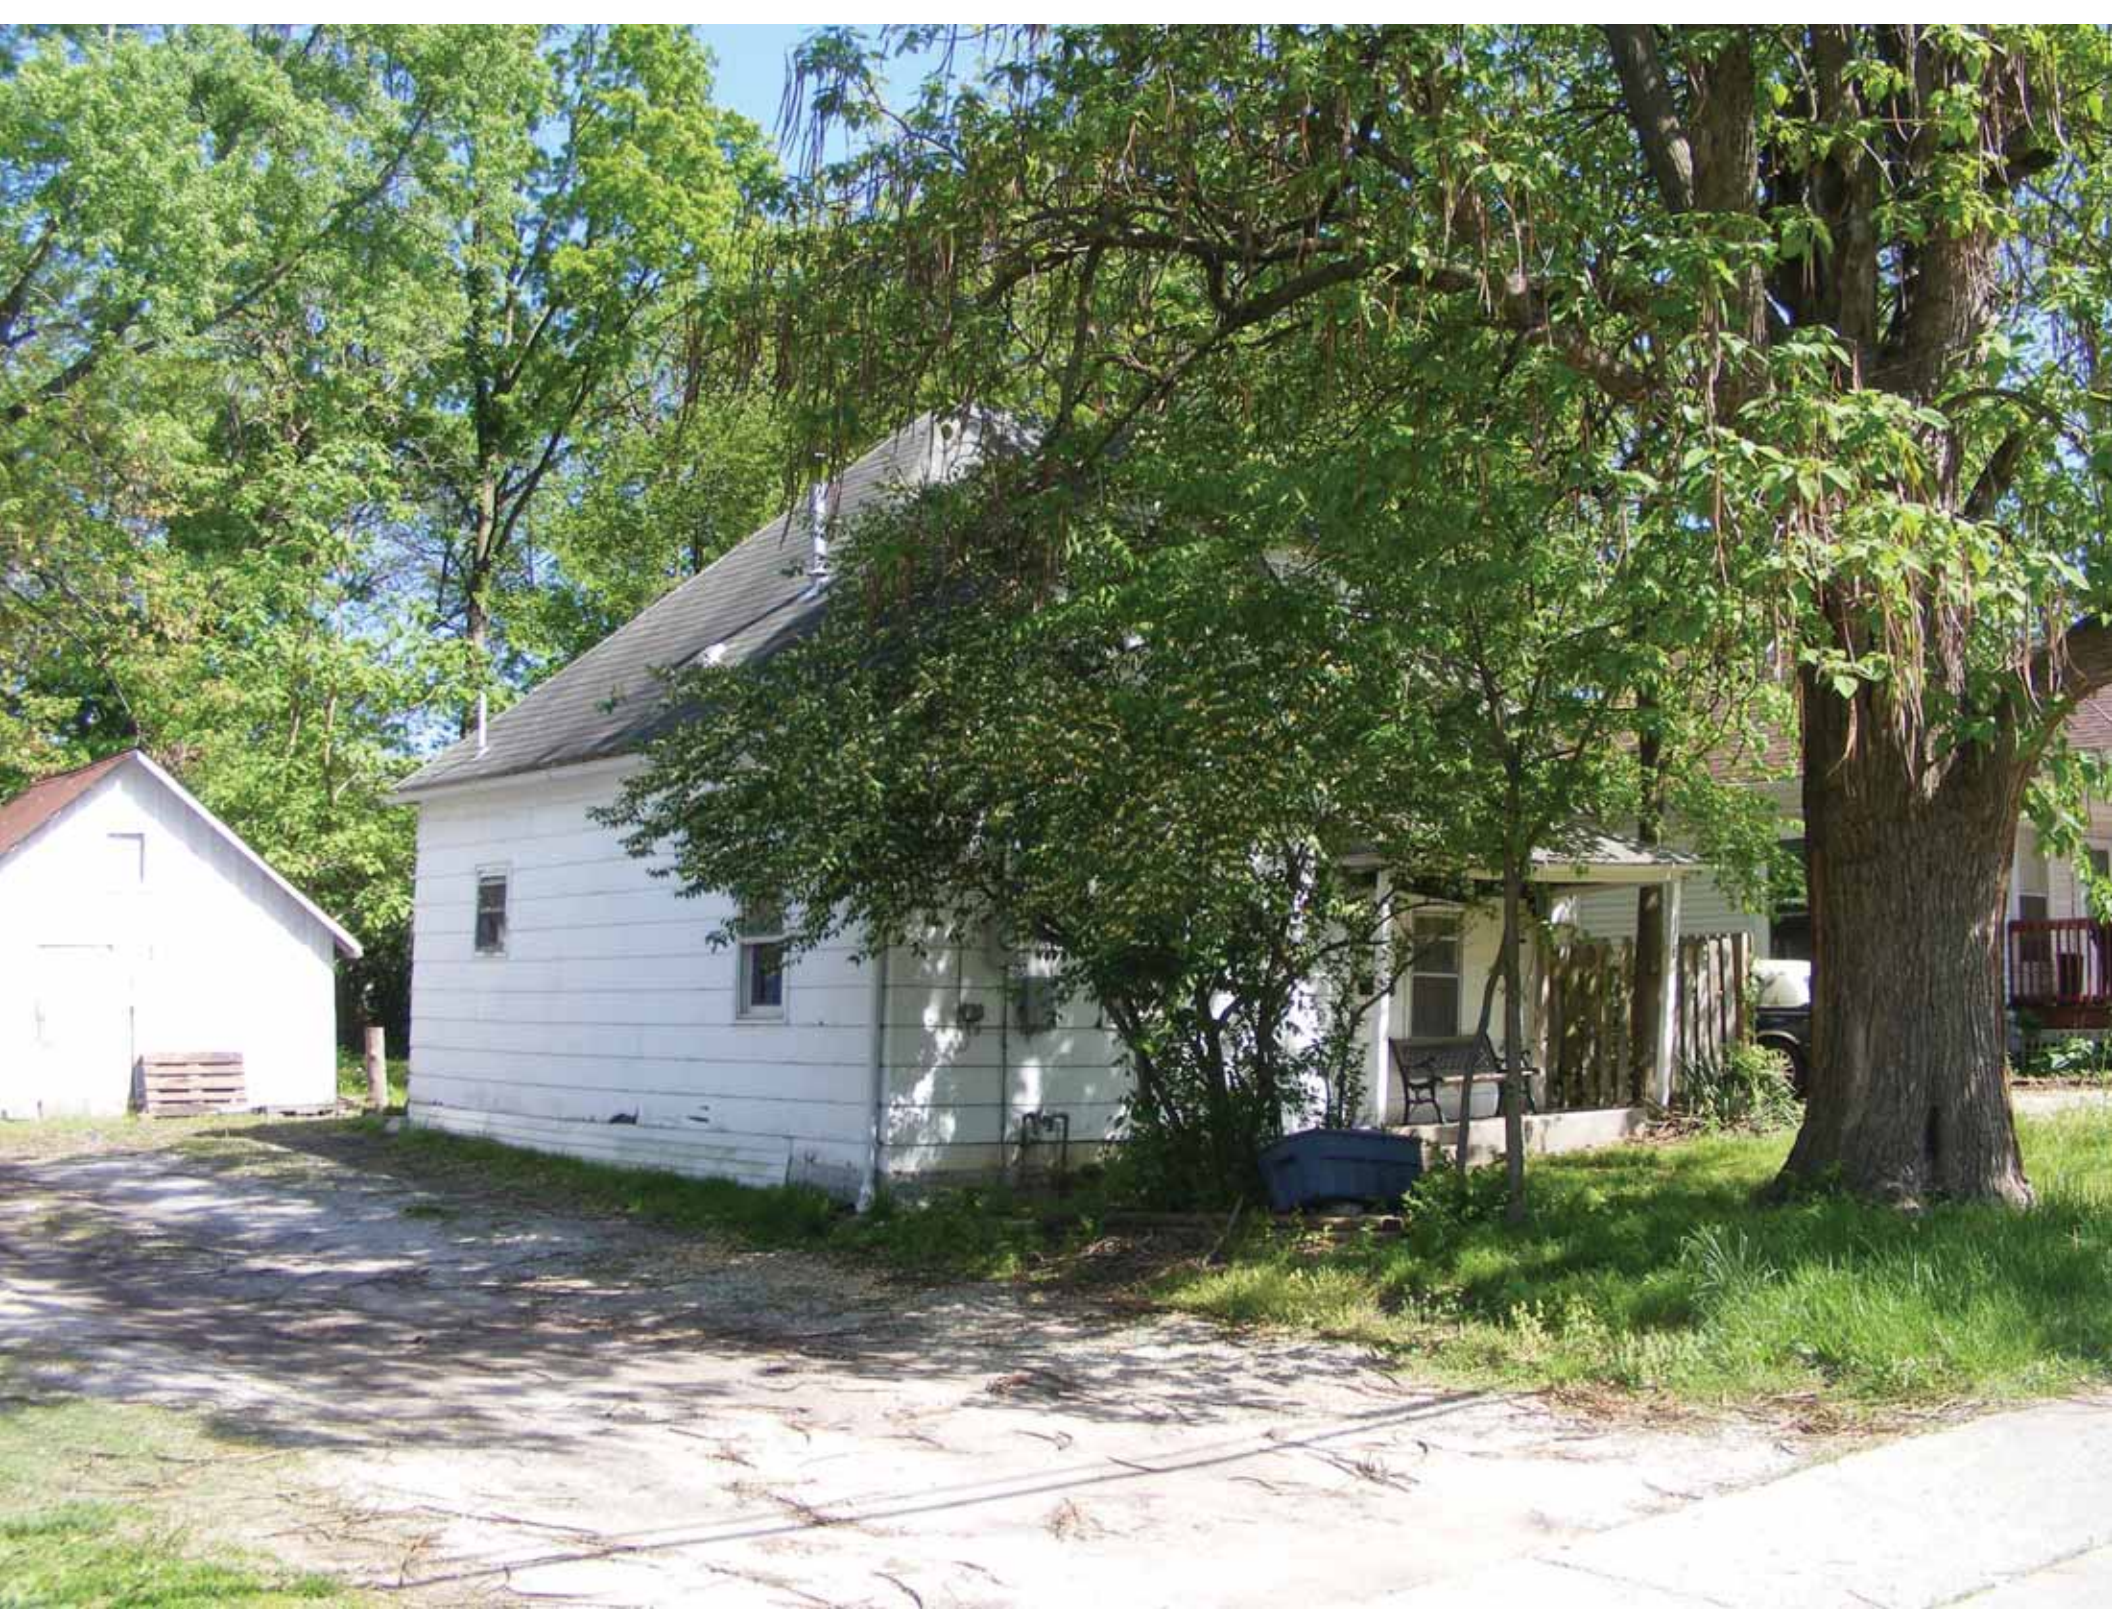
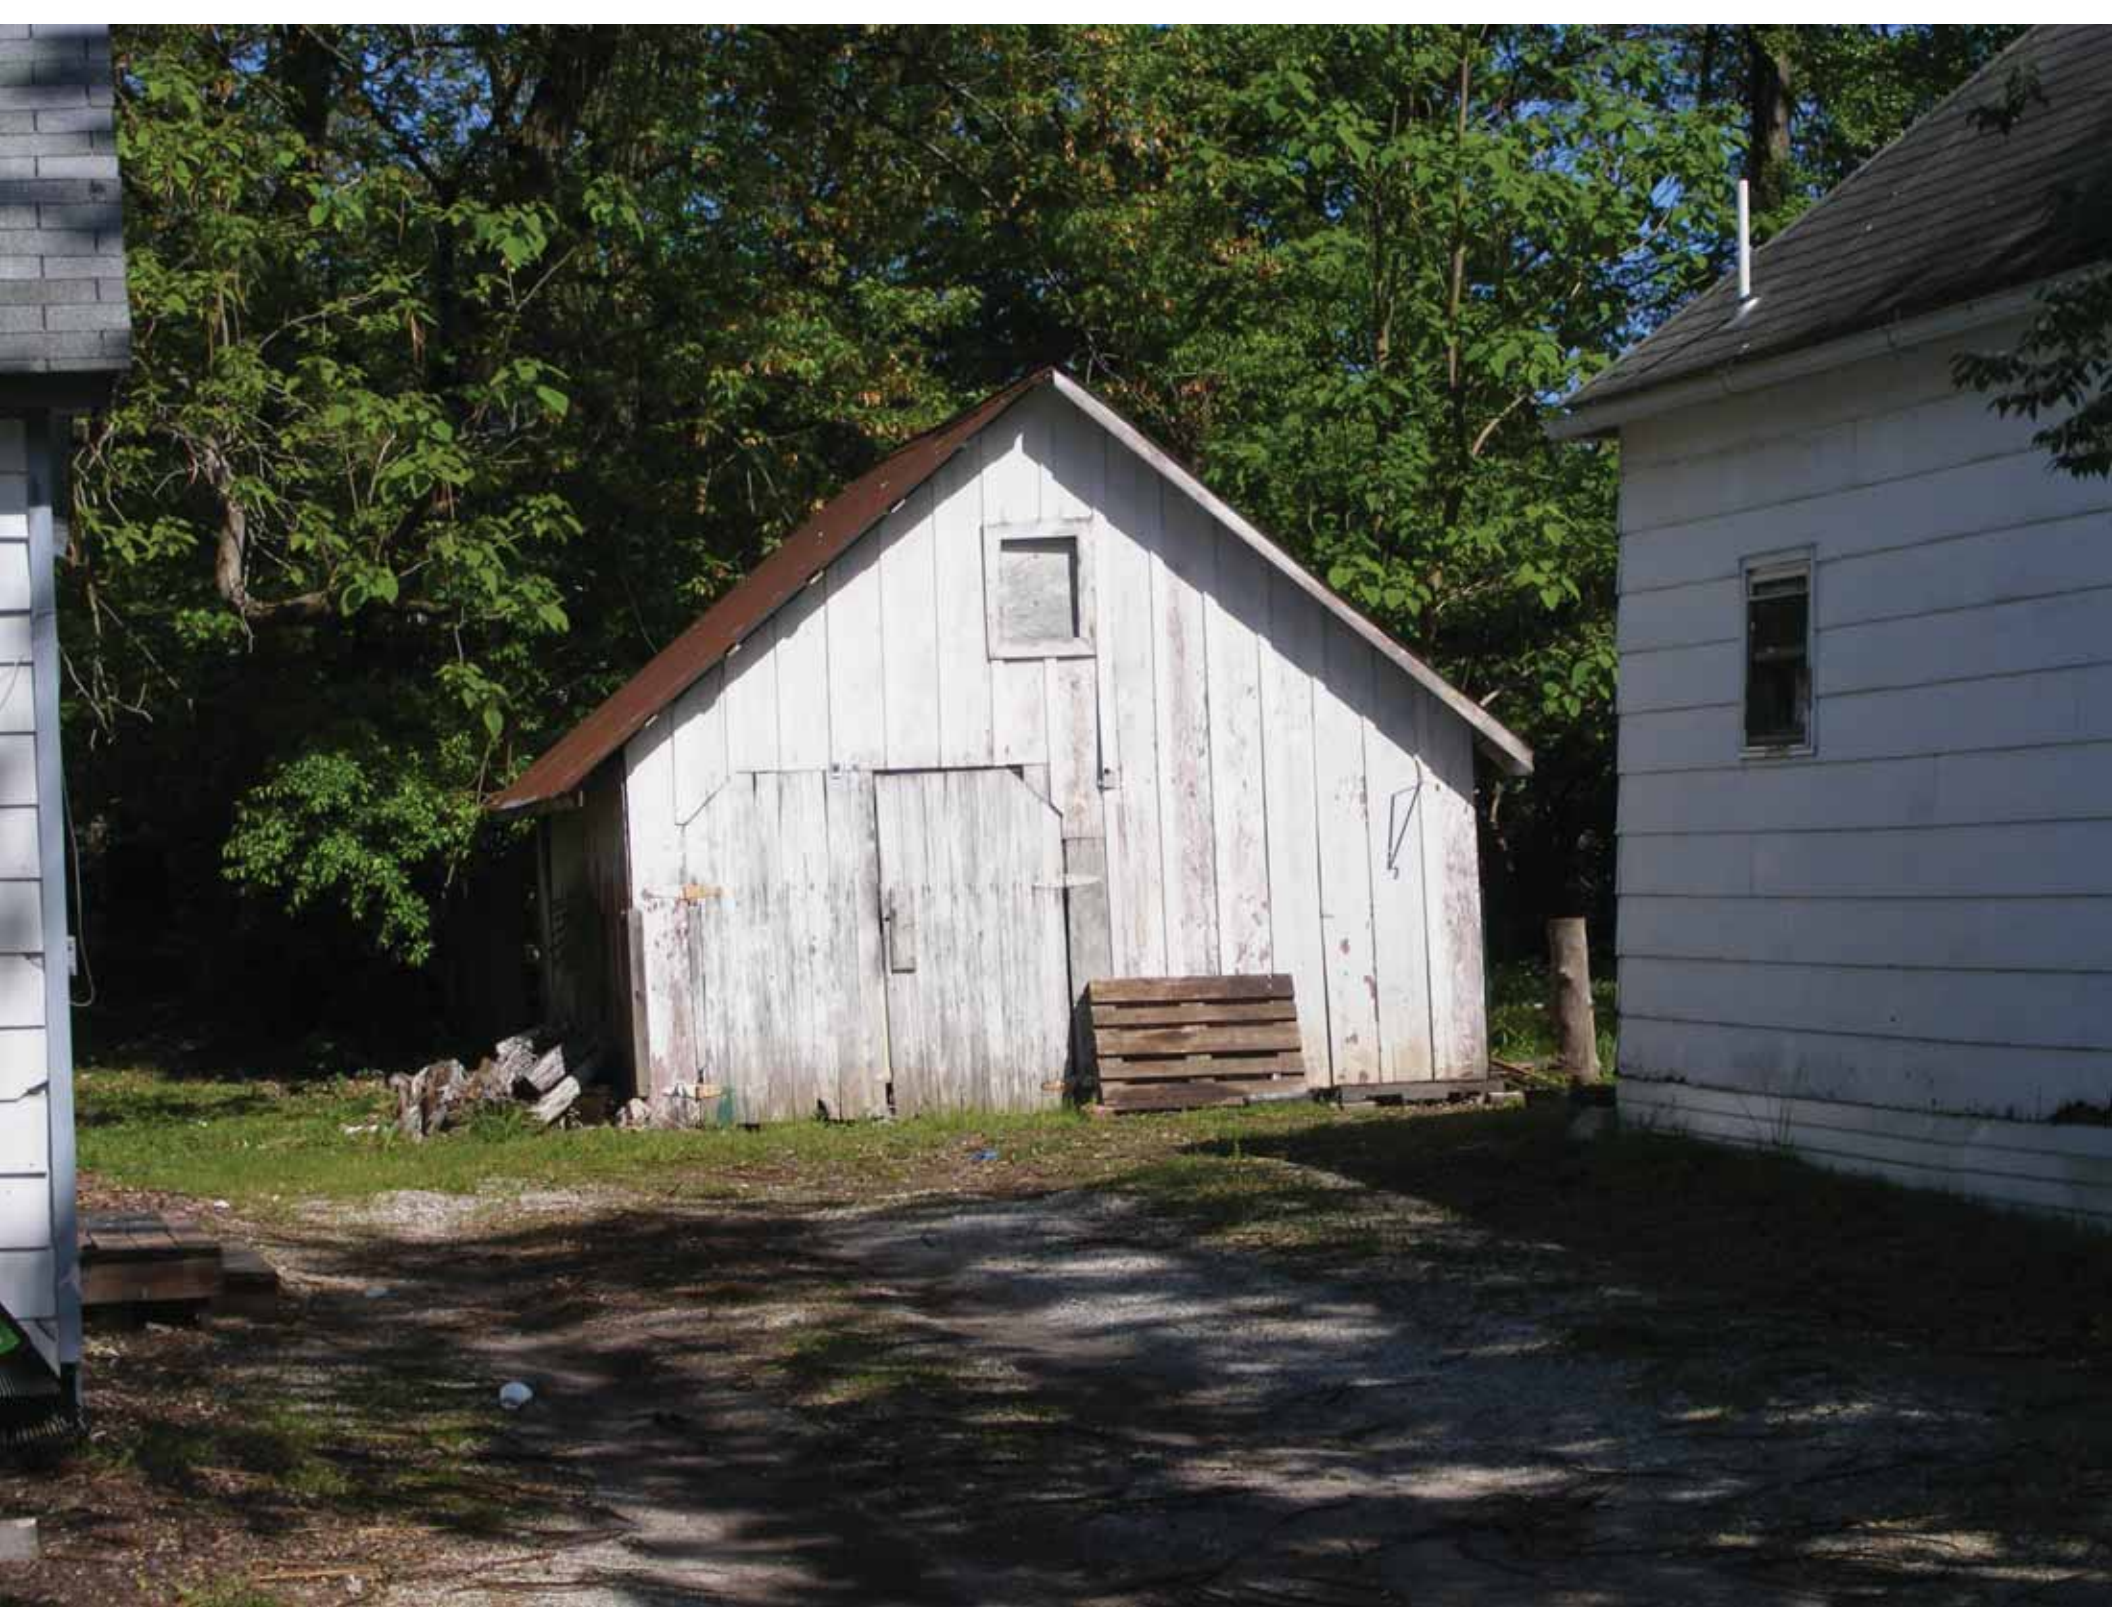
40. (cont.) Description of environment and outbuildings. Expand box as necessary, or add continuation pages.
The property is located on the east side of Range Line Street. The dwelling is situated on the western portion of the property on a grass covered residential lot in an urban setting. A concrete public sidewalk runs adjacent to the western edge of the property. The property has mature trees located in the eastern portion of the property. A wood fence runs along the southwest and southern portions of the property. A gravel driveway is present on the north side of the dwelling. At the end of the driveway is a front gabled outbuilding with vertical wood siding and double doors. The outbuilding is not eligible for the National Register of Historic Places.

41. (cont.) Description of primary resource. Expand box as necessary, or add continuation pages.
The wood sided 1.5 story dwelling has an asphalt-shingled cross gable to a lower hip (façade porch) and a front gable dormer with a paired one-over-one window on the front sloping roofline. The façade features a half-width porch sheltered by the hip supported by square posts with a concrete deck. Entrance is at the "L" and offset to the right by a one-over-one window. The front gable holds a one-over-one window on the lower section and gable end. Side elevations hold one-over-one windows.
