MISSOURI DEPARTMENT OF NATURAL RESOURCES
STATE HISTORIC PRESERVATION OFFICE, P.O. Box 176, Jefferson City, MO 65102
ARCHITECTURAL/HISTORIC INVENTORY FORM

1. Survey No. BO-AS-011-0087		2. Survey name: North Central Columbia Survey Phase II	
3. County: Boone		4. Address (Street No.) 902	Street (name) N. Seventh Street
5. City: Columbia	Vicinity: <input type="checkbox"/>	6. Geographical Reference:	7. Township/Range/Section: T: R: S:
8. Historic name (if known):		9. Present/other name (if known):	
10. Ownership: <input checked="" type="checkbox"/> Private <input type="checkbox"/> Public		11a. Historic use (if known): Domestic/single dwelling	11b. Current use: Domestic/single dwelling

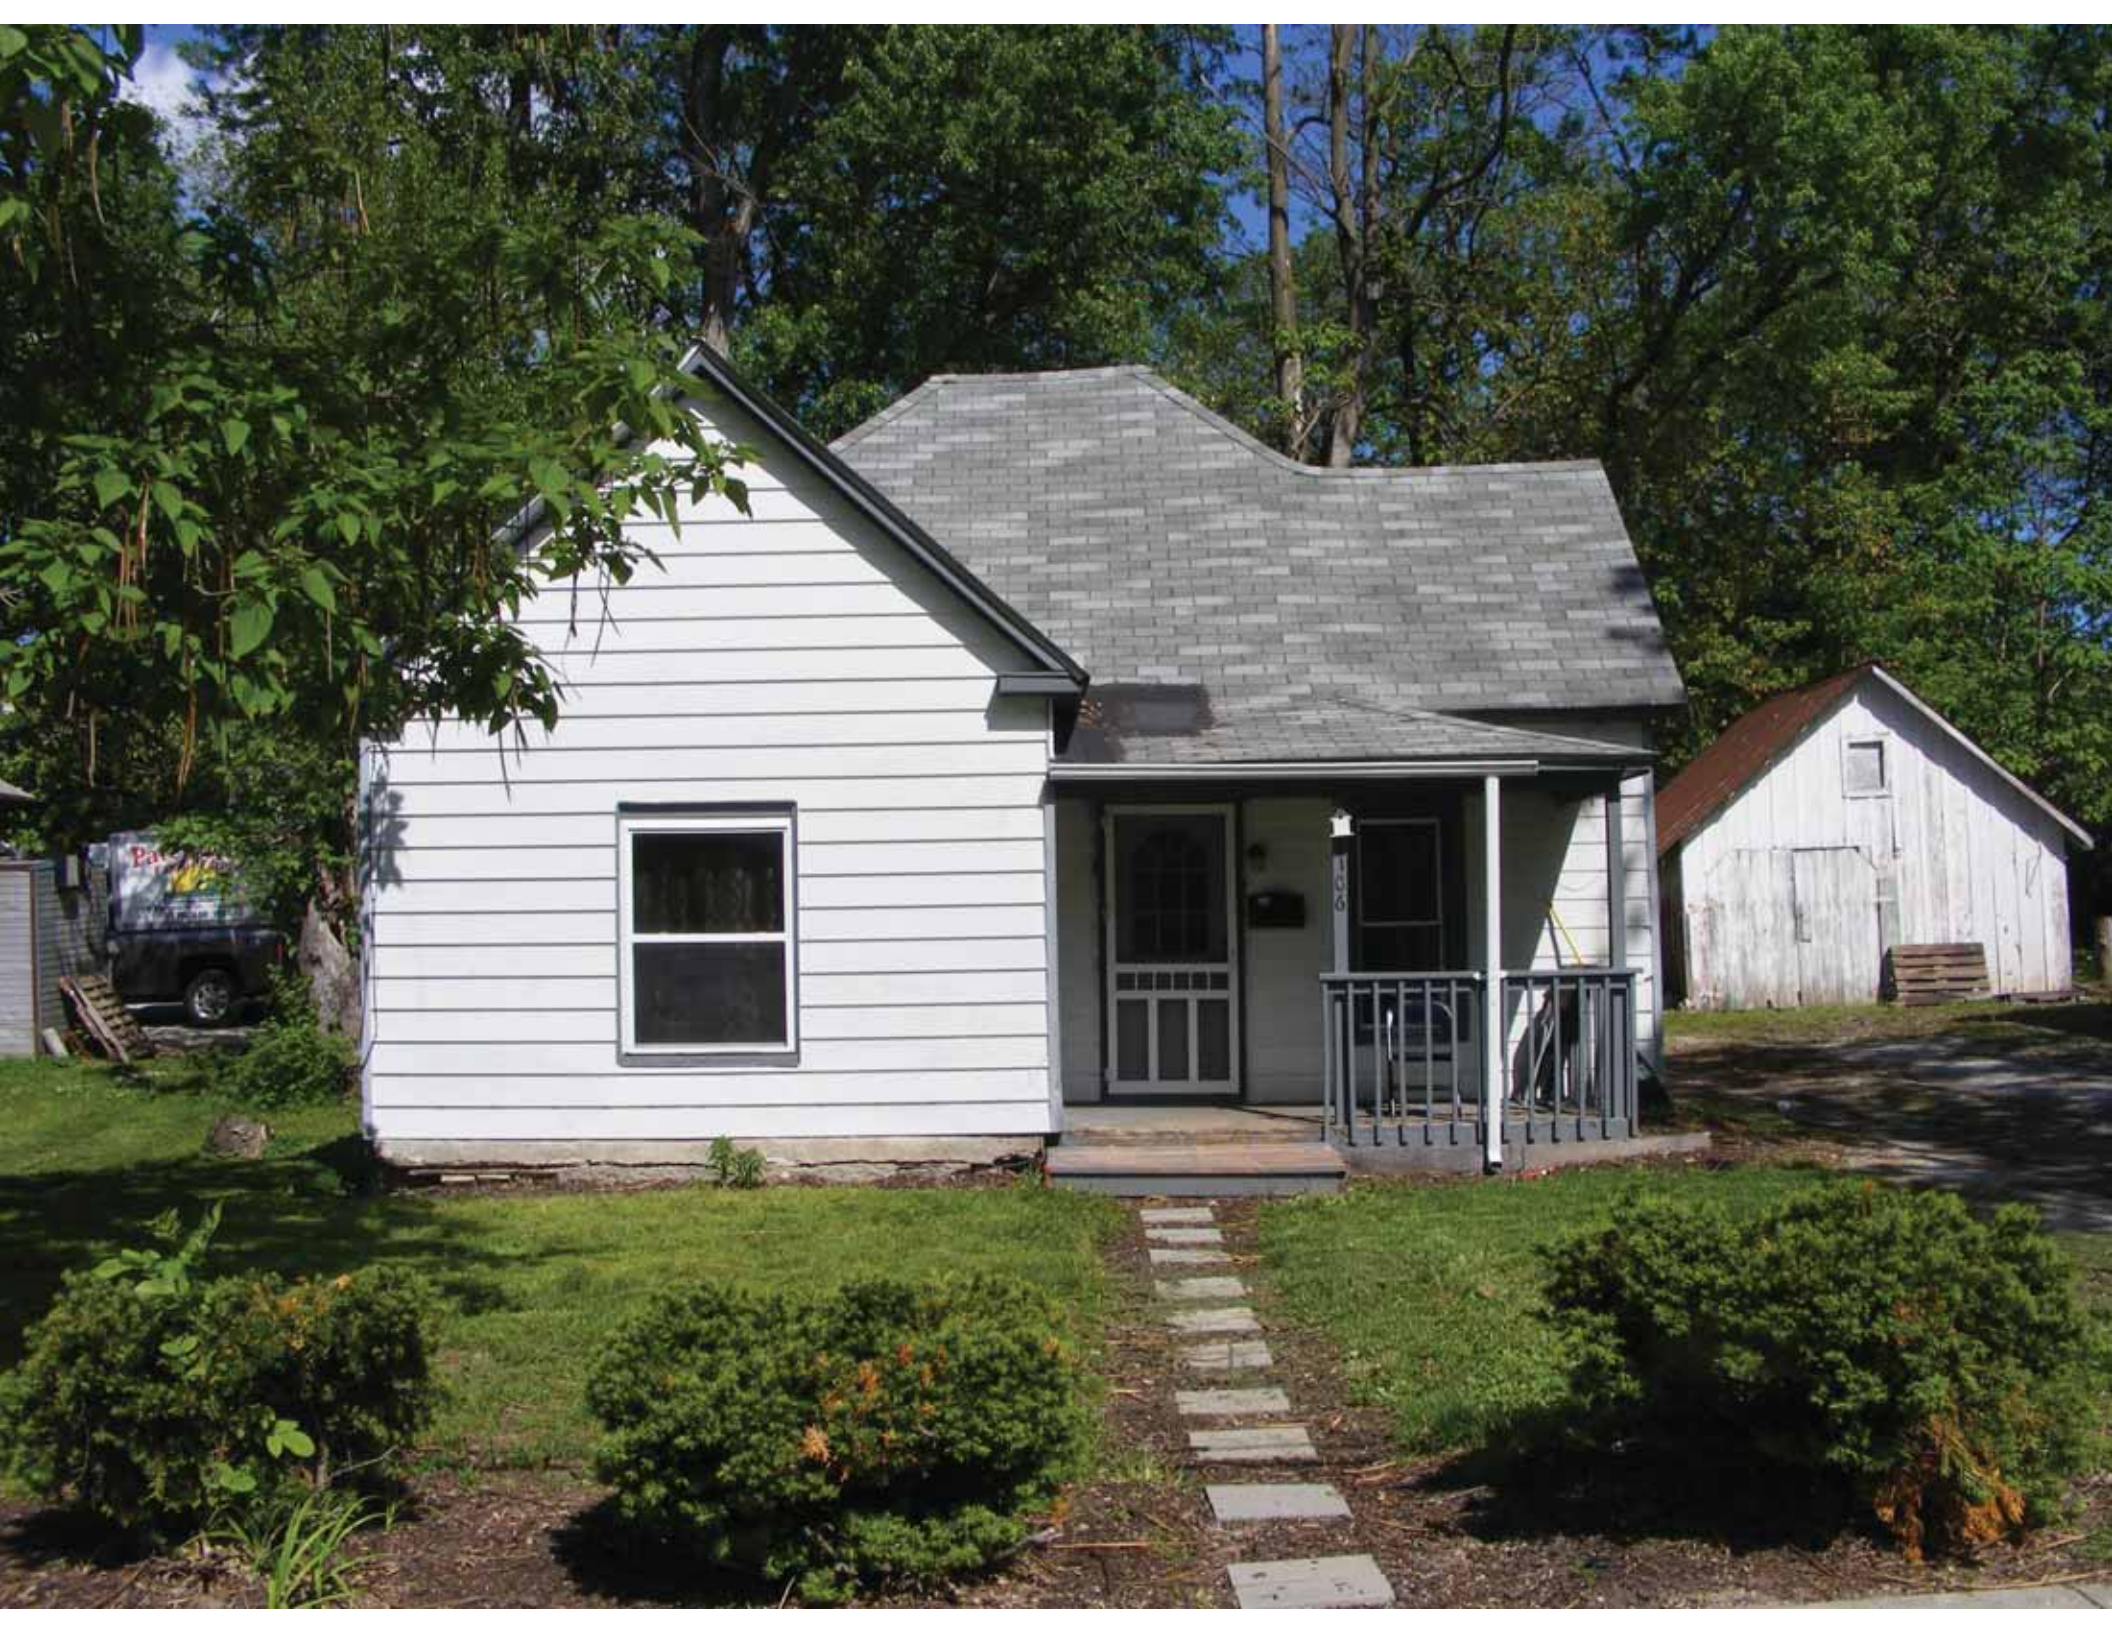
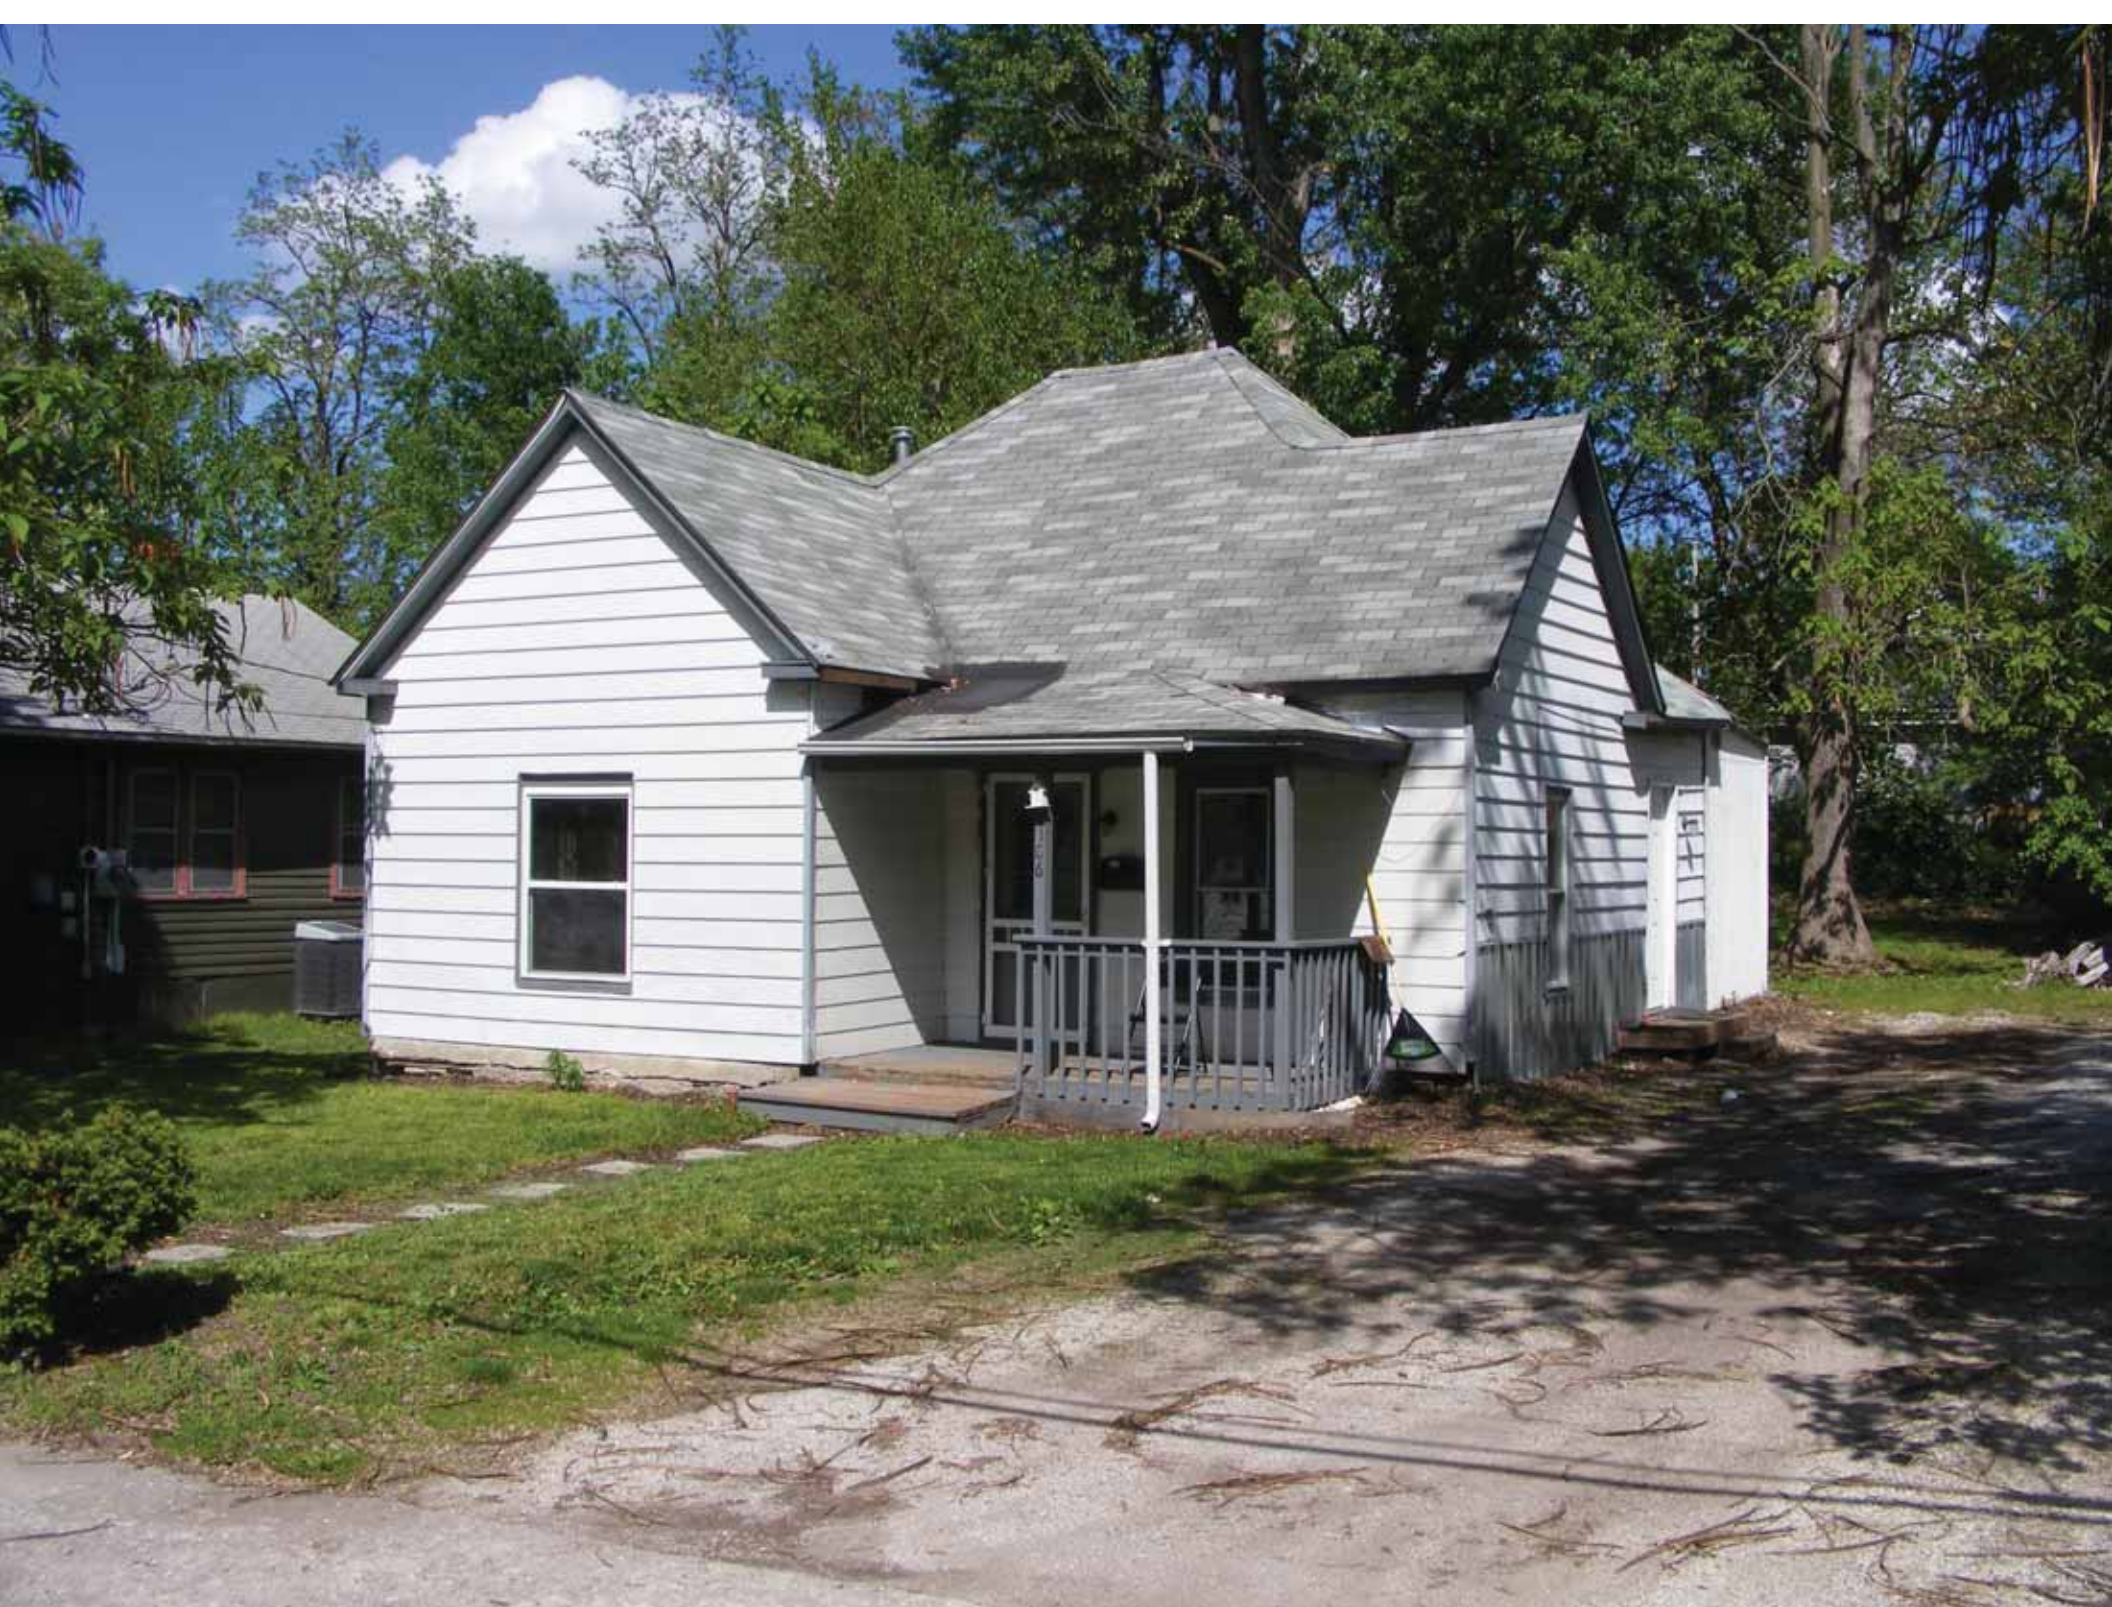
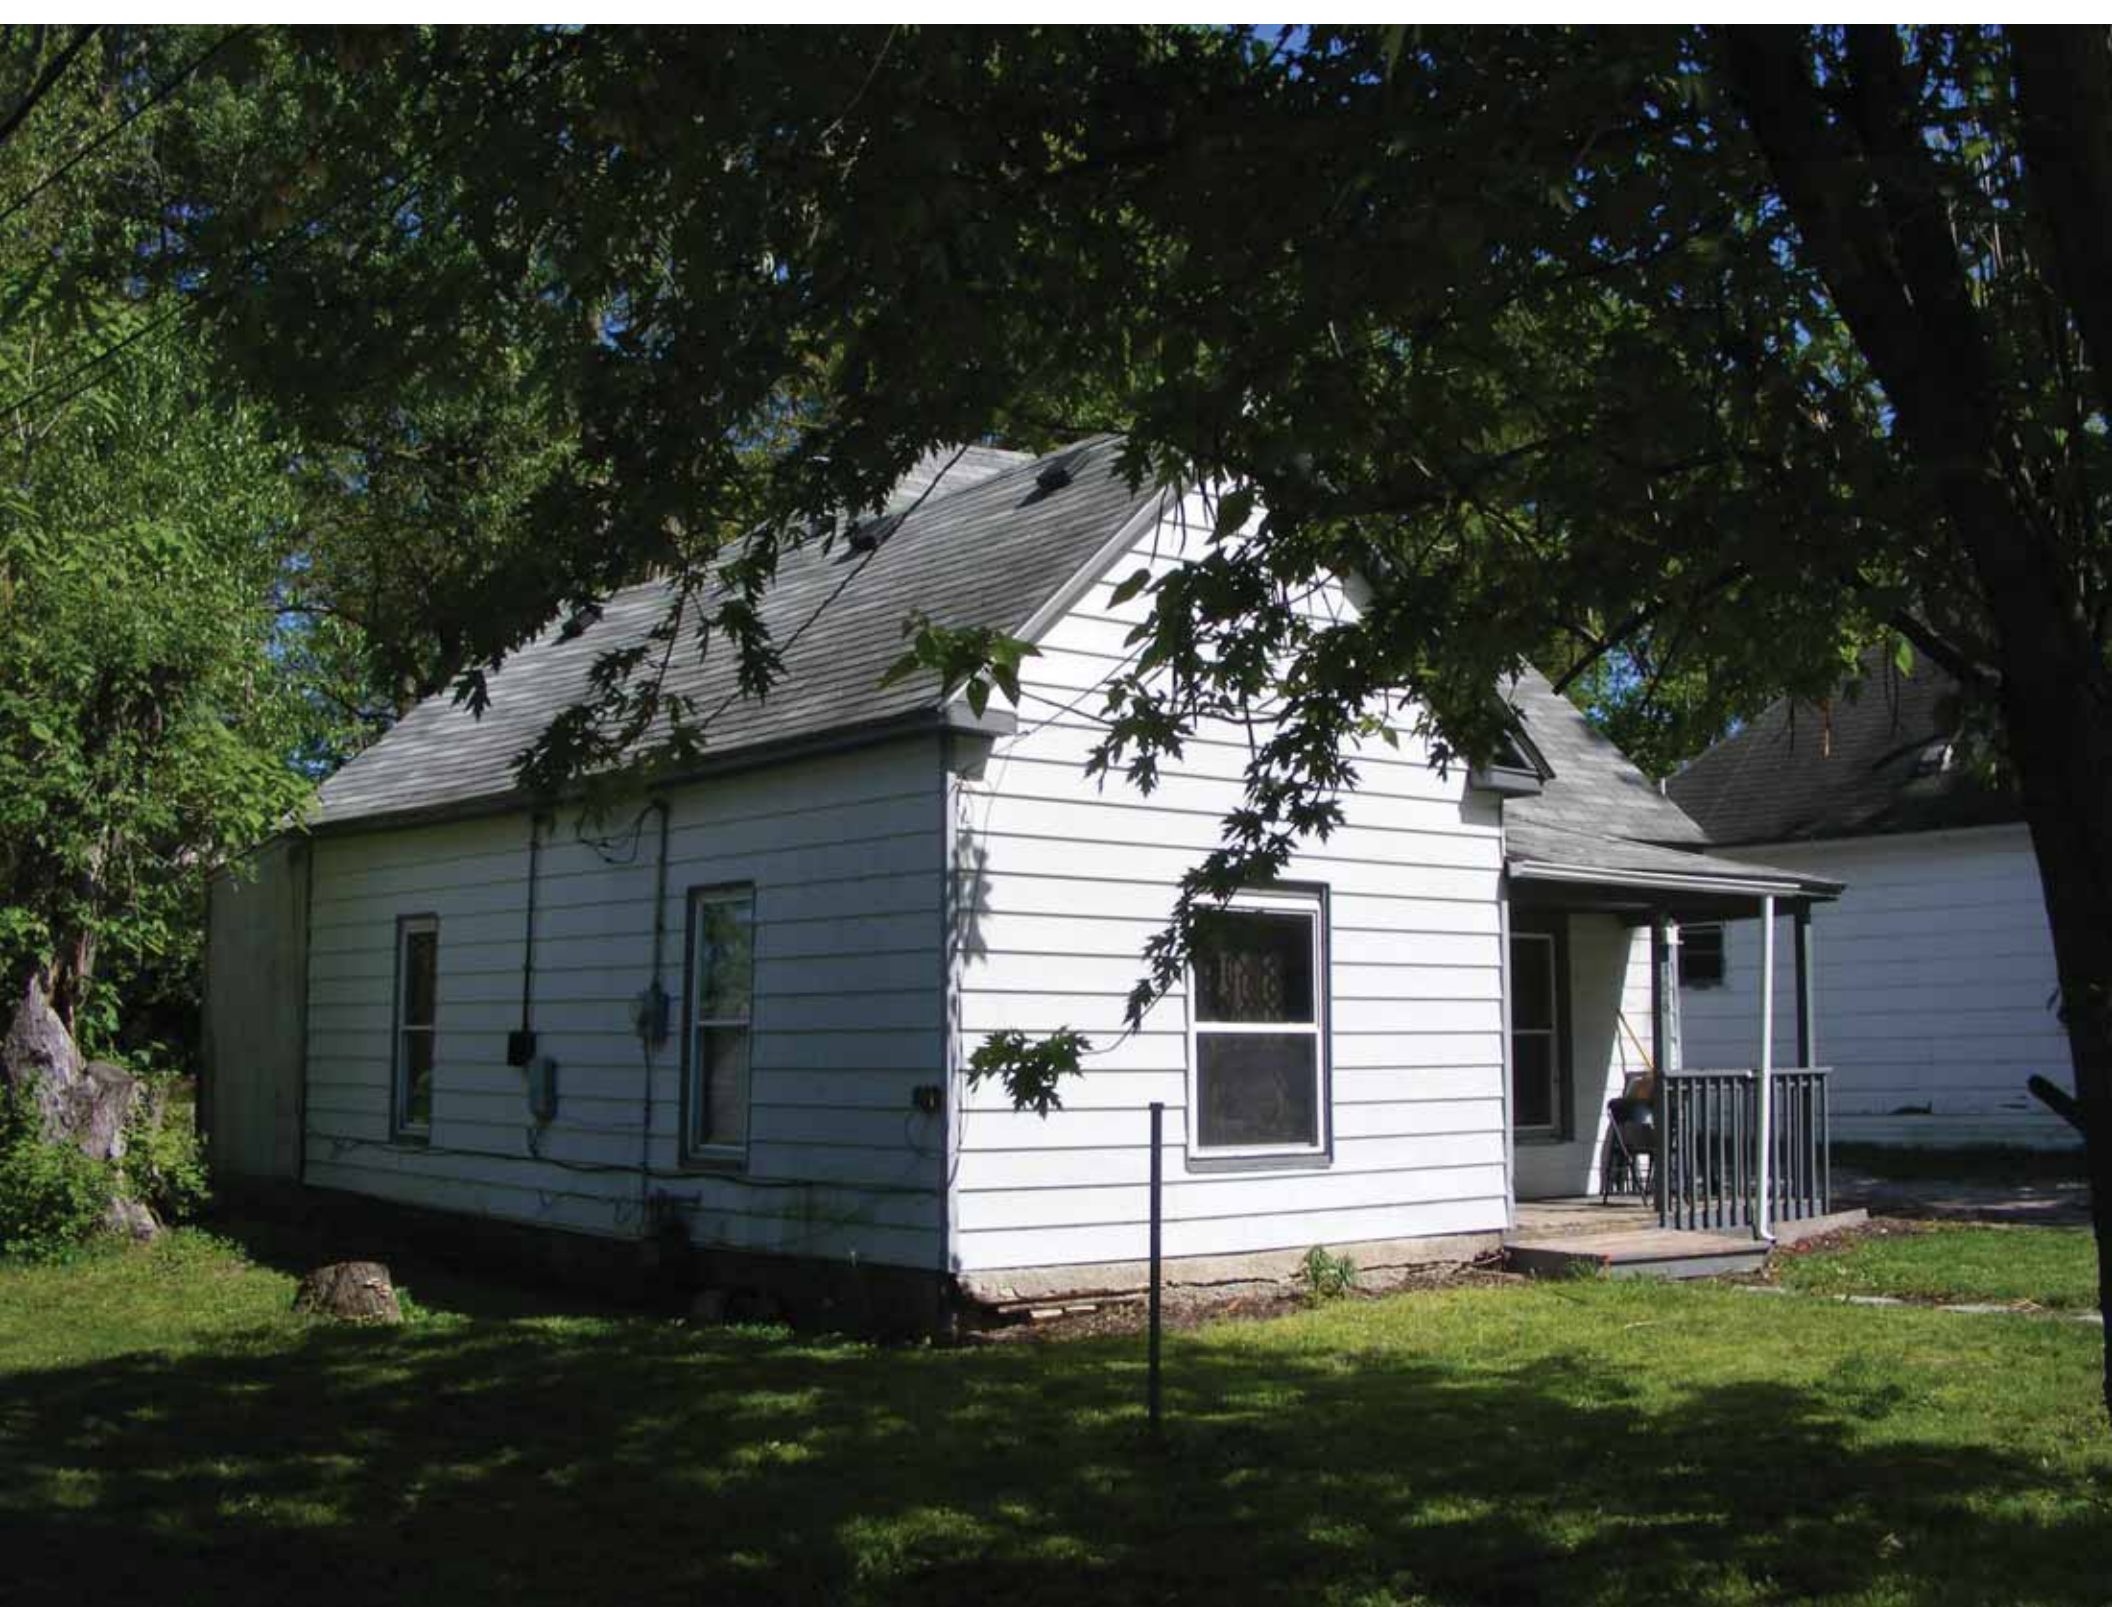
41. (cont.) Description of primary resource. Expand box as necessary, or add continuation pages.
The dwelling is a single-story has an asphalt-shingled cross gable on hip wit lower hip (façade porch), vinyl sided and concrete foundation. The façade features a partial-width porch under the lower hip supported by wood post with rood railings and decking. Entrance is at the "L" and offset to the right by a one-over-one window. Front gable holds a one-over-one window. Side elevations holds one-over-one windows. The south elevation a stoop side entrance.

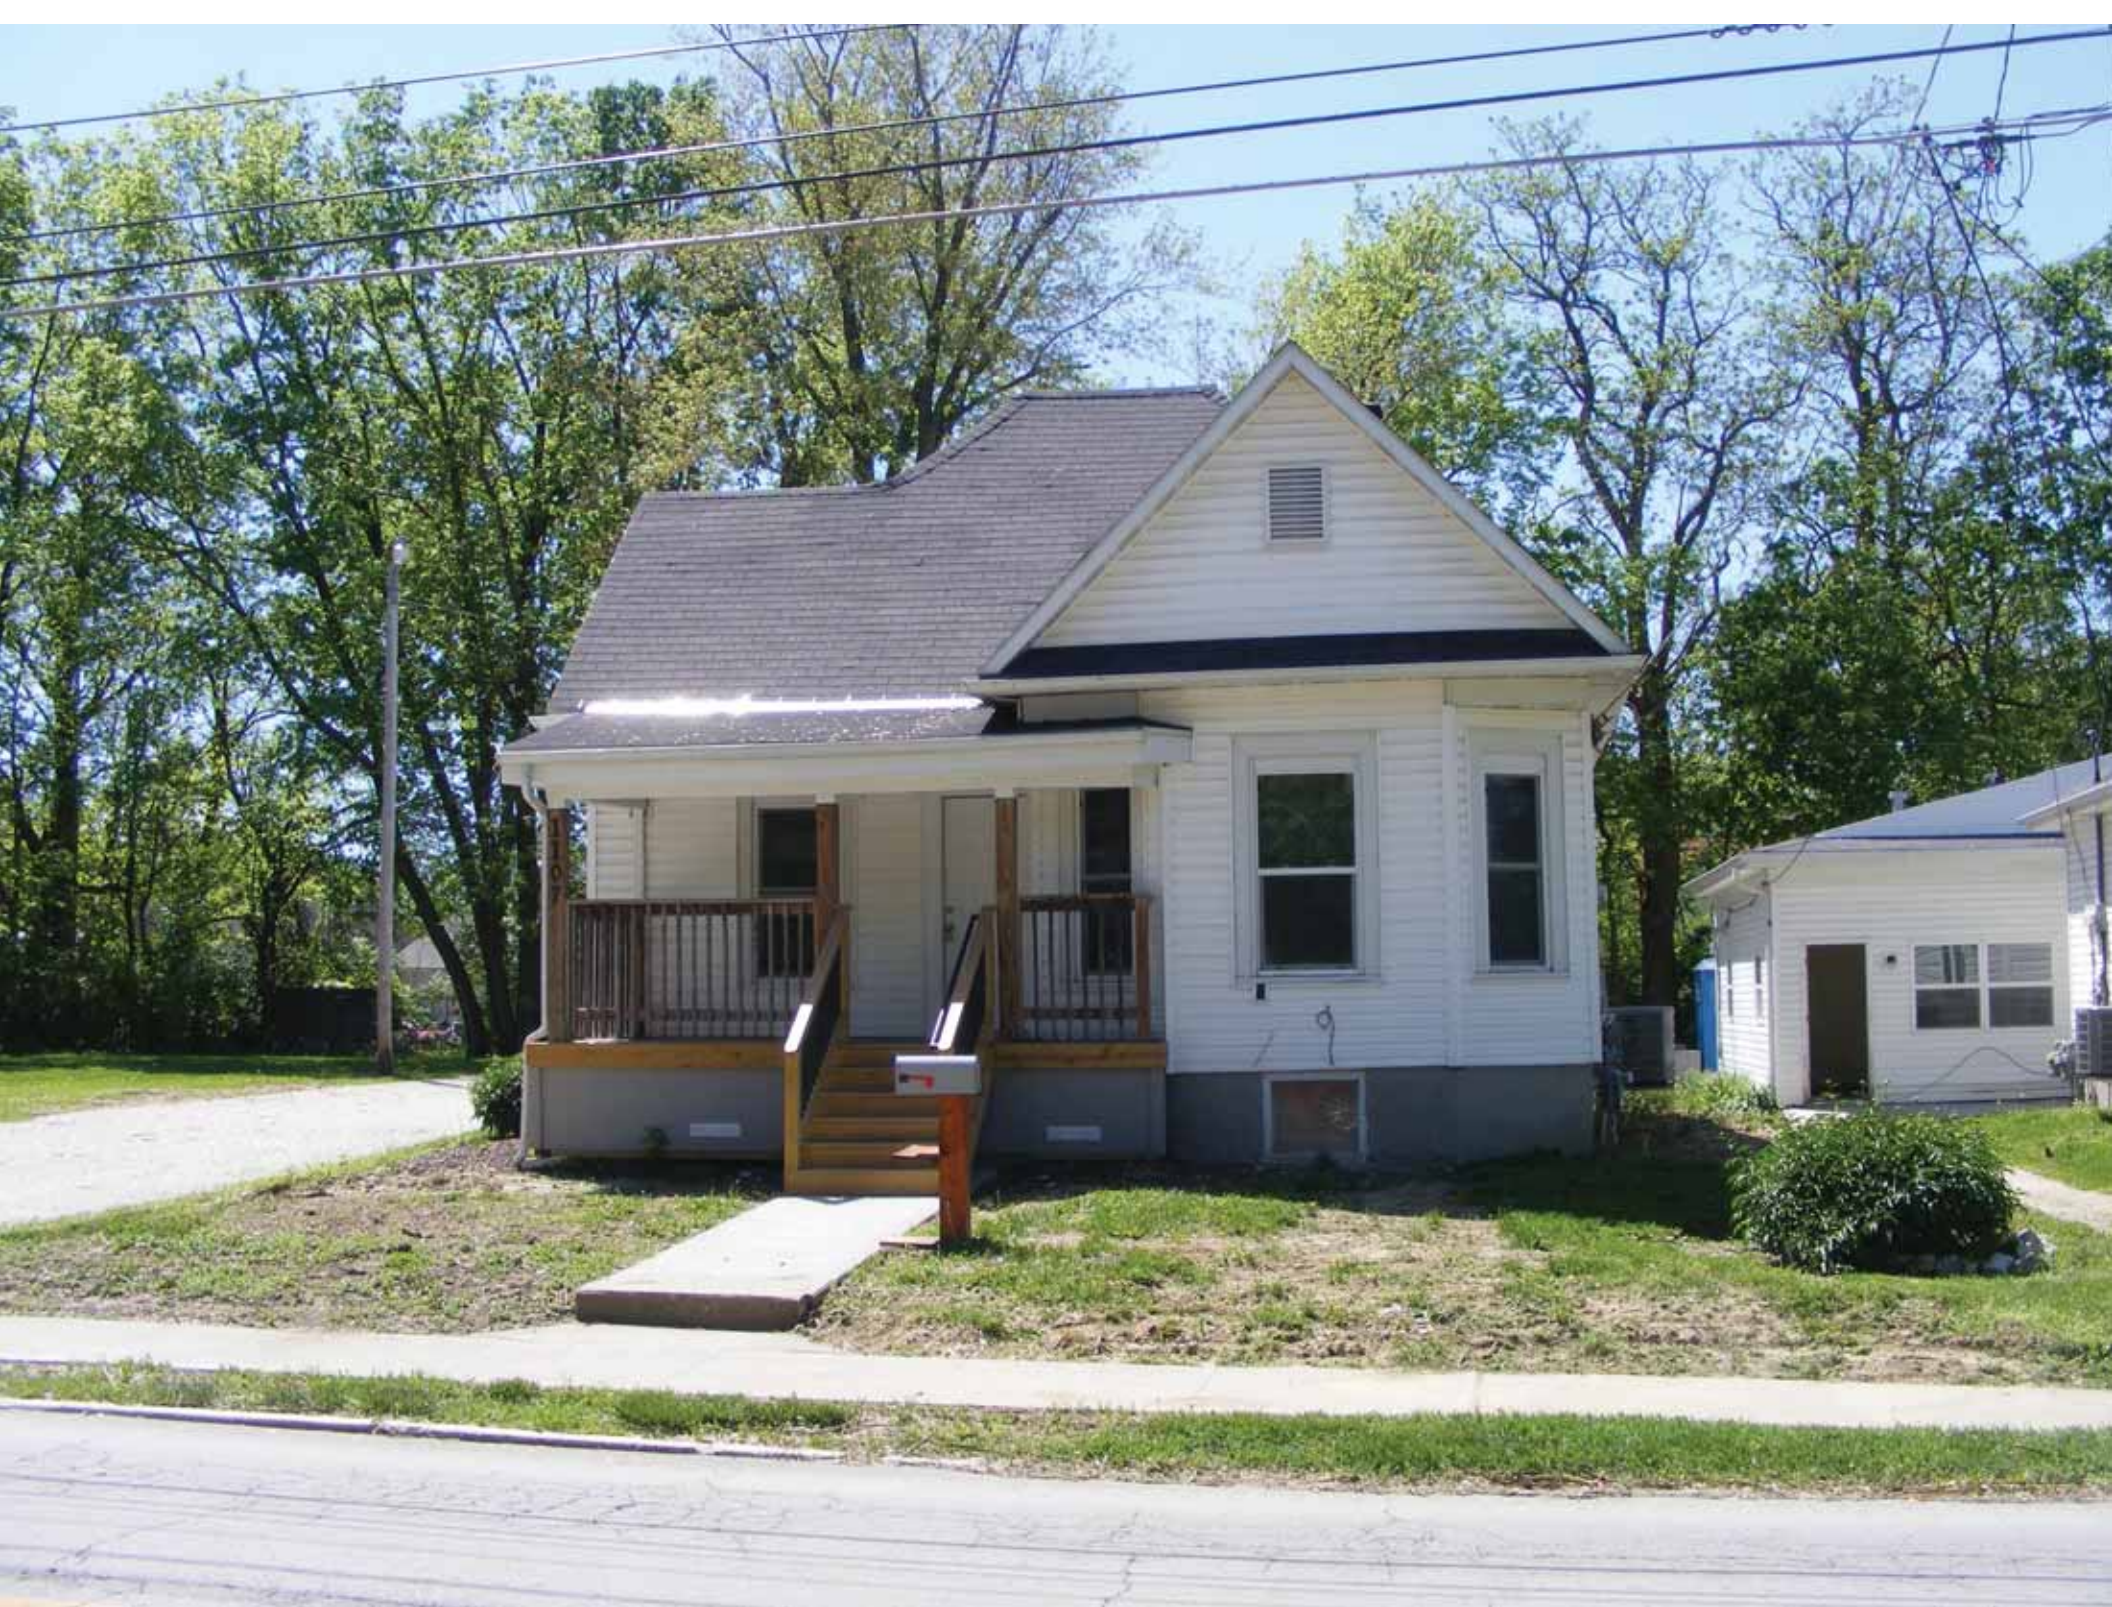
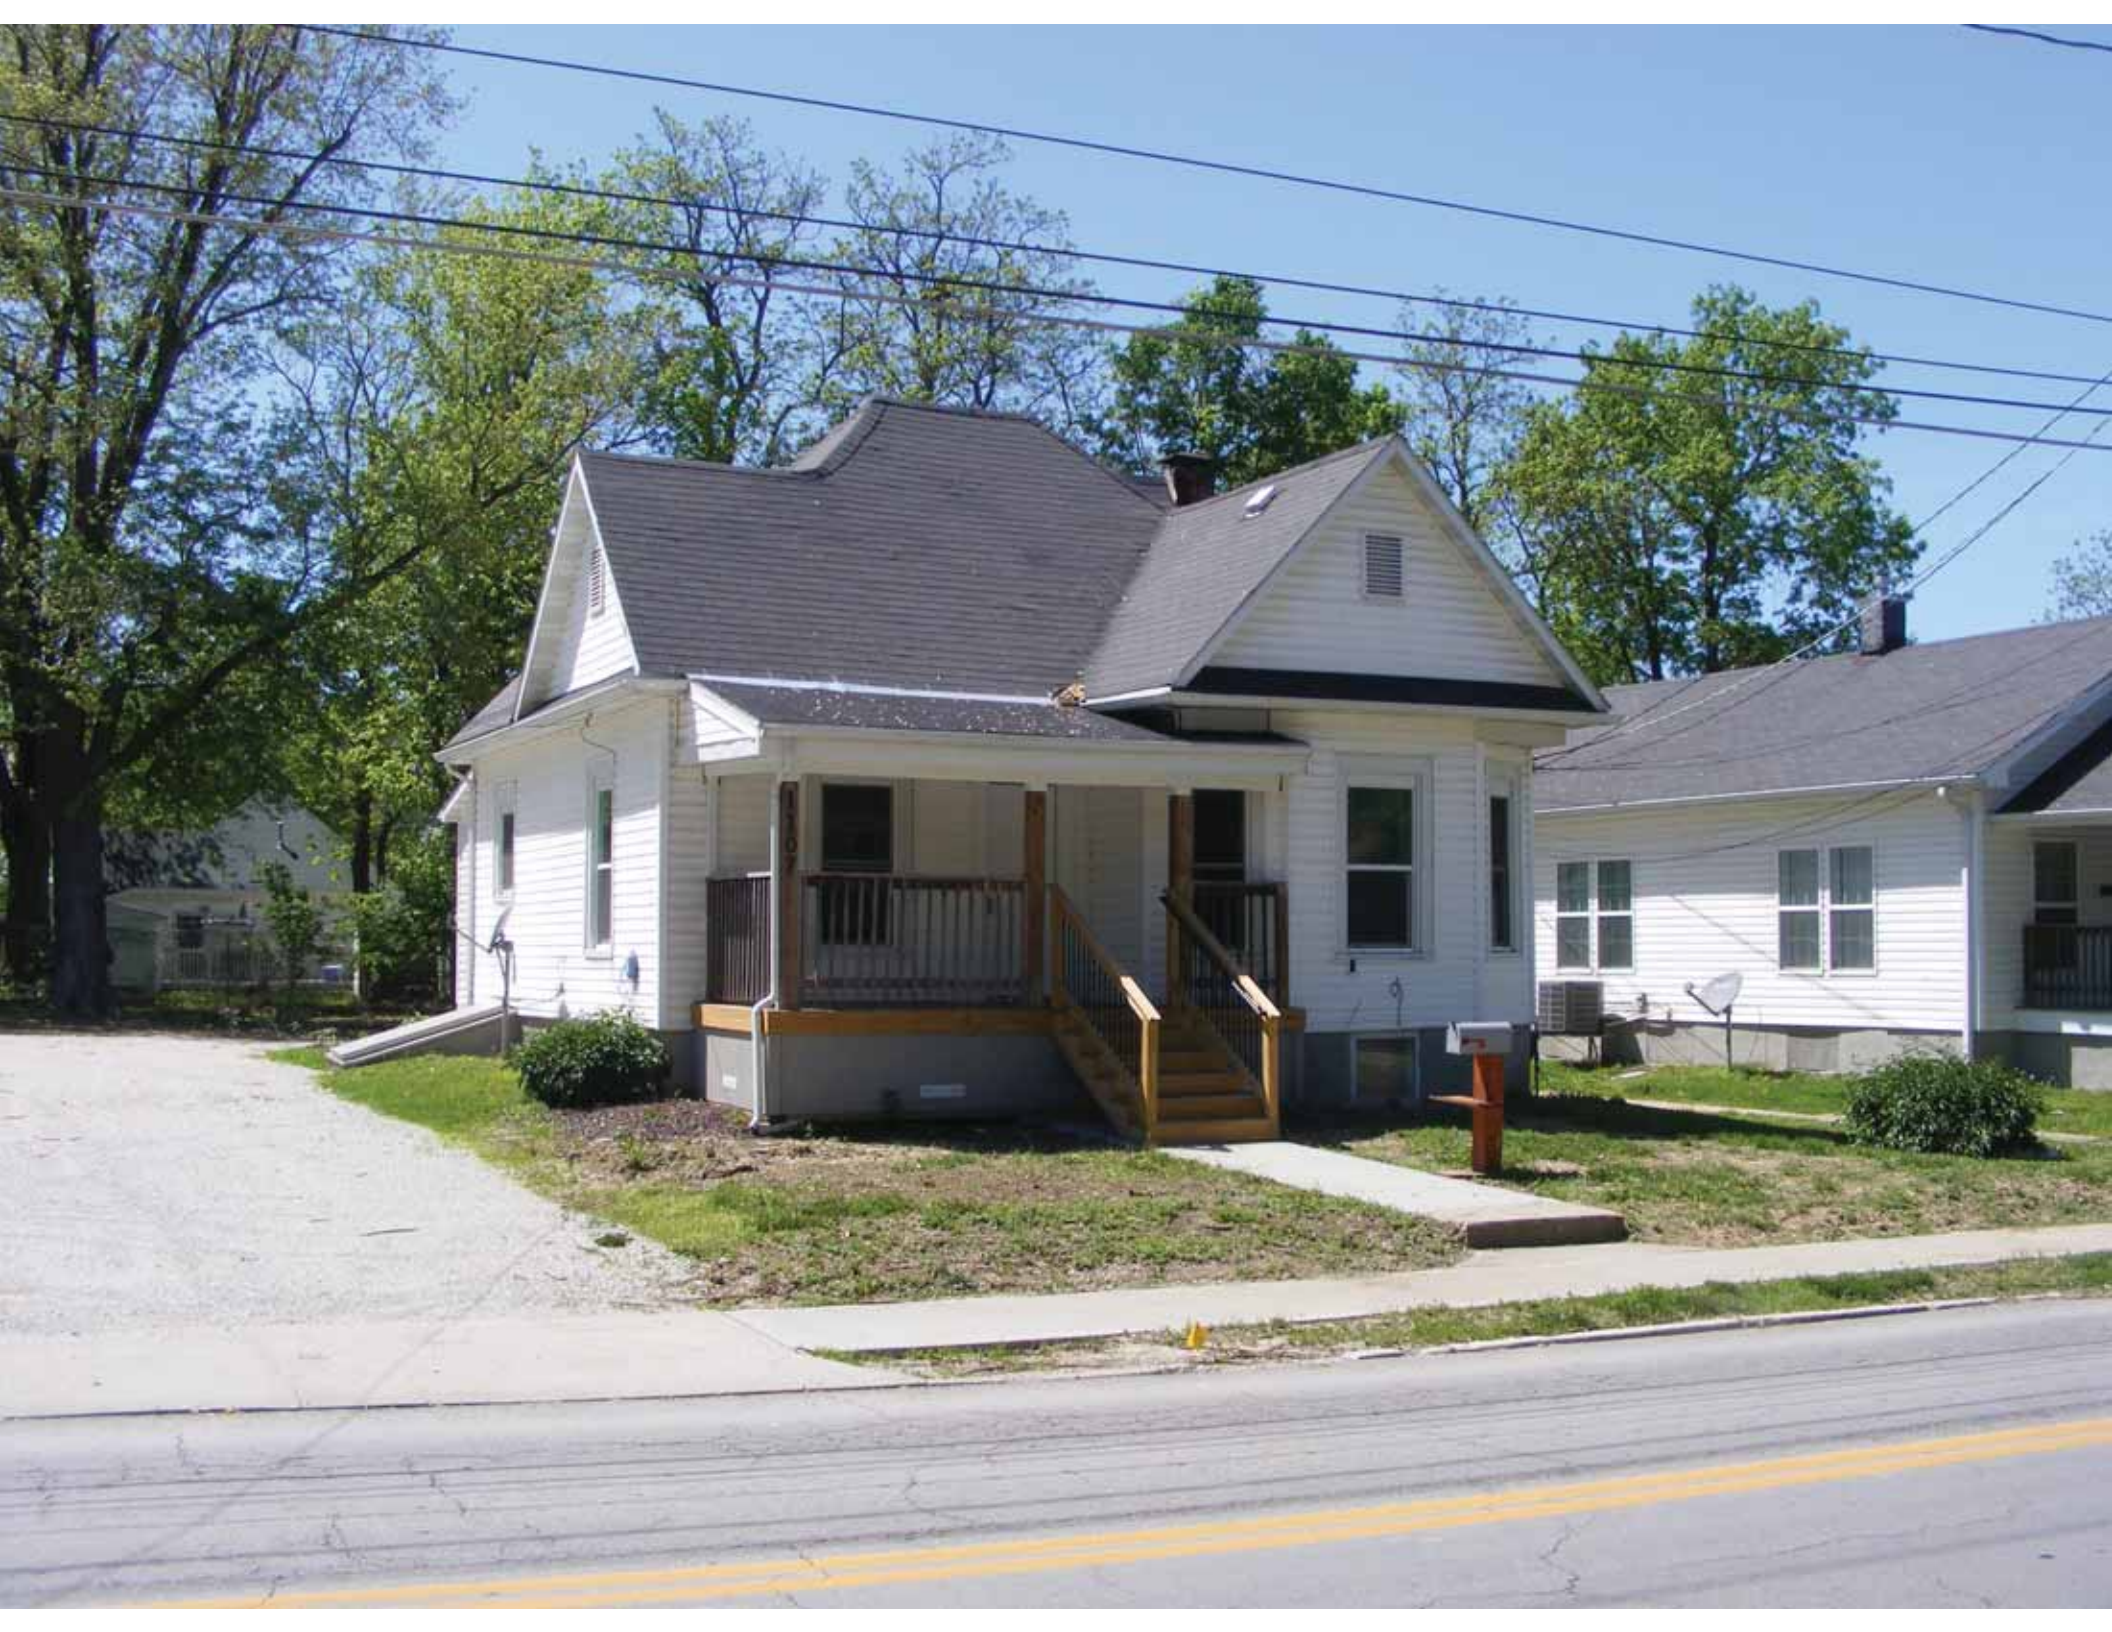
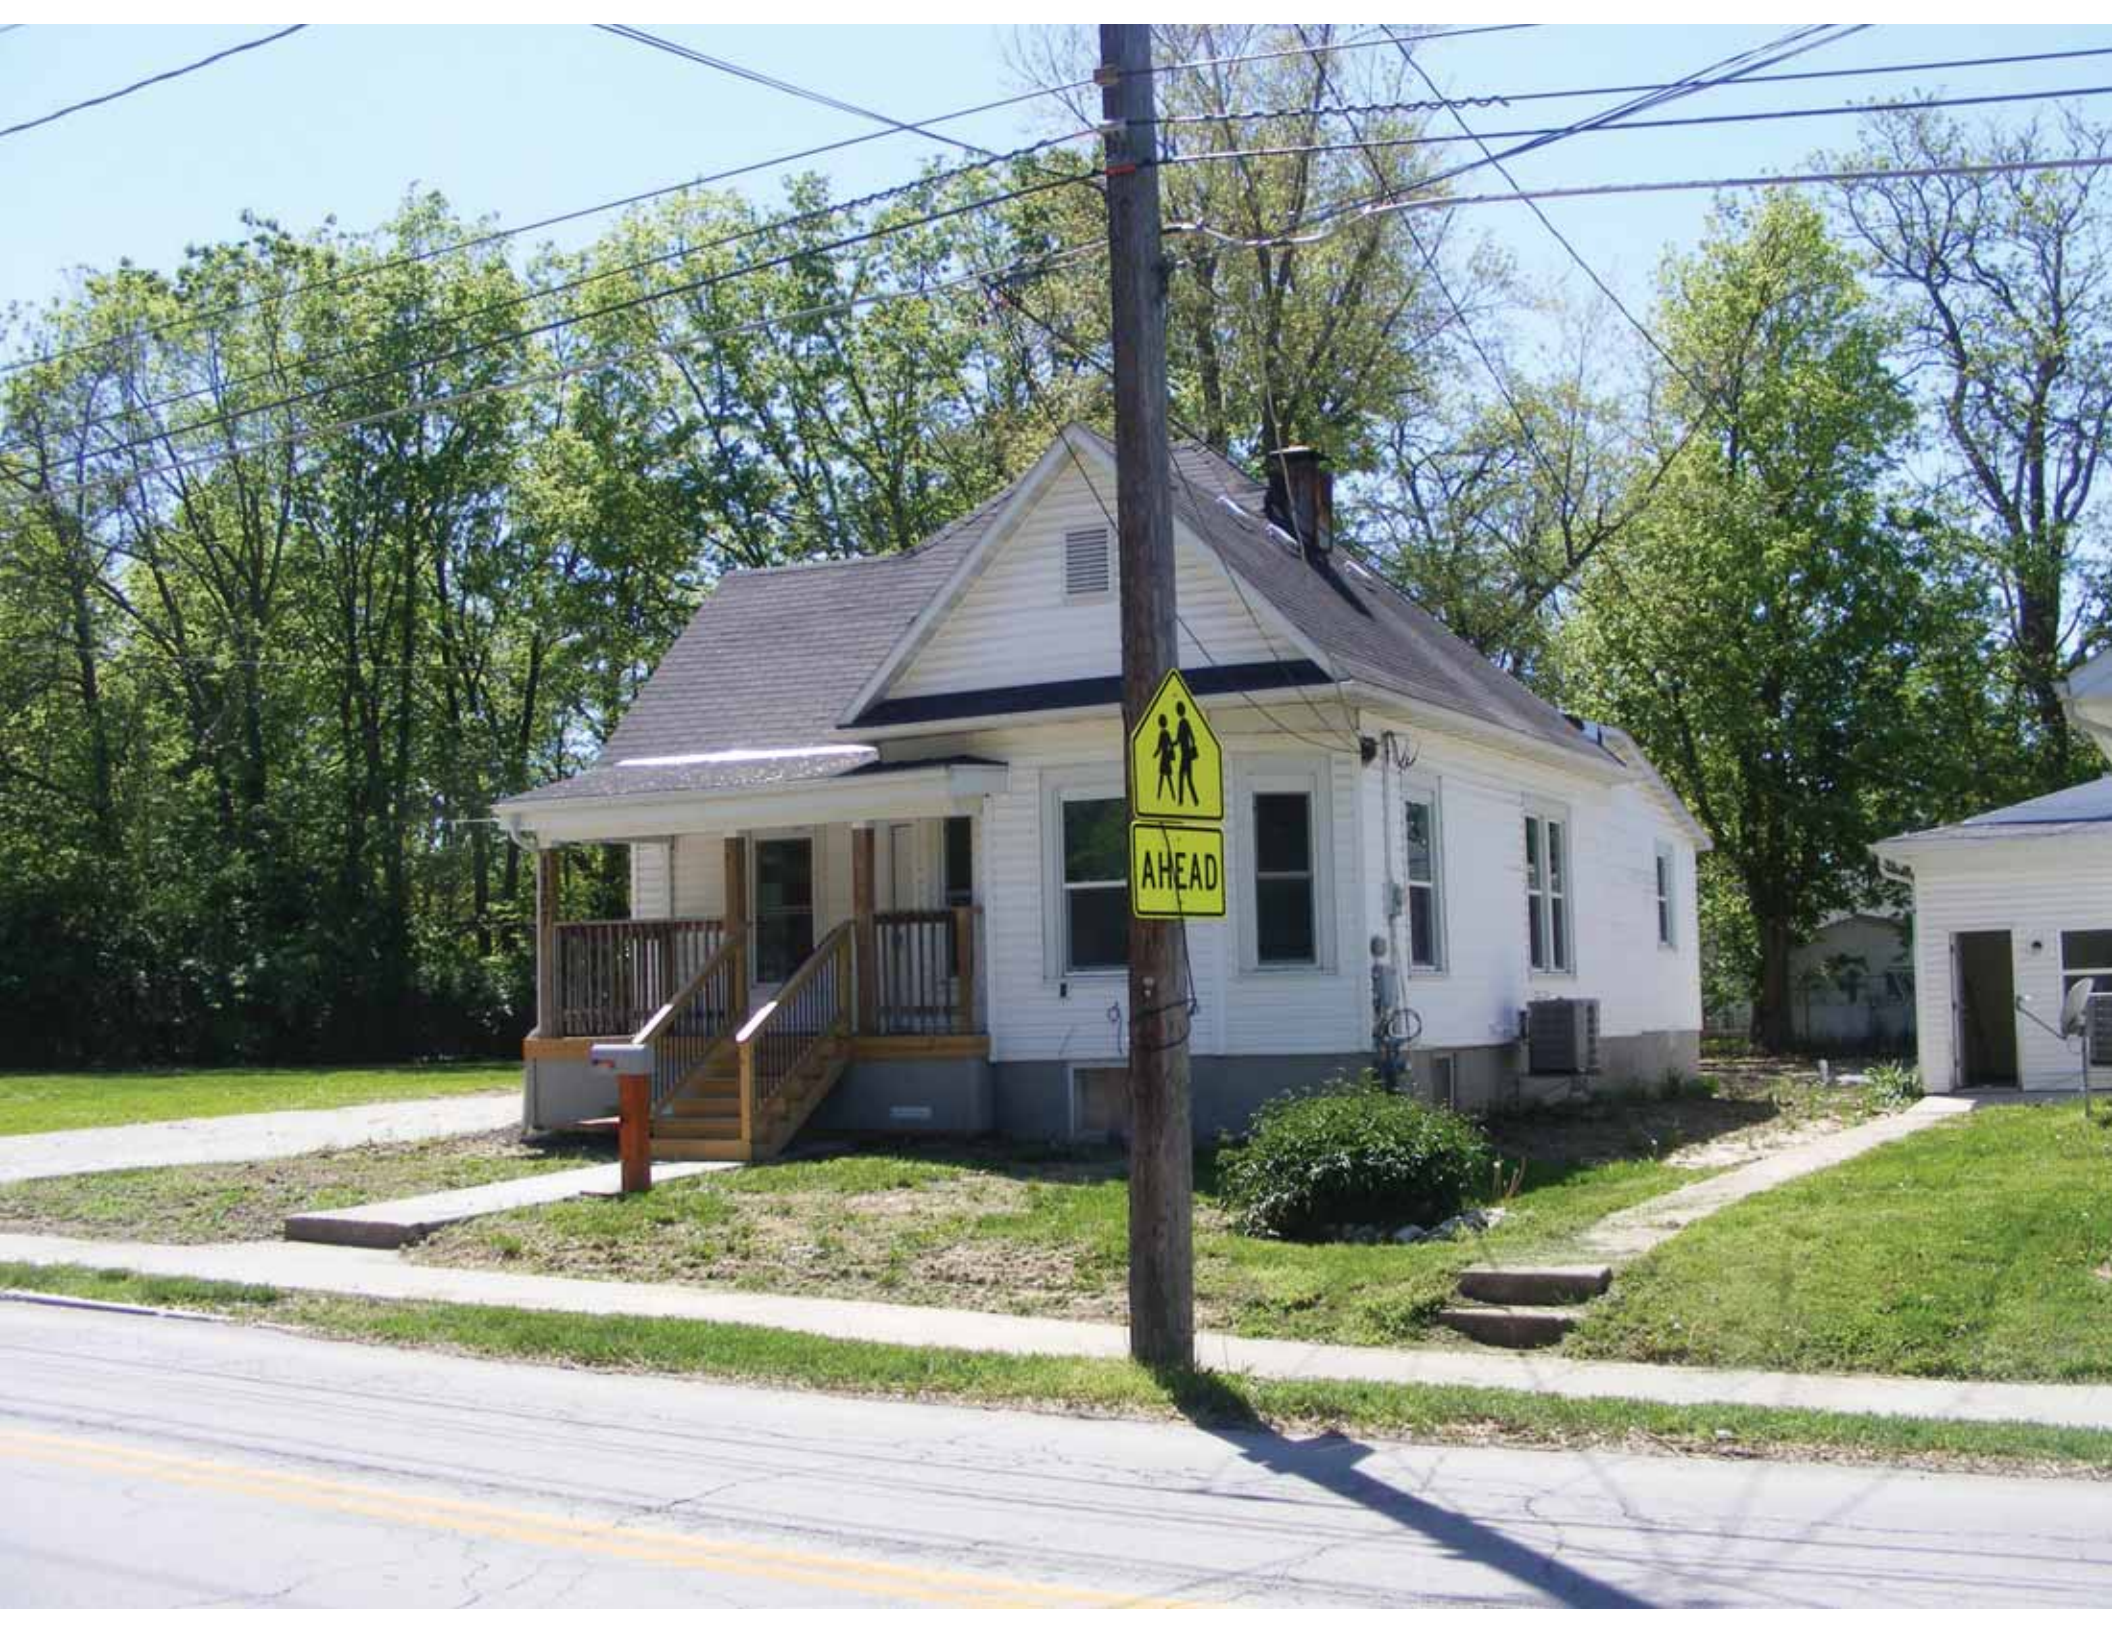
The dwelling has a cross-gabled roof with a central hip. The roof is covered with asphalt shingles and an interior brick chimney is noted near the north elevation. The exterior is clad with synthetic siding and the foundation is poured concrete and raised, supporting fixed sash basement windows. Windows throughout the dwelling otherwise are one-over-one replacement. The primary (east) elevation supports a shed off-center porch with replacement wood columns and a contemporary balustrade/handrail (also wood). Within the porch bay is a c. 2015 paneled door offset by a one-over-one window. The north end of the façade supports a projecting gabled wing with a projecting window bay below the gable overhang. The gable field holds a louvered vent. The window bay has one window on each exposed wall (southeast, east and northeast). At the base of the south elevation is a cellar entry.
