MISSOURI DEPARTMENT OF NATURAL RESOURCES
STATE HISTORIC PRESERVATION OFFICE, P.O. Box 176, Jefferson City, MO 65102
ARCHITECTURAL/HISTORIC INVENTORY FORM

1. Survey No. BO-AS-011-0087		2. Survey name: North Central Columbia Survey Phase II	
3. County: Boone		4. Address (Street No.) 902	Street (name) N. Seventh Street
5. City: Columbia	Vicinity: <input type="checkbox"/>	6. Geographical Reference:	7. Township/Range/Section: T: R: S:
8. Historic name (if known):		9. Present/other name (if known):	
10. Ownership: <input checked="" type="checkbox"/> Private <input type="checkbox"/> Public		11a. Historic use (if known): Domestic/single dwelling	11b. Current use: Domestic/single dwelling

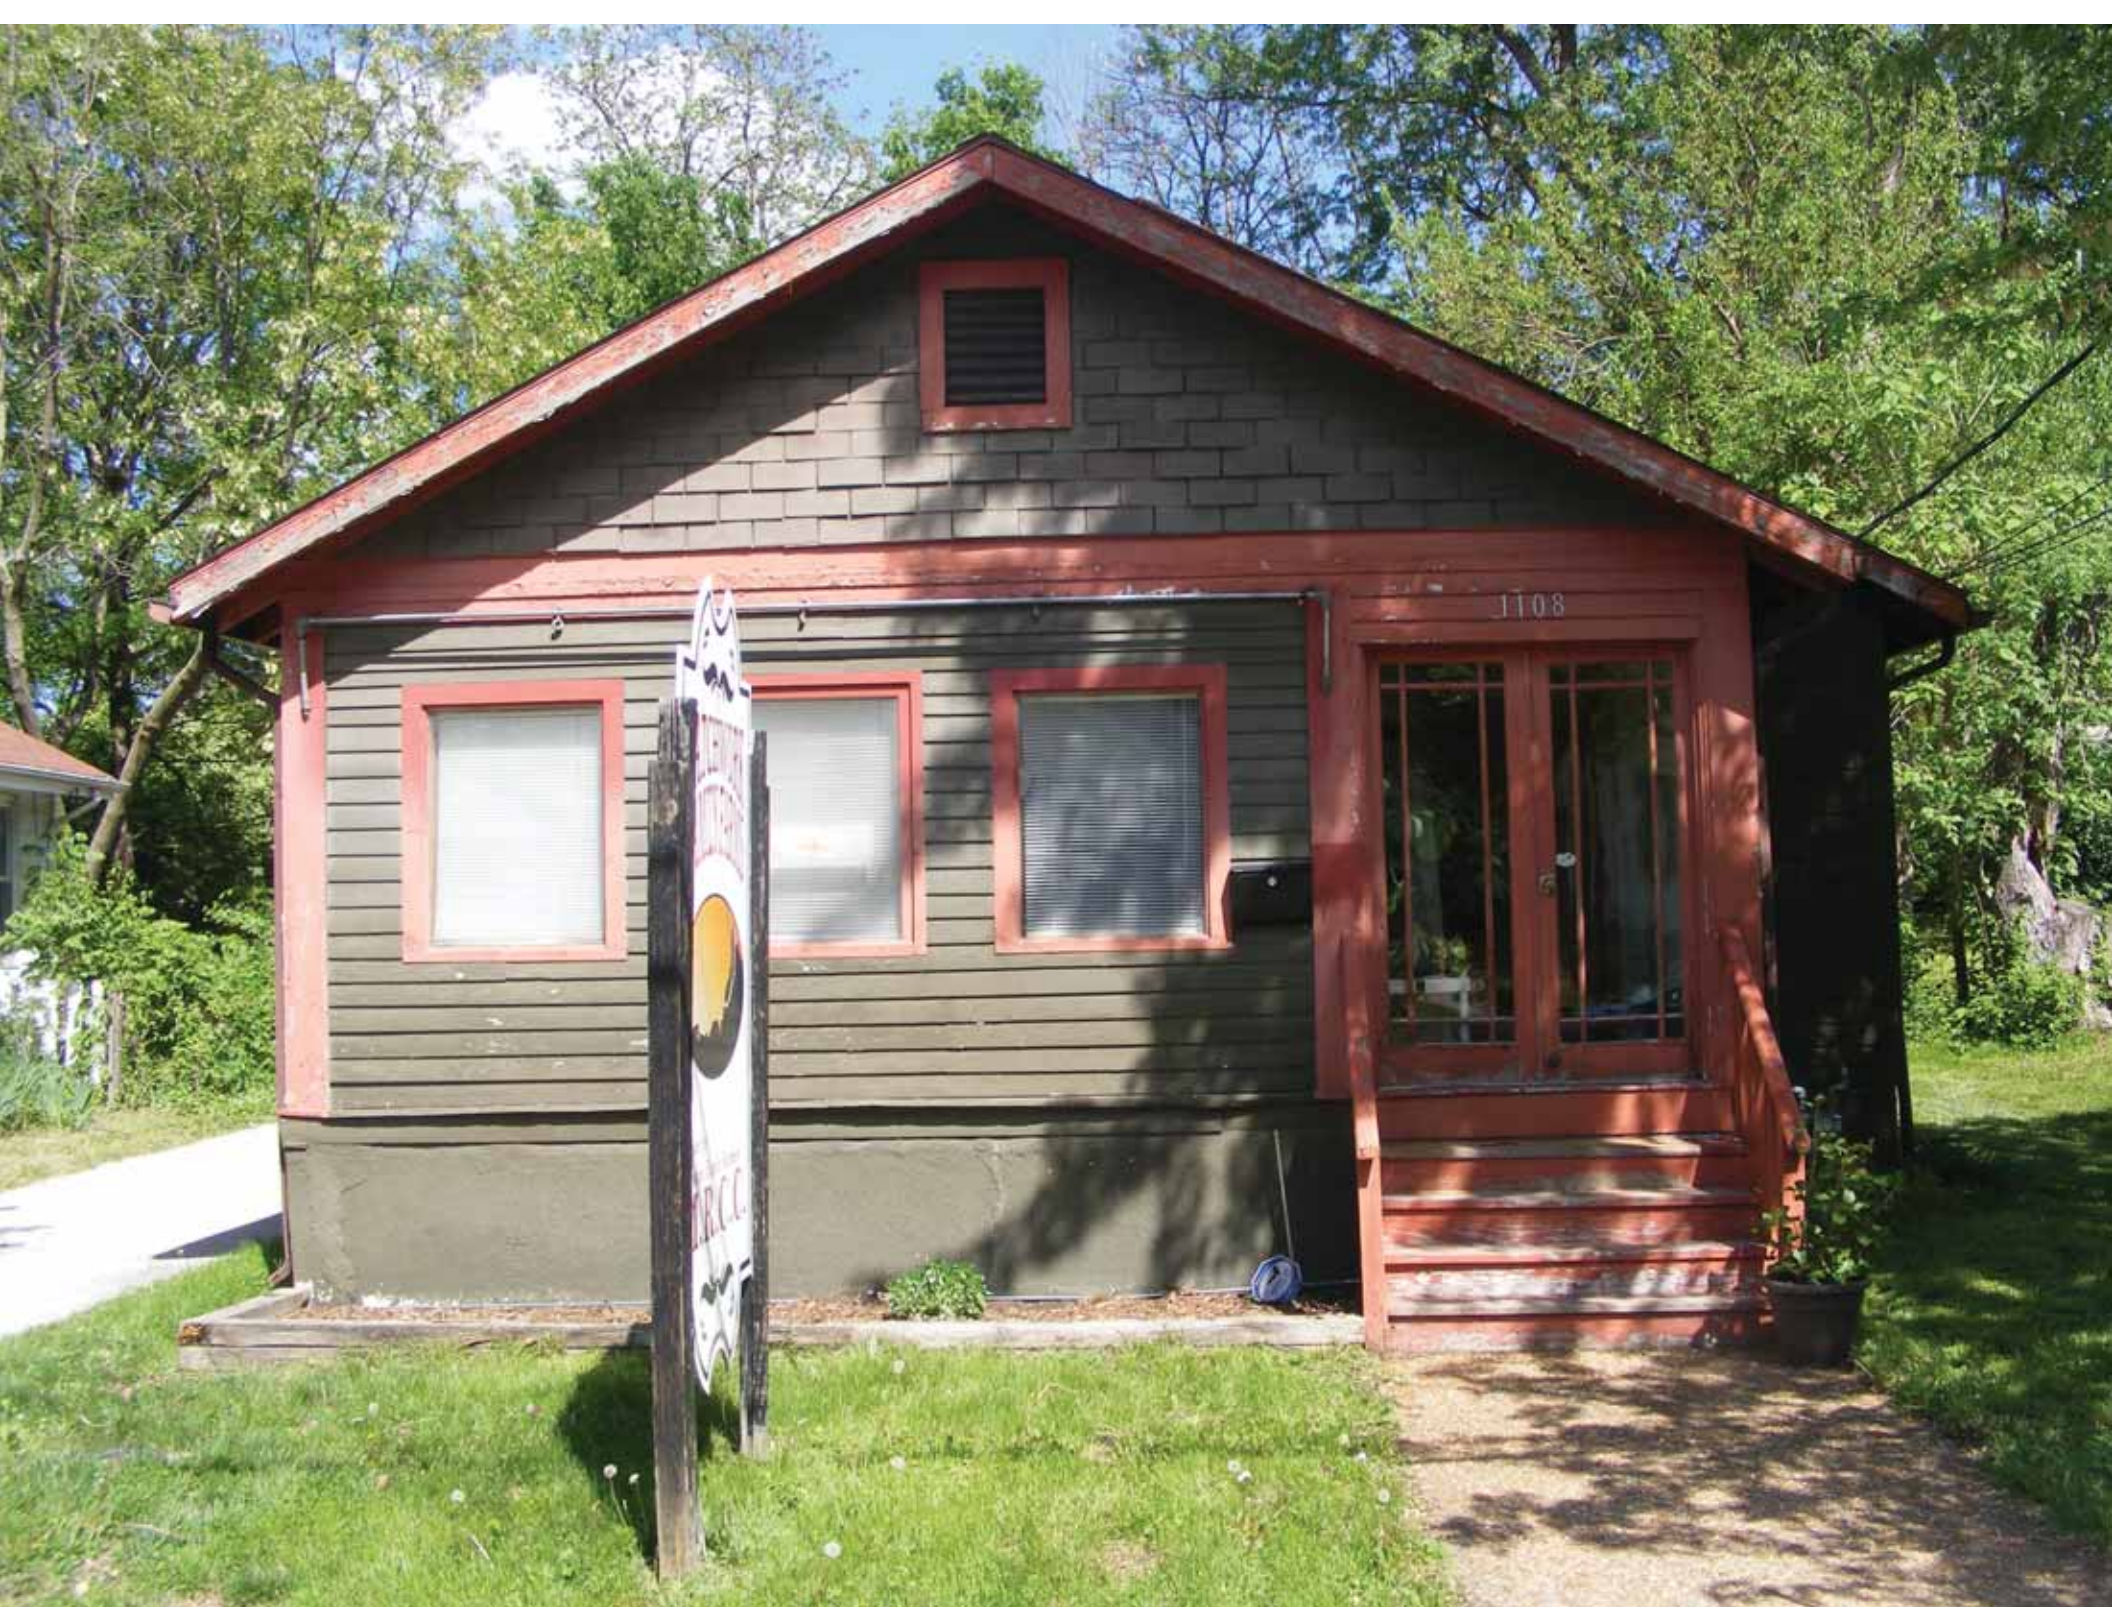
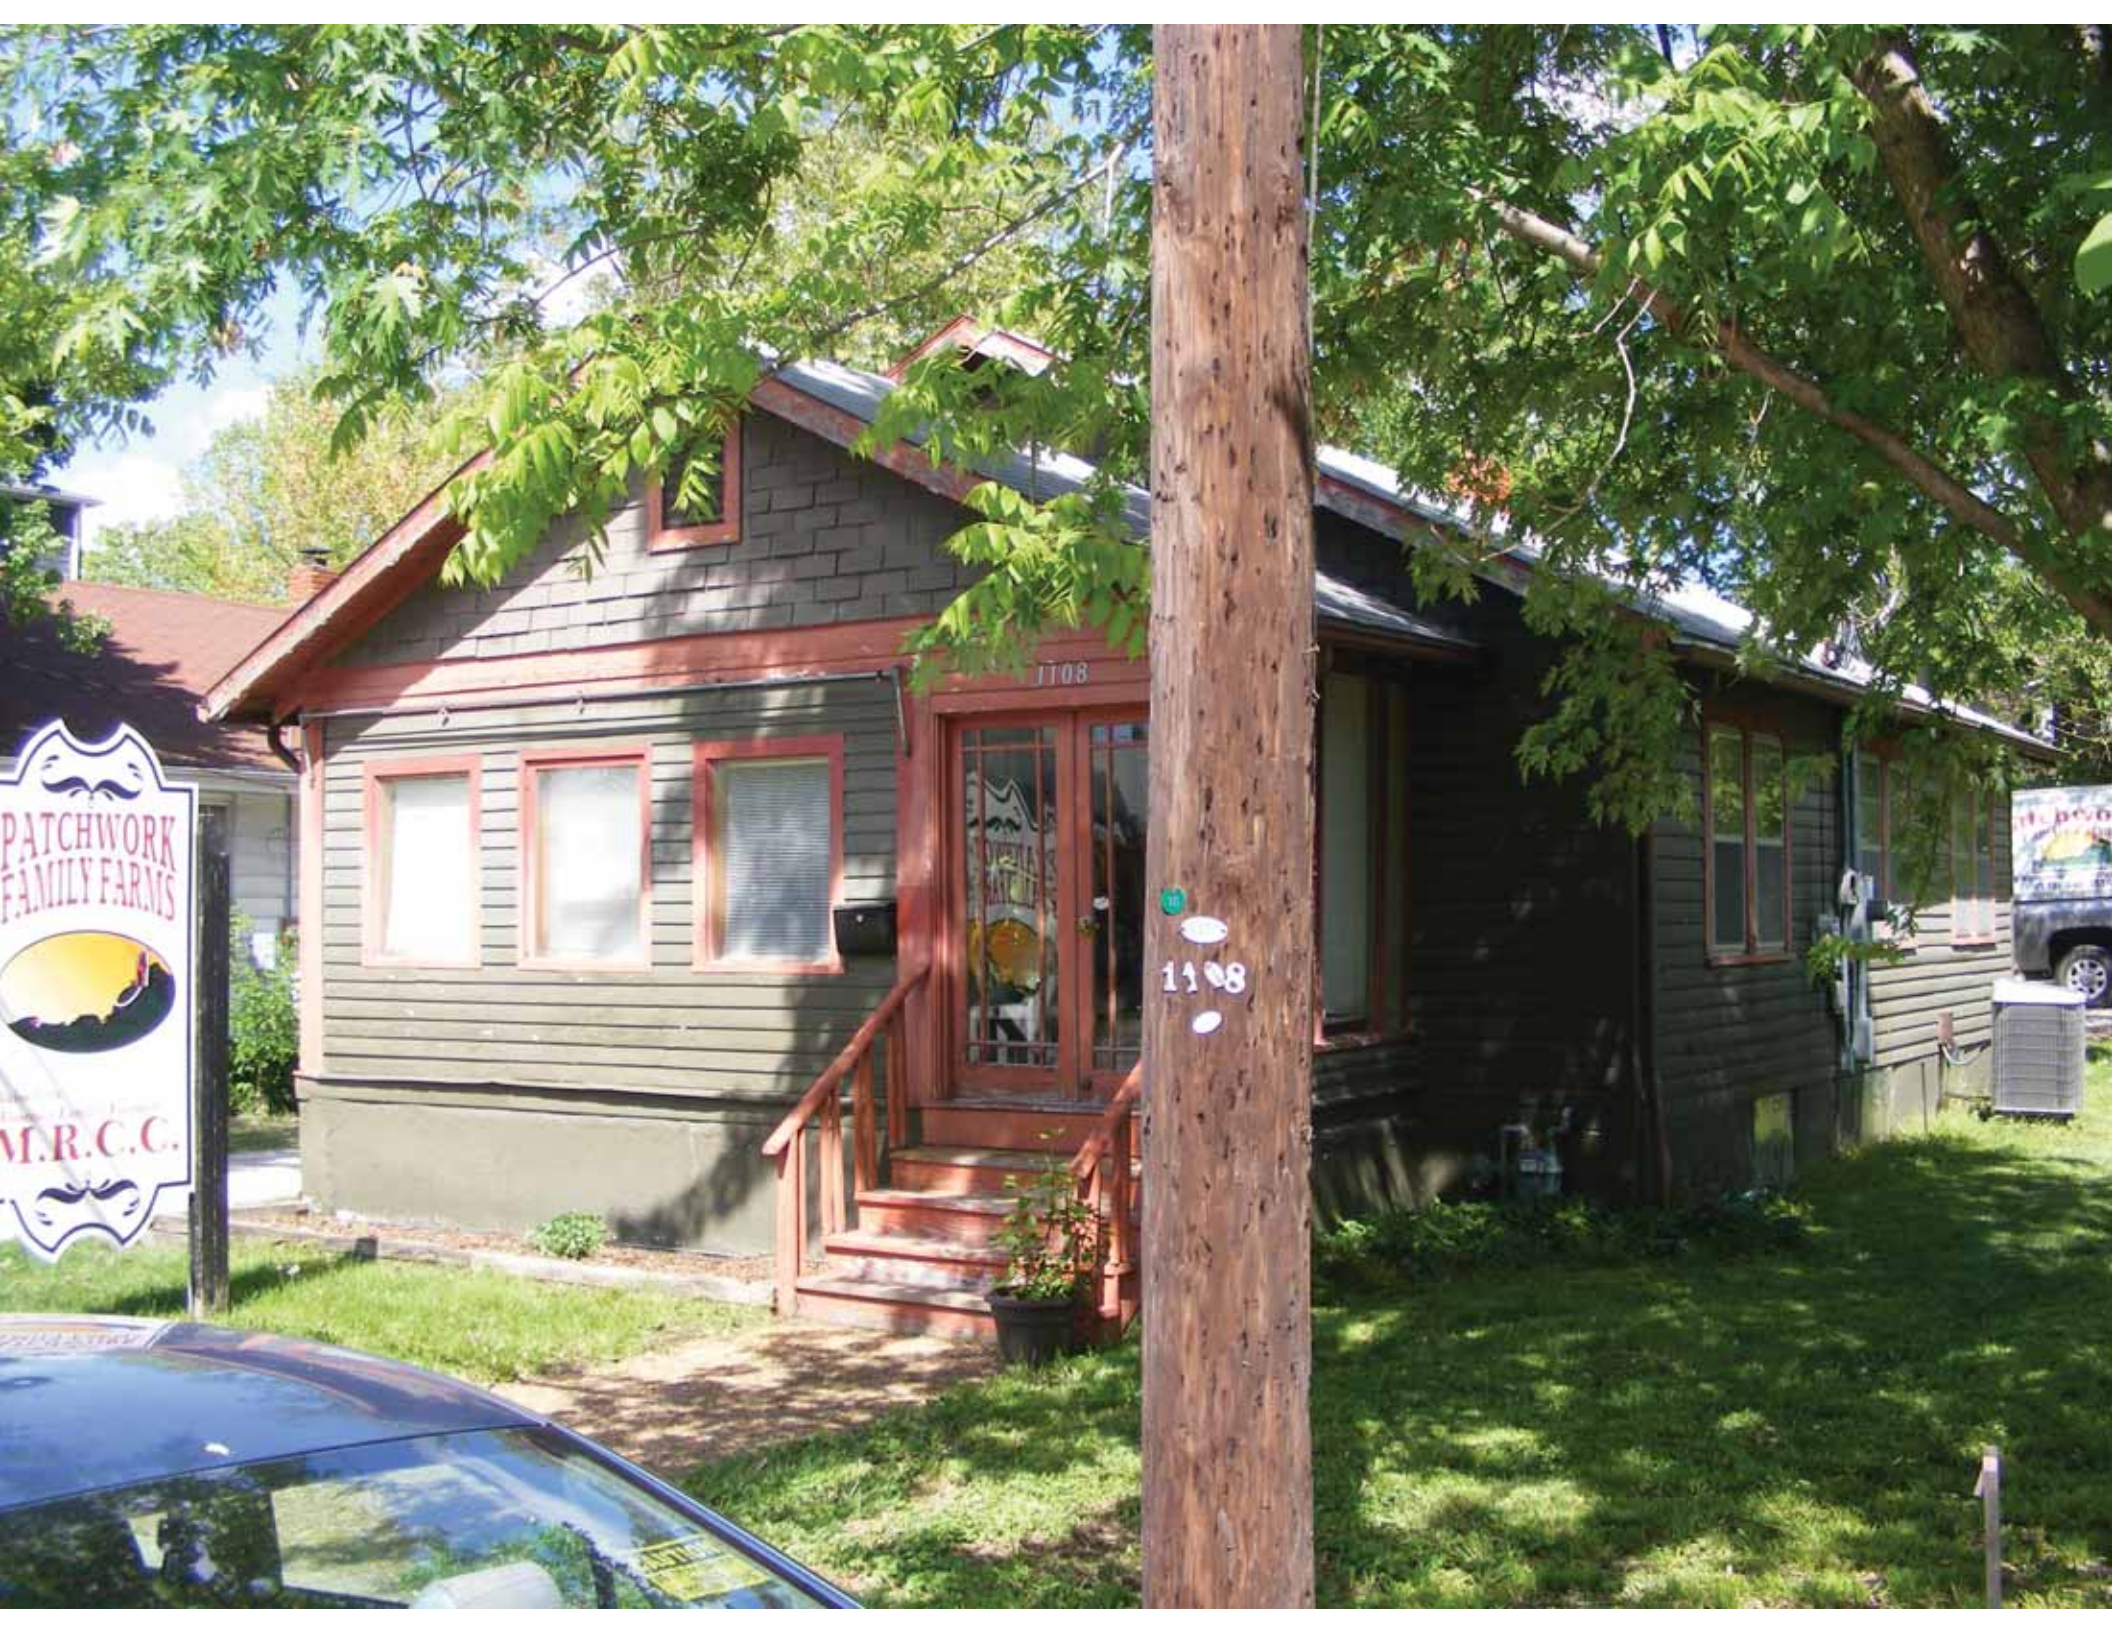
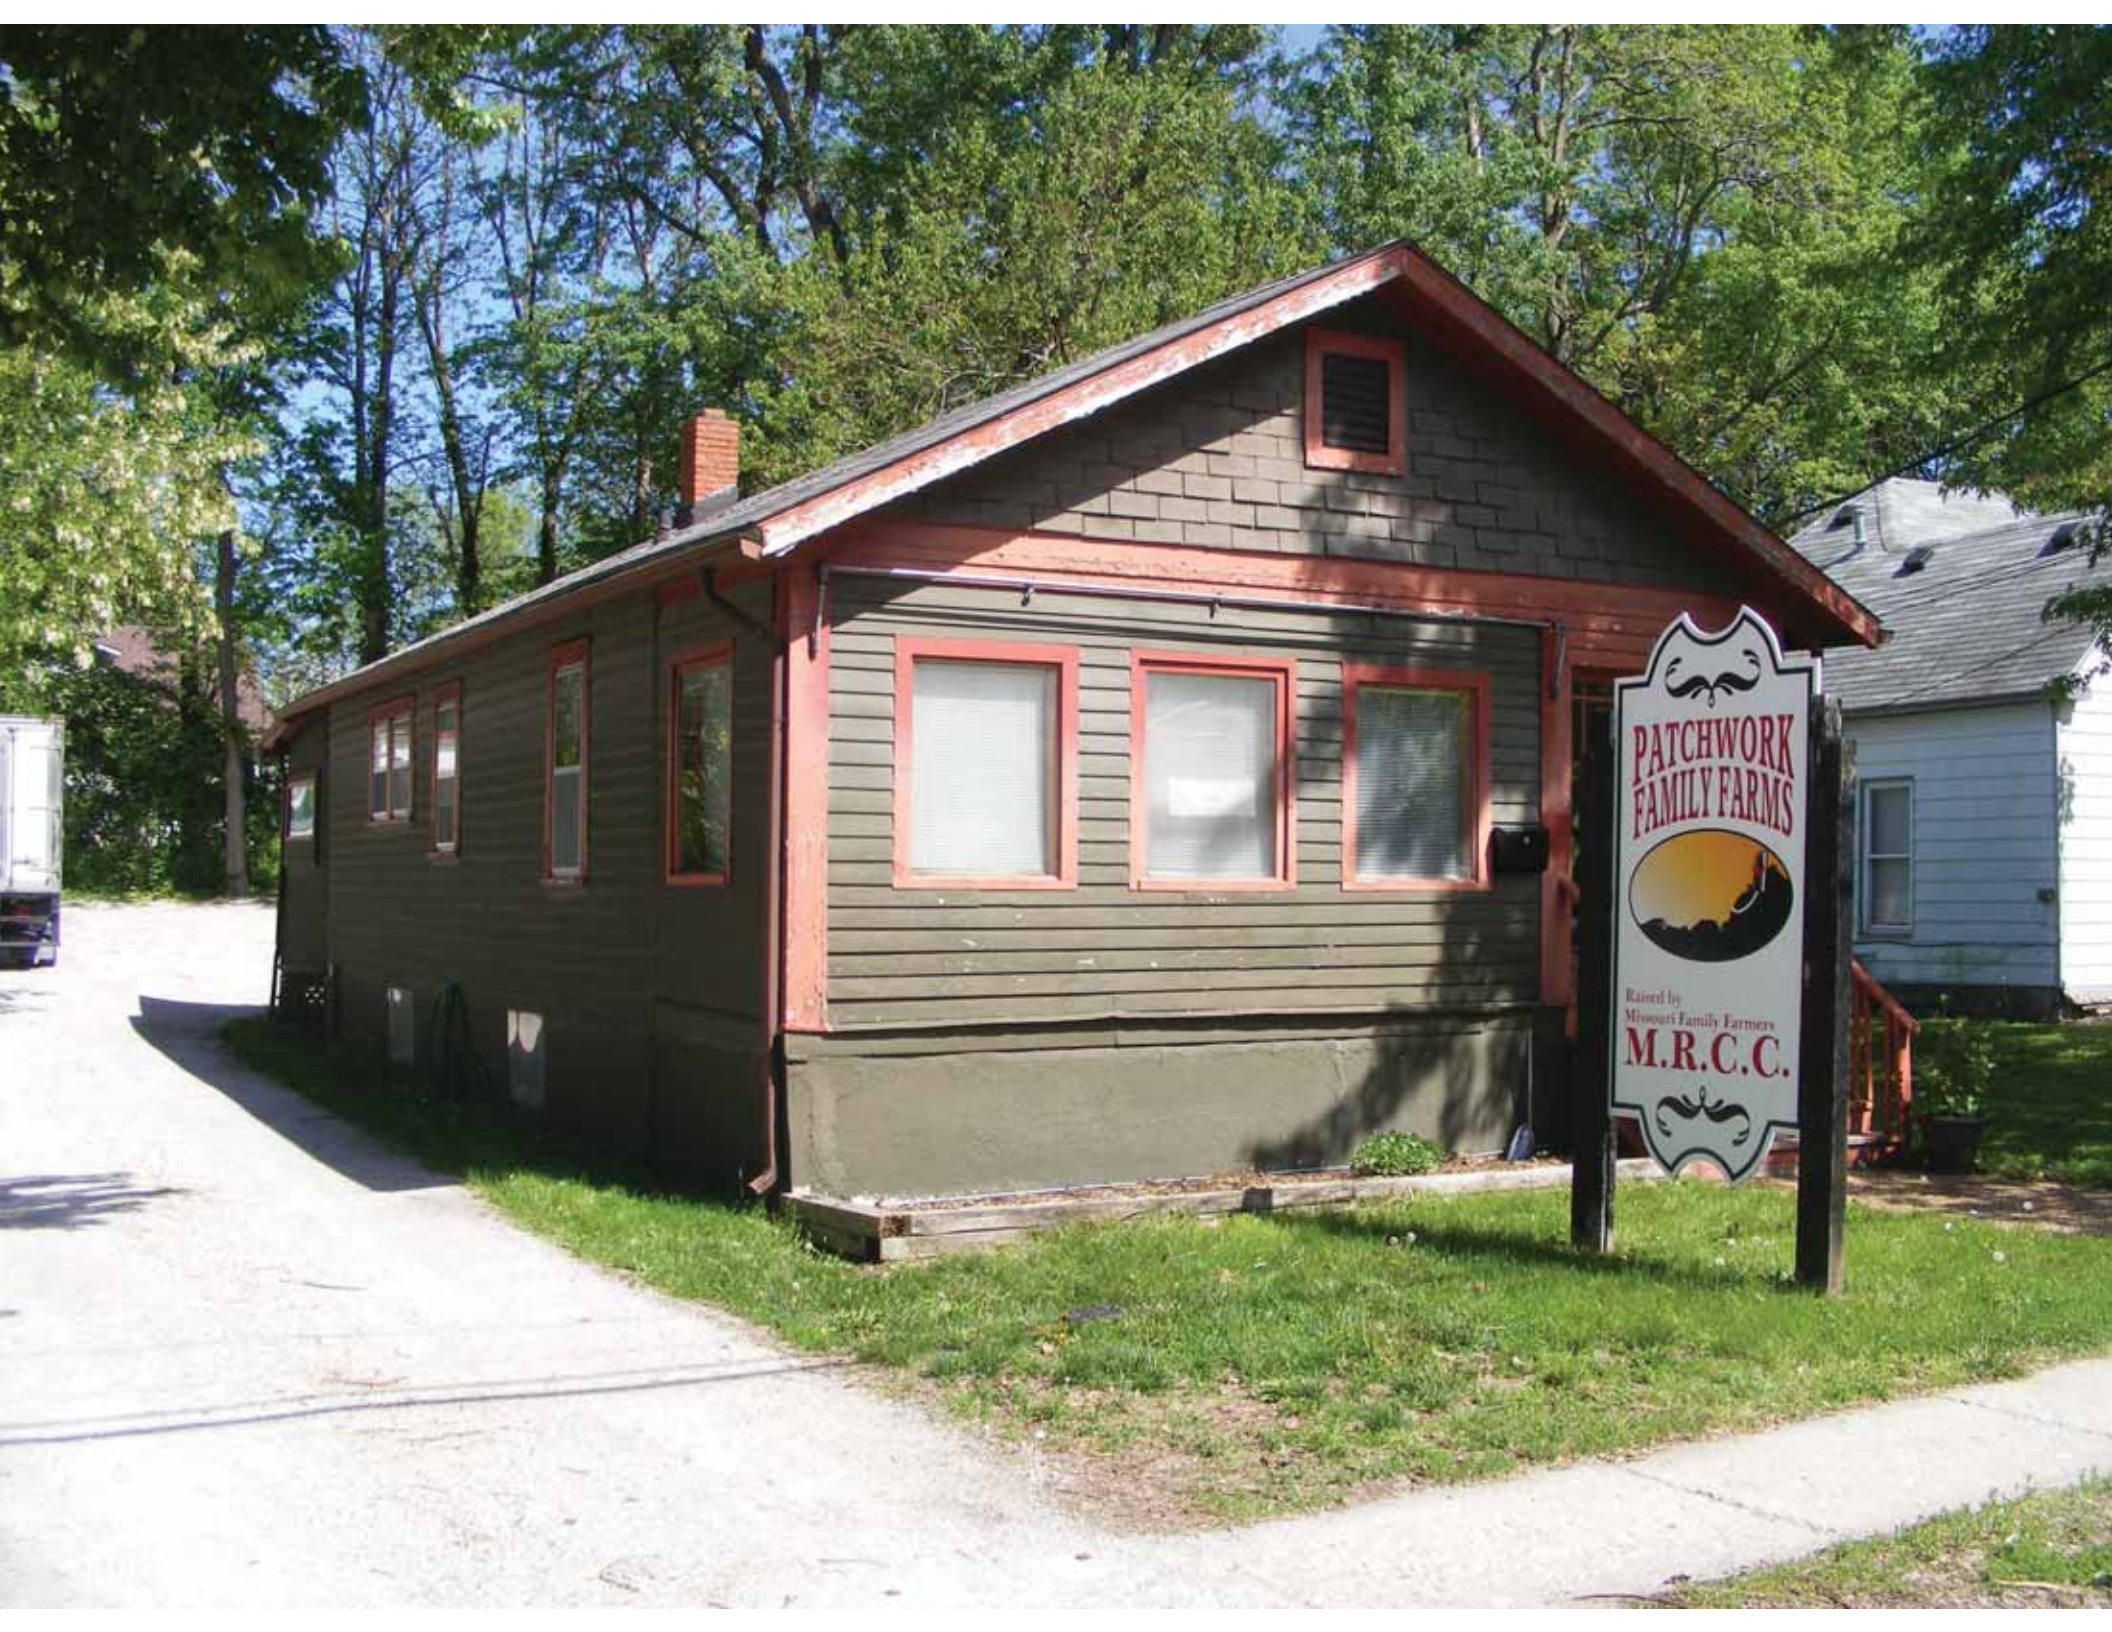
1108

41. (cont.) Description of primary resource. Expand box as necessary, or add continuation pages.
This is a one-story wood sided, asphalt-shingled front gable dwelling that has been converted to commercial use and has a raised concrete foundation. The façade features a wooden stoop with wooden steps and railings and double glass doors (Craftsman style) offset to the left by three fixed windows (non-original). A wooden cornice delineates the lower section from the gable end. The gable end is clad in wood shingles and holds a vent. Side elevations holds paired and single one-over-one windows.

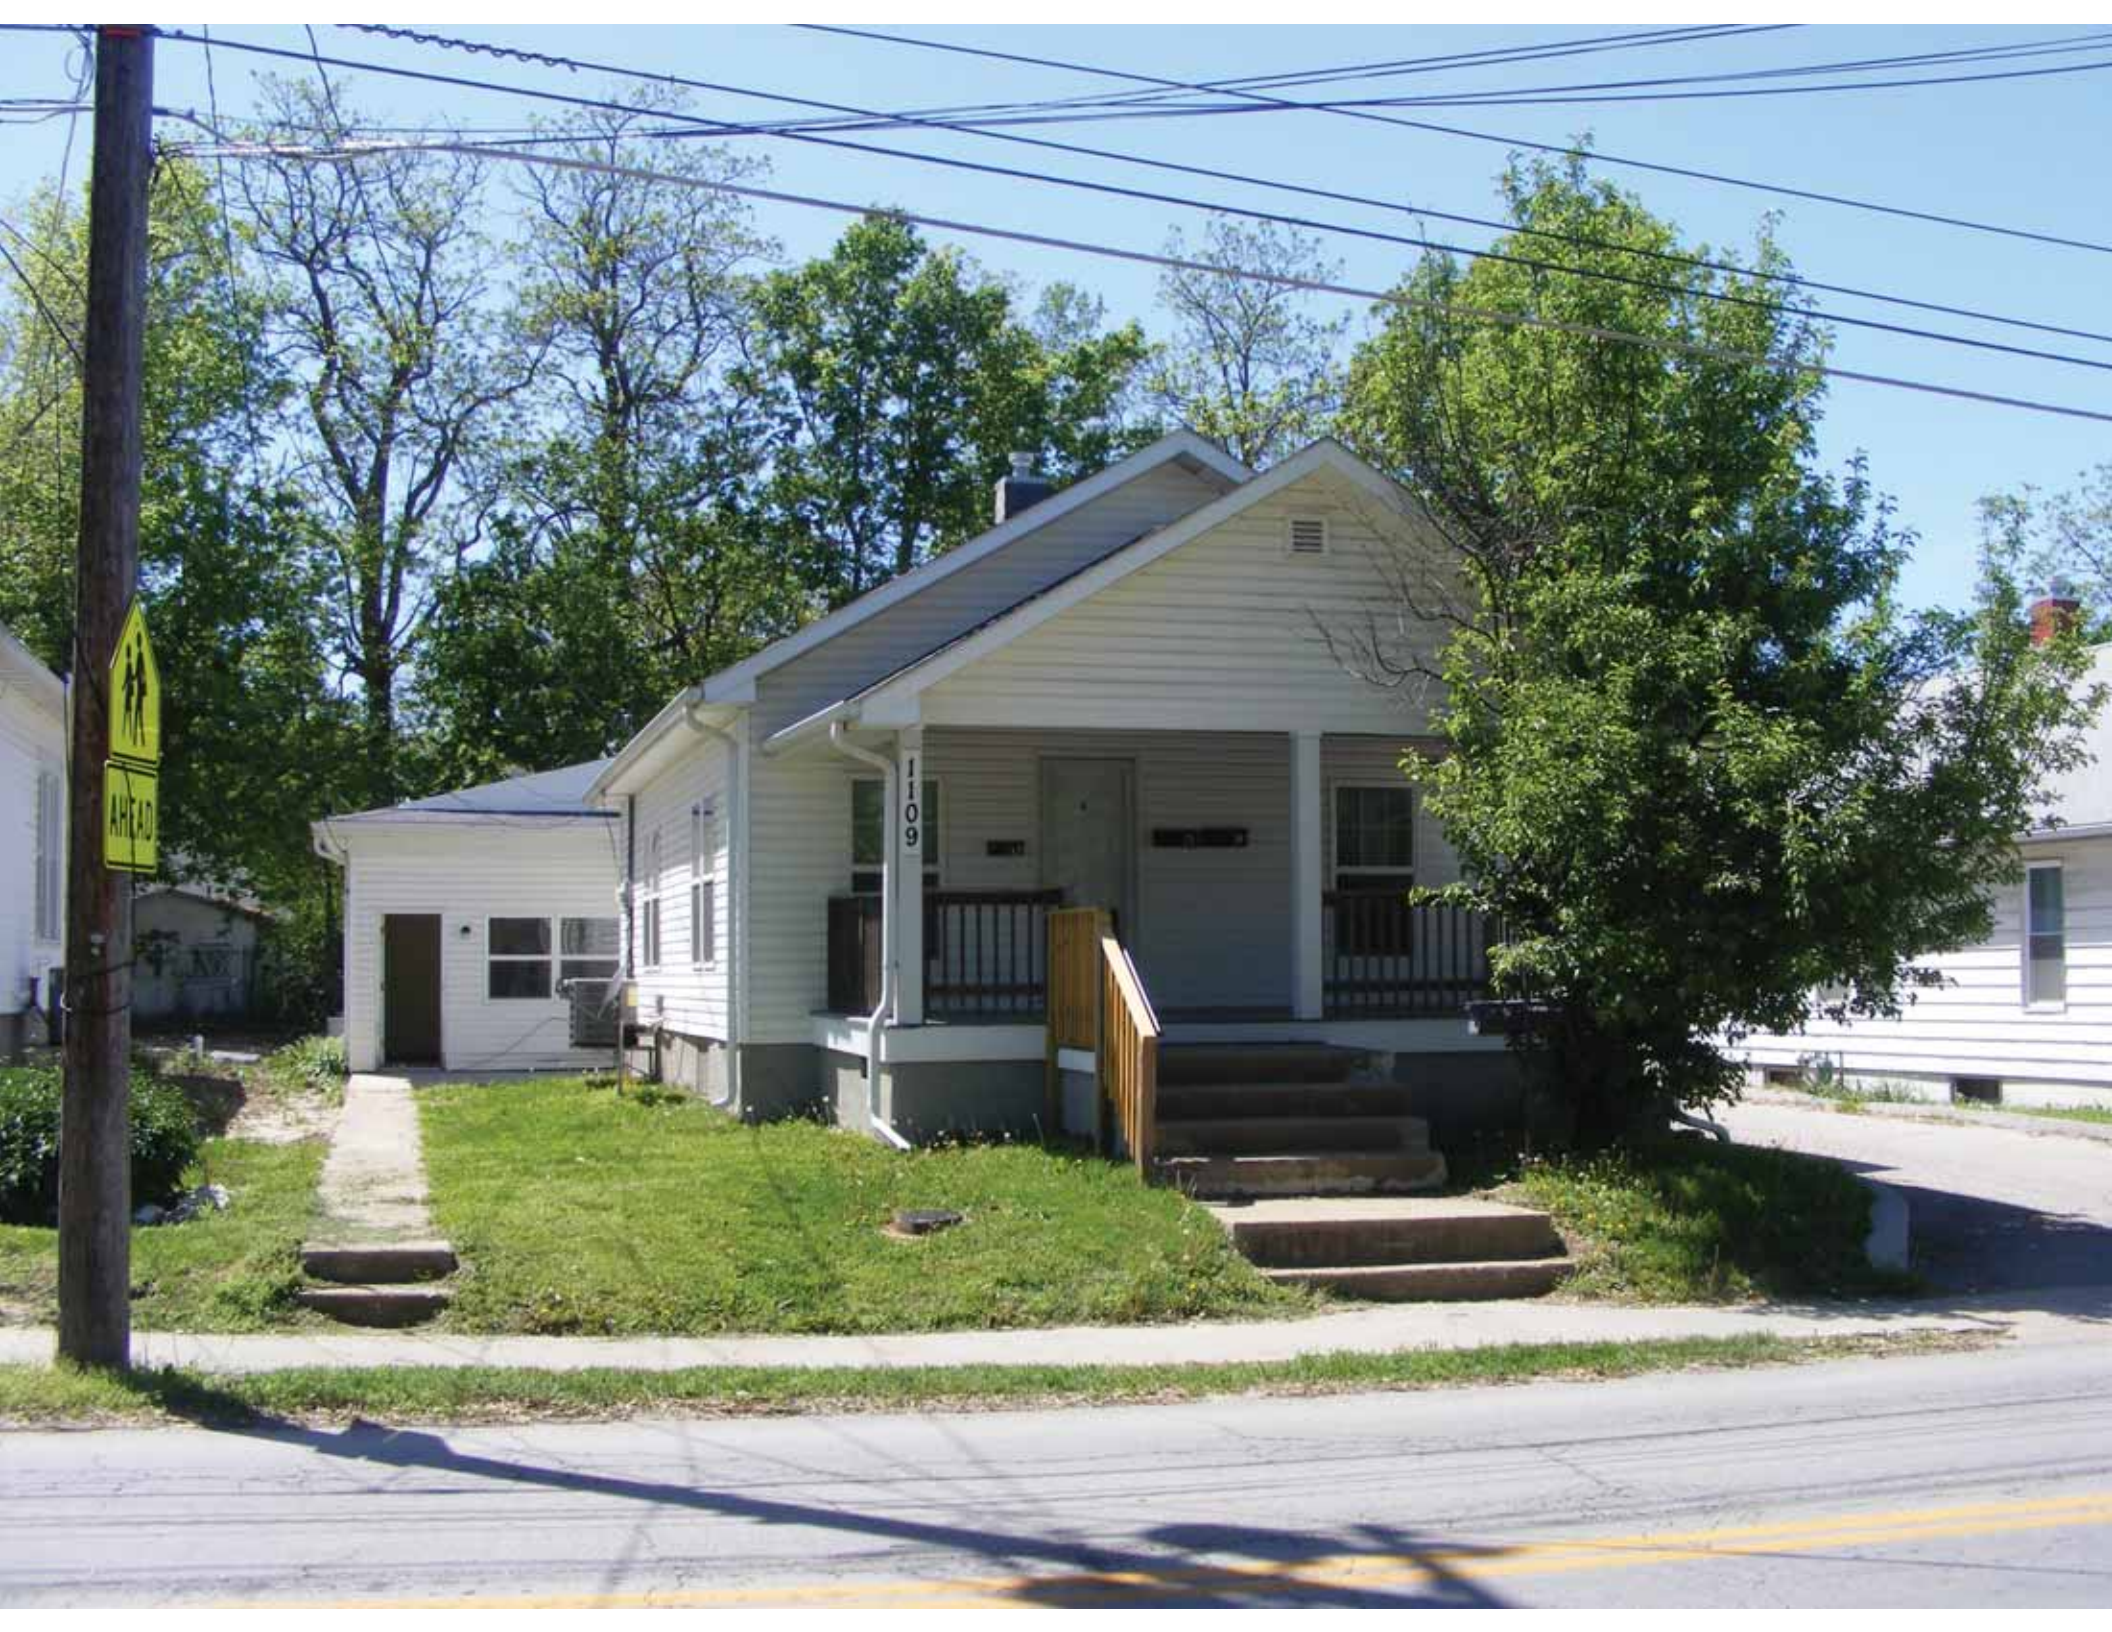
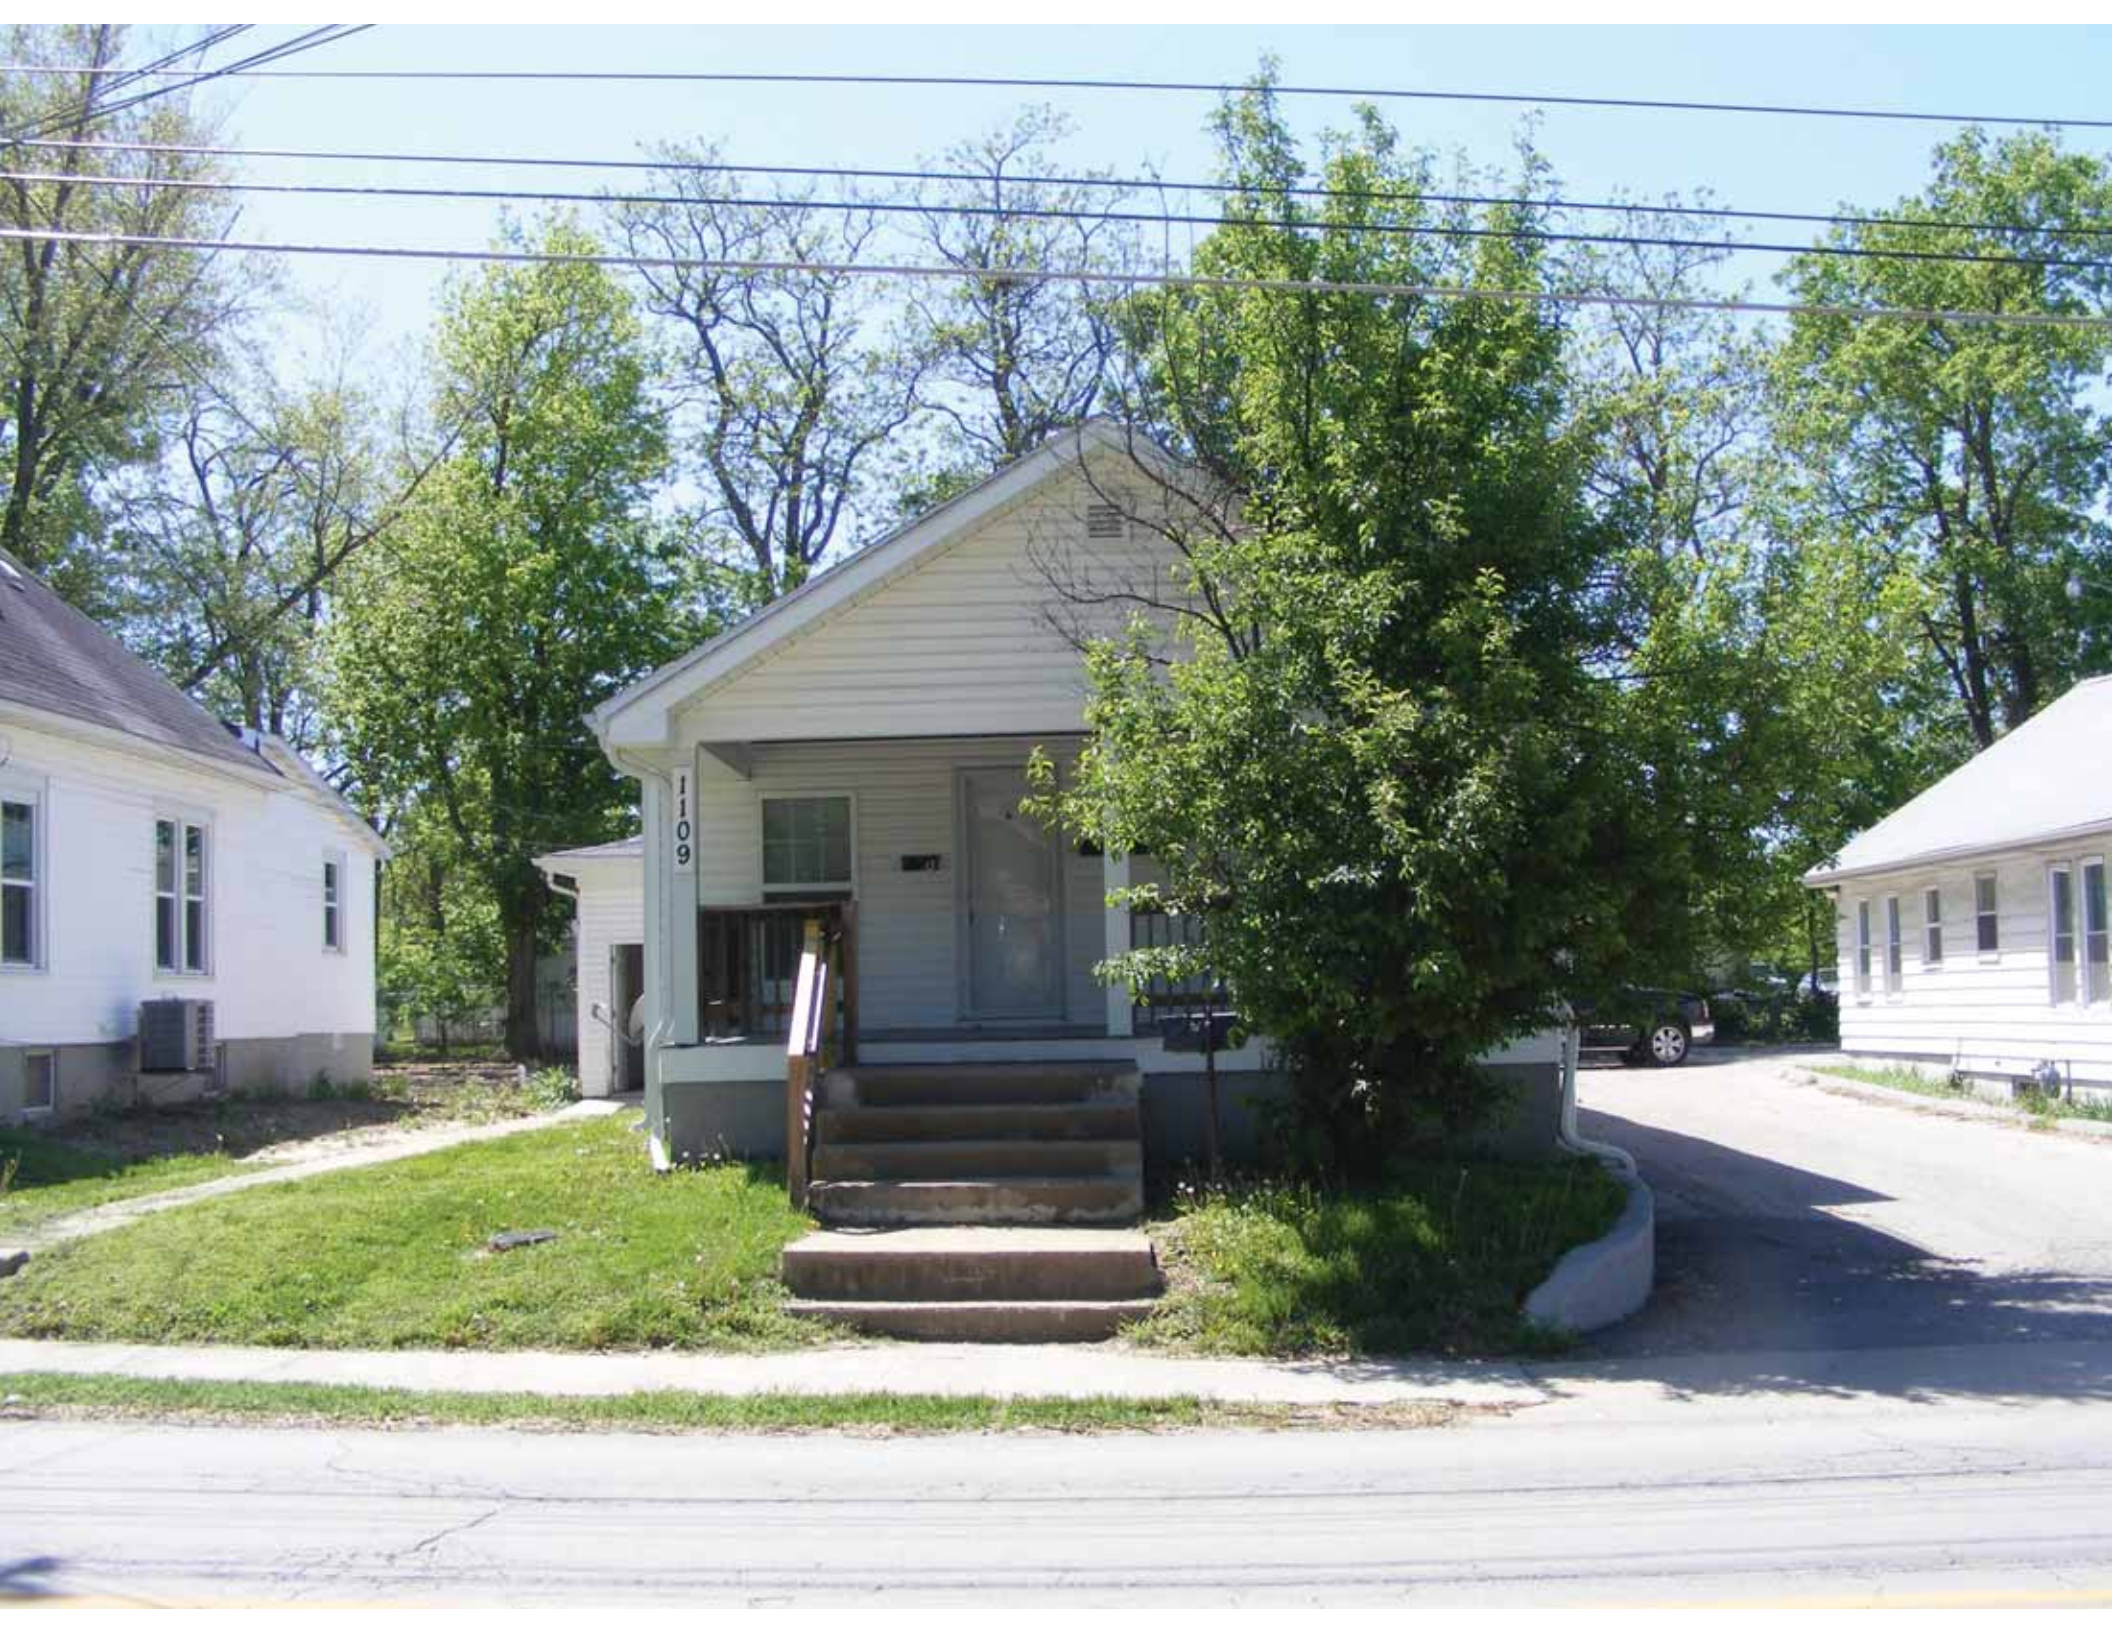
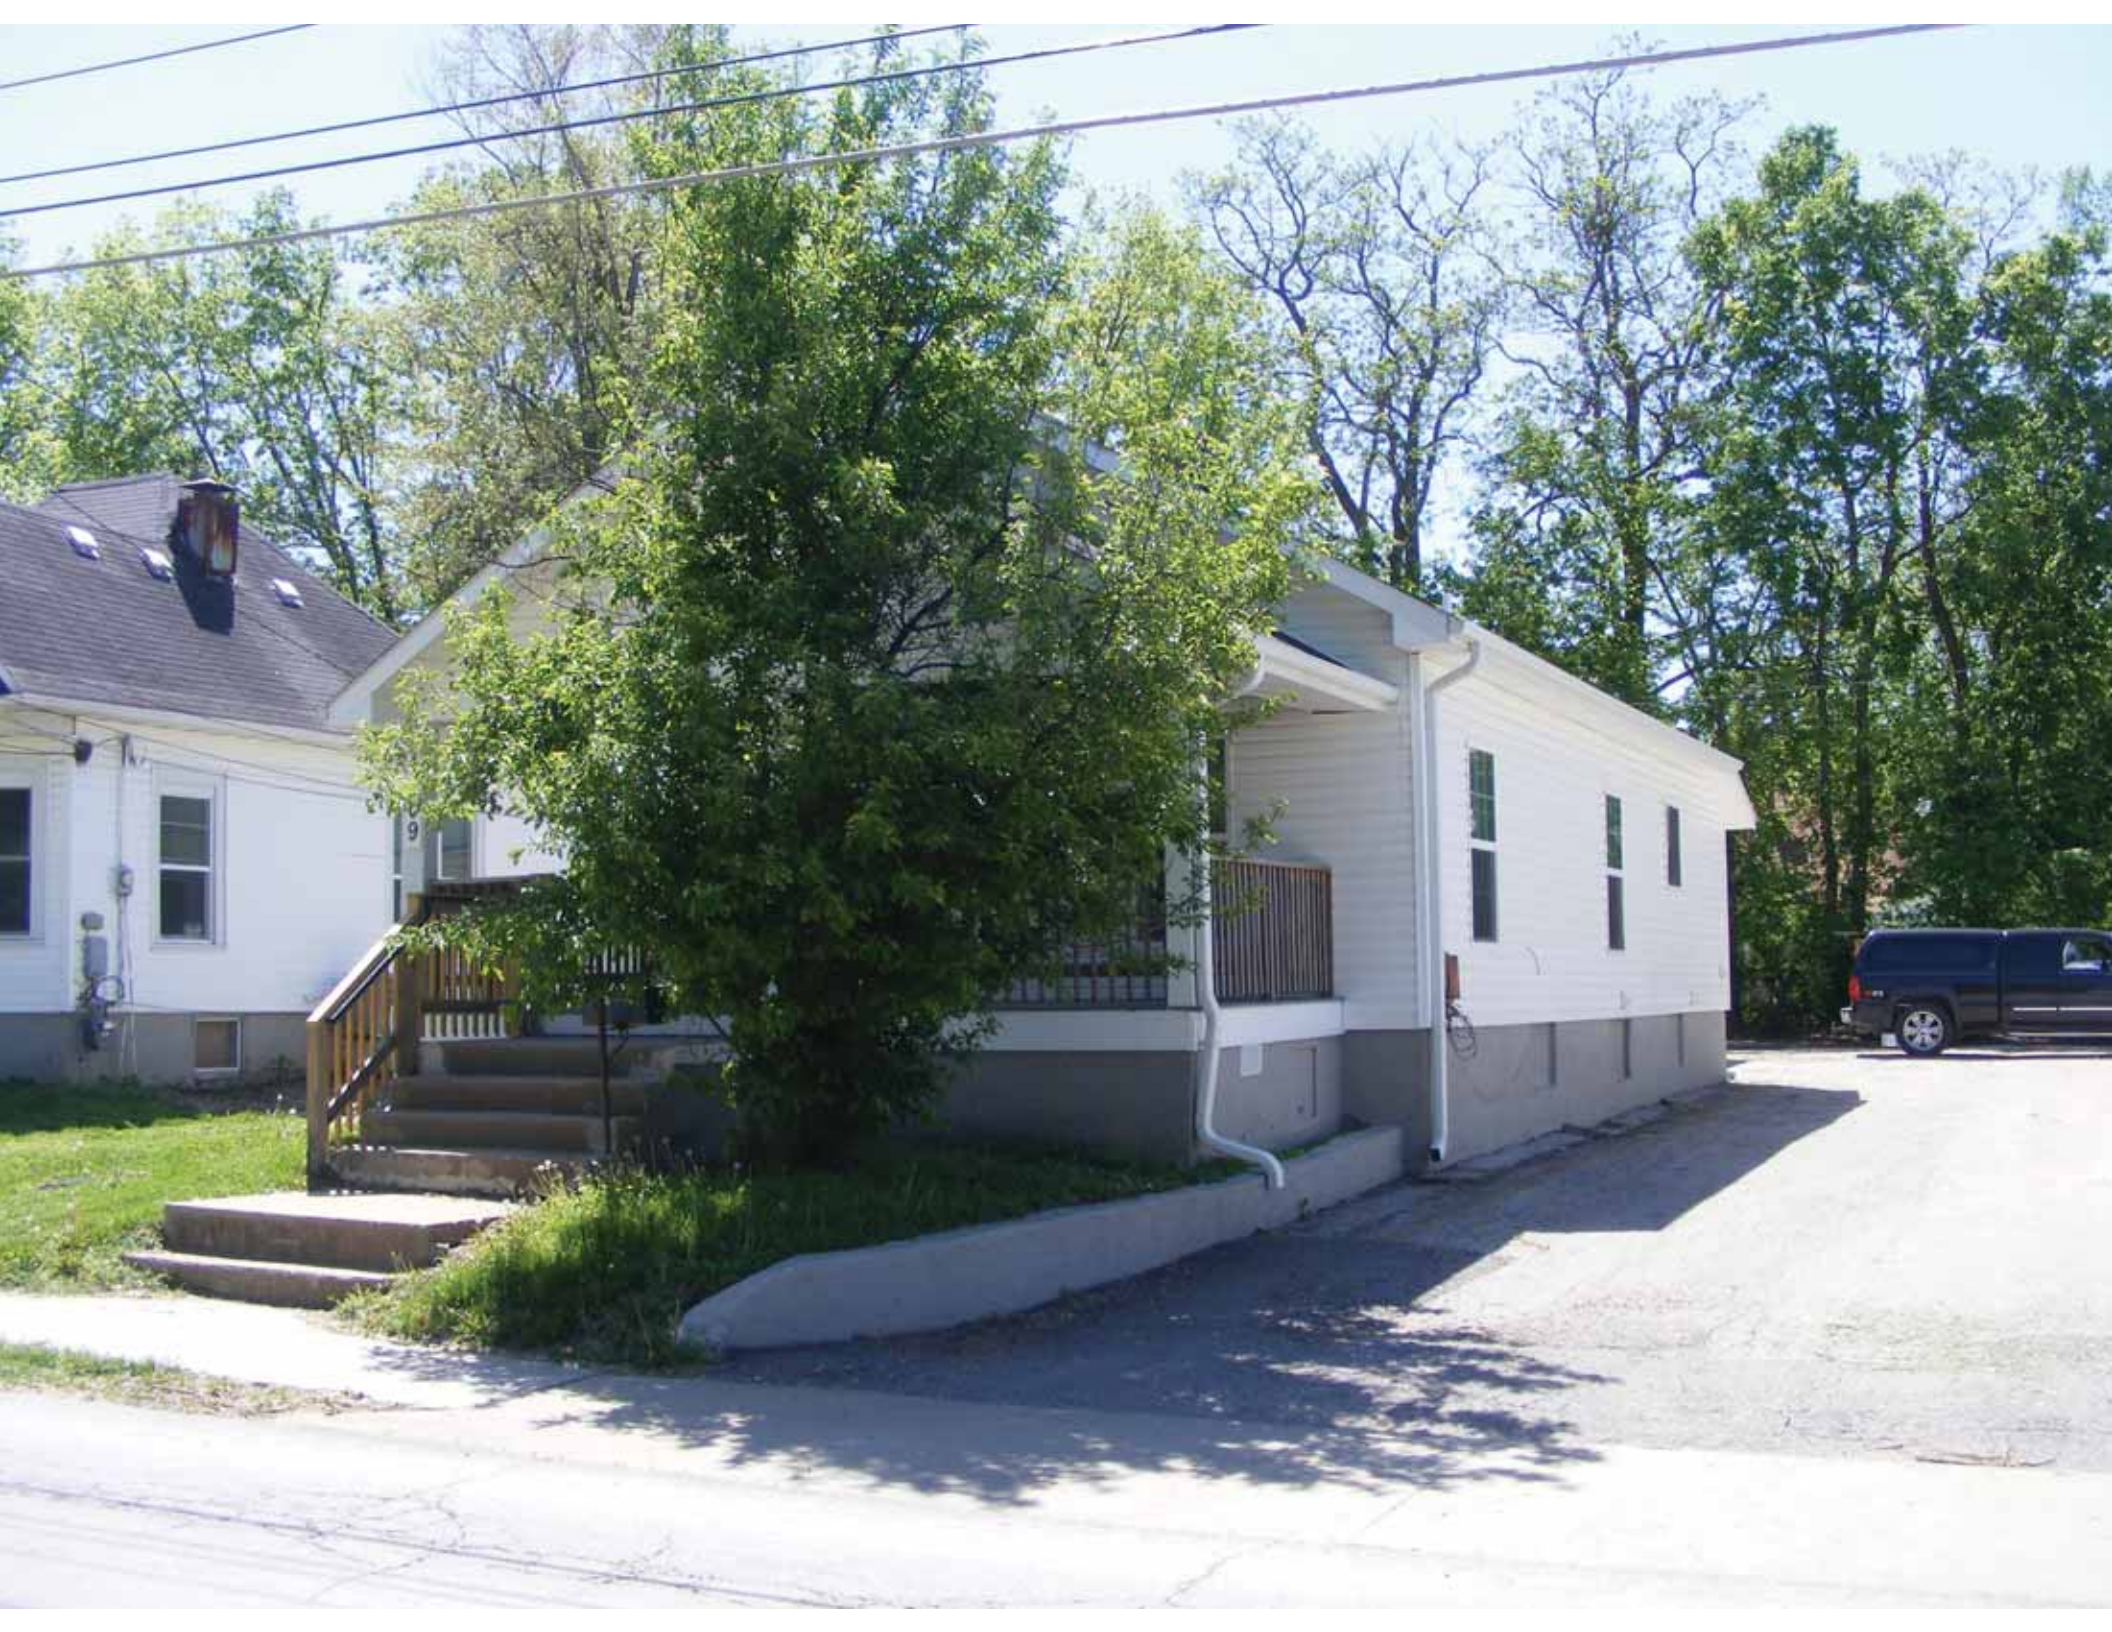
1109

The gable-front dwelling has an asphalt shingled roof and interior central brick chimney. The exterior is clad with synthetic siding and the foundation is concrete. The primary (east) elevation has a nearly full gabled porch supported by wood columns. A frame balustrade extends around the porch and along the steps as a single handrail. Within the porch bay is a c. 2015 paneled door that is slightly off center. The door is flanked by replacement windows of six-over-six design. Remaining windows are of similar configuration. The front gable field above the porch holds a louvered vent.
