MISSOURI DEPARTMENT OF NATURAL RESOURCES
STATE HISTORIC PRESERVATION OFFICE, P.O. Box 176, Jefferson City, MO 65102
ARCHITECTURAL/HISTORIC INVENTORY FORM

1. Survey No. BO-AS-011-0087		2. Survey name: North Central Columbia Survey Phase II	
3. County: Boone		4. Address (Street No.) 902	Street (name) N. Seventh Street
5. City: Columbia	Vicinity: <input type="checkbox"/>	6. Geographical Reference:	7. Township/Range/Section: T: R: S:
8. Historic name (if known):		9. Present/other name (if known):	
10. Ownership: <input checked="" type="checkbox"/> Private <input type="checkbox"/> Public		11a. Historic use (if known): Domestic/single dwelling	11b. Current use: Domestic/single dwelling

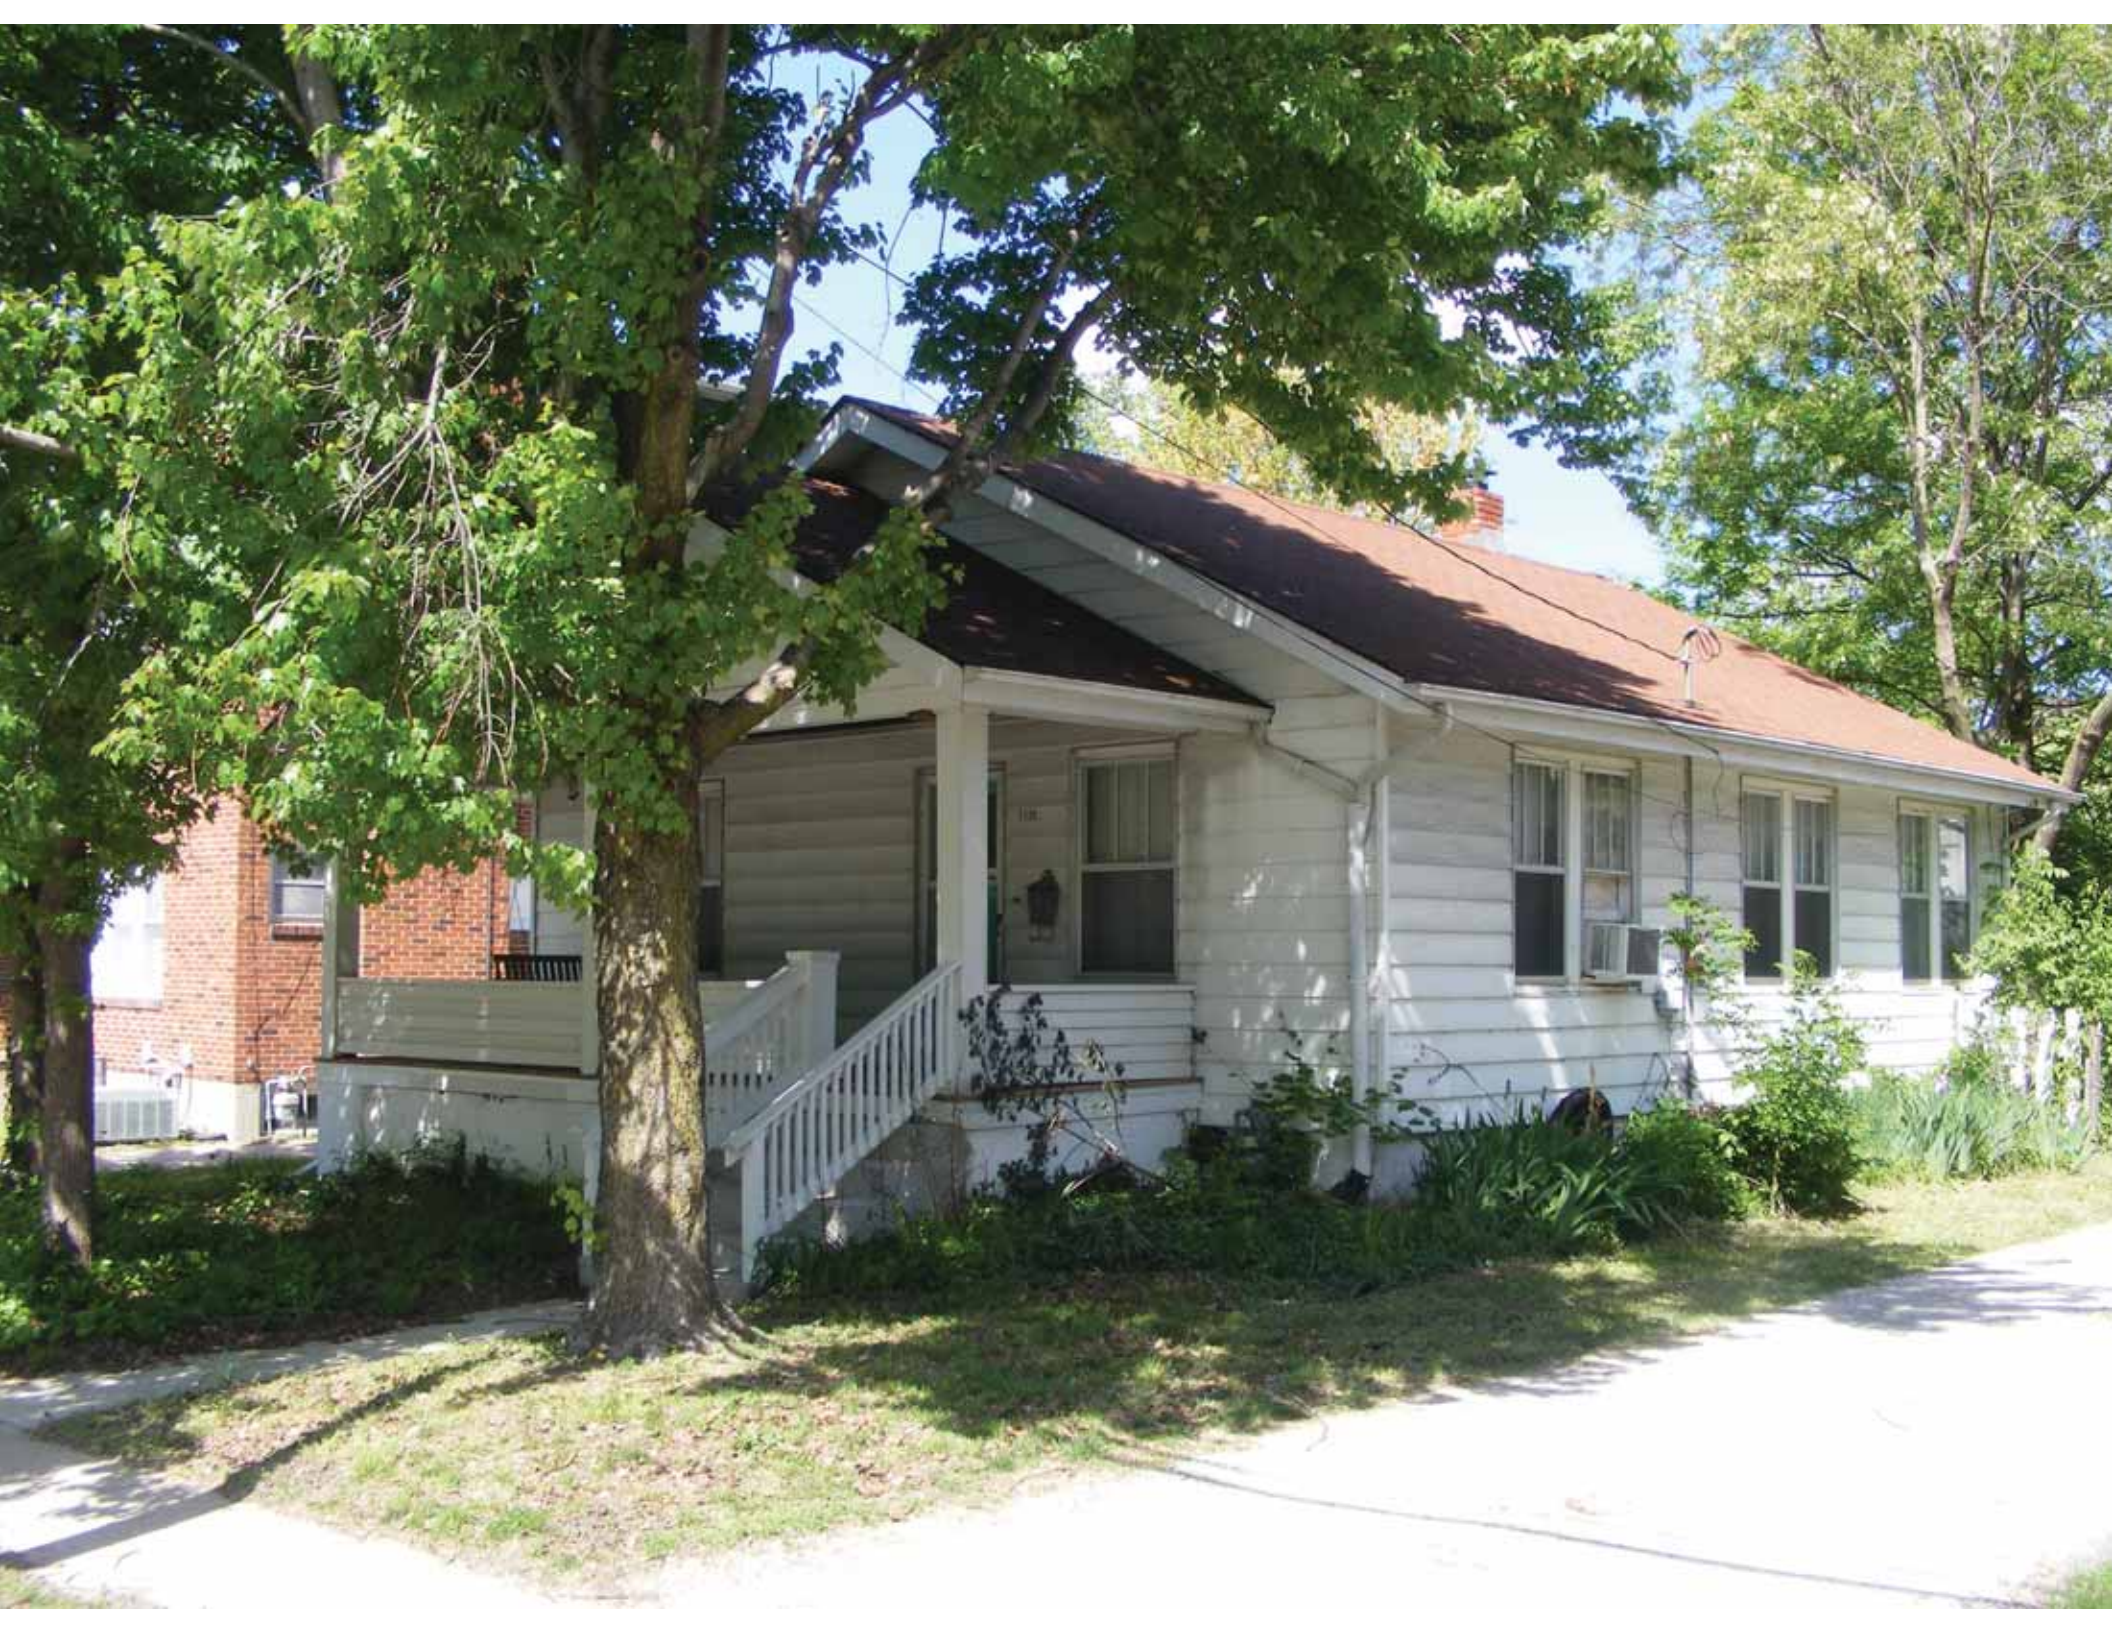
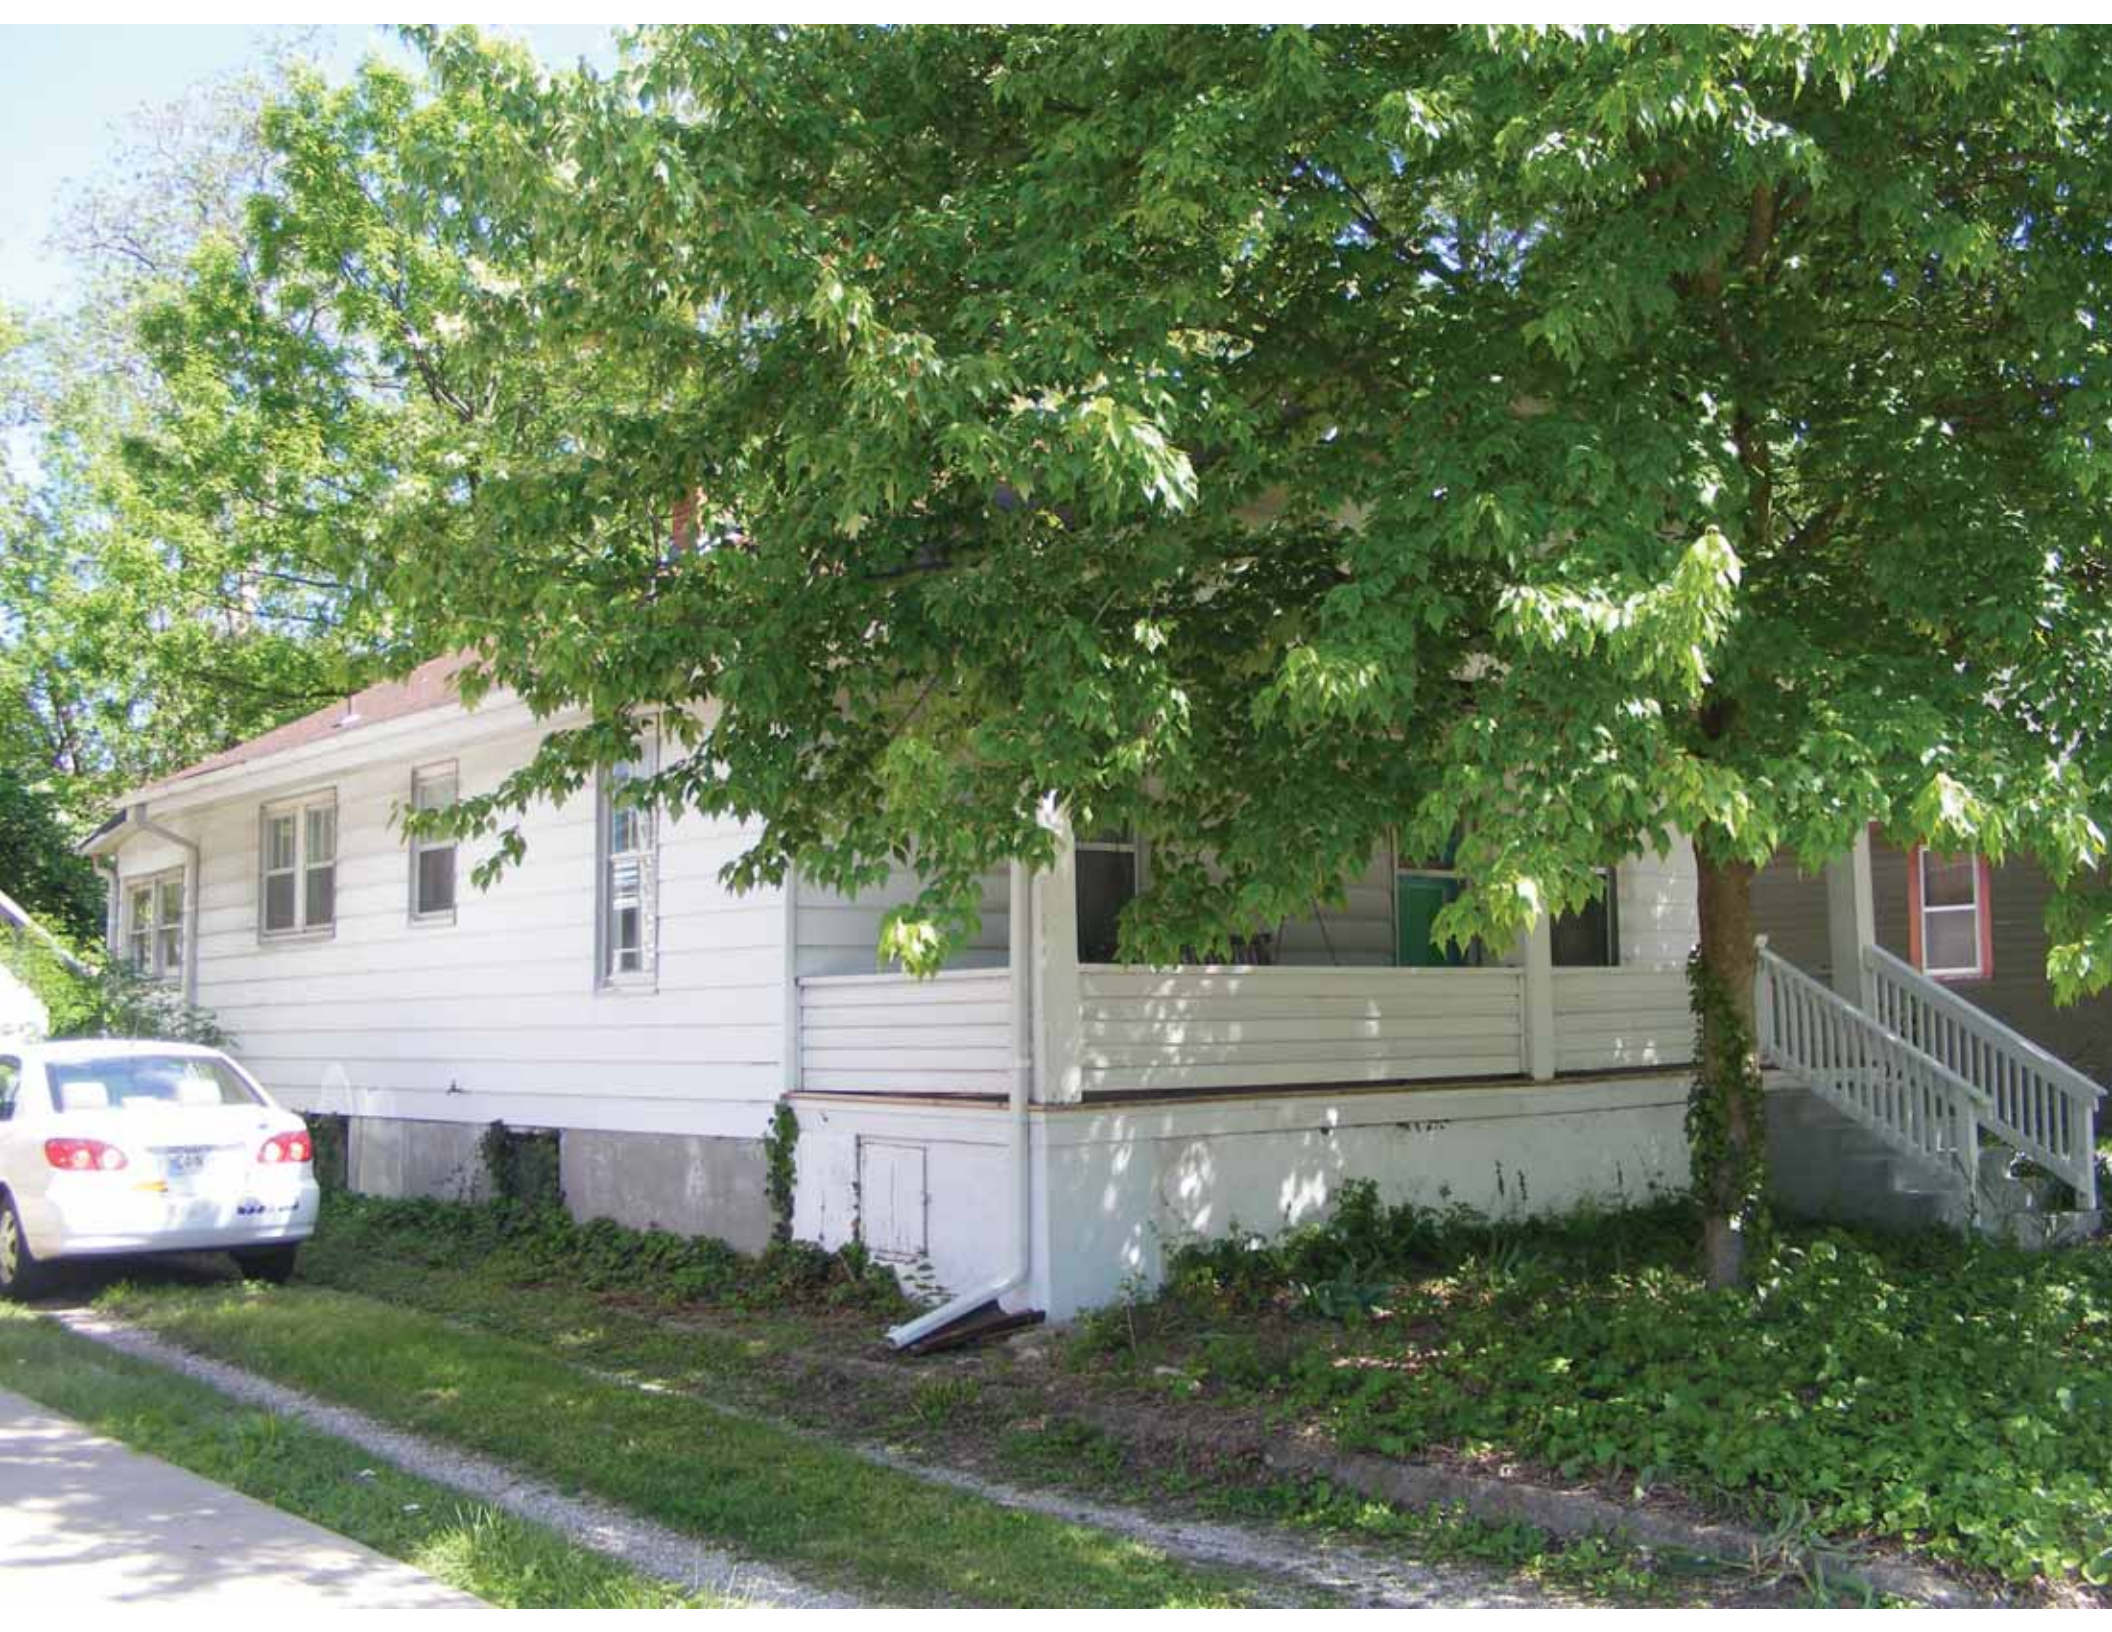
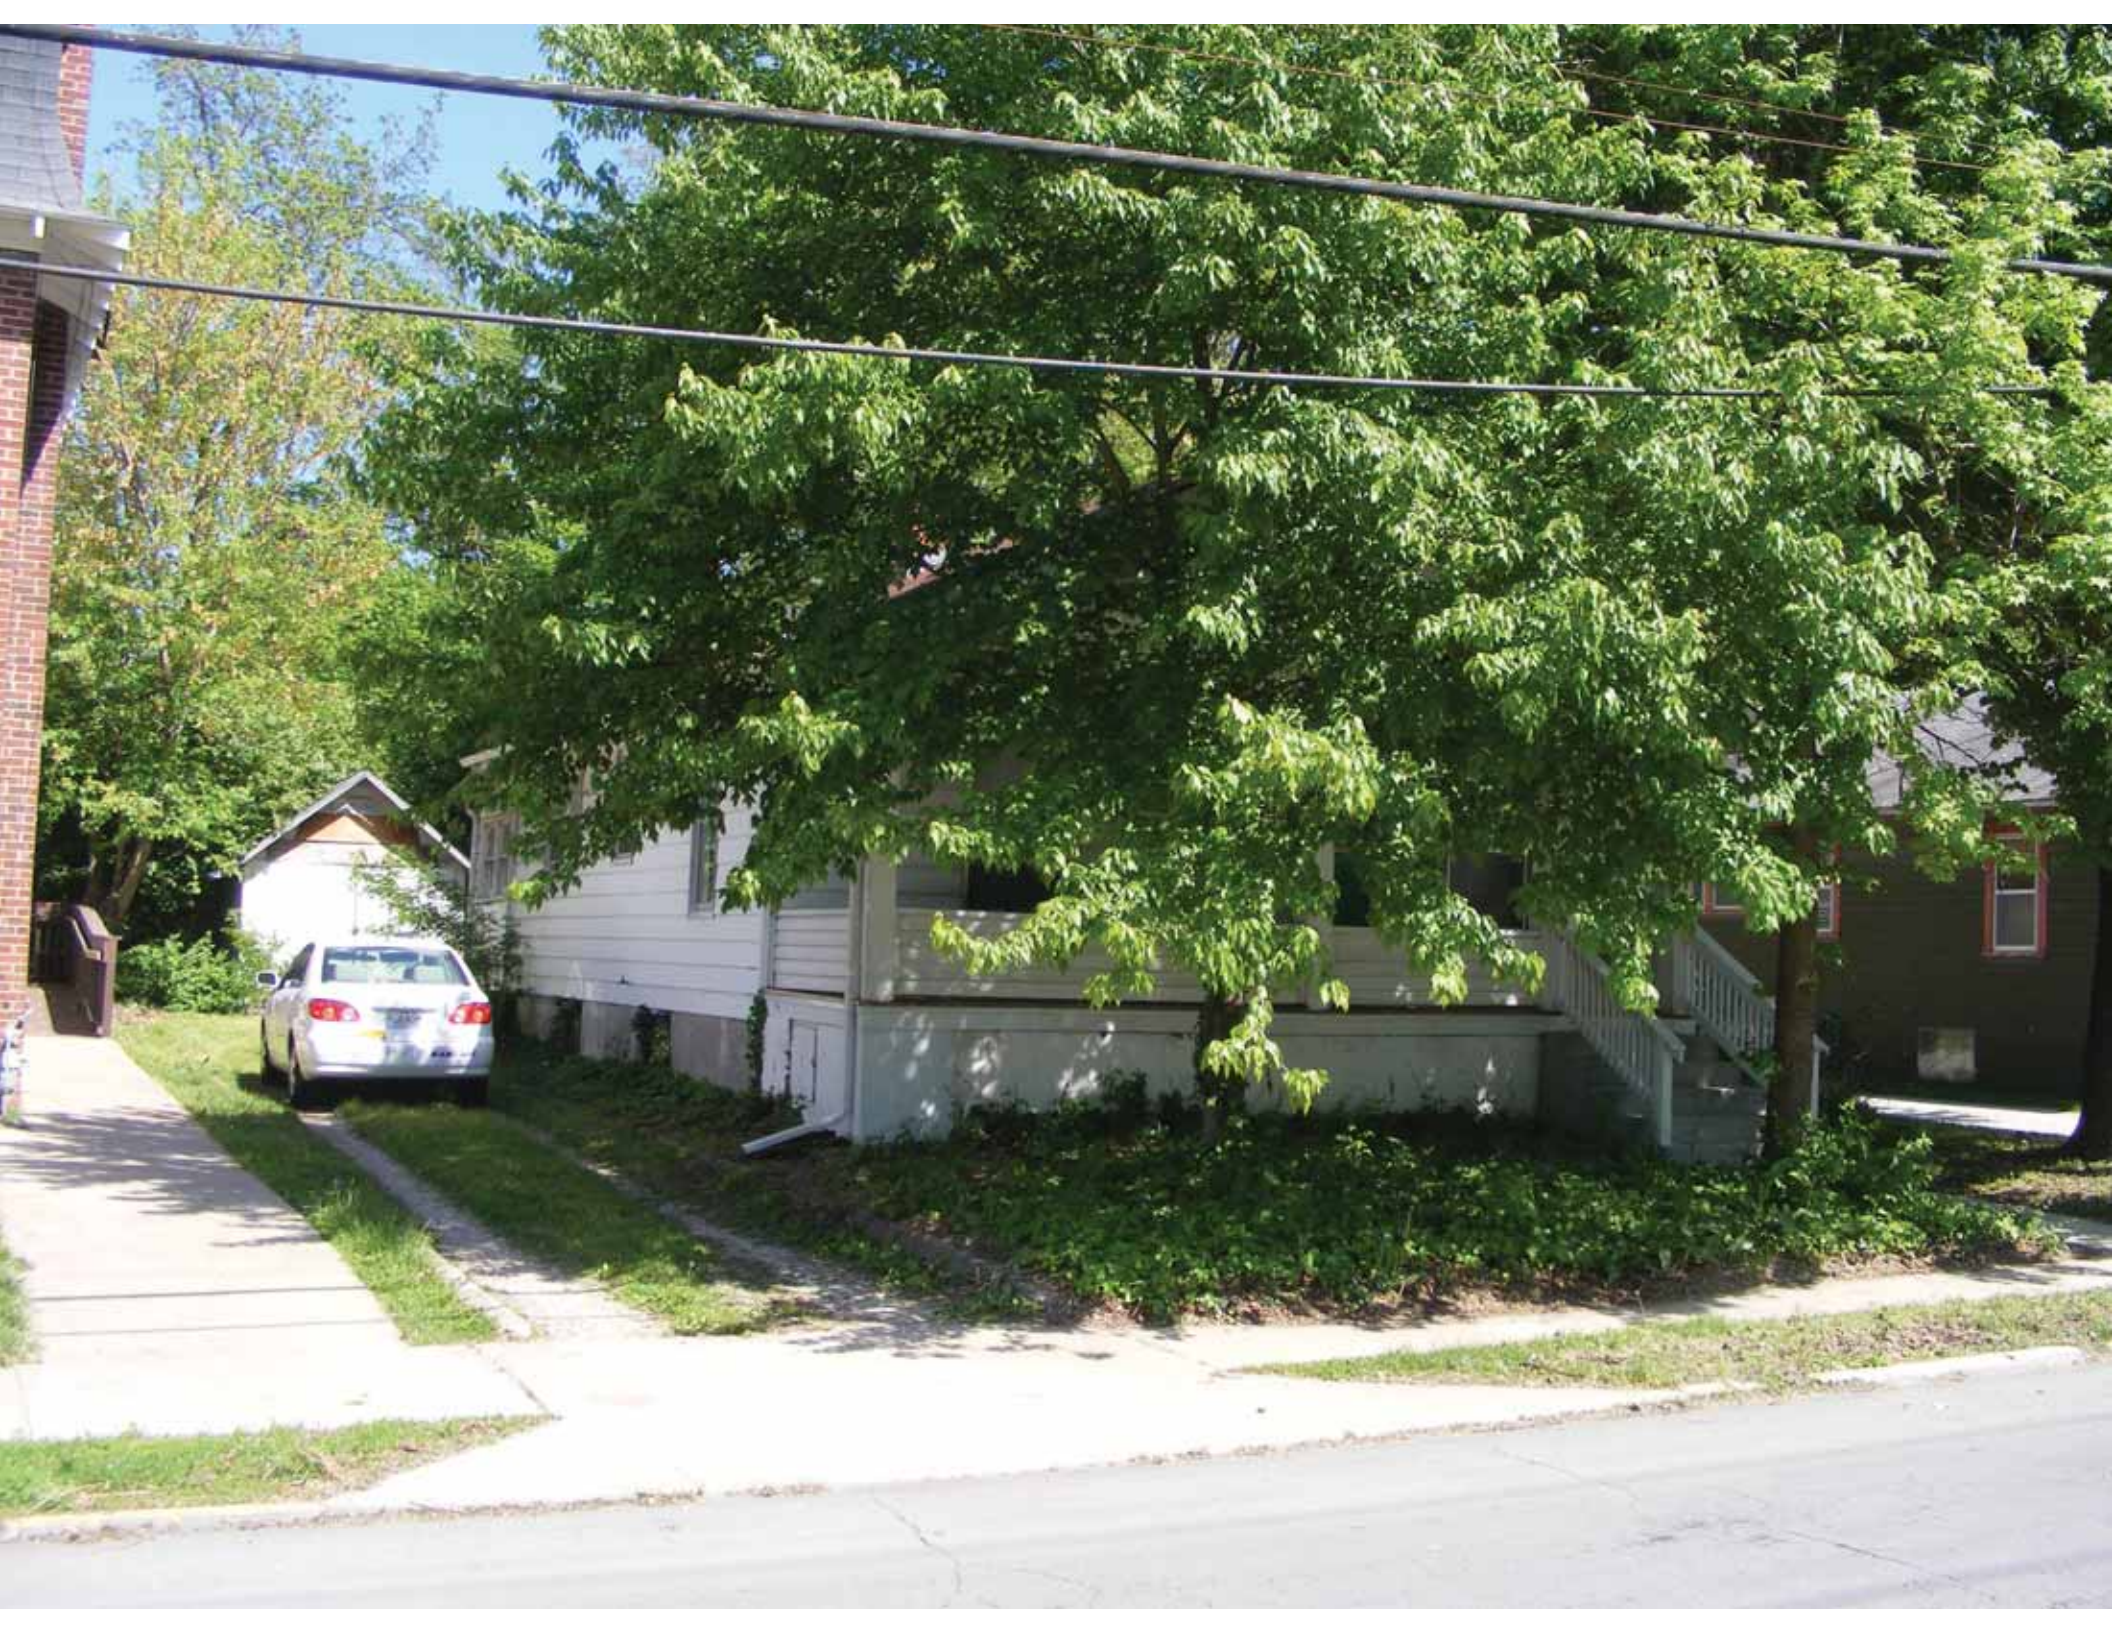
41. (cont.) Description of primary resource. Expand box as necessary, or add continuation pages.
A one-story vinyl clad dwelling with an asphalt-shingled front-gable to lower front-gable (façade porch) and a concrete foundation. The façade features a full-width porch sheltered under the gable and supported by square columns. Porch has a low wood-sided wall between columns, wood decking, railing and steps. Entrance is off-centered and flanked by three-over-one windows. Side elevations feature paired and single three-over-one windows. Basement level features window wells.

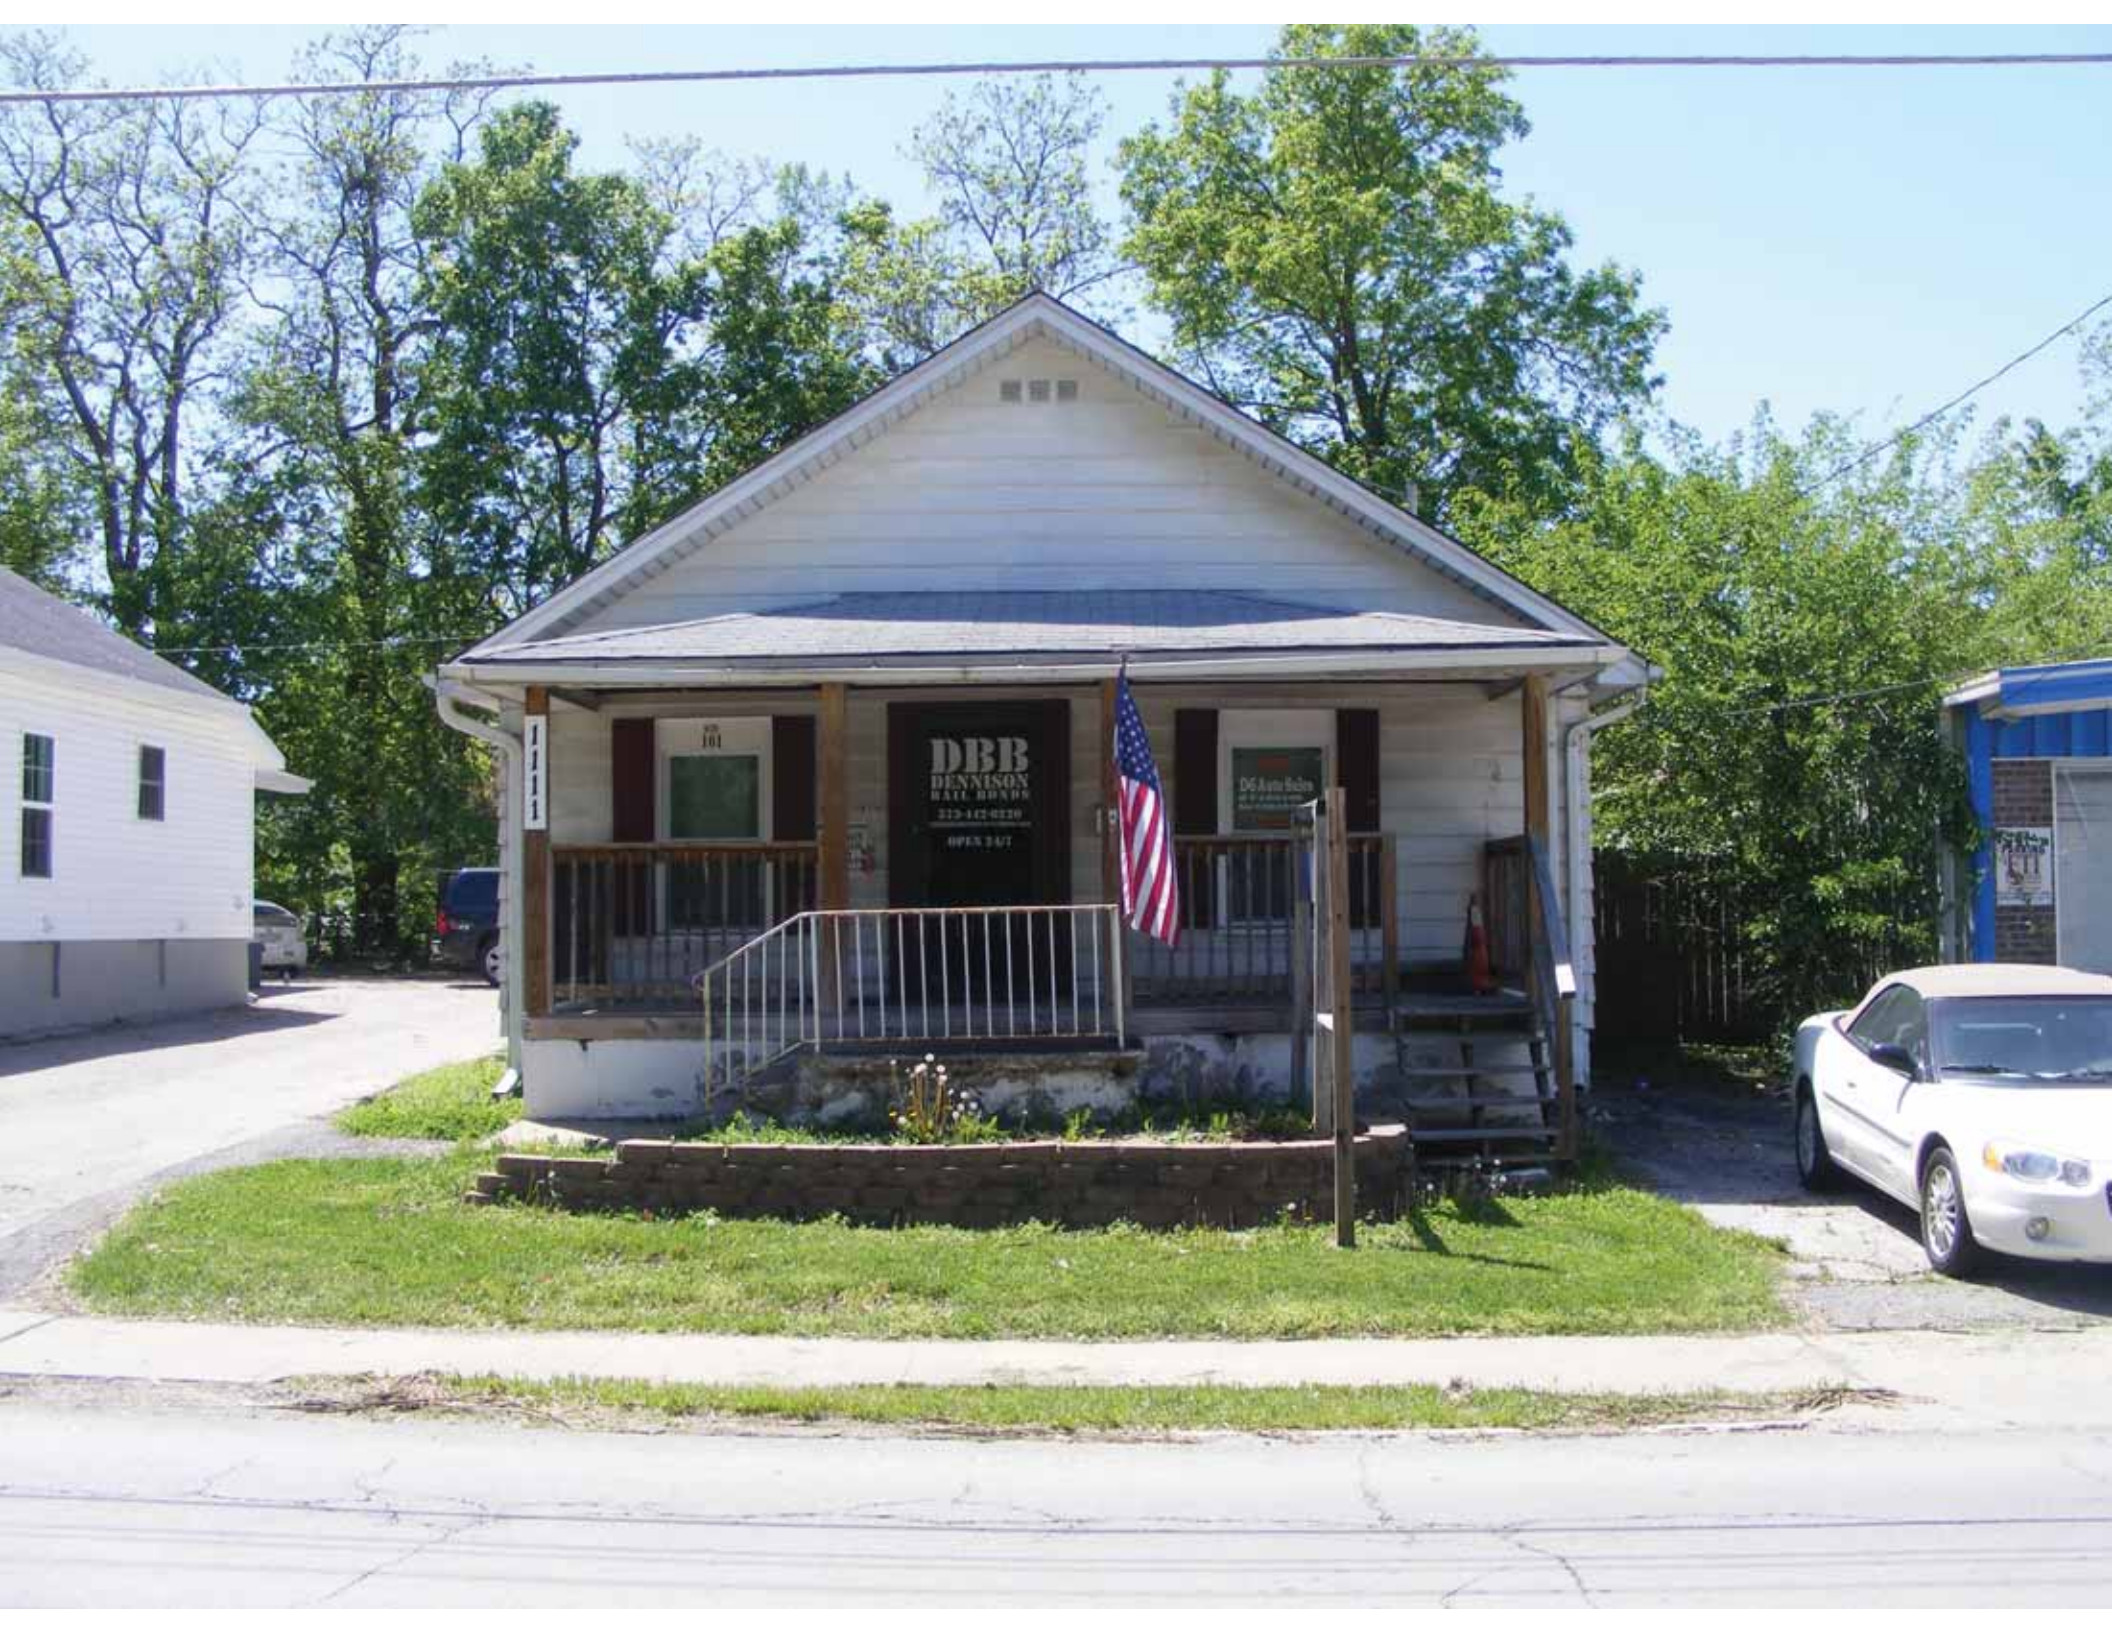
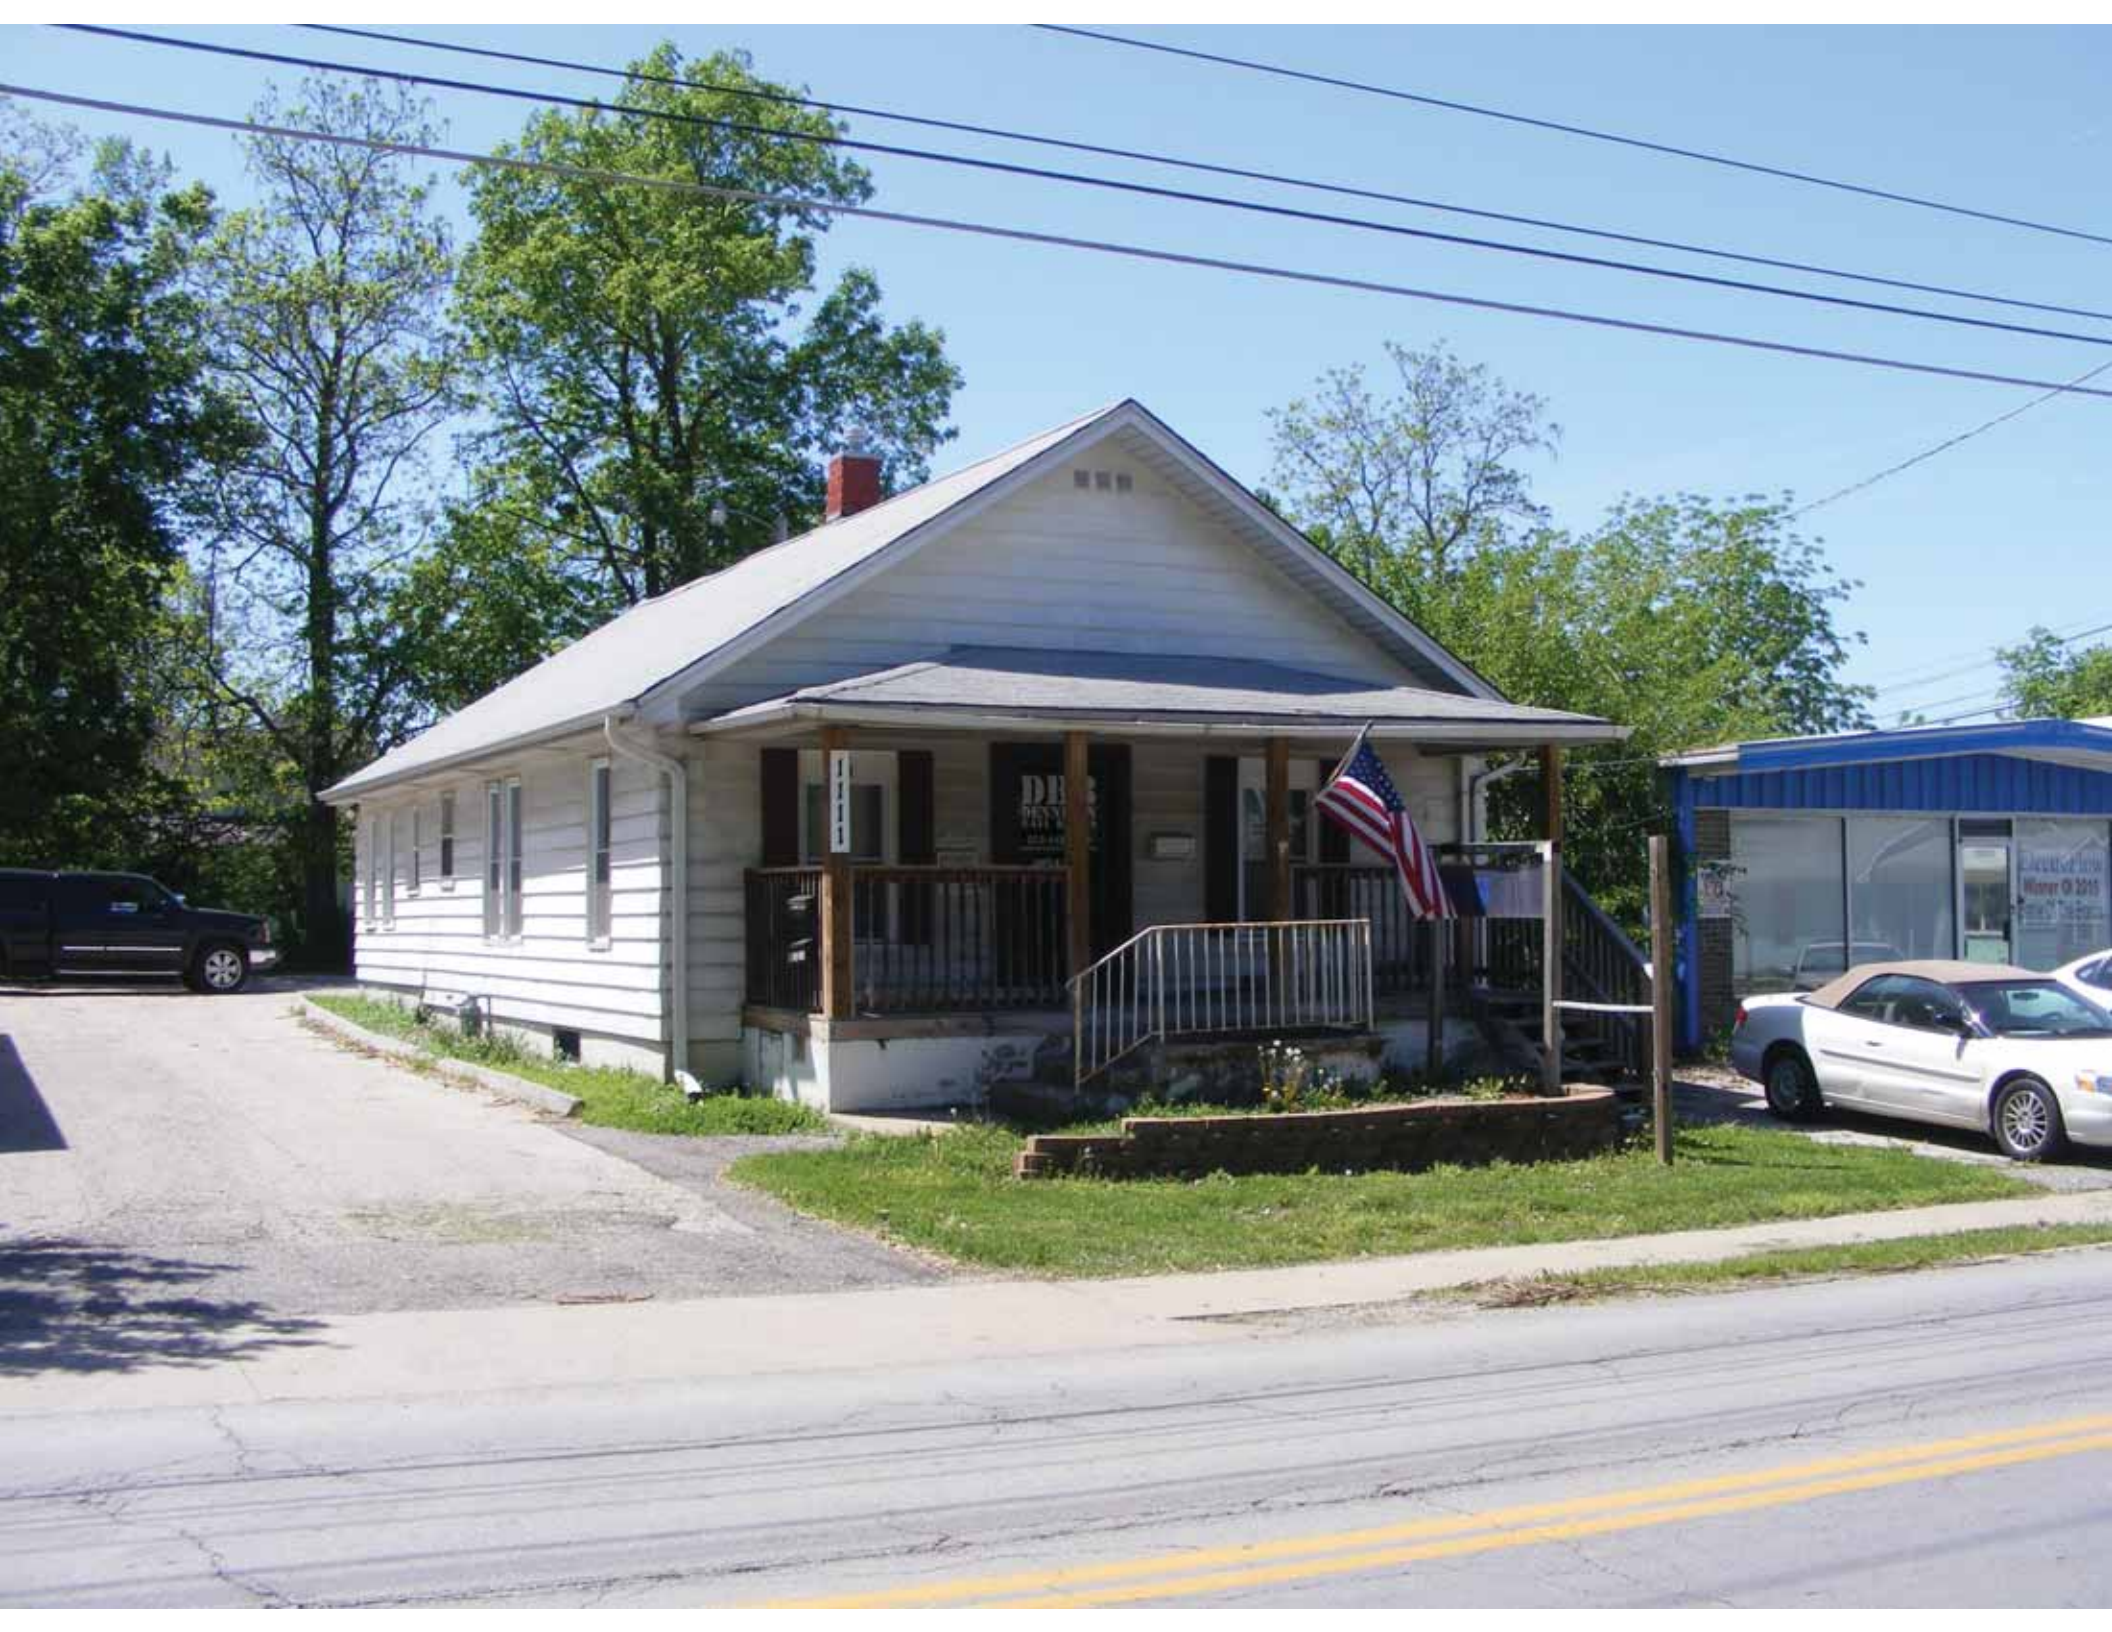
The dwelling has a gable-front asphalt shingled roof, exterior synthetic siding, enclosed eaves and a concrete foundation. The primary (east) elevation supports a hipped porch supported by replacement wood columns. The porch has a frame non-original balustrade. Steps to the porch are frame and situated at the north end. The original concrete porch steps are near the center of the house and lead to a short walk. The concrete steps are flanked by a wrought iron balustrade. Within the porch bay is a central commercial glass and metal door. The door is flanked by replacement windows with faux shutters. Windows are one-over-one.
