MISSOURI DEPARTMENT OF NATURAL RESOURCES
STATE HISTORIC PRESERVATION OFFICE, P.O. Box 176, Jefferson City, MO 65102
ARCHITECTURAL/HISTORIC INVENTORY FORM

1. Survey No. BO-AS-011-0087		2. Survey name: North Central Columbia Survey Phase II	
3. County: Boone		4. Address (Street No.) 902	Street (name) N. Seventh Street
5. City: Columbia	Vicinity: <input type="checkbox"/>	6. Geographical Reference:	7. Township/Range/Section: T: R: S:
8. Historic name (if known):		9. Present/other name (if known):	
10. Ownership: <input checked="" type="checkbox"/> Private <input type="checkbox"/> Public		11a. Historic use (if known): Domestic/single dwelling	11b. Current use: Domestic/single dwelling

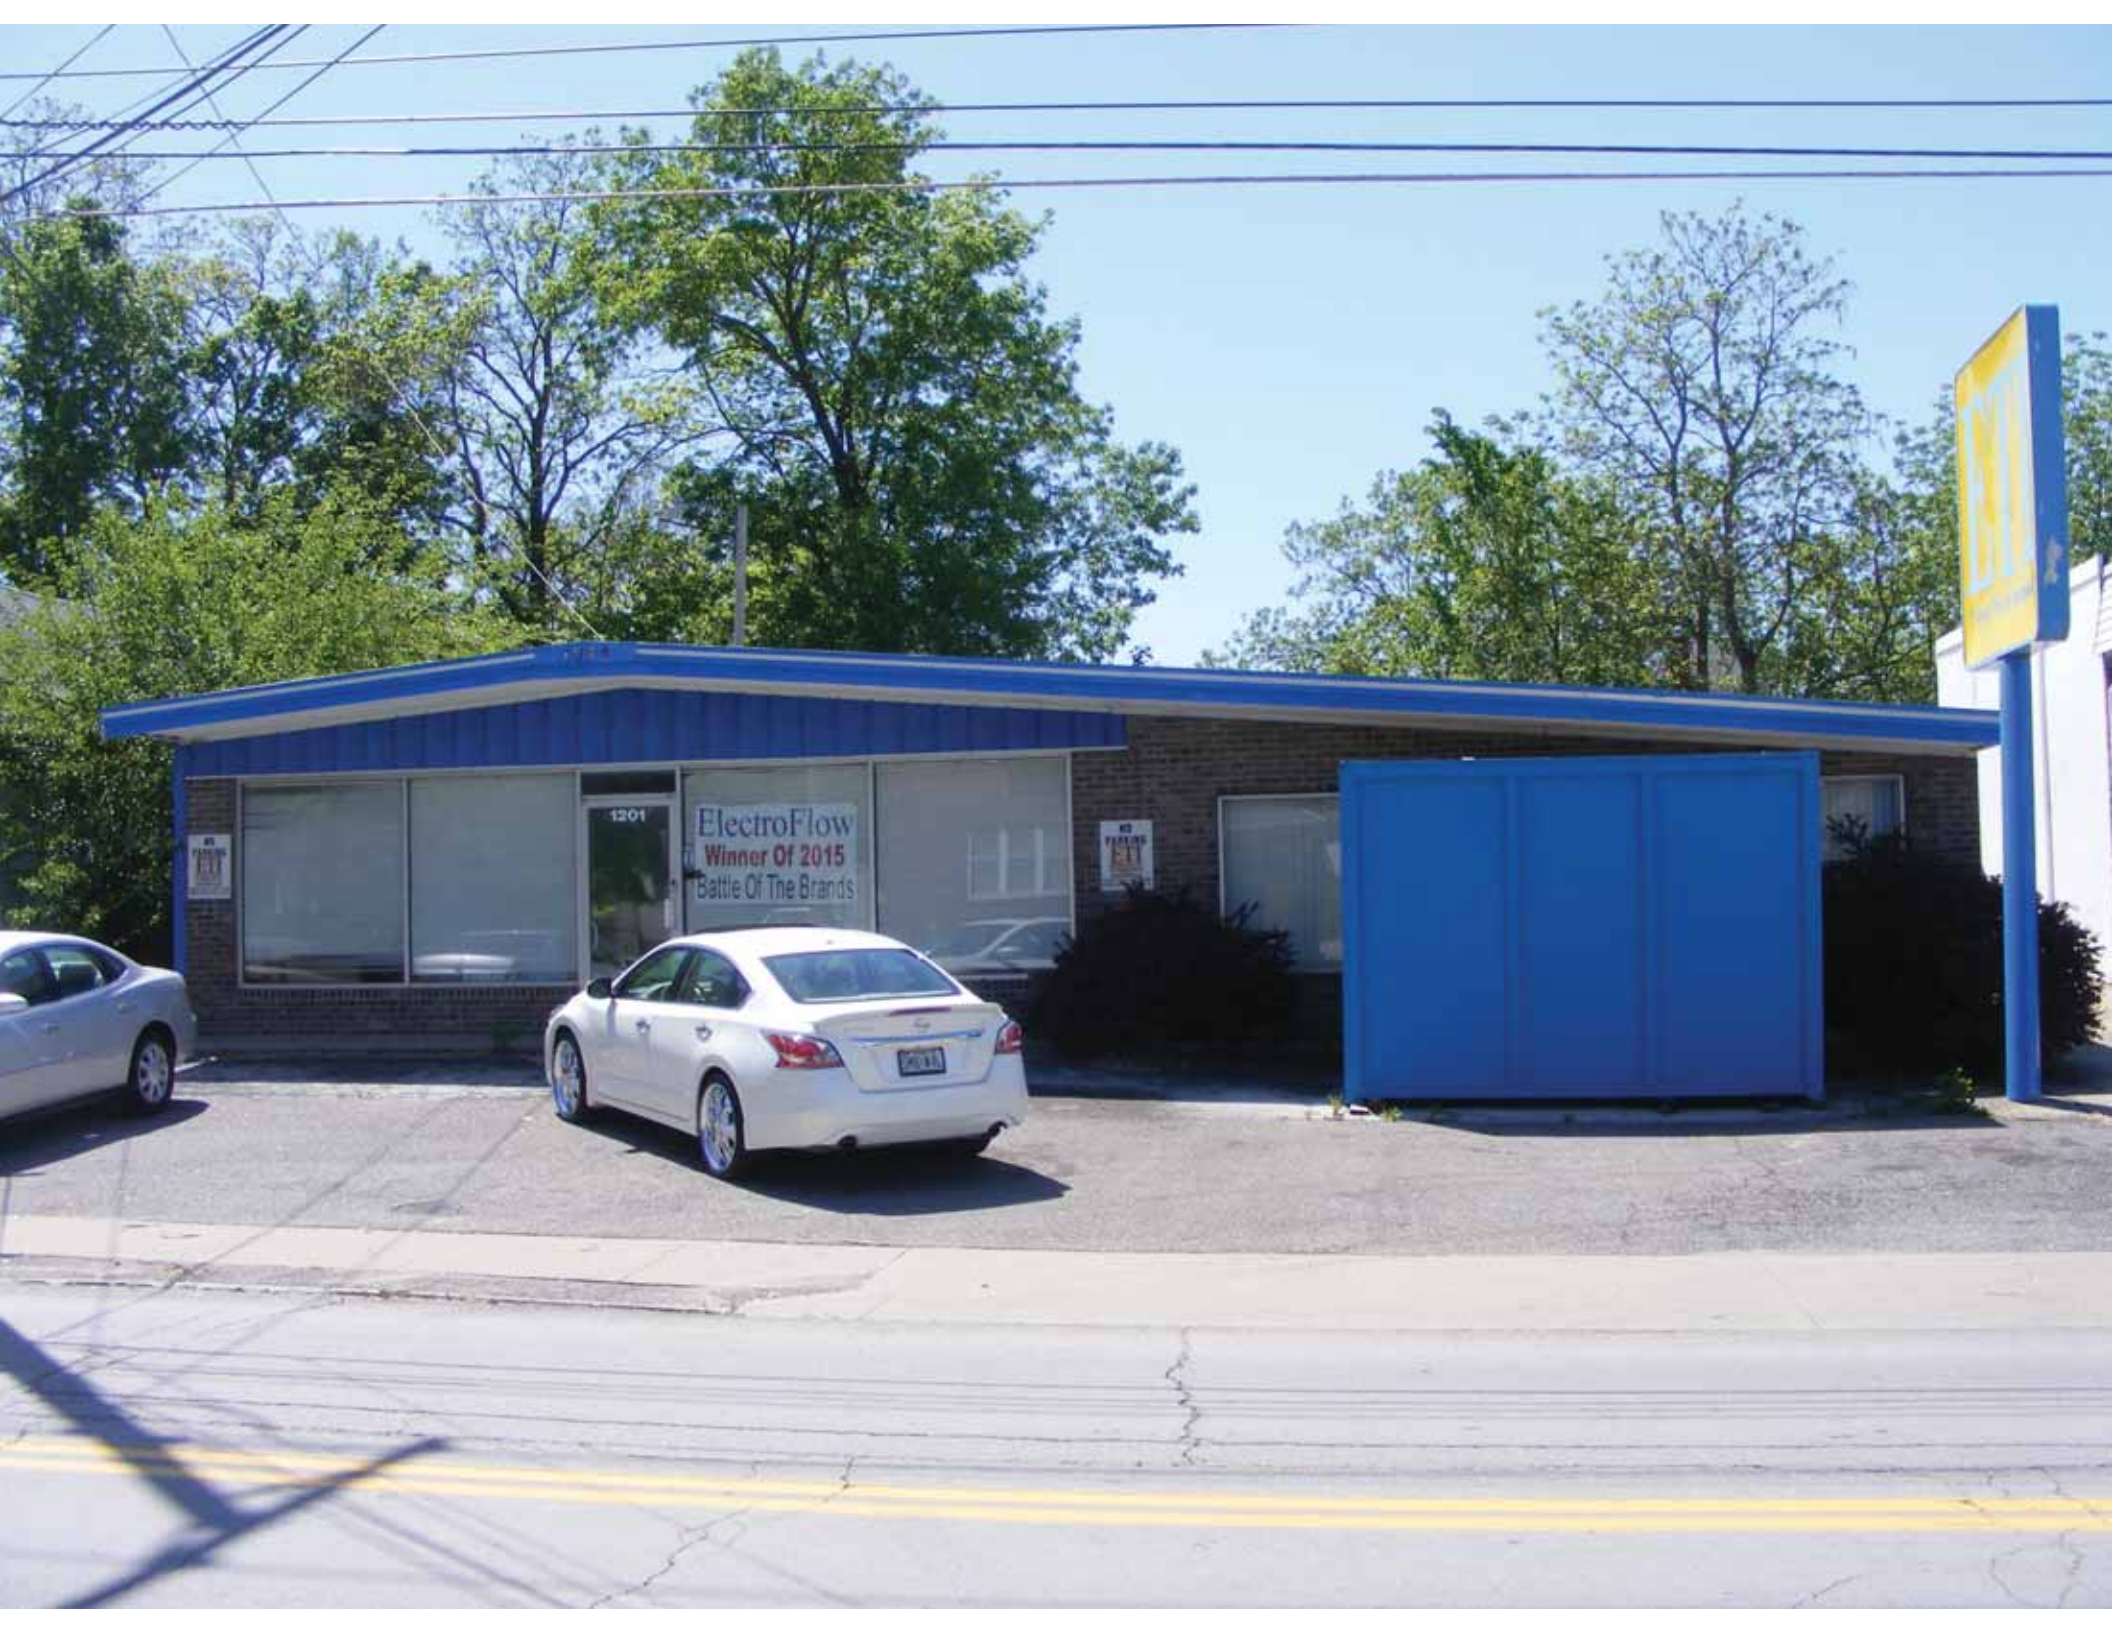
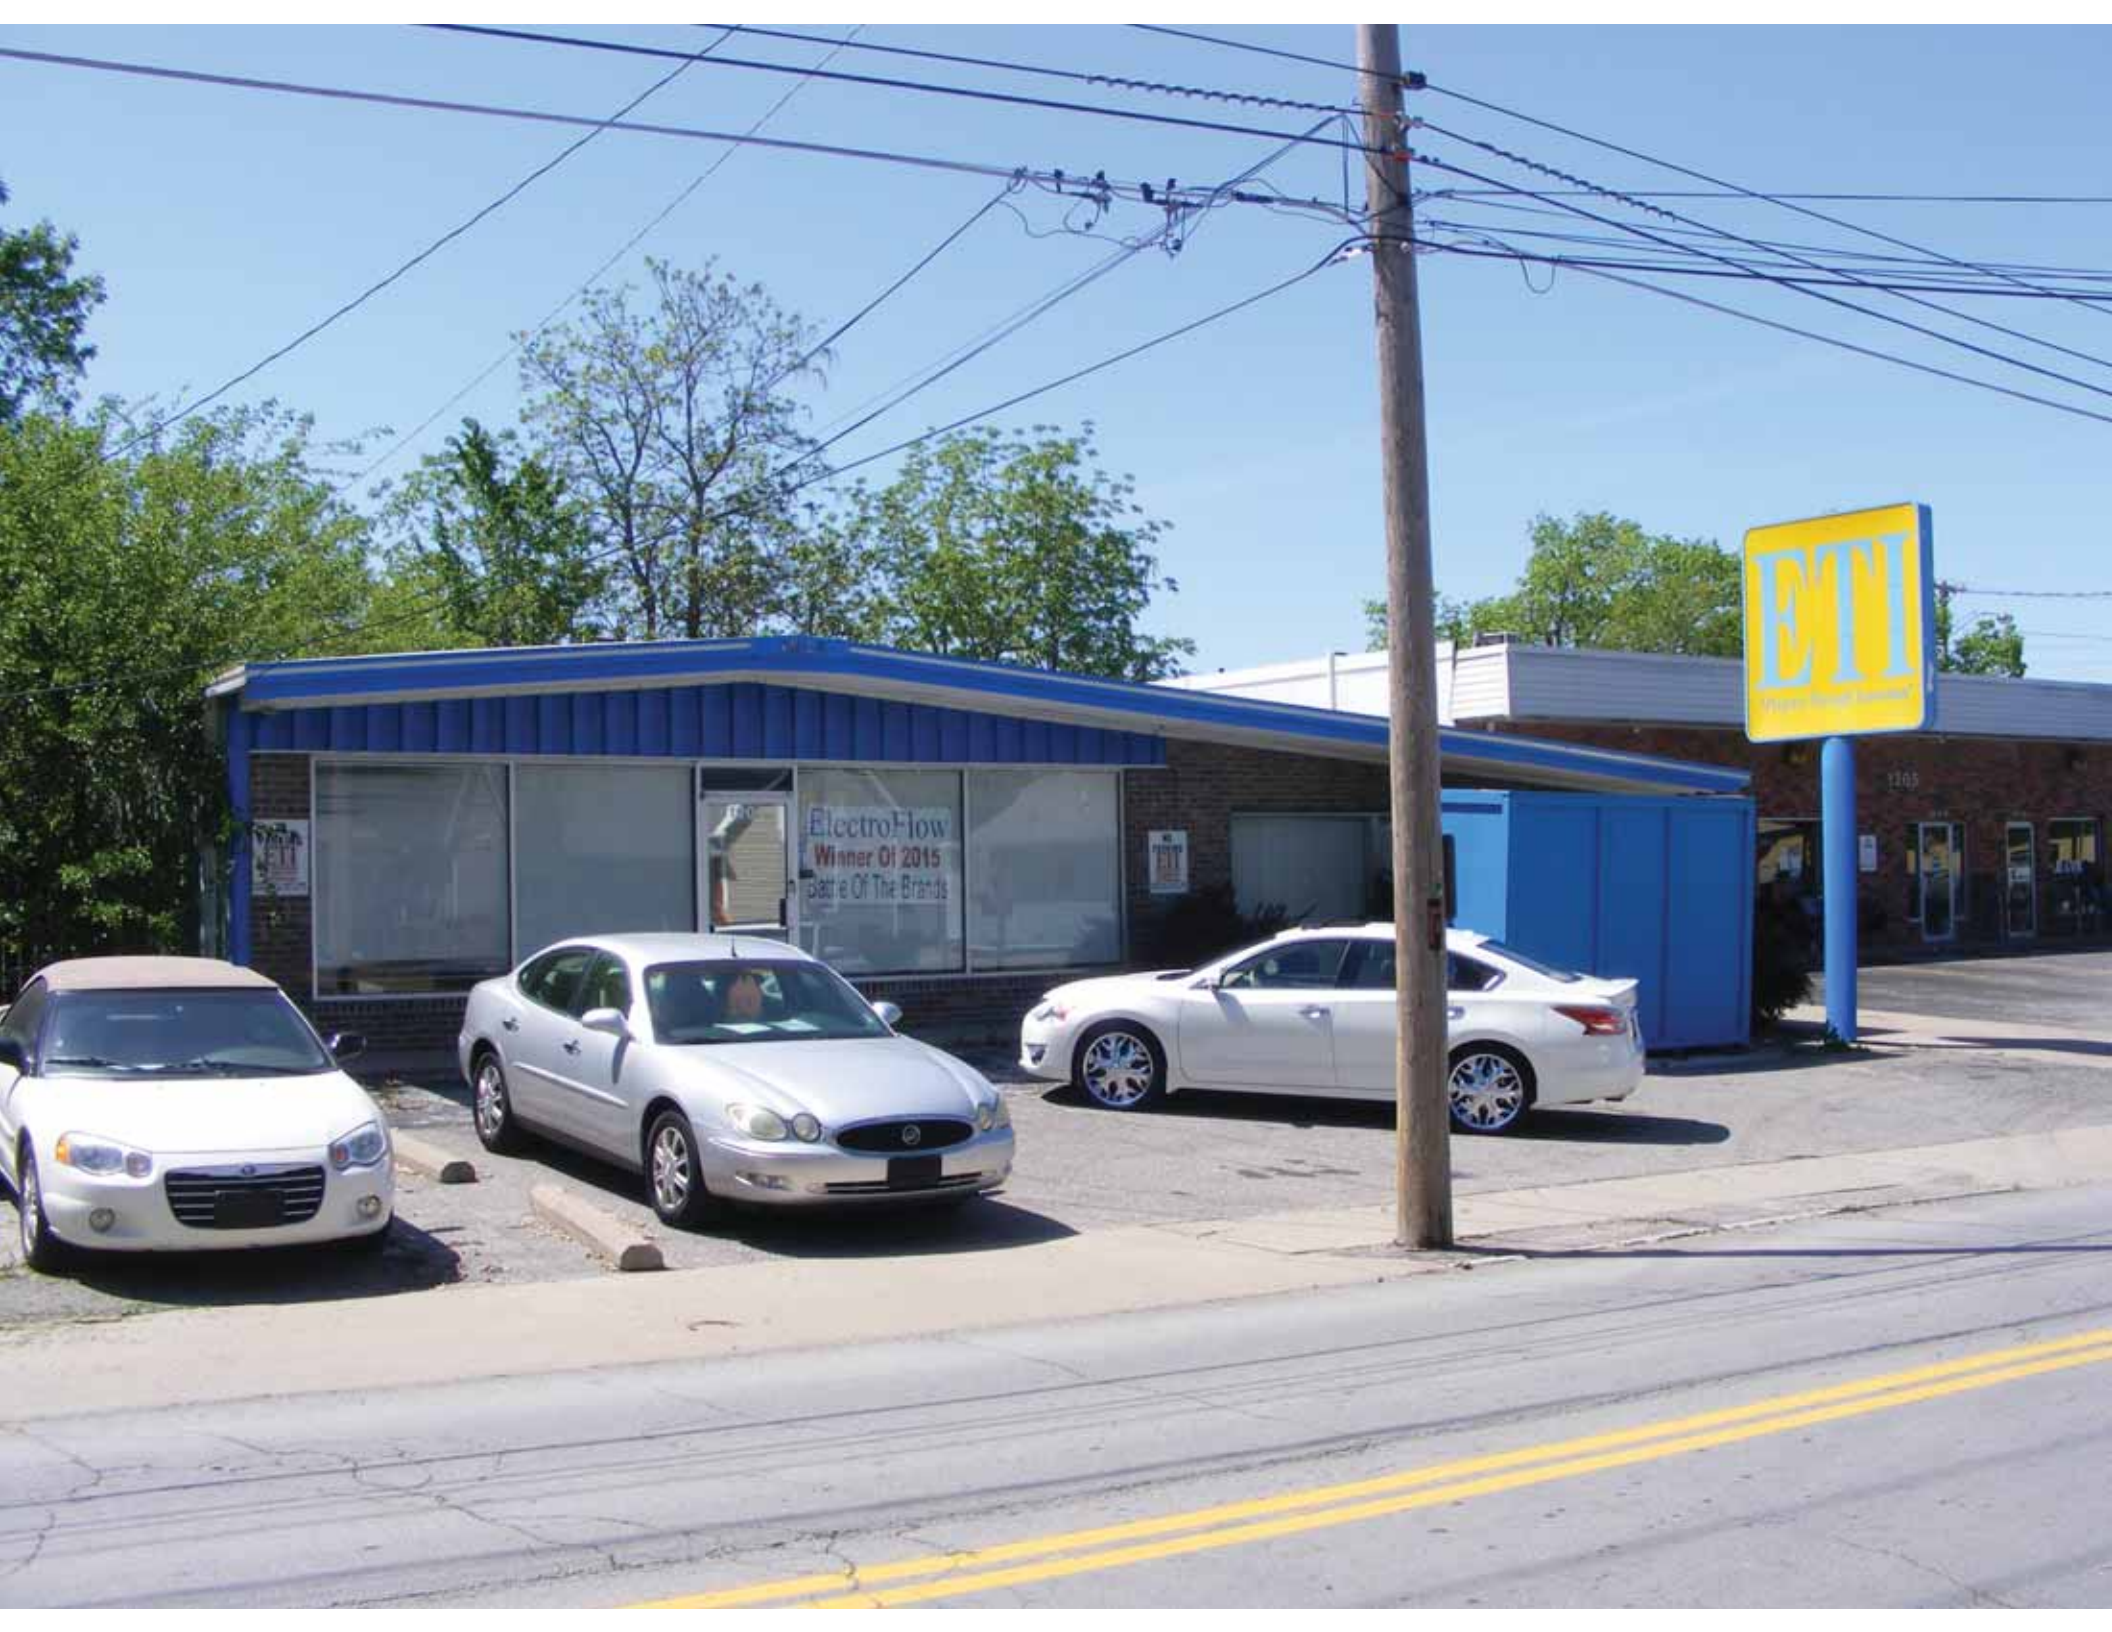
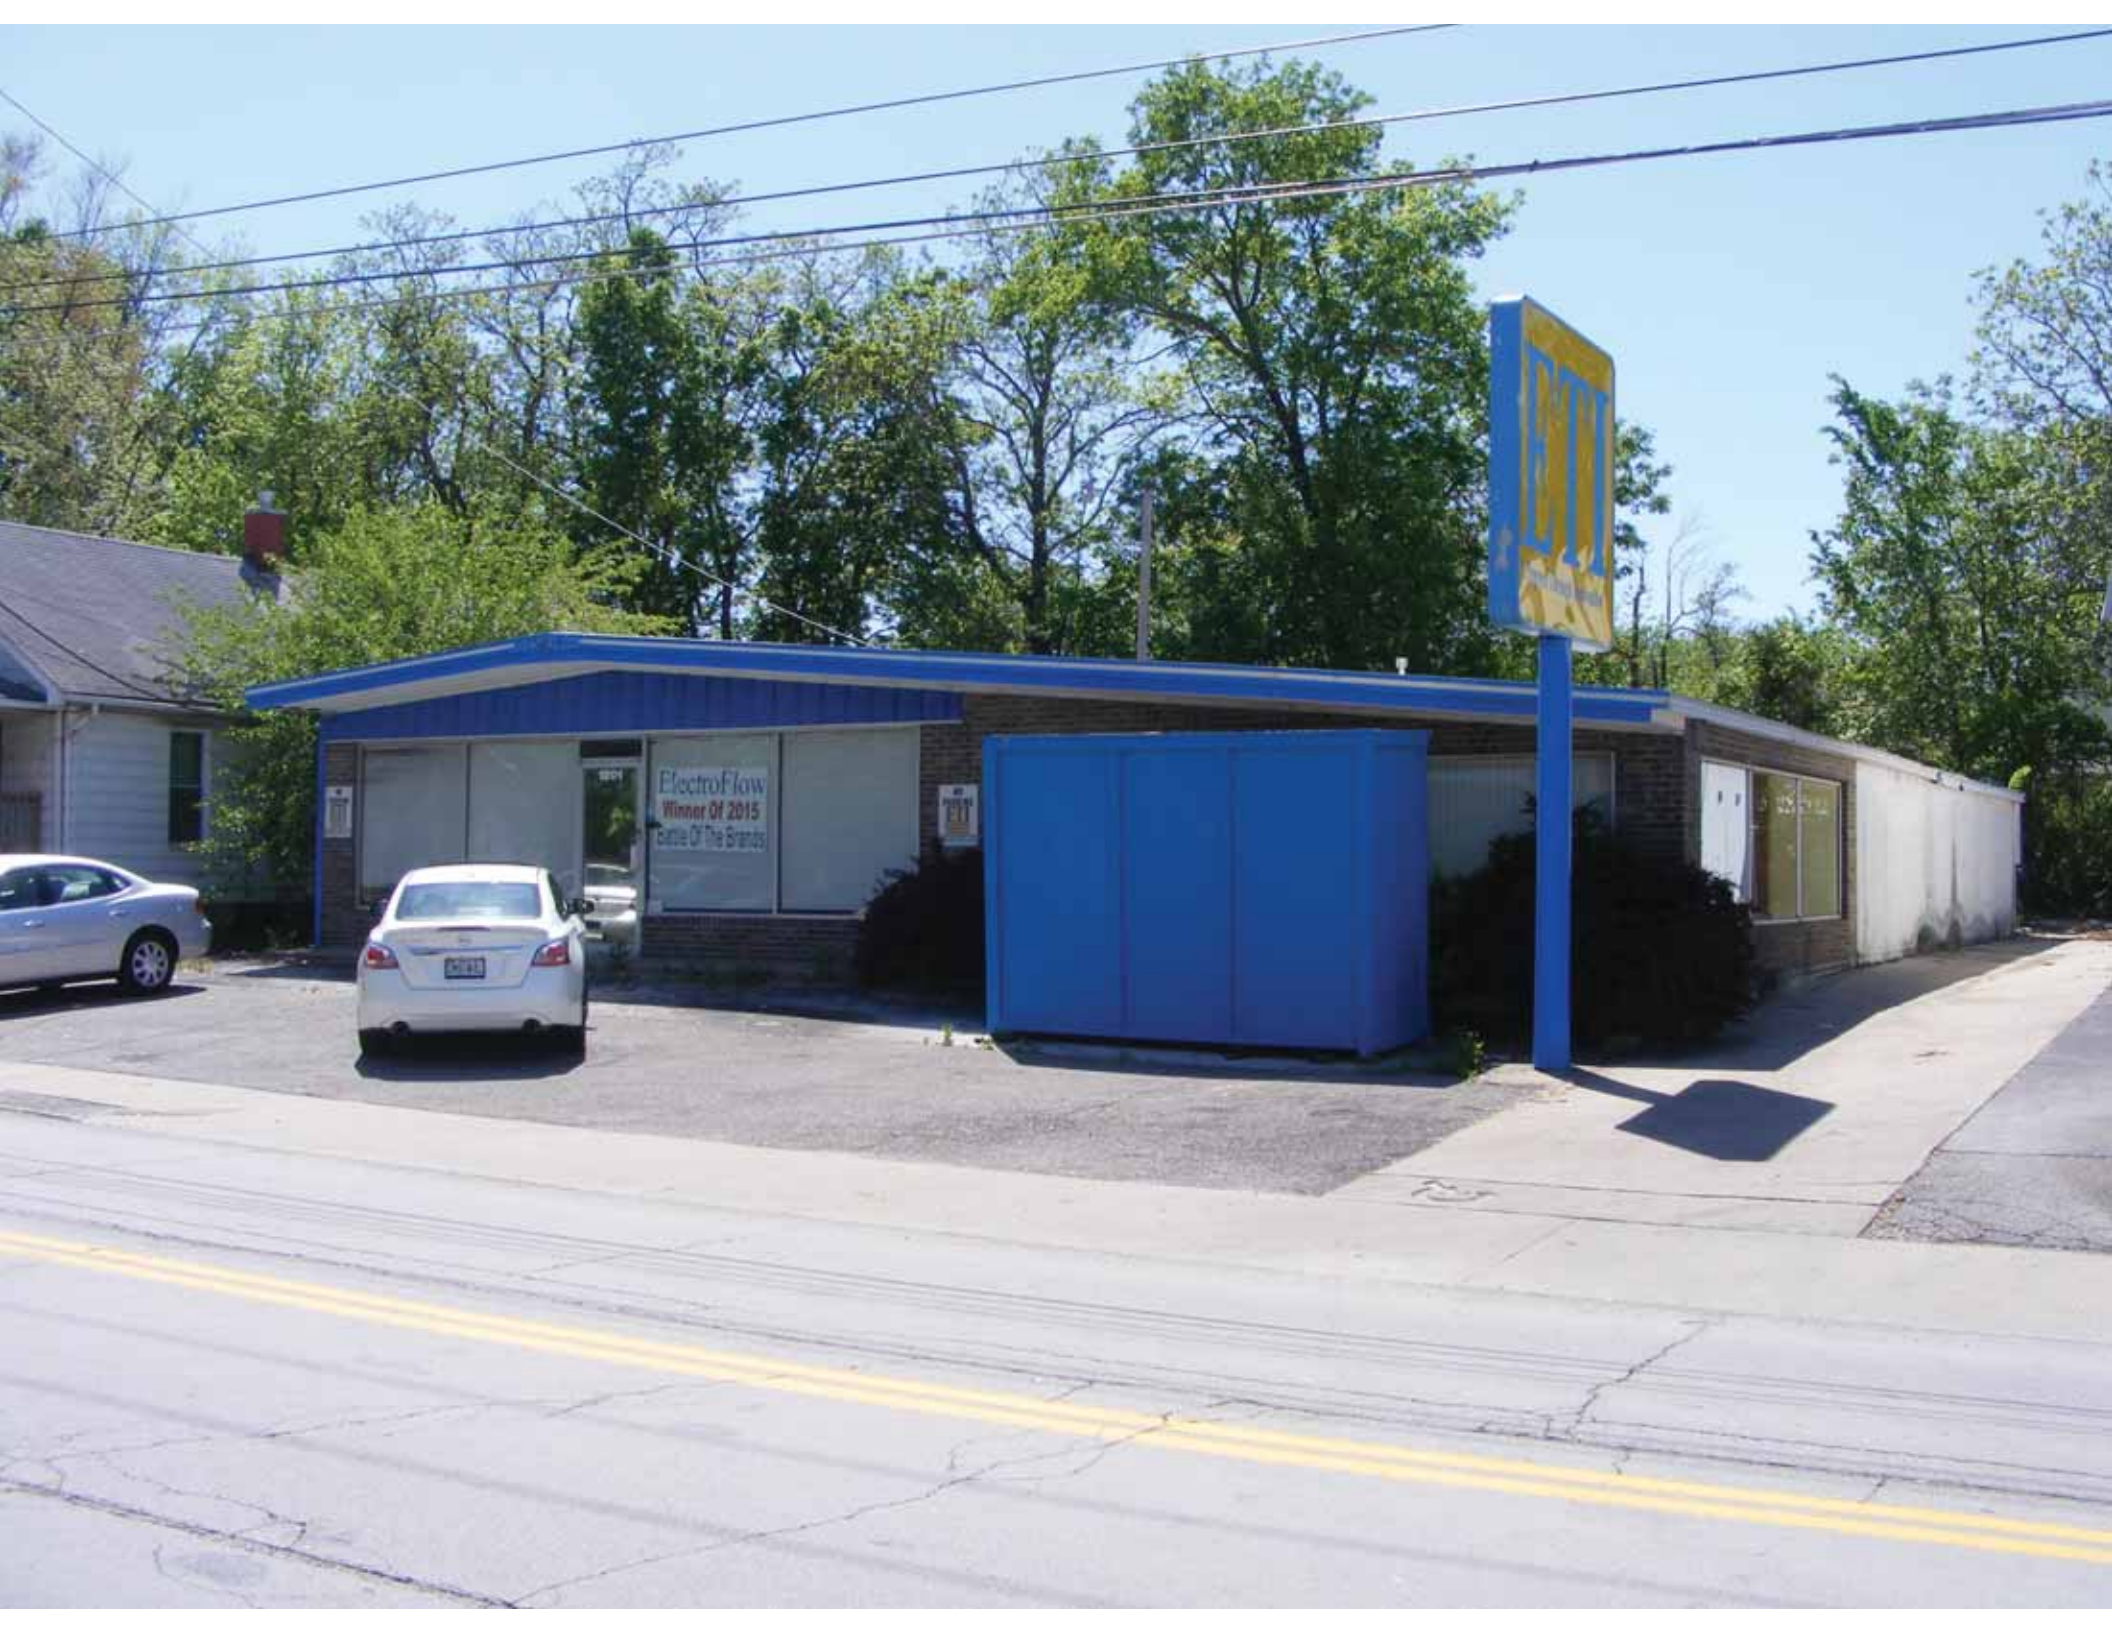
This one-story commercial building has a low gabled roof that extends to shed on the north end of the building. Exterior walls are primarily clad with brick veneer. The rear portion of the north wall is painted plywood. The primary (east) elevation has two multi-light window bays with fixed commercial aluminum sash windows. The bay near the south end of the elevation is centered below the roofline peak. This bay is composed of a central glass and aluminum commercial door below a fixed transom. The door is flanked by two commercial lights on either side. The north elevation has a three panel bay of aluminum sash windows. The east end of the three-panel bay on the north elevation is enclosed.

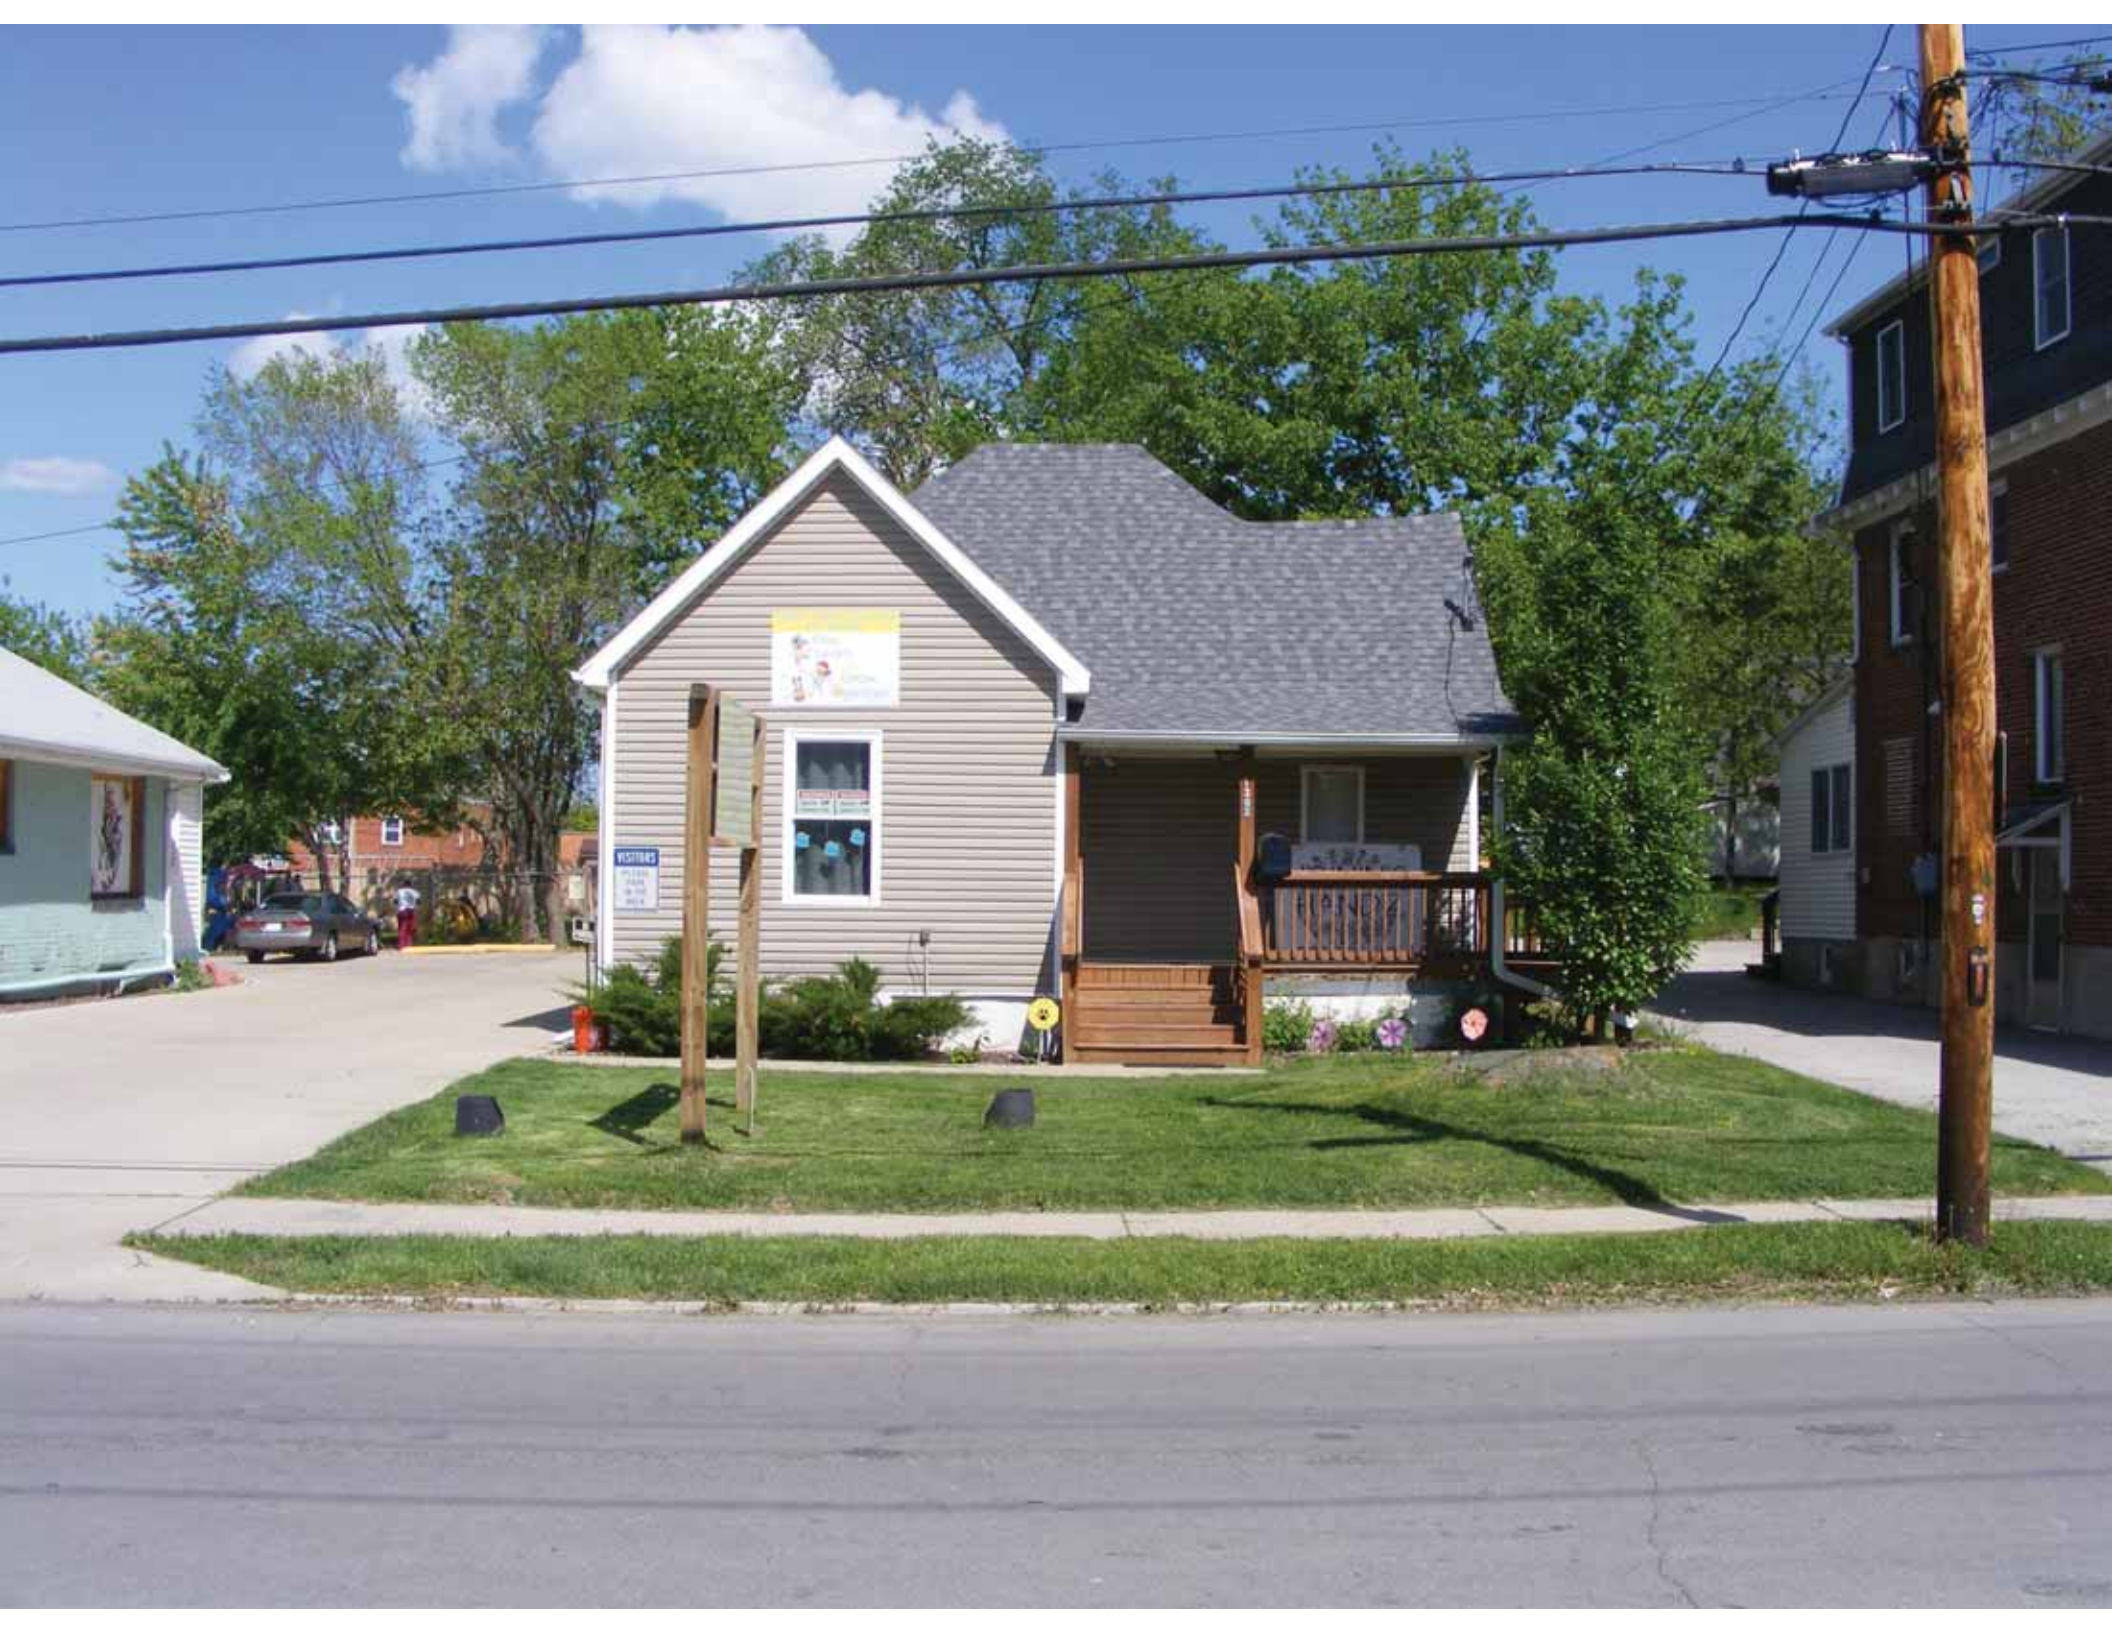
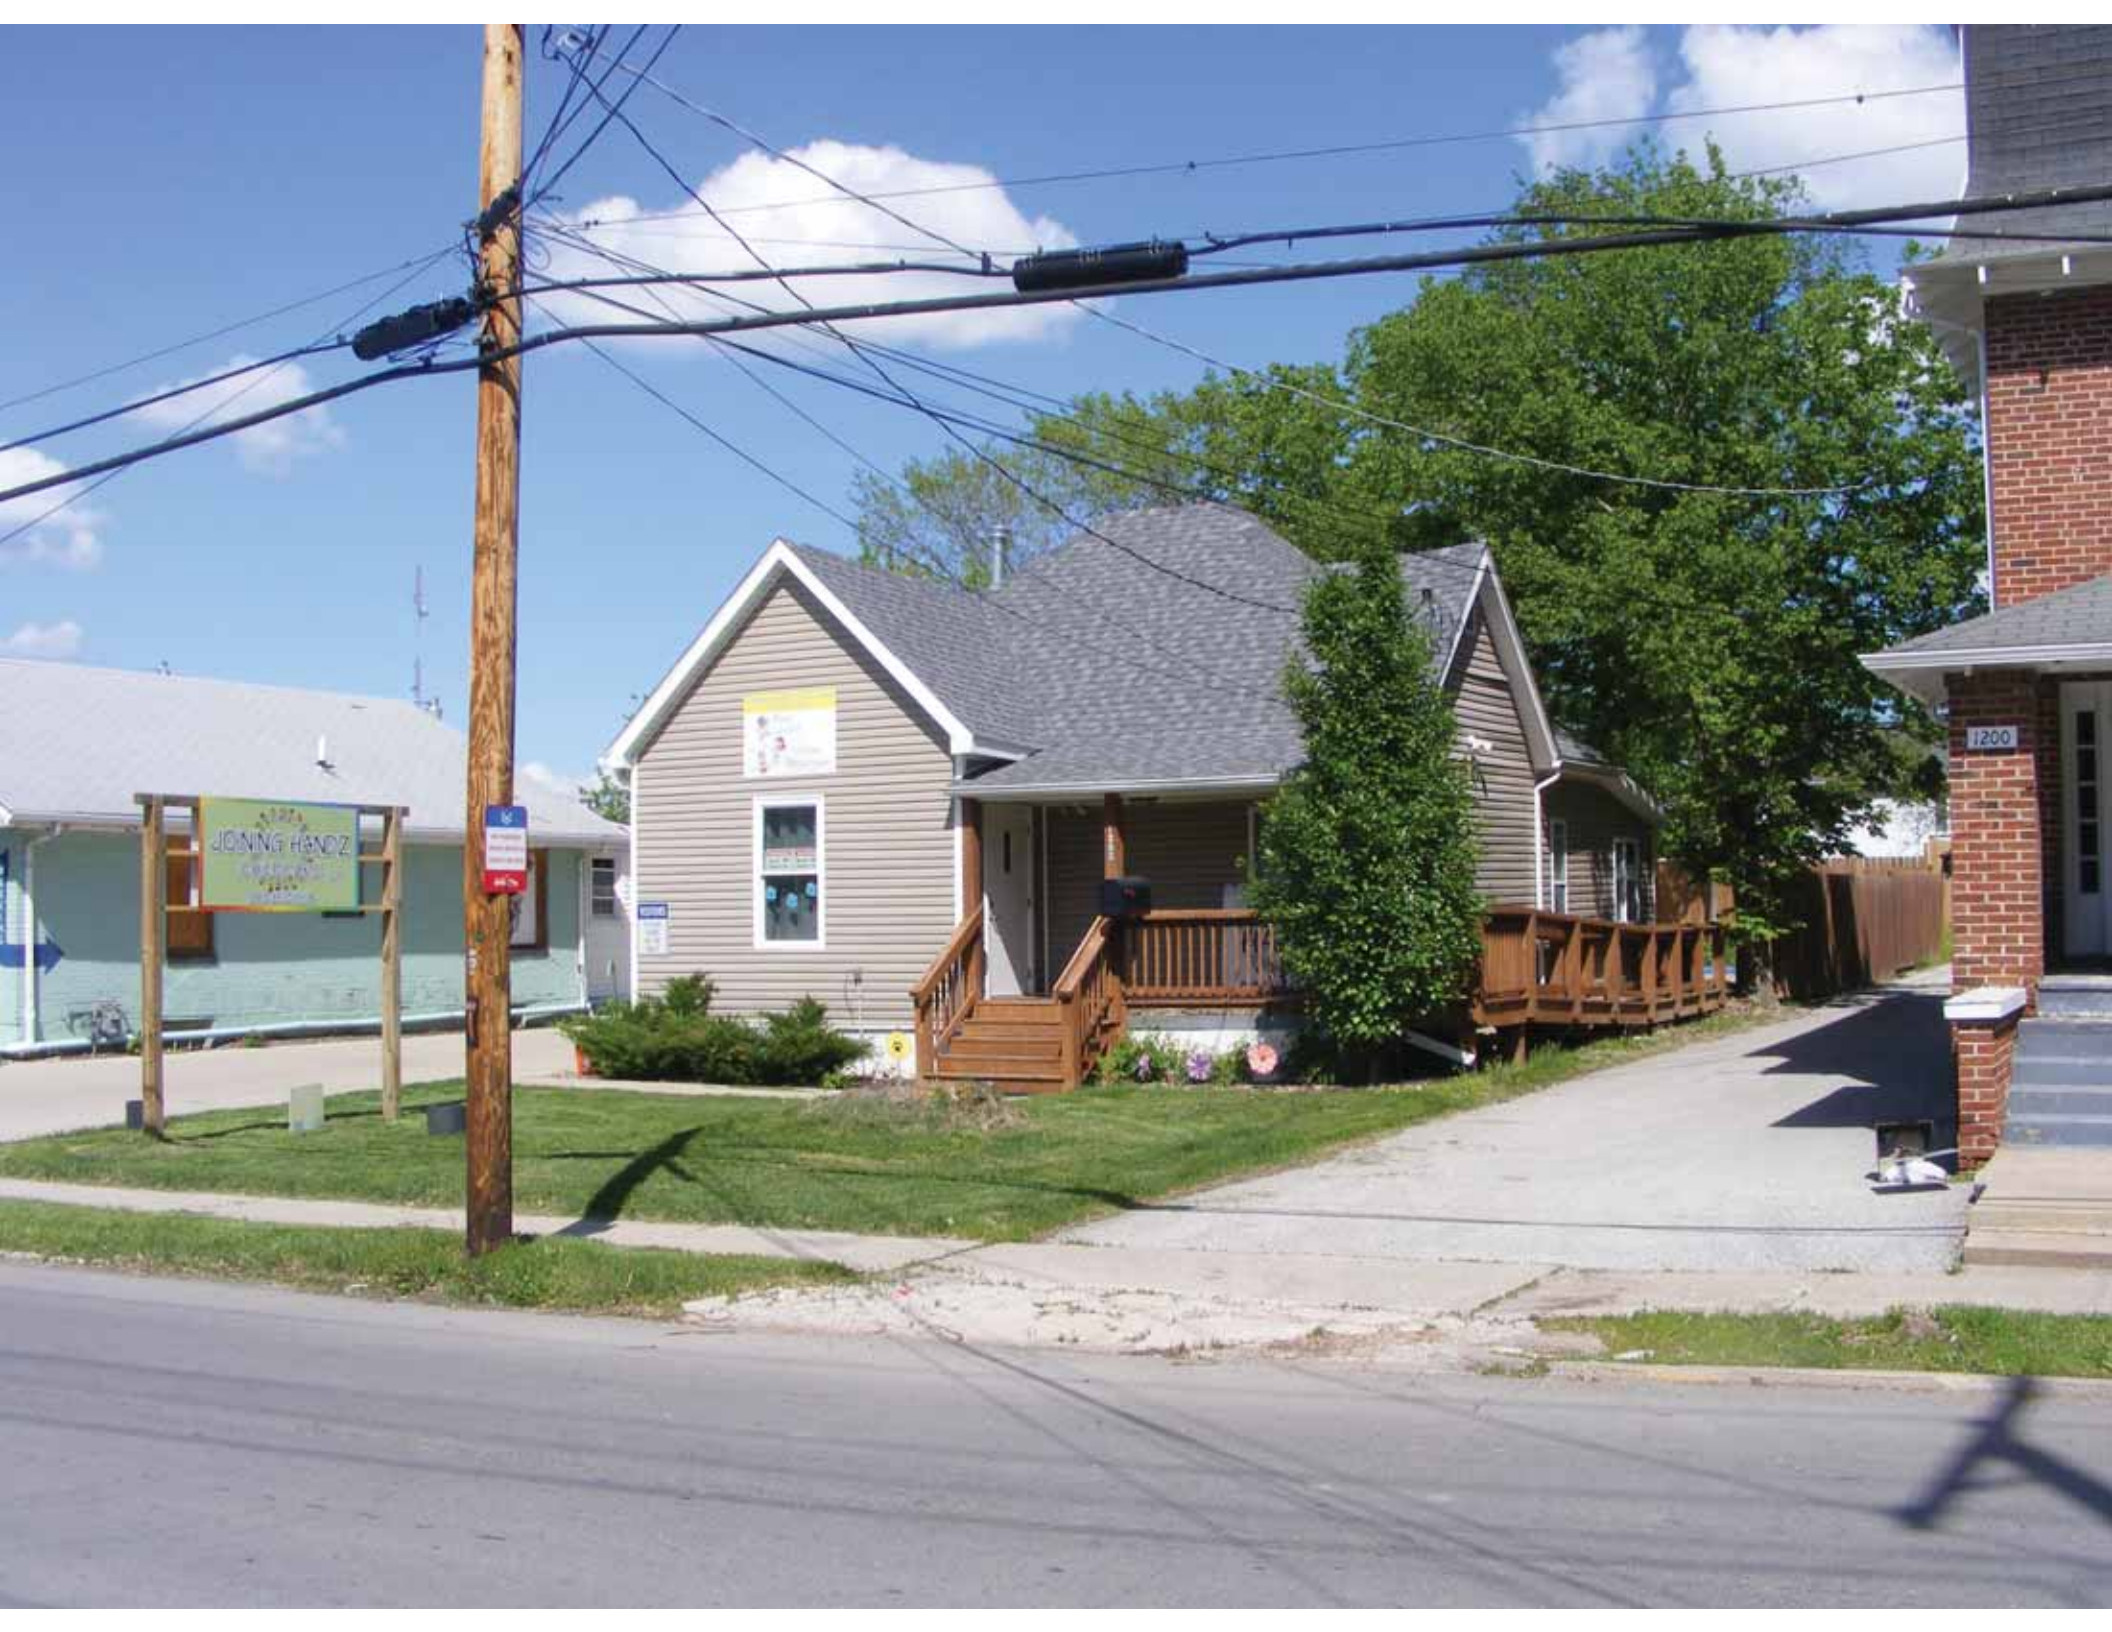
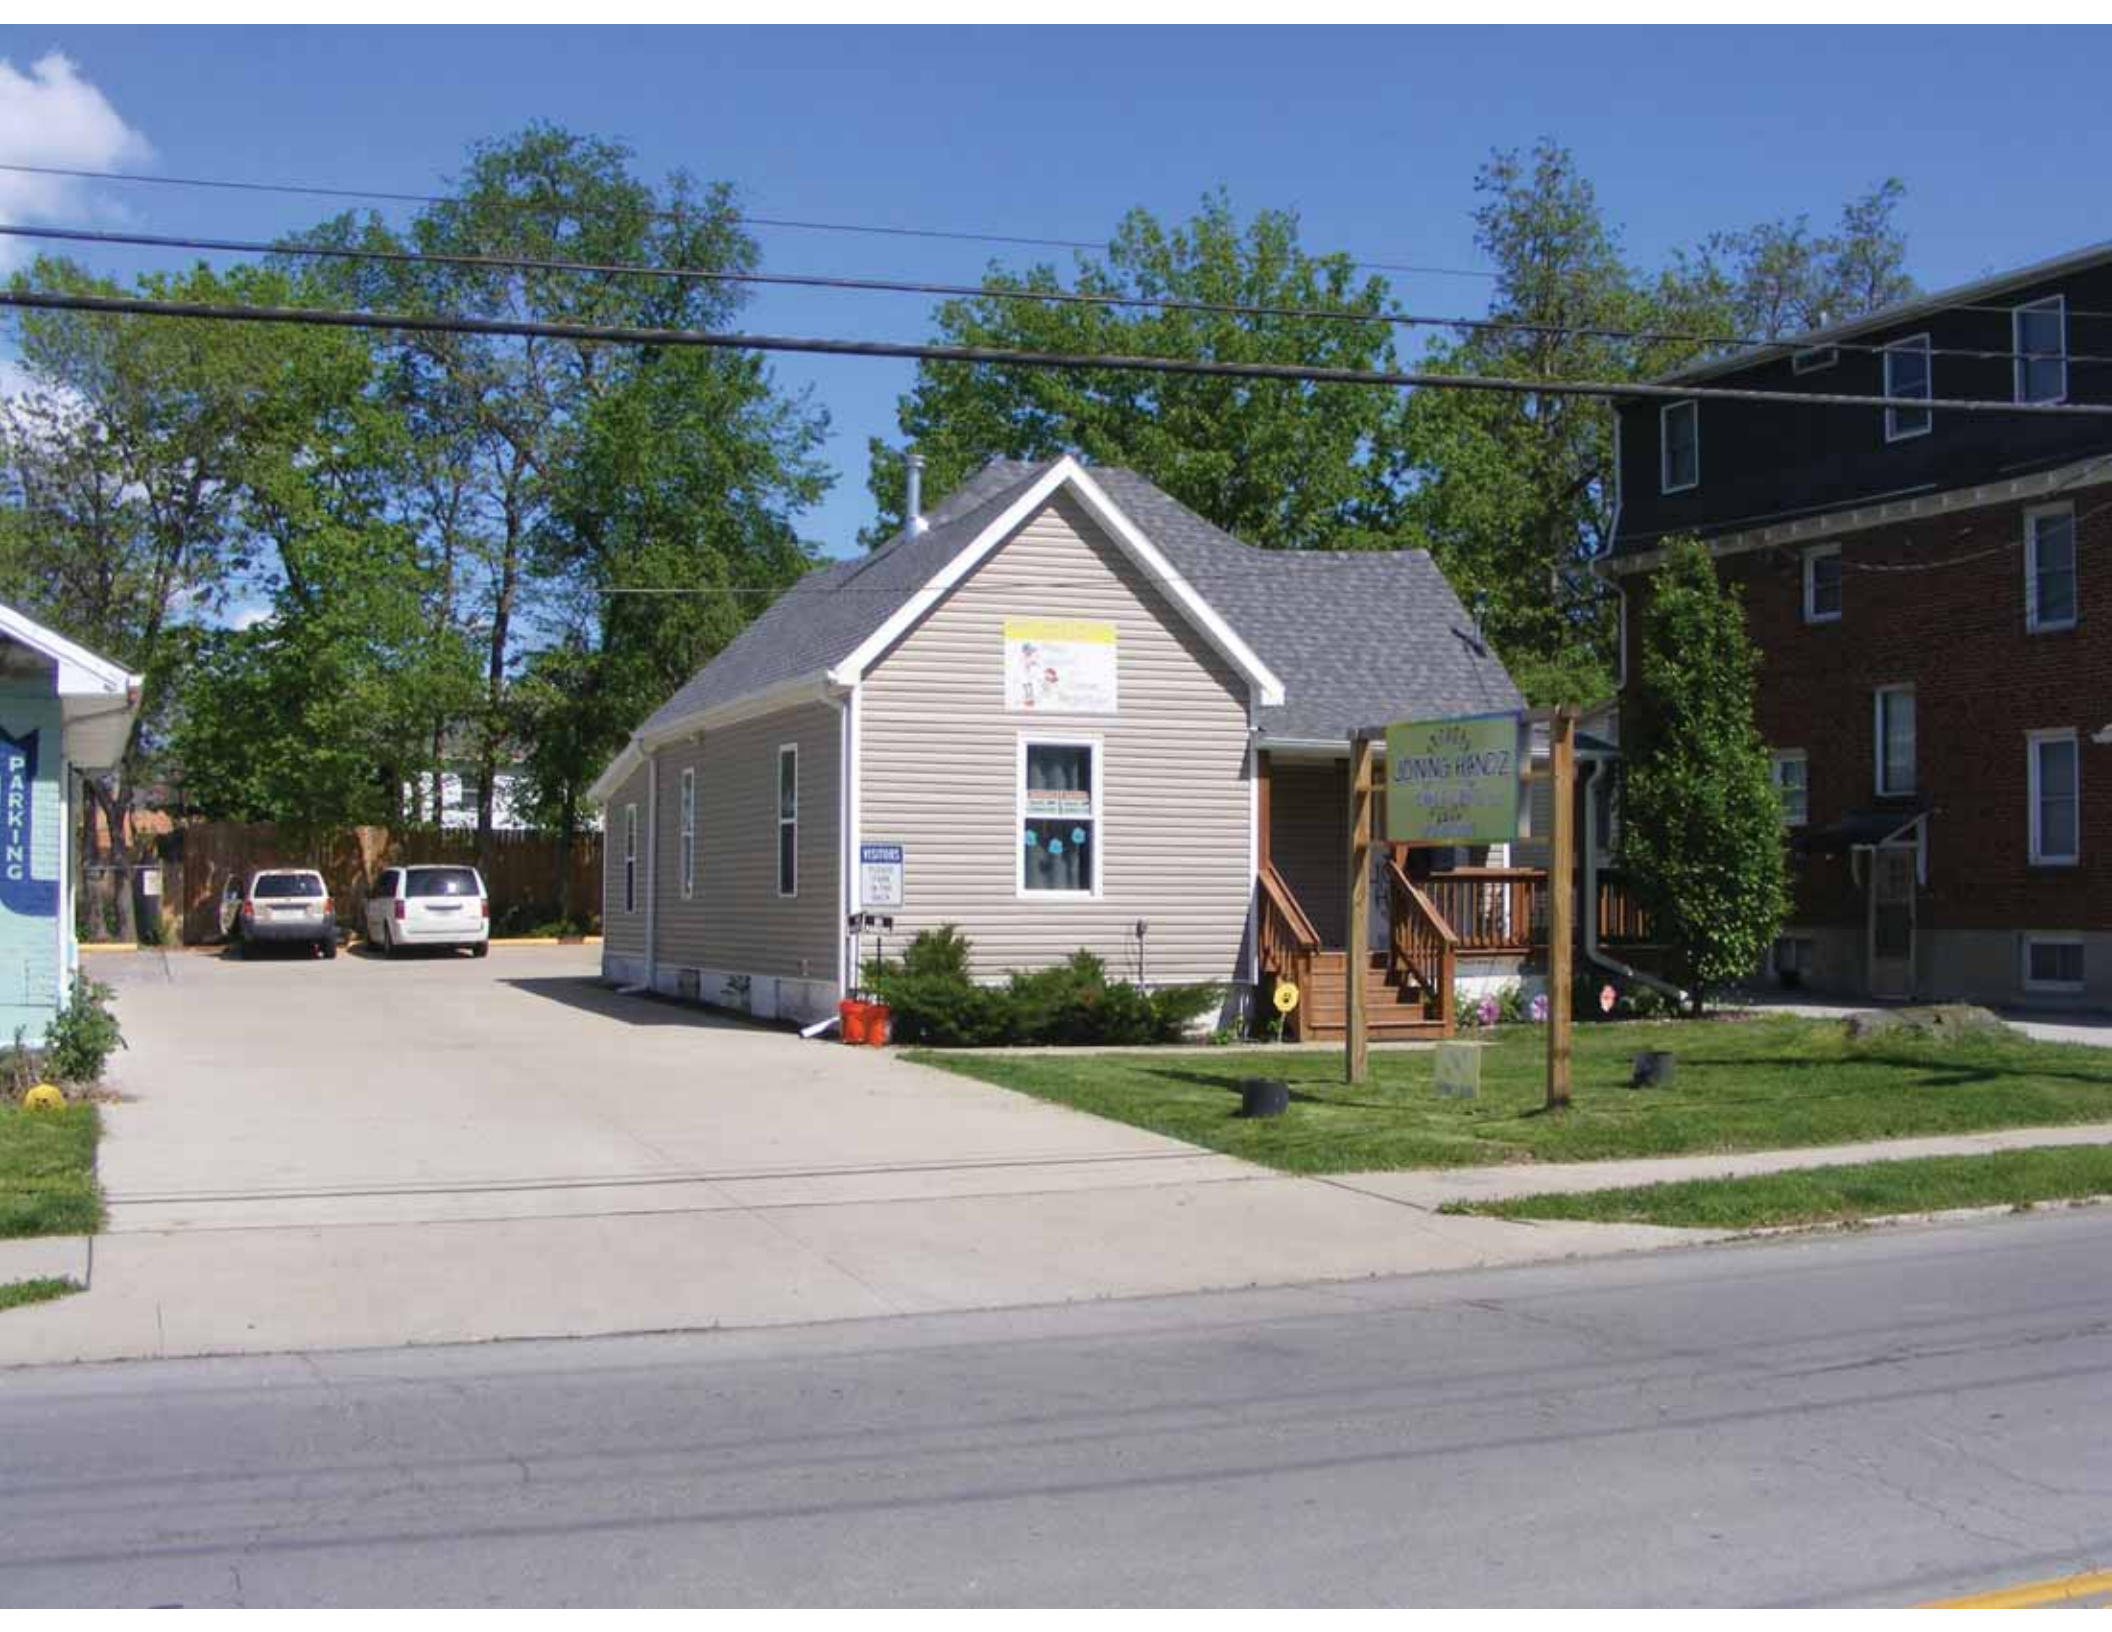
41. (cont.) Description of primary resource. Expand box as necessary, or add continuation pages.
This one-story asphalt-shingled cross-gable on hip dwelling has been converted to commercial use and has a raised concrete foundation. The façade features a replacement partial-width porch (ca. 2000) sheltered by a shed roof and is supported by wood columns. The porch has wood decking, railings and steps; an ADA accessible ramp intersects the porch on the side elevation (right), runs the length of the elevation with access gained at the back elevation parking lot. The porch bay area holds a one-over-one window; entrance is on the side (south) elevation wall. Gable end holds a one-over-one window. Side elevation feature paired and single one-over-one windows.
