MISSOURI DEPARTMENT OF NATURAL RESOURCES
STATE HISTORIC PRESERVATION OFFICE, P.O. Box 176, Jefferson City, MO 65102
ARCHITECTURAL/HISTORIC INVENTORY FORM

1. Survey No. BO-AS-011-0087		2. Survey name: North Central Columbia Survey Phase II	
3. County: Boone		4. Address (Street No.) 902	Street (name) N. Seventh Street
5. City: Columbia	Vicinity: <input type="checkbox"/>	6. Geographical Reference:	7. Township/Range/Section: T: R: S:
8. Historic name (if known):		9. Present/other name (if known):	
10. Ownership: <input checked="" type="checkbox"/> Private <input type="checkbox"/> Public		11a. Historic use (if known): Domestic/single dwelling	11b. Current use: Domestic/single dwelling

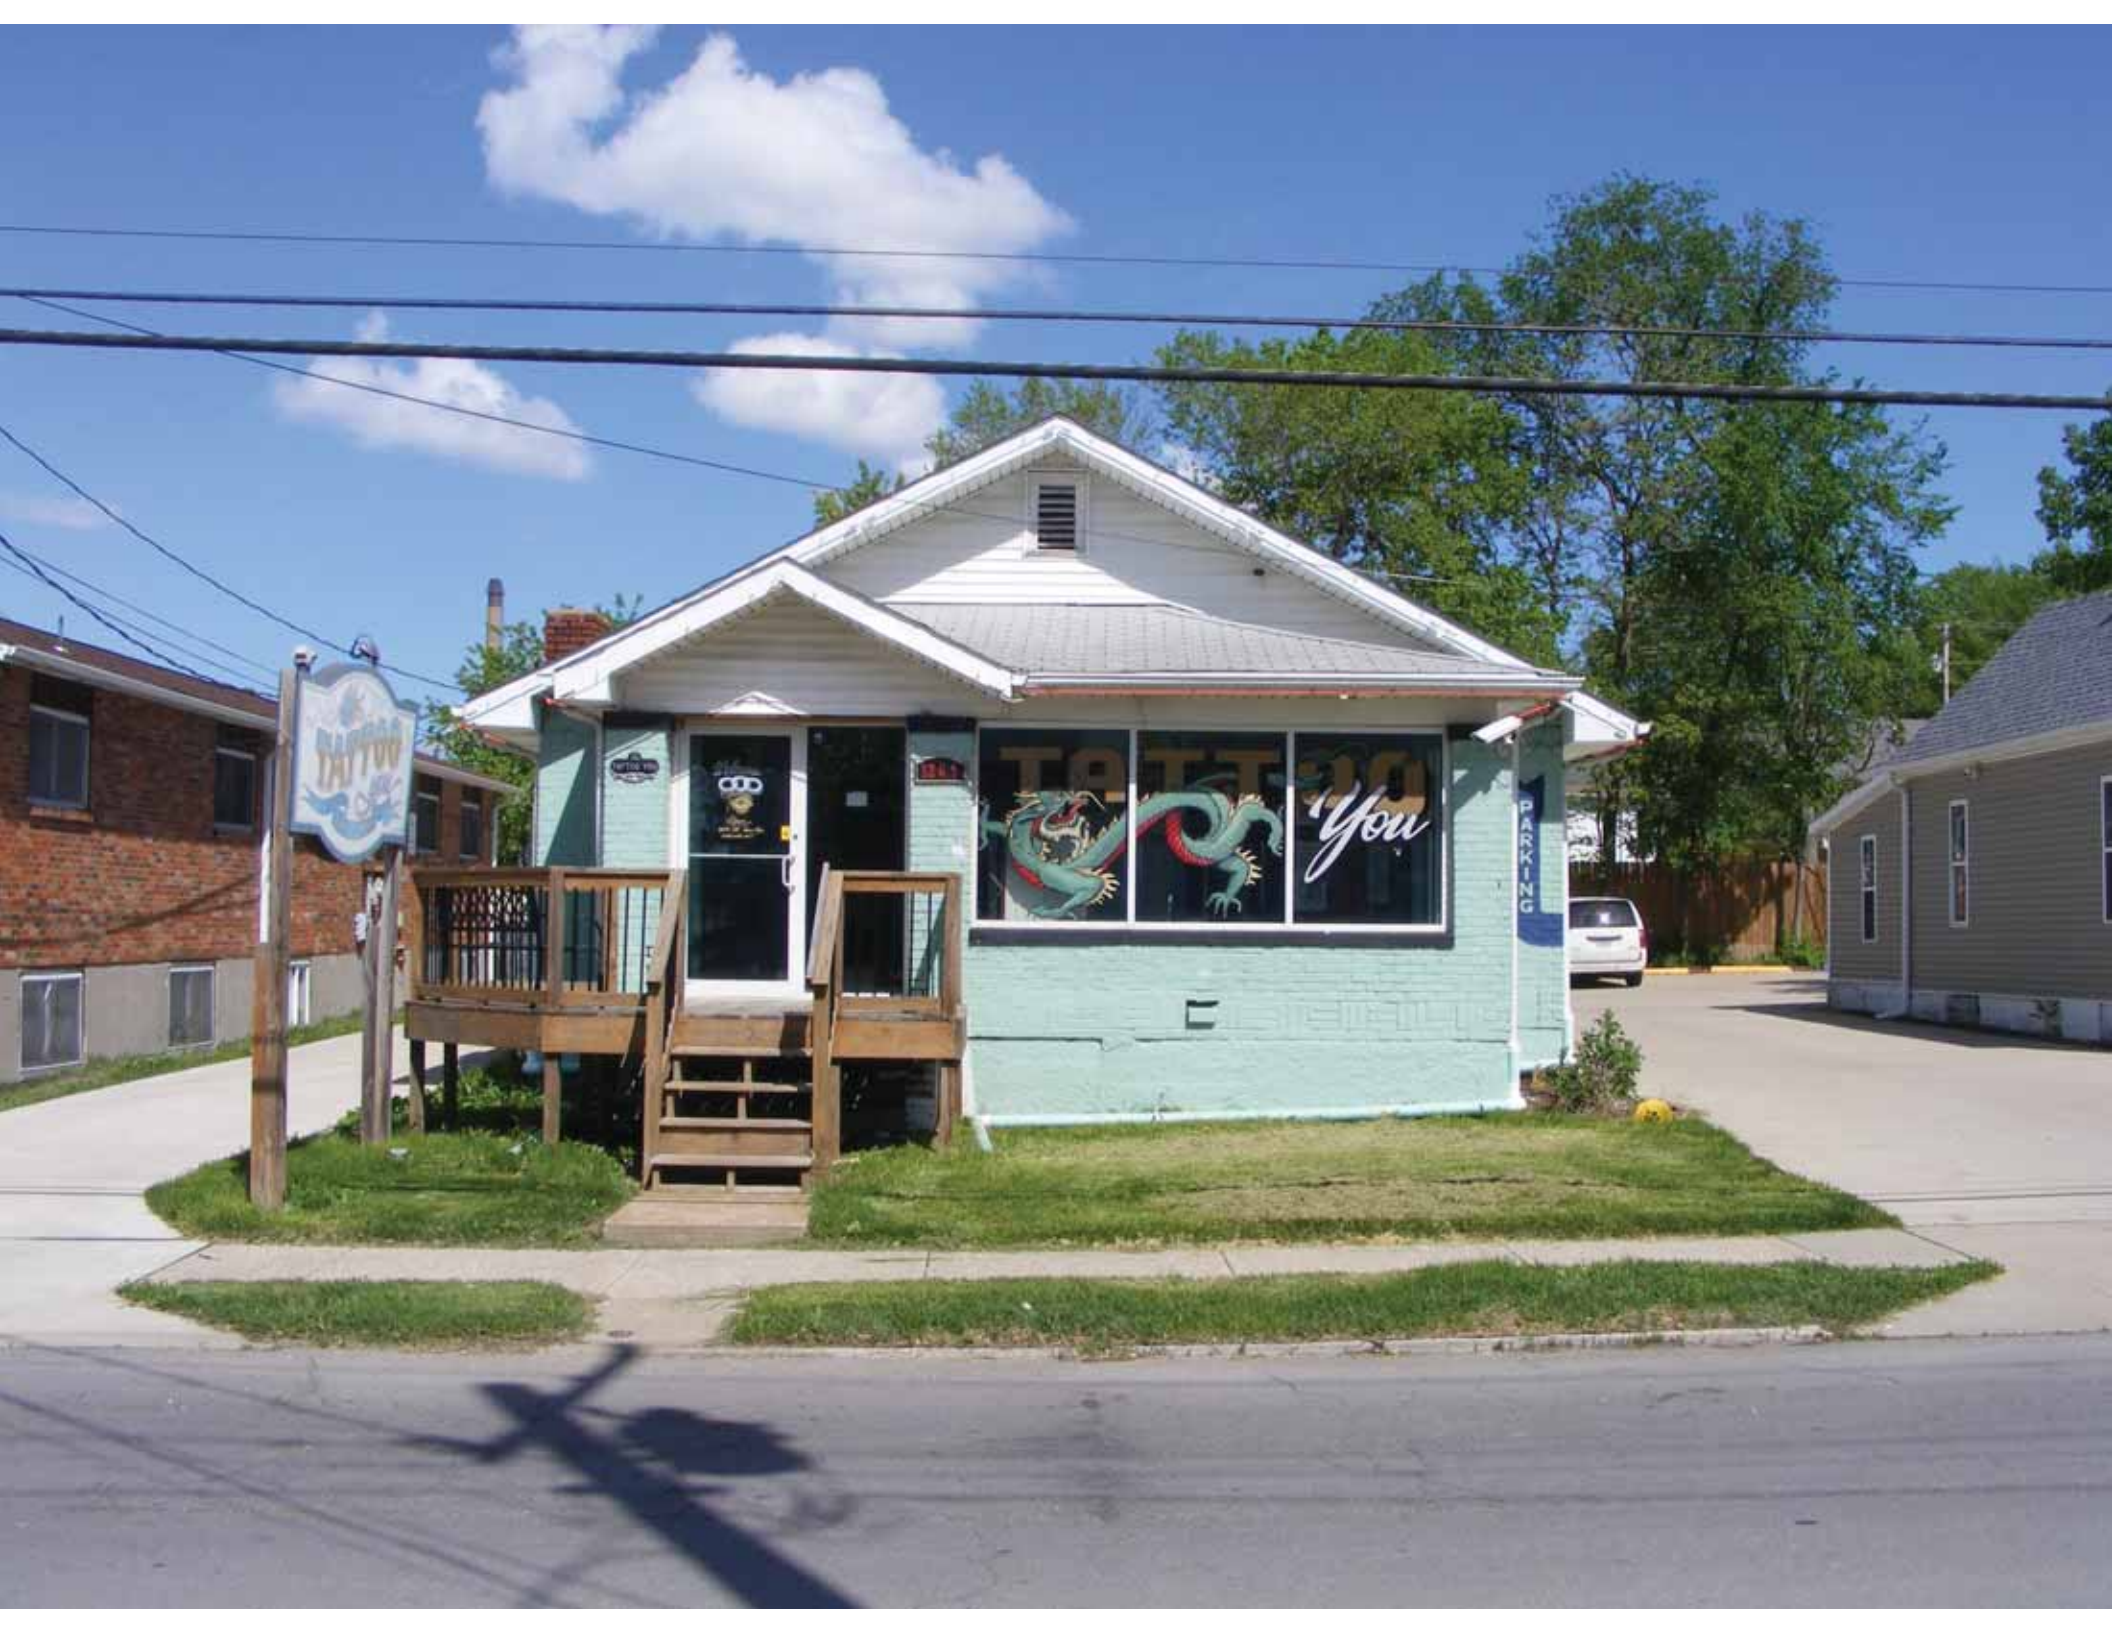
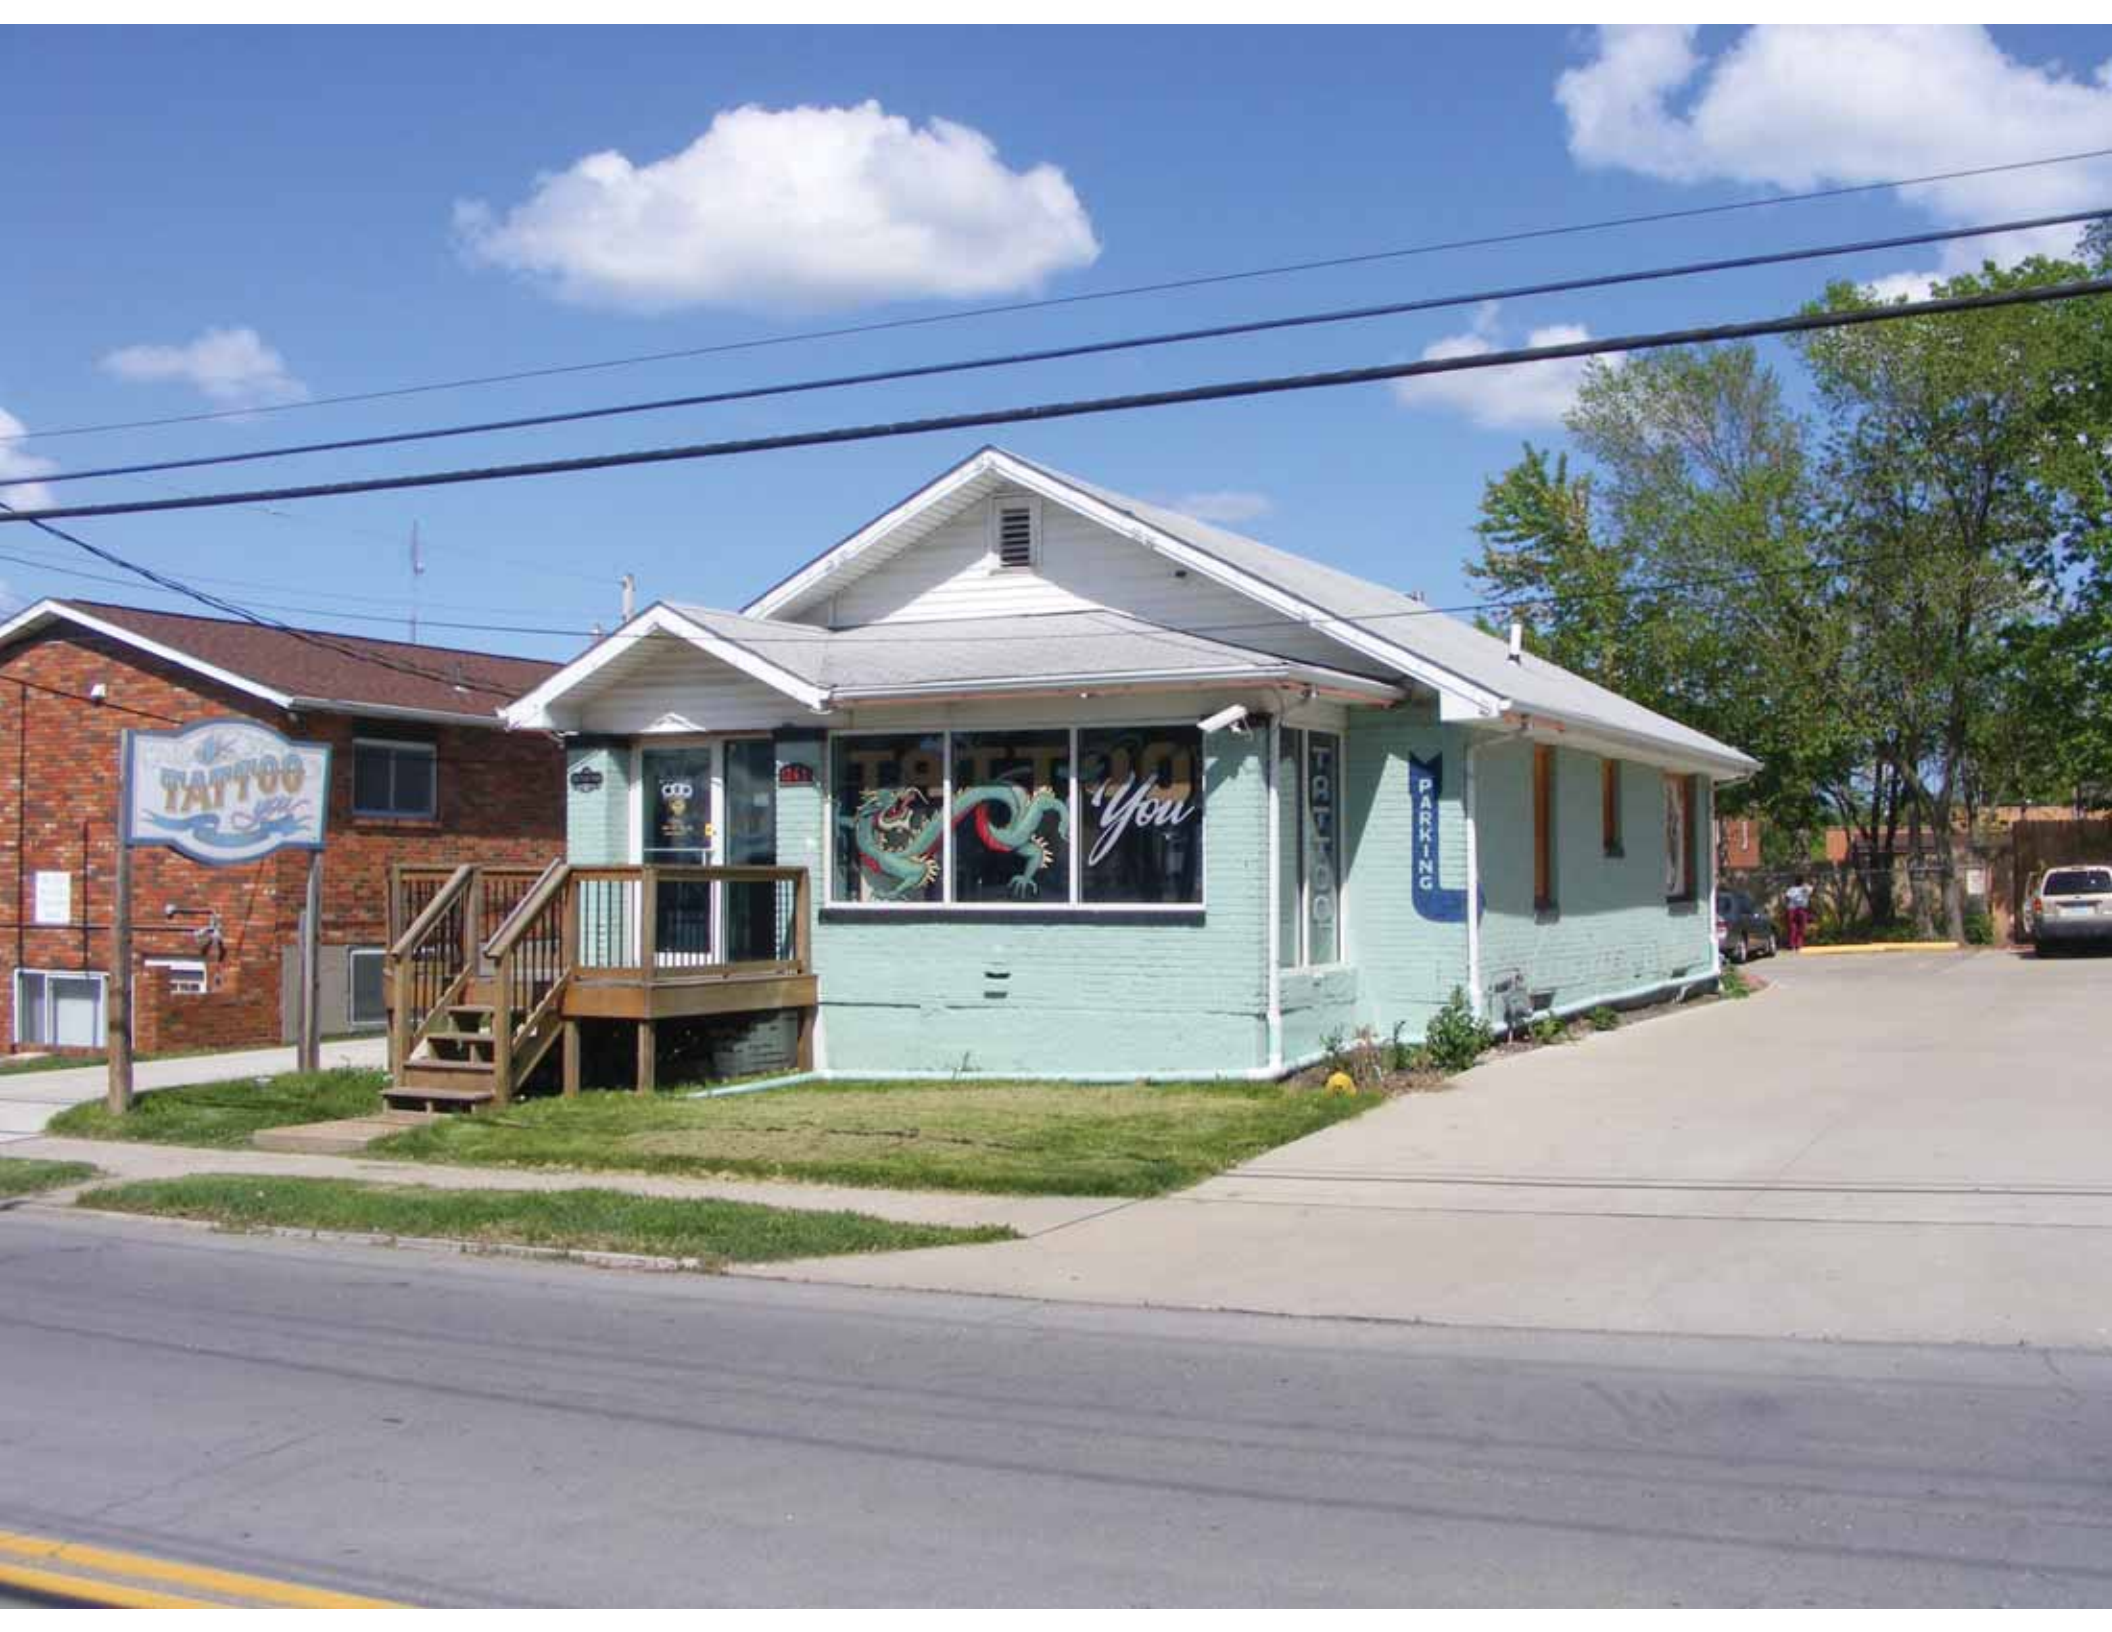
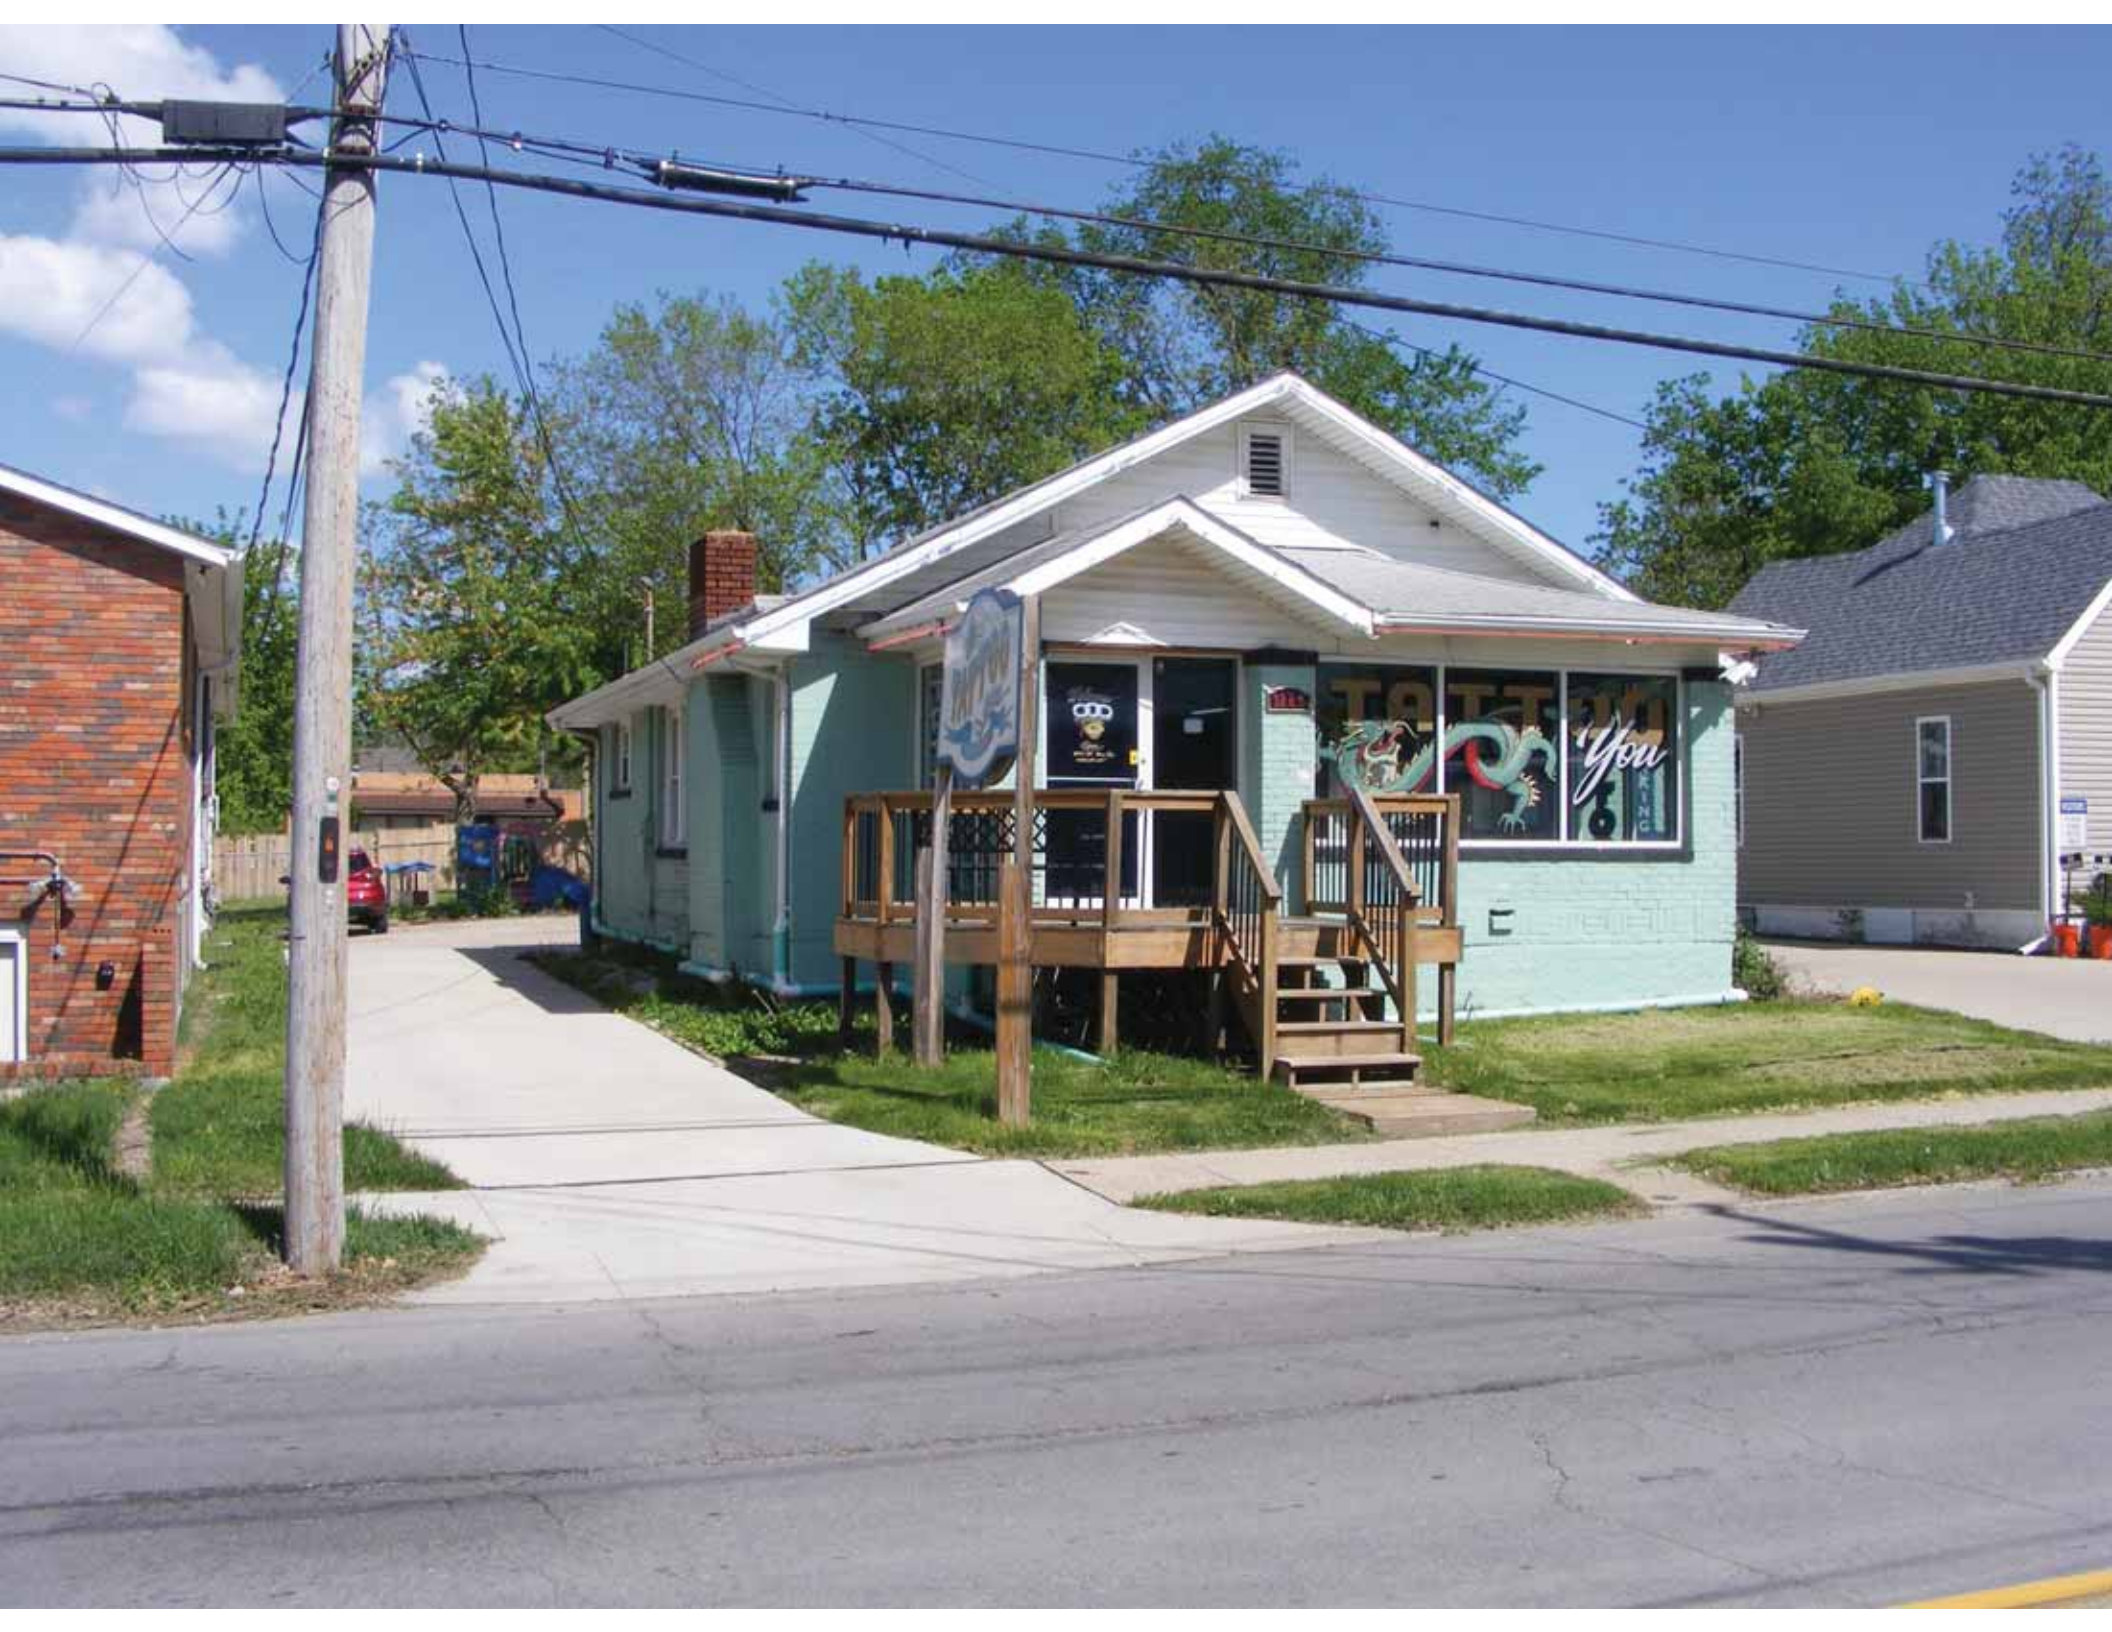
41. (cont.) Description of primary resource. Expand box as necessary, or add continuation pages.
This is a one-story brick, asphalt-shingle front gable dwelling converted to commercial use on a raised concrete foundation. The partial-width porch has been enclosed and features a low hip to front gable roof (asphalted-shingled). The enclosed porch area features the original brick columns. The entrance is located under the front gable and holds a double glass/metal door; gable end clad in vinyl siding. To the right of the entrance is a tripled paired display window; south elevation of enclosed porch holds paired display windows. A non-original open wooden porch with wood decking railings and steps is sited at the left section providing access to the entrance. The main front gable end is clad in vinyl siding with a vent. Windows are paired and single; south elevation windows are covered over. Above the raised foundation is a roll of brick in the basket weave design. The brick is painted.

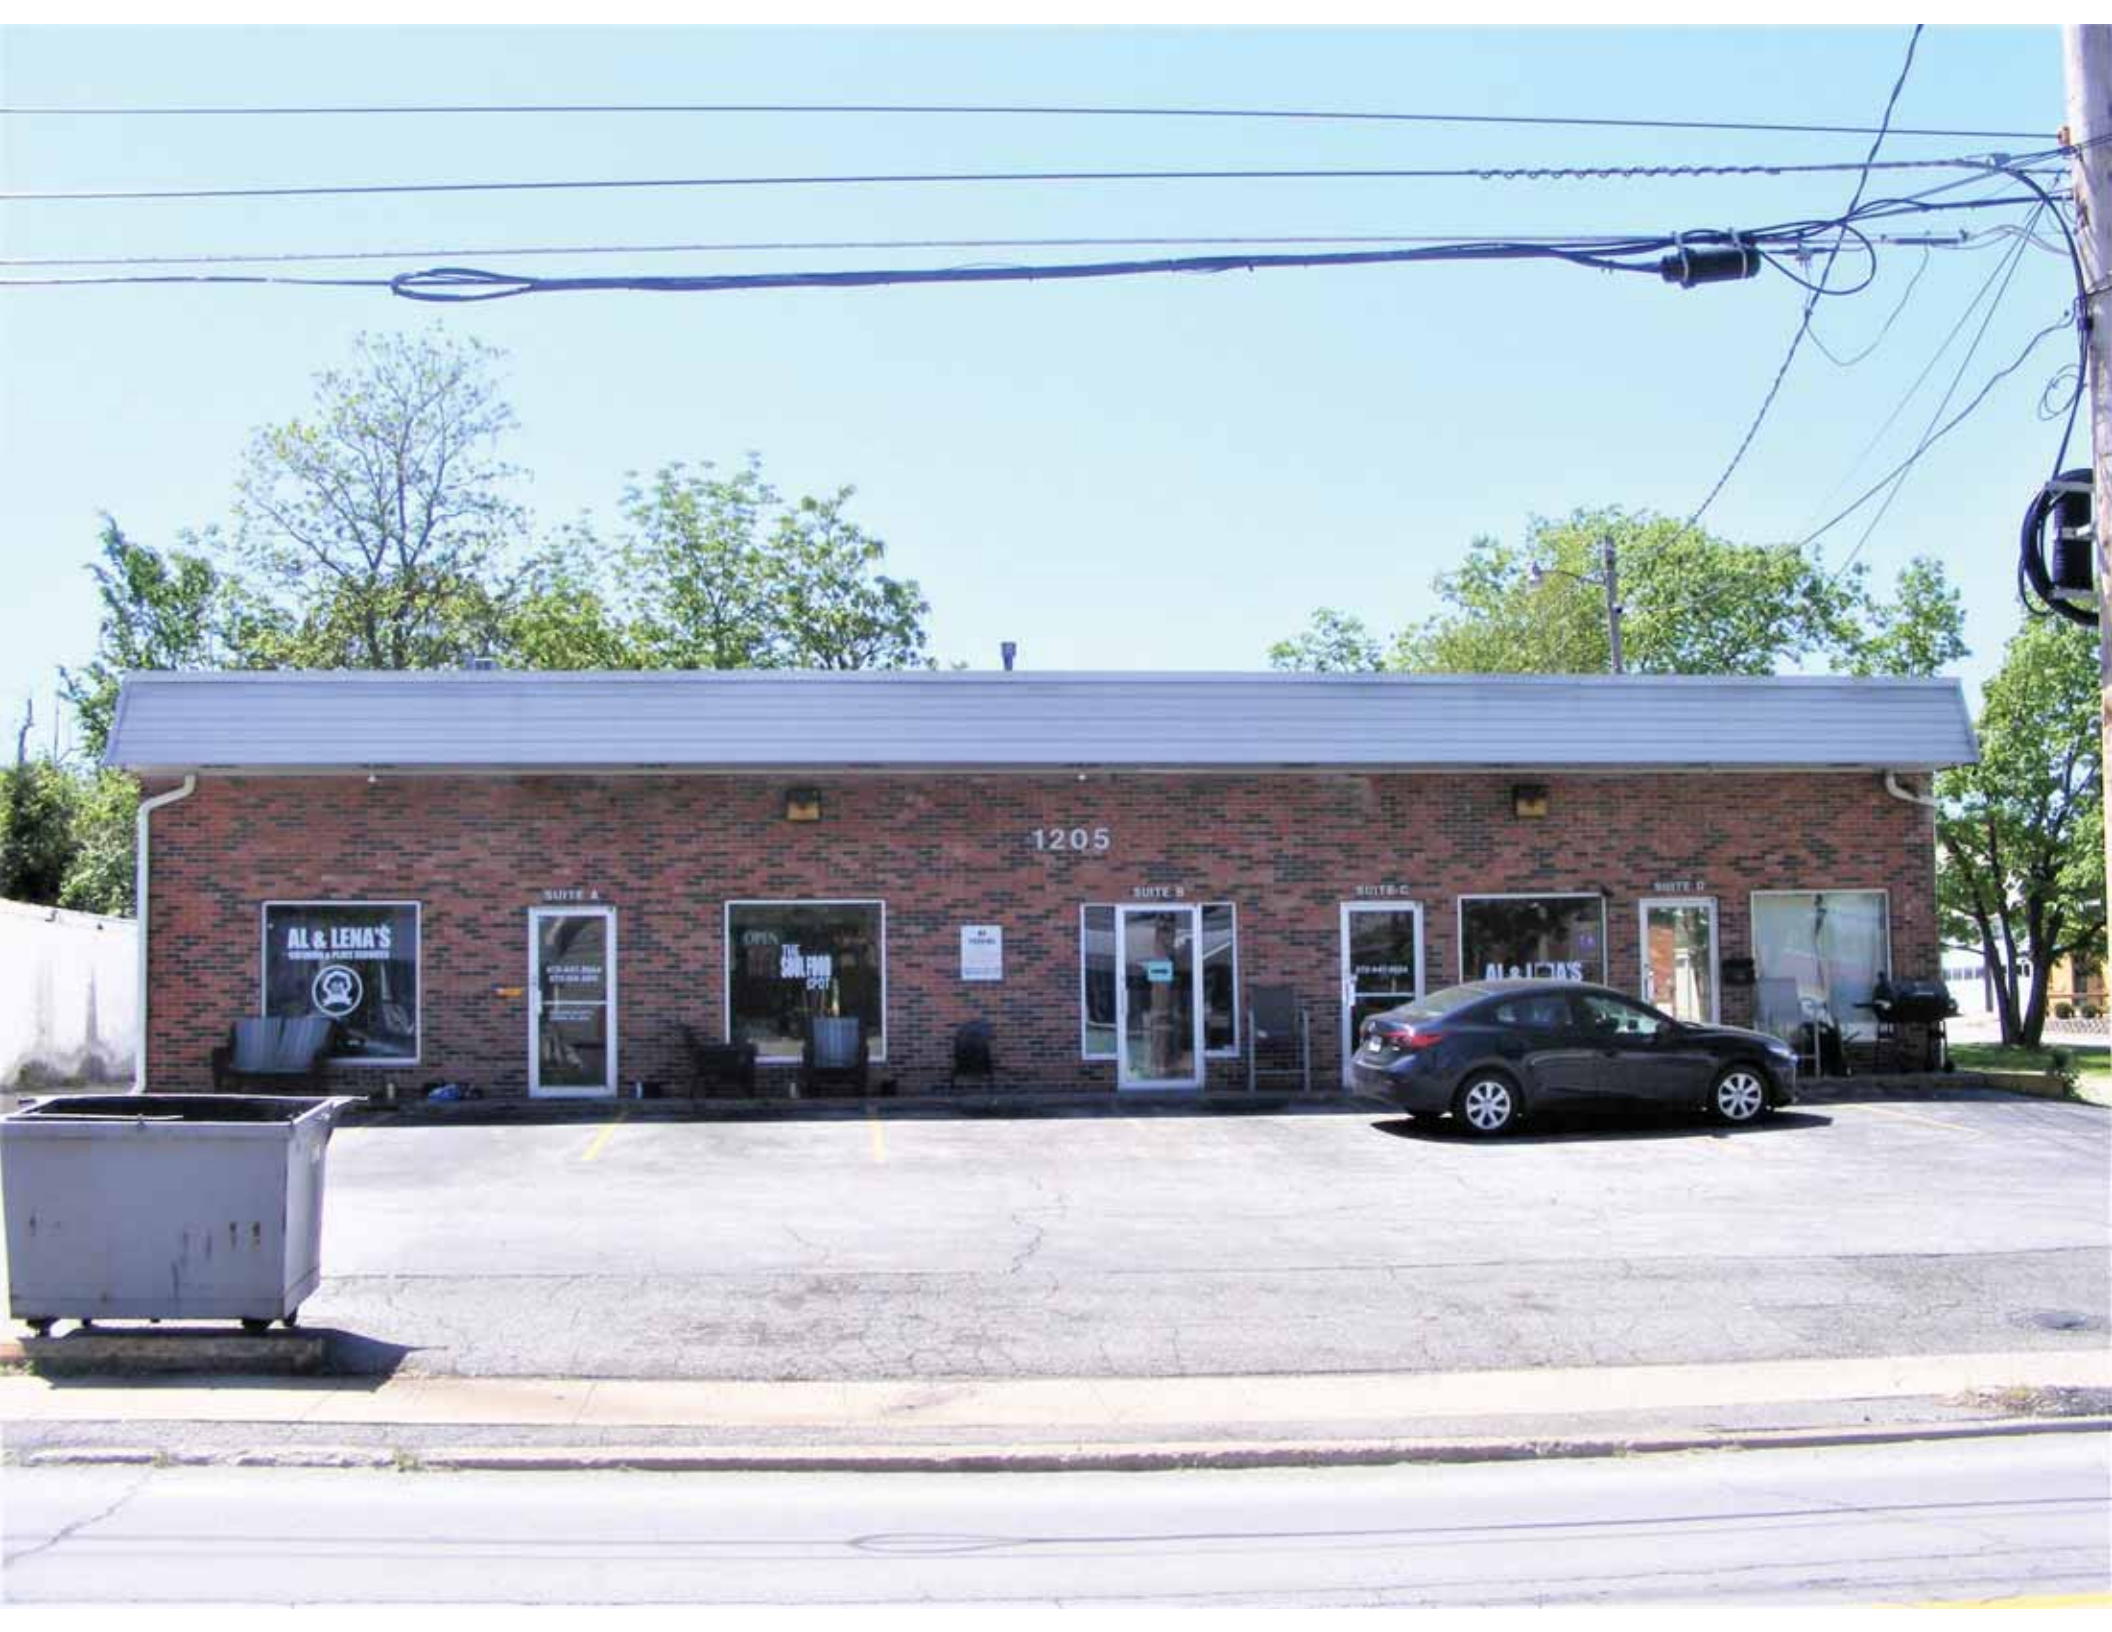
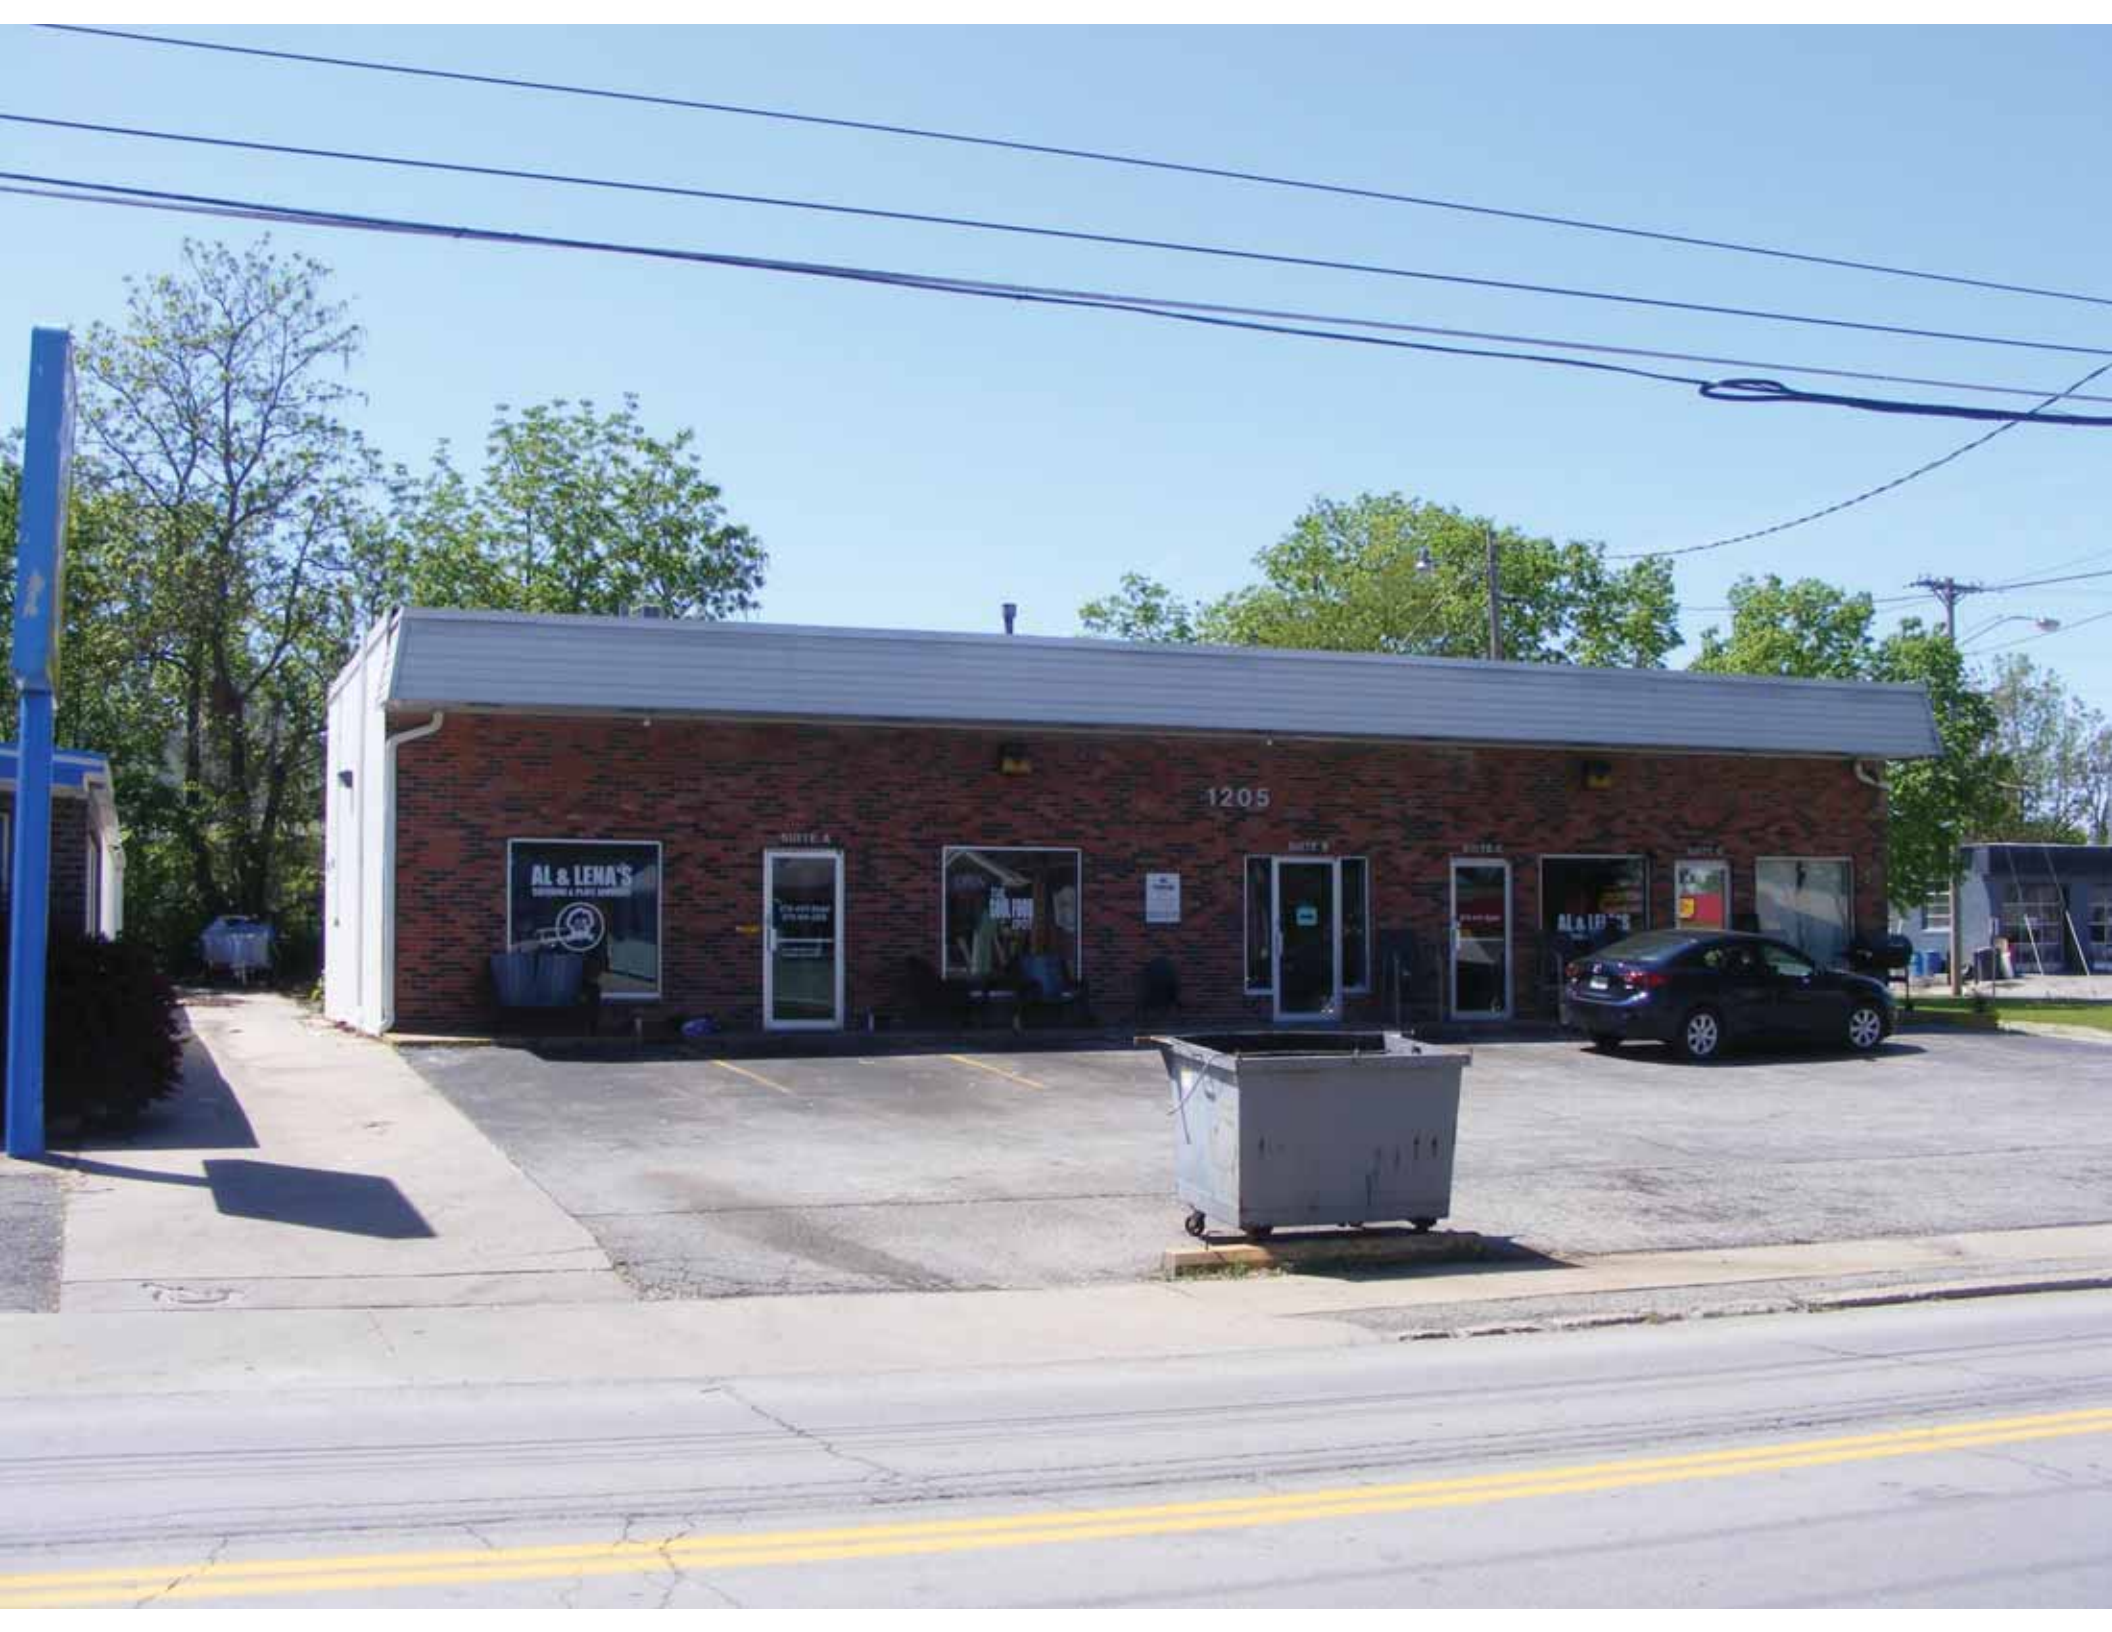
1205

The flat roof building has a faux mansard (façade) built-up roof, exterior brick veneer (façade only) and a concrete slab foundation. Side elevations (north and south) are painted concrete block and void of fenestration. The façade (east elevation) features the following bays, south to north: A single-sash commercial window, a single light glass commercial door with aluminum framing, a single-sash commercial window, a glass and aluminum door flanked by single-light sidelights, a single-light glass and aluminum door, a single-sash commercial window, a glass and aluminum door and a fixed sash commercial window.

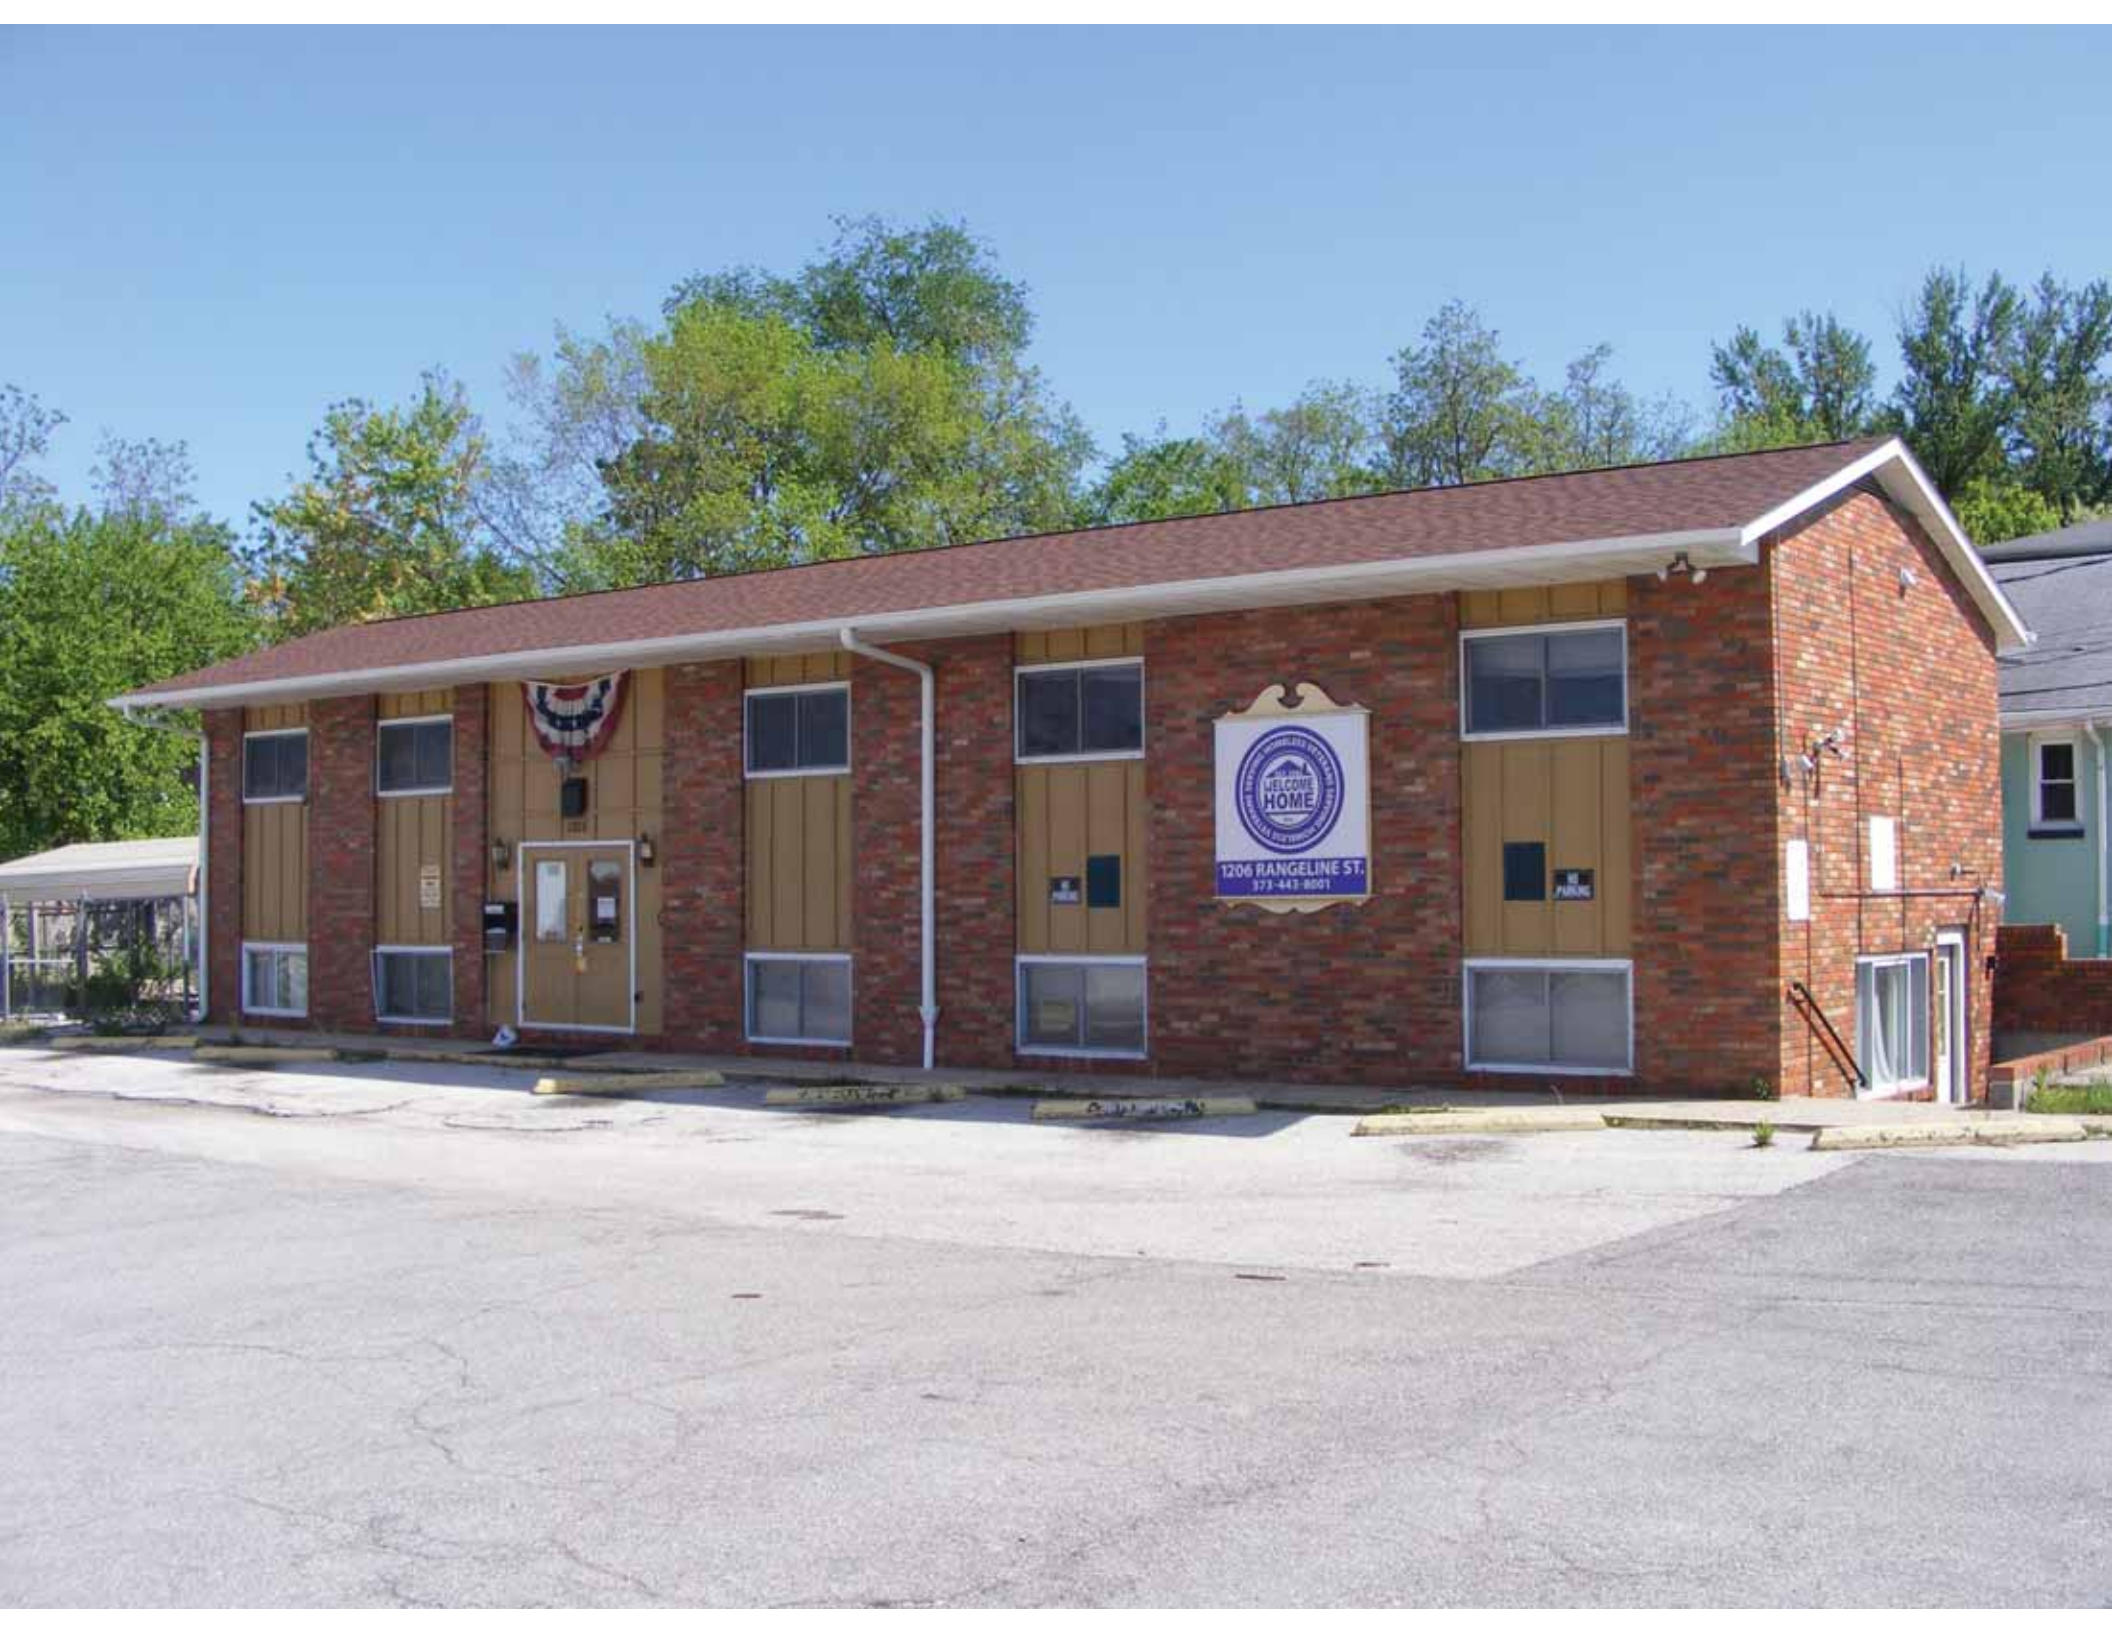
41. (cont.) Description of primary resource. Expand box as necessary, or add continuation pages.
A two-story asphalt-shingled side gable multiple family dwelling clad in brick with vertical wood siding accents. The façade features six bays; each bay is separated by brick pilasters with wall surface area between the pilasters infilled with vertical wood siding. The double paneled wooden door entrance is off-centered in the left section of the façade. The entrance is framed by a wood paneled surround of squares flanked by brick pilasters. There are two bays to the left of the entrance and three to the right; each bay holds slider windows. The upper level features slider windows above the lower windows. South elevation holds a picture window with fixed side lights and a side entrance on the lower level. Rear elevation holds slider windows.
