MISSOURI DEPARTMENT OF NATURAL RESOURCES
STATE HISTORIC PRESERVATION OFFICE, P.O. Box 176, Jefferson City, MO 65102
ARCHITECTURAL/HISTORIC INVENTORY FORM

1. Survey No. BO-AS-011-0087		2. Survey name: North Central Columbia Survey Phase II	
3. County: Boone		4. Address (Street No.) 902	Street (name) N. Seventh Street
5. City: Columbia	Vicinity: <input type="checkbox"/>	6. Geographical Reference:	7. Township/Range/Section: T: R: S:
8. Historic name (if known):		9. Present/other name (if known):	
10. Ownership: <input checked="" type="checkbox"/> Private <input type="checkbox"/> Public		11a. Historic use (if known): Domestic/single dwelling	11b. Current use: Domestic/single dwelling

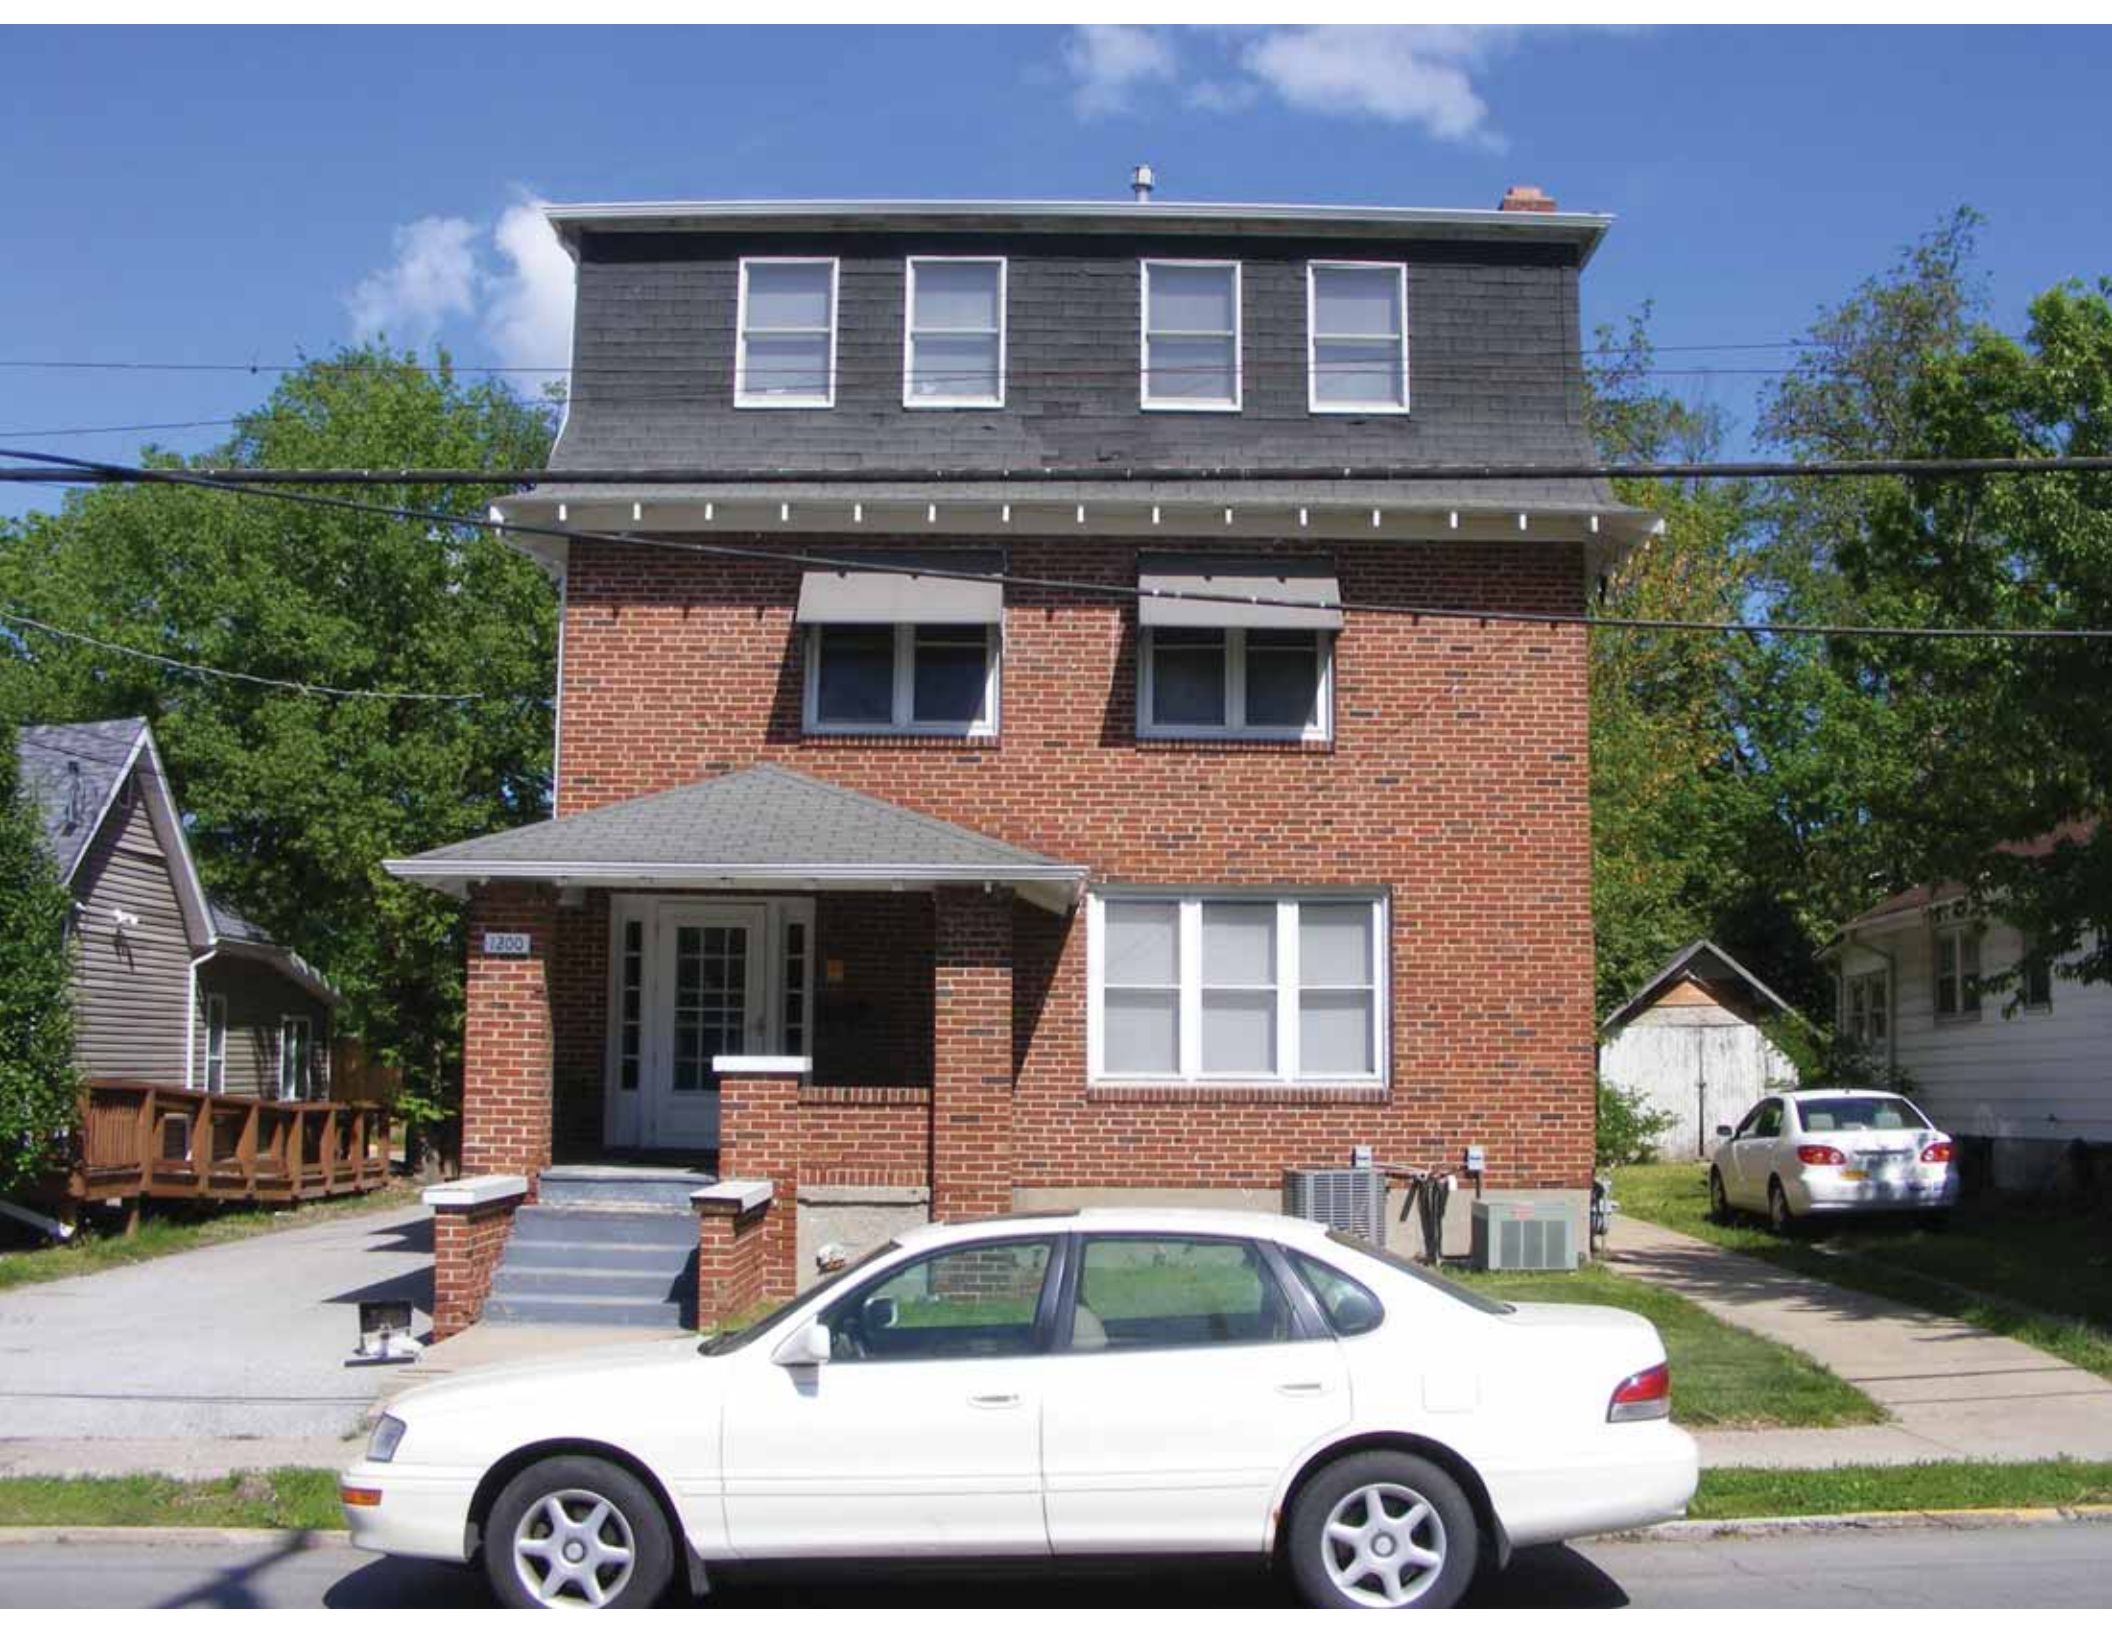
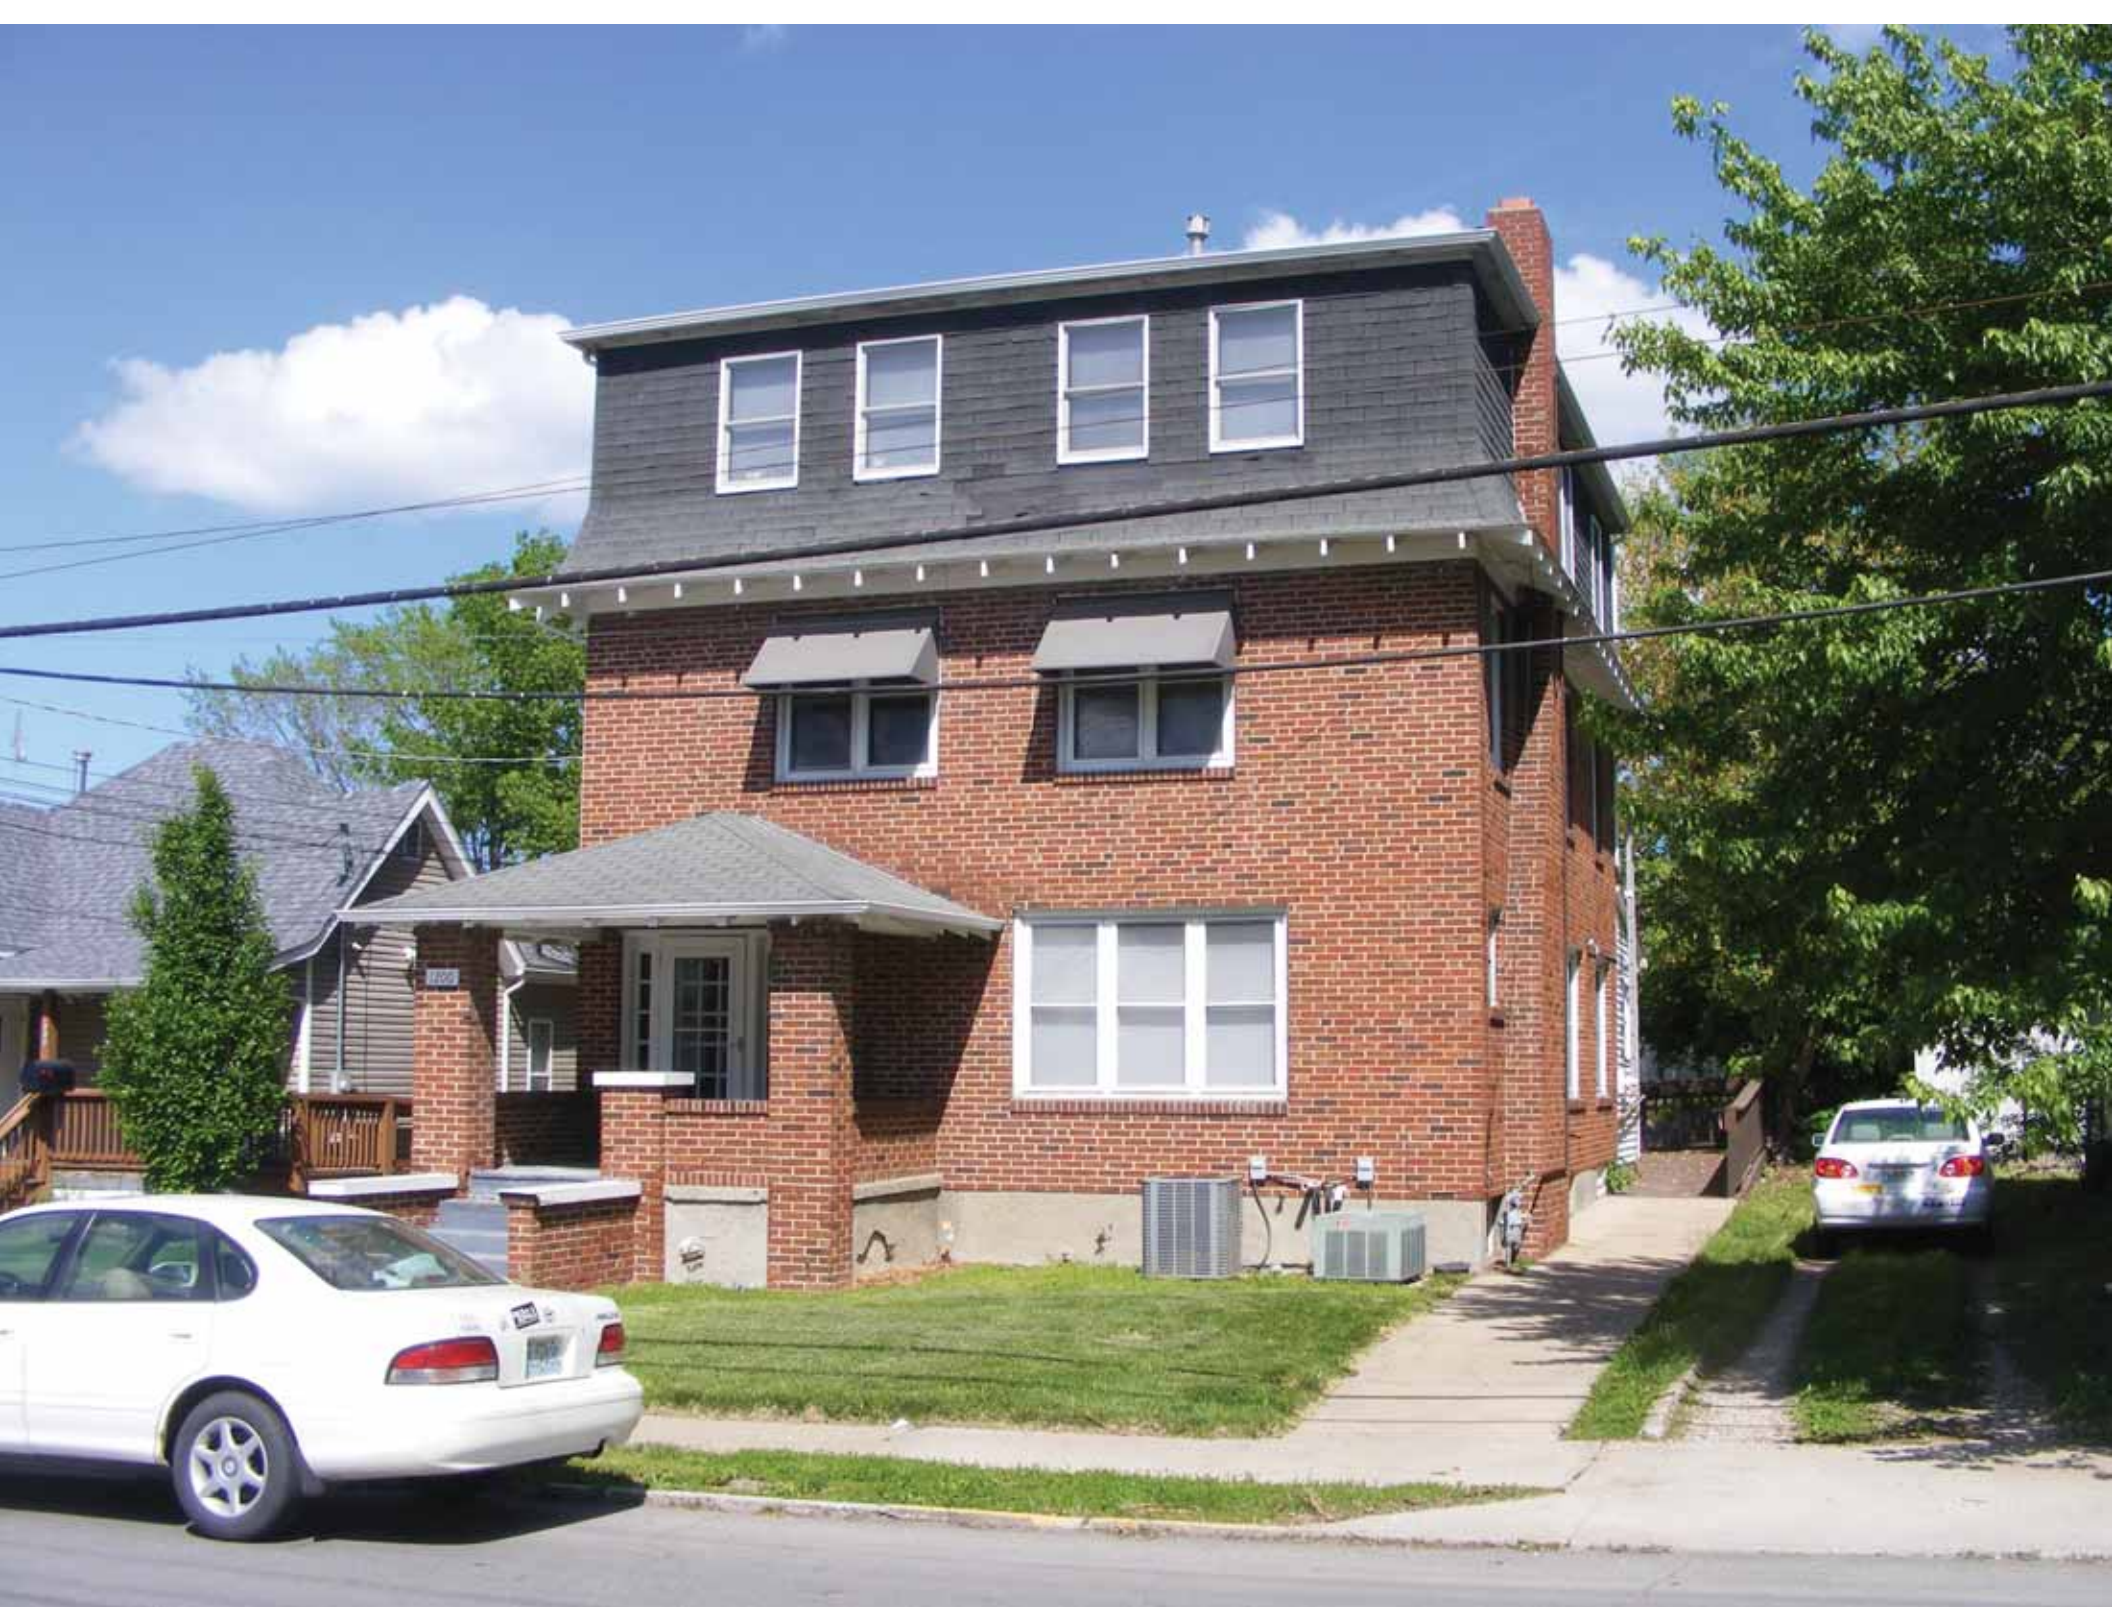
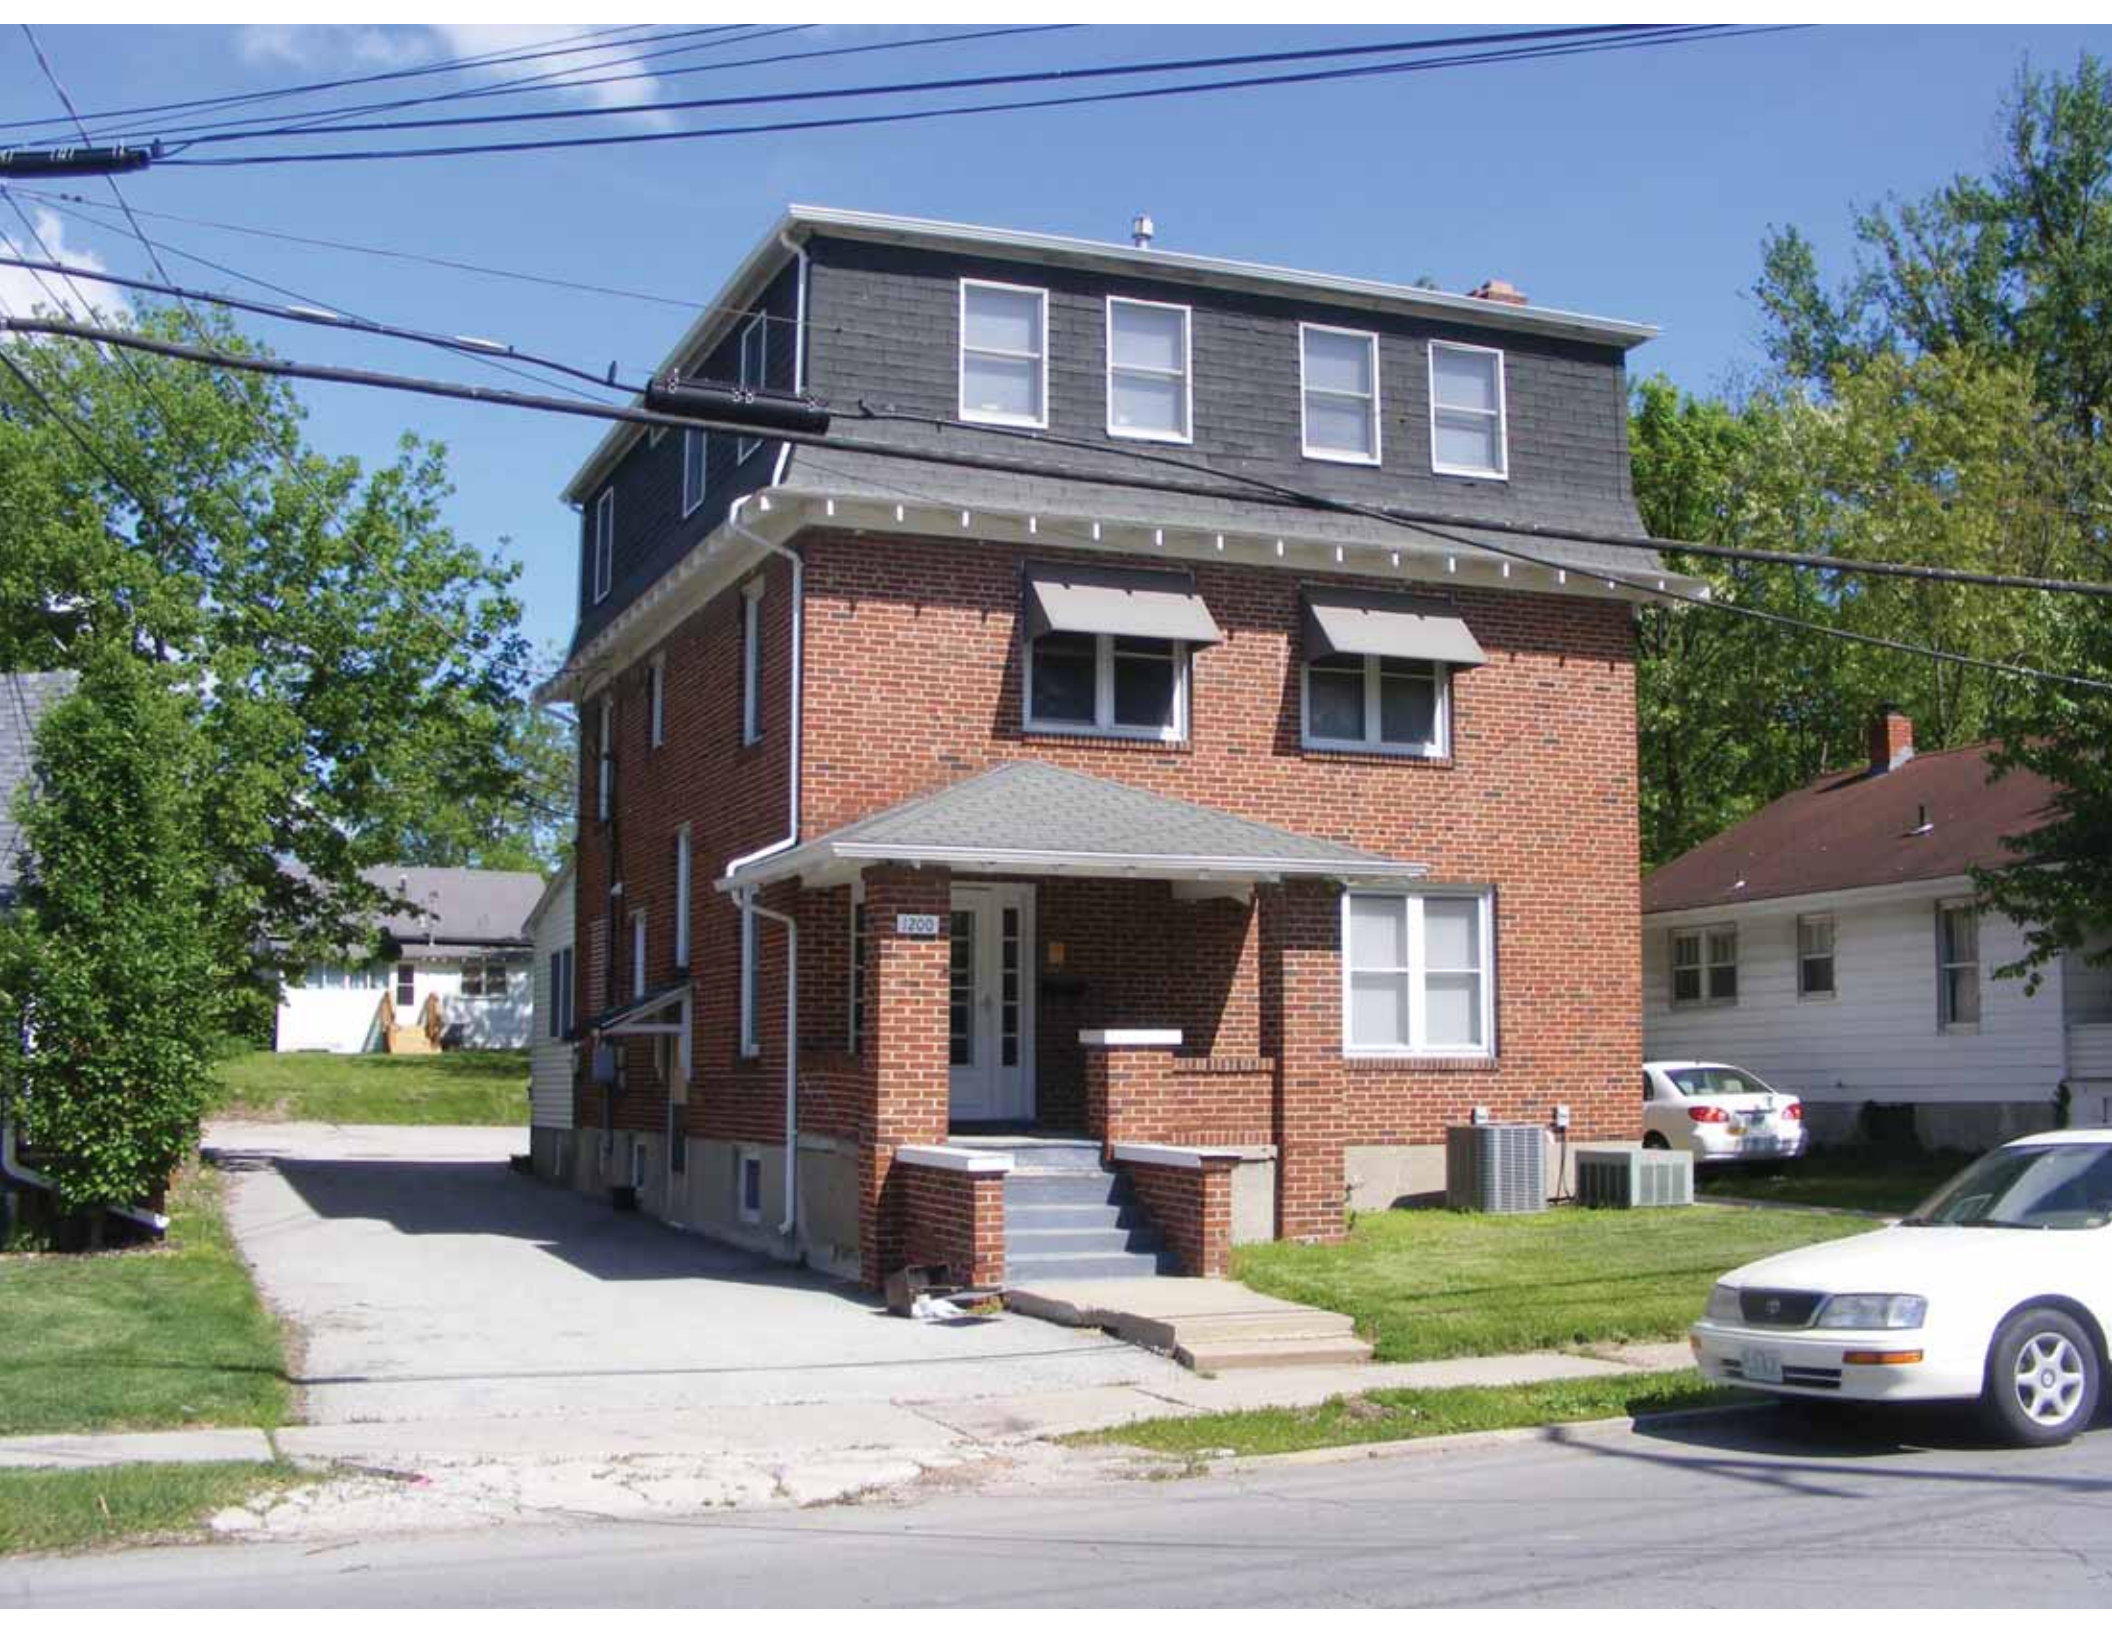
1200

41. (cont.) Description of primary resource. Expand box as necessary, or add continuation pages.
The dwelling was constructed as a 2.5-story American Foursquare. Contemporary alterations have replaced the original roofline with a third-floor mansard addition. Mansard exterior walls are clad with asphalt shingles. Original rafters are visible below the mansard overhang. The dwelling has a concrete foundation, exterior brick walls and replacement one-over-one windows. The primary (west) elevation features an off-center original porch with wide brick columns and a brick balustrade. The porch has a pyramidal roof and exposed rafter tails. Within the porch bay is an original multi-light Craftsman door with sidelights. Offsetting the entry bay (south of the porch) is a three-window ribbon with a shared brick sill. The second floor has paired windows with shed awnings and brick sills. The mansard façade holds four one-over-one windows. An engaged brick exterior brick chimney is noted at the south end of the dwelling. A rear shed wing is clad with vinyl siding. Alterations to the dwelling indicate that the property was modified to serve as a multi-family residence.

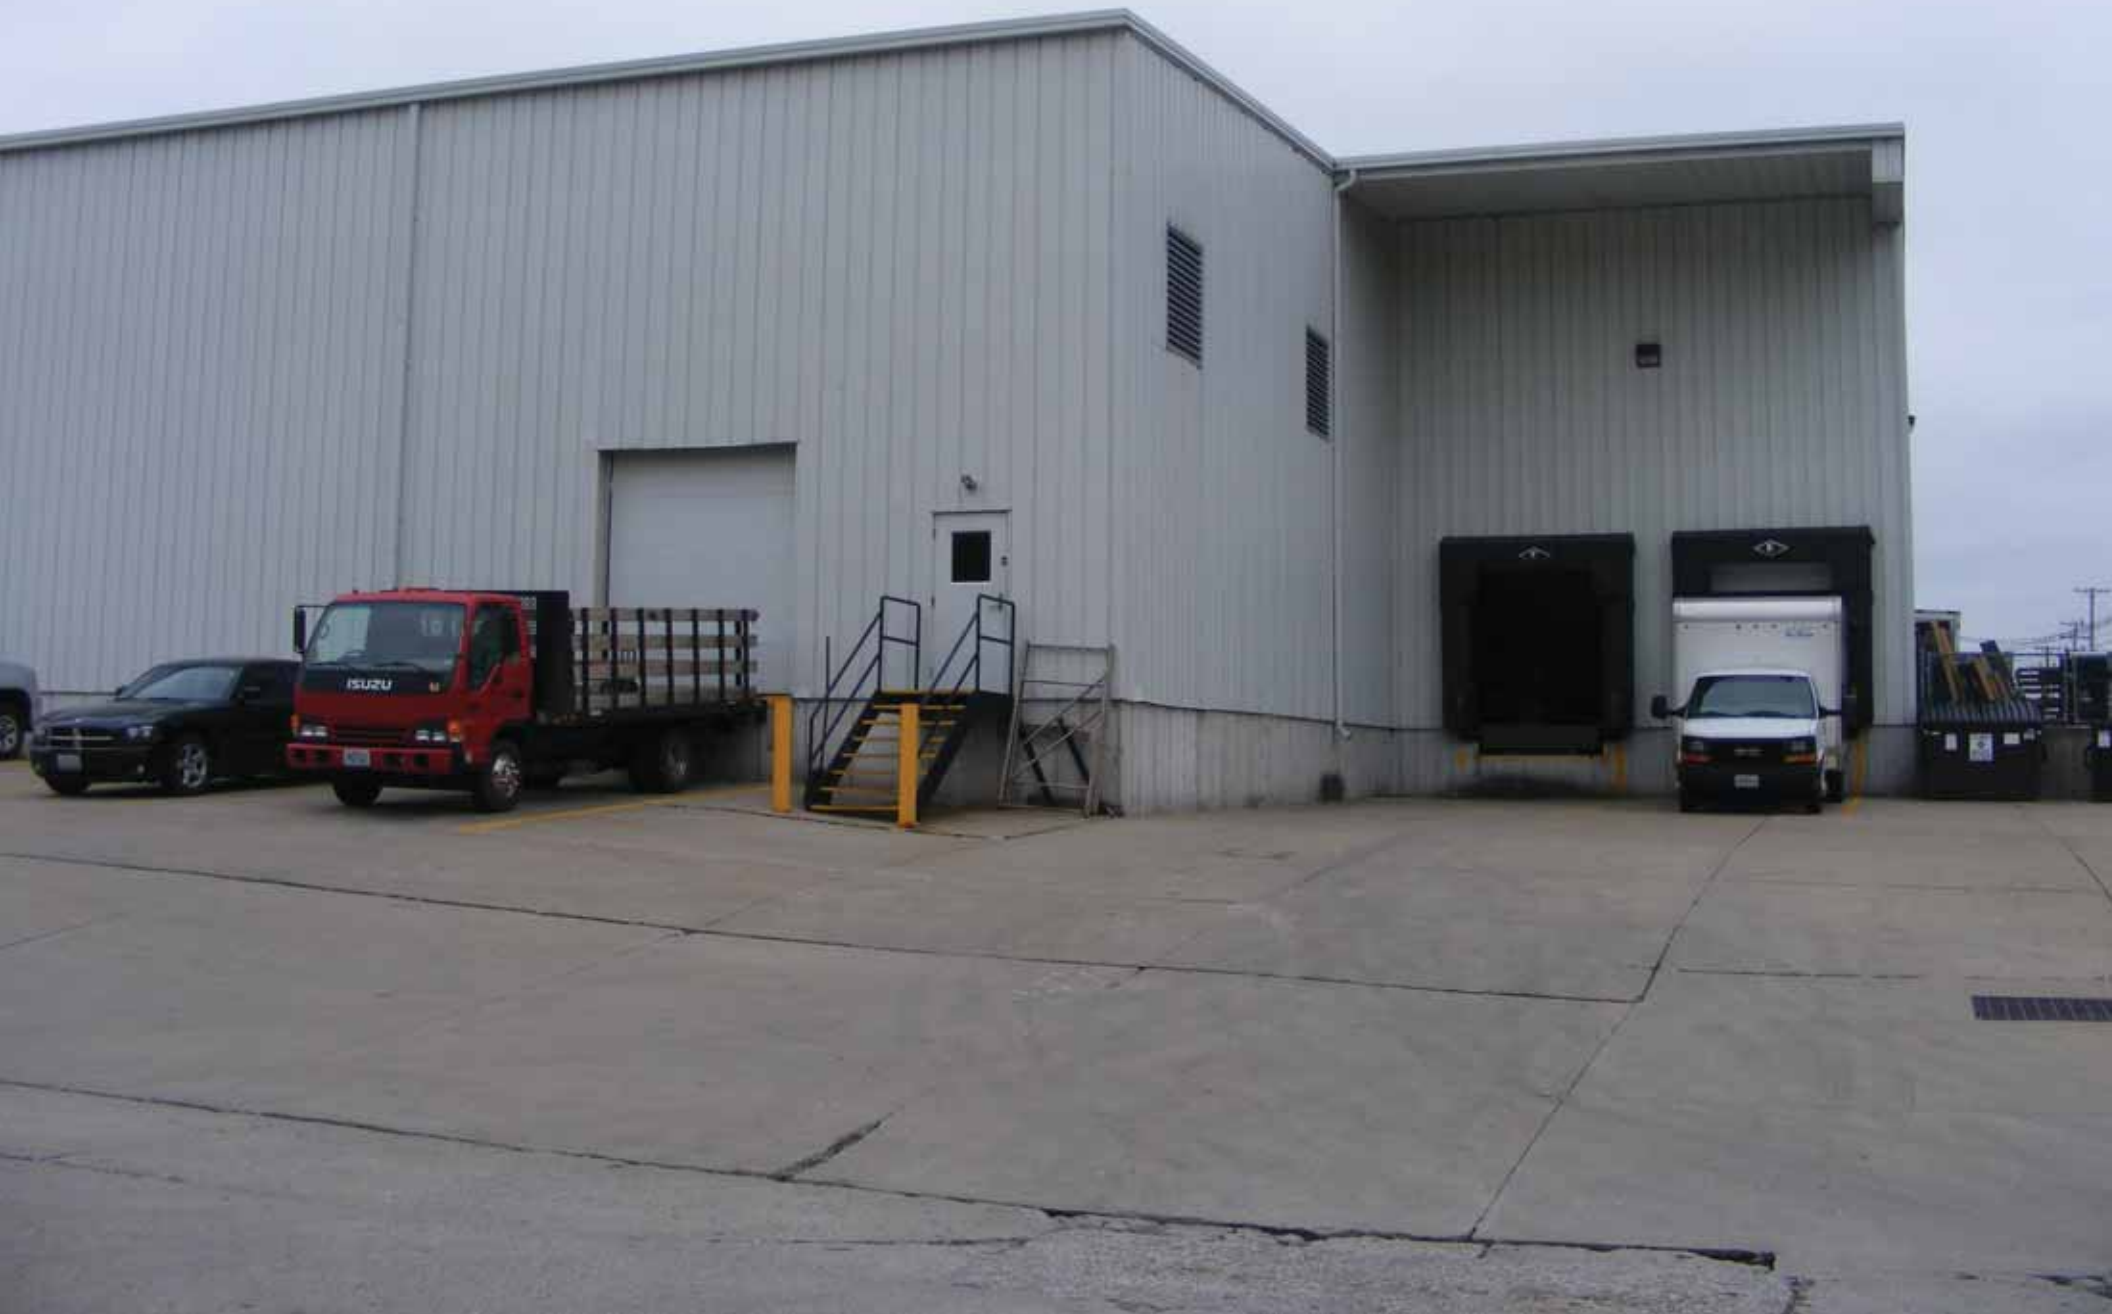
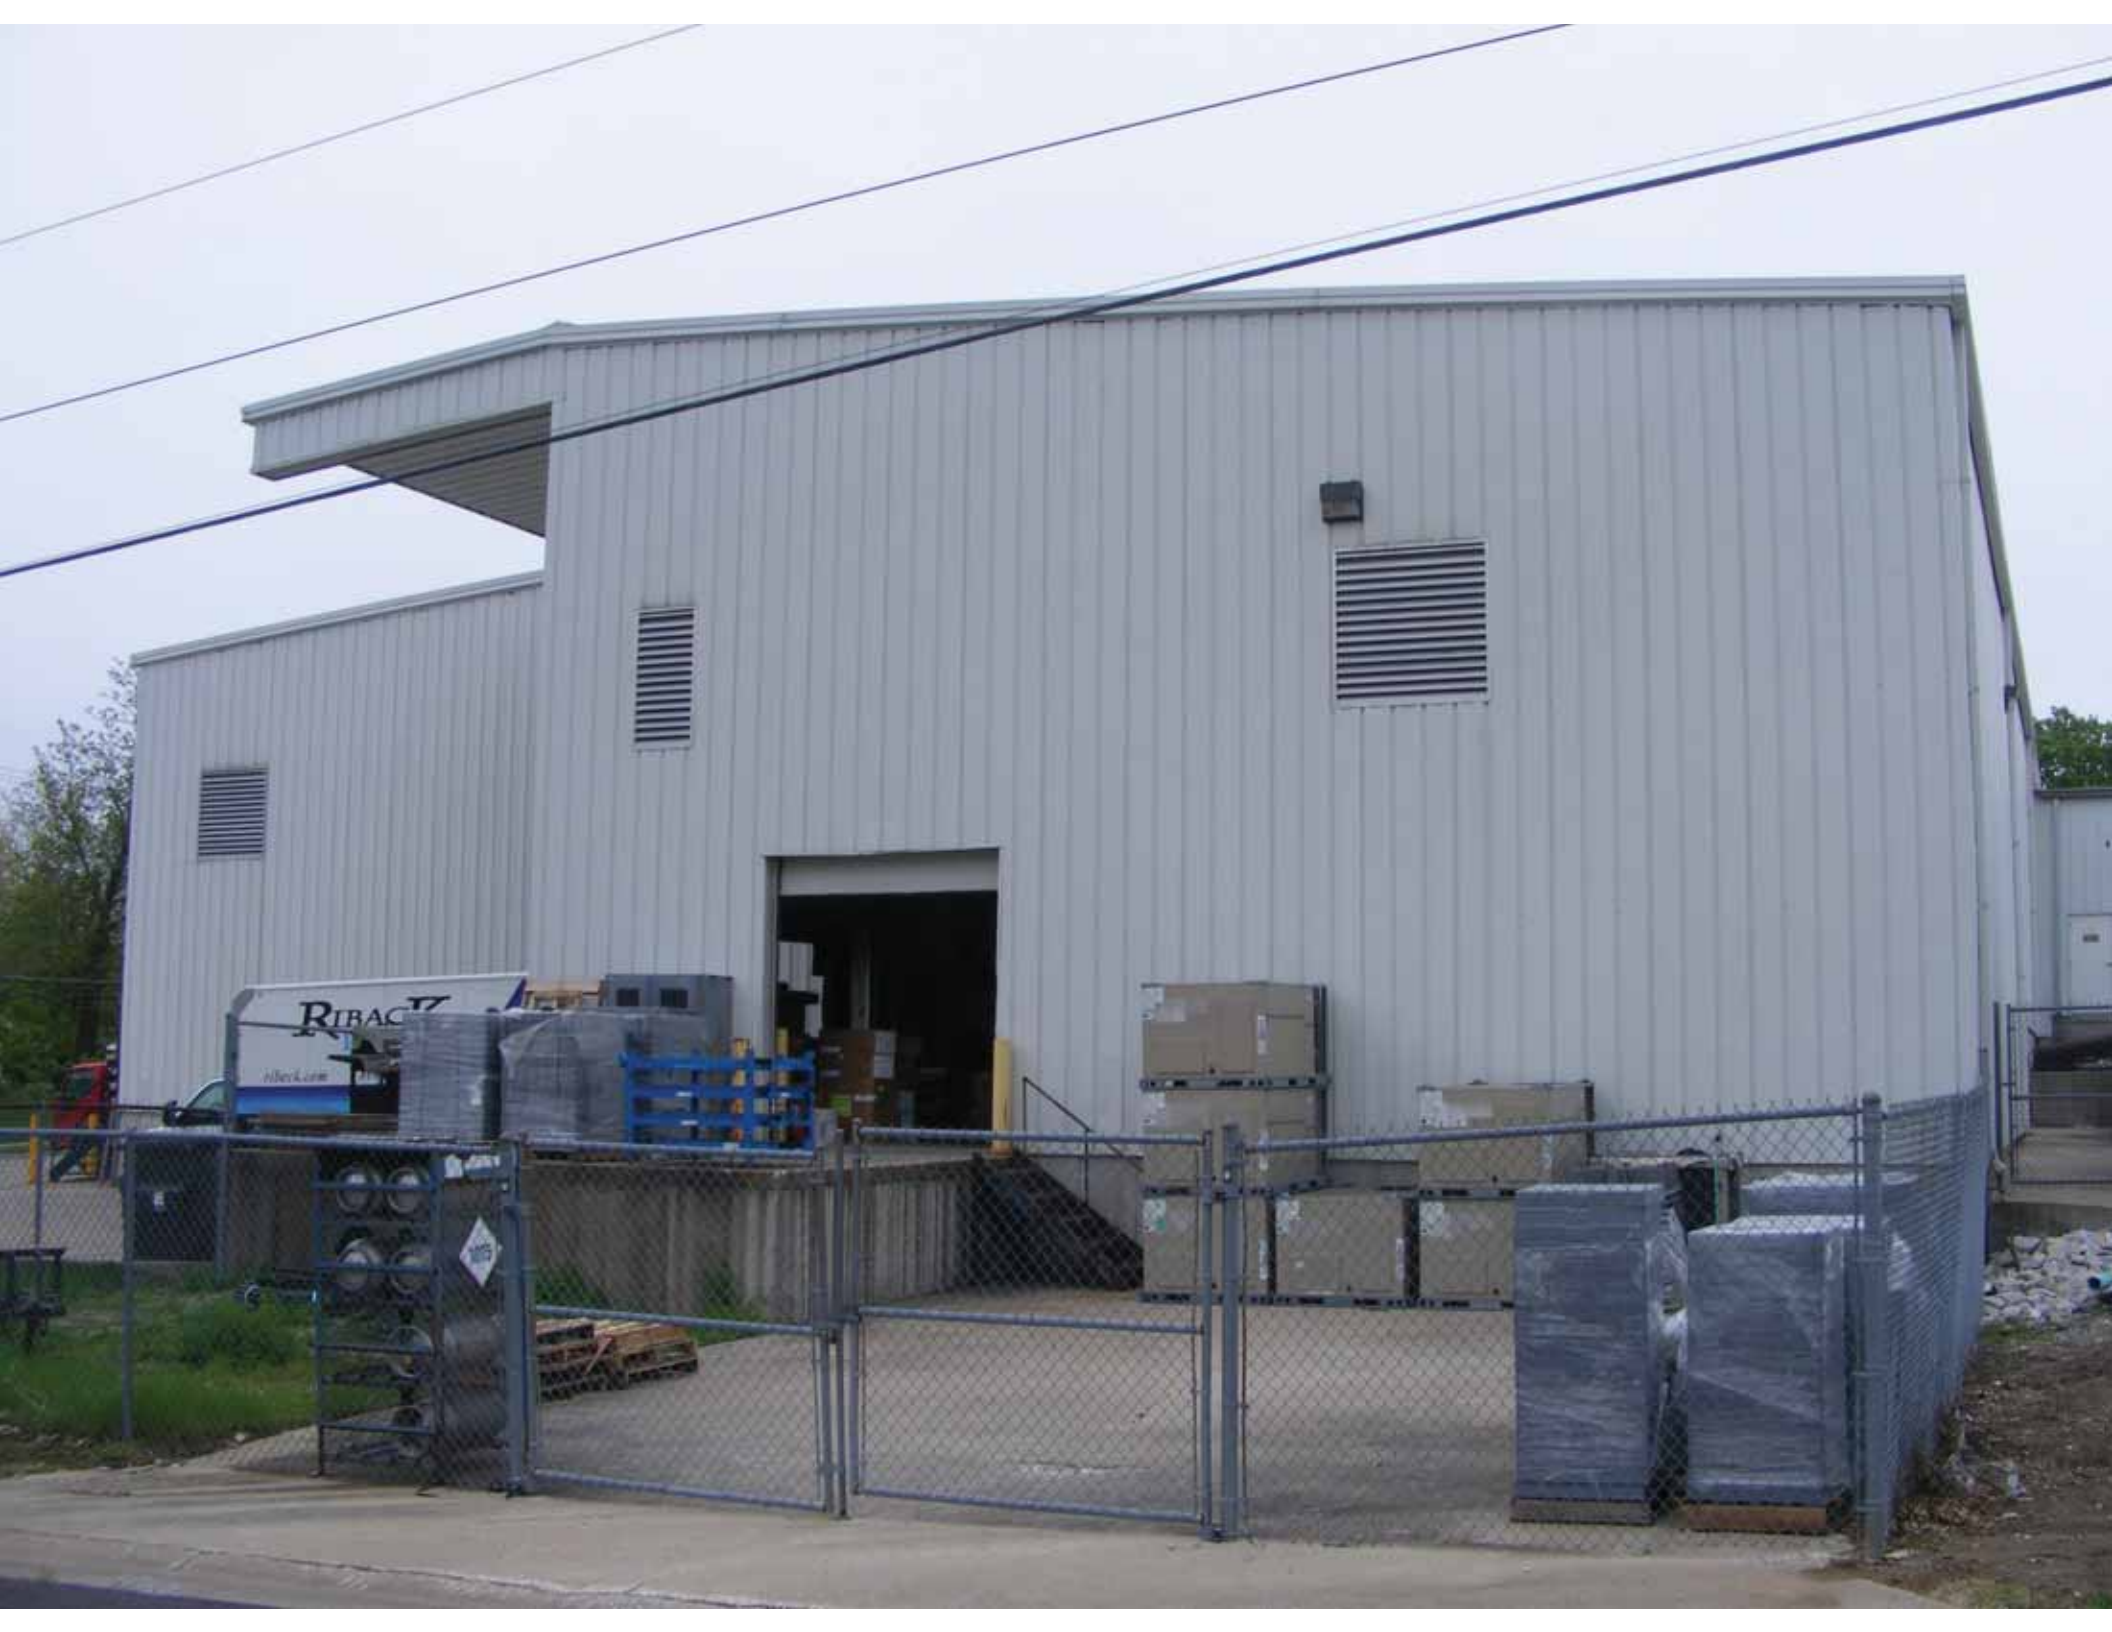
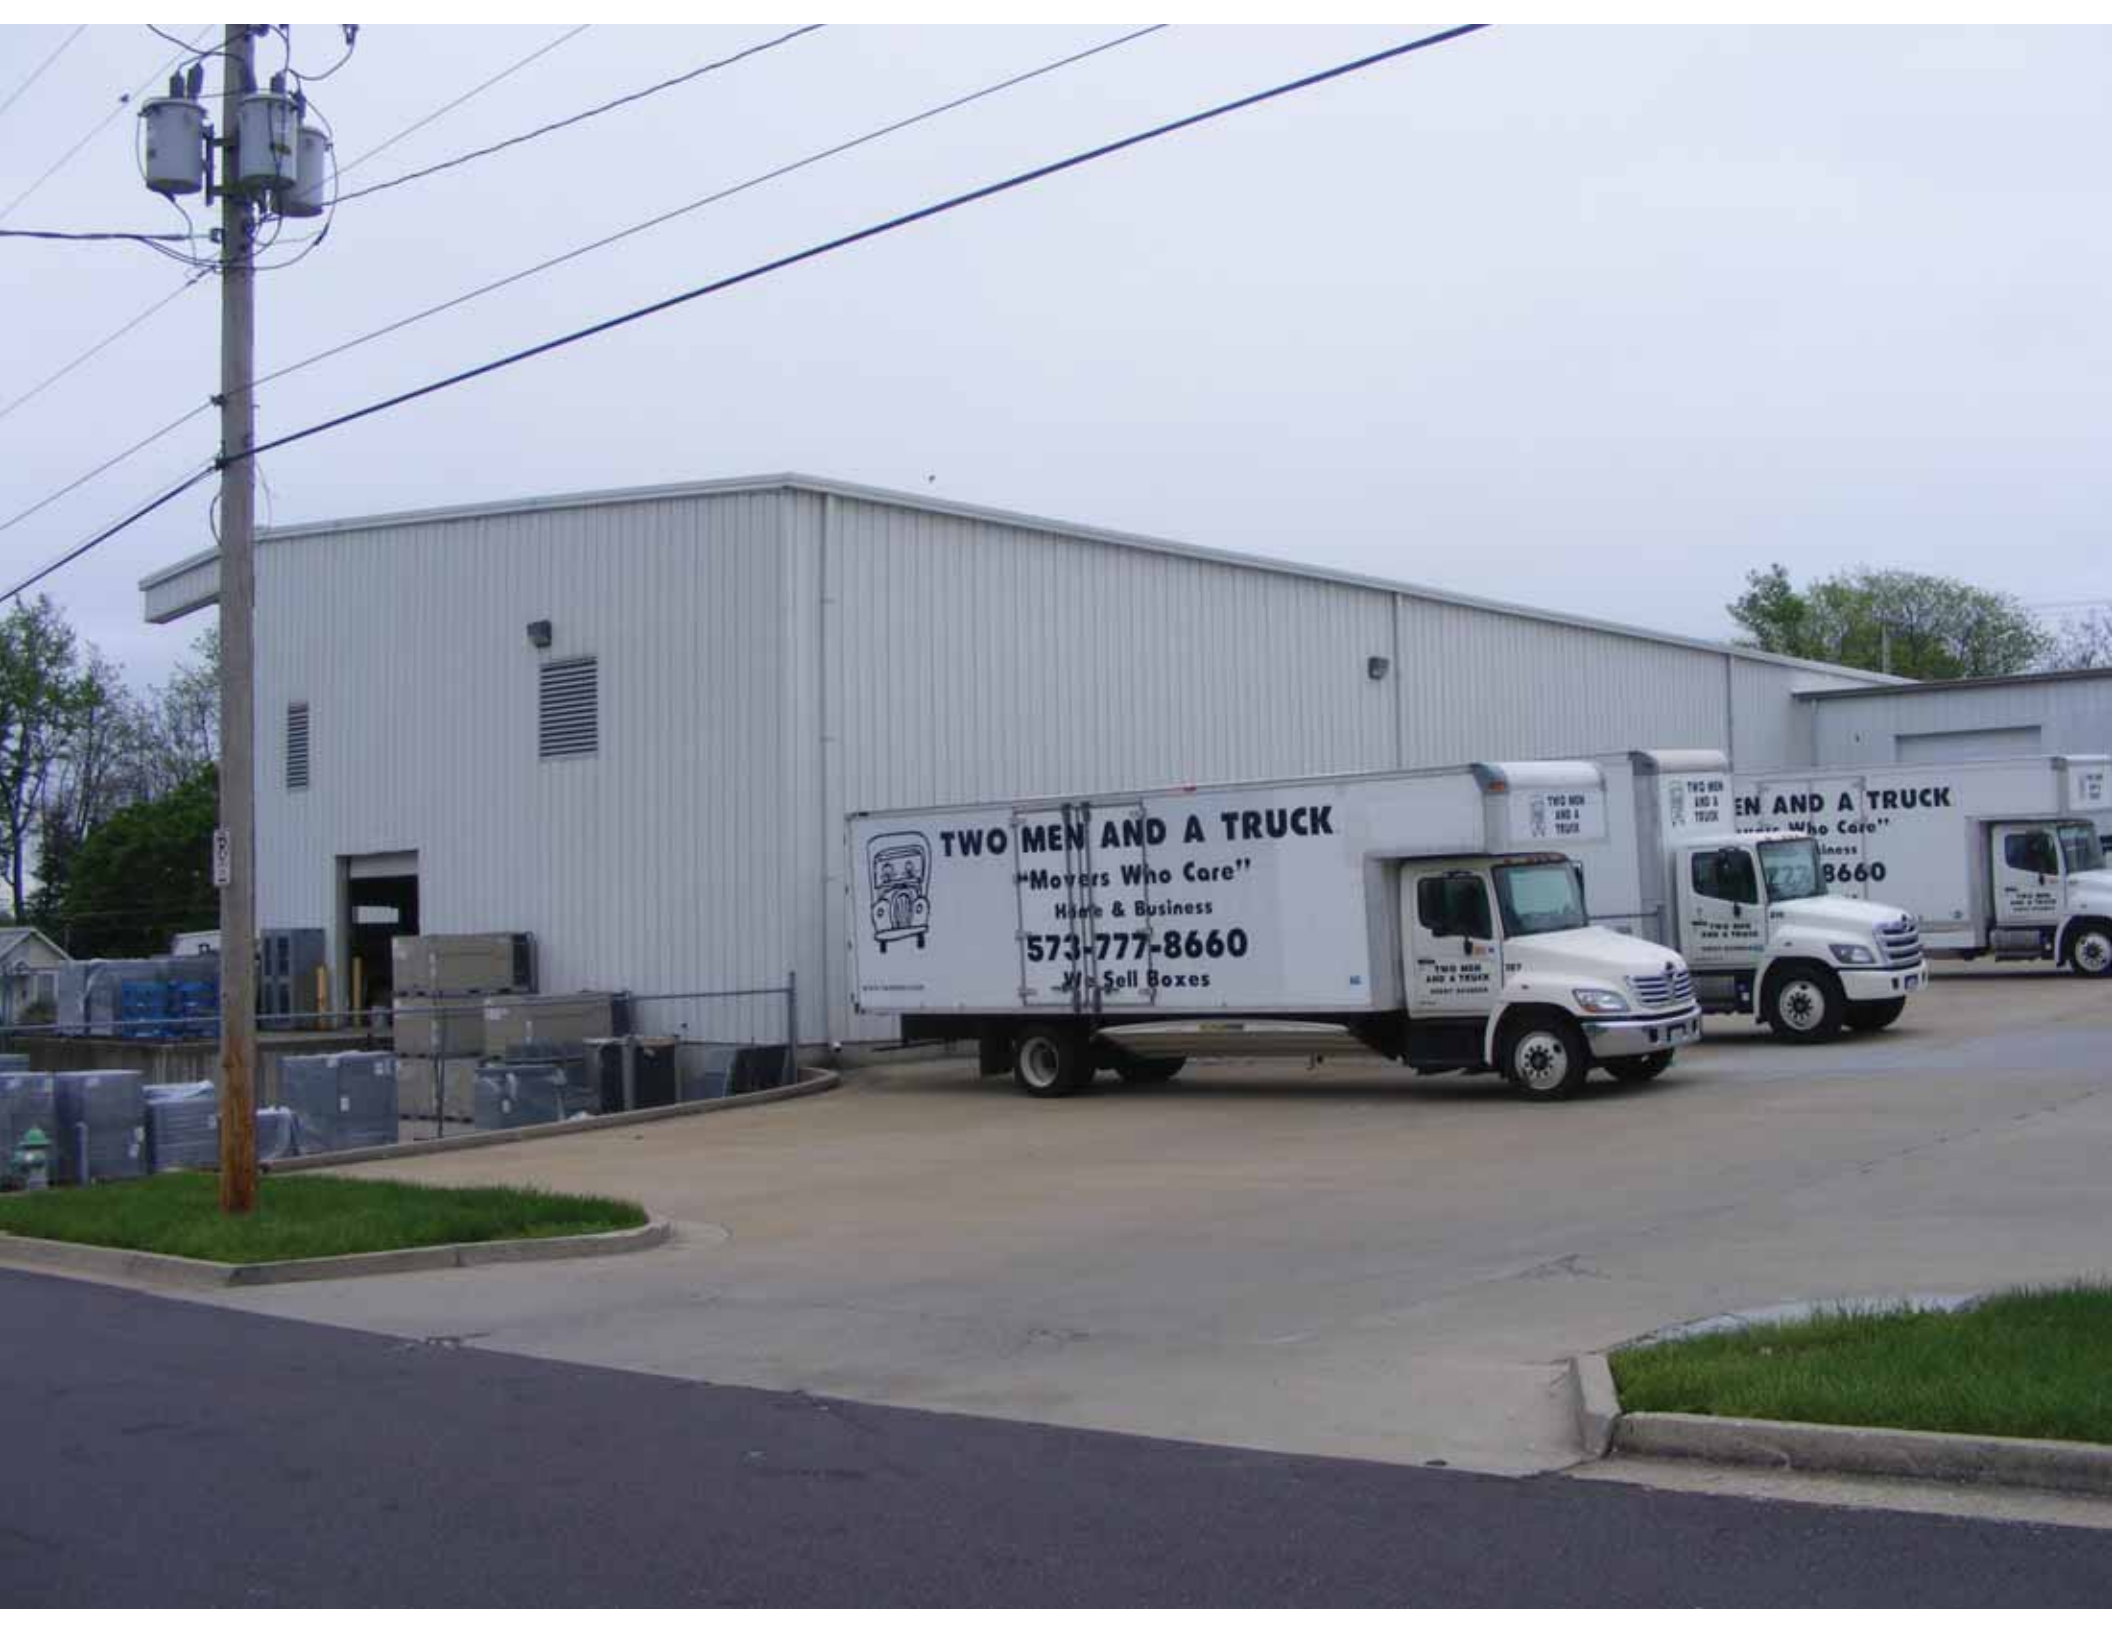
This one story commercial building is a prefabricated metal with a side gabled roof and has a concrete slab foundation. The primary elevation fronts north and has seven bays; three loading bays with metal doors, three single entrance doors (glass/metal, solid metal and metal with square window) and two fixed windows. At the west end of the building, is a setback section from the primary elevation. This setback area fronts north and holds two loading bays, the roofline projects out over the bays. The west elevation holds a bay opening with a concrete dock area. Attached to the rear elevation at the east corner is another pre-fabricated building with several loading bays.
