MISSOURI DEPARTMENT OF NATURAL RESOURCES
STATE HISTORIC PRESERVATION OFFICE, P.O. Box 176, Jefferson City, MO 65102
ARCHITECTURAL/HISTORIC INVENTORY FORM

1. Survey No. BO-AS-011-0087		2. Survey name: North Central Columbia Survey Phase II	
3. County: Boone		4. Address (Street No.) 902	Street (name) N. Seventh Street
5. City: Columbia	Vicinity: <input type="checkbox"/>	6. Geographical Reference:	7. Township/Range/Section: T: R: S:
8. Historic name (if known):		9. Present/other name (if known):	
10. Ownership: <input checked="" type="checkbox"/> Private <input type="checkbox"/> Public		11a. Historic use (if known): Domestic/single dwelling	11b. Current use: Domestic/single dwelling

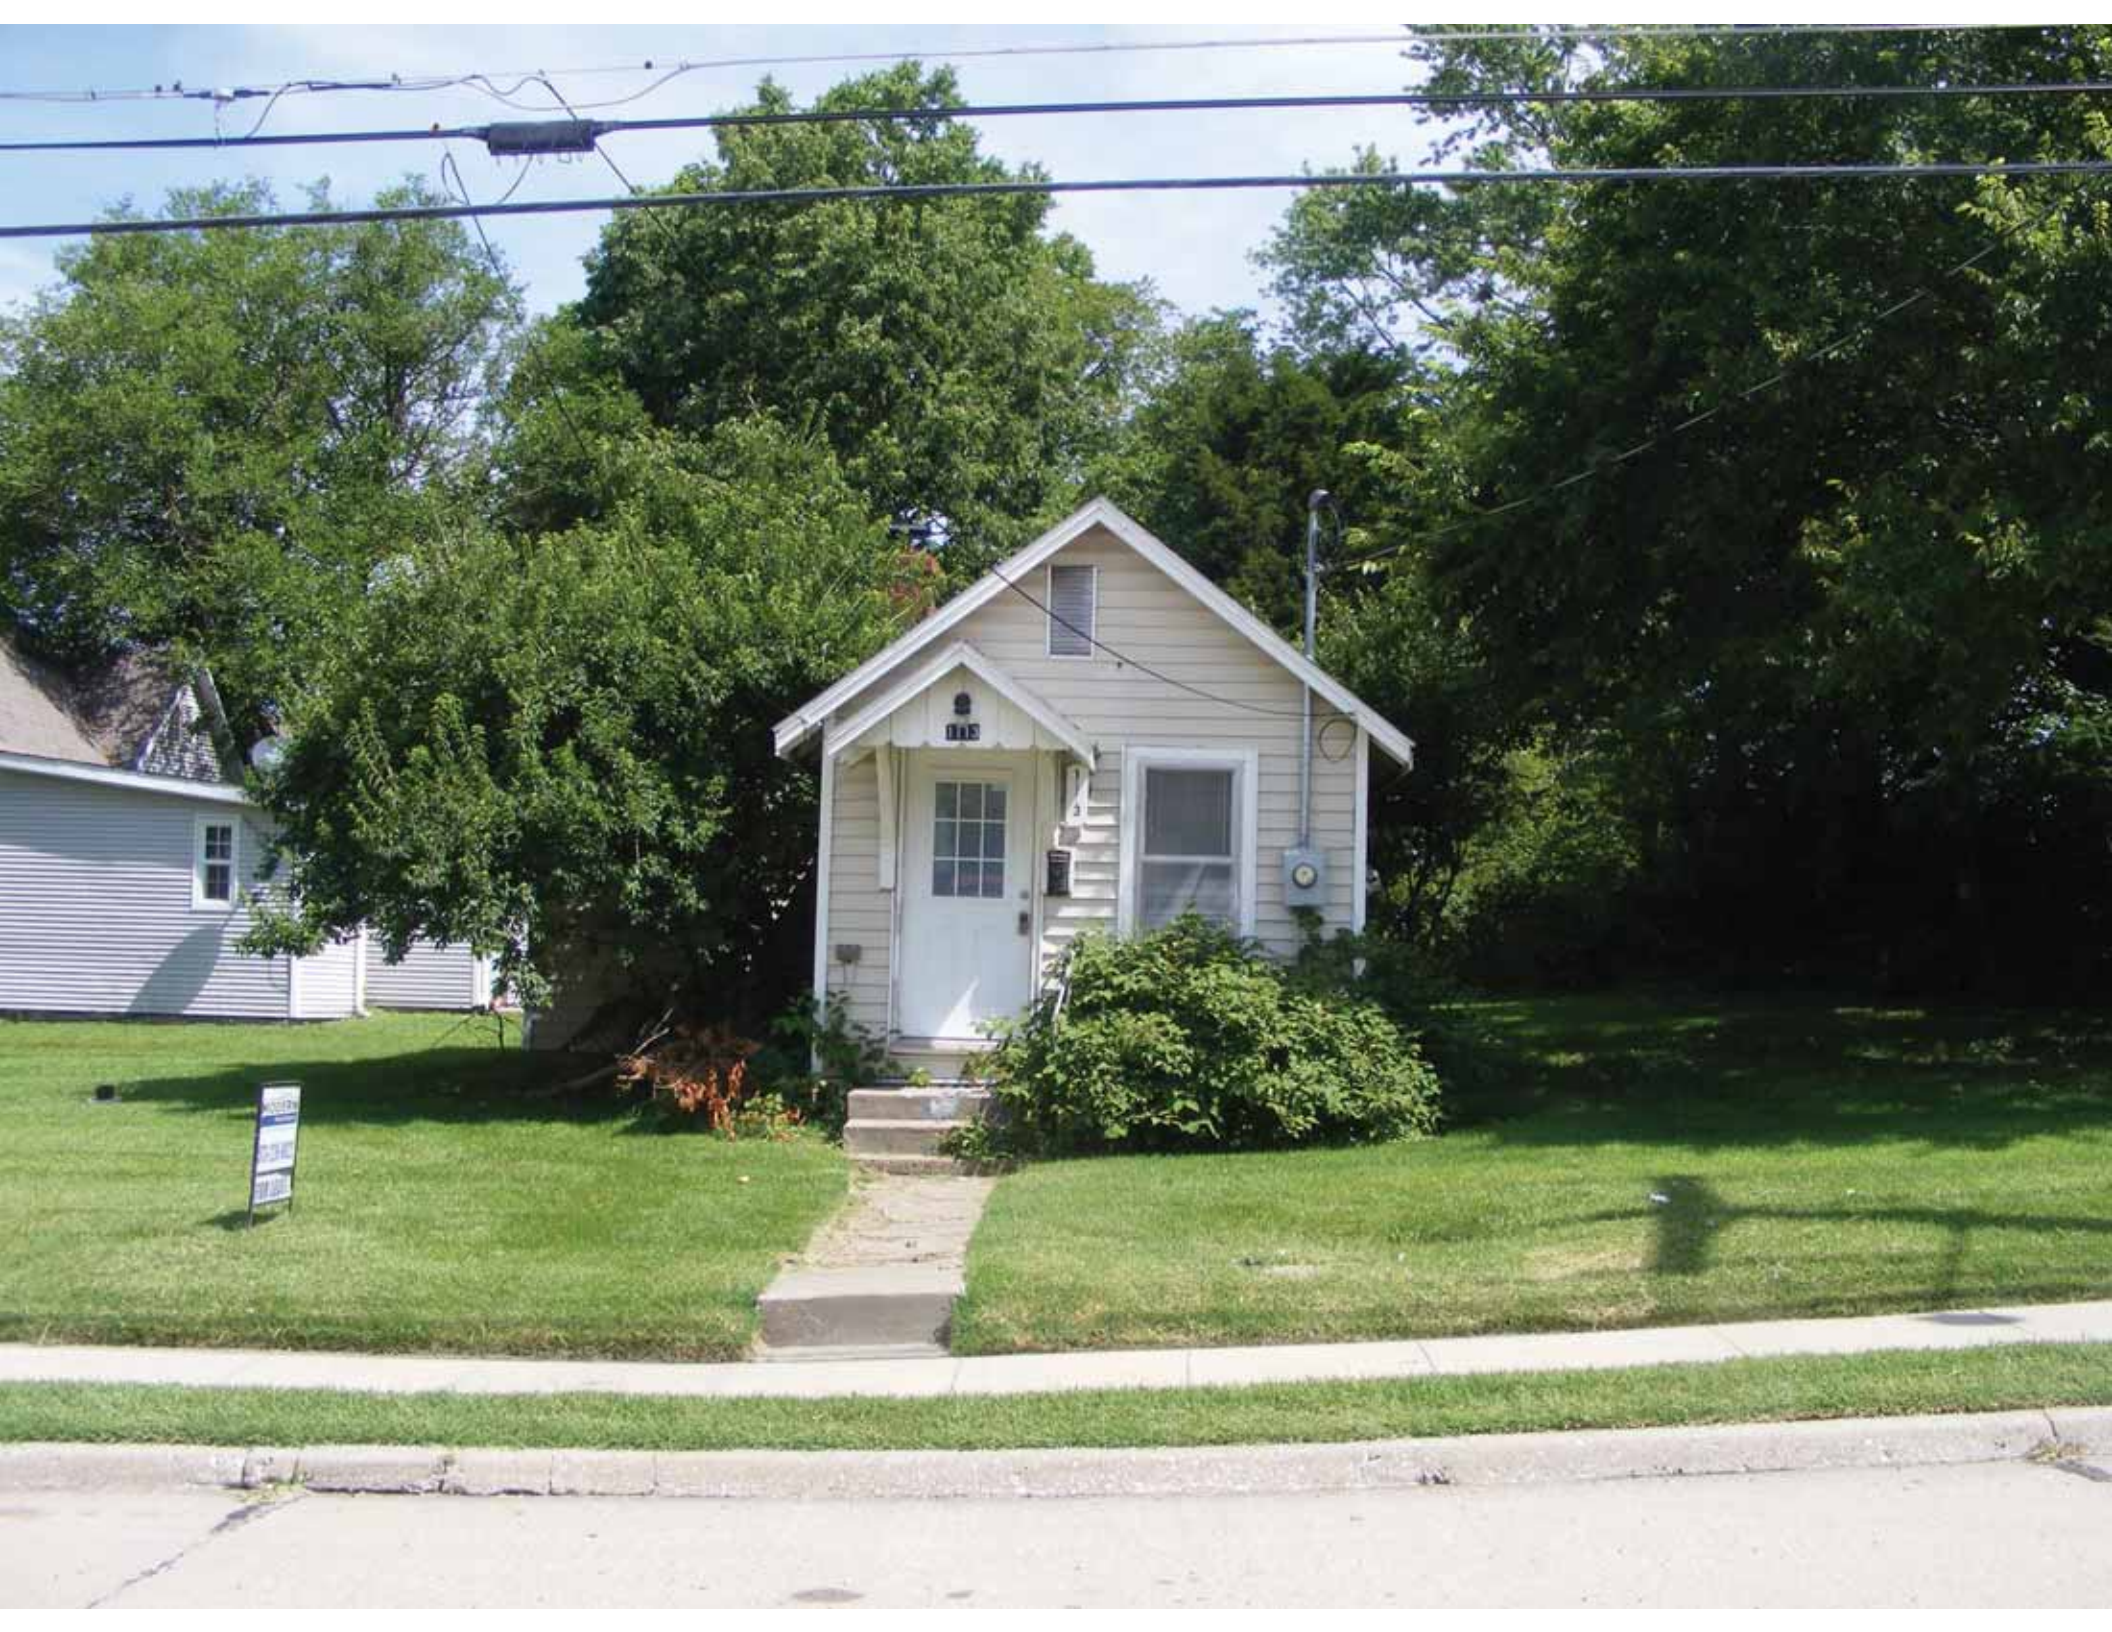
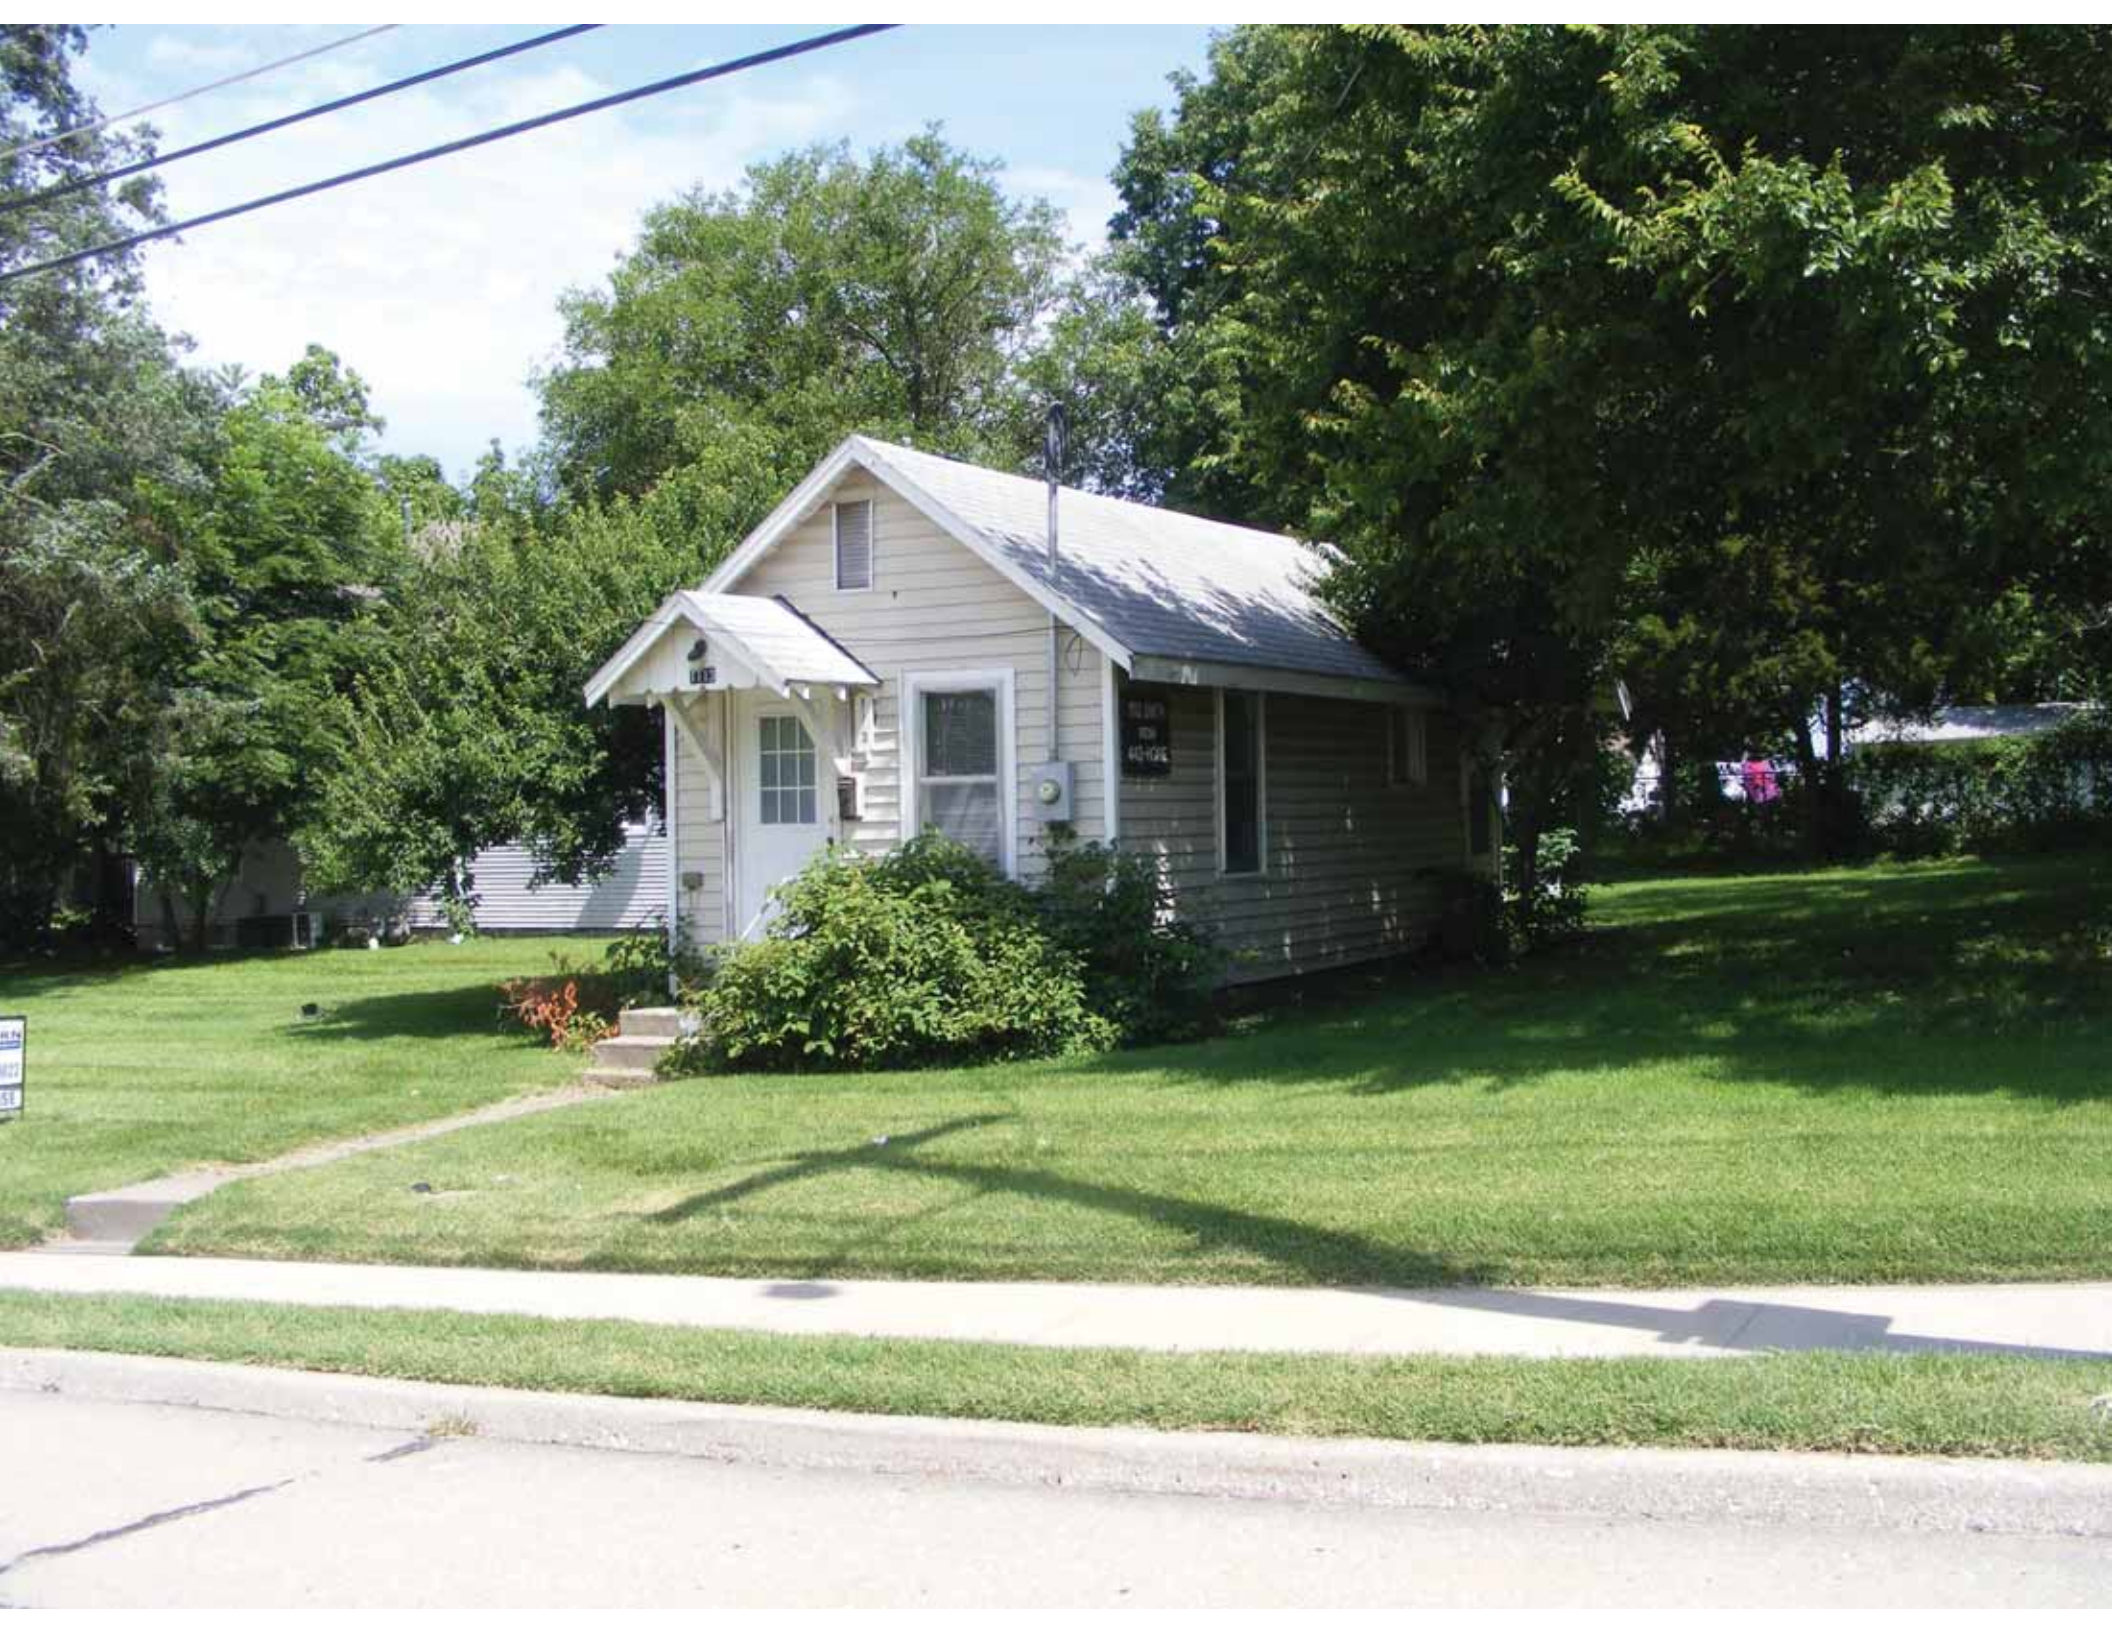
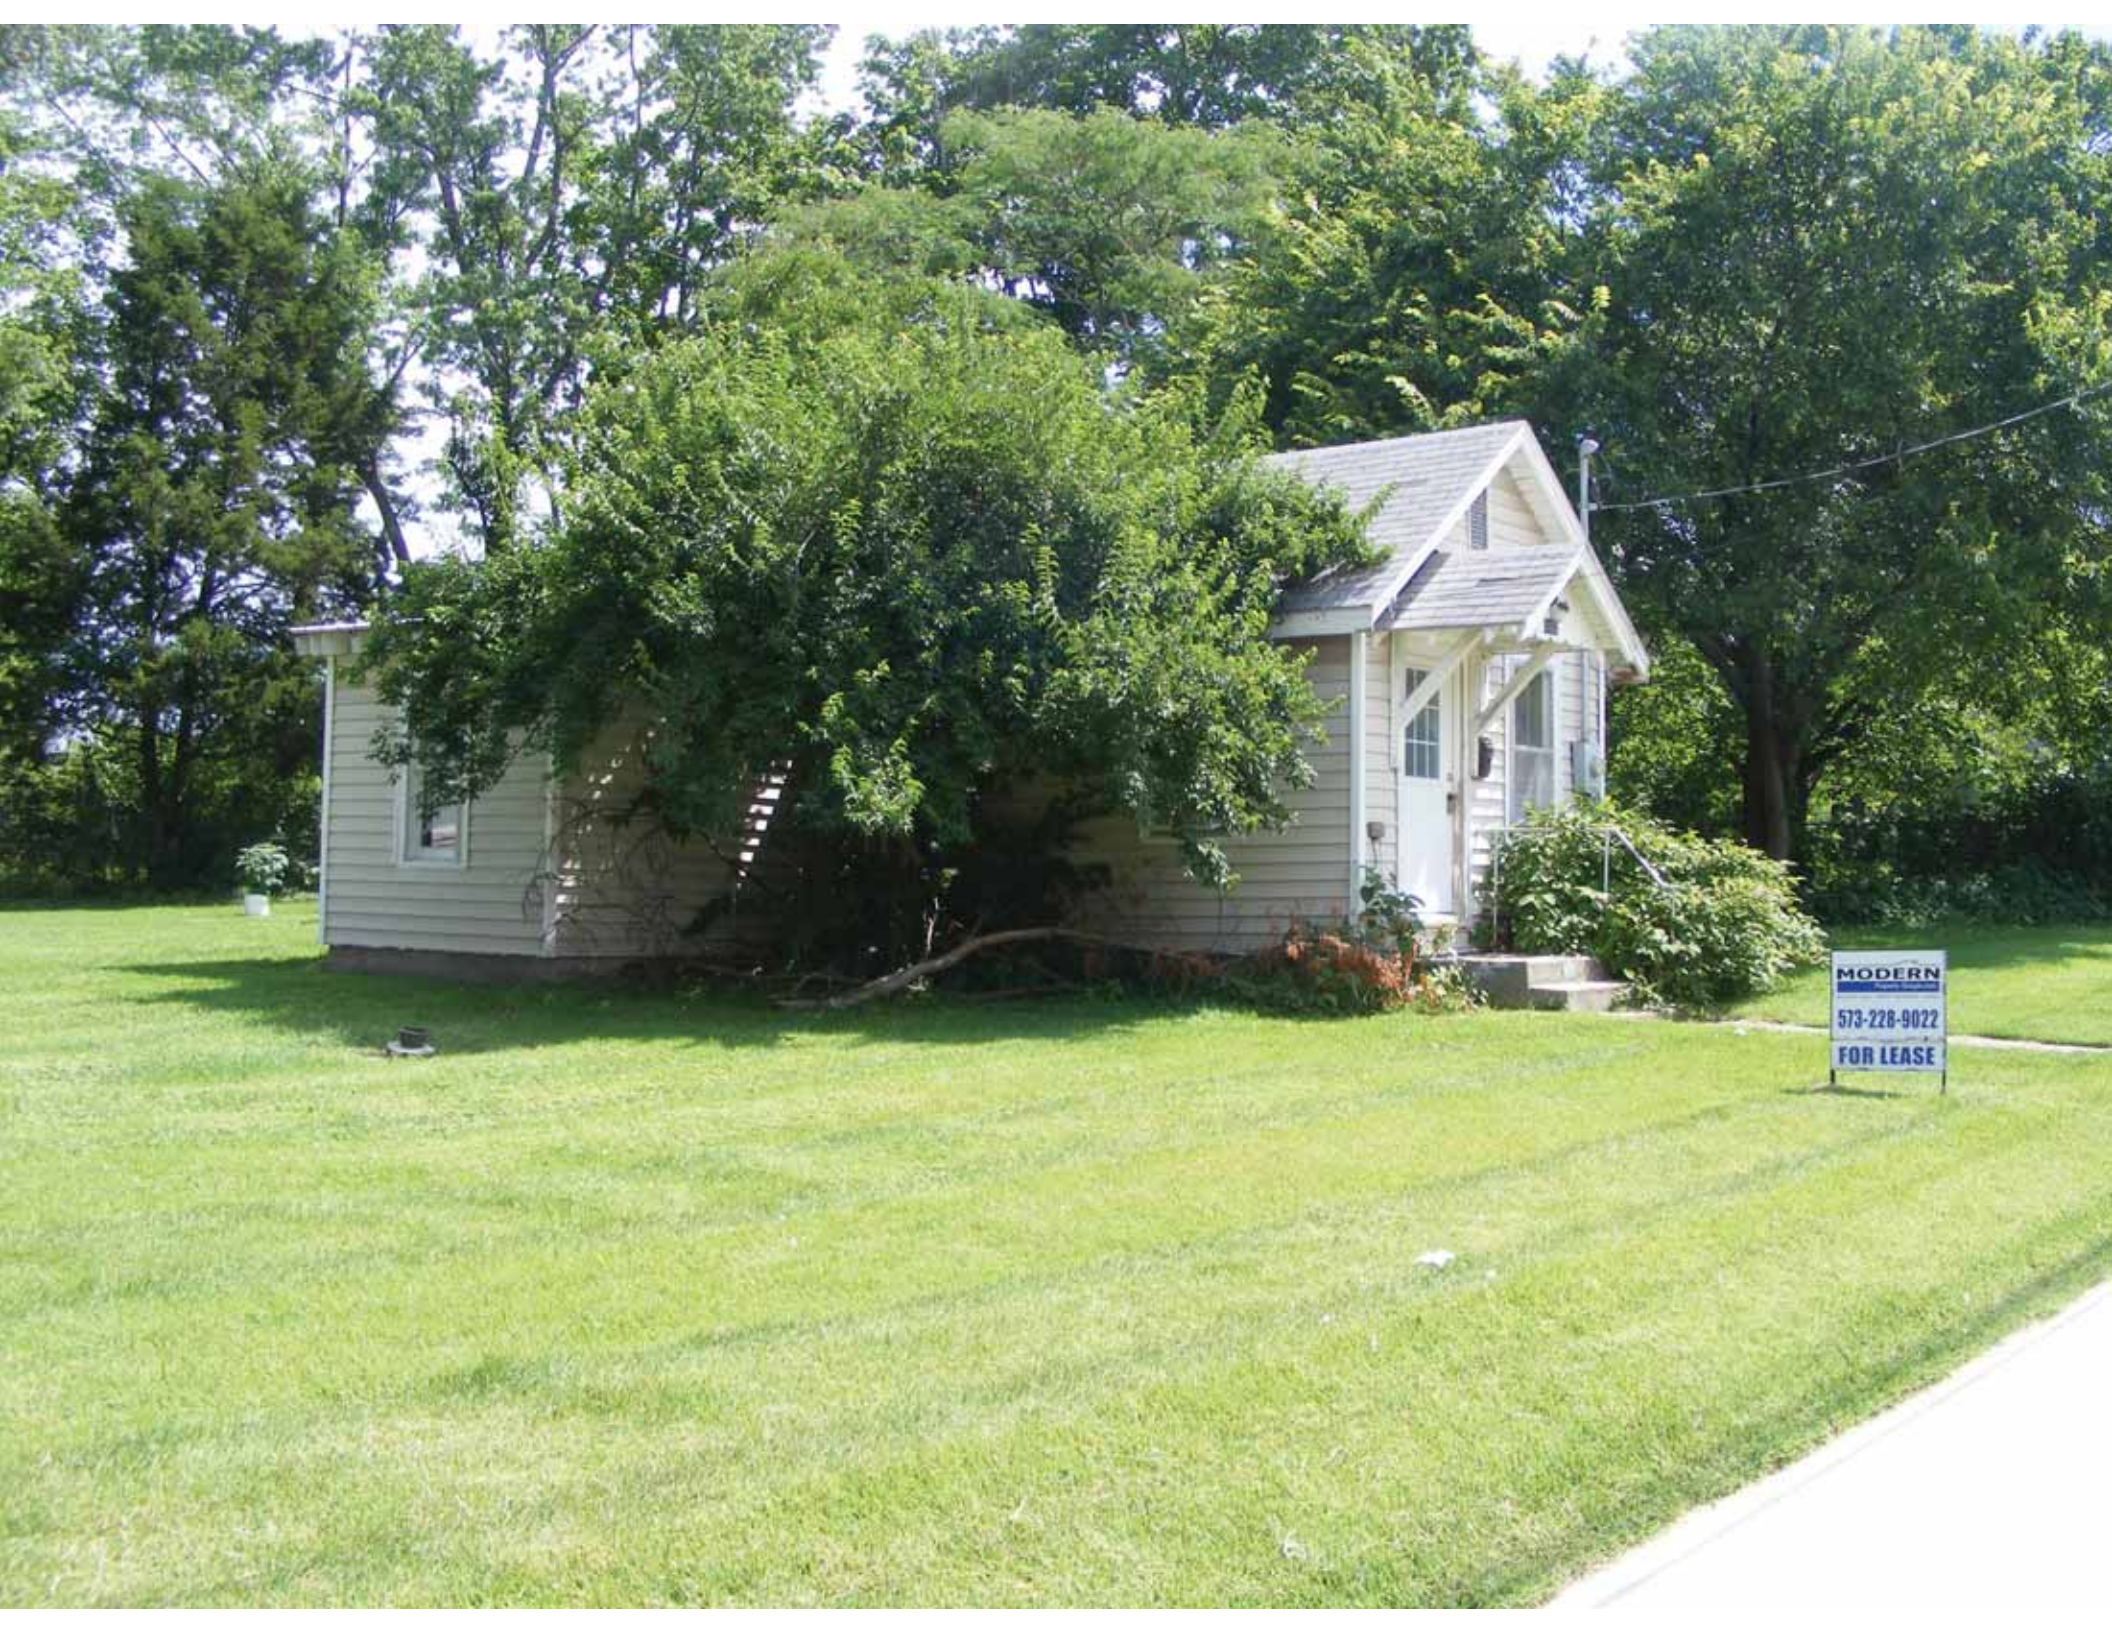
This is a vinyl clad, asphalt-shingled front gable to a shed and a concrete foundation. The dwelling features overhanging eaves with exposed rafters. The façade features a offset front gable stoop with knee brackets, gable end infilled with vertical wood siding, concrete decking and steps. The entry door is replacement metal paneled with nine lights and offset to the right by a one-over-one window. Gable end holds a vent. The west elevation at the north corner has an enclosed addition with a shed roof. Side elevations hold one-over-one windows.
