MISSOURI DEPARTMENT OF NATURAL RESOURCES
STATE HISTORIC PRESERVATION OFFICE, P.O. Box 176, Jefferson City, MO 65102
ARCHITECTURAL/HISTORIC INVENTORY FORM

1. Survey No. BO-AS-011-0087		2. Survey name: North Central Columbia Survey Phase II	
3. County: Boone		4. Address (Street No.) 902	Street (name) N. Seventh Street
5. City: Columbia	Vicinity: <input type="checkbox"/>	6. Geographical Reference:	7. Township/Range/Section: T: R: S:
8. Historic name (if known):		9. Present/other name (if known):	
10. Ownership: <input checked="" type="checkbox"/> Private <input type="checkbox"/> Public		11a. Historic use (if known): Domestic/single dwelling	11b. Current use: Domestic/single dwelling

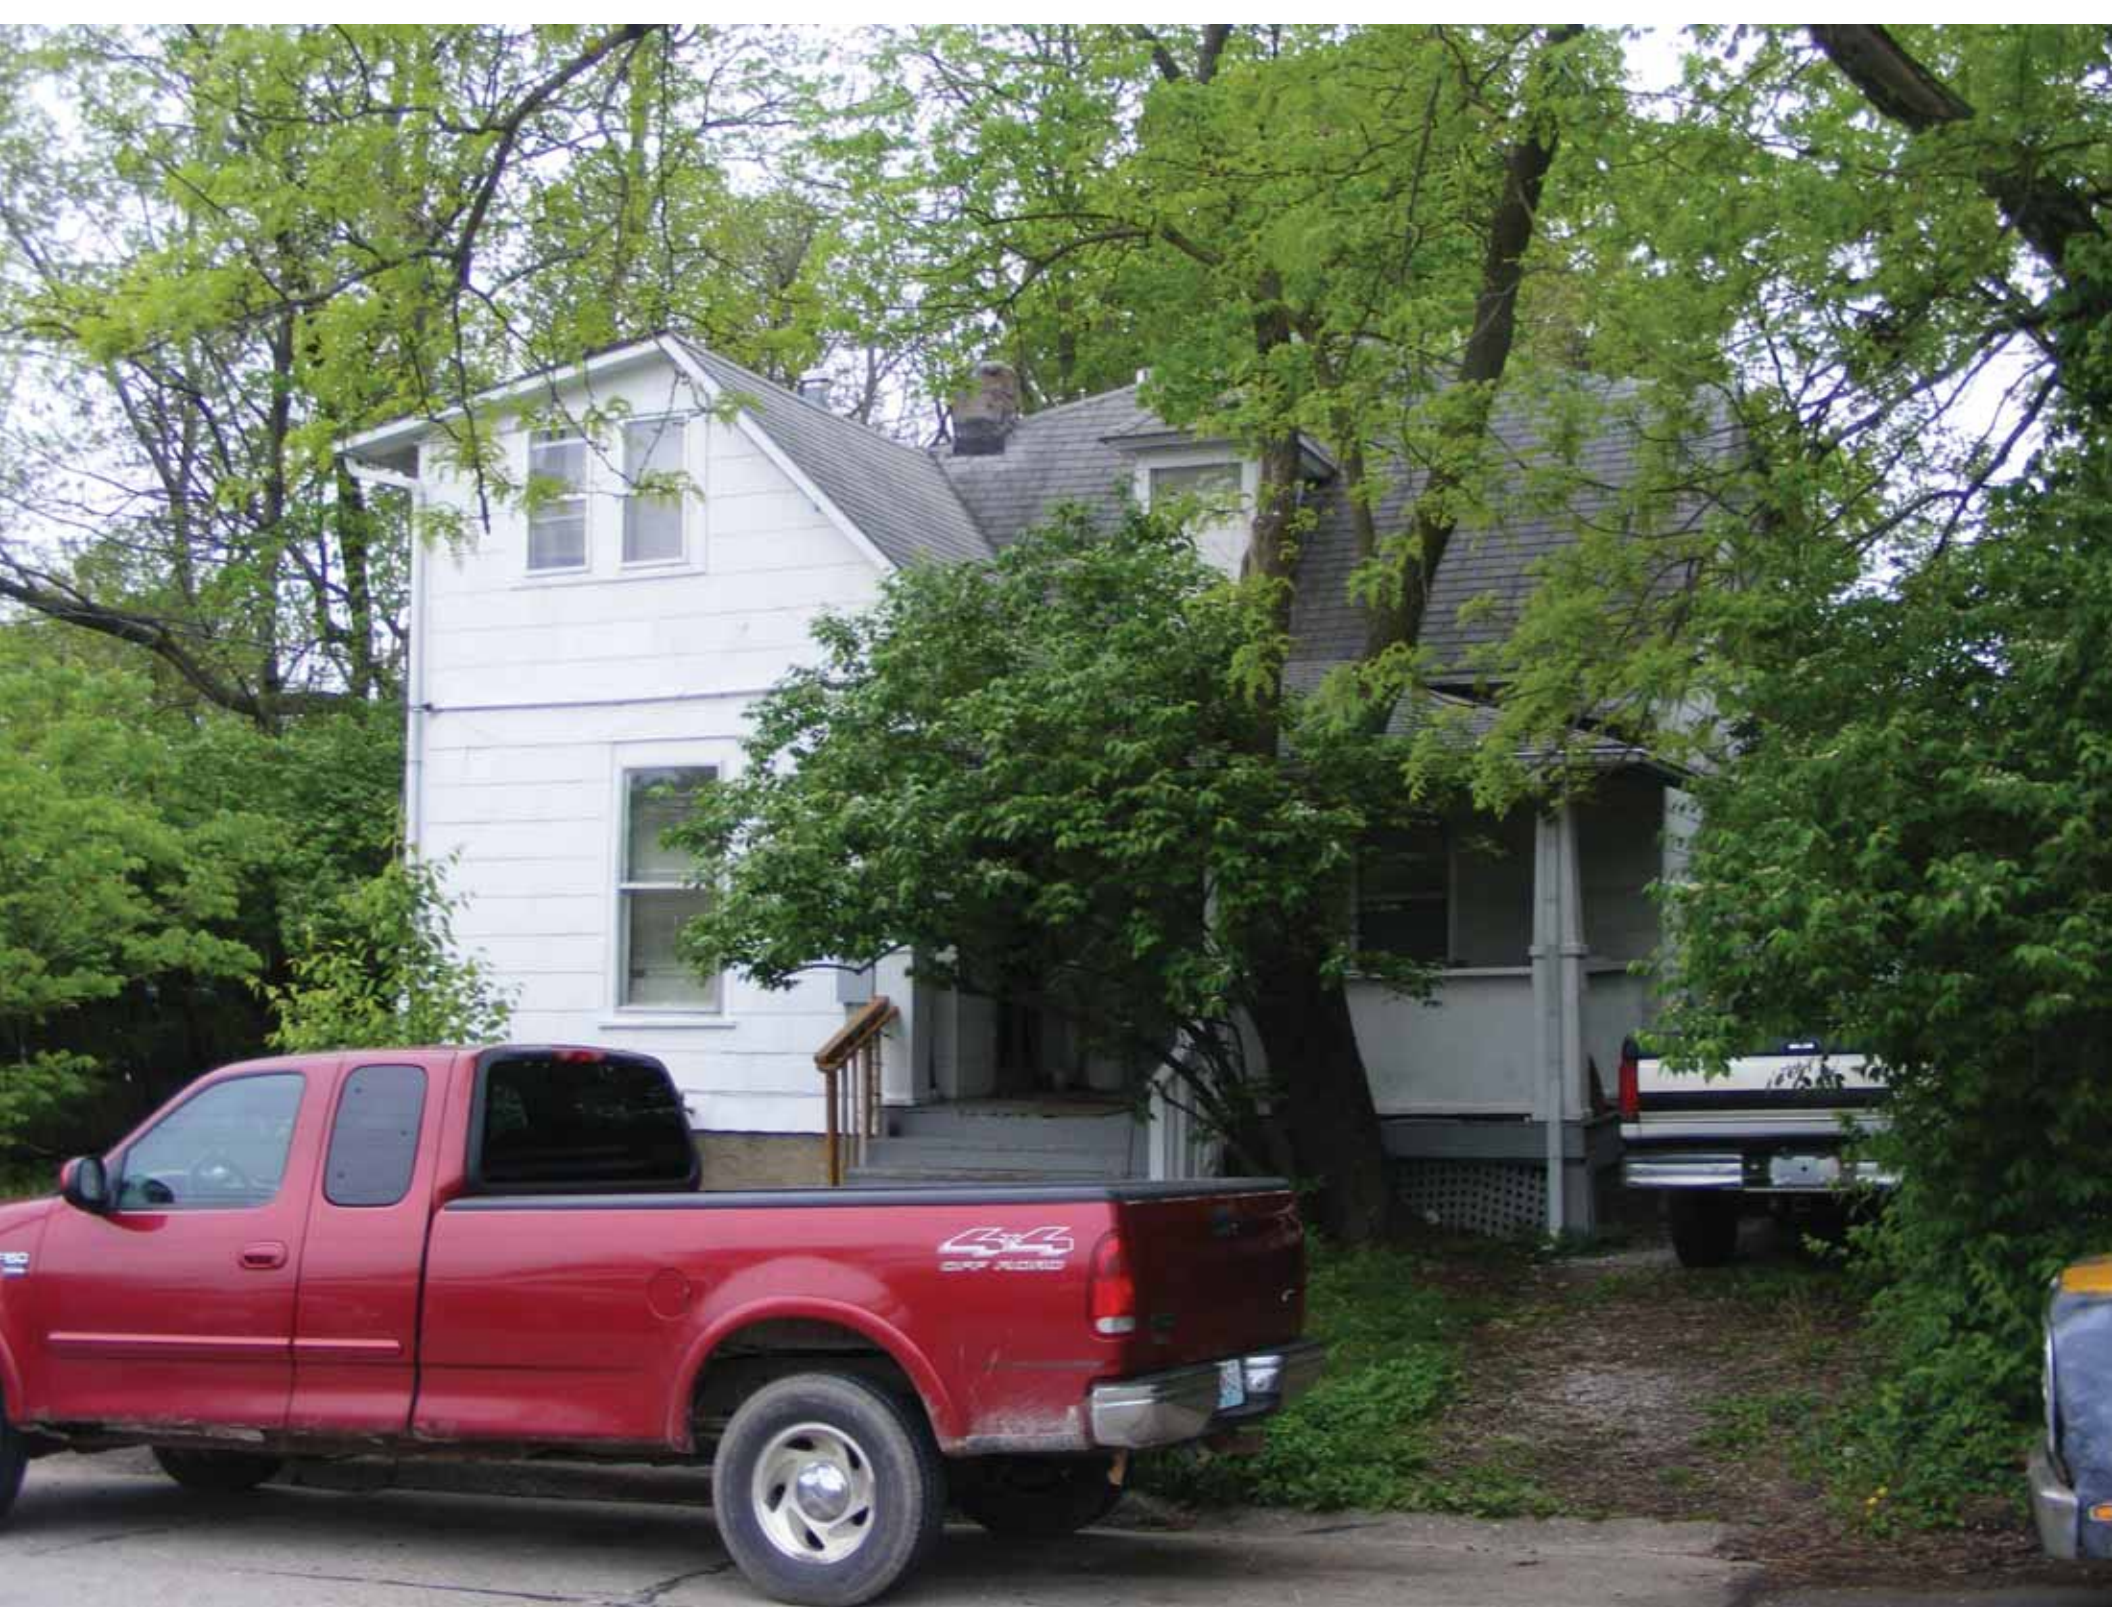
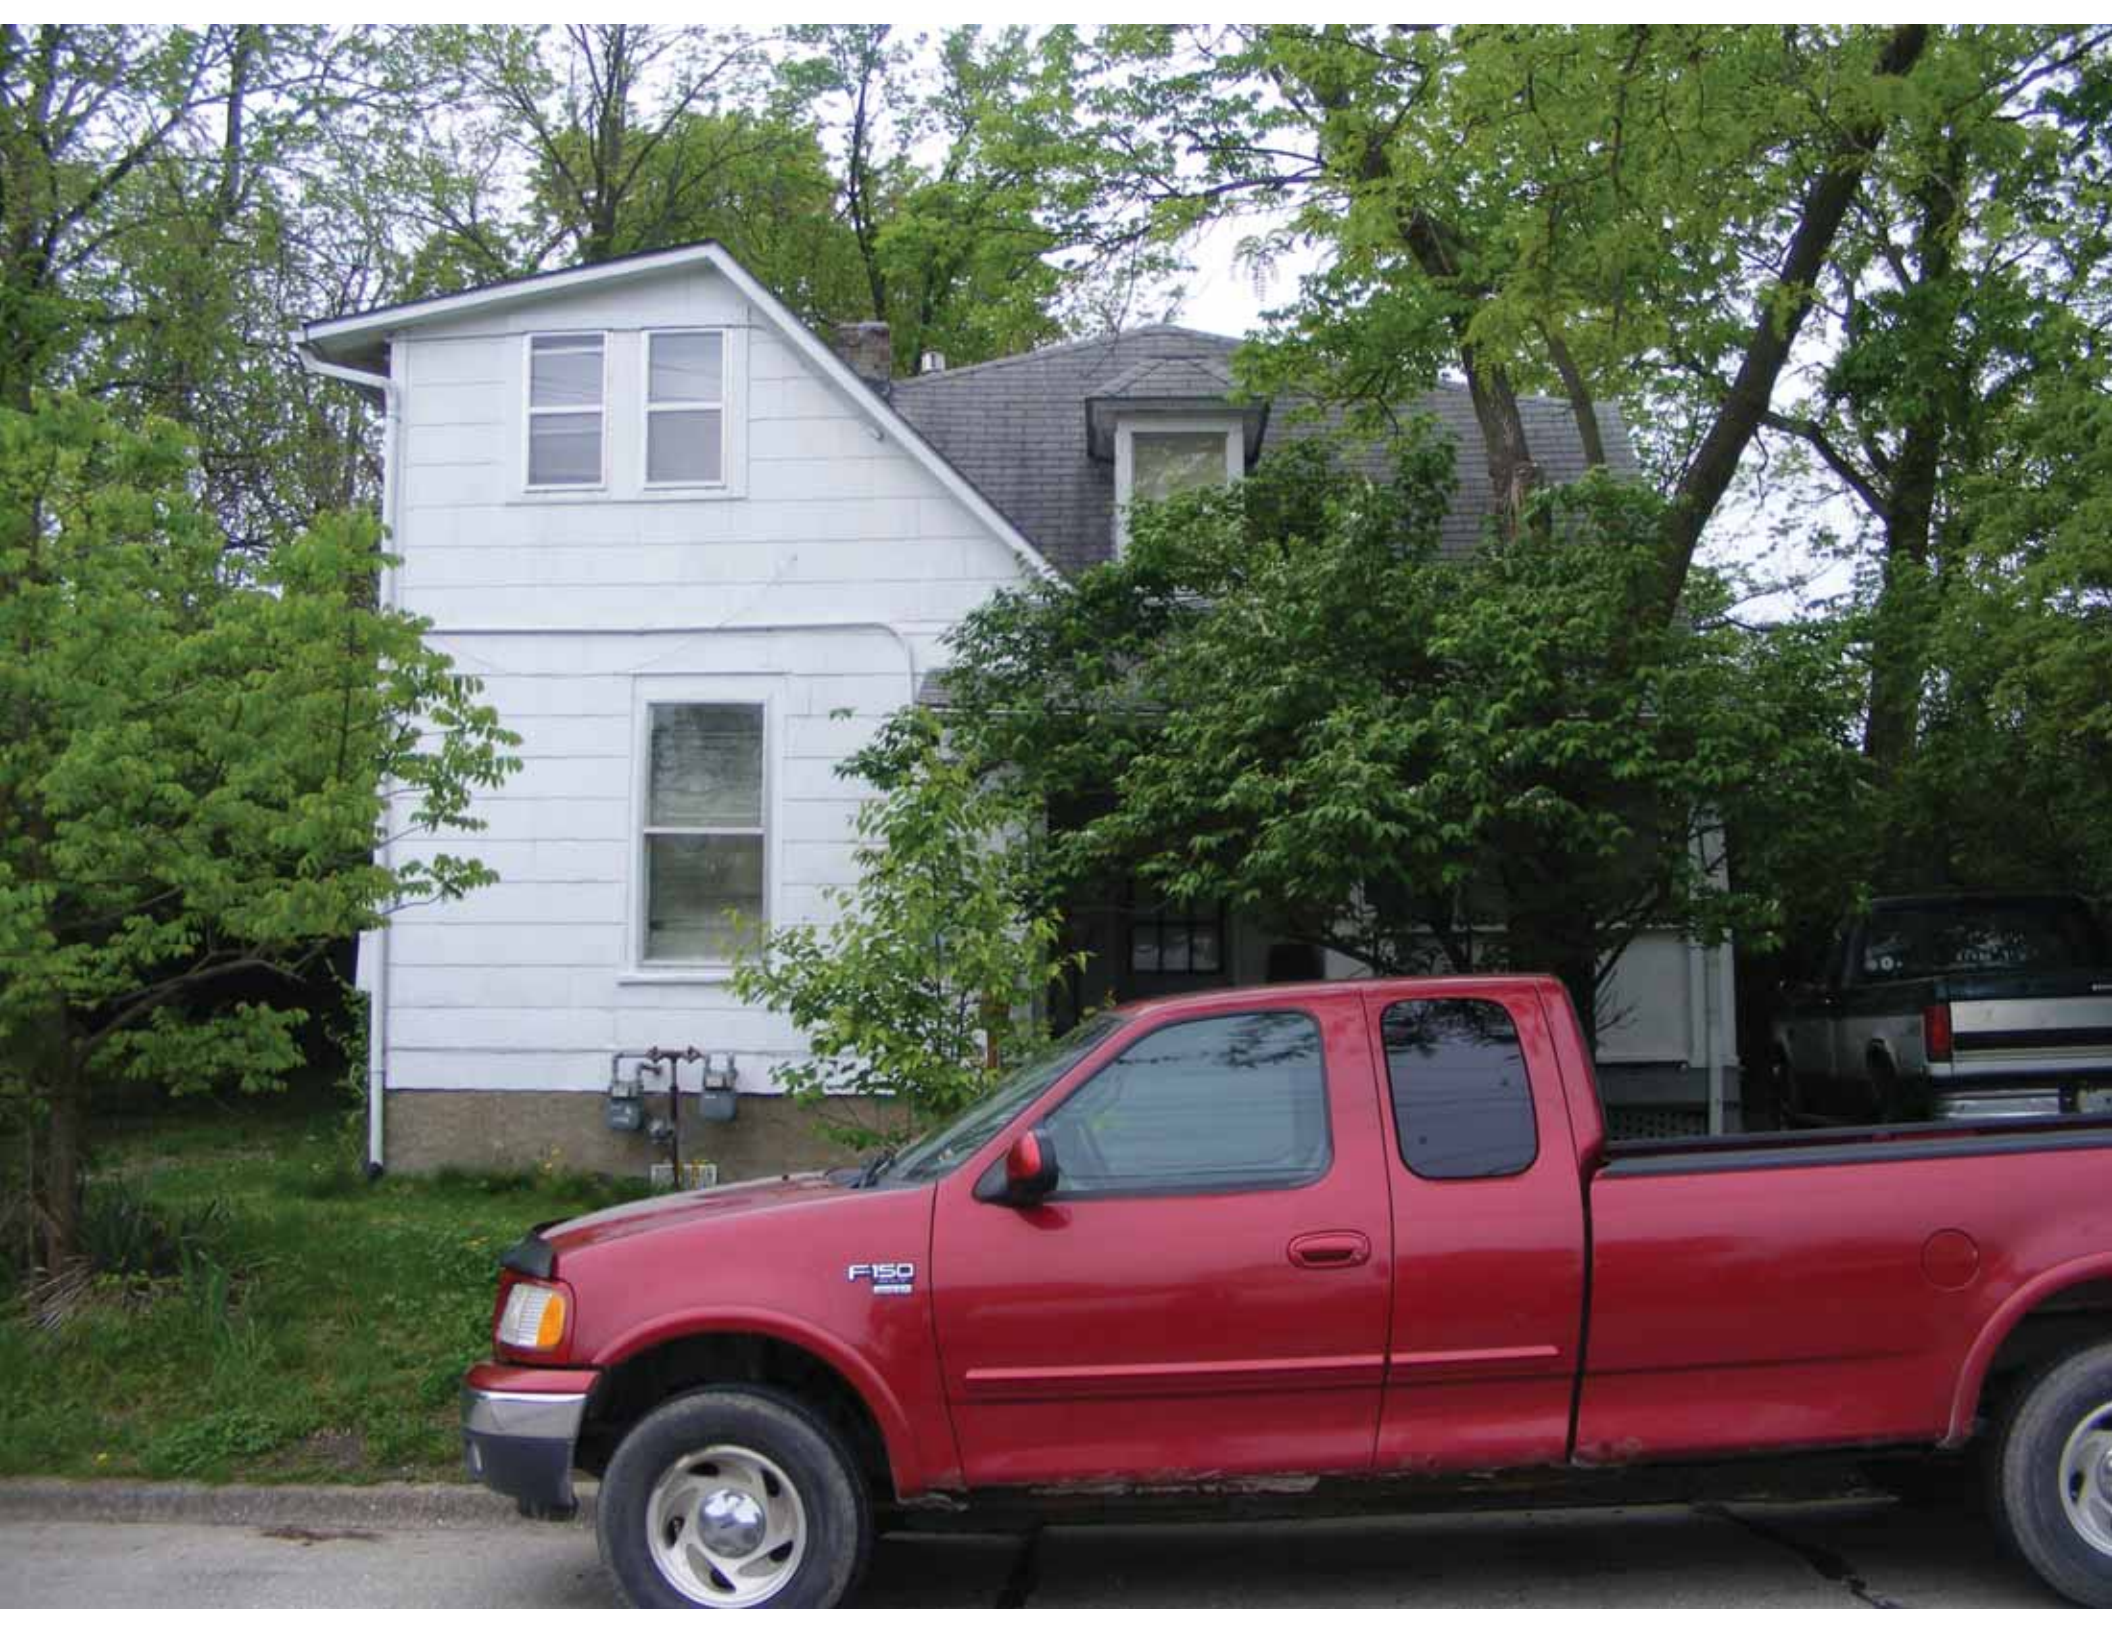
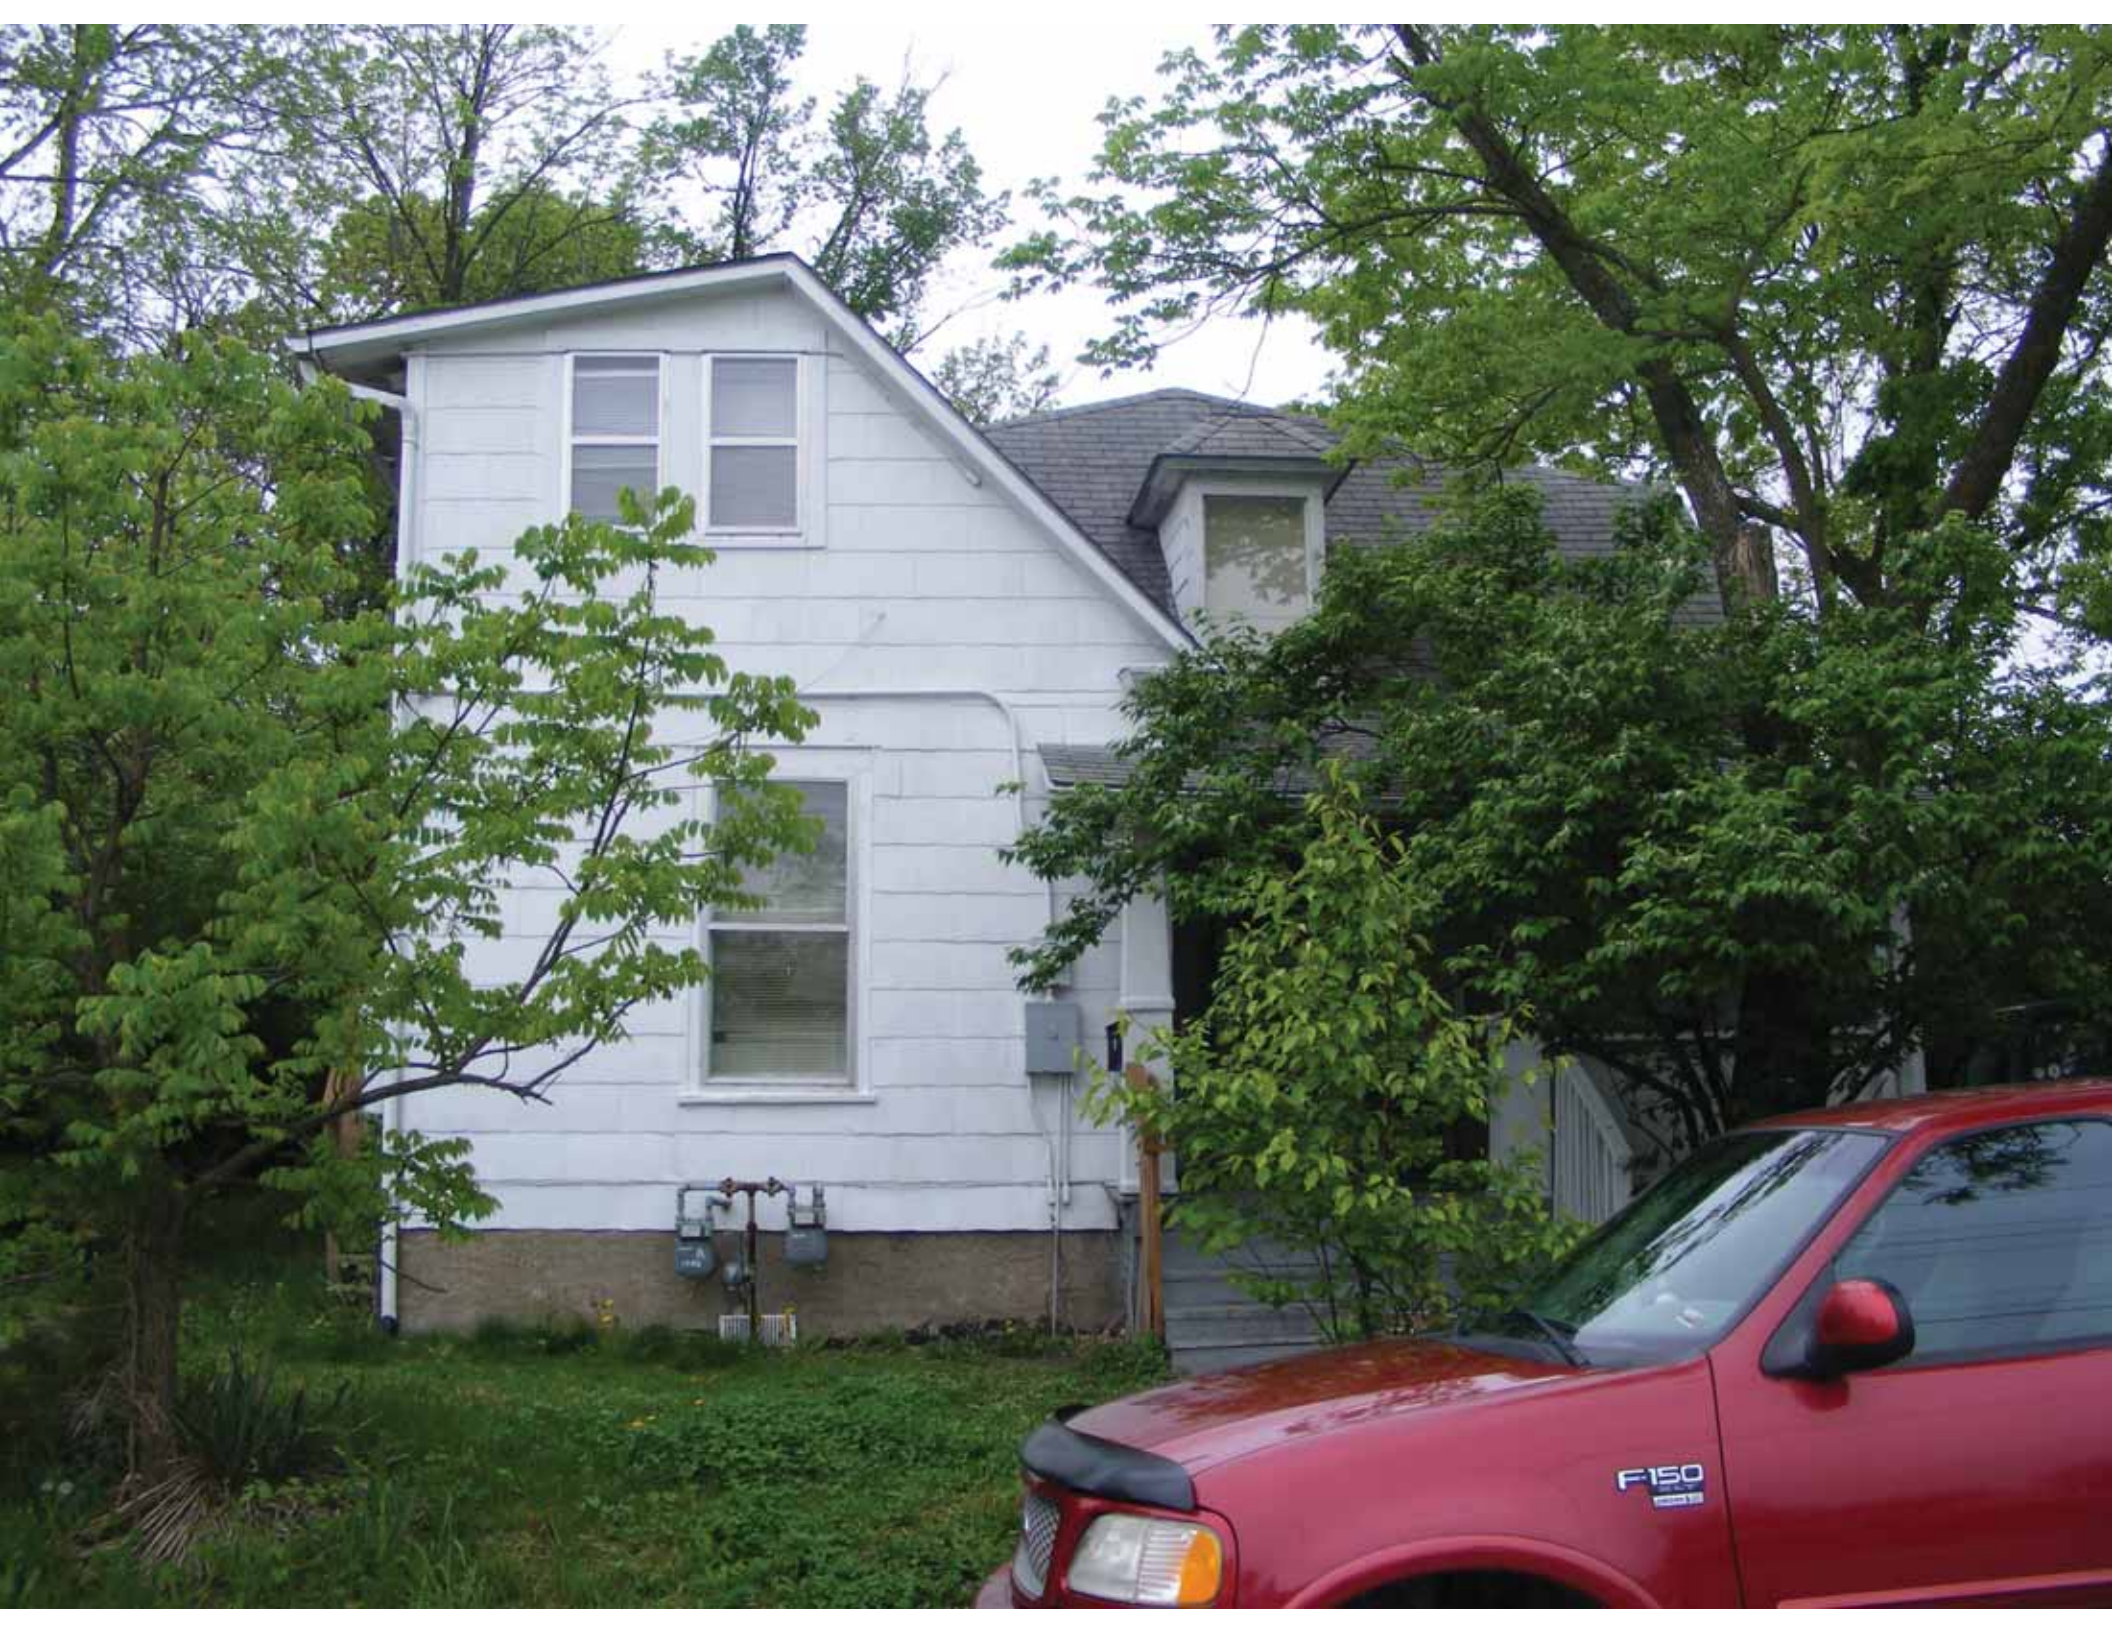
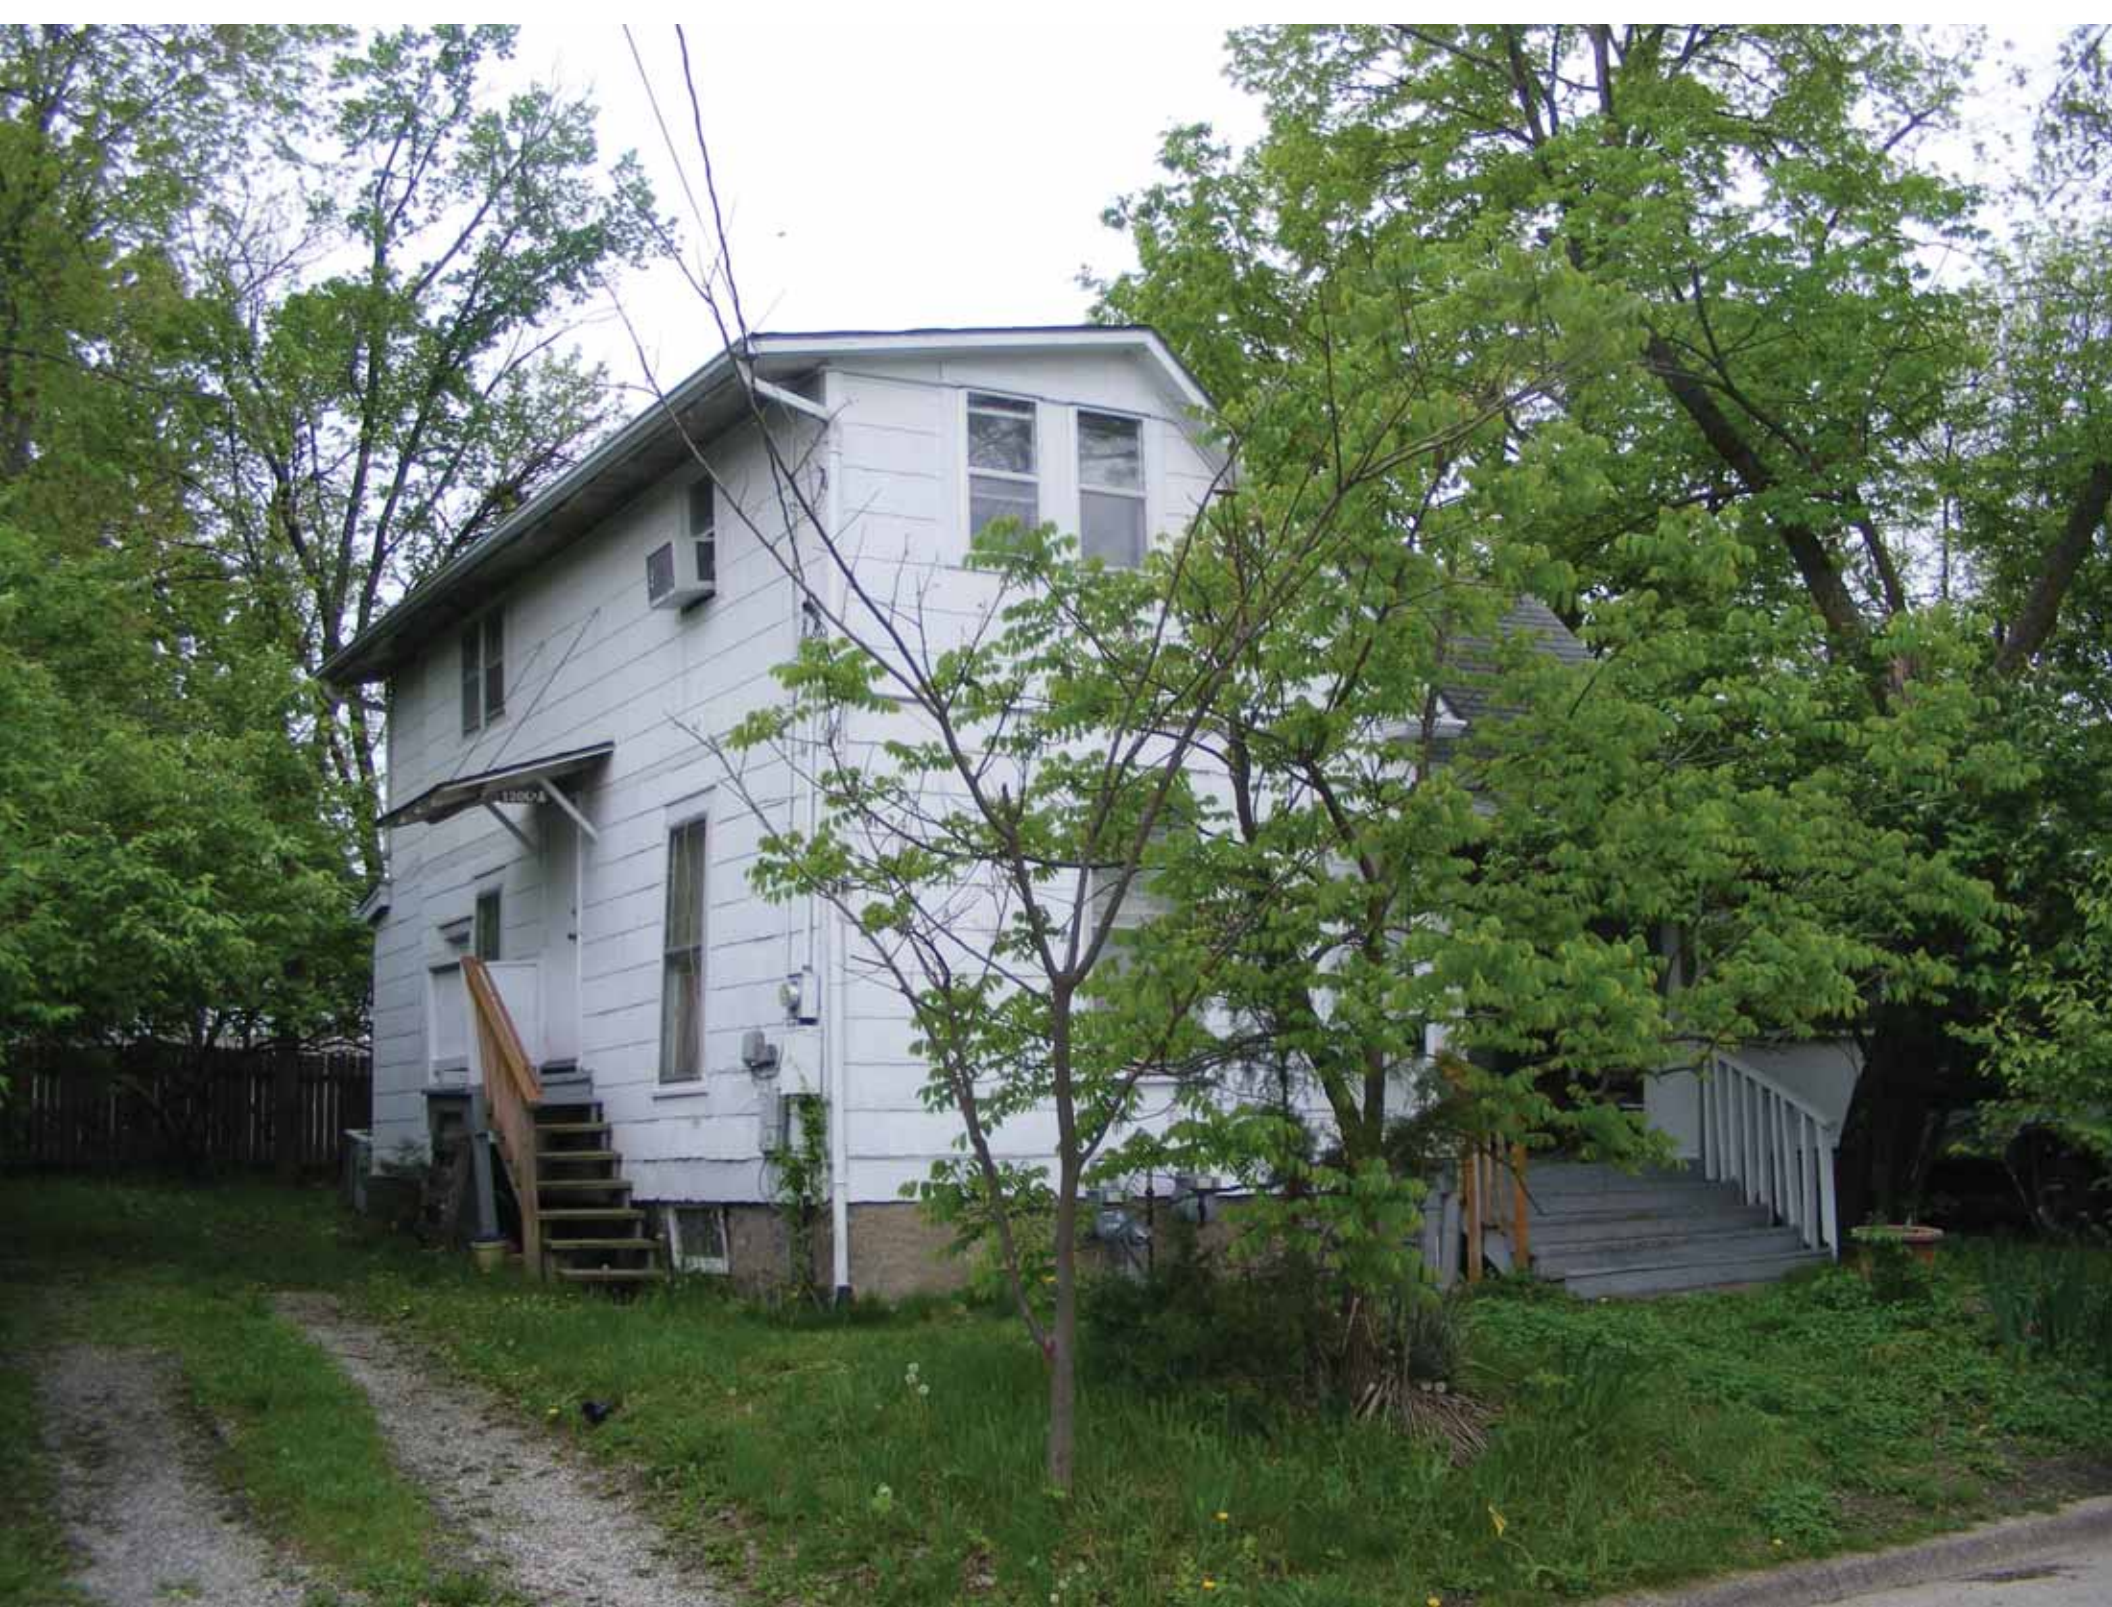
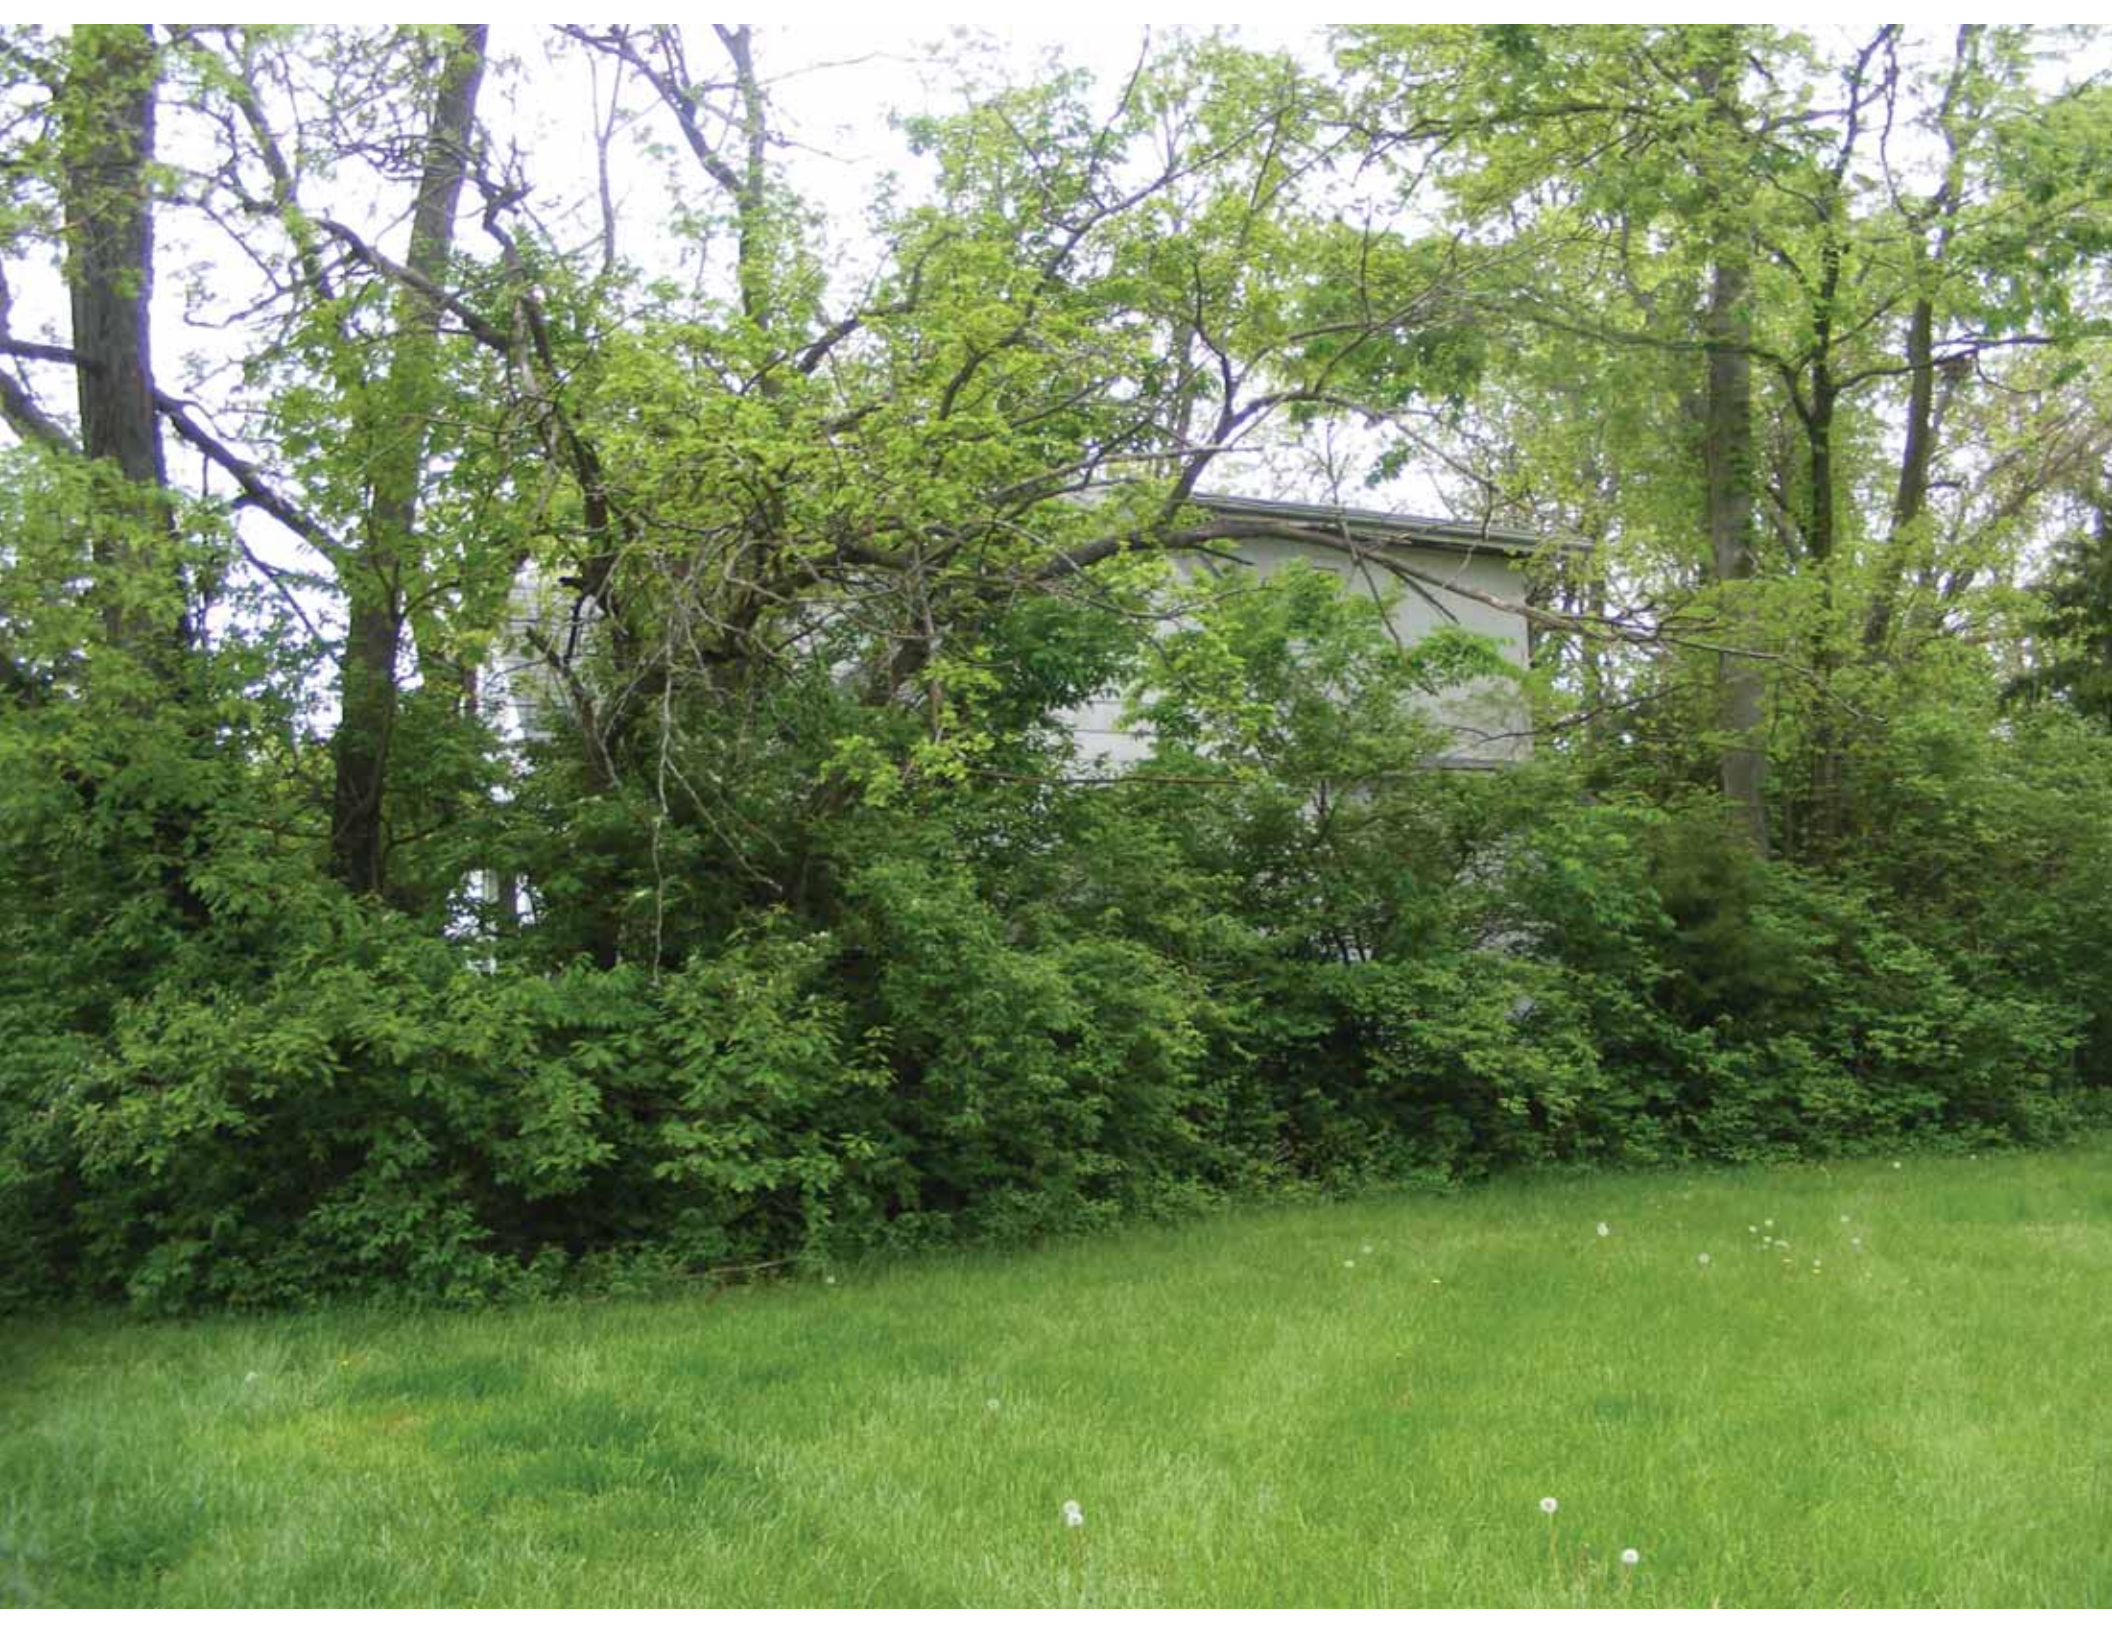
41. (cont.) Description of primary resource. Expand box as necessary, or add continuation pages.
A 1.5 story asbestos clad dwelling with an asphalt-shingled cross gable and concrete foundation. The primary elevation holds a front asymmetrical gable (low-pitched to steeply pitched). The gable end holds paired one-over-one windows and lower section holds a single one-over-one window. The partial-width hipped porch supported by tapered columns on wooden piers is to the right of the gable front. The porch features wood decking, steps and a low solid panel wood wall between piers. The entrance is at the "L" and offset to the right by a one-over-one window. A hipped dormer with a one-over-one window is sited on the front sloping roofline. The west elevation holds paired and single one-over-one windows. The lower level features a stoop entrance sheltered by a shed awning with exposed rafters and brackets; wood decking, steps and railing.
