MISSOURI DEPARTMENT OF NATURAL RESOURCES
STATE HISTORIC PRESERVATION OFFICE, P.O. Box 176, Jefferson City, MO 65102
ARCHITECTURAL/HISTORIC INVENTORY FORM

1. Survey No. BO-AS-011-0087		2. Survey name: North Central Columbia Survey Phase II	
3. County: Boone		4. Address (Street No.) 902	Street (name) N. Seventh Street
5. City: Columbia	Vicinity: <input type="checkbox"/>	6. Geographical Reference:	7. Township/Range/Section: T: R: S:
8. Historic name (if known):		9. Present/other name (if known):	
10. Ownership: <input checked="" type="checkbox"/> Private <input type="checkbox"/> Public		11a. Historic use (if known): Domestic/single dwelling	11b. Current use: Domestic/single dwelling

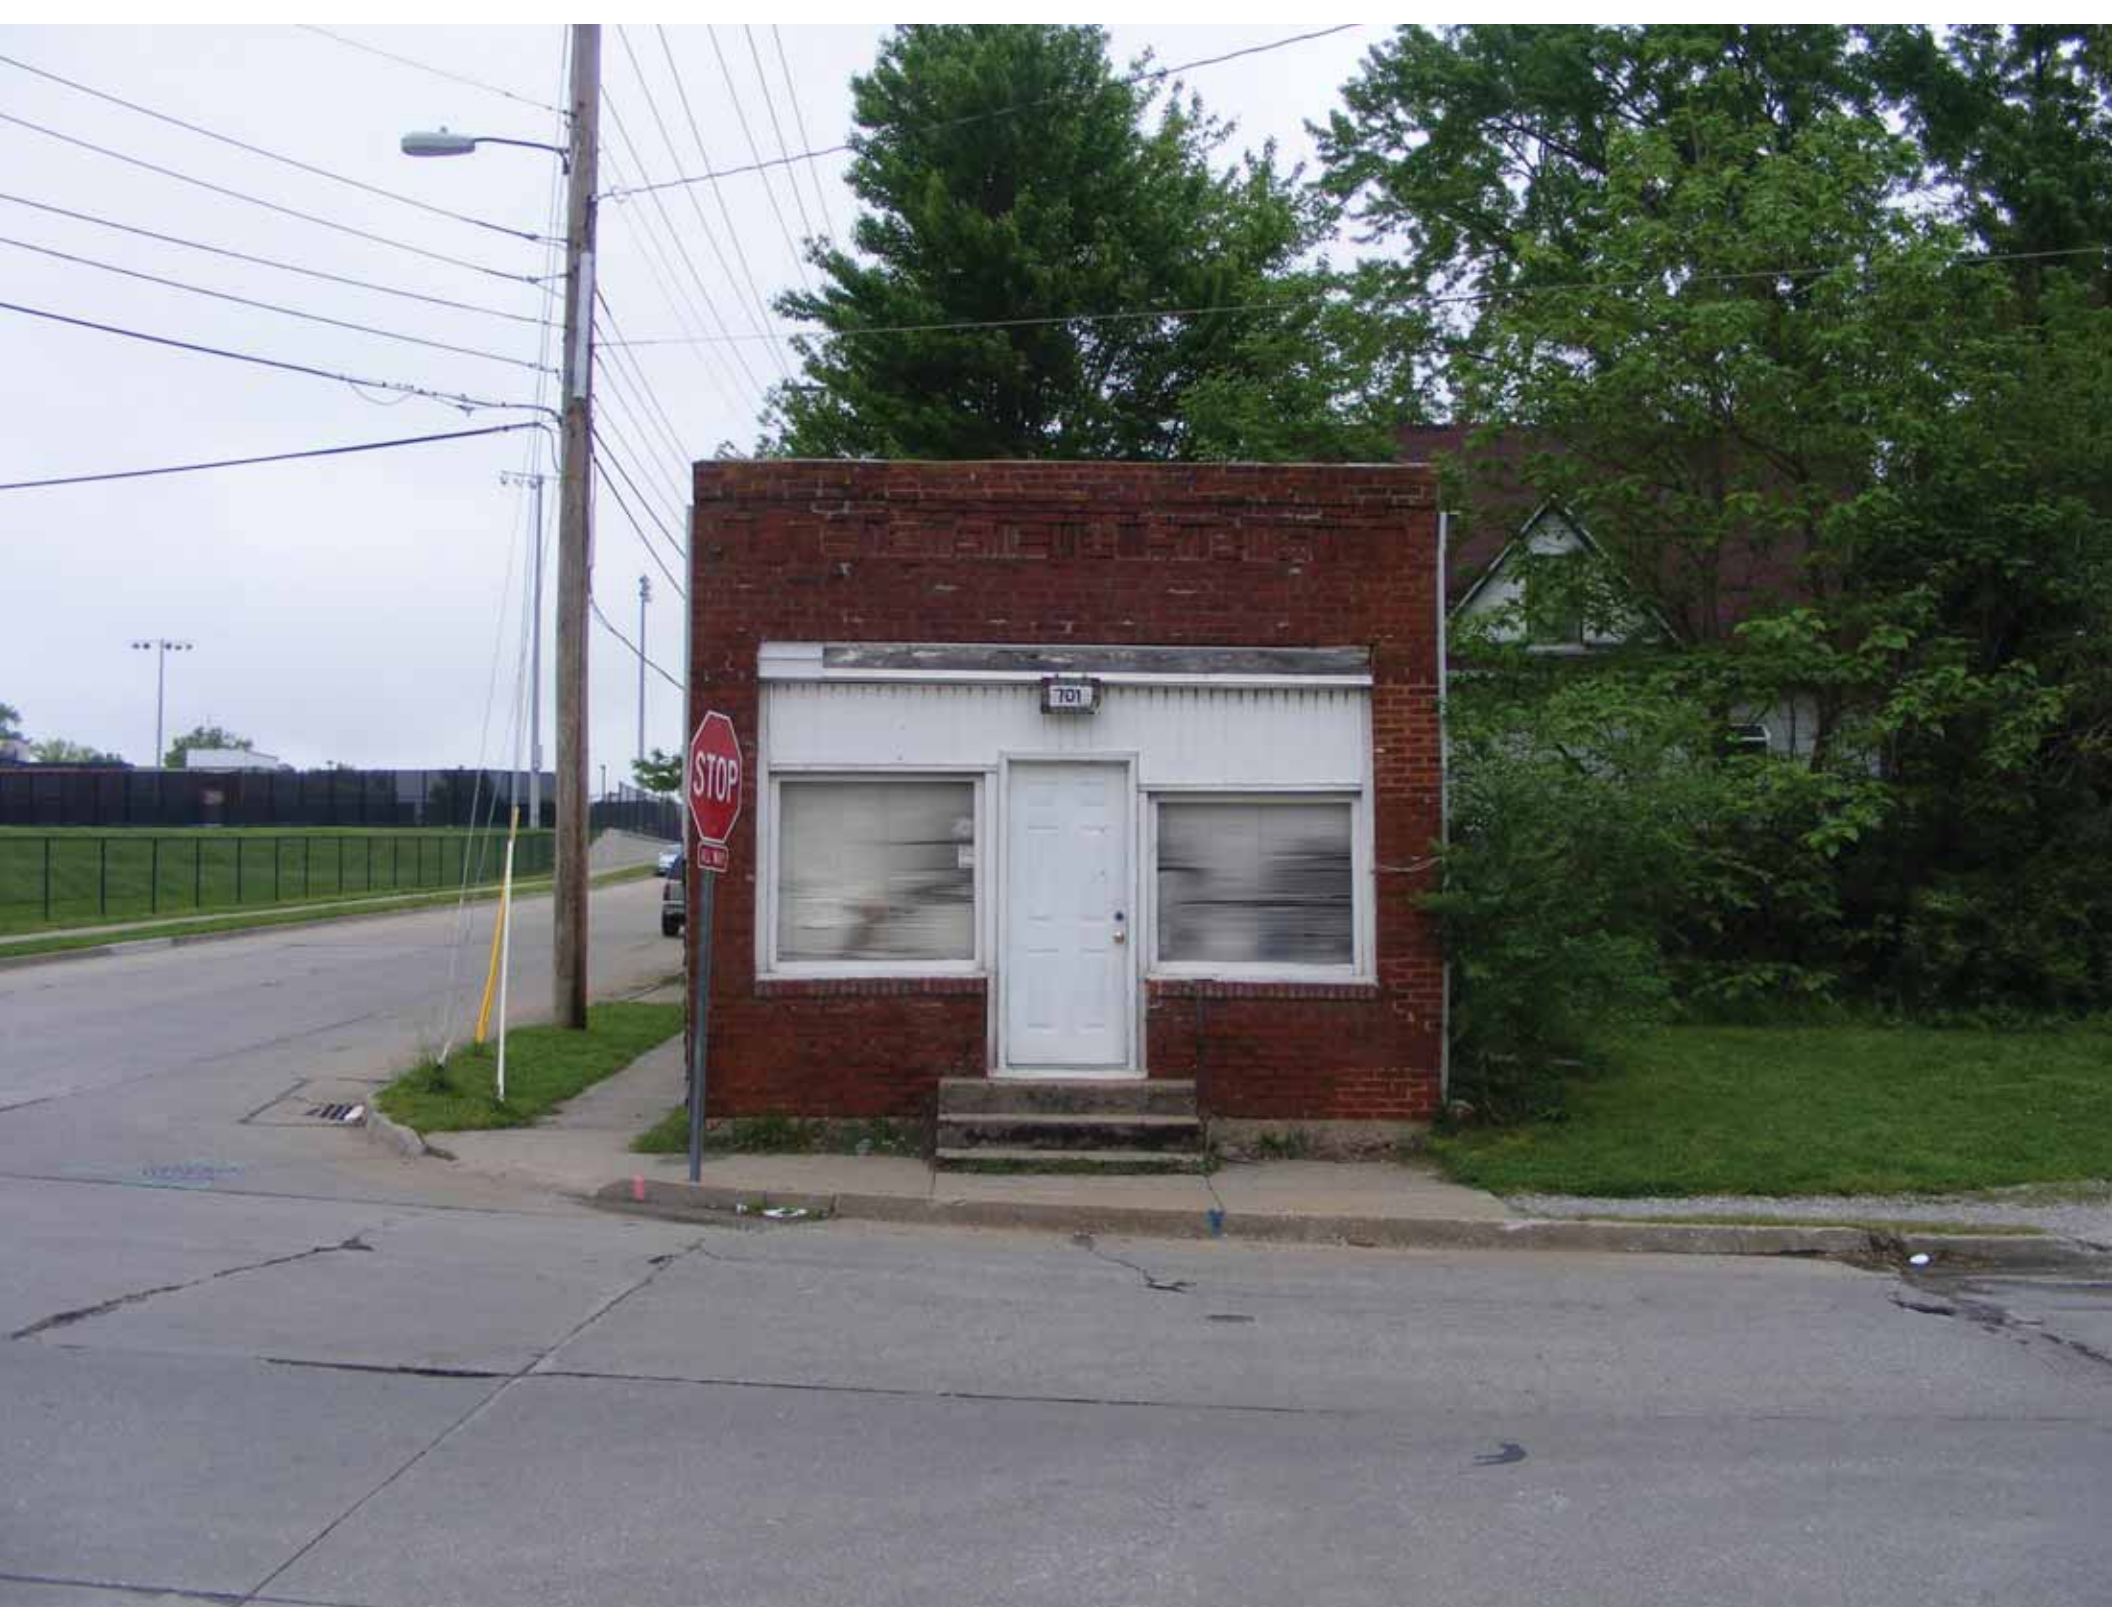
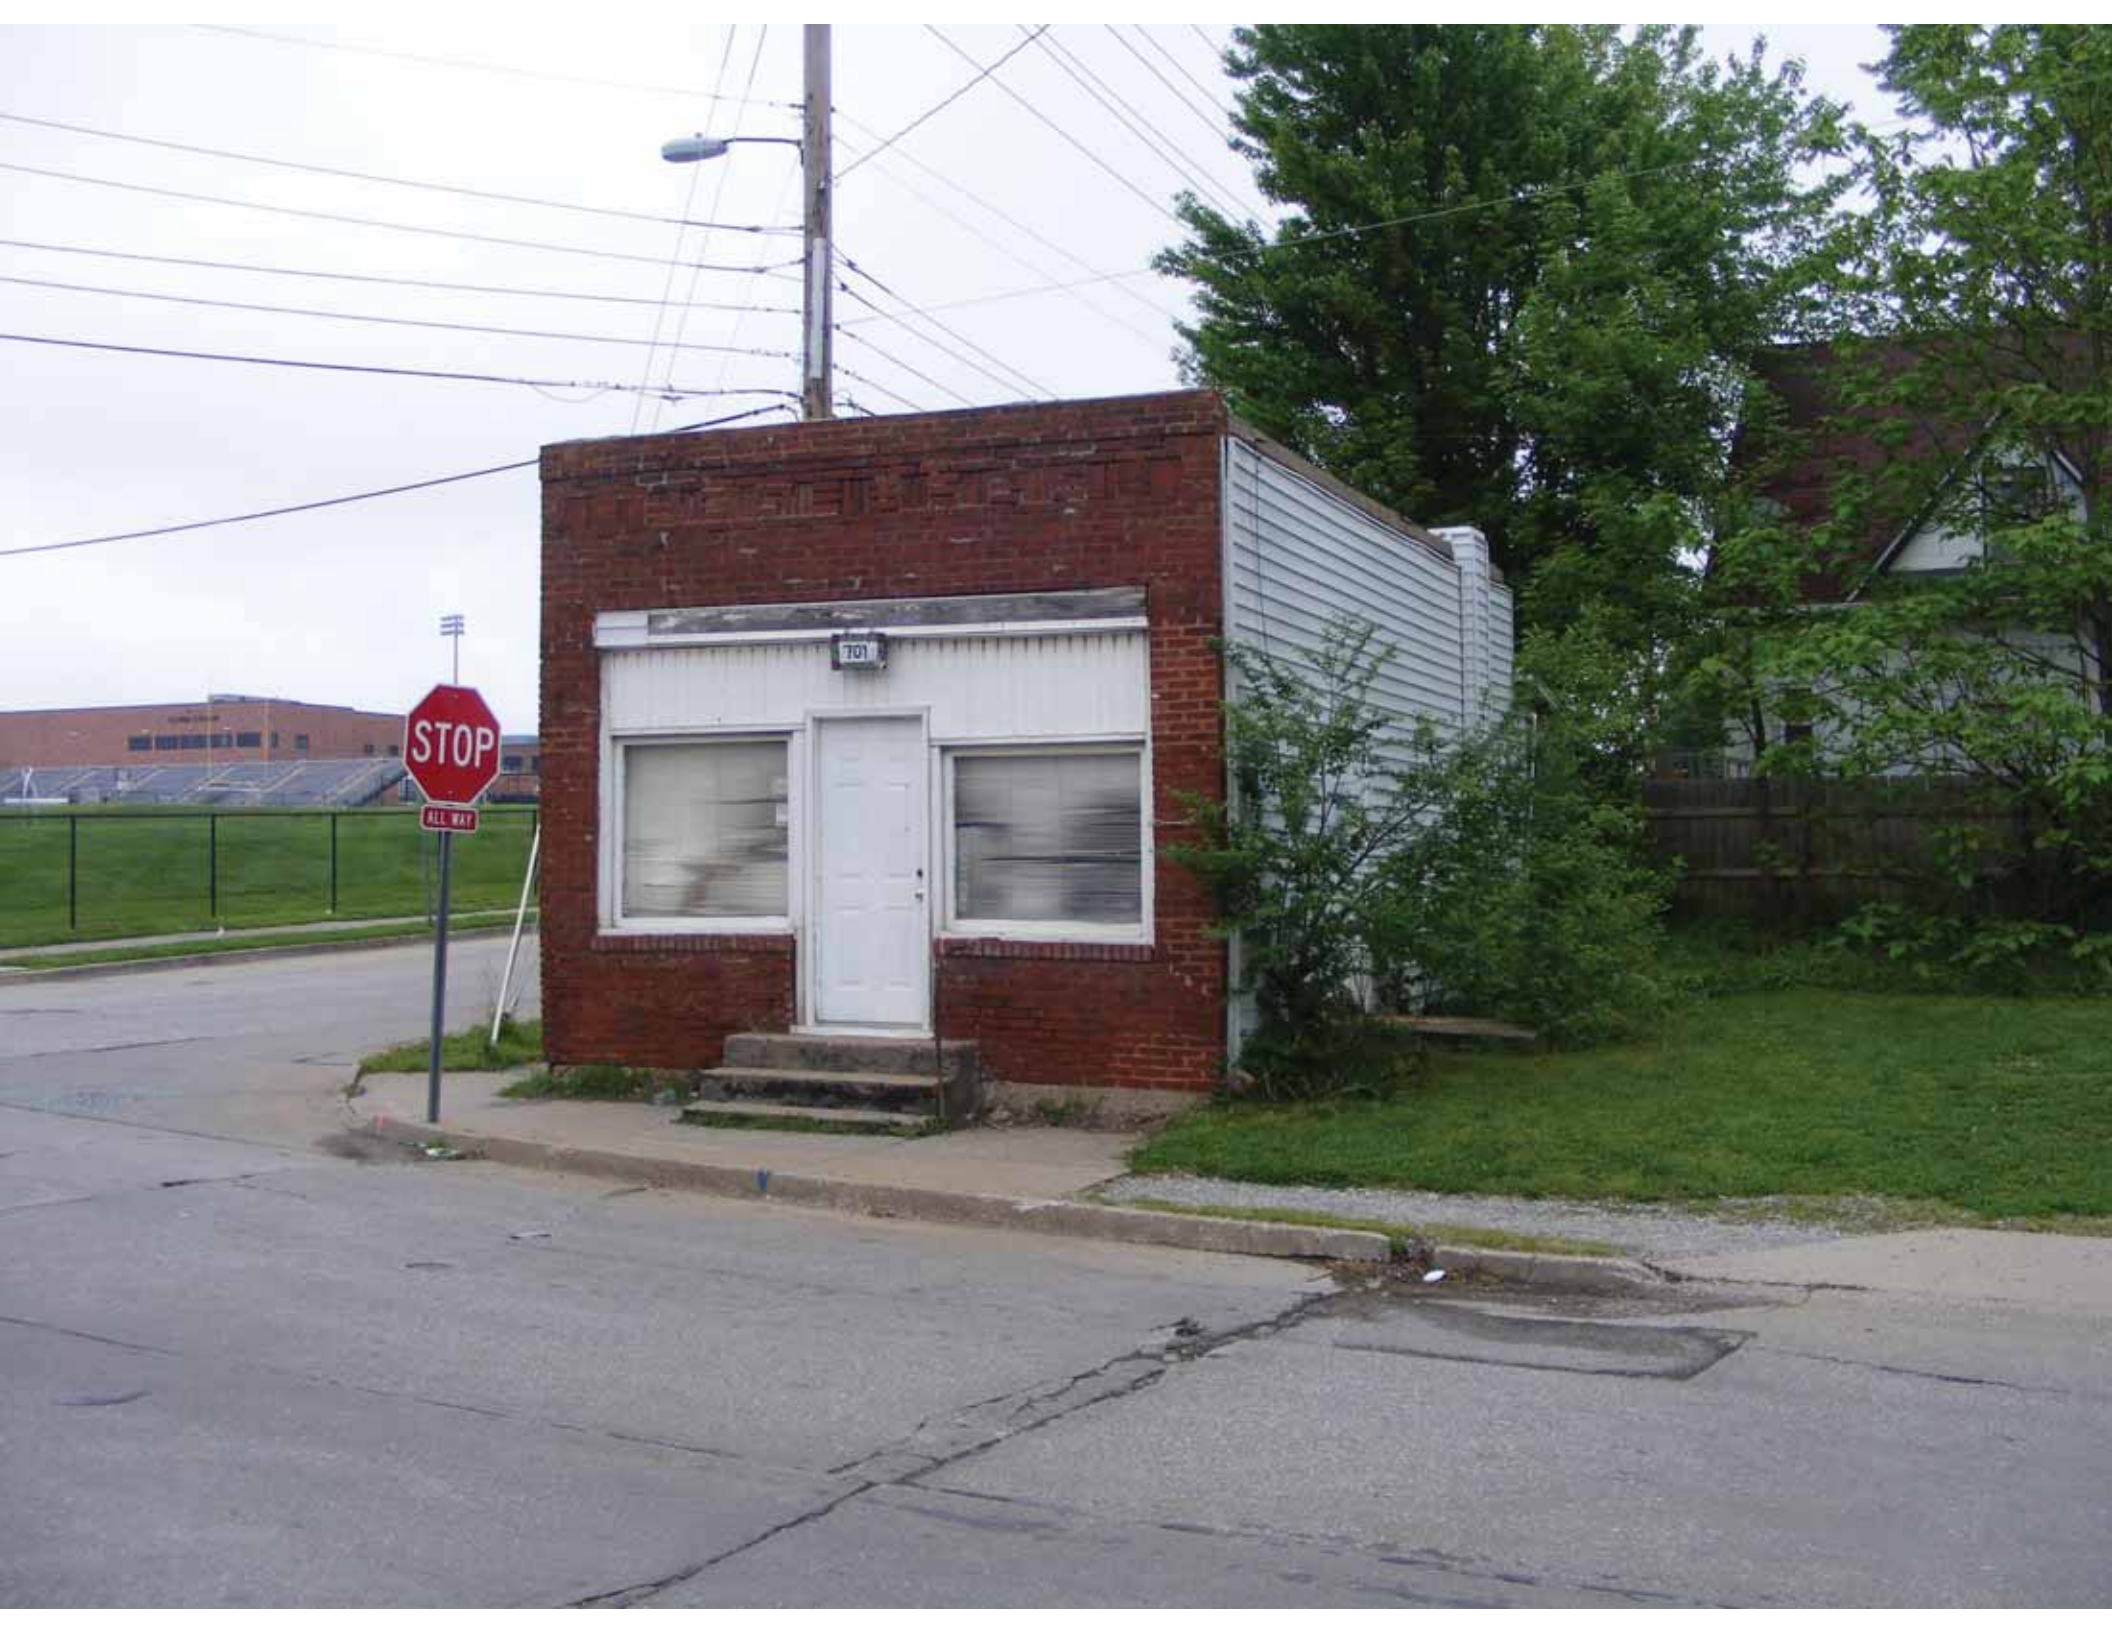
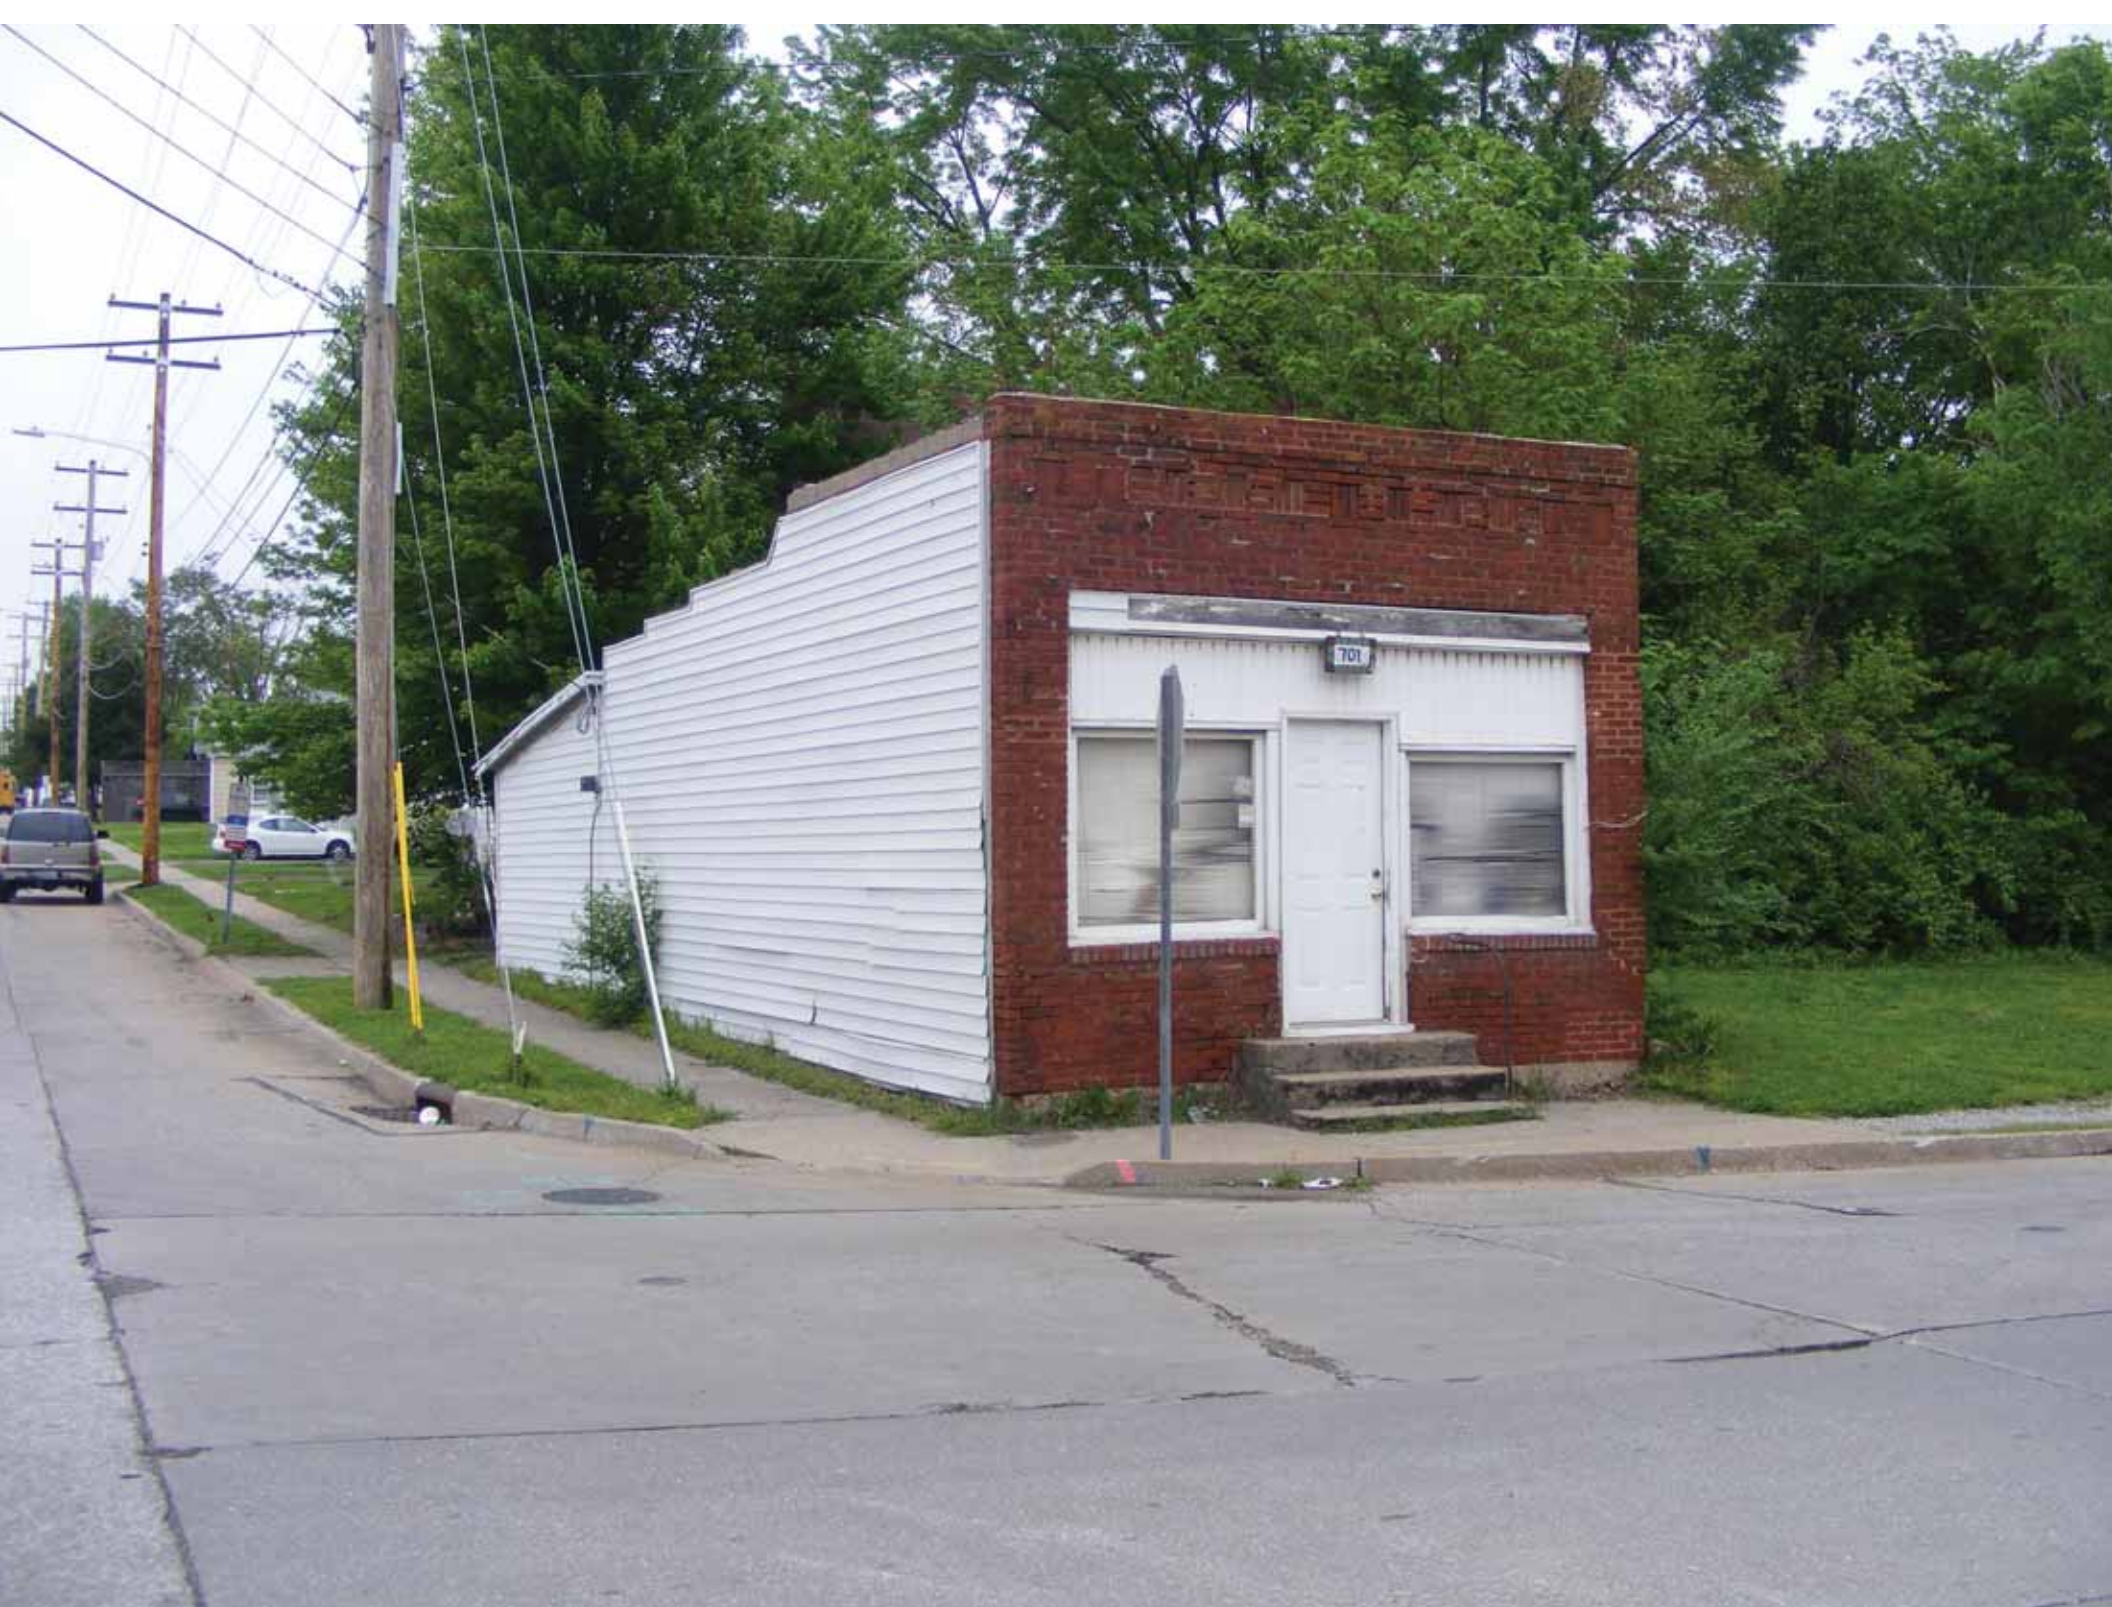
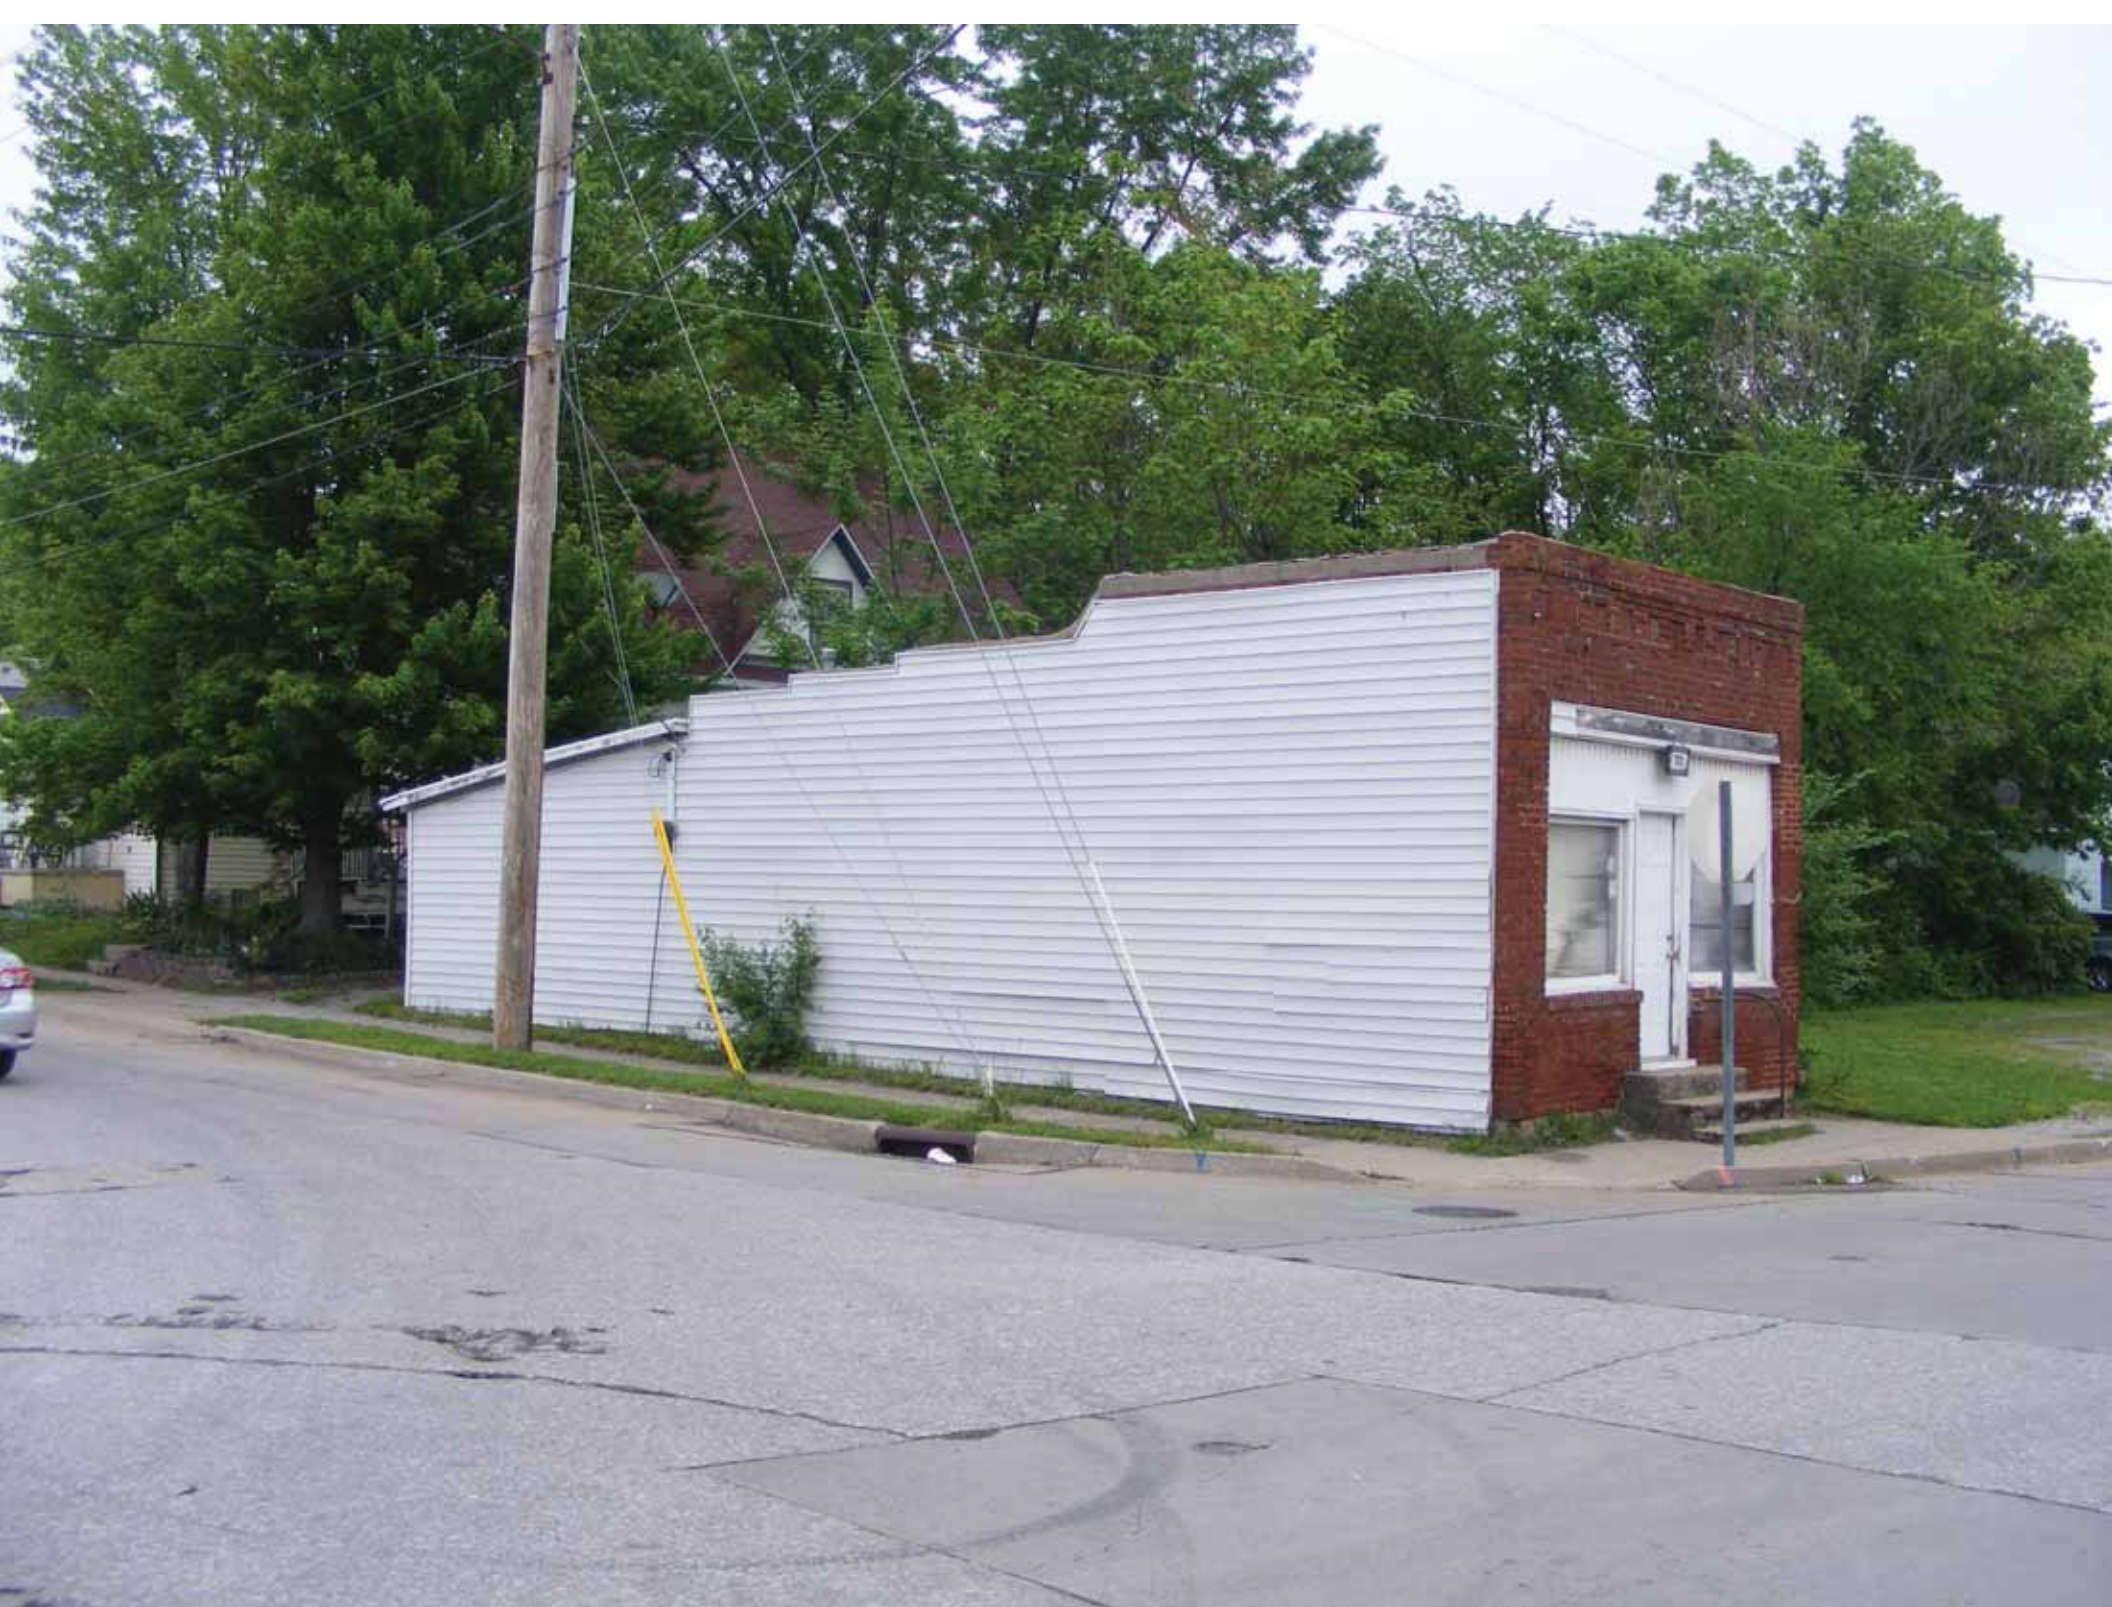
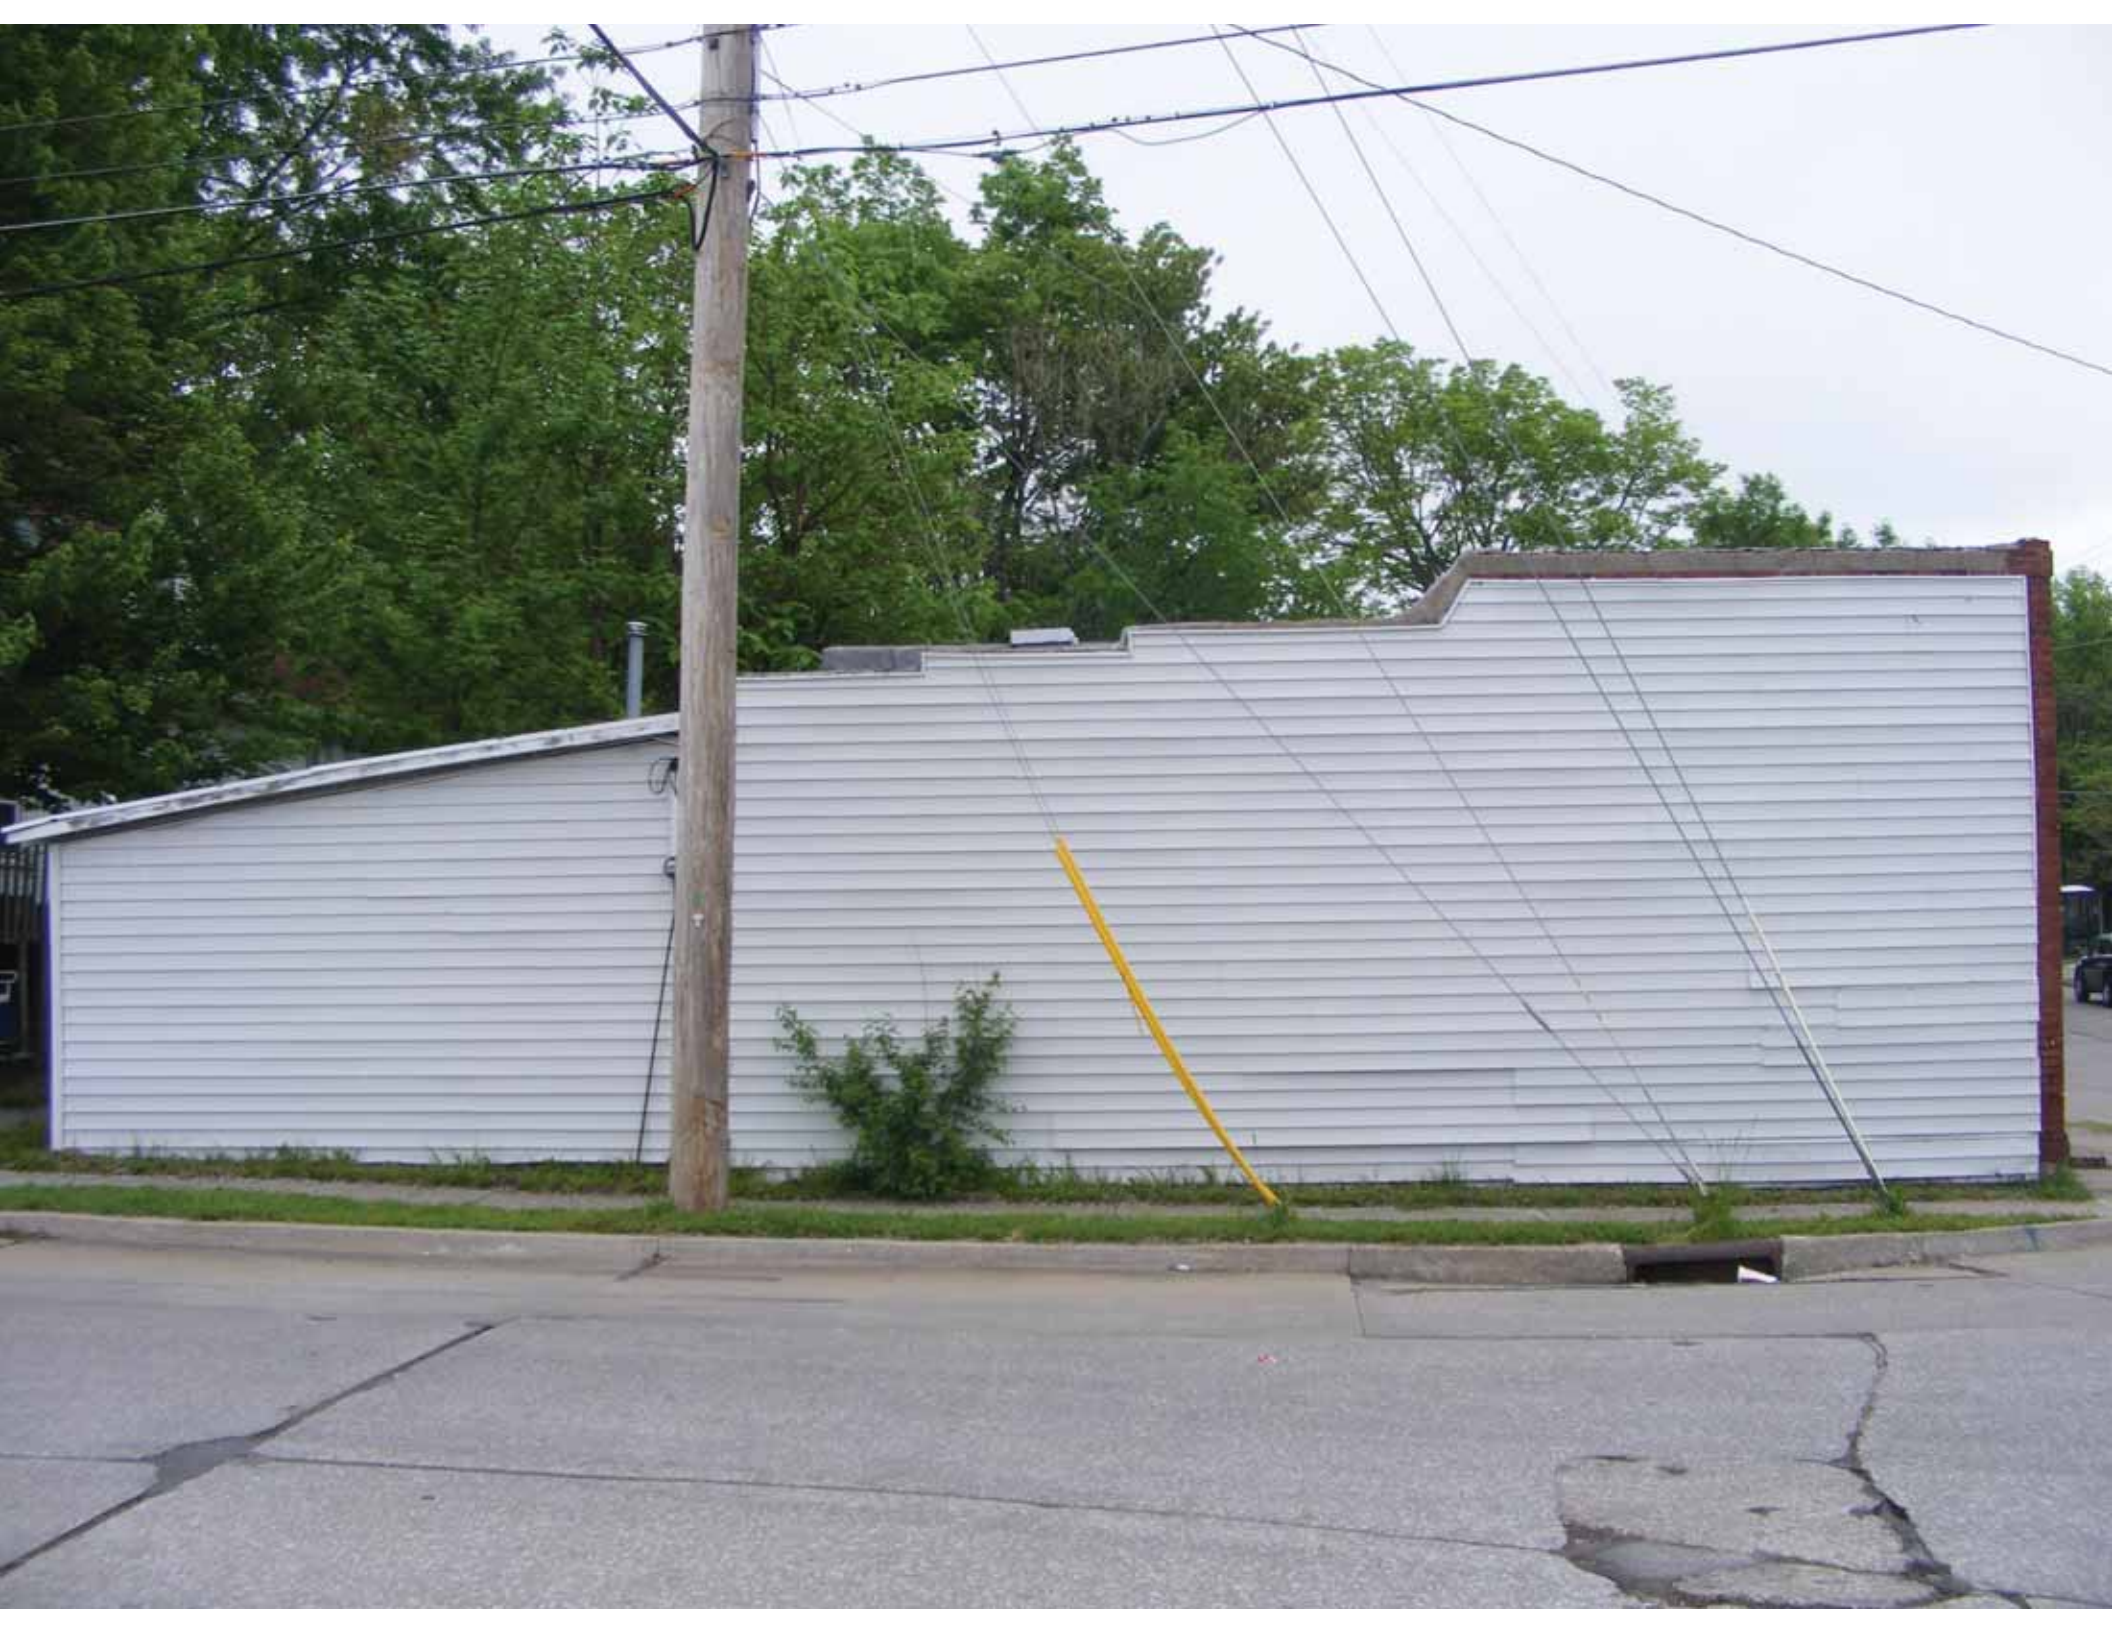
The single-story commercial building has stepped side elevations and a built-up roof with terra cotta coping. The primary (south) elevation is faced in brick. The elevation supports concrete steps that front the central entry bay. The entry is filled with a c. 2000 paneled door. The door is flanked by original window bays with replacement glass. The windows retain their original single sash commercial configuration. Above the door and windows, the elevation is filled with synthetic siding – this area likely featured transoms that may be beneath the siding. The upper façade has basket weave brick patterning. Side elevations are clad with synthetic siding (which appears to be metal). The rear (north) elevation supports a shed wing. There is no fenestration on the west and north elevations. The east elevation holds two entry bays (one appears to be an original loading bay). Both bays are covered with plywood. The elevation has a wrapped chimney cut off at the roofline.
