MISSOURI DEPARTMENT OF NATURAL RESOURCES
STATE HISTORIC PRESERVATION OFFICE, P.O. Box 176, Jefferson City, MO 65102
ARCHITECTURAL/HISTORIC INVENTORY FORM

1. Survey No. BO-AS-011-0087		2. Survey name: North Central Columbia Survey Phase II	
3. County: Boone		4. Address (Street No.) 902	Street (name) N. Seventh Street
5. City: Columbia	Vicinity: <input type="checkbox"/>	6. Geographical Reference:	7. Township/Range/Section: T: R: S:
8. Historic name (if known):		9. Present/other name (if known):	
10. Ownership: <input checked="" type="checkbox"/> Private <input type="checkbox"/> Public		11a. Historic use (if known): Domestic/single dwelling	11b. Current use: Domestic/single dwelling

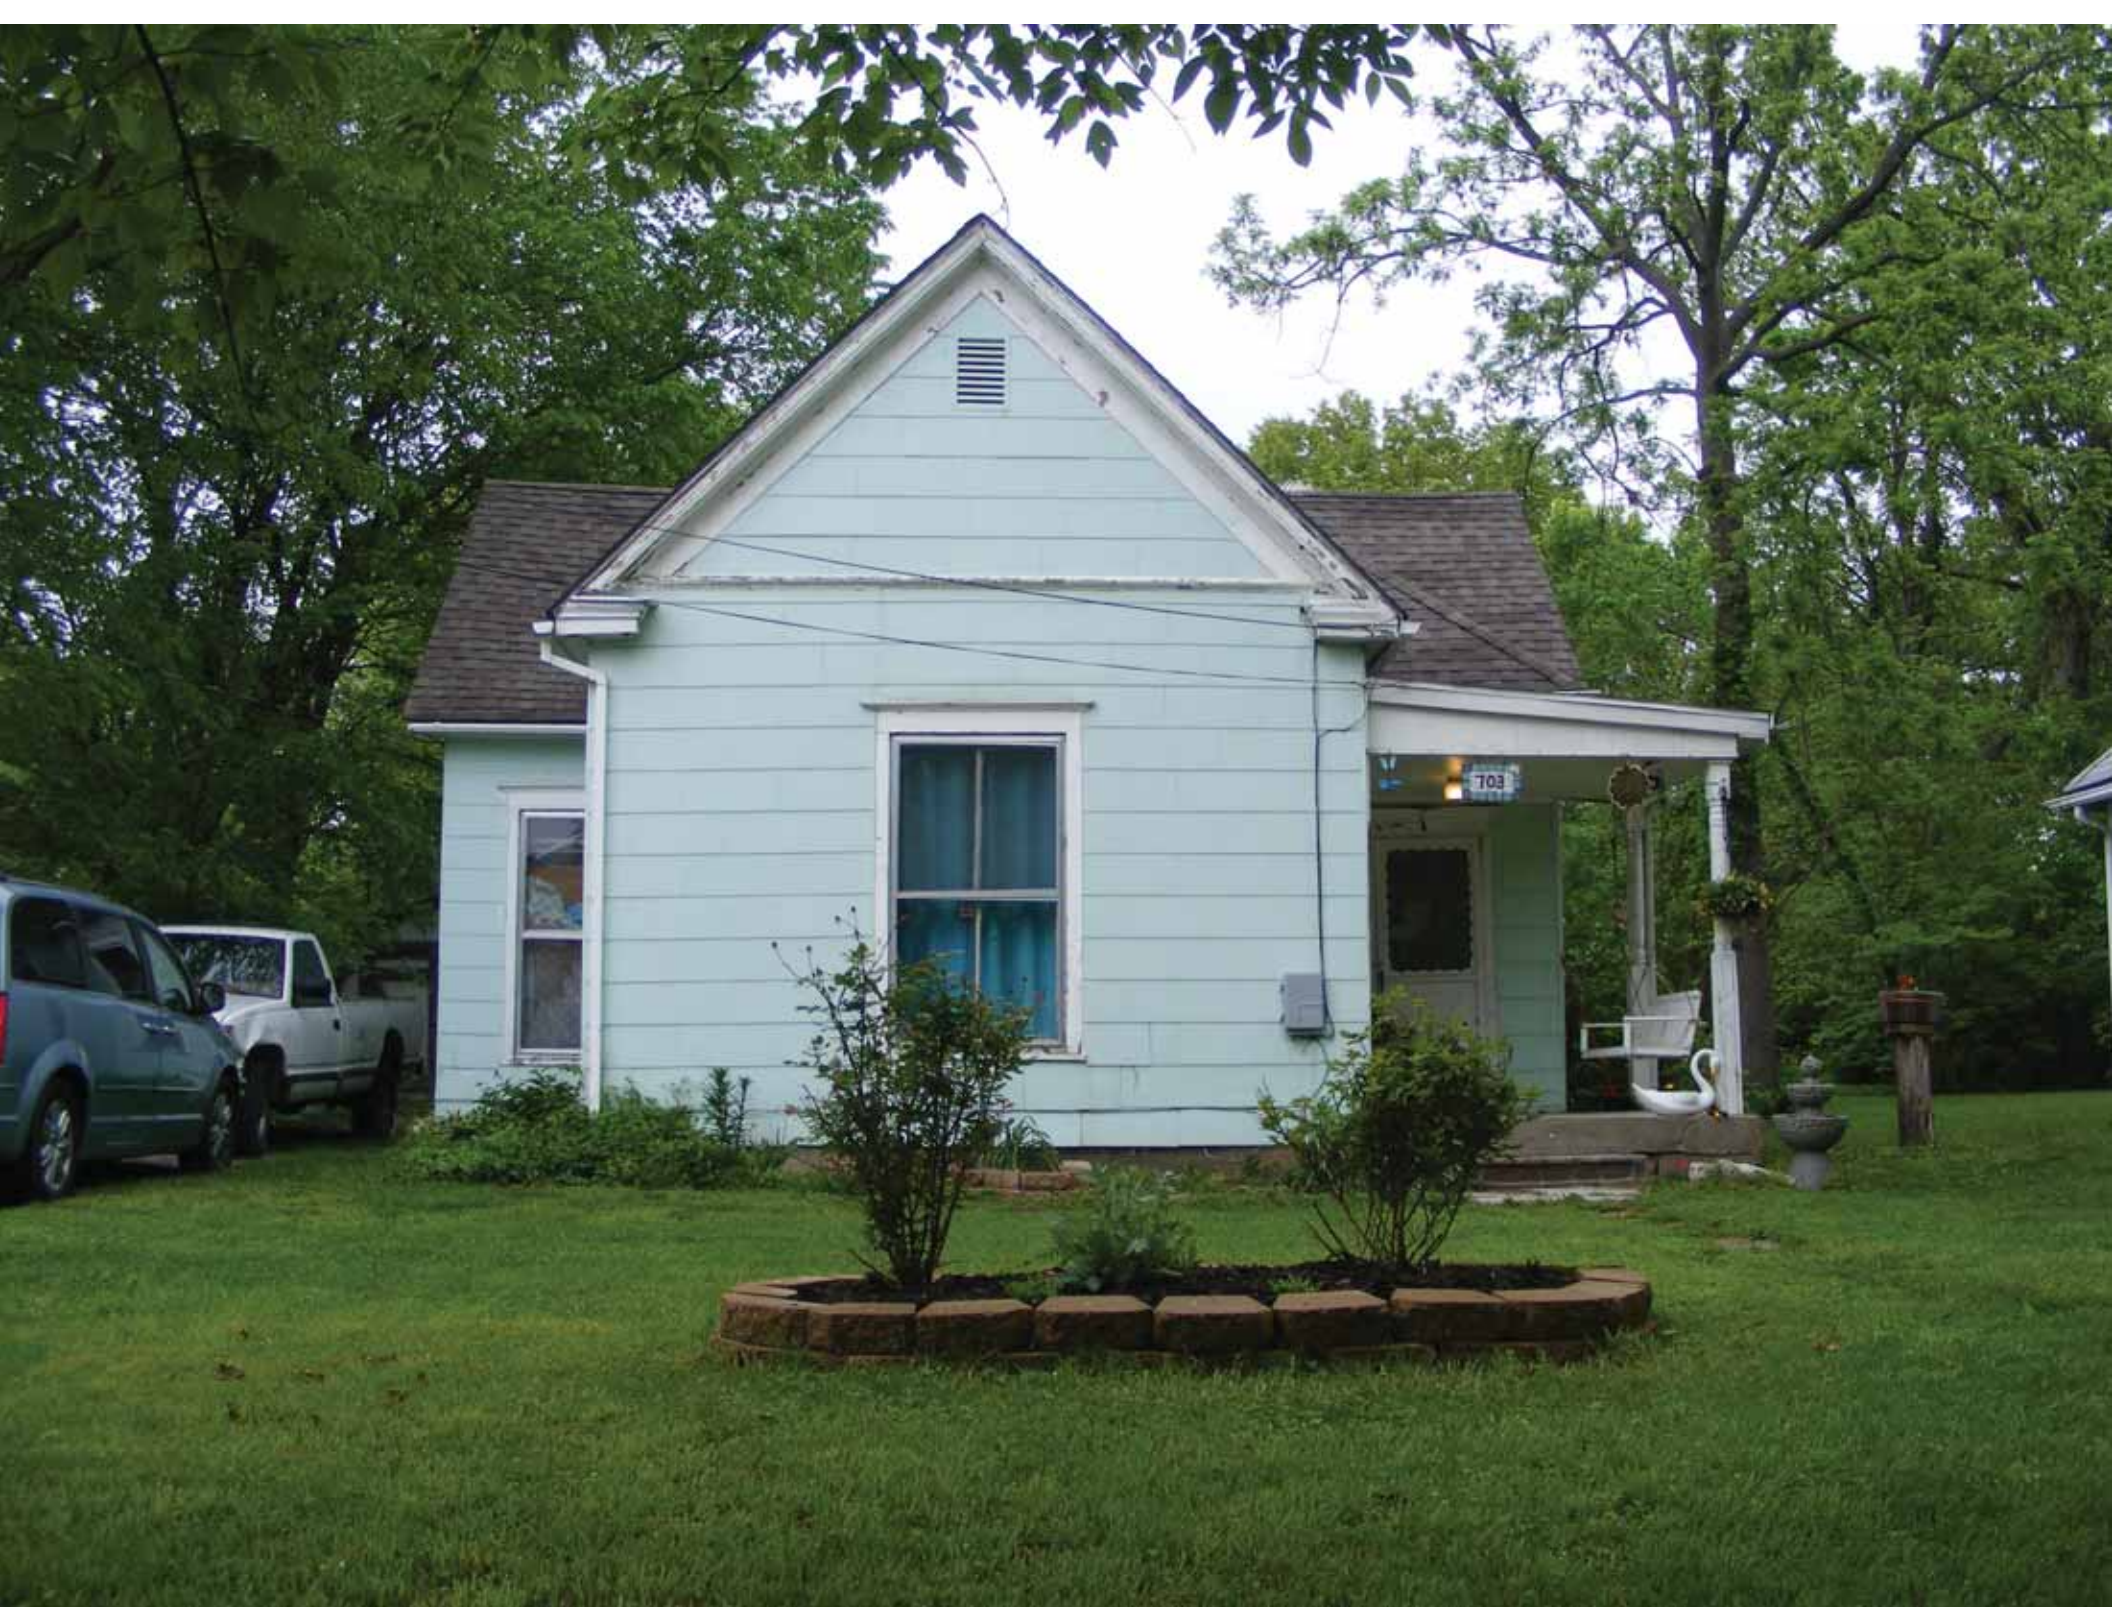
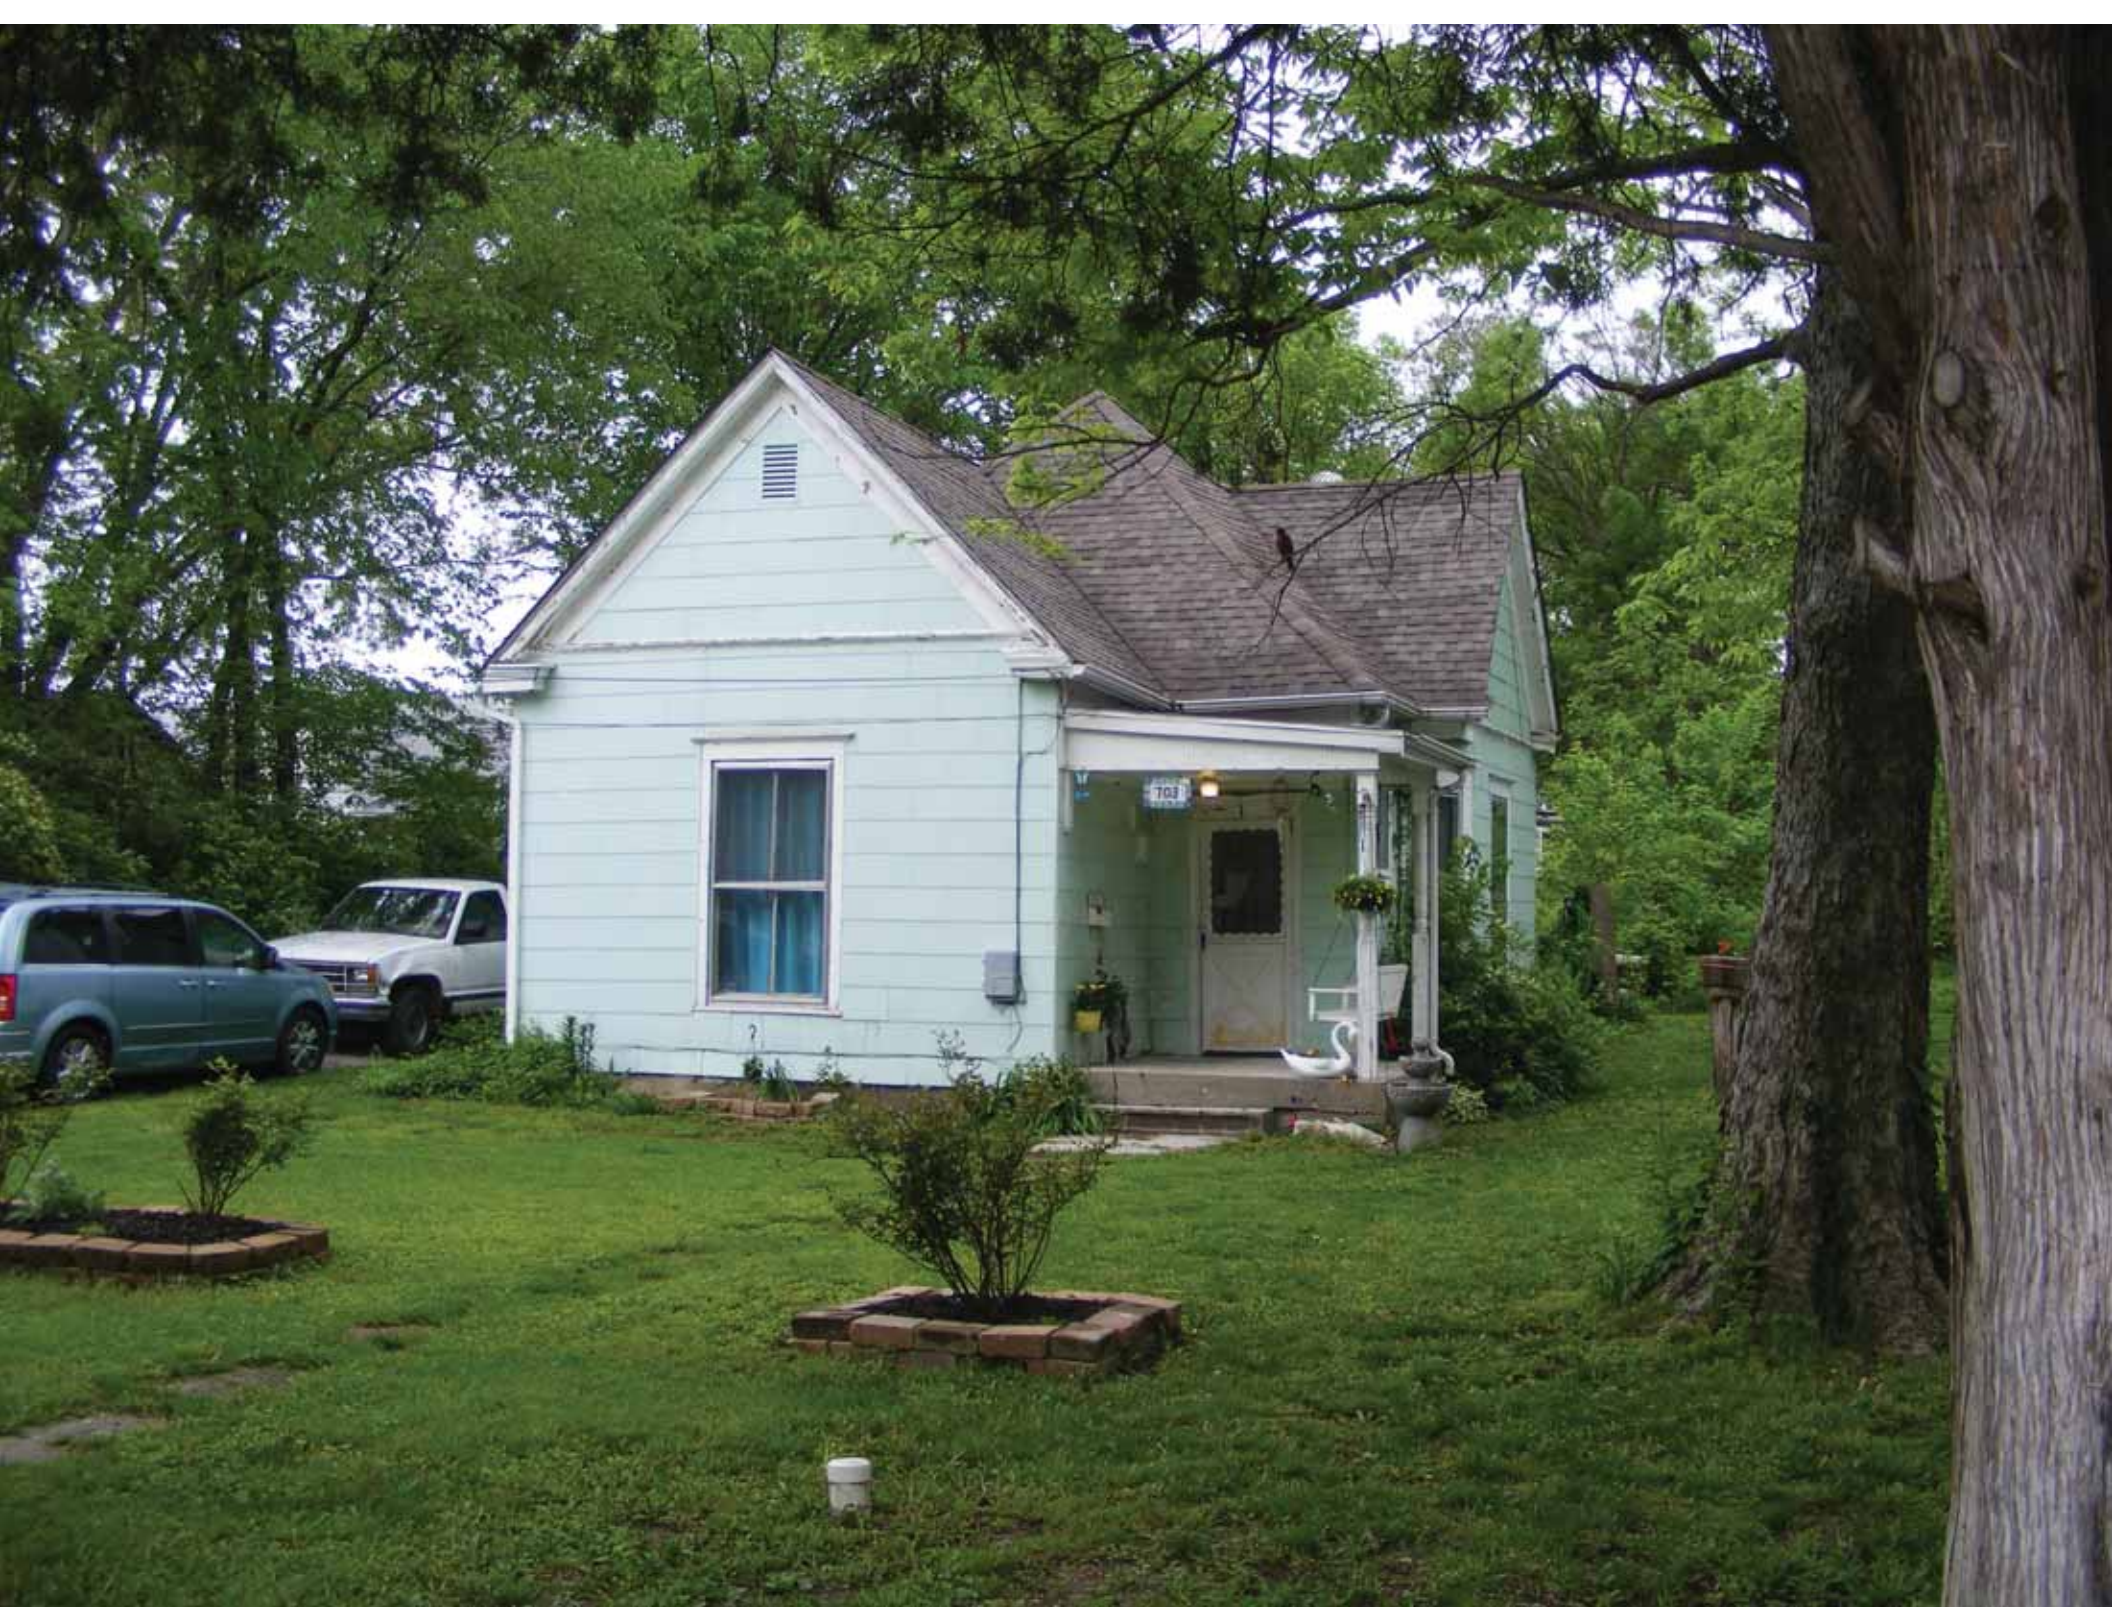
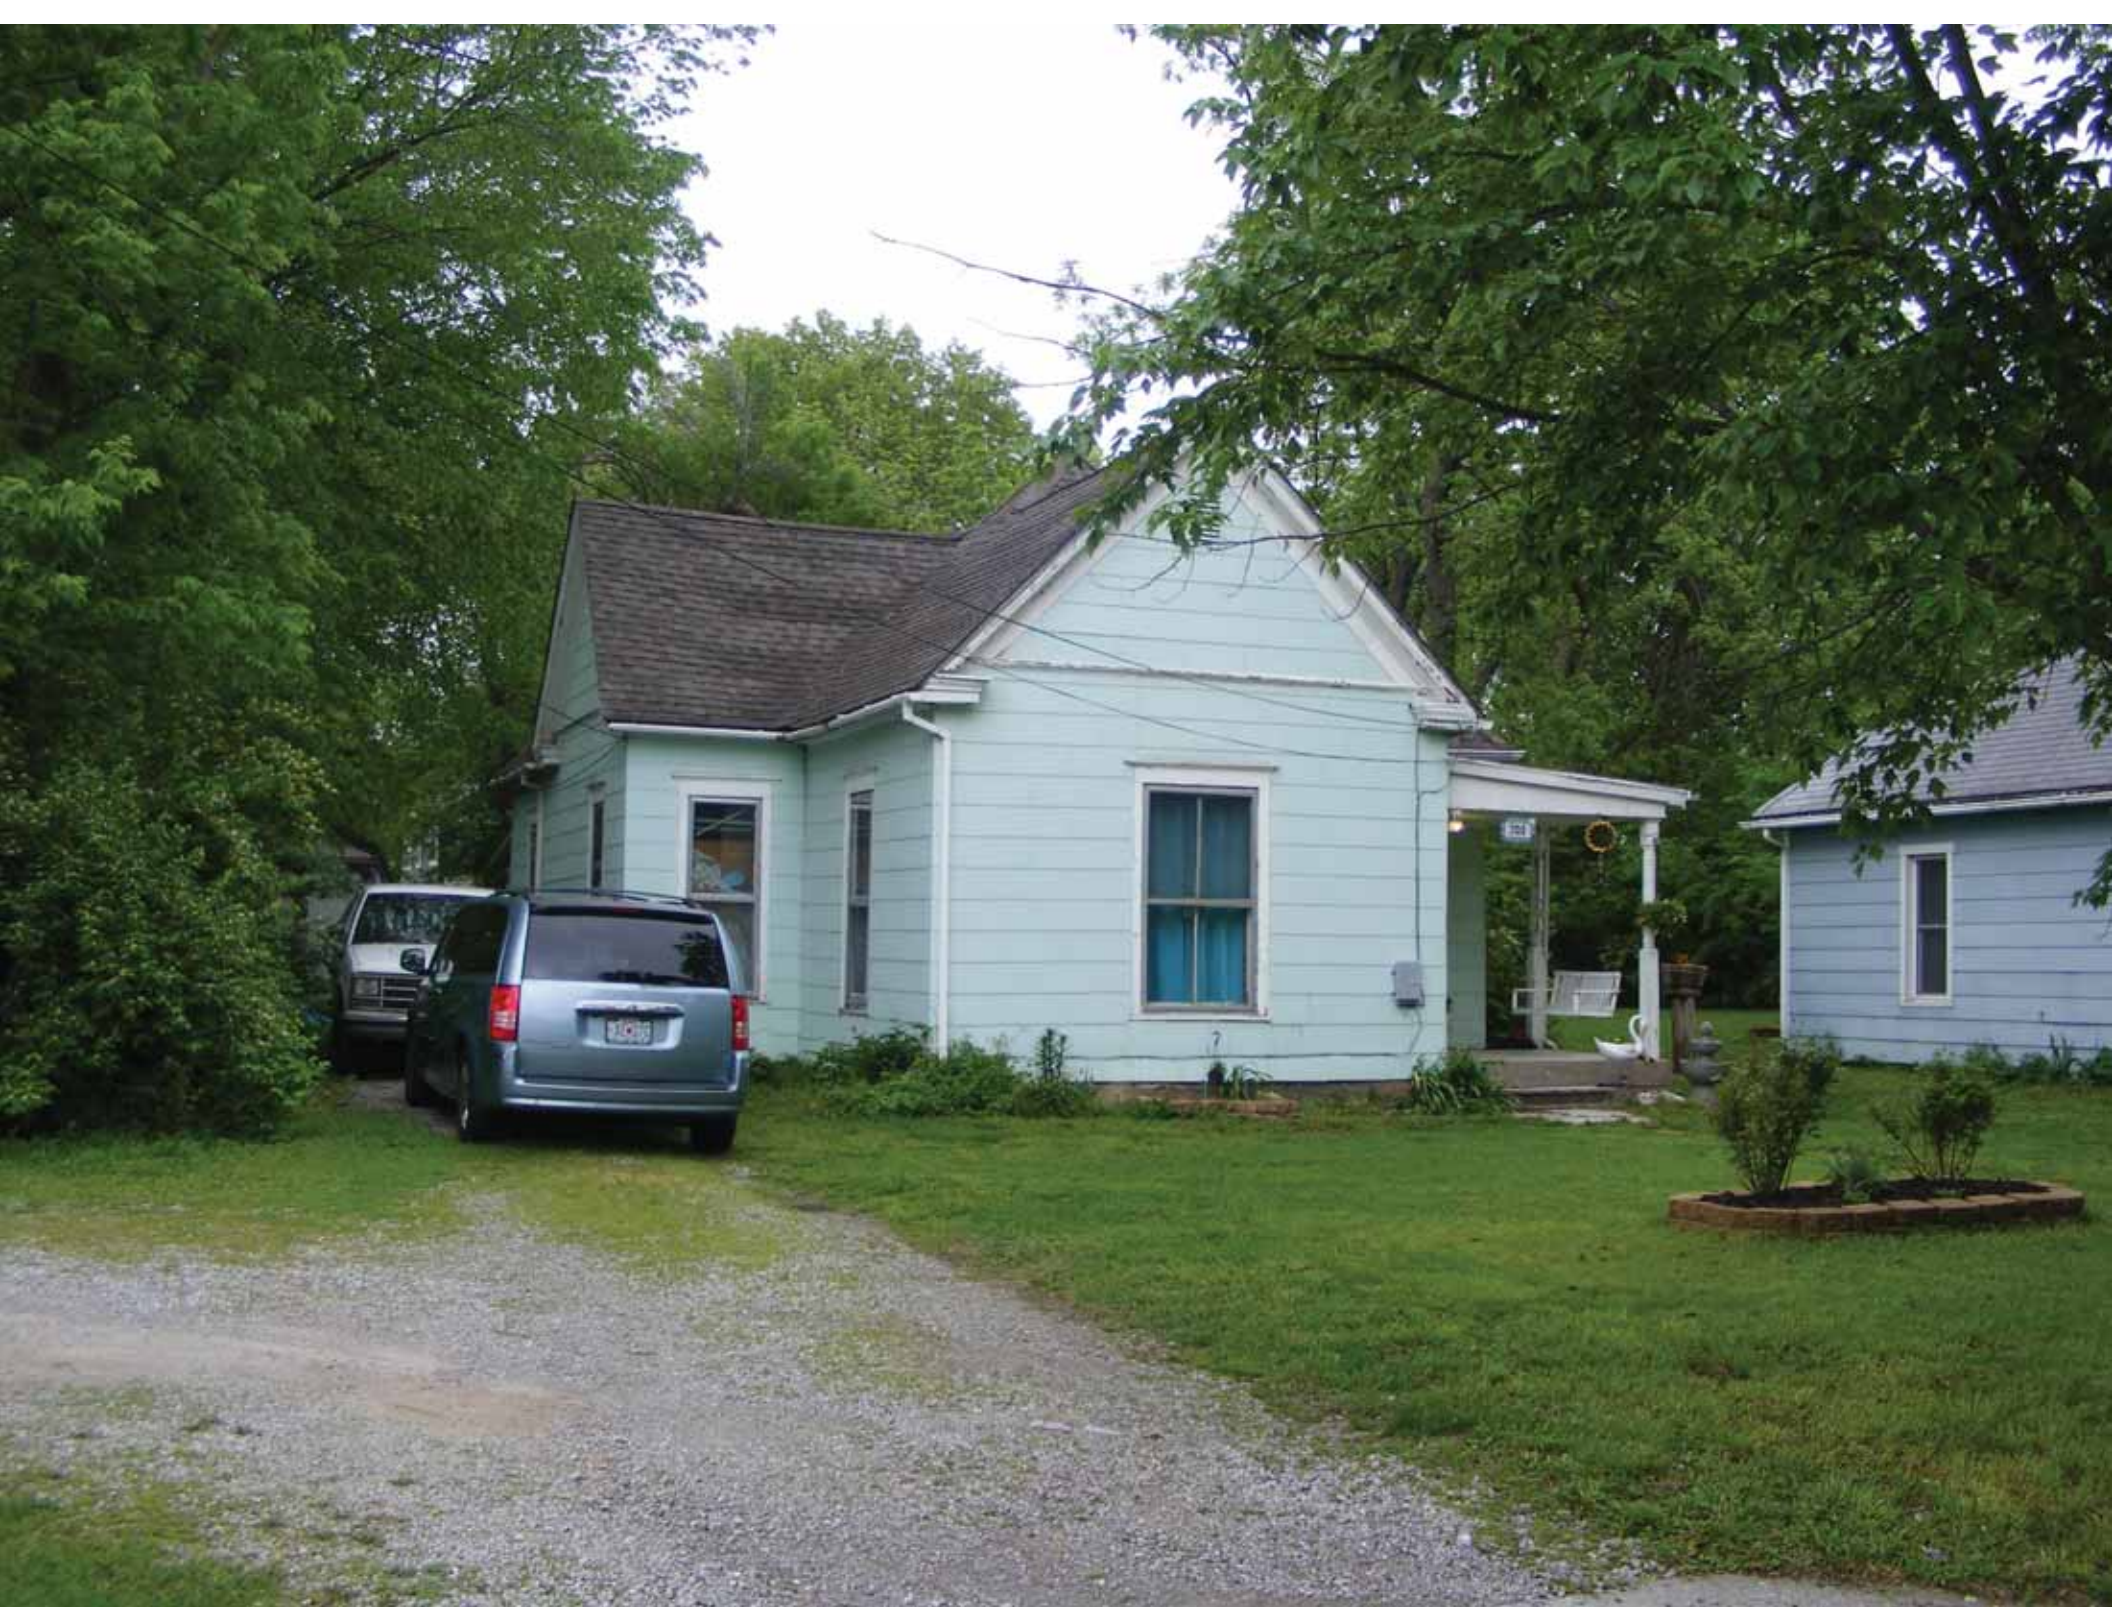
The dwelling has a cross gabled roof with a central pyramidal hip. The roof is clad with asphalt shingles and retains original gable returns. The dwelling has asbestos shingle siding and a concrete foundation. The primary (south) elevation has a shed porch extending from the east wall of the front gabled wing. The porch has milled columns resting on a concrete base. Within the porch bay is a single entry filled with a c. 1980 single-light storm door. The gabled wing façade holds an original two-over-two window. Most windows are one-over-one and appear original. The front gable has a louvered vent in the gable field.
