MISSOURI DEPARTMENT OF NATURAL RESOURCES
STATE HISTORIC PRESERVATION OFFICE, P.O. Box 176, Jefferson City, MO 65102
ARCHITECTURAL/HISTORIC INVENTORY FORM

1. Survey No. BO-AS-011-0087		2. Survey name: North Central Columbia Survey Phase II	
3. County: Boone		4. Address (Street No.) 902	Street (name) N. Seventh Street
5. City: Columbia	Vicinity: <input type="checkbox"/>	6. Geographical Reference:	7. Township/Range/Section: T: R: S:
8. Historic name (if known):		9. Present/other name (if known):	
10. Ownership: <input checked="" type="checkbox"/> Private <input type="checkbox"/> Public		11a. Historic use (if known): Domestic/single dwelling	11b. Current use: Domestic/single dwelling

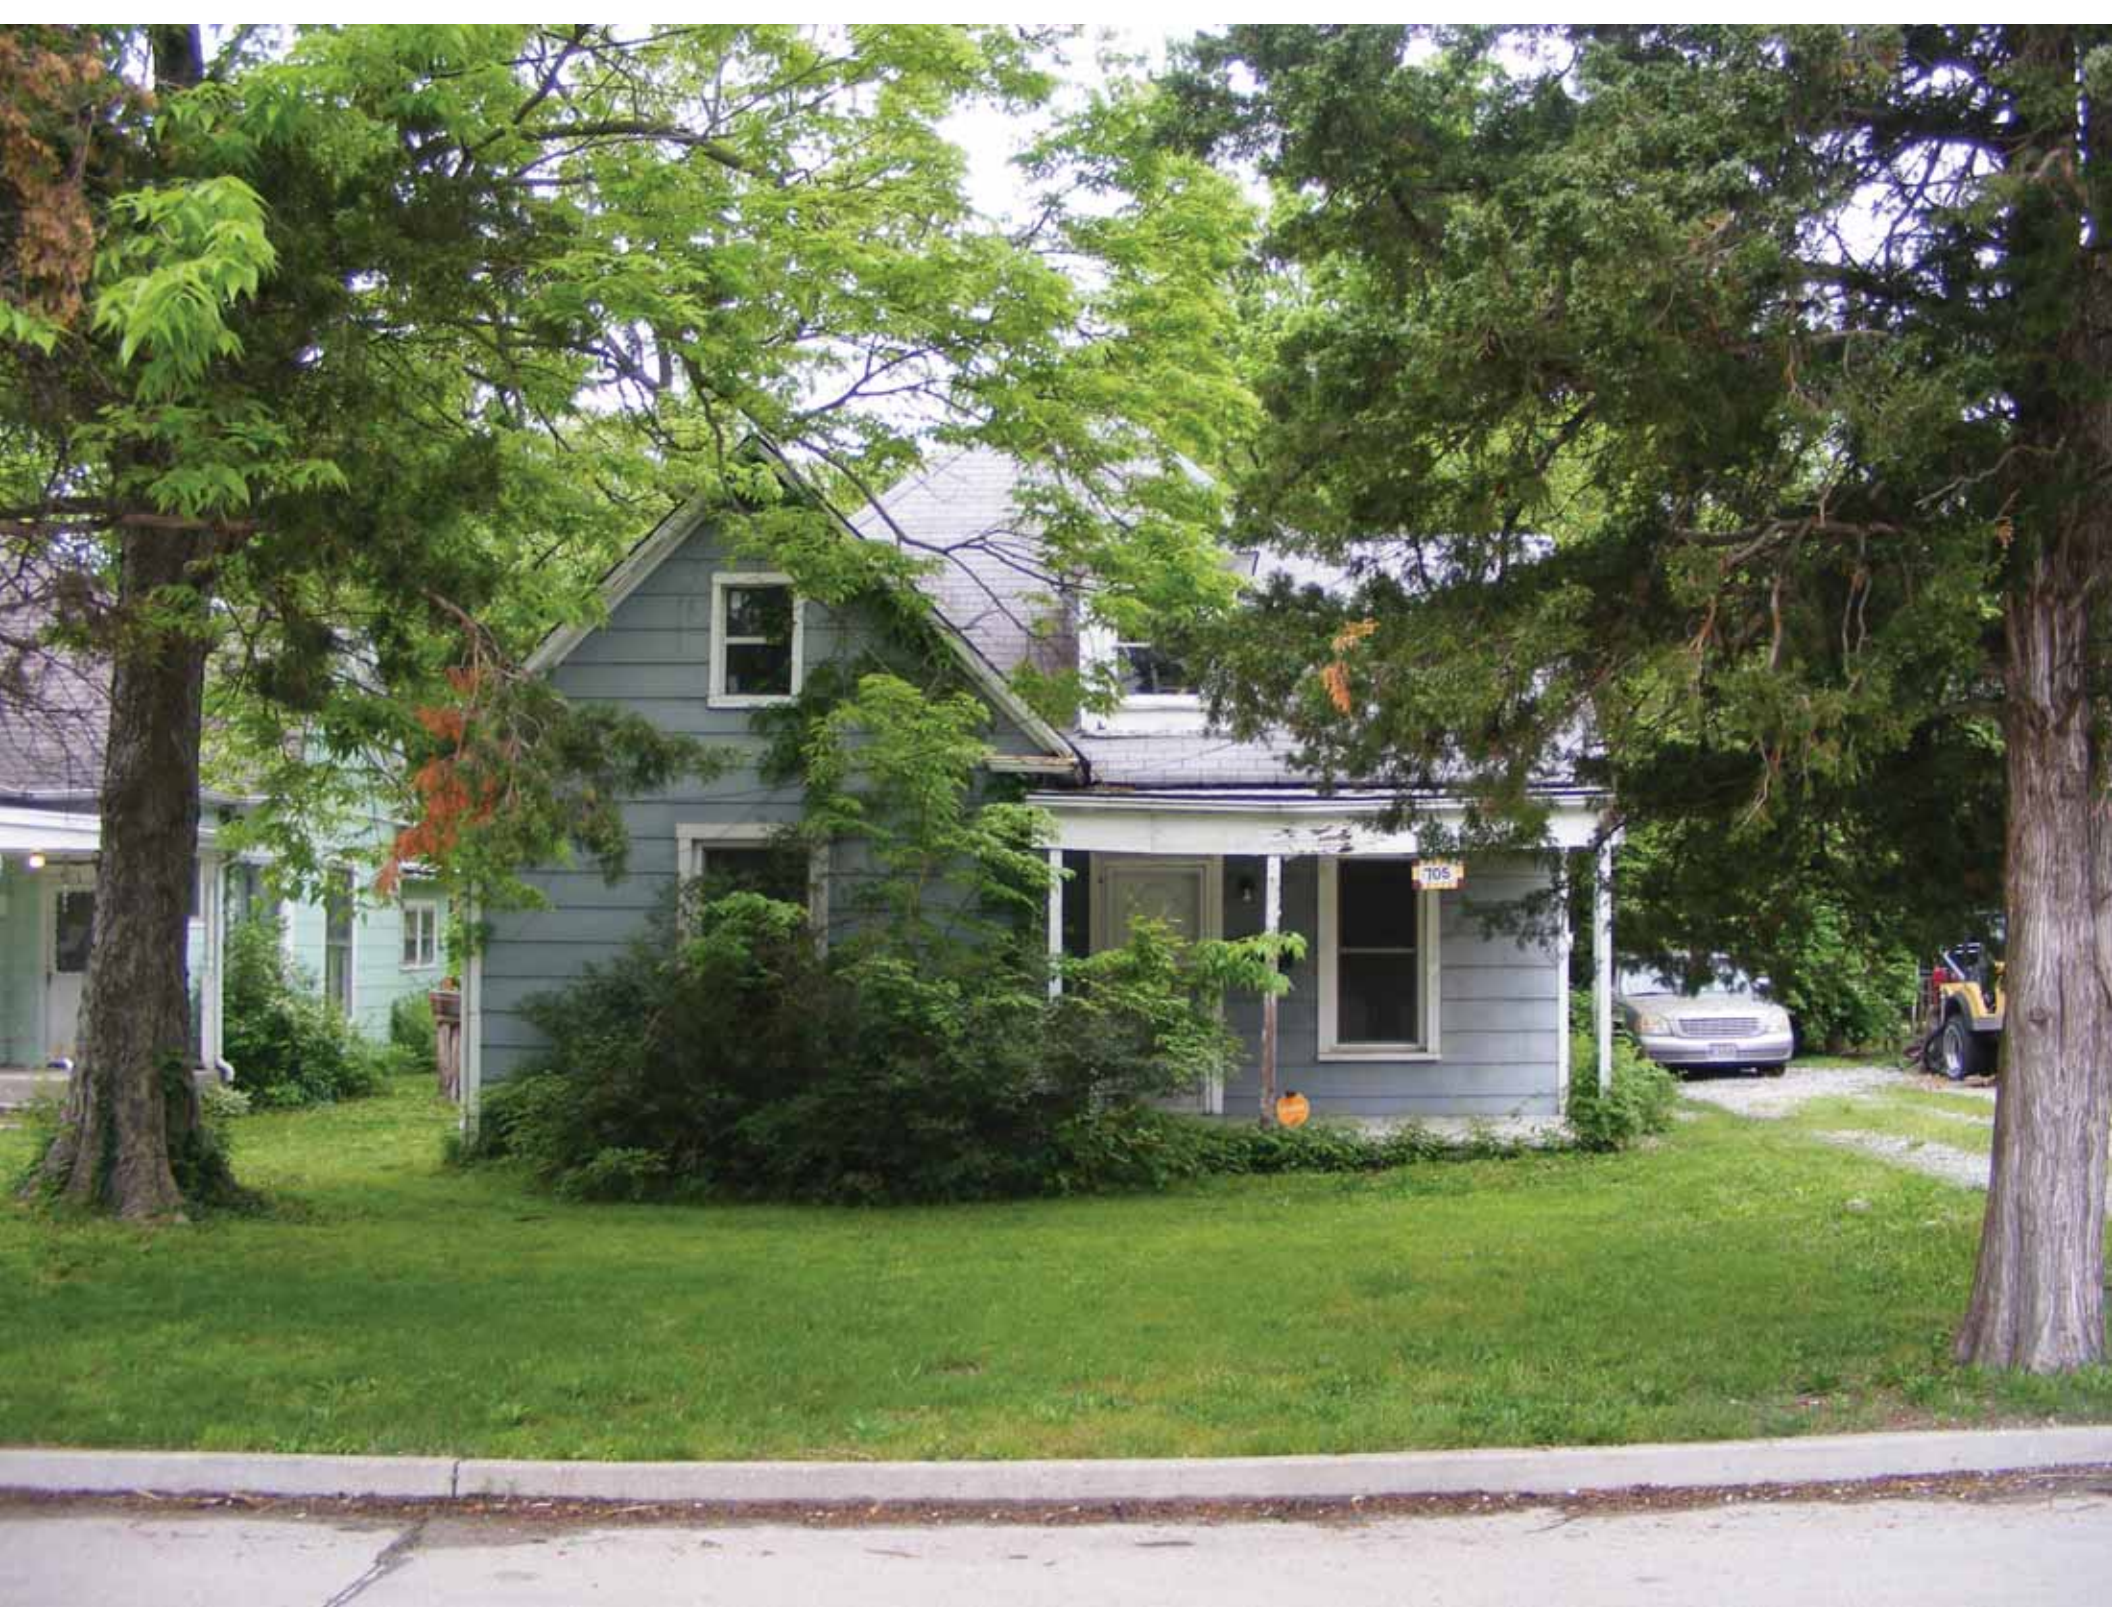
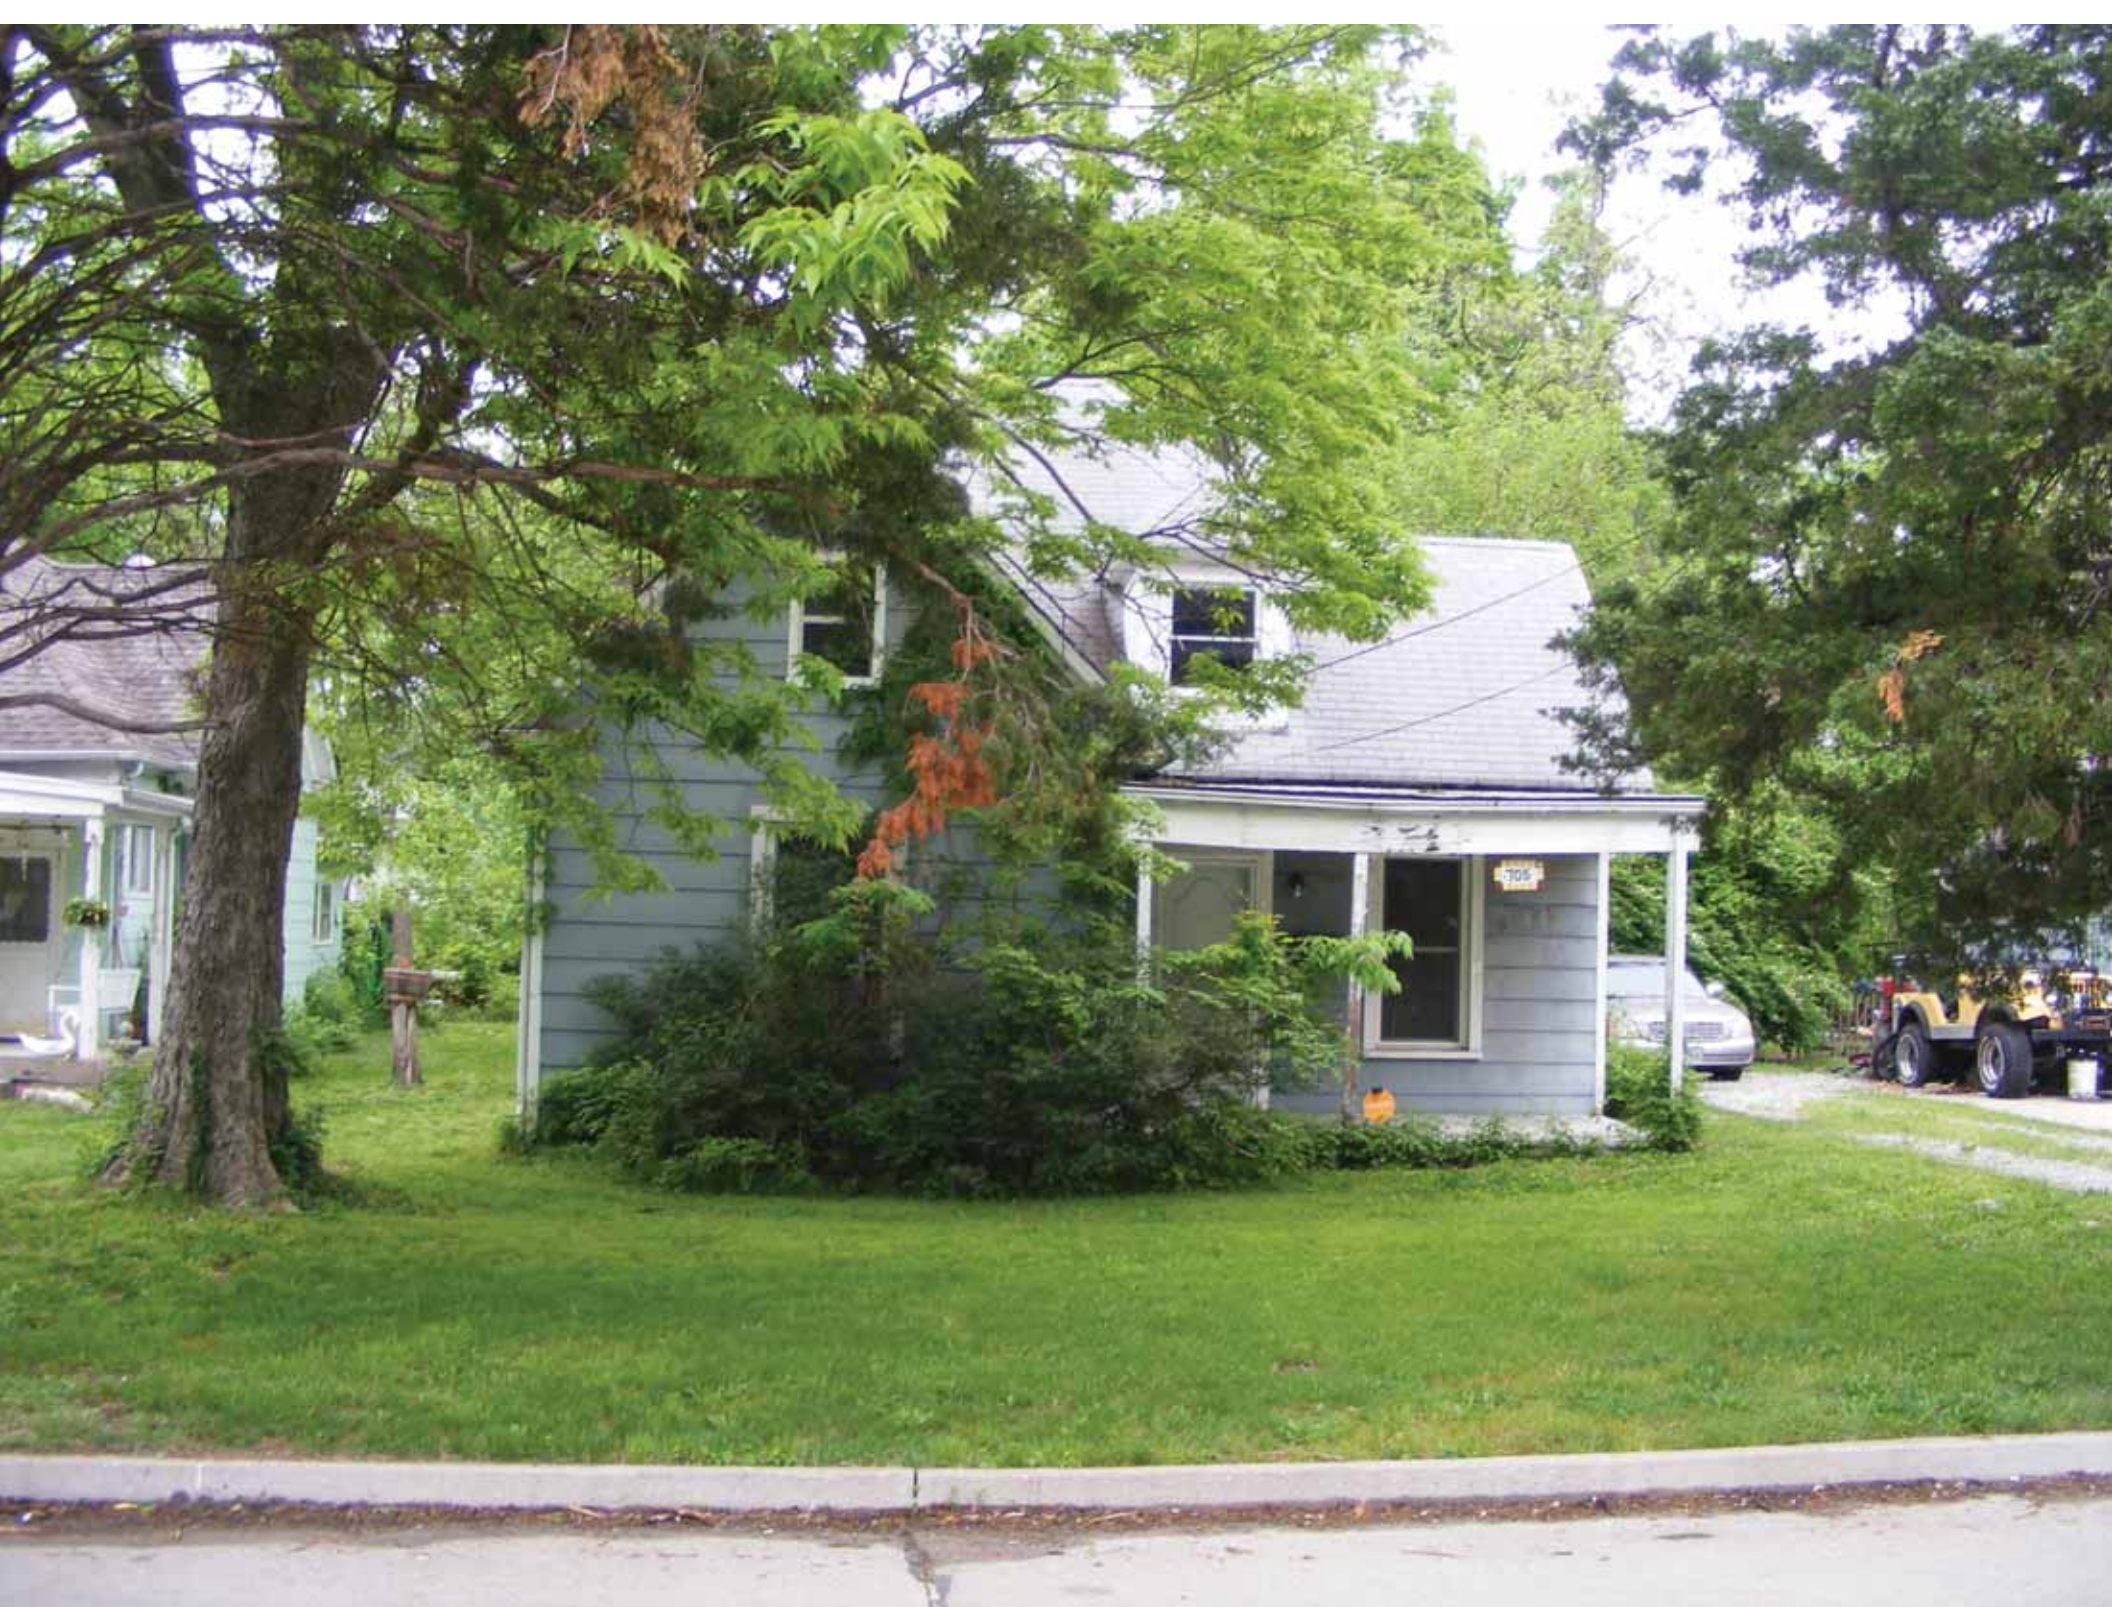
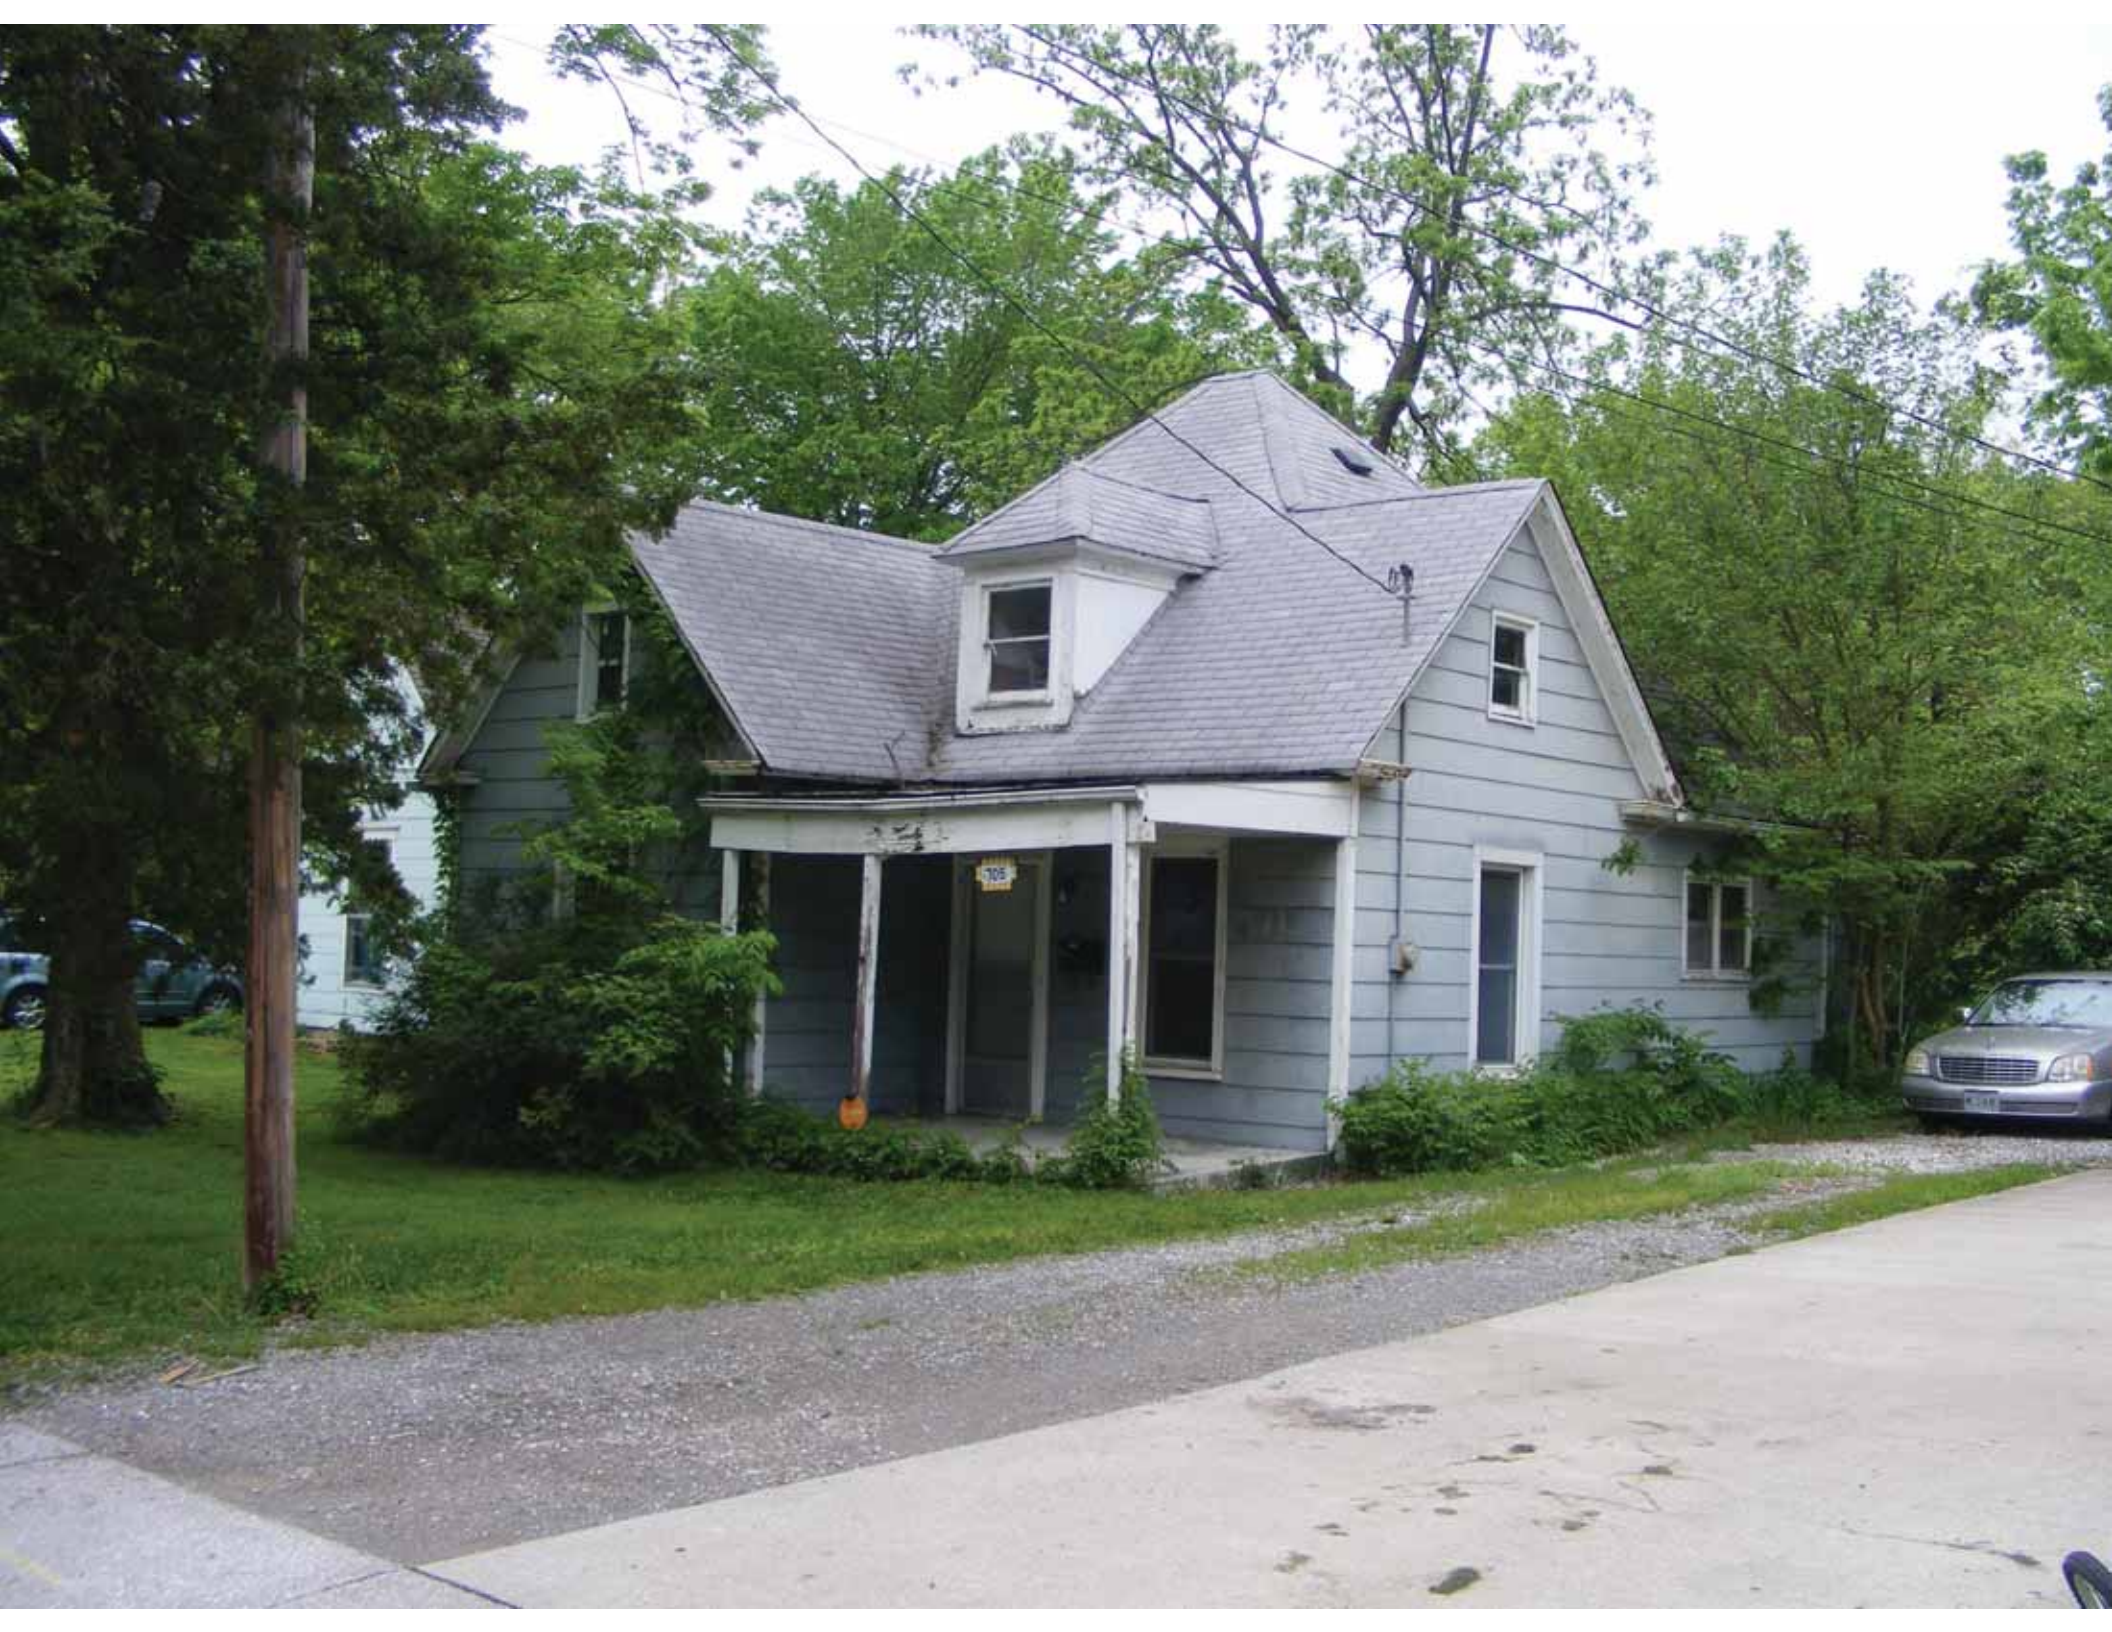
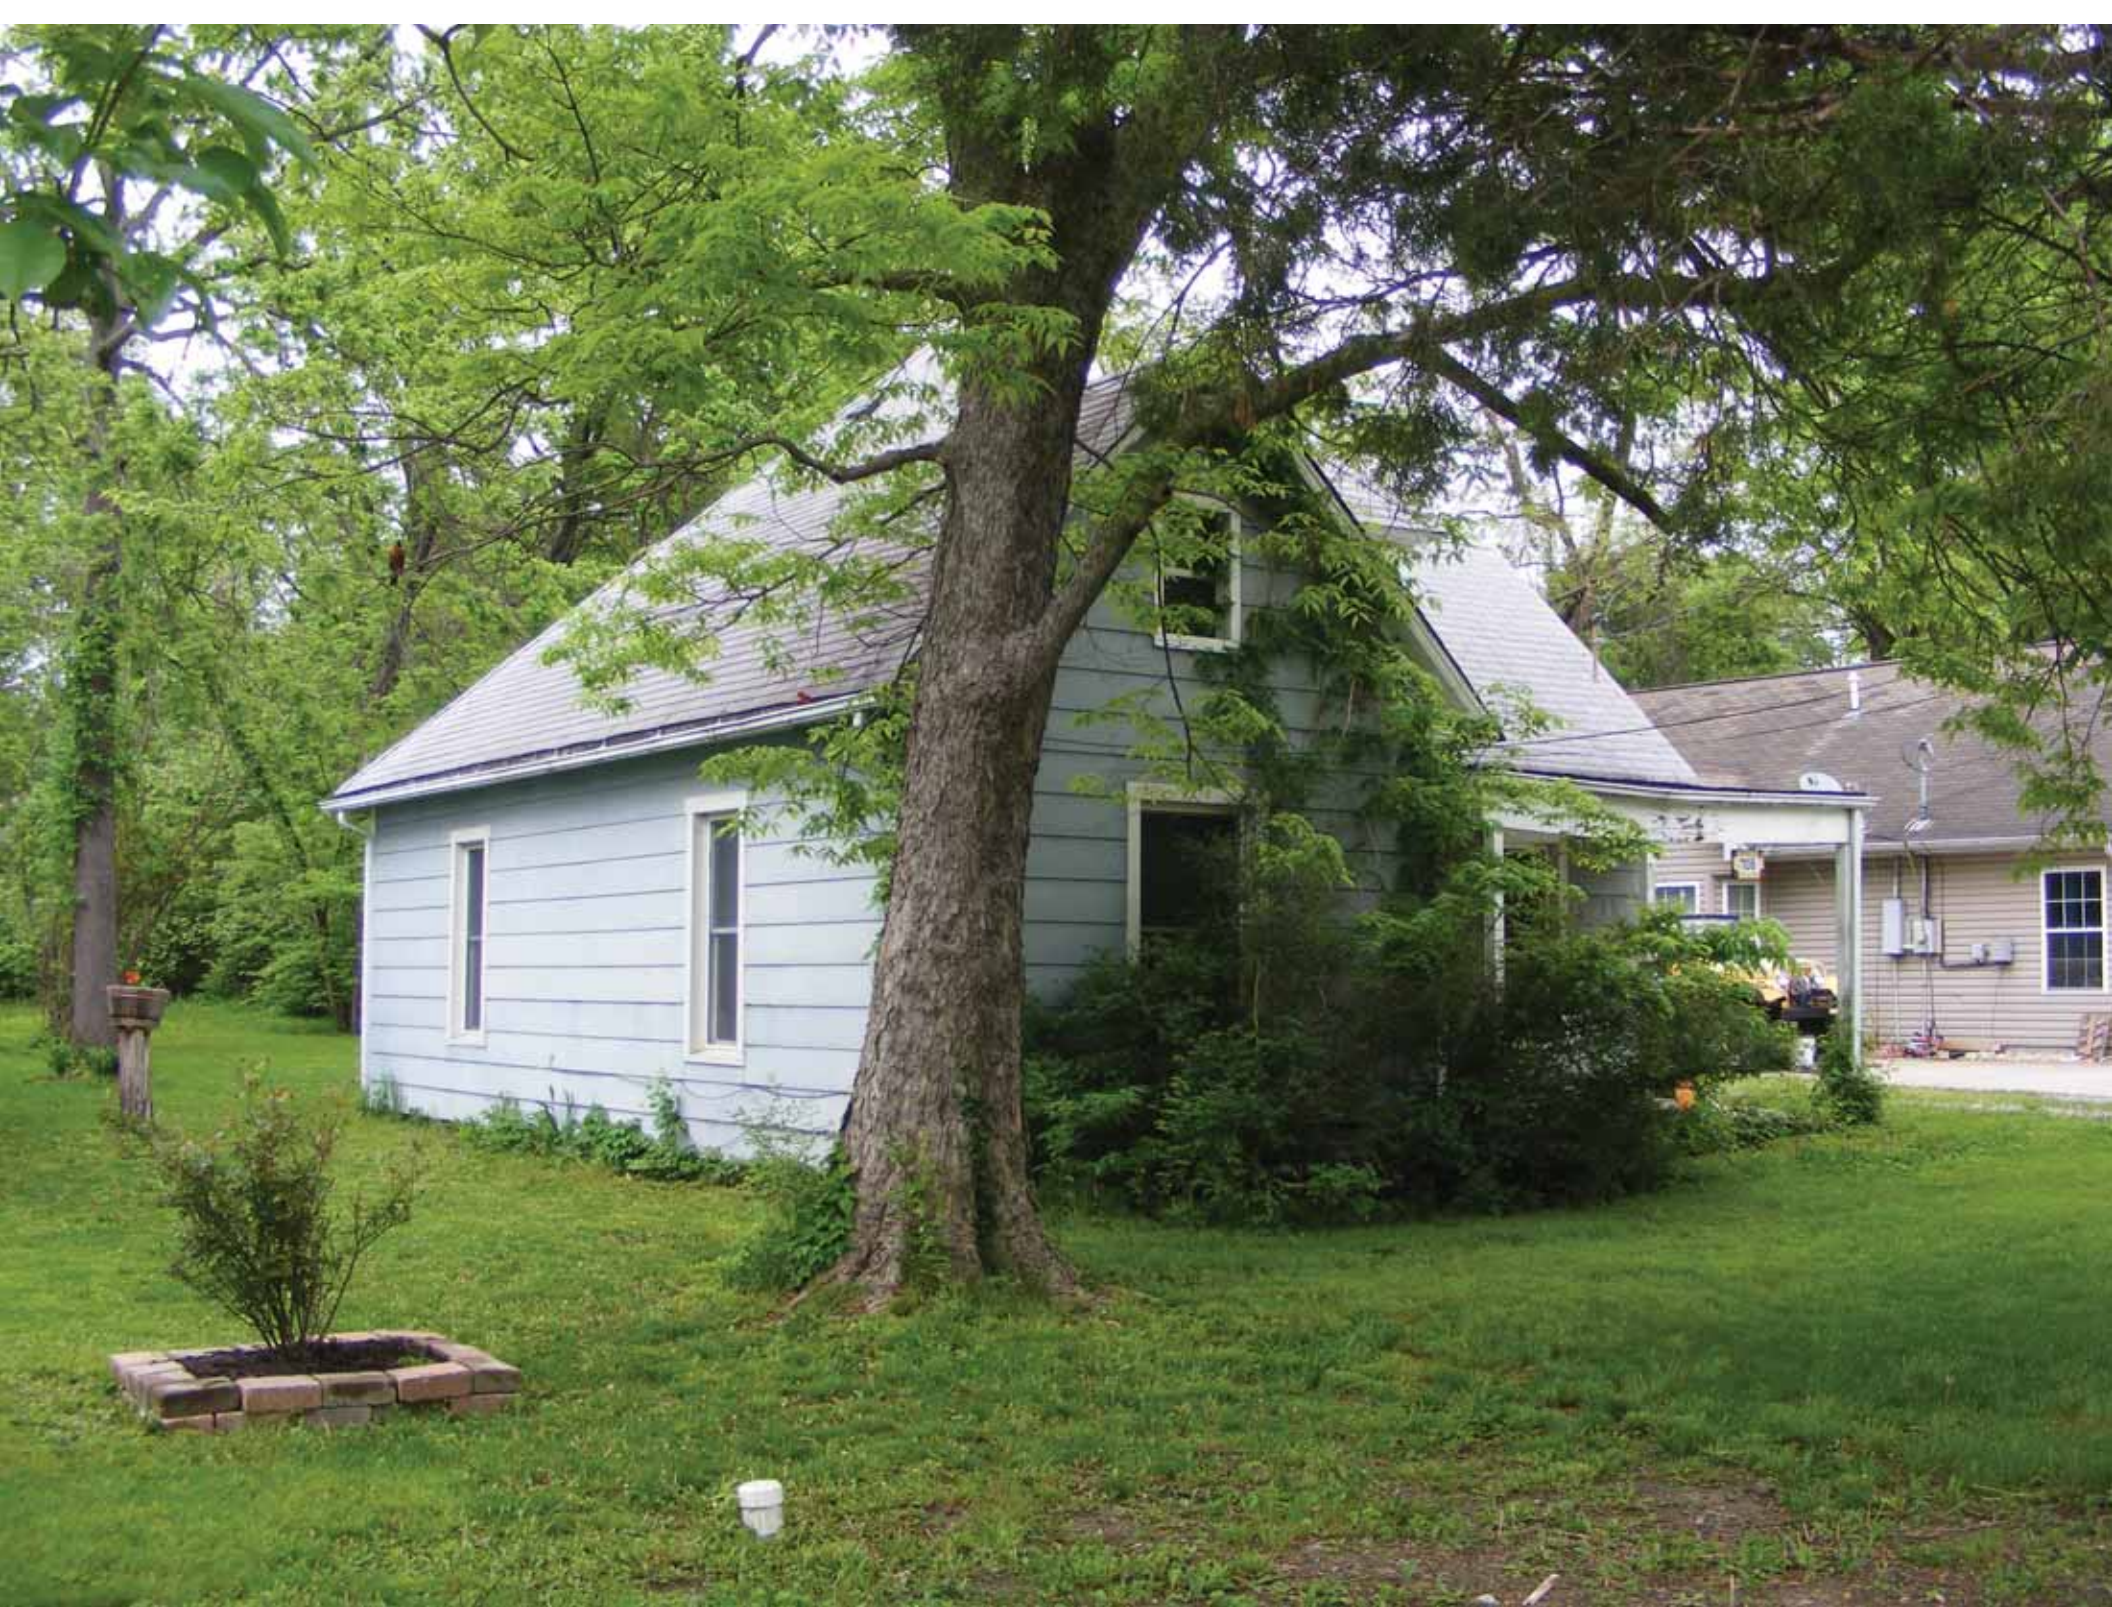
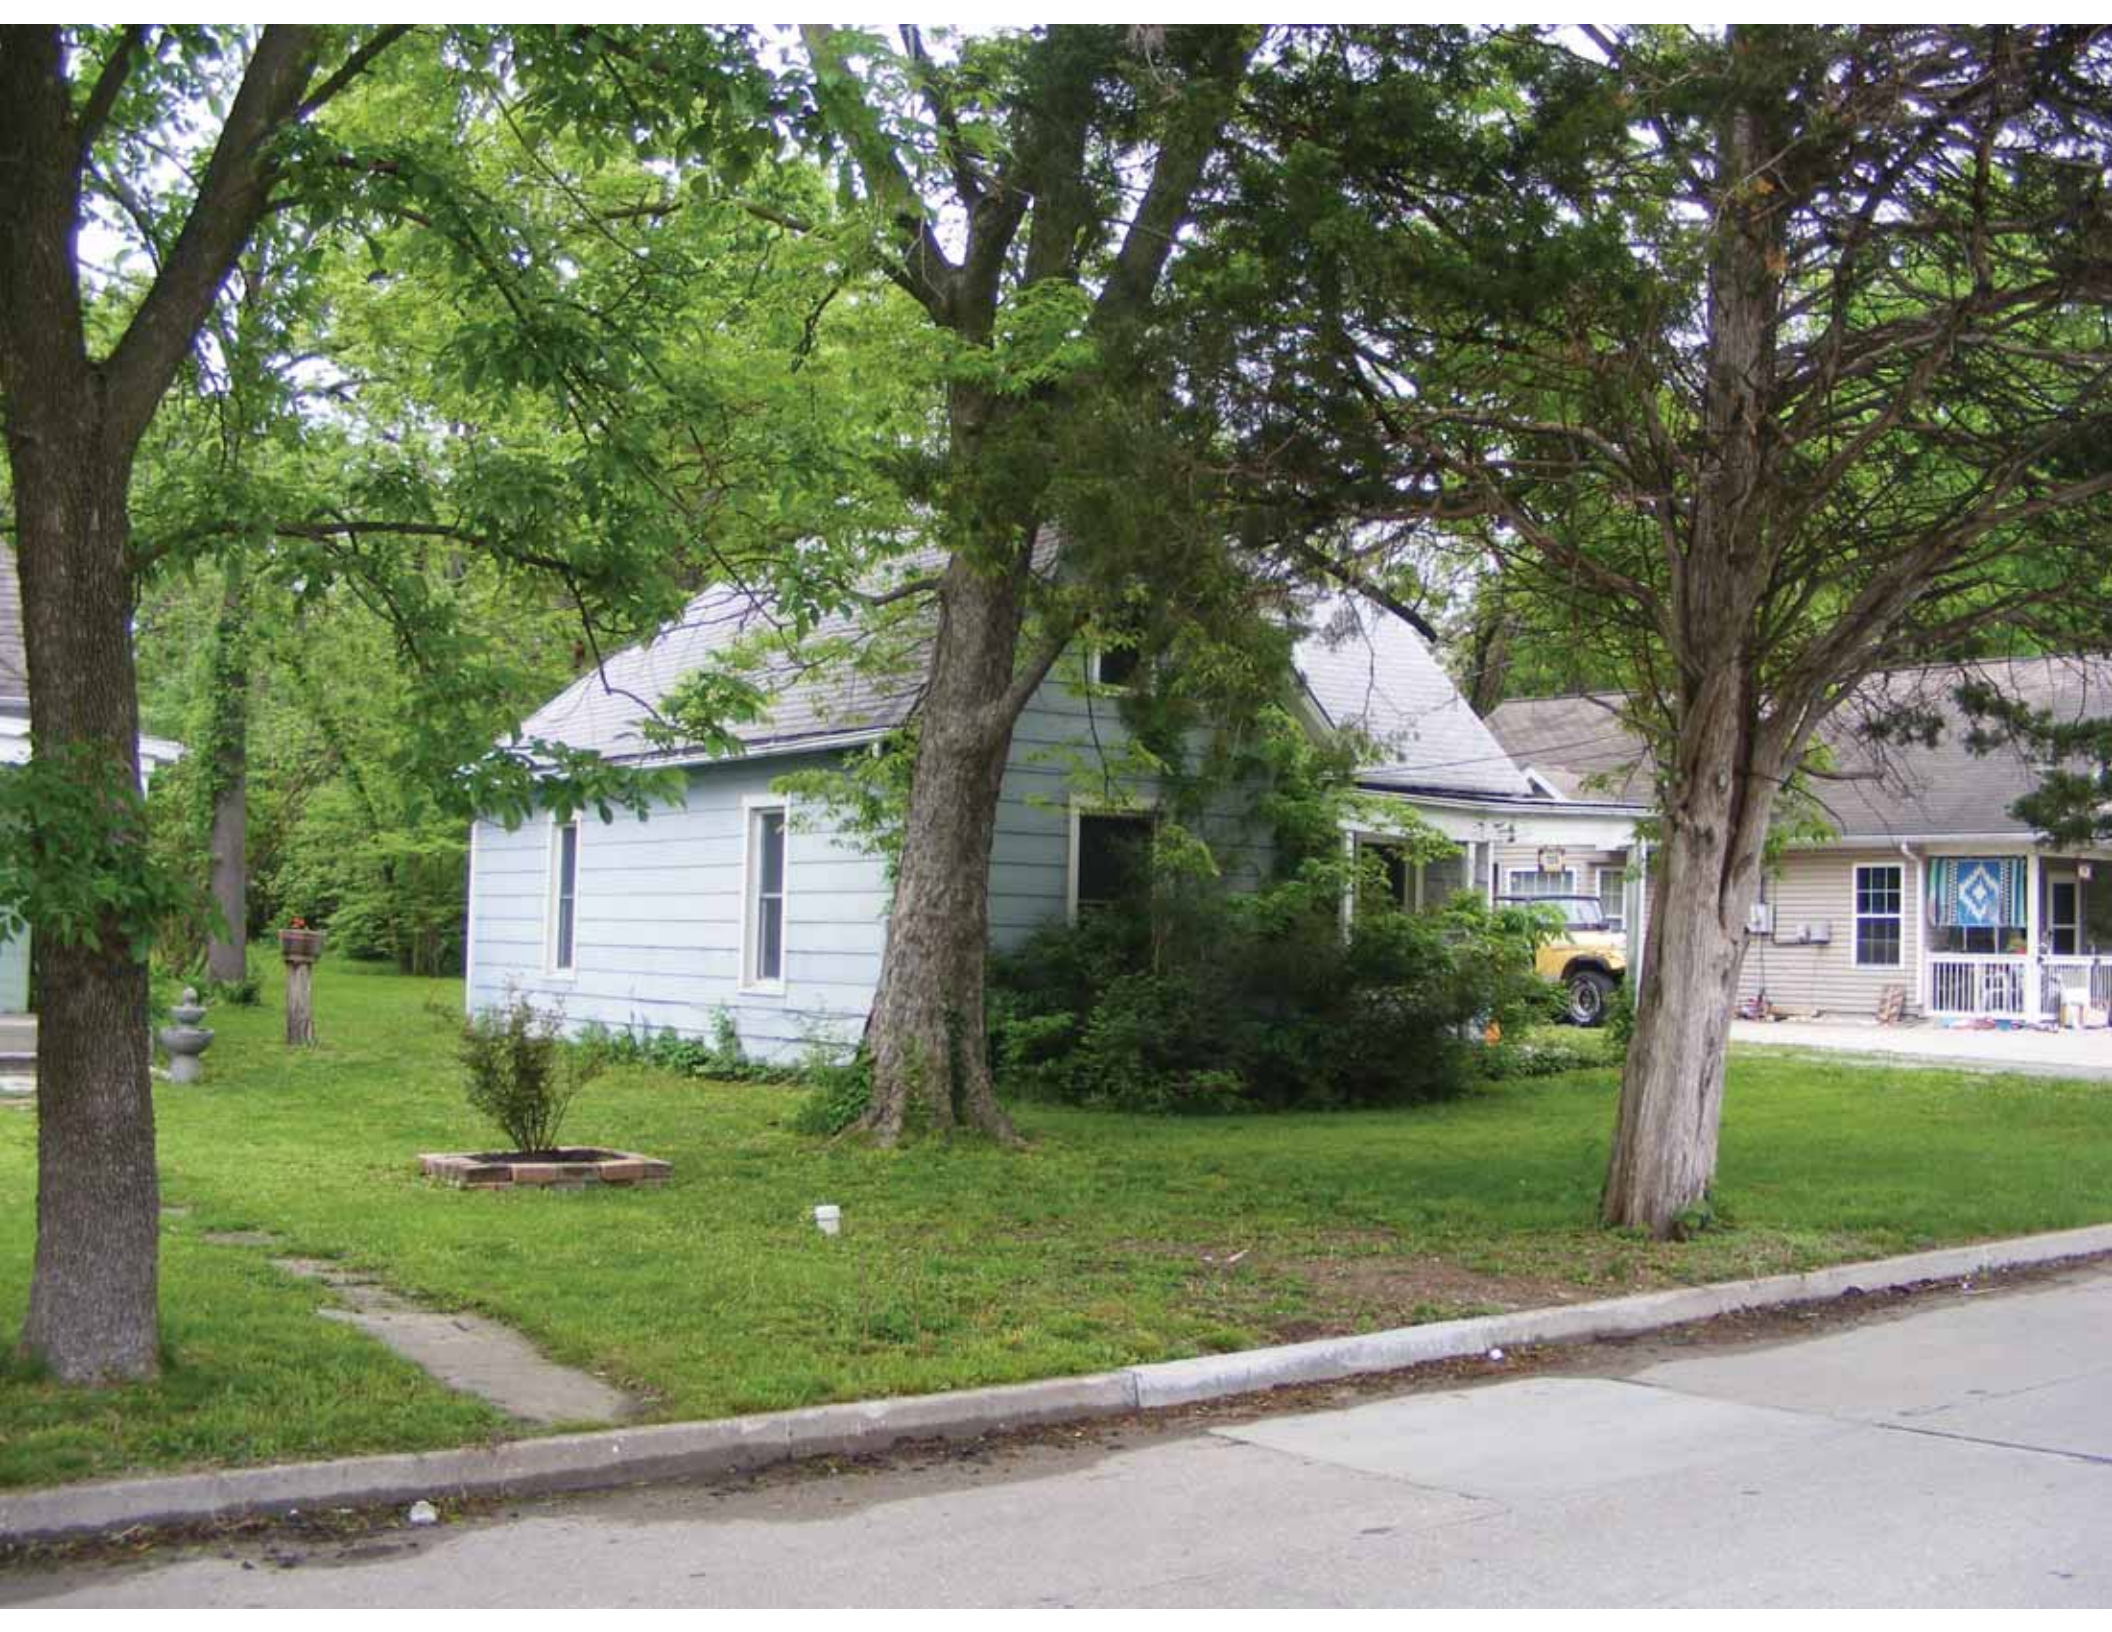
The dwelling has a hip on gable asphalt shingled roof and exterior wide board horizontal siding. The siding condition is much better than the wood on the eaves/soffits, which indicates that the siding may not be original. The front dormer is clad with stucco. The roof has asphalt shingles and the foundation is concrete, largely covered by foliage. The primary (south) elevation has a front facing gabled wing with gable returns. The façade of the wing has upper and lower single windows of original one-over-one. Remaining windows are of similar configuration. East of the gabled wing is a façade shed porch supported by wood columns. Within the porch bay is a replacement paneled door offset by a one-over-one window. Above the porch is a hipped dormer with a one over-one window.
