MISSOURI DEPARTMENT OF NATURAL RESOURCES
STATE HISTORIC PRESERVATION OFFICE, P.O. Box 176, Jefferson City, MO 65102
ARCHITECTURAL/HISTORIC INVENTORY FORM

1. Survey No. BO-AS-011-0087		2. Survey name: North Central Columbia Survey Phase II	
3. County: Boone		4. Address (Street No.) 902	Street (name) N. Seventh Street
5. City: Columbia	Vicinity: <input type="checkbox"/>	6. Geographical Reference:	7. Township/Range/Section: T: R: S:
8. Historic name (if known):		9. Present/other name (if known):	
10. Ownership: <input checked="" type="checkbox"/> Private <input type="checkbox"/> Public		11a. Historic use (if known): Domestic/single dwelling	11b. Current use: Domestic/single dwelling

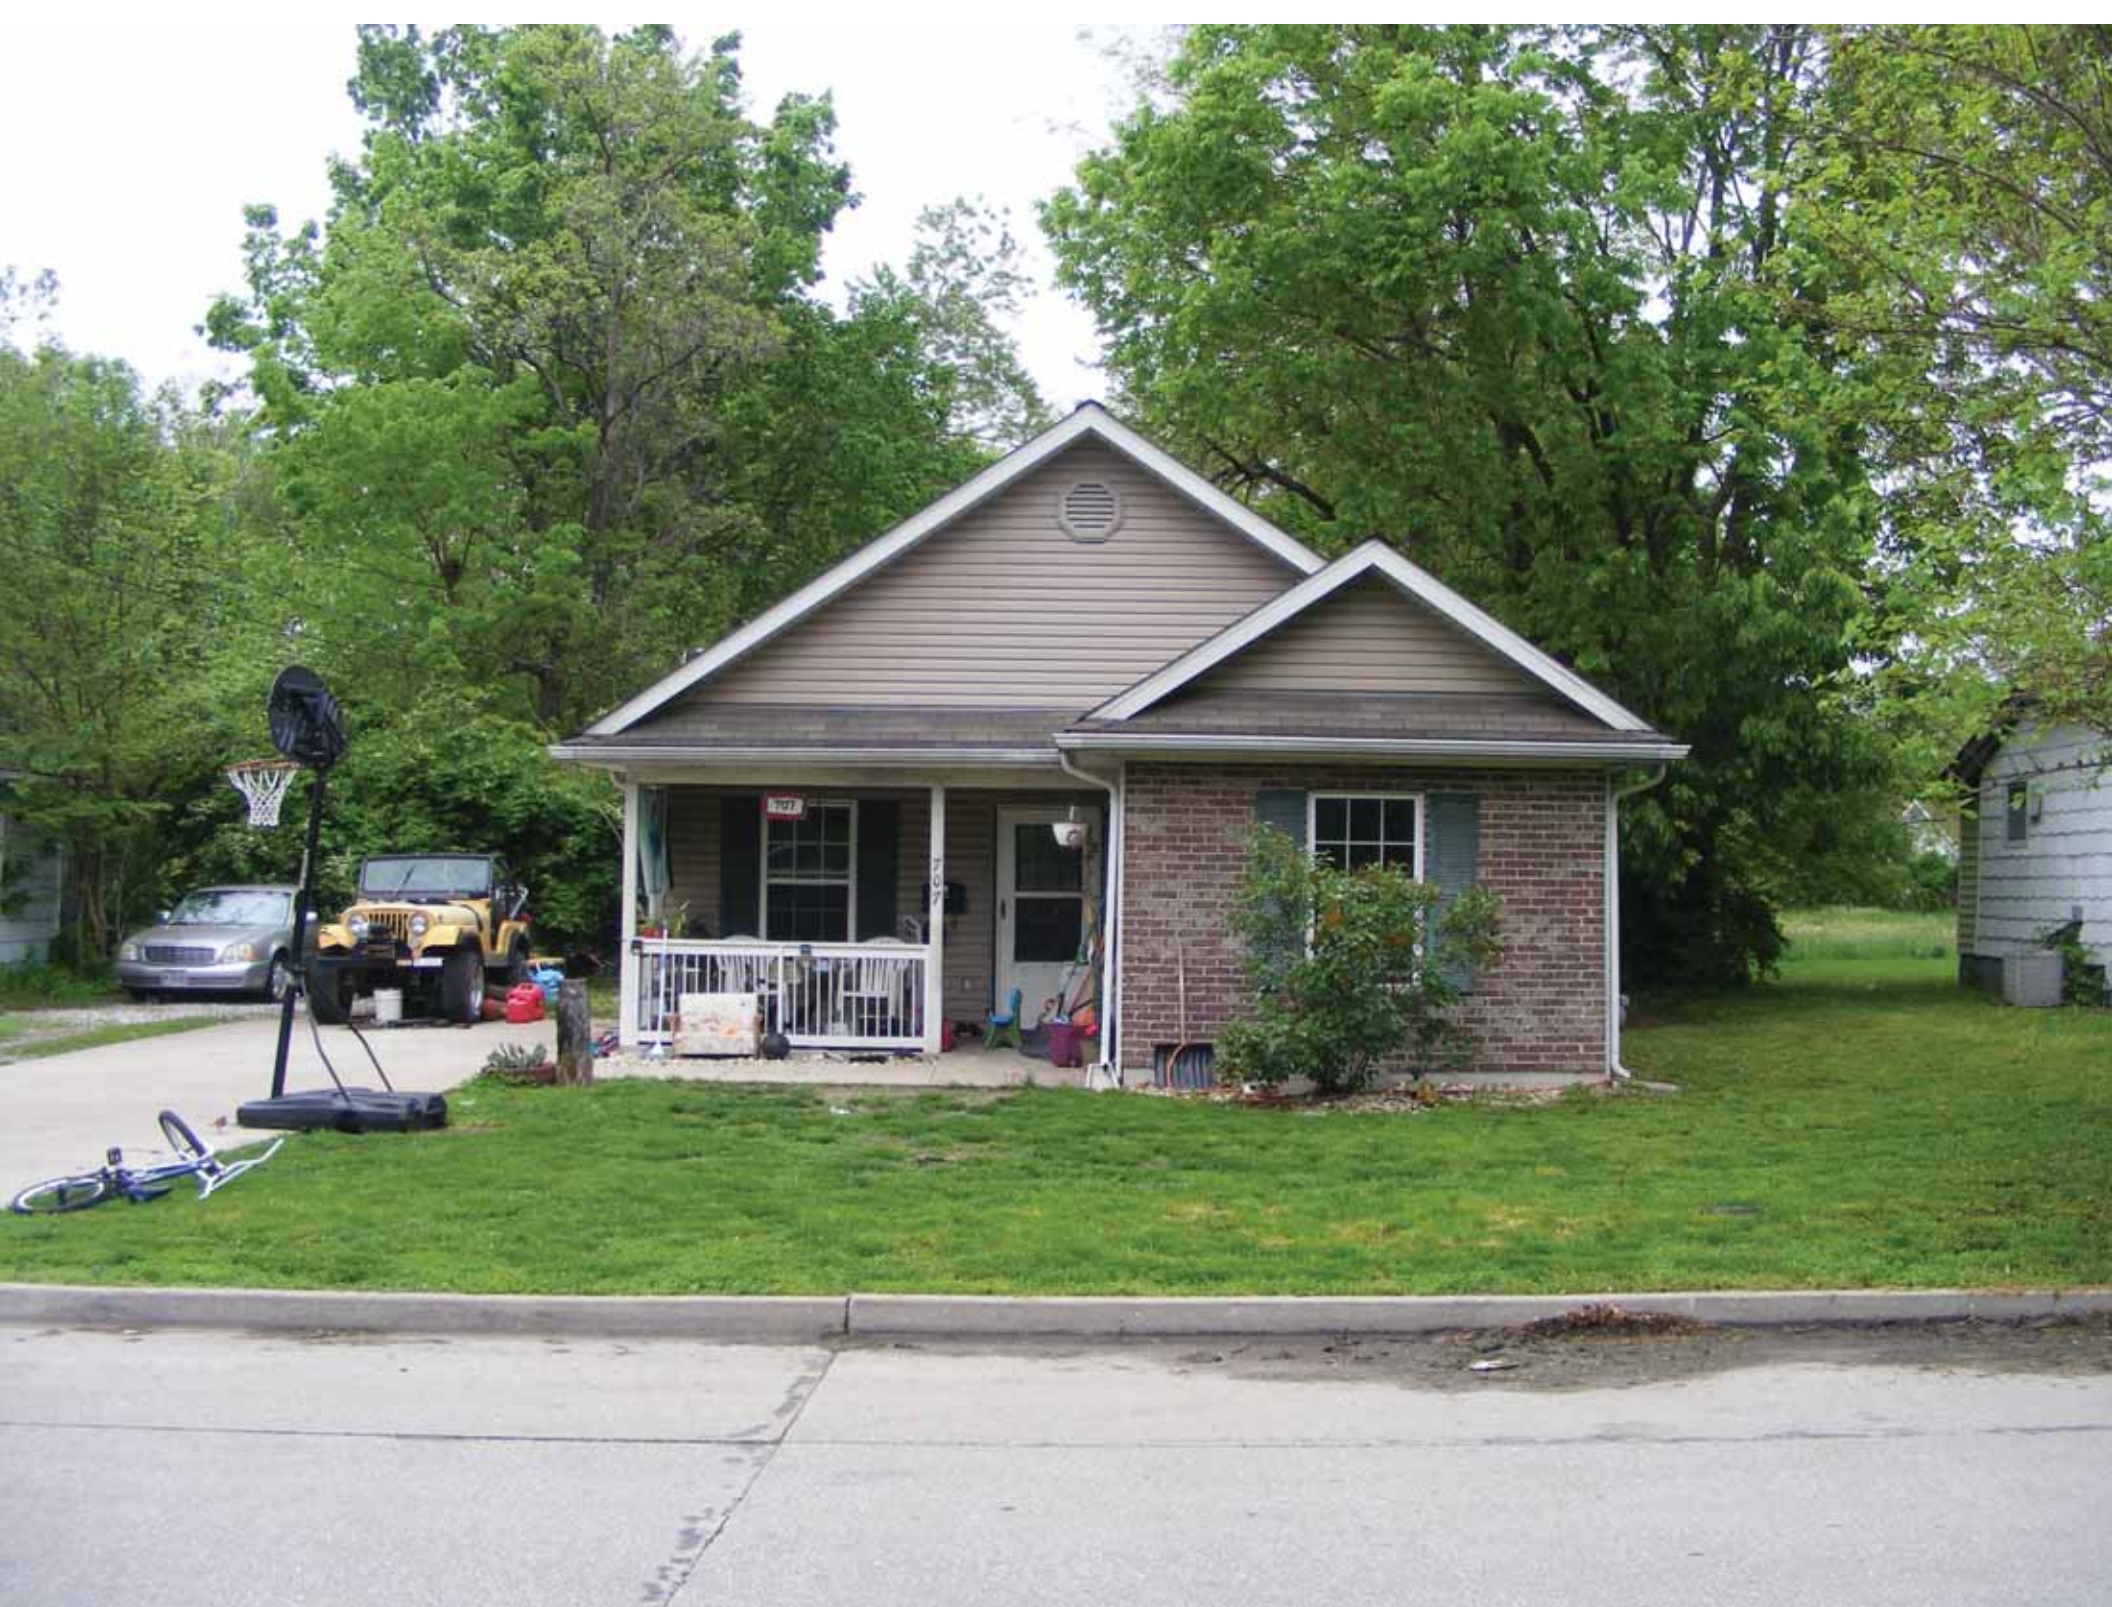
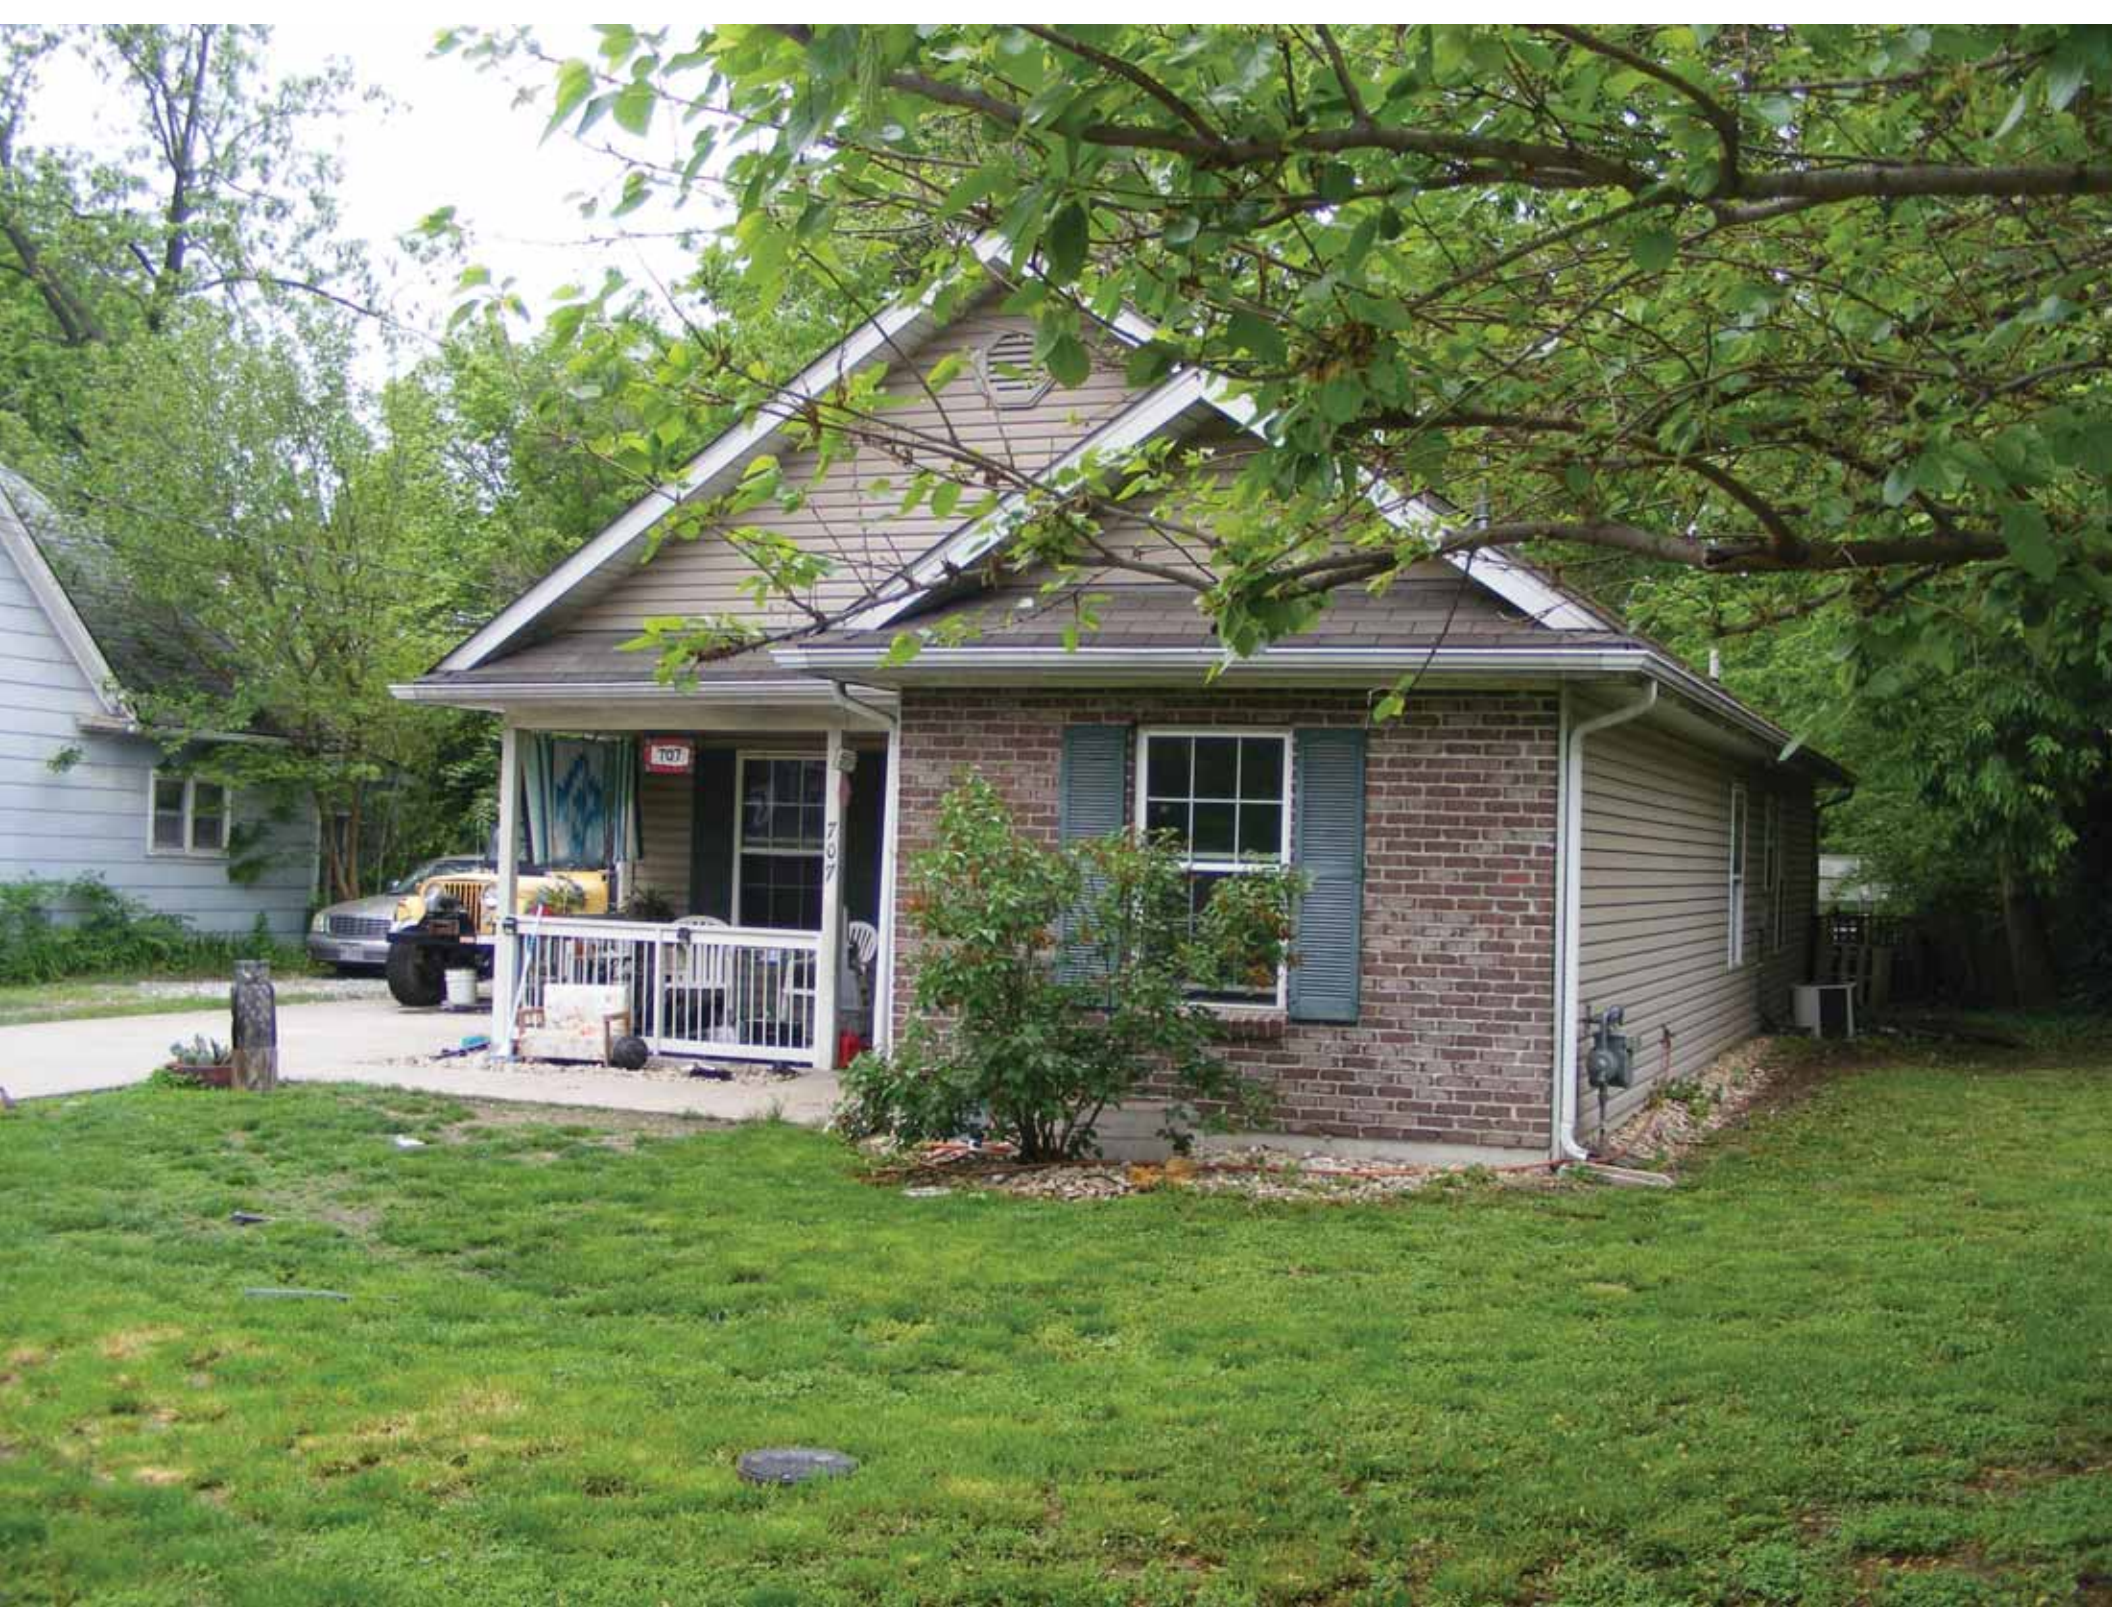
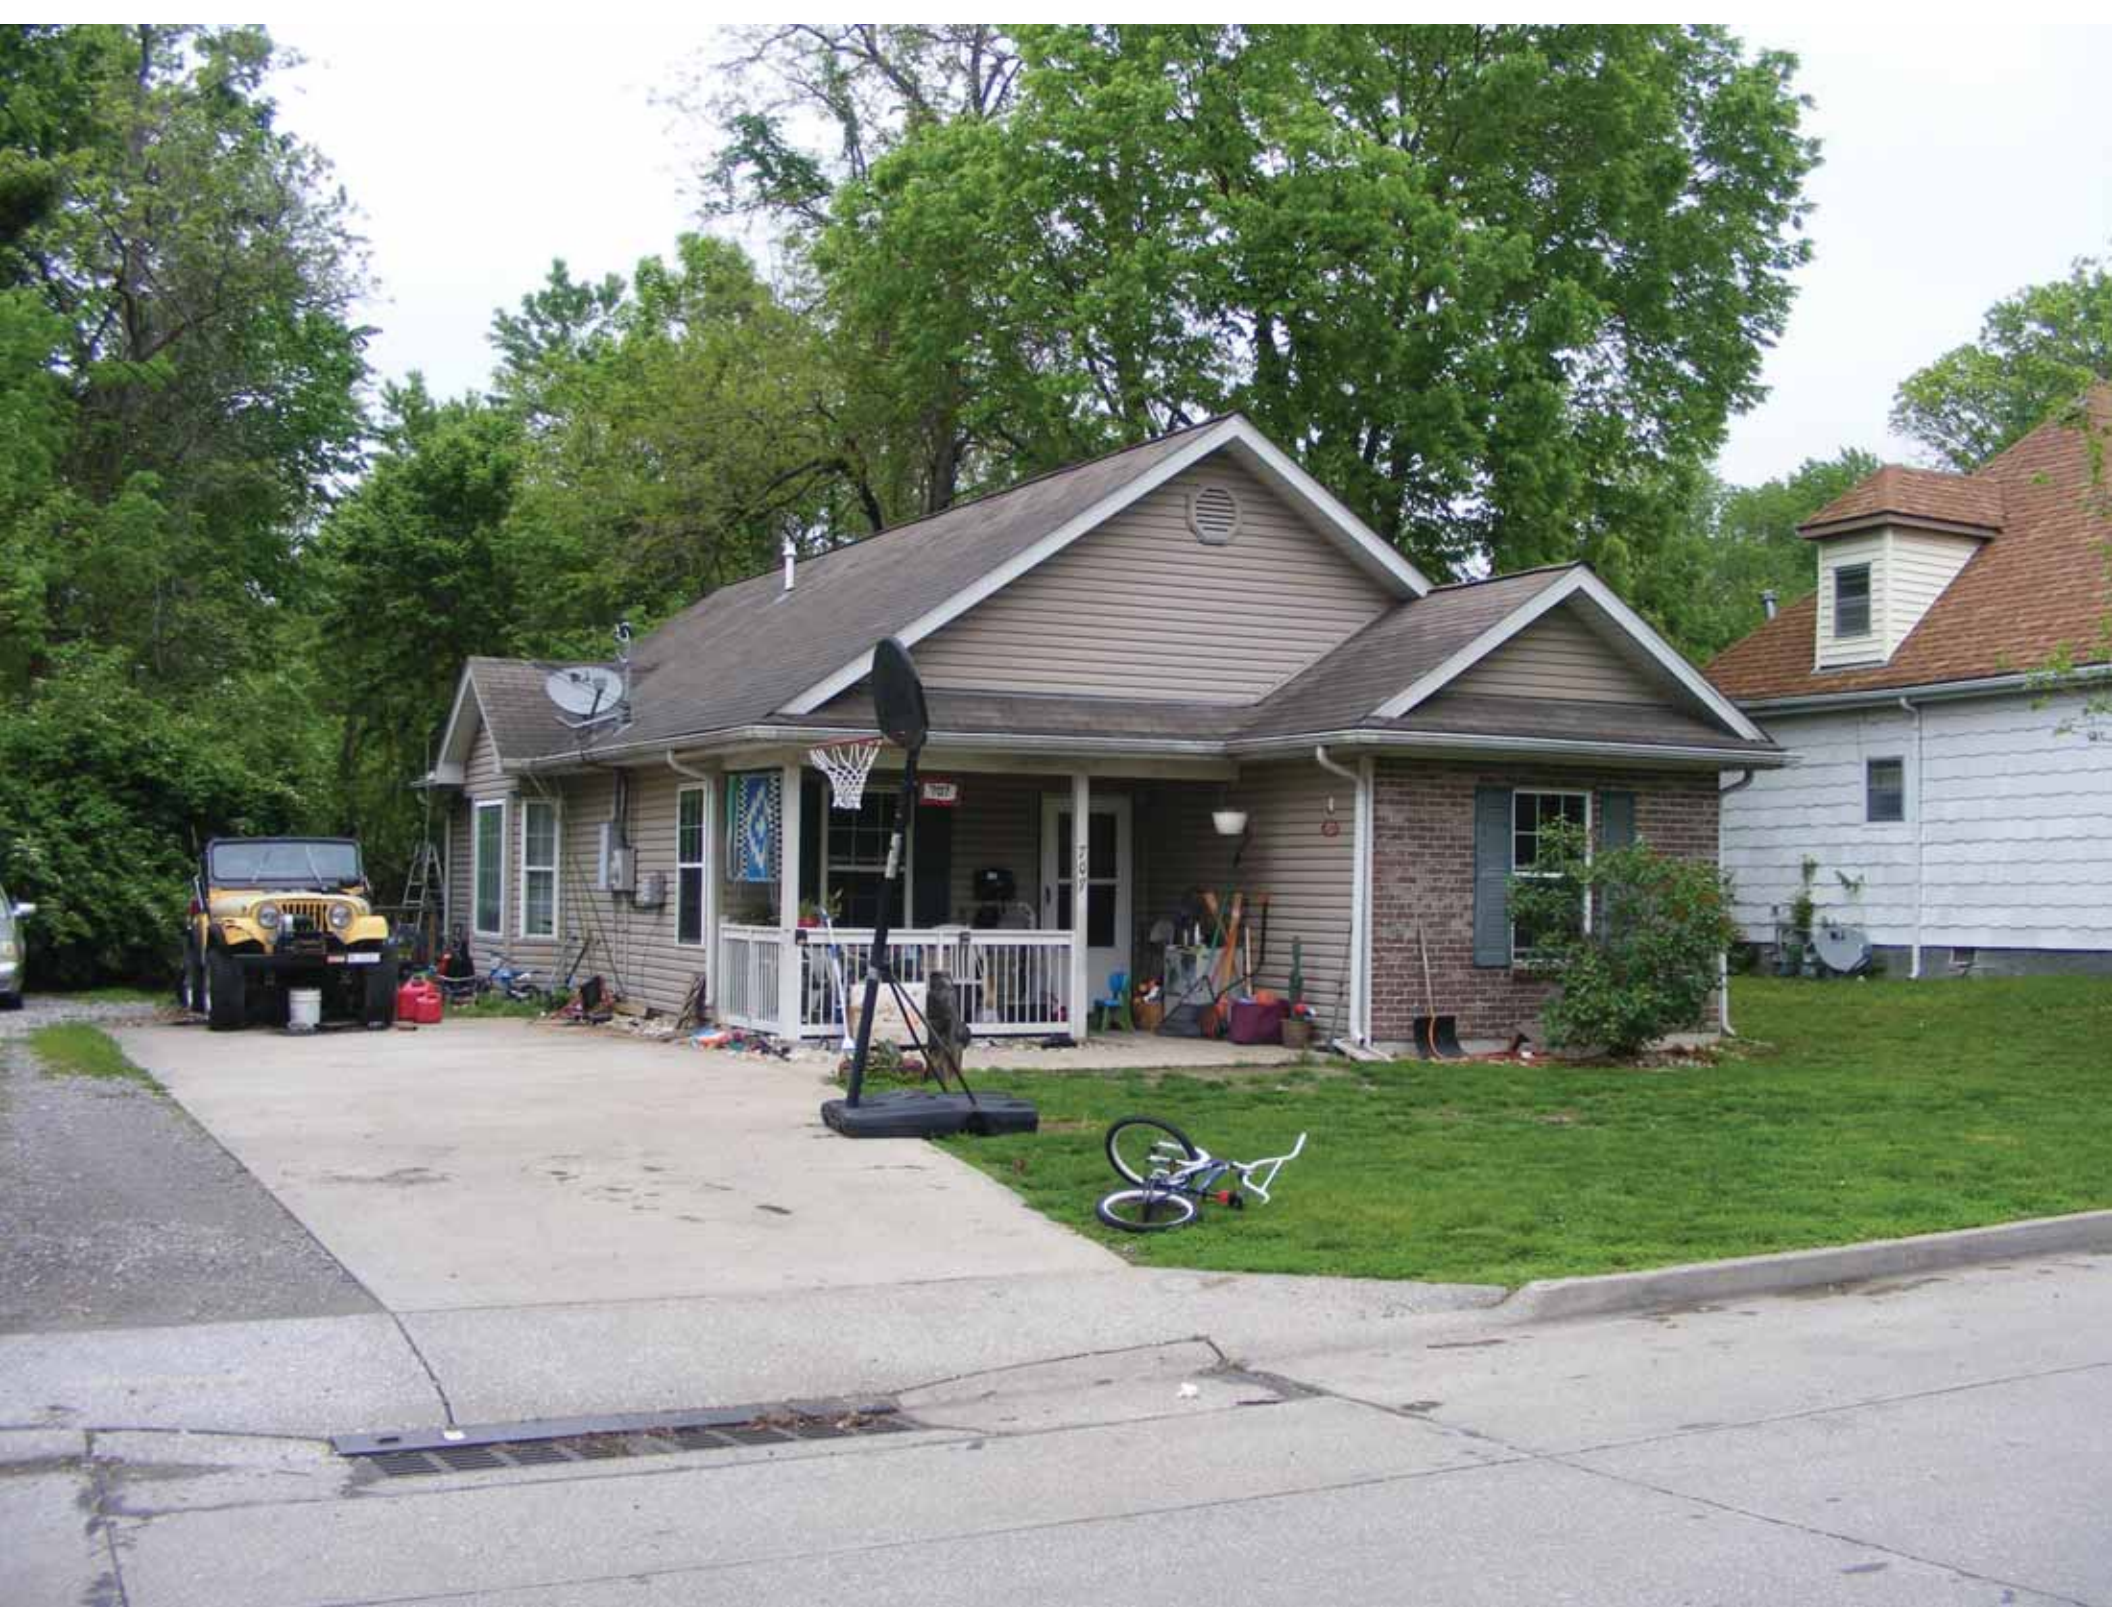
The dwelling has an asphalt-shingled front gabled roof, exterior brick and vinyl siding, and a concrete foundation. The primary (south) elevation has a front facing gabled wing clad with brick. The wing façade holds a six-over-six window with faux shutters. Offsetting the wing on the west is a shed porch supported by wood columns. The porch has a frame balustrade. Within the porch bay is a multi-light door offset by a six-over-six window with faux shutters. The porch wall and gabled areas are clad with vinyl siding. The front gable field of the primary wing has an octagonal louvered vent. A shed extension at the base of the gables spans the south elevation. Side elevations have vinyl siding, six-over-six and four-over-four windows.
