MISSOURI DEPARTMENT OF NATURAL RESOURCES
STATE HISTORIC PRESERVATION OFFICE, P.O. Box 176, Jefferson City, MO 65102
ARCHITECTURAL/HISTORIC INVENTORY FORM

1. Survey No. BO-AS-011-0087		2. Survey name: North Central Columbia Survey Phase II	
3. County: Boone		4. Address (Street No.) 902	Street (name) N. Seventh Street
5. City: Columbia	Vicinity: <input type="checkbox"/>	6. Geographical Reference:	7. Township/Range/Section: T: R: S:
8. Historic name (if known):		9. Present/other name (if known):	
10. Ownership: <input checked="" type="checkbox"/> Private <input type="checkbox"/> Public		11a. Historic use (if known): Domestic/single dwelling	11b. Current use: Domestic/single dwelling

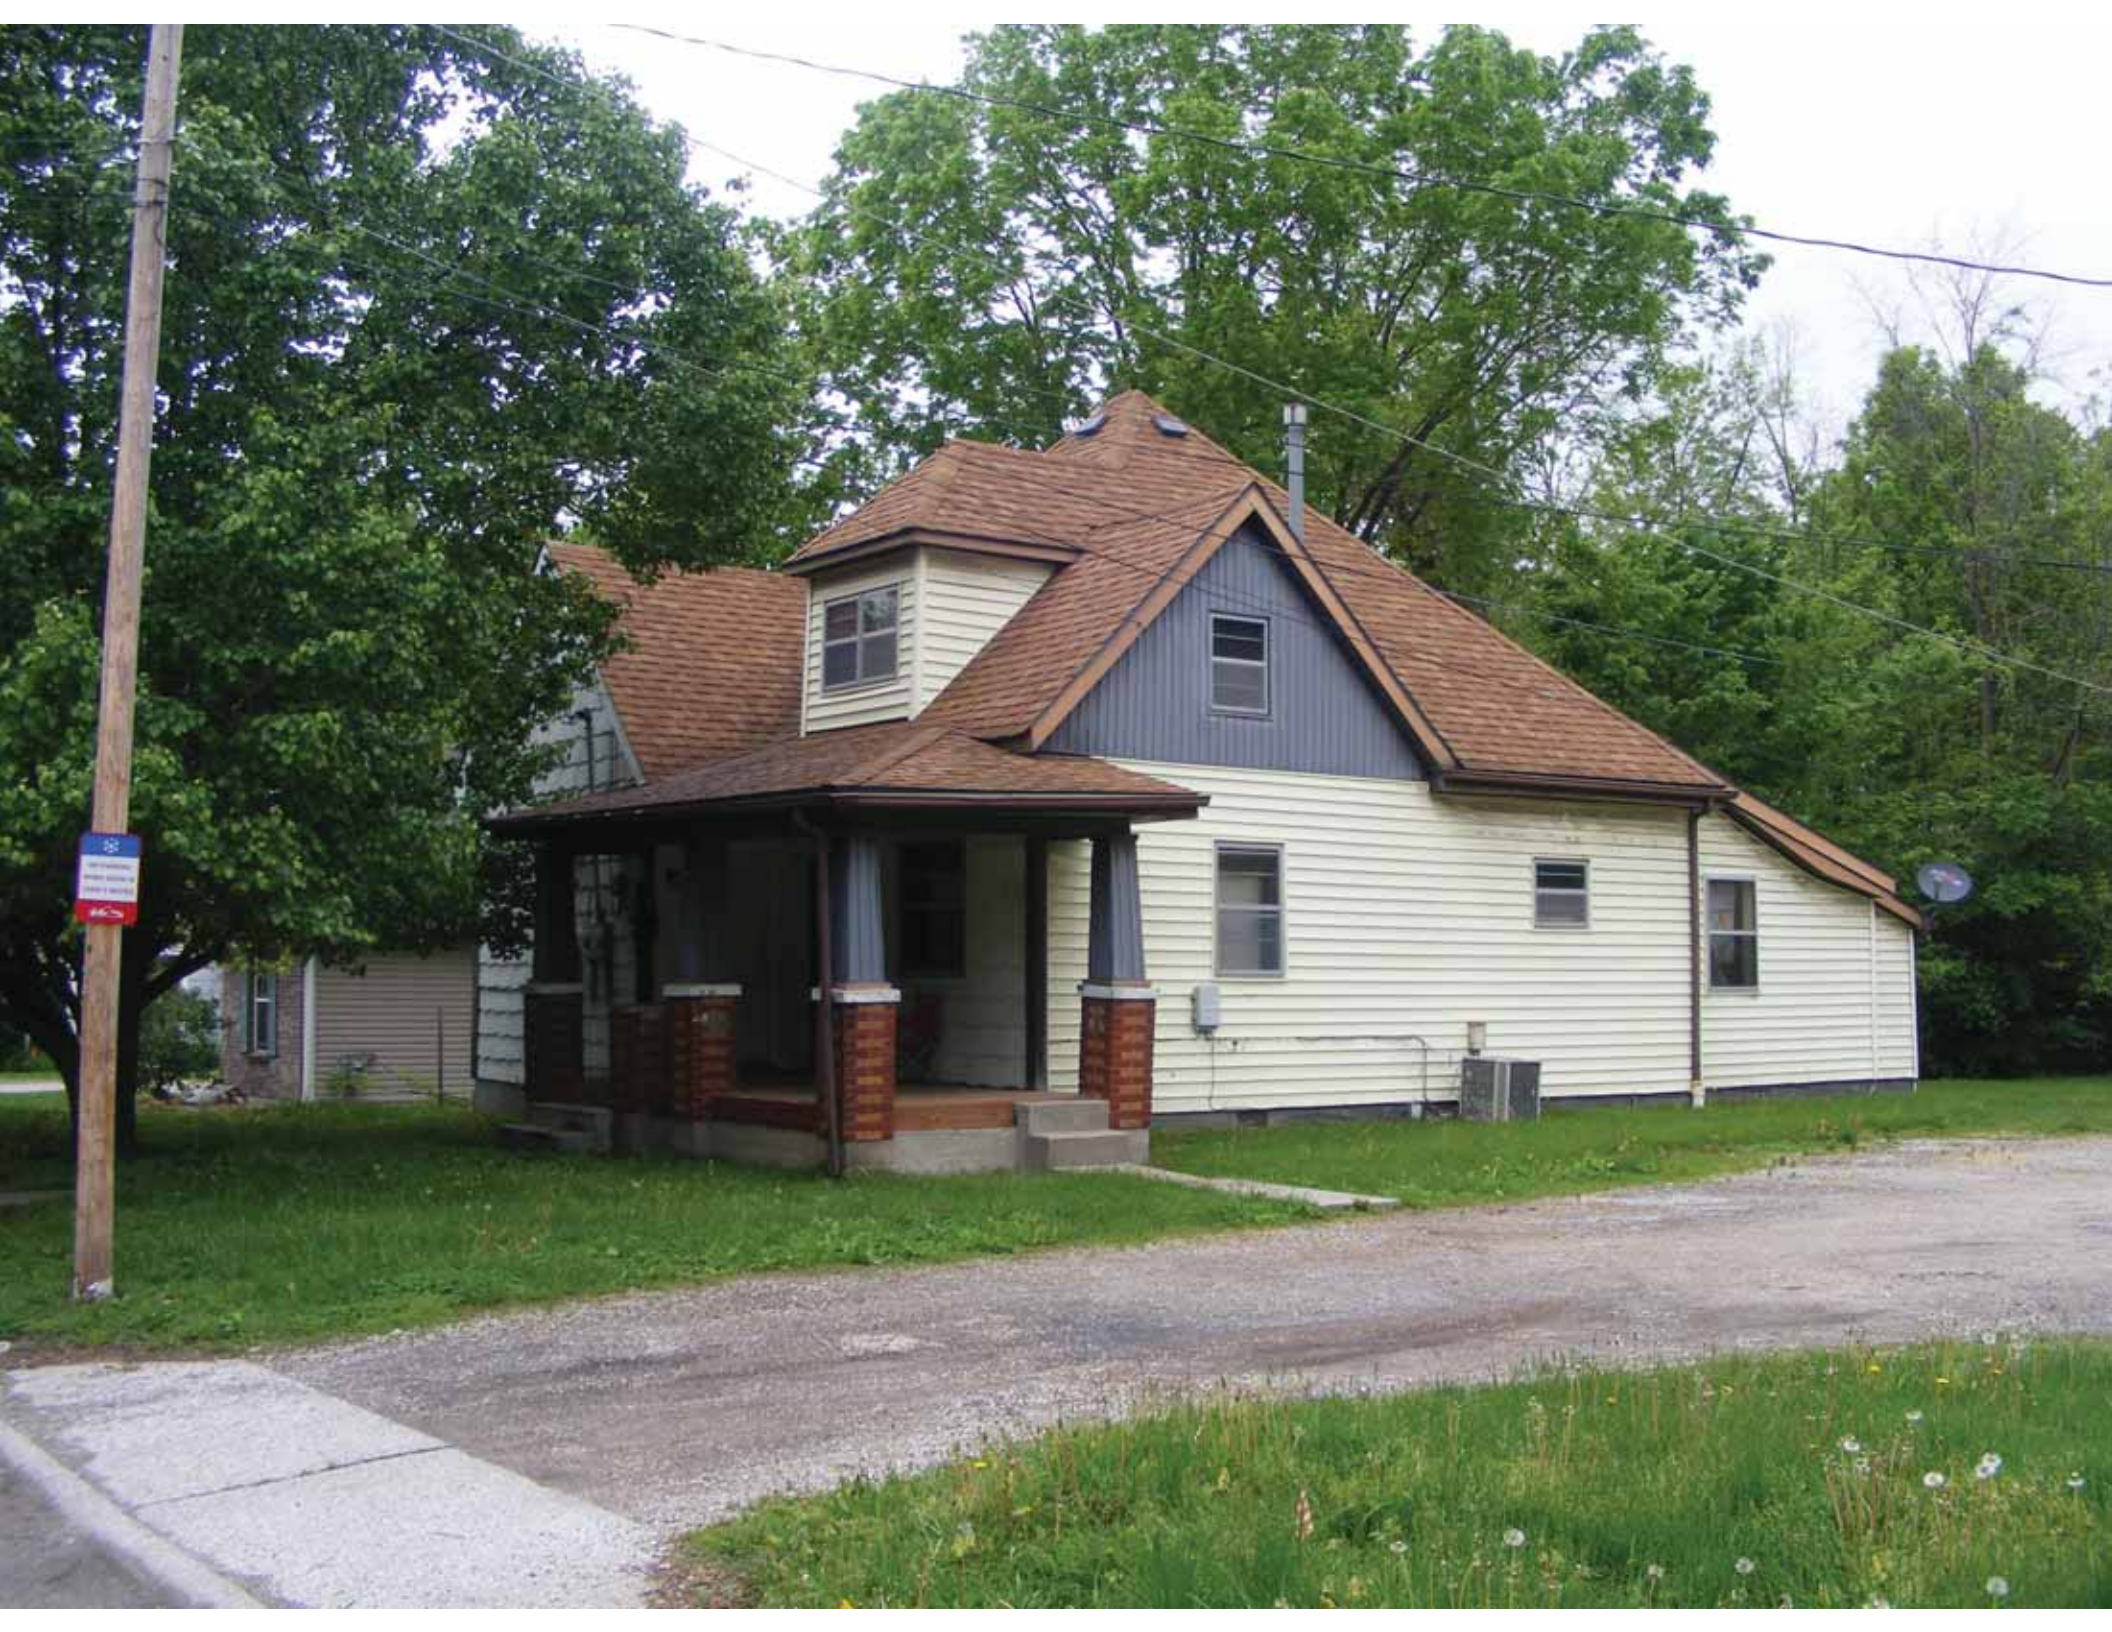
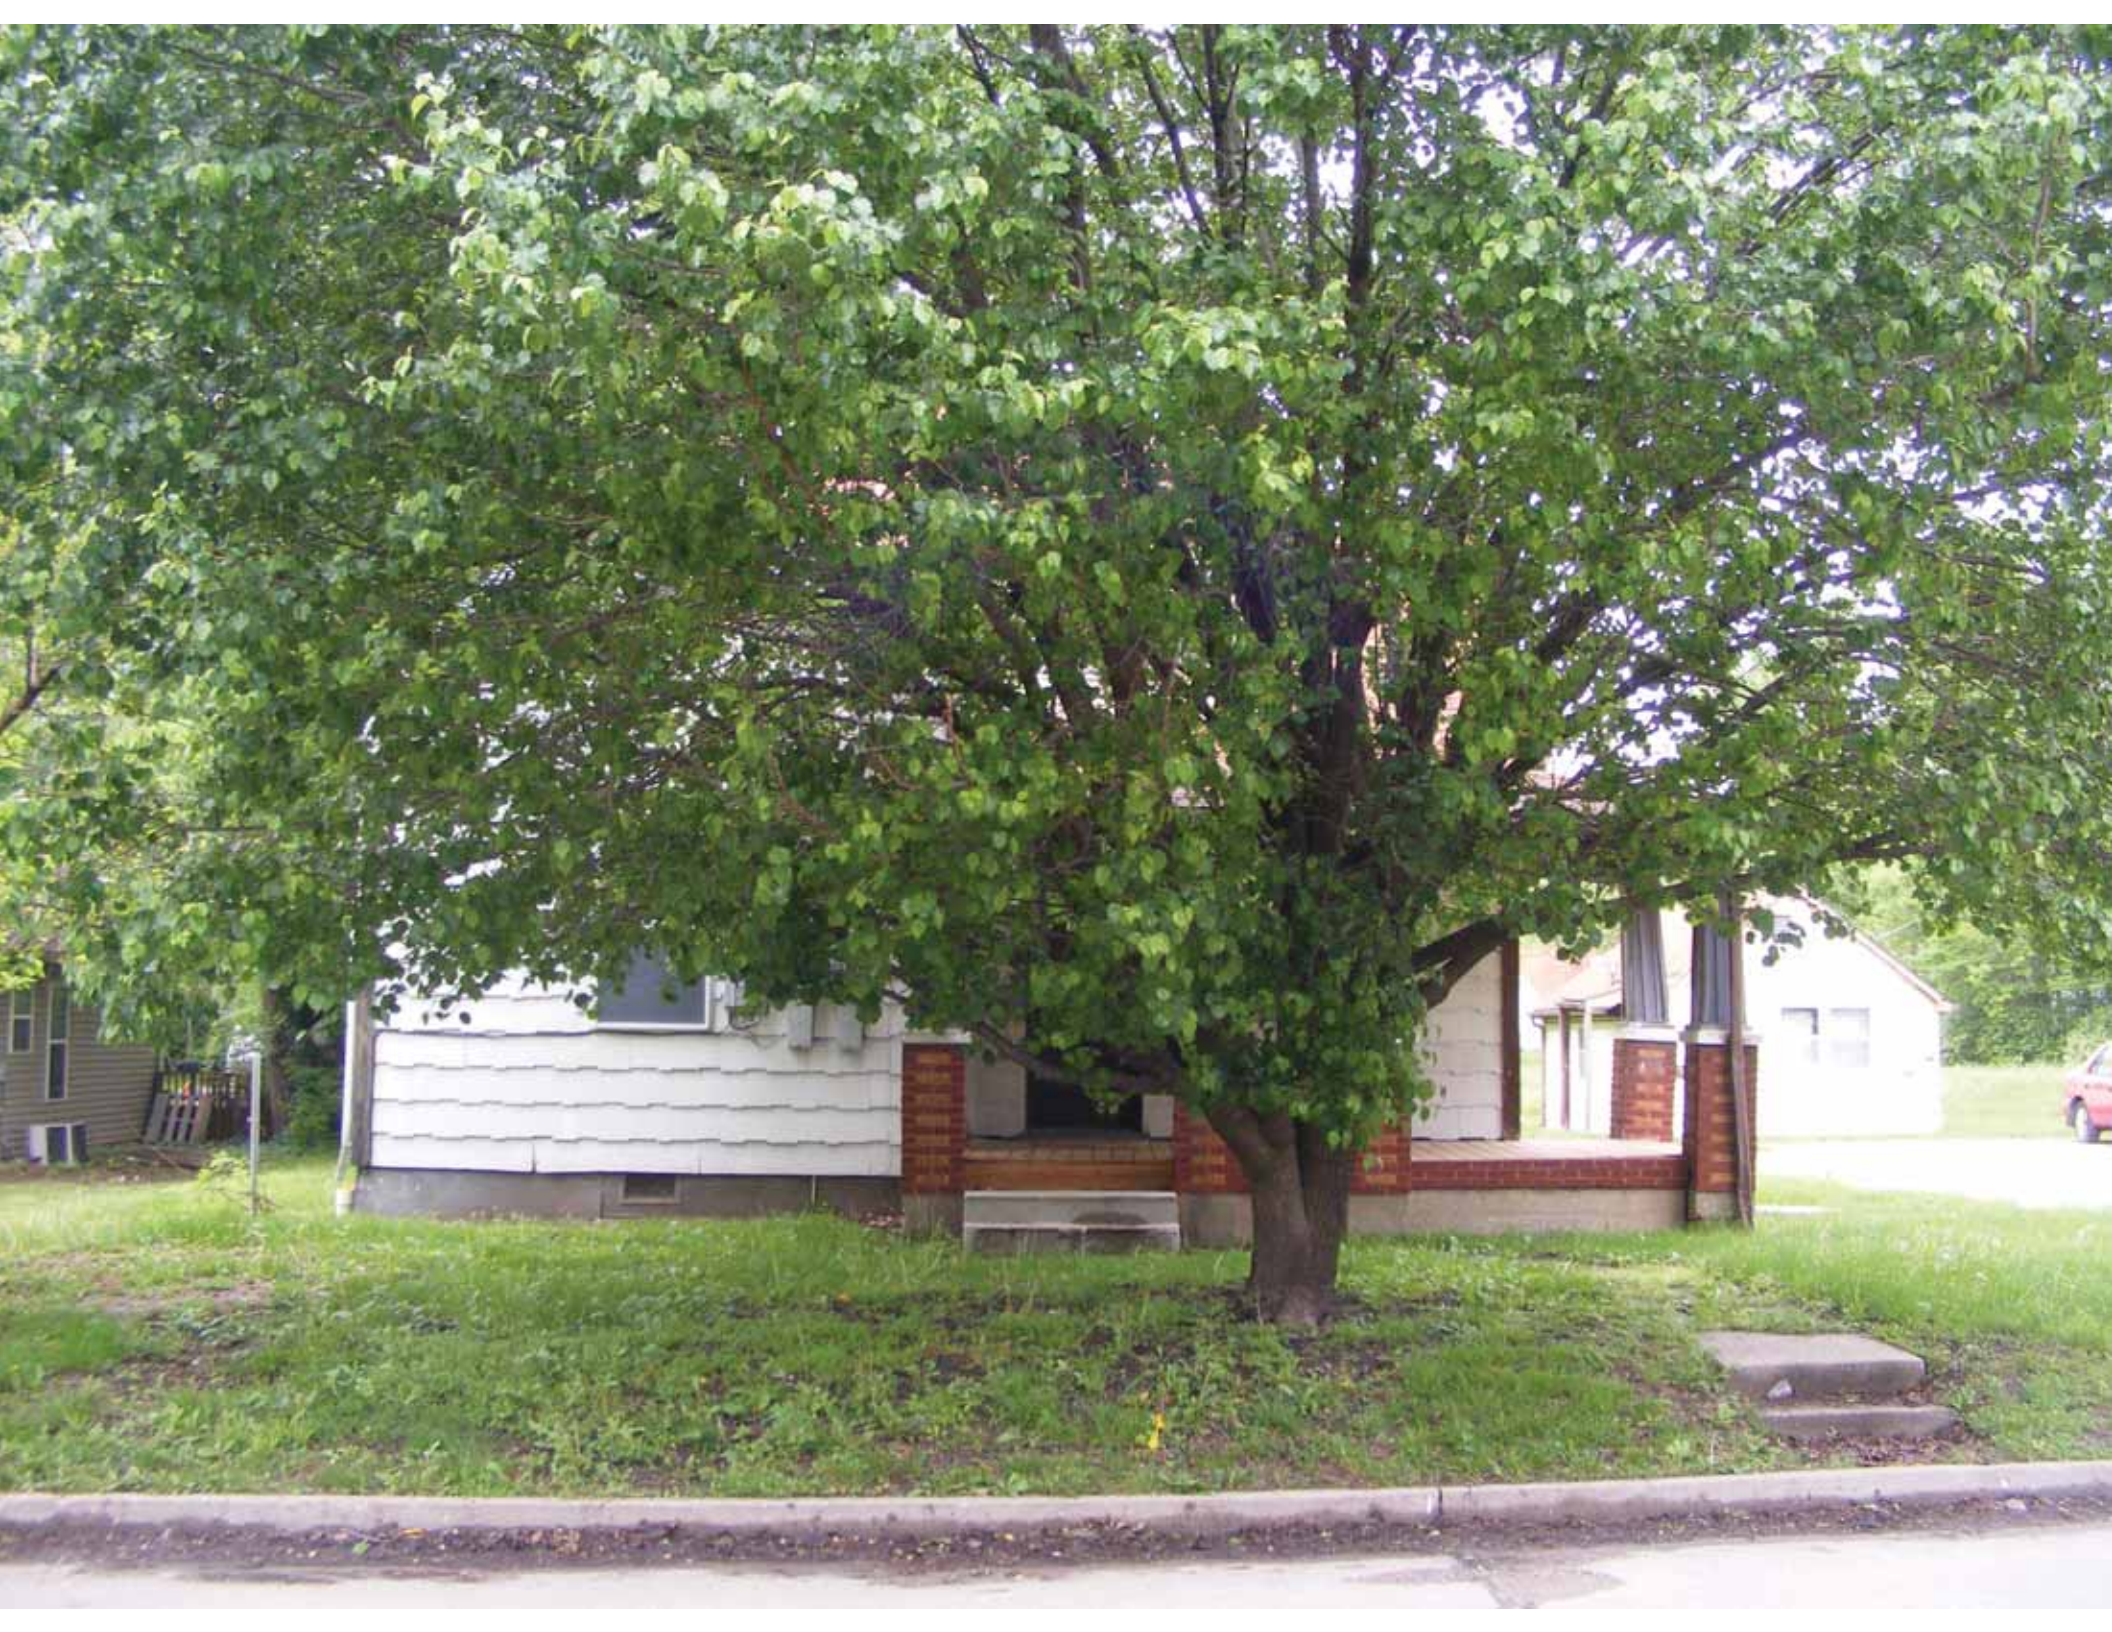
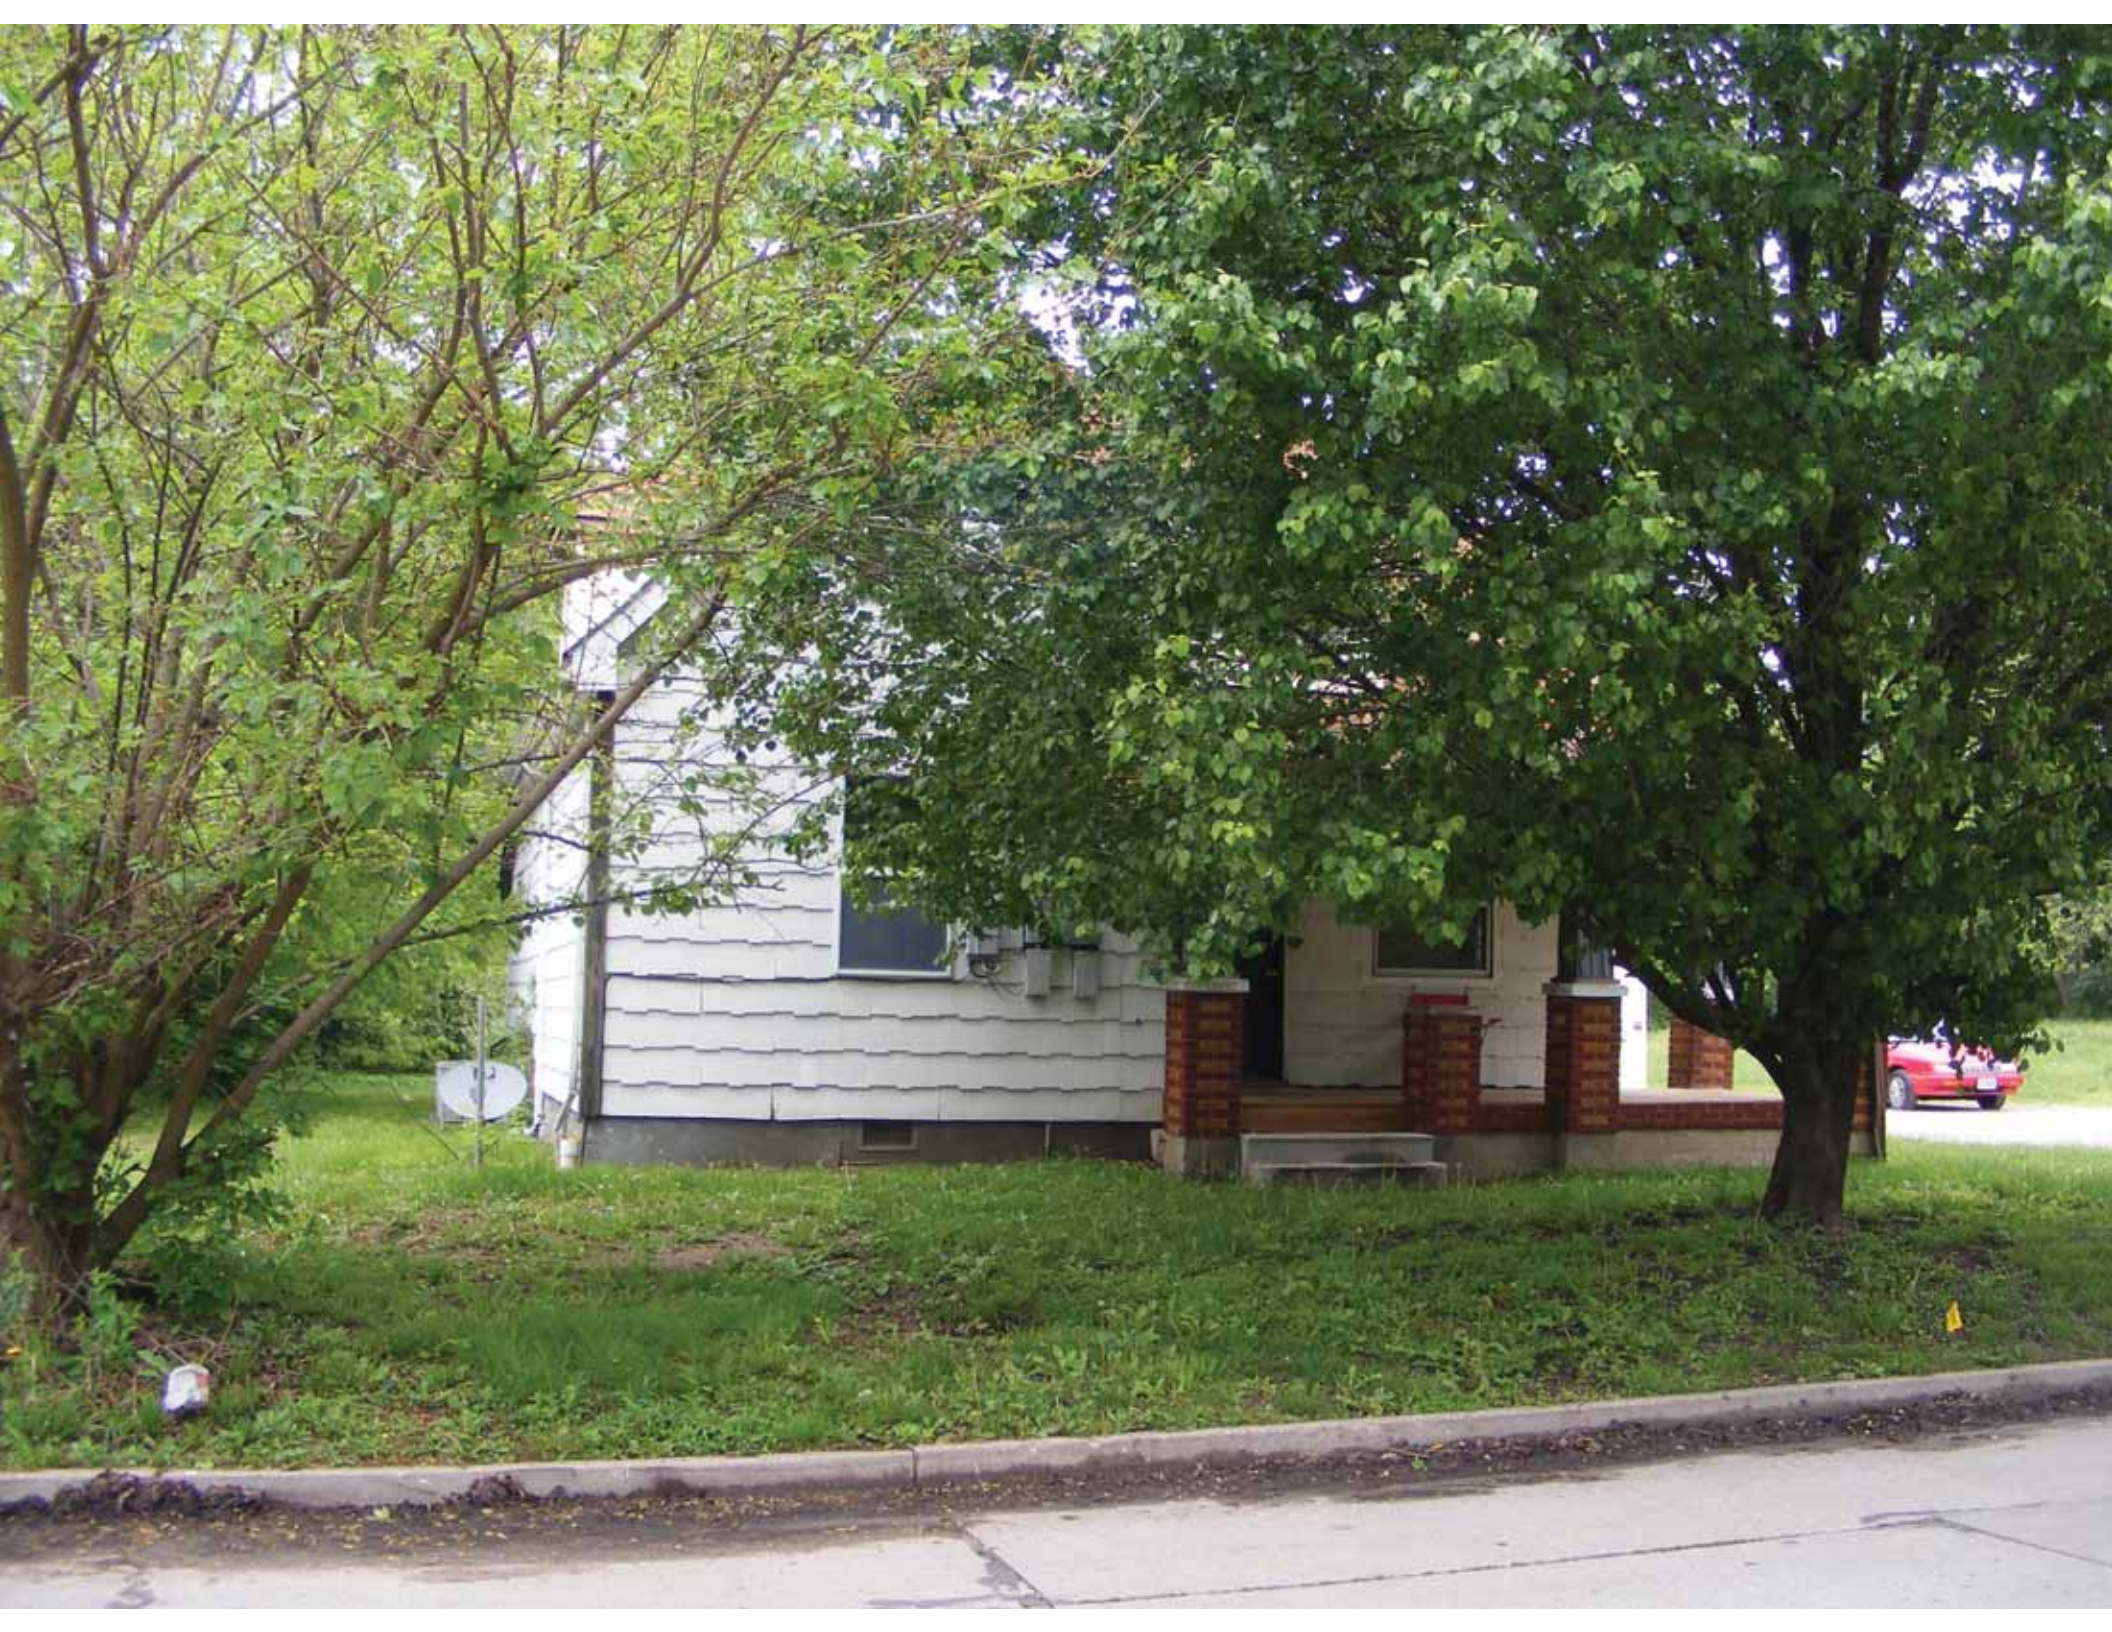
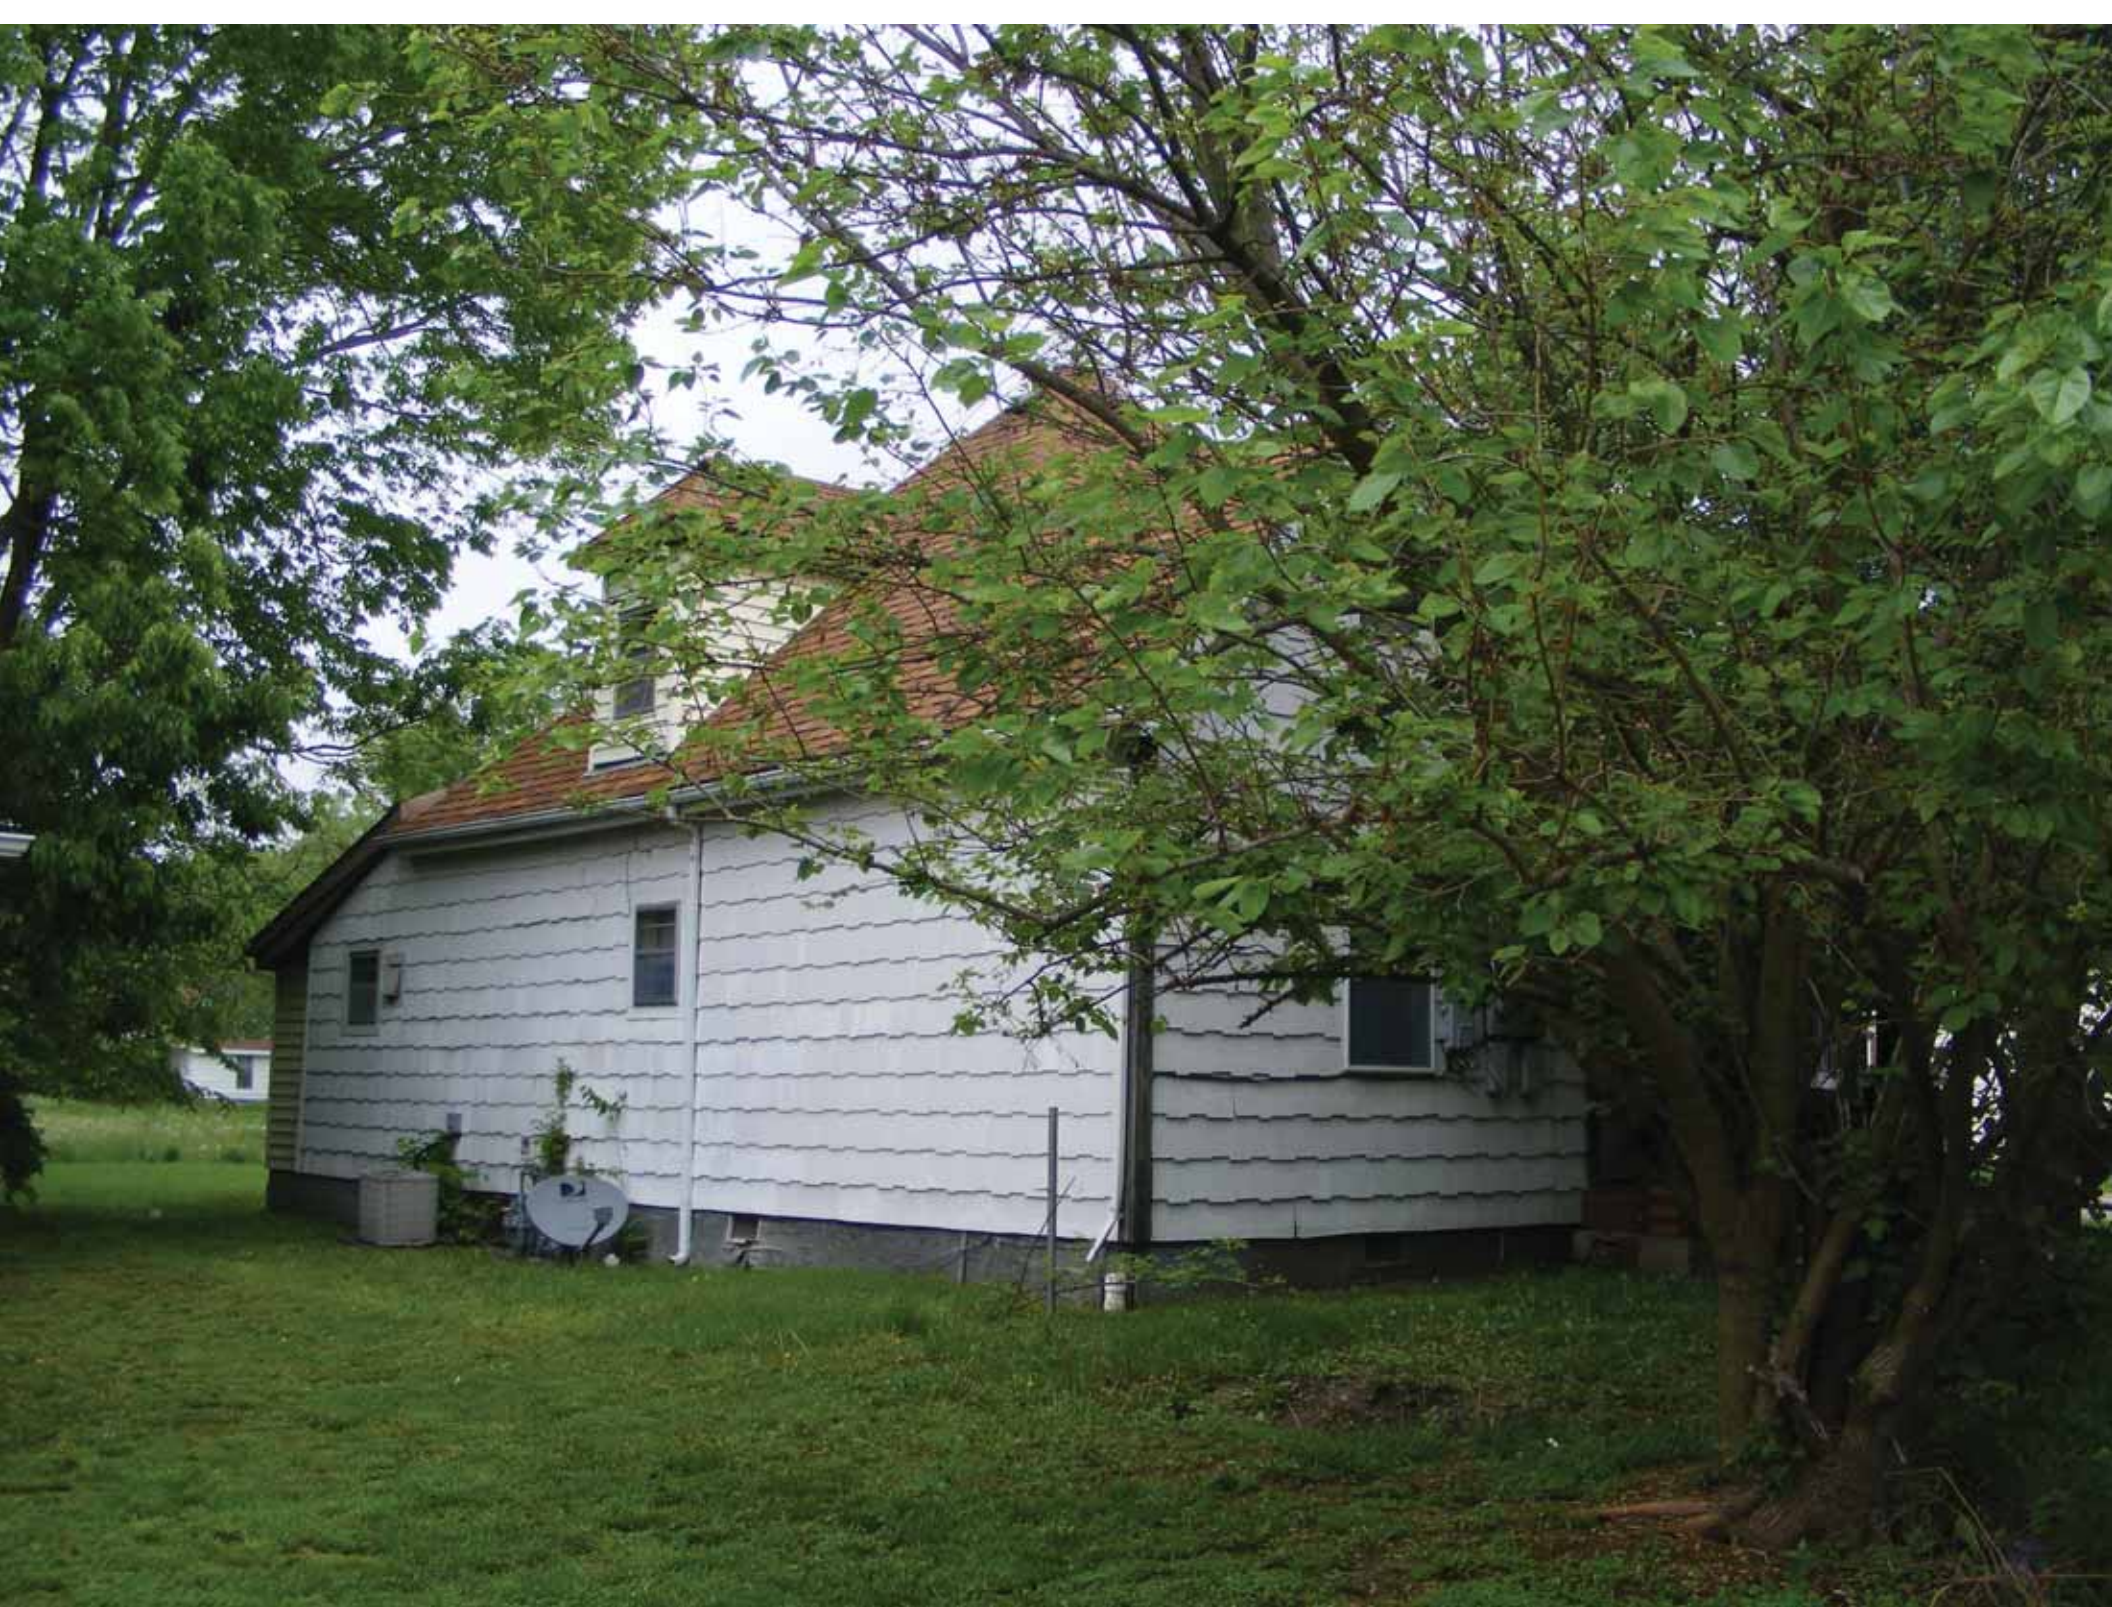
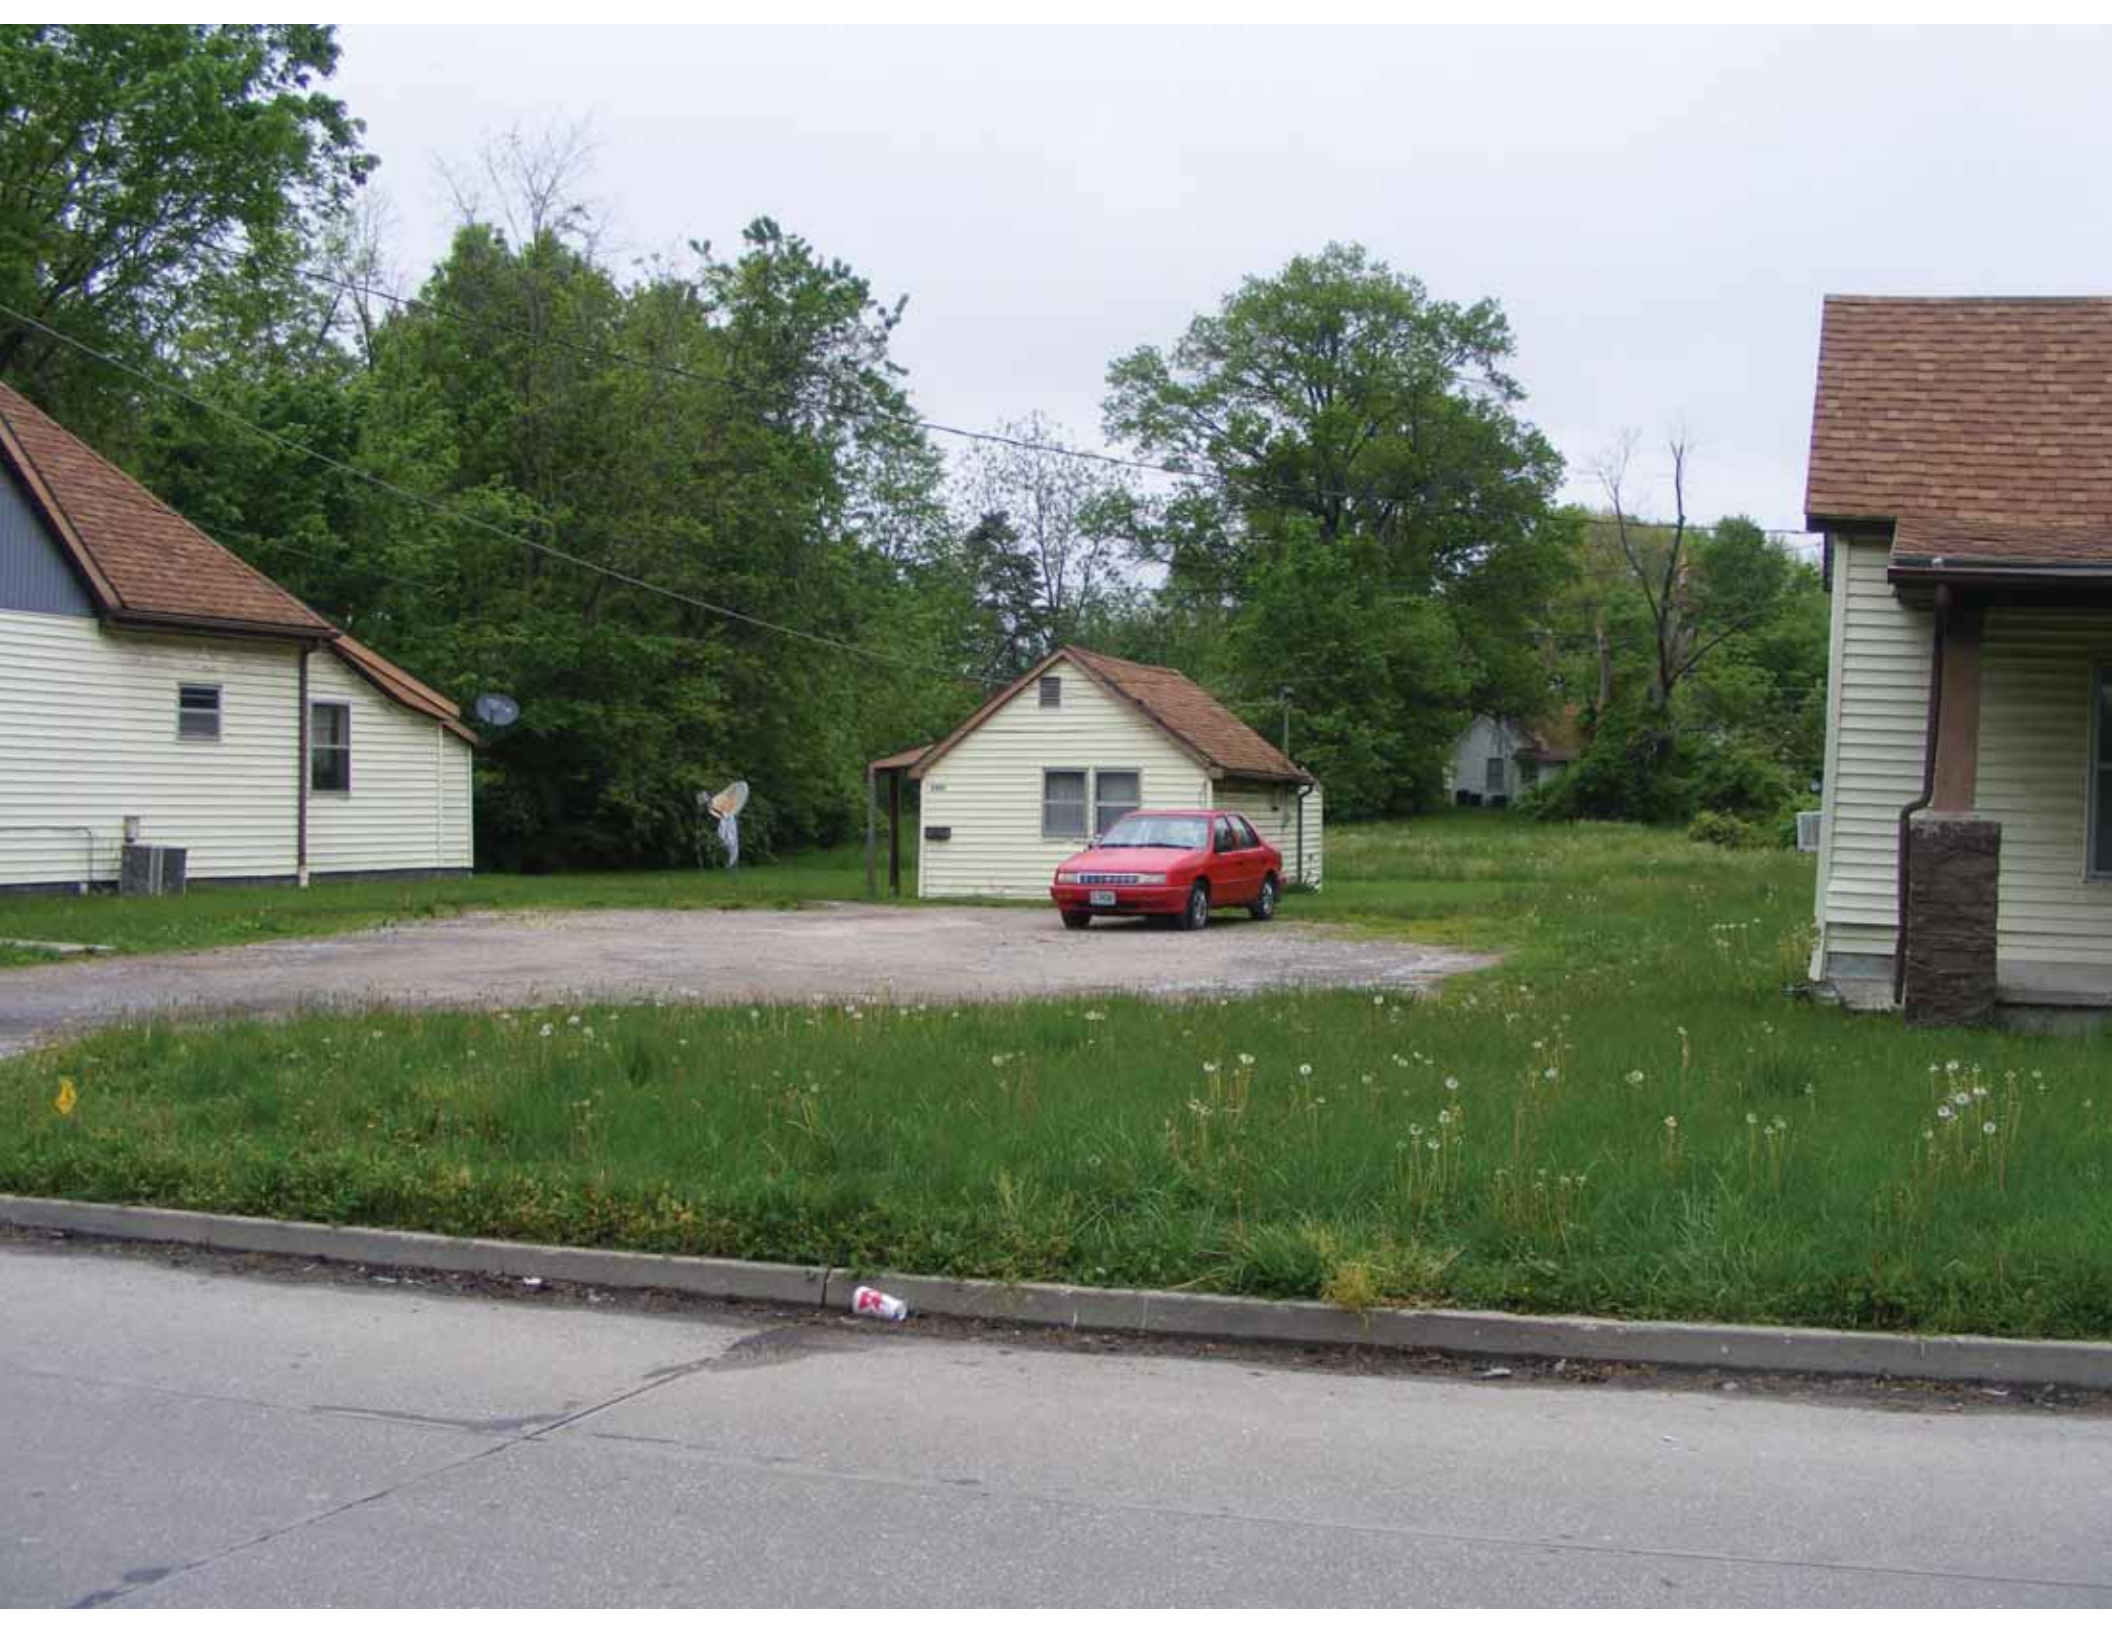
The dwelling has a cross-gabled roof with central pyramidal roofline. The roof is clad with asphalt shingles. The dwelling has a concrete foundation and is clad with sawtooth pattern asbestos (east) and vinyl (west) siding. On the primary (south) elevation is an off-center hipped Craftsman style porch with tapered piers resting on brick columns. Within the porch bay is a single door offset by a double-hung window. Windows are c. 1945 two-over-two horizontal sash. The front gabled wing (east end of the façade) is clad with asbestos siding and holds a single double-hung window. The dwelling has a rear shed wing clad with vinyl. Hipped dormers are situated on the south and west elevations. Each dormer holds a single double-hung window.
