MISSOURI DEPARTMENT OF NATURAL RESOURCES
STATE HISTORIC PRESERVATION OFFICE, P.O. Box 176, Jefferson City, MO 65102
ARCHITECTURAL/HISTORIC INVENTORY FORM

1. Survey No. BO-AS-011-0087		2. Survey name: North Central Columbia Survey Phase II	
3. County: Boone		4. Address (Street No.) 902	Street (name) N. Seventh Street
5. City: Columbia	Vicinity: <input type="checkbox"/>	6. Geographical Reference:	7. Township/Range/Section: T: R: S:
8. Historic name (if known):		9. Present/other name (if known):	
10. Ownership: <input checked="" type="checkbox"/> Private <input type="checkbox"/> Public		11a. Historic use (if known): Domestic/single dwelling	11b. Current use: Domestic/single dwelling

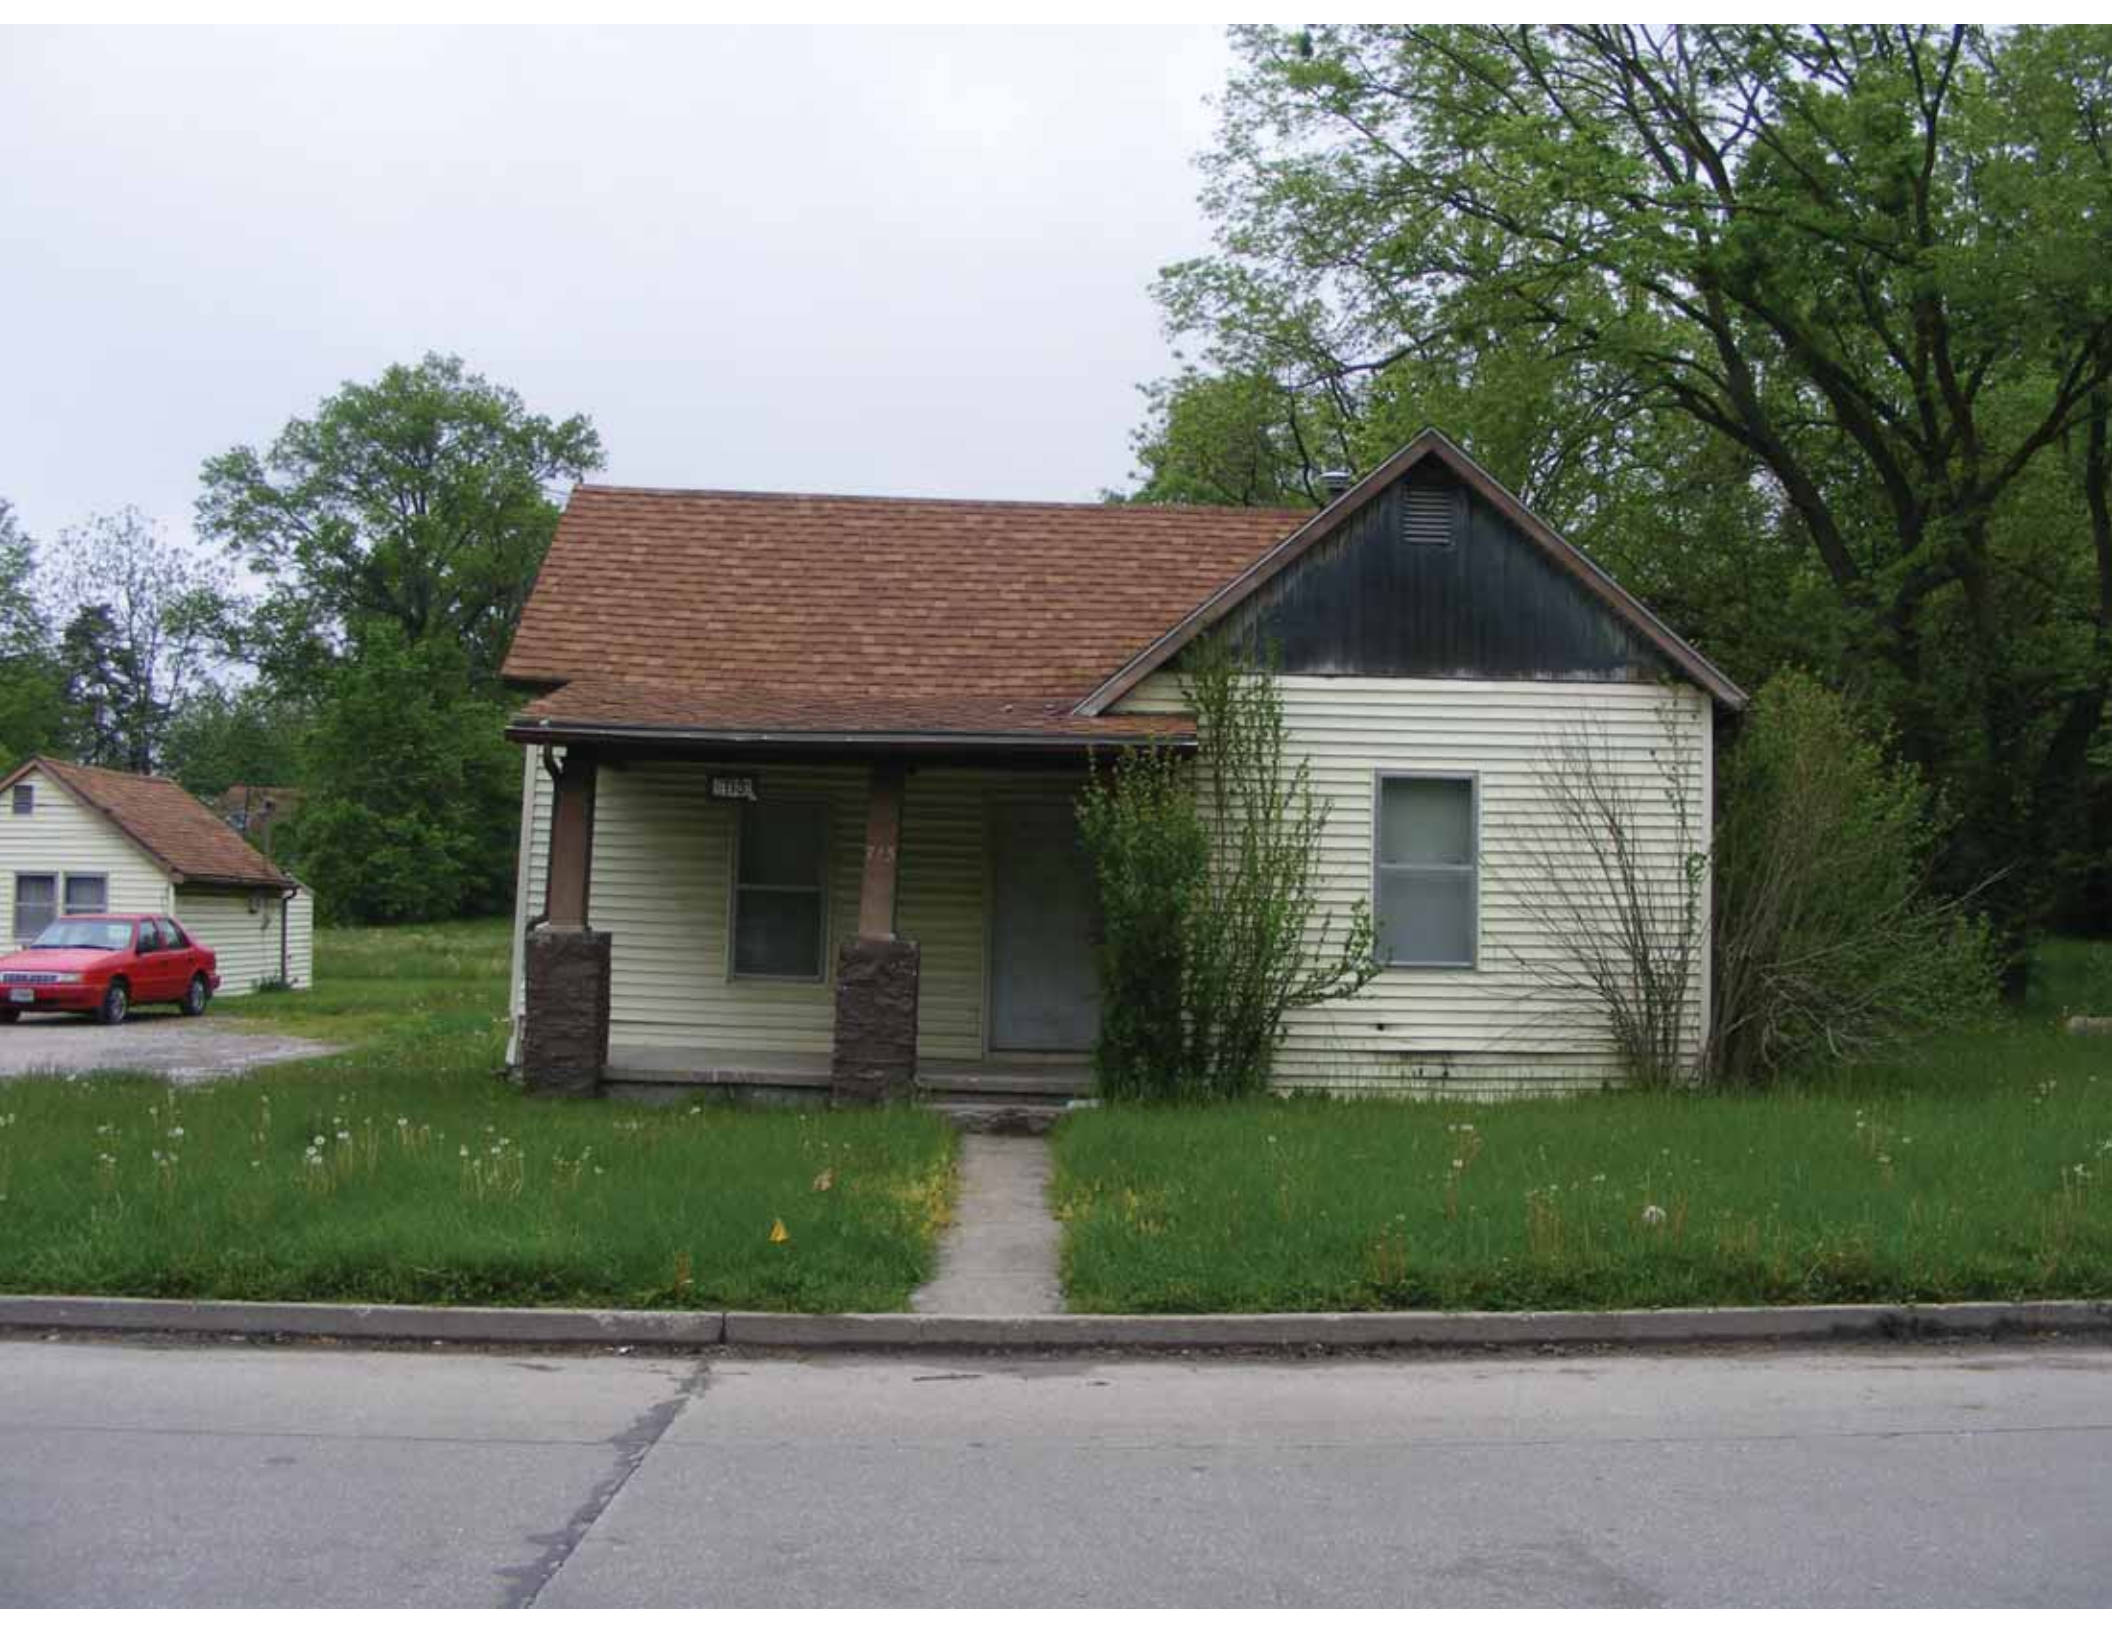
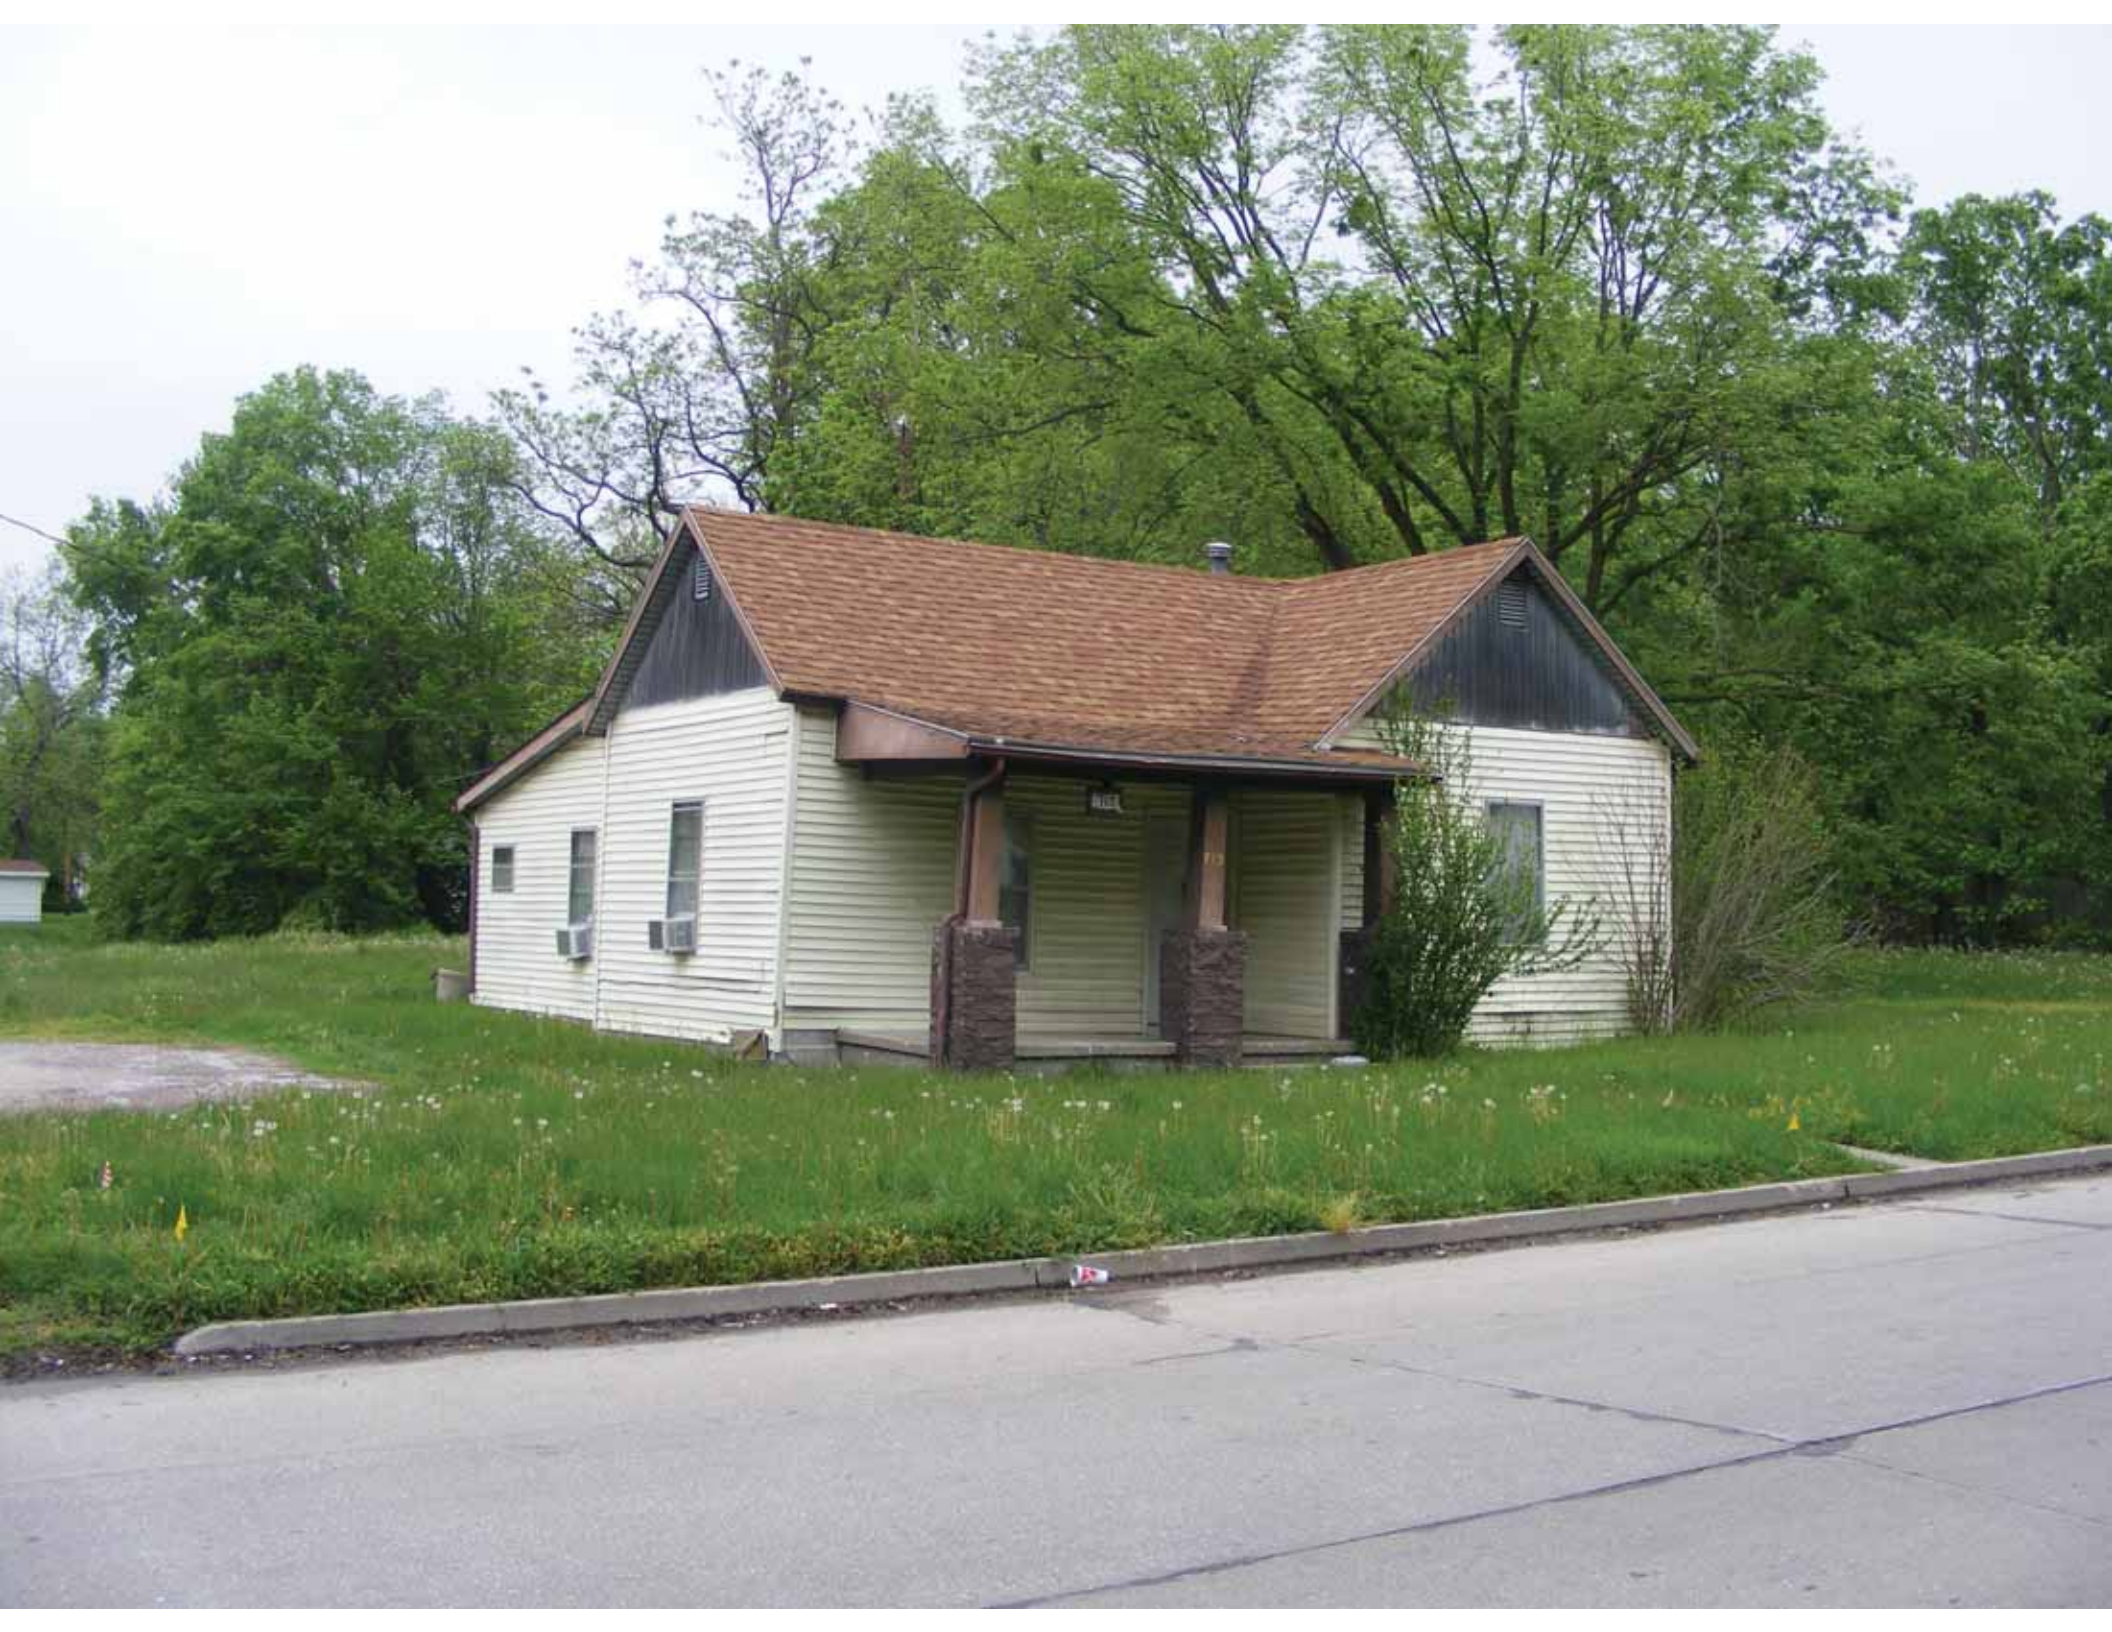
The dwelling has an asphalt-shingled cross gabled roof, exterior synthetic siding and a concrete foundation. The primary (south) elevation has a shed porch supported by tapered columns on battered piers. Within the porch bay is a c. 2010 paneled door offset by a one-over-one window. The front facing gabled wing has a single window of similar configuration. Gable fields are filled with vertical boards and support louvered vents. The rear elevation has a shed one-story wing.

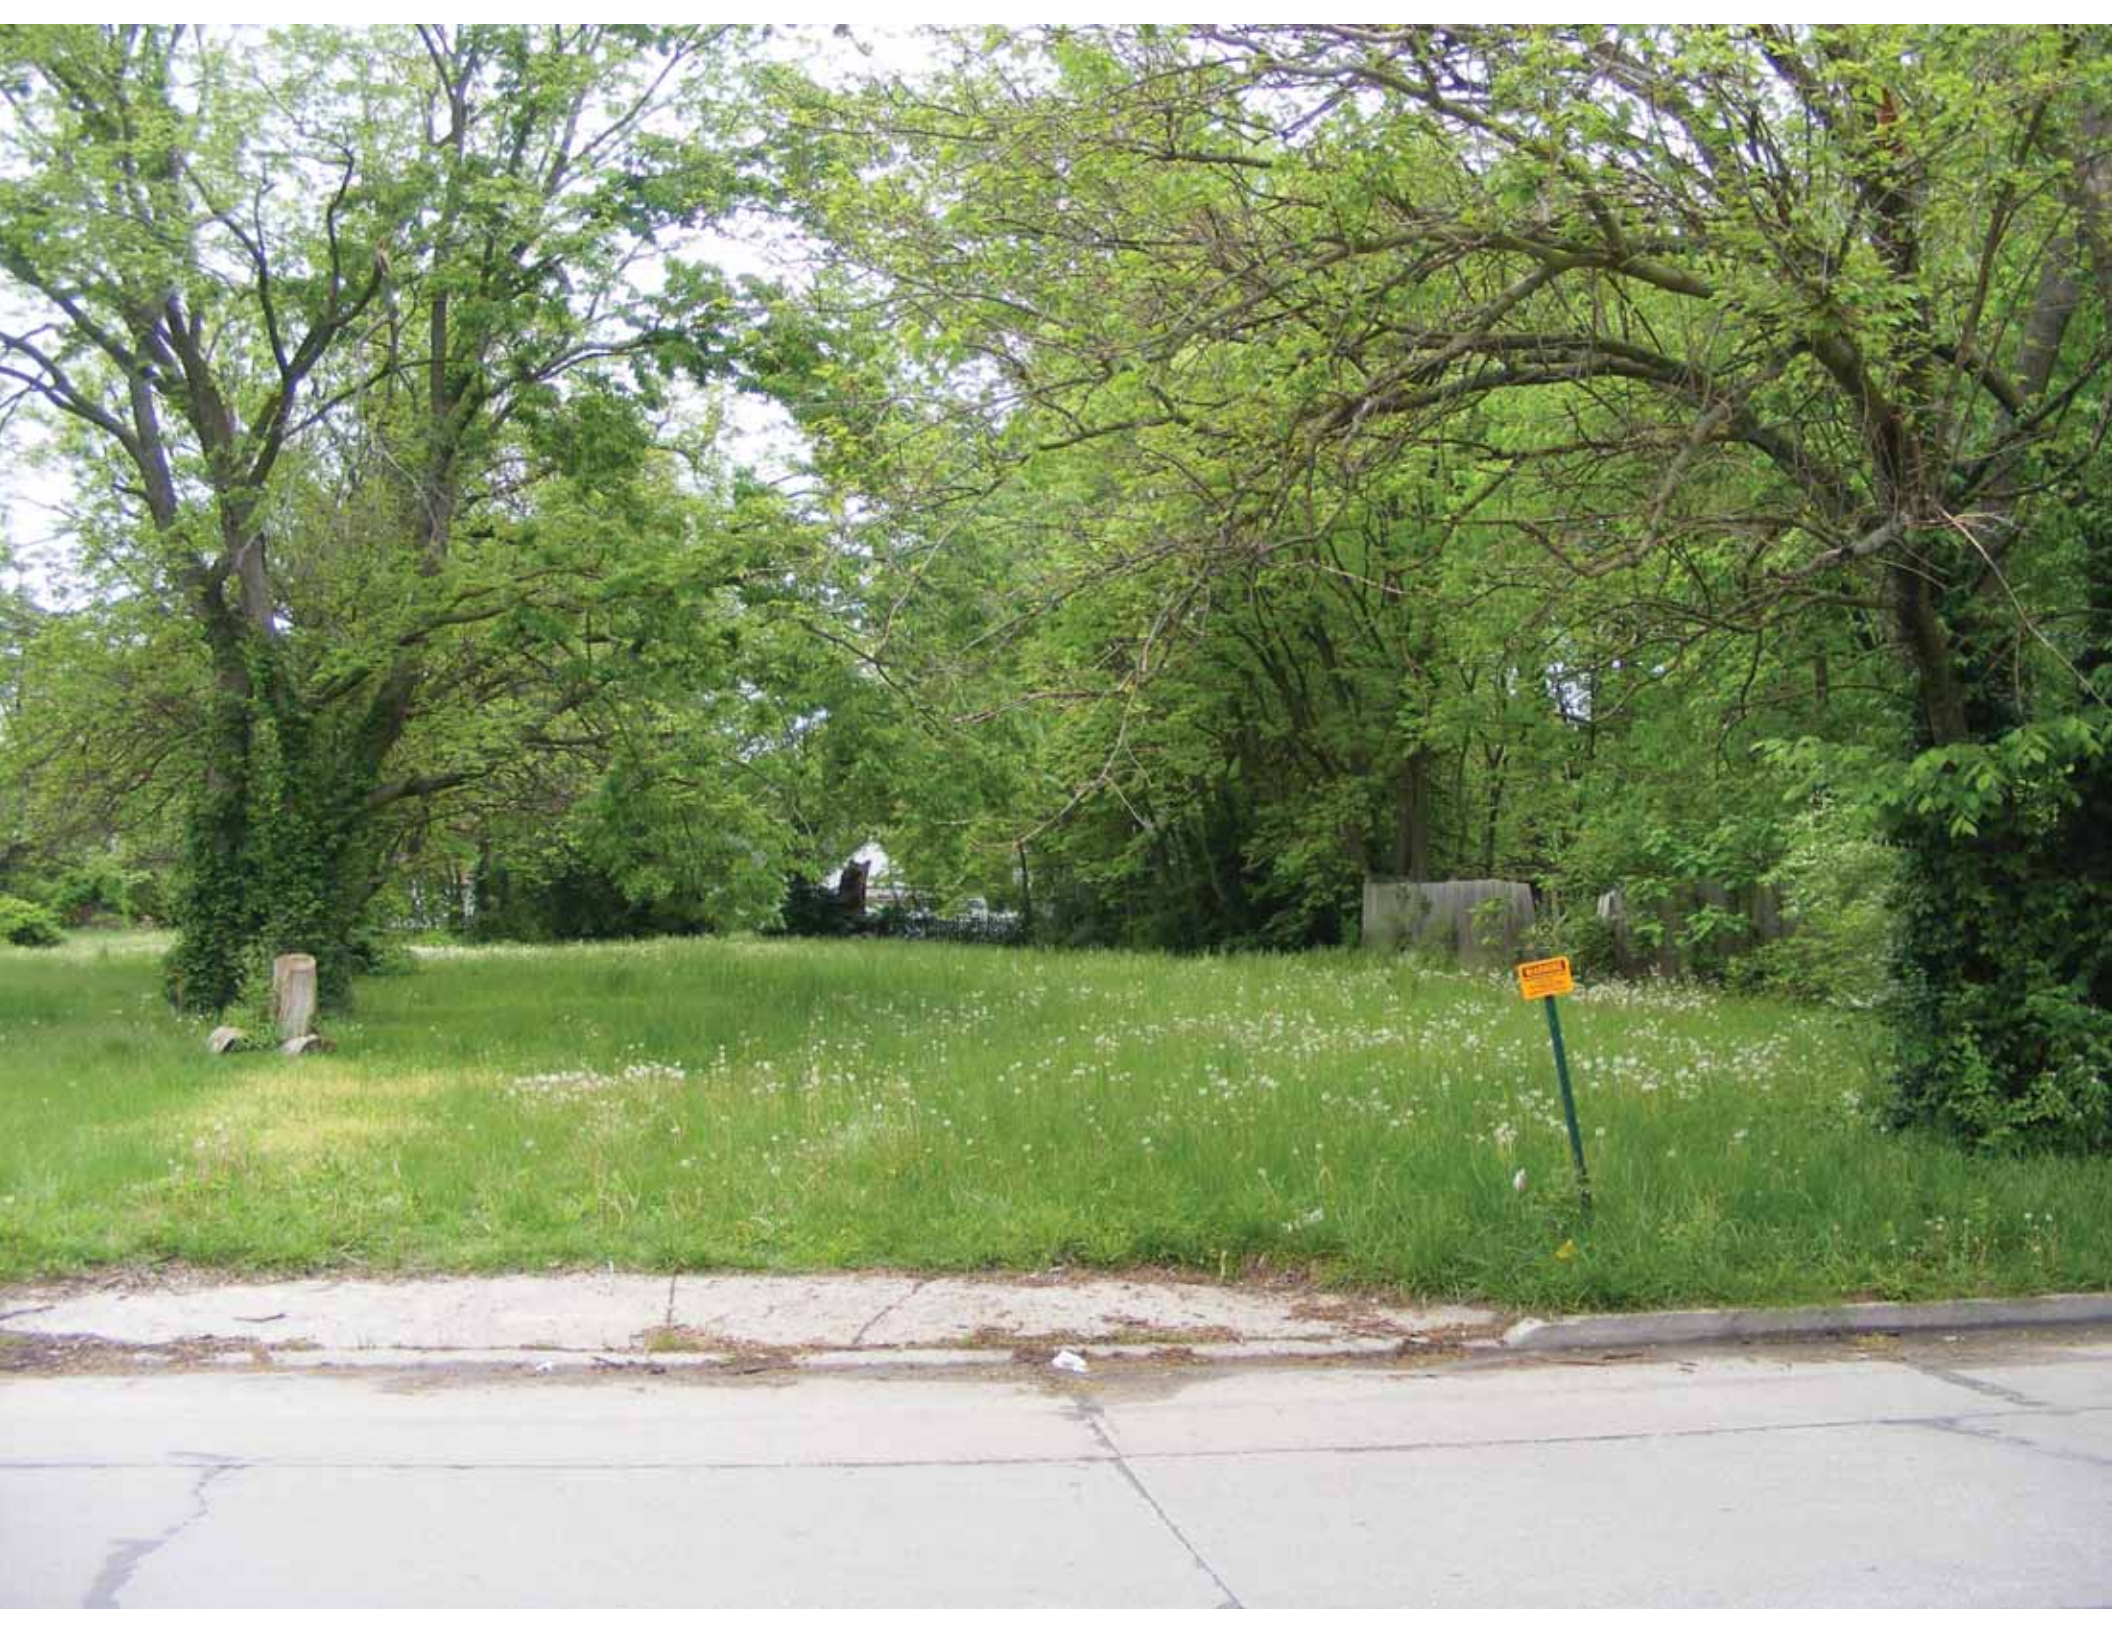
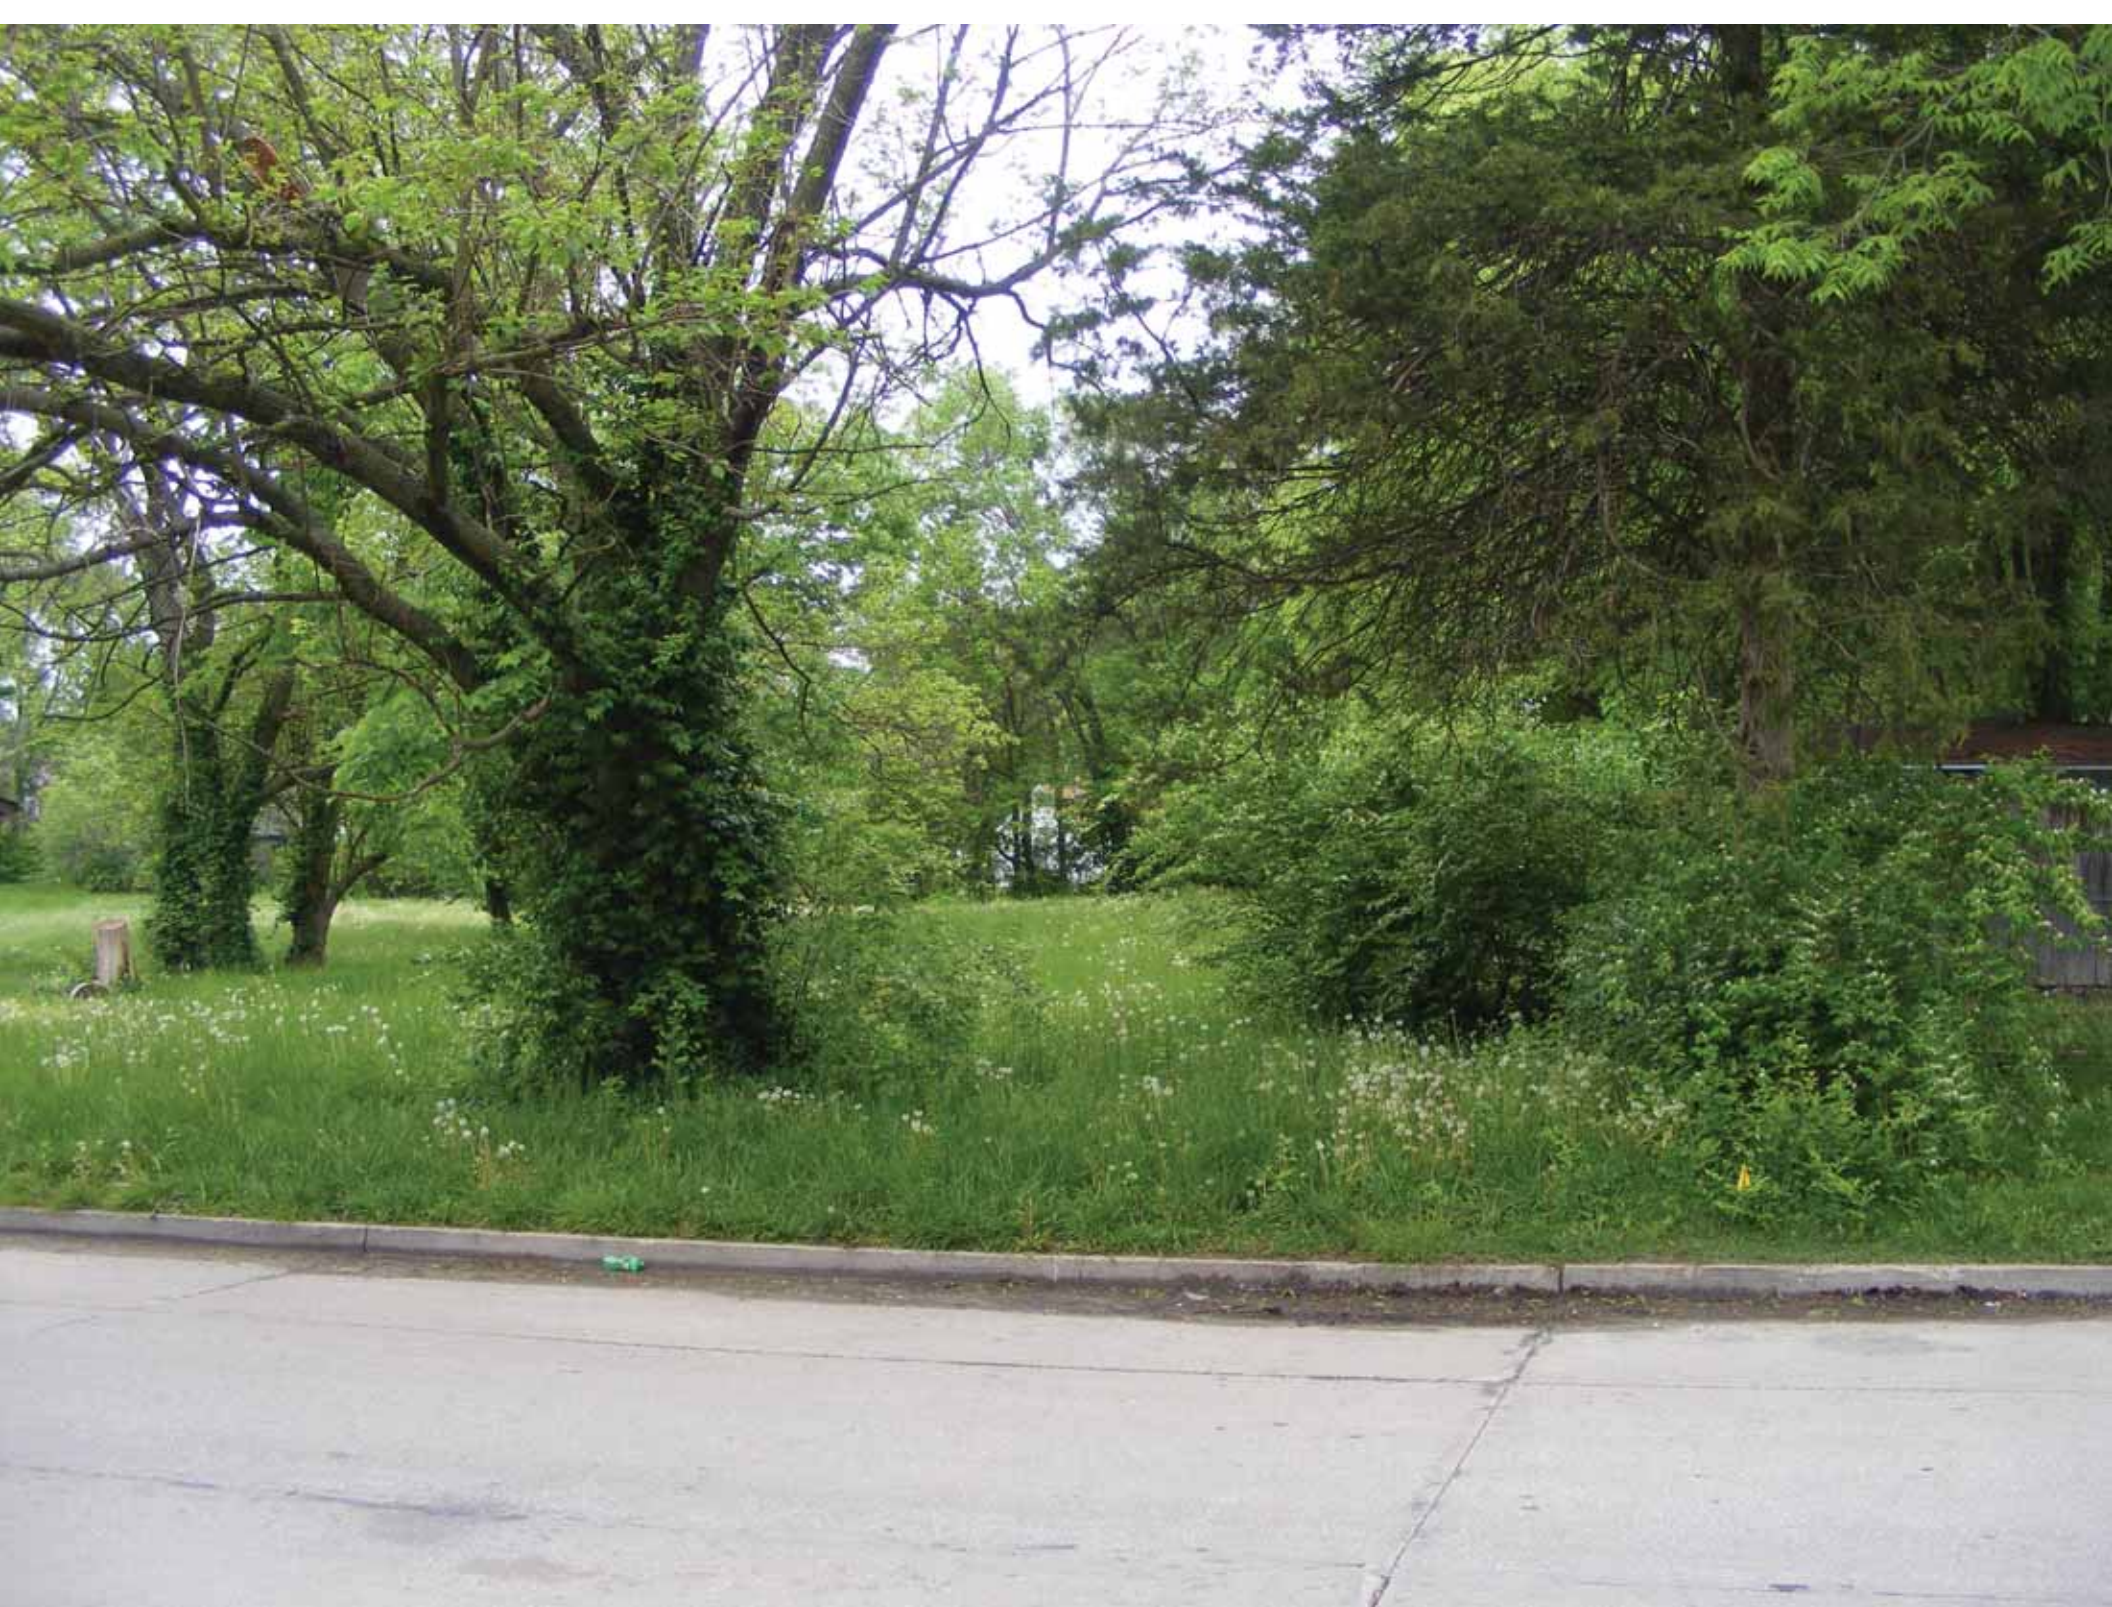
The property is a grass covered lot with mature trees as noted above.
