MISSOURI DEPARTMENT OF NATURAL RESOURCES
STATE HISTORIC PRESERVATION OFFICE, P.O. Box 176, Jefferson City, MO 65102
ARCHITECTURAL/HISTORIC INVENTORY FORM

1. Survey No. BO-AS-011-0087		2. Survey name: North Central Columbia Survey Phase II	
3. County: Boone		4. Address (Street No.) 902	Street (name) N. Seventh Street
5. City: Columbia	Vicinity: <input type="checkbox"/>	6. Geographical Reference:	7. Township/Range/Section: T: R: S:
8. Historic name (if known):		9. Present/other name (if known):	
10. Ownership: <input checked="" type="checkbox"/> Private <input type="checkbox"/> Public		11a. Historic use (if known): Domestic/single dwelling	11b. Current use: Domestic/single dwelling

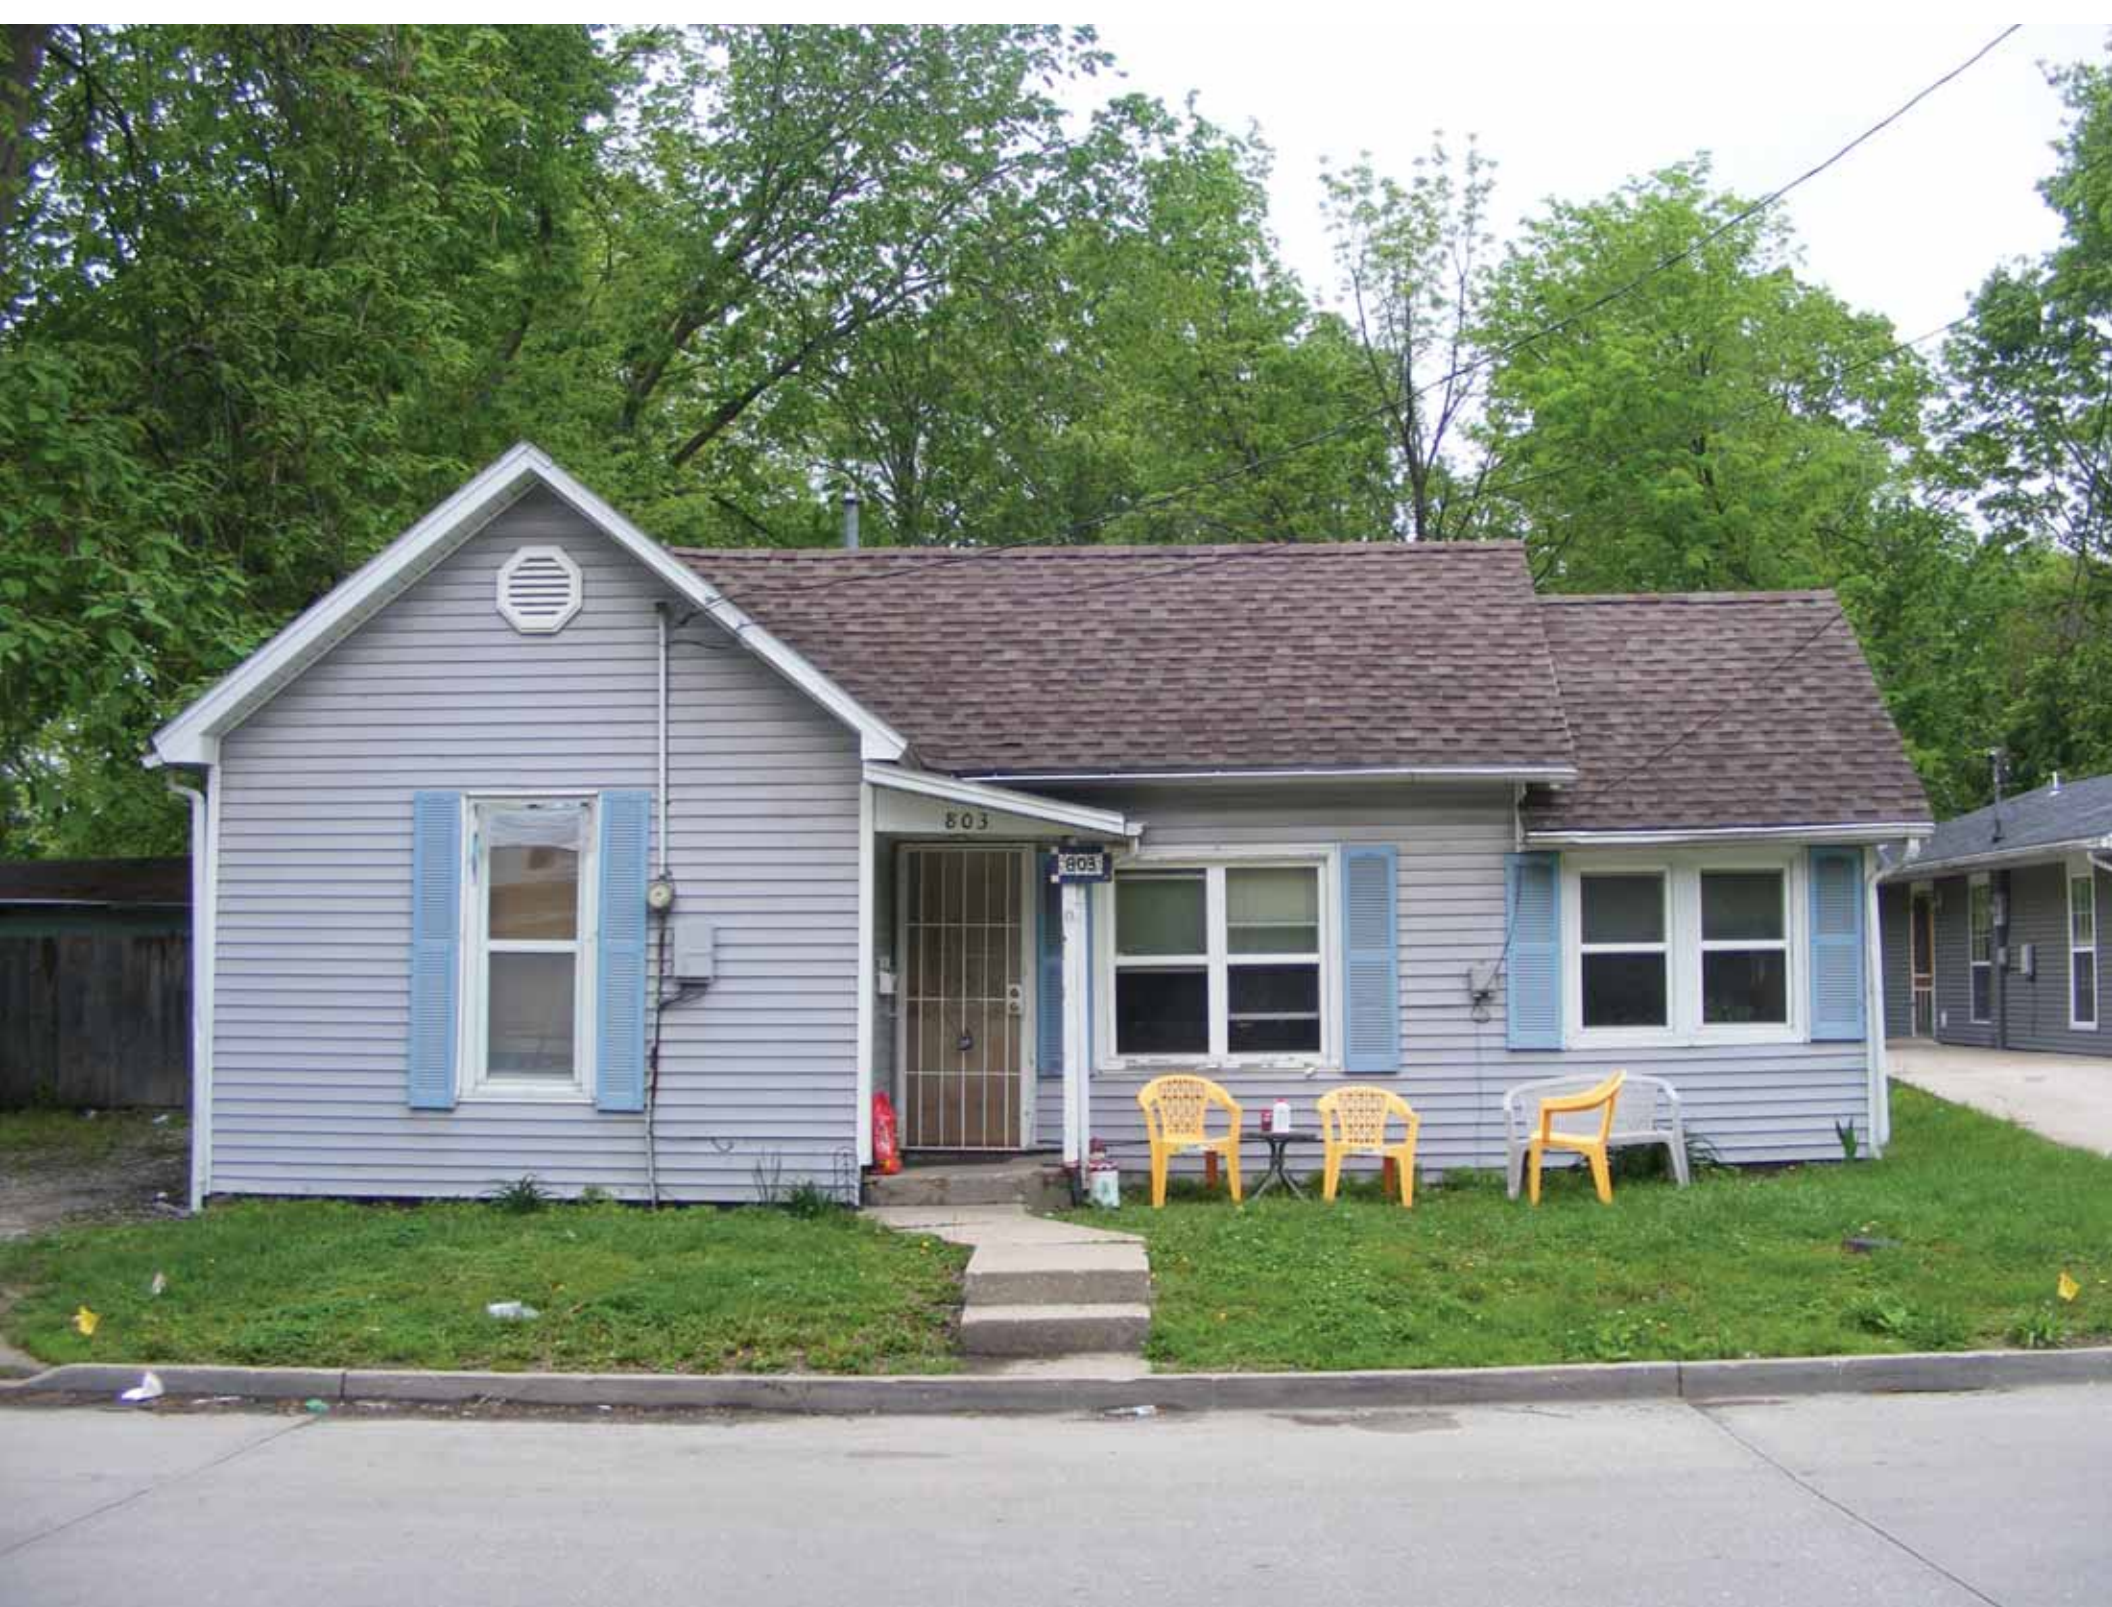
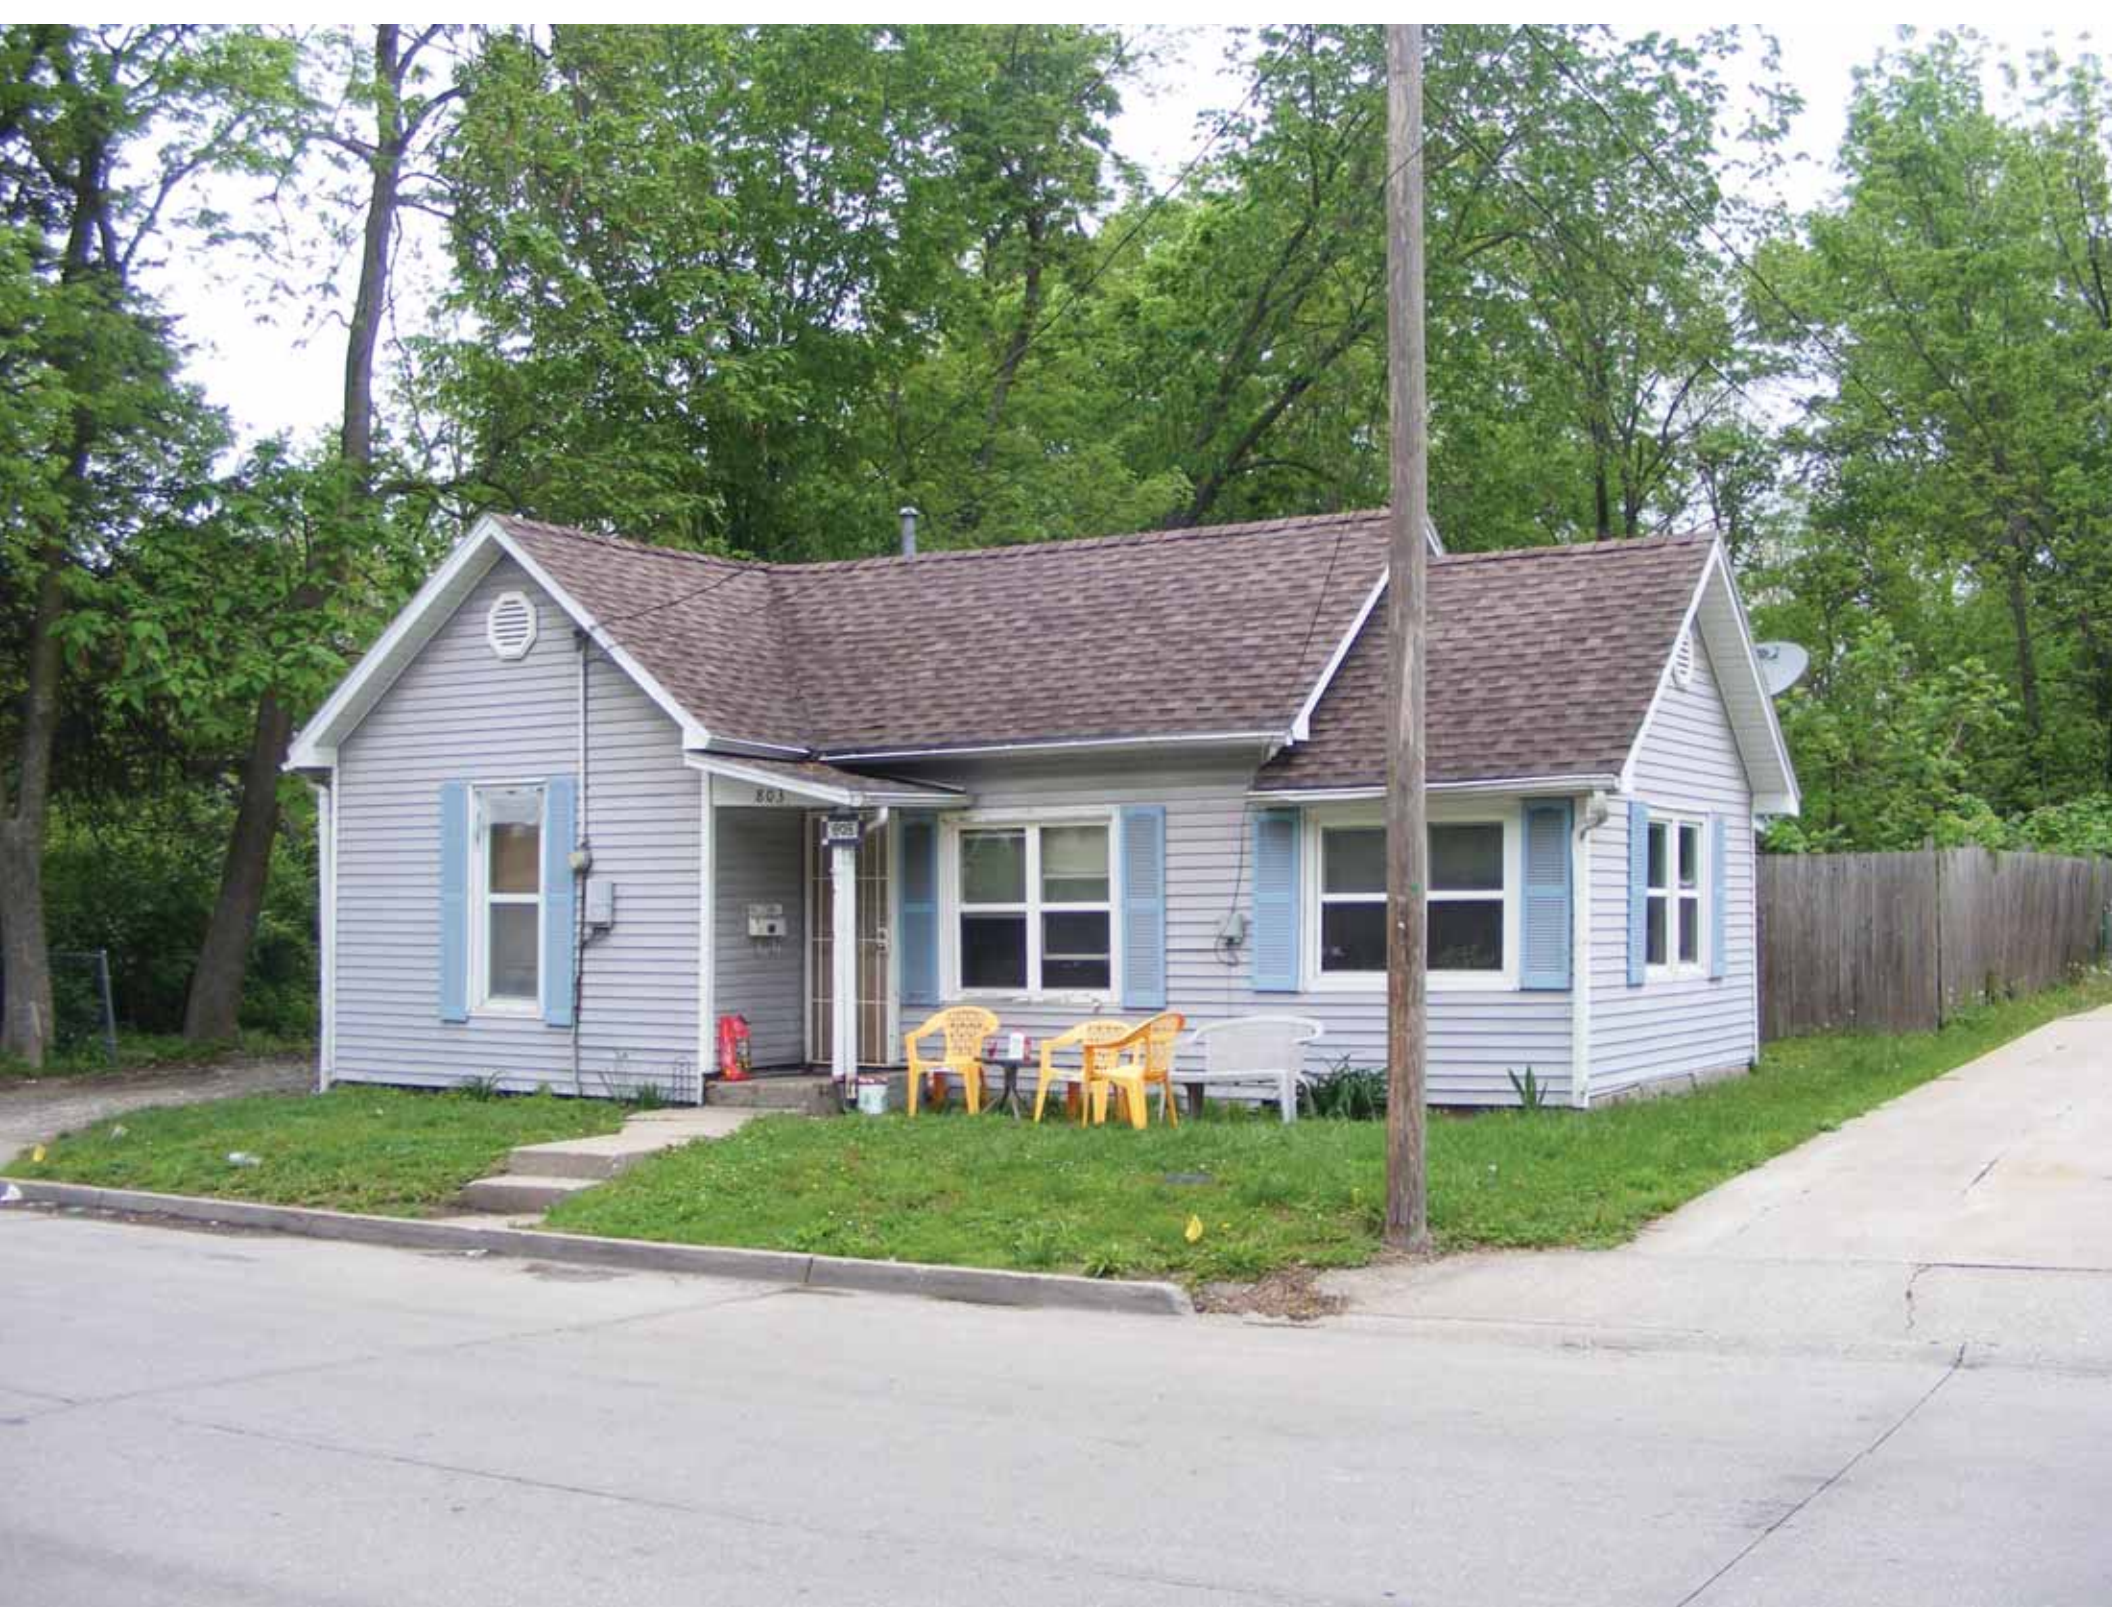
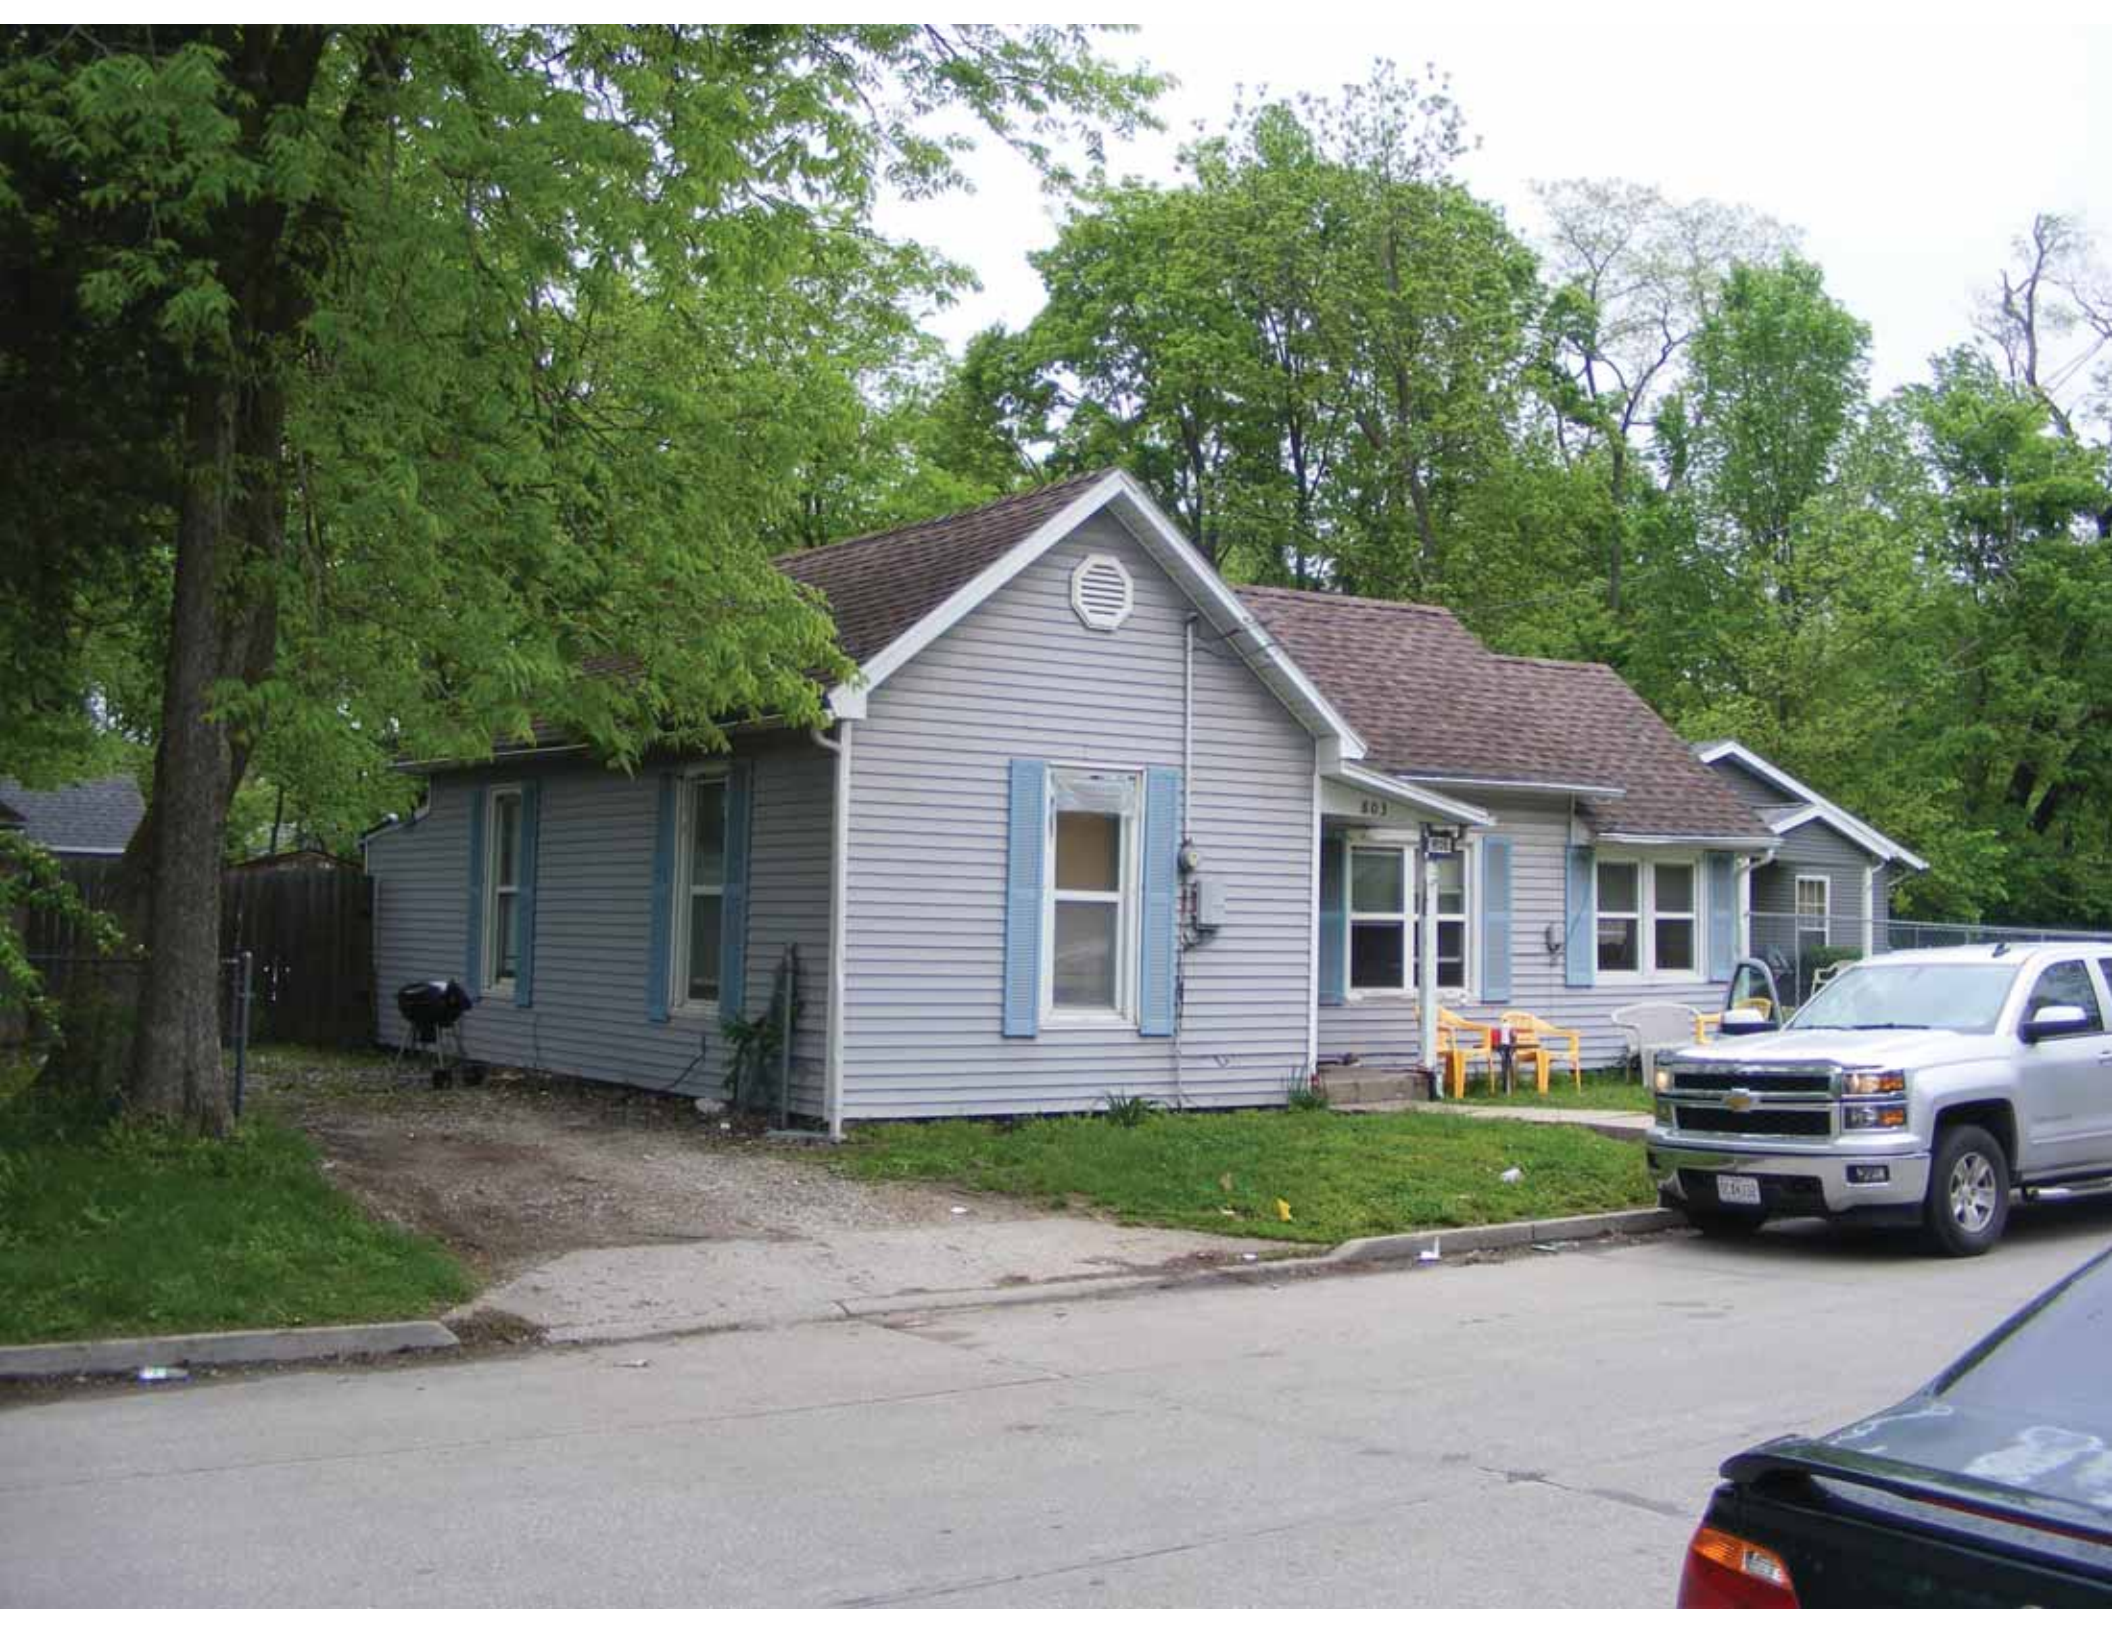
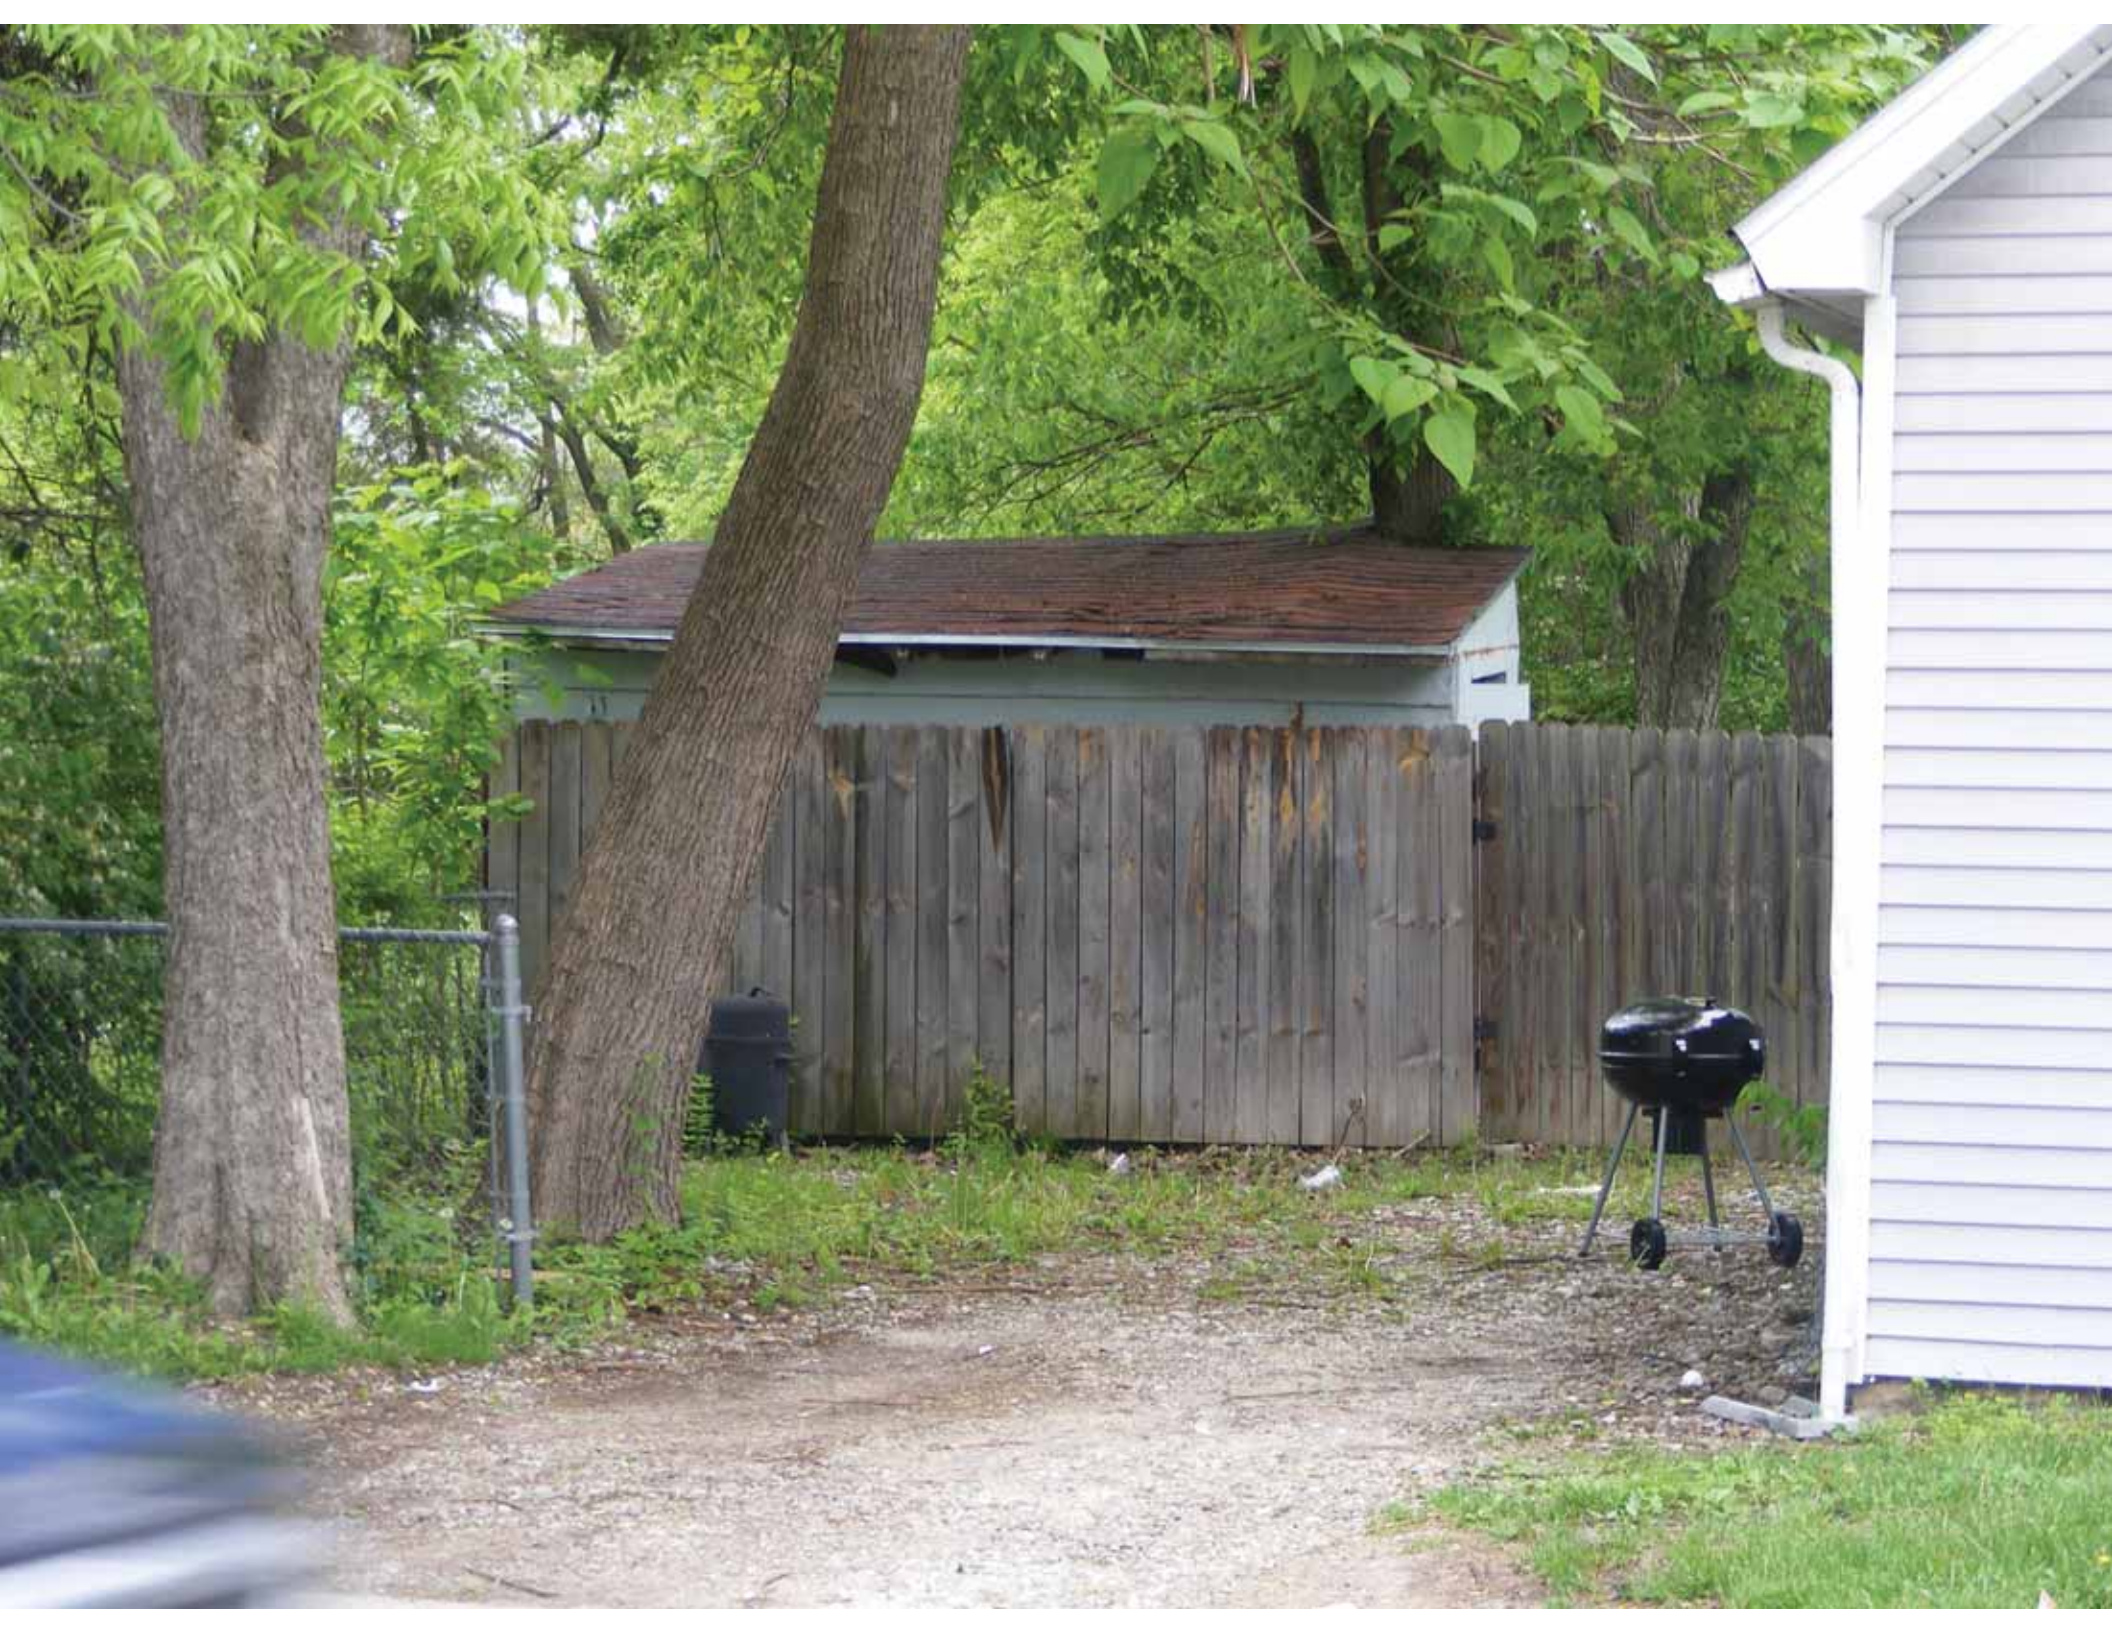
The dwelling has an asphalt shingled roof, exterior synthetic siding and a concrete foundation. The primary (south) elevation has a front facing gabled wing at the east end. The wing has a one-over-one window and gable field louvered vent. All windows are replacement, one-over-one with faux shutters. The west wall of the front gabled wing supports a shed awning supported by a single column resting on a concrete base. The portico is above a single door (south elevation) with upper multi-light window. Offsetting the entry to the east are two sets of paired windows.
