MISSOURI DEPARTMENT OF NATURAL RESOURCES
STATE HISTORIC PRESERVATION OFFICE, P.O. Box 176, Jefferson City, MO 65102
ARCHITECTURAL/HISTORIC INVENTORY FORM

1. Survey No. BO-AS-011-0087		2. Survey name: North Central Columbia Survey Phase II	
3. County: Boone		4. Address (Street No.) 902	Street (name) N. Seventh Street
5. City: Columbia	Vicinity: <input type="checkbox"/>	6. Geographical Reference:	7. Township/Range/Section: T: R: S:
8. Historic name (if known):		9. Present/other name (if known):	
10. Ownership: <input checked="" type="checkbox"/> Private <input type="checkbox"/> Public		11a. Historic use (if known): Domestic/single dwelling	11b. Current use: Domestic/single dwelling

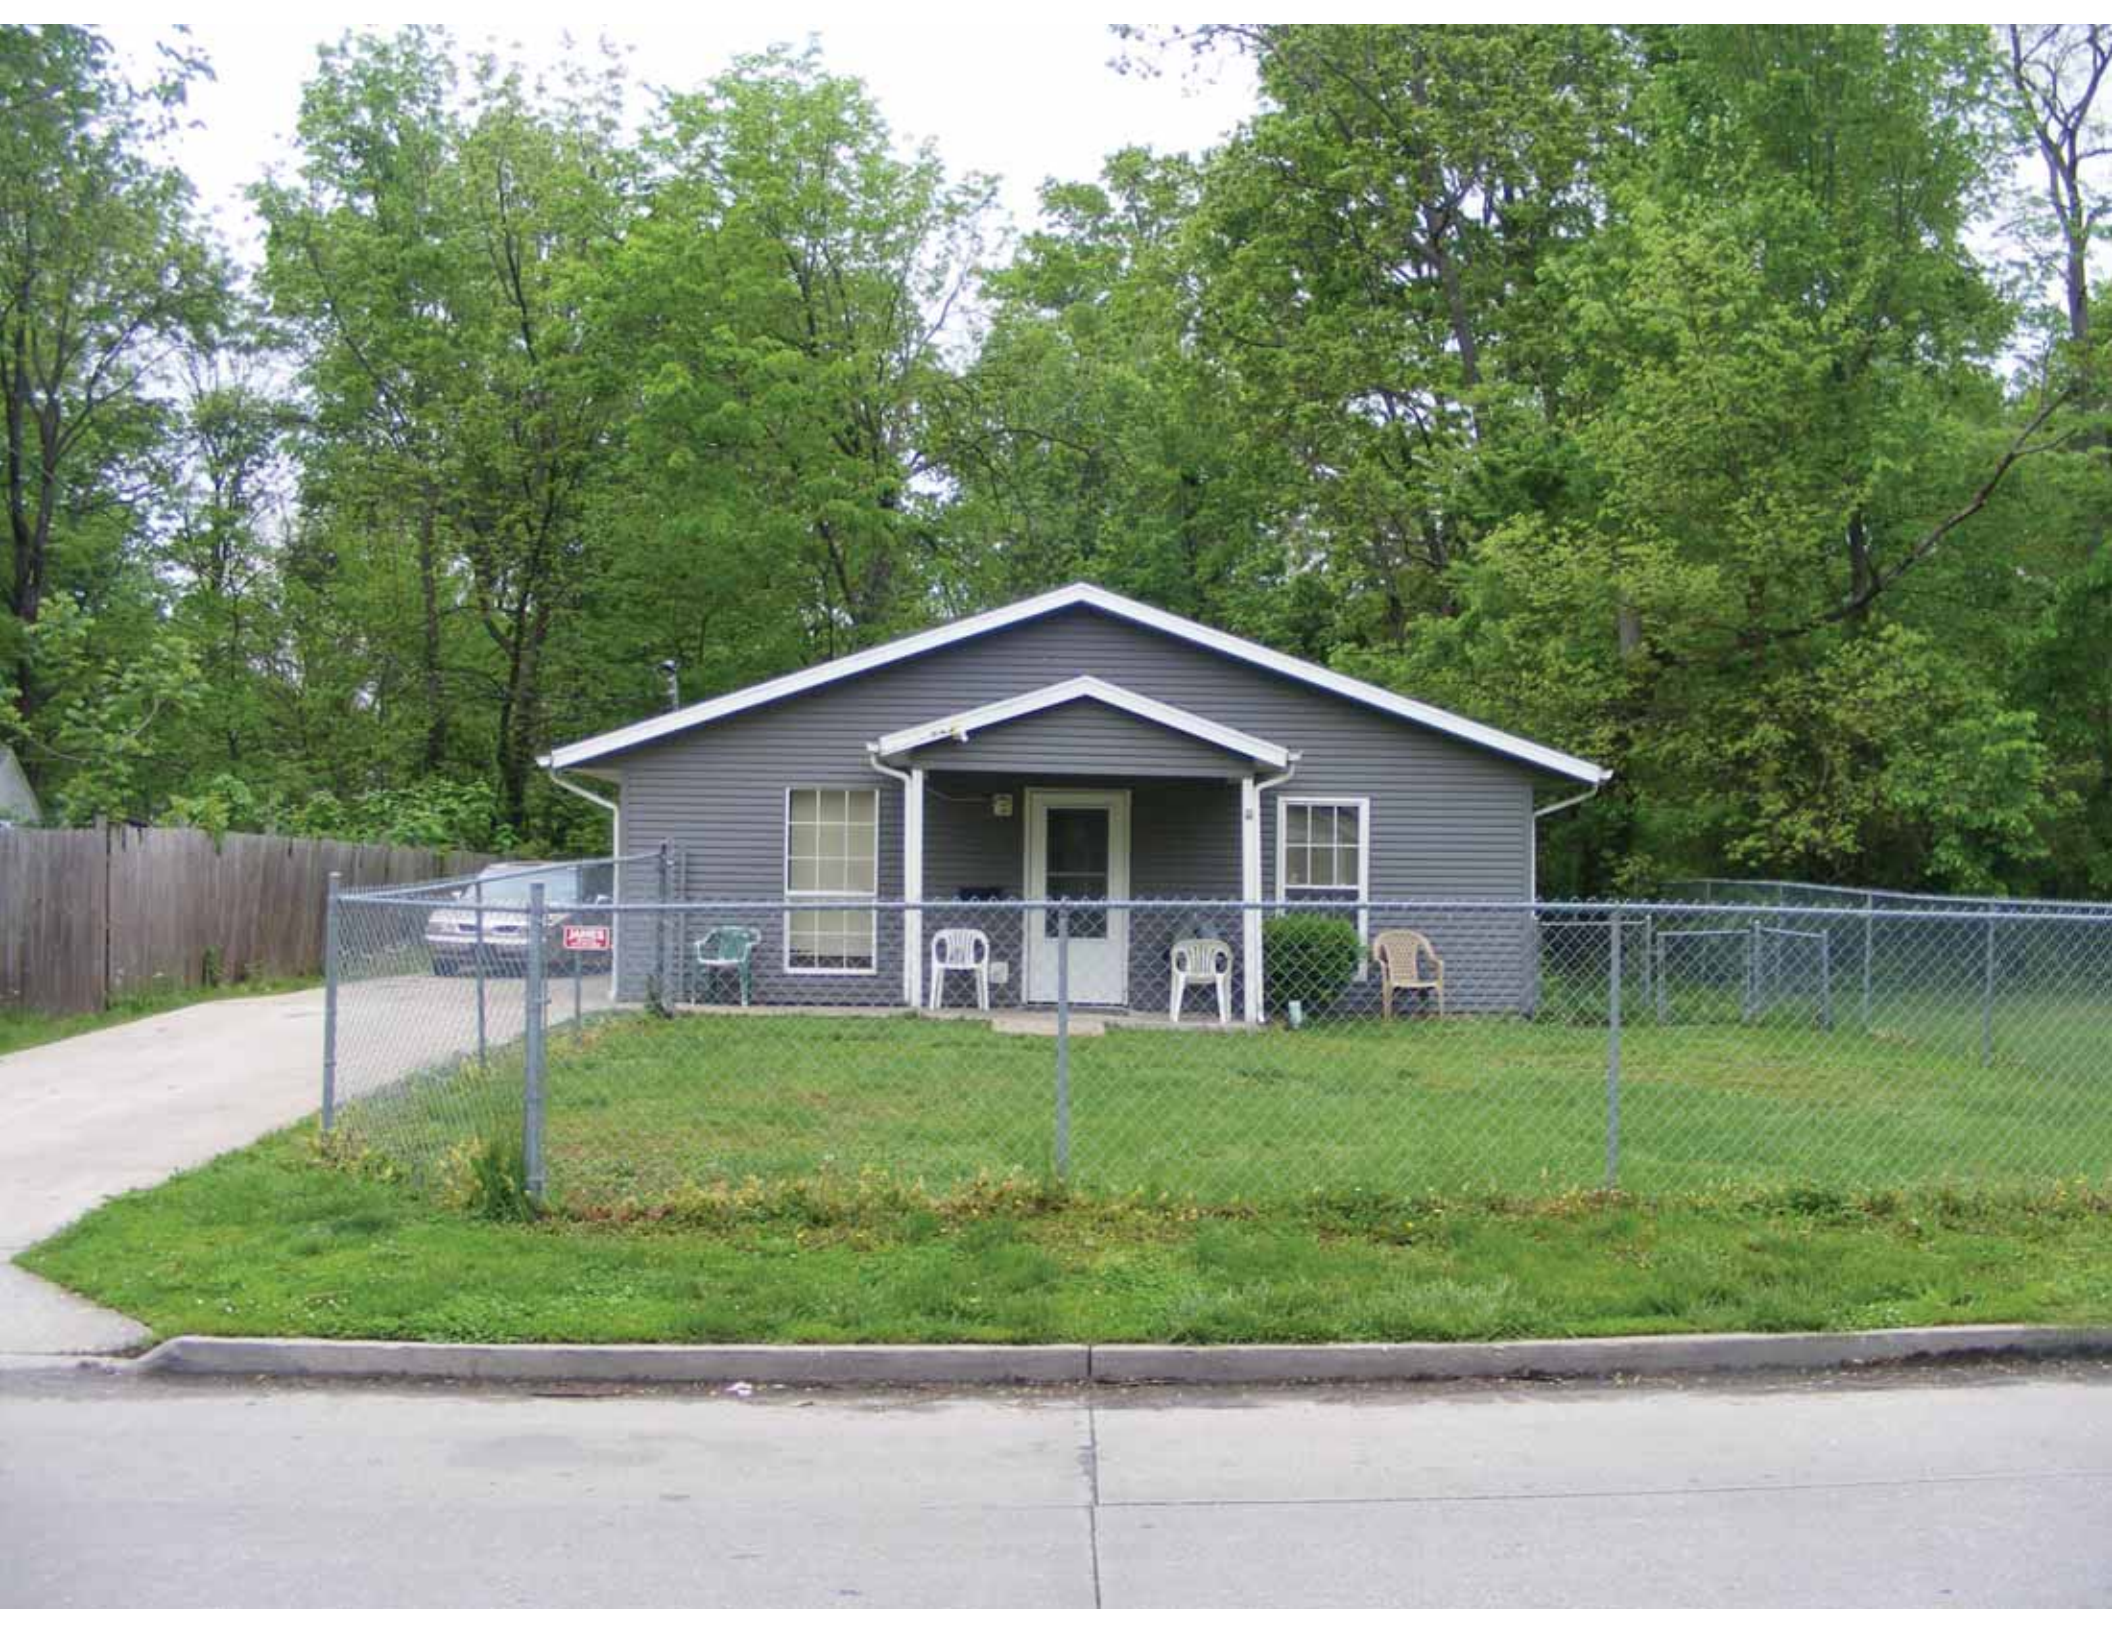
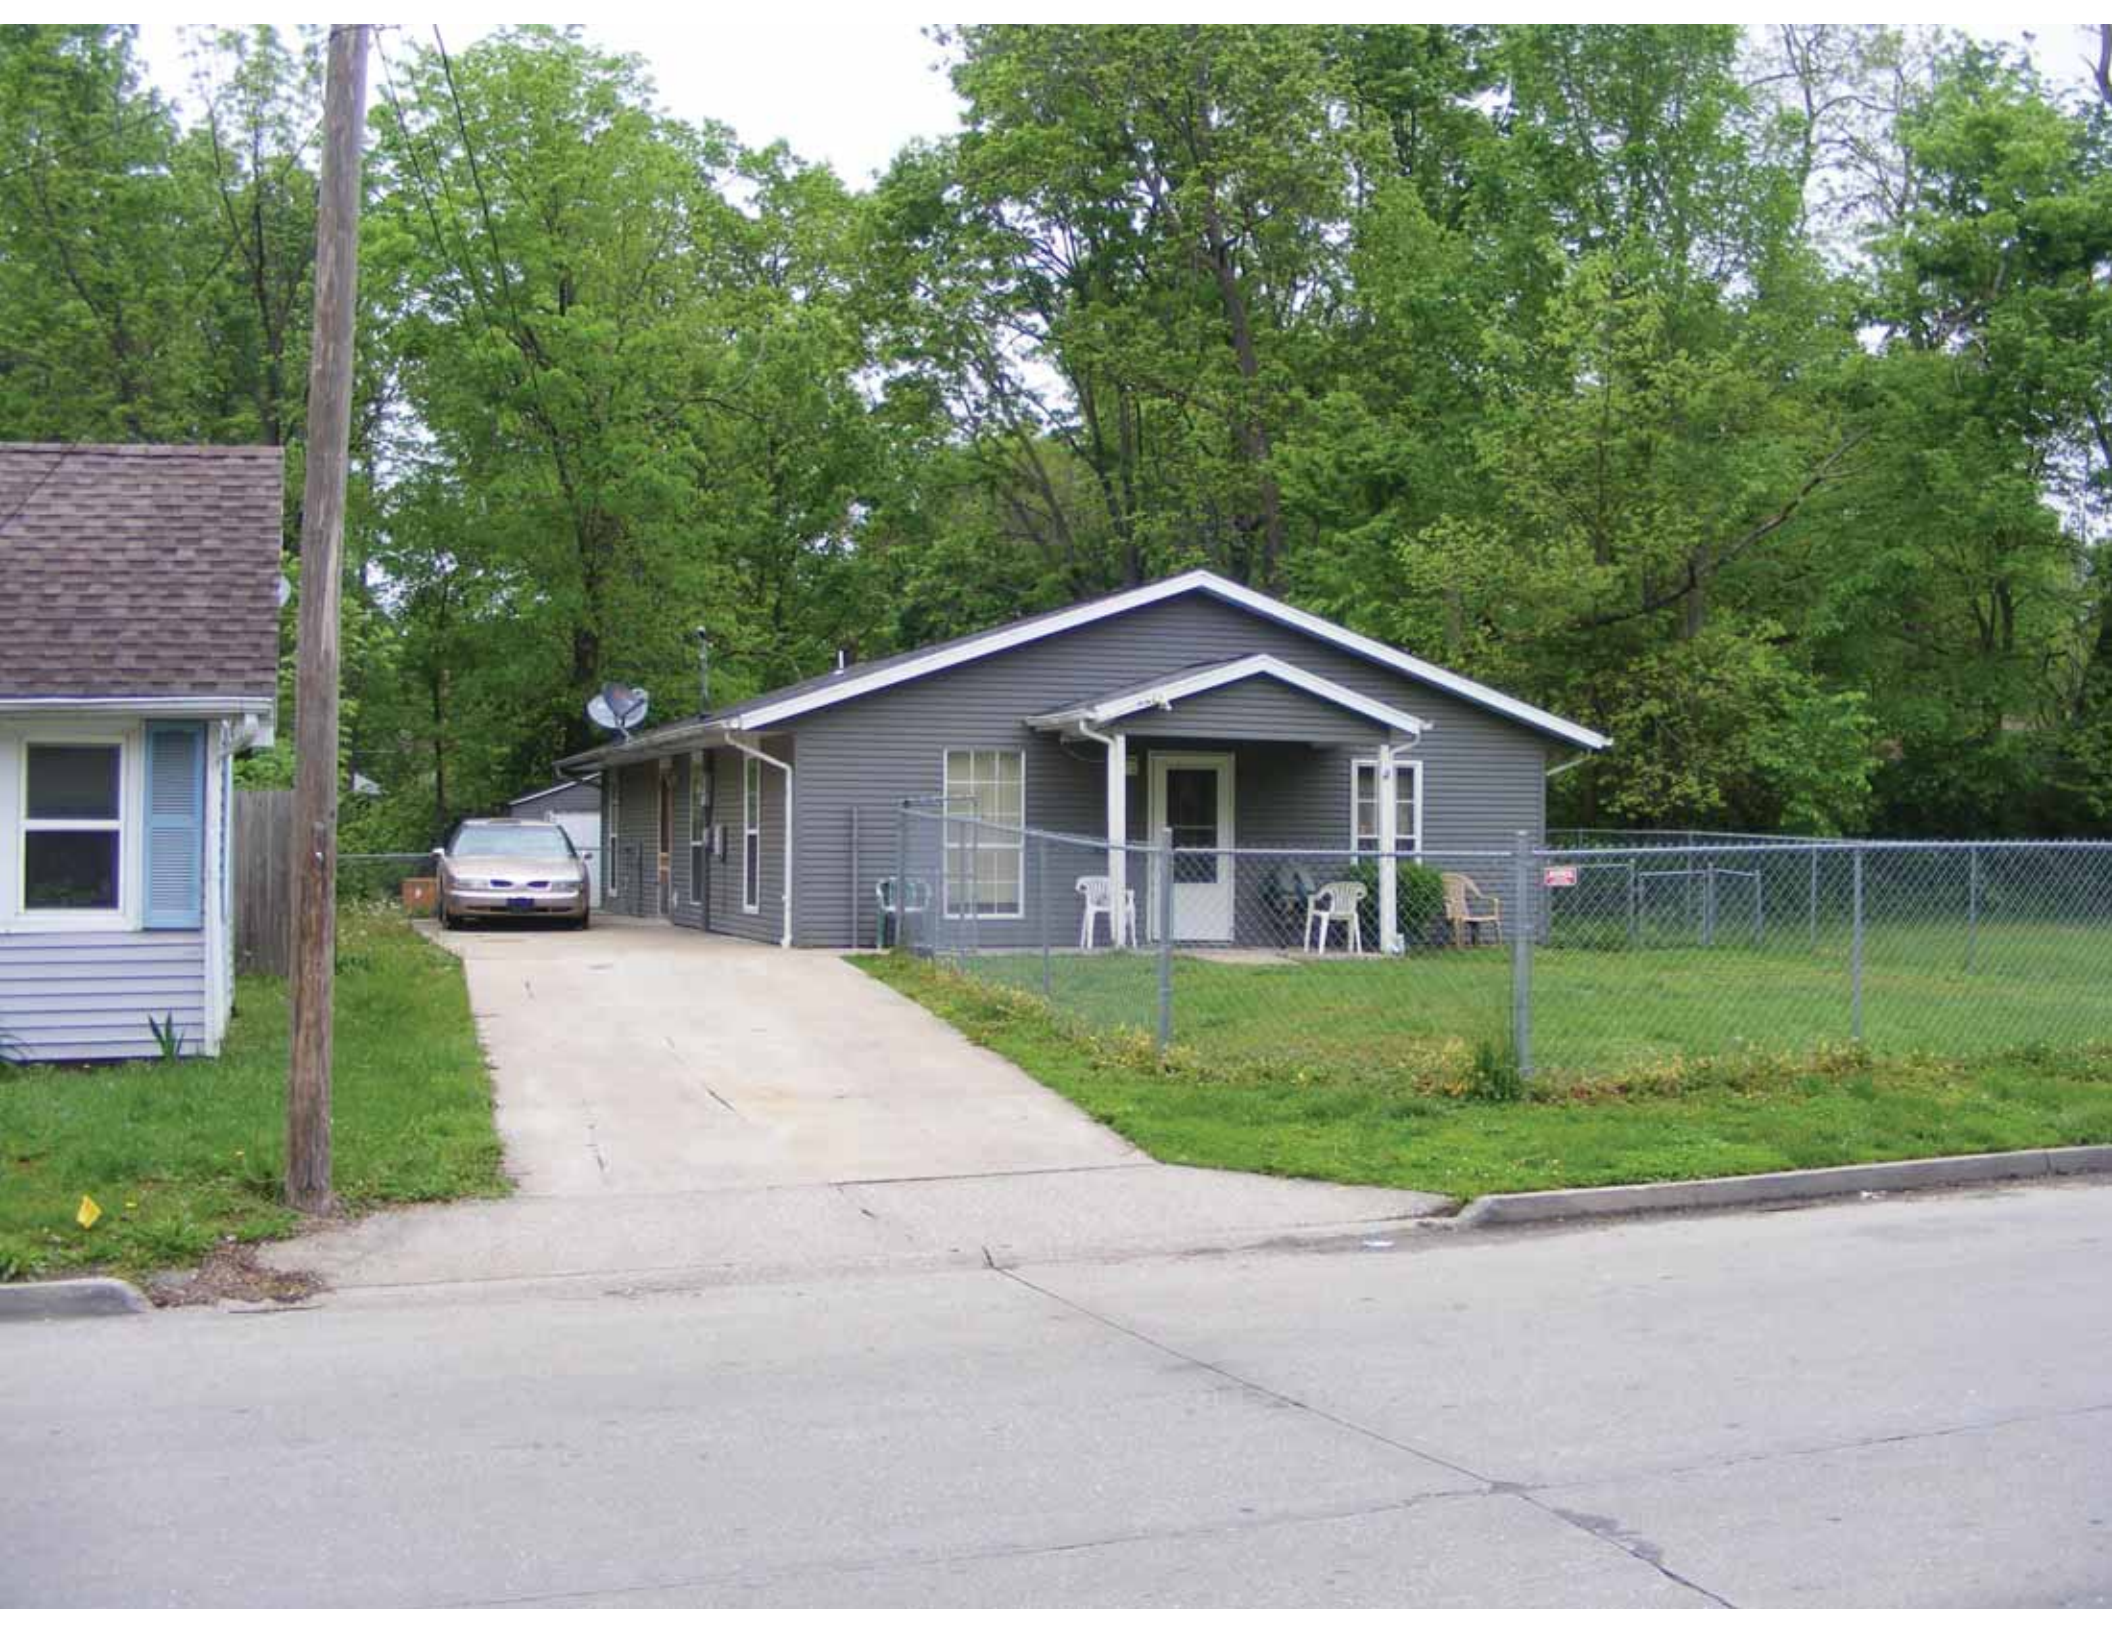
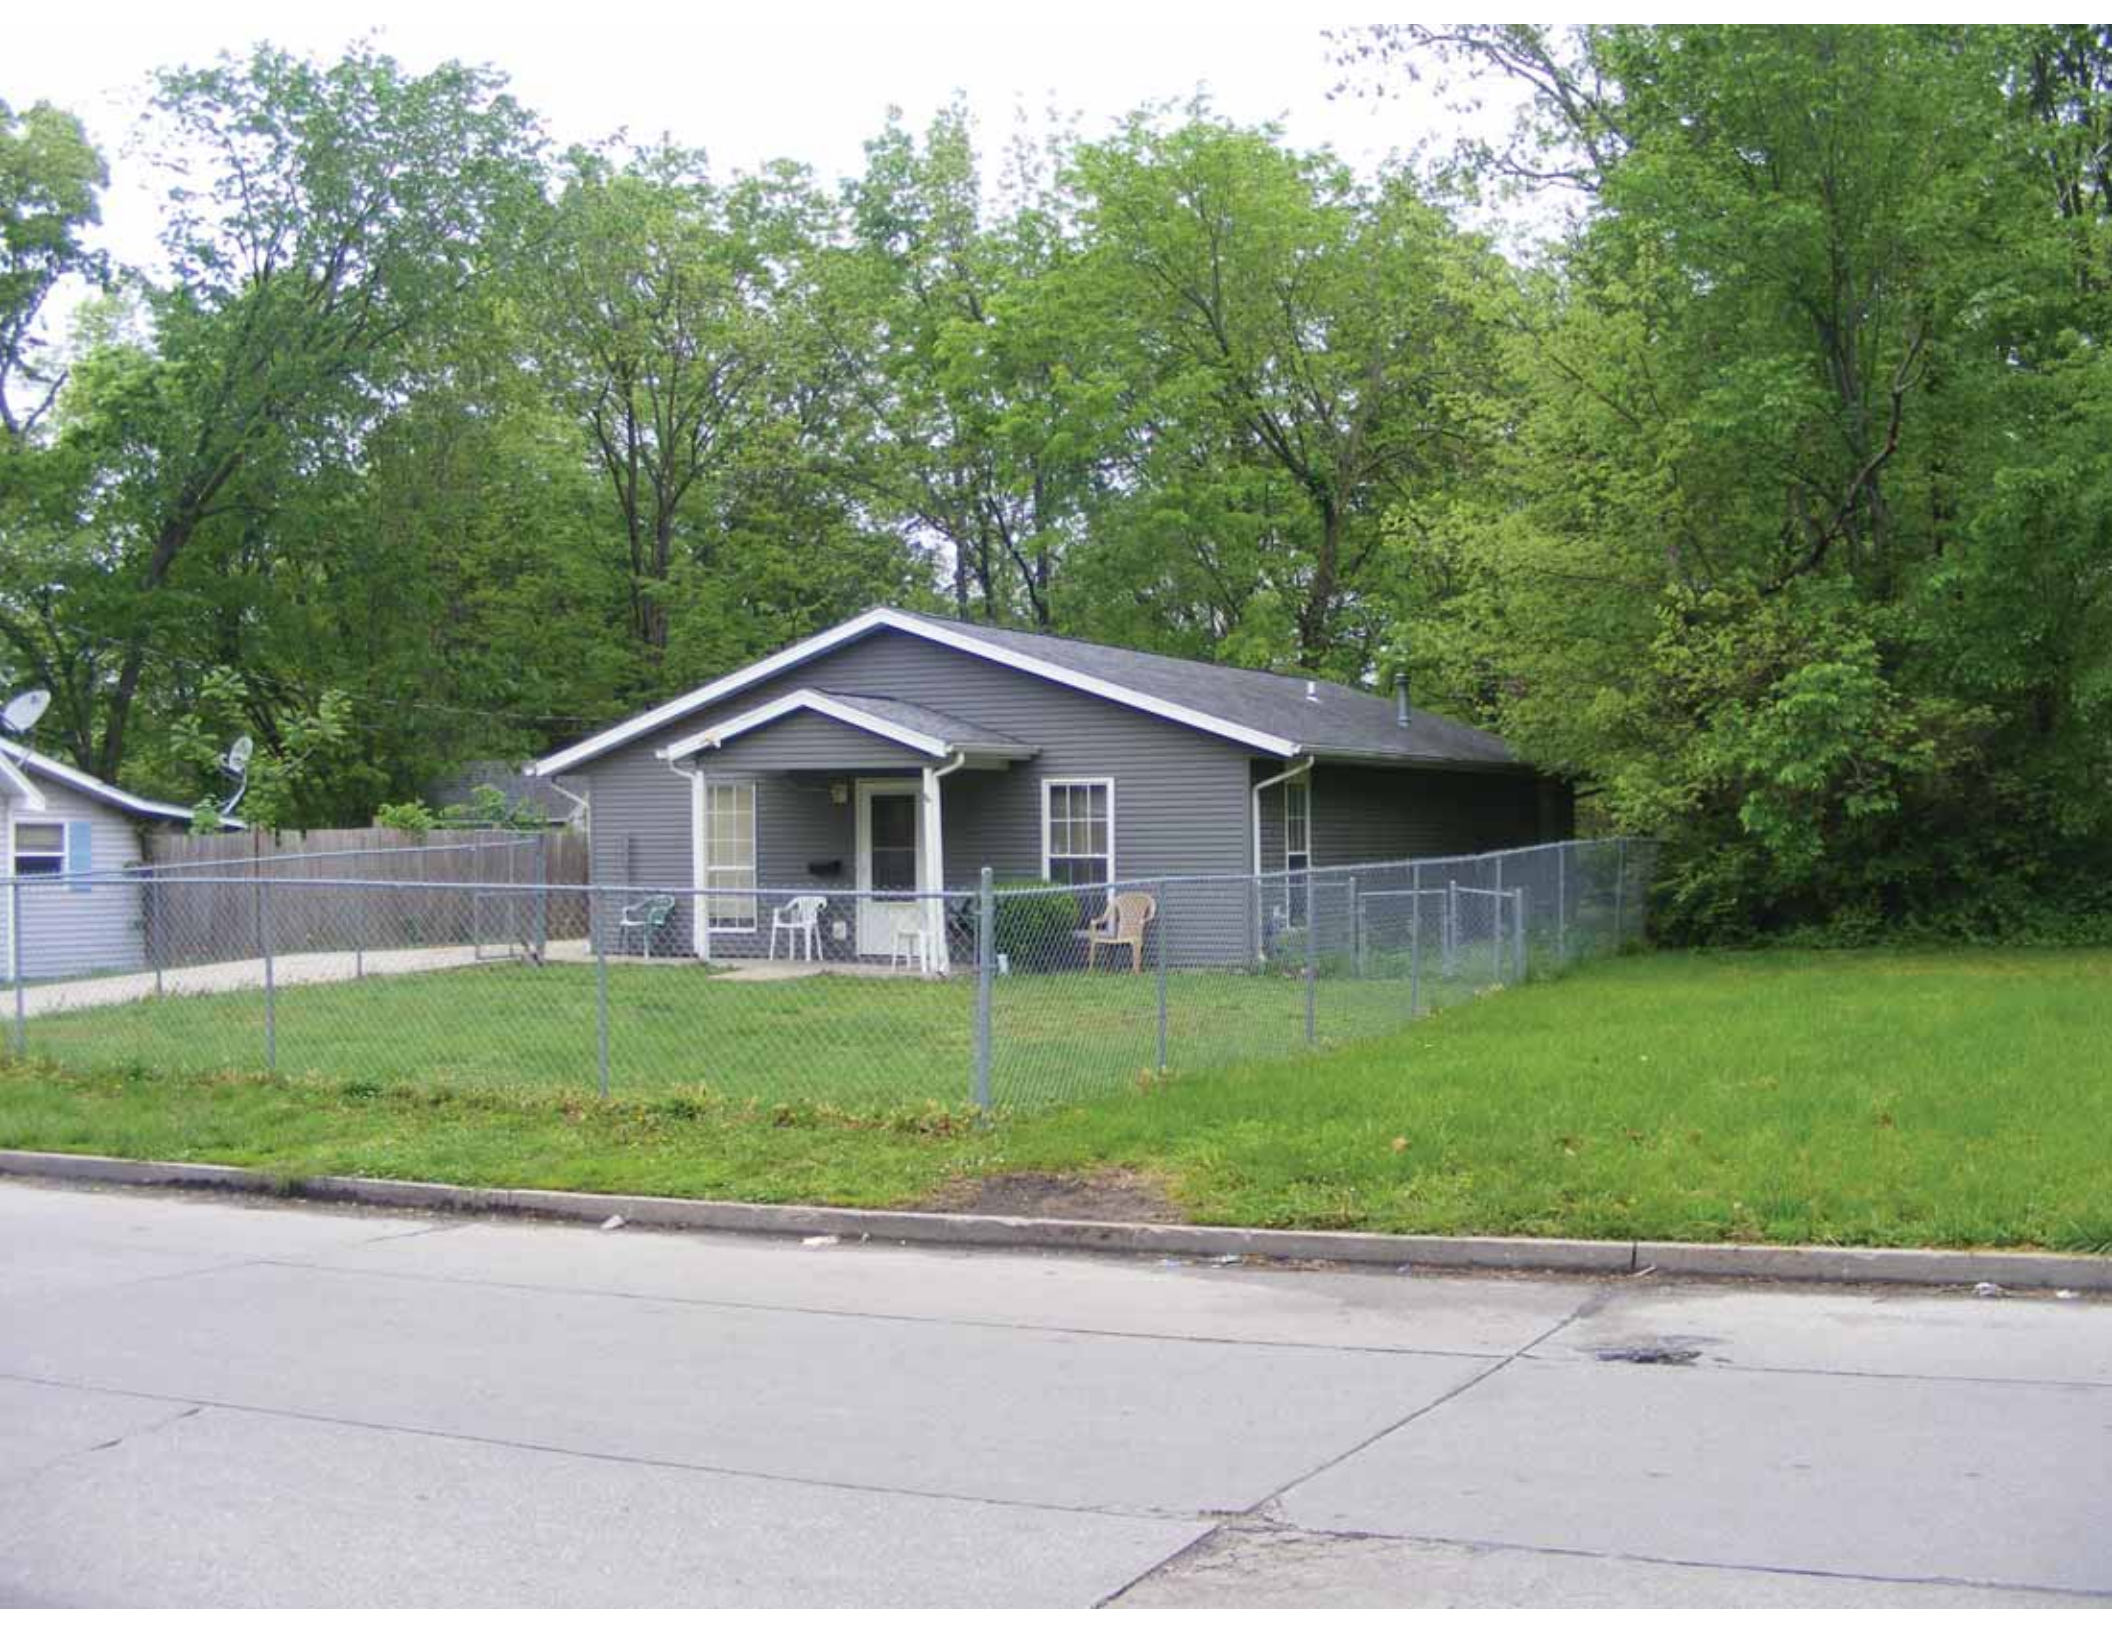
The dwelling has a low gabled asphalt-shingled roof, exterior synthetic siding and a concrete slab foundation. The primary (south) elevation has a central gabled portico supported by square wood columns. Below the porch roof, the façade wall holds a multi-light door. The portico is flanked by eight-over-six and six-over-six windows. The west elevation holds three windows and a secondary entry. The west elevation holds two windows.
