MISSOURI DEPARTMENT OF NATURAL RESOURCES
STATE HISTORIC PRESERVATION OFFICE, P.O. Box 176, Jefferson City, MO 65102
ARCHITECTURAL/HISTORIC INVENTORY FORM

1. Survey No. BO-AS-011-0087		2. Survey name: North Central Columbia Survey Phase II	
3. County: Boone		4. Address (Street No.) 902	Street (name) N. Seventh Street
5. City: Columbia	Vicinity: <input type="checkbox"/>	6. Geographical Reference:	7. Township/Range/Section: T: R: S:
8. Historic name (if known):		9. Present/other name (if known):	
10. Ownership: <input checked="" type="checkbox"/> Private <input type="checkbox"/> Public		11a. Historic use (if known): Domestic/single dwelling	11b. Current use: Domestic/single dwelling

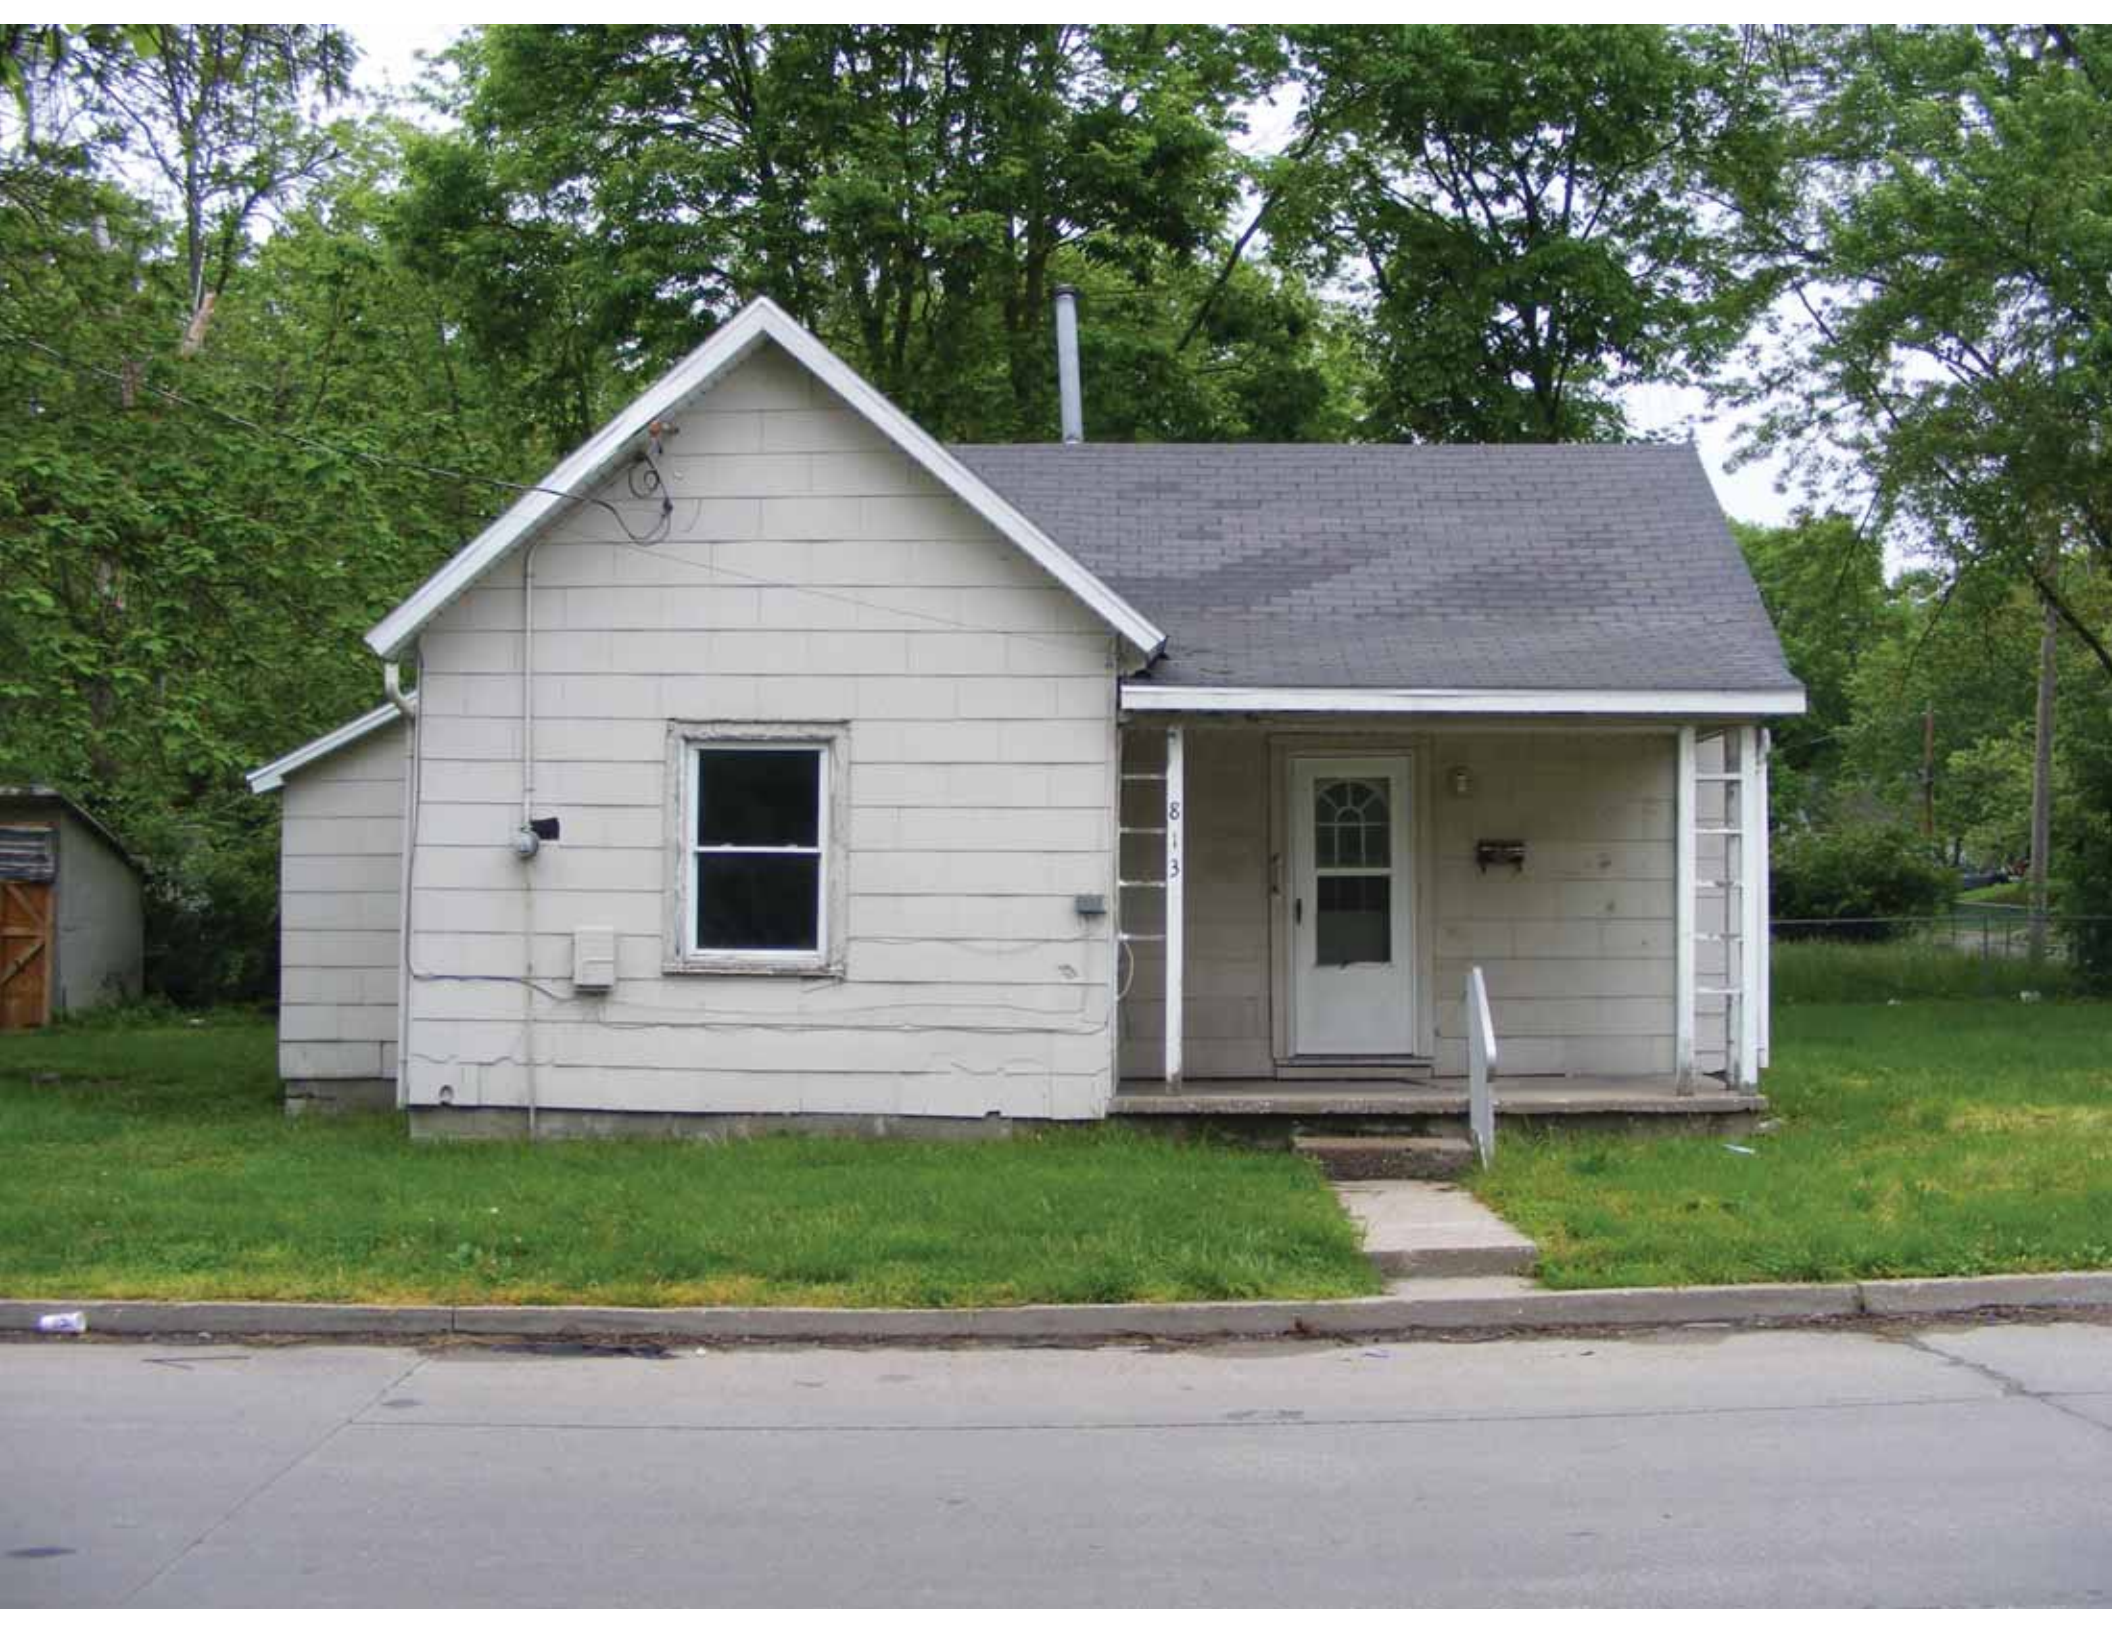
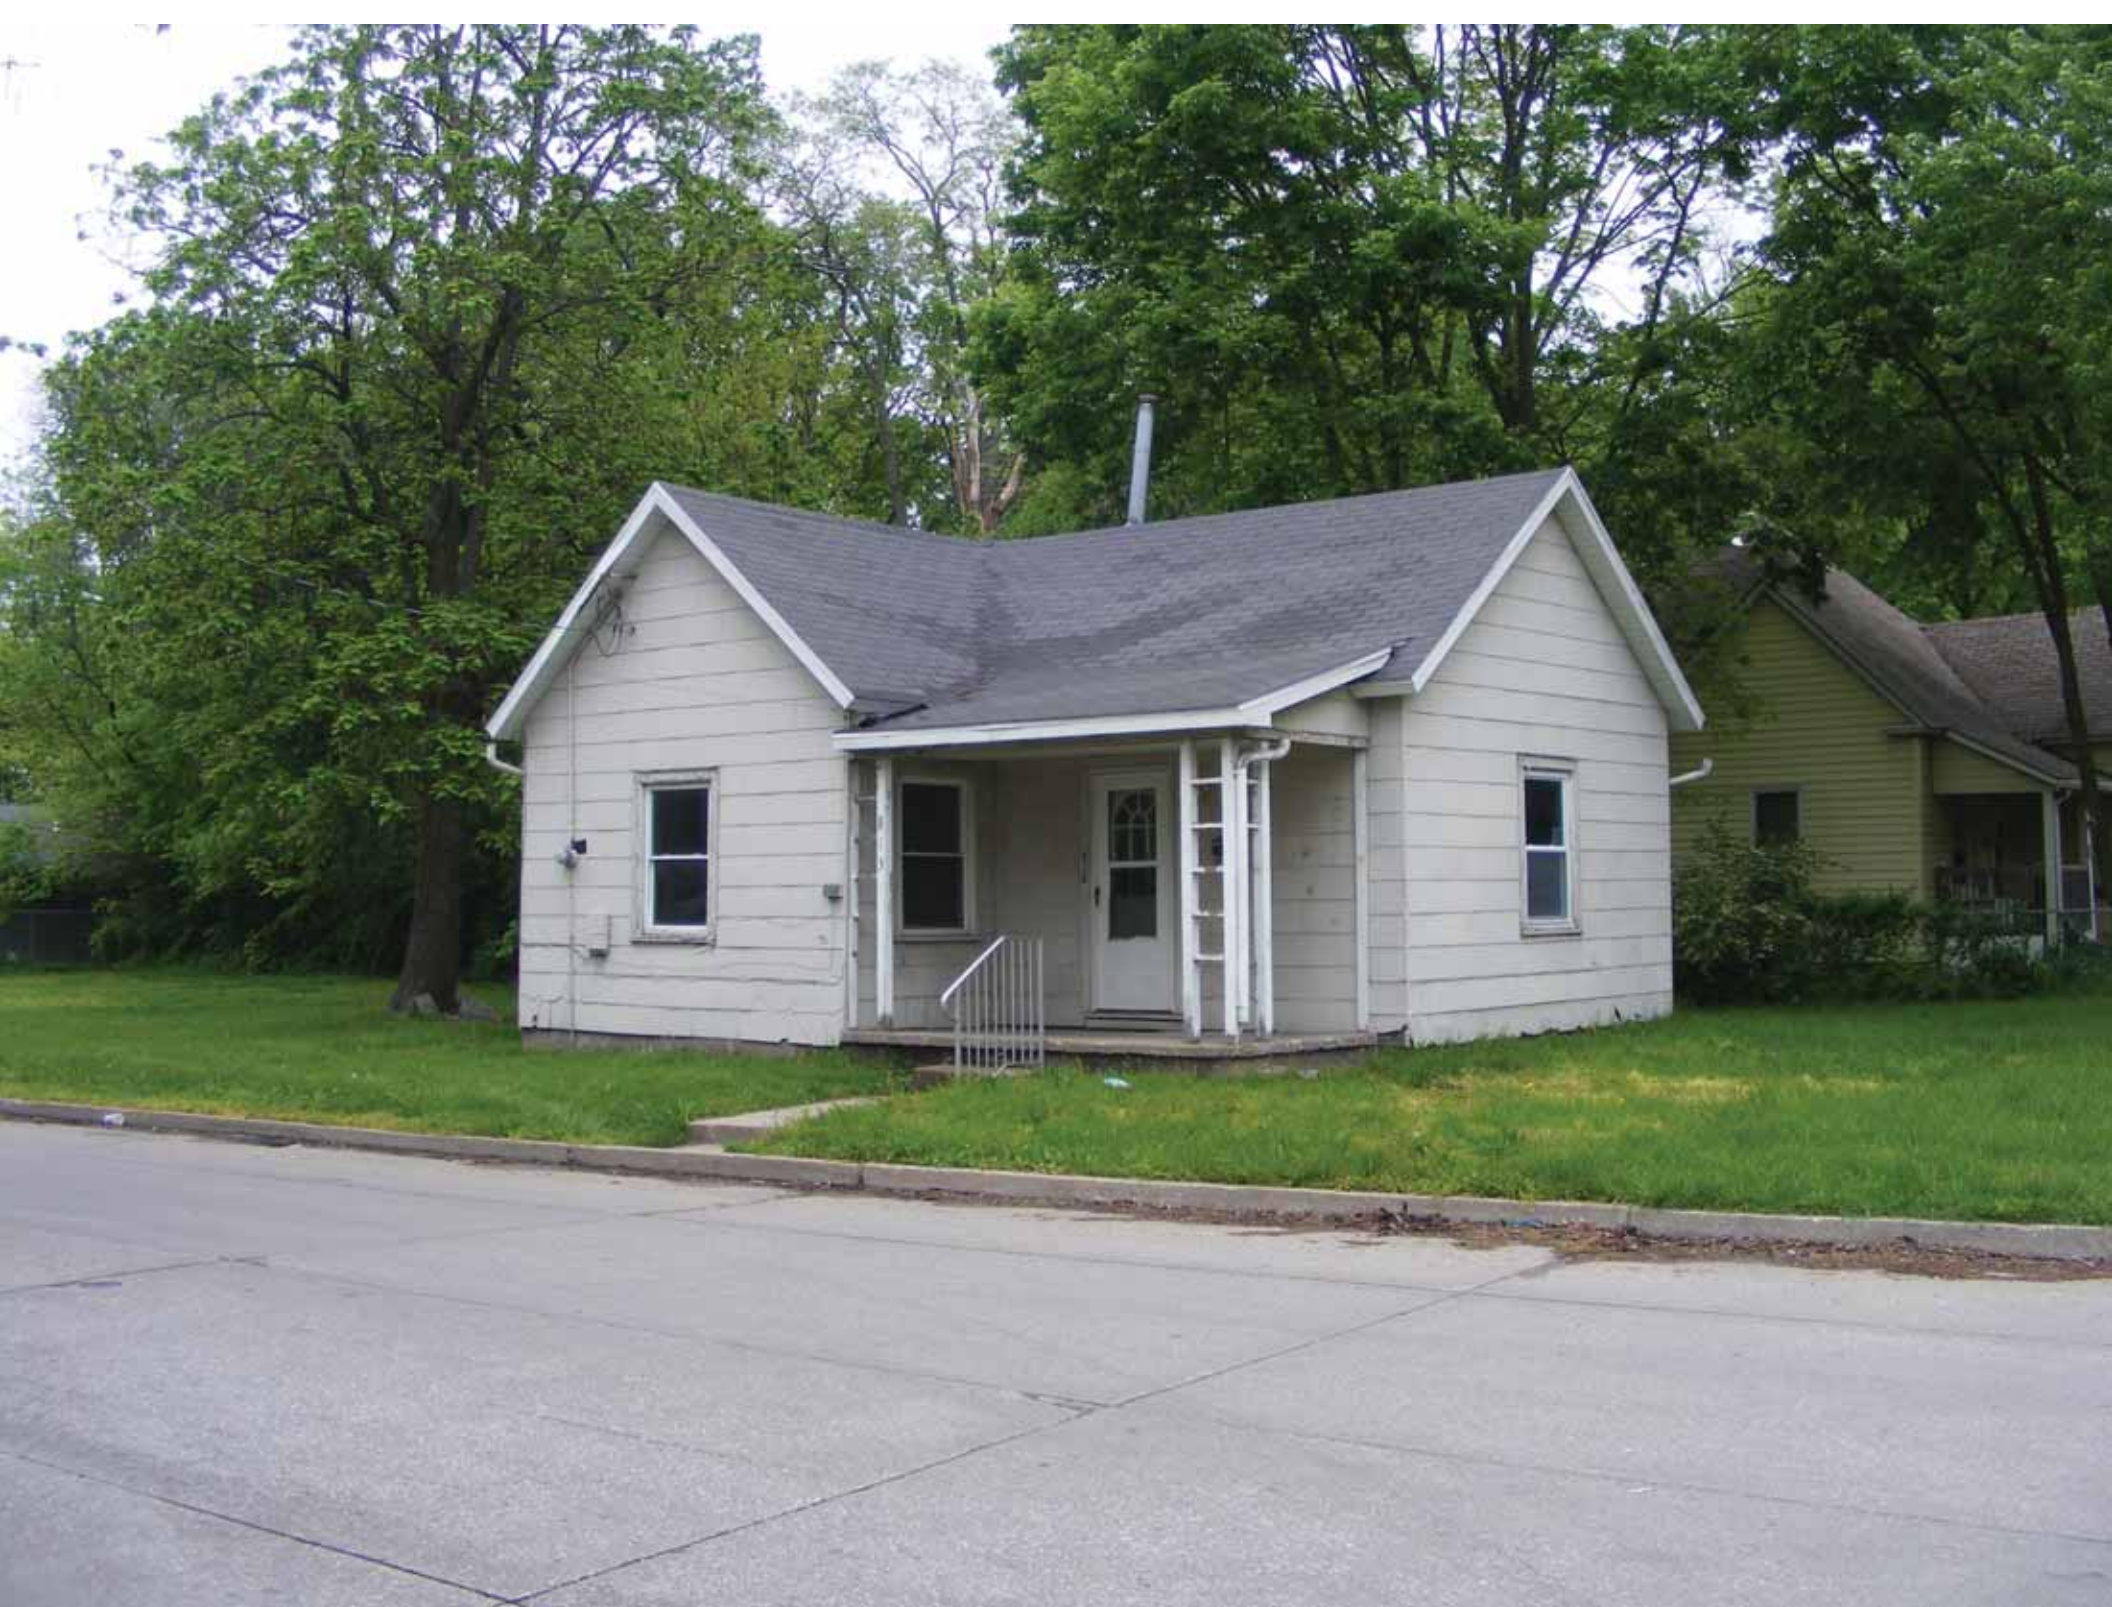
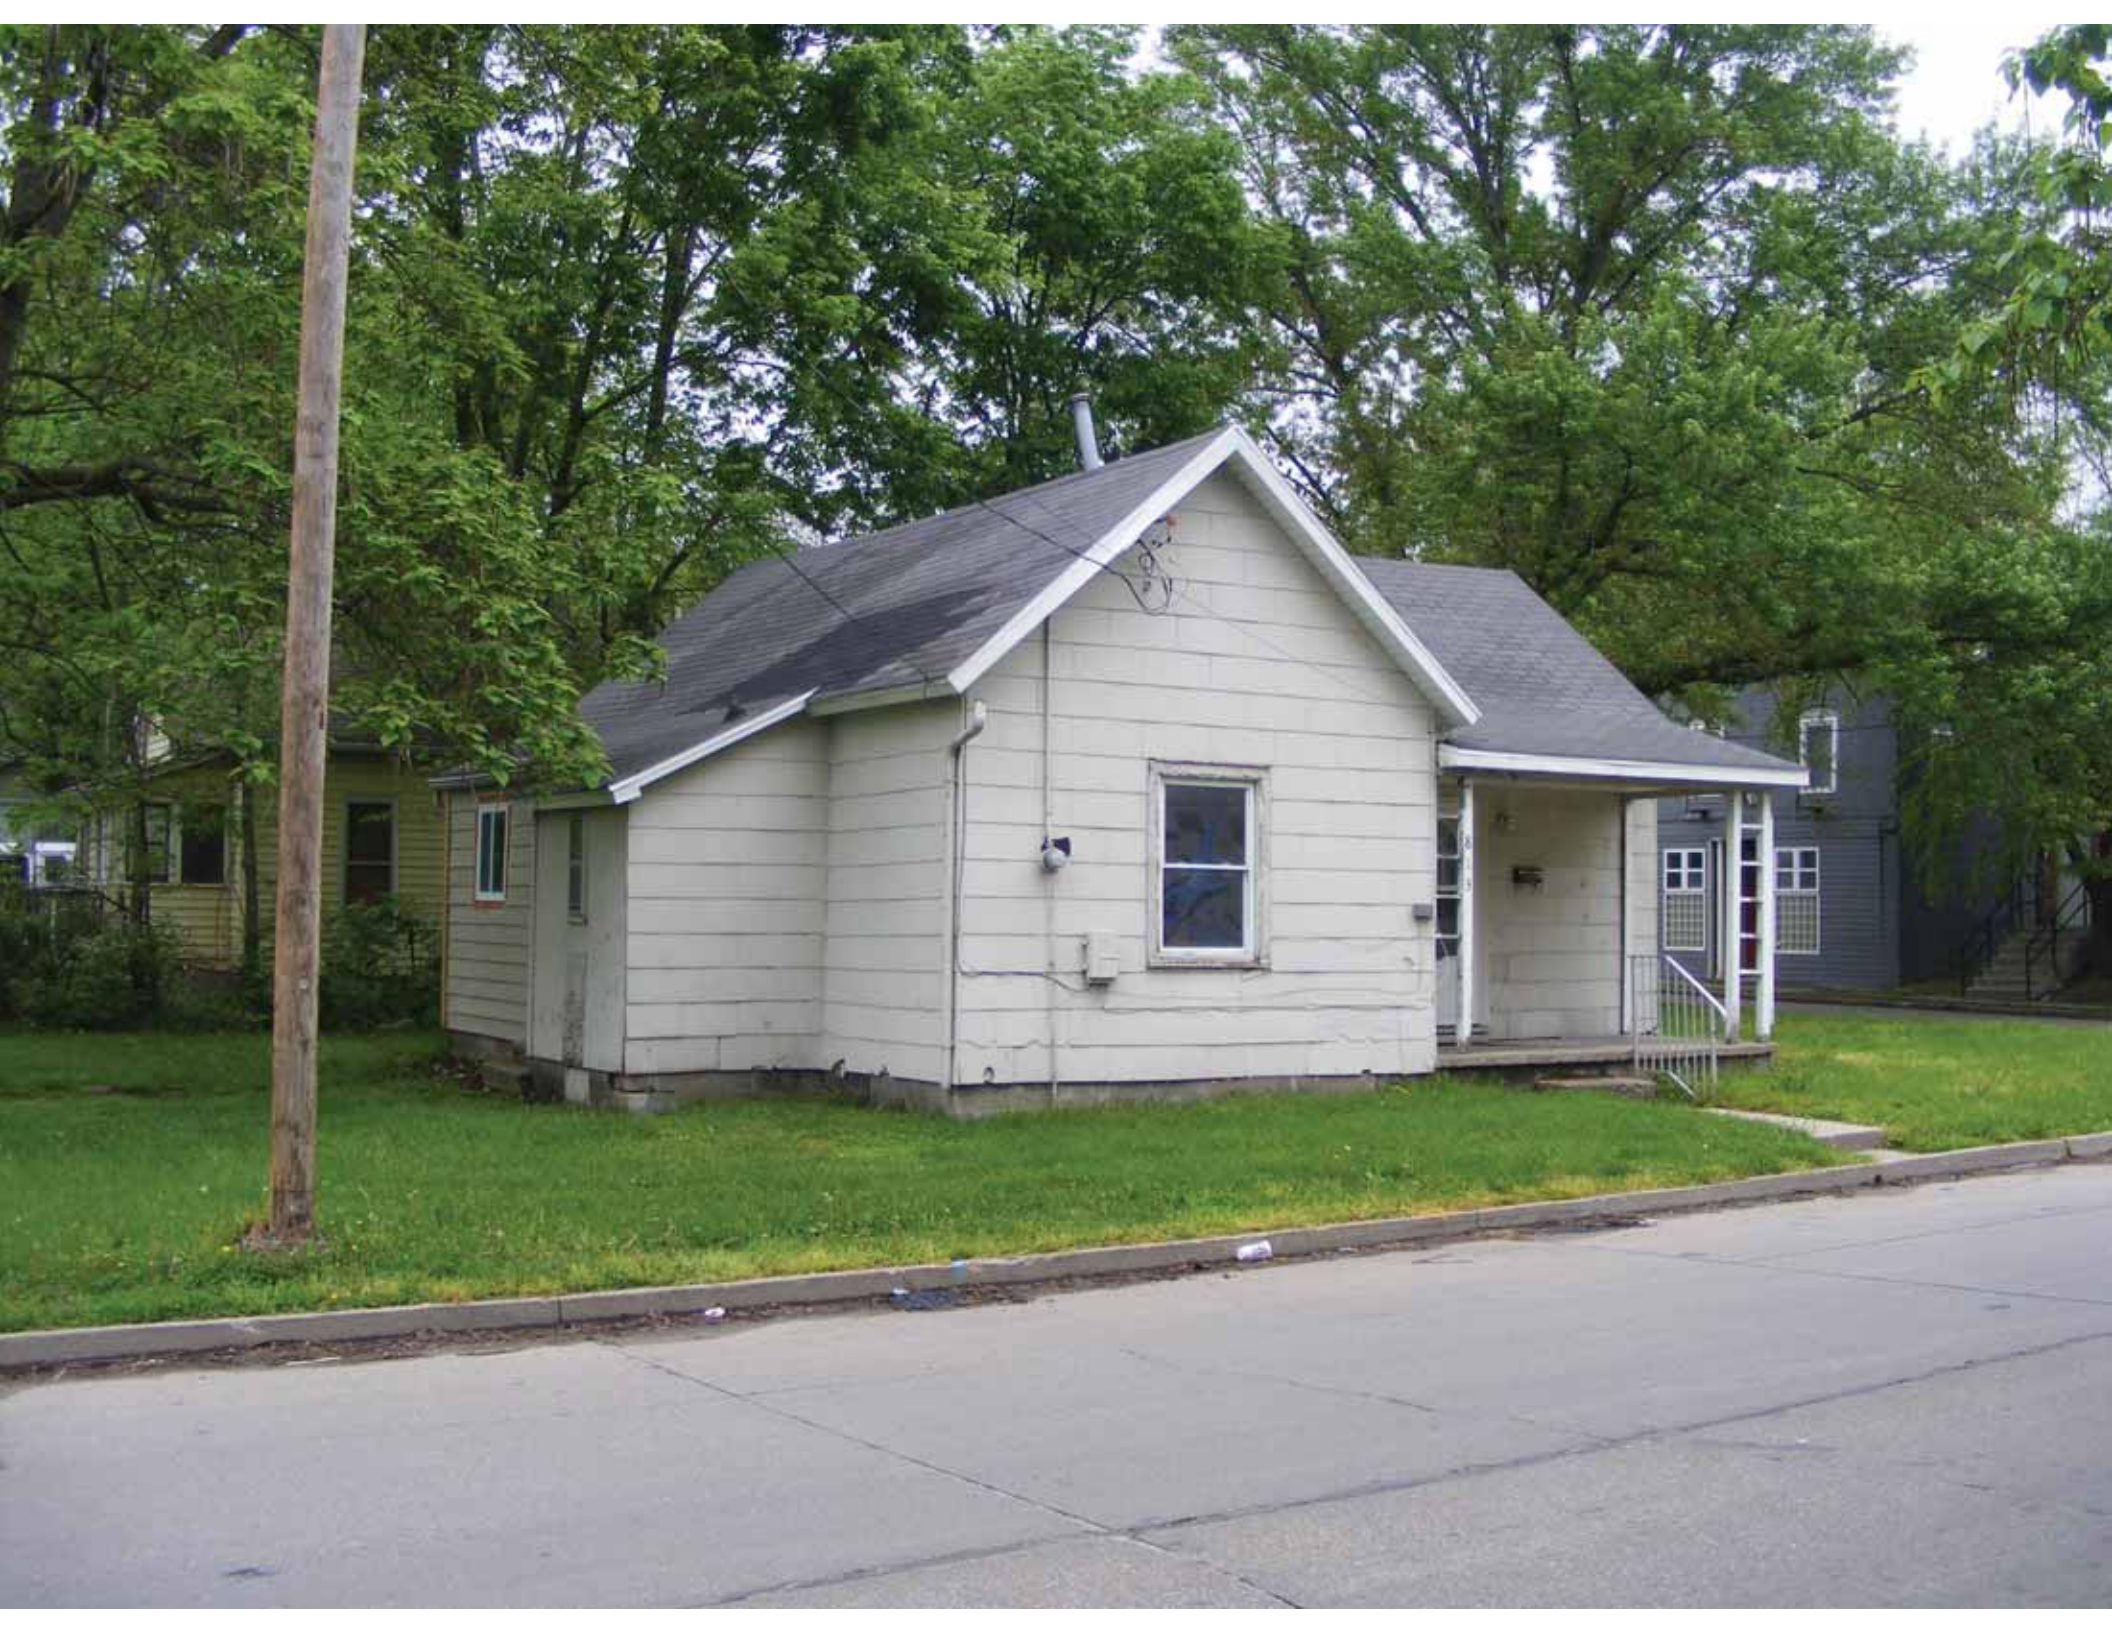
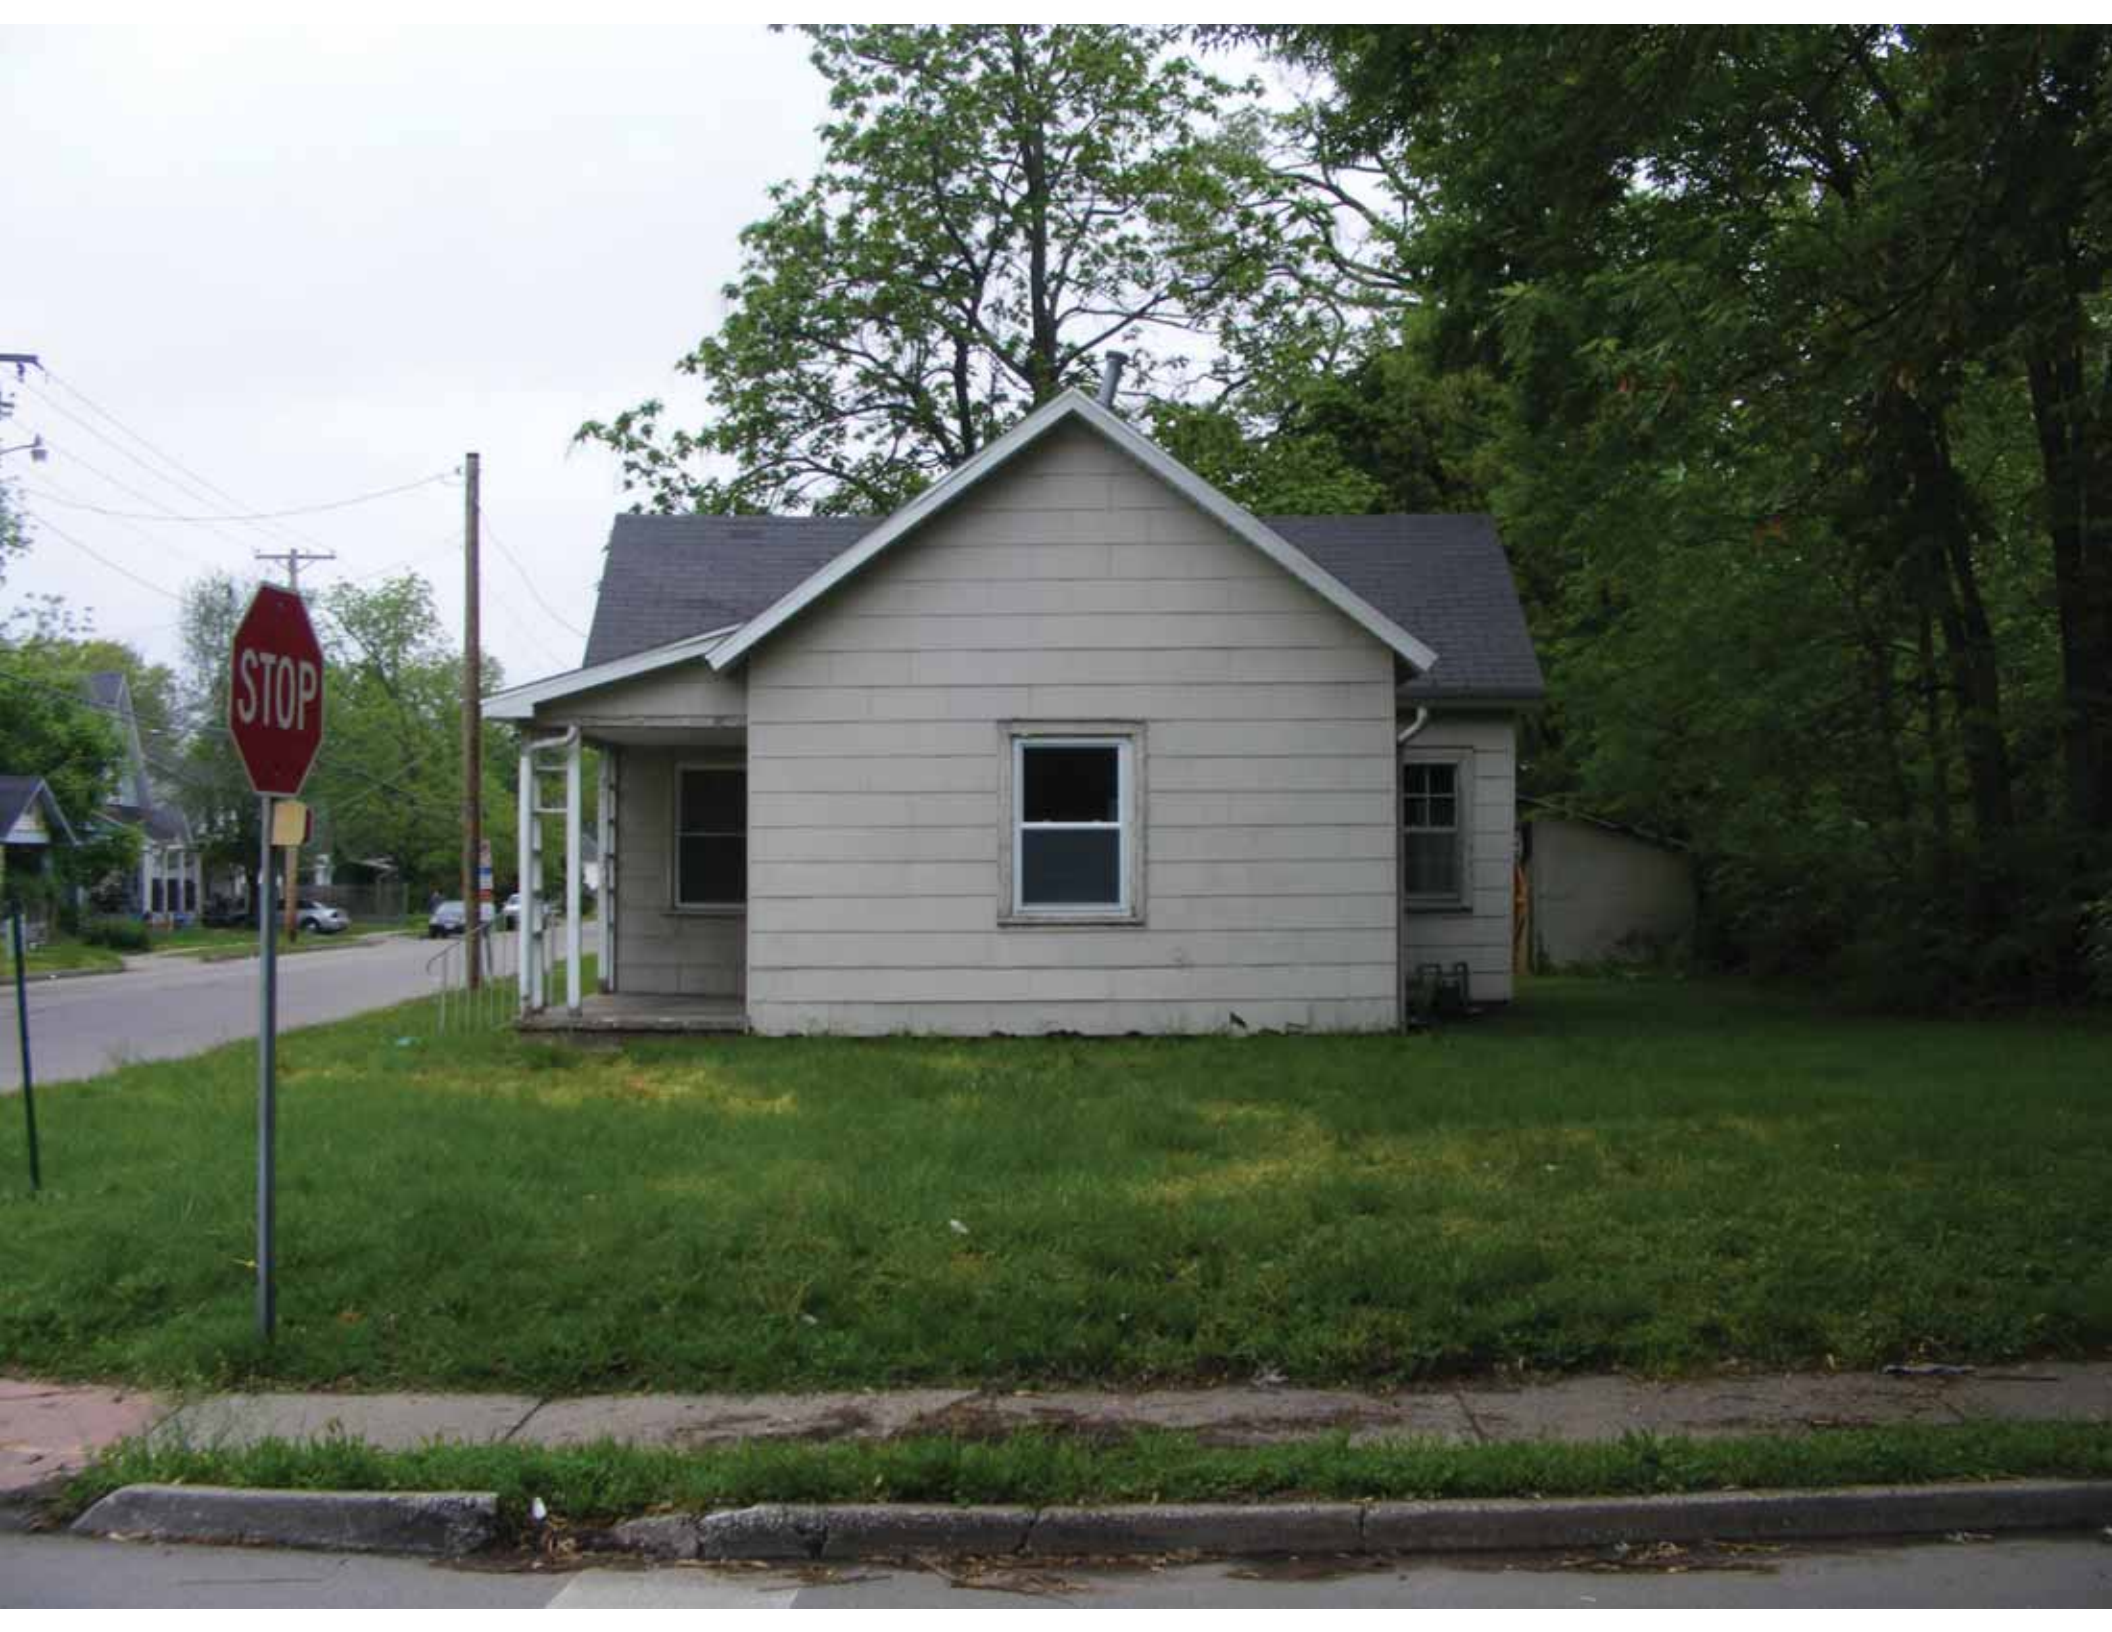
The dwelling has an asphalt-shingled cross gabled roof, exterior asbestos shingle siding and a concrete foundation. The primary (south) elevation has a front gabled wing with a one-over-one window. West of the wing, the façade supports a shed porch with ladder style columns. Within the porch bay are a c. 2000 door (south elevation) and single window (east elevation). Most windows are replacement one-over-one. The rear elevation has a projecting gabled wing. The wing and north elevation hold original six-over-six windows.
