MISSOURI DEPARTMENT OF NATURAL RESOURCES
STATE HISTORIC PRESERVATION OFFICE, P.O. Box 176, Jefferson City, MO 65102
ARCHITECTURAL/HISTORIC INVENTORY FORM

1. Survey No. BO-AS-011-0087		2. Survey name: North Central Columbia Survey Phase II	
3. County: Boone		4. Address (Street No.) 902	Street (name) N. Seventh Street
5. City: Columbia	Vicinity: <input type="checkbox"/>	6. Geographical Reference:	7. Township/Range/Section: T: R: S:
8. Historic name (if known):		9. Present/other name (if known):	
10. Ownership: <input checked="" type="checkbox"/> Private <input type="checkbox"/> Public		11a. Historic use (if known): Domestic/single dwelling	11b. Current use: Domestic/single dwelling

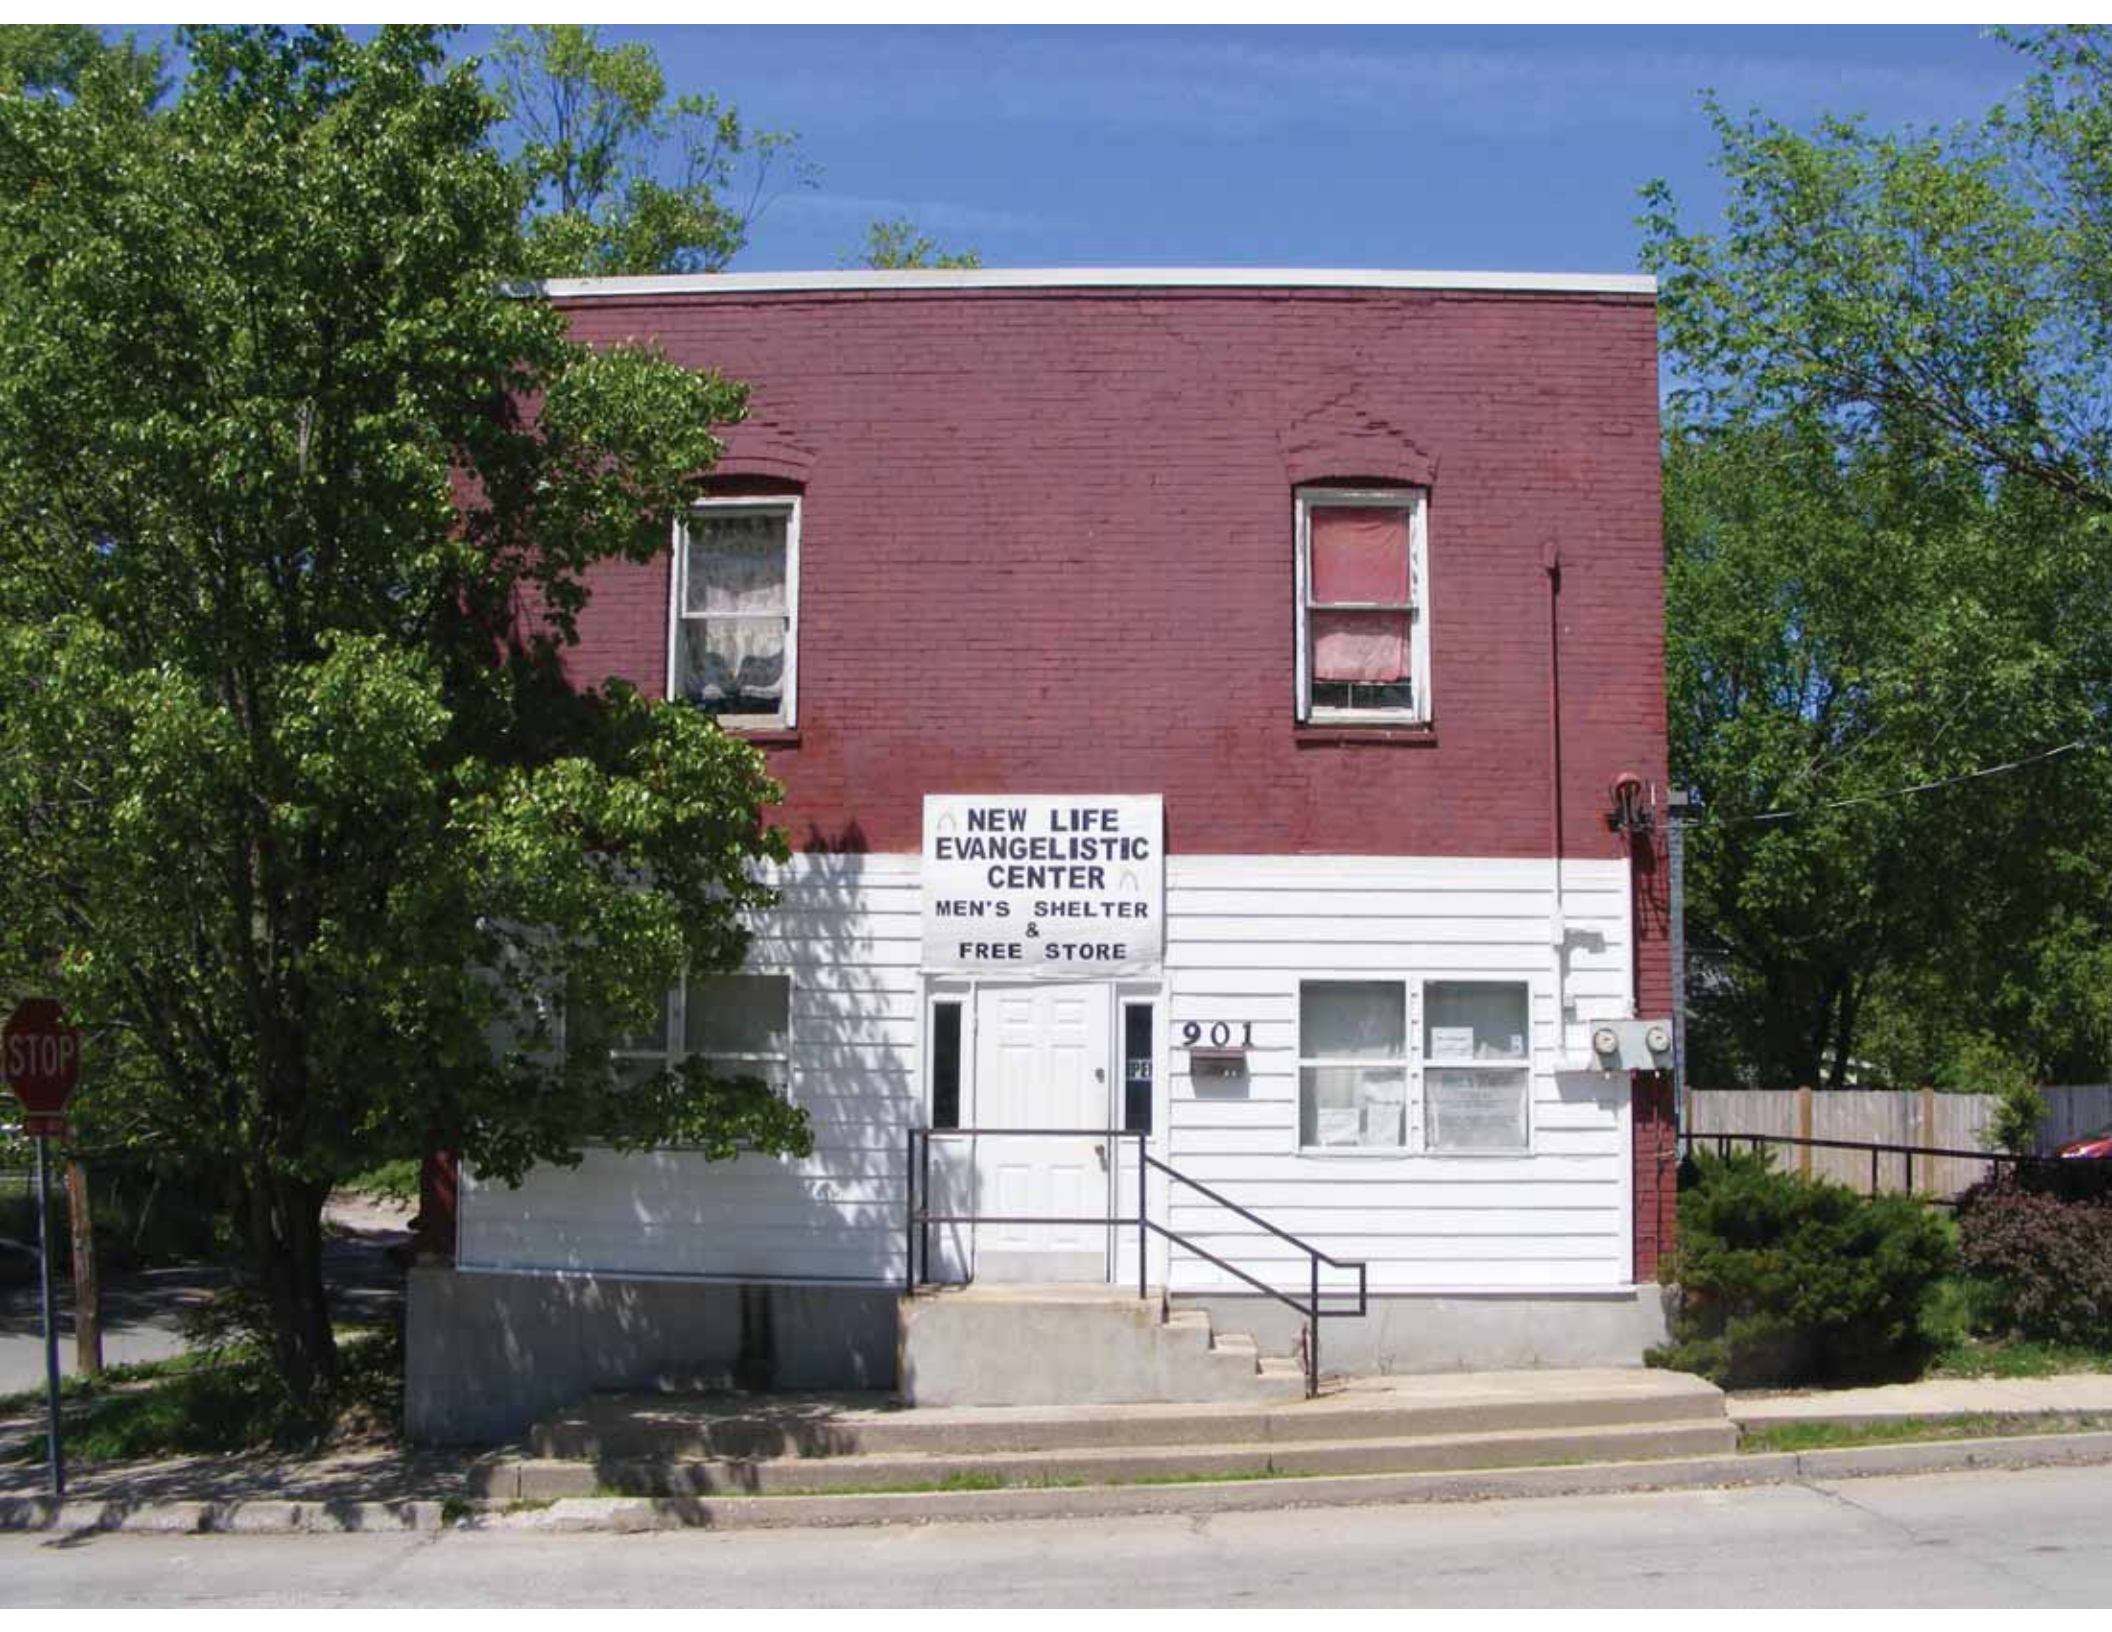
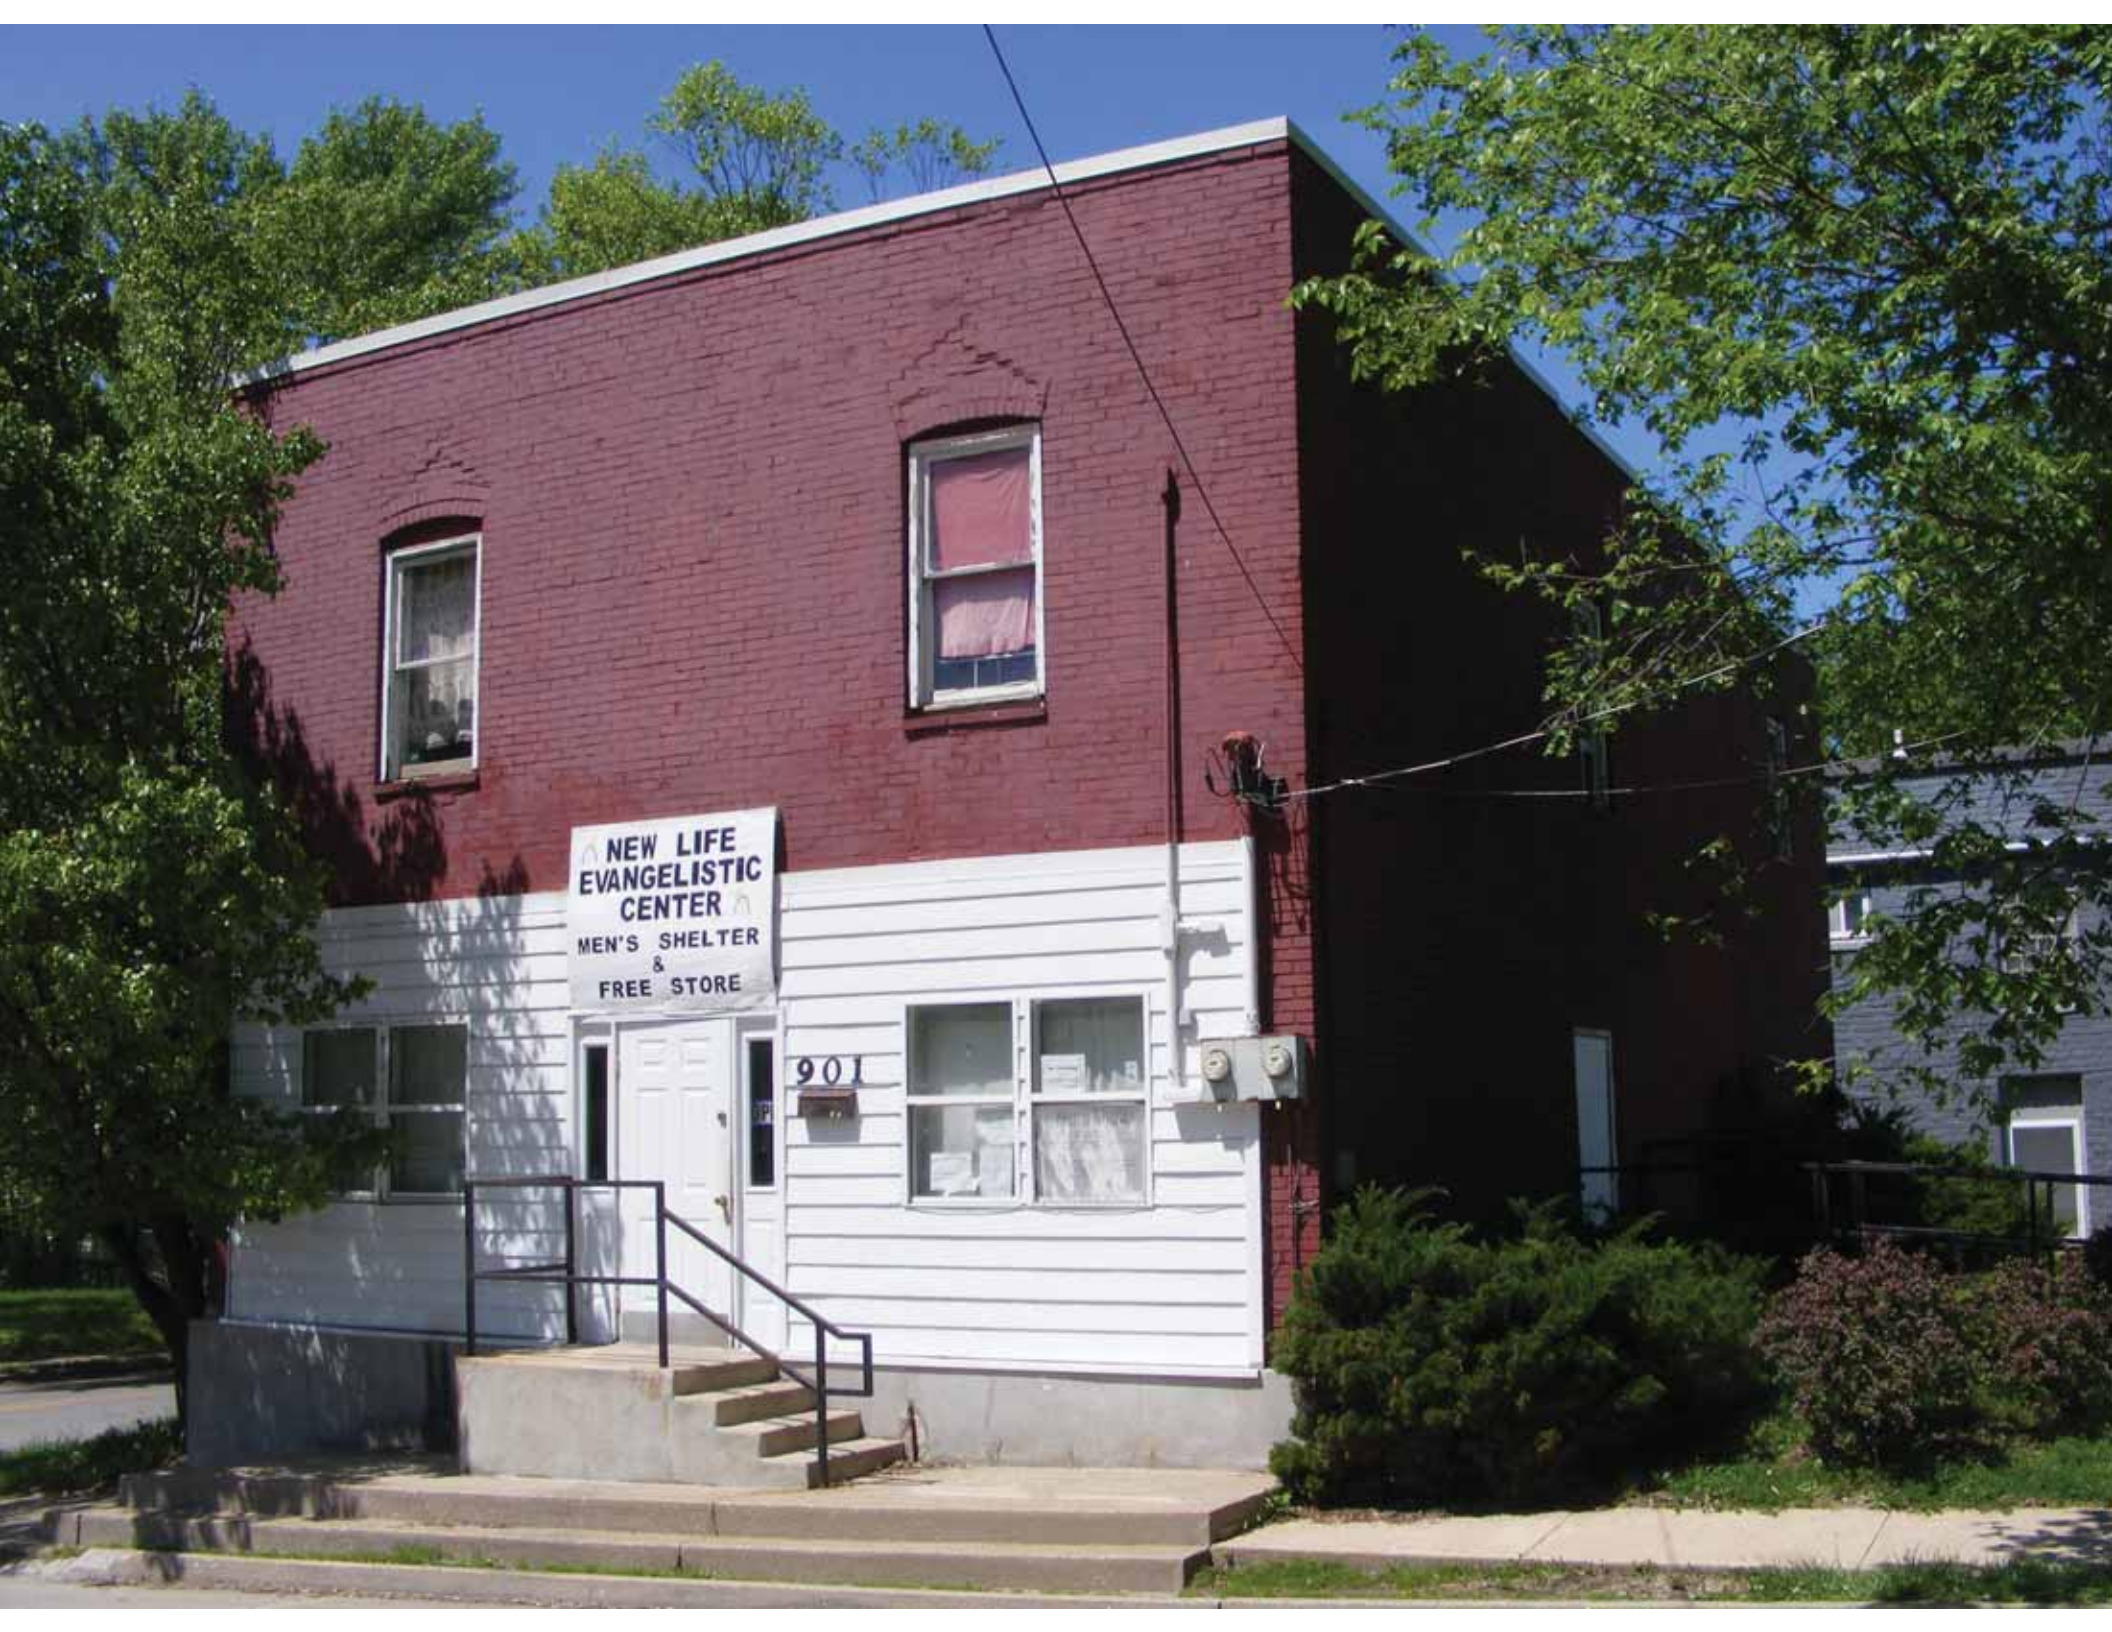
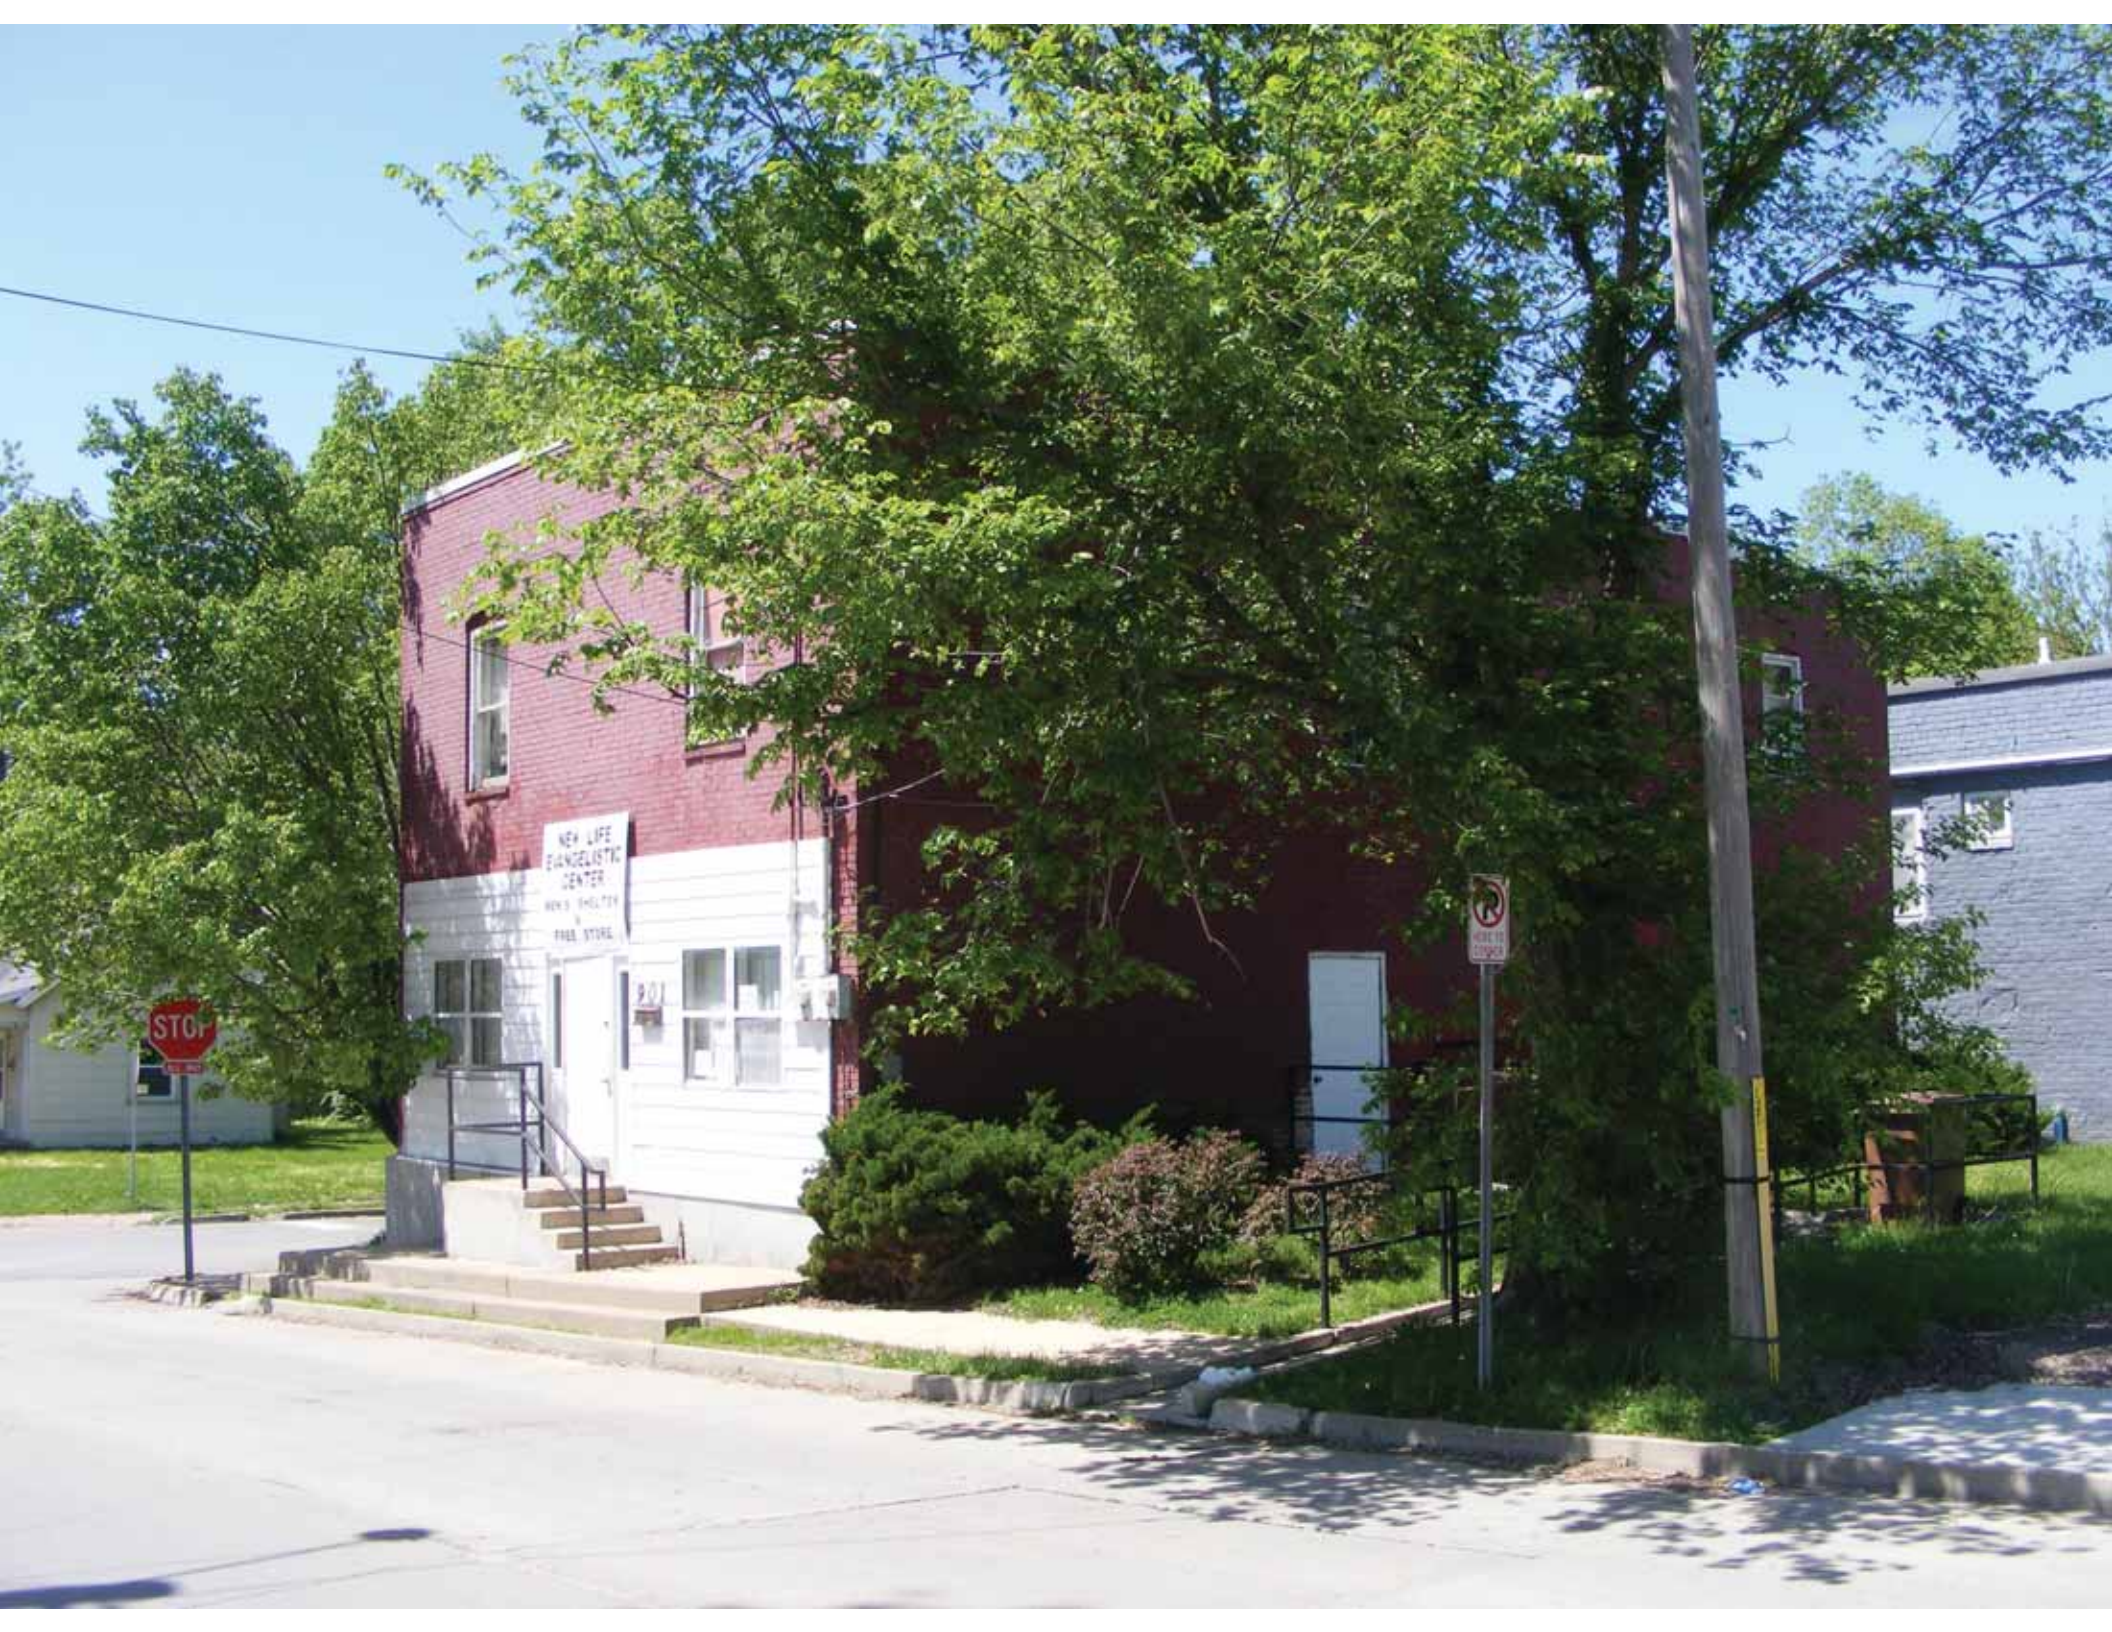
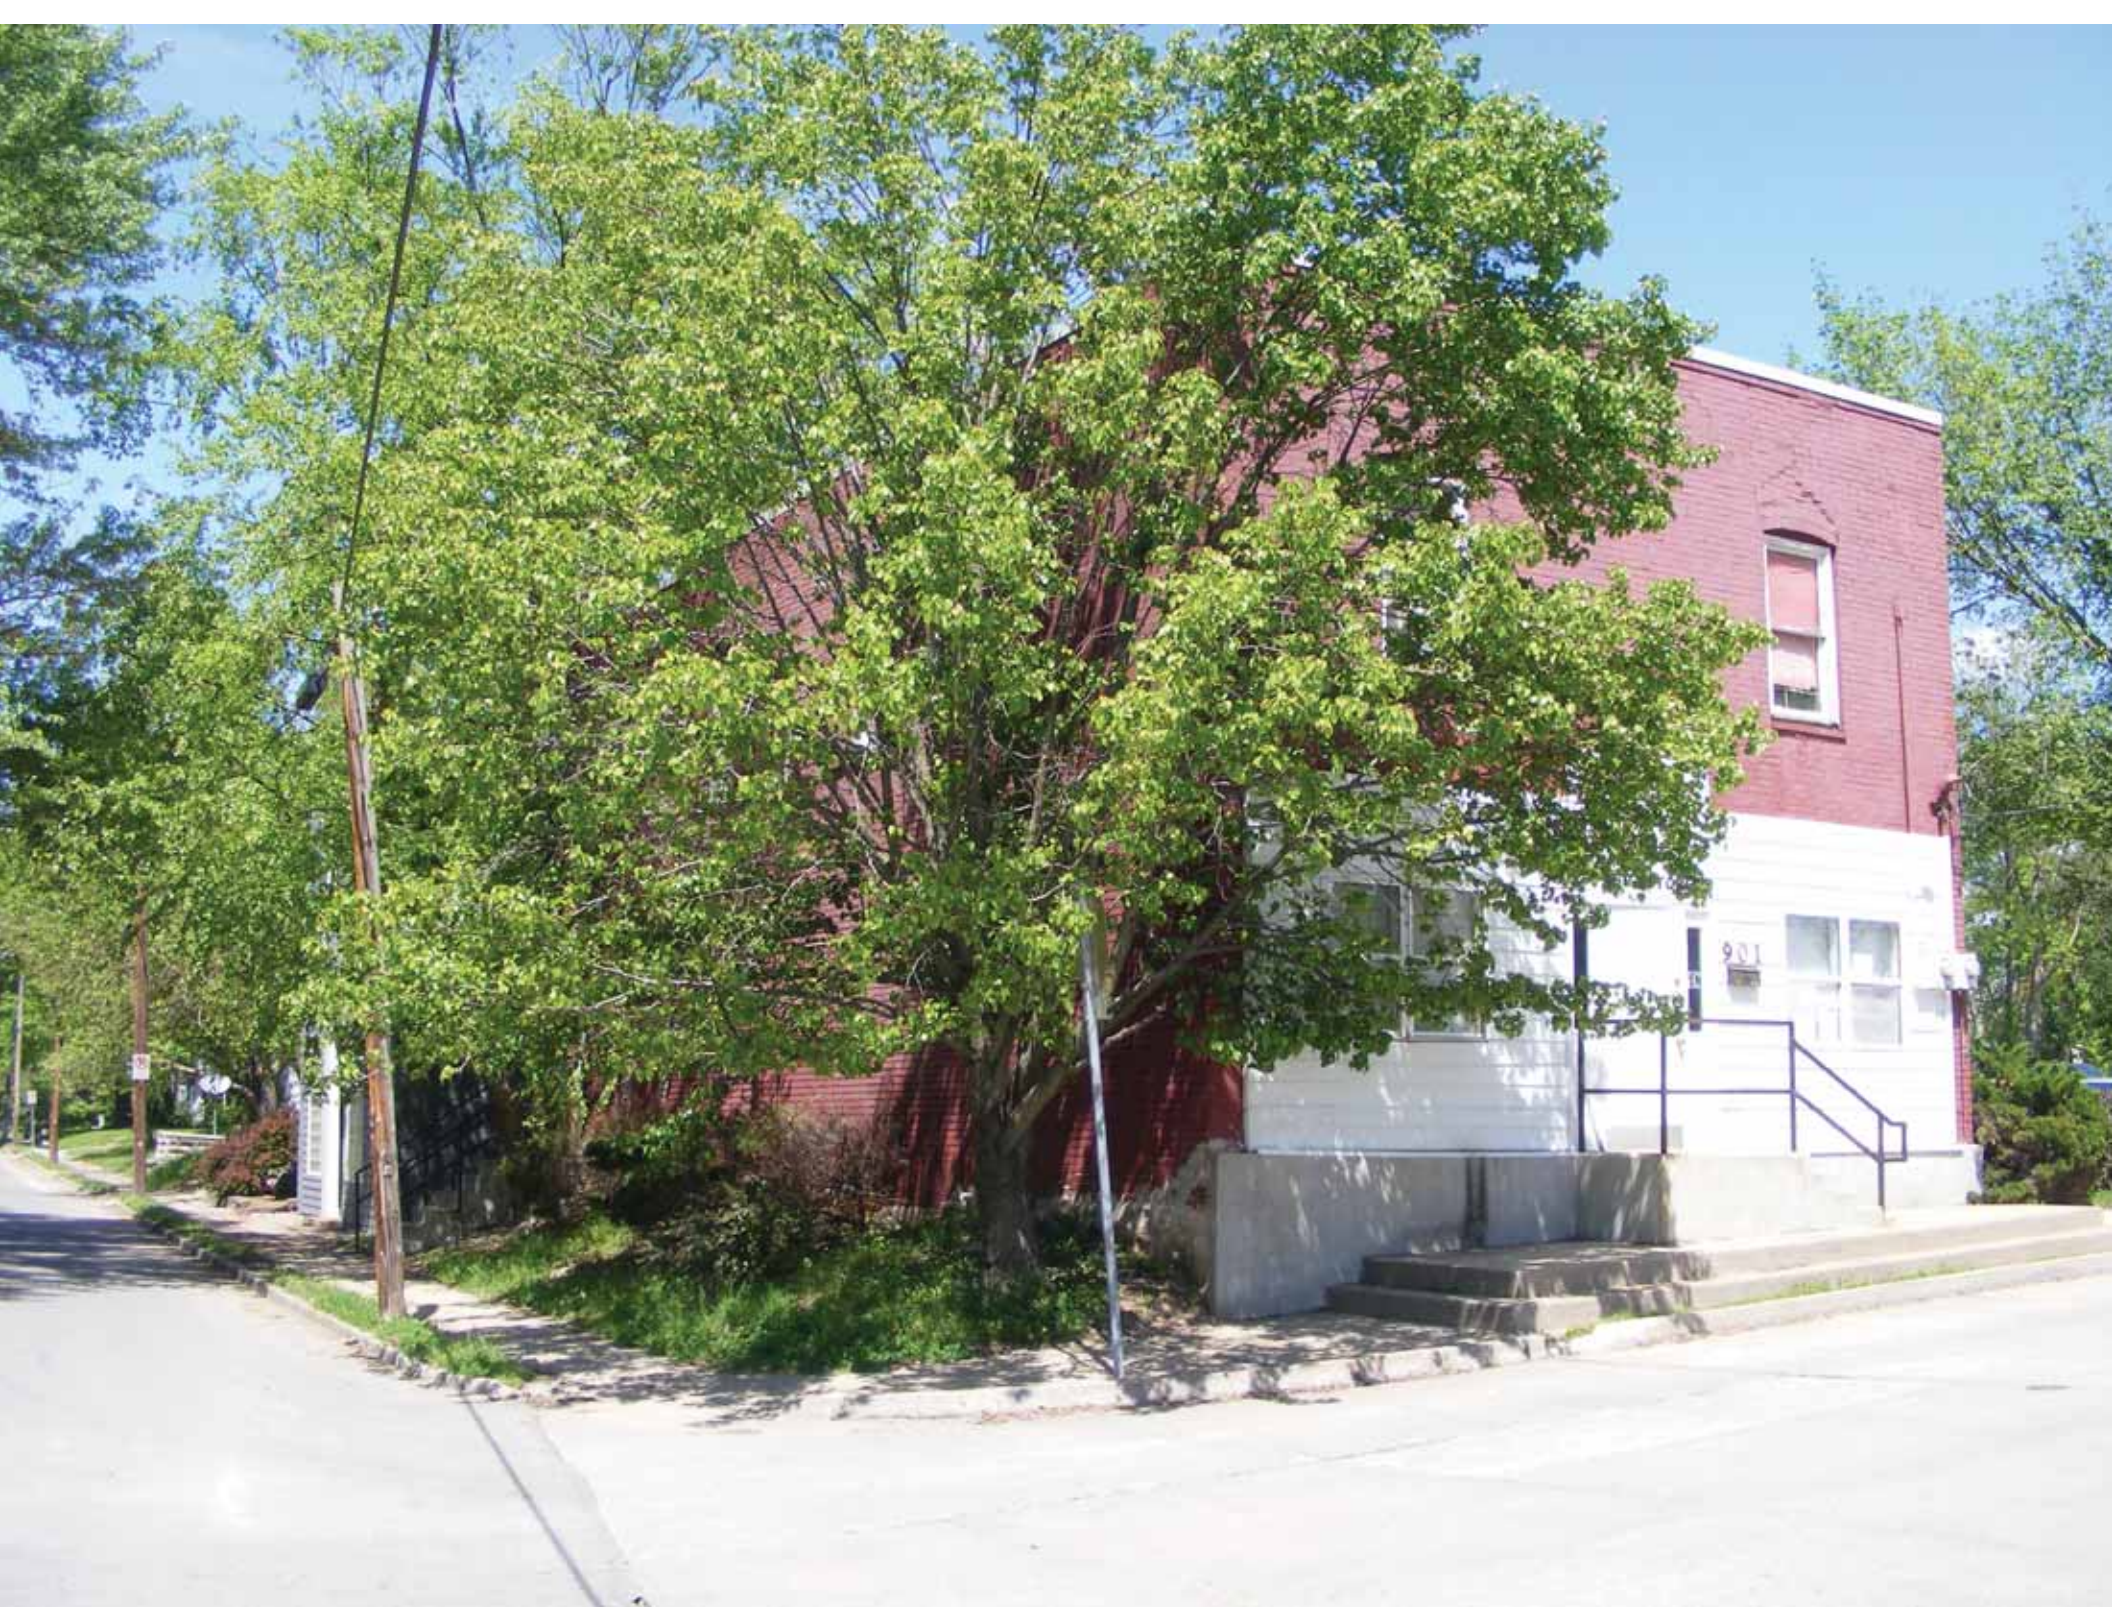
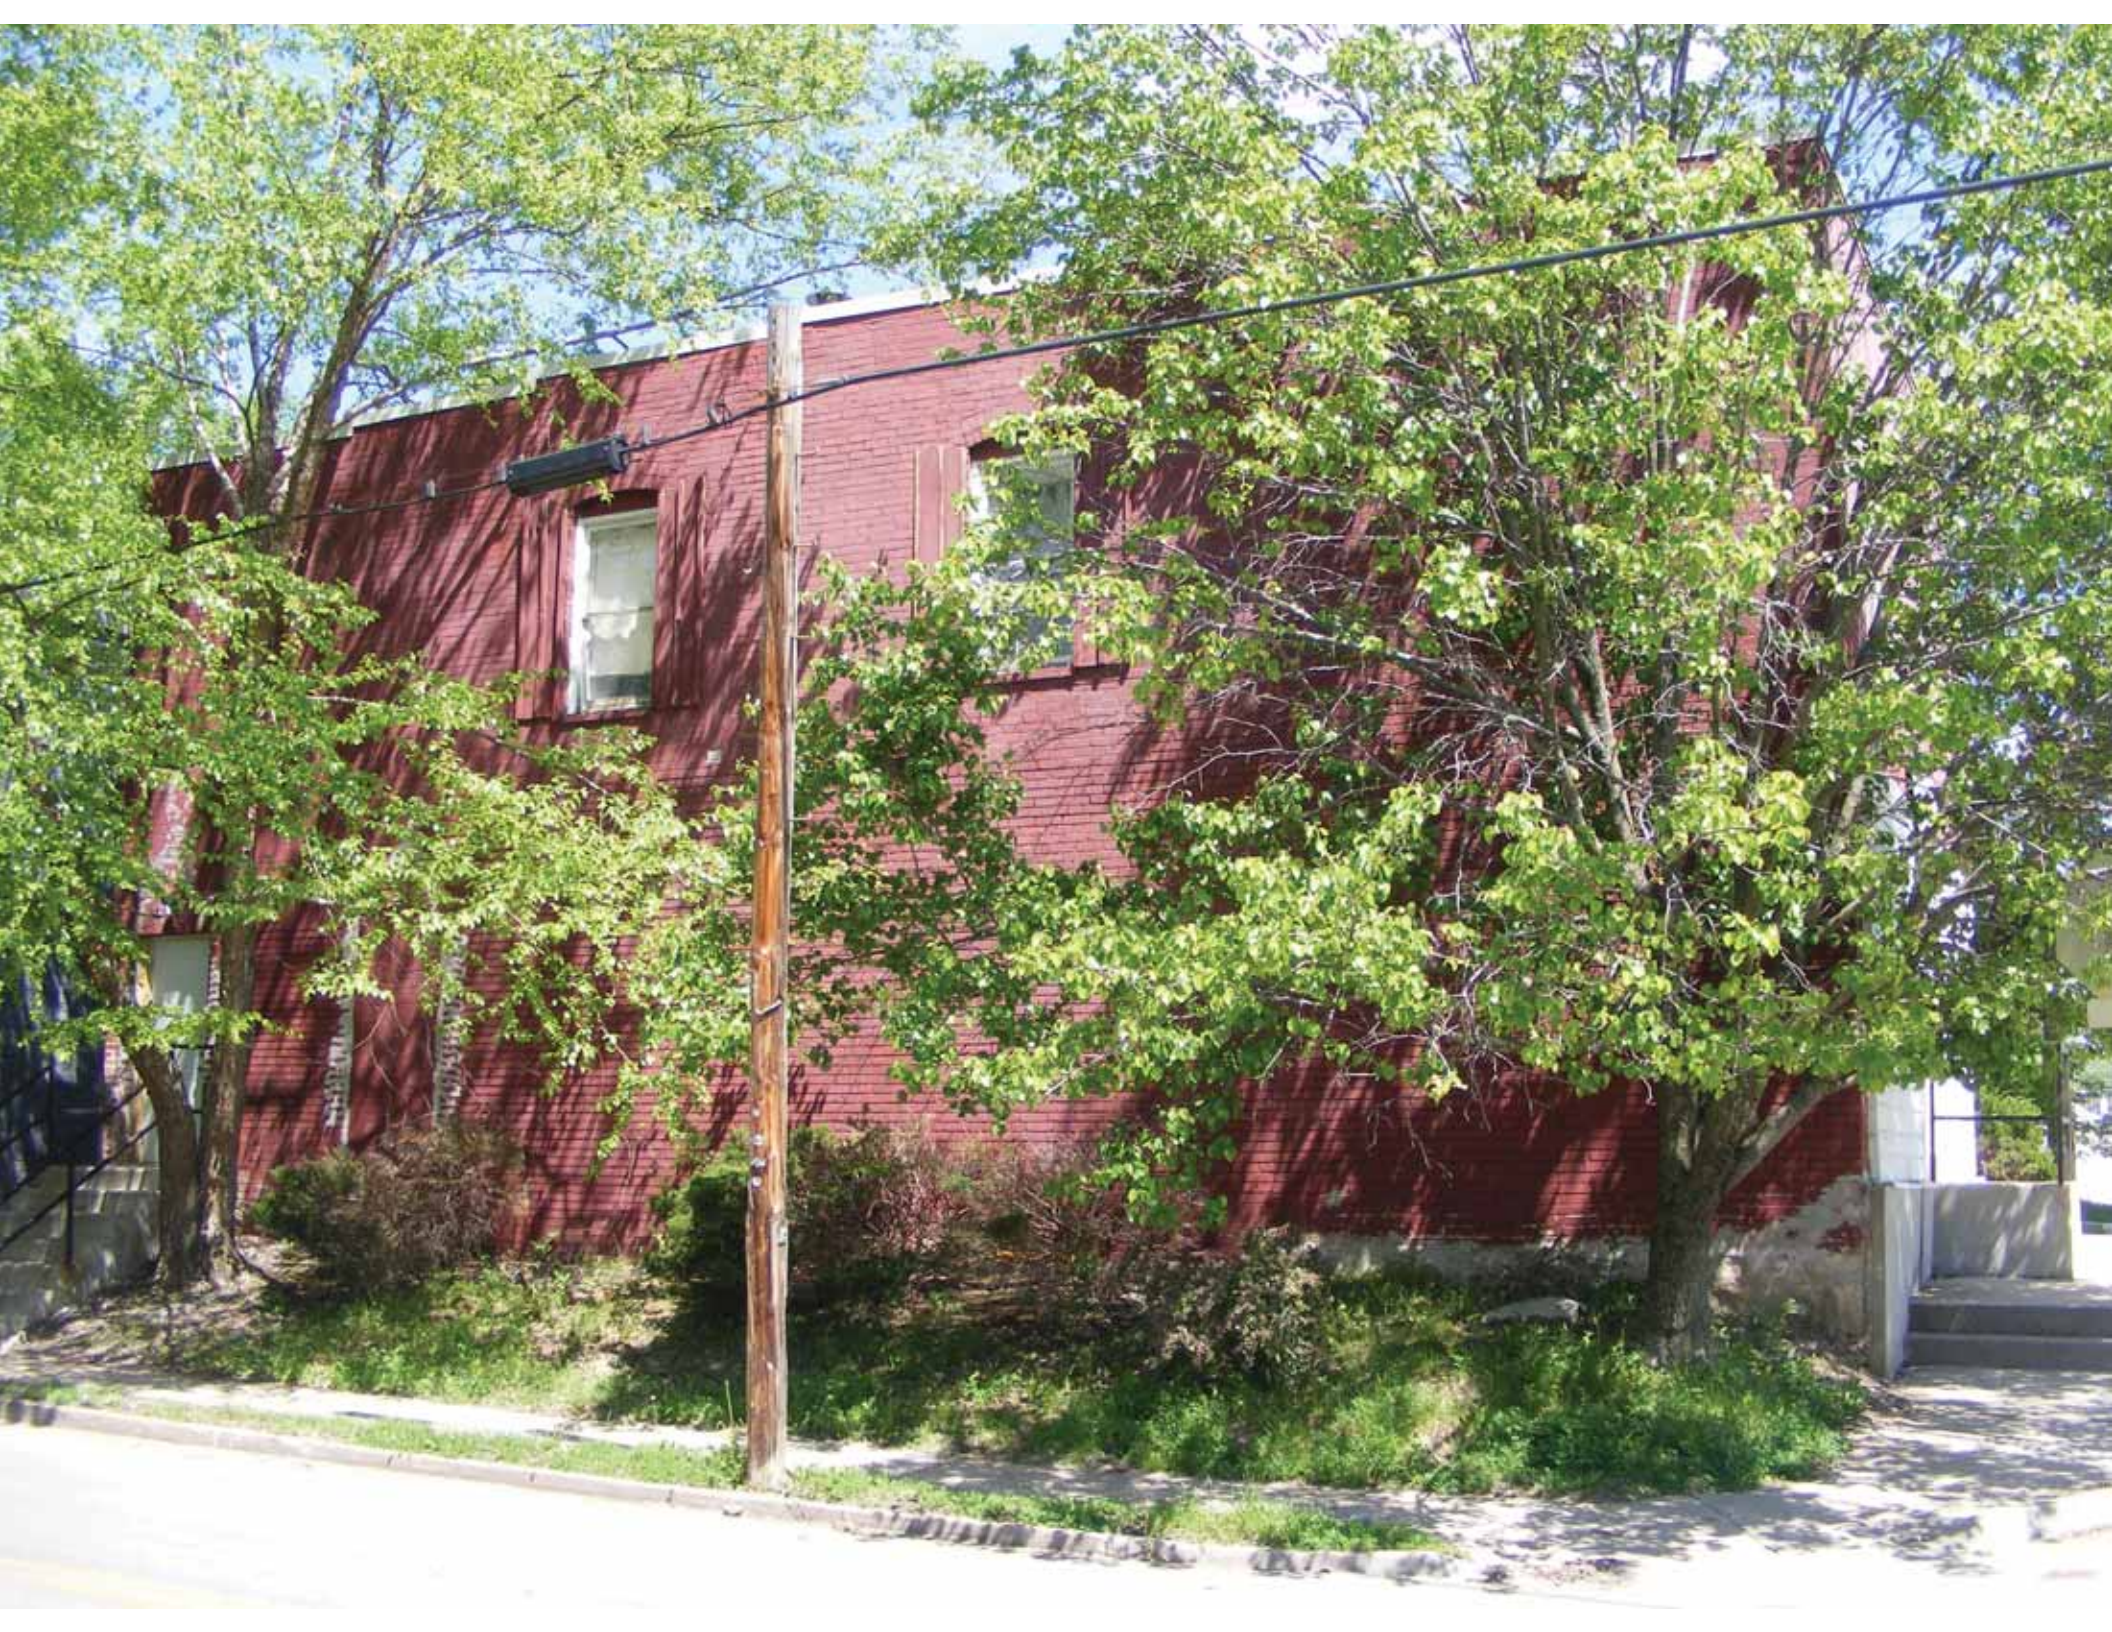
The two-story commercial building has a flat roof, exterior brick walls, and a concrete and limestone foundation. The lower façade (south) elevation is clad with synthetic siding. On the façade, lower level, is a central paneled contemporary door flanked by single-light sidelights. Flanking the entry bay are paired one-over-one windows (replacement). A concrete stoop with a metal handrail/balustrade fronts the entry bay. The second story façade holds two original one-over-one windows with brick sills and arches. The east elevation holds a secondary entry filled with a paneled contemporary door. The upper elevation has one-over-one windows. The west elevation is similar with a lower level entry bay and upper elevation windows.
