MISSOURI DEPARTMENT OF NATURAL RESOURCES
STATE HISTORIC PRESERVATION OFFICE, P.O. Box 176, Jefferson City, MO 65102
ARCHITECTURAL/HISTORIC INVENTORY FORM

1. Survey No. BO-AS-011-0087		2. Survey name: North Central Columbia Survey Phase II	
3. County: Boone		4. Address (Street No.) 902	Street (name) N. Seventh Street
5. City: Columbia	Vicinity: <input type="checkbox"/>	6. Geographical Reference:	7. Township/Range/Section: T: R: S:
8. Historic name (if known):		9. Present/other name (if known):	
10. Ownership: <input checked="" type="checkbox"/> Private <input type="checkbox"/> Public		11a. Historic use (if known): Domestic/single dwelling	11b. Current use: Domestic/single dwelling

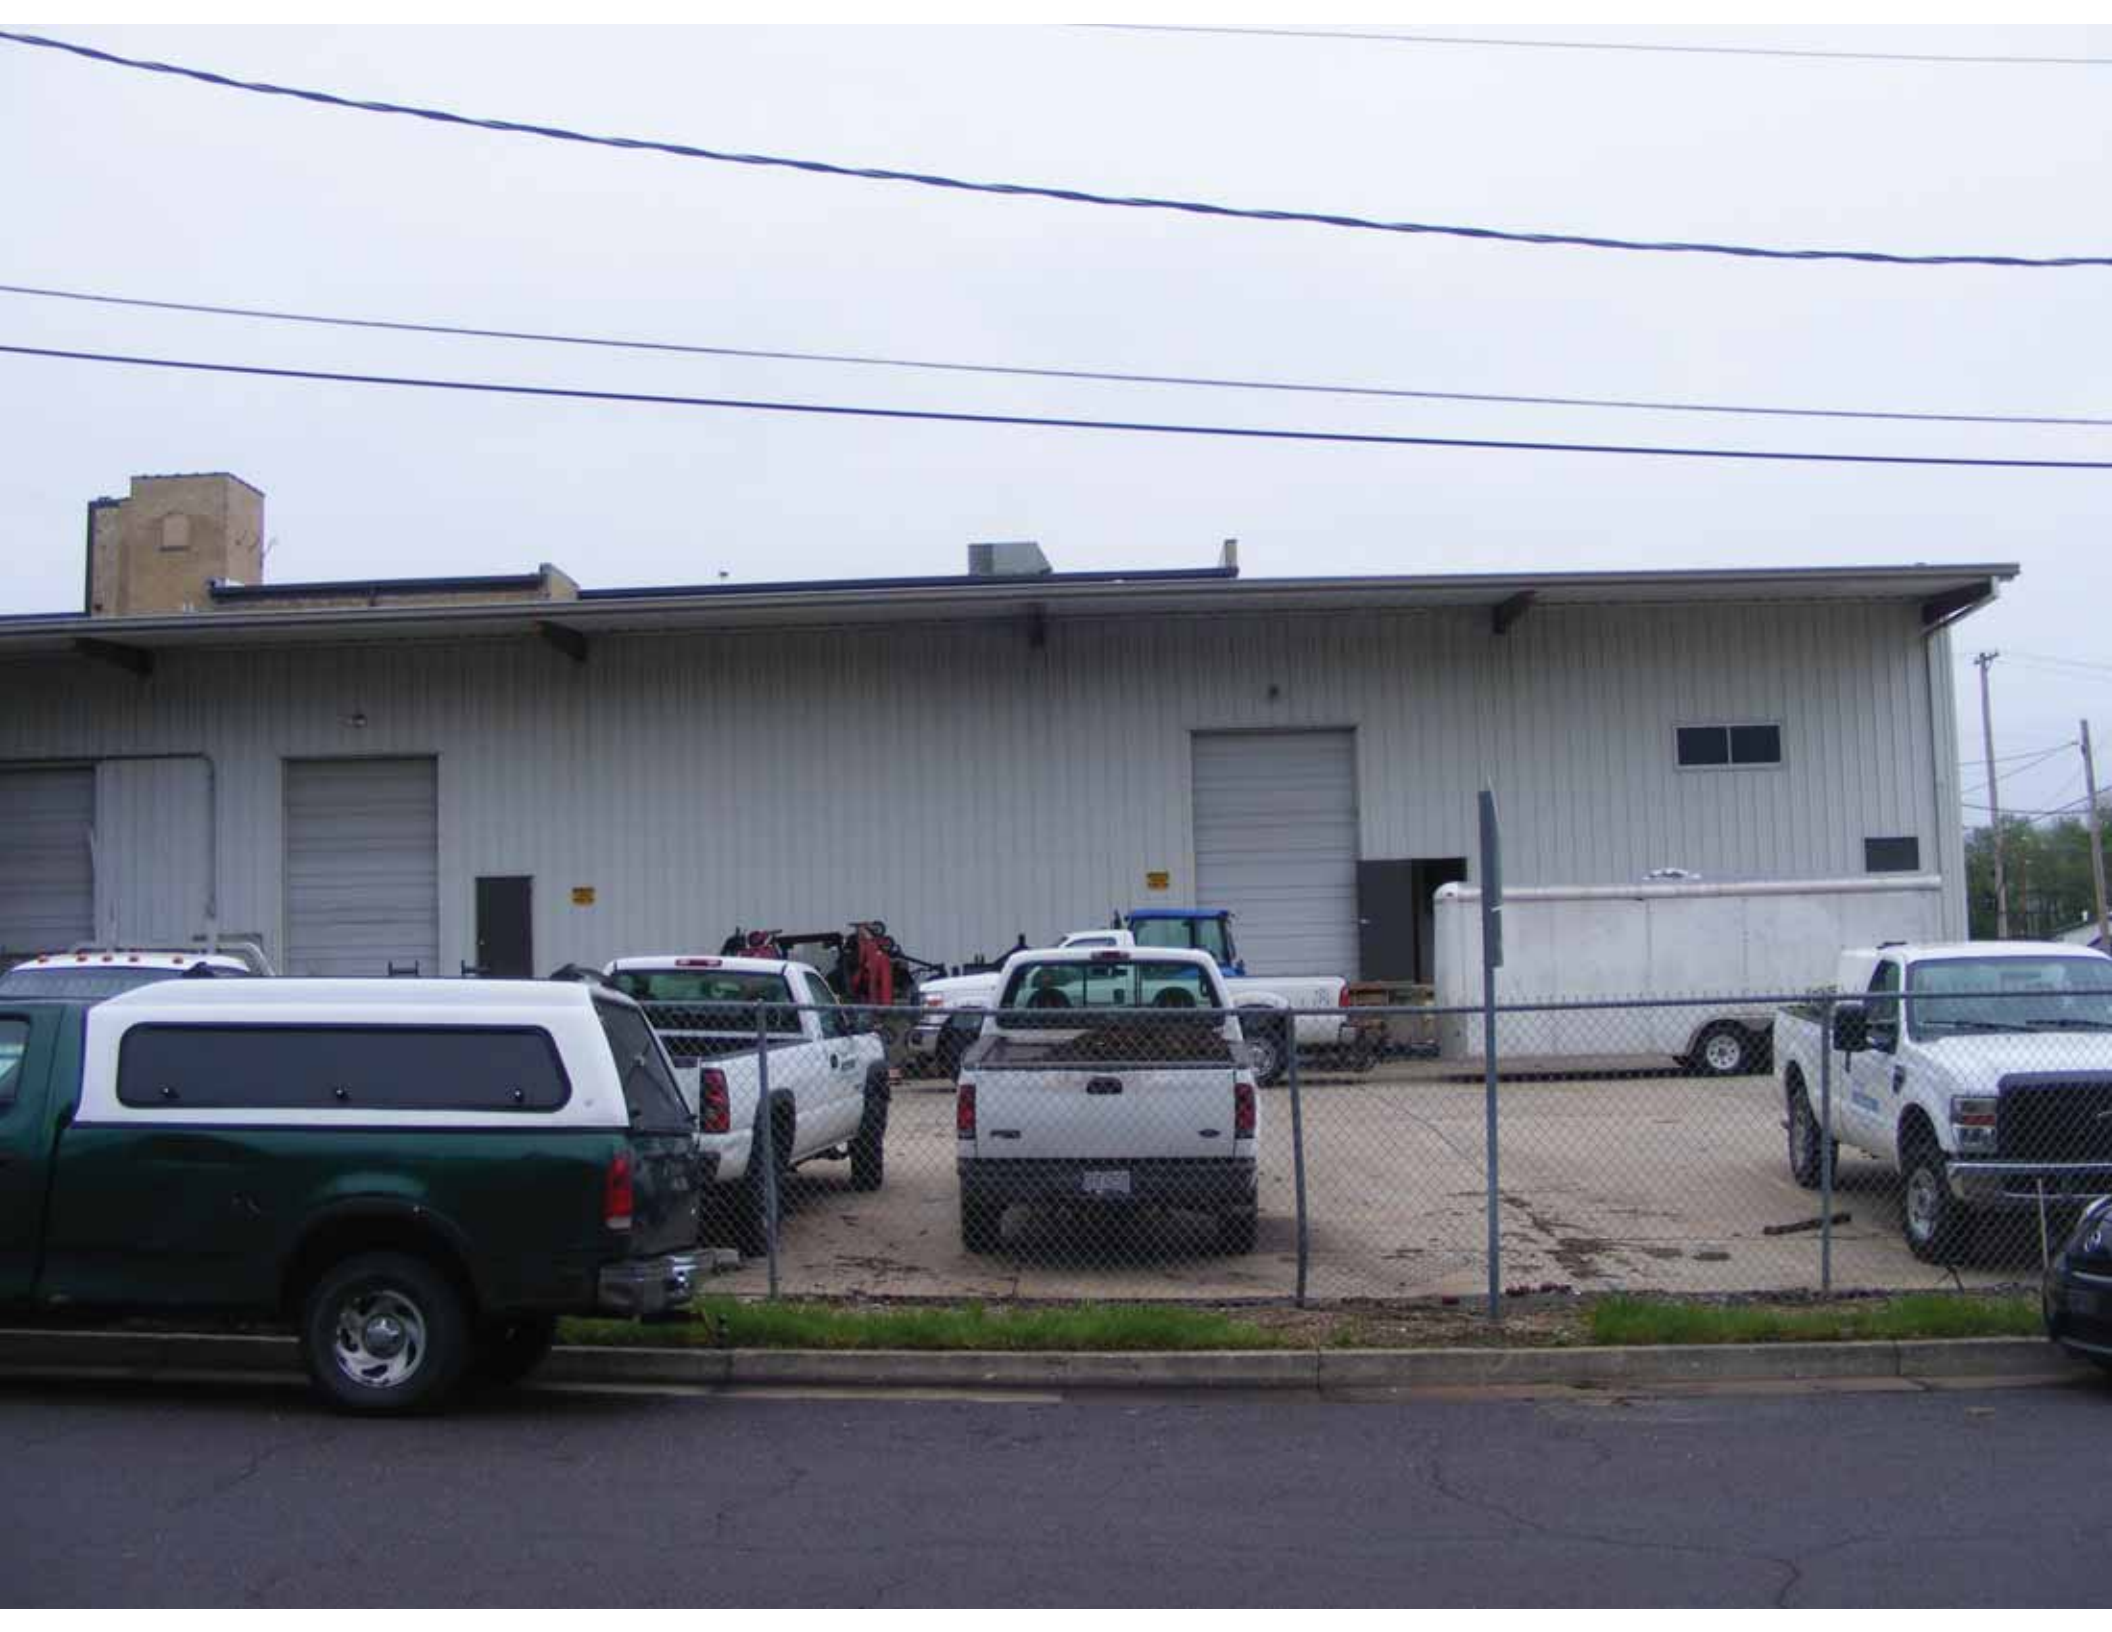
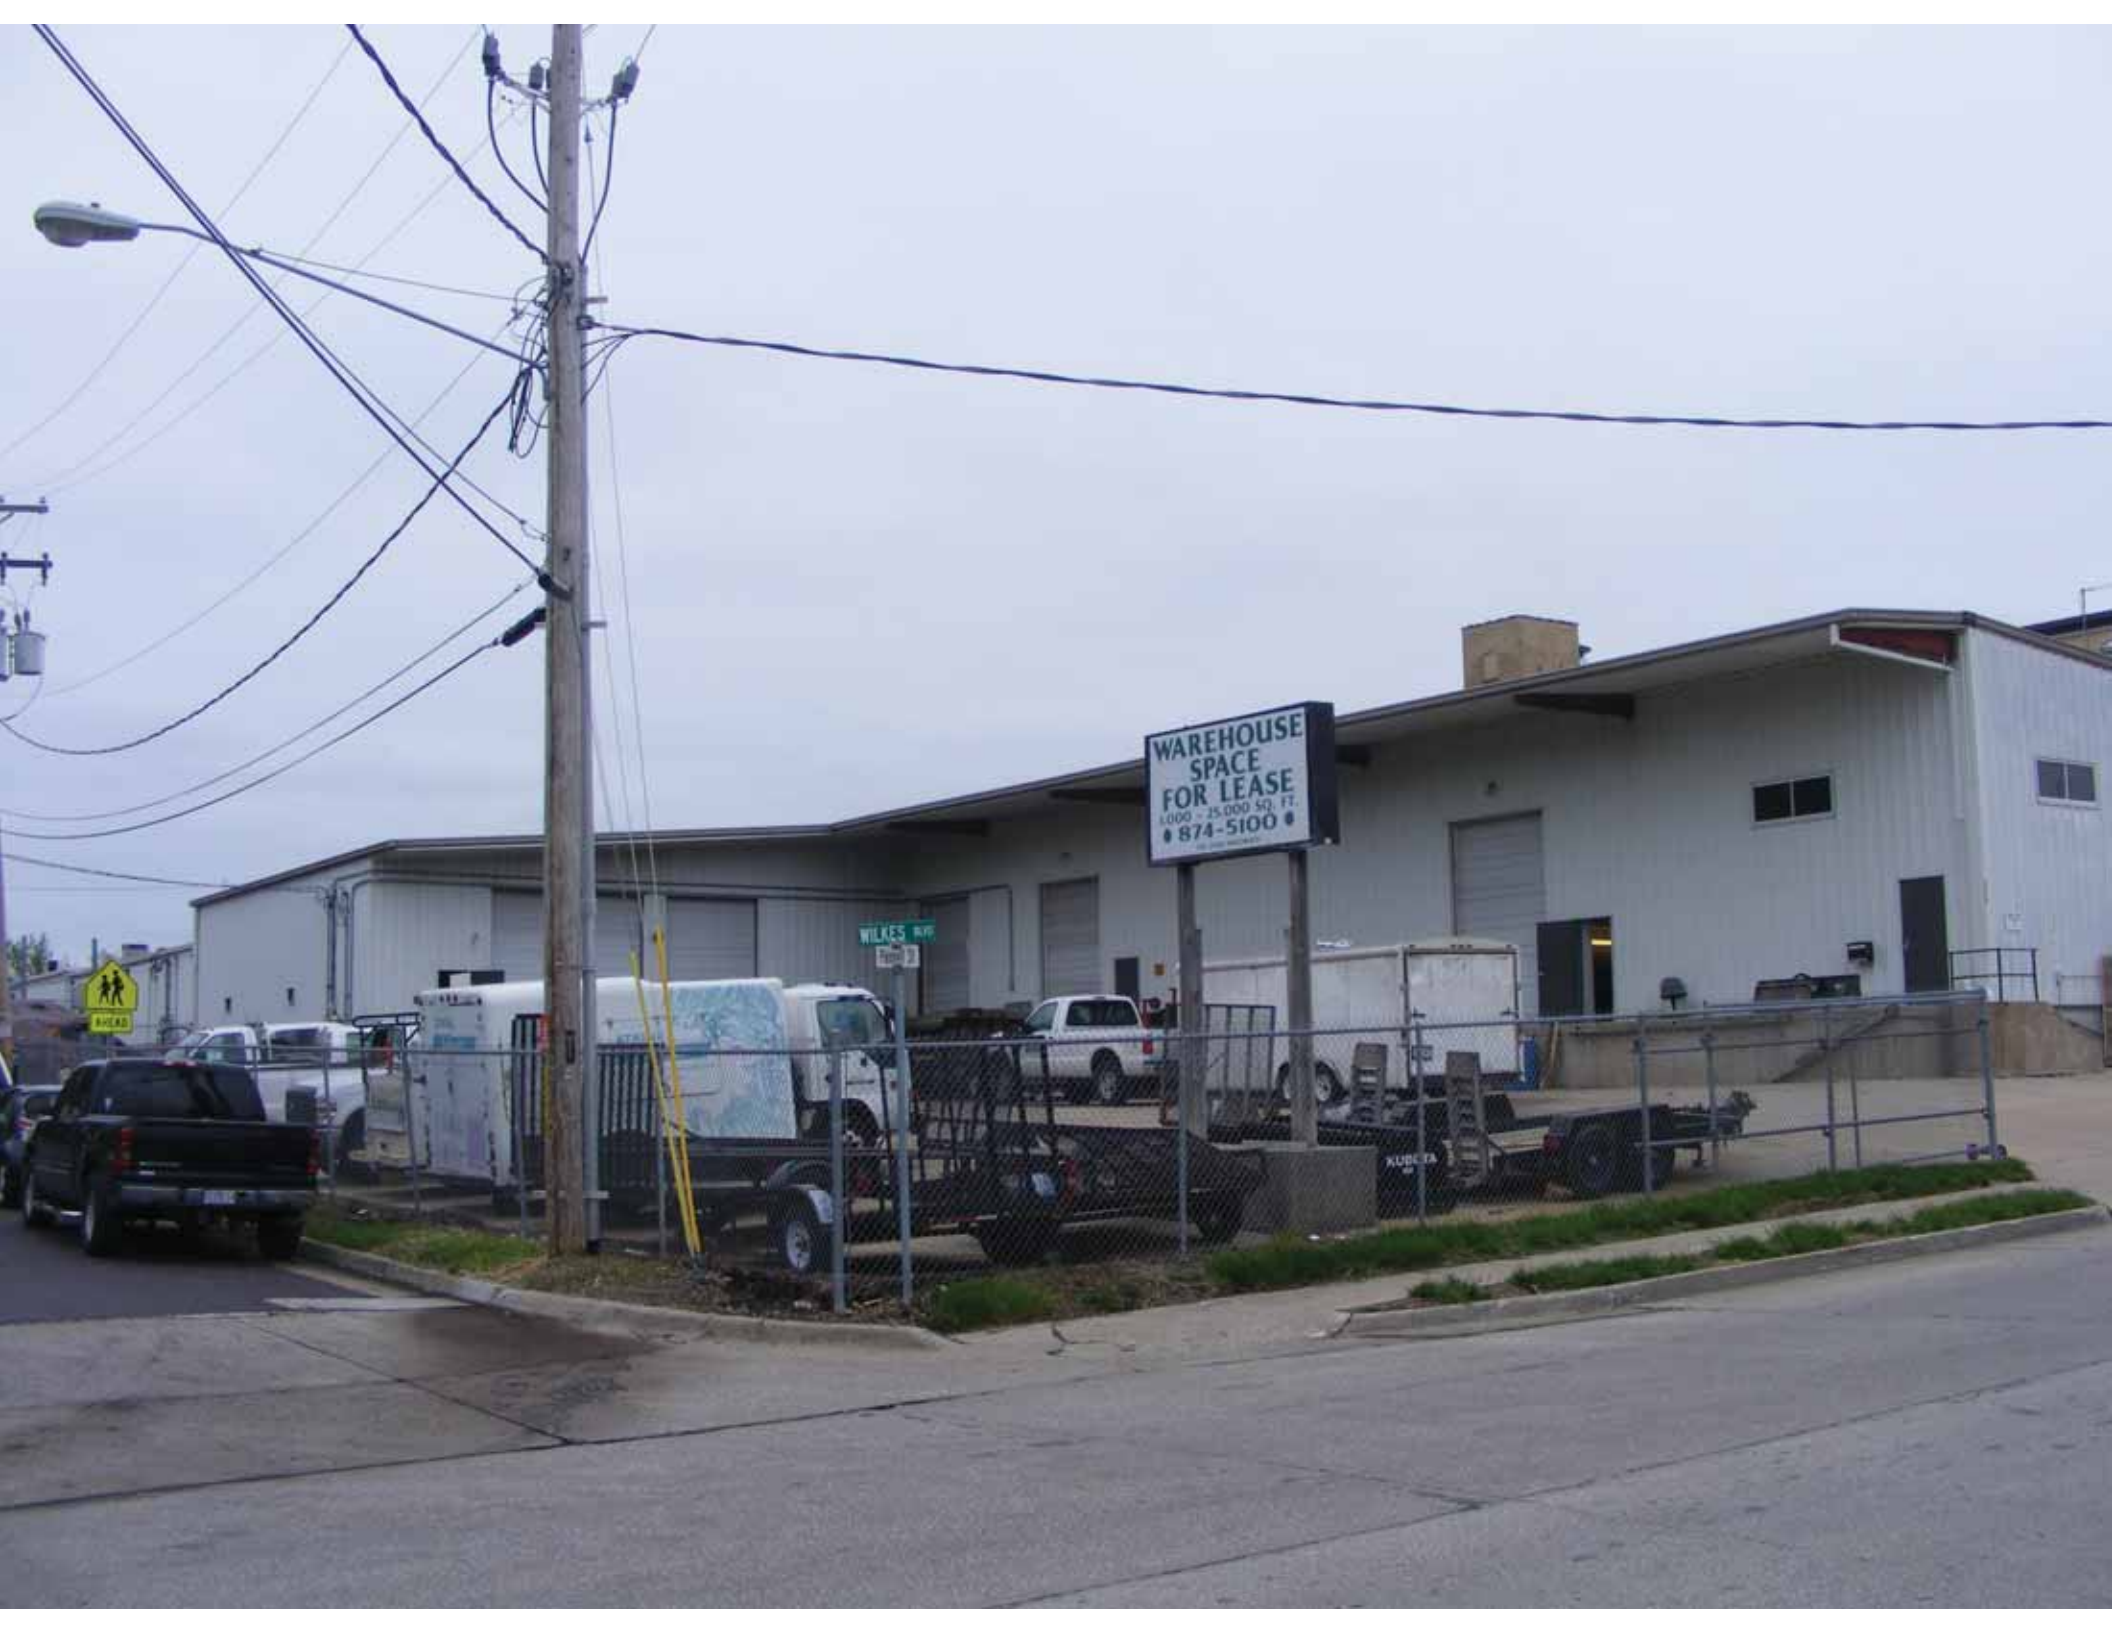
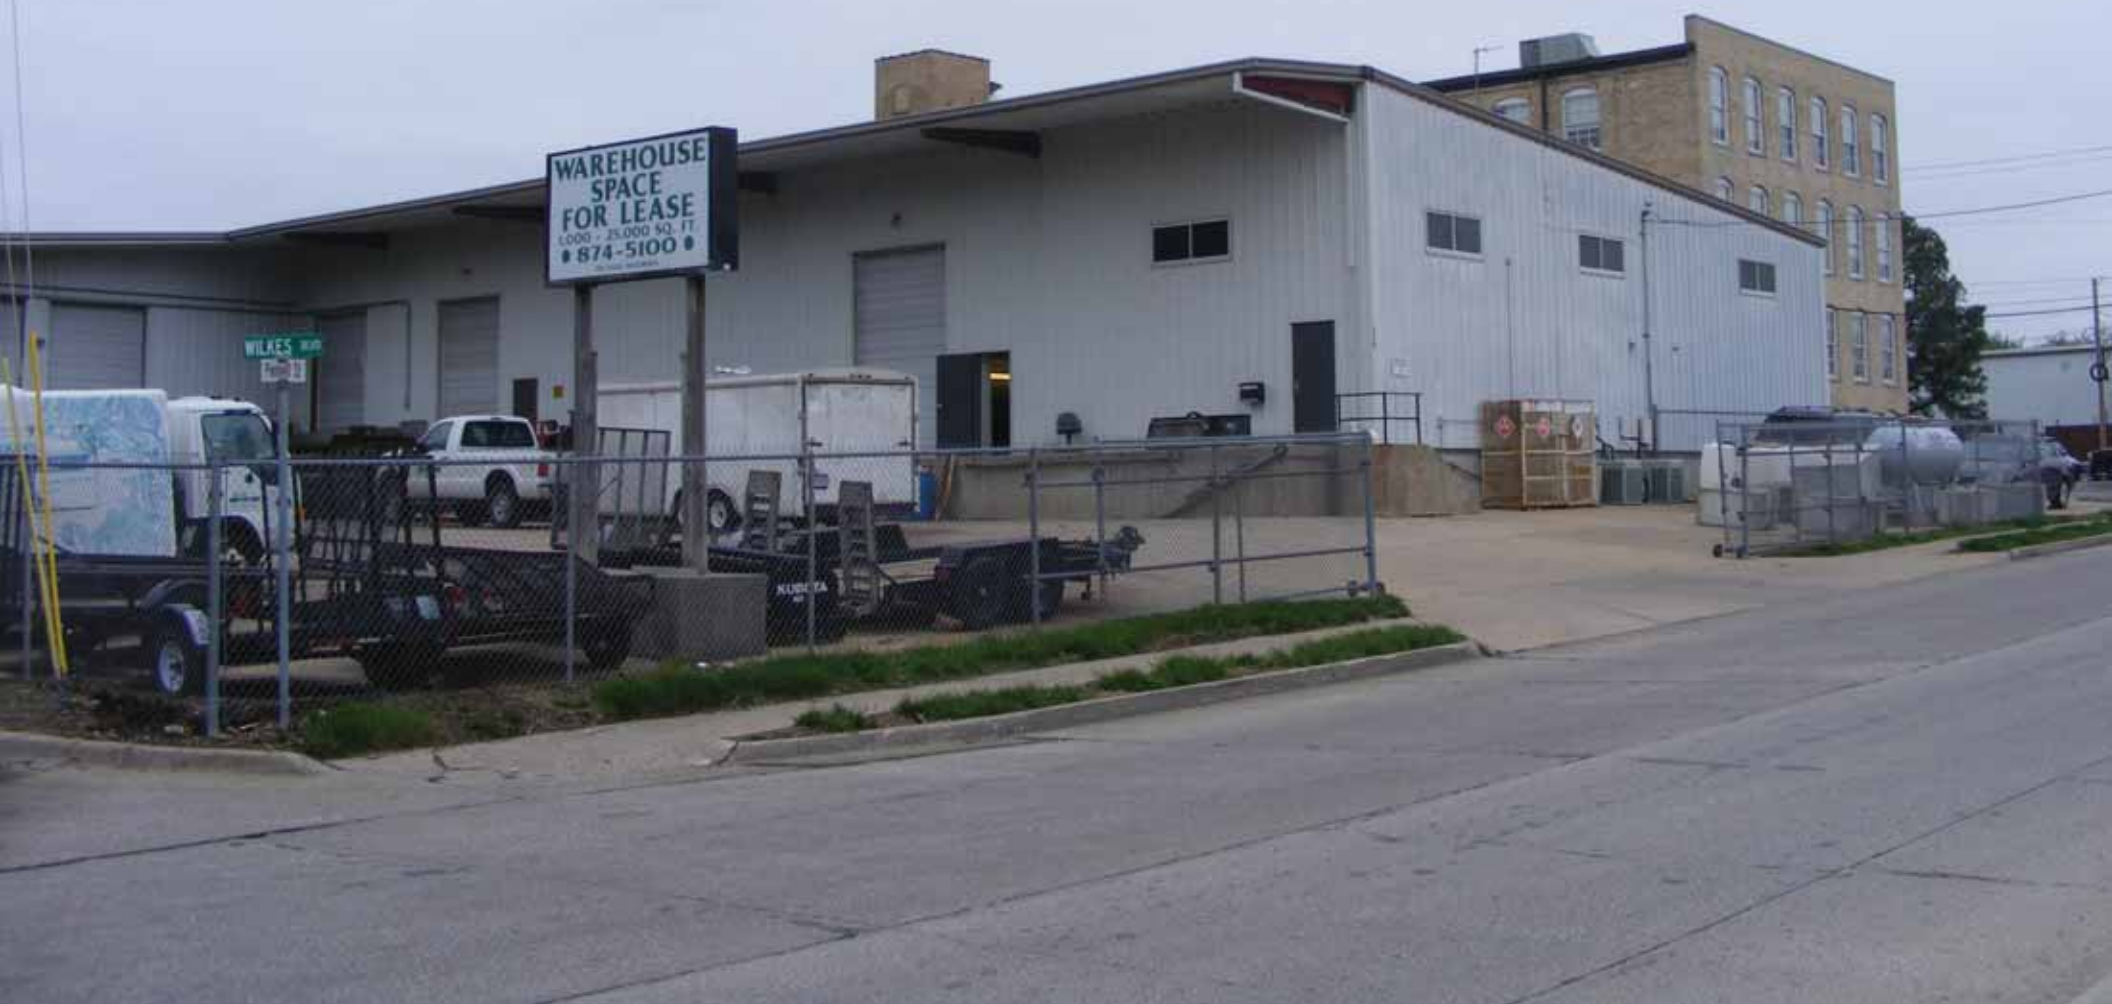
41. (cont.) Description of primary resource. Expand box as necessary, or add continuation pages.
This is a one story pre-fabricated metal seamed building with a side gable to shed and has a concrete foundation. The Wilkes Blvd. primary elevation holds three slider windows. The Pannell St. elevation holds three garage bays with metal paneled doors and two singles entry doors and a slider window in the upper section, at the right section near Wilkes Blvd. This section is sheltered by the overhanging roofline. At the left corner of this building, it intersects with the side gable section of the building. This elevation fronts Wilkes Blvd. and holds two garage bays with metal paneled doors. The side gable building elevation that fronts Wilkes Blvd. is void of openings.
