MISSOURI DEPARTMENT OF NATURAL RESOURCES
STATE HISTORIC PRESERVATION OFFICE, P.O. Box 176, Jefferson City, MO 65102
ARCHITECTURAL/HISTORIC INVENTORY FORM

1. Survey No. BO-AS-011-0087		2. Survey name: North Central Columbia Survey Phase II	
3. County: Boone		4. Address (Street No.) 902	Street (name) N. Seventh Street
5. City: Columbia	Vicinity: <input type="checkbox"/>	6. Geographical Reference:	7. Township/Range/Section: T: R: S:
8. Historic name (if known):		9. Present/other name (if known):	
10. Ownership: <input checked="" type="checkbox"/> Private <input type="checkbox"/> Public		11a. Historic use (if known): Domestic/single dwelling	11b. Current use: Domestic/single dwelling

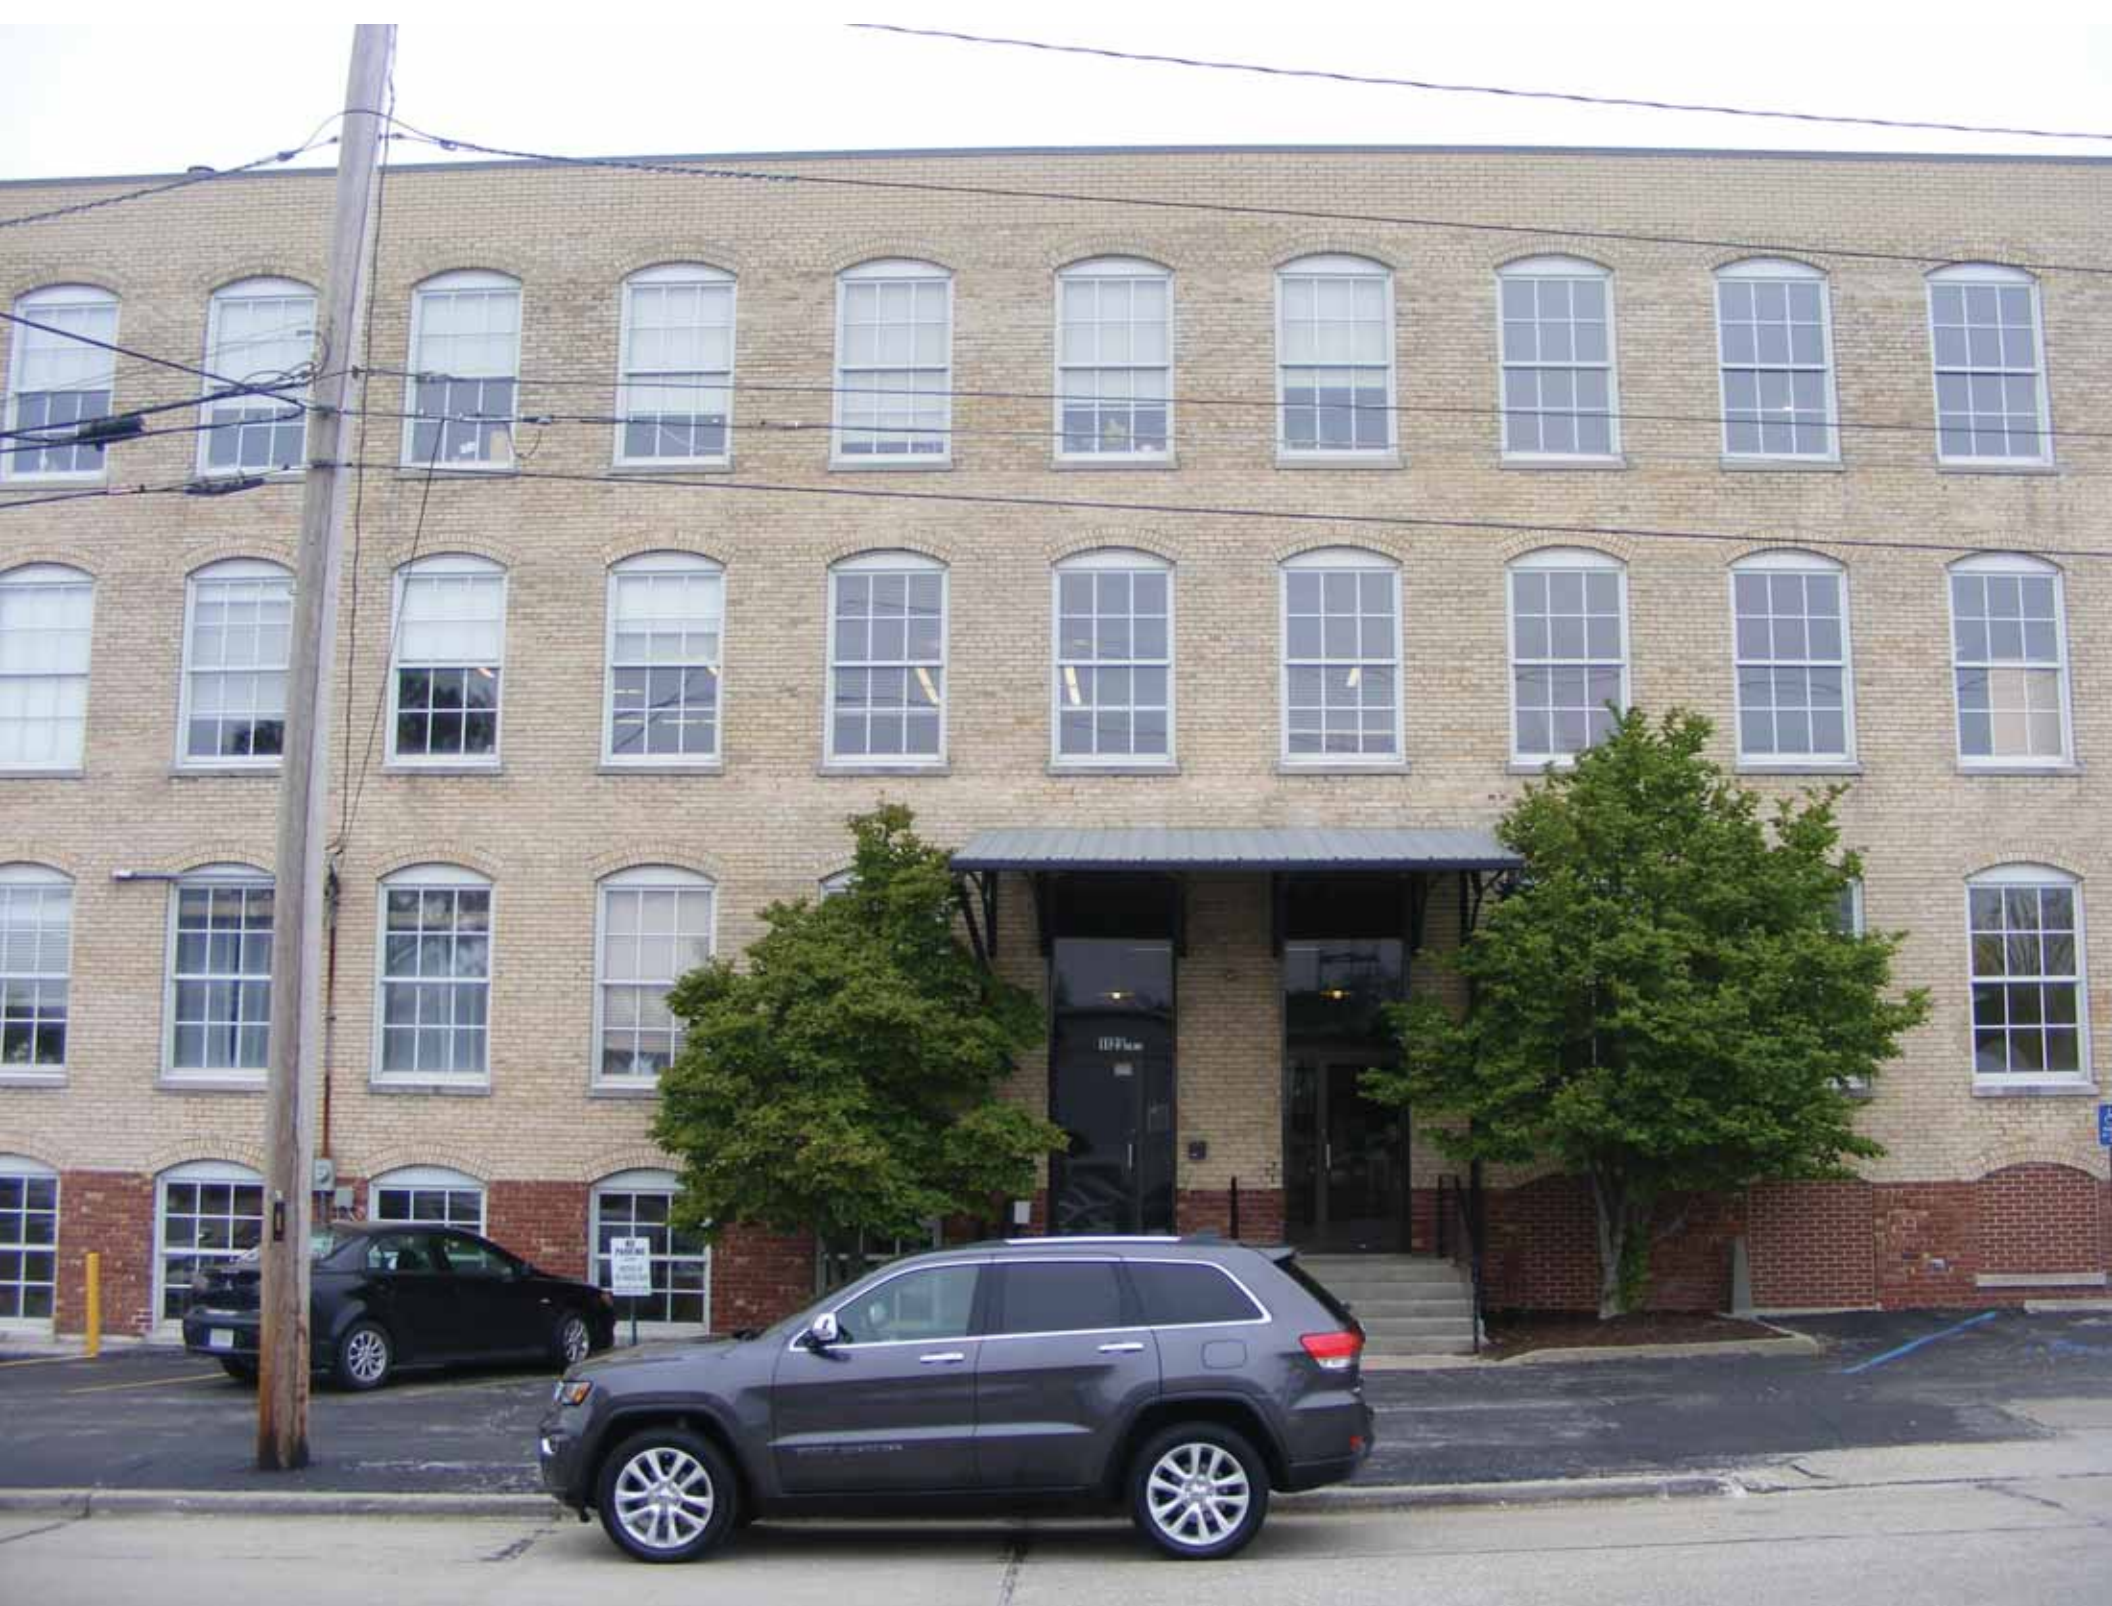
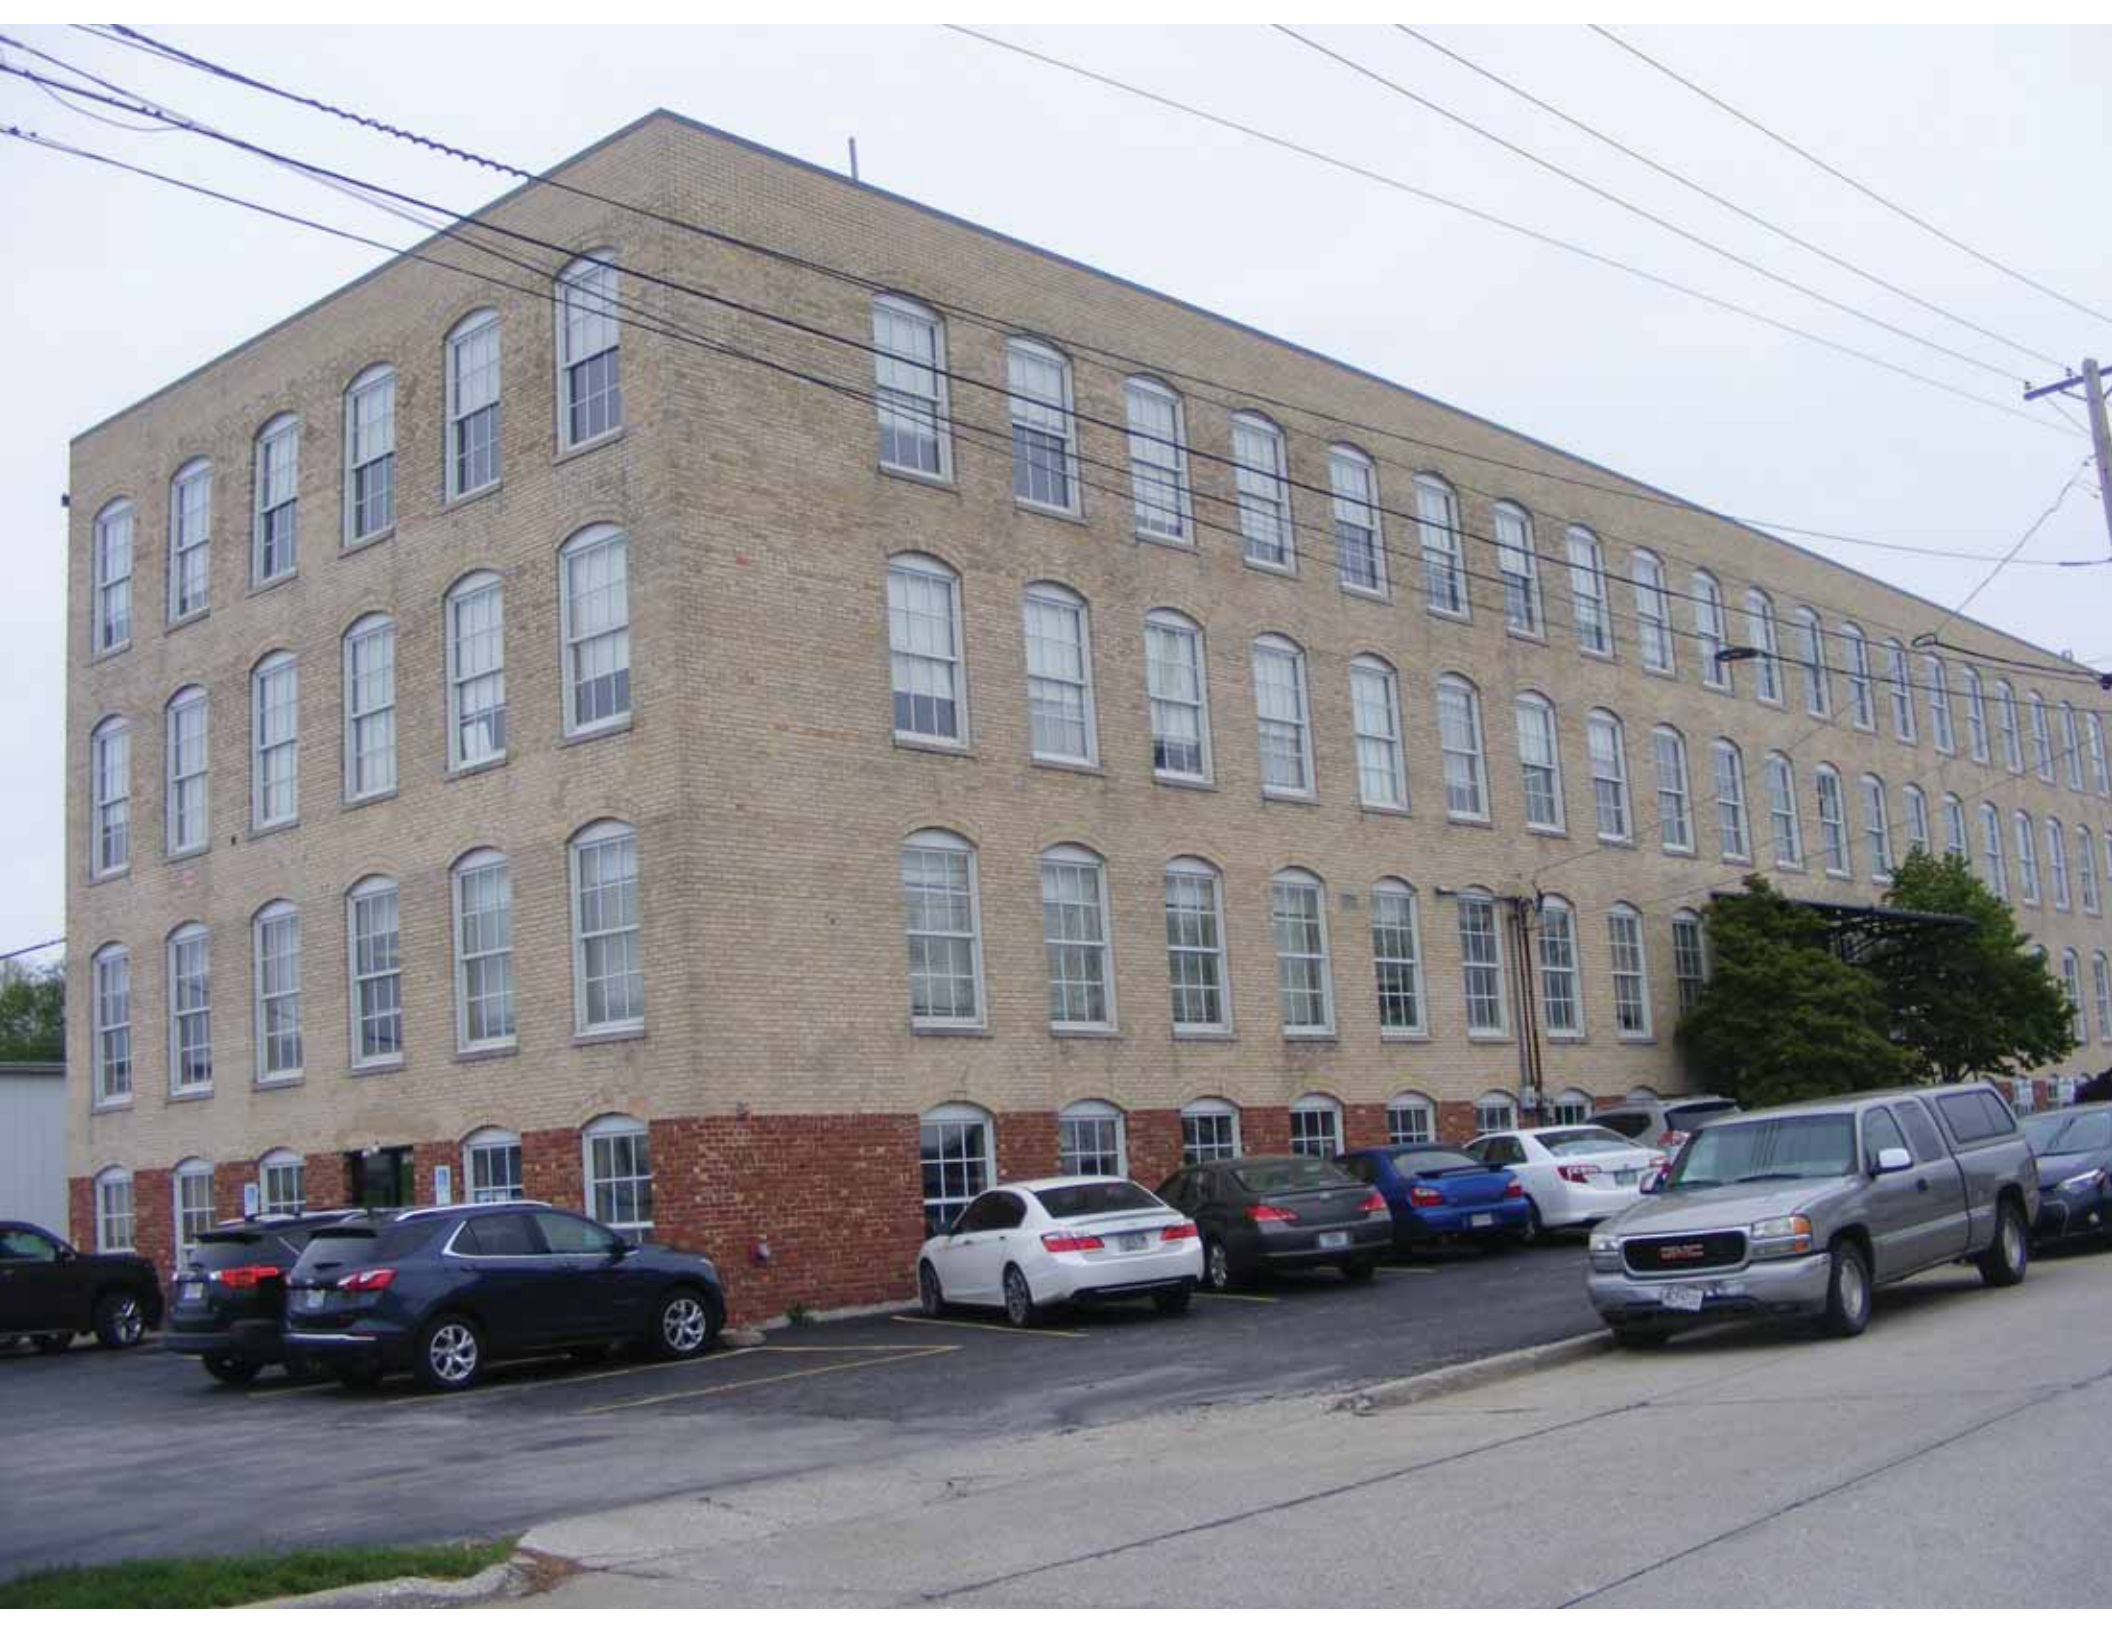
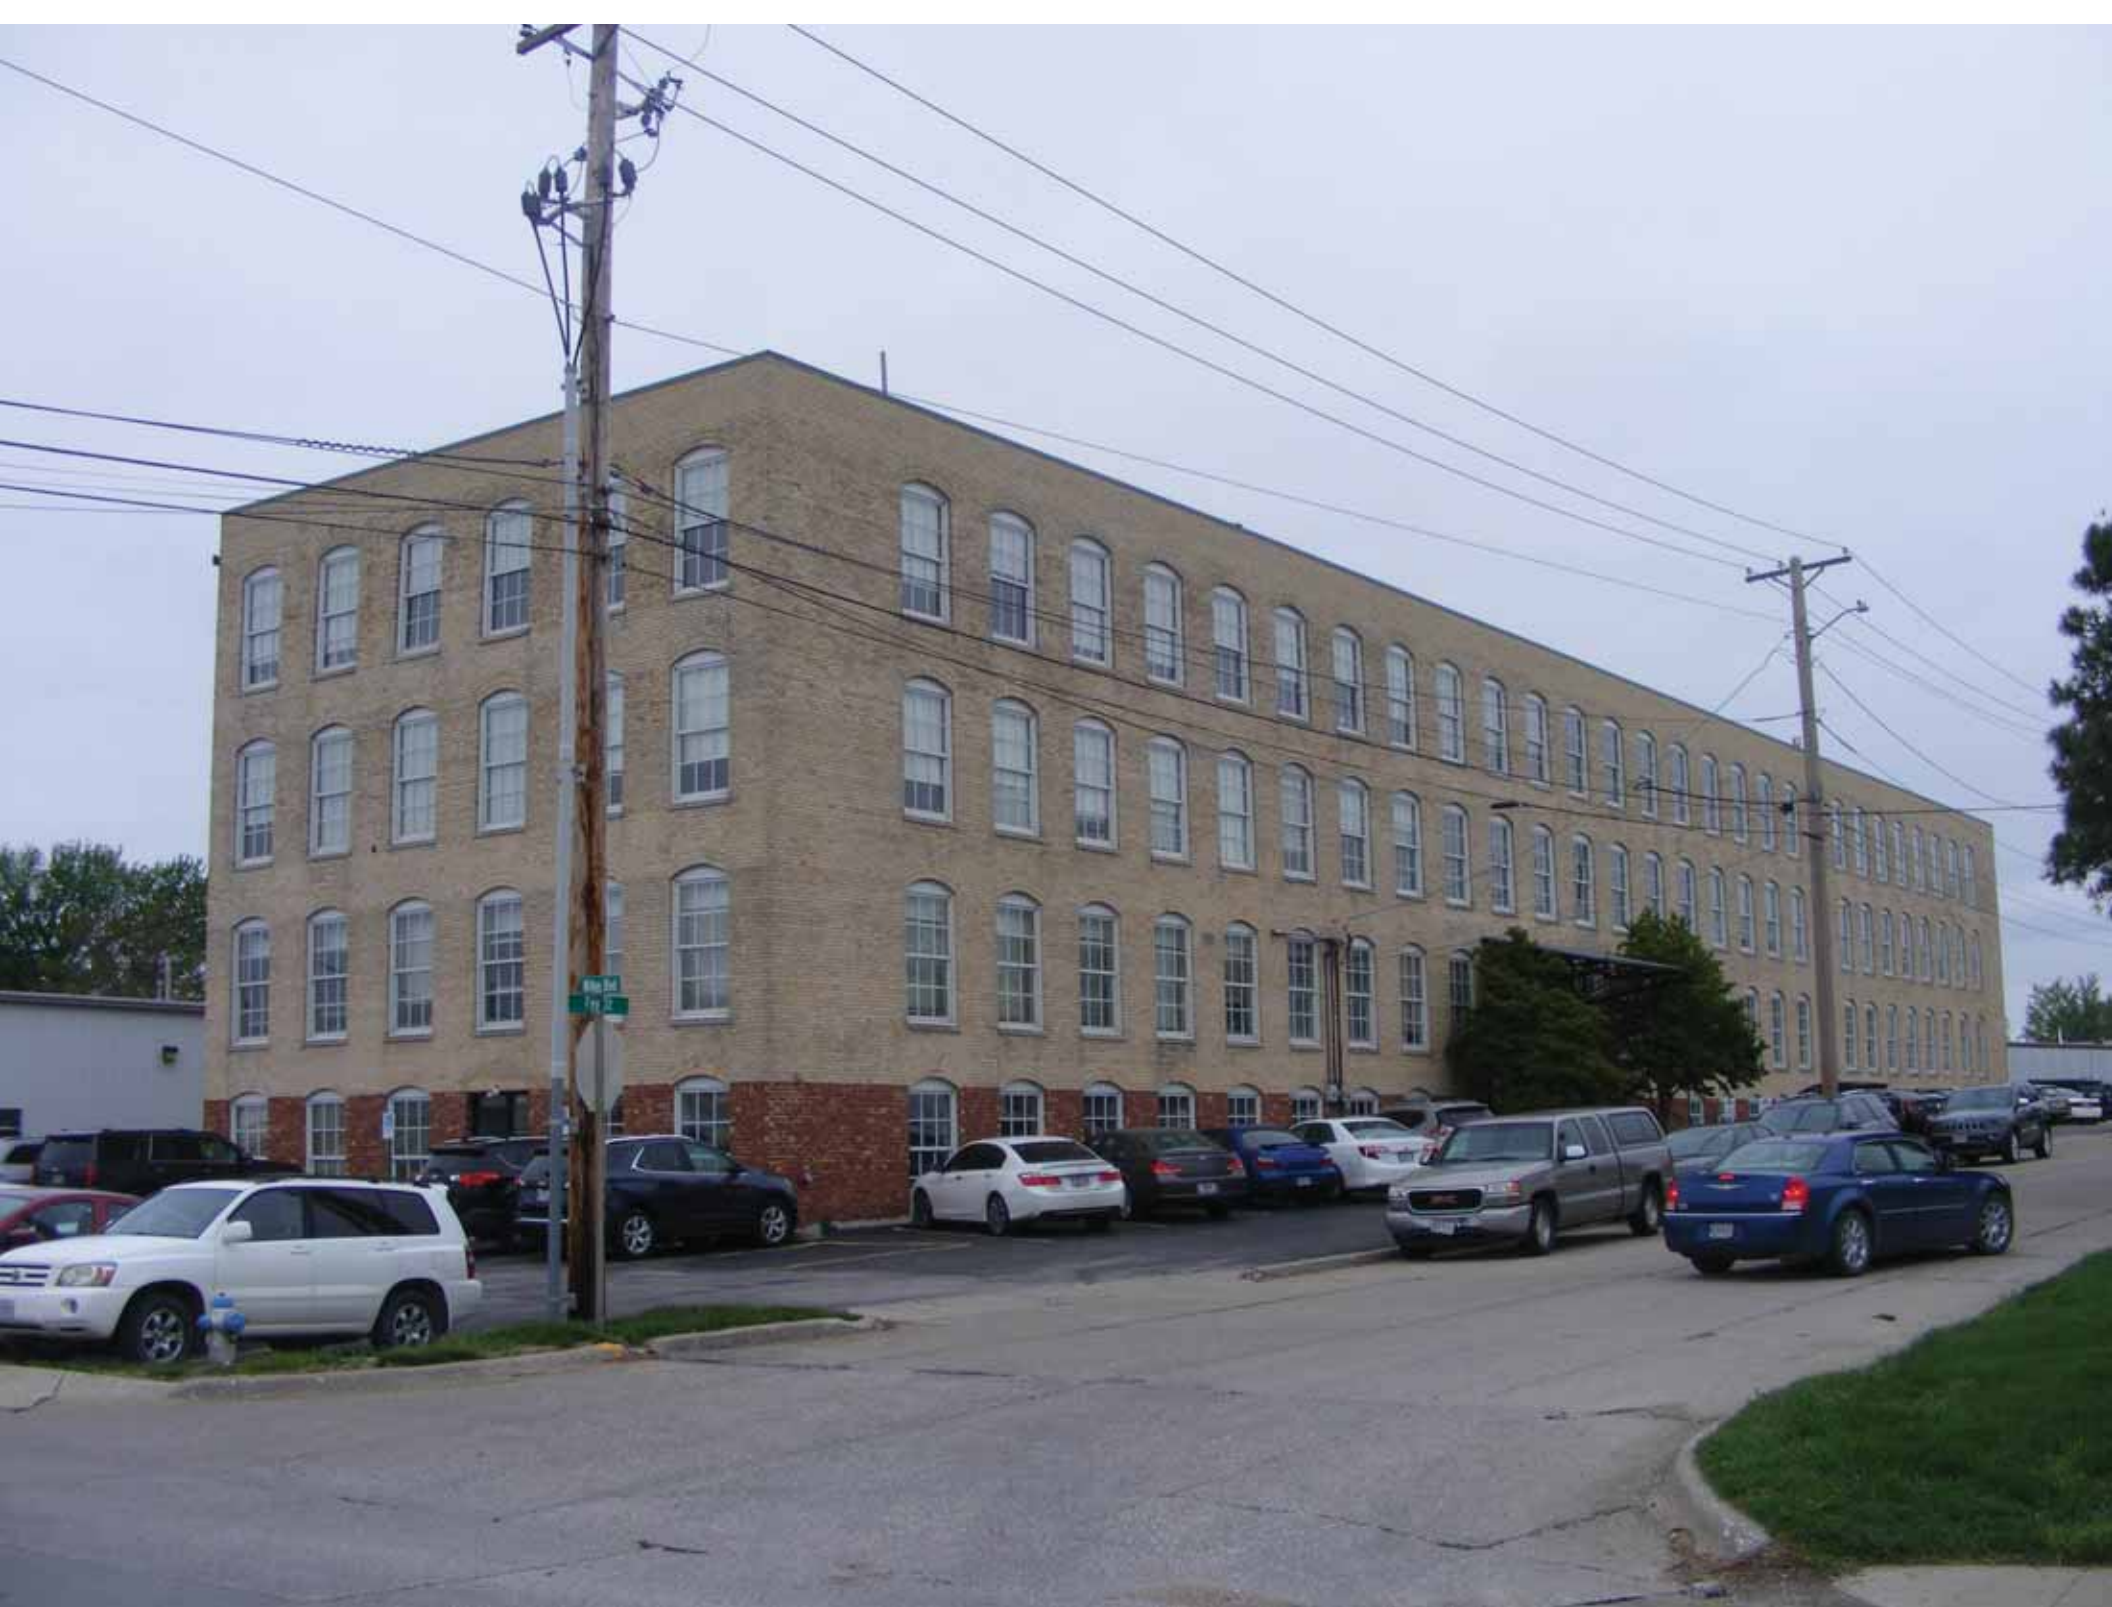
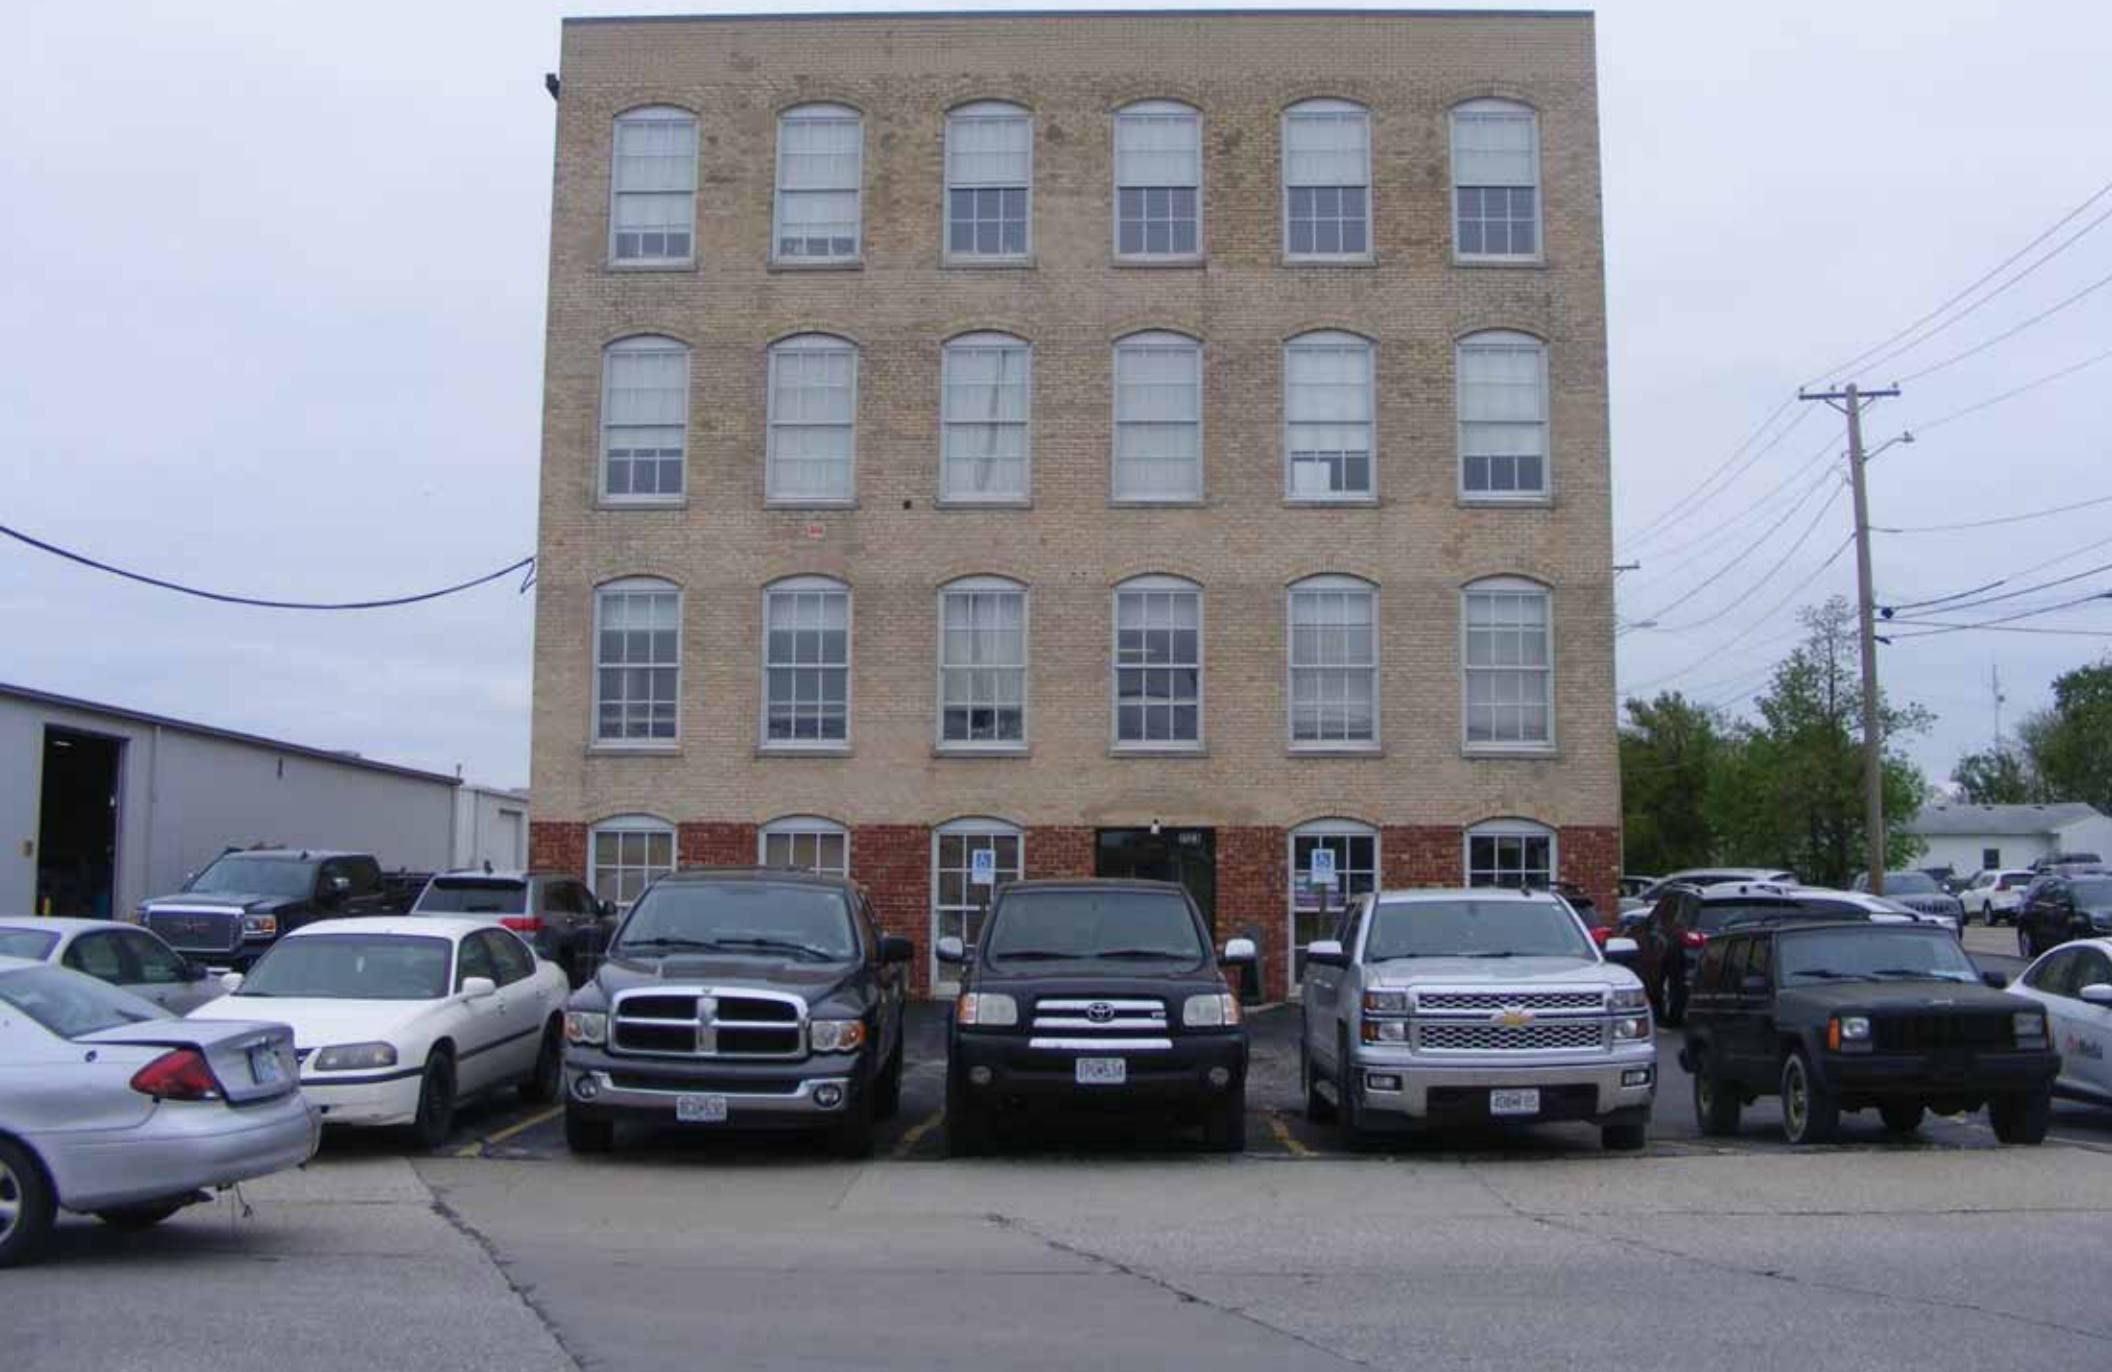
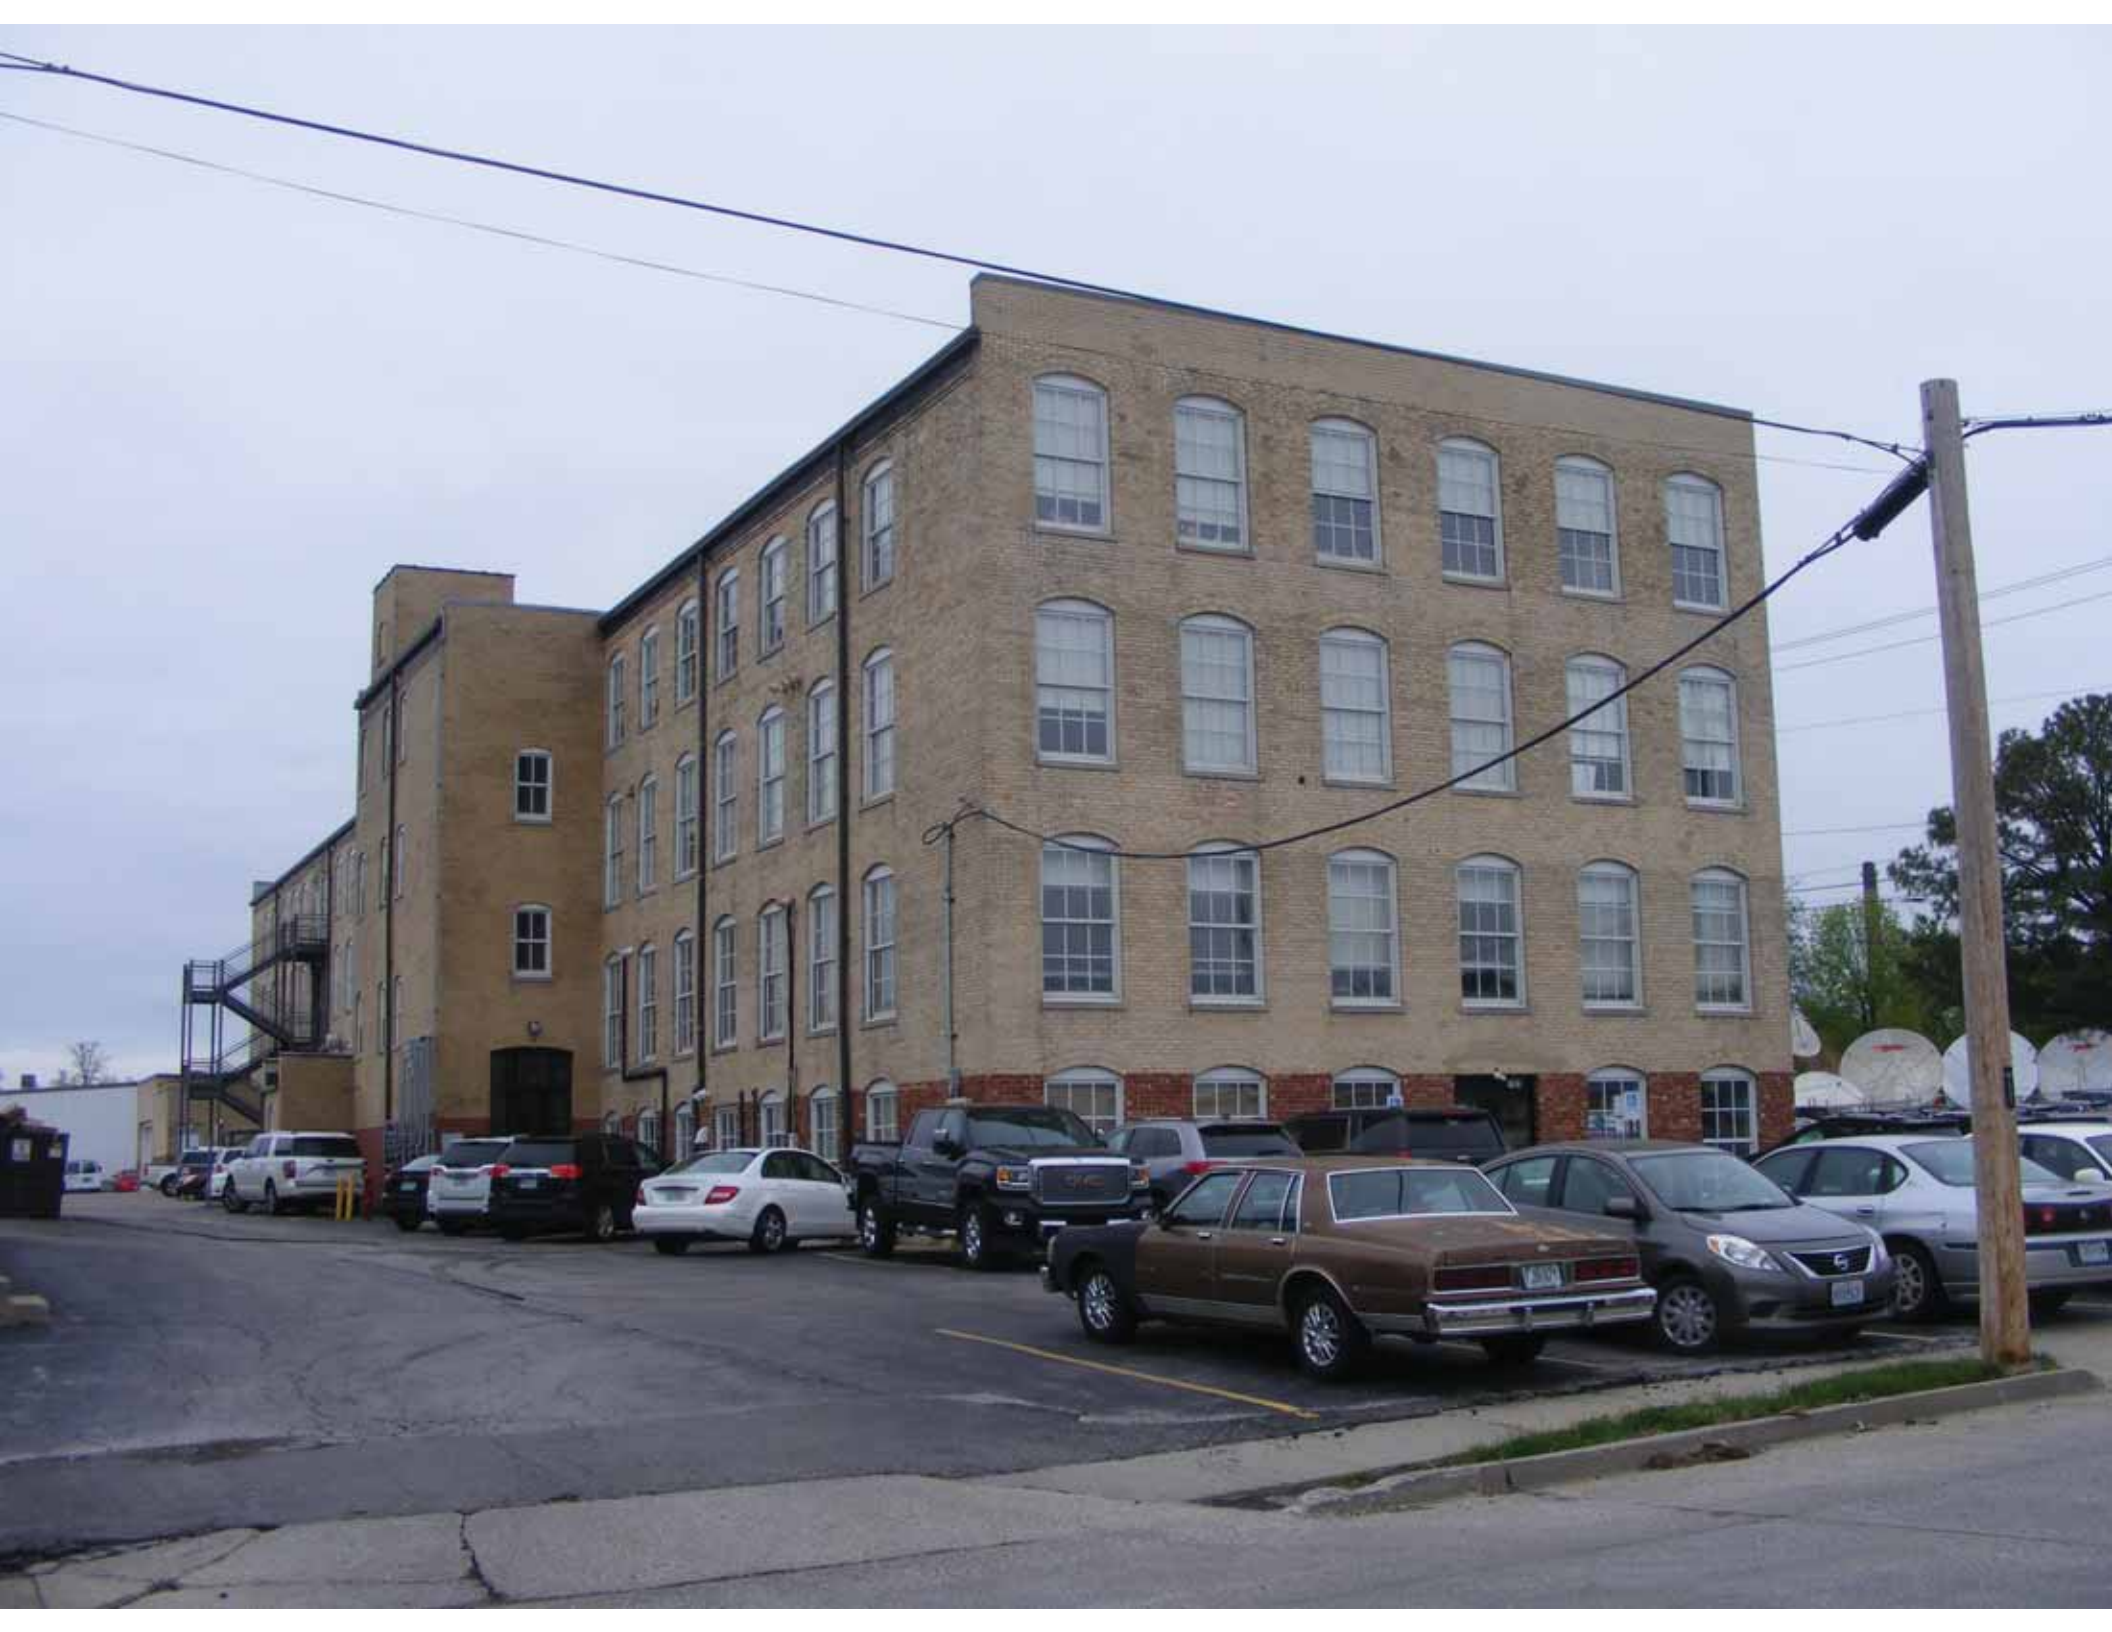
This is a brick 3.5 story building with a flat roof. The building has three levels (clad in tan brick) with a raised basement level clad in red brick. Each elevations features rows of six-over-six windows with segmental arches designed in double rows of sailor bricks. The primary elevation fronts Fay Street and holds an off-centered entrance of modern type single doors (two) with transoms sheltered by metal shed canopy. A secondary entrance is located on Wilkes Blvd elevation and is a modern type of glass/metal. The north elevation has a one story addition that holds boarded up openings on the Fay Street side and on the north elevation. For a more detailed architectural description please see the link provided in section 21 above.
