MISSOURI DEPARTMENT OF NATURAL RESOURCES  
STATE HISTORIC PRESERVATION OFFICE, P.O. Box 176, Jefferson City, MO 65102  
**ARCHITECTURAL/HISTORIC INVENTORY FORM**

1. Survey number: JA-AS-088-153		2. Survey Name: Town of Grandview, Resurvey	
3. County: JACKSON		4. Address (Street No.): 304 Street (name): Dewey Avenue	
5. City: Grandview	Vicinity <input type="checkbox"/>	6. Lat / Long:	7. Township/Range/Section: T: R: S:
8. Historic name (if known):		9. Present/other name (if known):	
10. Ownership: <input checked="" type="checkbox"/> Private <input type="checkbox"/> Public		11a. Historic use (if known): Domestic-Single Dwelling	11b. Current use: Domestic-Single Dwelling

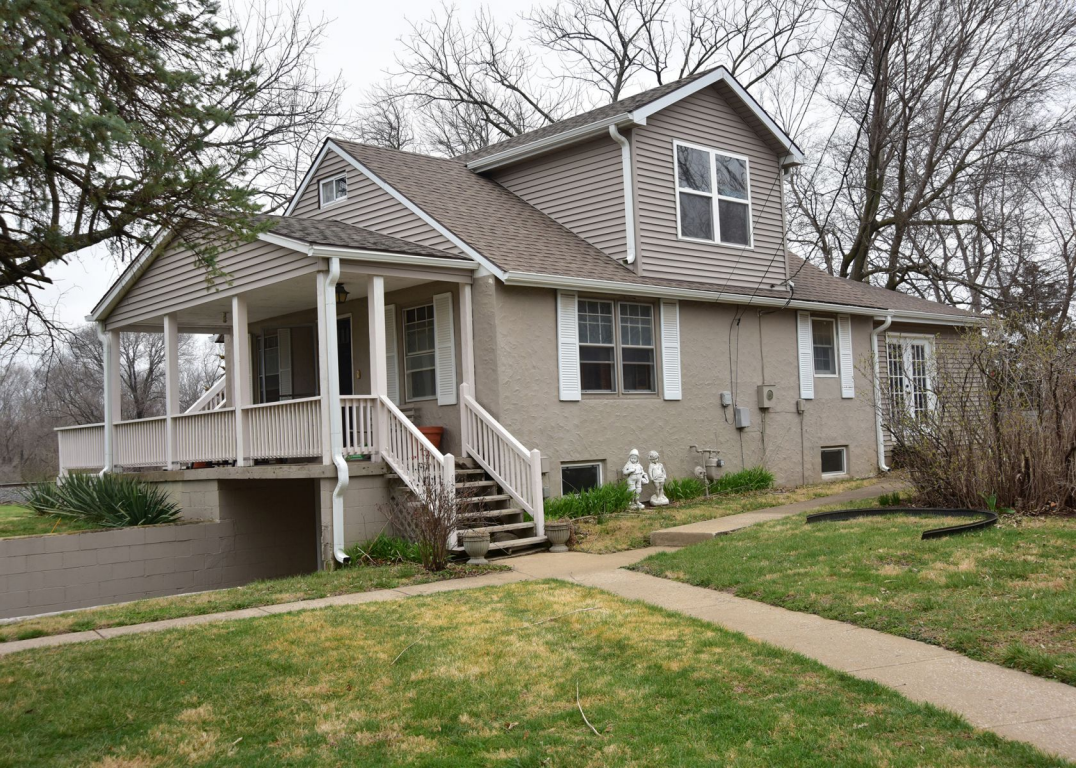
""This one-and-a-half-story, gable-front bungalow house has a rectangular footprint that is three symmetrical bays wide and, with a one-bay rear addition, three asymmetrical bays deep. Stucco covers the exterior walls and the exposed foundation. Non-original square wood posts support the three-quarter-width porch's gable-front roof, which shelters the center bay entrance. Defining the remaining bays are single and paired six-over-one light, double-hung sash windows flanked by shutters. A large, modern, gable-front dormer projects from the east roof slope. The combined application of non-original stucco to the exterior walls, the introduction of a large-scale dormer, and the replacement of original sashes compromise the integrity of this building (Davis and Schwenk, 2003).""The dormer, gables, and rear addition feature vinyl cladding. 304 Dewey Avenue does not appear significantly altered from its 2003 appearance. Dates of alteration are unknown, however they pre-date the 2003 survey."

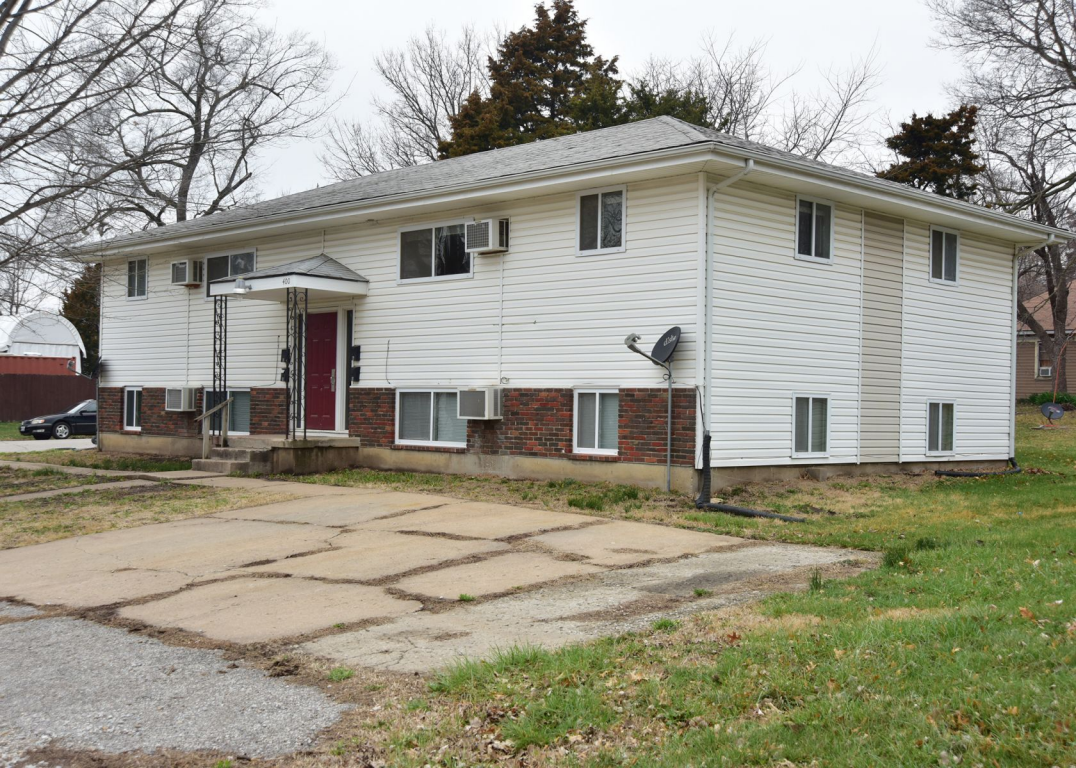
The replacement of original windows and cladding compromises the integrity of 400 Dewey Avenue. This resource has fair integrity but it is not eligible because there is no concentration of resources that would constitute a historic district. The determination of its eligibility is unchanged from the 2003 survey.

Vinyl clapboard has replaced the board and batten cladding. 400 Dewey Avenue otherwise does not appear significantly altered from its 2003 appearance.

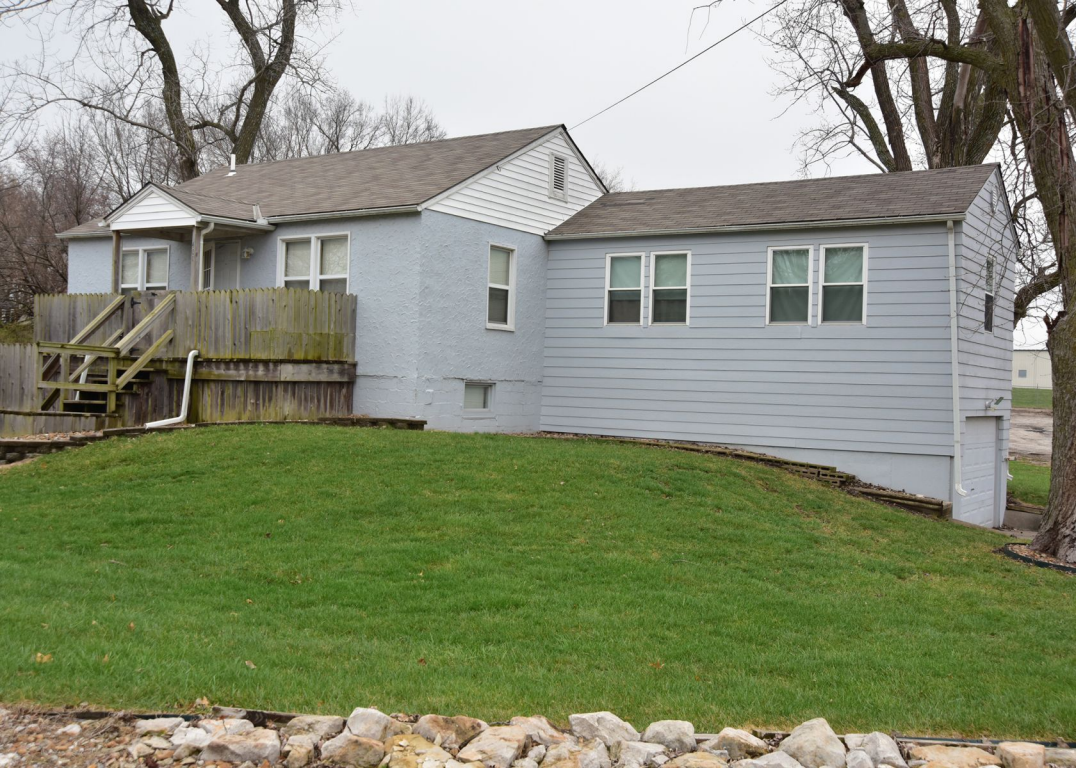
Non-historic cladding, replacement windows, and the loss of original porch elements compromise the integrity of the dwelling. 401 Dewey Avenue no longer conveys its historic associations. This resource has poor integrity and is not eligible. The determination of its eligibility is unchanged from the 2003 survey.

"This one-story, side-gabled house has a single-bay wing addition, resulting in a L-shaped footprint that is four bays wide and two bays deep. Stucco covers the exterior walls and the concrete block foundation. Wood shingles clad the wing addition. Non-original square wood posts support the single-bay porch's gable-front roof, which shelters the entrance in the second bay from the east end. Non-original, single and paired one-over-one light, double-hung window sashes define the remaining bays. Additional character-defining features include the tight eaves and the wood-shingle cladding on the gable walls. The application of non-original stucco to the exterior walls, the replacement of original sashes, and the loss of original porch elements compromises the integrity of this building (Davis and Schwenk, 2003)."

Wide profile vinyl clapboard now clads the wing addition and wood picket fencing with a hinged gate has replaced the open porch railing. 401 Dewey Avenue otherwise does not appear significantly altered from its 2003 appearance. Dates of all other alterations are unknown, however pre-date the 2003 survey.

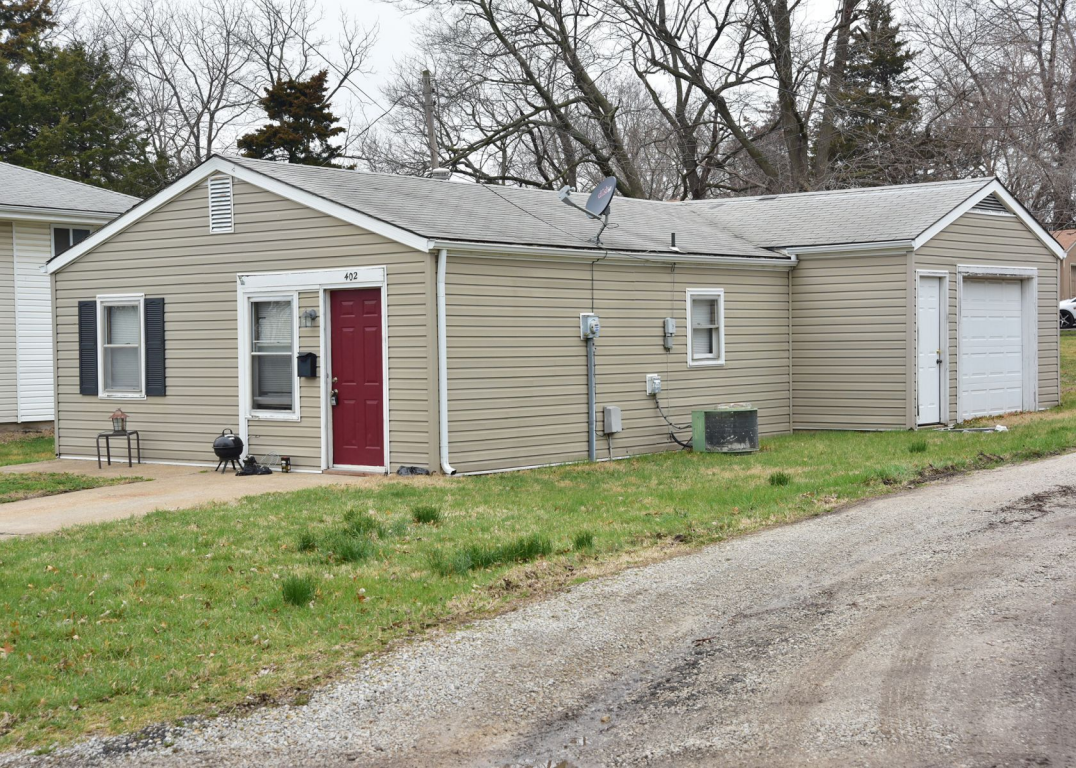
402 Dewey Avenue is within the "Old Town" Conservation District identified by the 2003 survey. This district includes resources which represent the early residential development of the city (Davis and Schwenk, 2003,104). Non- historic cladding, replacement windows, and a large rear addition compromise the integrity of 402 Dewey Avenue. The dwelling no longer conveys its historic associations. This resource has poor integrity and is not eligible. The determination of its eligibility is unchanged from the 2003 survey.

"This one-story, gable-front house has a rectangular footprint that is three asymmetrical bays wide. A vertical wood board-and-batten treatment covers the exterior walls. A metal awning shelters the entrance in the east end bay. Single one-over-one light, double-hung sash windows define the other bays. Additional character-defining features include the tight eaves. The application of non-original siding and the replacement of window sashes compromise the integrity of this building (Davis and Schwenk, 2003)."

The board-and-batten treatment has been replaced with vinyl clapboard and the metal awning has been removed.

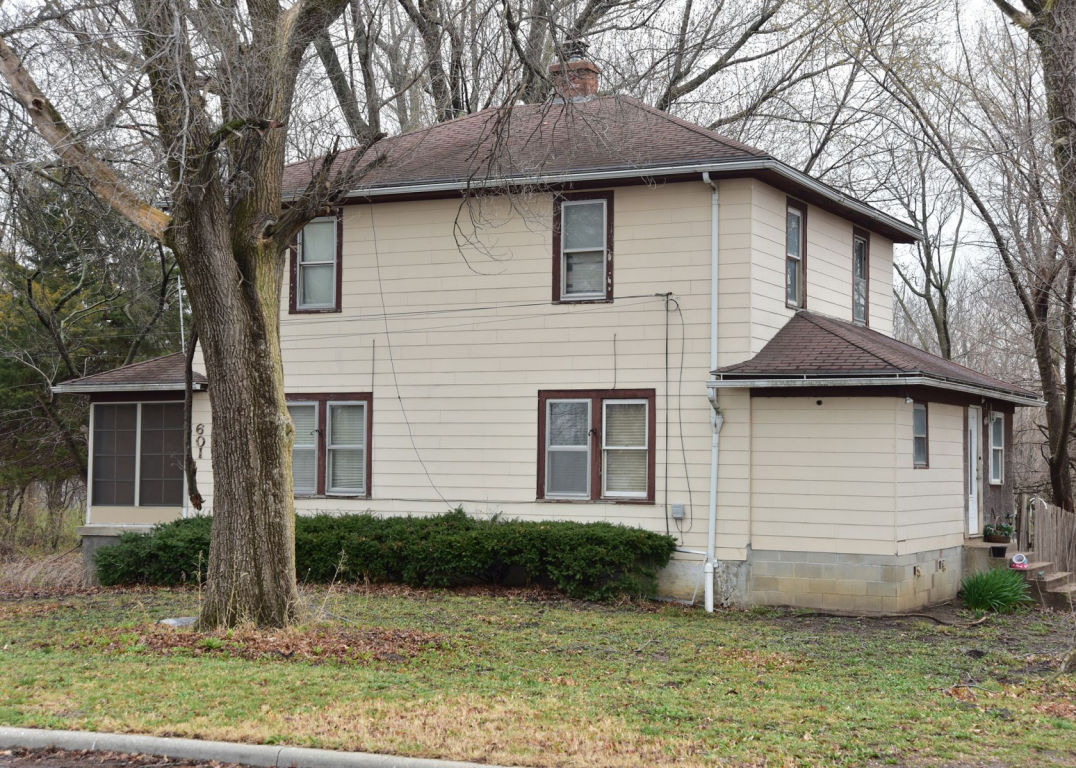
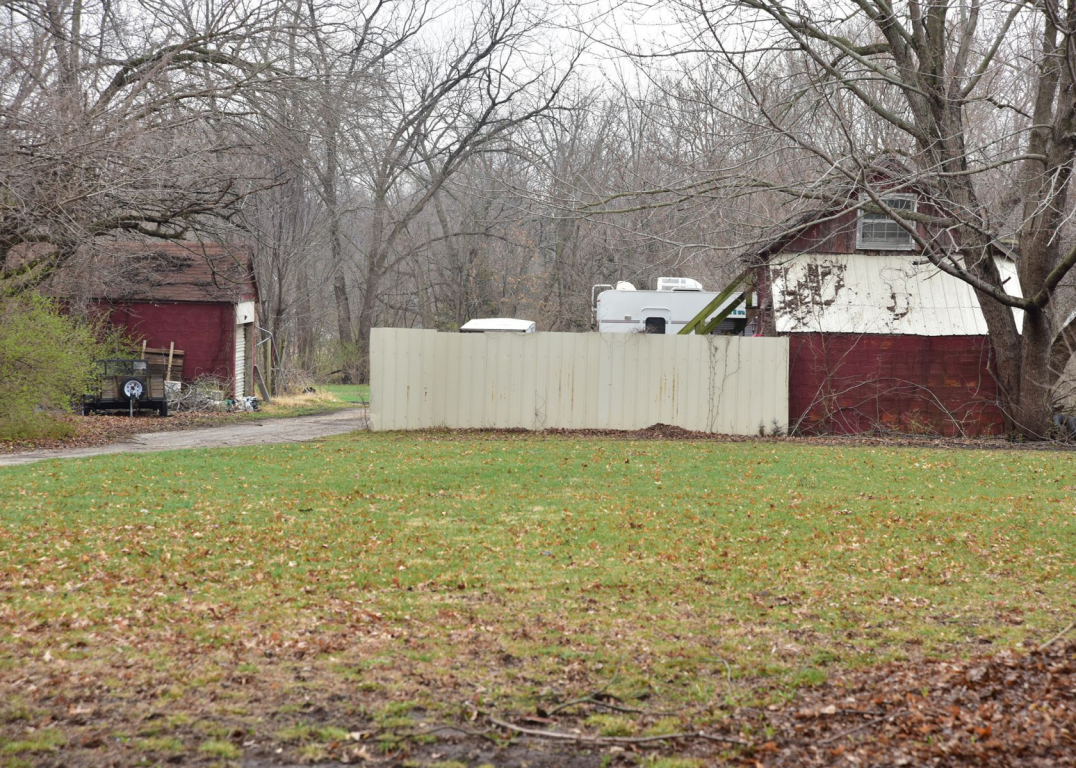
"This two-story Four Square folk house has a hipped roof and a rectangular footprint that is two bays wide and two bays deep. The enclosed full-width porch has a hipped roof that shelters the primary entrance in the east end bay. Single and paired one-over-one light, double-hung wood sash windows with flat board trim define the remaining bays. Decorative iron posts support the rear porch's hipped roof, which shelters a secondary entrance (Davis and Schwenk, 2003)."

The rear porch is now enclosed by an aluminum framed system. aluminum sash storm windows are present at all elevations visible from the right-of-way. 601 Dewey Avenue does not otherwise appear significantly altered from its 2003 appearance.

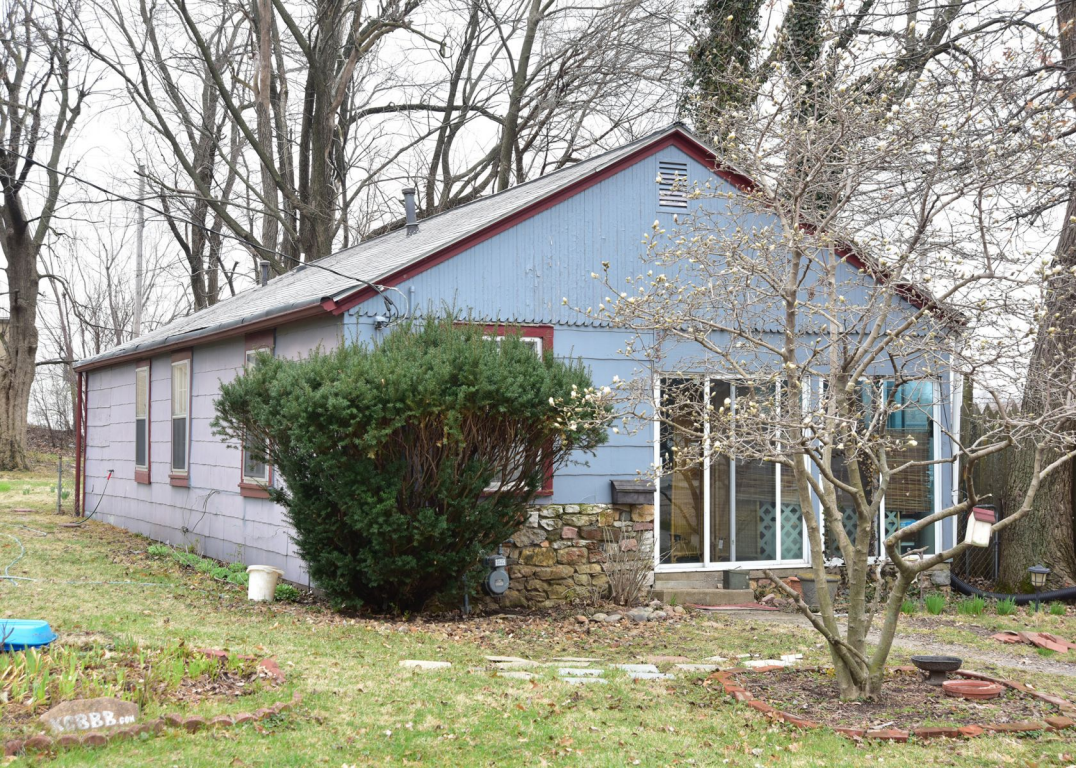
"This one-story, gable-front bungalow house has a rectangular footprint that is three bays wide and three bays deep. The three façade bays include an entrance door in the east end bay and two sliding glass doors that appear to enclose what was likely a recessed porch space. Scalloped beadboard covers the front gable and asbestos shingles clad the remaining exterior walls. Six-over-six light, double-hung wood sash windows with flat board trim define the three bays of the secondary façades. The combined application of modern wall cladding materials and the porch enclosure compromise the integrity of this building (Davis and Schwenk, 2003)."

Rough-cut stone veneer clads the lower third of the primary elevation. 505 Goode Avenue does not appear significantly altered from its 2003 appearance.

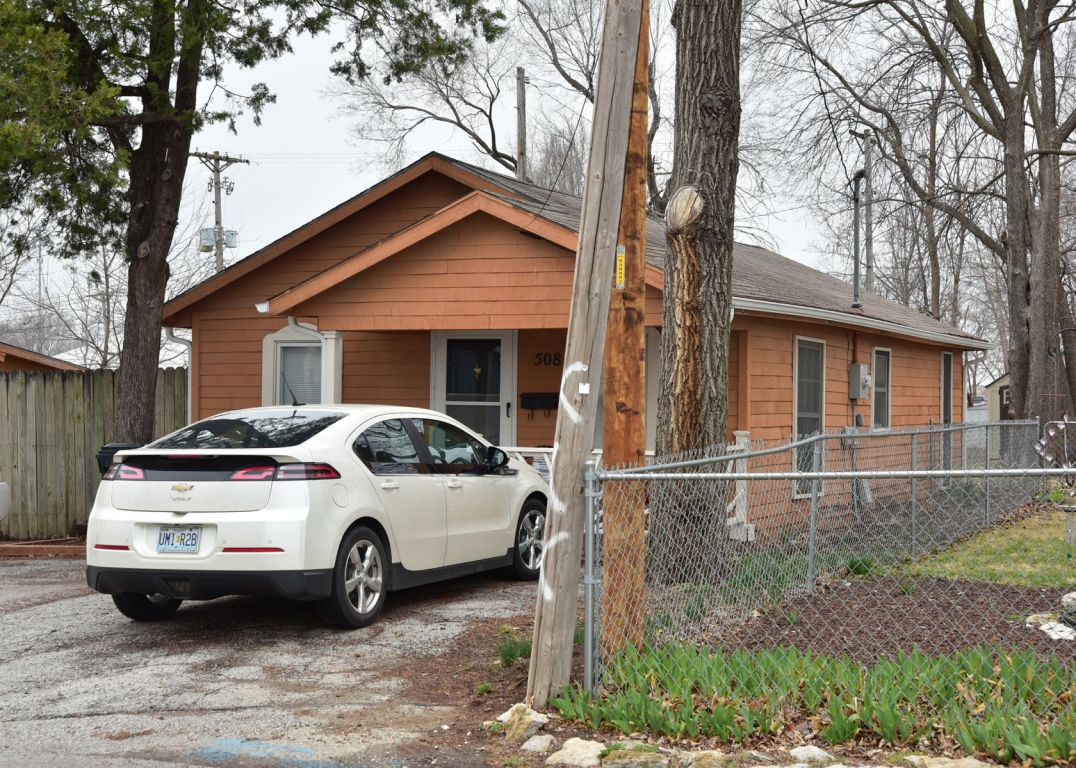
The replacement of windows and loss of original porch elements compromise the integrity of 508 Goode Avenue. However, the dwelling continues to convey its historic associations. This resource has fair integrity but it is not eligible because there is no concentration of resources that would constitute a historic district. The determination of its eligibility is unchanged from the 2003 survey.

"This one-story, gable-front bungalow house has a rectangular footprint that is three symmetrical bays wide and three bays deep. Aligned along the east side of the façade, the gable-front porch shelters the two east end bays, including the center bay entrance. Non-historic wood porch posts and balustrade replace the original materials. Single fixed-sash windows fill the remaining two bays (Davis and Schwenk, 2003)."

Screens obscure the sash of the six-over-six windows. 508 Goode Avenue does not appear significantly altered from its 2003 appearance. Dates of alteration are unknown, however they pre-date the 2003 survey.

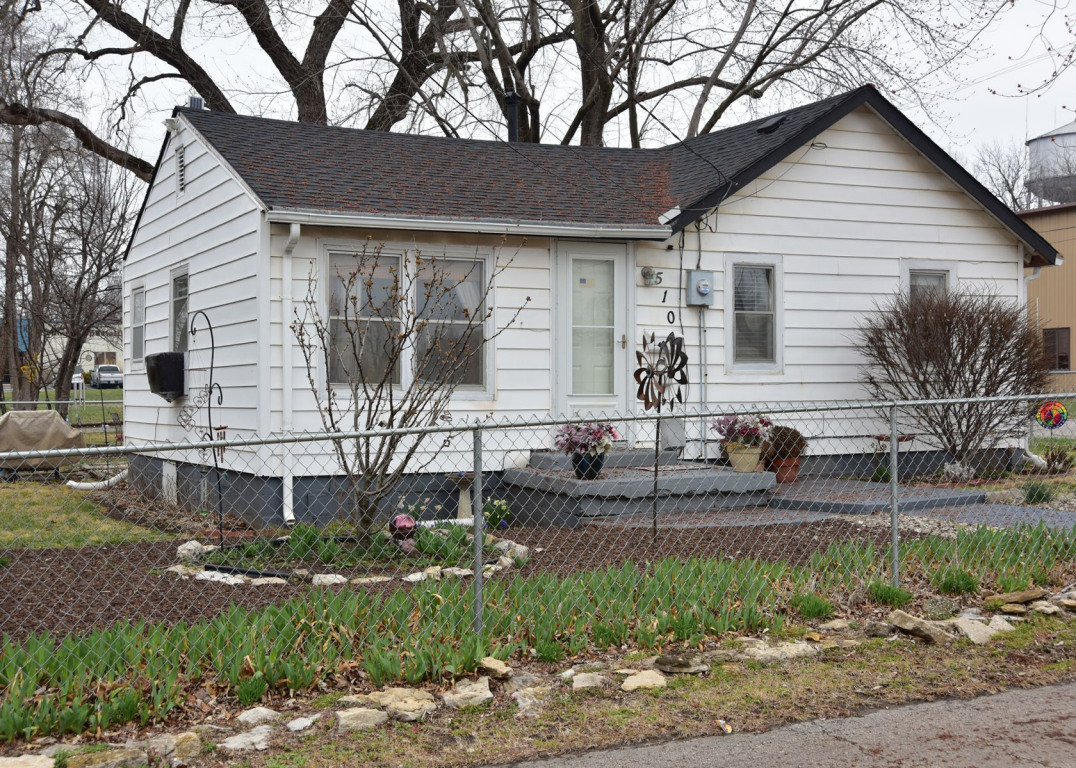
"This one-story, gable-front-and-wing folk house has a rectangular footprint that is four asymmetrical bays wide and two bays deep. The stoop entrance is located at the junction of the front gable with the intersecting eaves line at the second bay from the west end. Defining the remaining three bays of the primary façade are single and paired one-over-one light, double-hung wood sash windows, with flat board trim. The application of vinyl siding compromises the integrity of this building (Davis and Schwenk, 2003)."

510 Goode Avenue does not appear significantly altered from its 2003 appearance. Dates of alteration are unknown, however they pre-date the 2003 survey.

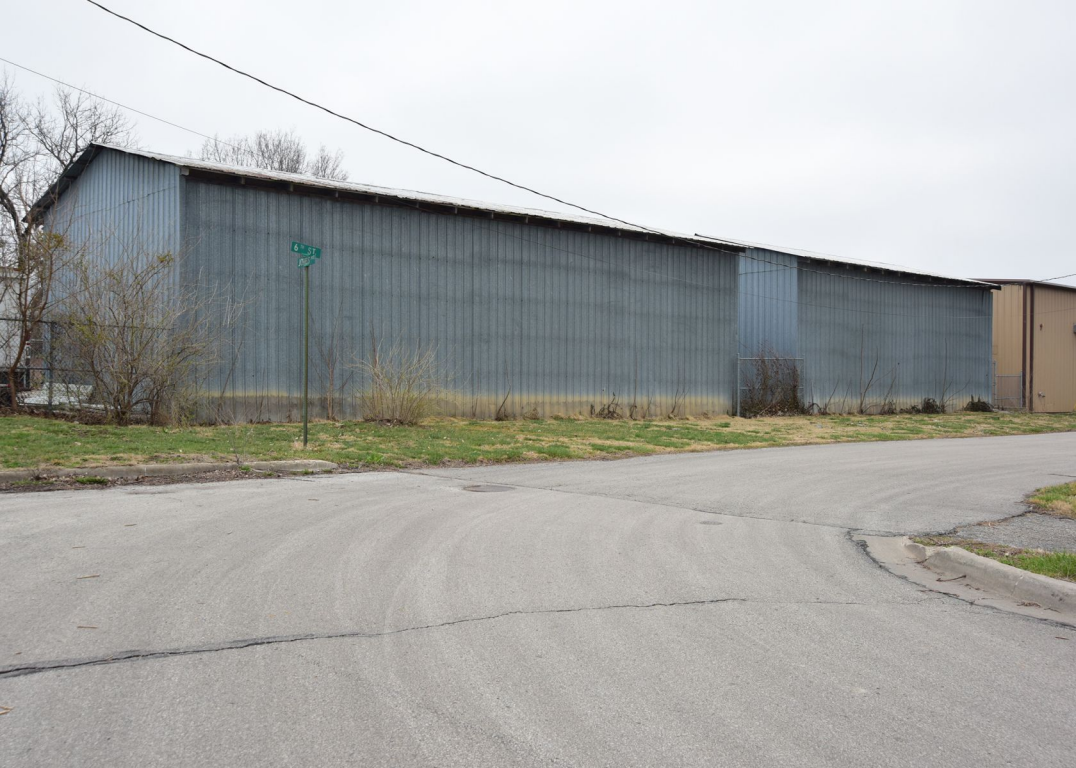
"There are two large, identical corrugated metal buildings with side-gabled roofs at the rear of the lot, behind 600b. Each building has a rectangular footprint that is one bay wide and one bay deep. The primary façade has a vehicular bay and a pedestrian entrance that pierces the secondary (south) façade. See 600b for a description of the remainder of this property (Davis and Schwenk, 2003)."

600a Goode Avenue does not appear significantly altered from its 2003 appearance.

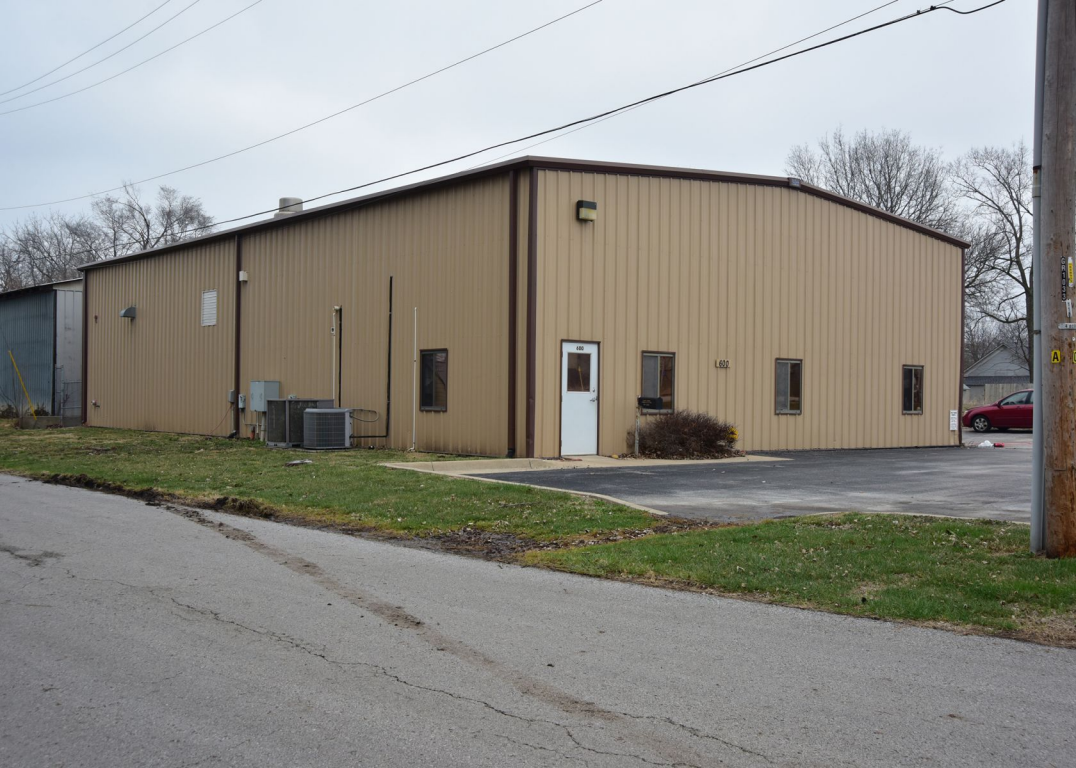
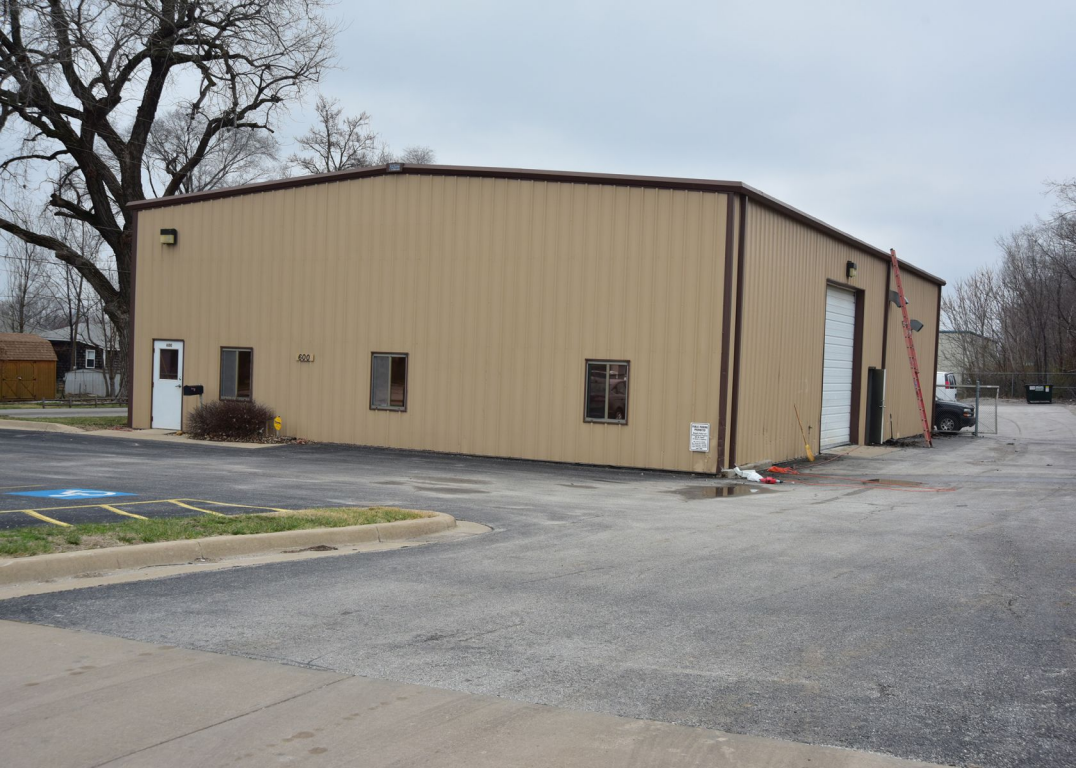
"This large, modern, corrugated metal building has a gable-front roof. The building has a rectangular footprint that is four asymmetrical bays wide and two asymmetrical bays deep. The primary façade bays include a pedestrian entrance in the west end bay and one-by-one sliding sash windows. A tall garage bay and an additional pedestrian entrance pierce the secondary (east) façade. See 600a for a description of the remainder of this property (Davis and Schwenk, 2003)."

600b Goode Avenue does not appear significantly altered from its 2003 appearance.

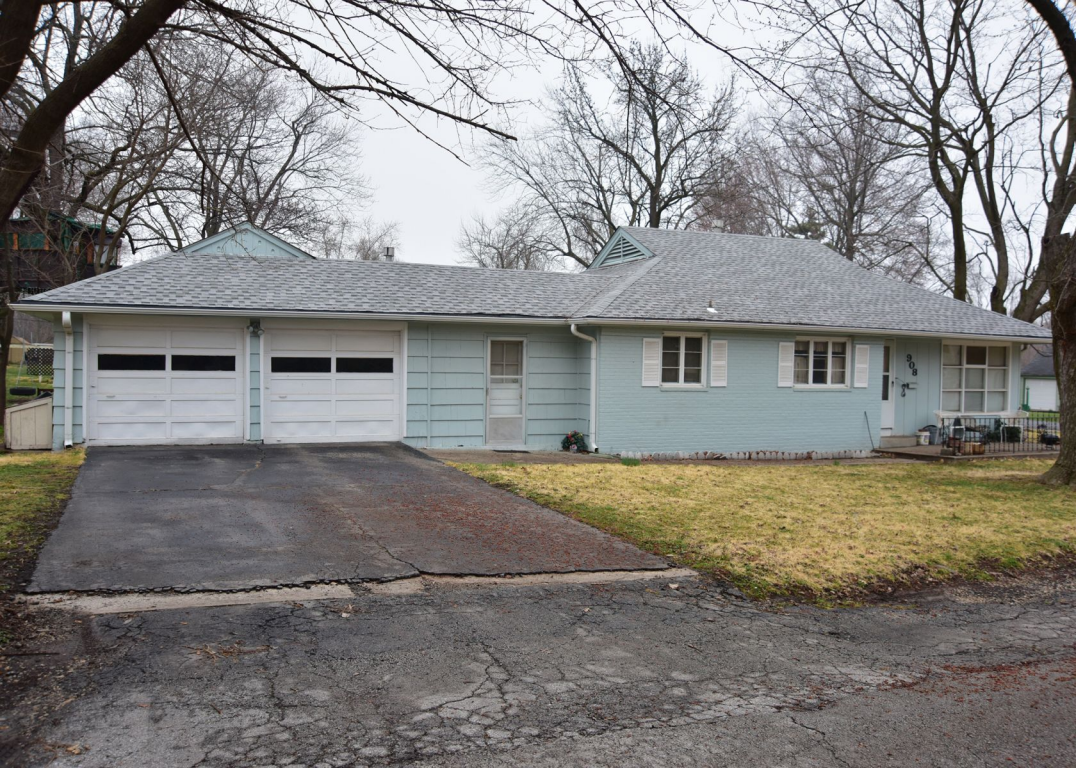
"This one-story Ranch style house has a side-gable-on-hip roof and a one-bay wing connecting the main block to a hipped roof garage, resulting in an irregular footprint that is seven asymmetrical bays wide and three bays deep. A combination of brick and asbestos shingles clad the exterior walls. The main block is four bays wide and features a recessed porch at the two east end bays that shelters the entrance in the second bay from the east end. Defining the remaining bays of the main block's primary and secondary façades are paired and triple three-light casements flanked by shutters; two large nine-light fixed picture windows; and two small hopper windows under the eaves. The single-bay connecting wing features a secondary entrance and the west end garage features two single-car bays. Additional character-defining features include the dwelling's wide eaves (Davis and Schwenk, 2003)."

908 Goode Avenue does not appear significantly altered from its 2003 appearance. A decorative iron railing surrounds the perimeter of the porch.

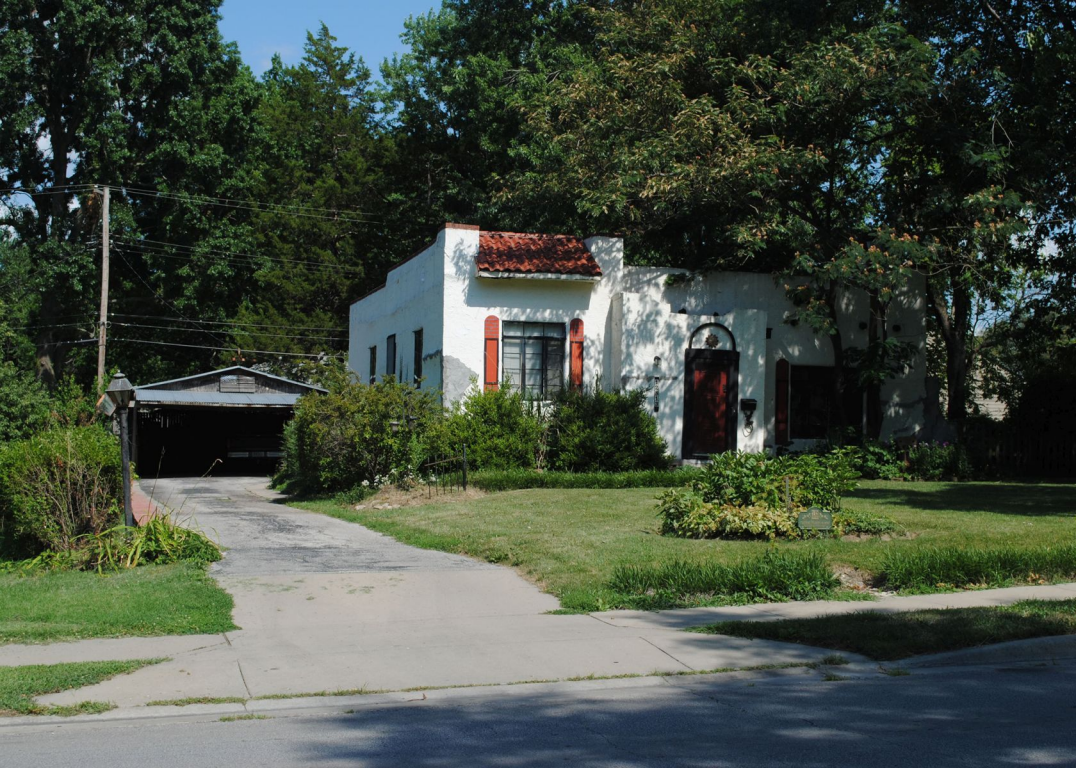
"This one-story Spanish Eclectic house has a flat roof and a rectangular footprint that is three asymmetrical bays wide and four bays deep. Stucco covers the exterior and parapet walls that feature projecting faux vigas. Fenestration defines the bays on the primary façade and includes an enclosed entrance porch with a flat roof in the center bay and multi-light steel sash windows flanked by arched plank shutters in the remaining bays. Additional character-defining features include brick coping, short wing walls, and a narrow, tile-covered shed roof above the north end bay. There are no apparent alterations to the original design or materials of this building (Davis and Schwenk, 2003)."

This dwelling does not appear significantly altered from its 2003 appearance.

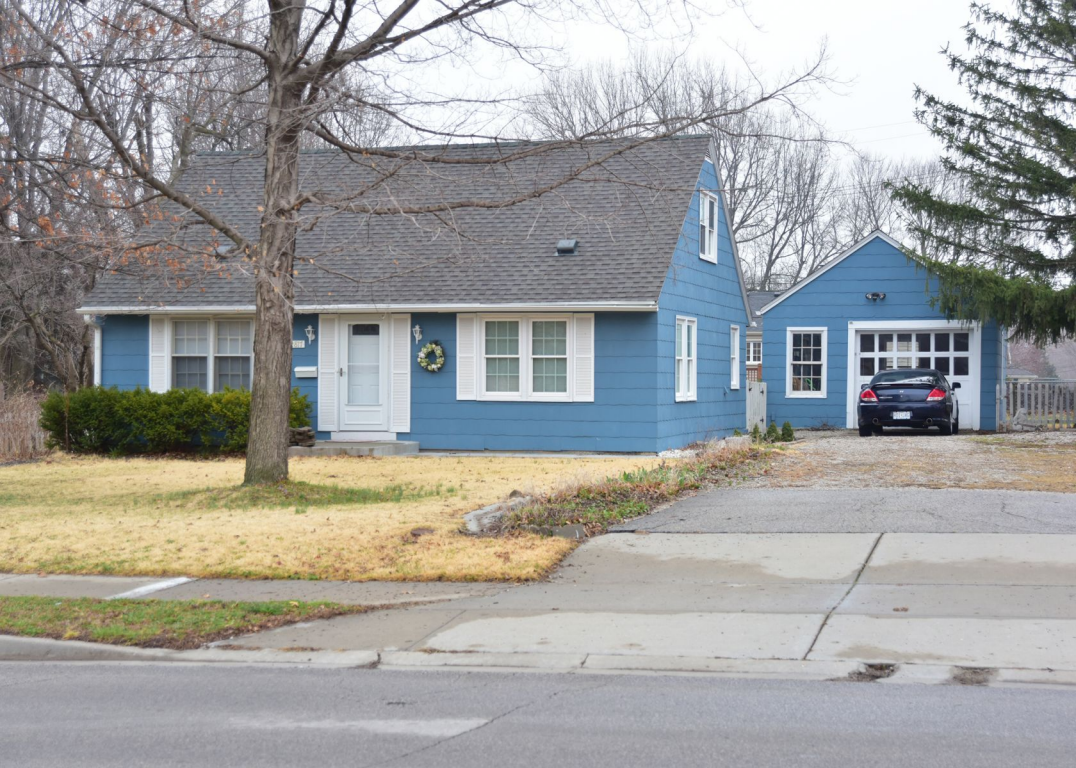
The asbestos-clad dwelling has an asphalt roof, concrete foundation, and appears unchanged in appearance since the 2003 survey. Fenestration is a mixture of historic and replacement windows. Remaining historic windows are wood sash while replacement windows are vinyl.

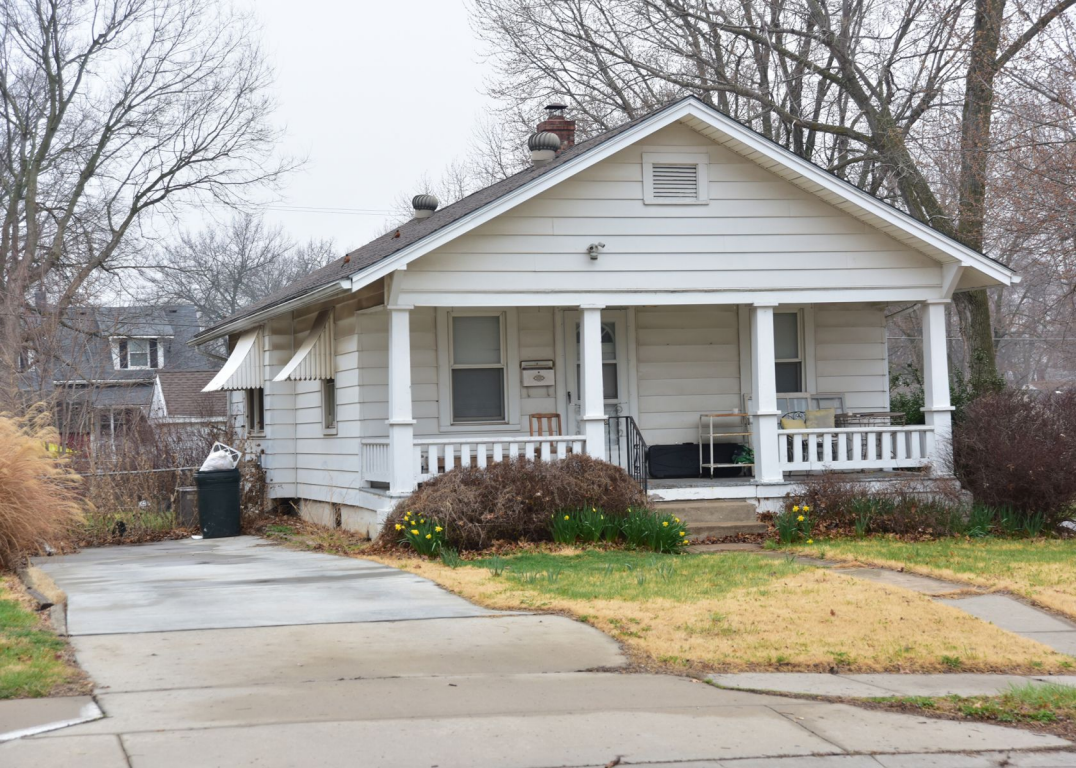
12818 Grandview Road does not appear significantly altered from its 2003 appearance. The date of alteration is unknown, however it pre-dates the 2003 survey.

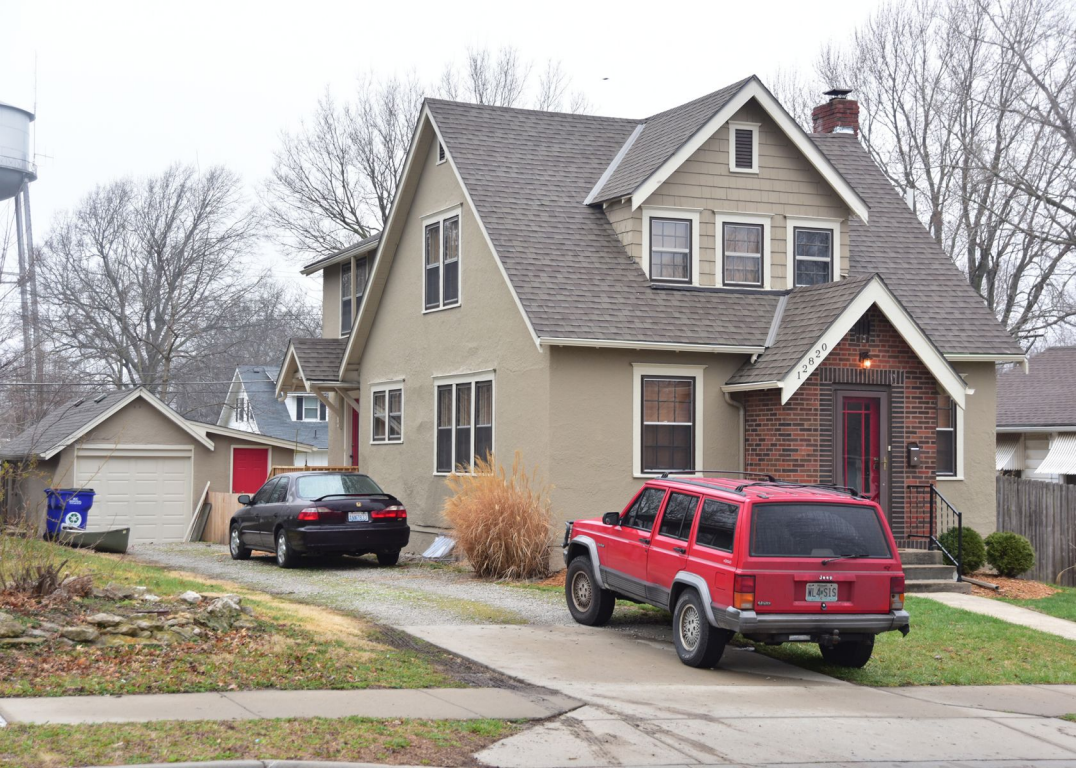
"This one-and-a-half-story, side-gabled, Tudor Revival style house has a two-story rear addition that is one bay wide. This dwelling has a rectangular footprint that is three symmetrical bays wide and three bays deep. In the center bay, brick clads the enclosed gable-front entrance porch. Defining the remaining bays are single, paired, and triple six-over-six light, double-hung sash windows with flat board trim. Wood shingles clad a large, central gabled dormer that projects from the front roof slope and contains three small windows. Additional character-defining features include the dwelling's exposed rafter tails. Non-original stucco covers the exterior walls and parging covers the exposed foundation (Davis and Schwenk, 2003)."

12820 Grandview Road does not appear significantly altered from its 2003 appearance. Dates of alteration are unknown, however pre-date the 2003 survey. Aluminum storm windows are present at all elevations visible from the right-of-way. Contrary to the previous survey, the stucco appears to be the original cladding material.

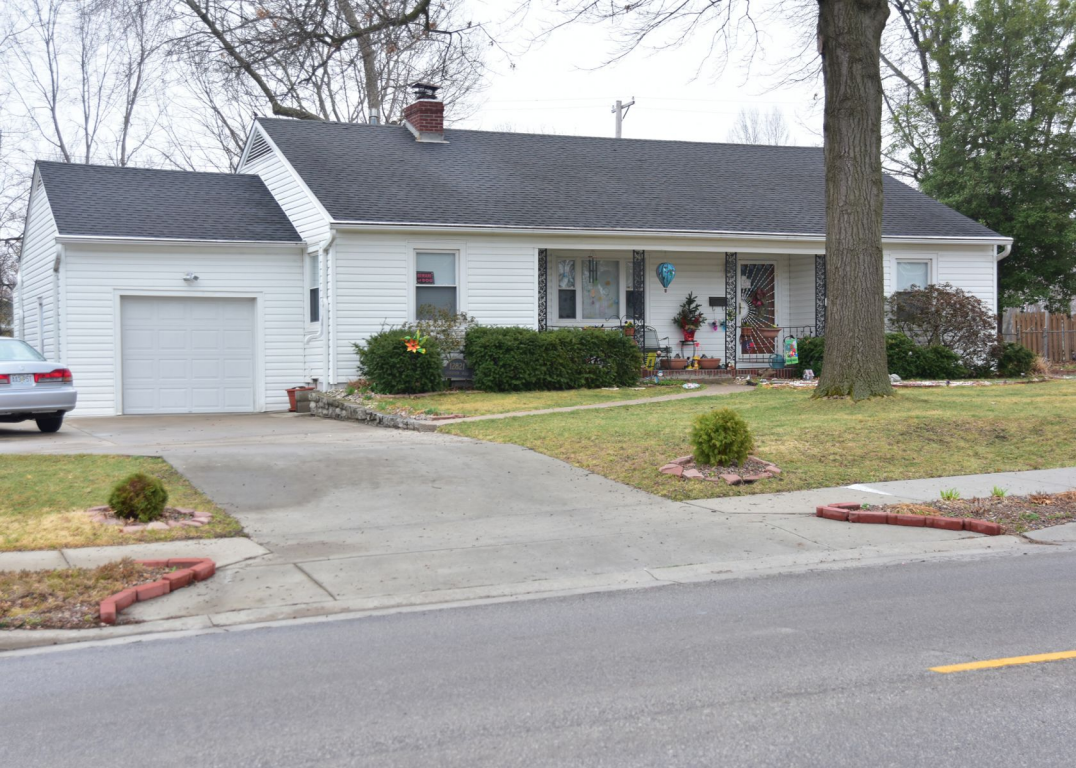
12821 Grandview Road does not appear significantly altered from its 2003 appearance. Dates of alteration are unknown, however they pre-date the 2003 survey. Windows are vinyl replacements.

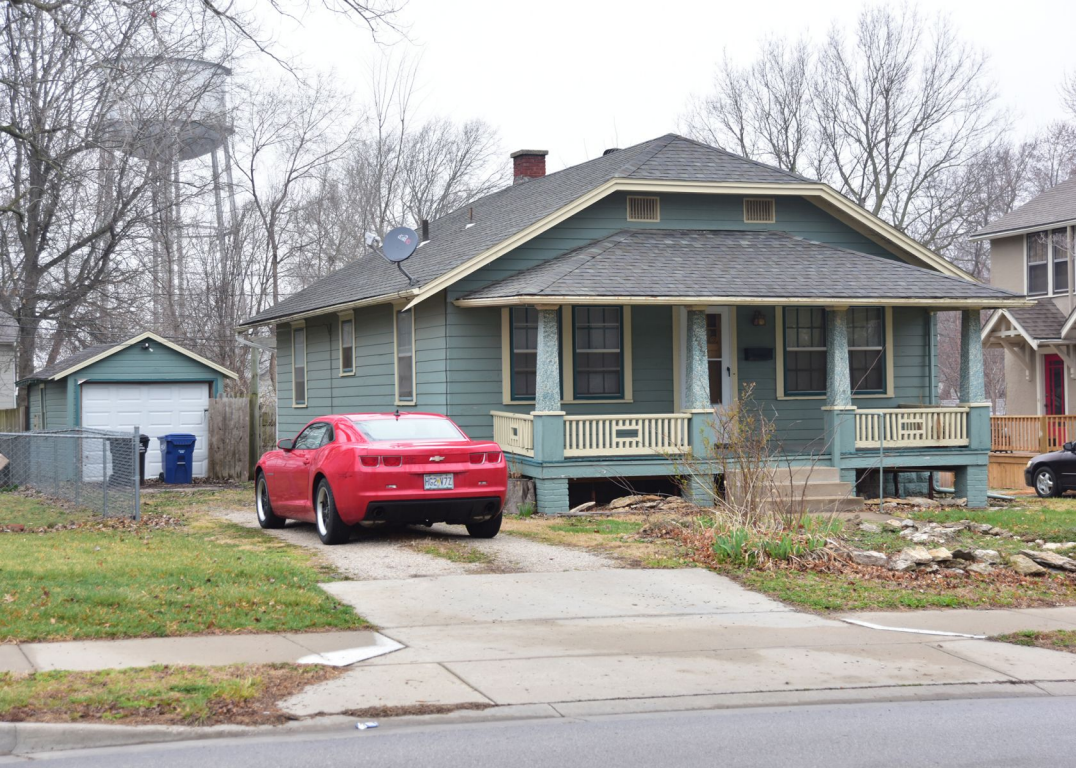
"This one-story bungalow has a clipped, gable-front roof and a rectangular footprint that is three symmetrical bays wide and three bays deep. The three-quarter-width porch has a hipped roof that shelters the center bay entrance and features tapered square columns and a matchstick balustrade. Fenestration includes single and paired six-over-six light, double-hung wood sash windows with flat board trim. Additional character-defining features include exposed rafter tails and very wide eaves. The only visible alteration to the original design and materials of this house is the application of aluminum siding to the exterior walls (Davis and Schwenk, 2003)."

12822 Grandview Road does not appear significantly altered from its 2003 appearance. The date of alteration is unknown, however pre-dates the 2003 survey.

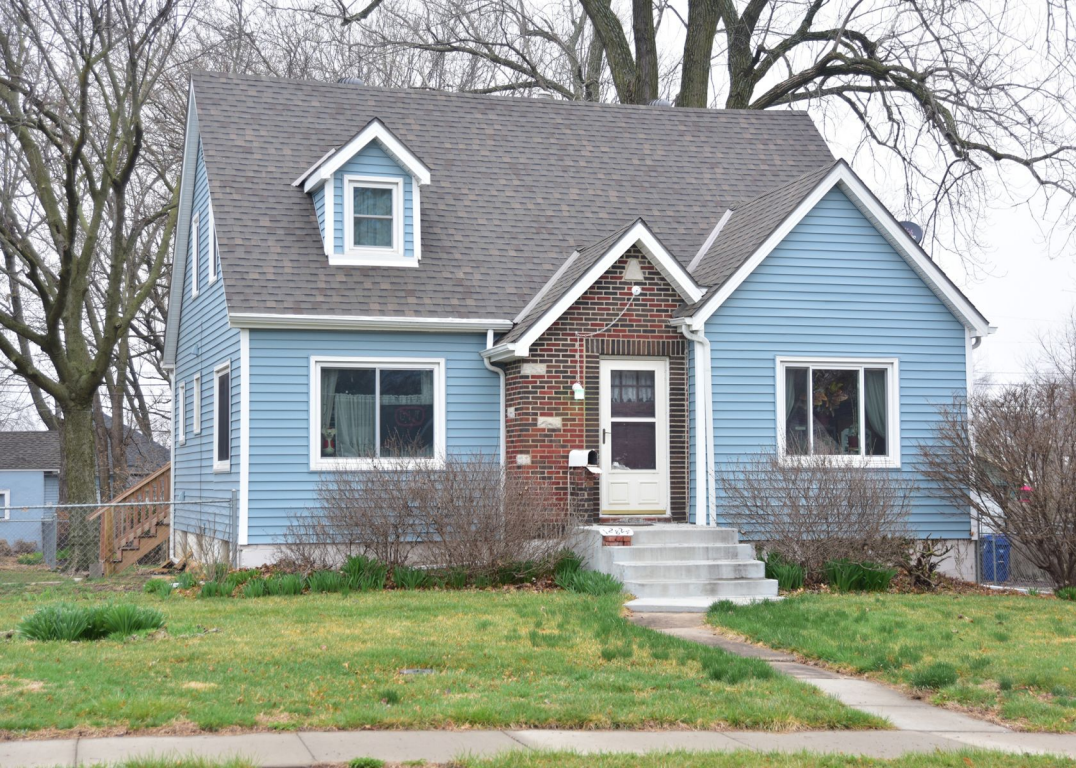
"This one-and-one-half story Minimal Traditional style house has a side-gabled roof and a rectangular footprint that is three asymmetrical bays wide and three bays deep. Distinguishing the façade are two lower projecting gables – one at the north end bay and one at the center bay – that form an enclosed entrance porch that is clad with brick and stone. These projecting gables form multiple eaves lines, a characteristic feature of the Minimal Traditional style. Defining the remaining bays are single and paired six-over-six light, double-hung wood sash windows. Additional character-defining features include exposed rafter tails and a single gabled dormer on the front roof slope (Davis and Schwenk, 2003)."

The dwelling features vinyl cladding and an asphalt roof. A one-by-one sliding sash window now defines the south bay while a tripartite picture window now defines the north bay. The remaining windows are now one-over-one double-hung sash. All windows are vinyl.

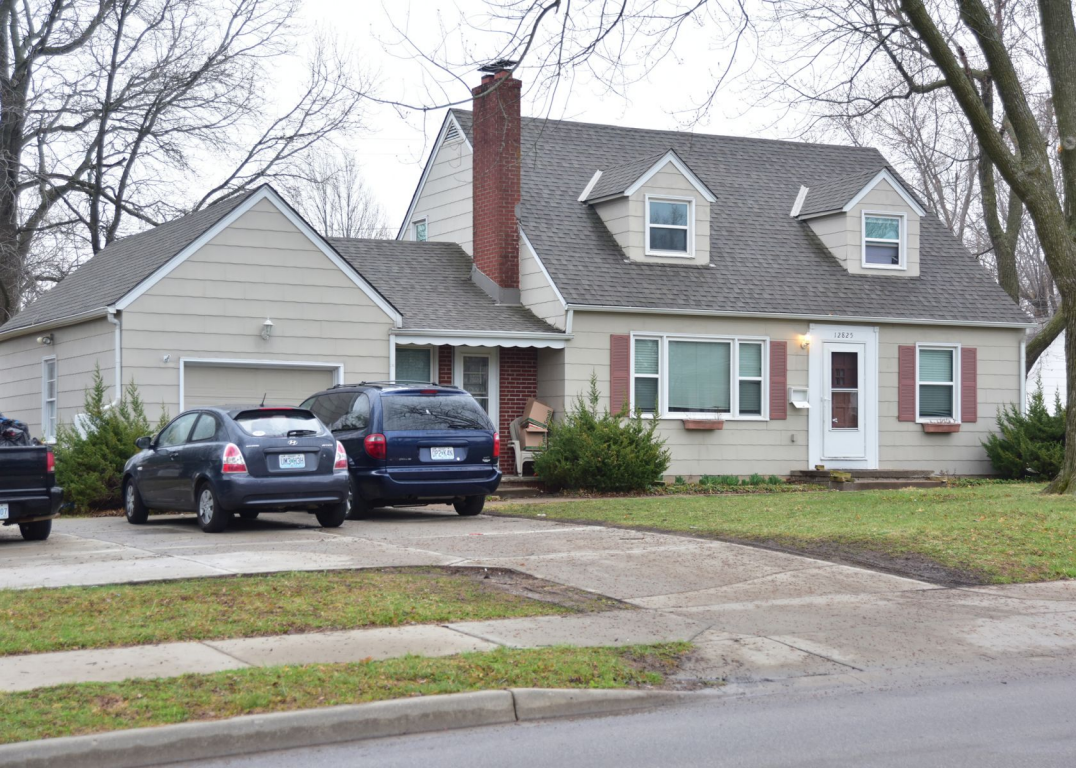
The windows have been replaced with vinyl windows since the 2003 survey, however they retain the pane arrangement noted at that time. 12825 Grandview Road does not appear significantly altered from its 2003 appearance. Dates of alteration are unknown, however pre-date the 2003 survey.
