MISSOURI DEPARTMENT OF NATURAL RESOURCES  
STATE HISTORIC PRESERVATION OFFICE, P.O. Box 176, Jefferson City, MO 65102  
**ARCHITECTURAL/HISTORIC INVENTORY FORM**

1. Survey number: JA-AS-088-153		2. Survey Name: Town of Grandview, Resurvey	
3. County: JACKSON		4. Address (Street No.): 304 Street (name): Dewey Avenue	
5. City: Grandview	Vicinity <input type="checkbox"/>	6. Lat / Long:	7. Township/Range/Section: T: R: S:
8. Historic name (if known):		9. Present/other name (if known):	
10. Ownership: <input checked="" type="checkbox"/> Private <input type="checkbox"/> Public		11a. Historic use (if known): Domestic-Single Dwelling	11b. Current use: Domestic-Single Dwelling

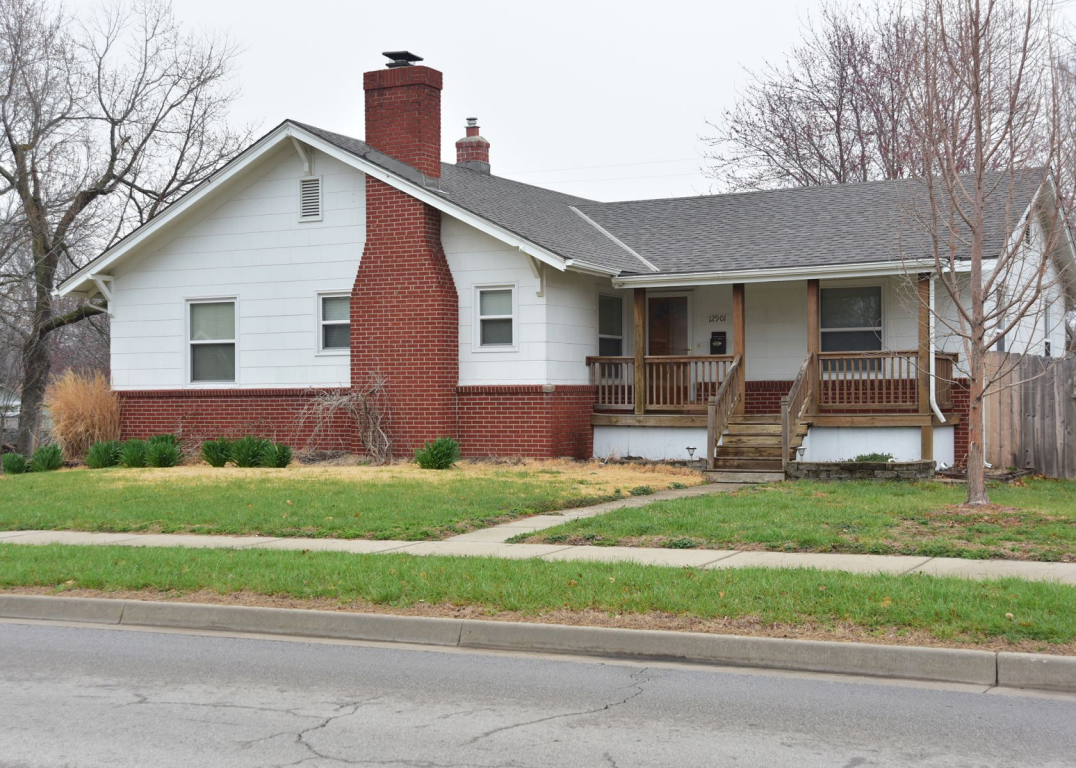
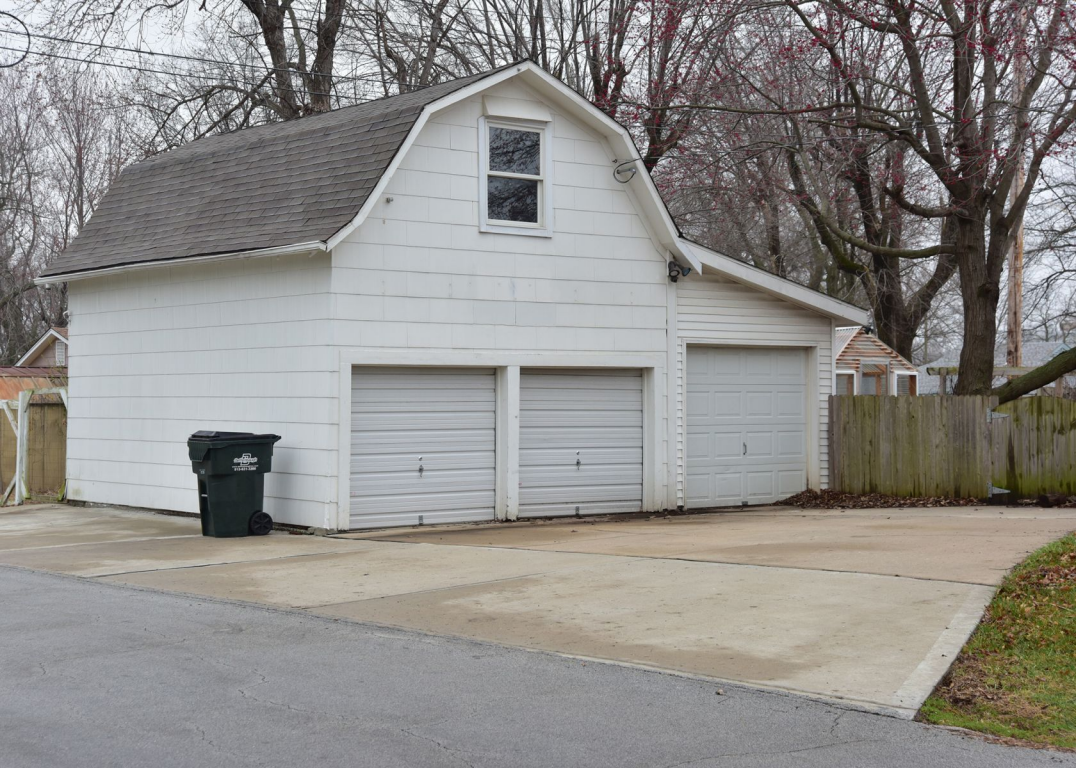
The porch has been extended to span the south two bays. It has a concrete foundation, squared wood support posts, and wood matchstick balustrade. Dates of prior alteration are unknown, however pre-date the 2003 survey.

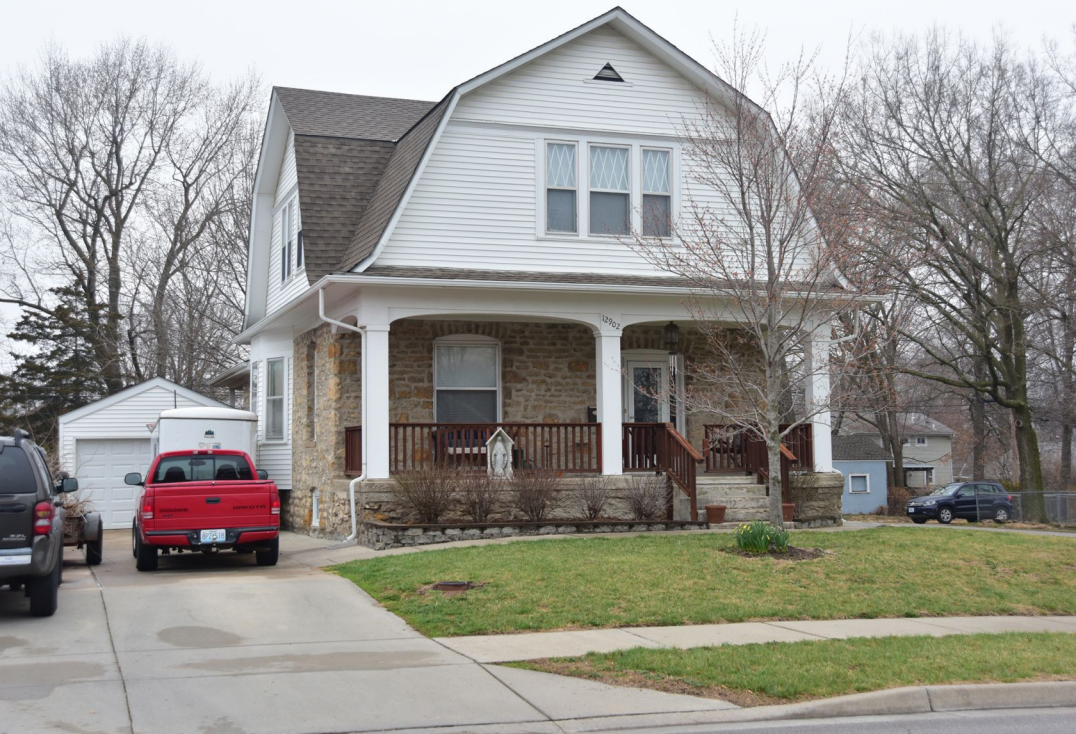
"This two-story Colonial Revival style house has an intersecting gambrel roof and a rectangular footprint that is two bays wide and three bays deep. The wide front gambrel projects to form the full-width porch that shelters the primary entrance, which is in the north end bay and features square posts, a matchstick balustrade, and curved beams. Irregularly coursed, rough-cut stone forms the entire first story and vinyl siding covers the gambrel walls of the second story. Fenestration defines the bays and includes segmental stone arched window openings with stone sills throughout the first story. Single, paired, and triple one-over-one light, double-hung wood sash windows, some of which have diamond-shaped glazing in the upper sash, fill the bays. The only visible alteration to the original design and materials of this house is the application of vinyl siding to the gambrel walls (Davis and Schwenk, 2003)."

12902 does not appear significantly altered from its 2003 appearance. The date of alteration is unknown, however pre-dates the 2003 survey. Aluminum storm windows are present at all elevations visible from the right-of-way.

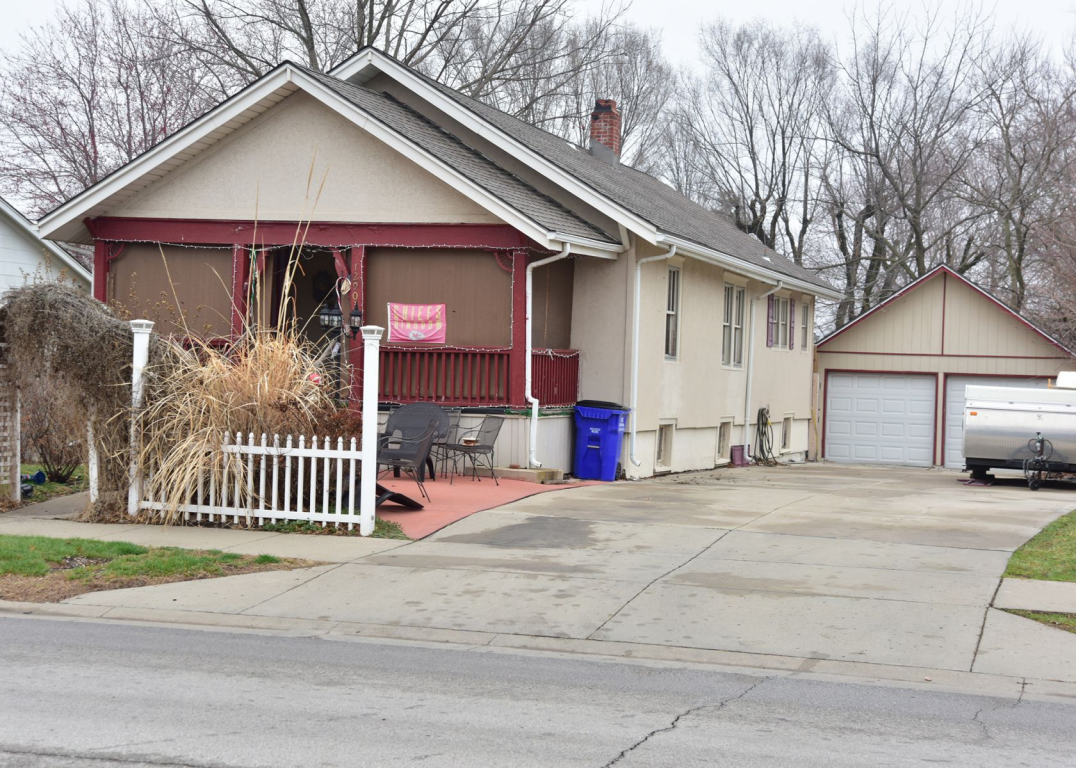
Large shades at the porch obscure the primary entrance and adjacent bays. 12903 does not appear significantly altered from its 2003 appearance. Dates of alteration are unknown, however pre-date the 2003 survey.

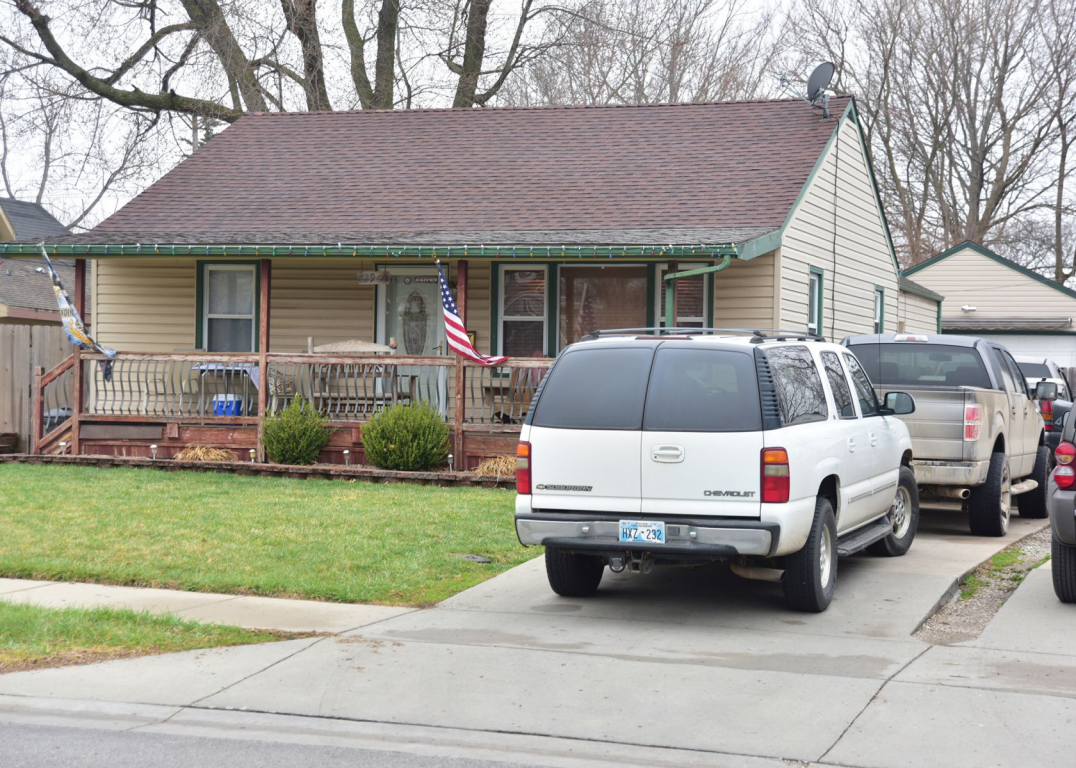
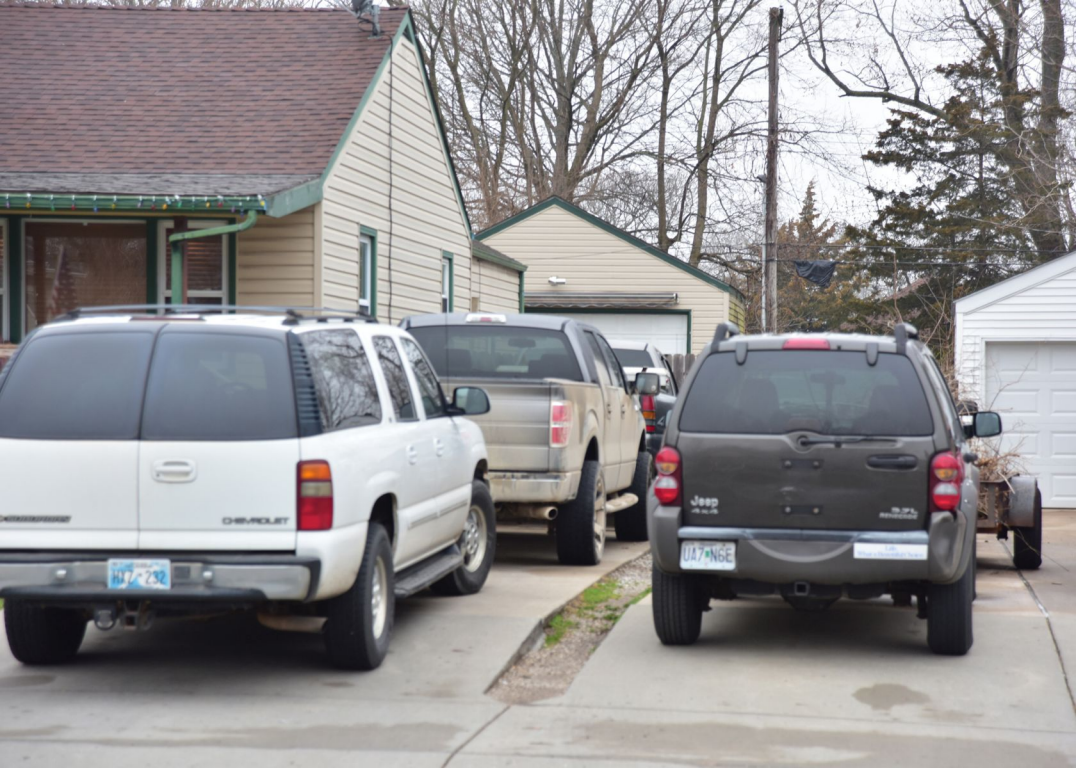
A balustrade with curved metal balusters and a wood rail has replaced the matchstick balustrade. 12904 Grandview Road otherwise does not appear significantly altered from its 2003 appearance. Dates of prior alteration are unknown, however pre-date the 2003 survey.

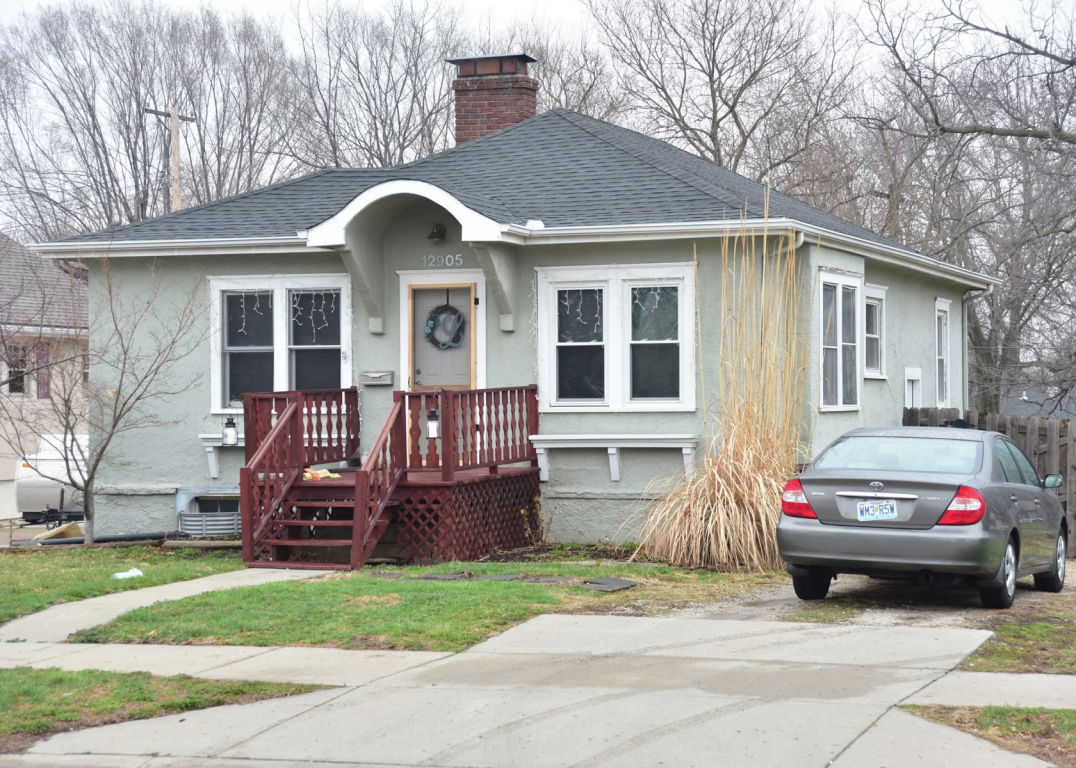
The paired one-over-one windows of the south bay at the primary elevation are replacement vinyl sash. However, all other windows visible from the right-of-way remain unchanged. 12905 Grandview Road does not appear significantly altered from its 2003 appearance. Dates of alteration are unknown, however pre-date the 2003 survey.

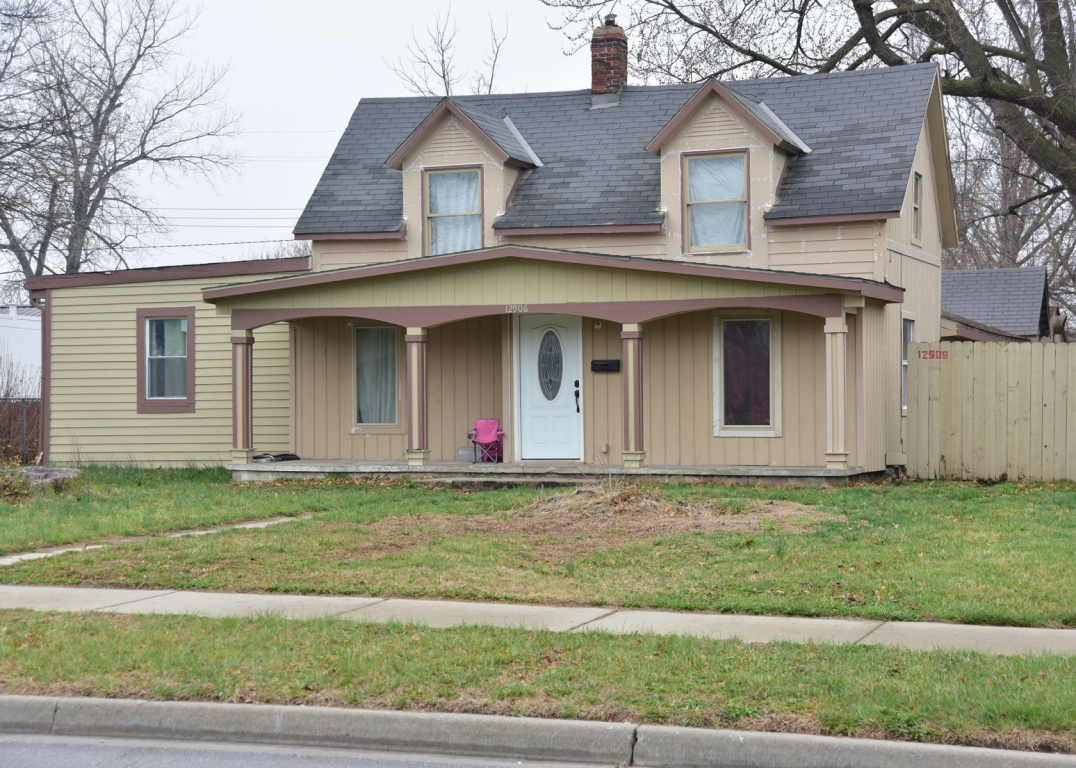
Cladding now consists of pressed wood and aluminum. Asbestos shingle remains in the south gable only. With the exception of the dormer windows, all windows visible from the right-of-way are replacement. One-light fixed sash windows form the second and fourth bays. Google Earth imagery indicates the fourth opening was not present at the time of the 2003 survey. Large scale additions are visible on aerial imagery but are not easily visible from the right-of-way.

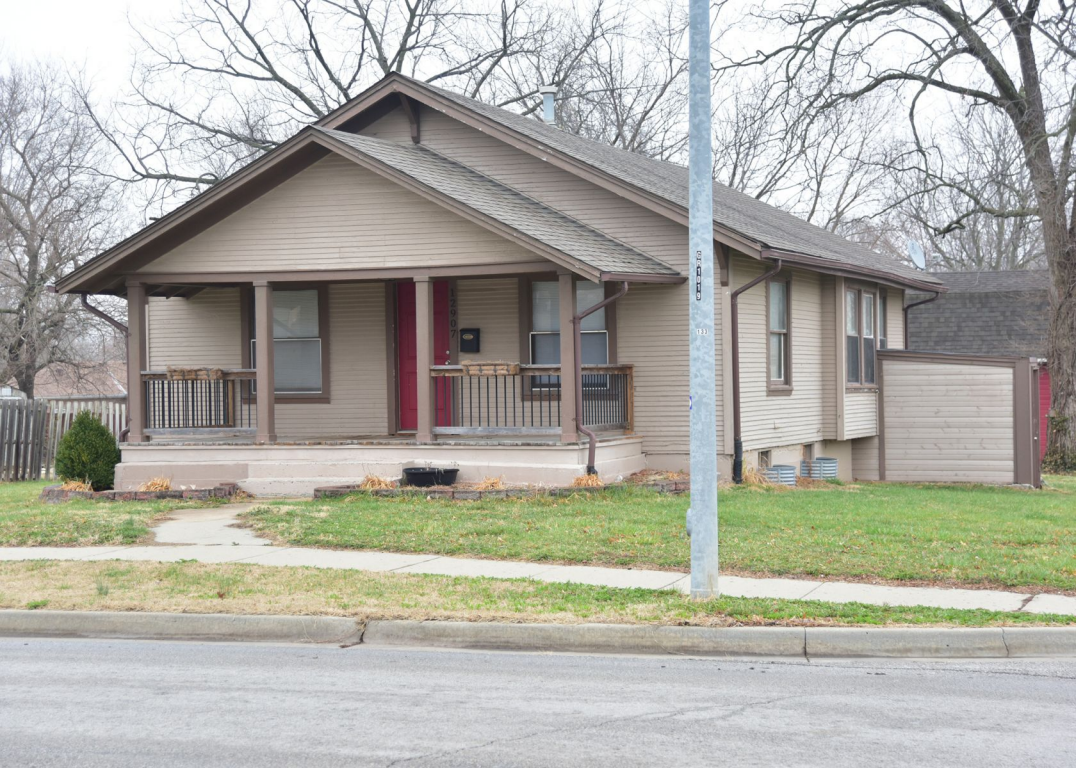
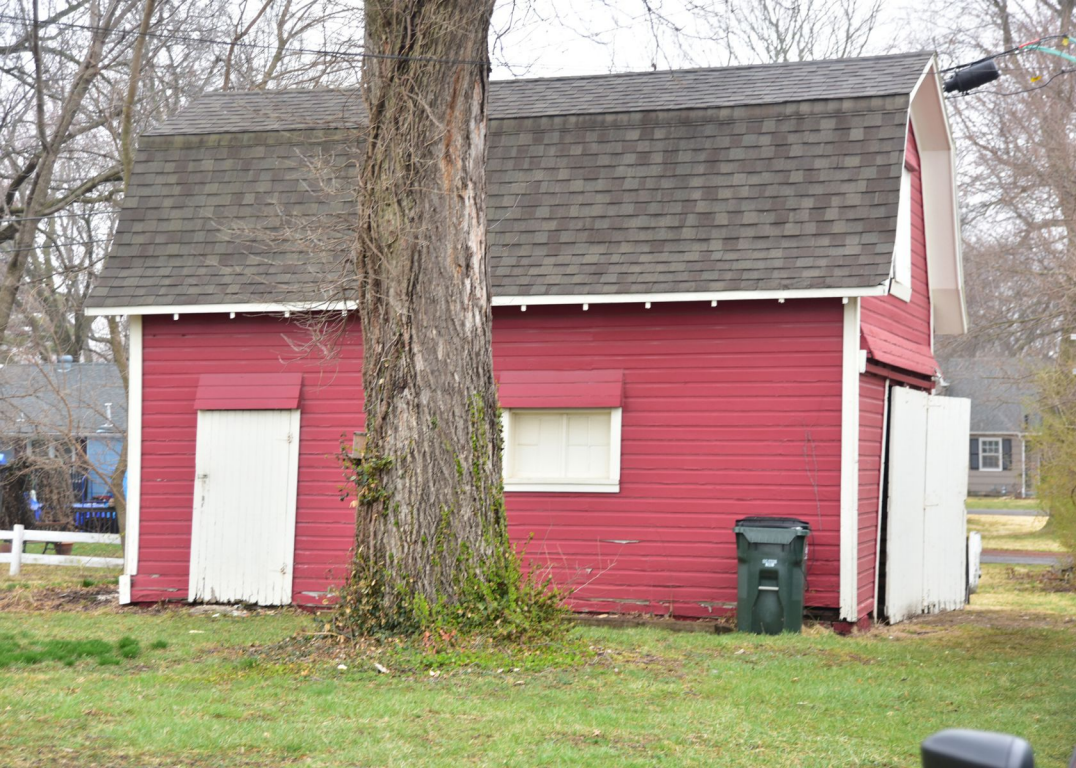
Little has been changed about the dwelling since the previous survey. The historic balustrade present at the 2003 survey has been replaced. However, no additional alterations are observed. The dwelling retains its wood sash windows, clapboard siding, and other defining characteristics. The roof of the dwelling is asphalt while the foundation is concrete. A non-historic secondary entrance with shed roof projects from the rear of the south elevation. It is unknown when this alteration was constructed.

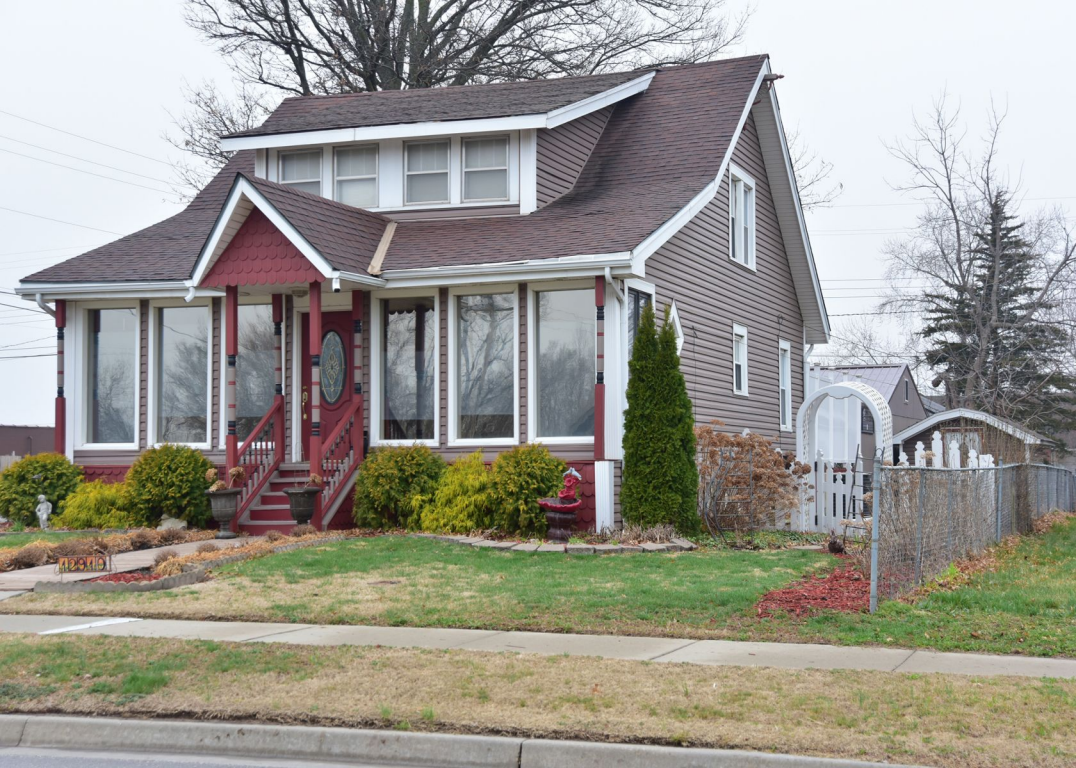
The dormer windows are three-over-one. The porch balustrade has been removed and turned wood balusters have been installed at the steps. 12910 Grandview Road does not appear significantly altered from its 2003 appearance. Dates of alteration are unknown, however they pre-date the 2003 survey.

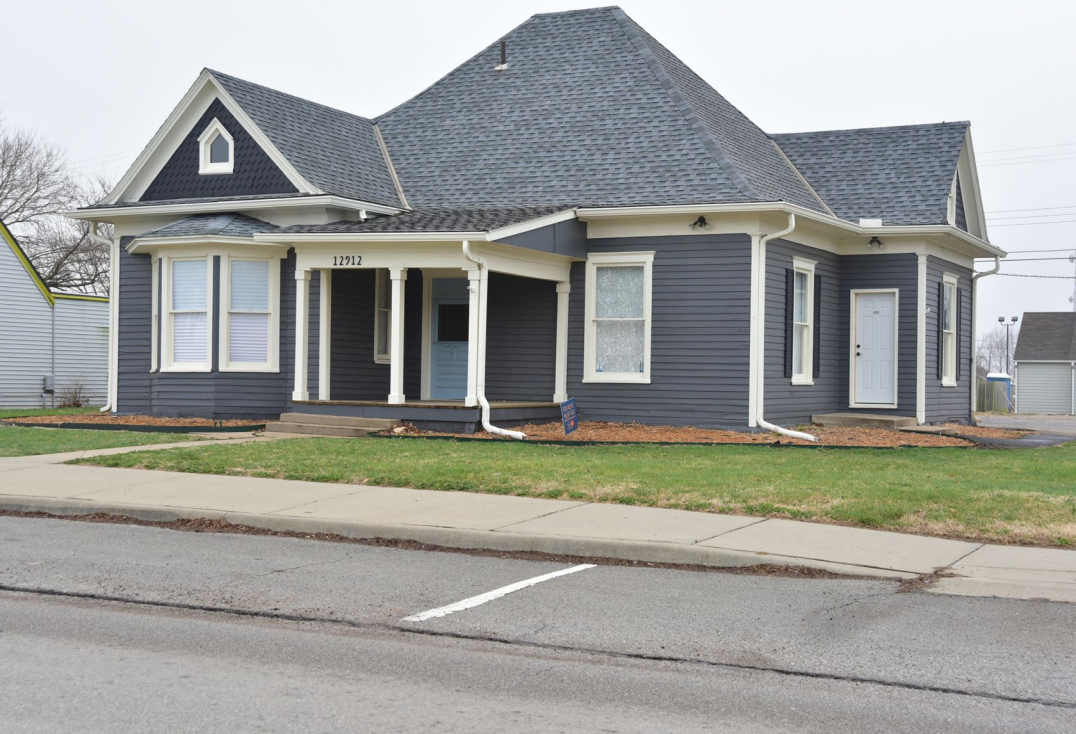
"This one-and-a-half-story Queen Anne cottage has a hipped roof with lower cross gables and an irregular footprint that is four bays wide and four bays deep. At the junction of the forward projecting gable, a deep entrance porch with a flat roof features turned posts and spindle balusters. Defining the other bays are a tripartite bay window and non-historic single one-over-one light, double-hung sash windows surrounded by flat board trim. Additional character-defining features include fishscale shingles in each gable and narrow corner pilasters. At the rear, a small square screened porch addition features a steeply pitched pyramidal roof (Davis and Schwenk, 2003)."

A secondary entrance is located at the east elevation of the north projecting gable. The primary entrance includes an ornamented wood door which appears historic. The wood windows are possibly historic. 12912 Grandview Road does not appear significantly altered from its 2003 appearance. Dates of alteration are unknown, however they pre-date the 2003 survey.

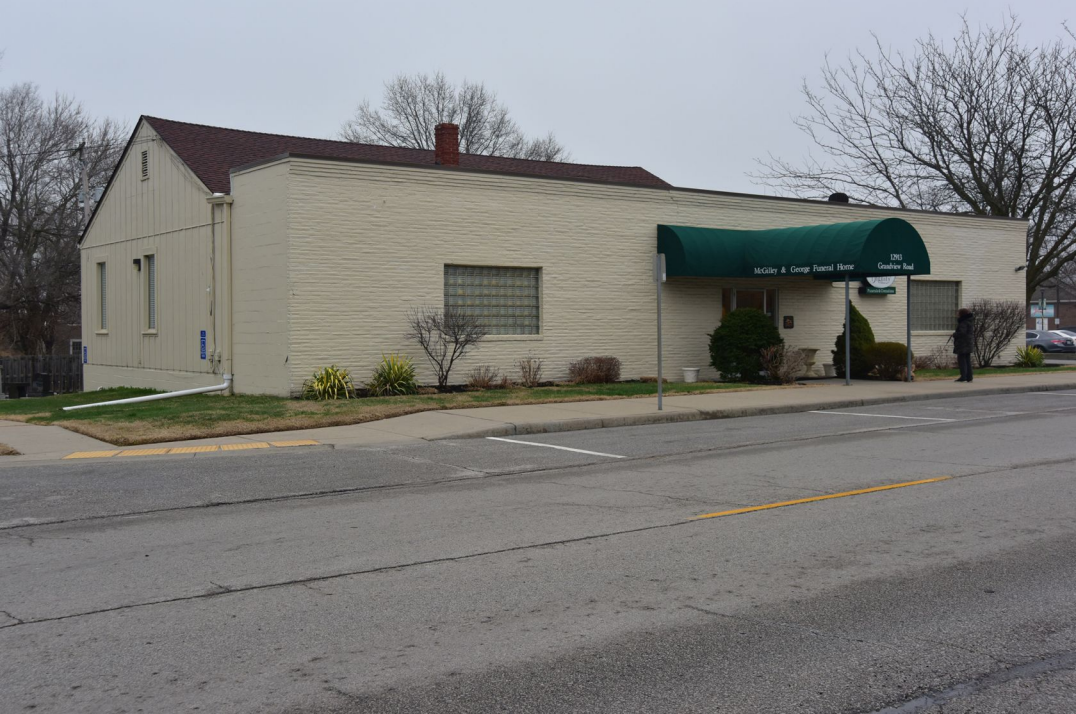
"This one-story building consists of the original, one-story, wood-framed building with a side-gabled roof that is fronted by a mid-twentieth-century concrete block addition with brick facing and a flat roof. The addition is three bays wide and six asymmetrical bays wrap around the south side to form an L-shaped footprint. An awning shelters the center bay entrance that contains an aluminum-framed glass door with sidelights. Defining the other two bays of the primary façade are single windows with glass block infill and stone sills. Additional character-defining features include modest corbel courses forming a streamlined façade cornice. The original Craftsman features of this building have been removed. The removal of the original Craftsman elements and the subsequent obscuring of the primary façade compromise the integrity of this building (Davis and Schwenk, 2003)."

The 1928 frame building features non-historic board and batten cladding, an asphalt roof, and one-light fixed sash windows. 12913 Grandview Road does not appear significantly altered from its 2003 appearance. The addition and alterations pre-date the 2003 survey.

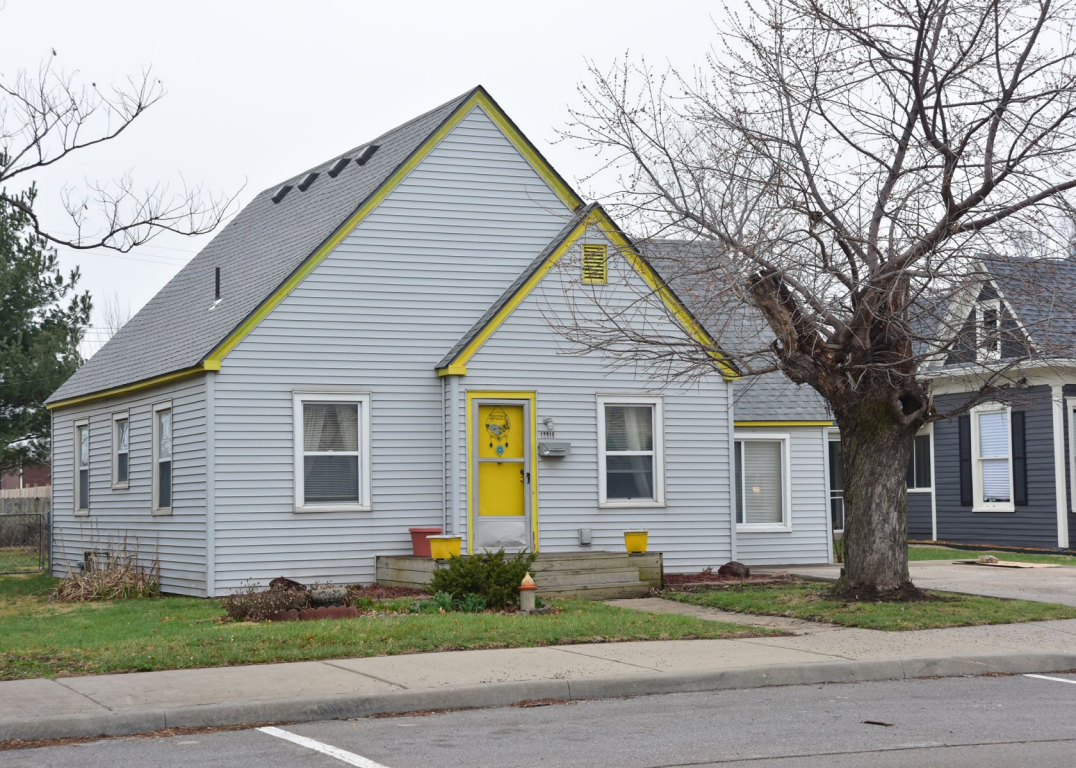
12914 Grandview Road does not appear significantly altered from its 2003 appearance. Dates of alteration are unknown, however they pre-date the 2003 survey.

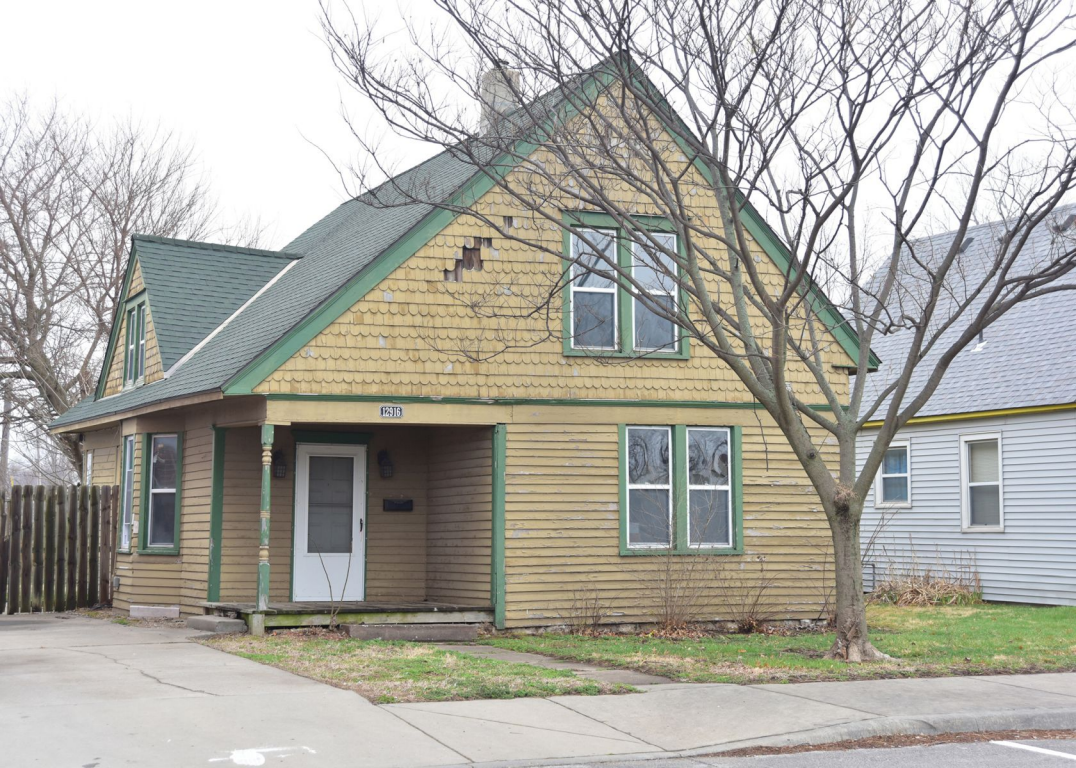
"This one-and-a-half-story, gable-front house has a rectangular plan that is two bays wide and three bays deep. Dominating the intersecting gable roof is a wide, slightly asymmetrical, front gable clad with fishscale shingles. The south end bay contains a recessed porch that shelters the primary entrance, which is surrounded by flat board trim and modest crown molding. Defining the remaining bays are paired one-over-one light, double-hung sash windows with flat board trim and, on the south elevation, a tripartite bay window. Additional character-defining features include a wide band of flat board trim that forms a beltcourse along the base of the front gable, modest corner pilasters, and wide eaves (Davis and Schwenk, 2003)."

Windows are one-over-one aluminum sash. 12916 Grandview Road does not appear significantly altered from its 2003 appearance. The date of alteration is unknown, however pre-dates the 2003 survey.

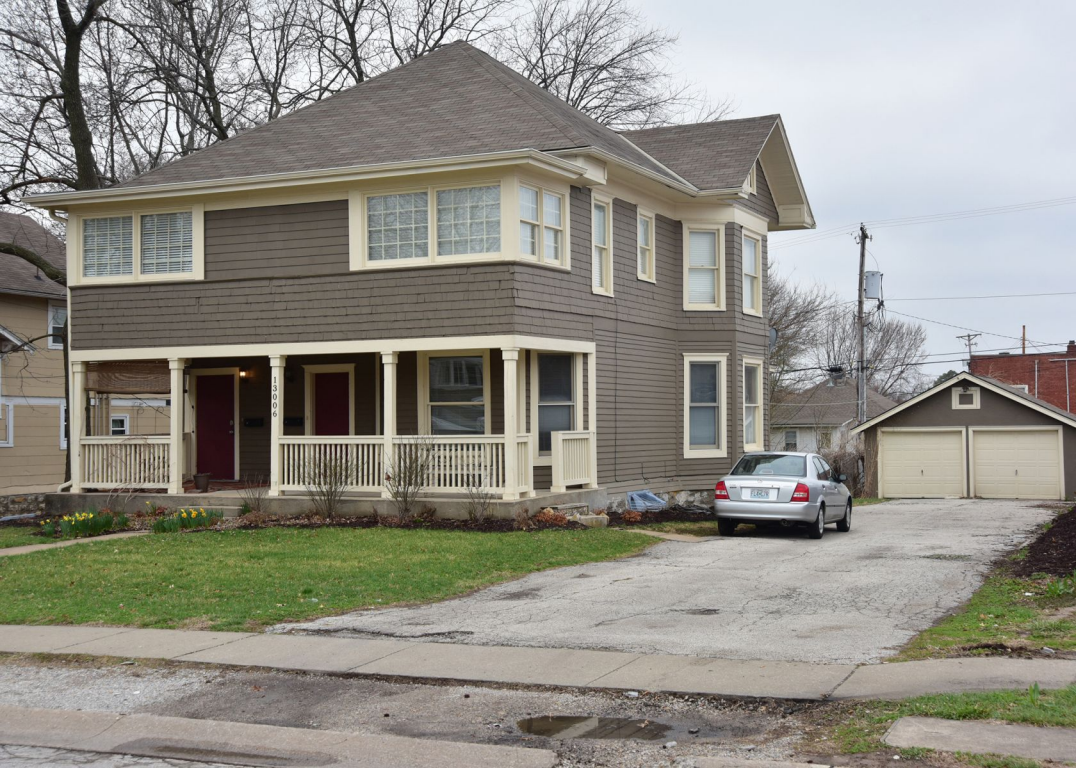
Non-historic square columns now support the sleeping porch and a wood matchstick balustrade lines the perimeter. The sleeping porch windows are sixteen-light with snap-in muntins.

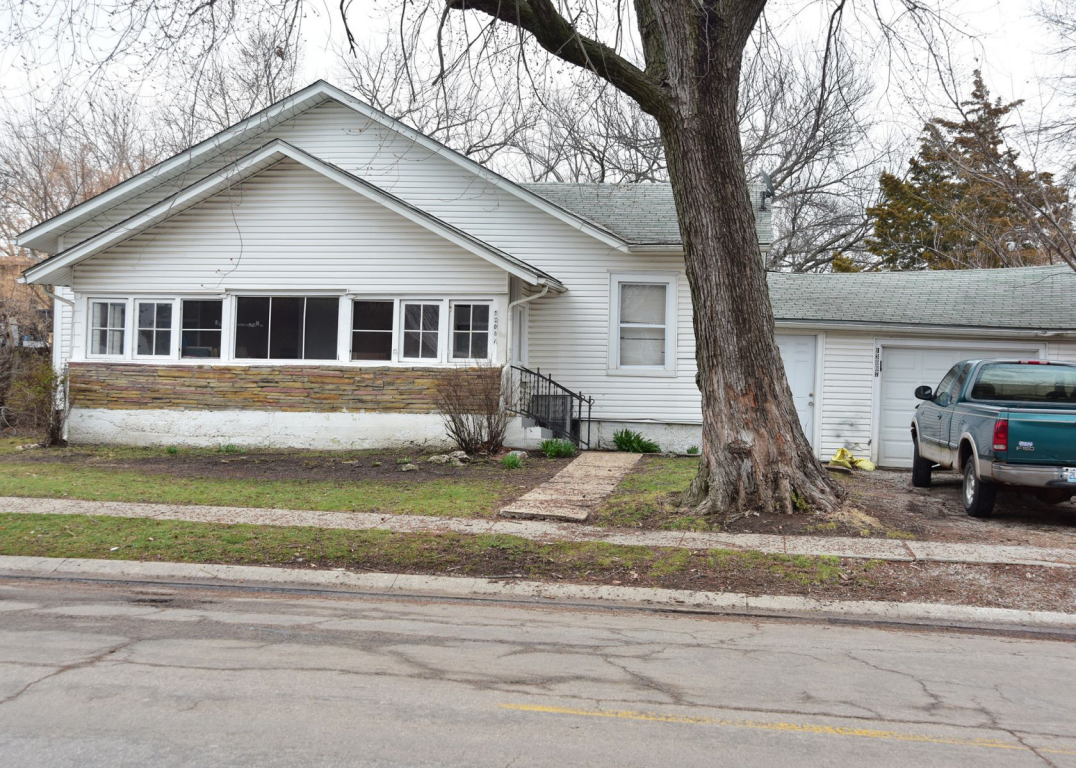
Windows are predominately one-over-one replacements with vinyl sash. Two four-light wood casement sash windows remain in the northern bay and the third from north bay. 13007 Grandview Road does not otherwise appear significantly altered from its 2003 appearance. Dates of alteration are unknown, however pre-date the 2003 survey.

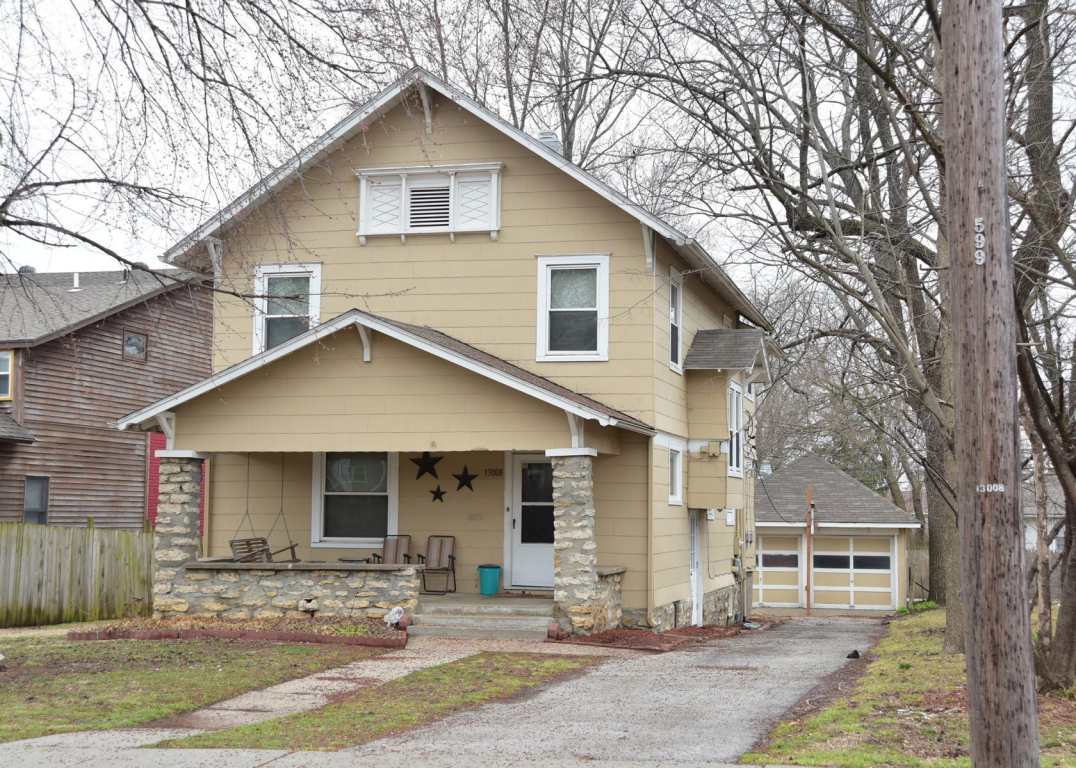
Windows are now one-over-one vinyl replacements. The dwelling features asbestos cladding and an asphalt roof. The date of cladding alteration is unknown, however pre-dates the 2003 survey.

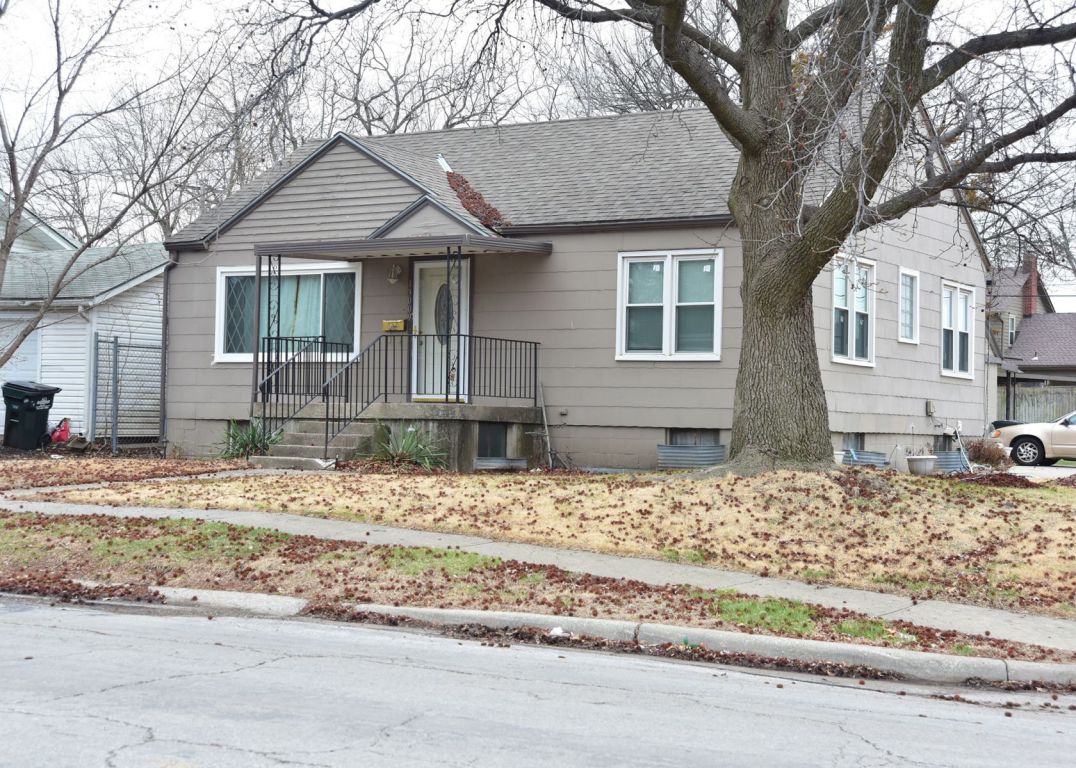
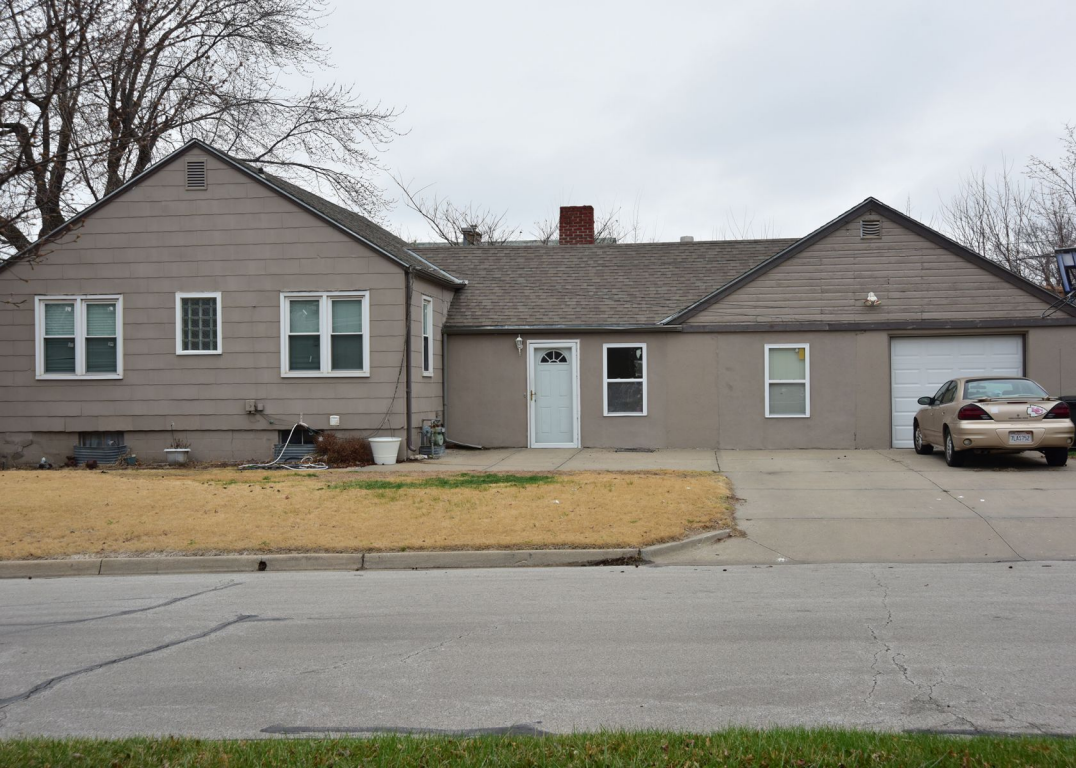
The brick chimney is located on the north slope of the connecting wing addition. The windows are now one-over-one vinyl sash replacements and the shed-roof awning in front of the garage has been removed. 13009 Grandview Road does not otherwise appear significantly altered from its 2003 appearance. Dates of prior alteration are unknown, however pre-date the 2003 survey.

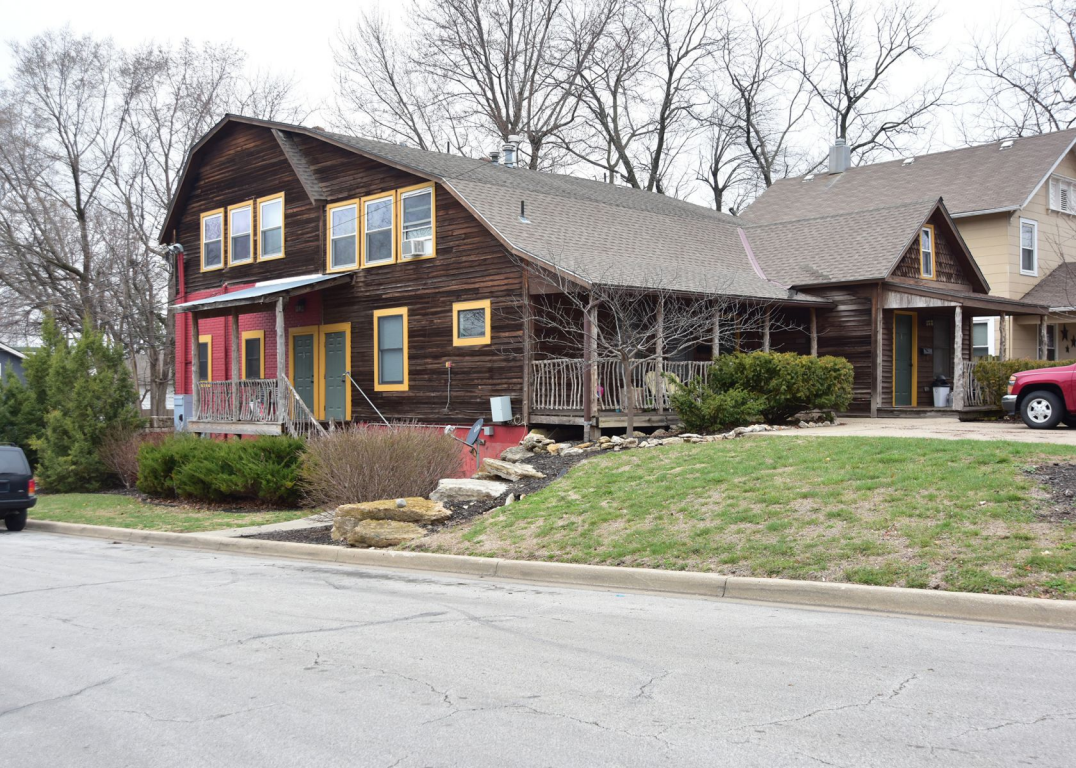
The square wood posts and matchstick balustrades have been replaced with raw wood elements. A shed roof porch now shelters two post-2003 entrances at the south elevation. Dates of prior alteration are unknown, however pre-date the 2003 survey.

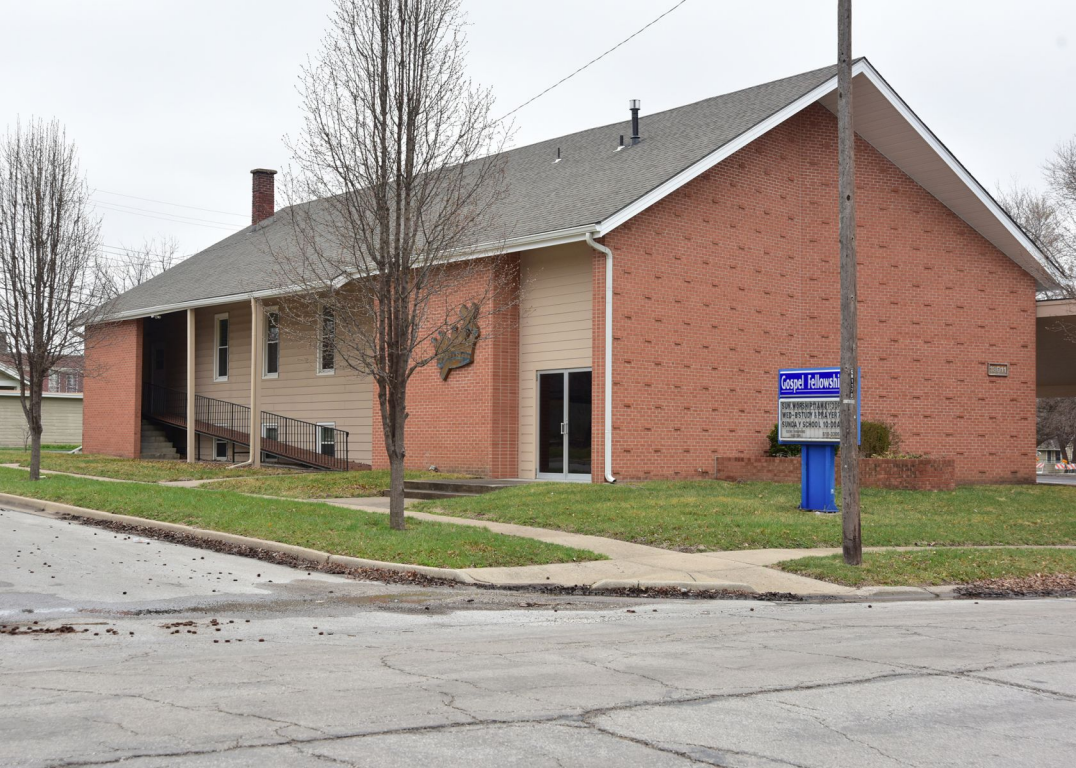
The aluminum framed system of colored glass panels is no longer extant. Vinyl cladding now surrounds the doors and the windows have been replaced. 13011 Grandview Road otherwise does not appear significantly altered from its 2003 appearance.

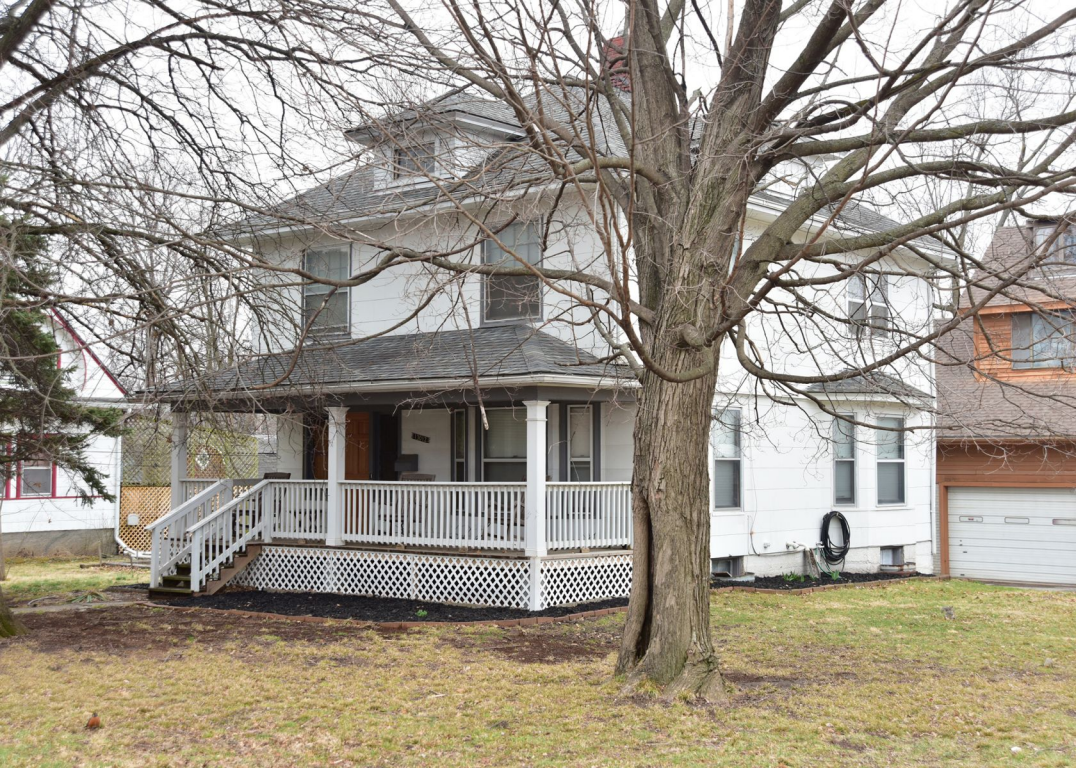
Storm windows are present at all elevations visible from the right-of-way. A non-historic second floor entry is located at the south elevation and opens to a non-historic deck. The porch columns and balustrade have been replaced. The columns are now squared Tuscan columns. Dates of prior alteration are unknown, however they pre-date the 2003 survey.
