MISSOURI DEPARTMENT OF NATURAL RESOURCES  
STATE HISTORIC PRESERVATION OFFICE, P.O. Box 176, Jefferson City, MO 65102  
**ARCHITECTURAL/HISTORIC INVENTORY FORM**

1. Survey number: JA-AS-088-153		2. Survey Name: Town of Grandview, Resurvey	
3. County: JACKSON		4. Address (Street No.): 304 Street (name): Dewey Avenue	
5. City: Grandview	Vicinity <input type="checkbox"/>	6. Lat / Long:	7. Township/Range/Section: T: R: S:
8. Historic name (if known):		9. Present/other name (if known):	
10. Ownership: <input checked="" type="checkbox"/> Private <input type="checkbox"/> Public		11a. Historic use (if known): Domestic-Single Dwelling	11b. Current use: Domestic-Single Dwelling

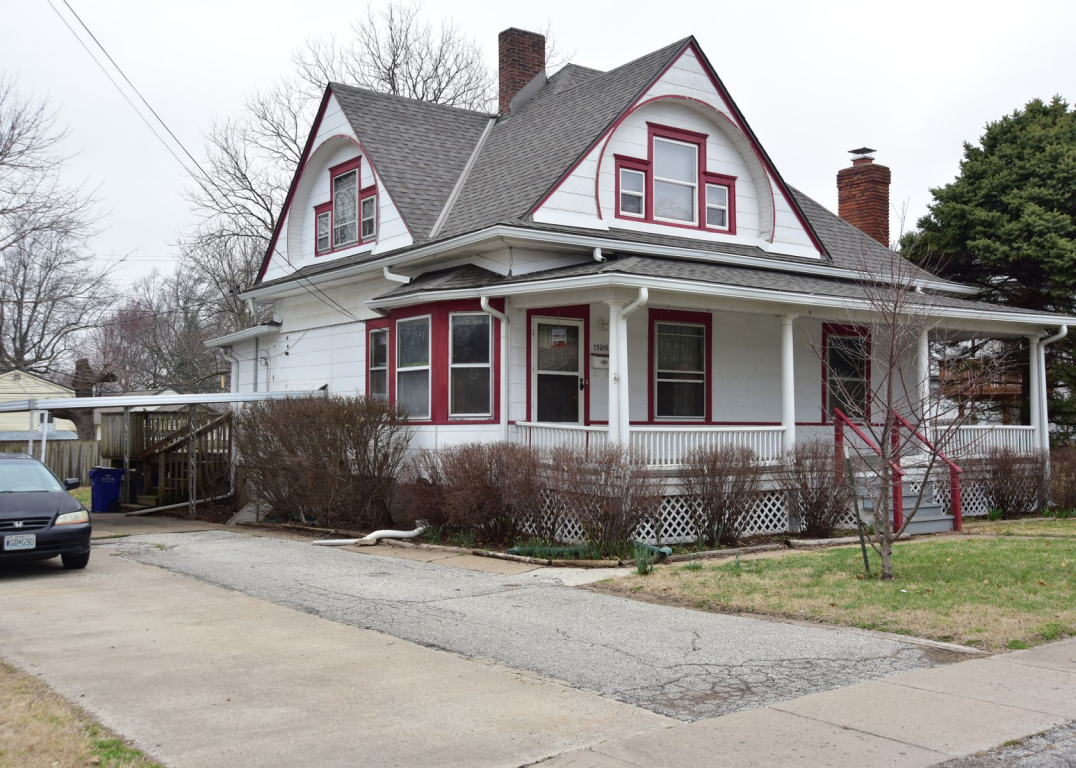
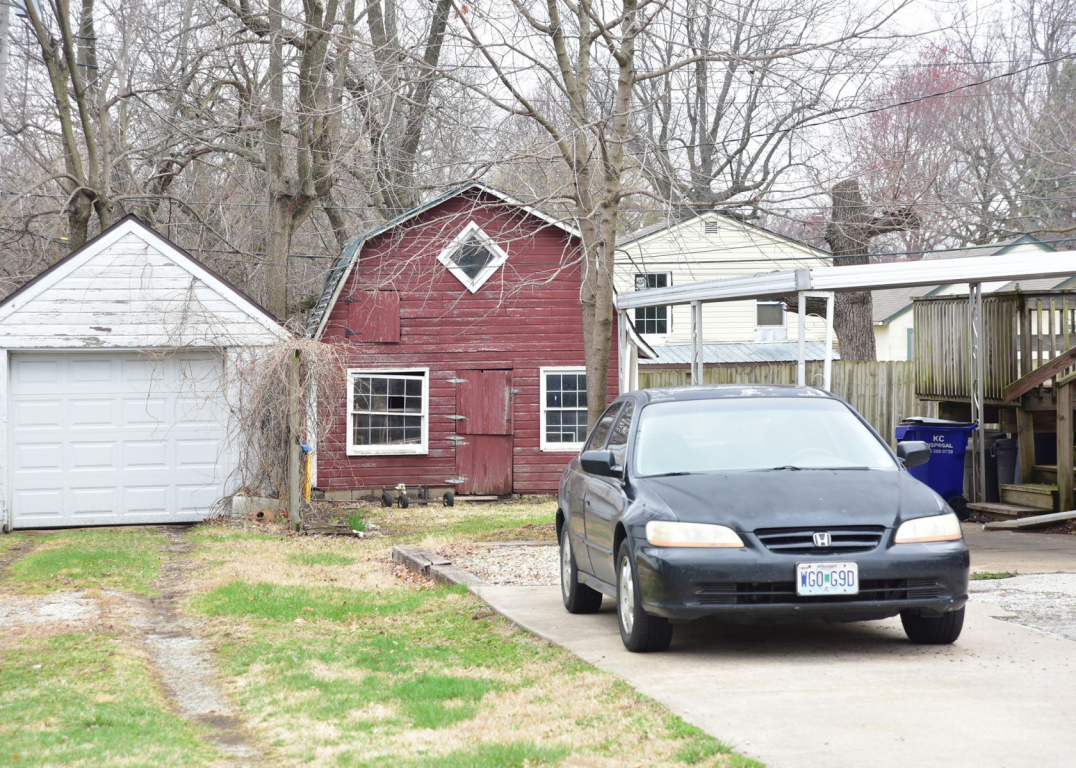
"This one-and-a-half-story Queen Anne cottage has a hipped roof with lower cross gables and an irregular footprint that is three asymmetrical bays wide and three bays deep. A recessed round arch containing a squared Palladian window distinguishes each gable. Tuscan columns support the full-width porch's hipped roof, which shelters the south end bay entrance and features a matchstick balustrade. One-over-one light, double-hung sash windows with flat board trim and modest crown molding define the remaining bays. Additional character-defining features include a bay window on the south elevation, wide boxed eaves, and two brick chimneys (Davis and Schwenk, 2003)."

Two brick chimneys are present, on exterior at the north elevation and one on the south side slope of the hipped roof. The asbestos cladding is a historic alteration. 13016 Grandview Road does not appear significantly altered from its 2003 appearance. Dates of alteration are unknown, however they pre-date the 2003 survey.

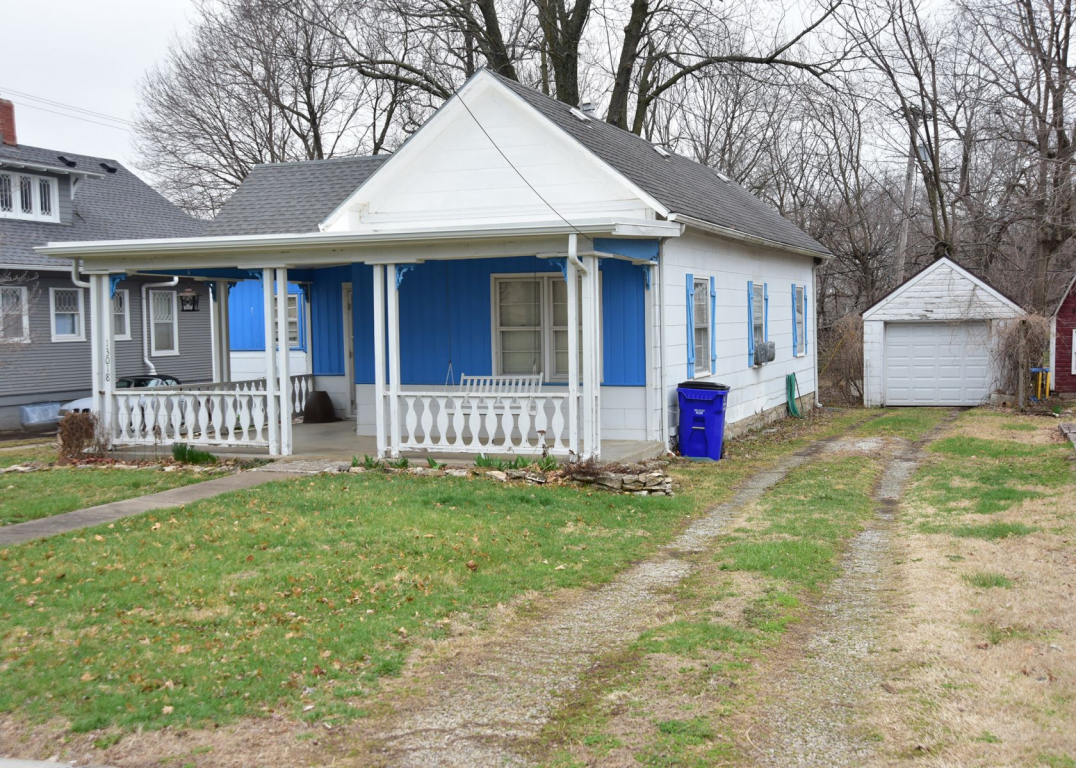
"This one-story gable-front-and-wing house has an L-shaped footprint that is three bays wide and three bays deep. A combination of asbestos shingles and board-and-batten siding covers the exterior walls. Paired square posts with non-historic decorative brackets support the porch's flat roof, which wraps around to the inside of the forward gable projection. Non-historic cut-out balusters surround the concrete porch floor. The entrance is in the center bay at the projecting gable junction. Defining the remaining bays are one-over-one light, double-hung wood sash windows, arranged singly and in pairs. The introduction of modern porch elements combined with the application of modern wall cladding and roof materials compromise the integrity of this building (Davis and Schwenk, 2003)."

Aluminum storm windows are present at all elevations visible from the right-of-way. 13018 Grandview Road does not appear significantly altered from its 2003 appearance. Dates of alteration are unknown, however pre-date the 2003 survey.

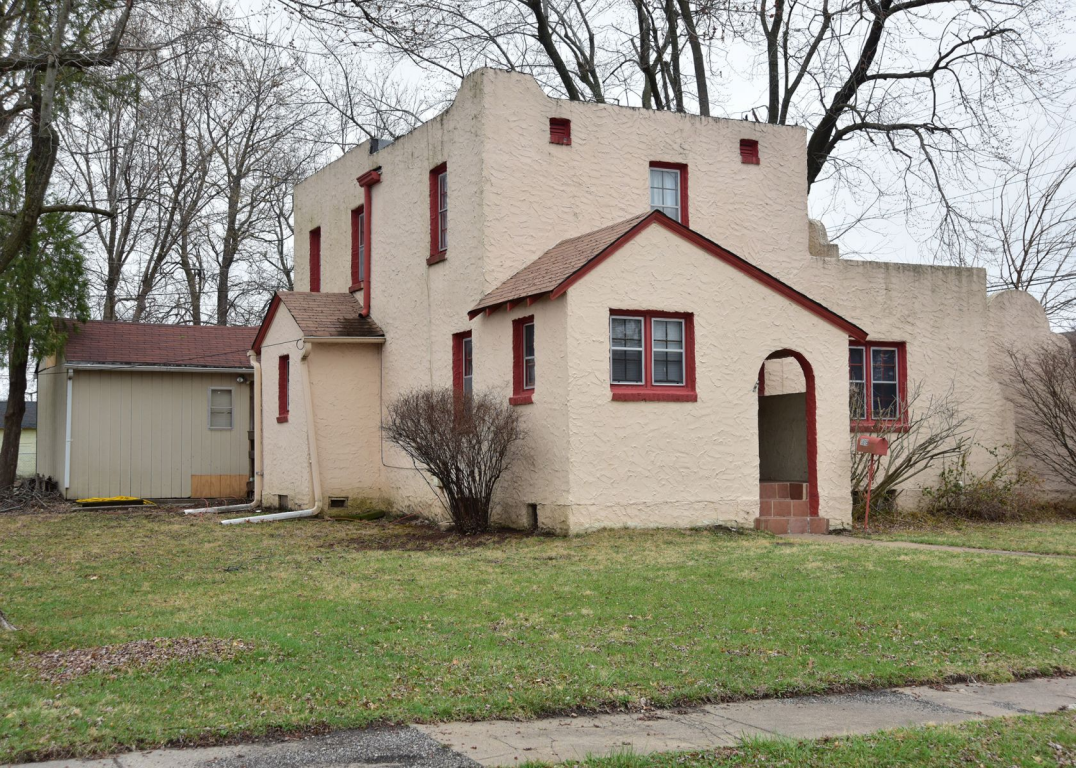
"This two-story, multi-level Spanish Eclectic style house has a flat roof. This dwelling has an irregular footprint that is three asymmetrical bays wide and three asymmetrical bays deep. Yellow stucco covers the exterior walls. Brick embellishes the square vents at the parapet walls. The asymmetrical, enclosed entrance porch has a gable-front roof and features an arched entryway and exposed rafter tails. Filling the remaining bays are four-over-four light, double-hung wood sash windows and eight-light casement sash windows, arranged singly and in pairs, with brick sills. Additional character-defining features include stepped-up wing walls and a second-story patio on the roof of the first story. There are no apparent alterations to the original design or materials of this building (Davis and Schwenk, 2003)."

13019 Grandview Road does not appear significantly altered from its 2003 appearance. Storm windows are present at all elevations visible from the right-of-way. Large red tiles clad the porch stairs.

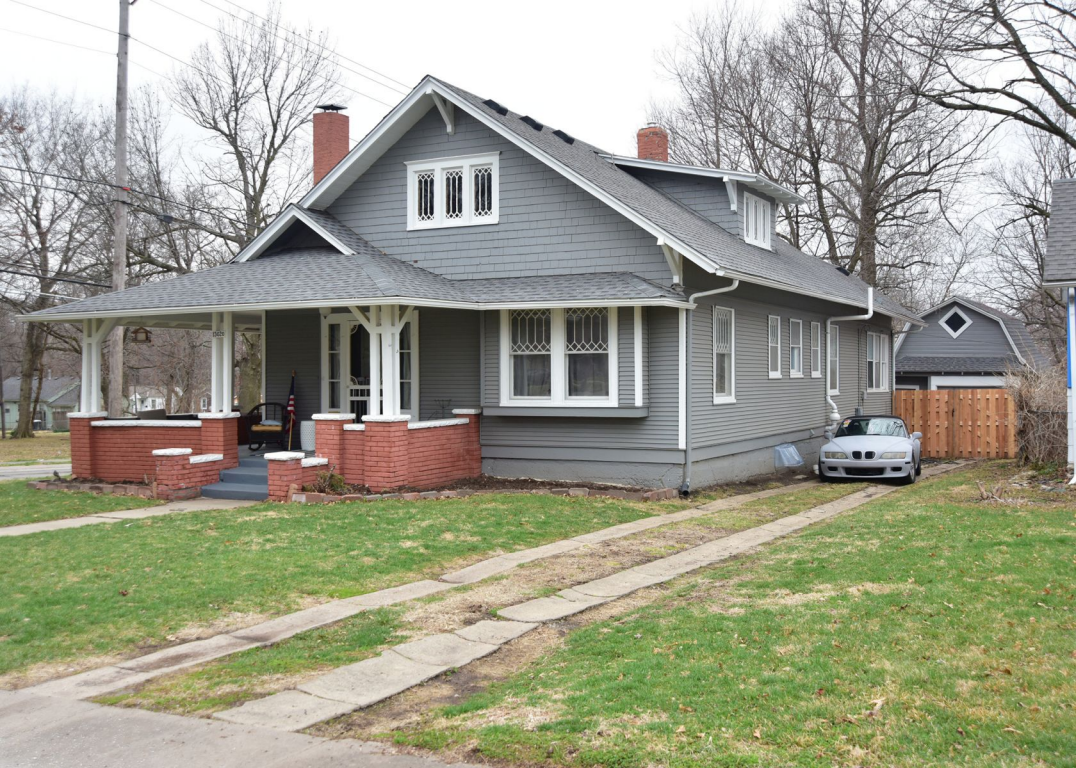
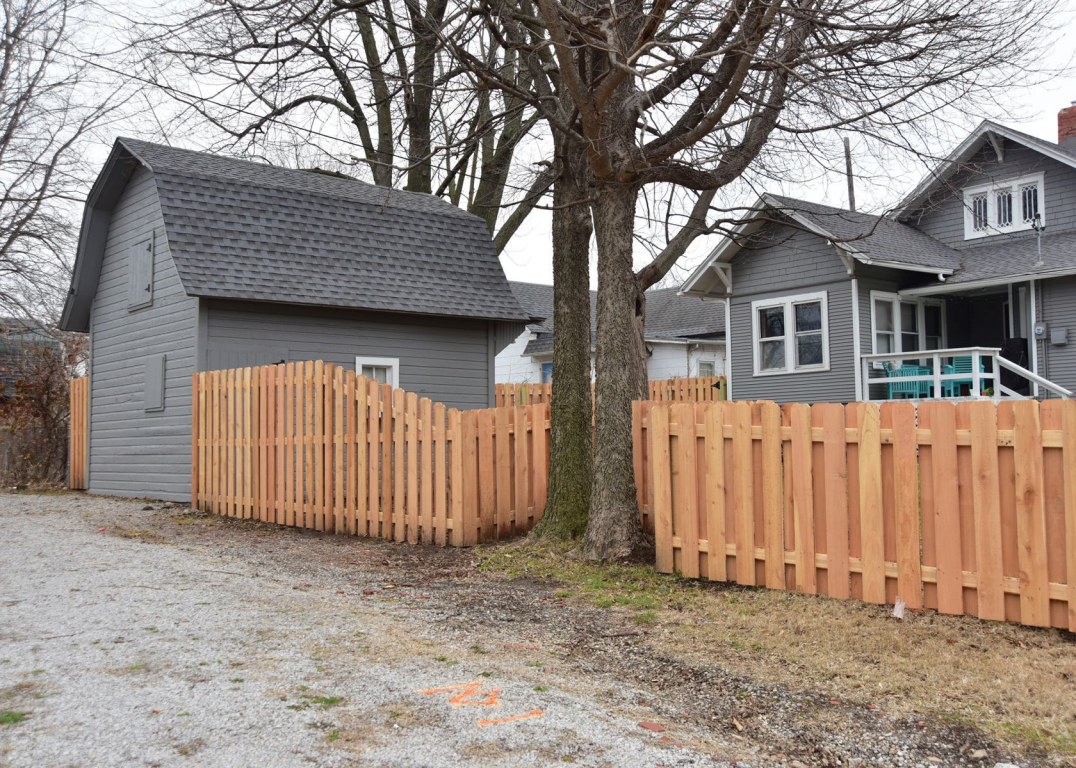
Vinyl clads the exterior walls. The crown molding noted by the 2003 survey is no longer extant at most windows. 13020 Grandview Road does not otherwise appear significantly altered from its 2003 appearance.

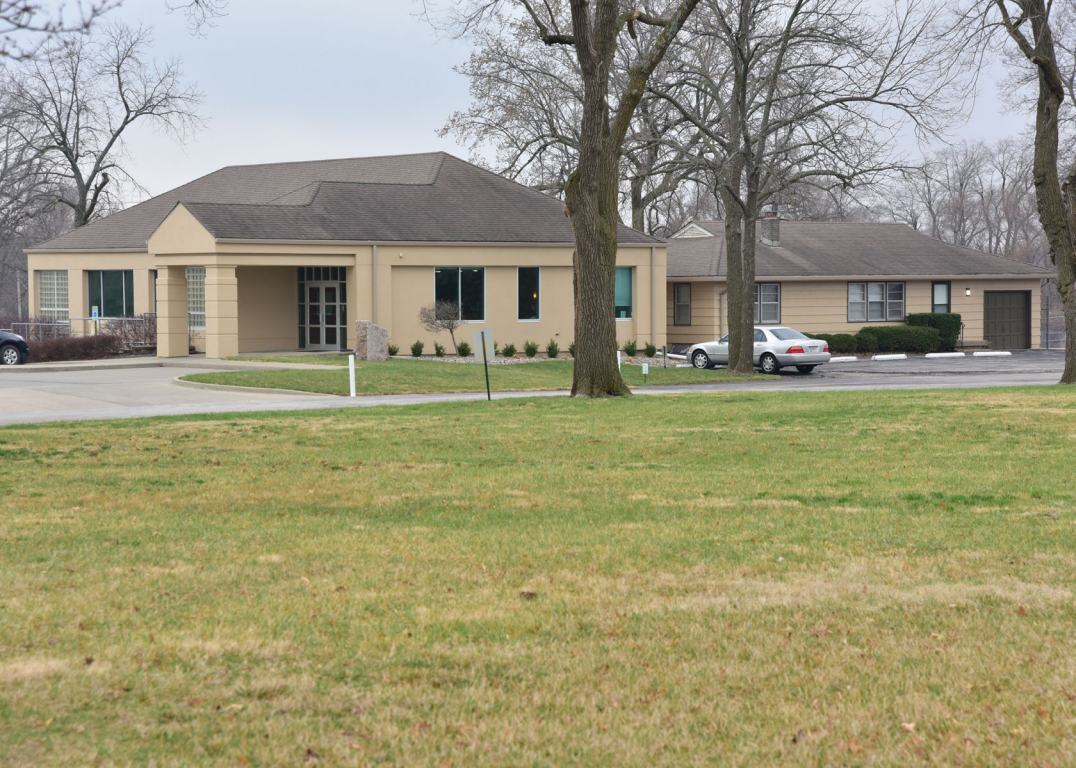
"A large, modern, one-story forward addition obscures the view of the front façade of this one-story Ranch style house and forms an irregular footprint that is six asymmetrical bays wide and eight deep. Stucco covers the exterior walls of the addition and asbestos shingles clad the original house. At the north end bay, a hipped roof addition features a projecting gable-front entrance porch. Three-part, fixed-sash windows and glass block fill the remaining bays, which are delineated by stucco piers and patchwork patterning below the window sills. The original house features a gable-on-hip roof with wide eaves. The four primary façade bays include a stoop entrance in the second bay from the west end; paired and triple one-over-one light, double-hung sash windows; and a single-car garage bay at the west end. A recessed, one-bay wing connects the original house to the forward addition. The large front addition compromises the integrity of this building (Davis and Schwenk, 2003)."

Windows are wood sash. Aerials indicate the addition was built between March 1997 and July 2002. 408 Highgrove Road does not appear significantly altered from its 2003 appearance. Dates of alteration are unknown, however pre-date the 2003 survey.

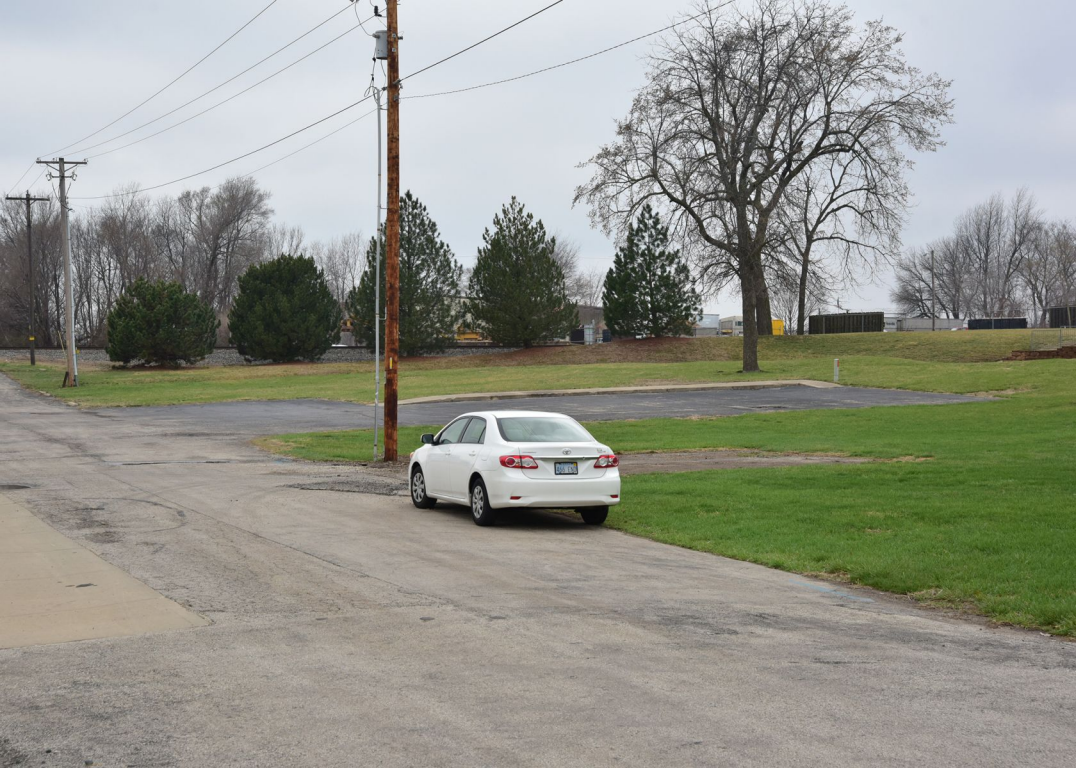
412 Highgrove Road is a parking lot located near the northwest corner of 5th Street and Highgrove Road. The lot is narrow. A slim open grass area abuts the parking lot at the east edge and wraps around the north edge. A telephone line spans the south end of the lot.

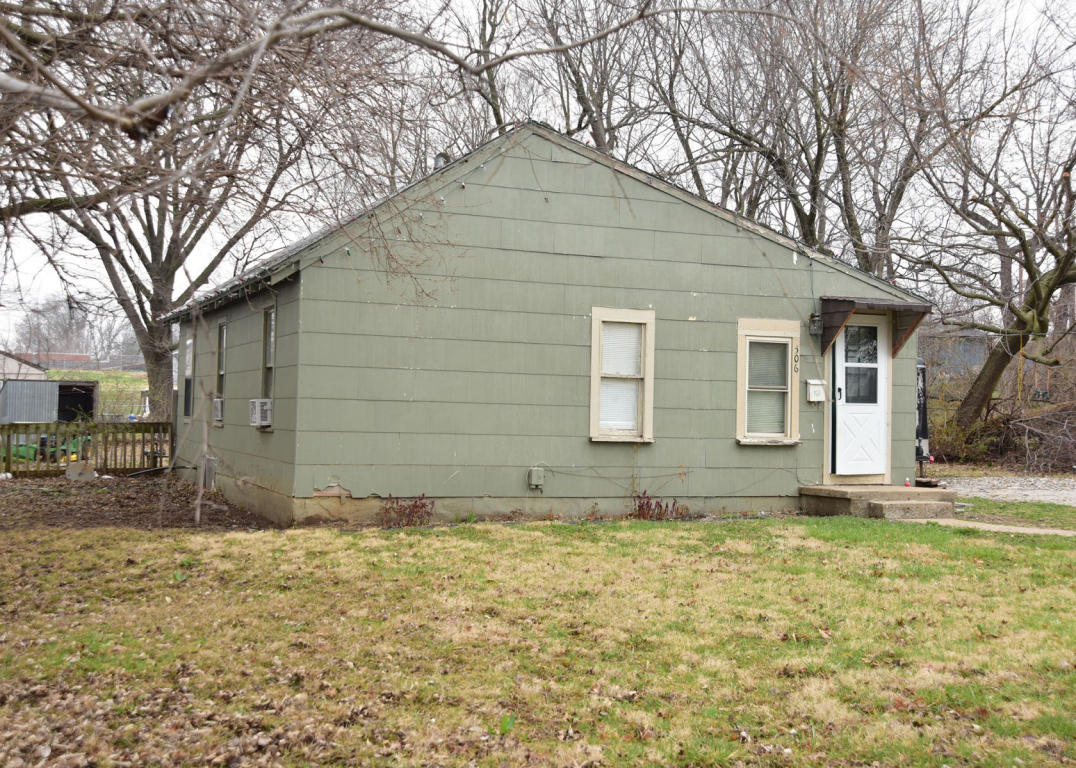
"This one-story, gable-front house has a rectangular footprint that is three asymmetrical bays wide and three symmetrical bays deep. A metal awning shelters the stoop entrance in the east end bay. Defining the other bays are original one-over-one light, double-hung wood sash windows with flat board trim. Additional character-defining features include tight eaves and exposed rafter tails. The original form of this house has been altered and, combined with the application of asbestos shingle cladding, the integrity has been compromised (Davis and Schwenk, 2003)."

506 Highgrove Road does not appear significantly altered from its 2003 appearance. Dates of alteration are unknown, however pre-date the 2003 survey. However, since there are no indications of alterations, Sanborn maps do not cover this area, and historic aerials are inconclusive, this survey cannot support the claim that the form has changed.

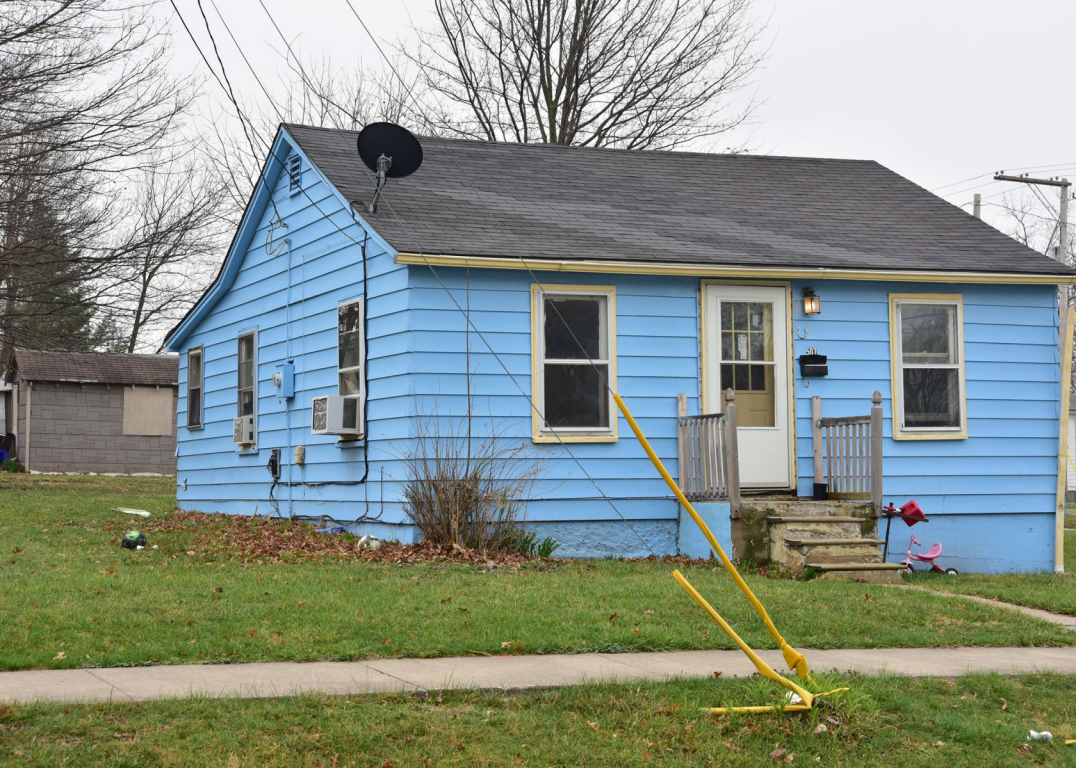
"This one-story, side-gabled house has a rectangular plan that is three symmetrical bays wide and, including a one-bay rear addition with a shed roof, is three bays deep. Flanking the center entrance are one-over-one light, double-hung wood sash windows with flat board trim. Additional character-defining features include the tight eaves. The application of modern wall, roof, and porch materials compromises the integrity of this building (Davis and Schwenk, 2003)."

The dwelling features aluminum cladding, asphalt roofing, and a concrete stoop. Aluminum storm windows are present at all elevations visible from the right-of-way. 507 Highgrove Road does not appear significantly altered from its 2003 appearance. Dates of alteration are unknown, however pre-date the 2003 survey.

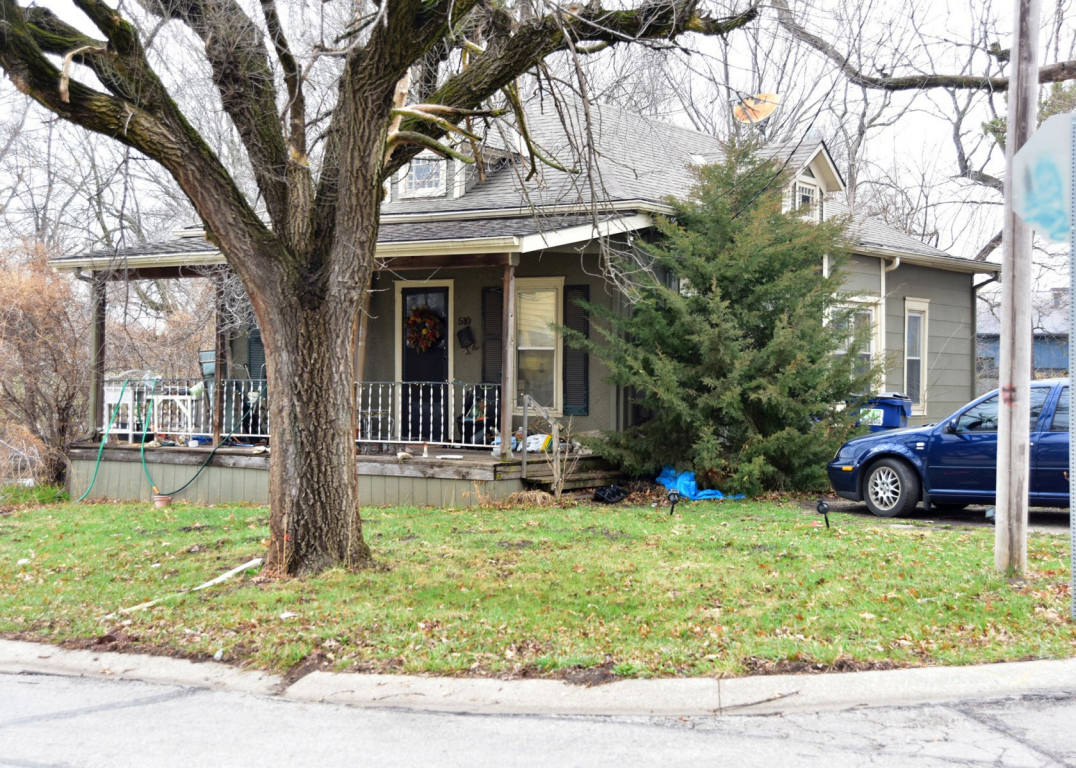
The short brick chimney is no longer extant. A chimney vent pipe is present at the roof peak. Asbestos shingle is present at the east elevation. 510 Highgrove Road does not appear significantly altered from its 2003 appearance. Dates of alteration are unknown, however they pre-date the 2003 survey.

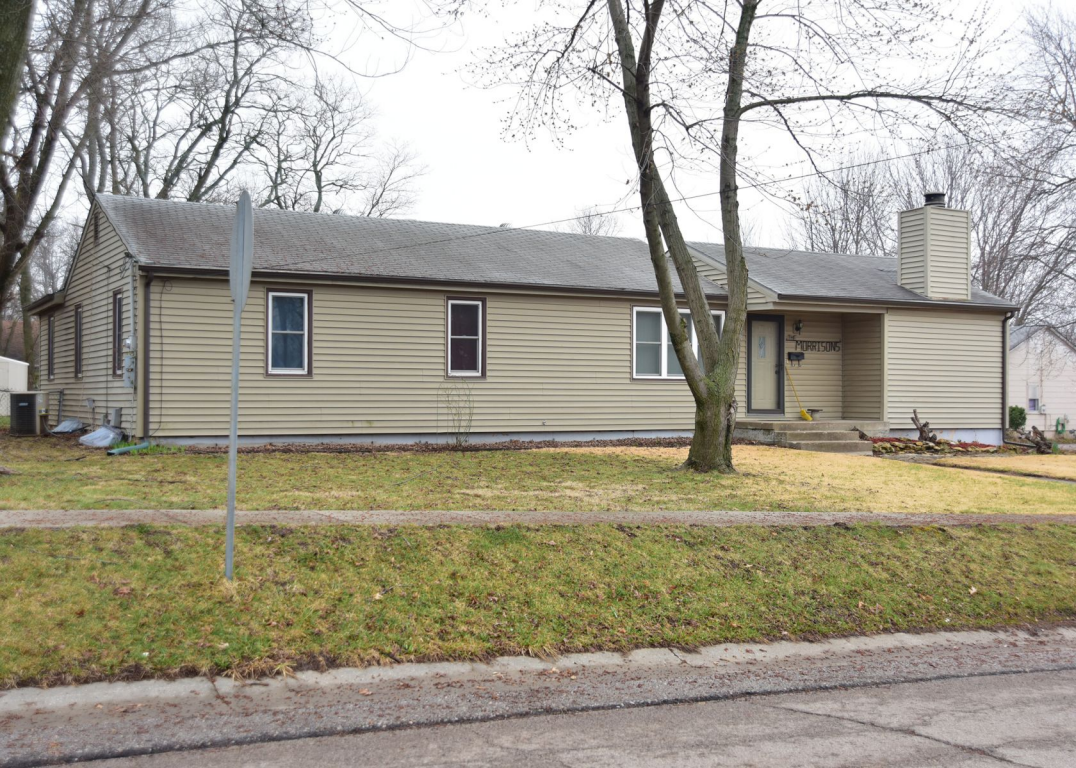
"This one-story, side-gabled Ranch style house has a L-shaped footprint that is four asymmetrical bays wide and two bays deep. The front roof slope and front wall project forward at the west end, forming the recessed one-bay entrance porch. Single and triple one-over-one light, double-hung sash windows define the other bays. Additional character-defining features include tight eaves and a broad chimney that rises through the front roof slope at the west end. The application of vinyl siding to the exterior walls and the brick chimney compromise the integrity of this building (Davis and Schwenk, 2003)."

601 Highgrove Road does not appear significantly altered from its 2003 appearance. Dates of alteration are unknown, however pre-date the 2003 survey.

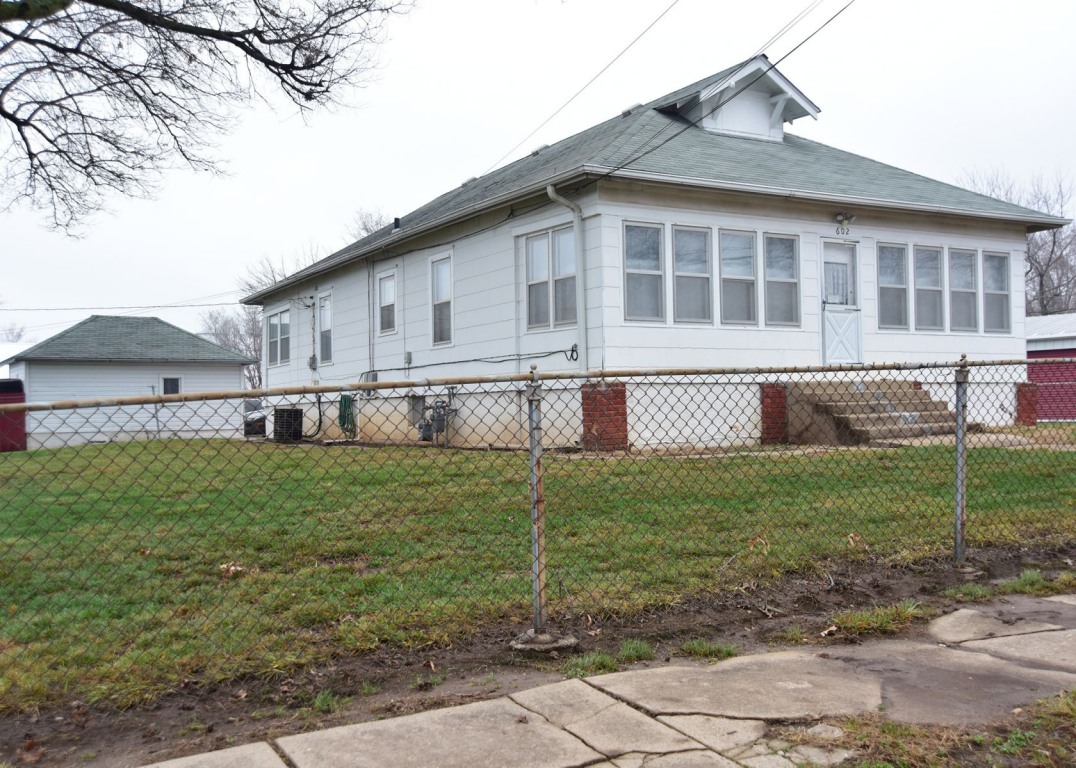
The dormer window is currently boarded up, obscuring the condition or presence of the ten-light hopper sash. Aluminum storm windows are present at all elevations visible from the right-of-way. 602 Highgrove Road does not appear significantly altered from its 2003 appearance. Dates of alteration are unknown, however pre-date the 2003 survey.

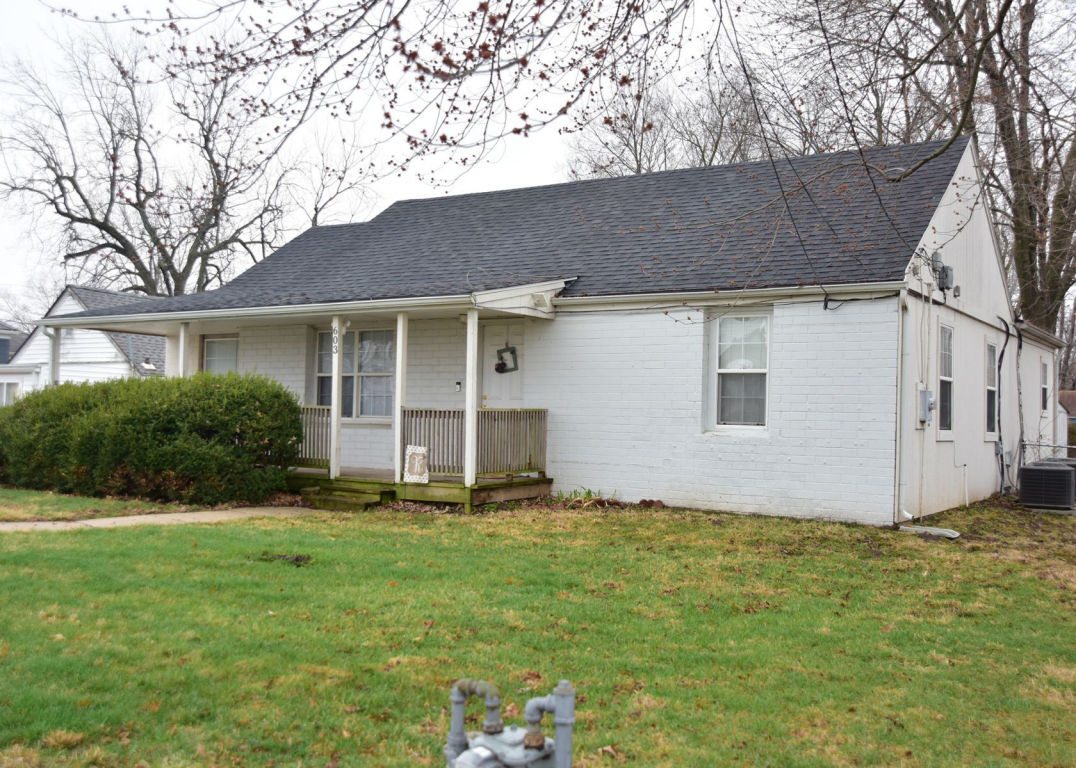
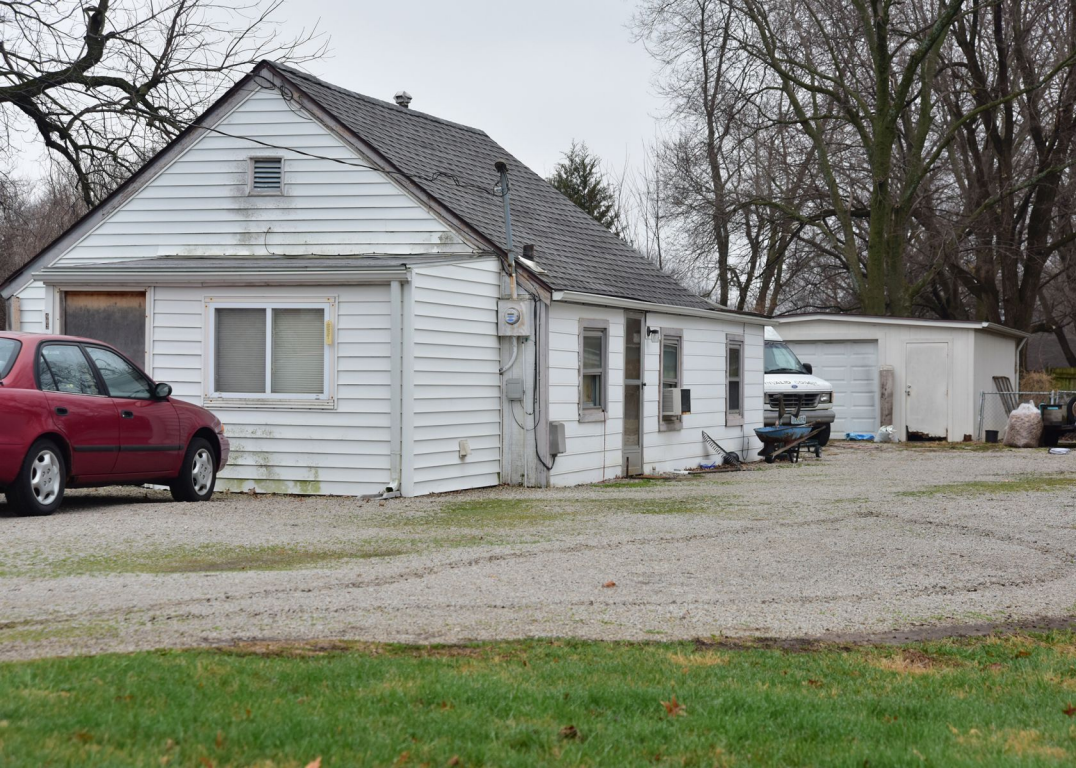
"This one-story, side-gabled Ranch style house has a rectangular footprint that is four asymmetrical bays wide and two bays deep. Brick covers the front wall, which recesses at the east end bay. Wide-profile wood clapboards clad the secondary elevations. Non-original square wood posts support the porch's shed roof, which shelters the three east end bays, including the entrance at the third bay from the east end. Single and paired one-over-one light, double-hung sash windows with shutters define the remaining bays. The loss of original porch elements and wall and roof materials compromise the integrity of this building (Davis and Schwenk, 2003)."

Windows are now six-over-six vinyl sash. Pressed wood now clads the secondary elevations. 603 Highgrove Road otherwise does not appear significantly altered from its 2003 appearance. Dates of alteration are unknown, however post-date the 2003 survey.

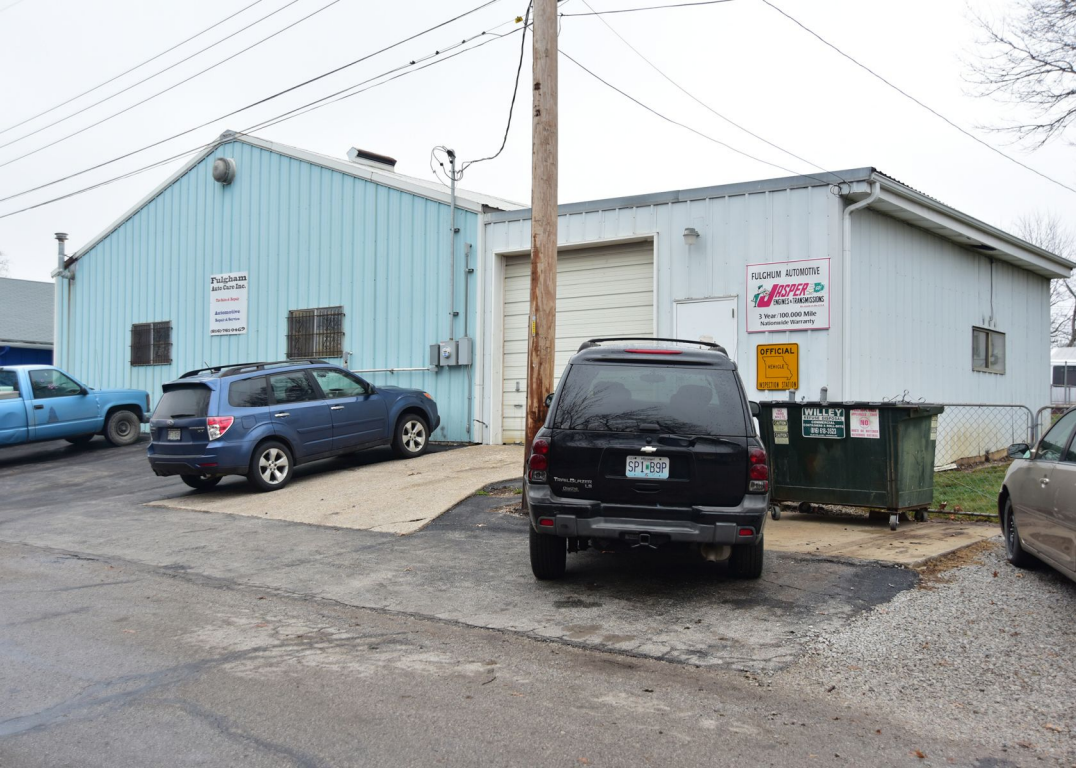
"This one-story, gable-front building has a side addition with a shed roof, resulting in a rectangular plan that is four bays wide and one bay deep. Metal covers the roof and exterior walls. The south end bay contains a pedestrian entrance with a steel door. Moving north, a tall vehicular bay occupies the following bay and one-by-one sliding sash windows occupy the other two bays (Davis and Schwenk, 2003)."

604 Highgrove Road does not appear significantly altered from its 2003 appearance.

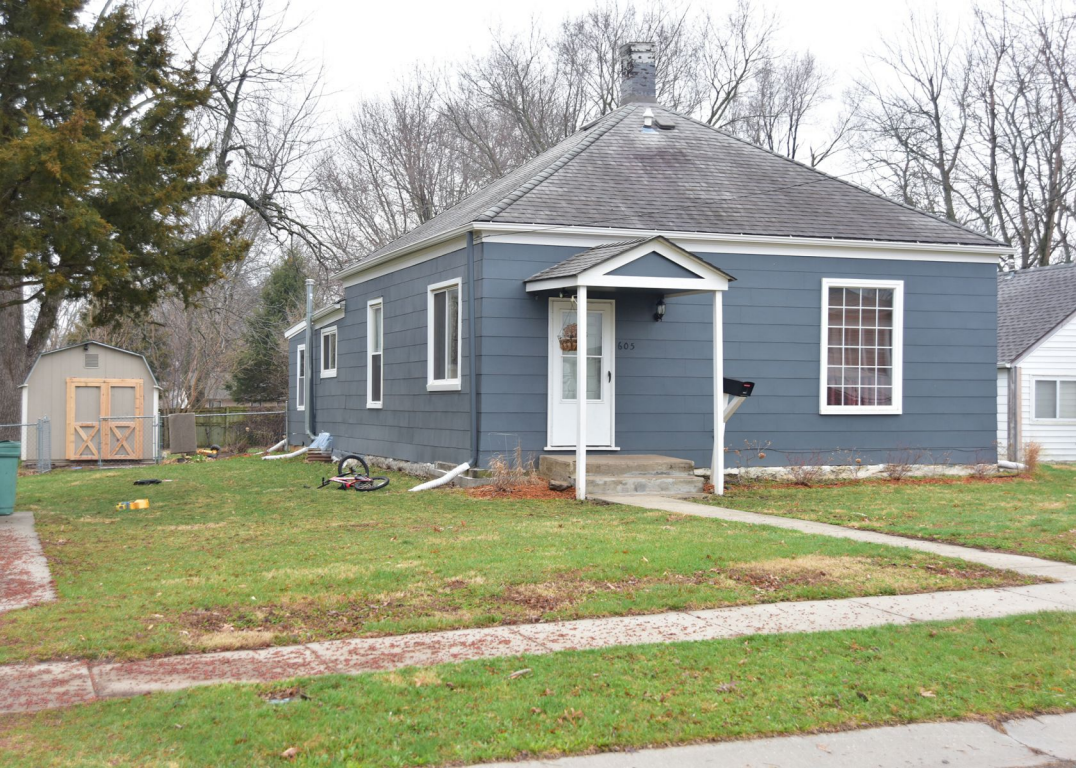
Windows are vinyl replacement sash. The west bay is defined by a twenty-four-light fixed window. 605 Highgrove Road does not otherwise appear significantly altered from its 2003 appearance. Dates of alteration are unknown, however pre-date the 2003 survey.

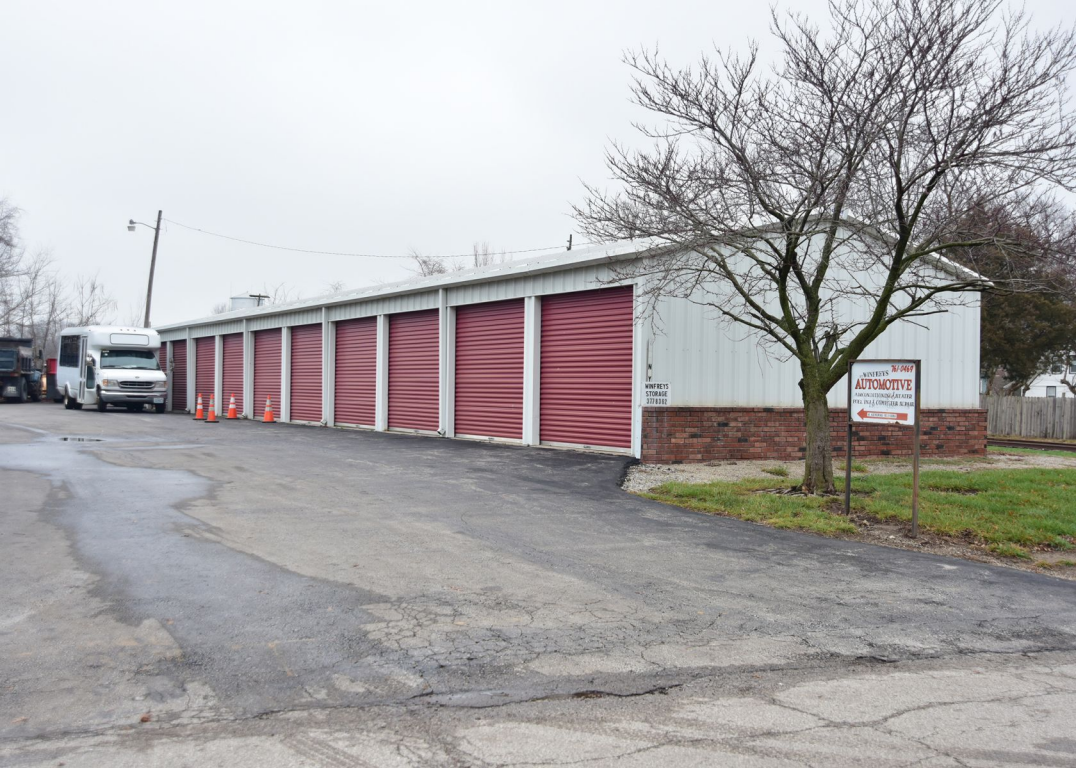
606 Highgrove Road does not appear significantly altered from its 2003 appearance.

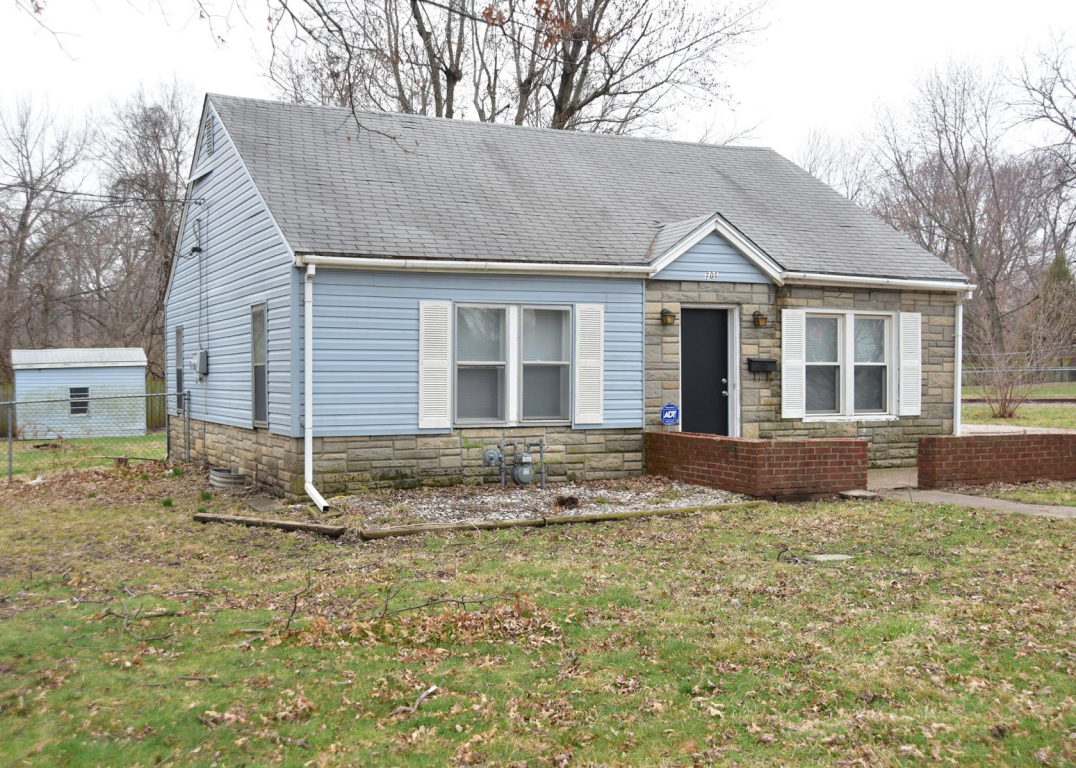
The pressed wood cladding has been replaced with narrow profile vinyl siding. 701 Highgrove Road does not otherwise appear significantly altered from its 2003 appearance. Dates of other alterations are unknown, however pre-date the 2003 survey.

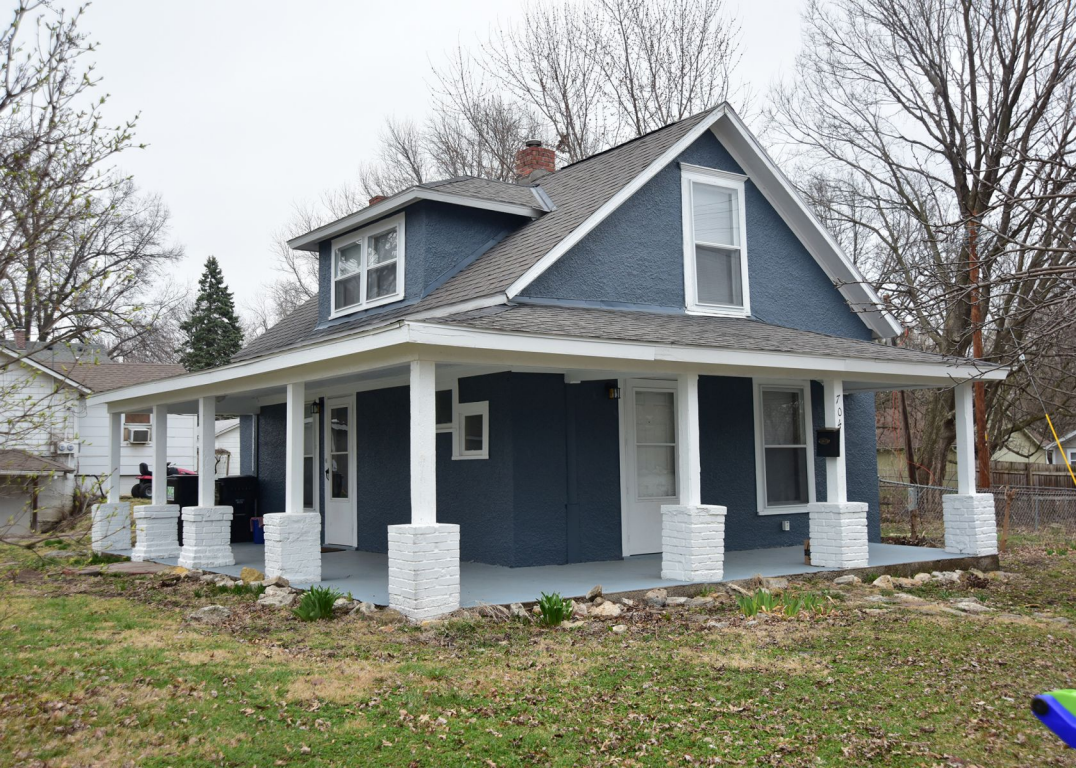
"This one-and-a-half-story, gable-front house has a rectangular footprint that is two bays wide and two bays deep. Square wood posts resting on brick piers support the hipped-roof porch that wraps the primary façade and the first bay of the west elevation. The entrance occupies the west end bay of the primary façade and one-over-one light, double-hung sash windows with flat board trim and crown molding define the remaining bays of each elevation. A hipped dormer projects from the east roof slope and features a pair of six-over-one light, double-hung wood sash windows (Davis and Schwenk, 2003)."

The dormer now features one-over-one double-hung windows. Storm windows are present at all elevations visible from the right-of-way.

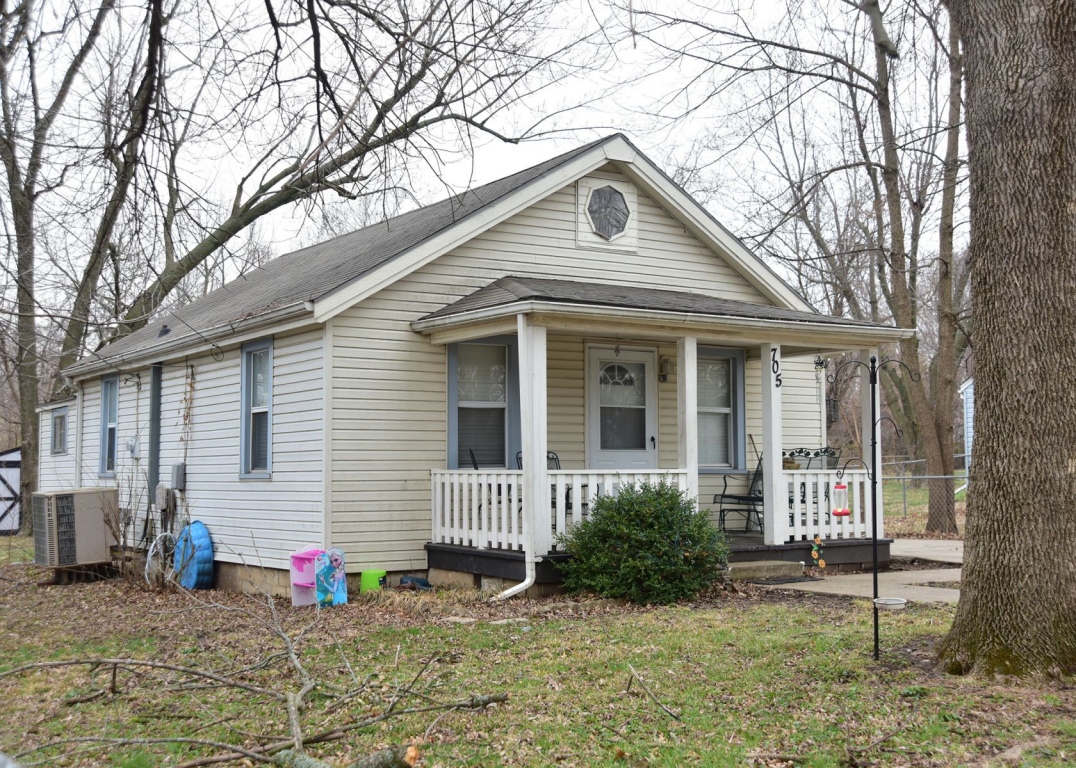
A non-historic door defines the center bay. 705 Highgrove Road does not appear significantly altered from its 2003 appearance. Dates of alteration are unknown, however pre-date the 2003 survey.

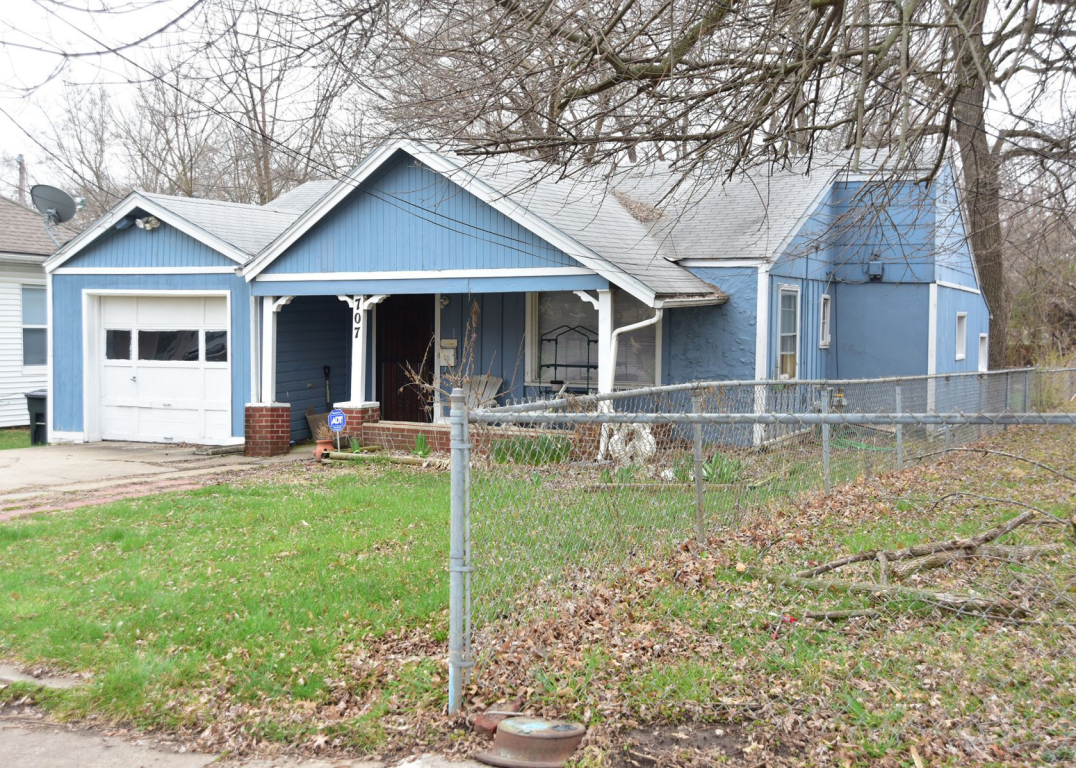
"This one-story house has an intersecting gable roof and an irregular footprint that is three asymmetrical bays wide and two bays deep. Square wood posts with decorative brackets that rest on short brick piers support the two-bay porch's gable-front roof, which shelters the center bay entrance. A second projecting gable over the east end bay distinguishes a single-car garage. A single fixed-sash picture window defines the remaining bay of the primary façade. A combination of board-and-batten and pressed wood siding covers the exterior walls. The non-original wall materials and additions compromise the integrity of this building (Davis and Schwenk, 2003)."

707 Highgrove Road does not appear significantly altered from its 2003 appearance. Dates of alteration are unknown, however pre-date the 2003 survey.

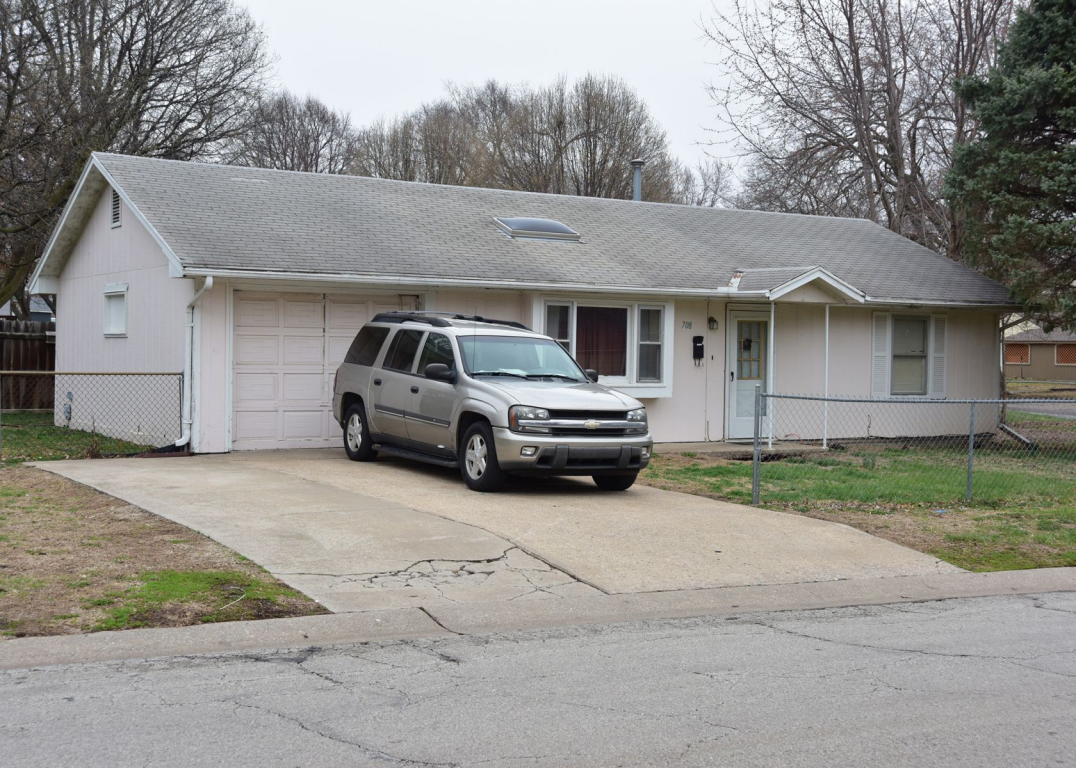
"This one-story, side-gabled Ranch style house has a rectangular footprint that is four asymmetrical bays wide and one bay deep. A shallow gable projects from the eaves to distinguish and shelter the entrance at the second bay from the east end. The west end bay contains a single-car garage with the original overhead door intact. A single one-over-one light, double-hung sash window and a tripartite picture window define the other bays. Additional character-defining features include the wide eaves and the geometric, interlocking rectangle design on the garage door (Davis and Schwenk, 2003)"

708 Highgrove Road does not appear significantly altered from its 2003 appearance.
