MISSOURI DEPARTMENT OF NATURAL RESOURCES  
STATE HISTORIC PRESERVATION OFFICE, P.O. Box 176, Jefferson City, MO 65102  
**ARCHITECTURAL/HISTORIC INVENTORY FORM**

1. Survey number: JA-AS-088-153		2. Survey Name: Town of Grandview, Resurvey	
3. County: JACKSON		4. Address (Street No.): 304 Street (name): Dewey Avenue	
5. City: Grandview	Vicinity <input type="checkbox"/>	6. Lat / Long:	7. Township/Range/Section: T: R: S:
8. Historic name (if known):		9. Present/other name (if known):	
10. Ownership: <input checked="" type="checkbox"/> Private <input type="checkbox"/> Public		11a. Historic use (if known): Domestic-Single Dwelling	11b. Current use: Domestic-Single Dwelling

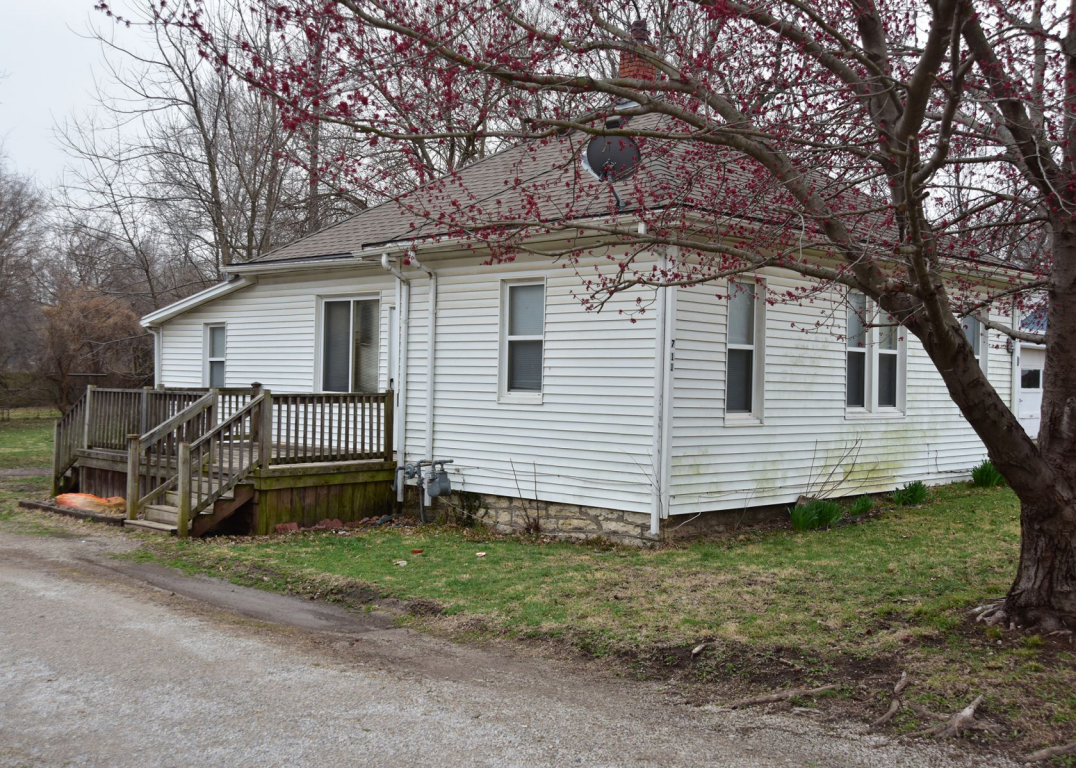
711 Highgrove Road does not appear significantly altered from its 2003 appearance. Dates of alteration are unknown, however pre-date the 2003 survey.

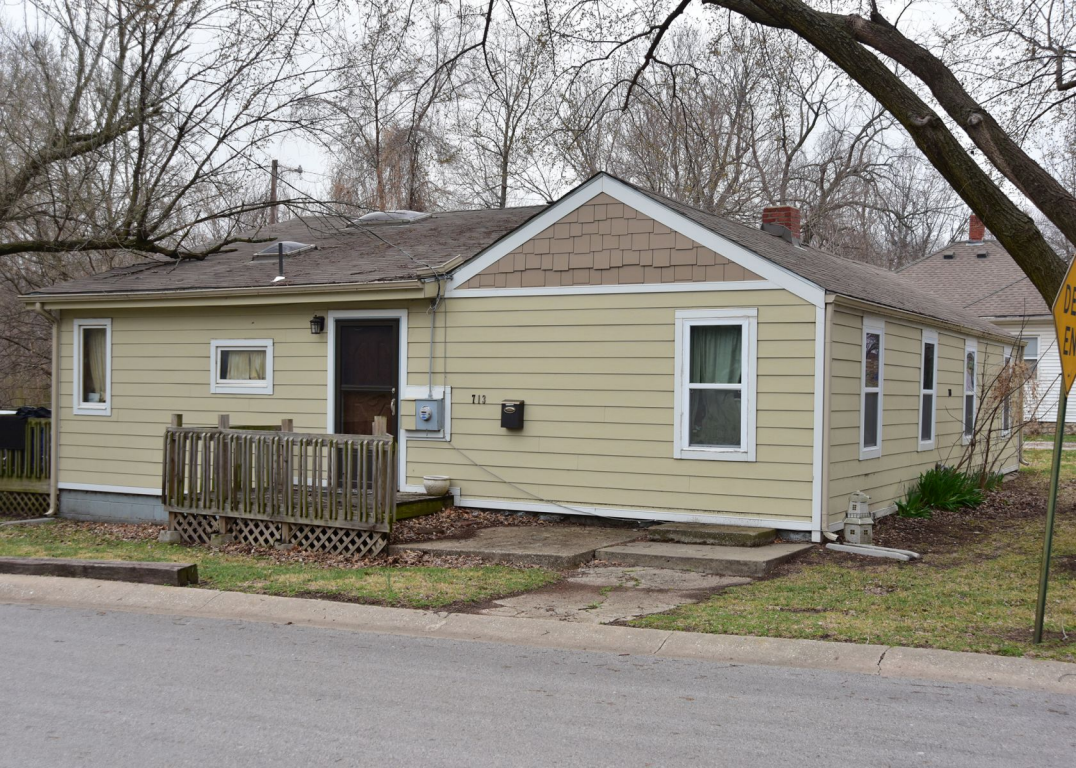
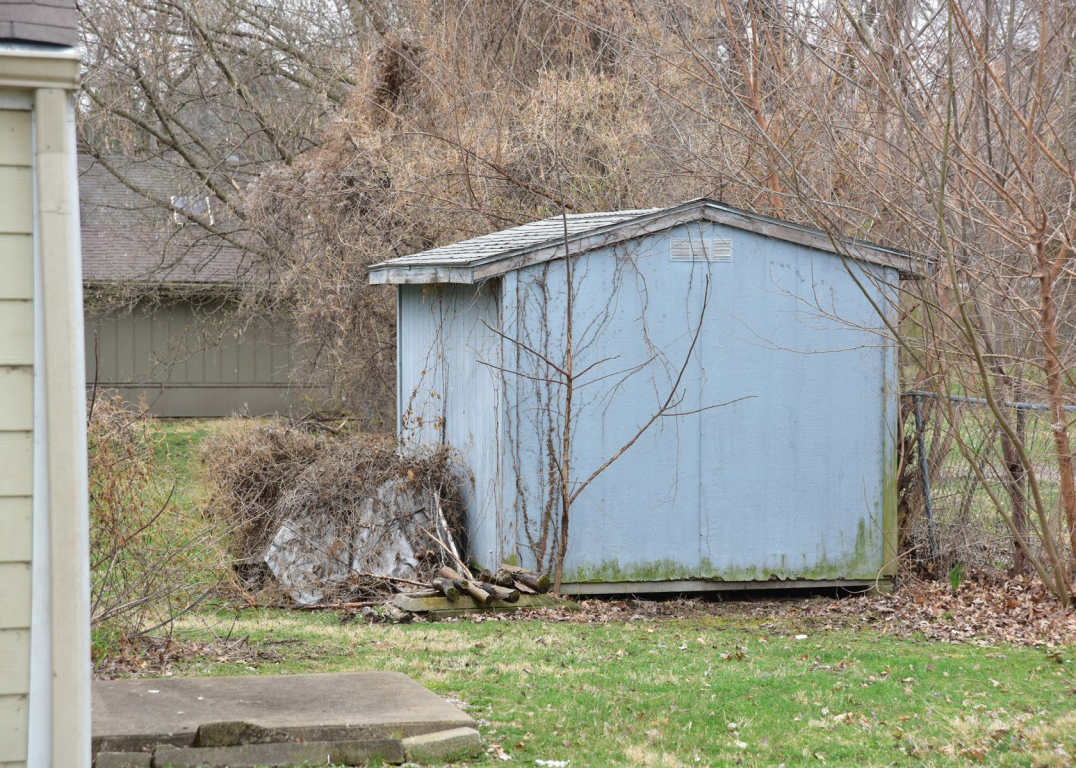
The wood cladding has been replaced with aluminum siding. Faux-shingles clad the gable end. Dates of prior alteration are unknown, however pre-date the 2003 survey.

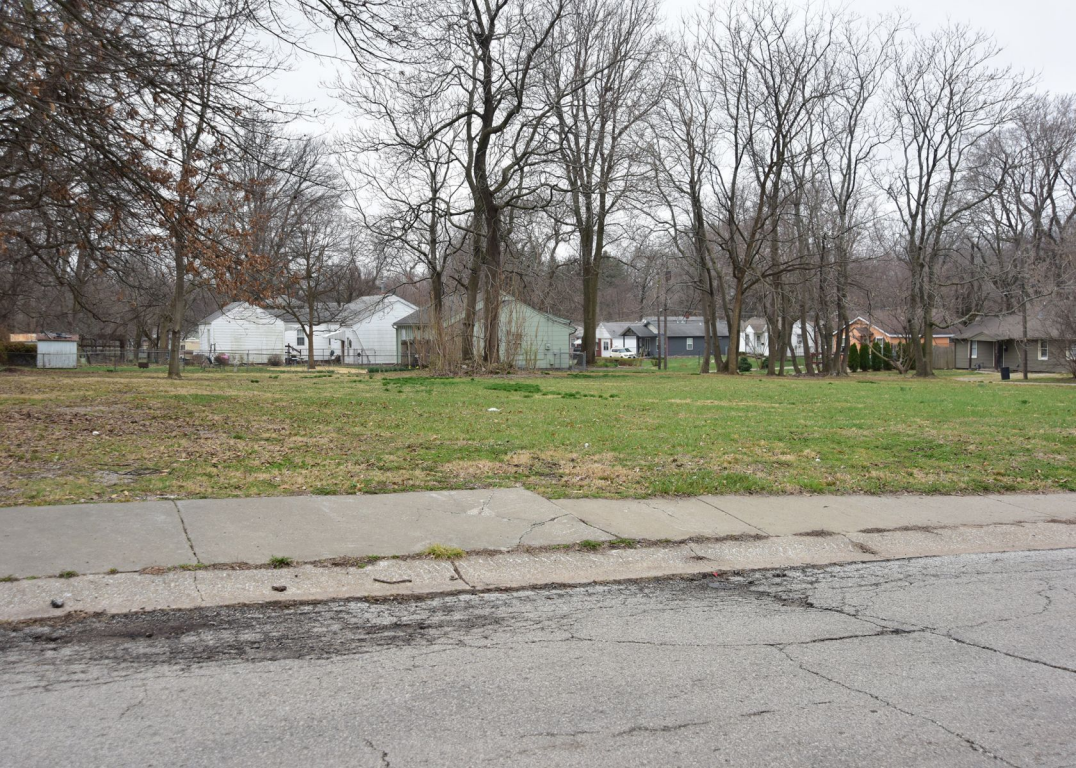
803 Highgrove road is no longer extant. Aerial imagery indications demolition was complete by 2013.

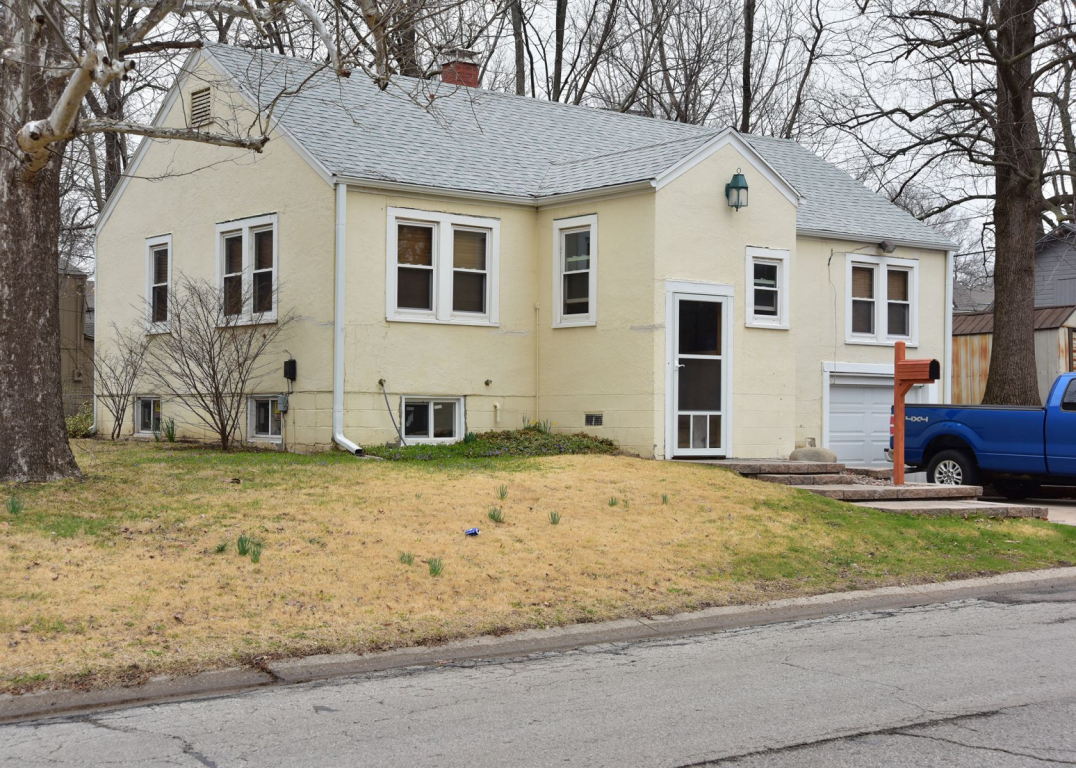
804 Highgrove Road features non-original stucco cladding, one-over-one vinyl sash replacement windows, and asphalt roofing.

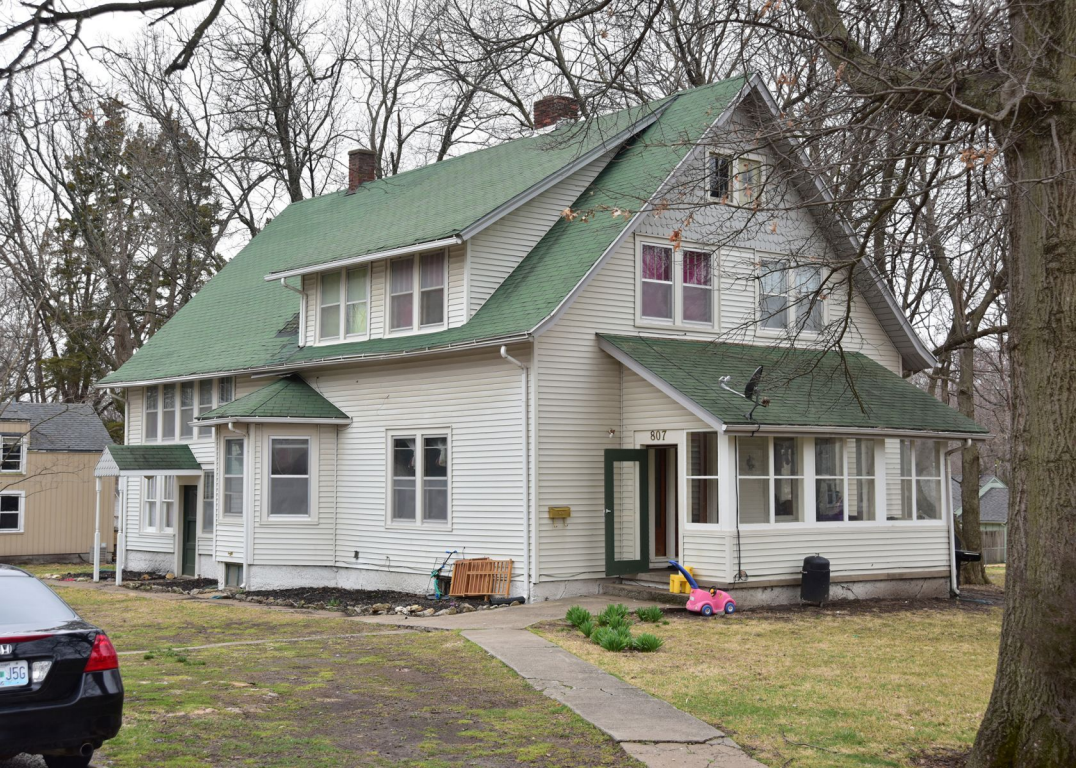
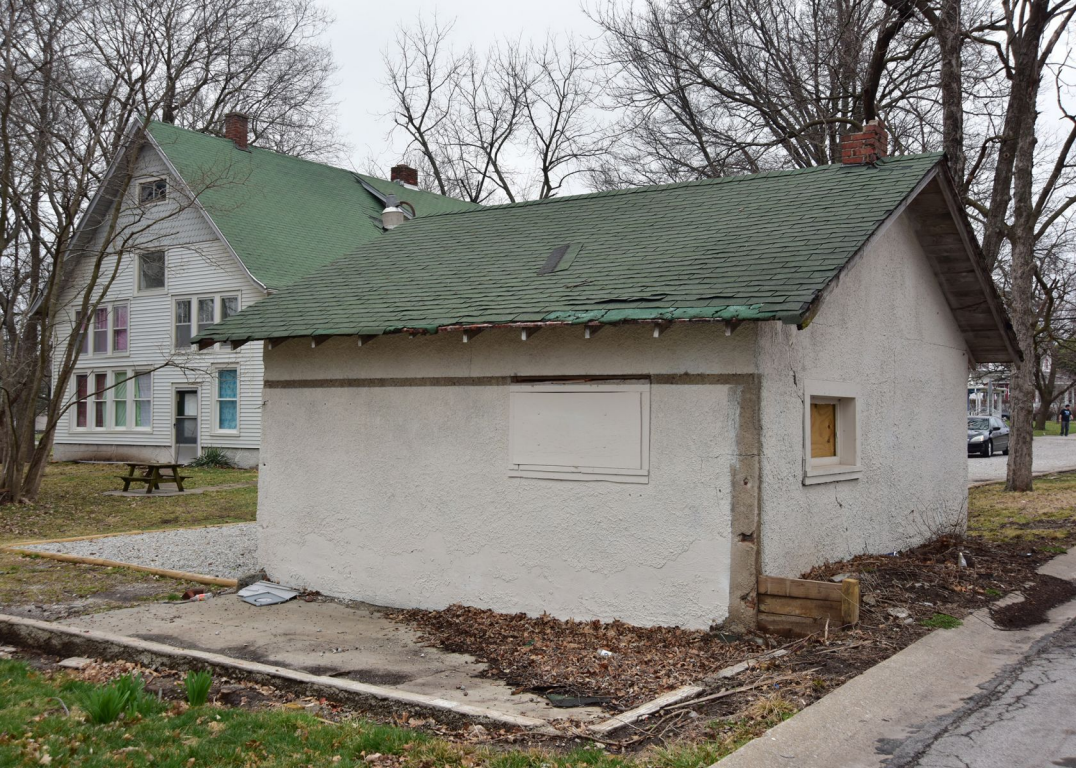
Windows are predominately four-over-one wood sash however several one-over-one replacements are present. 807 Highgrove Road does not appear significantly altered from its 2003 appearance. Dates of alteration are unknown, however pre-date the 2003 survey.

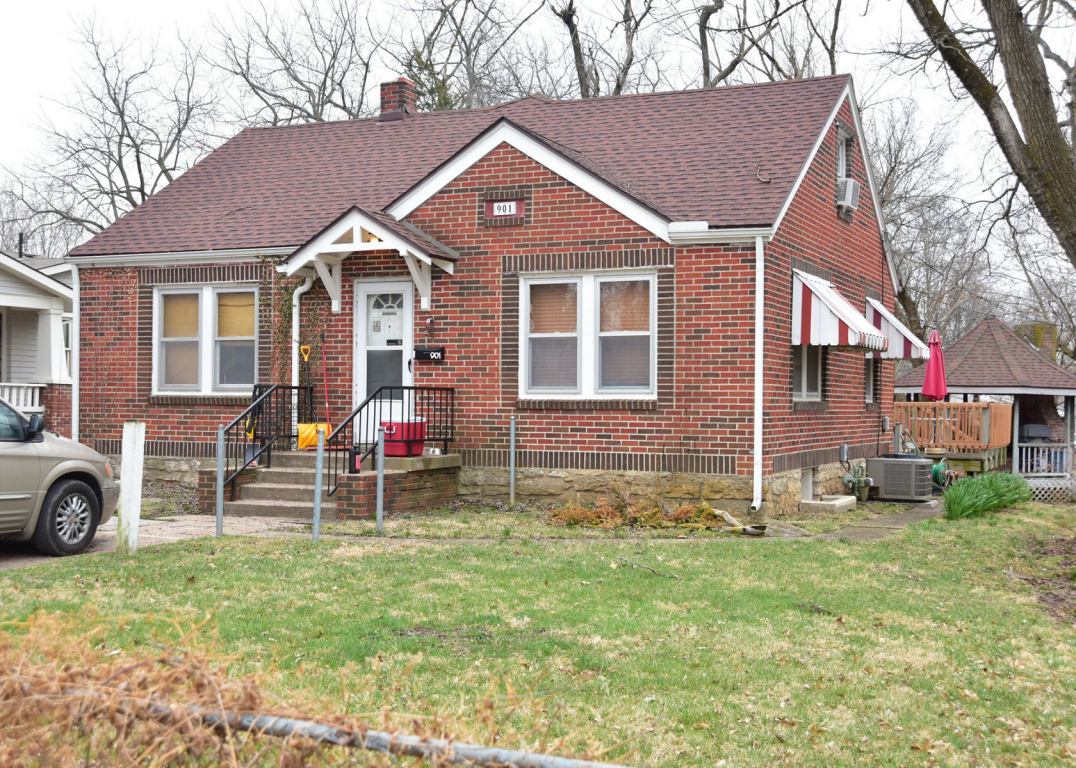
"This one-and-a-half-story, side-gabled brick house has a rectangular footprint that is three symmetrical bays wide and two bays deep. A stout lower cross gable over the two west end bays features a gable-front porch roof, which is supported by knee brackets and shelters the stoop entrance. This porch features exposed truss work and rafter tails. Defining the other bays are paired one-over-one light, double-hung sash windows with soldier brick trim and header brick sills. Additional character-defining features include a course of soldier brick at each exterior wall sill, tight eaves, the exposed rough-cut stone foundation, and a stout brick chimney at the ridge line (Davis and Schwenk, 2003)."

Metal awnings cover windows at the west elevation. A non-historic deck projects from the rear elevation. 901 Highgrove Road does not appear significantly altered from its 2003 appearance. Dates of alteration are unknown, however pre-date the 2003 survey.

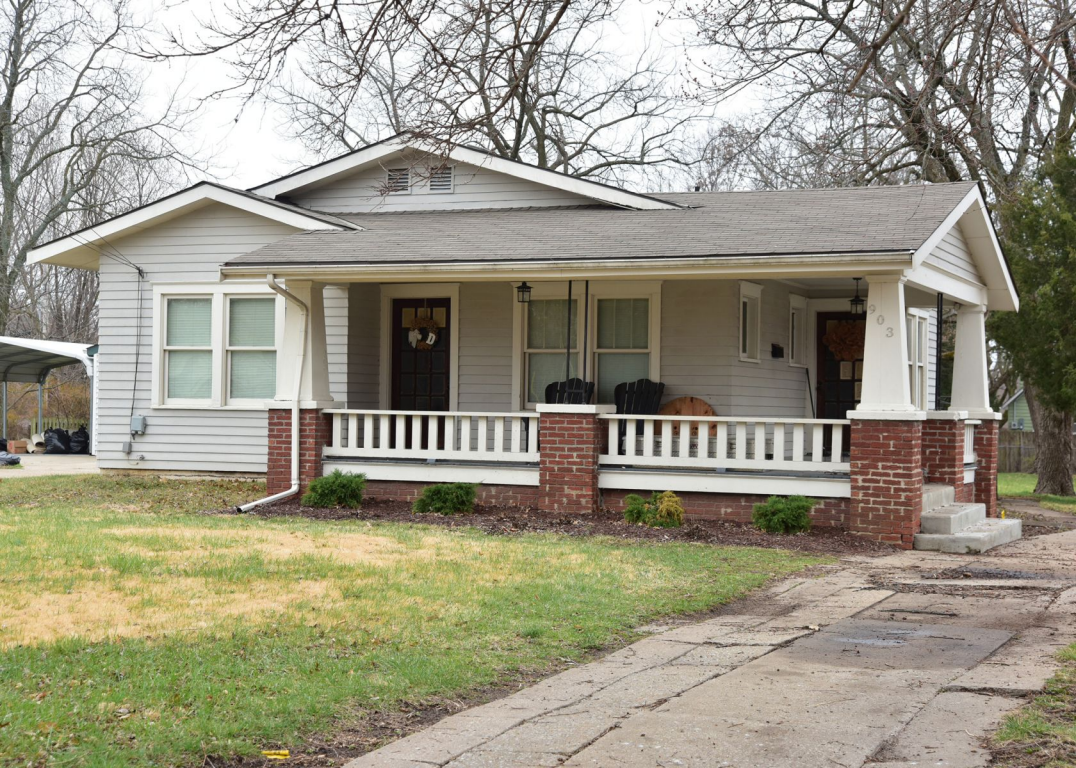
Two one-over-one replacement windows now define the east bay of the primary elevation. 903 Highgrove Road otherwise does not appear significantly altered from its 2003 appearance.

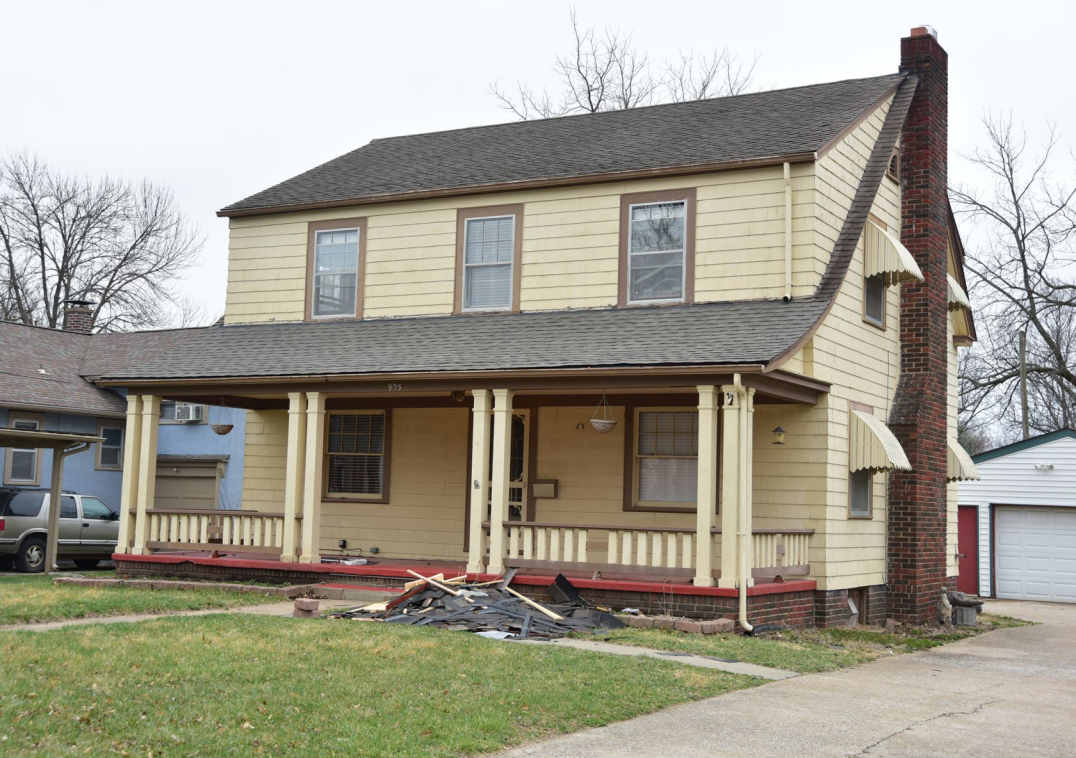
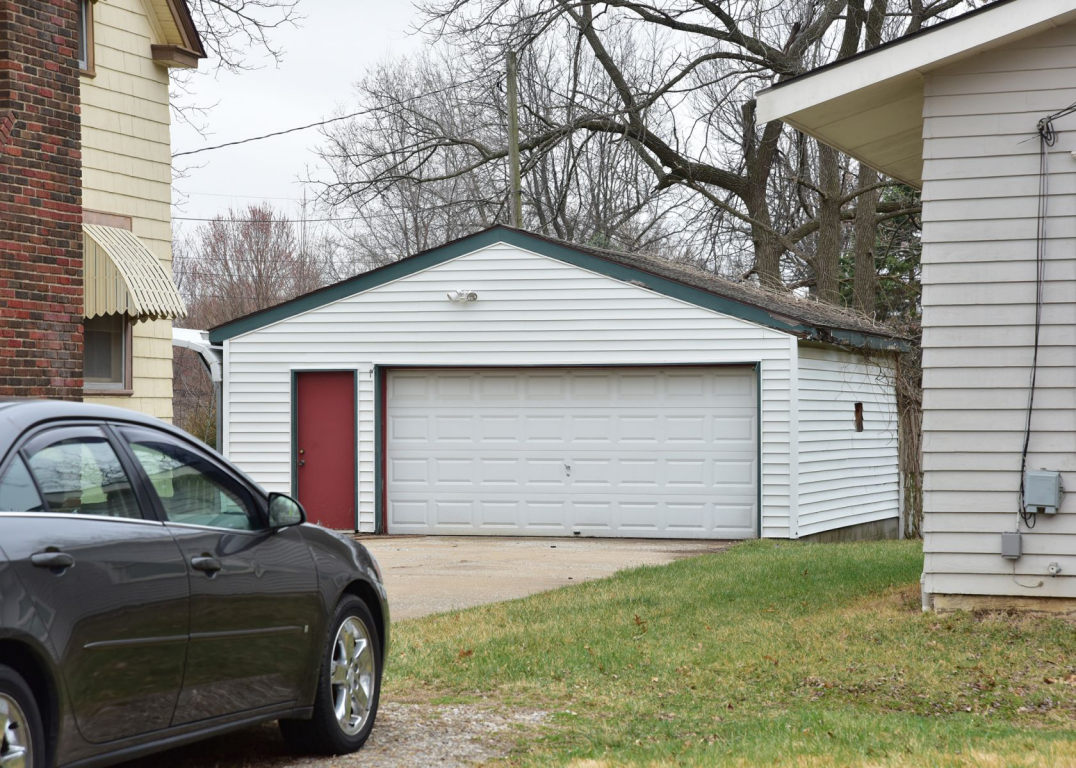
"This two-story, side-gabled Colonial Revival house has a rectangular footprint that is three symmetrical bays wide and two bays deep. The main roof slope flares slightly and projects forward to form the full-width porch roof, which is supported by paired and triple square wood posts, sheltering the center bay entrance. Defining the remaining bays of the primary façade are original six-over-one light, double-hung windows with flat board trim. A full-width dormer extends from the roof ridge and dominates the second story of the primary façade. Additional character-defining features include wood shingle cladding the exterior walls, the wide-profile wood plank balusters, and the exterior brick chimney at the west elevation (Davis and Schwenk: 2003)."

The historic wood windows at the first floor have an eight-over-one pane arrangement while the second floor windows have a six-over-one pane arrangement. Additional details include metal awnings over windows at the west elevation and aluminum storm windows installed at all locations visible from the right of way. The dwelling possess an asphalt roof and brick foundation.

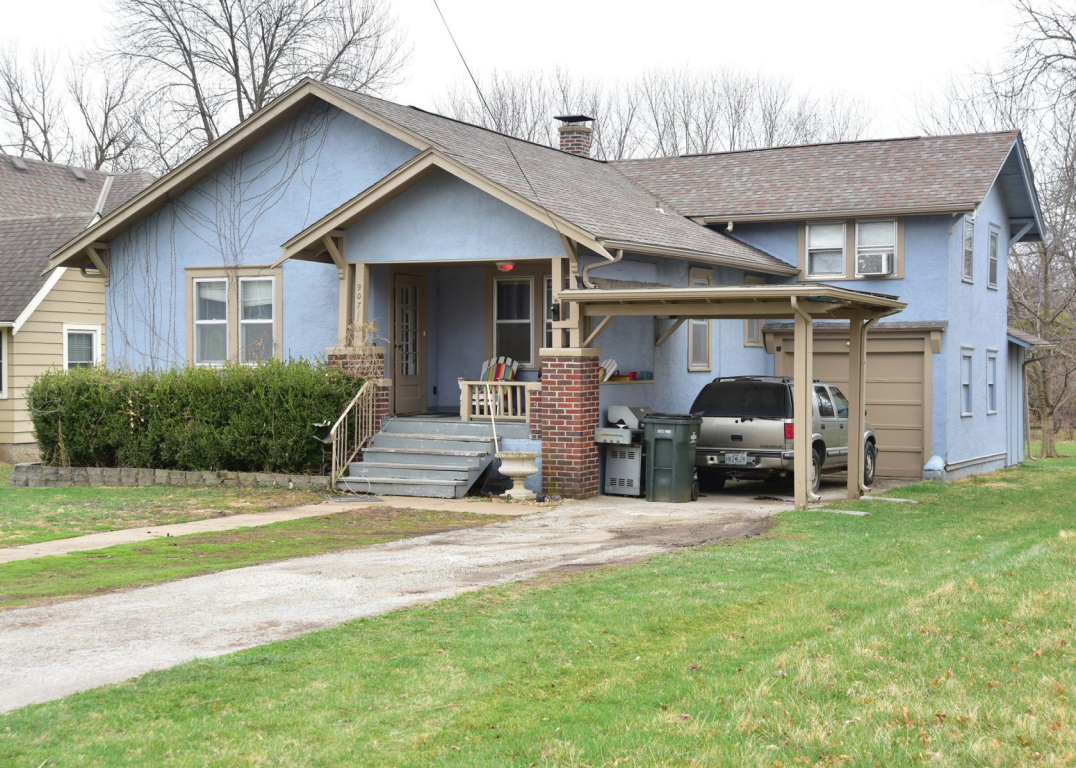
"This one-and-a-half-story, gable-front bungalow has two nested front gables and an intersecting gable wing at the rear. This dwelling has an L-shaped plan that is three bays wide and five bays deep. A single-bay, gable-front porch projects from the center bay where the front wall recesses and further shelters the perpendicular entrance. Paired square wood posts resting on brick piers support the porch roof. Forming the two east end bays are paired one-over-one light, double-hung sash windows with flat board trim. Defining the east end bay, leading into the intersecting wing, is a single-car garage bay. Additional character-defining features include the wide eaves with knee brackets, exposed rafter tails, bracketed molding below pair of windows in the east end bay, and the original wood frame carport that resembles a pergola (Davis and Schwenk, 2003)."

907 Highgrove Road does not appear significantly altered from its 2003 appearance.

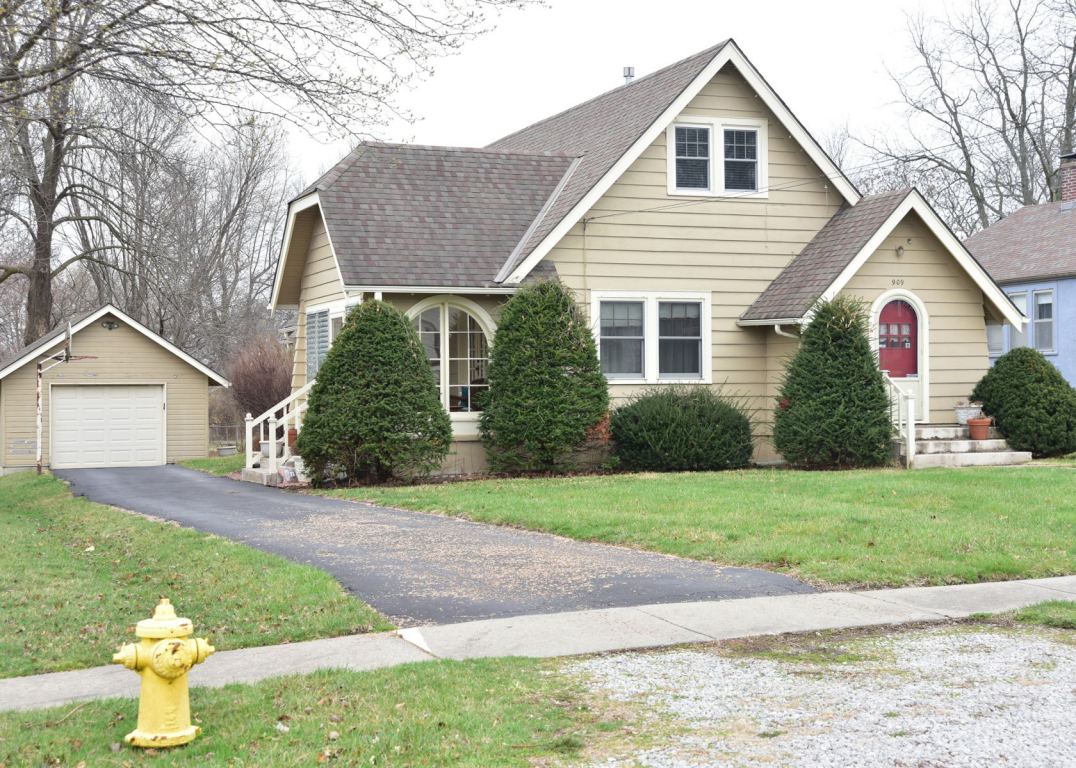
"This one-and-a-half-story, gable-front house has two nested front gables and a lower cross clipped gable at the east end. This dwelling has a L-shaped footprint that is three bays wide and three bays deep. A projecting gable at the west end bay forms the entrance stoop and foyer. Defining the other bays of the primary façade are paired six-over-one light, double-hung wood sash windows with flat board trim and, at the east end bay, a large round-arched, multi-light casement sash window. Additional character-defining features include the wide eaves, the round-arched entrance door, the wide-profile wood clapboards, and the exposed rafter tails (Davis and Schwenk, 2003)."

909 Highgrove Road does not appear significantly altered from its 2003 appearance.

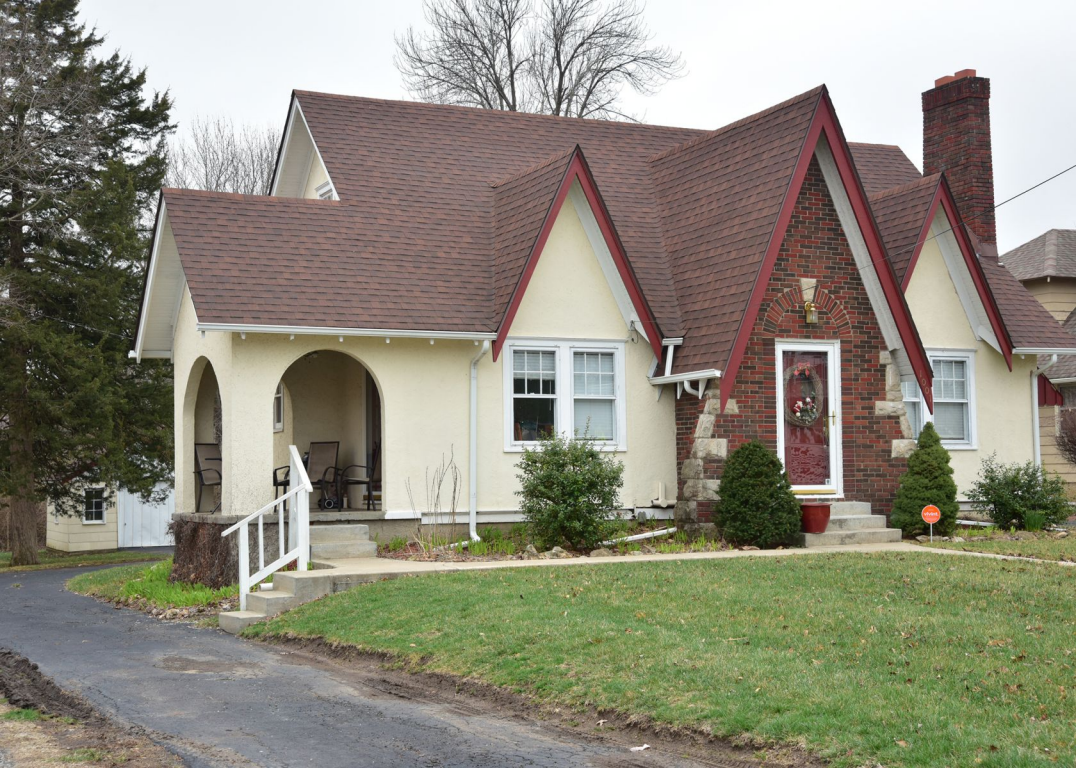
"This one-and-a-half-story Tudor Revival style house has a L-shaped plan that is four bays wide and two bays deep. The design features three steeply pitched projecting cross gables of different heights. The tallest front gable projects slightly in the second bay from the west end and features brick facing and rough-cut stone quoins, effectively distinguishing the primary entrance. The two shorter cross gables flank the tallest one and contain paired six-over-six light, double-hung sash windows with flat board trim. A side-gabled extension of the front roof slope forms a faux porte-cochere with round-arched openings forming a secondary entrance porch. Additional character-defining features include stucco cladding on the remaining exterior walls, round-arched soldier brick trim with keystone surrounding the entrance, wide eaves with exposed rafter tails, and a broad exterior brick chimney at the west elevation (Davis and Schwenk, 2003)."

The windows are six-over-one. The 2003 survey photograph confirms this arrangement in 2003. 1001 Highgrove Road does not appear significantly altered from its 2003 appearance.

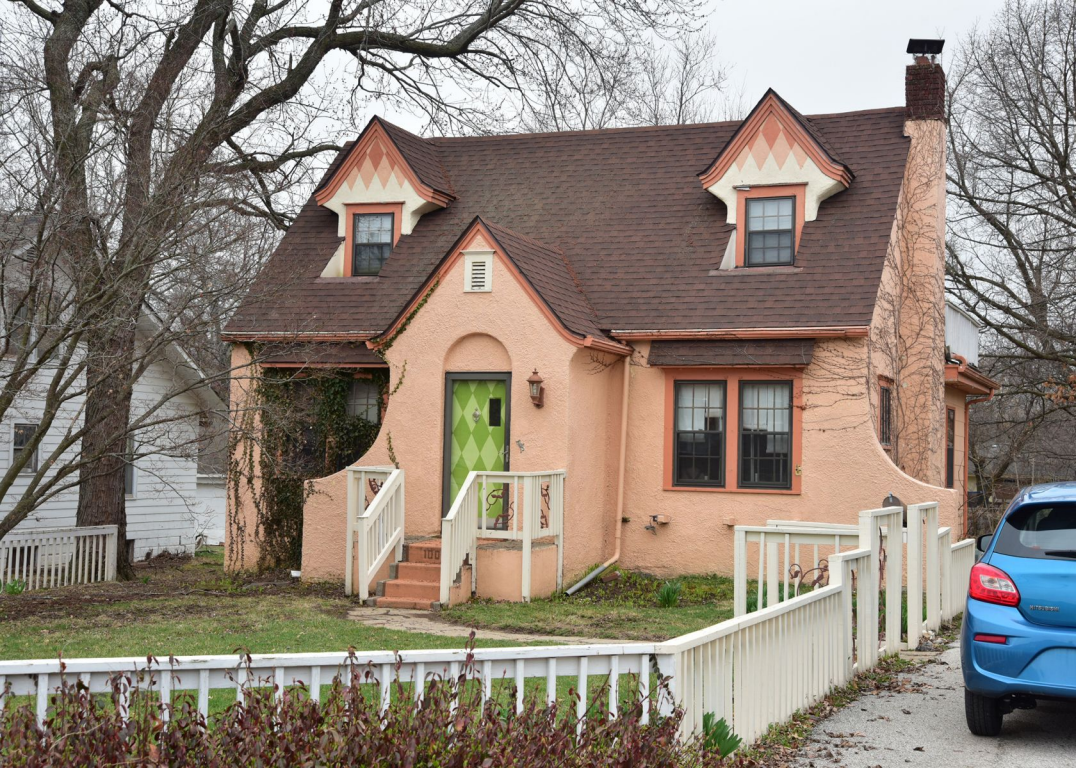
"This one-and-a-half-story, side-gabled Tudor Revival house has a T-shaped footprint that is three bays wide and two bays deep. A lower projecting gable forms the stoop entrance in the center bay. Paired six-over-six light, double-hung wood sash windows with flat board trim and pent roofs define the other two bays of the primary façade. Piercing the front roof slope are two recessed shed dormers, each containing a single sash window with six-over-six lights. Additional character-defining features include flared eaves, stucco cladding the exterior walls, sloped wing walls, a round-arched entrance, and the stucco-clad exterior chimney at the west elevation (Davis and Schwenk, 2003).

1003 Highgrove Road does not appear significantly altered from its 2003 appearance. An upper-story deck is present at the rear elevation, however it is not readily visible from the right-of-way. This date of alteration is unknown, however appears to pre-date the 2003 survey. The conversion of the shed dormers to gabled dormers post-dates the 2003 survey but pre-dates the 2005 nomination.

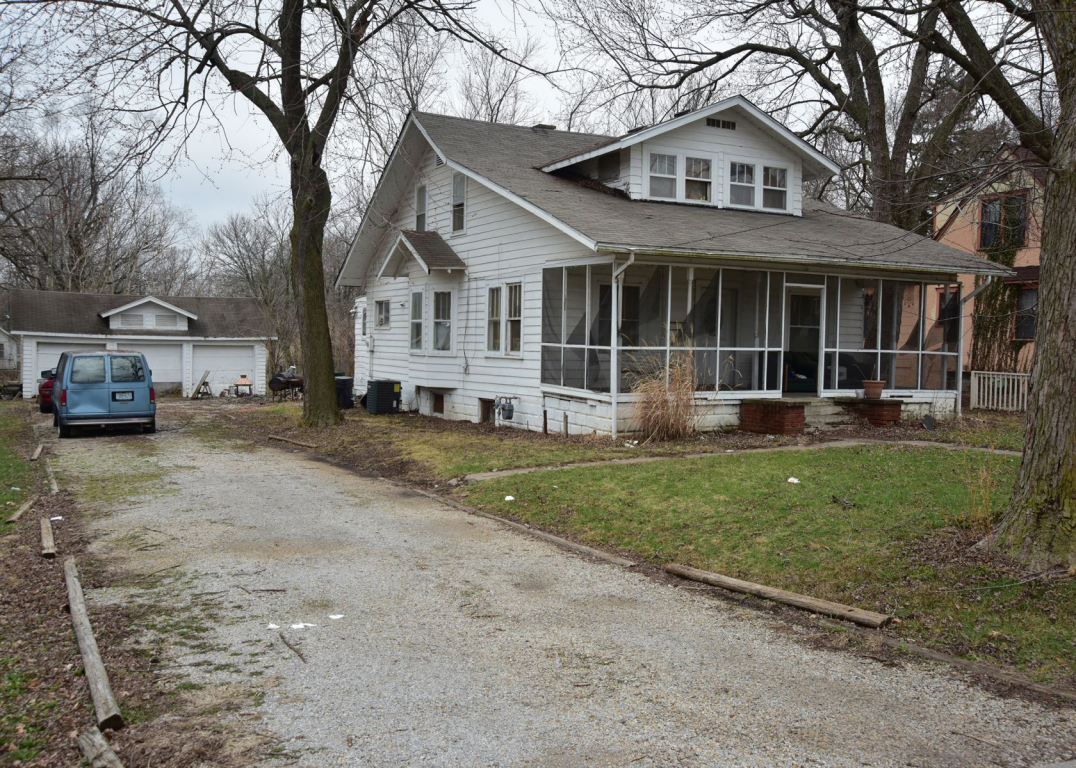
"This one-and-a-half-story, side-gabled bungalow has a rectangular footprint that is three symmetrical bays wide and three bays deep. The front roof slope extends to form the full-width porch's roof, which features non-original square wood posts and shelters the center bay entrance. Defining the other bays are original, paired three-over-one light, double-hung wood sash windows with flat board trim. A large gable-front dormer projects from the front roof slope and contains two pairs of small three-over-one light, double-hung wood sash windows. Additional character-defining features include wide eaves with exposed rafter tails, wide-profile wood clapboards, and a gabled, tripartite bay window on the east elevation (Davis and Schwenk, 2003)."

The porch is enclosed with screens. 1005 Highgrove Road does not appear significantly altered from its 2003 appearance. Dates of alteration are unknown, however pre-date the 2003 survey.

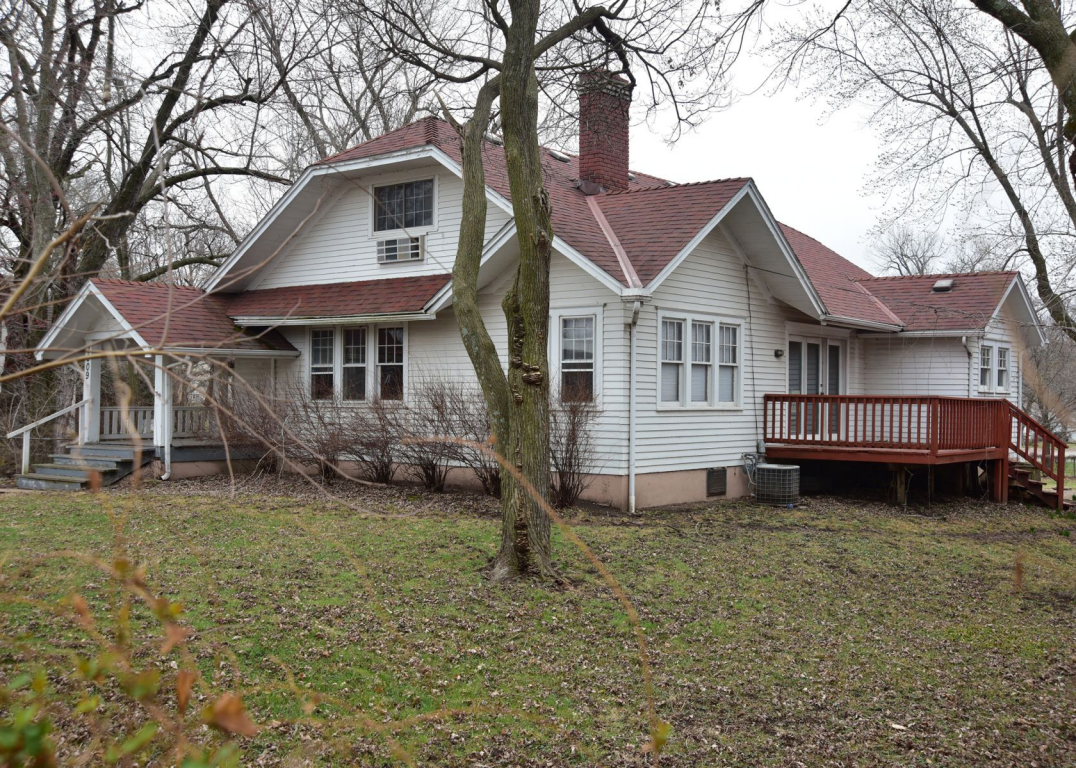
"This one-and-a-half-story, clipped gable-front bungalow has a rectangular footprint that is three bays wide and four bays deep. The primary façade features a pent roof effectively connecting two smaller front gables — one distinguishing the entrance porch at the east end bay and one over the west end bay. Defining the other bays are original, paired and triple six-over-one-light, double-hung wood sash windows with flat board trim. Additional character-defining features include wide eaves, wide profile wood clapboards, a lower cross gable at the west elevation, an interior brick chimney piercing the west roof slope, and the original square wood porch posts and matchstick balustrade (Davis and Schwenk, 2003)."

A modern deck projects from the west elevation. 1009 Highgrove Road does not appear significantly altered from its 2003 appearance.

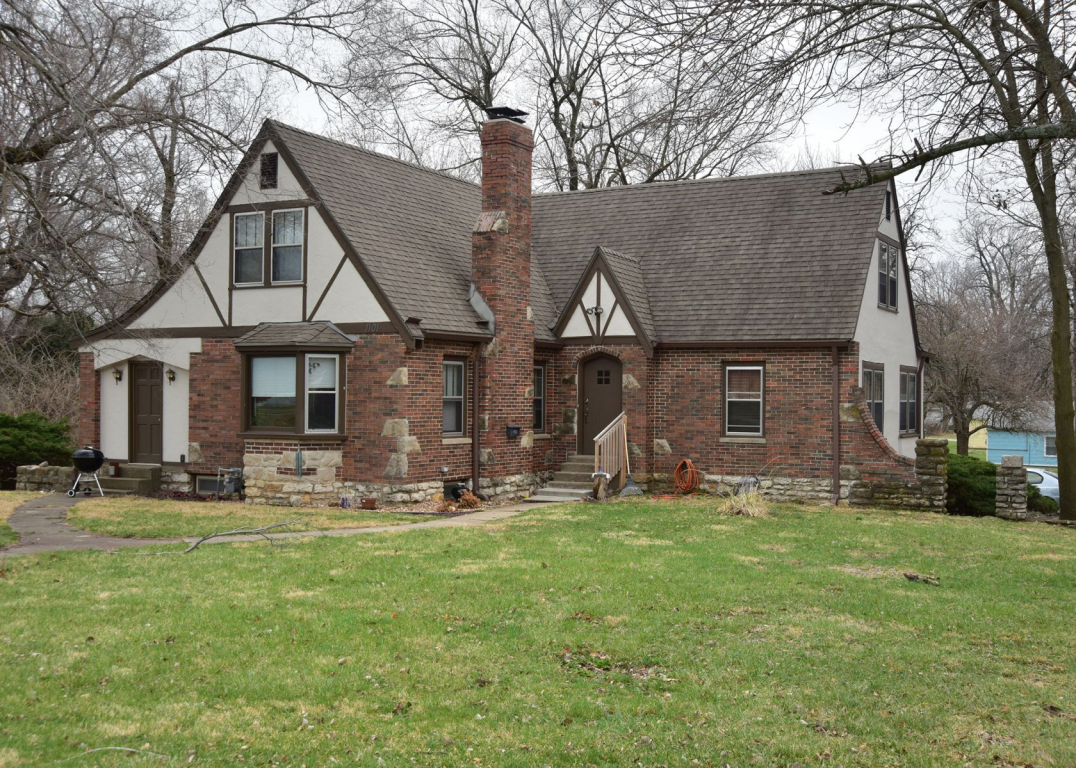
"This one-and-a-half-story Tudor Revival style house has a steeply pitched, intersecting gable roof. This dwelling has a front-facing L-shaped footprint that is four bays wide and three bays deep. Distinguishing the arched entrance at the second bay from the west end is a shorter steeply pitched cross gable. The original faux porte-cochere with peaked arch openings at the east end bay has been enclosed with stucco and contains a secondary entrance. Defining the remaining bays of the primary façade are single and paired three-over-one light, double-hung sash windows and a tripartite bay window. Additional character-defining features include false half-timbering in each gable peak; brick cladding with rough-cut stone accents; the exposed rough-cut stone foundation; an exterior brick chimney adjacent to the entrance with rough-cut stone accents; the original wood door at the primary entrance, which features a small four-light opening; flared eaves; and sloping wing walls (Davis and Schwenk, 2003)."

Aluminum storm windows are present at all elevations visible from the right-of-way. 1101 Highgrove Road does not appear significantly altered from its 2003 appearance.

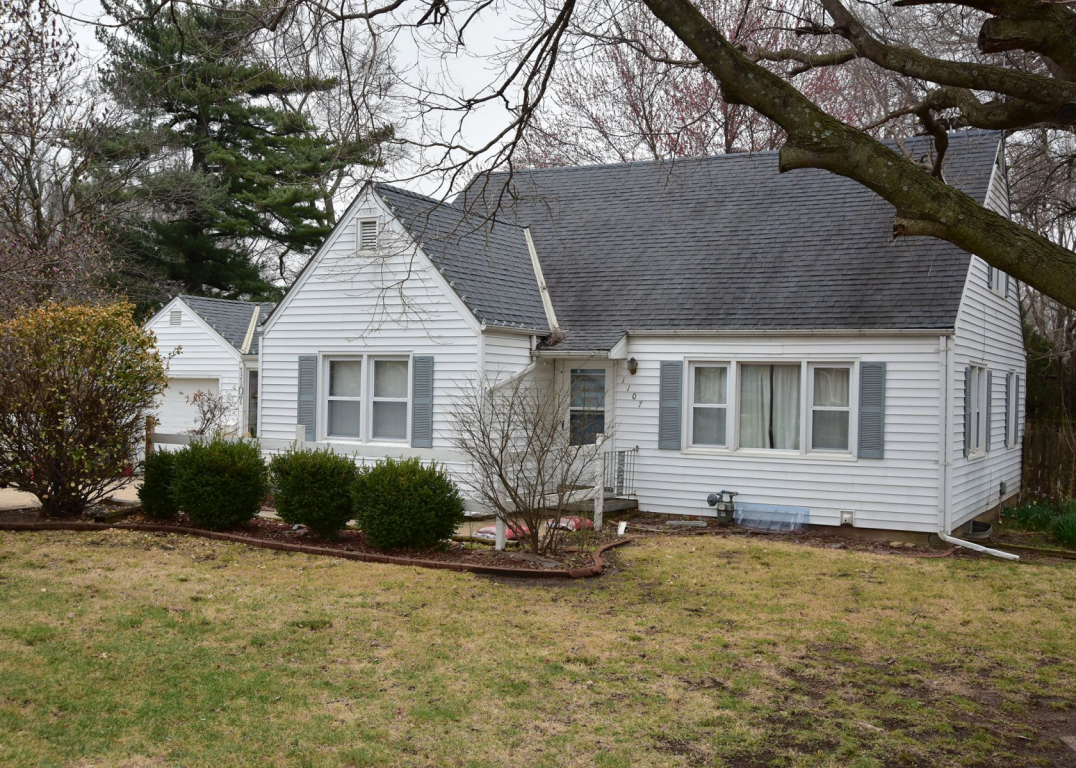
"This one-and-a-half-story, side-gabled Minimal Traditional style house has a lower cross gable, a single-car garage with a gable-front roof in the east end bay, and a three-bay connecting wing. This dwelling has an irregular footprint that is seven asymmetrical bays wide and two bays deep. A slight projection of the front eaves shelters the stoop entrance at the second bay from the west end. A secondary entrance is located in the connecting wing at the third bay from the east end. Defining the remaining bays are paired one-over-one light, double-hung sash windows and a tripartite picture window. Additional character-defining features include this dwelling's tight eaves. The application of vinyl siding compromises the integrity of this building (Davis and Schwenk, 2003)."

Windows are one-over-one vinyl sash. 1107 Highgrove Road does not appear significantly altered from its 2003 appearance. Dates of alteration are unknown, however pre-date the 2003 survey.

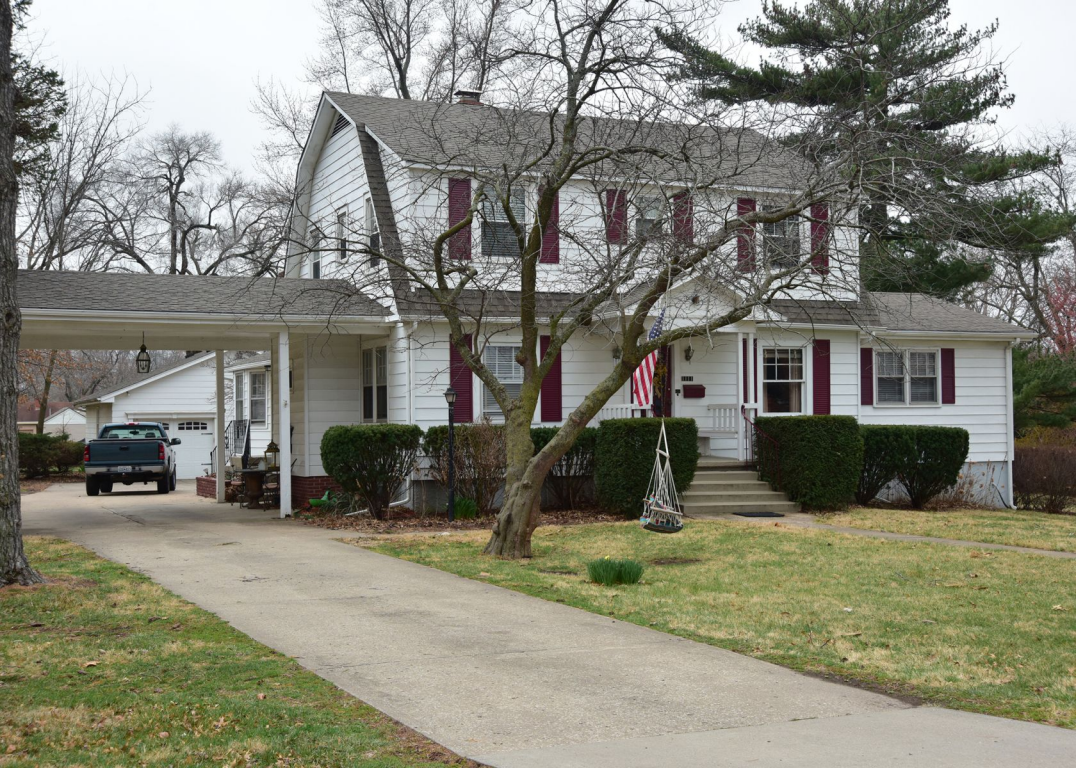
"This two-story Colonial Revival style house has a side-gambrel roof. This dwelling has two one-story projections with side gable roofs and a rear kitchen ell with a gable roof, resulting in a T-shaped footprint that is five bays wide and three bays deep. Sheltering the center bay entrance is a projecting gable-front porch roof supported by paired square wood posts and featuring boxed cornice returns. A side-gabled porte-cochere extends to define the east end bay. The original, single and paired six-over-one light, double-hung wood sash windows with shutters fill the remaining bays. Occupying the entire front roof slope, a full-width, three-bay shed dormer extends forward from the roof ridge. The application of vinyl siding compromises the integrity of this building (Davis and Schwenk, 2003)."

1111 Highgrove Road does not appear significantly altered from its 2003 appearance and 2005 nomination. Dates of alteration are unknown, however pre-date the 2003 survey.

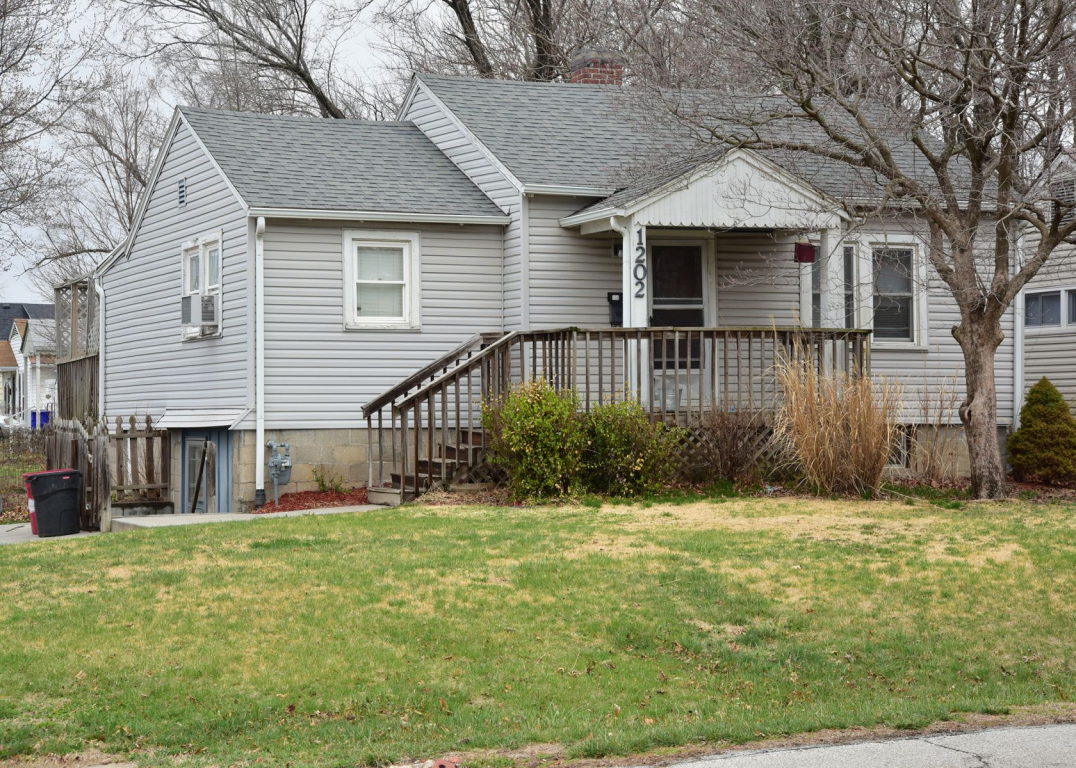
The wood shingle cladding has been replaced with vinyl siding.

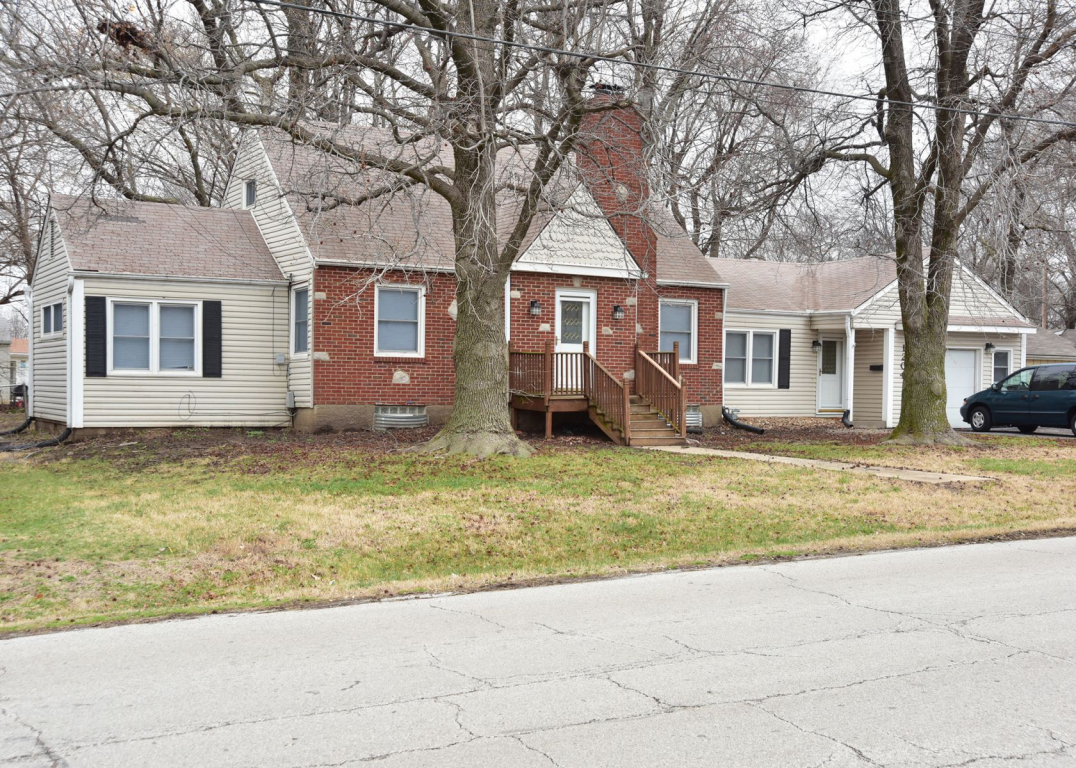
A wood porch with matchstick balustrade has replaced the concrete stoop. 1204 Highgrove Road does not otherwise appear significantly altered from its 2003 appearance. Dates of prior alteration are unknown, however pre-date the 2003 survey.

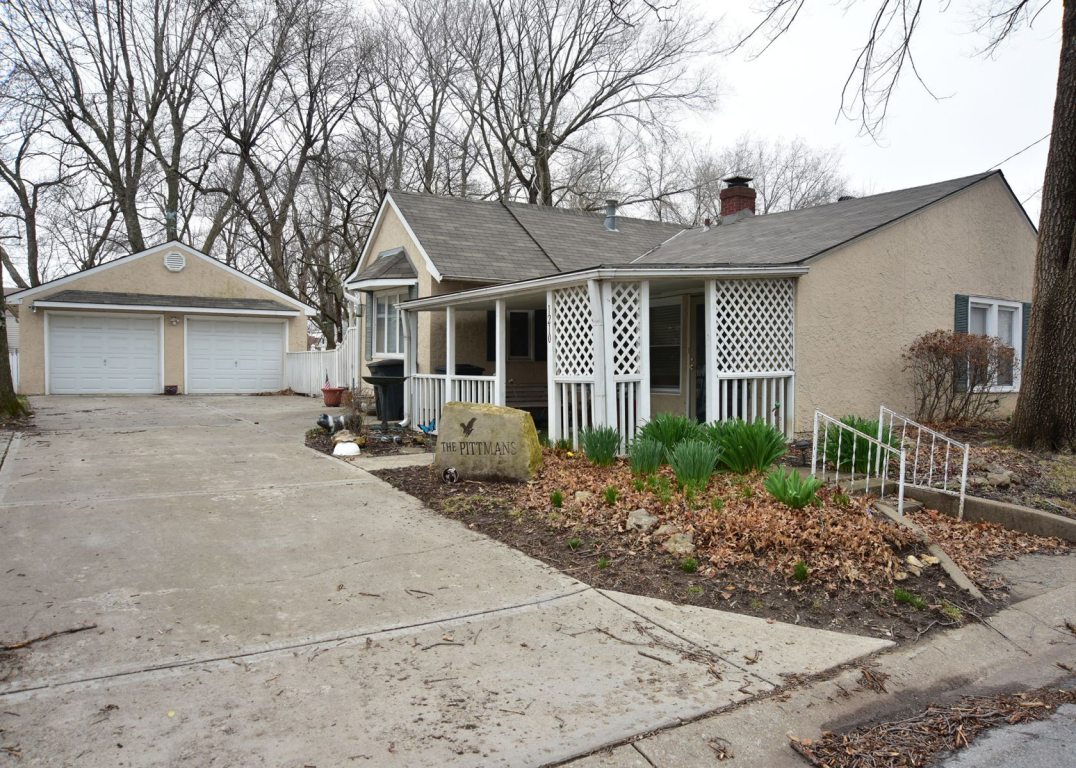
Windows are one-over-one vinyl replacement sash. 1210 Highgrove Road does not otherwise appear significantly altered from its 2003 appearance.
