MISSOURI DEPARTMENT OF NATURAL RESOURCES  
STATE HISTORIC PRESERVATION OFFICE, P.O. Box 176, Jefferson City, MO 65102  
**ARCHITECTURAL/HISTORIC INVENTORY FORM**

1. Survey number: JA-AS-088-153		2. Survey Name: Town of Grandview, Resurvey	
3. County: JACKSON		4. Address (Street No.): 304 Street (name): Dewey Avenue	
5. City: Grandview	Vicinity <input type="checkbox"/>	6. Lat / Long:	7. Township/Range/Section: T: R: S:
8. Historic name (if known):		9. Present/other name (if known):	
10. Ownership: <input checked="" type="checkbox"/> Private <input type="checkbox"/> Public		11a. Historic use (if known): Domestic-Single Dwelling	11b. Current use: Domestic-Single Dwelling

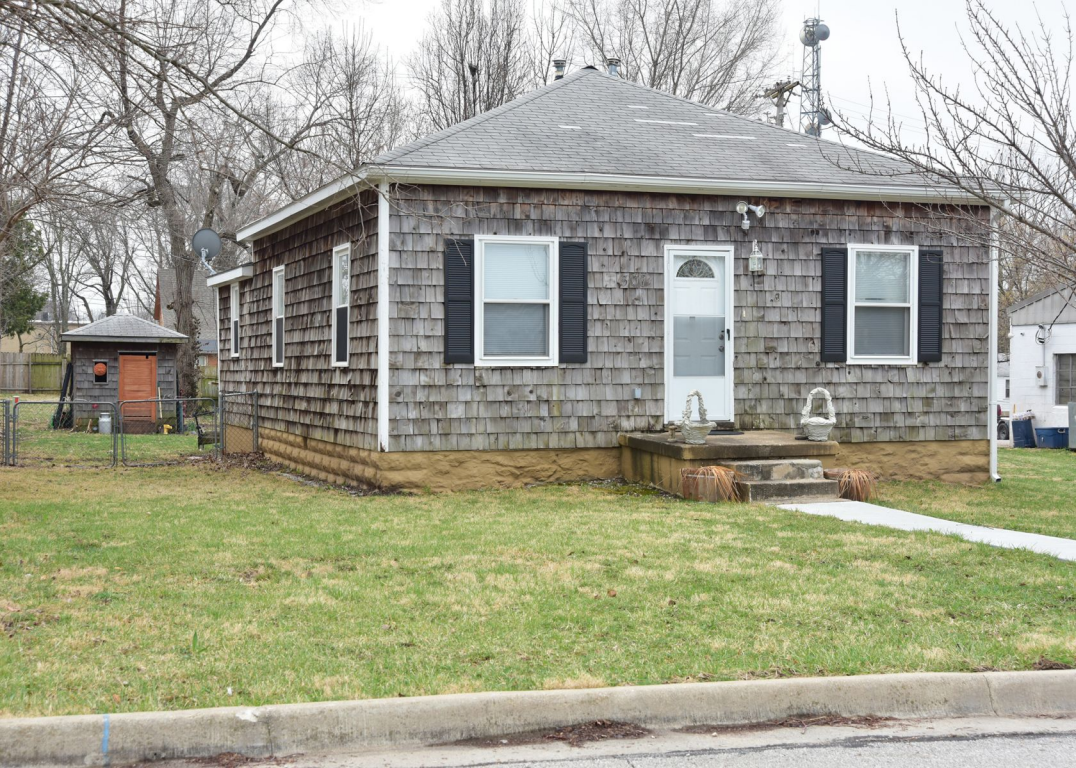
507 Jones Avenue does not appear significantly altered from its 2003 appearance. Dates of alteration are unknown, however they pre-date the 2003 survey.

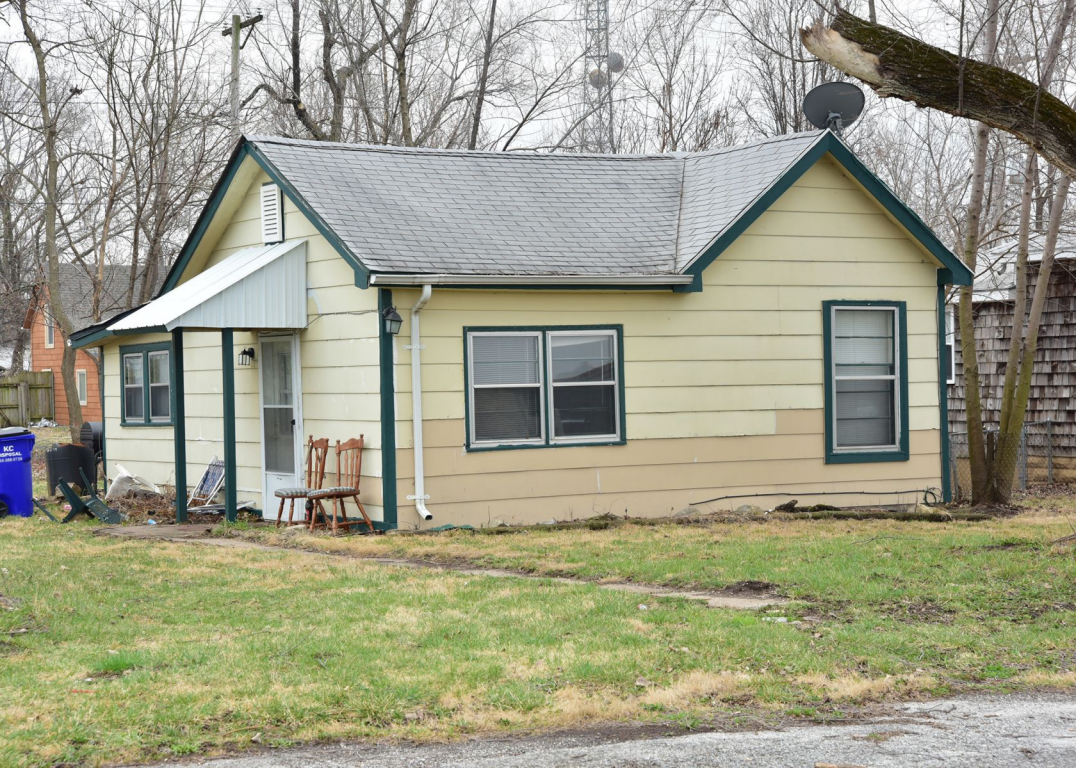
Windows are predominately two-over-two or two-over-three double hung with wood sash. A corrugated shed- roof porch shelters the entrance and replaces a non-historic pentagonal shingled porch. Aluminum storm windows are present at all elevations visible from the right-of-way. 509 Jones Avenue does not appear significantly altered from its 2003 appearance. Dates of prior alteration are unknown, however they pre-date the 2003 survey.

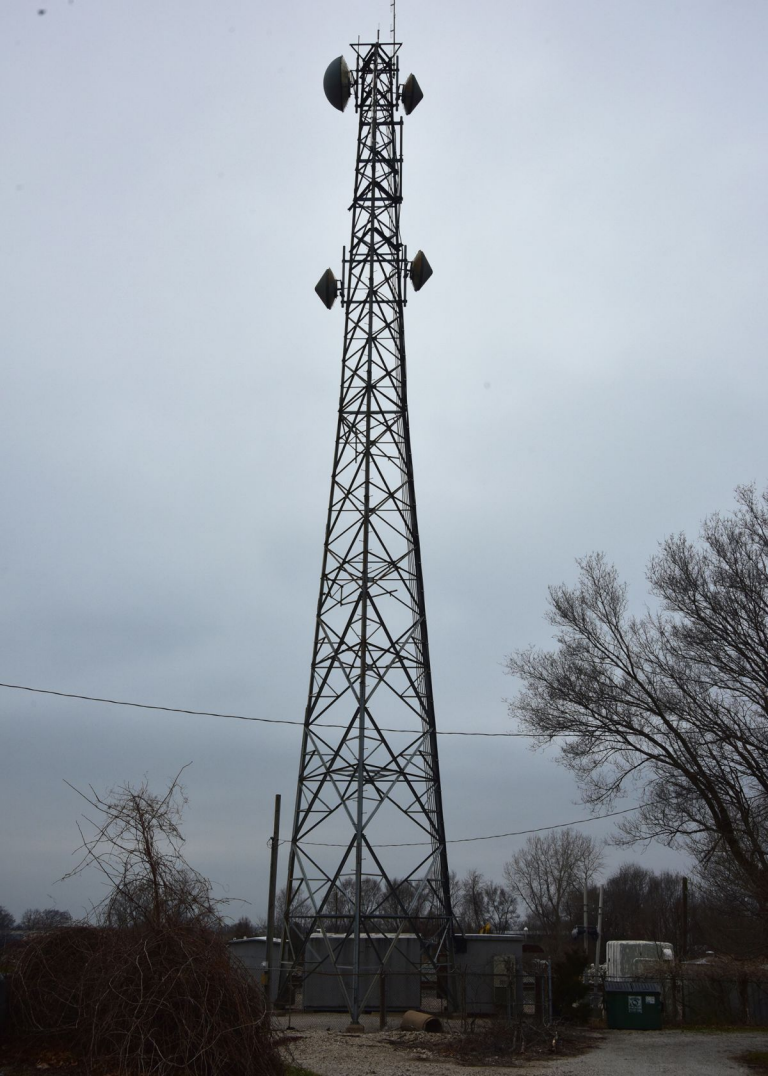
The steel antenna tower located at the northwest corner of 4th and Main Streets does not appear significantly altered from its 2003 appearance.

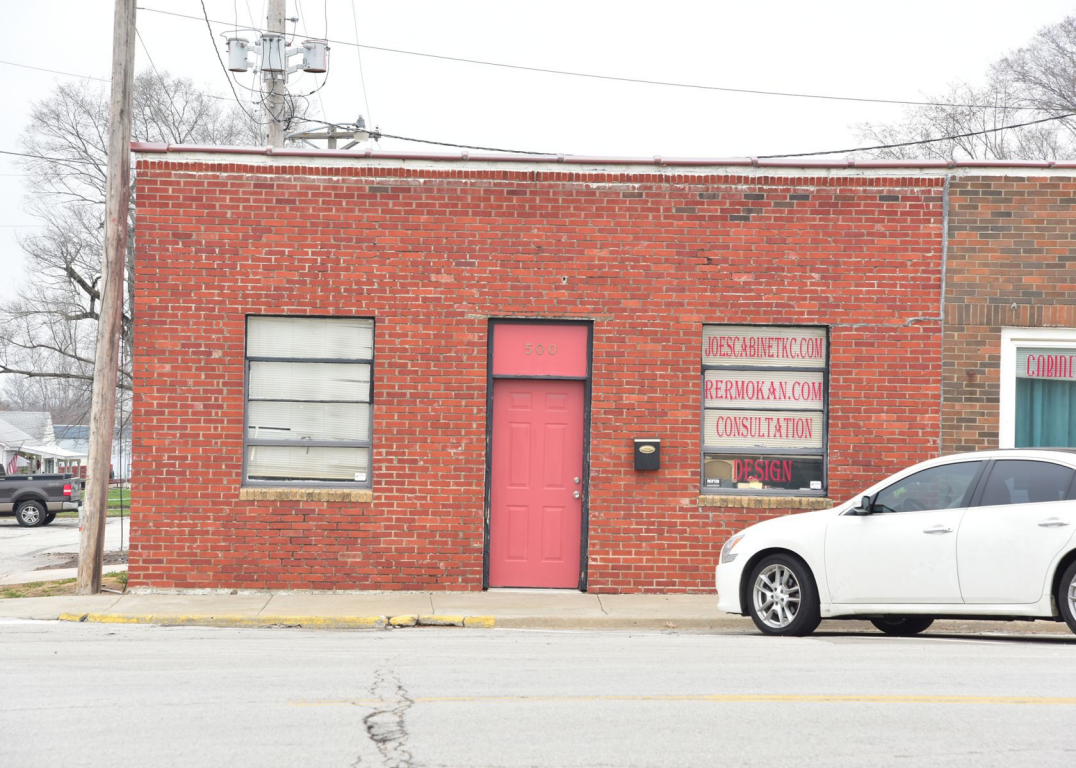
The one-part fixed sash display windows of the east storefront have been replaced with two-part vinyl display windows. 500-5002 Main Street does not otherwise appear significantly altered from its 2003 appearance.

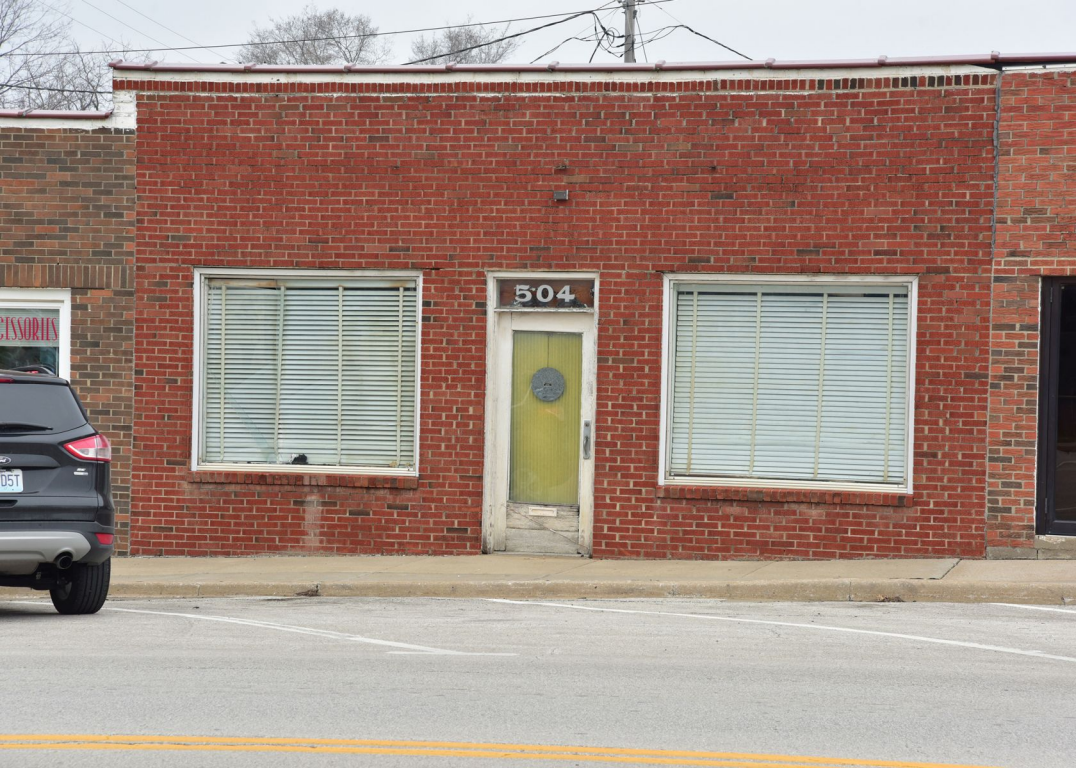
"This one-part commercial block is concrete block with brick facing and has a rectangular footprint that is three symmetrical bays wide. Flanking the center bay entrance and transom window are single fixed-sash display windows with header brick sills. Additional character-defining features include clay tile parapet coping (Davis and Schwenk, 2003)."

The fixed-sash display windows are aluminum sash. 504 Main Street does not appear significantly altered from its 2003 appearance.

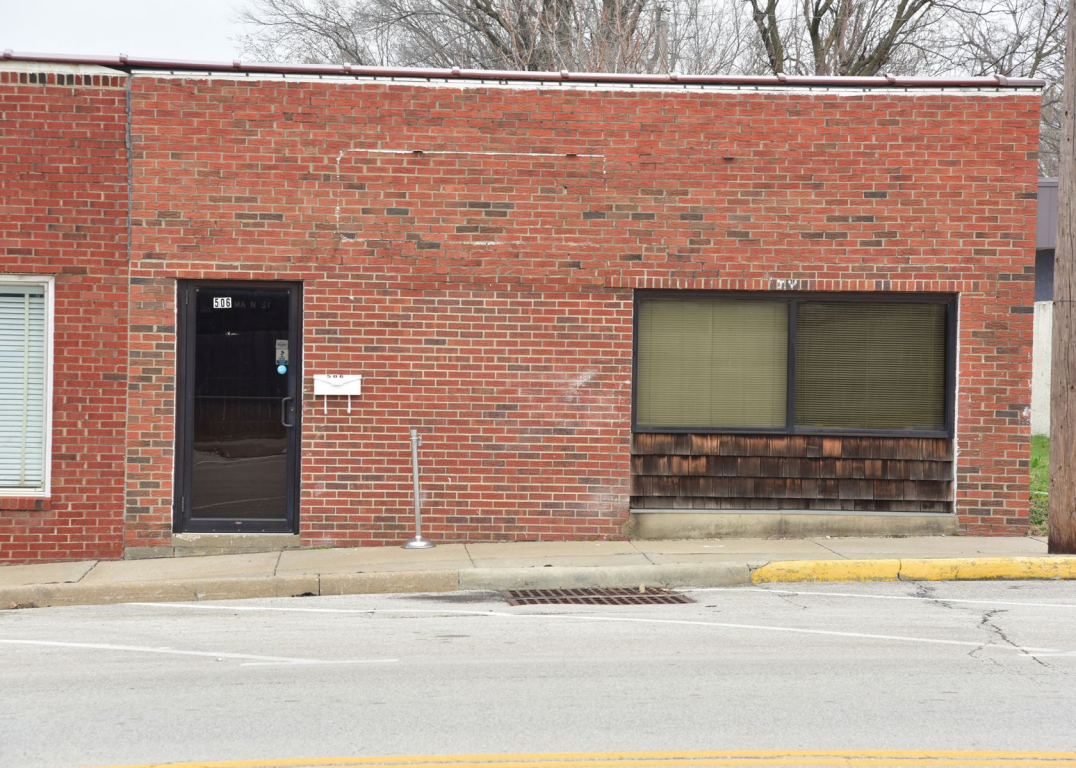
The single-car vehicular entry bay has been replaced by a two-part fixed sash display window which fills the top half of the opening. Wood shingle fills the remainder of the filled opening.

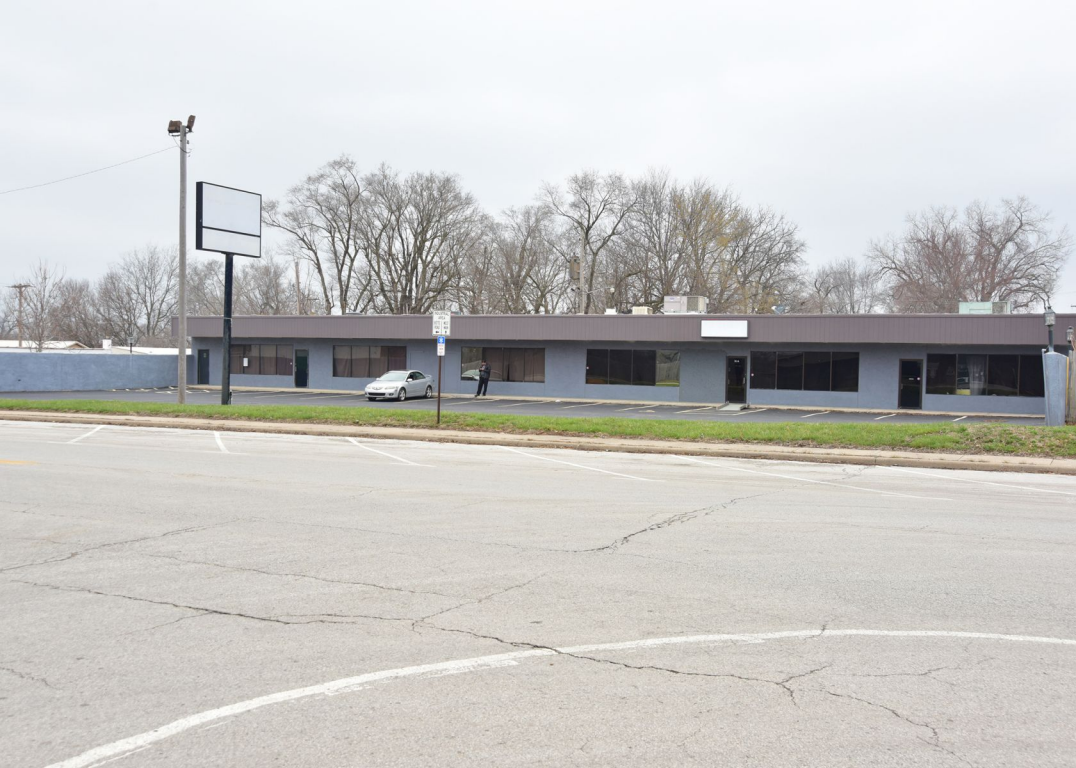
"This one-part commercial block has a rectangular footprint that is twelve asymmetrical bays wide and two bays deep. The façade features six pedestrian entrance doors alternating with four-part, fixed-sash display windows. Corrugated metal covers the projecting flat porch roof that spans the width of the primary façade (Davis and Schwenk, 2003)."

The third and fourth from west pedestrian entrances have been covered. However, it is unclear if this is a permanent alteration. 508 does not appear significantly altered from its 2003 appearance.

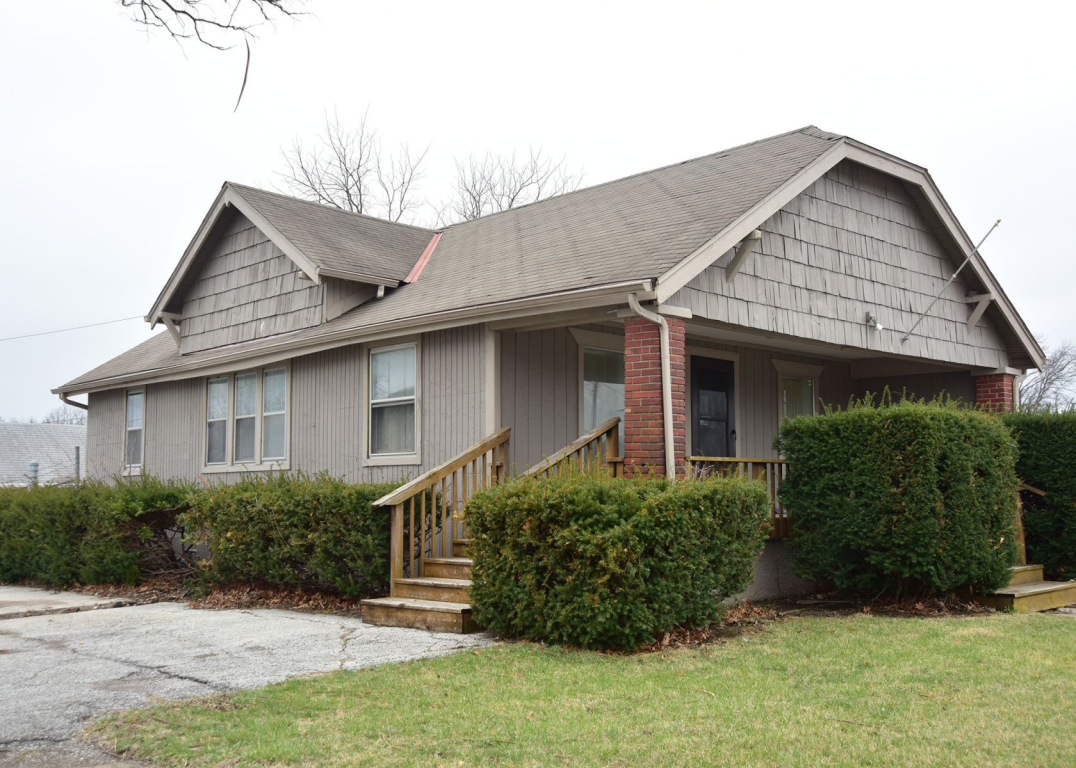
The windows of all other elevations are predominately historic three-over-one wood sash. aluminum storm windows are present at the east, south, and west elevations. Non-historic shed roof porches shelter secondary entrances at the south and west elevations. 509 Main Street does not appear significantly altered from its 2003 appearance. Dates of alteration are unknown, however pre-date the 2003 survey.

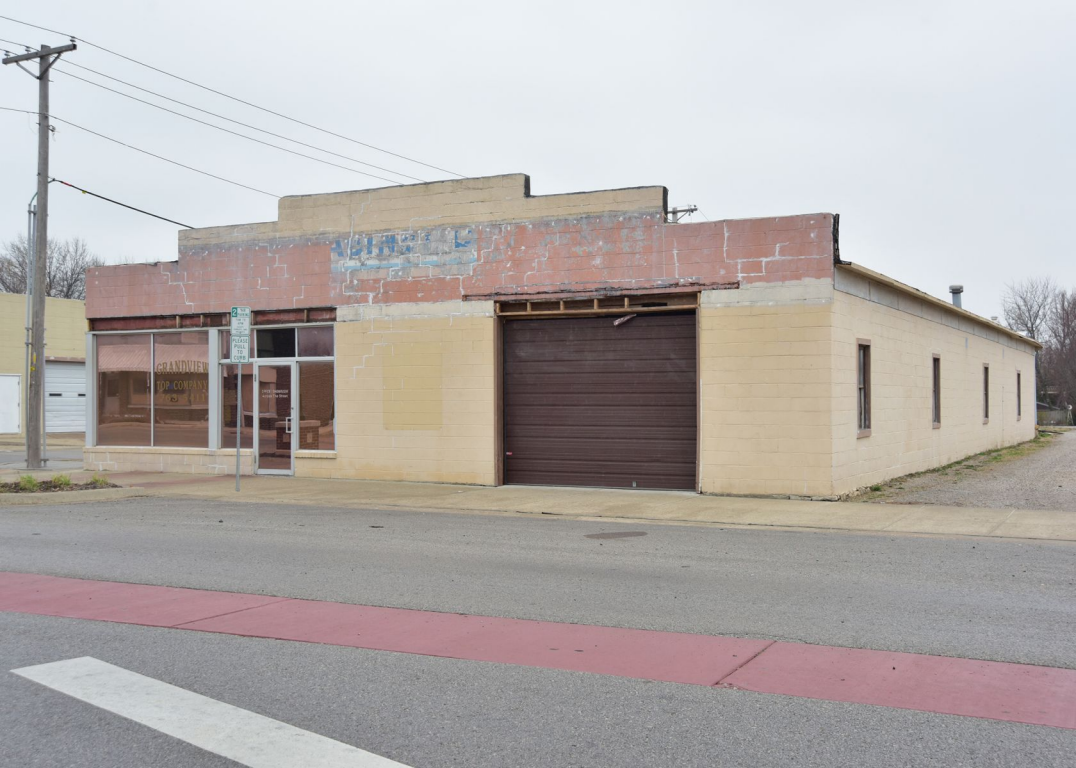
Windows located at the east and west elevations are one-over-one double-hung wood sash. The aluminum-framed display system appears to be replacement. A shingle-clad pent which wrapped around the north and south corners has been removed from the primary elevation. A gabled vent has been removed from the north slope of the roof. Dates of prior alteration are unknown, however pre-date the 2003 survey. After 2003, the non-historic asphalt shingle pent roof was removed from above the front façade, revealing the historic parapet.

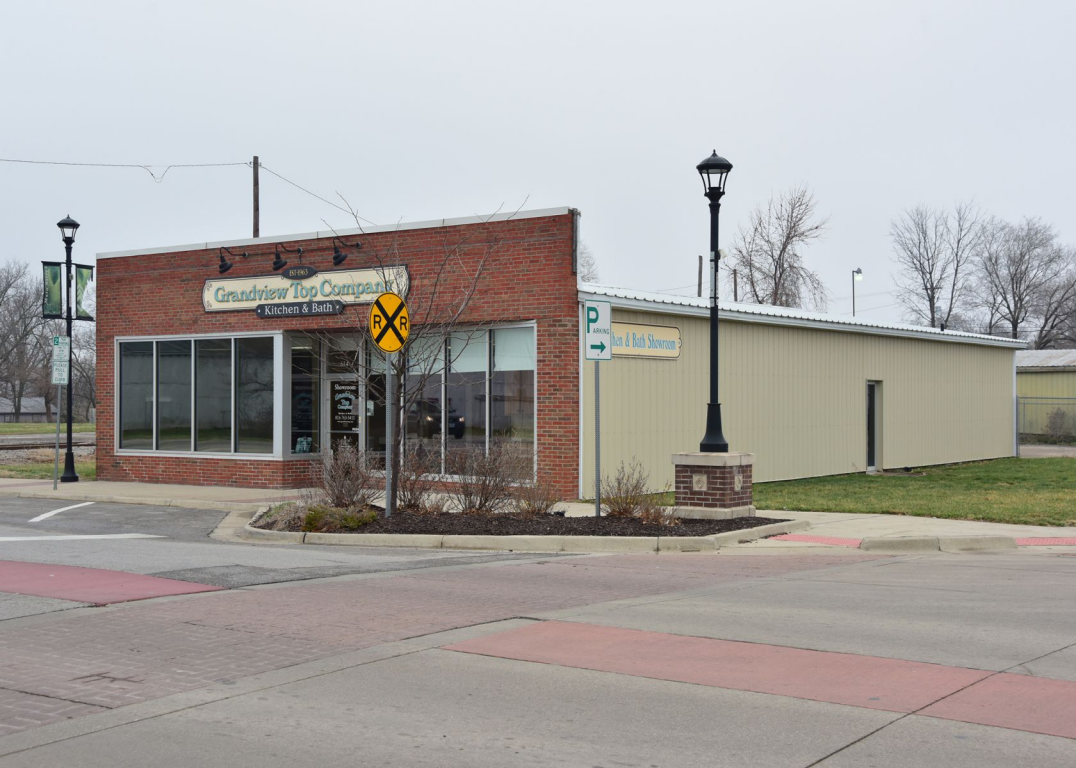
The display windows have been replaced and a metal awning frame has been removed since the 2003 survey.

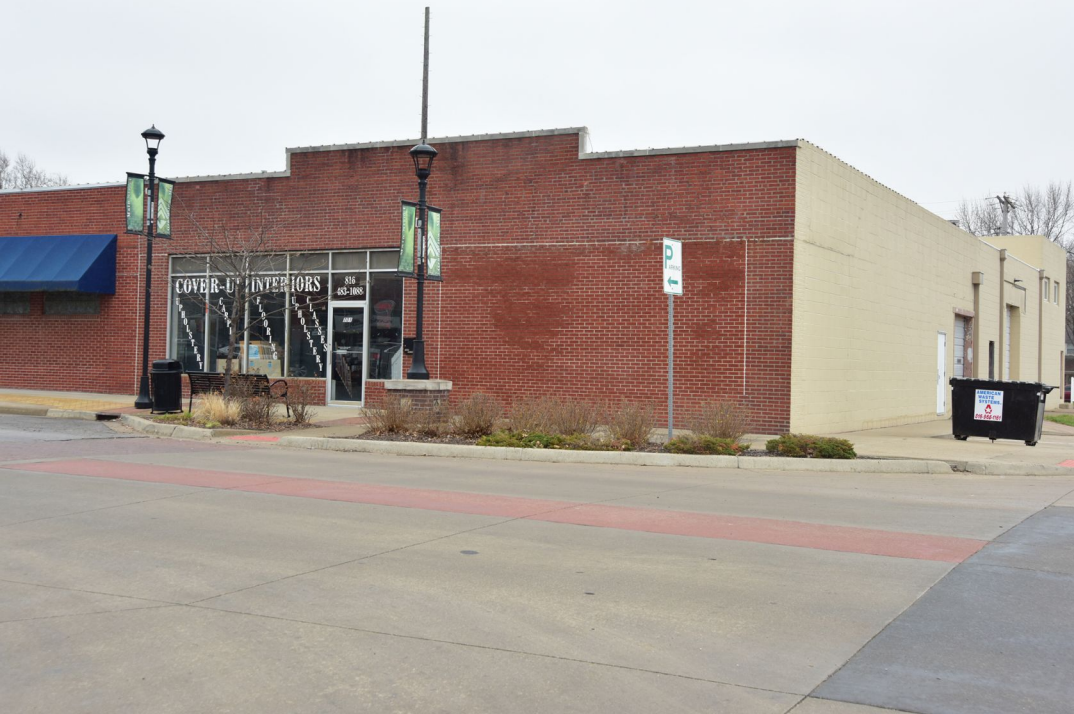
"This one-part commercial block is concrete block with brick facing and has a rectangular footprint that is two bays wide and four bays deep. The east end bay contains a glass entrance door with a transom that is part of an aluminum-framed six-part display window system. Brick fills the display window in the west bay. Additional character-defining features include the raised center section of the front parapet wall and stone coping (Davis and Schwenk, 2003)."

A fabric awning has been removed and the door opening has been enlarged to reach ground level. Dates of prior alteration are unknown, however pre-date the 2003 survey.

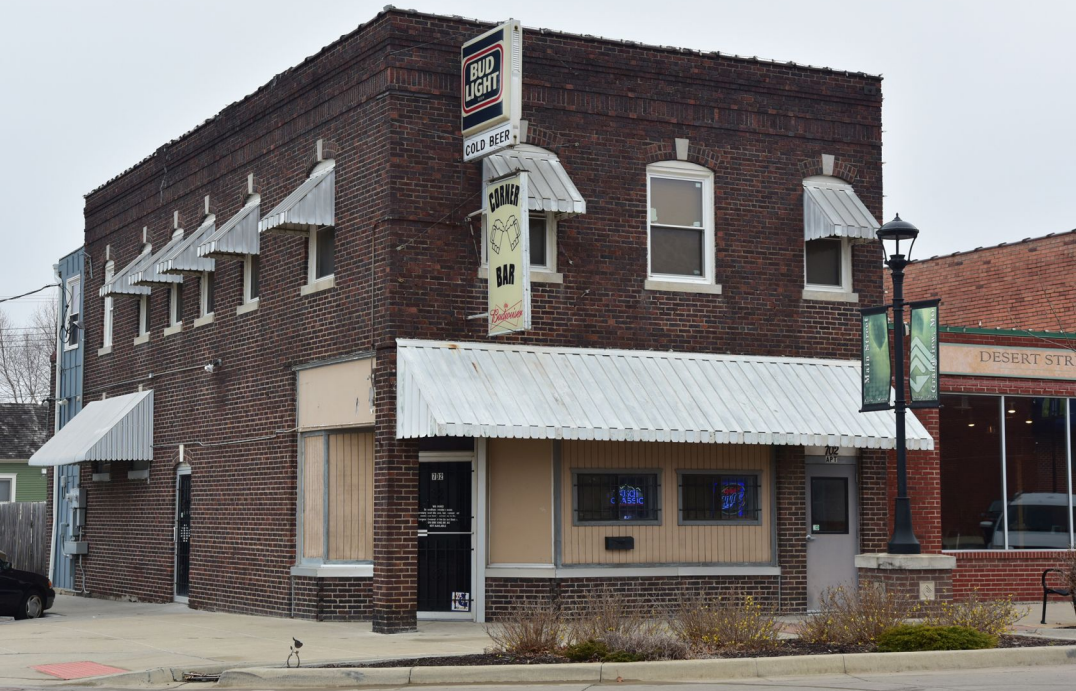
"This brick two-part commercial block has a rectangular footprint that is three bays wide and six bays deep. The storefront features a recessed corner entrance, plywood-covered display and transom windows, a brick bulkhead capped with a stone sill, and an entrance to the second story in the east end bay. Fenestration includes segmental arch windows with keystones and stone sills arranged singly. A soldier brick frieze and modest corbel courses embellish the cornice of the primary (south and west) façades. Additional character-defining features include clay tile coping and a segmental arch pedestrian entrance with a keystone at the center of the west (7th Street) façade. Metal awnings shelter the storefront transom and each of the sash windows (Davis and Schwenk, 2003)."

Windows are predominantly one-over-one vinyl sash replacements. The fixed-sash display windows are filled with vertical wood. A set of two rectangular fixed-sash windows are set within the vertical wood in the eastern most portion of the display window. 702 Main Street does not otherwise appear significantly altered from its 2003 appearance. The upper story is residential while the lower story is commercial.

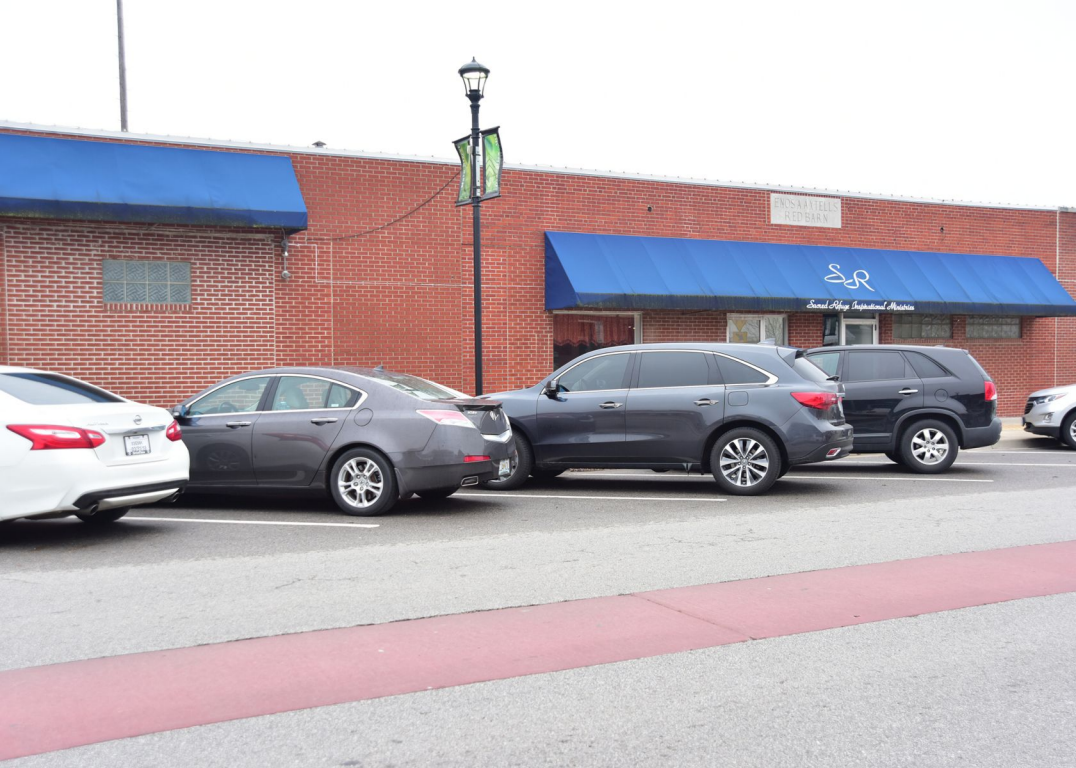
"This one-part commercial block is concrete block with brick facing and has a rectangular footprint that is six asymmetrical bays wide. Occupying the third and fourth bays from the west end are aluminum-framed glass entrance doors with sidelights and a fixed transom sash. Filling the remaining bays are single fixed-sash windows and glass block. Additional character-defining features include a rectangular stone sign panel in the parapet wall with letters in relief that read, "ENOS AXTELL'S / RED BARN" and stone coping on the parapet wall (Davis and Schwenk, 2003)."

The east bay includes brick infill and a four-by-two glass block window. 707 Main Street does not appear significantly altered from its 2003 appearance. Dates of alteration are unknown, however pre-date the 2003 survey.

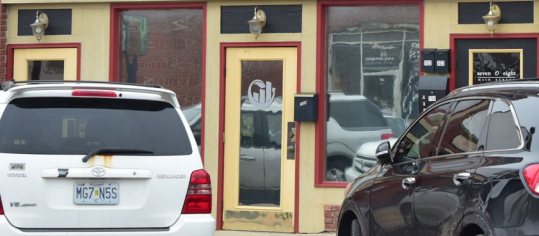
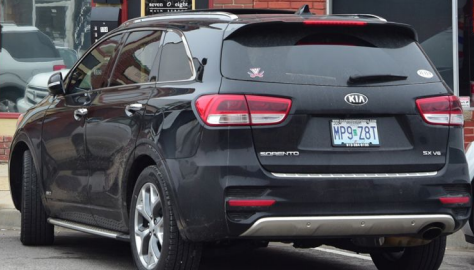
The aluminum-framed storefront window system has been replaced with wood framing since the 2003 survey. This new system dominates the primary elevation. The first floor bays are formed by three pedestrian entrances separated by one-light fixed sash display windows. A band of four two-part casement windows defines the second floor. The first floor is commercial in use while the upper floor is residential.

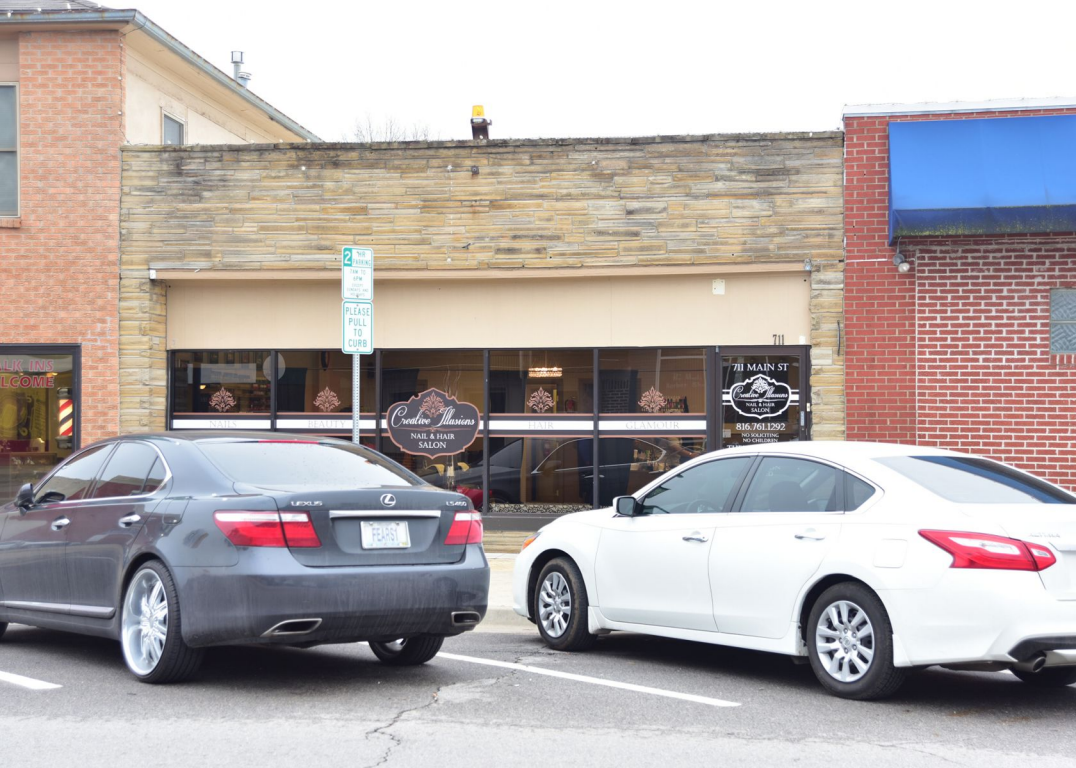
"This one-part commercial block has a rectangular footprint that is one bay wide and features thinly cut stone (Permastone) facing. The single bay contains a modern, six-part, aluminum-framed storefront display system with a glass entrance door and a fixed transom sash. The Permastone cladding and modern storefront system compromise the historic integrity of this building (Davis and Schwenk, 2003)."

711 Main Street does not appear significantly altered from its 2003 appearance, although the cladding material appears to be stone veneer rather than Permastone. Stone veneer cladding would be in keeping with its estimated 1960 construction date, although the contemporary aluminum storefront system would not.

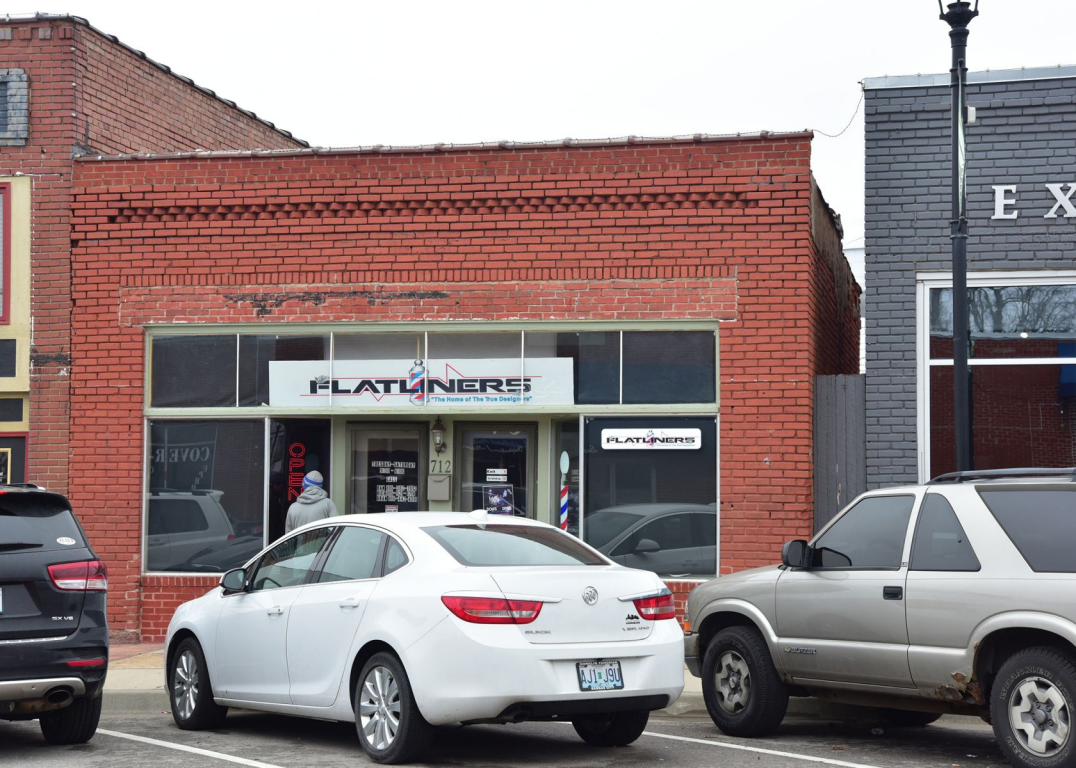
"This brick one-part commercial block has a rectangular footprint that is four symmetrical bays wide. Occupying the two center bays, two-part display windows resting on brick bulkheads flank the recessed paired entrance doors. Two courses of recessed patterned brick form a modest decorative frieze band at cornice level. Clay tile coping caps the parapet wall. Alterations include a wood-shingled pent roof that covers the historic transom window opening (Davis and Schwenk, 2003)."

The pent roof is no longer extant. 712 Main Street otherwise does not appear significantly altered from its 2003 appearance.

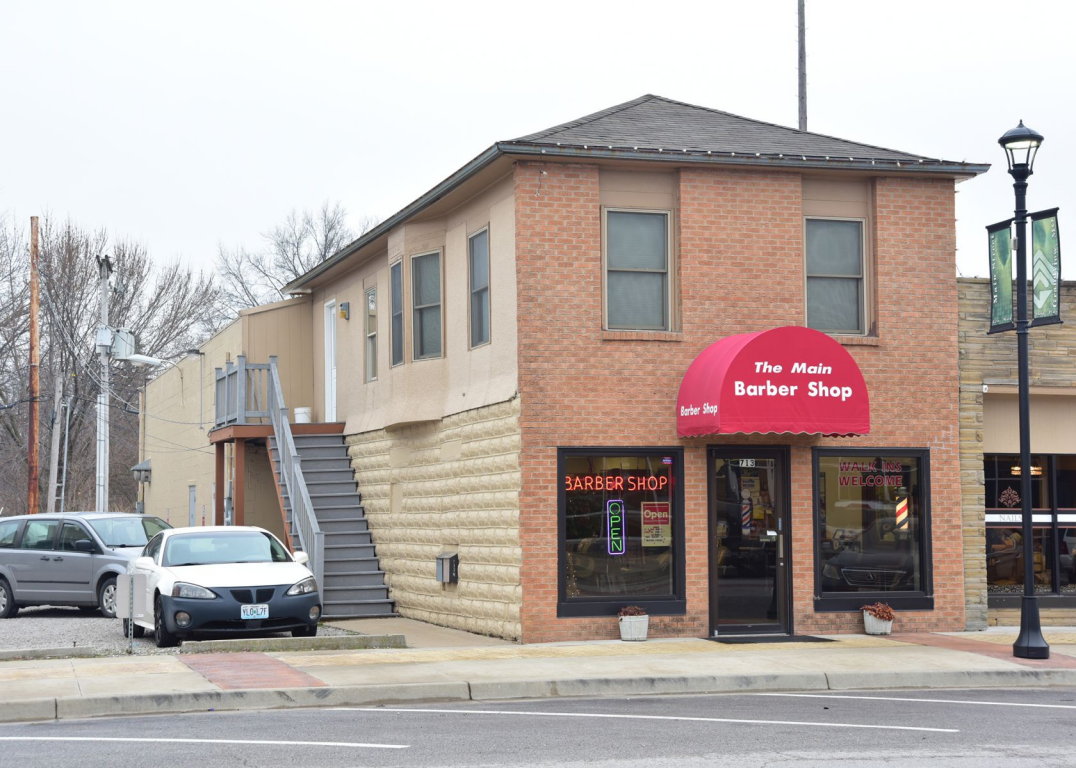
"This two-story commercial building is concrete block with brick facing and has a hipped-roof. This building has a rectangular footprint that is three bays wide and four bays deep. Flanking the center bay entrance are glass block windows with brick headers and sills. Defining the remaining bays on each second-story elevation are modern one-over-one light, double-hung sash windows. Although the modern brick facing and alteration of the storefront fenestration hinders the building's integrity, it continues to convey its historic associations (Davis and Schwenk, 2003)."

Non-historic aluminum storefront display windows fill the masonry openings on the first story, replacing the glass block. Non-historic stucco clads the second story of the east elevation. A modern staircase provides access to a pedestrian entrance at rear of the east elevation. The second floor is residential in use and the first floor is commercial. 713 Main Street does not appear significantly altered from its 2003 appearance, except for the storefront display windows and entrance. Dates of alteration are unknown, however some alterations pre-date the 2003 survey while others post-date the 2003 survey.

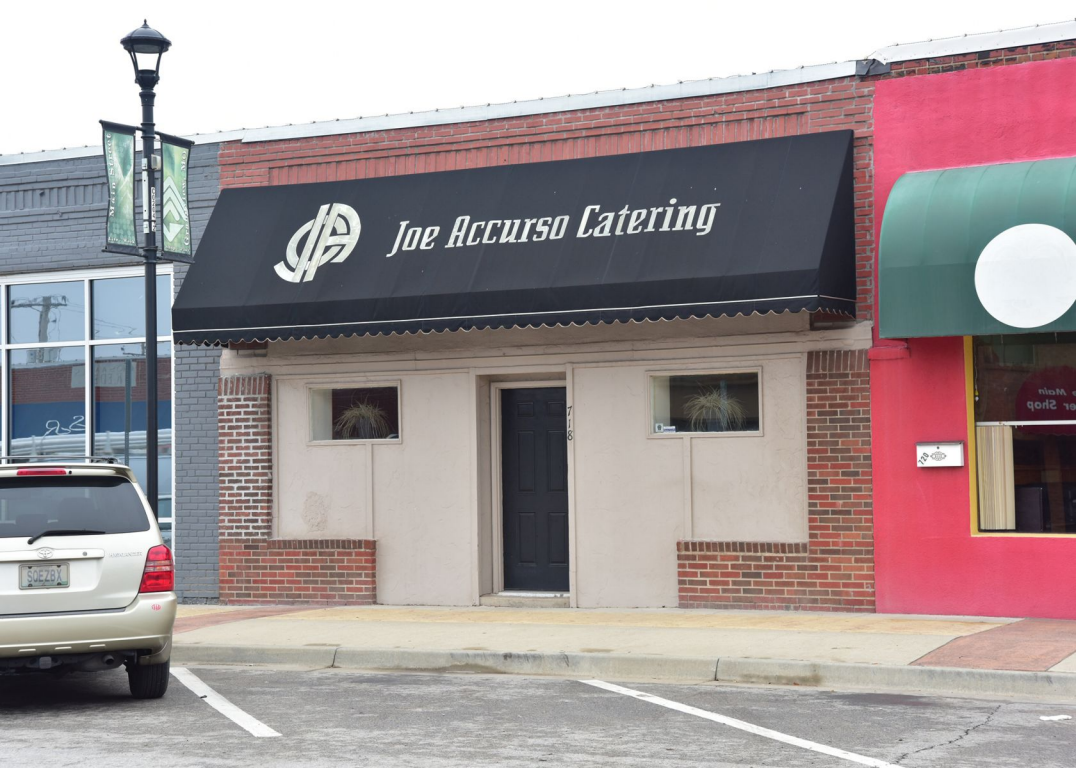
The plywood area noted by the 2003 survey now features stucco. A fabric awning with a metal frame has been installed and the former door with three-light glazing has been replaced by a paneled wood door. Dates of prior alteration are unknown, however pre-date the 2003 survey

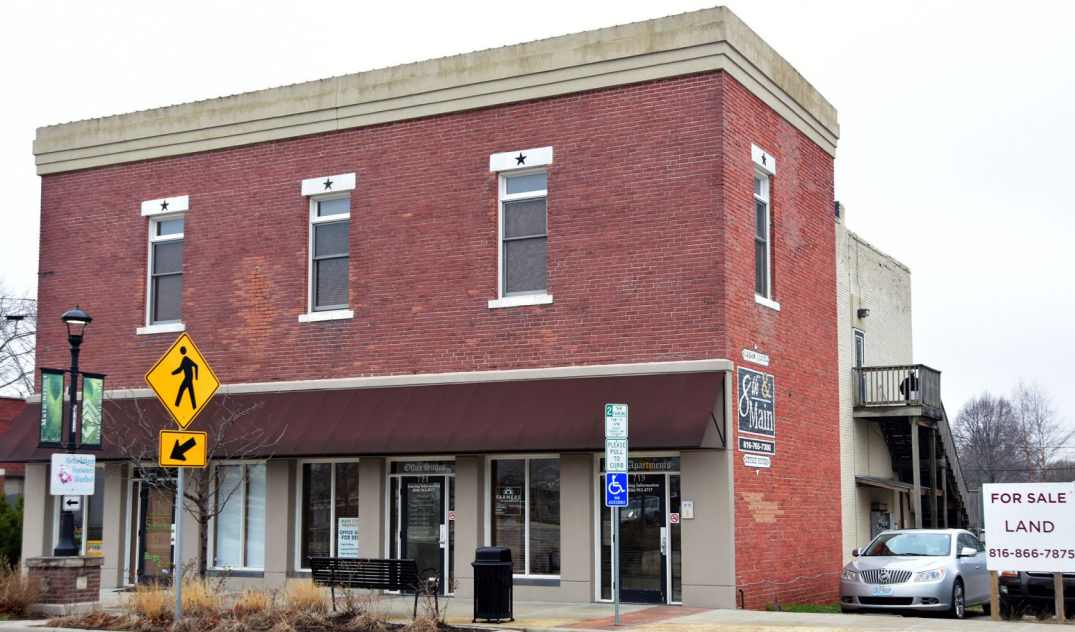
"This brick two-part commercial block has a rectangular footprint that is seven asymmetrical bays wide and four bays deep. Stucco clads the modern storefront system containing entrance doors in the first, third, and sixth bays from the west end. Defining the remaining storefront bays are paired fixed-sash windows. Filling the second-story bays are modern one-over-one light, double-hung window sashes with fixed transoms. The window openings retain their original stone sills and lintels. A modern stucco cornice treatment covers the modest original corbeled courses. The modern storefront treatment compromises the building's integrity. However, it still minimally conveys its historic associations (Davis and Schwenk, 2003)."

719-723 Main Street does not appear significantly altered from its 2003 appearance. Dates of alteration are unknown, however pre-date the 2003 survey.

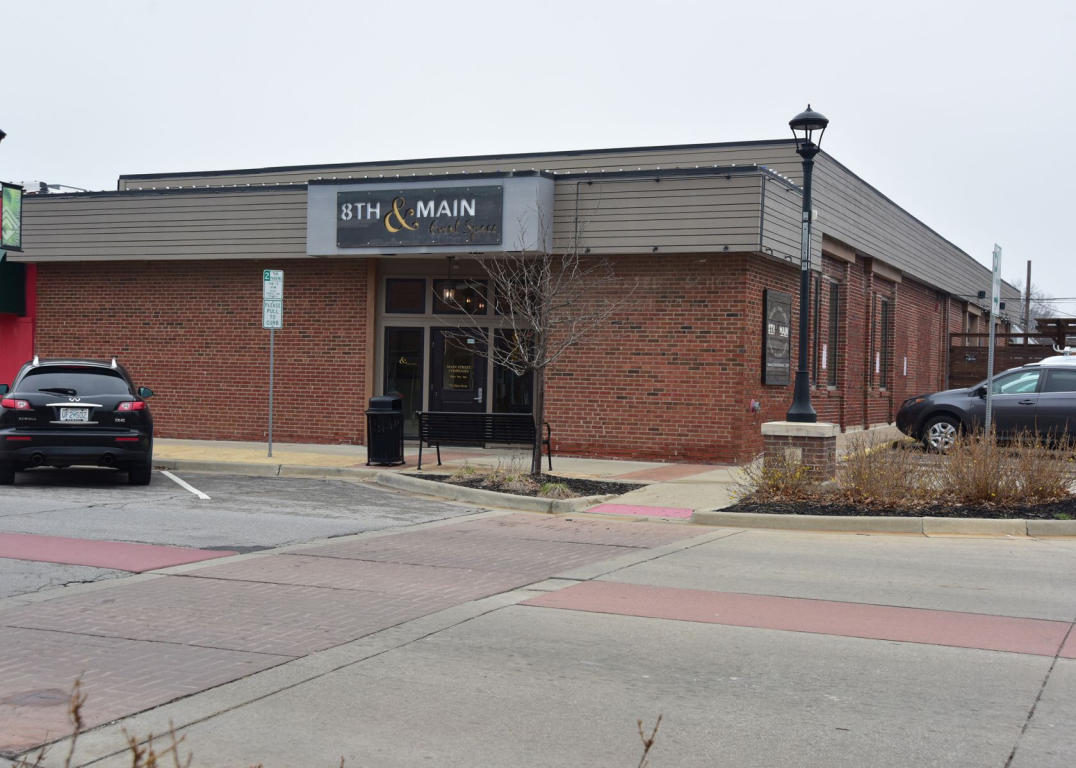
Horizontal wood planks have replaced the white grooved parapet treatment. The entrance now features a three-part aluminum frame system with transoms. The system a central door flanked by inwardly angled windows. A modern fence with pergola projects from the rear of the east elevation.

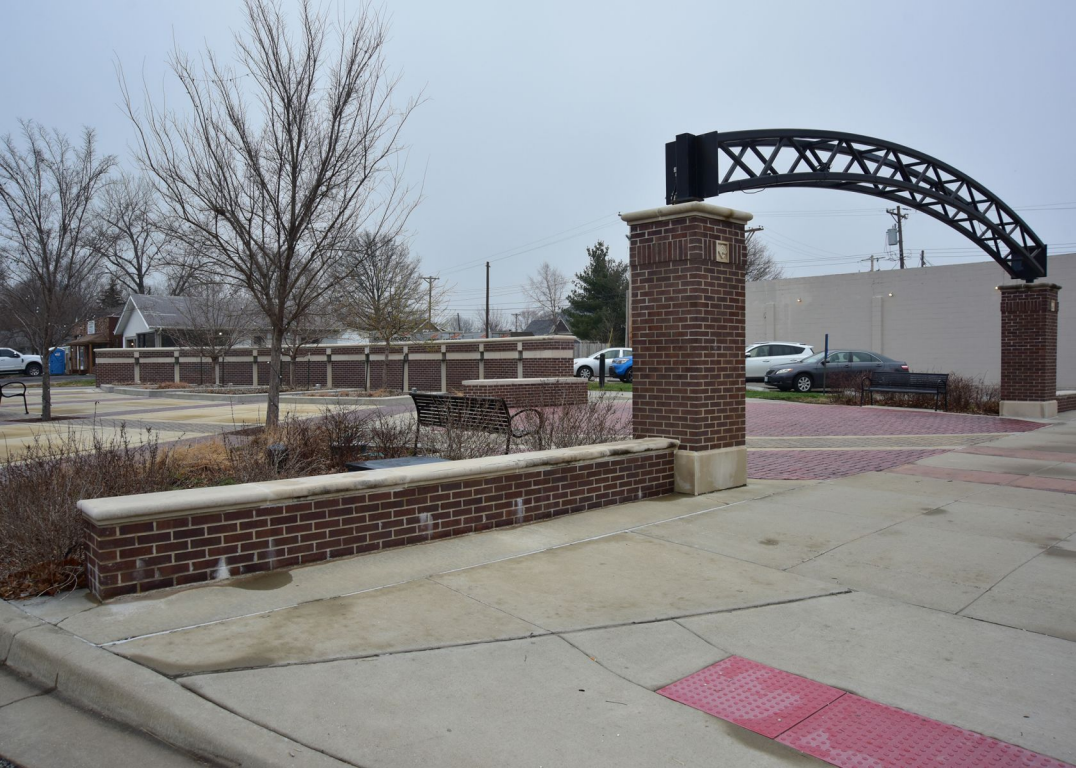
This roughly ovoid concrete plaza with pathways is bordered to the east by a narrow grassy area. A metal gateway with square brick piers and low brick wingwalls straddles the plaza entrance at Main Street. The piers have limestone caps and bases. Limestone inlays of the city logo are located in bands of decorative brick near the top of the piers. Planting beds with shrubbery abut the wingwalls. A large circle composed of red pavers emphasizes the entrance. Five pathways composed of dark red pavers radiate west from a curved wall located at the center of the plaza. The curved brick wall features limestone inlays in a grid pattern at its east and west elevations. It faces west and contains a water feature along its length. A low brick wall with limestone cap is located at the south end and is perpendicular to the wall. Small concrete curbed planting beds are located between the pathways at the curved wall's edge. A curved buff paver pathway mirrors the wall and intersects all five red paver pathways near the west edge of the lot. Metal benches are located throughout the plaza.

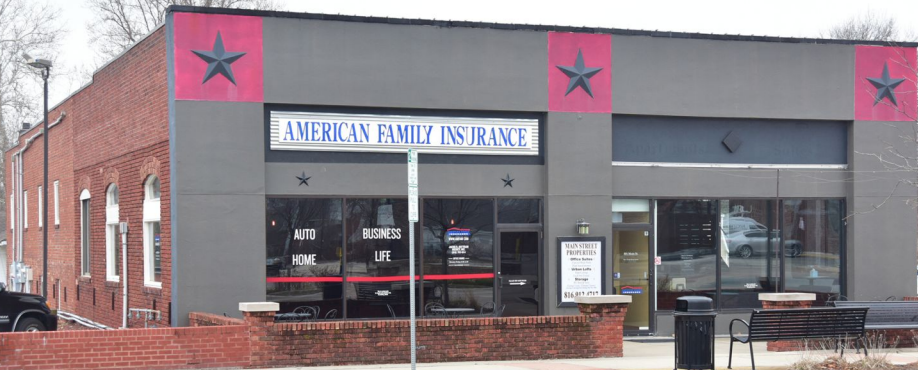
"This brick one-part commercial block has a rectangular footprint that is two symmetrical bays wide and six bays deep. Each bay contains an aluminum-frame, four-part storefront display window system including a glass entrance door with a fixed transom. Stucco panels cover the remainder of the primary façade. The original segmental arch window openings are intact on the secondary elevation. The stucco façade treatment and modern storefront systems compromise the integrity of the building (Davis and Schwenk, 2003)."

801 Main Street does not appear significantly altered from its 2003 appearance. Dates of alteration are unknown, however pre-date the 2003 survey.

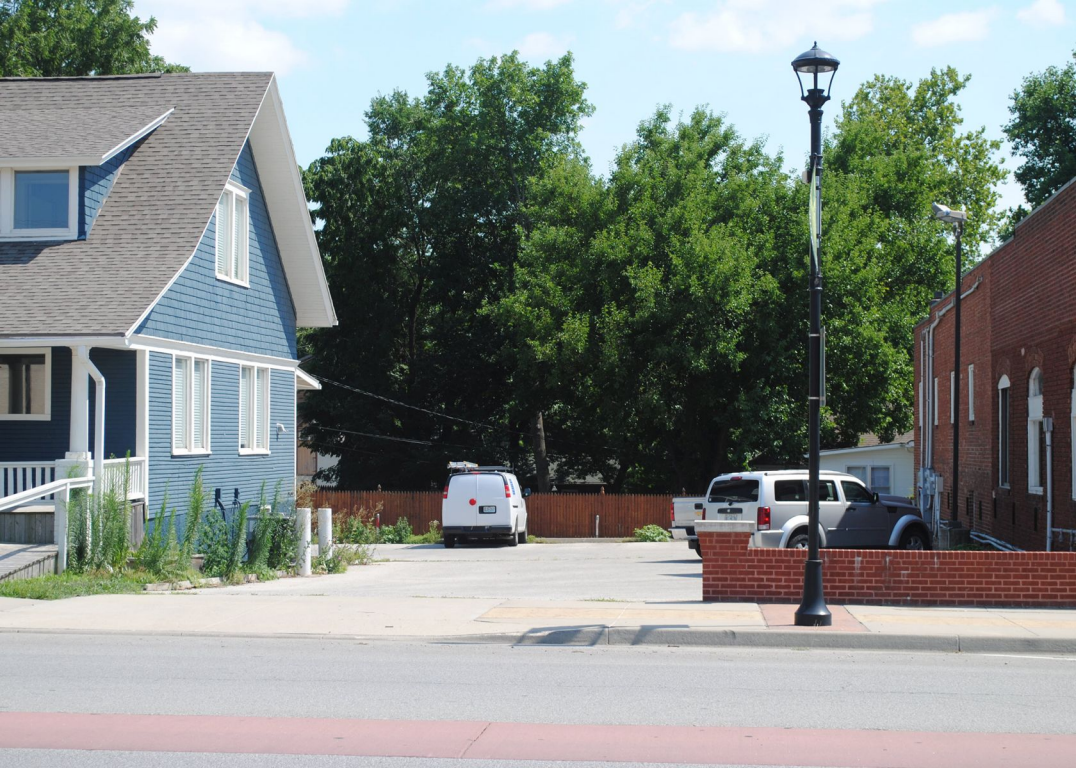
This paved parking lot has an L-shaped plan. A wood fence lines the south edge.

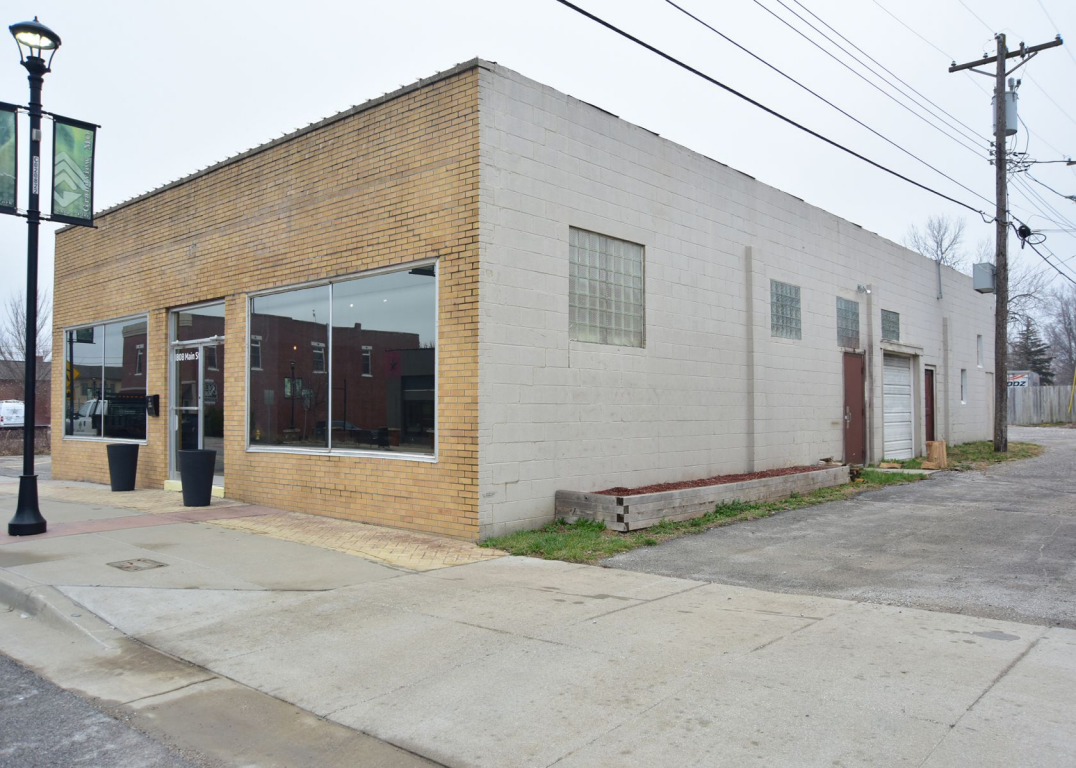
"This one-part commercial block is concrete block with blonde brick facing and has a rectangular footprint that is three symmetrical bays wide. Flanking the paired aluminum-framed glass door entrance are two-part display windows on tall bulkheads. Above a rectangular central sign panel, cast stone caps the façade parapet wall (Davis and Schwenk, 2003)."

The east elevation features square windows with glass block infill. A vehicular entrance is centered on the elevation and flanked by pedestrian entrances. The central sign panel is no longer extant and the awning has been removed. 808 Main Street otherwise does not appear significantly altered from its 2003 appearance.
