MISSOURI DEPARTMENT OF NATURAL RESOURCES  
STATE HISTORIC PRESERVATION OFFICE, P.O. Box 176, Jefferson City, MO 65102  
**ARCHITECTURAL/HISTORIC INVENTORY FORM**

1. Survey number: JA-AS-088-153		2. Survey Name: Town of Grandview, Resurvey	
3. County: JACKSON		4. Address (Street No.): 304 Street (name): Dewey Avenue	
5. City: Grandview	Vicinity <input type="checkbox"/>	6. Lat / Long:	7. Township/Range/Section: T: R: S:
8. Historic name (if known):		9. Present/other name (if known):	
10. Ownership: <input checked="" type="checkbox"/> Private <input type="checkbox"/> Public		11a. Historic use (if known): Domestic-Single Dwelling	11b. Current use: Domestic-Single Dwelling

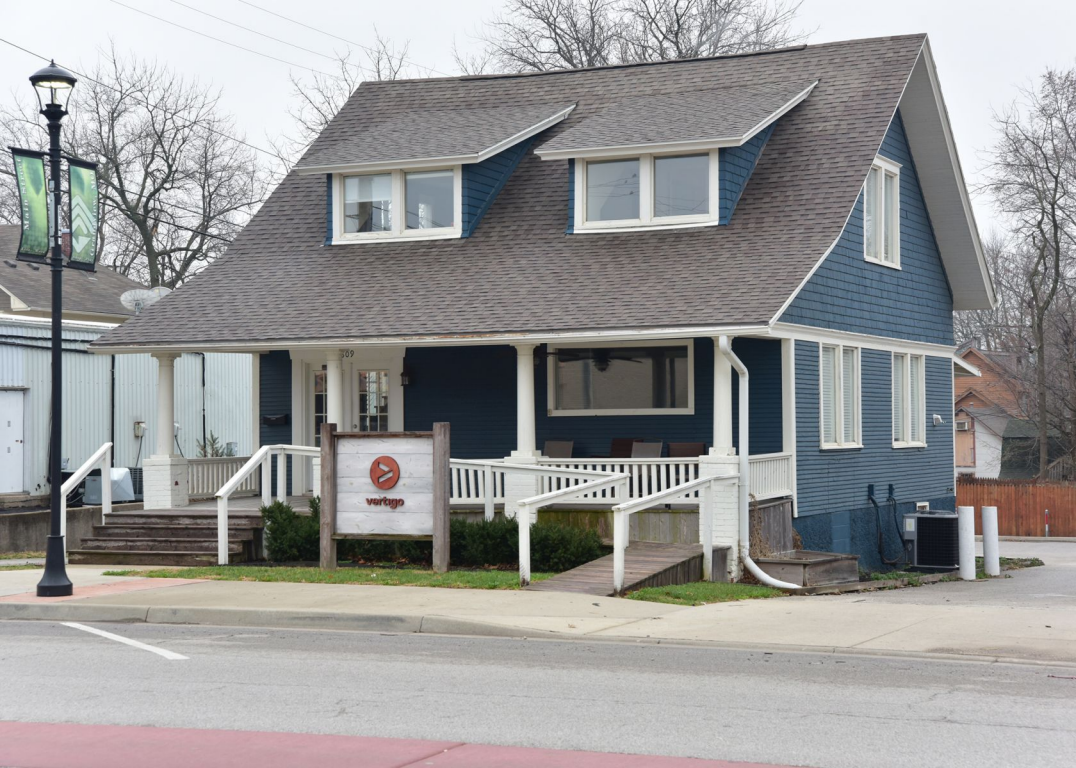
The porch is no longer enclosed. It is supported by Tuscan columns. The porch features a non-historic matchstick balustrade and wood ramp with railing. French doors form the entrance. All other alterations pre-date the 2003 survey. Removal of the non-historic porch enclosure has restored the historic openness of the porch.

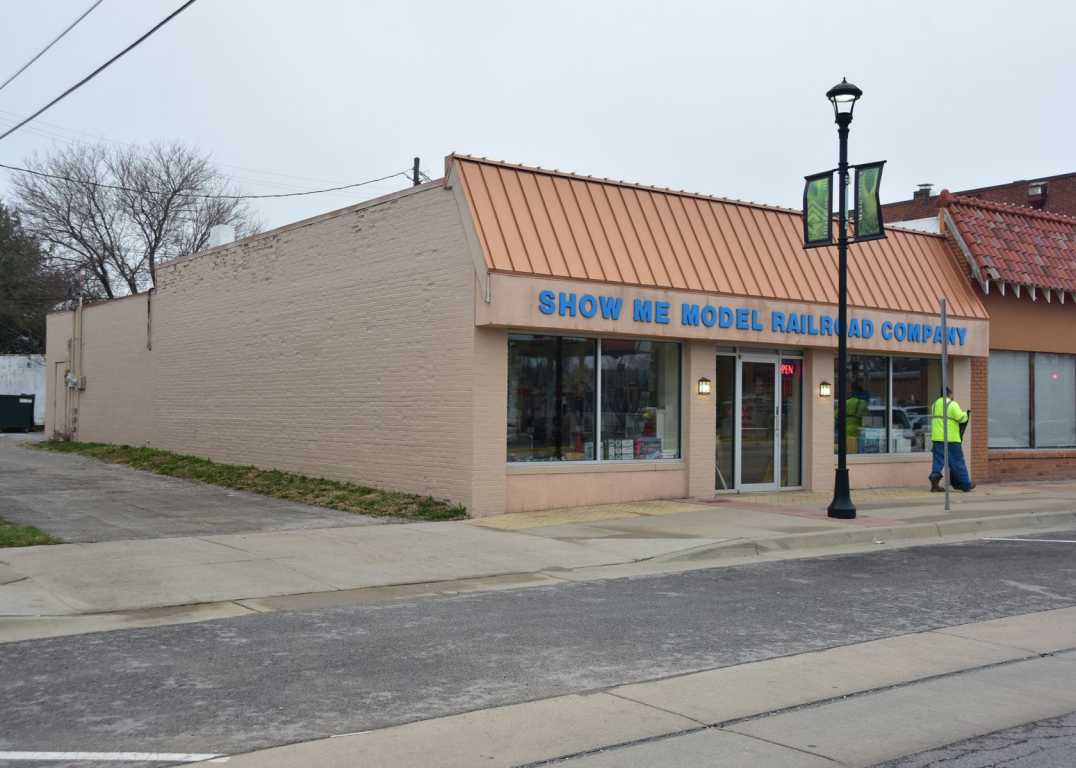
The stucco has been removed from the brick piers. Small sections of stucco remain under the aluminum two-part fixed-sash display windows. 810 Main Street otherwise does not otherwise appear significantly altered from its 2003 appearance. Dates of alteration are unknown, however pre-date the 2003 survey.

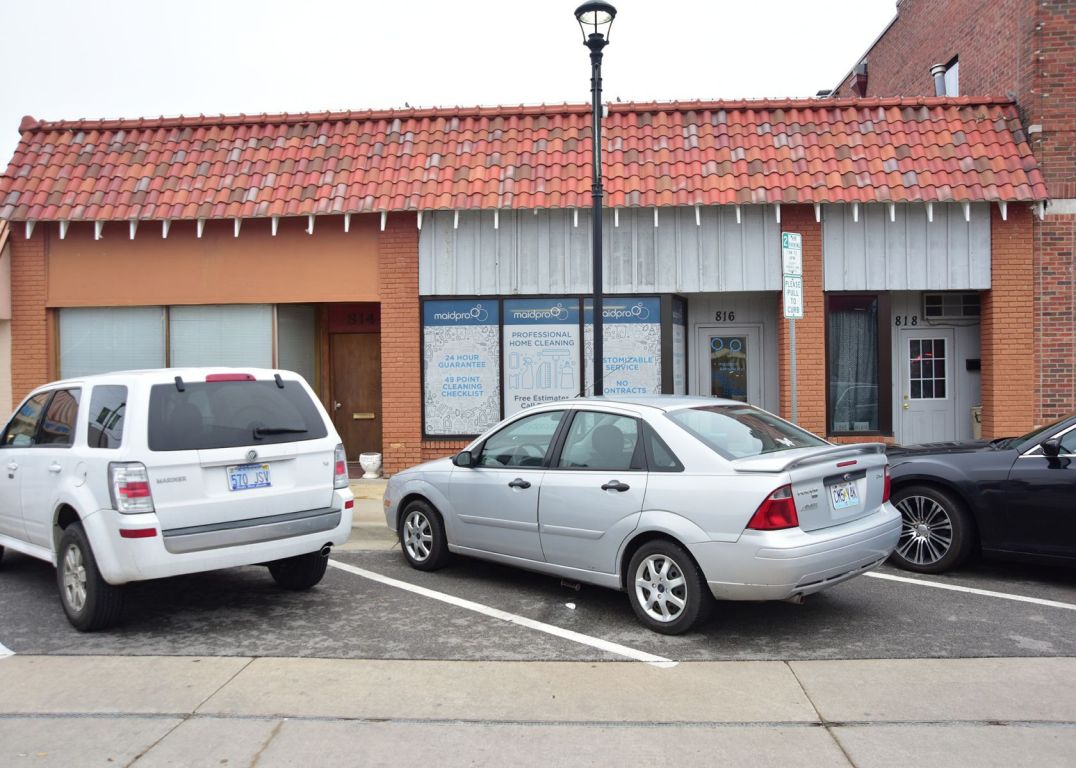
"This brick one-part commercial block has a rectangular footprint and features a façade with three storefronts. Projecting brick piers define the storefronts, each of which contains a recessed entrance in the east end bay and aluminum-framed display windows over original brick bulkheads. The original ceramic tile pent roof with exposed rafter tails spans the width of the façade. Plywood and signboards cover the storefront transom windows (Davis and Schwenk, 2003)."

814-816 Main Street does not appear significantly altered from its 2003 appearance. Dates of alteration are unknown, however pre-date the 2003 survey.

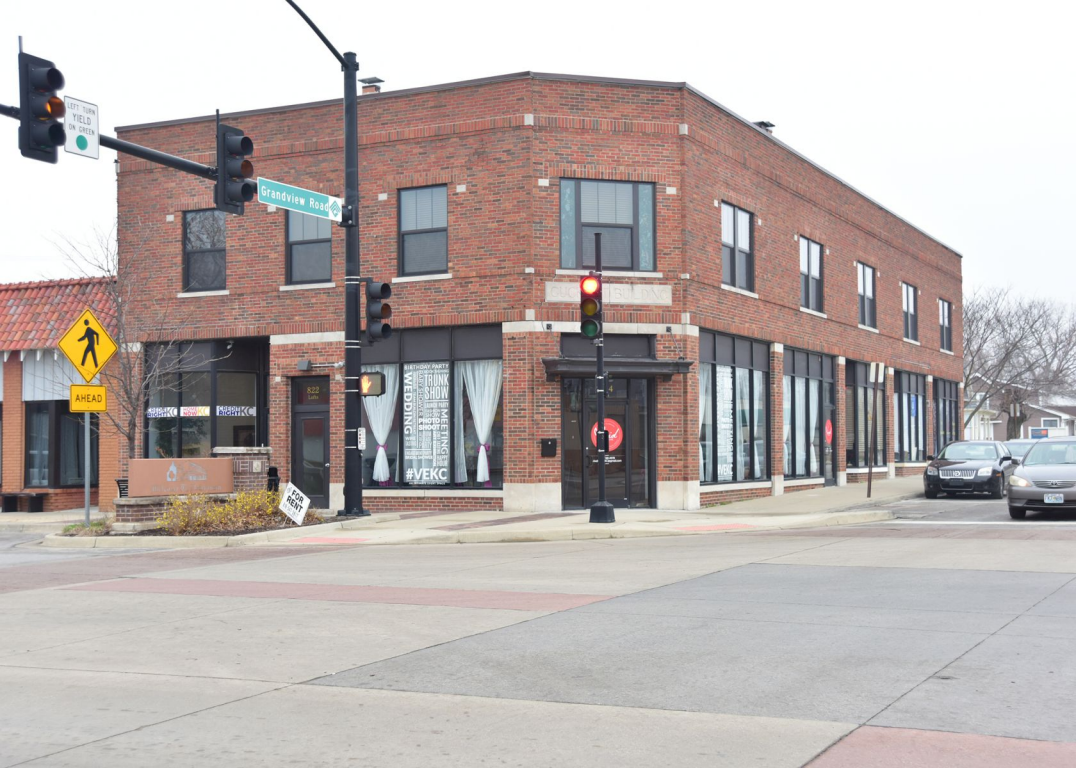
"This brick two-part commercial block stands on a corner lot and features two primary façades. This building has a rectangular footprint that is four bays wide and five bays deep. Brick piers with stone bases and square capitals delineate the storefronts at street level. Punctuating the street-level façade are seven entrance doors, four of which are recessed, and seven display windows resting on original brick and stone bulkheads. Plywood covers most of the original transom windows. Filling the second-story bays are original three-over-one light, double-hung wood sash windows, each of which features stone corner blocks, stone sills, and soldier brick lintels. The full-height canted corner distinguishes this building from most that are on Main Street. Additional character-defining features include a rectangular stone sign panel with letters in relief that read, "GUCKERT BUILDING," a band of soldier brick at cornice-level, and the parapet wall with stone coping (Davis and Schwenk, 2003)." This building also displays the addresses 12918, 12920, and 12922 Grandview Road. The corner entrance forms the fourth bay. The windows have been replaced since the 2003 survey. The second bay door is now metal with glazing and the boards have been removed from the transom. The storefront window in the third primary elevation bay is now three-part rather than two. The door and sidelights occupying the fourth bay have been replaced with a metal system with narrower mullions. The storefront systems present at the east elevation are now four-part and metal. The transoms remain boarded. The second story windows are now three-over-one metal replacement windows. The stone coping is now metal.

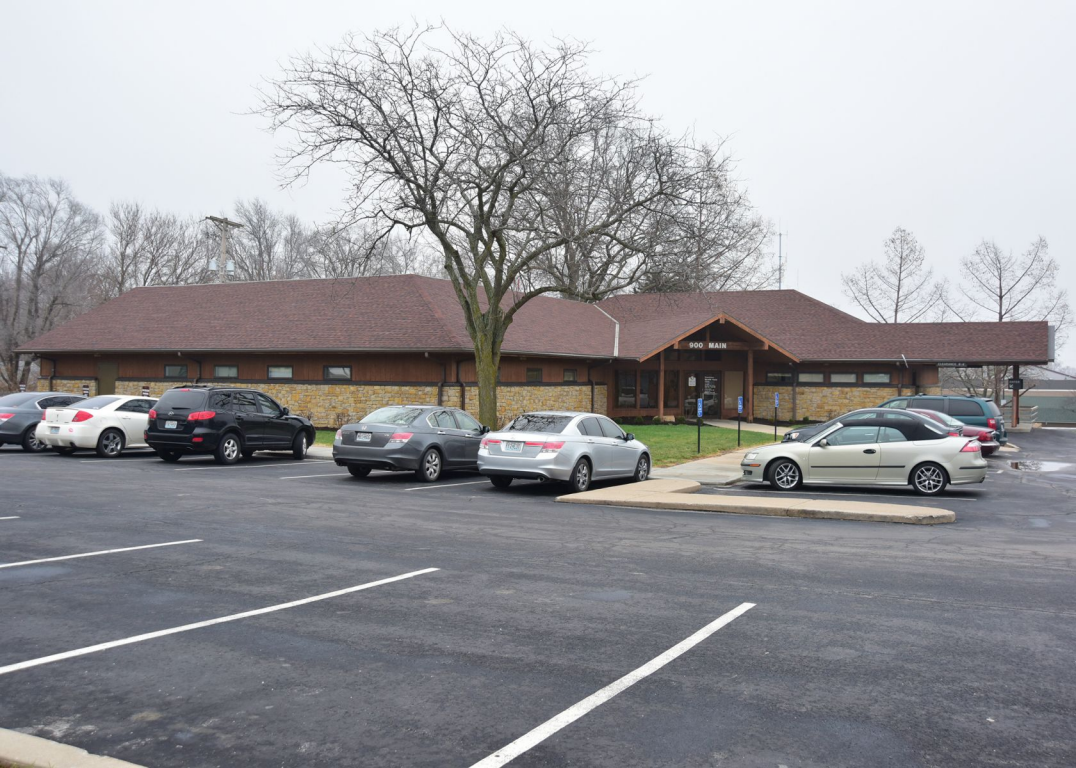
"This modern, one-story professional building has an L-shaped footprint that is five bays wide and five bays deep. Dominating the building's appearance are the complex hipped roof system and the irregularly coursed stone covering the lower three-quarters of the exterior walls. A projecting gable distinguishes the primary entrance located at the junction of the two intersecting wings. Small, horizontal, one-light, fixed-sash windows form the remaining bays, piercing a narrow wall band under the wide eaves which is covered with pressed wood siding. Additional character-defining features include a projecting gable porte-cochere and exposed rafter tails (Davis and Schwenk, 2003)."

900 Main Street does not appear significantly altered from its 2003 appearance.

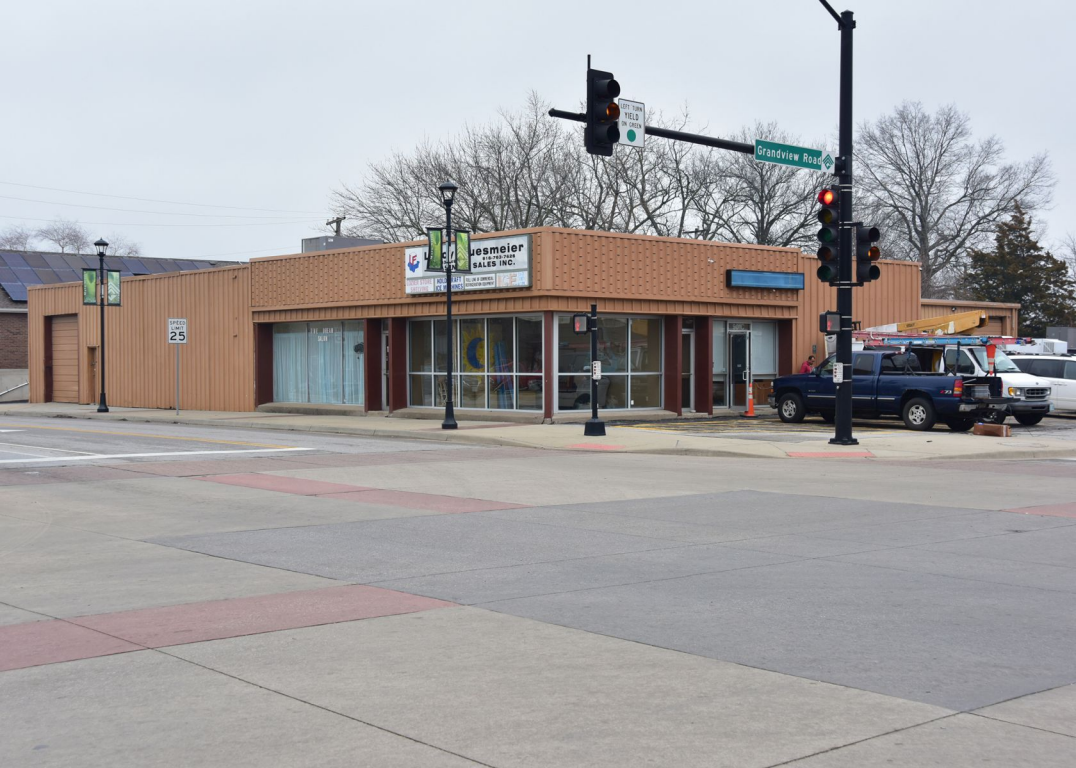
The north recessed three-part storefront is now five-part. The two-part storefront system at the north bay of the west elevation is now three-part rather than two-part. Replacement metal overhead garage doors now occupy the vehicular bays. 901-03 Main Street otherwise does not appear significantly altered from its 2003 appearance.

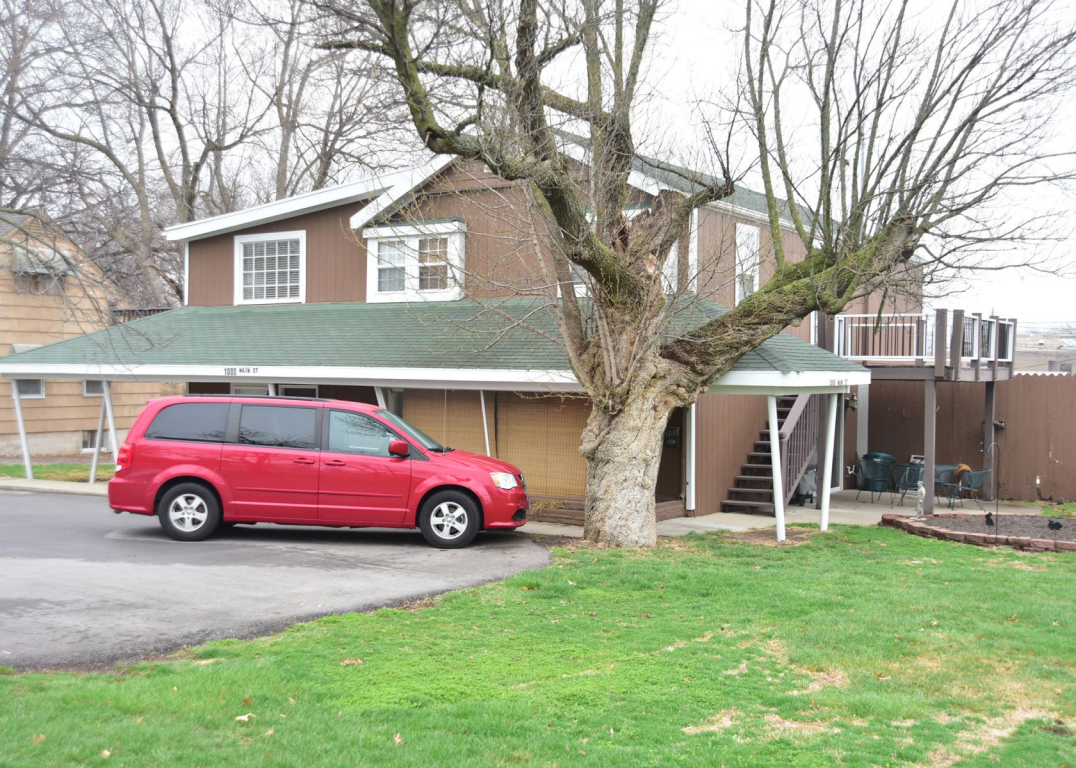
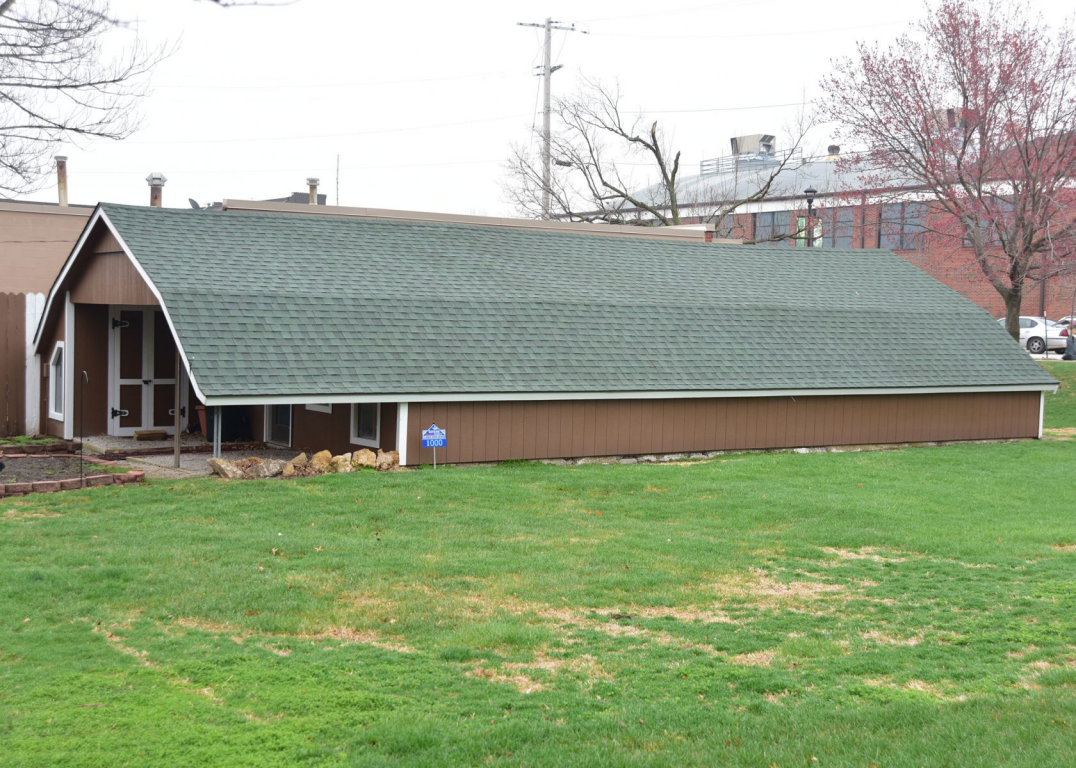
"A large, modern greenhouse and a storefront addition on the two primary façades obscure the view of this two-story, side-gabled house. The irregular footprint is two bays wide and three bays deep. Hollow steel posts support the porch's projecting hipped roof, which shelters the new primary entrance in the north end bay. Fixed-sash display windows define the other bays. Single one-over-one light, double-hung sash windows with flat board trim fill the second story bays. Additional character-defining features include the tight eaves (Davis and Schwenk, 2003)."

The single one-over-one windows are now six-over-six with snap-in muntins. The windows are replacement vinyl sash. Secondary entrances are located at the second story at the north and south elevations. The secondary entrances are accessed via modern wood stairs and decks. The greenhouse addition was partially demolished ca. 2005 and converted into the outbuilding.

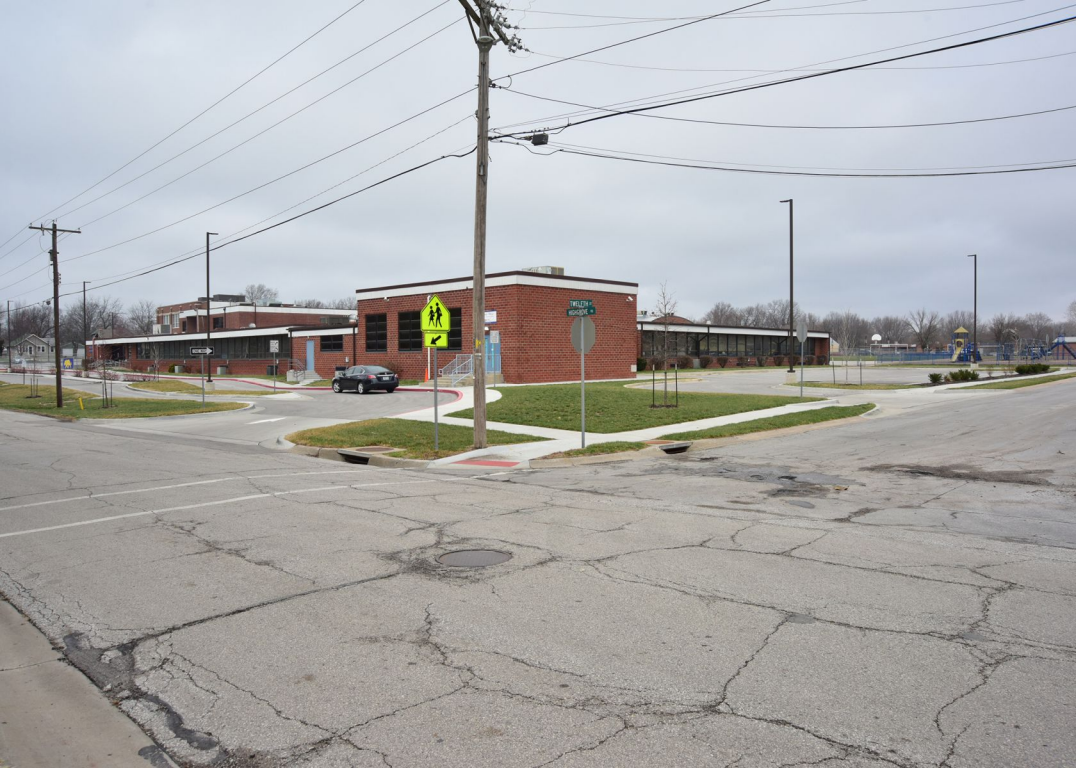
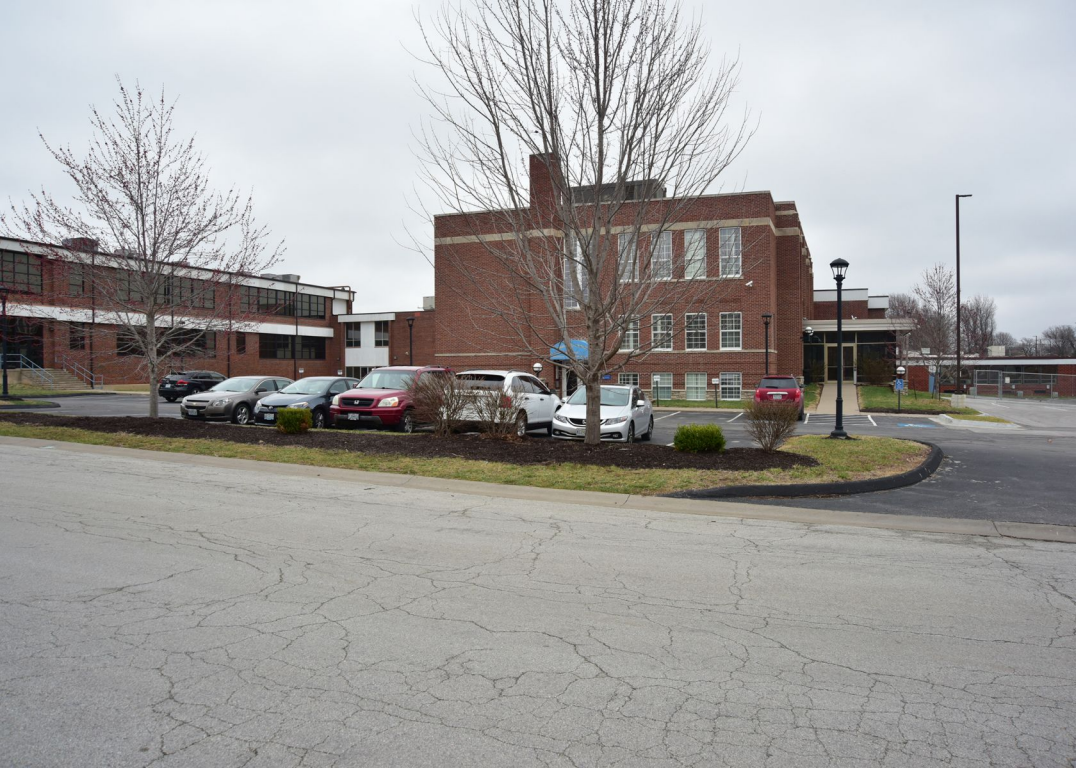
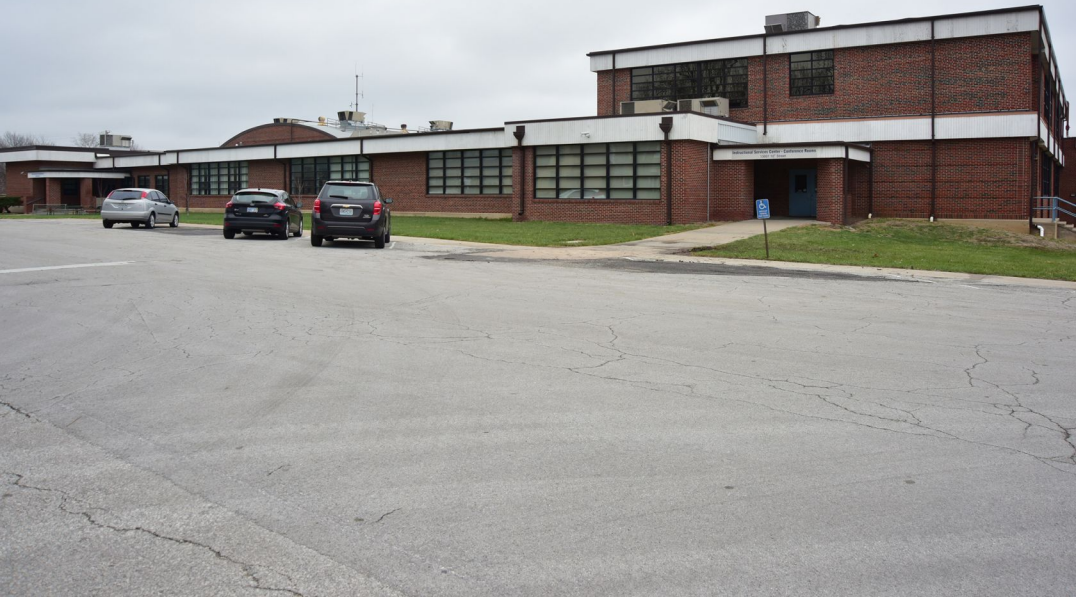
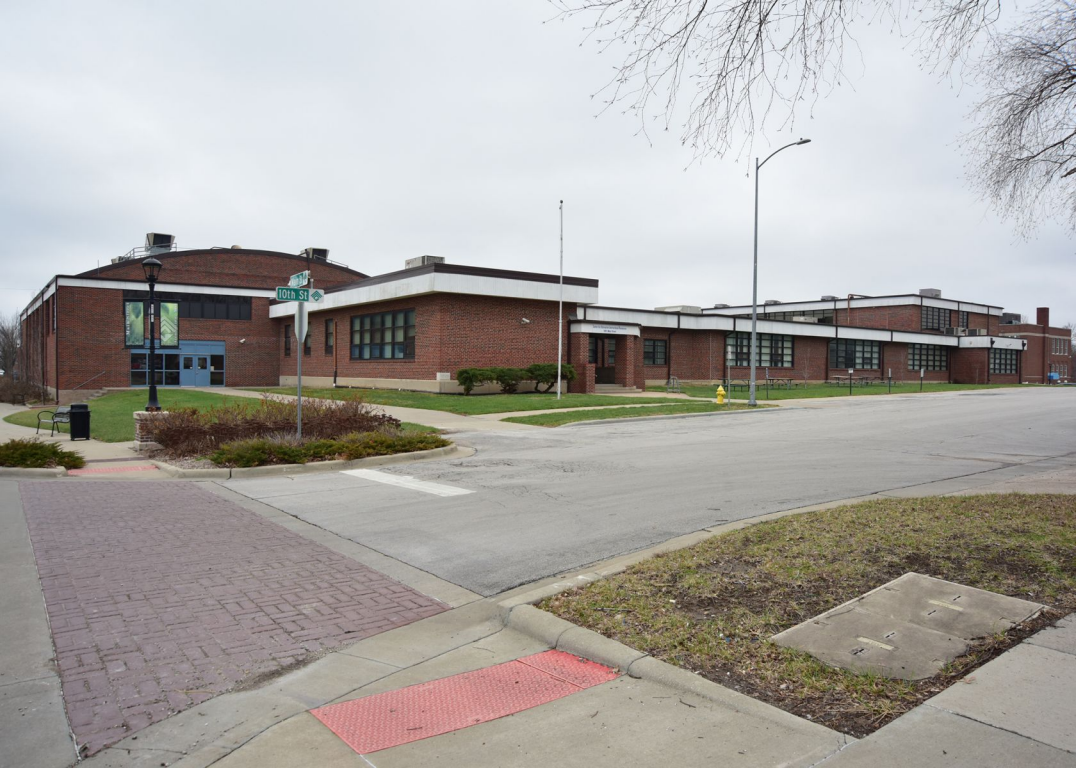
"This complex of connected school buildings consists of three significant building blocks. The original 1922 block is two stories tall, stands at the southwest corner of the lot and has load-bearing brick walls, a flat roof, and a rectangular footprint that is seven bays wide and five bays deep. Brick pilasters define the bays. Fenestration includes large, multi-sash, one-over-one light, double-hung windows with operable hopper sash windows above. Character-defining features include stone belt courses and sills. Modern connecting wings clad with matching brick link this block to the 1946 block located at the northwest corner of the lot. The 1946 block forms an irregular footprint and features intersecting one- and two-story wings, as well as a gymnasium wing with a barrel-shaped roof. The 1952 block is a one-story elementary school that stands at the southeast corner of the school property lot. The 1952 block forms a rear-facing U-shaped footprint and features brick walls composed of very large bricks and long bands of steel windows with operable hopper sash windows. White pressed wood siding applied vertically wraps the parapet walls of each building, visually unifying the complex (Davis and Schwenk, 2003)."

White pressed wood siding is absent from the original block's parapet. A modern glass enclosure is located at the south elevation of the original block. The original block has twelve-over-nine and nine-over-nine replacement windows. The later blocks have multi-light fixed sash metal replacement windows.

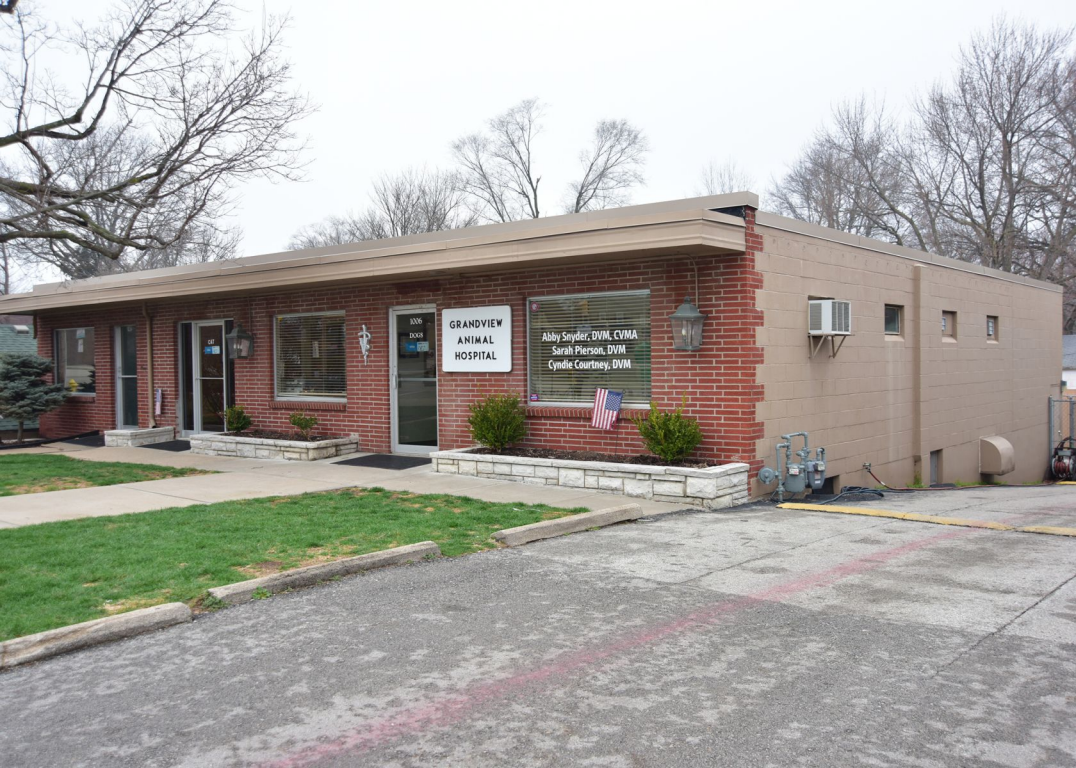
"This one-part commercial block is concrete block with brick facing and has an L-shaped footprint that is six bays wide and four bays deep. Entrances at the second, third, and fifth bays from the west end contain aluminum-framed glass doors. Fixed-sash display windows with header brick sills form the other bays. Additional character-defining features include a shallow visor porch roof and low limestone planters. The building displays the addresses 1002 through 1006 (Davis and Schwenk, 2003)."

One-light aluminum framed sidelights flank the third bay door. 1004 Main Street does not appear significantly altered from its 2003 appearance.

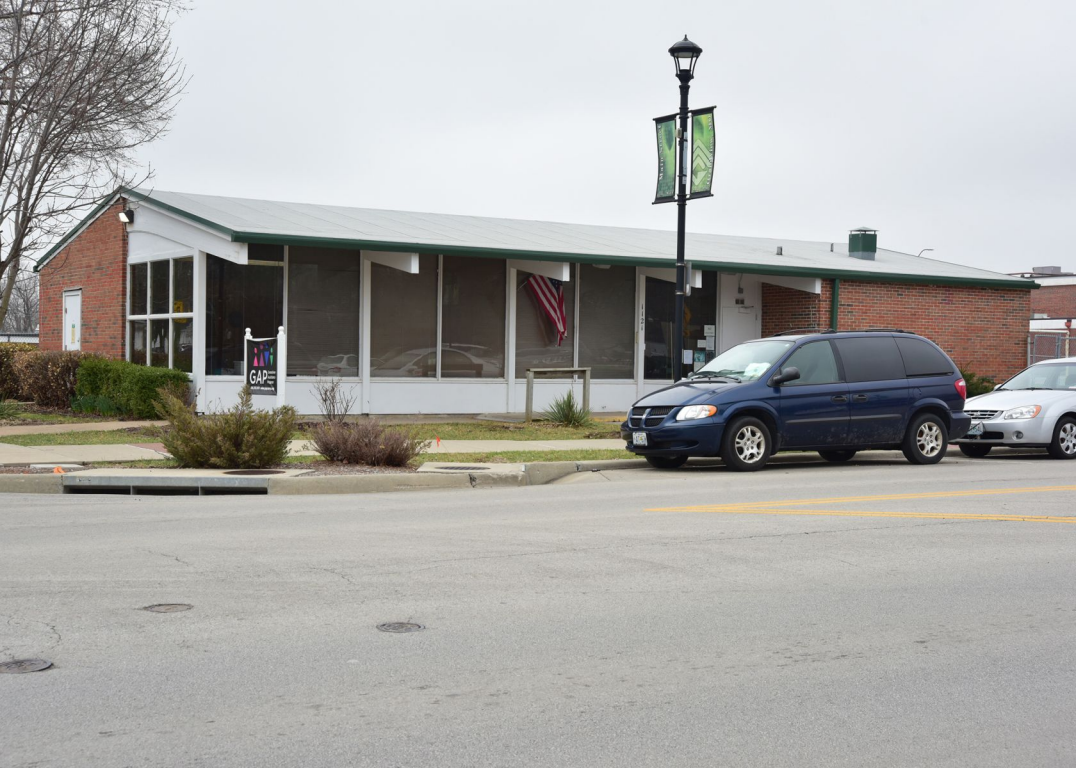
"This one-story, side-gabled building has a rectangular footprint that is four asymmetrical bays wide and two bays deep. The front wall recesses across the four primary façade bays, sheltering the entrance at the west end bay. Two-part display windows define the other bays. Additional character-defining features include the exposed porch roof rafters (Davis and Schwenk, 2003)."

1121 Main Street does not appear significantly altered from its 2003 appearance.

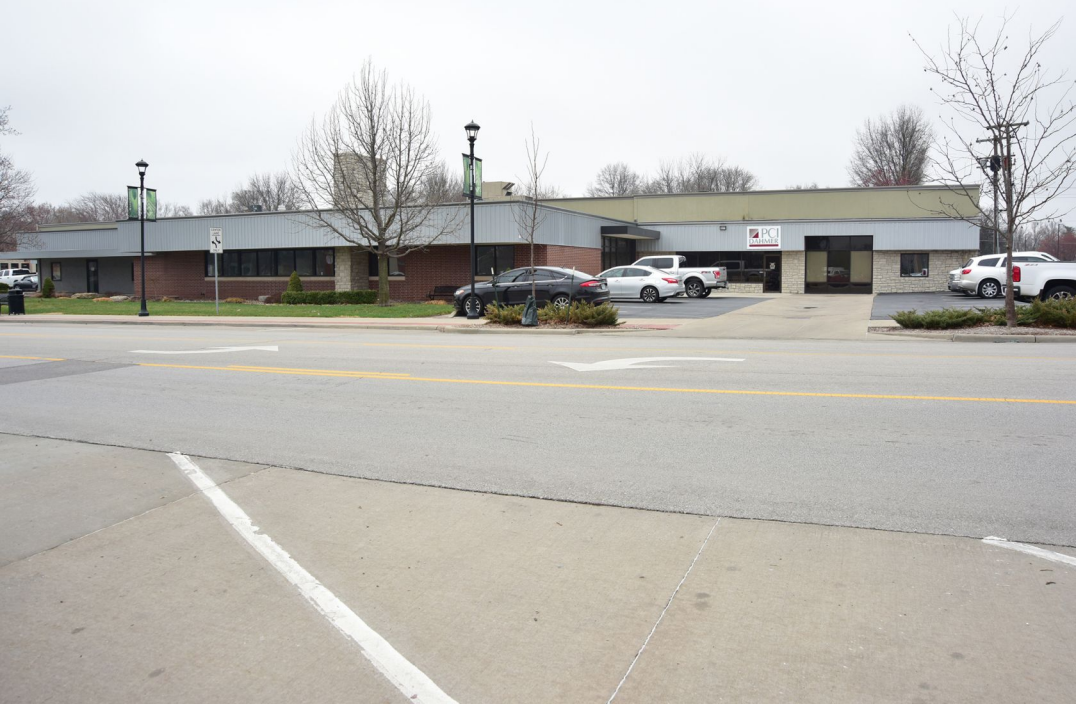
"This one-story commercial building has an irregular footprint that is eight asymmetrical bays wide and four bays deep. The building is distinguished by a corrugated metal siding treatment that vertically wraps the parapet walls and projects to shelter the three pedestrian entrances, as well as the vehicular entrance in the east end bay. Defining the remaining bays are single, paired, and bands of both three and eight single-light, fixed-sash windows. Additional character-defining features include a vertical brick wall that is perpendicular to the façade, rising through the visor porch roof between the second and third bays from the west end. This building displays the address 1215 (Davis and Schwenk, 2003)."

The building displays the addresses 1203, 1213, and 1215 Main Street. It does not appear significantly altered from its 2003 appearance.

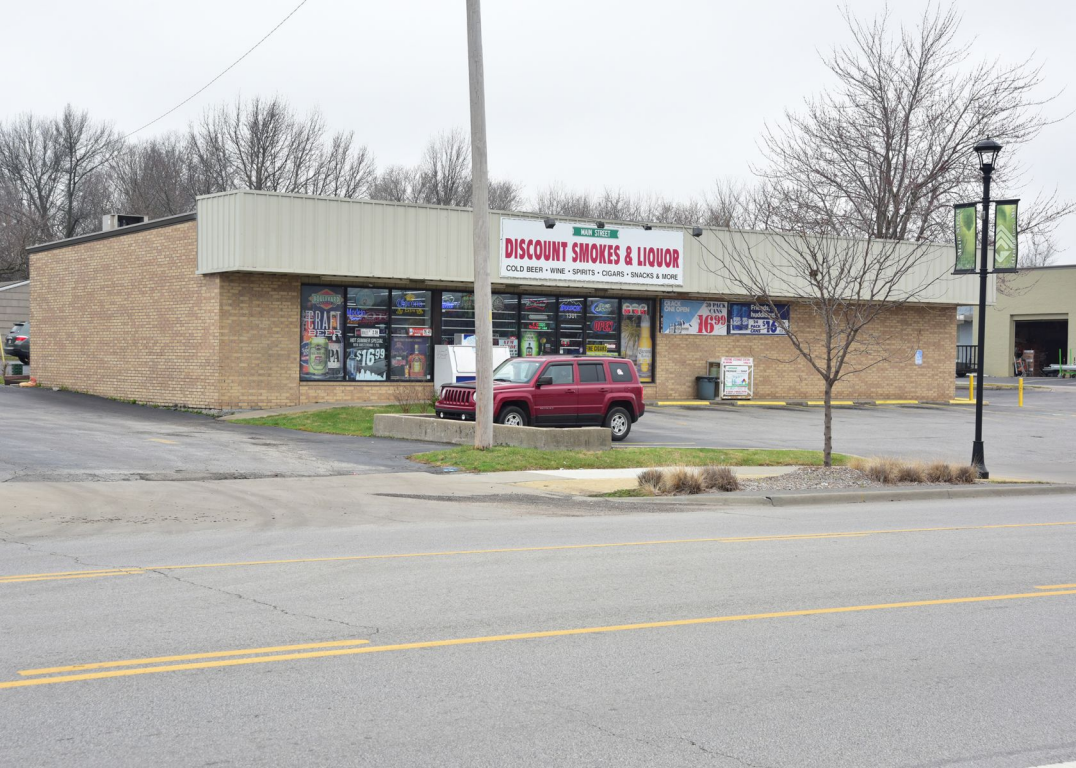
"This modern, one-part commercial block has a rectangular footprint that is one bay wide and two bays deep. The single façade bay contains a nine-part, aluminum-framed display window system that includes a glass entrance door and a fixed transom. Corrugated metal wraps the parapet walls vertically and projects to form a shallow porch (Davis and Schwenk, 2003)."

1301 Main Street does not appear significantly altered from its 2003 appearance.

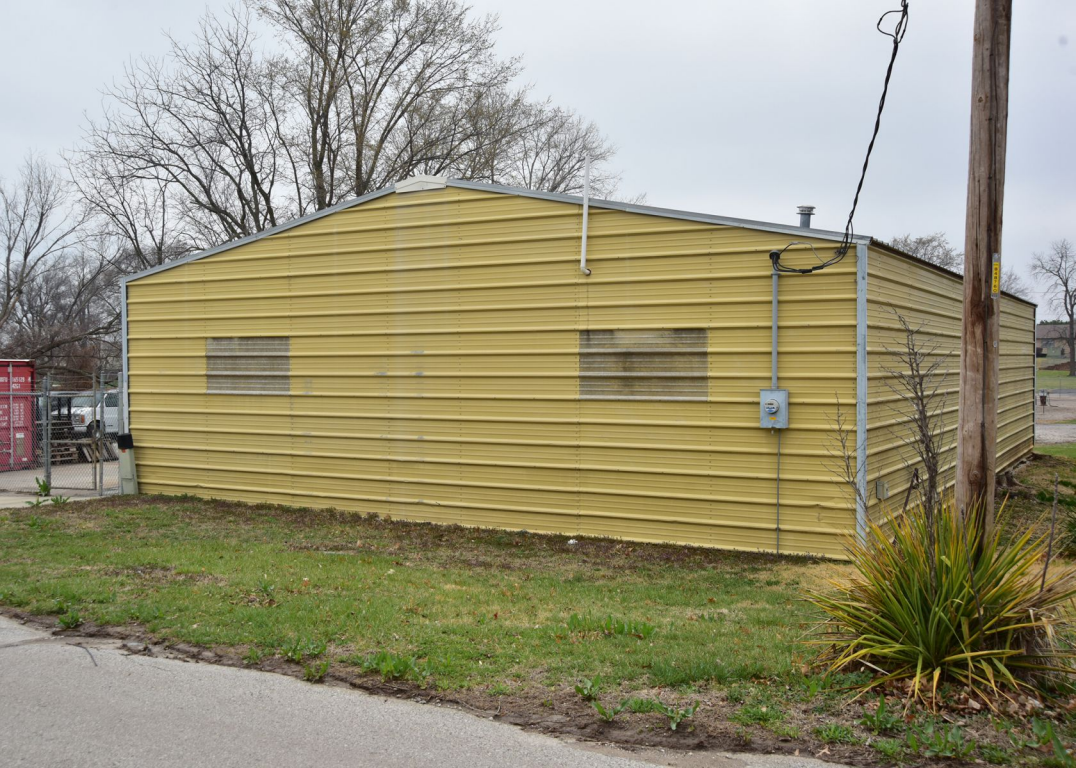
"This one-story, side-gabled building has a perpendicular orientation to the road. Corrugated metal siding covers the roof and exterior walls. Forming the two asymmetrical bays of the primary (west) façade are a pedestrian entrance at the south end bay and a central garage bay entrance with sliding metal doors. The remainder of the elevations do not have windows (Davis and Schwenk, 2003)."

402 Pinktson Avenue does not appear significantly altered from its 2003 appearance.

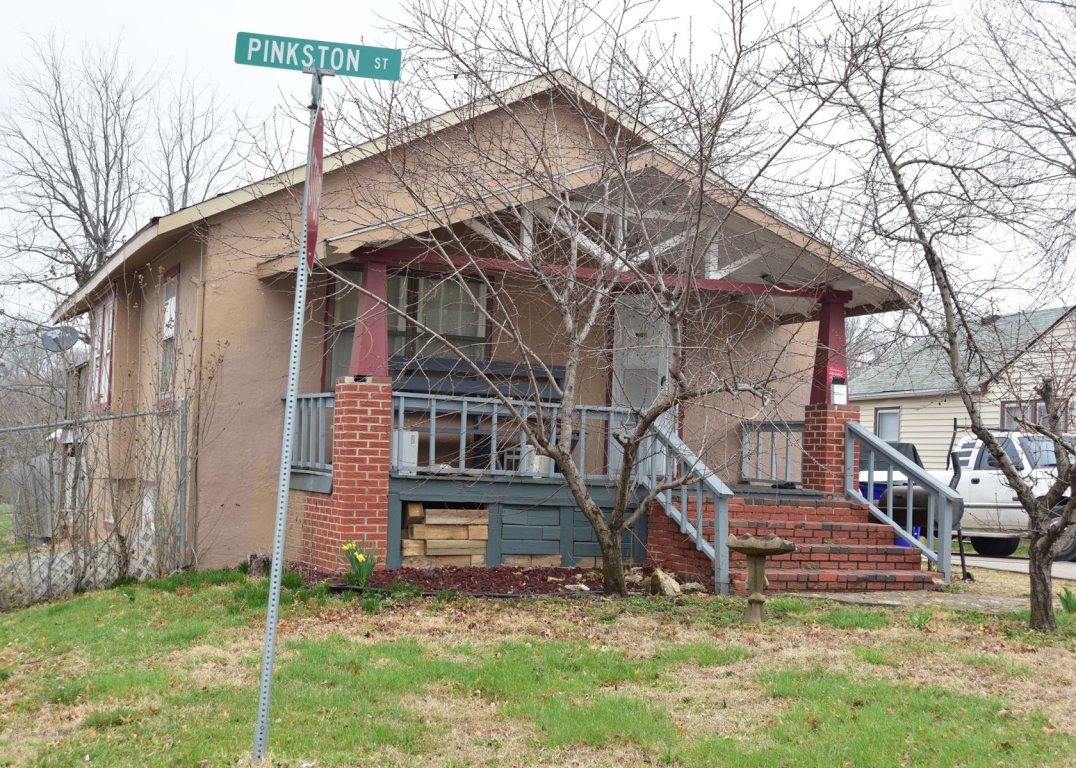
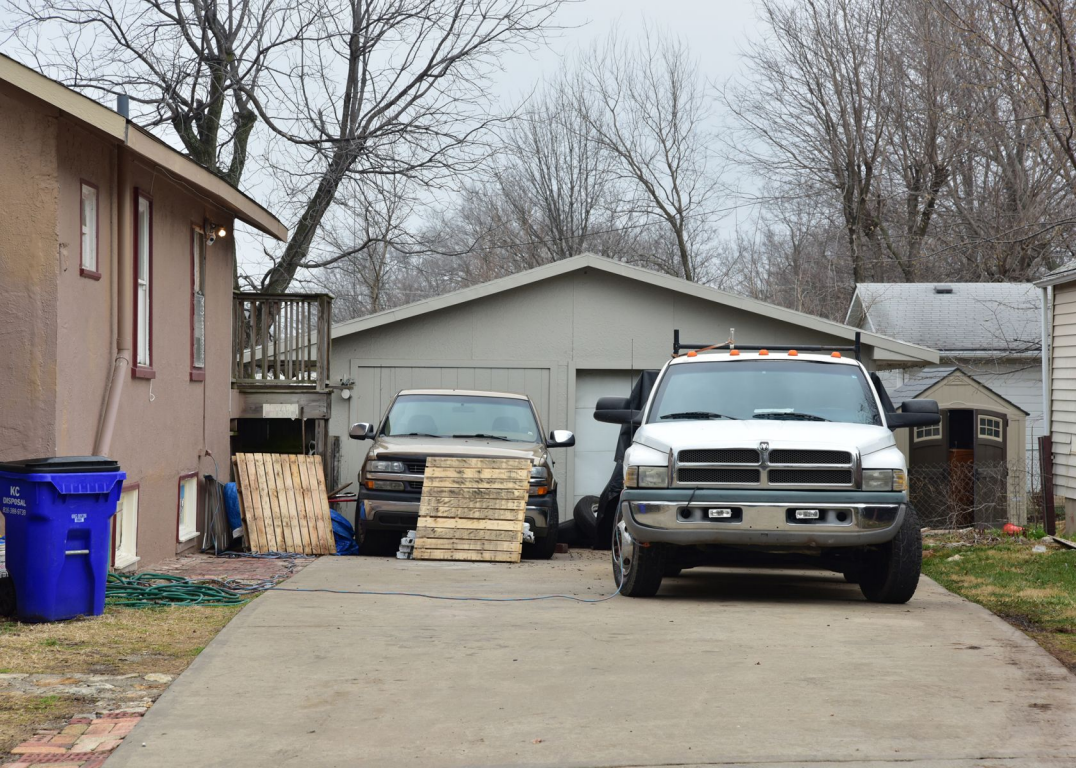
The gravel driveway has been replaced with concrete. The east bay of the garage features a roll-up door while the west bay door features vertical wood planks. Door hardware is not visible. The garage is not eligible because there is no concentration of resources that would constitute a historic district.

"This one-story, gable-front Craftsman bungalow has a rectangular footprint that is two bays wide and three bays deep. Stucco covers the exterior walls and the exposed foundation. Tapered square columns resting on brick piers support the three-quarter porch's gable-front roof, which shelters the primary entrance in the east end bay and features exposed truss work and exposed rafter tails. Defining the remaining bays are single and paired three-over-one light, double-hung wood sash windows. A modern matchstick balustrade replaces the original (Davis and Schwenk, 2003)."

502 Pinkston Avenue does not appear significantly altered from its 2003 appearance. Dates of alteration are unknown, however they pre-date the 2003 survey.

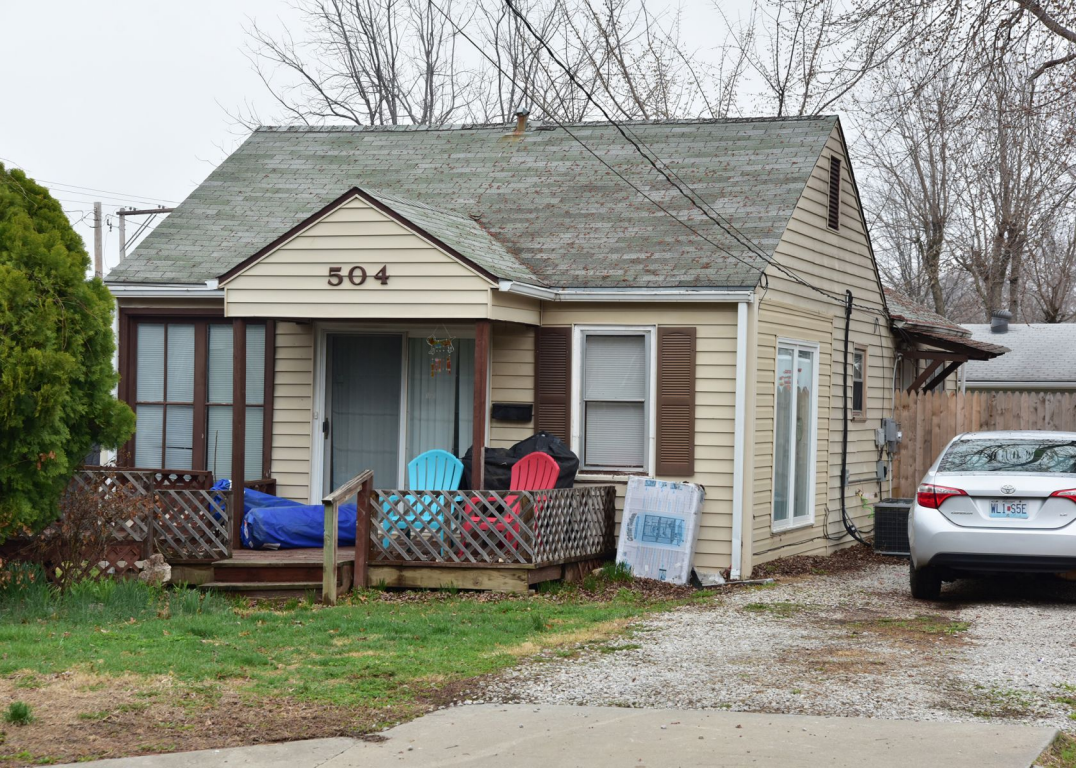
"This one-story, side-gabled Hall and Parlor Folk House has a rectangular footprint that is three bays wide and three bays deep. There is a one-bay rear addition. A non-original, gable-front porch shelters a modern, sliding glass door entrance at the center bay. Defining the remaining bays are tall, single and paired two-over-two light, double-hung wood sash windows, at least one of which is a replacement window. Vinyl siding covers the exterior walls. The application of vinyl siding and the replacement of the center bay entrance with a modern sliding glass door compromises the integrity of this building (Davis and Schwenk, 2003)."

Aluminum storm windows cover one-over-one wood sash windows at all elevations visible from the right-of-way. Windows are a combination of historic and replacement. A large, modern wood porch projects from the primary elevation. The addition's concrete block foundation is visible at the west elevation. 504 Pinkston Avenue does not appear significantly altered from its 2003 appearance. Dates of alteration are unknown, however pre-date the 2003 survey.

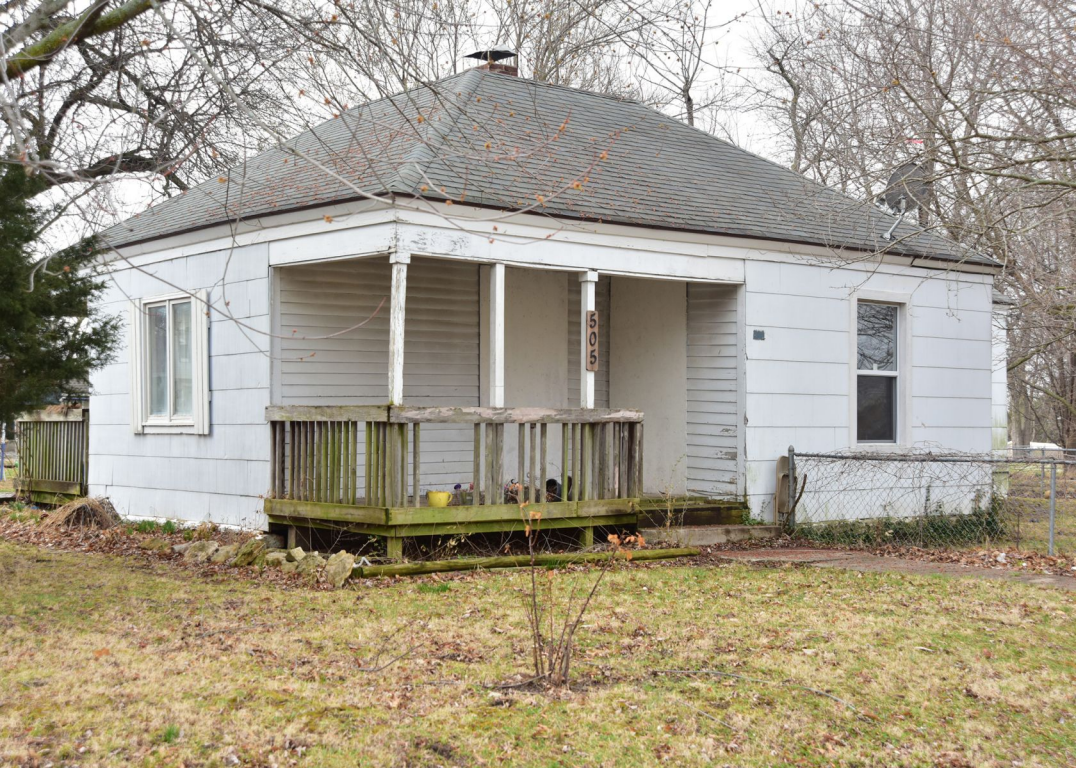
"This one-story Pyramidal Roof folk house has a rectangular footprint that is three bays wide and three bays deep. The building has a one-bay rear addition. Distinguishing the house is the flattened peak of the pyramidal roof form, as well as the two single-bay recessed entrance porches flanking the center bay containing a window. Defining the three primary façade bays are tall one-over-one light, double-hung wood sash windows, at least one of which has been replaced. New wood porch posts and matchstick balustrades replace the originals (Davis and Schwenk, 2003)."

Windows are vinyl sash replacements. 505 Pinkston Avenue does not otherwise appear significantly altered from its 2003 appearance. Dates of alteration are unknown, however pre-date the 2003 survey.

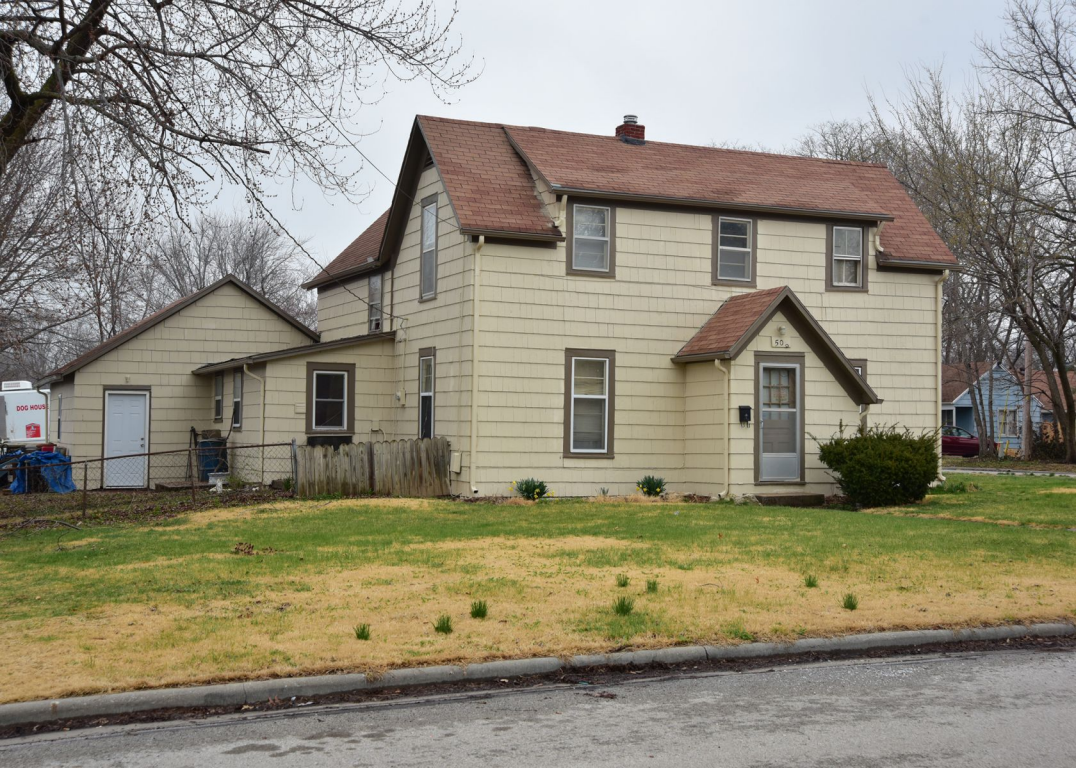
"This two-story, I-house is three bays wide and has an irregular footprint. This dwelling has a two-story addition with an intersecting gable roof and a one-story addition with a shed roof that connect to a side-gabled garage. Sheltering the central bay entrance is an asymmetrical, gable-front, enclosed entrance porch. A shallow shed dormer containing three window bays rises flush with the front wall and above the eaves. Defining the remaining bays are two-over-two light, four-over-four light, and six-over-six light, double-hung wood sash windows with flat board trim. At least two of the original windows have been replaced with modern one-over-one light, vinyl sash windows (Davis and Schwenk, 2003)."

506 Pinkston Avenue does not appear significantly altered from its 2003 appearance. The creation of the dormer and addition of the vestibule are likely historic alterations from the c.1920s.

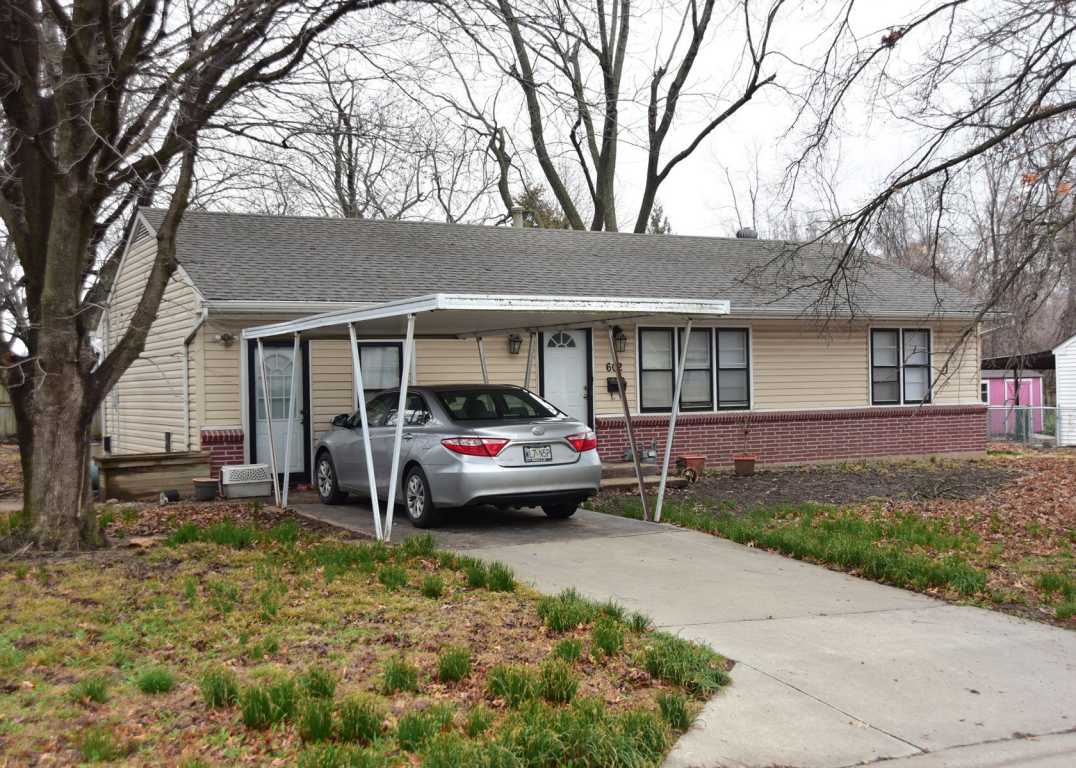
"This one-story, side-gabled Ranch house has a rectangular footprint that is five asymmetrical bays wide and one bay deep. Wide eaves along the front façade shelter the primary entrance in the center bay. Defining the remaining bays on the primary façade are single, paired, and triple one-over-one light, double-hung sash windows. Light-colored brick covers the lower third of the primary façade and pressed wood siding covers the remainder of the exterior walls. The original single-car garage at the west end bay has been modified and now contains a pedestrian entrance and single window. A metal carport stands in front of the two west end bays (Davis and Schwenk, 2003)."

The lower third of the primary elevation now features red brick veneer. The pressed wood siding has been replaced by vinyl. The windows are historic with aluminum storm windows present at all elevations visible from the right-of-way.
