MISSOURI DEPARTMENT OF NATURAL RESOURCES  
STATE HISTORIC PRESERVATION OFFICE, P.O. Box 176, Jefferson City, MO 65102  
**ARCHITECTURAL/HISTORIC INVENTORY FORM**

1. Survey number: JA-AS-088-153		2. Survey Name: Town of Grandview, Resurvey	
3. County: JACKSON		4. Address (Street No.): 304 Street (name): Dewey Avenue	
5. City: Grandview	Vicinity <input type="checkbox"/>	6. Lat / Long:	7. Township/Range/Section: T: R: S:
8. Historic name (if known):		9. Present/other name (if known):	
10. Ownership: <input checked="" type="checkbox"/> Private <input type="checkbox"/> Public		11a. Historic use (if known): Domestic-Single Dwelling	11b. Current use: Domestic-Single Dwelling

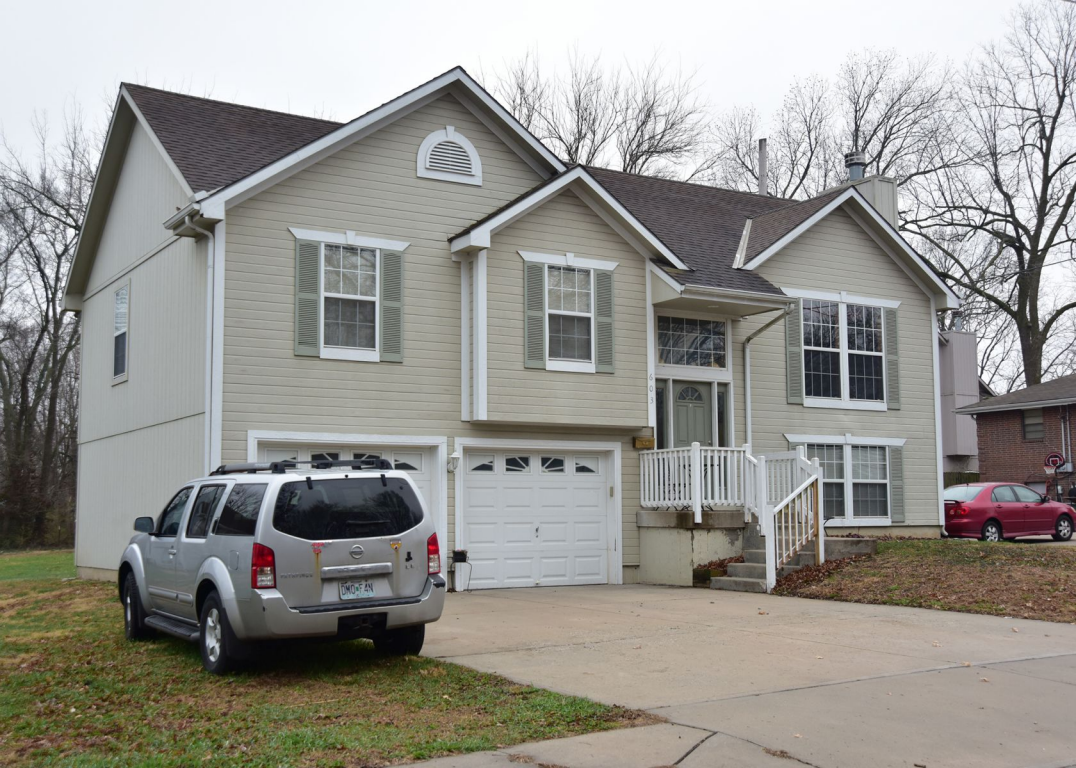
"This modern, two-story split-level house has a side-gabled roof and Neo-Colonial style detailing. This dwelling has a rectangular footprint and is four asymmetrical bays wide. It features three large gable-front wall dormers. A projection of the eaves line forms a stoop porch roof that shelters the primary entrance in the second bay from the west end. Defining the remaining bays of the primary façade are one-over-one light, double-hung vinyl windows with six-over-six and eight-over-eight snap-in muntins. The two east end bays each contain a single-car garage bay. Additional character-defining features include faux window lintels and keystones, entrance door sidelights, and a blind louvered fanlight. (Davis and Schwenk, 2003)."

603 Pinkston Avenue does not appear significantly altered from its 2003 appearance.

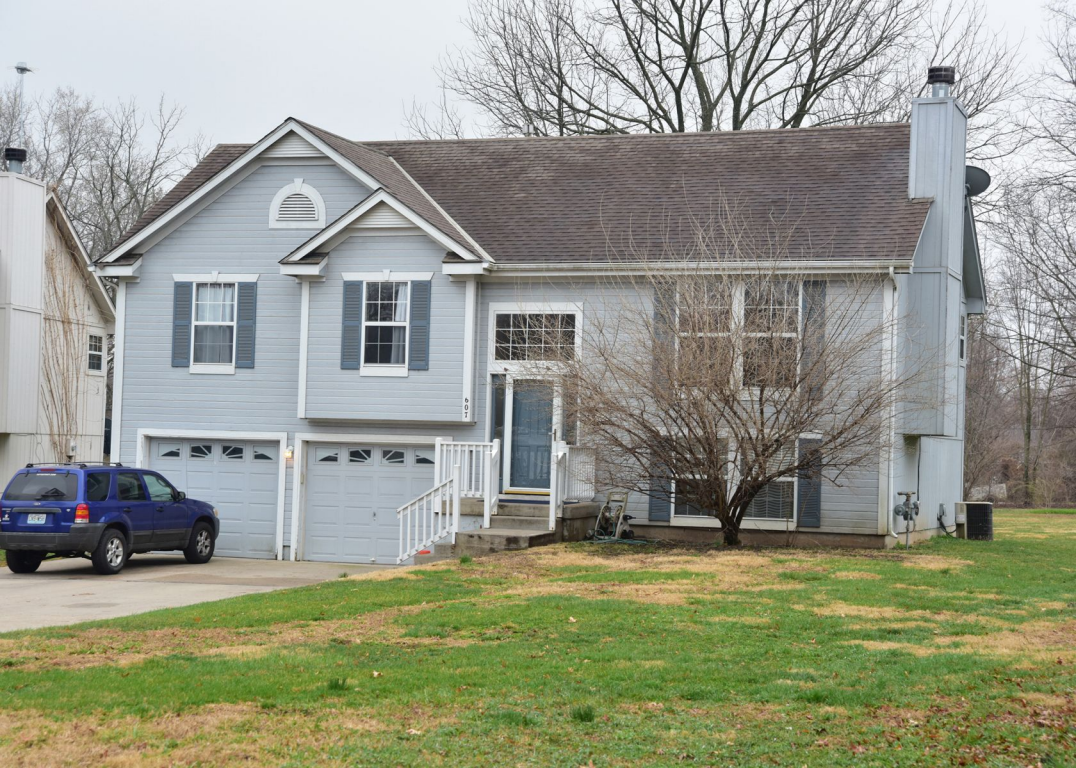
607 Pinkston Avenue is a two-story split-level Neo-Colonial single-family dwelling. It has a rectangular footprint and is four bays wide. The primary entrance defines the second from west bay. Two single-car garage doors define the east two bays while a set of paired double-hung vinyl sash windows with eight-over-eight snap-in muntins occupies the west bay. Two nested, front-gable wall dormers are located at the east end of the side gable roof. The easternmost wall dormer features a blind louvered light. The dwelling features vinyl cladding and an asphalt roof. Additional character-defining features include faux lintels and keystones and entrance sidelights. 607 Pinkston Avenue is a near-twin to the adjacent dwelling, 603 Pinkston Avenue. 607 Pinkston Avenue was constructed after the 2003 survey.

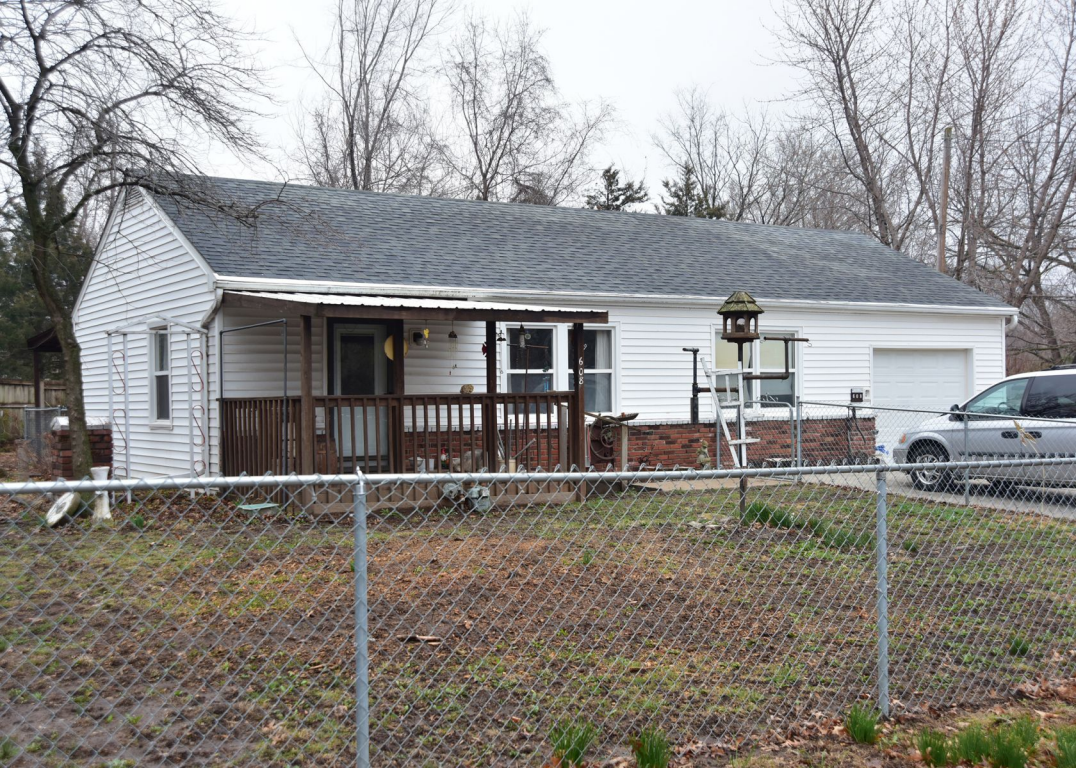
"This one-story, side-gabled Ranch house has a rectangular footprint that is four asymmetrical bays wide and one bay deep. Board-and-batten siding covers the exterior walls. Sheltering the entrance in the west end bay is a modern porch with a non-original balustrade and a shed roof. Defining the remaining bays of the primary façade are paired one-over-one light, double-hung sash windows flanked by Z-brace wood shutters and, in the east end bay, a single-car garage. The loss of original porch elements and the replacement of original windows compromises the integrity of this building (Davis and Schwenk, 2003)."

The lower third of the primary elevation features red brick veneer. The board-and-batten siding has been replaced with vinyl. 608 Pinkston Avenue does not otherwise appear significantly altered from its 2003 appearance. Dates of earlier alterations are unknown, however they pre-date the 2003 survey.

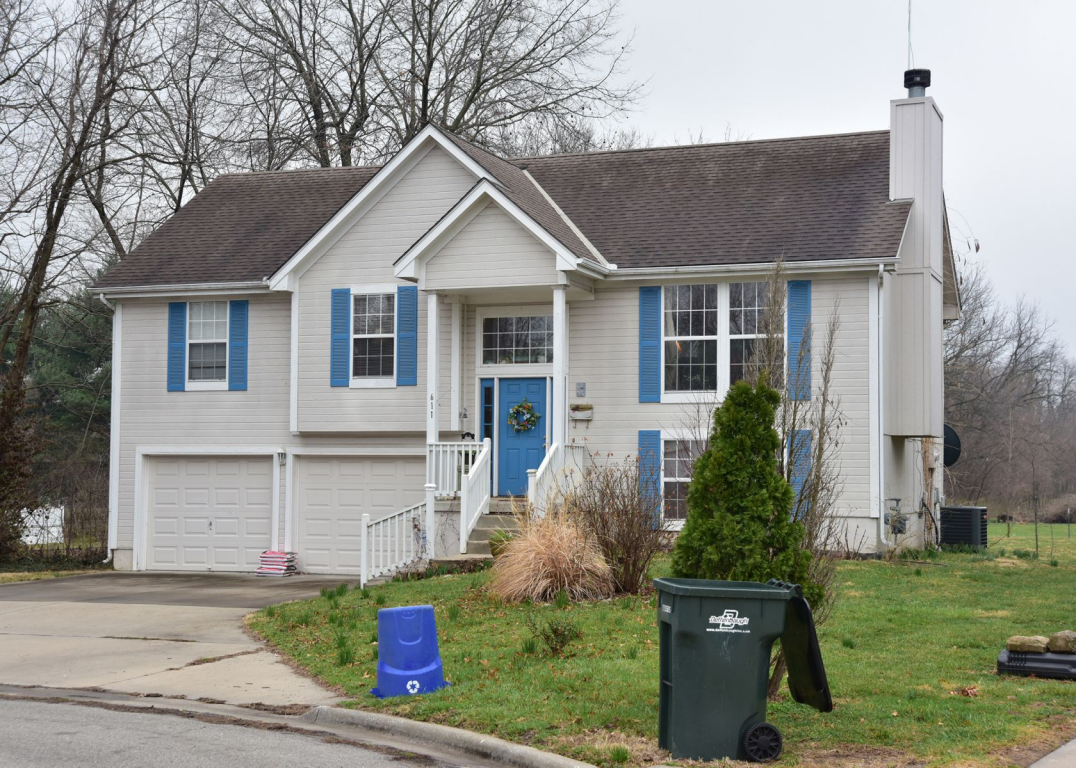
This modern, two-story split-level house has a side-gabled roof and Neo-Colonial style detailing. This dwelling has a rectangular footprint and is four asymmetrical bays wide. It features one large gable-front wall dormer. A gabled projection nested within the wall dormer forms a stoop porch roof that shelters the primary entrance in the second bay from the west end. Defining the remaining bays of the primary façade are one-over-one light, double-hung vinyl windows with six-over-six and eight-over-eight snap-in muntins. The two east end bays each contain a single-car garage bay. 611 Pinkston Avenue was constructed after the 2003 survey.

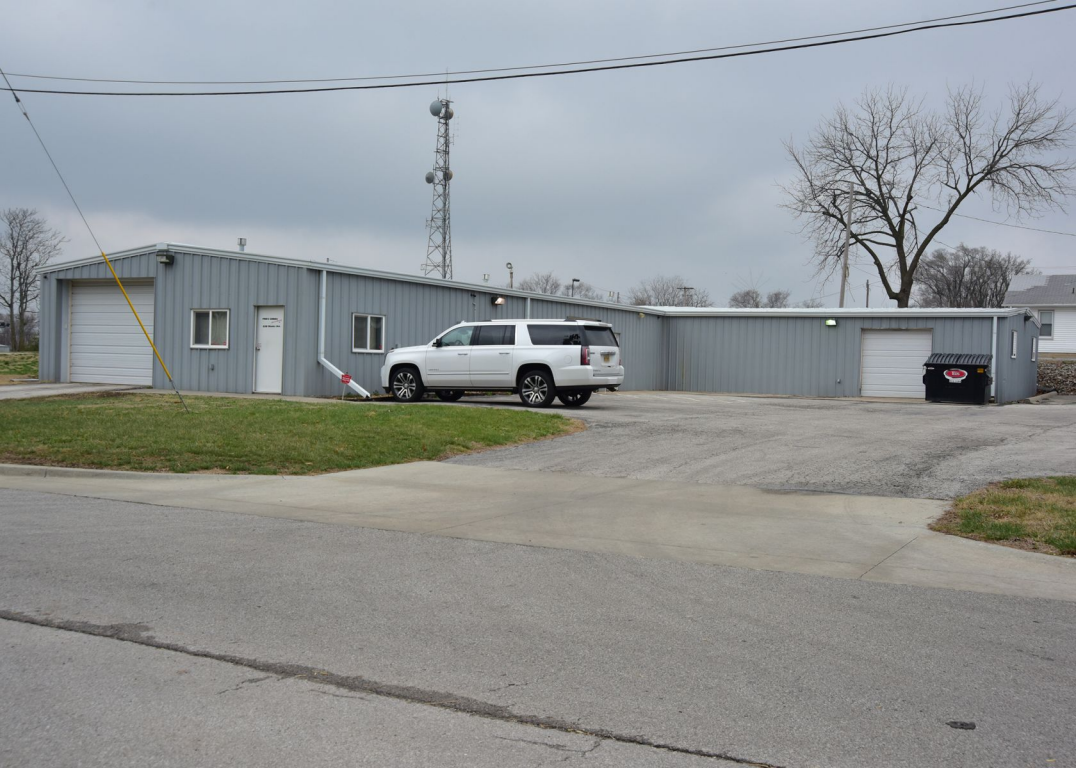
"This one-story utilitarian building has an intersecting gable roof and a long, front-facing, L-shaped plan that is three bays wide and five bays deep. Corrugated metal covers the roof and exterior walls. In the east end bay, the front gable contains a steel entrance door; the remaining bays contain two vehicular bays. Defining the bays of the secondary (east) façade is a secondary entrance, a secondary vehicular bay, and two fixed-sash windows (Davis and Schwenk, 2003)."

The windows are now one-by-one sliding sash. 520 Rhodes Avenue otherwise does not appear significantly altered from its 2003 appearance.

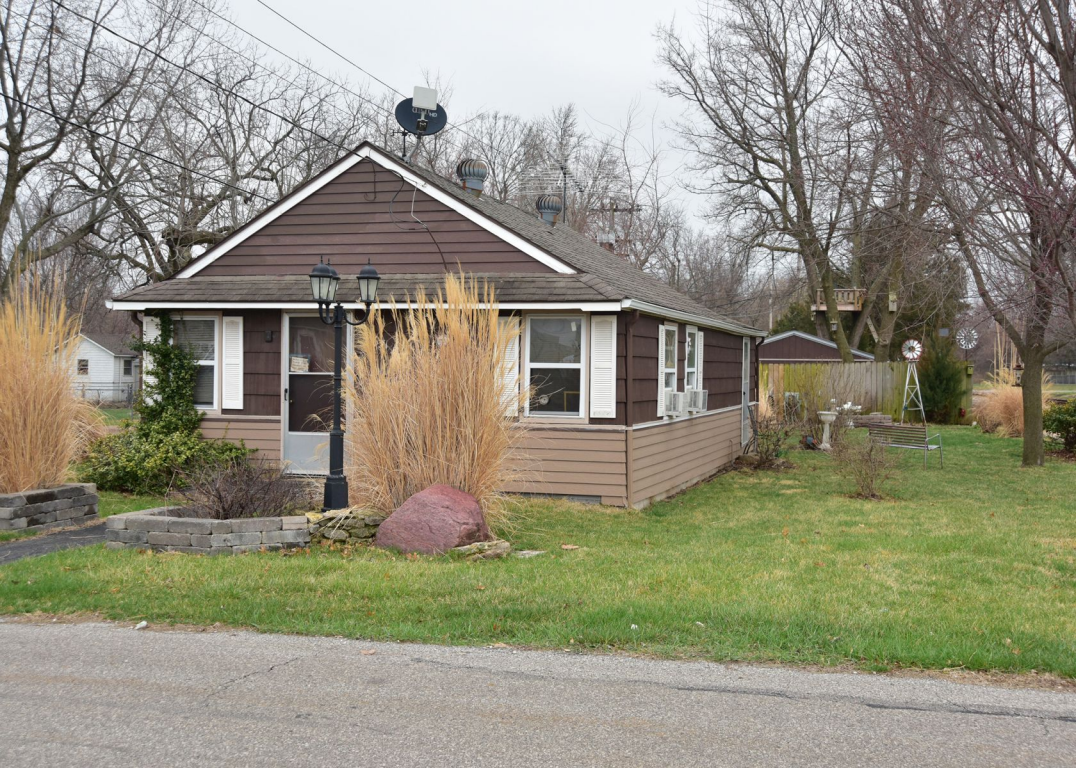
"This one-story, gable-front house has a rectangular footprint that is three asymmetrical bays wide and three asymmetrical bays deep. The side eaves wrap the front façade to form a pent roof that shelters the stoop entrance in the center bay. Defining the remaining bays are single one-over-one light, double-hung sash windows flanked by shutters. Wood clapboards with a wide profile clad the lower half of the exterior walls and wood shingles clad the upper half of the exterior walls (Davis and Schwenk, 2003)."

Vinyl siding now clads the lower third of the dwelling. 611 Rhodes Avenue otherwise does not appear significantly altered from its 2003 appearance. Dates of alteration are unknown, however pre-date the 2003 survey.

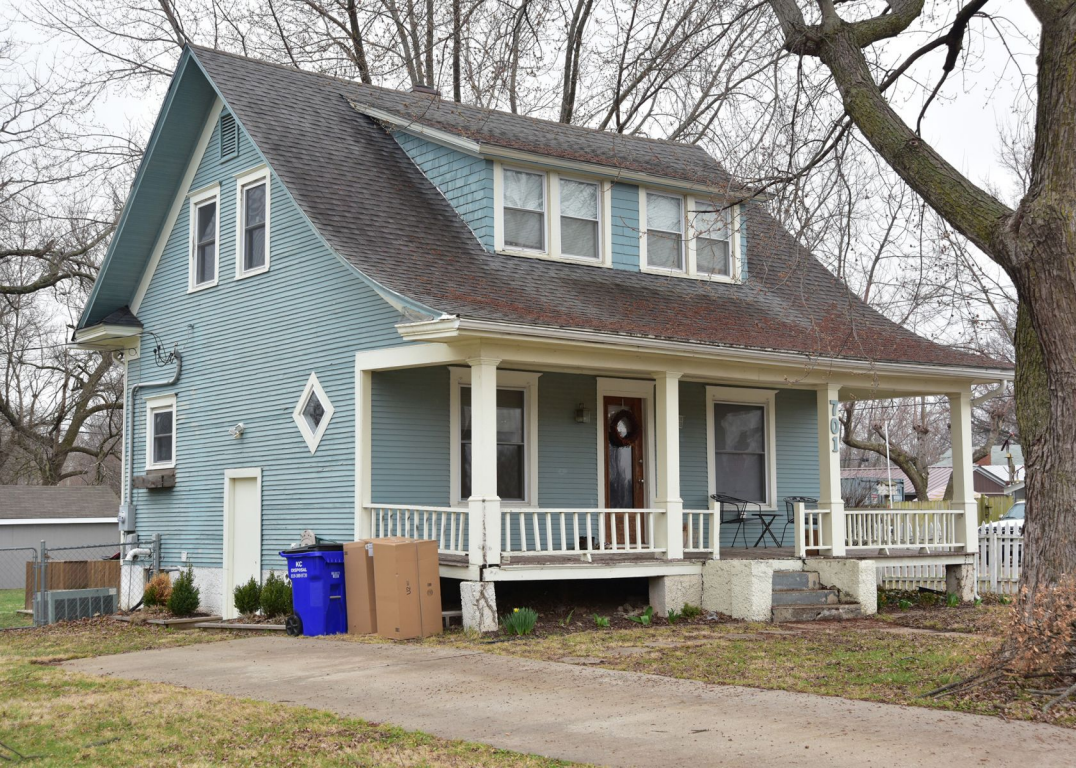
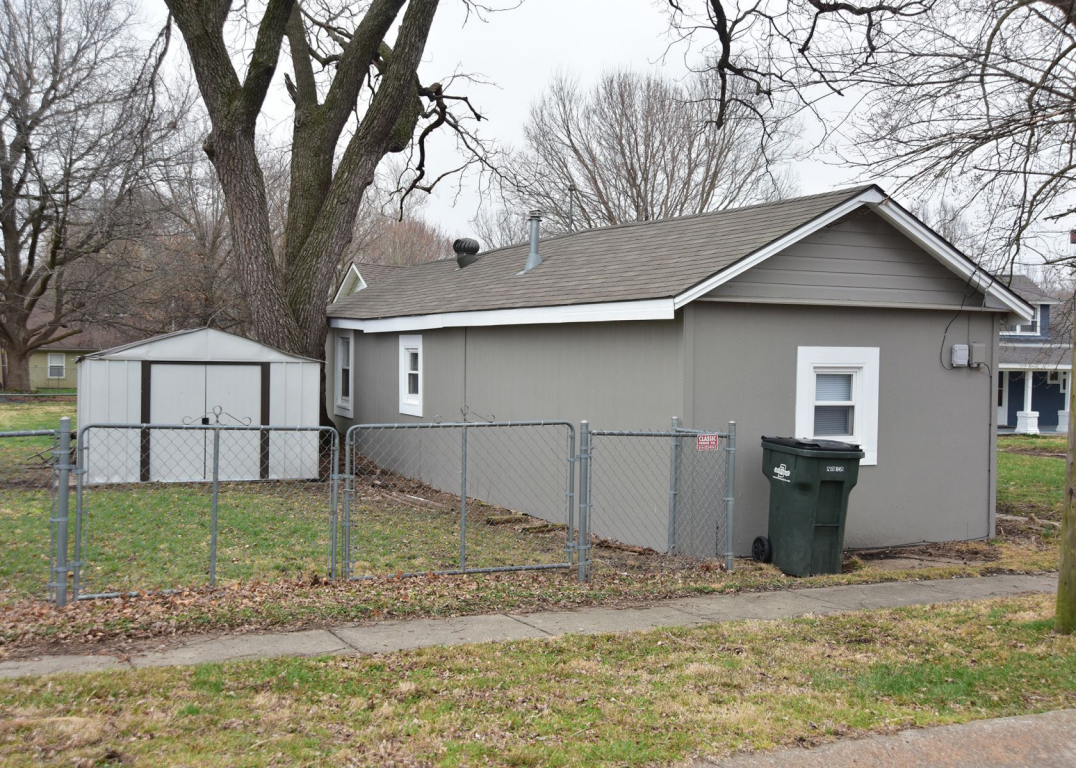
"This one-and-a-half-story, side-gabled bungalow has a rectangular footprint that is three symmetrical bays wide and three bays deep. The front roof slope projects to form the full-width porch roof, which is supported by square columns and shelters the center bay entrance. Defining the other two bays are single one-over-one light, double-hung sash windows with flat board trim and modest crown molding. A shed dormer centered in the front roof slope contains two paired one-over-one light, double-hung sash windows. Additional character-defining features include the matchstick porch balustrade, wide eaves, a diamond-shaped window on the secondary (east) façade, narrow profile clapboards, and wood shingle cladding on the dormer (Davis and Schwenk, 2003)."

701 Rhodes Avenue does not appear significantly altered from its 2003 appearance.

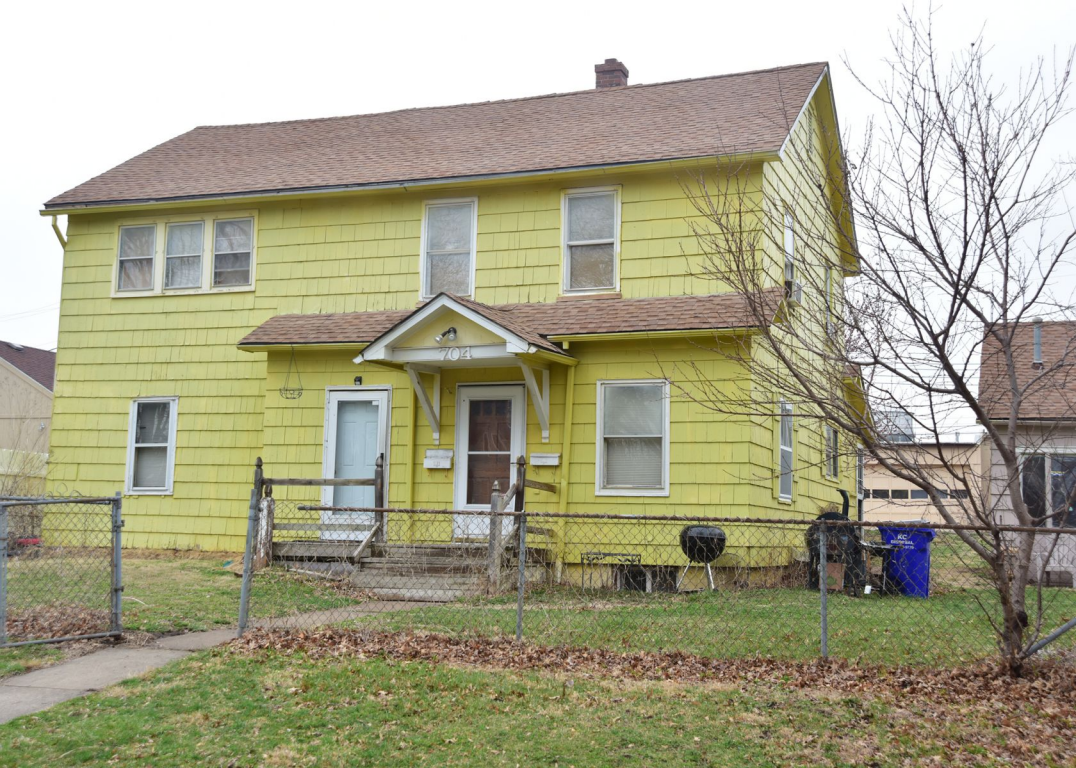
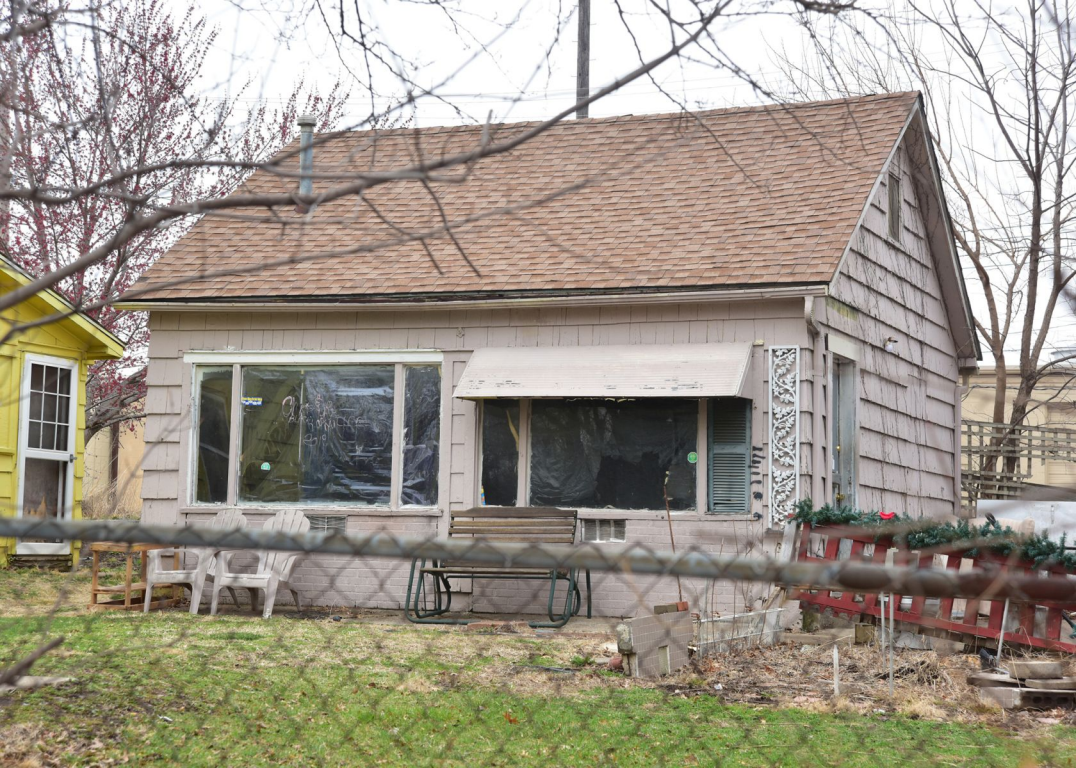
"This two-story, side-gabled duplex has a rectangular footprint that is four asymmetrical bays wide and two bays deep. This building has a one-bay rear addition with a shed roof. Painted wood shingles clad the exterior walls. At the three east end bays, a shallow pent roof shelters a small projection of the front wall. Knee brackets support the gable-front roof above the stoop for the eastern entrance of the two center bay entrances. The west entrance is unsheltered. Defining the remaining bays of the primary façade are single and triple one-over-one light, double-hung sash windows flanked by three-plank shutters (Davis and Schwenk, 2003)."

The shutters are no longer present. 704 Rhodes Avenue otherwise does not appear significantly altered from its 2003 appearance.

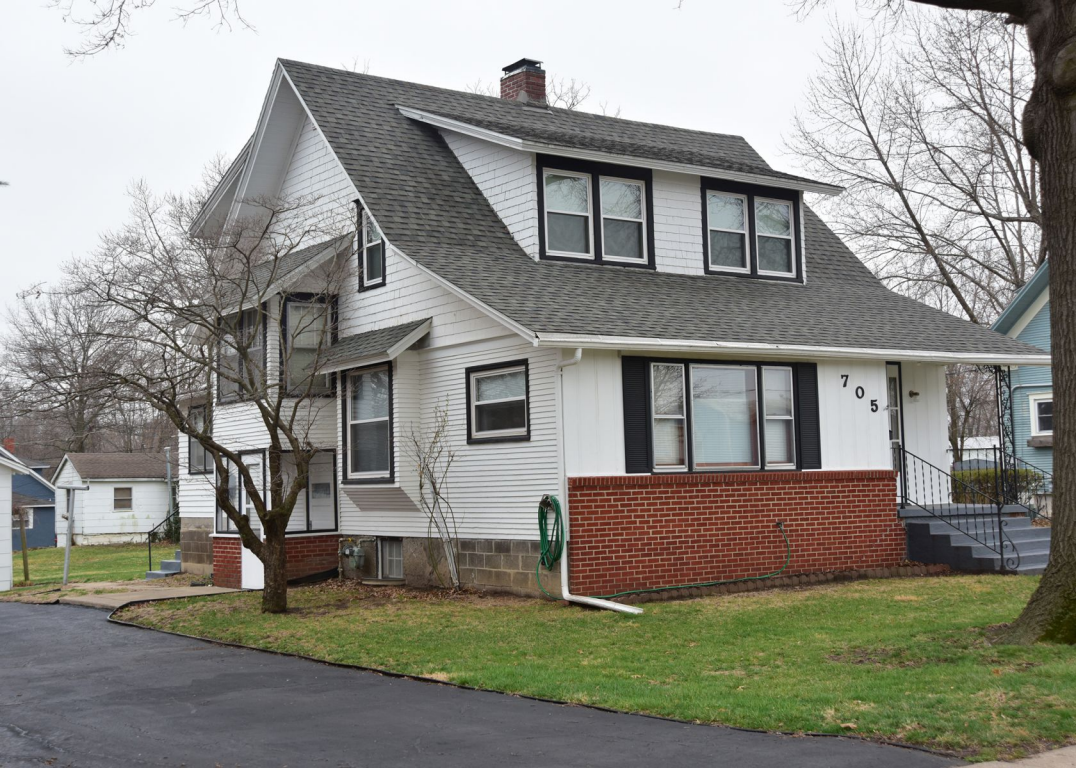
"This one-and-a-half-story, side-gabled bungalow house has a rectangular footprint that is two asymmetrical bays wide and four bays deep. The front roof slope projects to form the full-width porch roof. Decorative iron posts support the west third of porch roof, sheltering the west end bay entrance with sidelights. The east two-thirds of the porch has been enclosed and contains a tripartite picture window flanked by one-over-one light, double-hung sash windows and shutters. A shed dormer centered in the front roof slope contains two paired one-over-one light, double-hung sash windows with flat board trim. Additional character-defining features include wide eaves, first-story narrow clapboard cladding, second-story wood shingle cladding, and square window bays with shed roofs on secondary elevations. The enclosure of the character-defining front porch and the introduction of modern materials and window sash compromise the integrity of this building (Davis and Schwenk, 2003)."

The primary elevation features brick veneer at the lower third of the enclosed porch. The remainder of the primary elevation features board-and-batten siding. 705 Rhodes Avenue otherwise does not appear significantly altered from its 2003 appearance.

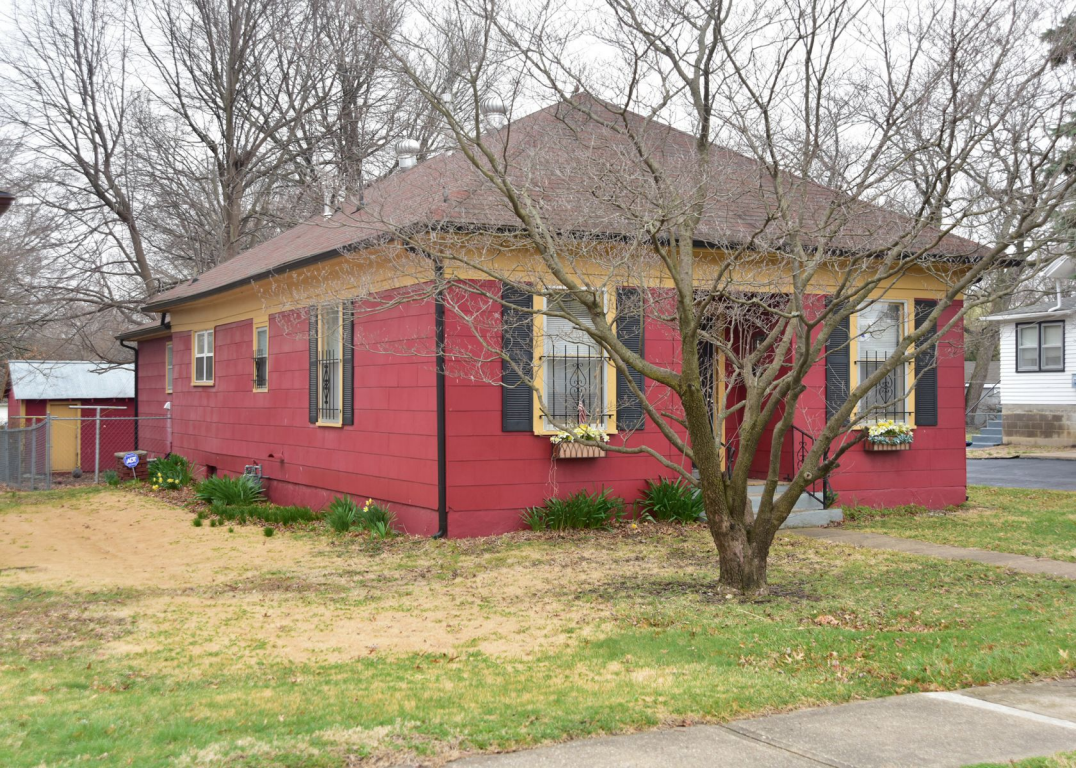
"This one-story Pyramidal Roof folk house has a rectangular footprint that is three symmetrical bays wide and three bays deep. The recessed center bay shelters the entrance, which features flat board trim and modest crown molding. Defining the other two bays of the primary façade are single one-over-one light, double-hung sash windows with flat board trim and shutters. Additional character-defining features include a tall, plain frieze band under the wide eaves (Davis and Schwenk, 2003)."

Aluminum storm windows are present at all elevations visible from the right-of-way. 707 Rhodes Avenue does not appear significantly altered from its 2003 appearance. Dates of alteration are unknown, however pre-date the 2003 survey.

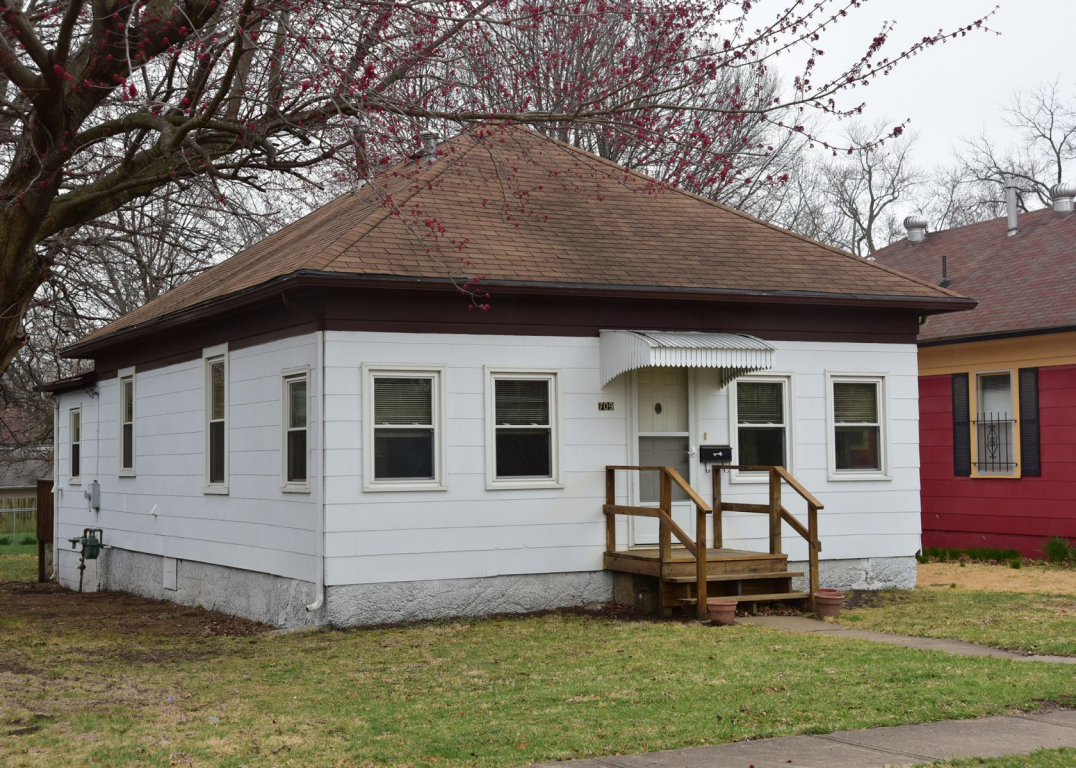
"This one-story Pyramidal Roof folk house has a rectangular footprint that is five symmetrical bays wide and four asymmetrical bays deep. An aluminum awning shelters the center bay entrance. Single one-over-one light, double-hung sash windows define the remaining bays of the primary façade. Additional character-defining features include a deep, plain frieze band under the wide eaves. The application of non-original wall cladding materials and the replacement of original sash windows compromise the integrity of this building. However, because of its unique form, it still conveys its historic associations to the folk house property type (Davis and Schwenk, 2003)."

The dwelling features asbestos shingle siding, vinyl replacement windows, an asphalt roof, and a parged foundation. A wood deck projects from the south elevation and a short run of modern, wood stairs has been placed over the existing concrete stairs at the façade. It unknown when the alterations were made, however they pre-date the 2003 survey. 709 Rhodes Avenue does not appear to be significantly altered from its 2003 appearance.

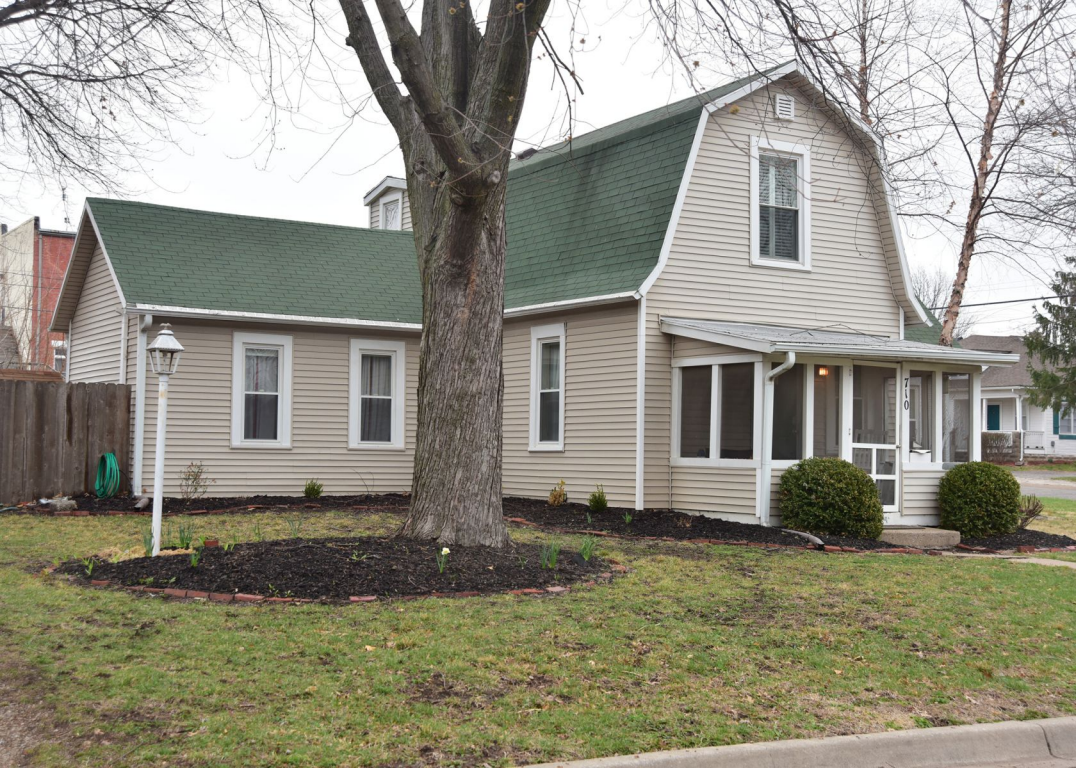
"This one-and-a-half-story house has a gambrel-front roof and two lower cross gable roofs that project from the rear of each side elevation, resulting in a complex roof shape. This dwelling has an irregular footprint that is three bays wide and three bays deep. In the center bay, the enclosed porch has a shed roof sheltering the entrance. Defining the remaining bays on each elevation are single one-over-one light, double-hung sash windows. Projecting from each side slope of the front gambrel roof are two shallow gabled dormers (Davis and Schwenk, 2003)."

The dwelling has been reclad with aluminum siding. Dates of prior alteration are unknown, however pre-date the 2003 survey.

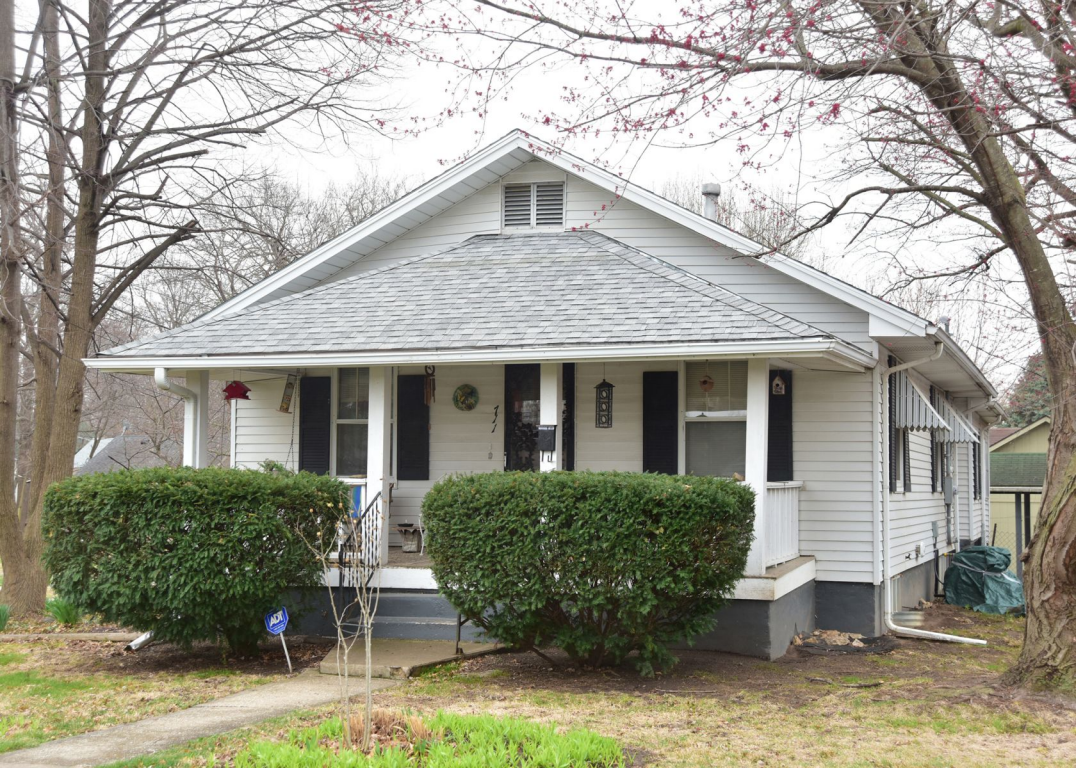
"This one-story, gable-front bungalow has a rectangular footprint that is three symmetrical bays wide and five bays deep. Square wood posts support the three-quarter-width porch's hipped roof, which shelters the center bay entrance and features a matchstick balustrade. Defining the remaining bays are original, single three-over-one light, double-hung wood sash windows flanked by shutters. Additional character-defining features include wide eaves. The application of vinyl siding combined with the loss of original porch elements compromise the integrity of this building (Davis and Schwenk, 2003)."

711 Rhodes Avenue does not appear significantly altered from its 2003 appearance. Dates of alteration are unknown, however pre-date the 2003 survey.

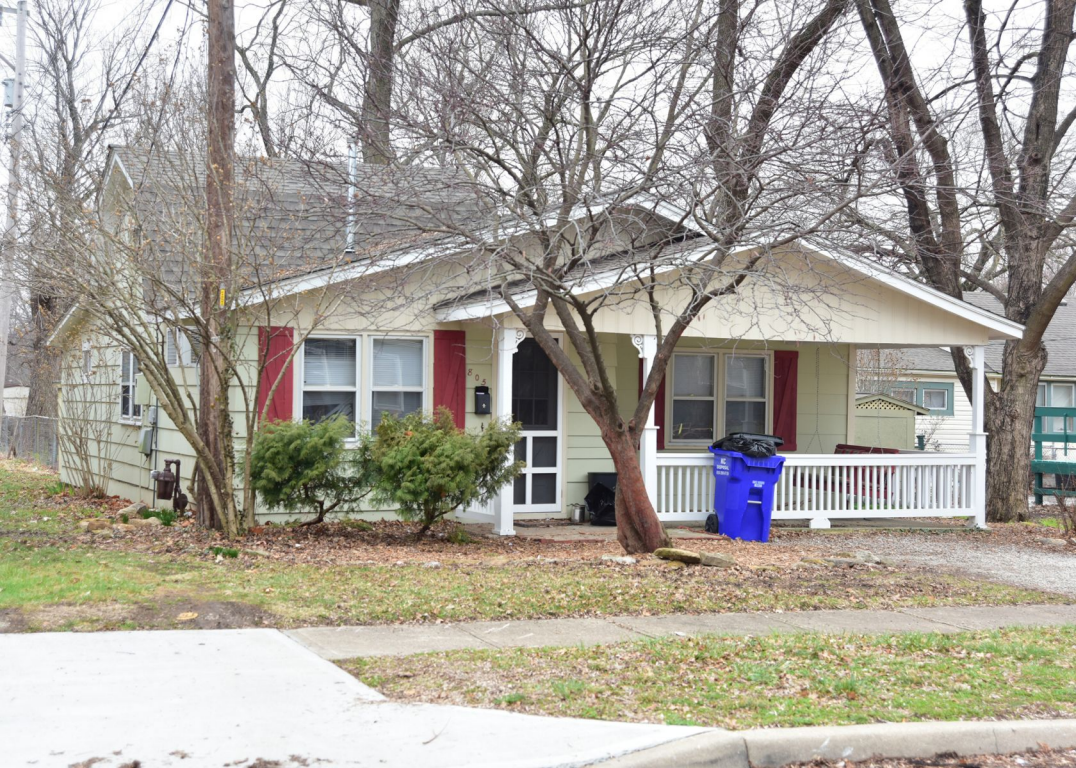
"This one-story, gable-front house incorporates an early-twentieth-century gambrel roof barn at the rear, resulting in an irregular footprint that is three asymmetrical bays wide and two bays deep. Dominating the primary façade are two shallow-pitched nested gables, the narrower of which projects and shelters the entrance in the center bay. Defining the other bays are paired one-over-one light, double-hung sash windows with shutters. Additional character-defining features include the recessed front wall at the west and bay (Davis and Schwenk, 2003)."

Storm windows partially obscure wood sash windows at all elevations visible from the right-of-way. 805 Rhodes Avenue does not appear significantly altered from its 2003 appearance. Dates of alteration are unknown, however pre-date the 2003 survey.
