MISSOURI DEPARTMENT OF NATURAL RESOURCES
STATE HISTORIC PRESERVATION OFFICE, P.O. Box 176, Jefferson City, MO 65102
ARCHITECTURAL/HISTORIC INVENTORY FORM

1. Survey number: JA-AS-088-001		2. Survey Name: Town of Grandview, Resurvey	
3. County: JACKSON		4. Address (Street No.): 13114 Street (name): 4th Street	
5. City: Grandview	Vicinity <input type="checkbox"/>	6. Lat / Long:	7. Township/Range/Section: T: R: S:
8. Historic name (if known):		9. Present/other name (if known):	
10. Ownership: <input checked="" type="checkbox"/> Private <input type="checkbox"/> Public		11a. Historic use (if known): Domestic-Single Dwelling	11b. Current use: Domestic-Single Dwelling

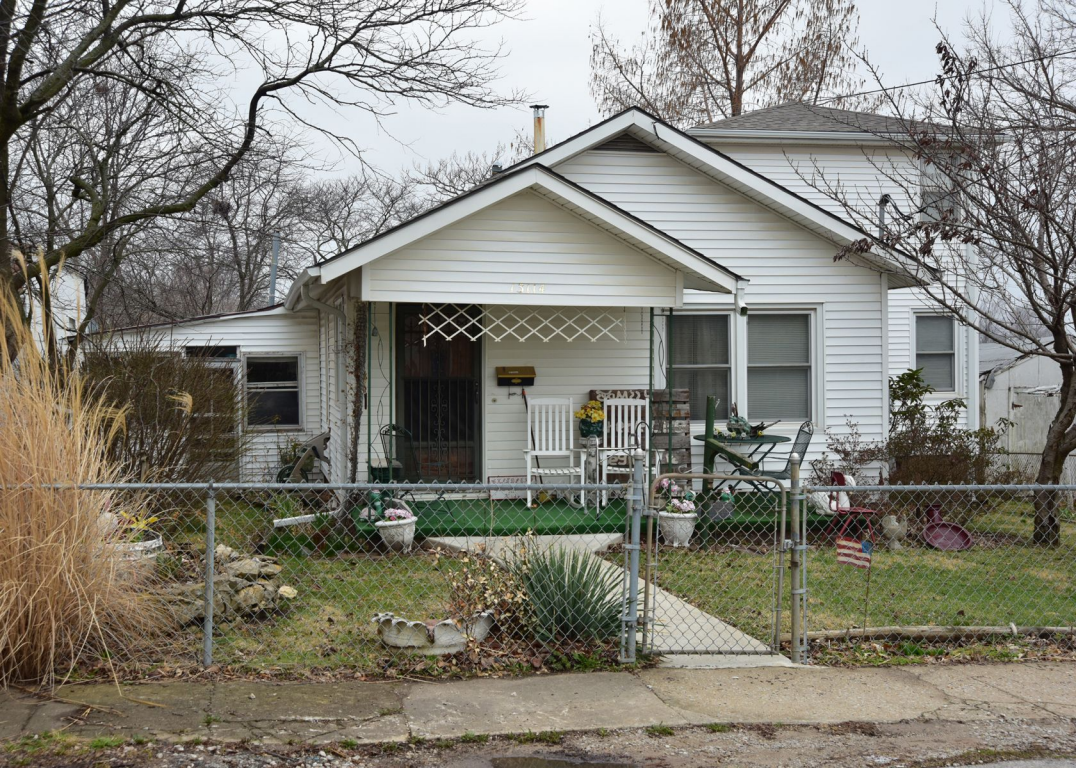
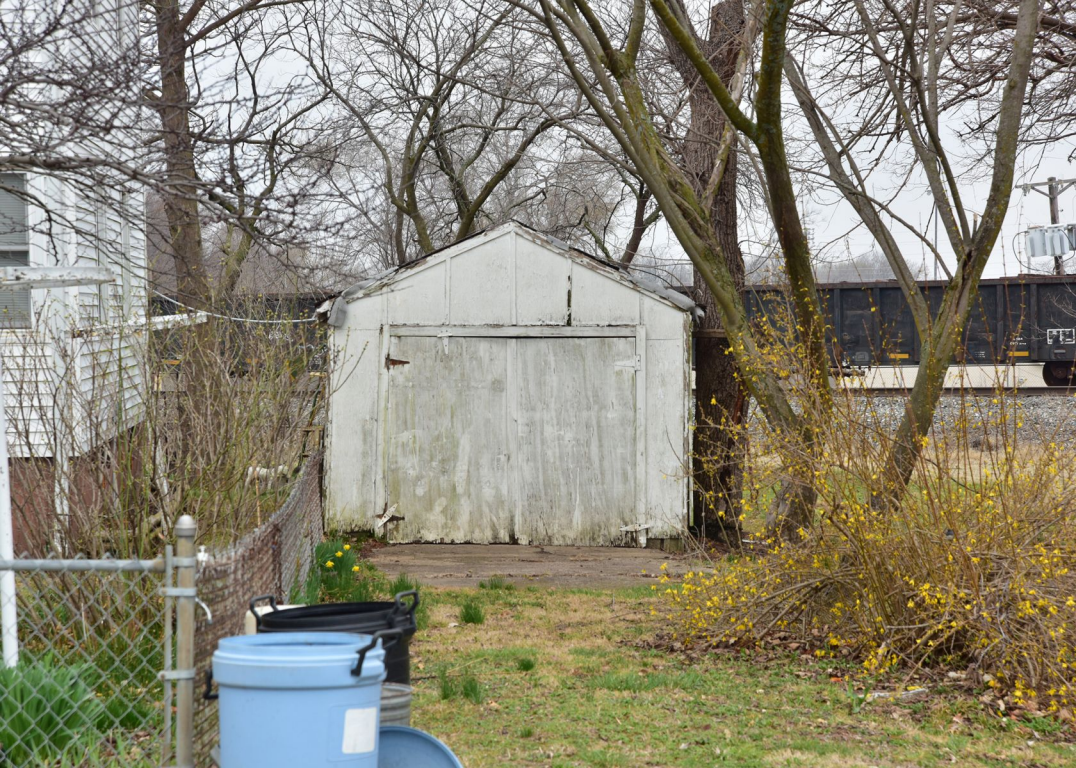
The dwelling appears unchanged since the 2003 survey. Materials include vinyl siding, asphalt roof, and concrete block foundation. Windows are a mixture of aluminum and vinyl.

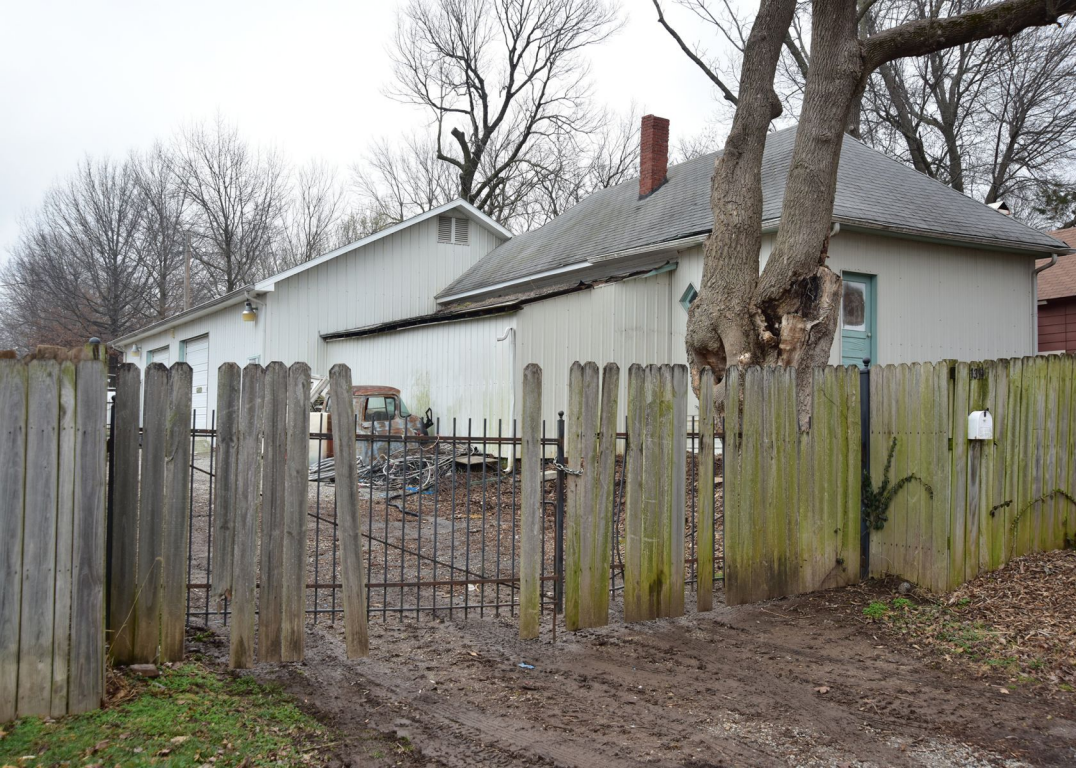
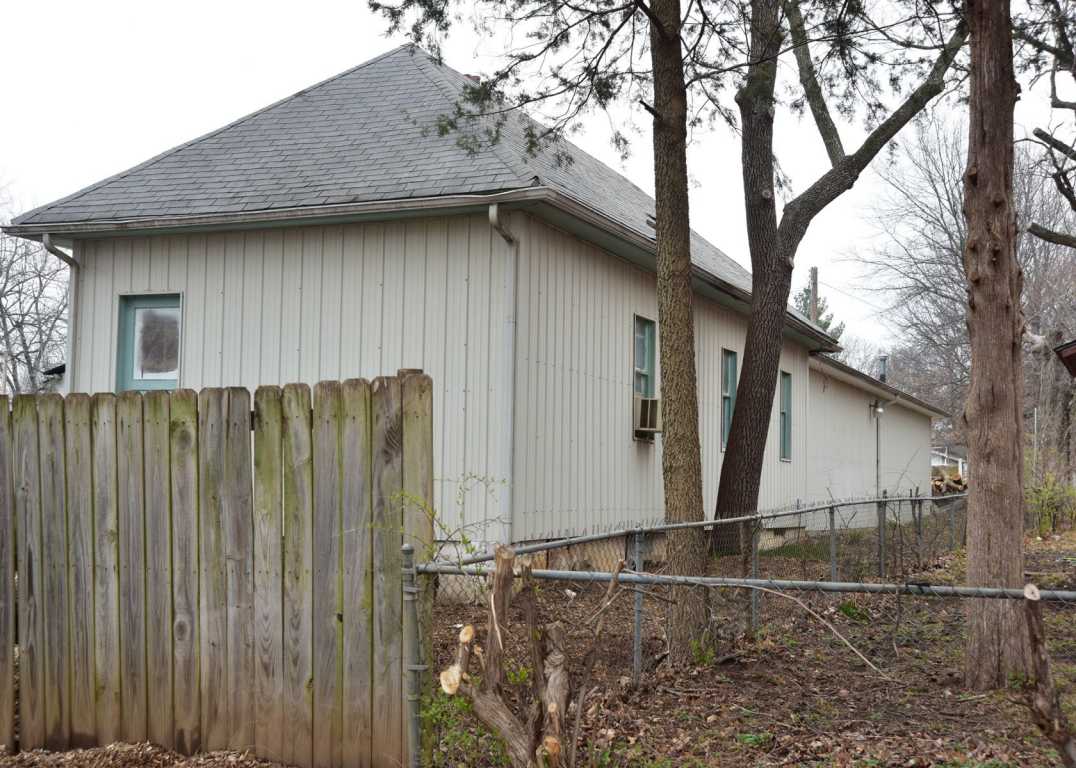
13115 4th Street has been significantly altered through the replacement of historic materials, additions, and the closing of historic fenestration. Consequently, it no longer retains sufficient integrity to clearly convey its historic associations. This resource has poor integrity and is not eligible. The determination of its eligibility is unchanged from the 2003 survey.

13115 4th Street appears unchanged since the 2003 survey. In addition to corrugated metal siding, the building also exhibits an asphalt roof and parged foundation.

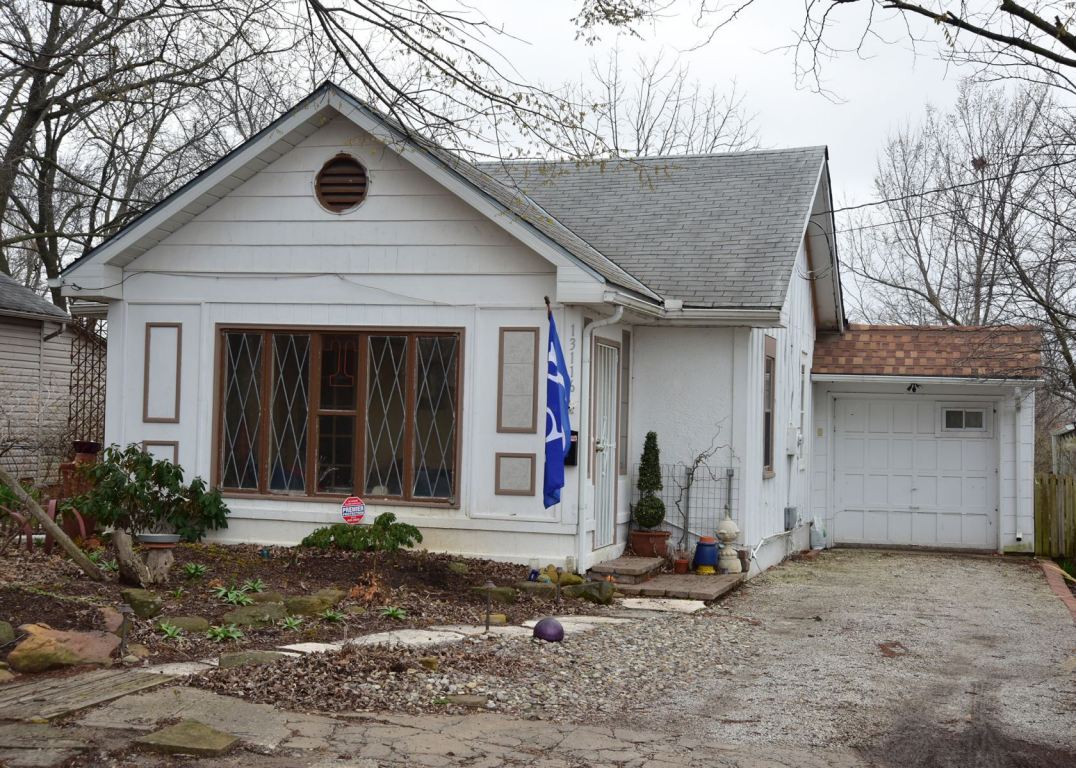
"A projecting enclosed entrance porch with a gable-front roof dominates the façade of this one-story Bungalow house with an intersecting gable roof. The dwelling has an irregular footprint that is one bay wide and five bays deep. The single bay of the primary façade consists of a four-part casement sash window with diamond-shaped leaded glazing. The entrance, which features sidelights, leads perpendicularly into the entrance porch from the south elevation. Additional character-defining features include the wide eaves and the original six-over-one light, double-hung wood sash windows occupying the side elevation bays. The application of non-original stucco wall covering and the enclosure of the front porch compromise the integrity of this building (Davis and Schwenk 2003)."

13116 4th Street does not appear significantly altered from its 2003 appearance. Additional materials include asphalt roofing and wood shingle cladding.

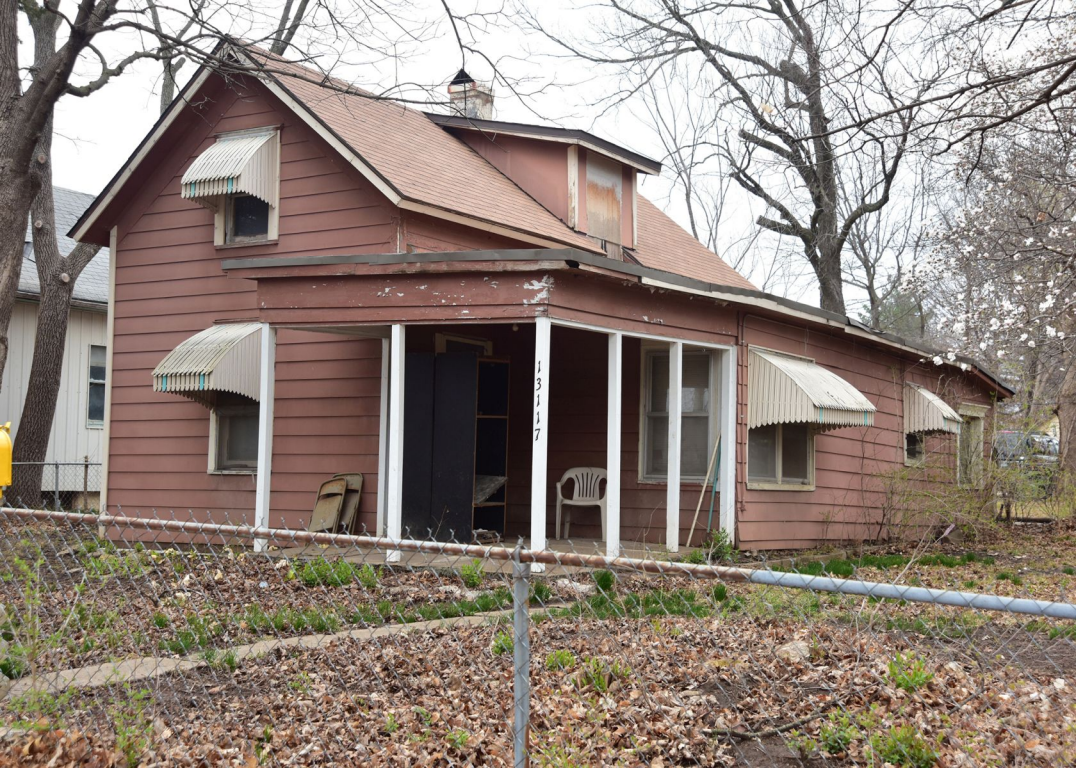
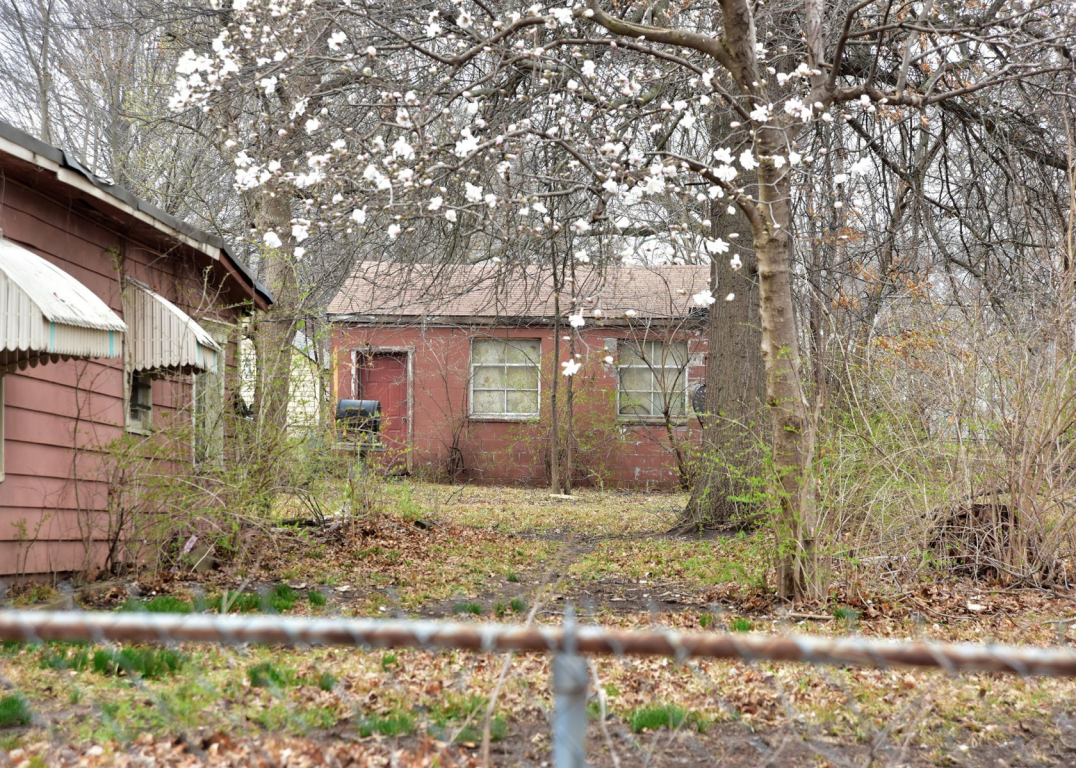
13117 4th Street has been significantly altered through additions and material replacements. These alterations heavily impact the dwelling's ability to convey its historic associations. This resource has fair integrity and is not eligible because there is no concentration of resources that would constitute a historic district. The determination of its eligibility is unchanged from the 2003 survey.

"This one-and-a-half-story, side-gabled house is oriented perpendicular to the street and forms an L-shaped footprint that is two bays wide and four bays deep. Obscuring the original house form are two successive additions with shed roofs and an entrance porch addition with a flat roof. The entrance occupies the first bay of the south elevation. Fenestration defines the bays and includes single one-over-one light, double-hung sash windows. A shed dormer projects from the south roof slope and contains a single window opening covered with plywood. The additions to the south façade compromise the building's ability to convey its historic associations (Davis and Schwenk, 2003)."

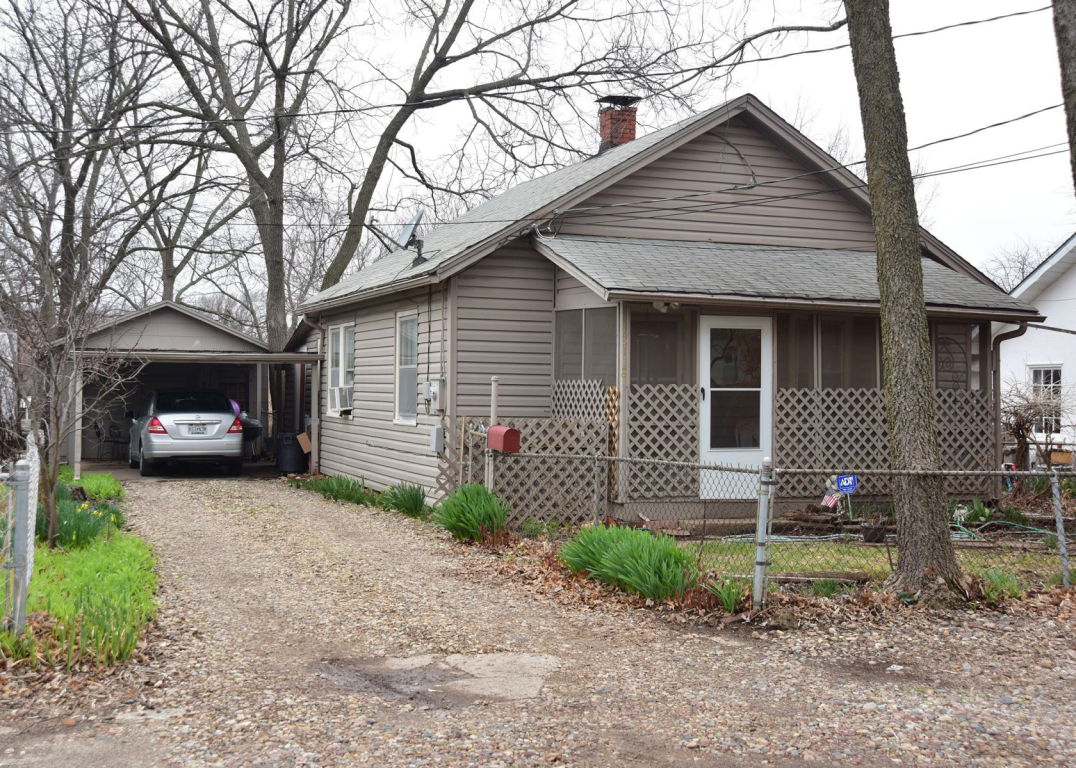
The roof features asphalt shingles and the foundation is not visible. Modern lattice work is attached to the screened porch. The dwelling does not appear significantly altered from its 2003 appearance.

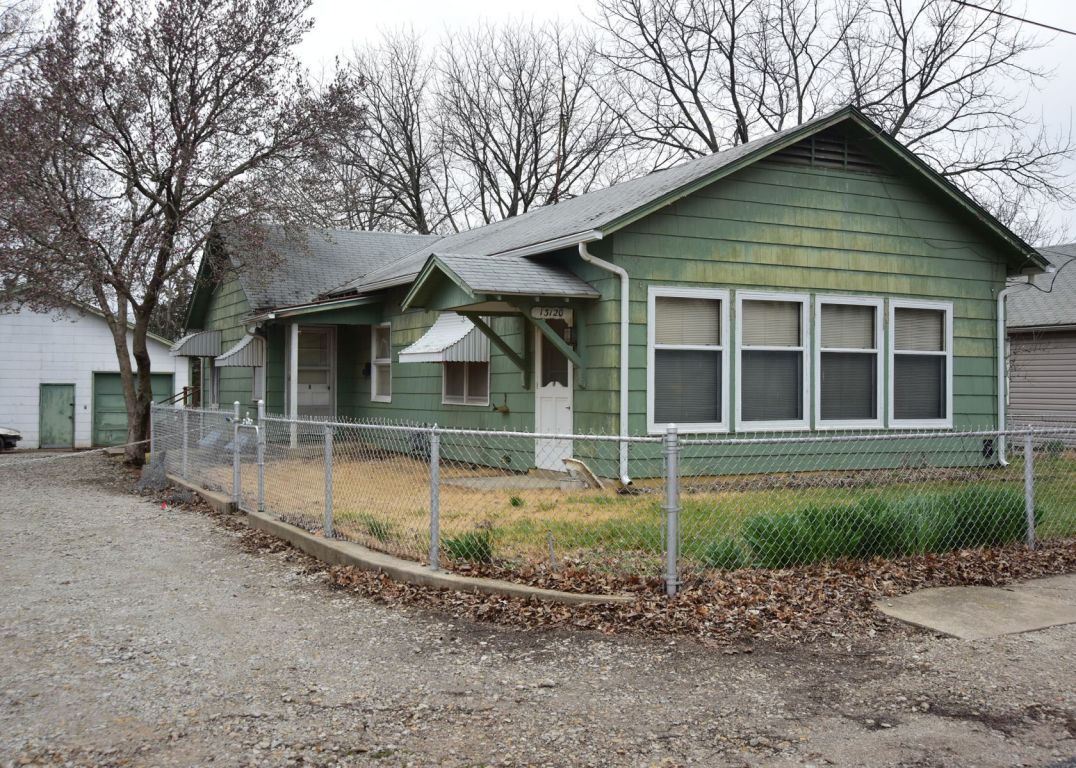
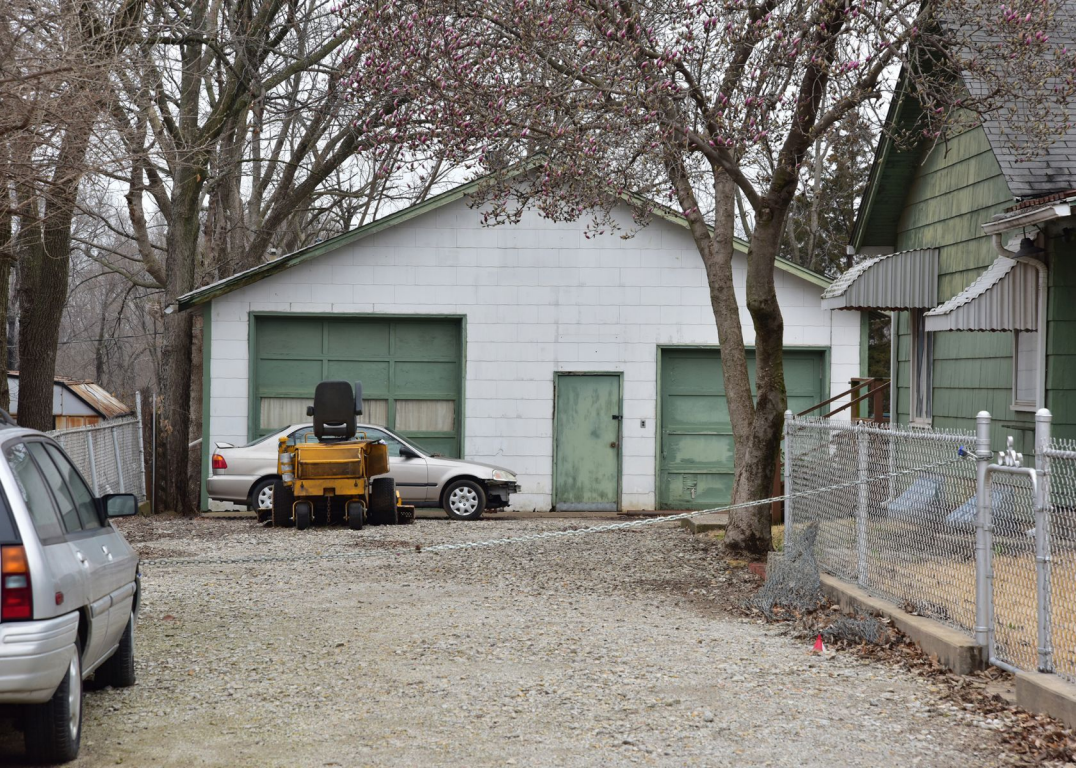
13120 4th Street has been altered through numerous material replacements and the enclosure of the porch. These alterations reduce the dwelling's integrity and negatively impact its ability to convey its historic associations. This resource has fair integrity and is not eligible because there is no concentration of resources that would constitute a historic district. The determination of its eligibility is unchanged from the 2003 survey.

"This one-story, gable-front house has a rear intersecting gable roof and a front-facing L-shaped footprint that is five asymmetrical bays wide and five bays deep. Knee brackets support the projecting gable roof above the stoop at the first bay of the south (side) elevation, leading perpendicularly into the enclosed entrance porch. Defining the remaining bays of each elevation are single, paired, and a band of four modern one-over-one light, double-hung sash windows. Additional character-defining features include the dwelling's wide eaves. The application of non-original wall cladding, the porch enclosure, and alteration of the façade fenestration compromise the integrity of this building (Davis and Schwenk, 2003)."

13120 4th Street does not appear significantly altered from it's 2003 appearance. Metal awnings are present at the south elevation while false shutters are located at the north.

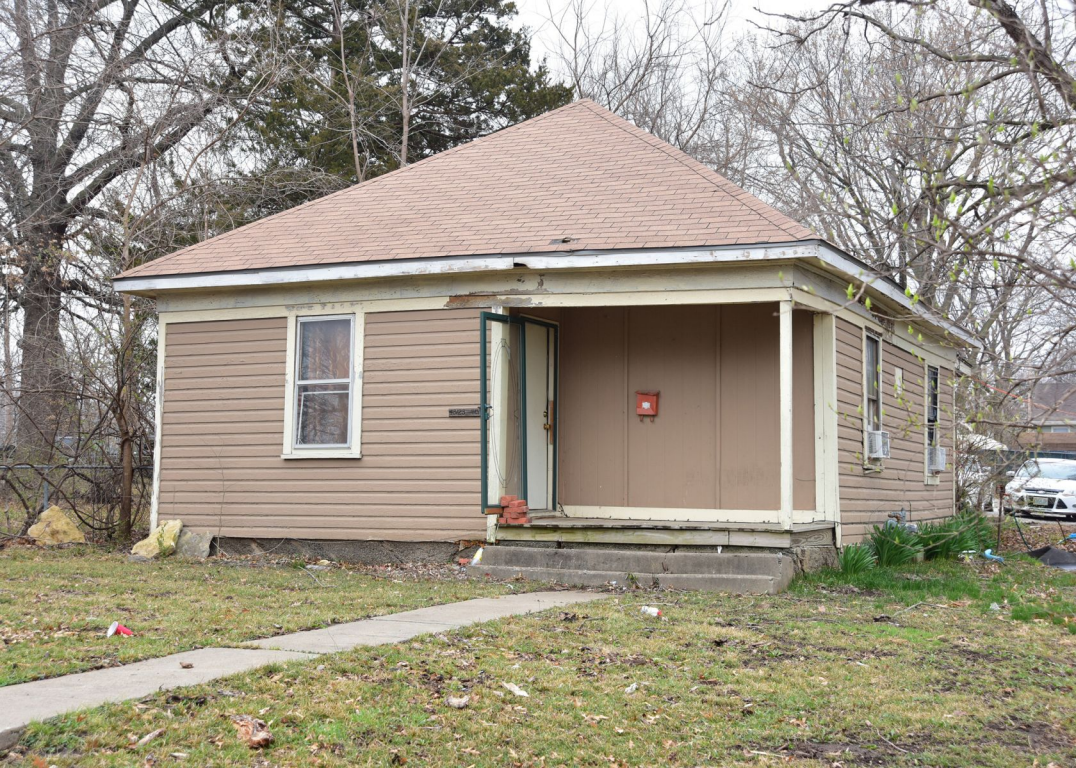
The dwelling appears unchanged since the 2003 survey. Materials include an asphalt roof, wood clapboard siding, and wood sash windows. The foundation is parged and the entry doors are not historic.

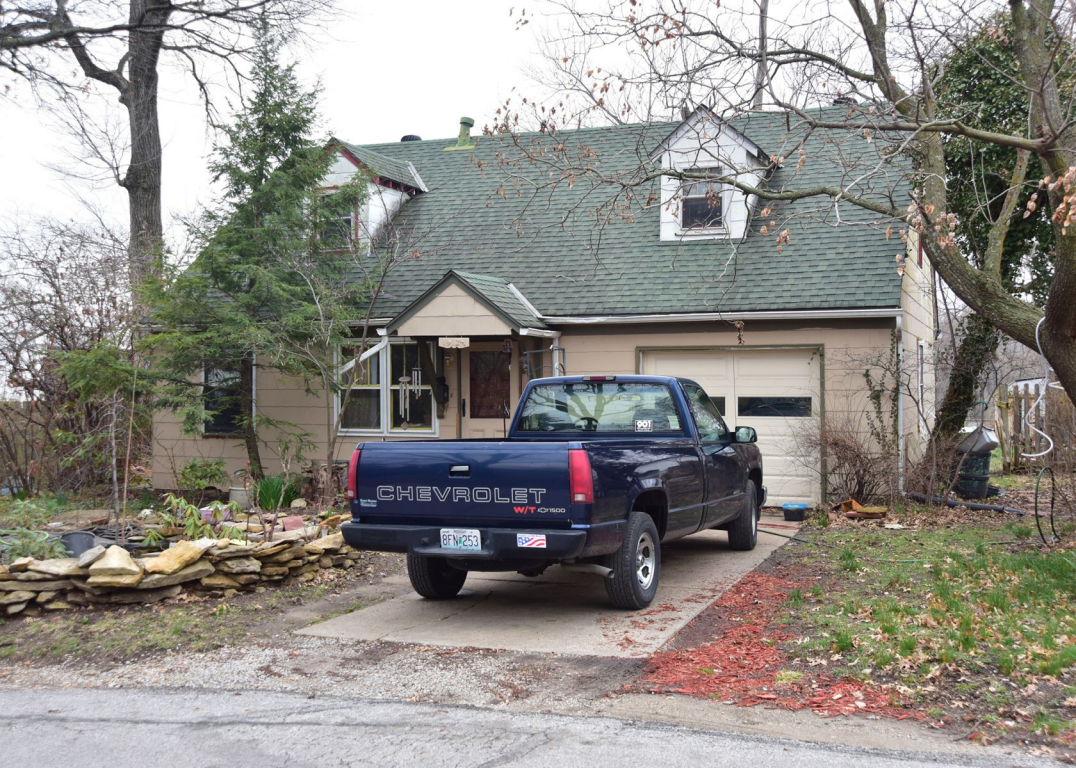
"This one-and-a-half-story, side-gabled Colonial Revival house has a rectangular footprint that is four asymmetrical bays wide. Knee brackets support a small projecting gable that shelters the stoop entrance at the second bay from the north end. Forming the two south end bays are the original single and paired three-over-one light, double-hung wood sash windows. A single-car garage forms the north end bay. Two gabled dormers pierce the front roof slope, each containing a single three-over-one light, double-hung wood sash window. Additional character-defining features include the original asbestos shingle siding, exposed rafter tails at the dormers, and the tight eaves (Davis and Schwenk, 2003).

13124 does not appear significantly altered from its 2003 appearance with the exception of one dormer addition to the rear slope of the roof. This dormer is not readily visible from the right-of-way.

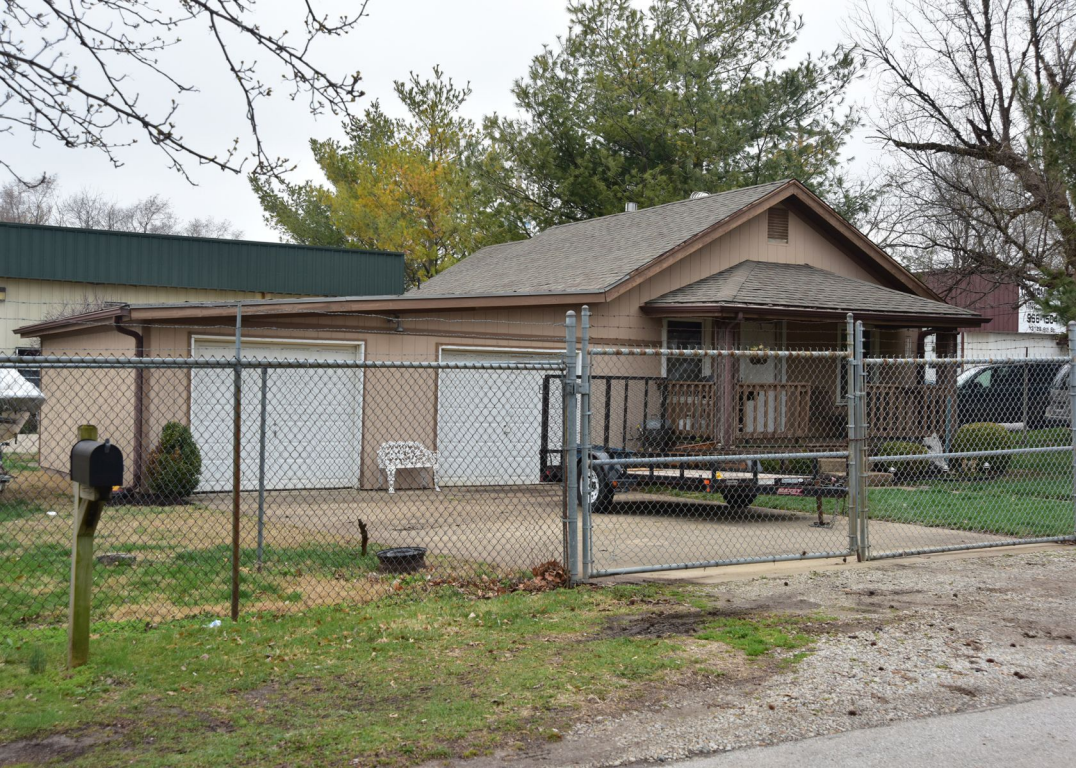
13202 4th Street is within the "Old Town" Conservation District identified by the 2003 survey. This conservation district includes resources associated with the early residential development of Grandview (Davis and Schwenk, 2003,104). 13202 is significantly altered by large additions, the removal of historic porch elements, and material replacements. These alterations significantly impact the dwelling's integrity and resulting ability to convey its historic associations. This resource has poor integrity and is not eligible. The determination of its eligibility is unchanged from the 2003 survey.

"This one-story, gable-front bungalow house has a rectangular footprint that is five asymmetrical bays wide. The two-bay, two-car garage addition at the south elevation has a shed roof. Square wood posts support the three-quarter-width porch's hipped roof, which shelters the center bay entrance. Forming the remaining bays are two single one-over-one light, double-hung sash windows. The large addition to the south elevation, combined with the loss of porch elements and the introduction of new wall cladding and roof materials, compromises the integrity of this building (Davis and Schwenk, 2003)."

13202 4th Street does not appear significantly altered from its 2003 appearance. The dates of alteration are unknown, however they pre-date the 2003 survey.

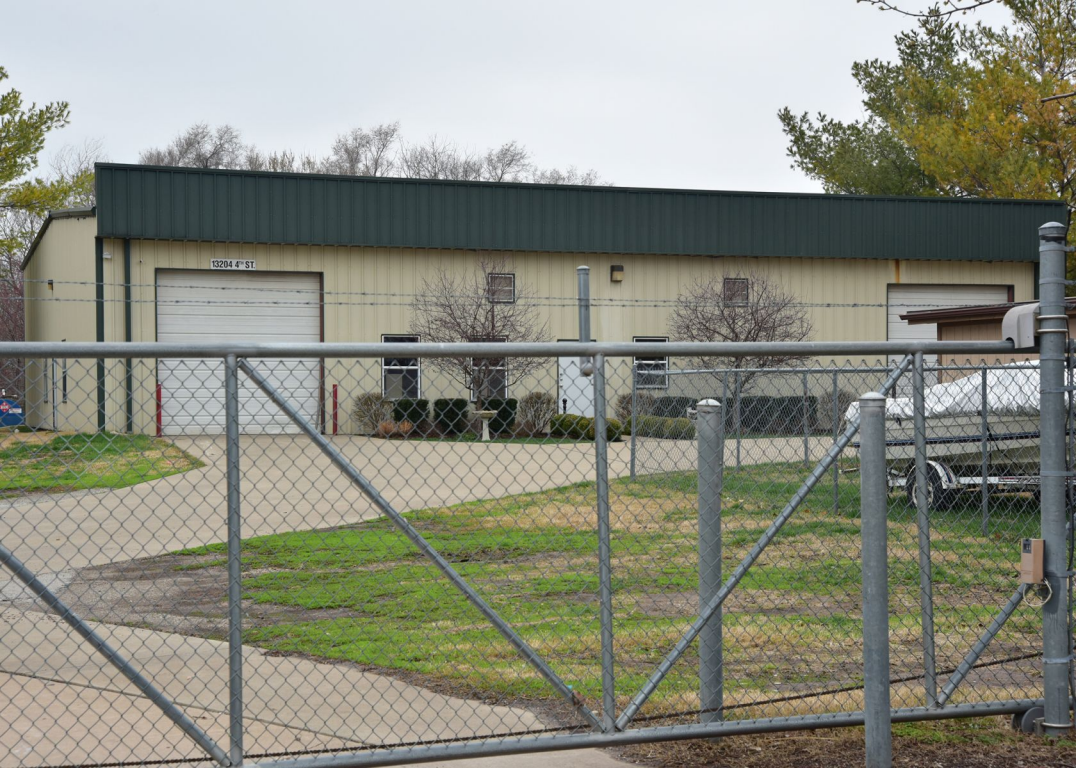
13204 4th ST

"This large, modern, side-gabled commercial building has a rectangular footprint that is six asymmetrical bays wide and three bays deep. Metal clads the roof, exterior walls, and a false-front wall across the front eaves.

Fenestration defines the bays and includes two tall vehicular entrances at the outermost bays, an entrance door at the third bay from the north end, and single one-over-one light, double-hung sash windows (Davis and Schwenk, 2003)." This resource does not appear altered from its 2003 appearance.

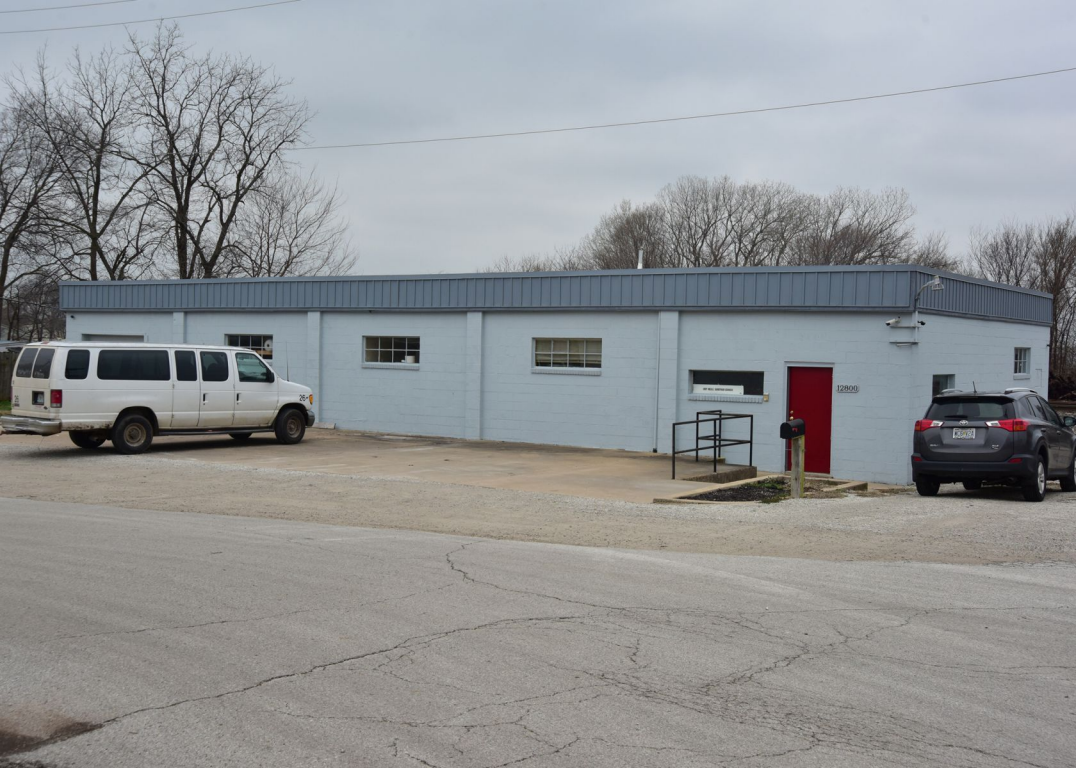
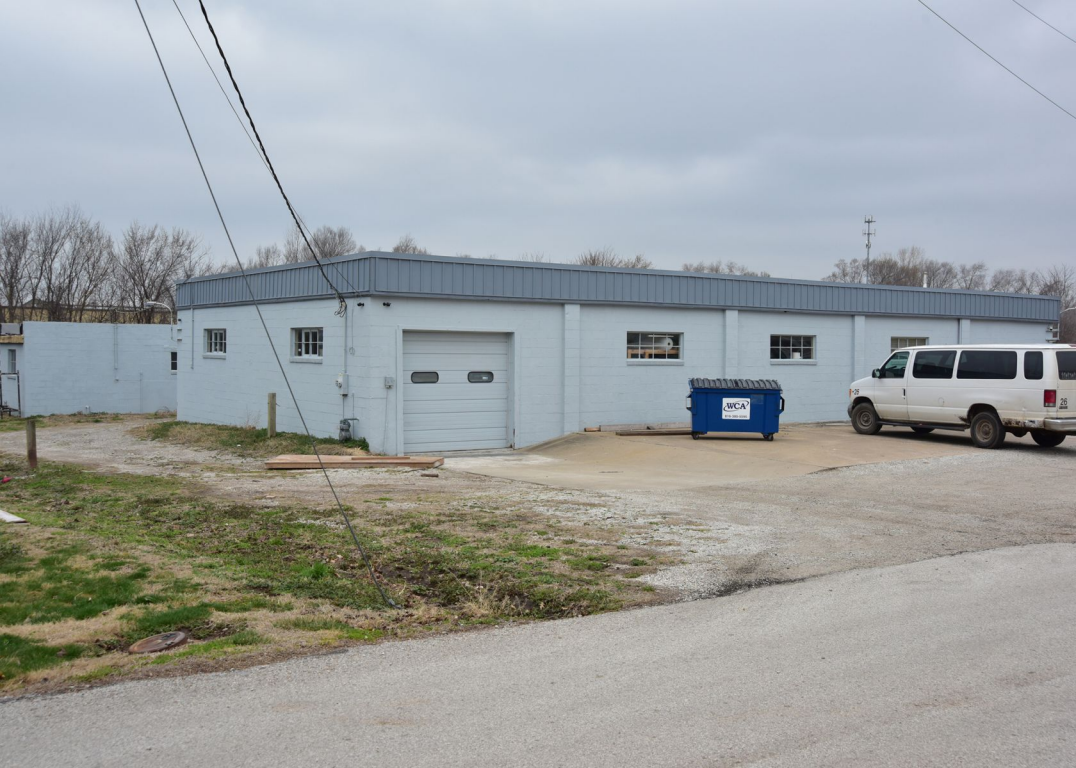
The pent roof is no longer extant. A ca. 2010 flat roof with a metal-wrapped parapet has replaced it.

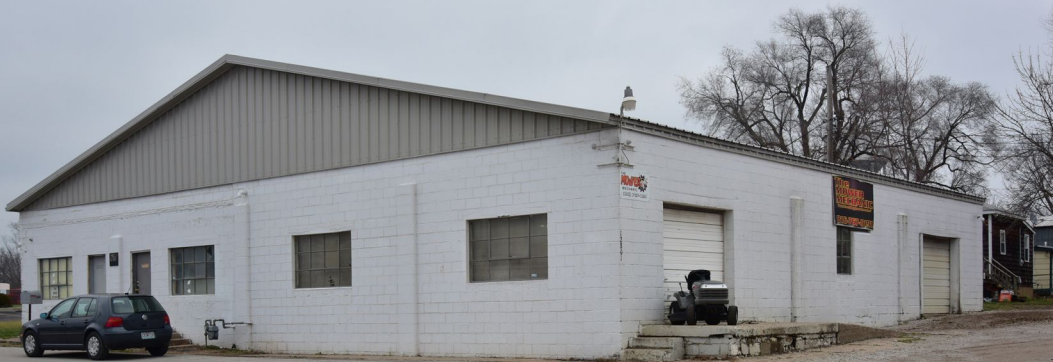
"This one-story, concrete-block industrial storage building has a flat roof and a rectangular footprint that is three bays wide and three bays deep. Concrete block pilasters define the bays of each elevation. A shed roof enclosure shelters the entrance at the north end bay. Twelve-light, steel sash windows with operable hopper sashes form the other bays. A vehicular entrance occupies the first bay of the south (side) elevation (Davis and Schwenk, 2003)."

The roof is now front gabled and the shed roof enclosure has been removed,

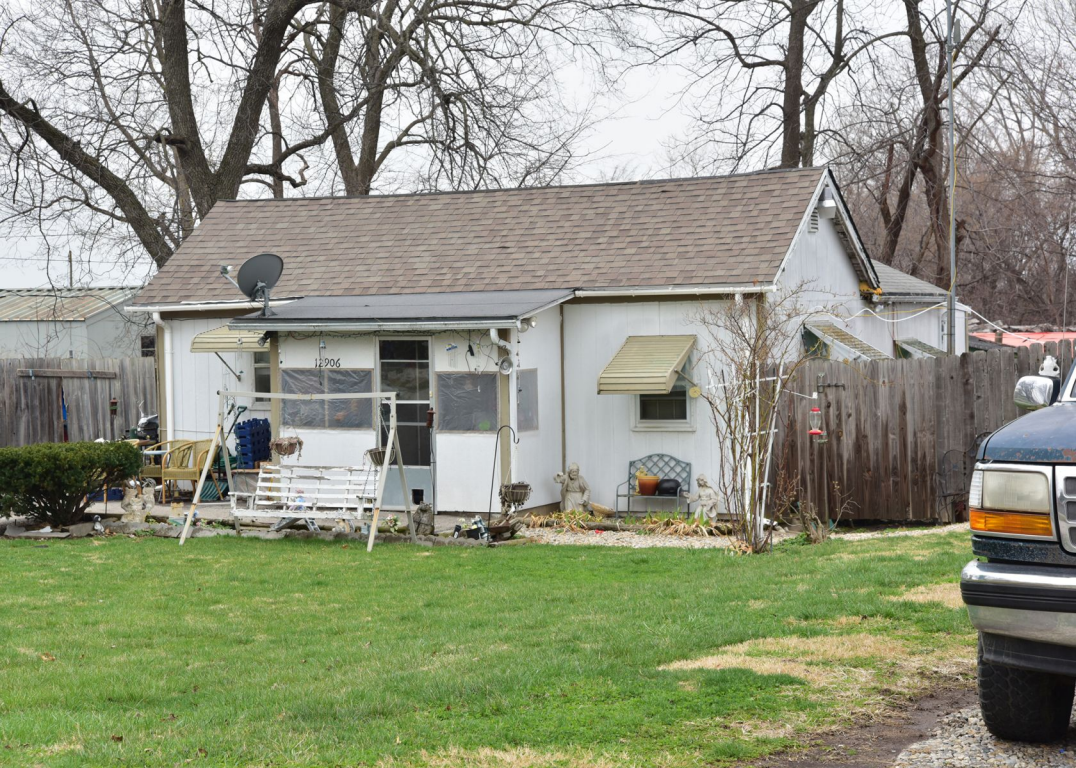
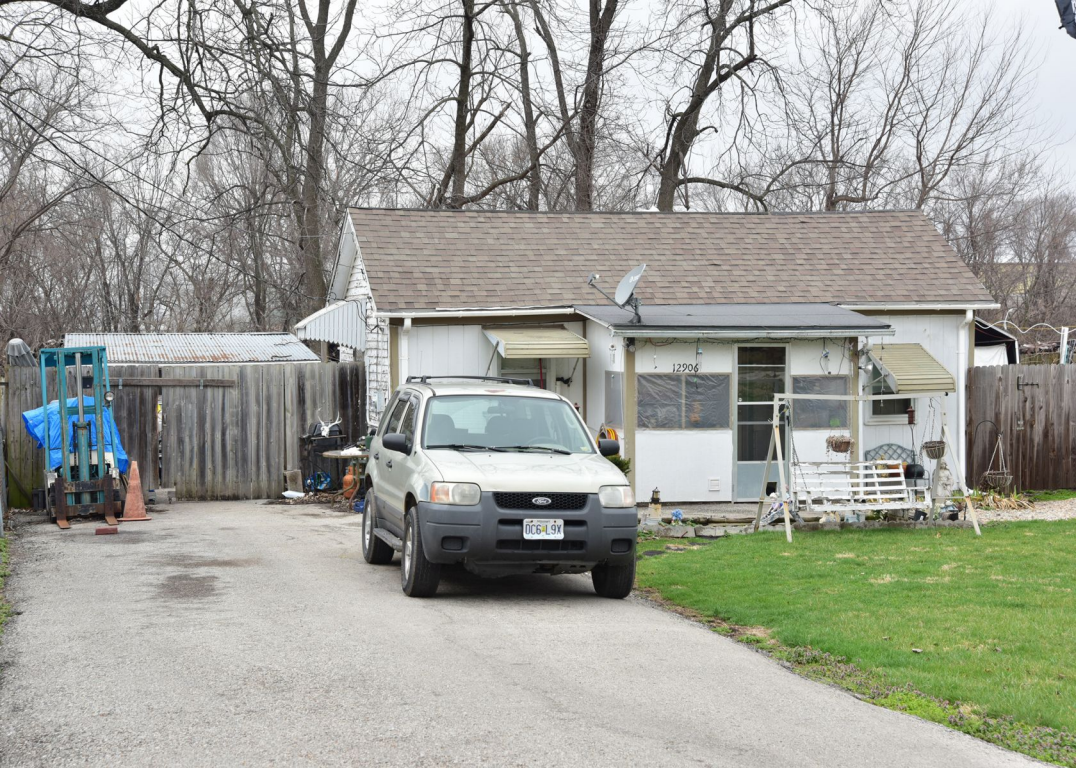
12906 exhibits several alterations. The rear addition and porch enclosure pre-date the 2003 survey. Metal awnings obscure most windows. The roof is asphalt shingle and the foundation for the dwelling is not visible. The porch foundation is concrete.

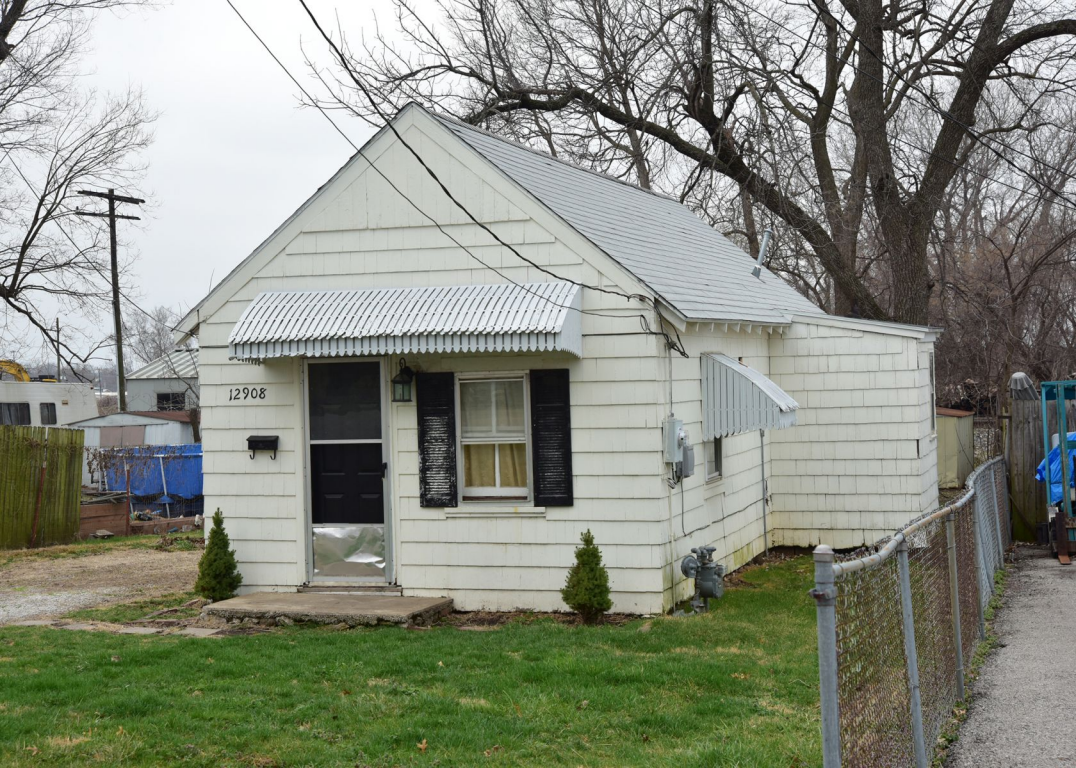
Additional features of 12908 5th Street include metal awnings located at the north and south elevations, asphalt roof, and shutters flanking windows at the façade (east) and south elevation.

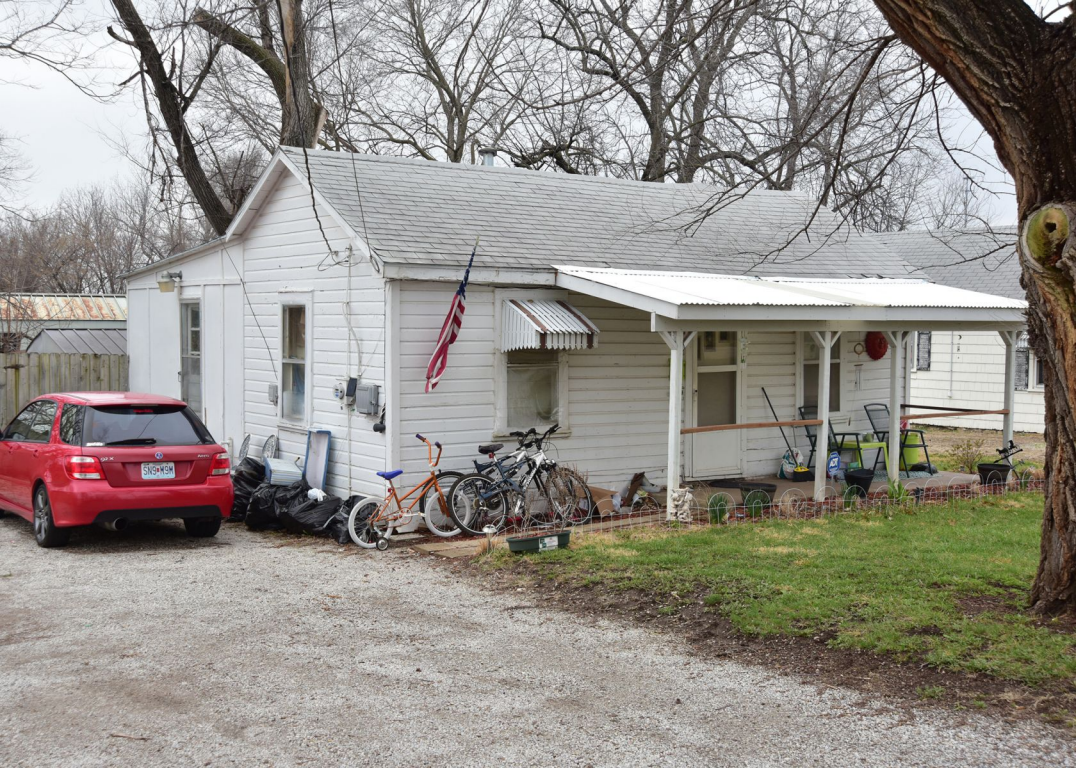
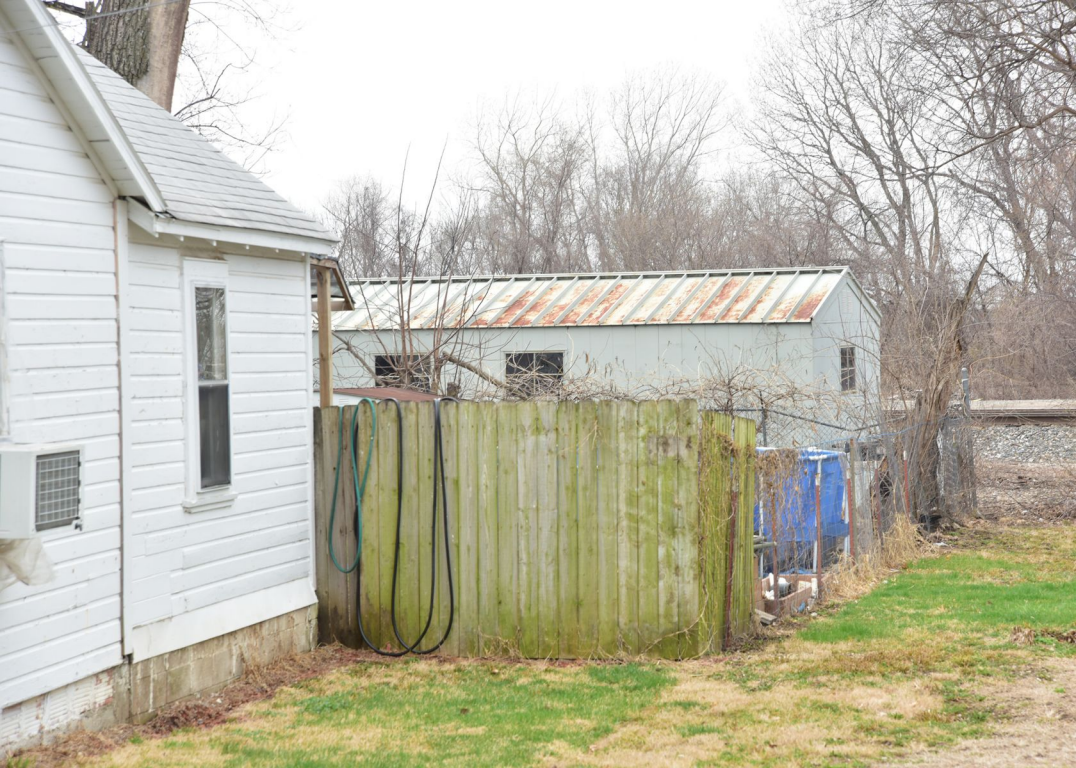
"This one-story Hall and Parlor folk house has a rectangular footprint that is three bays wide and, with a rear shed addition, two bays deep. The Fenestration defines the bays and includes the stoop entrance in the center bay and the single one-over-one light, double-hung sash windows with flat board trim. Additional character-defining features include shiplap wood clapboards with corner boards (Davis and Schwenk, 2003)."

A ca. 2015 corrugated metal shed roof with squared support posts now shelters the concrete porch.

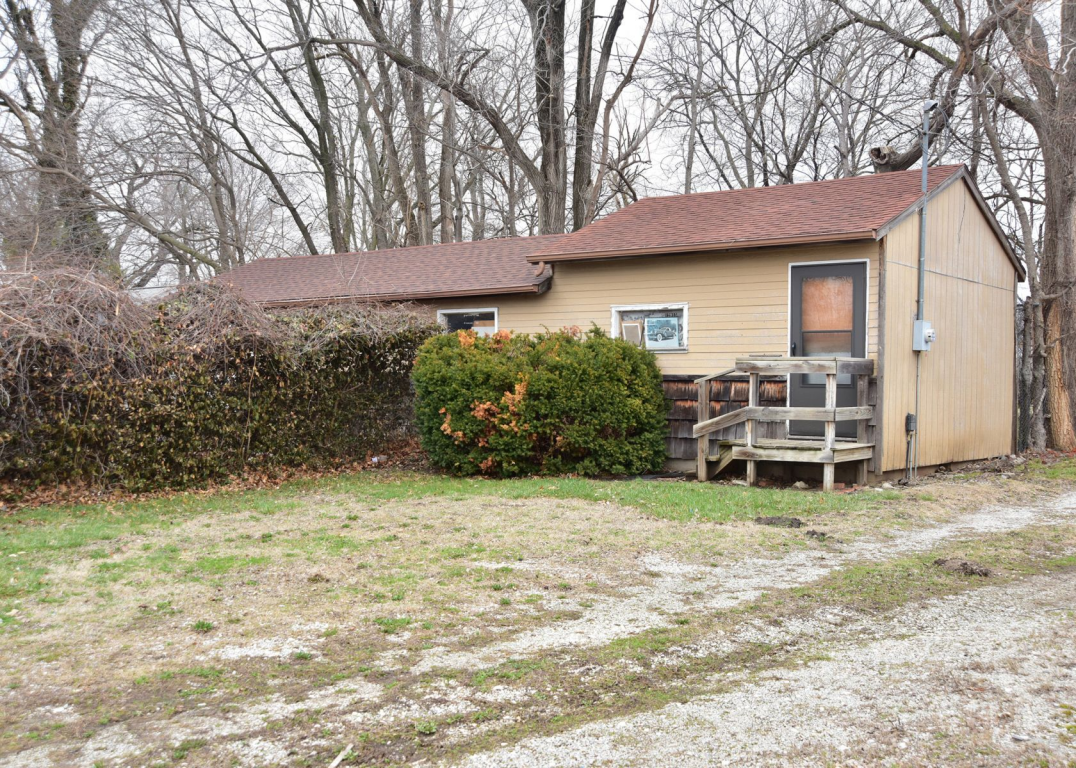
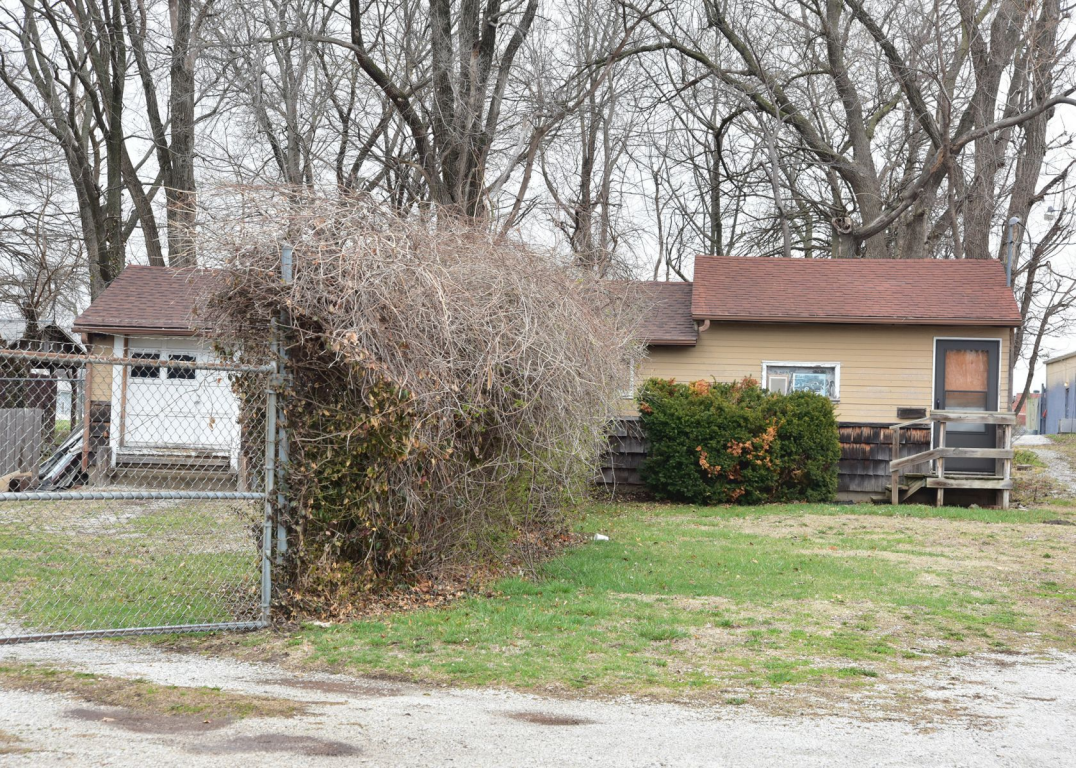
12915 5th Street does not appear significantly altered from its 2003 appearance. The dates of cladding and window replacement are unknown, however they pre-date the 2003 survey.

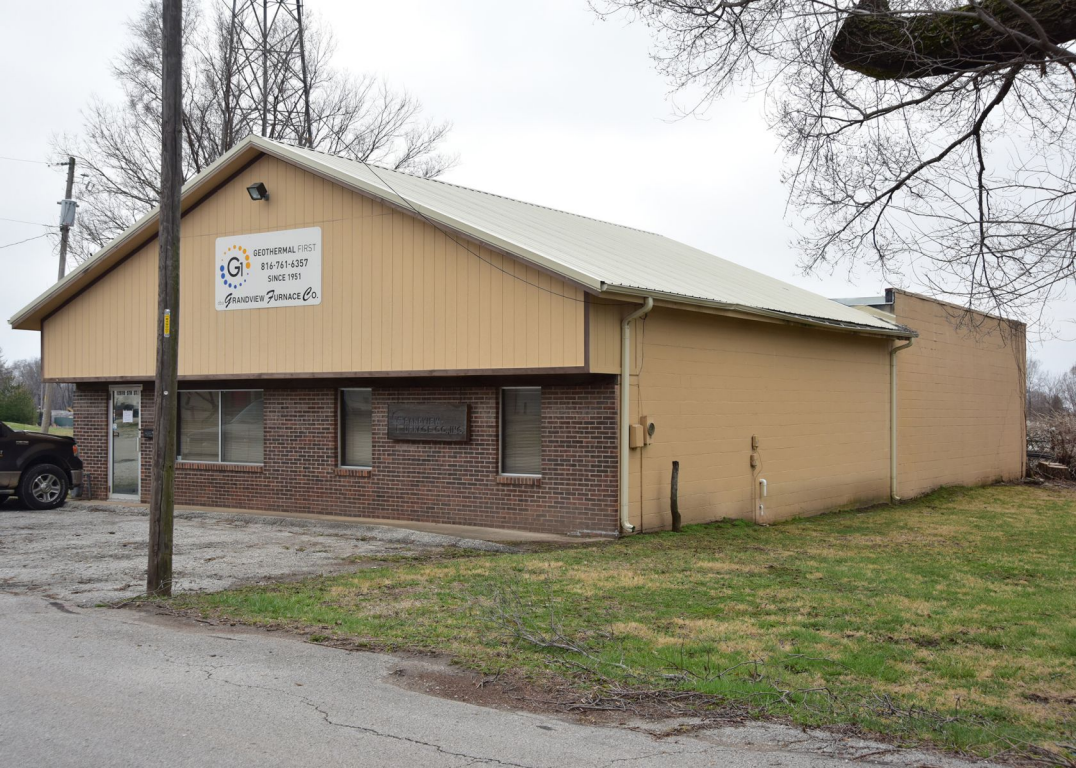
12916 5th Street has been significantly altered since the 2003 survey. The front portion of the formerly flat roof has been replaced by a corrugated metal front-gable roof. The pent roof has been recladded with pressed wood and extended to fill the gable apex. These alterations date ca. 2012 according to aerial imagery.
