MISSOURI DEPARTMENT OF NATURAL RESOURCES
STATE HISTORIC PRESERVATION OFFICE, P.O. Box 176, Jefferson City, MO 65102
ARCHITECTURAL/HISTORIC INVENTORY FORM

1. Survey number: JA-AS-088-001		2. Survey Name: Town of Grandview, Resurvey	
3. County: JACKSON		4. Address (Street No.): 13114 Street (name): 4th Street	
5. City: Grandview	Vicinity <input type="checkbox"/>	6. Lat / Long:	7. Township/Range/Section: T: R: S:
8. Historic name (if known):		9. Present/other name (if known):	
10. Ownership: <input checked="" type="checkbox"/> Private <input type="checkbox"/> Public		11a. Historic use (if known): Domestic-Single Dwelling	11b. Current use: Domestic-Single Dwelling

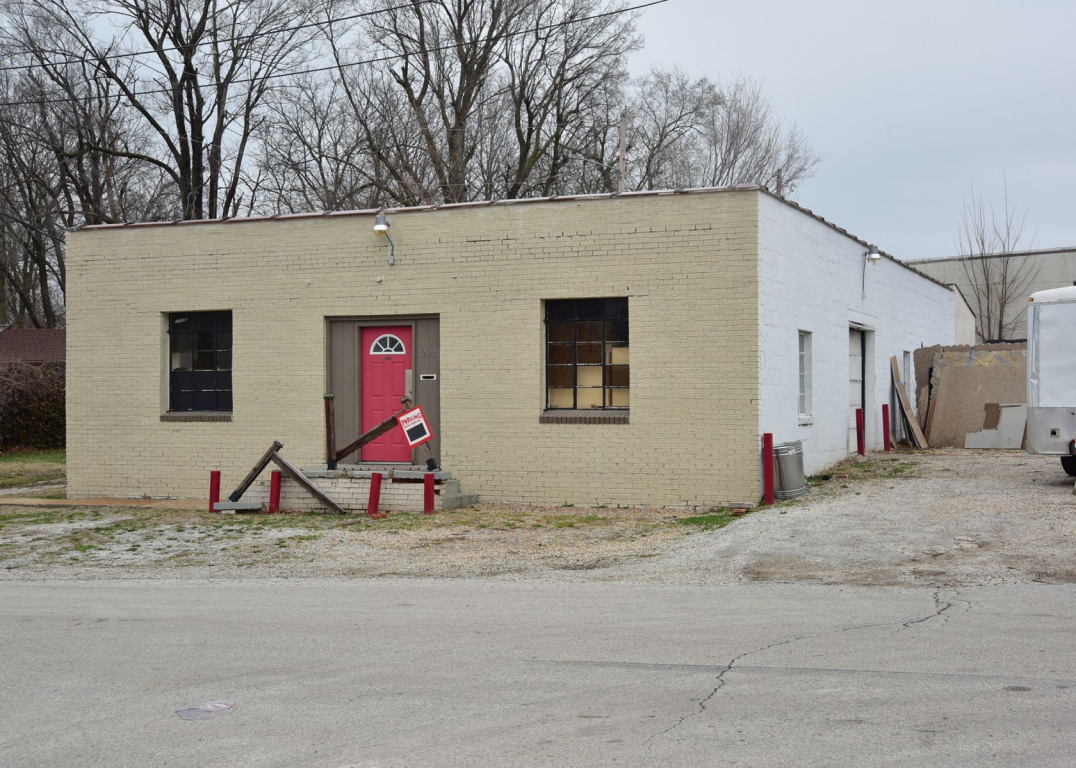
"This one-story industrial storage building is concrete block with brick facing and has a flat roof. It has a rectangular footprint that is three symmetrical bays wide and six bays deep. Fenestration defines the bays and includes the center bay entrance with paired half-light, wood panel doors. Forming the other bays are fifteen-light steel casement sash windows with header brick sills. A vehicular entrance occupies the second bay on the south (side) elevation. Additional character-defining features include the terracotta parapet coping tiles (Davis and Schwenk, 2003)."

12921 5th Street does not appear significantly altered from its 2003 appearance with the exception of the covering of the entry sidelights with wood. A rear addition of unknown date pre-dates the 2003 survey.

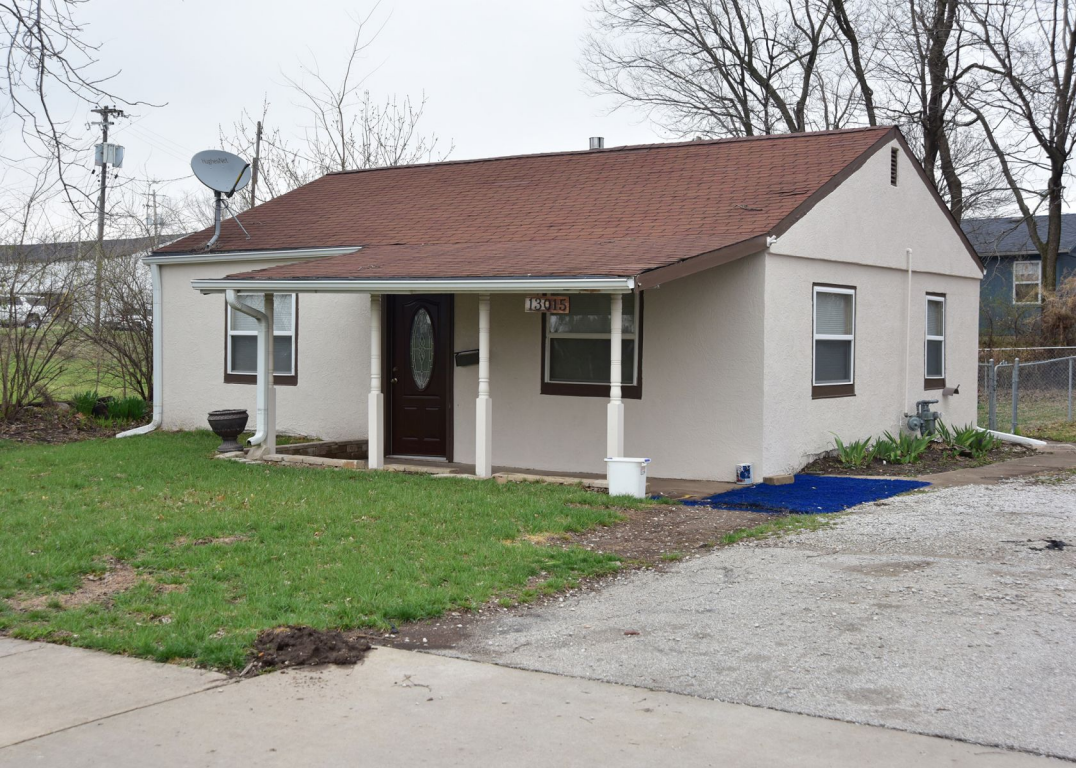
13015 5th Street is significantly altered from its 2003 appearance. Stucco has been applied to the exterior and steel casement windows have been replaced with one-over-one vinyl. Decorative iron porch elements have been replaced with wood supports.

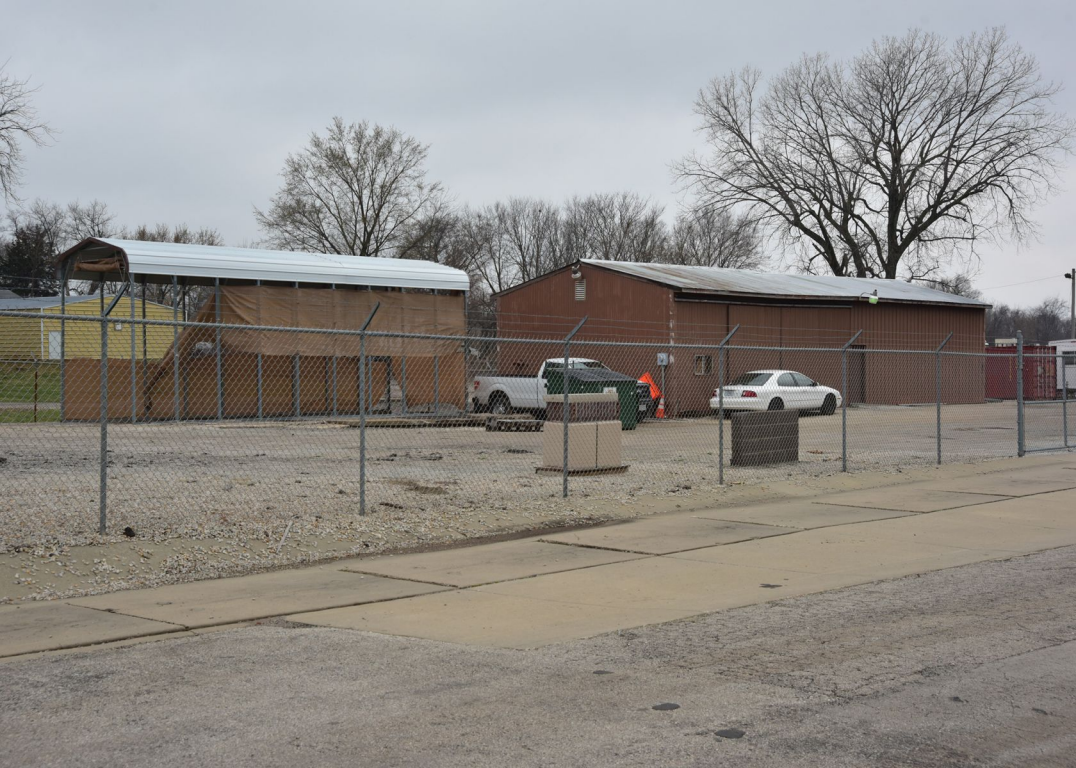
"This one-story, side-gabled vehicular shed building has a rectangular footprint. Corrugated metal covers the roof and exterior walls. The loss of setting compromises the integrity of this building (Davis and Schwenk, 2003)."

13102 5th Street does not appear significantly altered from its 2003 appearance.

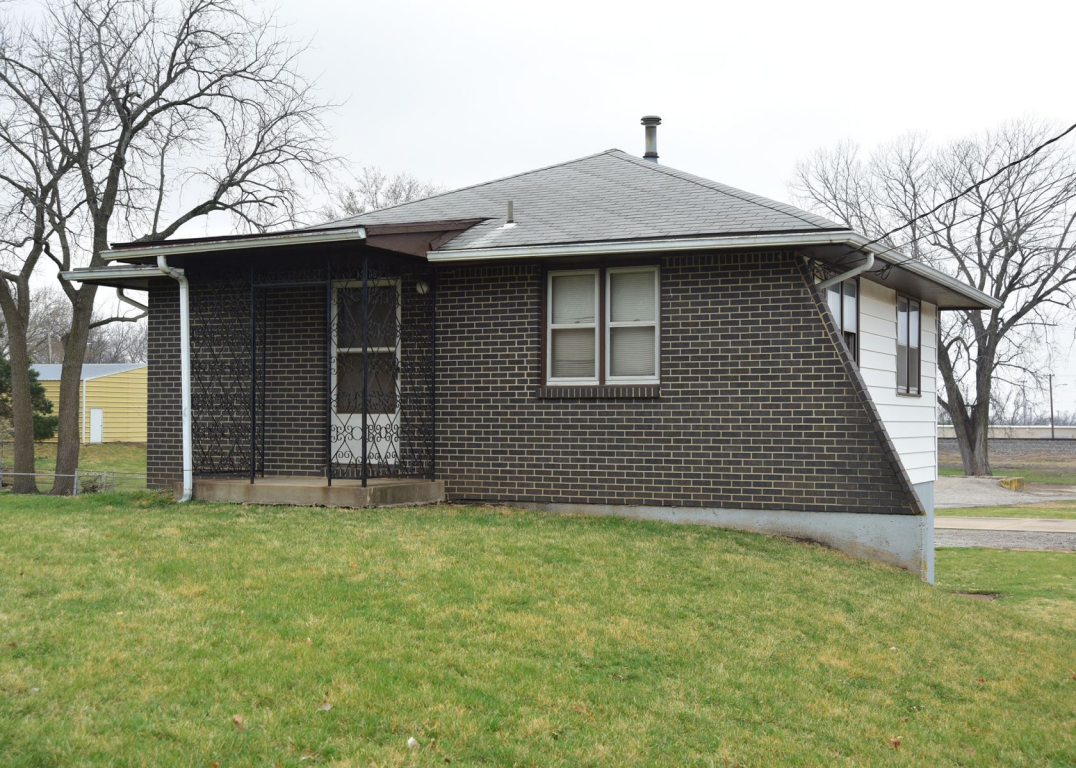
"This one-story house has a unique angled wing wall and an irregular footprint that is two bays wide and two bays deep. Decorative iron posts support the porch's shed roof, which shelters the entrance at the south end bay. Forming the other bay is a pair of one-over-one light, double-hung sash windows with header brick sills. Additional character-defining features include the very shallow hipped roof, very wide eaves, very dark wall cladding on the façade, and the distinctive angled wing wall at the north end of the façade (Davis and Schwenk, 2003)."

13106 5th Street does not appear significantly altered from its 2003 appearance. Storm windows are present at all elevations visible from the right-of-way.

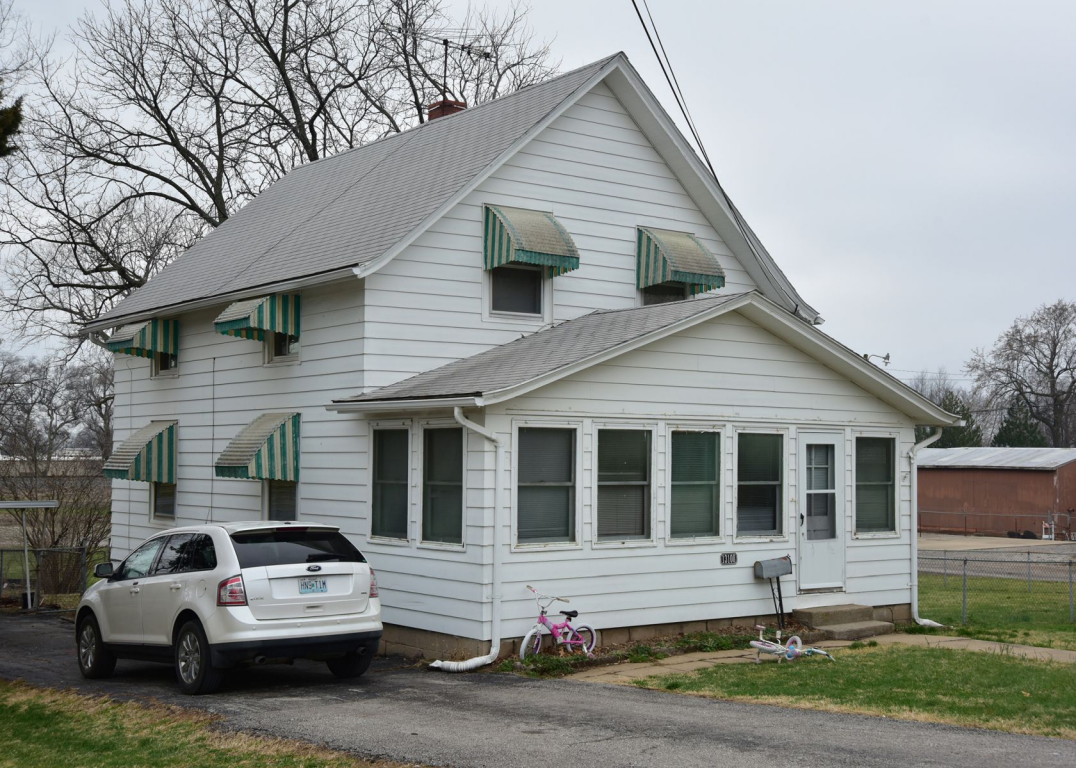
"This two-story, gable-front Four Square house has a rectangular footprint that is six bays wide and four bays deep. The enclosed full-width porch has a gable-front roof and an entrance door at the second bay from the north end. Flanking the entrance are one-over-one light, double-hung wood sash windows that form the remaining façade bays and the first two bays of the side elevations. Additional character-defining features include the wide, flared eaves and flat board window trim. The enclosure of the character-defining front porch and the application of modern siding to the exterior walls compromise the integrity of this building (Davis and Schwenk, 2003)."

13108 5th Street does not appear significantly altered from its 2003 appearance. Metal awnings are present at windows visible from the right-of-way except for those of the enclosed porch. The dates of alteration are unknown, however they pre-date the 2003 survey.

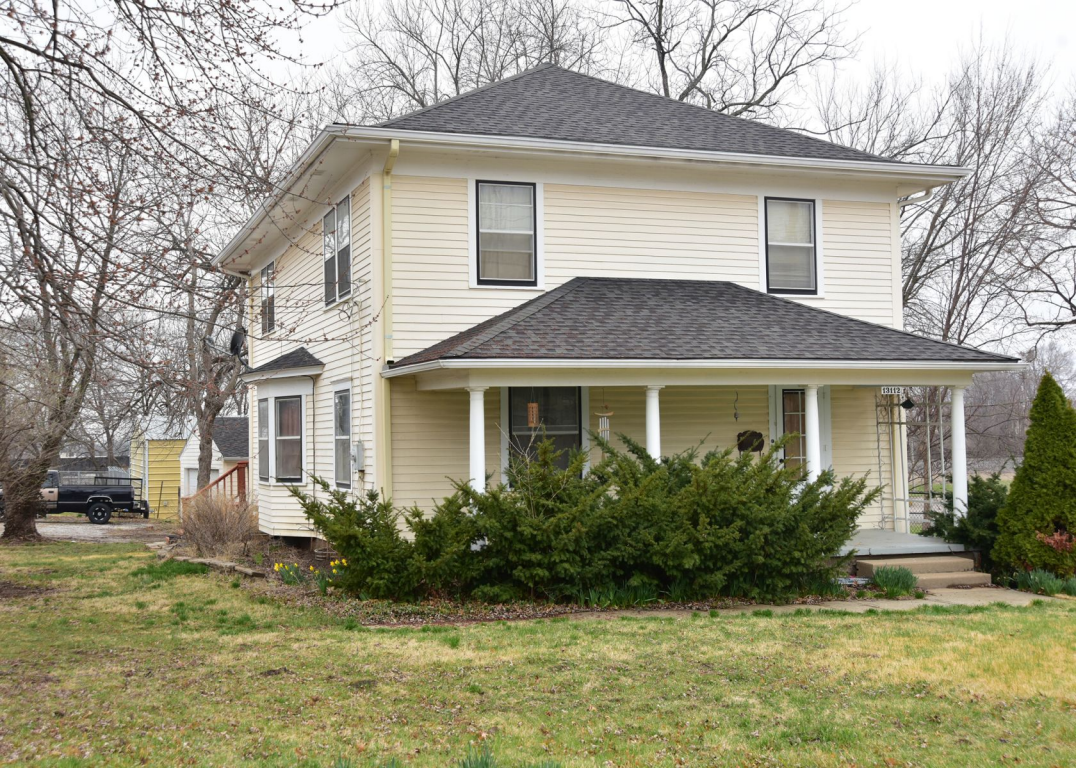
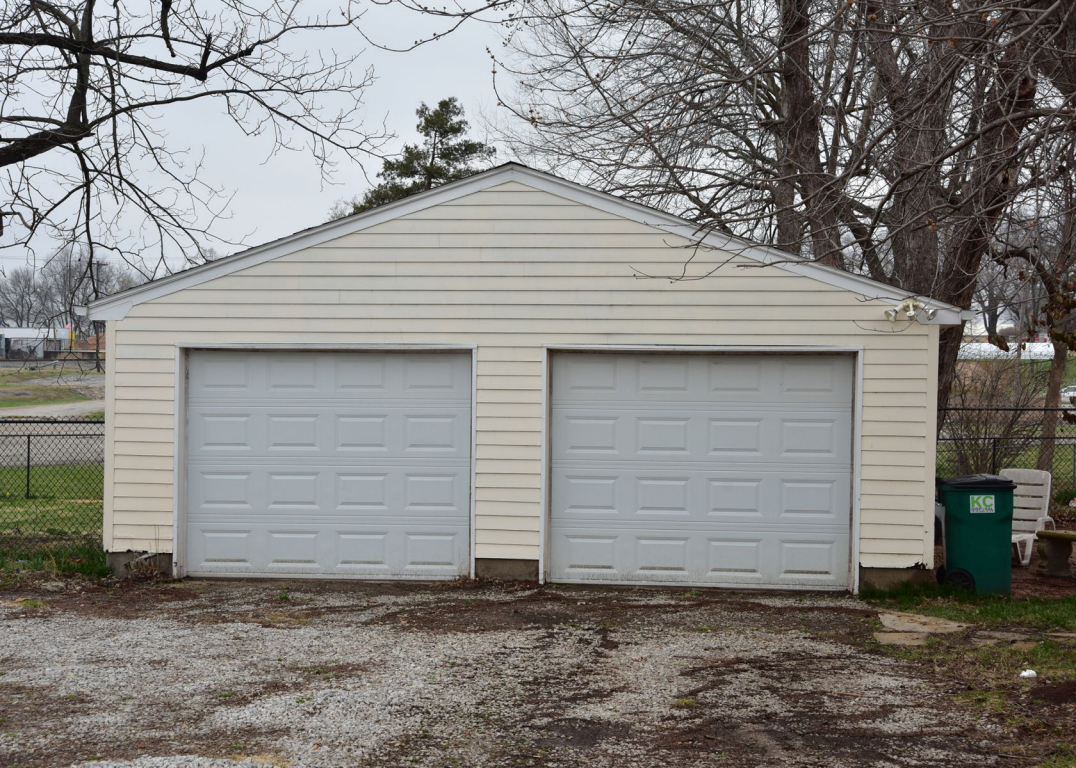
"This two-story Four Square house has a hipped roof and a rectangular footprint that is two bays wide and three bays deep. Tuscan columns support the full-width porch's hipped roof, which shelters the entrance at the north end bay. Single one-over-one light, double-hung sash windows with flat board trim form the other bays. Additional character-defining features include the wide, slightly flared eaves with frieze band below and the wood clapboard cladding with corner boards (Davis and Schwenk, 2003)."

13112 5th Street does not appear significantly changed from its 2003 appearance.

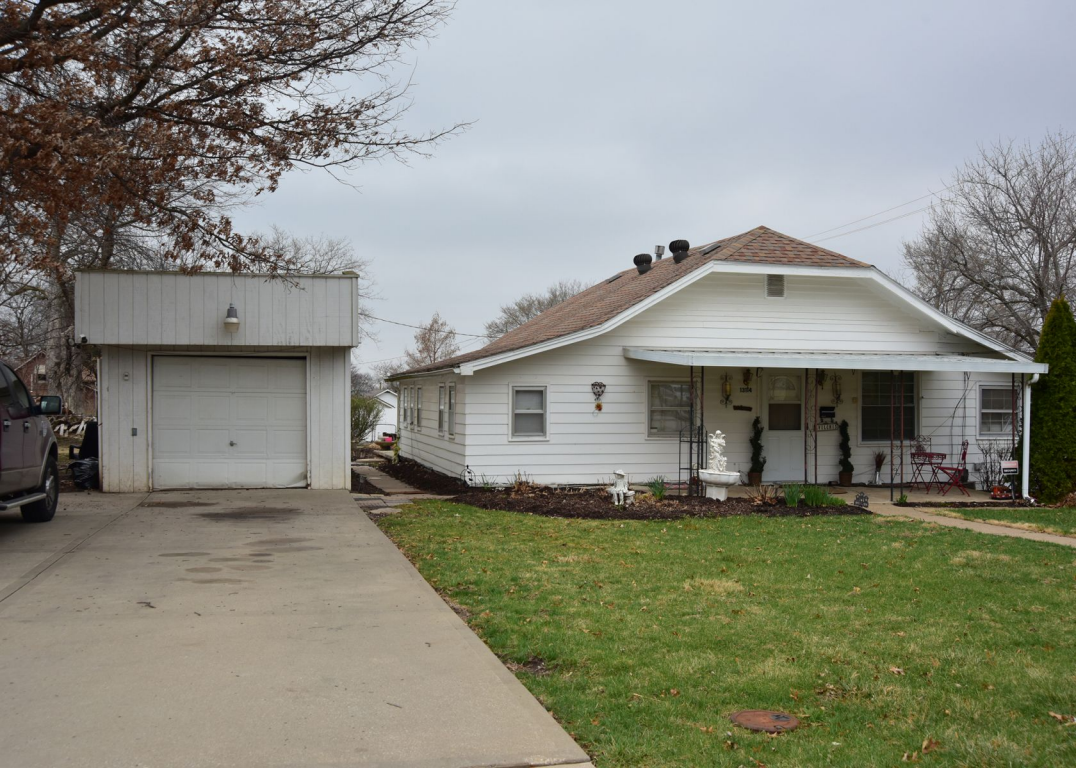
"This one-story house features a clipped front gable and has a rectangular footprint that is five bays wide and five bays deep. Decorative iron posts support the modern porch's flat roof, which shelters the three center bays, including the center bay entrance. Single one-over-one light, double-hung sash windows with flat board trim form the remaining bays. Additional character-defining features include the wide eaves (Davis and Schwenk, 2003)."

13114 5th Street does not appear significantly altered from its 2003 appearance.

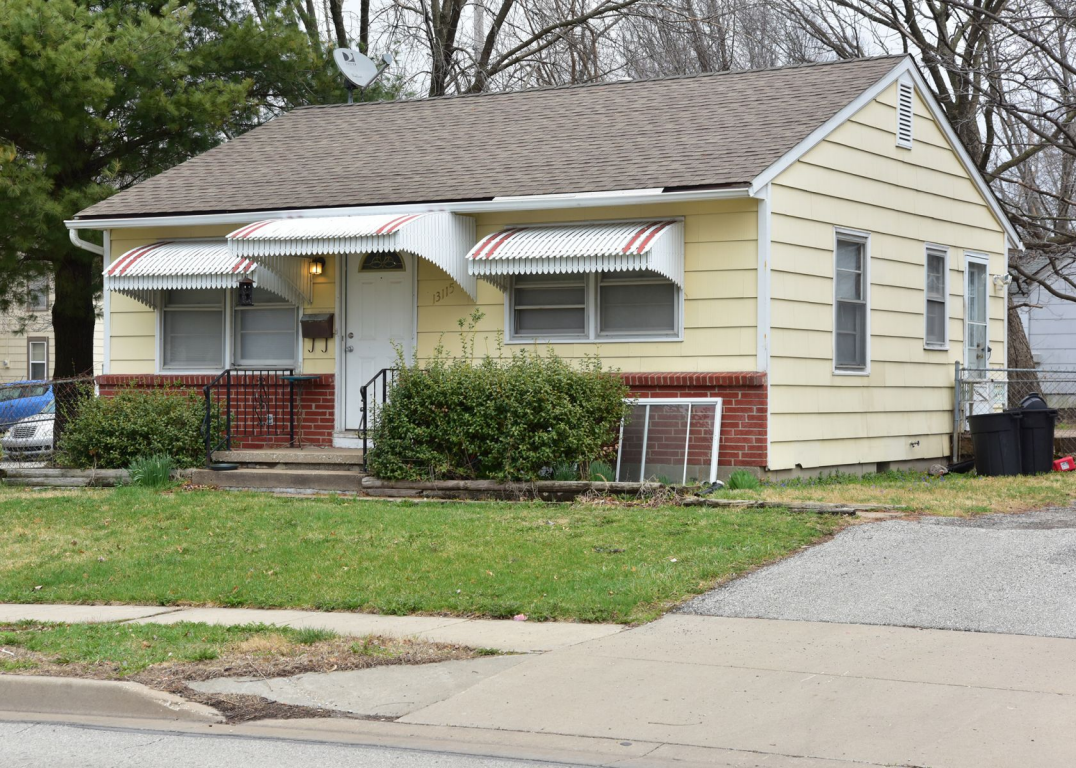
13115 5th Street does not appear significantly altered from its 2003 appearance. The date of alteration is unknown, however pre-dates the 2003 survey.

Metal awnings are present above each bay of the façade.

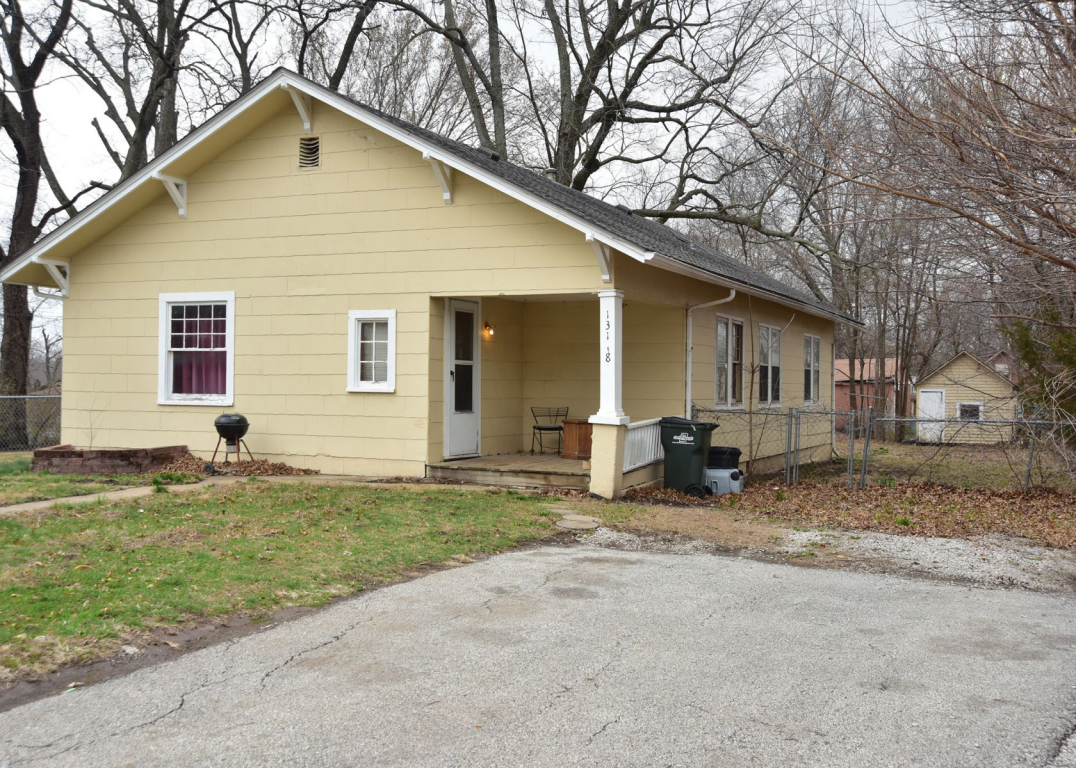
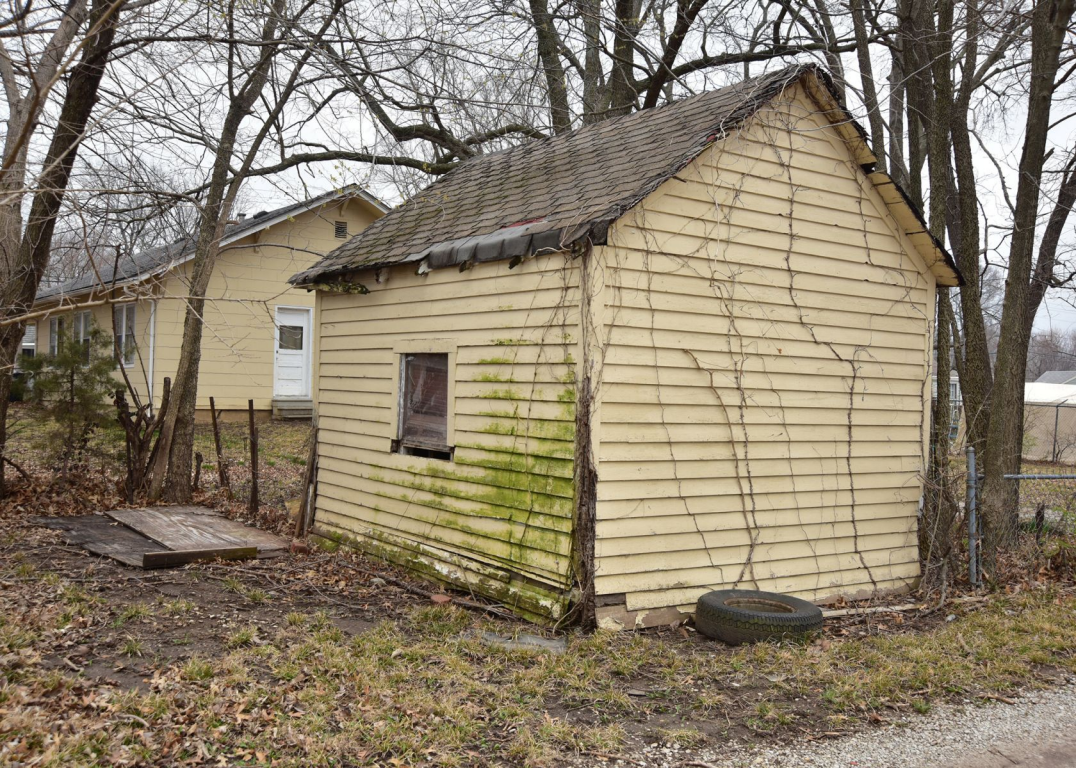
"This one-story, gable-front bungalow house has a rectangular footprint that is three bays wide and three bays deep. The front wall recesses at the north end bay, sheltering the perpendicular entrance. Defining the other bays are a twelve-over-one light, double-hung sash window and a six-light casement sash window, each with flat board trim. Additional character-defining features include wide eaves with knee brackets and the original square porch post and matchstick balustrade (Davis and Schwenk, 2003)."

13118 does not appear significantly altered from its 2003 appearance. Dates of alteration are unknown, however pre-date the 2003 survey.

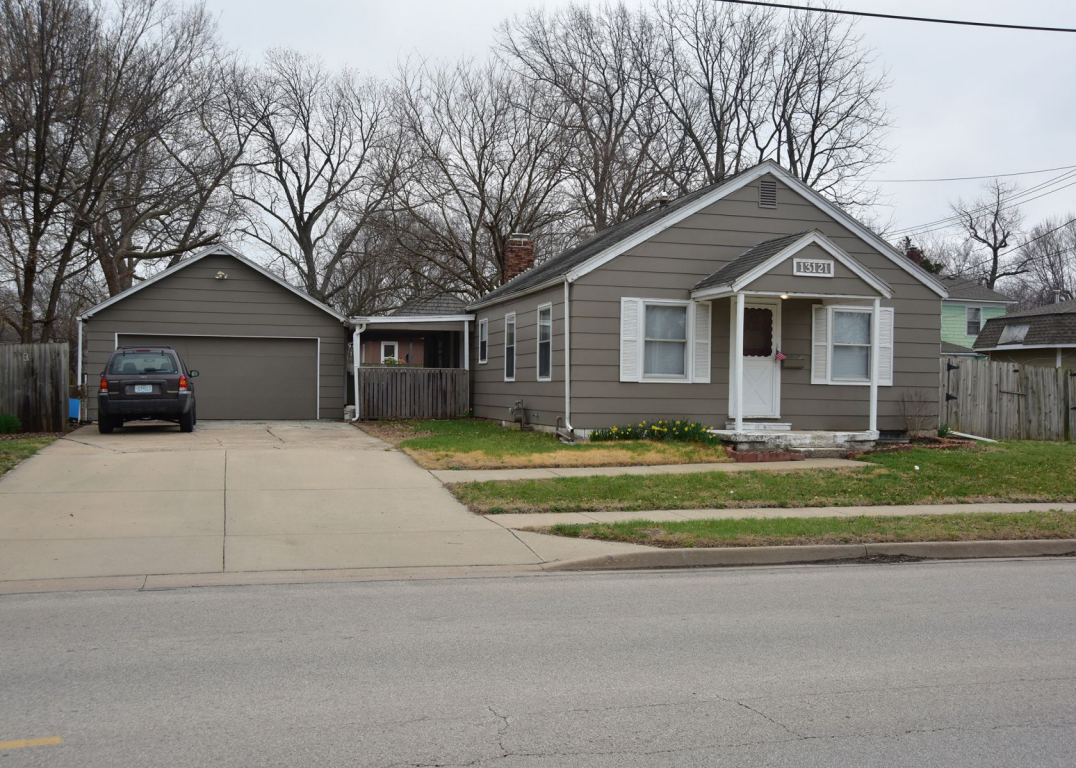
13121 has been altered from its 2003 appearance. The turned porch support posts have been replaced with squared posts. The glass-walled addition has been replaced with a covered open passage which connects the dwelling to the garage.

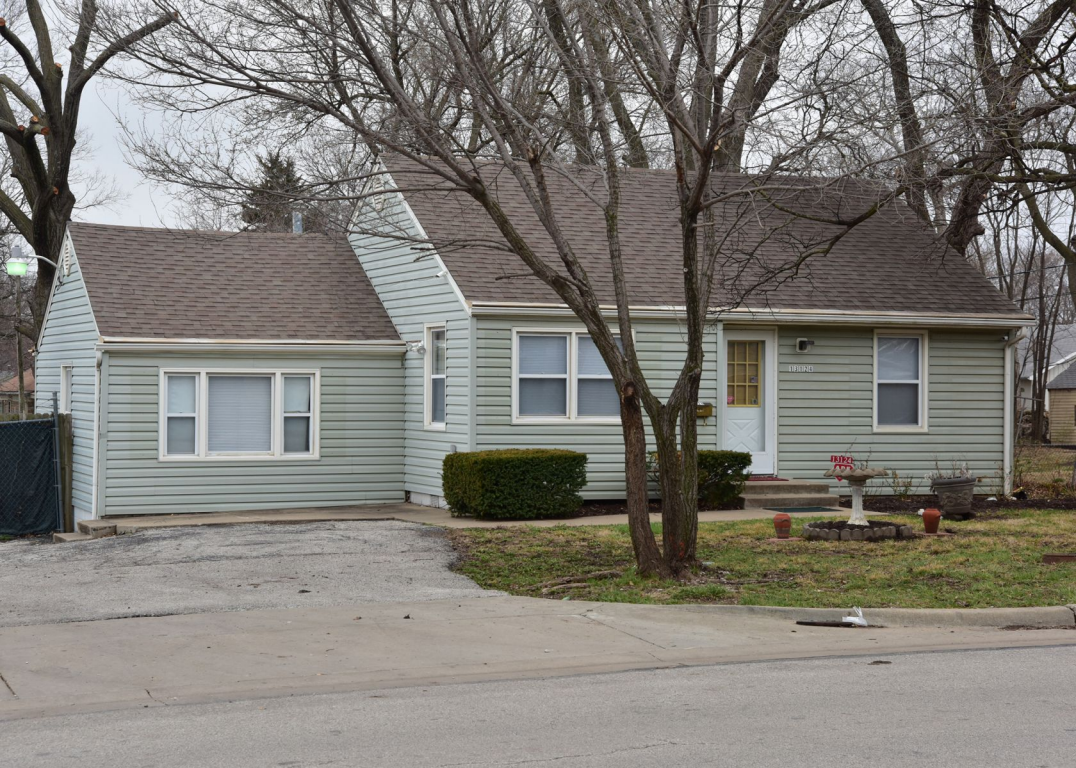
Shutters have been removed since the 2003 survey, however the dwelling otherwise does not appear significantly altered from its 2003 appearance. The dates of alteration are unknown, however they pre-date the 2003 survey.

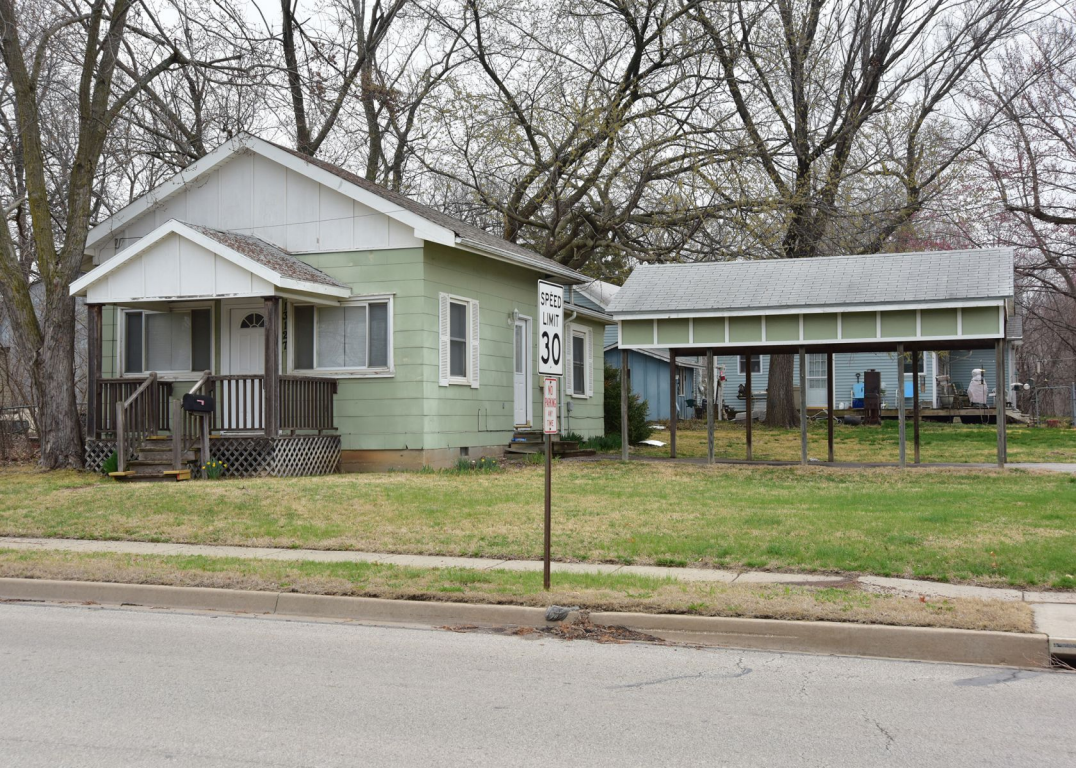
13127 5th Street does not appear significantly altered from its 2003 appearance. The dates of alteration are unknown, however they pre-date the 2003 survey.

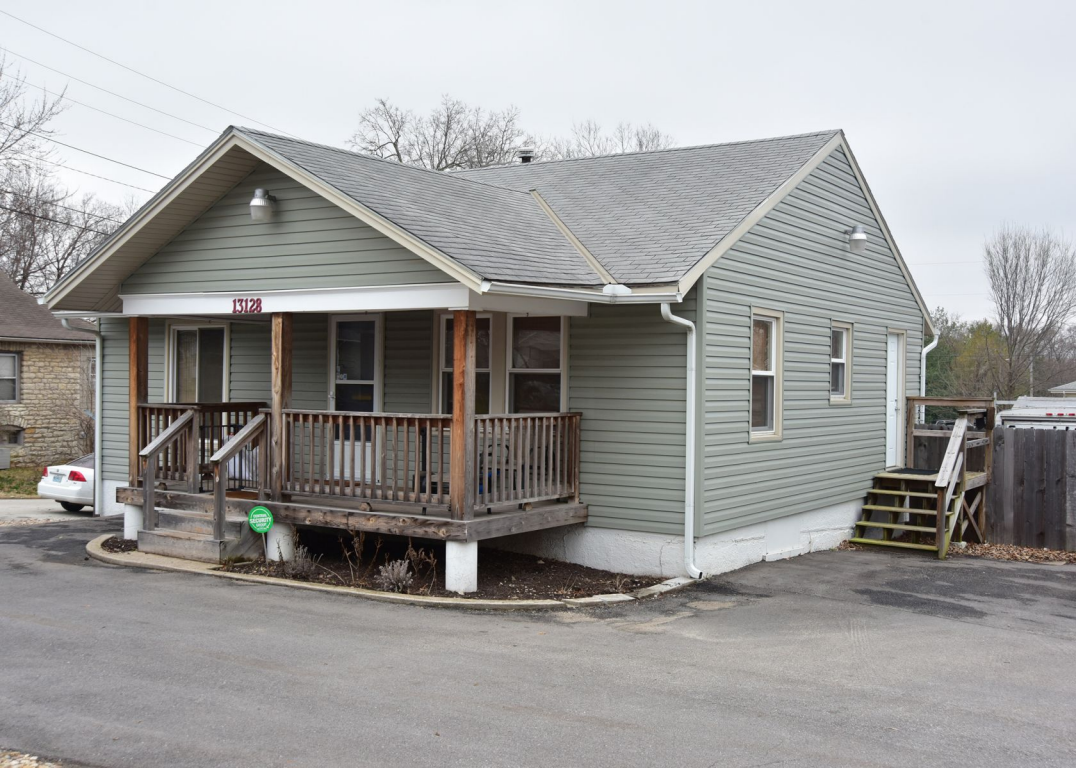
The pressed wood siding and wood sash windows were replaced with vinyl components at post-2005. 13128 5th Street otherwise does not appear significantly altered from its 2003 appearance. Dates of prior alteration are unknown, however they pre-date the 2003 survey.

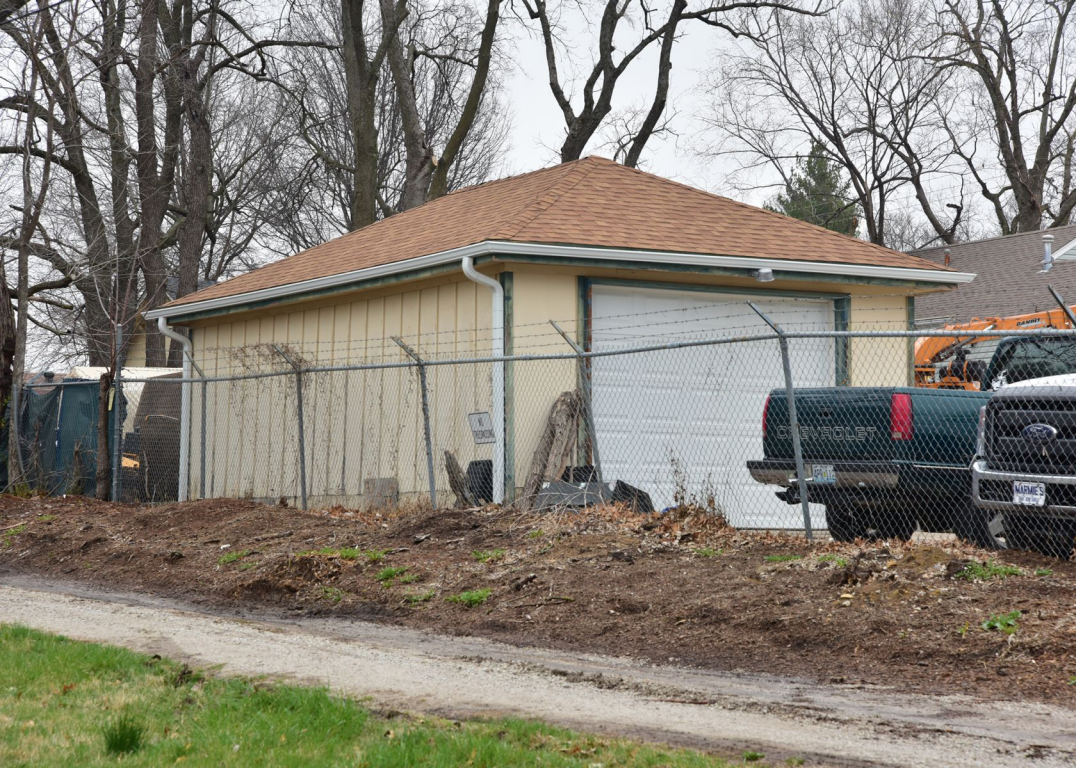
"This one-story, side-gabled house has a projecting gable-front porch and a front-facing L-shaped footprint that is three bays wide and three bays deep. Modern pressed wood siding covers the exterior walls. Non-original square wood posts support the porch roof, which shelters the two north end bays, including the center bay entrance. Defining the other bays are paired three-over-one light, double-hung wood sash windows and a large multi-light, fixed-sash window. The non-original wall cladding, loss of original porch elements, and replacement sash compromise the integrity of this building (Davis and Shwenk, 2003)."

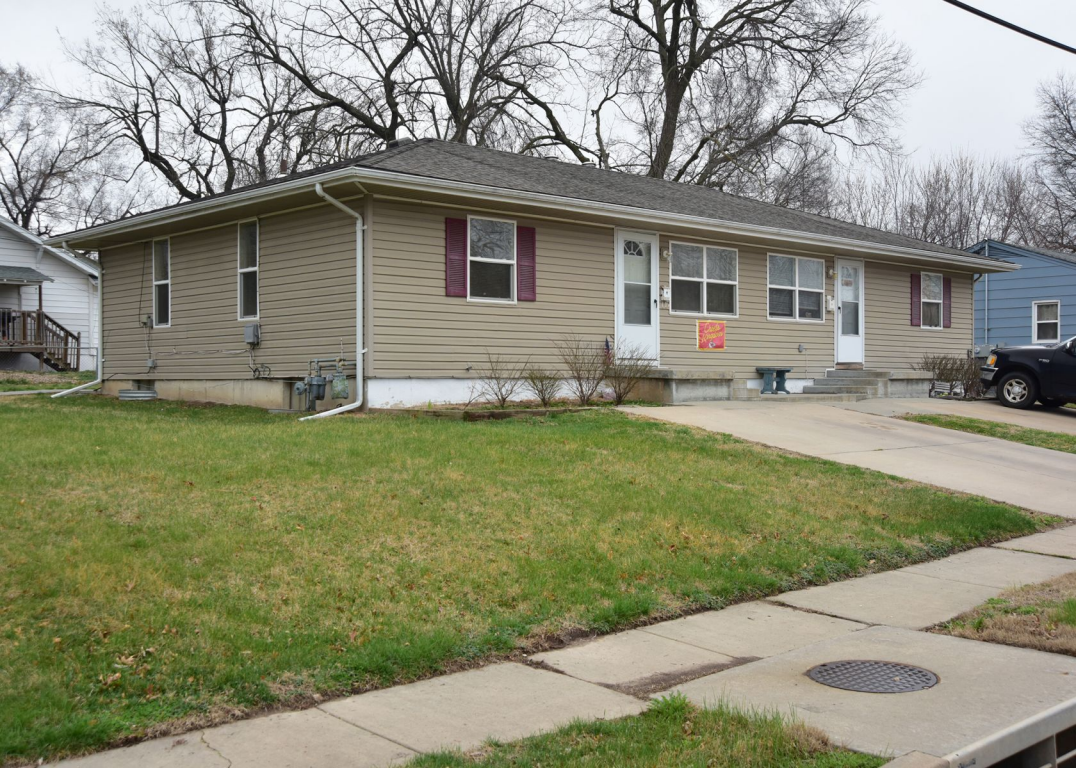
The exterior cladding, doors, and windows of 13201-03 5th Street have been replaced since the 2003 survey. The date of this alteration is unknown.

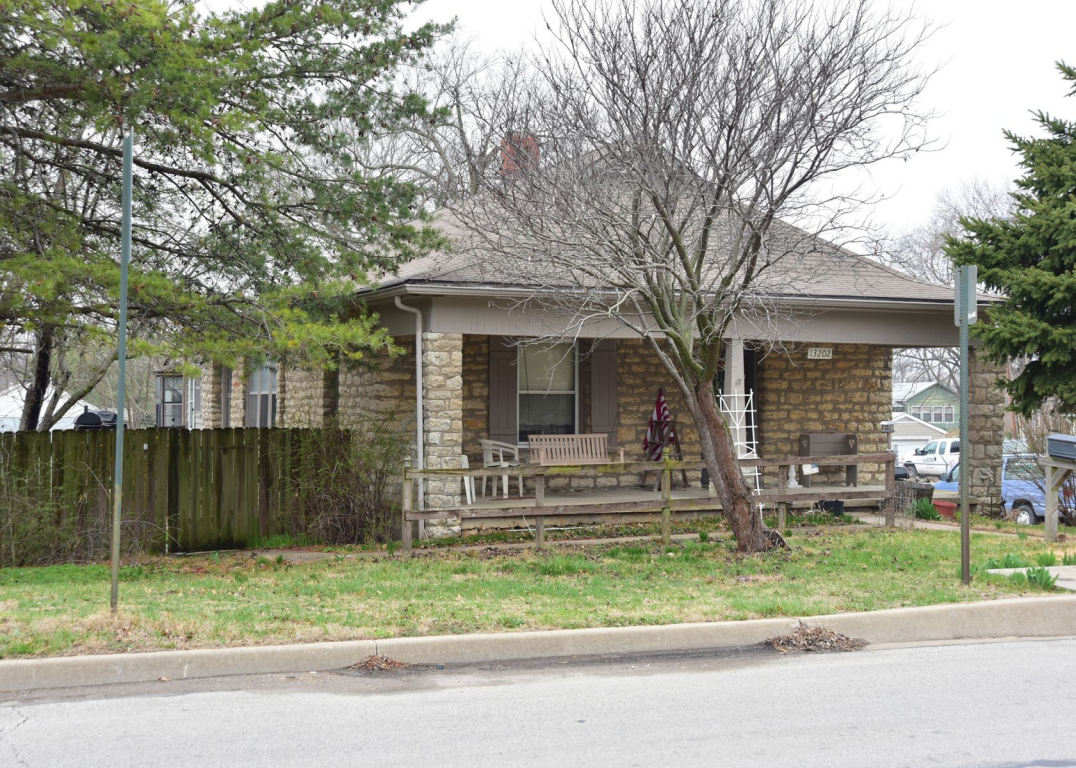
"Rough-cut limestone walls and porch posts distinguish this one-story bungalow with a gable-on-hip roof. The dwelling has a rectangular footprint that is two bays wide and four bays deep. The front roof slope extends to form the full-width porch roof, which is supported by two square stone columns and a central, tapered square wood column. Fenestration defines the bays and includes the entrance at the north end bay and a single one-over-one light, double-hung sash window with shutters at the other bay. Additional character-defining features include the wide, flared eaves; a bead board frieze band under the front eaves; and a brick ridge chimney (Davis and Schwenk, 2003)."

A rear addition with wood cladding is present. Aluminum storm windows are installed at multiple elevations. The roof features asphalt shingle. 13202 5th Street does not appear significantly altered from its 2003 appearance. Although dates of alteration are unknown, they pre-date the 2003 survey.

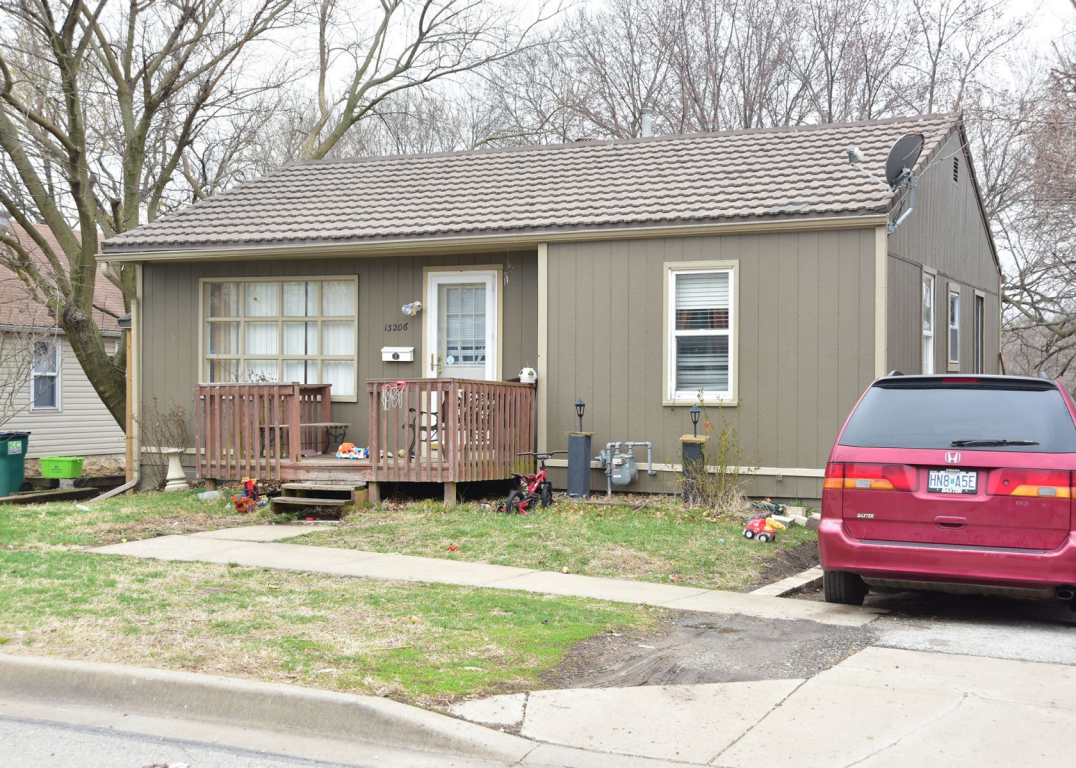
13206

Google Earth imagery indicates the presence of a ca. 2010 rear addition. This addition is not visible from the right-of-way. The asbestos single cladding was replaced with vertical wood siding at an unknown date following the 2003 survey. Windows are vinyl replacement and the decorative shutters have been removed. The roof is comprised of synthetic tile.

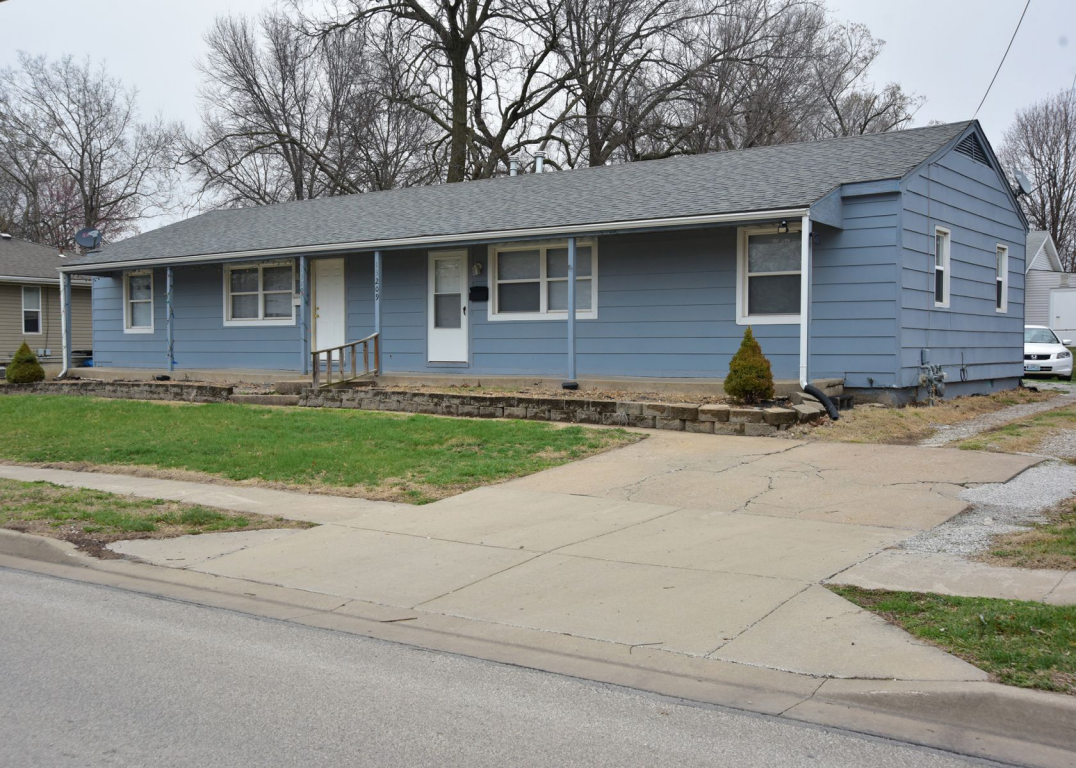
Fenestration appears altered from its 2003 appearance, with bays defined by single and double one-over-one vinyl replacement windows rather than the single and tripled observed during the 2003 survey. The primary elevation cladding has been replaced with vinyl siding. These dates of alteration are unknown, however post-date the 2003 survey.

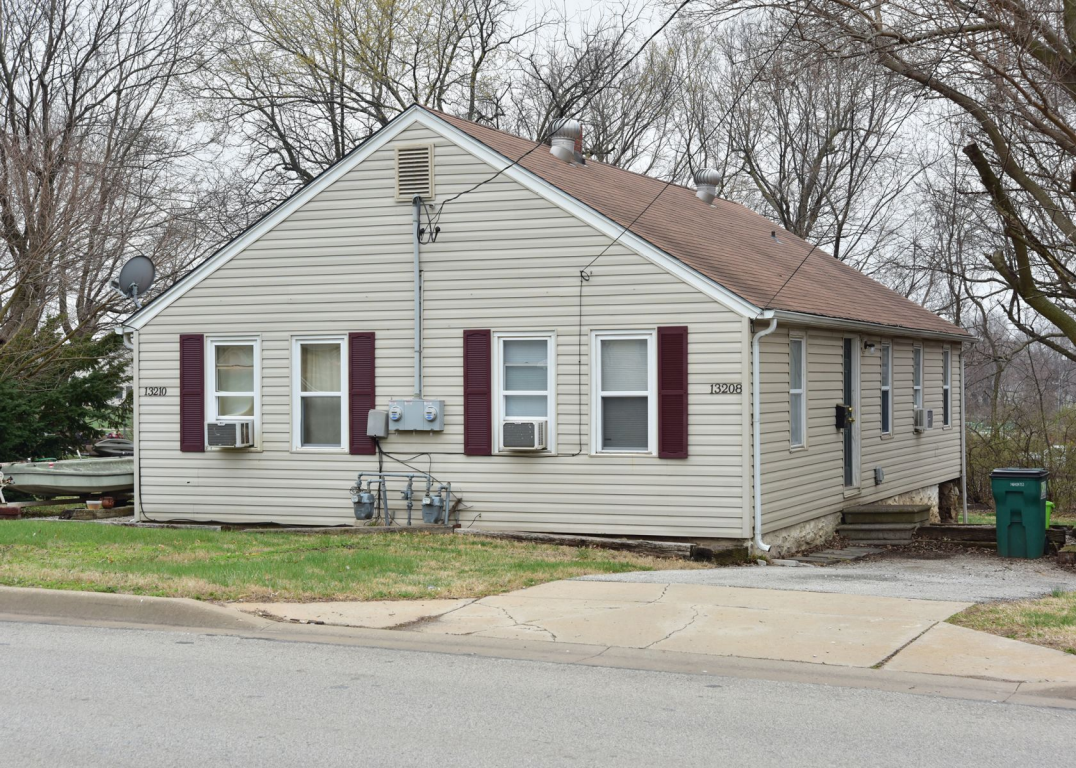
Windows have been replaced with vinyl components and the wood shingle cladding has been replaced with aluminum. The date of this alteration is unknown, however it post-dates the 2003 survey. The remaining alteration dates are unknown, however they pre-date the 2003 survey. The dwelling currently displays 13210 and 13208 house numbers.

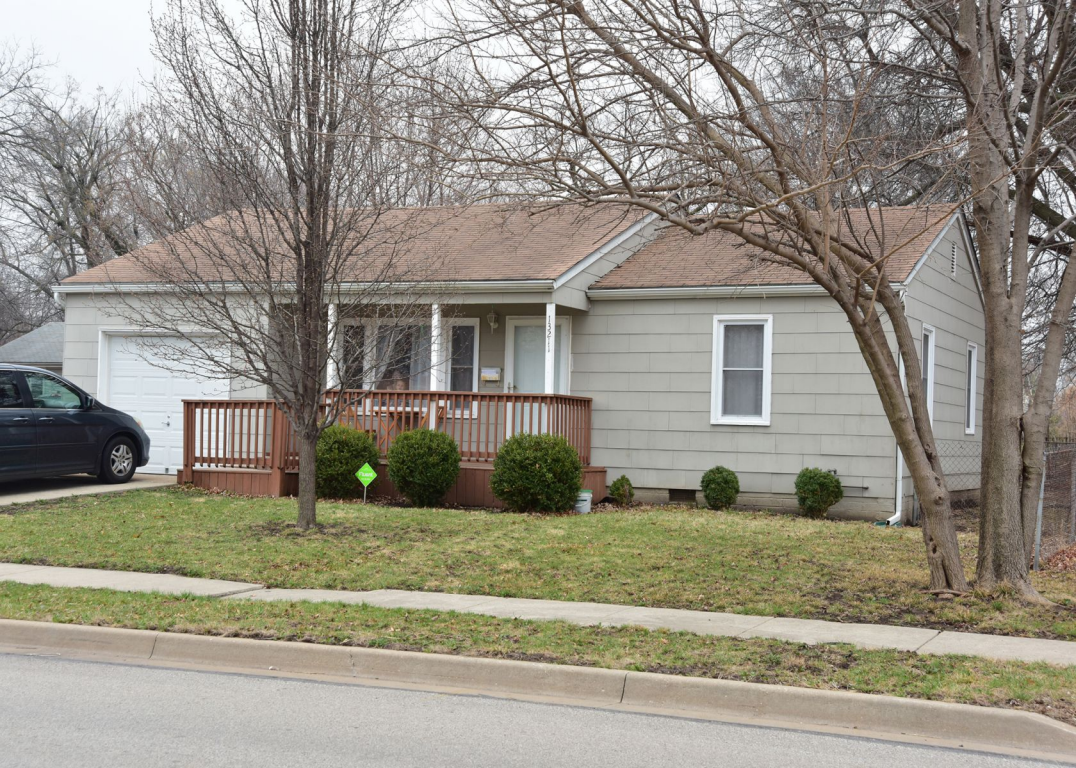
"This one-story Ranch style house has a side-gabled roof and a rectangular footprint that is four asymmetrical bays wide and two bays deep. The front wall steps forward at the north end bay, which houses a single-car garage. While the roof slope recesses at the south end bay, the front roof slope extends to shelter the two center bays, which includes the entrance at the second bay from the south end. A single one-over-one light, double-hung sash window and a tripartite picture window form the remaining bays. Additional character-defining features include tight eaves and the original asbestos shingle wall cladding (Davis and Schwenk, 2003)."

13211 5th Street possess an asphalt roof and vinyl windows. The matchstick porch balusters are modern. The dwelling does not appear significantly altered from its 2003 appearance. Dates of alteration are unknown, however they pre-date the 2003 survey.

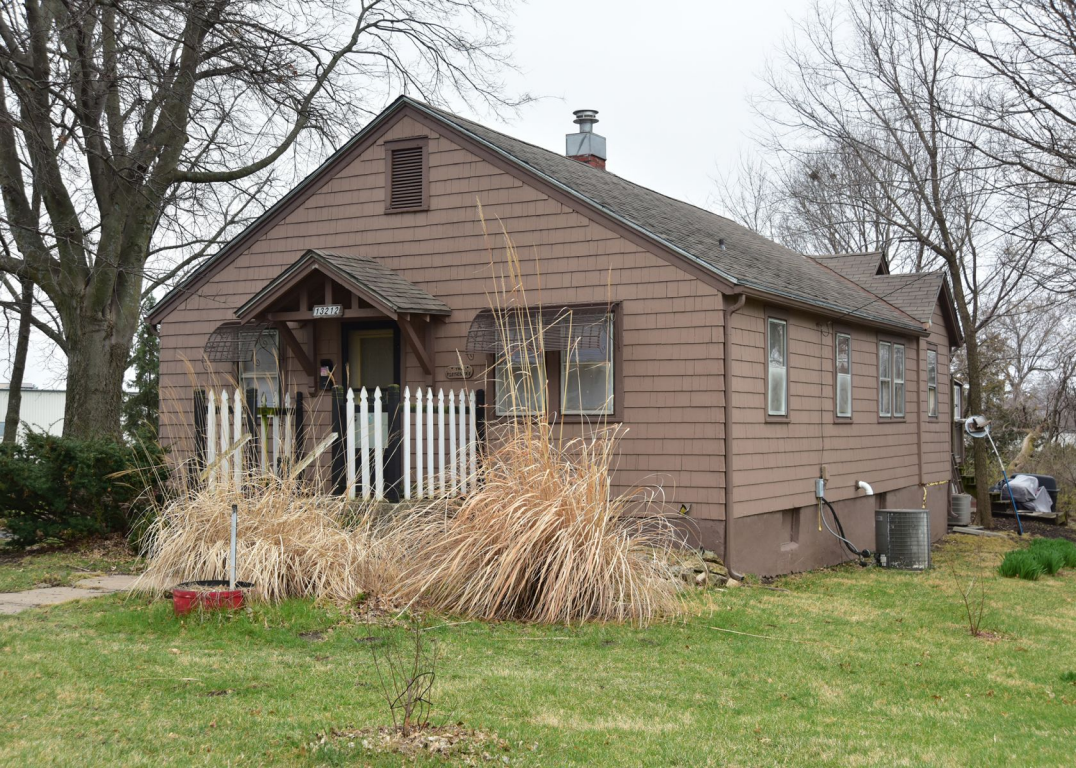
A modern deck projects from the rear of the south elevation. An addition of unknown age is present at the rear of the dwelling. The front porch features modern balusters in the form of picket fence boards. Decorative metal awnings are located above the façade windows, The roof is asphalt while the foundation is parged. Windows are wood with exterior aluminum storm windows. Dates of alteration are unknown, however pre-date the 2003 survey.

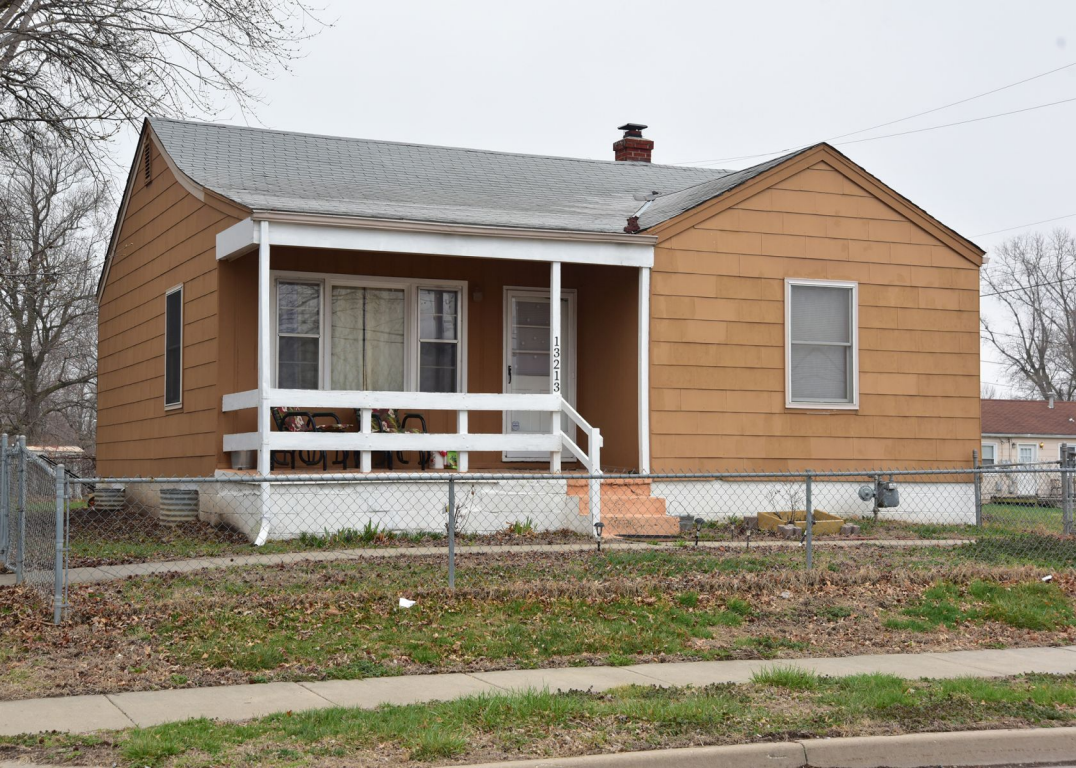
"This one-story, side-gabled house has a projecting gable at the south end bay that dominates the façade. This dwelling has a rectangular footprint that is three bays wide and two bays deep. The front roof slope extends over the two north end bays to form the porch roof, which is supported by non-original square wood posts and shelters the center bay entrance. A single one-over-one light, double-hung sash window and a tripartite picture window define the remaining bays. Additional character-defining features include the tight eaves and the original asbestos shingle wall cladding (Davis and Schwenk, 2003)."

13213 does not appear significantly altered from its 2003 appearance. The date of porch alteration is unknown, however its pre-dates the 2003 survey.
