MISSOURI DEPARTMENT OF NATURAL RESOURCES
STATE HISTORIC PRESERVATION OFFICE, P.O. Box 176, Jefferson City, MO 65102
ARCHITECTURAL/HISTORIC INVENTORY FORM

1. Survey number: JA-AS-088-001		2. Survey Name: Town of Grandview, Resurvey	
3. County: JACKSON		4. Address (Street No.): 13114 Street (name): 4th Street	
5. City: Grandview	Vicinity <input type="checkbox"/>	6. Lat / Long:	7. Township/Range/Section: T: R: S:
8. Historic name (if known):		9. Present/other name (if known):	
10. Ownership: <input checked="" type="checkbox"/> Private <input type="checkbox"/> Public		11a. Historic use (if known): Domestic-Single Dwelling	11b. Current use: Domestic-Single Dwelling

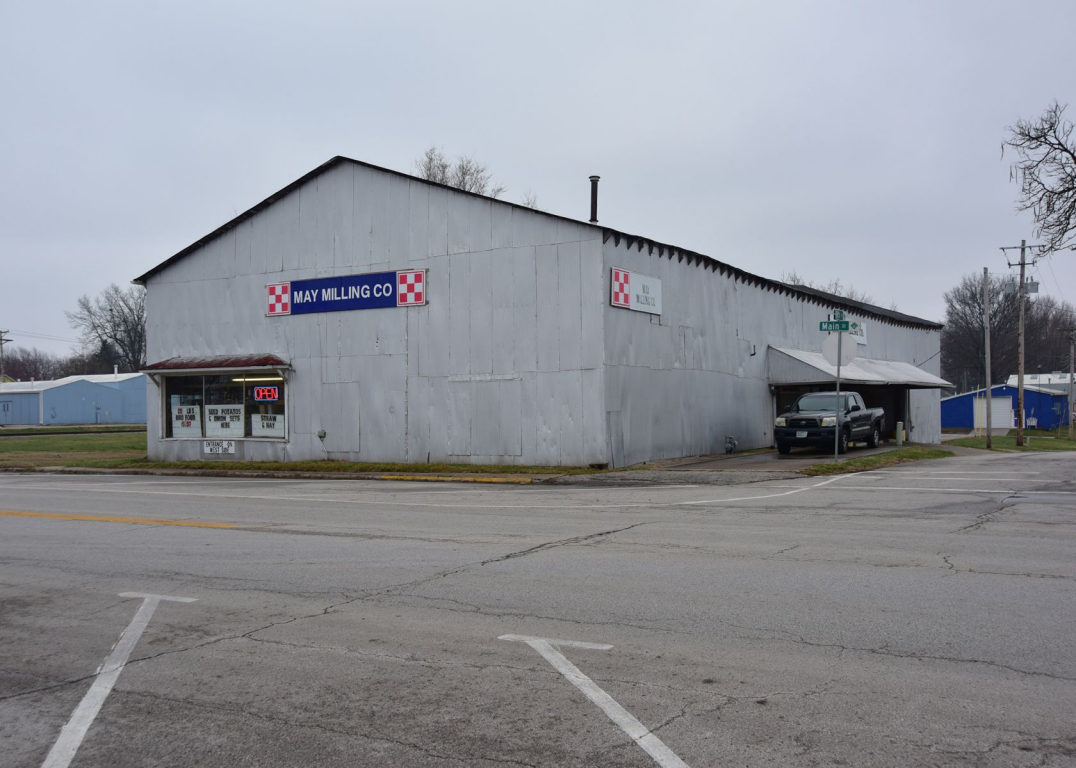
"This one-and-a-half-story, side-gabled warehouse sits perpendicular to Main Street and features a large, primary entrance/service bay on the 6th Street (west) elevation. The building has a rectangular footprint that is one bay wide and one bay deep. Corrugated metal covers the roof and the exterior walls. A pent roof shelters a three-part display window on the Main Street (north) elevation. Additional character-defining features include exposed rafter tails and three secondary service bays with sliding doors along the east elevation (Davis and Schwenk, 2003)."

13001 6th Street does not appear significantly altered from its 2003 appearance.

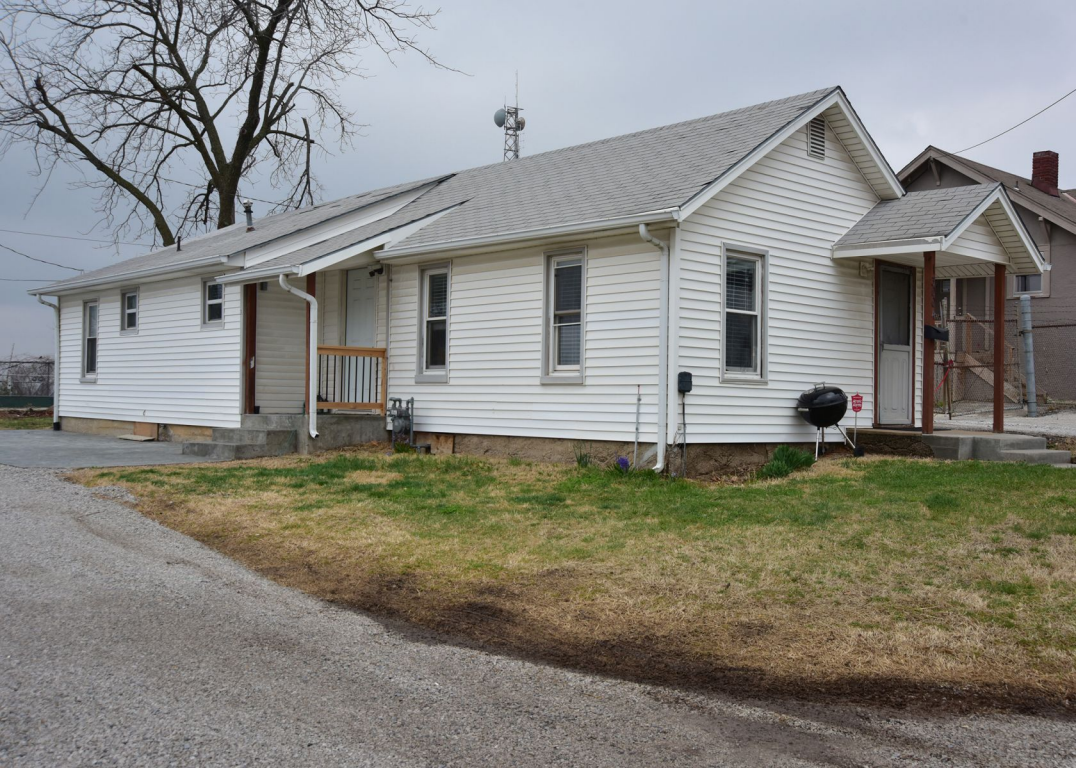
"This one-story, gable-front house has a three-bay rear addition. The dwelling has a rectangular footprint that is two bays wide and six bays deep. Non-original, square wood posts support the porch's projecting gable roof, which shelters the entrance at the north end bay. A single one-over-one light, double-hung wood sash window with flat board trim defines the other bay. The application of vinyl siding, the loss of original porch elements, and the large rear addition compromise the integrity of this building (Davis and Schwenk, 2003.)."

13004 6th Street does not appear significantly altered from its 2003 appearance. Dates of alteration and the addition are unknown, however they pre-date the 2003 survey.

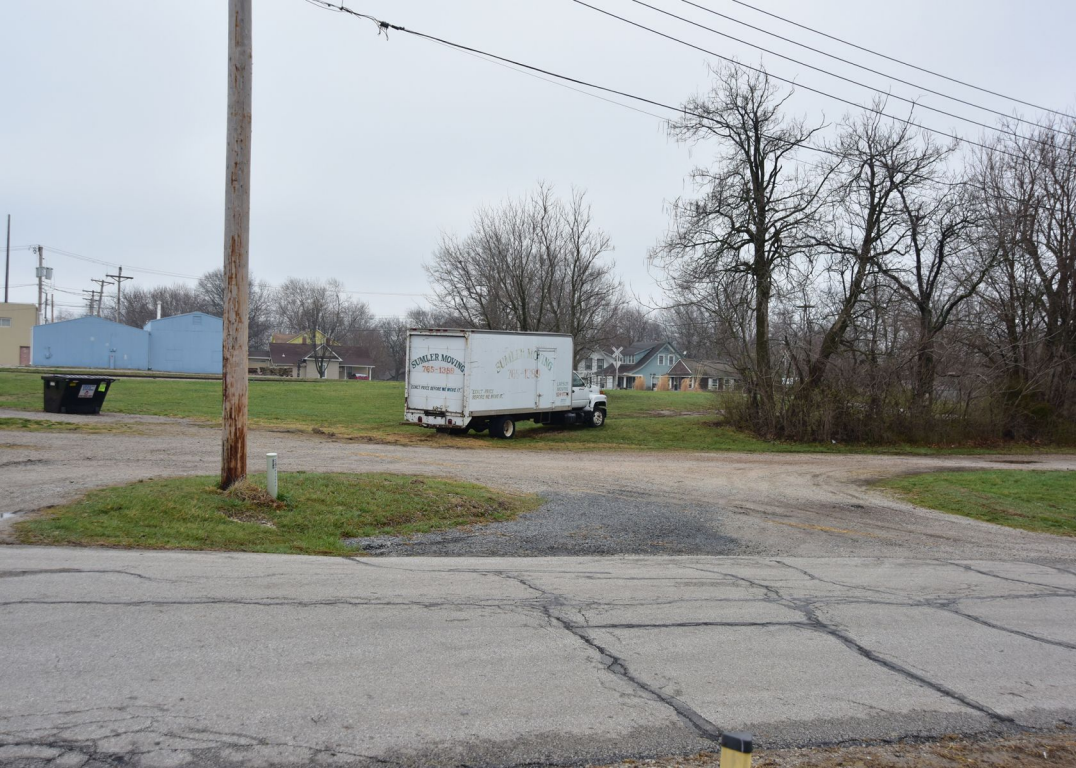
This gravel drive and parking area has an amorphous plan and is bordered by open grass areas. It is accessible from both 6th Street and Rhodes Avenue. An ovoid grassy area occupies the southwest corner of the lot and contains one power pole.

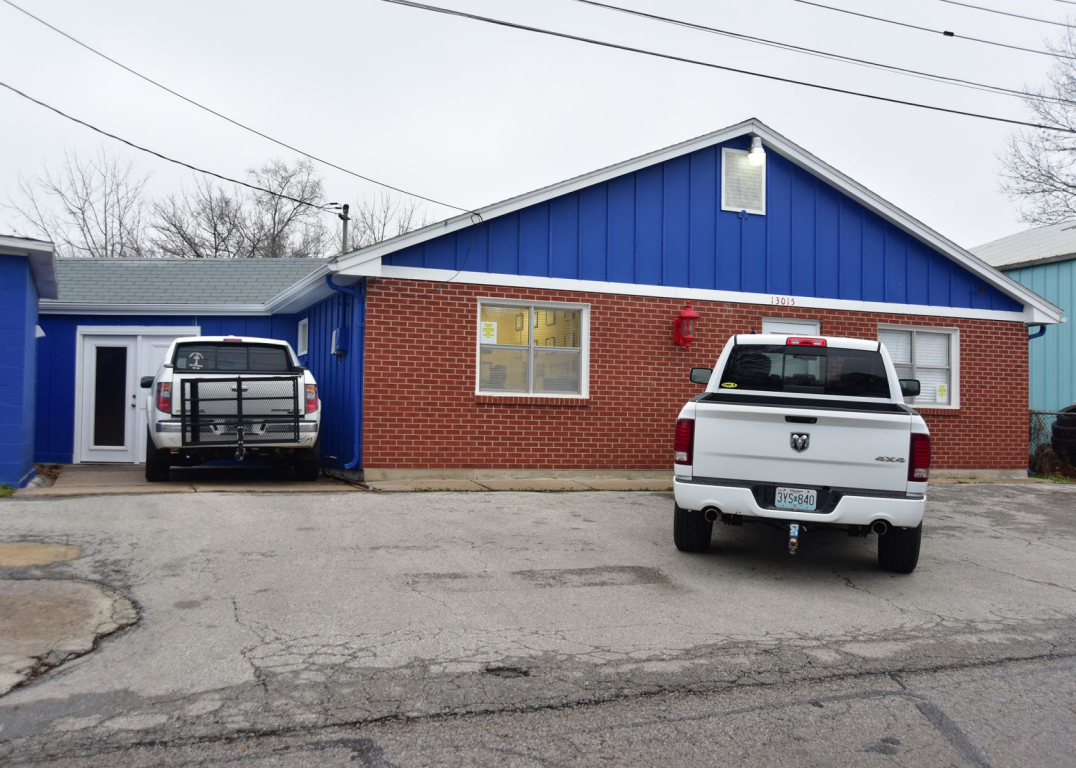
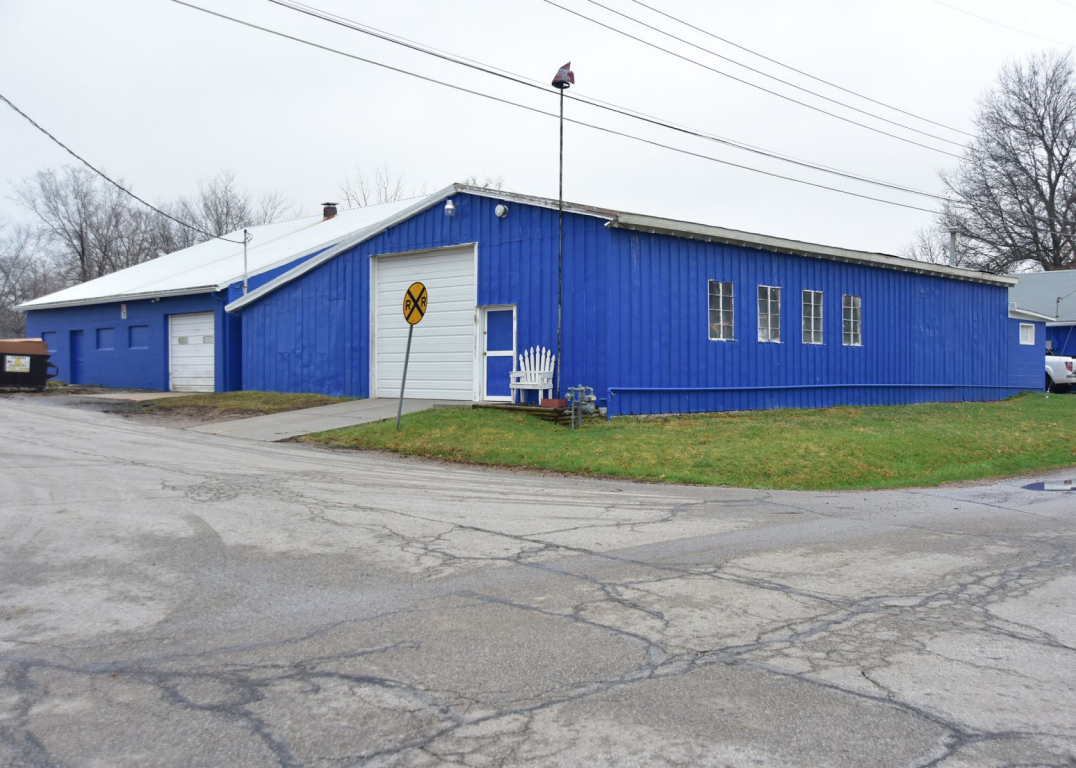
"This one-story manufacturing complex consists of four building blocks linked by shed-roof connectors. Facing onto Rhodes Avenue, the earliest block features concrete block walls; a side-gabled roof; six-light, steel hopper windows; and a wood-paneled entrance door. A side-gabled block at the rear and another block along 6th Street feature matching vertical wood siding; exposed rafter tails; and six-light, steel hopper and casement sash windows. Square and cylindrical ventilators pierce the ridge of these three blocks. A modern, gable-front block facing onto 6th Street features Ranch style elements that include brick and board-and-batten cladding; wide, boxed eaves; and aluminum-framed fenestration, which includes a glass entrance door and paired one-over-one light, double-hung sash windows (Davis and Schwenk, 2003)."

13015 6th Street does not appear significantly altered from its 2003 appearance. Although dates of alteration are unknown, they pre-date the 2003 survey.

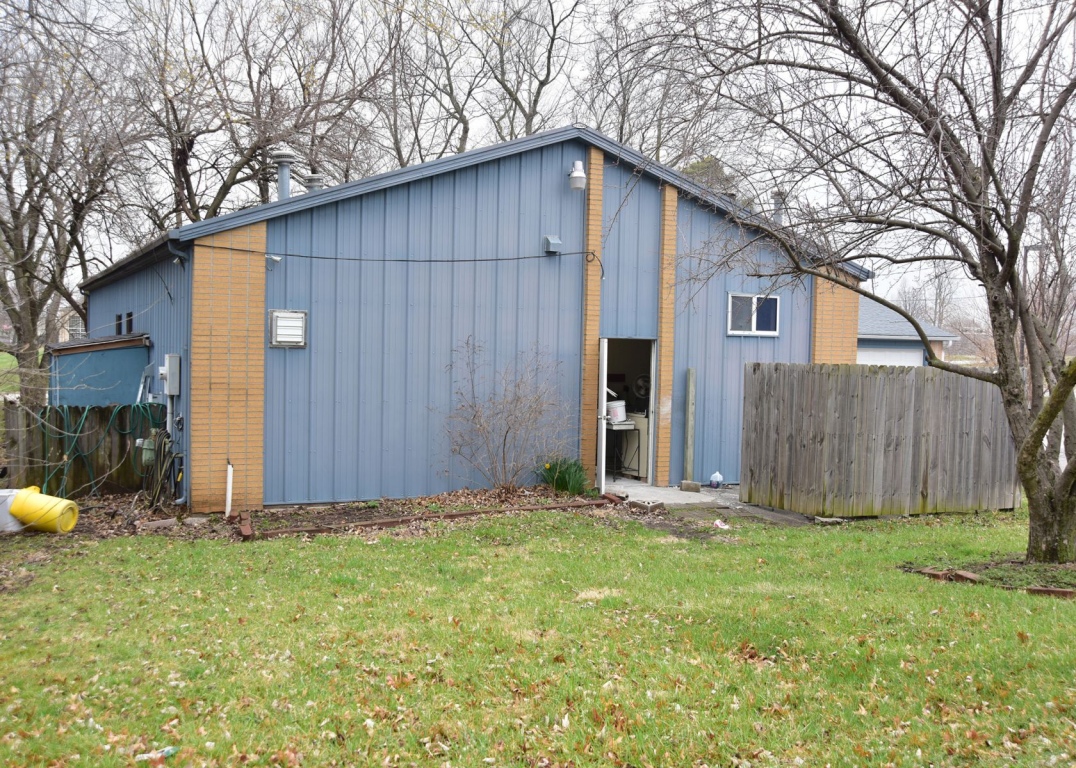
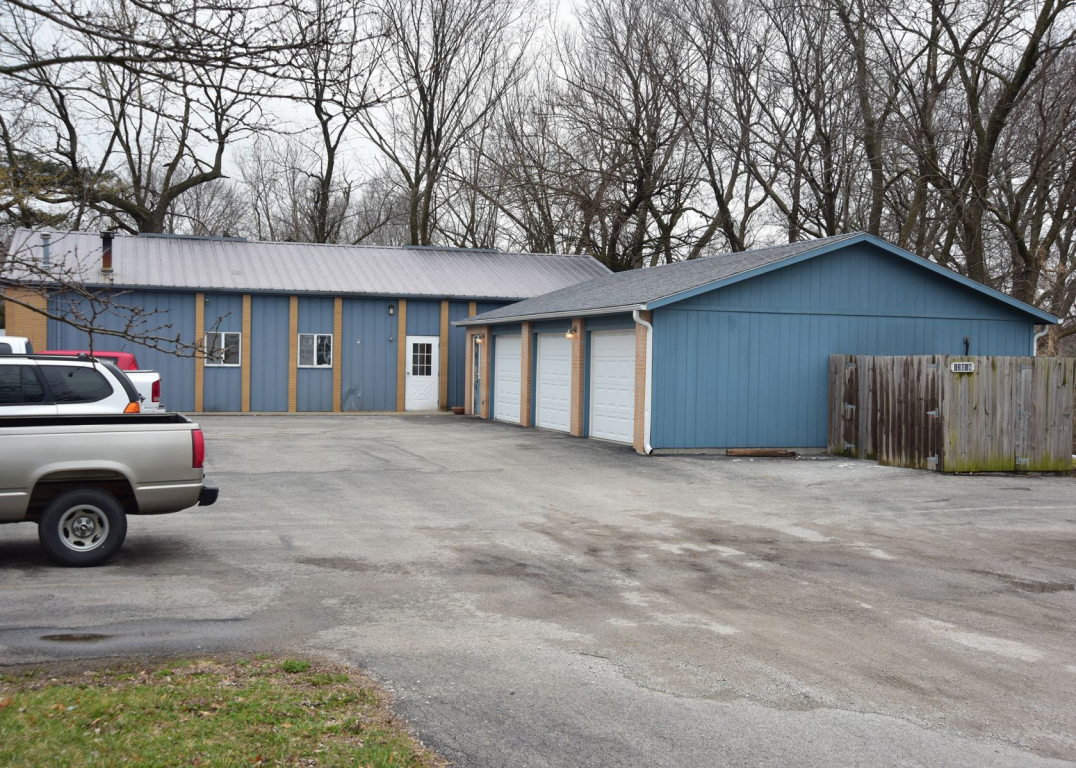
"This modern, one-story commercial building has a gable-front roof and a rectangular footprint that is three bays wide and three bays deep. Corrugated metal covers the roof and exterior walls. Brick pilasters define the façade bays that include a steel entrance door at the center bay and a small one-by-one sliding sash window at the north end bay (Davis and Schwenk, 2003)."

13016 6th Street does not appear significantly altered from its 2003 appearance.

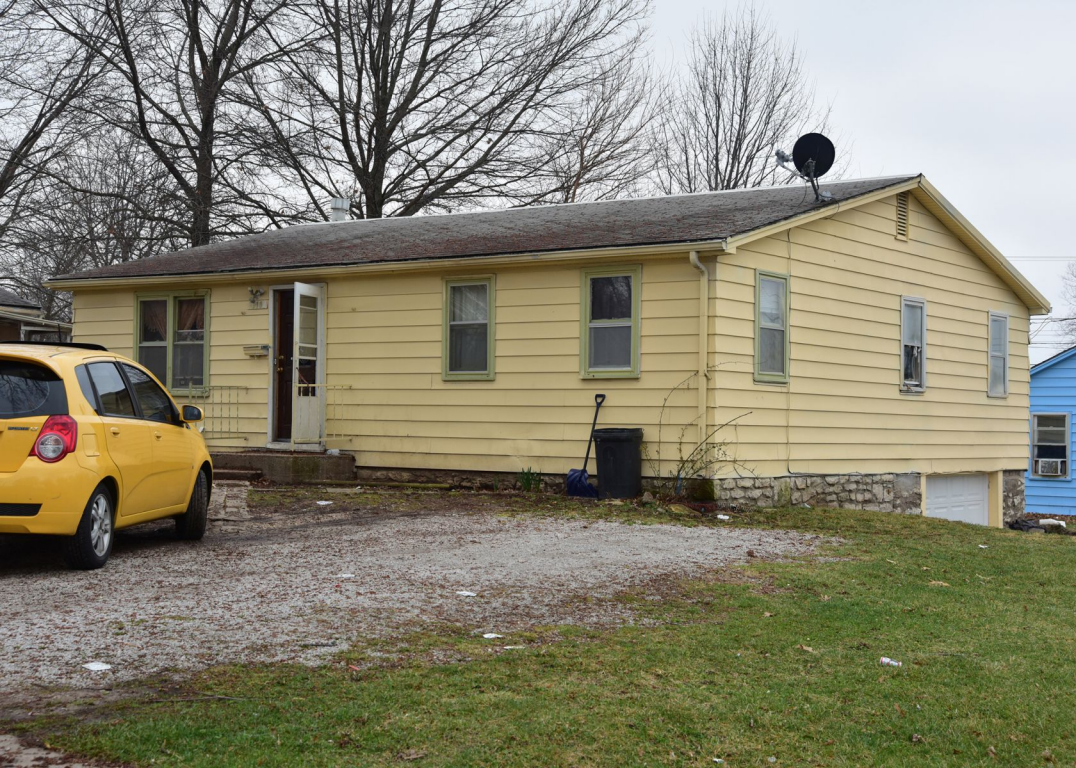
"This one-story, side-gabled house has a rectangular footprint that is four asymmetrical bays wide and two bays deep. Fenestration defines the bays and includes a stoop entrance at the second bay from the south end and single and paired one-over-one light, double-hung sash windows with flat board trim (Davis and Schwenk, 2003)."

13100 6th Street does not appear significantly altered from its 2003 appearance. Windows are wood sash with aluminum storm windows.

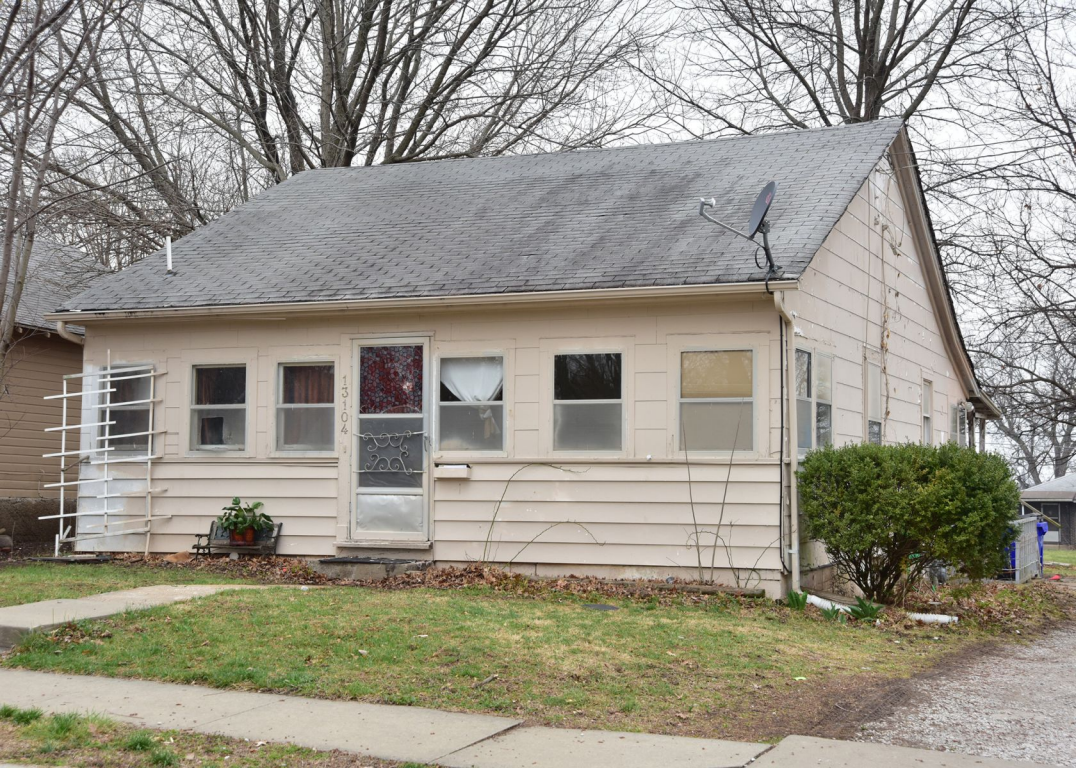
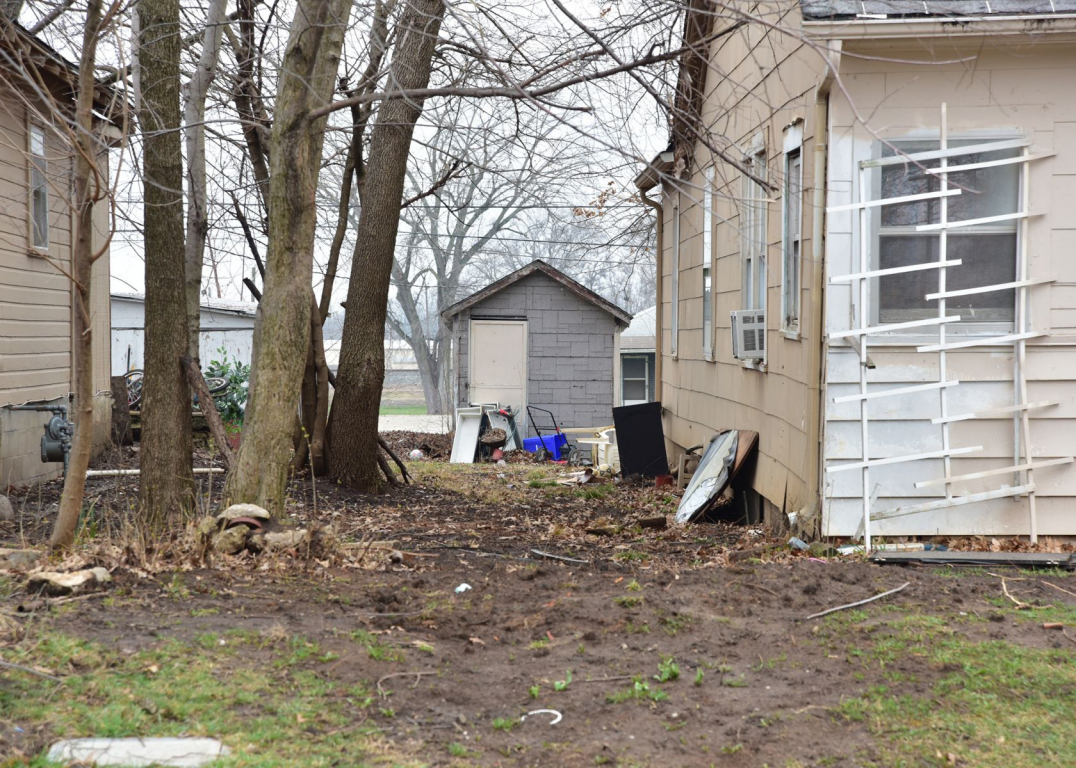
"This one-story, side-gabled house has a rectangular footprint that is seven bays wide and five bays deep. The front roof slope extends to form the full-width porch roof, which is enclosed. A metal awning shelters the stoop entrance at the center bay. Single one-over-one light, double-hung wood sash windows with flat board trim define the other bays. Additional character-defining features include wide-profile wood clapboard cladding and asbestos shingle cladding, both of which are historic alterations. The application of modern wall cladding and the porch enclosure, also a historic alteration, compromise the integrity of this building (Davis and Schwenk, 2003)."

13104 6th Street does not appear significantly altered from its 2003 appearance. Dates of alteration are unknown, however pre-date the 2003 survey. Minor alterations post-2003 include the removal of the metal awning and the installation of aluminum storm windows at all elevations visible from the right-of-way.

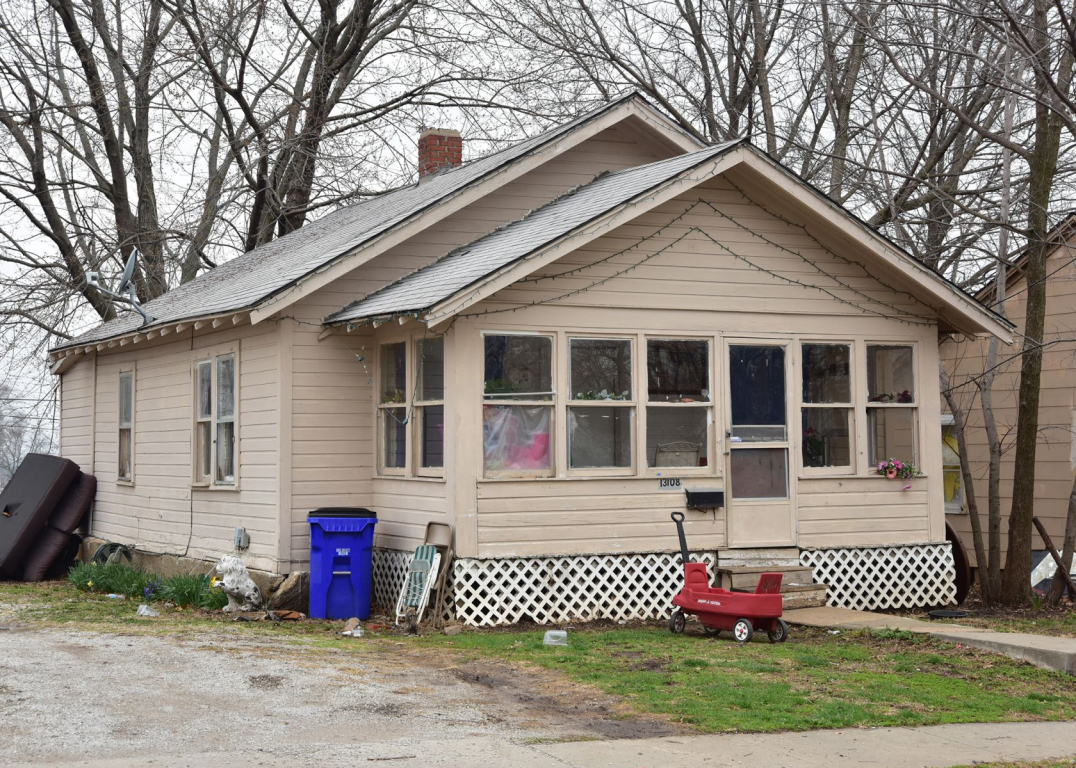
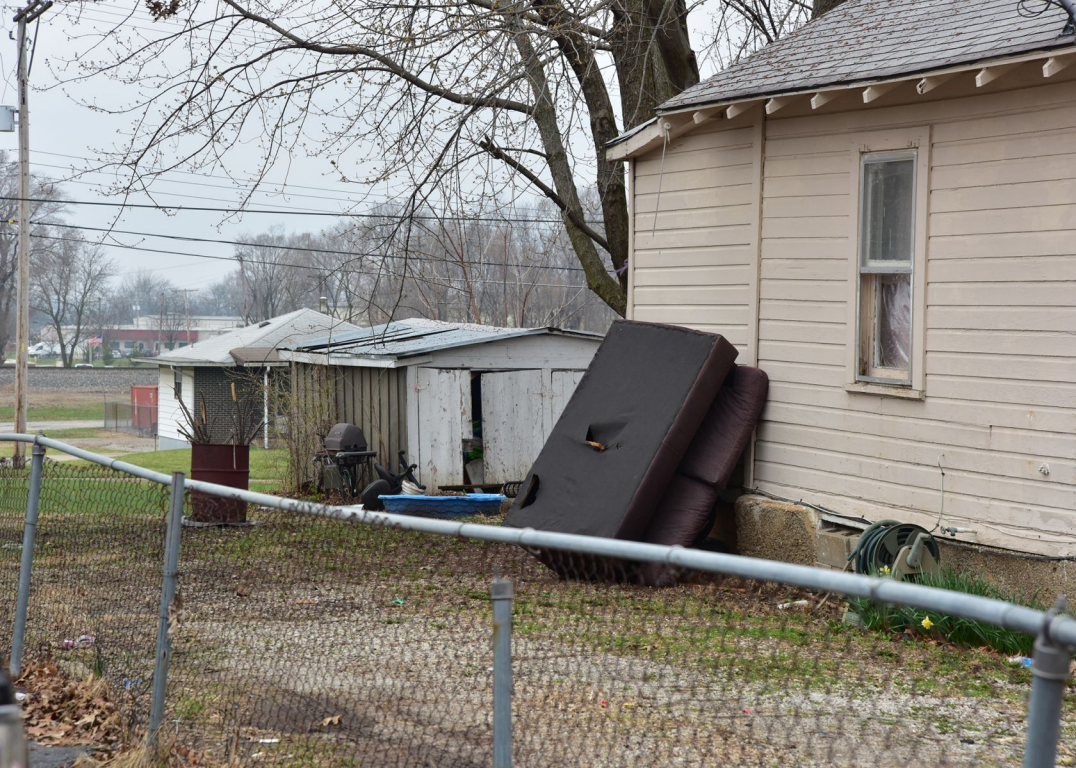
"This one-story, gable-front bungalow has a rectangular footprint that is three bays wide and three bays deep. The three-quarter-width, gable-front porch is enclosed (a historic alteration) and features a center bay stoop entrance flanked by paired and tripled one-over-one light, double-hung wood sash windows. Additional character-defining features include wide eaves with exposed rafter tails, shiplap wood clapboards, flat board window trim, and a stout brick ridge chimney (Davis and Schwenk, 2003)."

13108 6th Street does not appear significantly altered from its 2003 appearance. Dates of alteration are unknown, however they pre-date the 2003 survey.

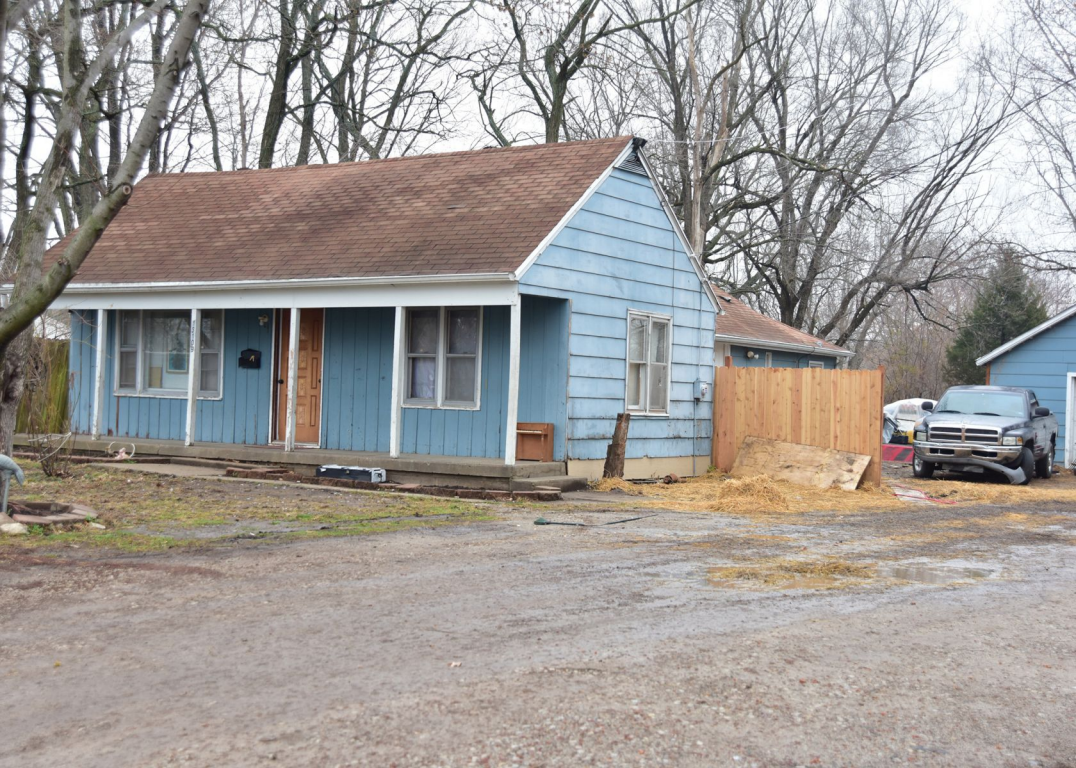
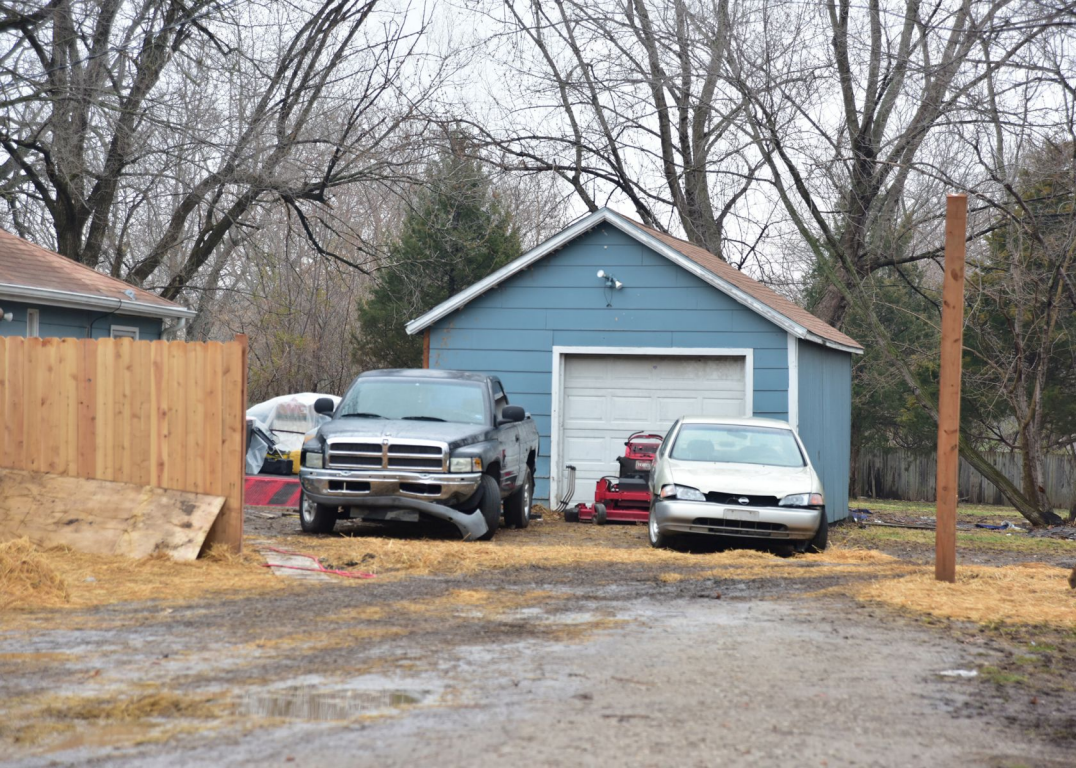
13109 6th Street features board and batten cladding at the front elevation and asbestos at all other elevations visible from the right-of-way. The roof is asphalt. Windows are wood with aluminum storm windows.

13109 6th Street does not appear significantly altered from its 2003 appearance. Dates of alteration are unknown, however they pre-date the 2003 survey.

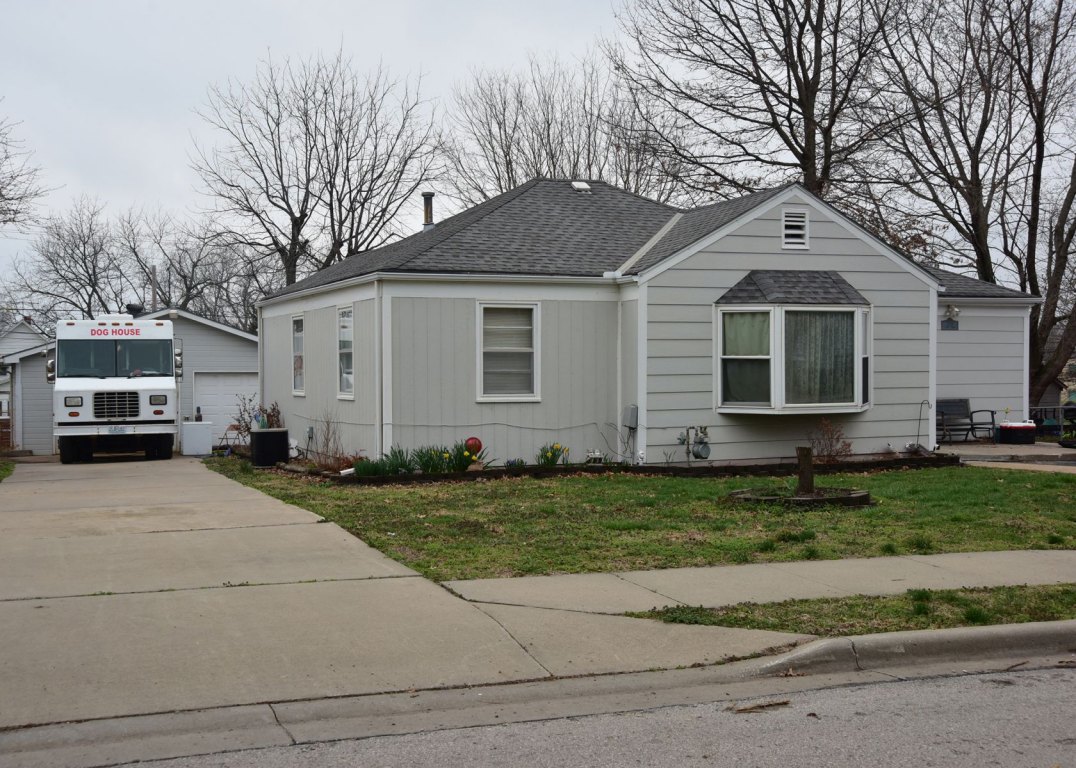
Vinyl cladding has replaced the asbestos shingle noted in the 2003 survey. A vinyl bay window with a 1/1-1-1/1 pane arrangement has replaced the tripartite picture window. Although dates for the other alterations are unknown, they pre-date the 2003 survey.

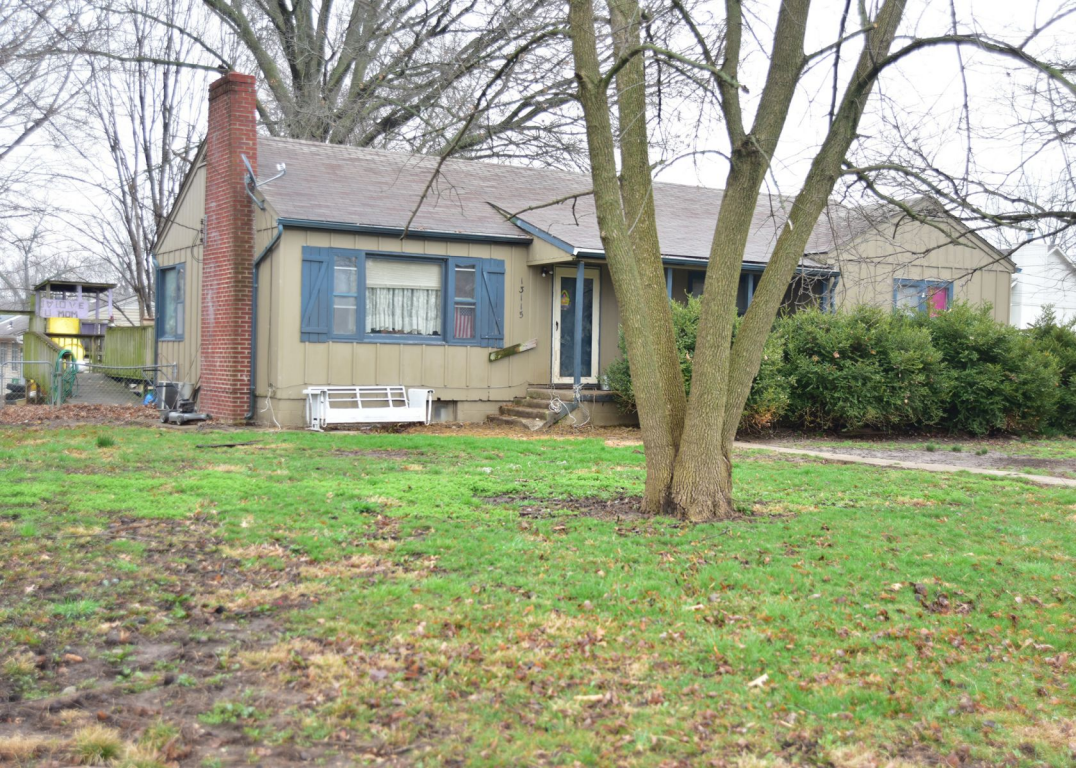
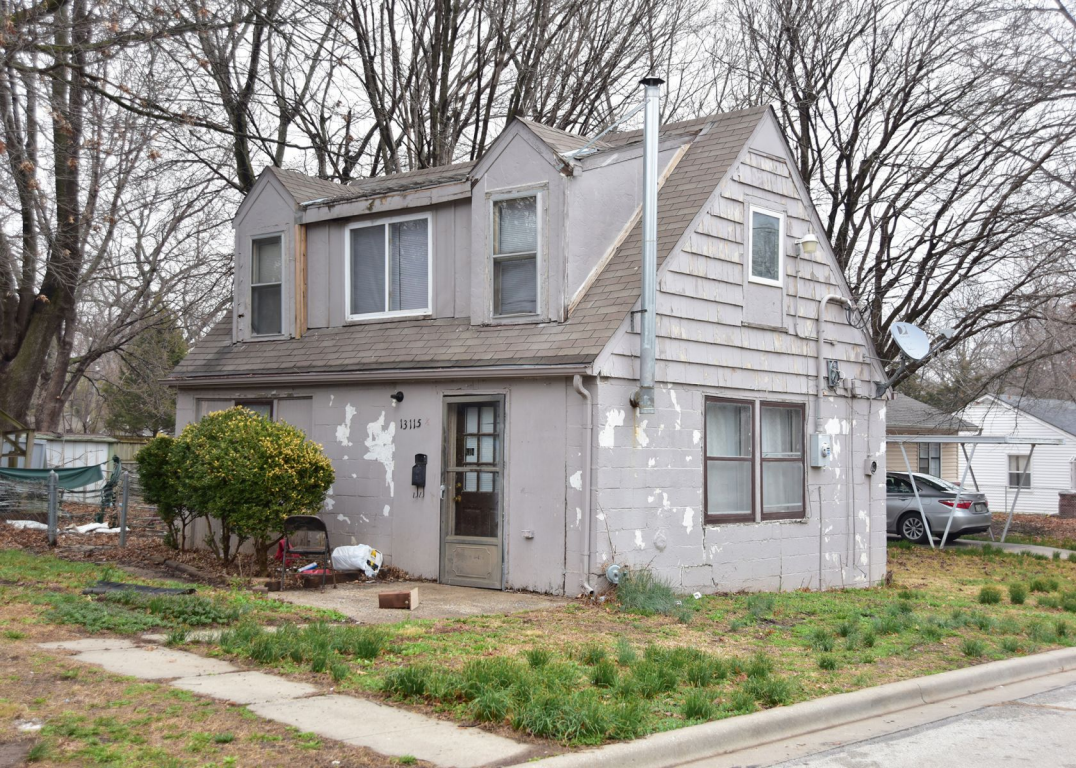
"This one-story Ranch style house has a side-gabled roof and a forward-projecting gable at the south end bay. This dwelling has a front-facing L-shaped footprint that is four bays wide and three bays deep. The front slope extends to form the porch roof, which is supported by square wood posts. The porch shelters the two center bays, which includes the entrance at the second bay from the north end. Paired one-over-one light, double-hung windows and a tripartite picture window with Z-brace shutters define the remaining bays. Additional character-defining features include tight eaves and a broad exterior brick chimney at the north elevation (Davis and Schwenk, 2003)."

13115 6th Street does not appear significantly altered from its 2003 appearance.

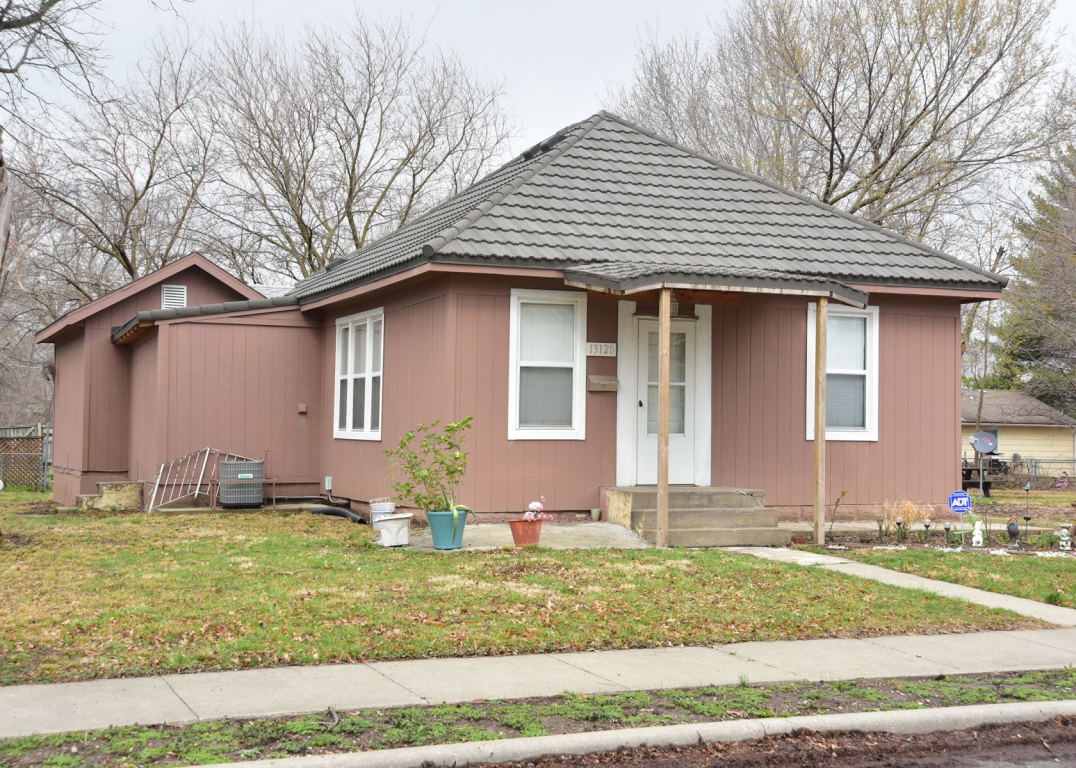
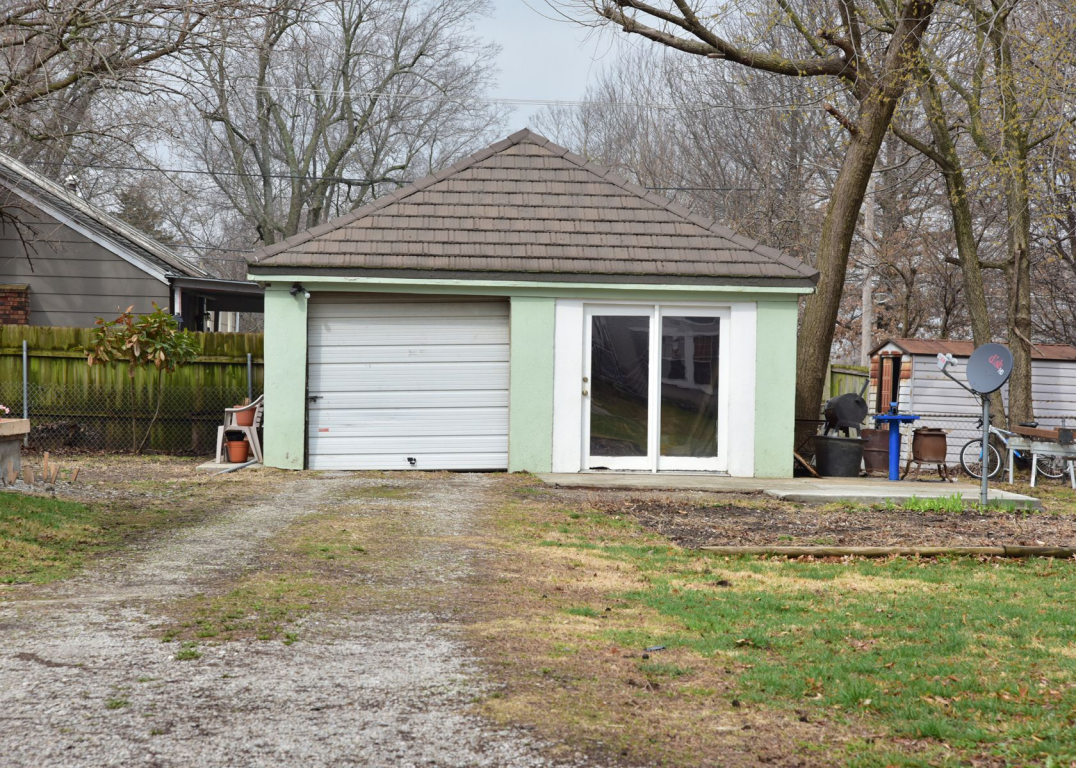
13120 6th Street has been significantly altered since the 2003 survey. A ca. 2017 front gable addition is located at the rear. The awning has been replaced by a synthetic tile roof supported by wood posts. Vertical pressed wood siding has replaced the wood clapboard. Windows are vinyl replacement.

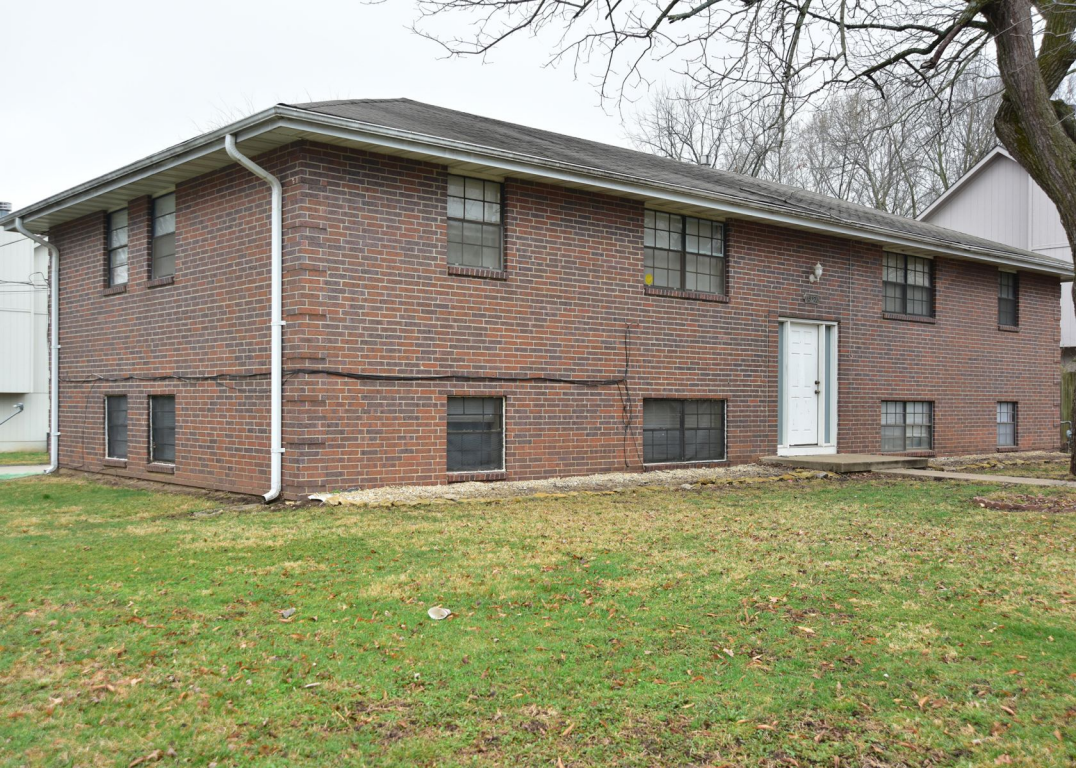
"This two-story, split-level Ranch style four-plex has a hipped roof. The building has a rectangular footprint that is five symmetrical bays wide and two bays deep. Fenestration defines the bays and includes the common hall entrance with sidelights in the center bay and the single and paired six-over-six light, double-hung sash windows in the remaining bays. Additional character-defining features include header brick windowsills, very wide eaves, and projecting brick corner quoins (Davis and Schwenk, 2003)."

1312 6th Street does not appear significantly altered from its 2003 appearance.

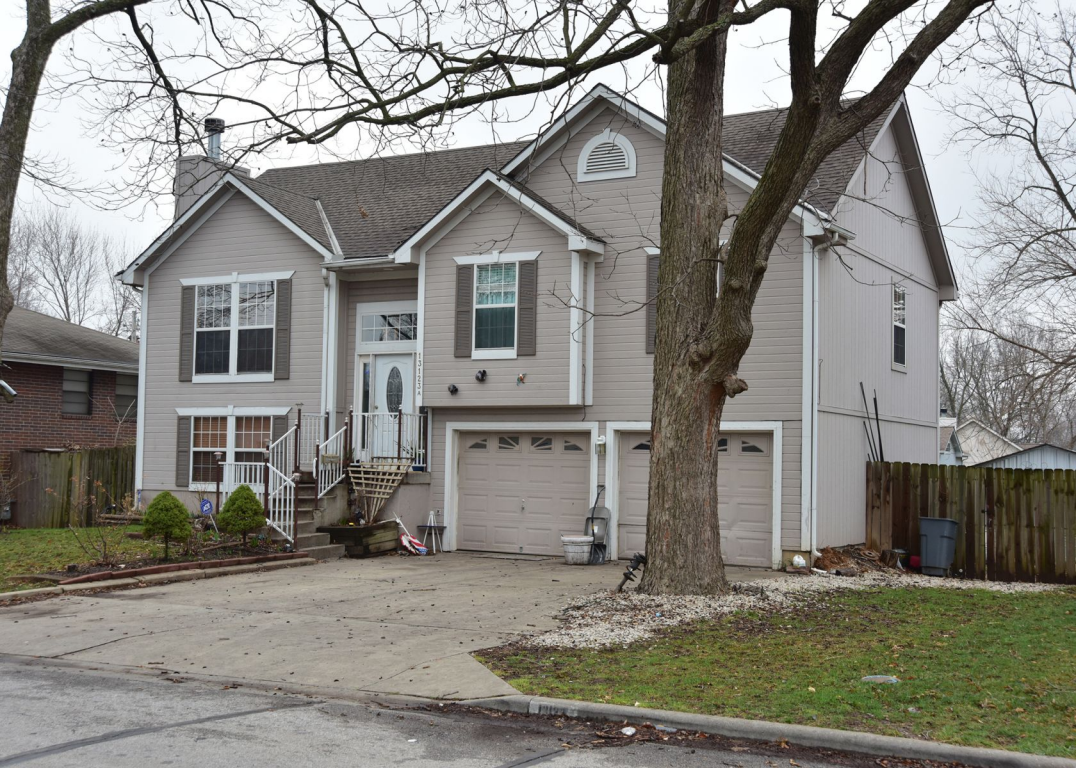
"This modern, two-story, split-level house has a side gable roof and features Neo-Colonial style detailing. The building has a rectangular footprint that is four asymmetrical bays wide and features three lower cross gables. A projection of the eaves forms a porch roof above the stoop, sheltering the primary entrance in the second bay from the north end. The two east end bays each contain a single-car garage bay. Defining the remaining bays of the primary façade are single and paired one-over-one light, double-hung sash vinyl windows with six-over-six and eight-over-eight snap-in muntins. Additional character-defining features include faux window lintels with keystones, entrance door sidelights, and a blind, louvered fanlight (Davis and Schwenk, 2003)."

13123A 6th Street does not appear significantly altered from its 2003 appearance.

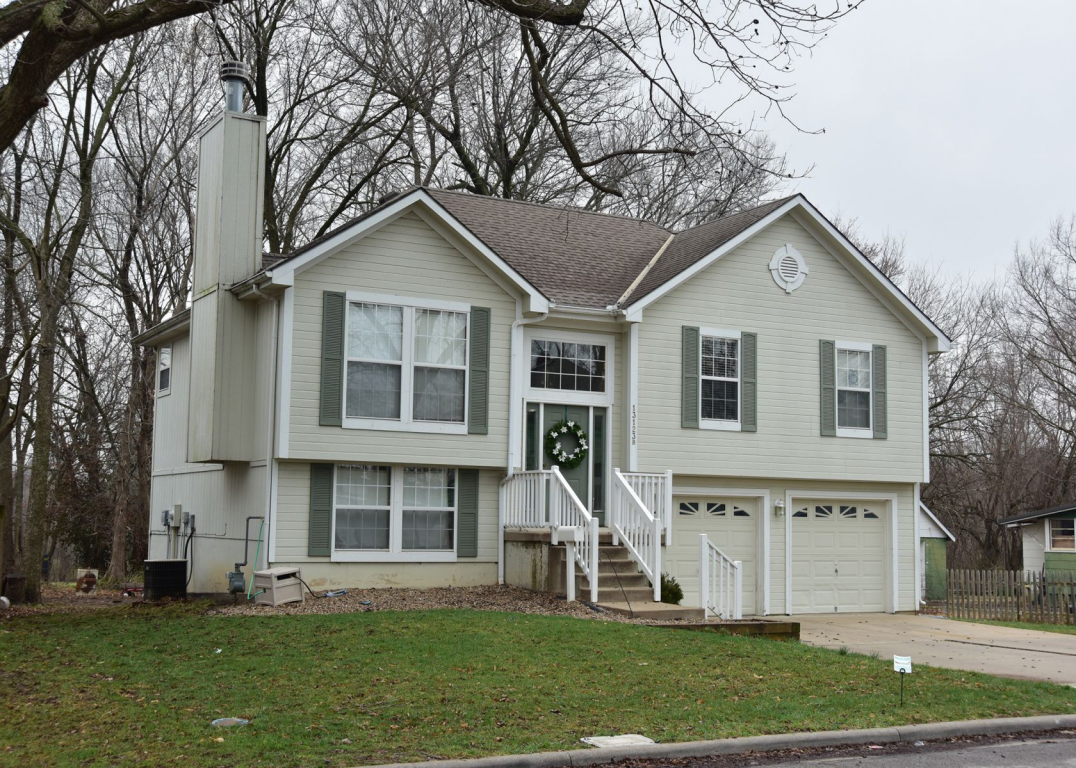
"This modern, two-story, split-level house has a hipped roof and features Neo-Colonial detailing. The building has a rectangular footprint that is four asymmetrical bays wide and features two large lower cross gables. A projection of the eaves line forms a porch roof above the stoop, sheltering the primary entrance in the second bay from the north end. The two east end bays each contain a single-car garage bay. Defining the remaining bays of the primary façade are single and paired one-over-one light, double-hung vinyl windows with six-over-six and eight-over-eight snap-in muntins. Additional character-defining features include wide eaves, entrance door sidelights, and a blind, louvered oculus (round window opening) (Davis and Schwenk, 2003)."

13123B 6th Street does not appear significantly altered from its 2003 appearance.

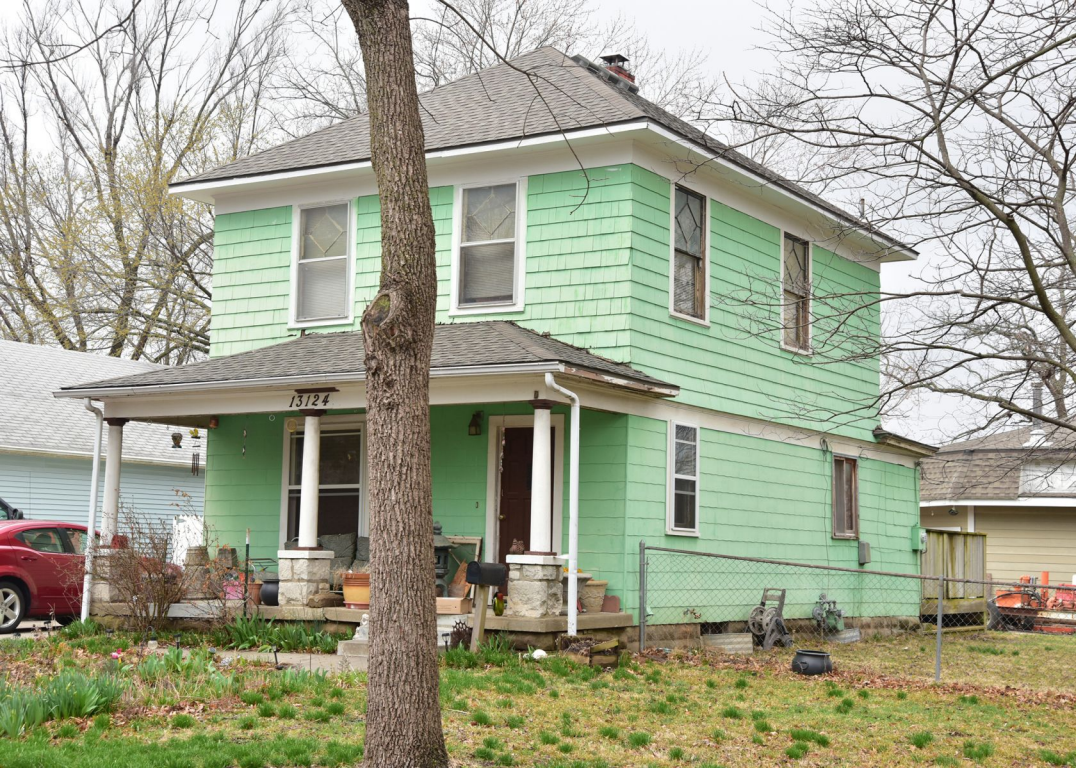
"This two-story Four Square house has a hipped roof and a two-story, single-bay intersecting wing with a hipped roof at the rear of the south (side) elevation. The dwelling has an irregular footprint that is four bays wide and three bays deep. Tuscan columns resting on stone piers support the full-width porch's hipped roof, which shelters the two north end bays, including the entrance at the north end bay. Single one-over-one light, double-hung sash windows with flat board trim define the other bays. Additional character-defining features include the wide eaves with frieze band below and the wood shingle cladding the second story. The one-story, single-bay shed addition that projects from the rear of the south elevation and the one-story, hipped-roof addition to the rear elevation appear to be later alterations that may be more than fifty years in age (Davis and Schwenk, 2003)."

13124 6th Street does not appear significantly altered since the 2003 survey. Dates of alteration are unknown, however they pre-date the 2003 survey.

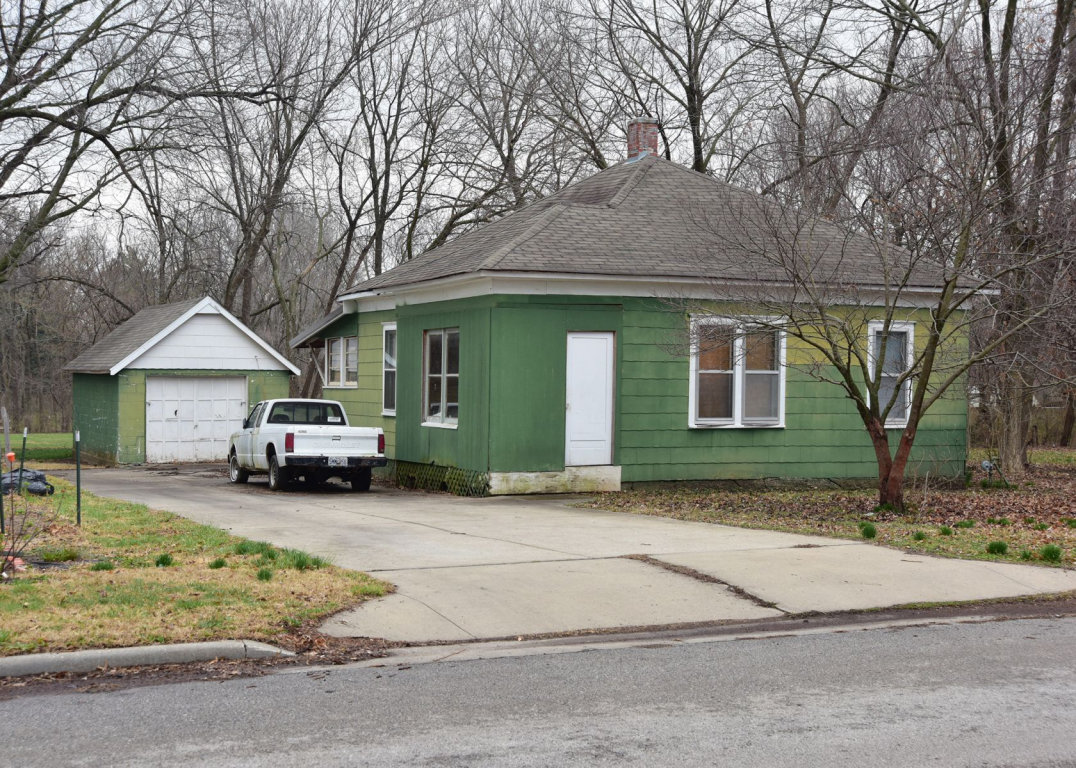
The porch is now enclosed by one non-historic door, a set of paired one-over-one wood sash windows, and vertical wood planks. aluminum storm windows are present at all elevations visible from the right-of-way. The dwelling features an asphalt roof and parged foundation.
