MISSOURI DEPARTMENT OF NATURAL RESOURCES
STATE HISTORIC PRESERVATION OFFICE, P.O. Box 176, Jefferson City, MO 65102
ARCHITECTURAL/HISTORIC INVENTORY FORM

1. Survey number: JA-AS-088-001		2. Survey Name: Town of Grandview, Resurvey	
3. County: JACKSON		4. Address (Street No.): 13114 Street (name): 4th Street	
5. City: Grandview	Vicinity <input type="checkbox"/>	6. Lat / Long:	7. Township/Range/Section: T: R: S:
8. Historic name (if known):		9. Present/other name (if known):	
10. Ownership: <input checked="" type="checkbox"/> Private <input type="checkbox"/> Public		11a. Historic use (if known): Domestic-Single Dwelling	11b. Current use: Domestic-Single Dwelling

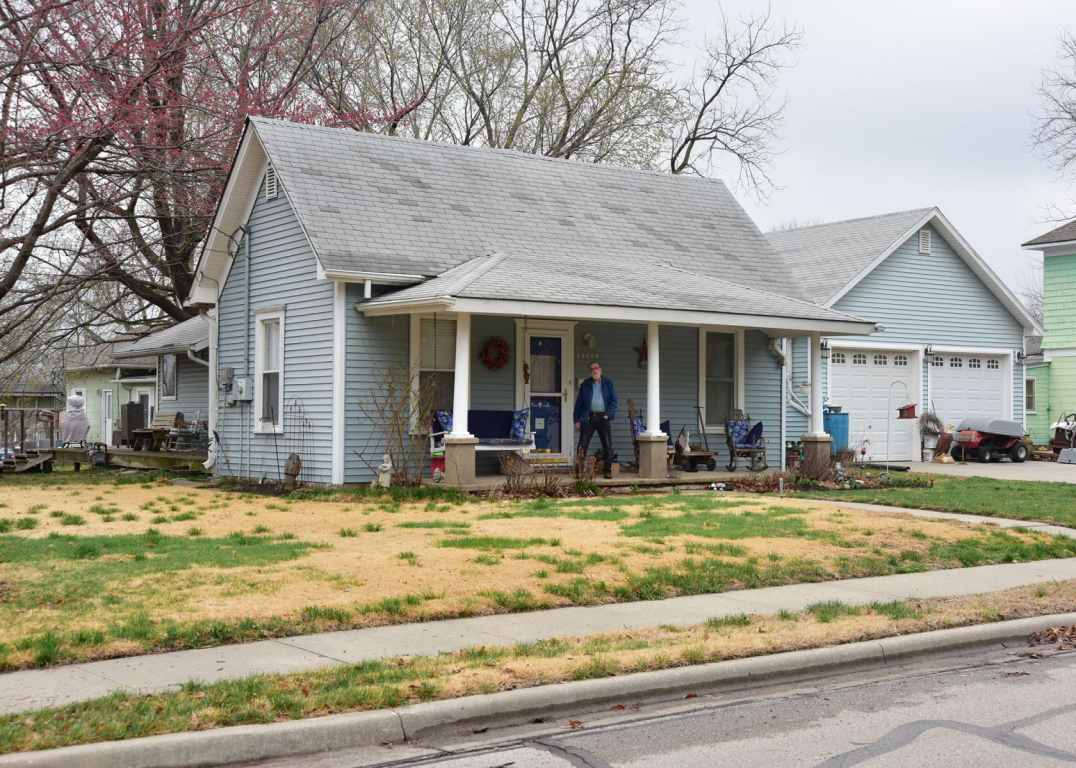
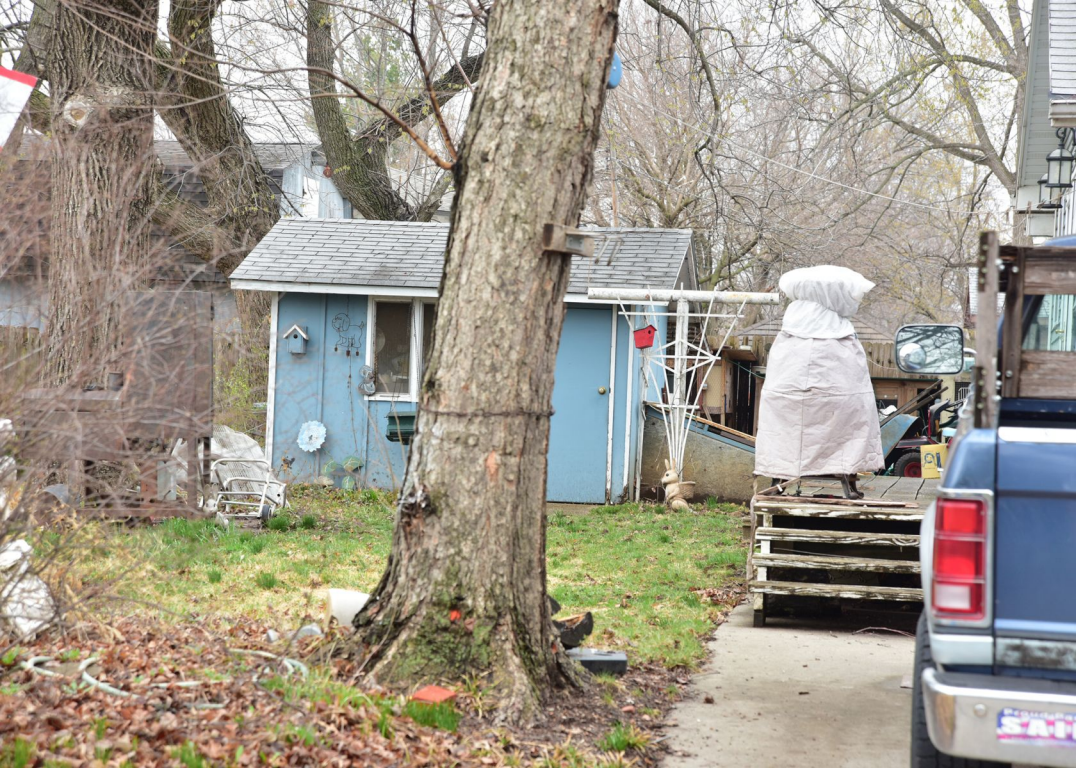
This dwelling has been altered since the 2003 survey. The wood clapboard cladding has been replaced with aluminum. The chimney and second-from-north bay entrance have been removed. Aluminum storm windows are present at all elevations visible from the right-of-way.

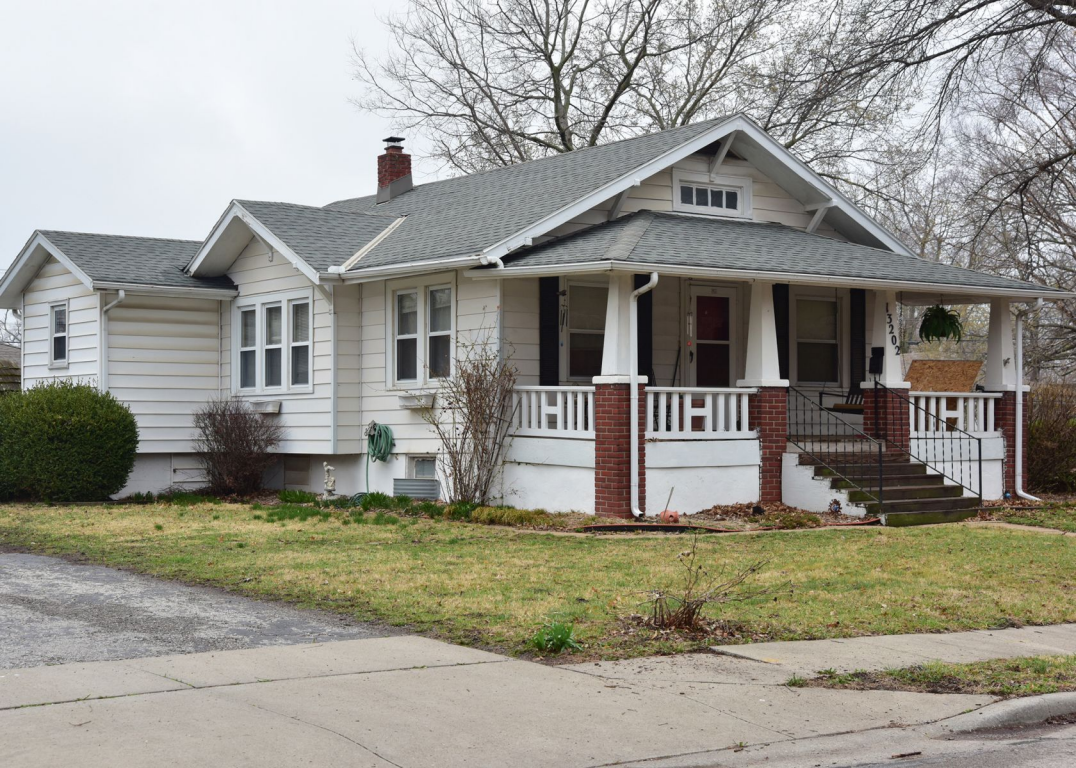
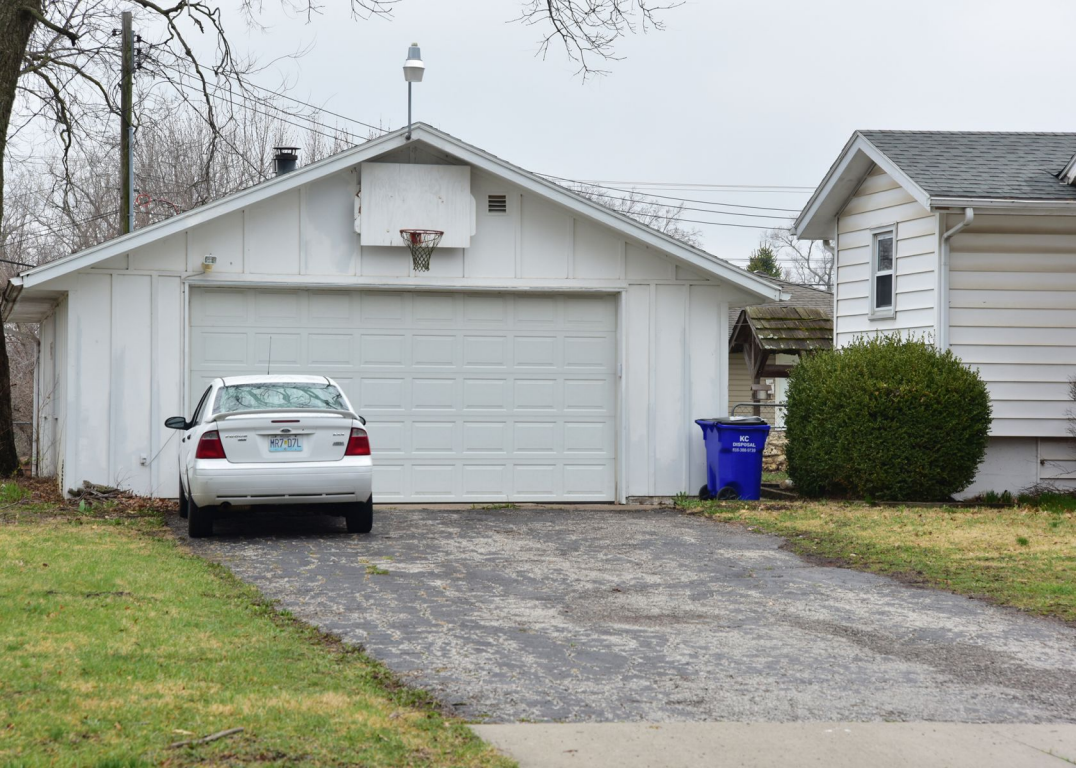
"This one-and-a-half-story, gable-front bungalow has an irregular footprint that is three bays wide and three bays deep. Tapered square columns resting on brick piers support the full-width porch's hipped roof, which shelters the center bay entrance. Single one-over-one light, double-hung sash windows with shutters define the remaining bays. Projecting from the rear of the south (side) elevation are two lower cross gables. Additional character-defining features include a matchstick porch balustrade, wide eaves with knee brackets, and a four-light, wood hopper window in the gable peak (Davis and Schwenk, 2003).

13202 6th Street does not appear significantly altered from its 2003 appearance.

The replacement of historic windows with non-historic materials compromises the integrity of the dwelling, however it retains its ability to convey its historic associations. This resource has fair integrity but it is not eligible because there is no concentration of resources that would constitute a historic district. The determination of its eligibility is unchanged from the 2003 survey.

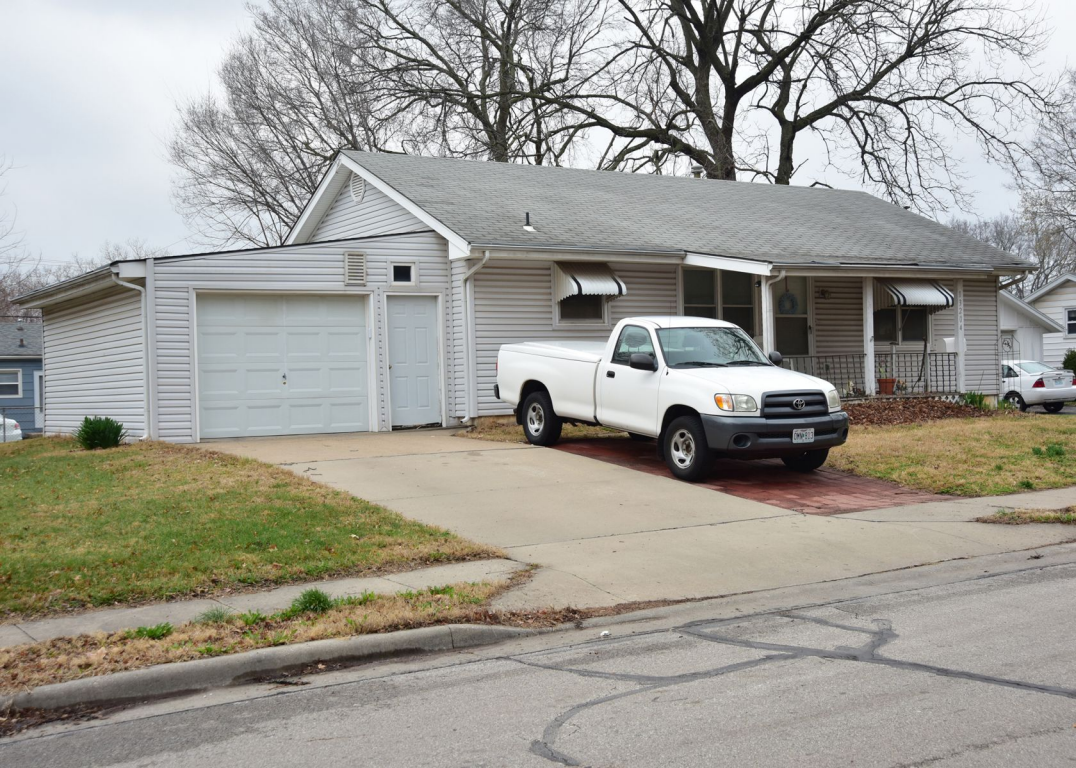
"This one-story, side-gabled Ranch style house has a rectangular footprint that is six asymmetrical bays wide. Square wood posts support the porch's shed roof, which shelters the three north end bays, including the entrance at the second bay from the north end. A single-car garage and a secondary entrance define the two south end bays which appears to be a shed roof addition. Single and paired one-over-one light, double-hung sash windows define the remaining bays. The application of vinyl siding and loss of original porch elements compromise the integrity of this building (Davis and Schwenk, 2003)."

13204 6th Street does not appear significantly altered from its 2003 appearance. Dates of alteration are unknown, however they pre-date the 2003 survey. Metal awnings are present at the north and east elevations.

Material alterations including the application of vinyl siding and the replacement of porch elements, as well as the garage addition, compromise the integrity of 13204 6th Street. This resource has poor integrity and is not eligible. The determination of its eligibility is unchanged from the 2003 survey.

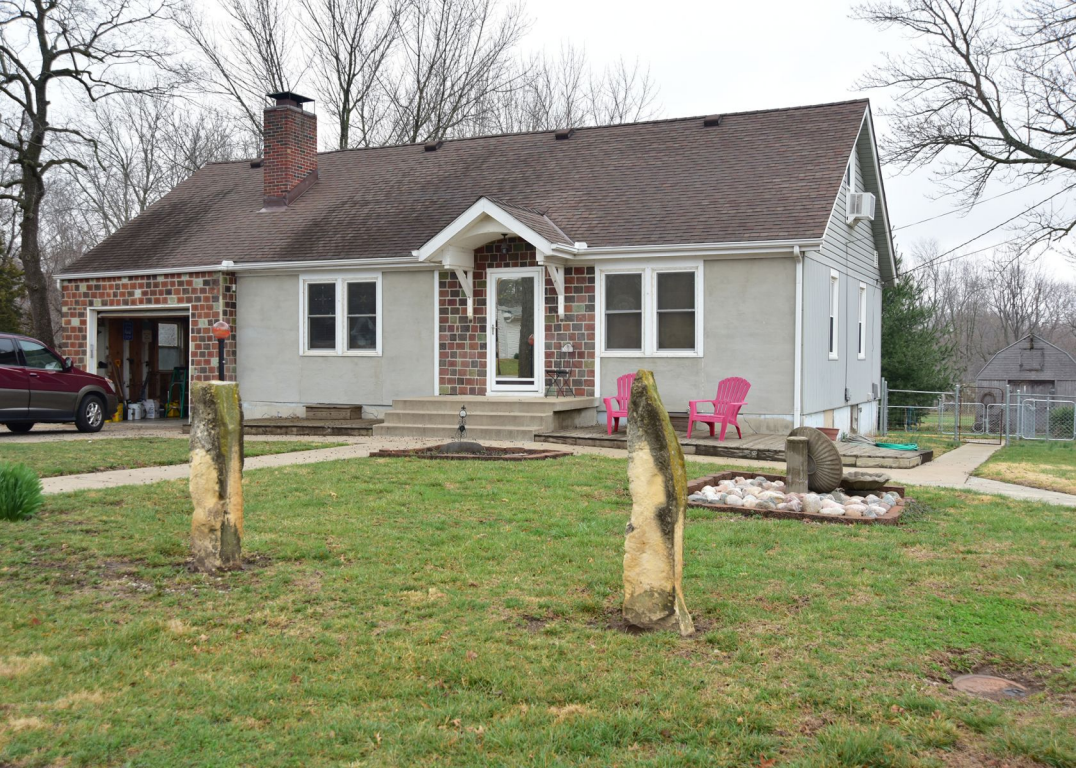
Stucco has replaced the wood cladding at the primary elevation. Stone veneer is present at the north end and entrance bays. Vinyl cladding is present at the south elevation. Windows are one-over-one vinyl replacements. The roof is asphalt shingle and the foundation is parged.

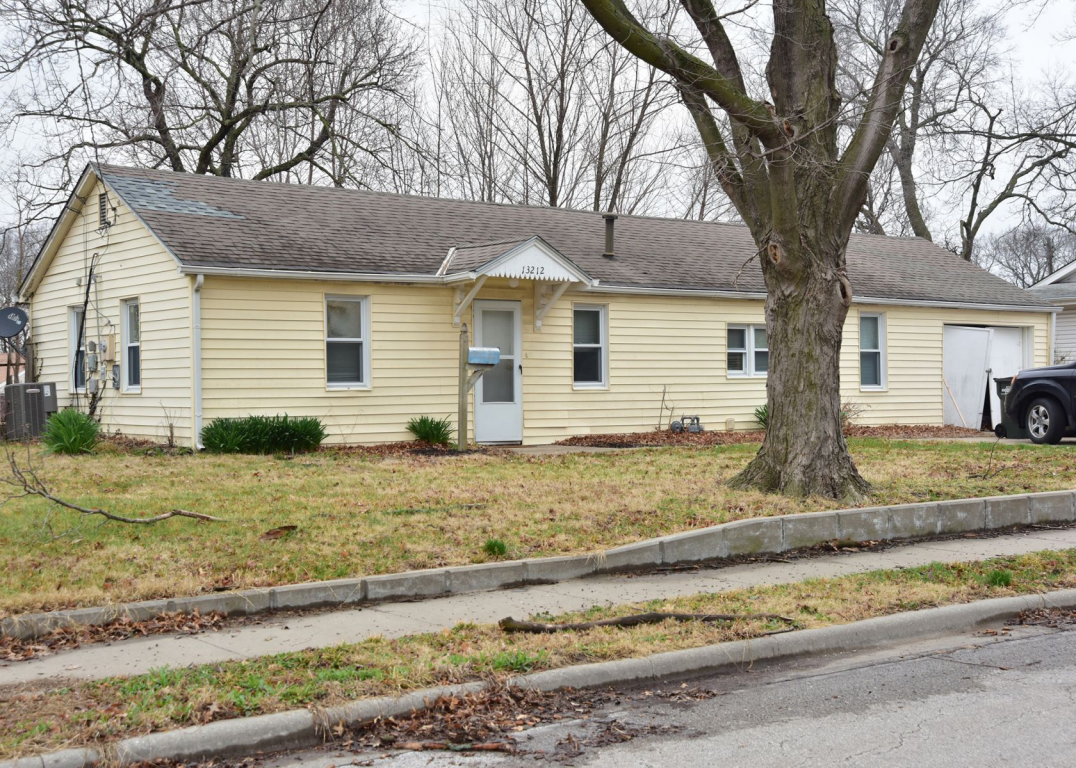
"This one-story, side-gabled Ranch style house has a rectangular footprint that is six asymmetrical bays wide and two bays deep. A Knee brackets support a small projecting gable that shelters the stoop entrance at the second bay from the south end. A single-car garage entrance occupies the north end bay. Single and paired one-over-one light, double-hung sash windows define the remaining bays. The application of vinyl siding compromises the integrity of this building (Davis and Schwenk, 2003)."

13212 6th Street does not appear significantly altered from its 2003 appearance. Alteration dates are unknown, however they pre-date the 2003 survey.

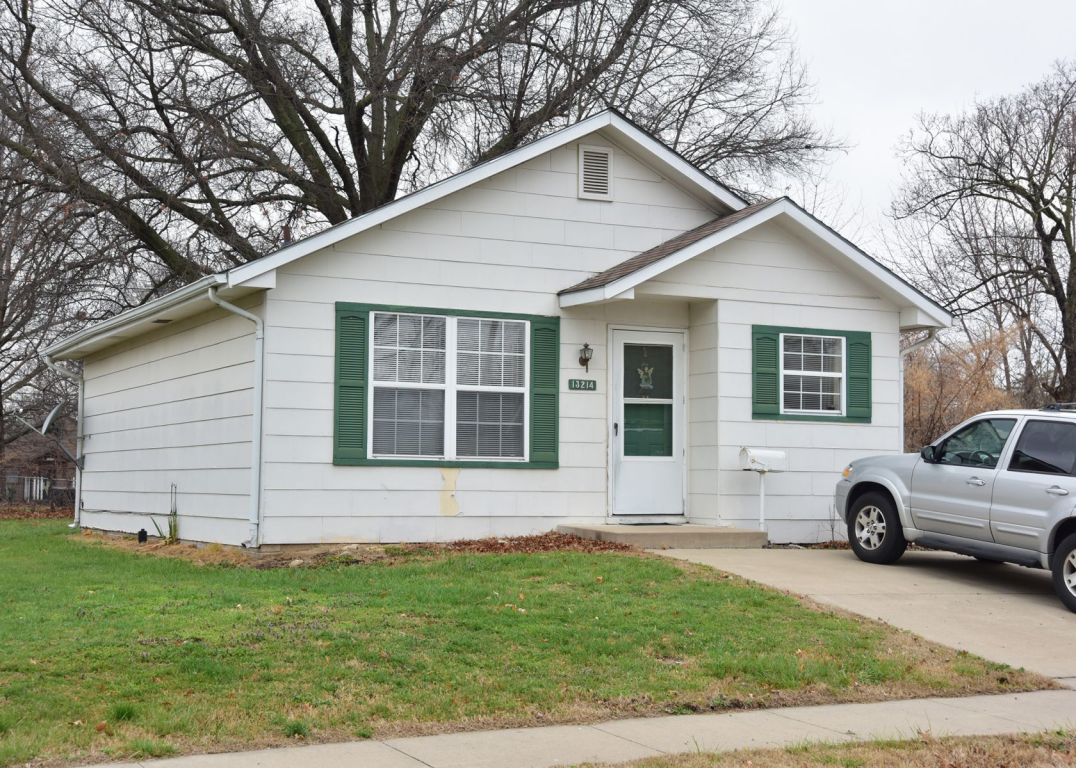
13214 6th Street does not appear significantly altered from its 2003 appearance. The date of window replacement is unknown, however it pre-dates the 2003 survey.

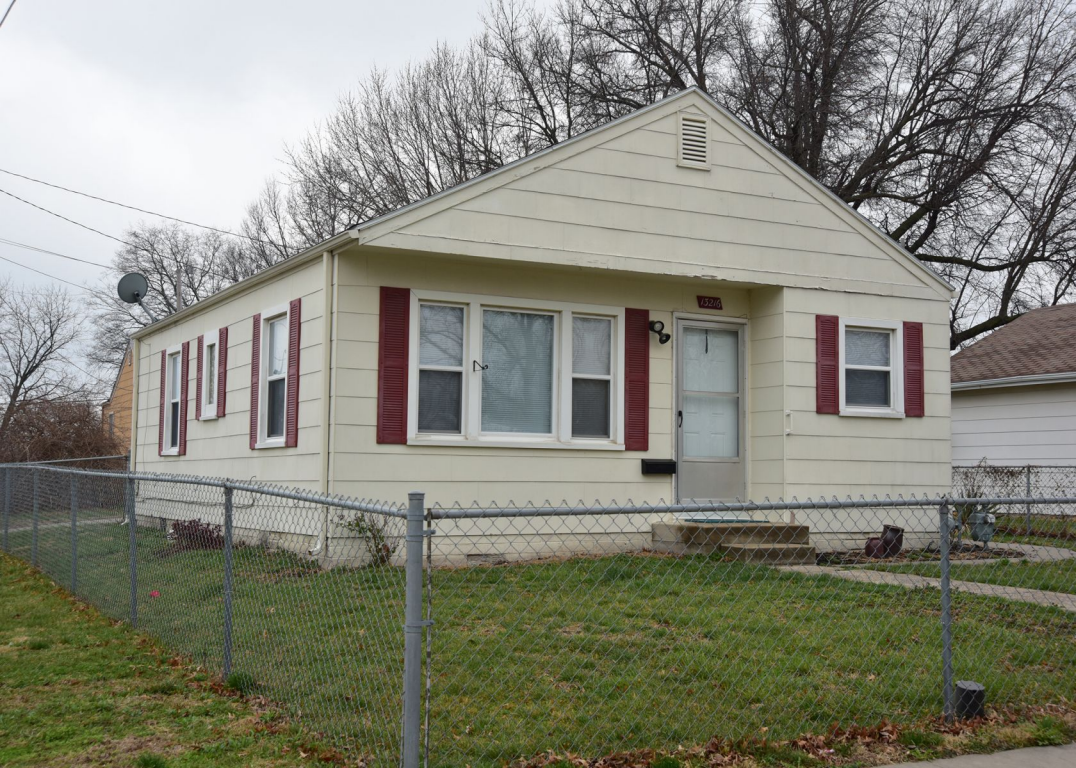
13216 6th Street does not appear significantly altered from its 2003 appearance. The windows may have been replaced since the 2003 survey, however retain their shape and pane arrangement.

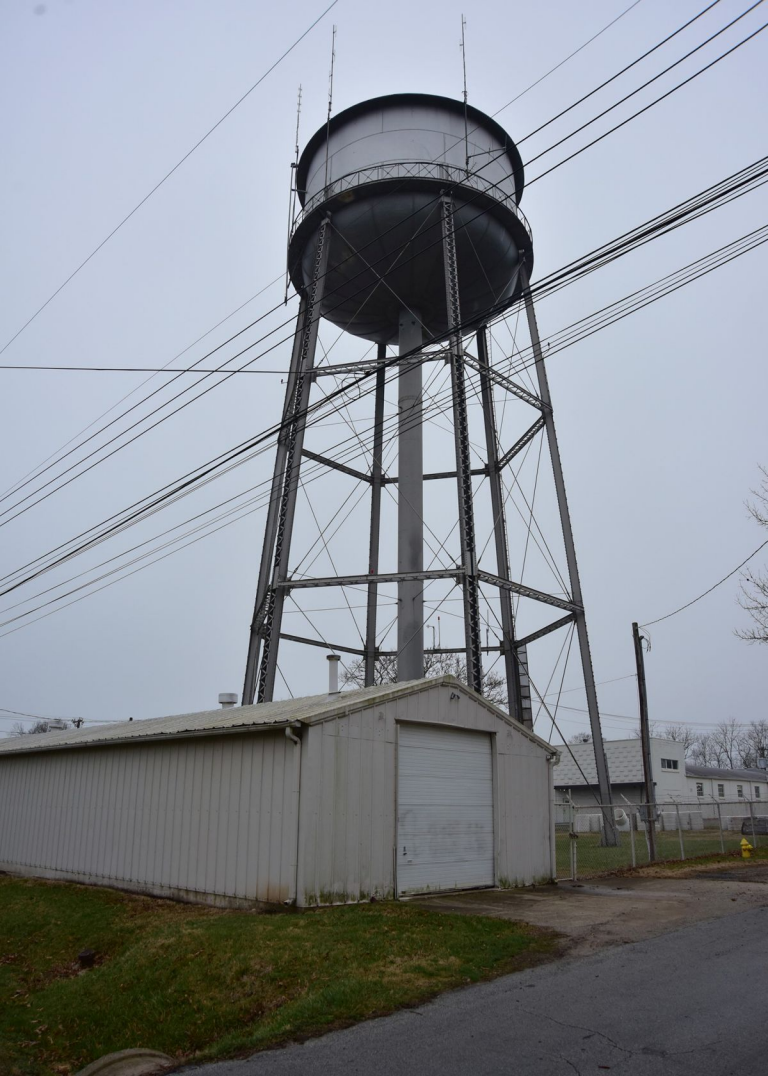
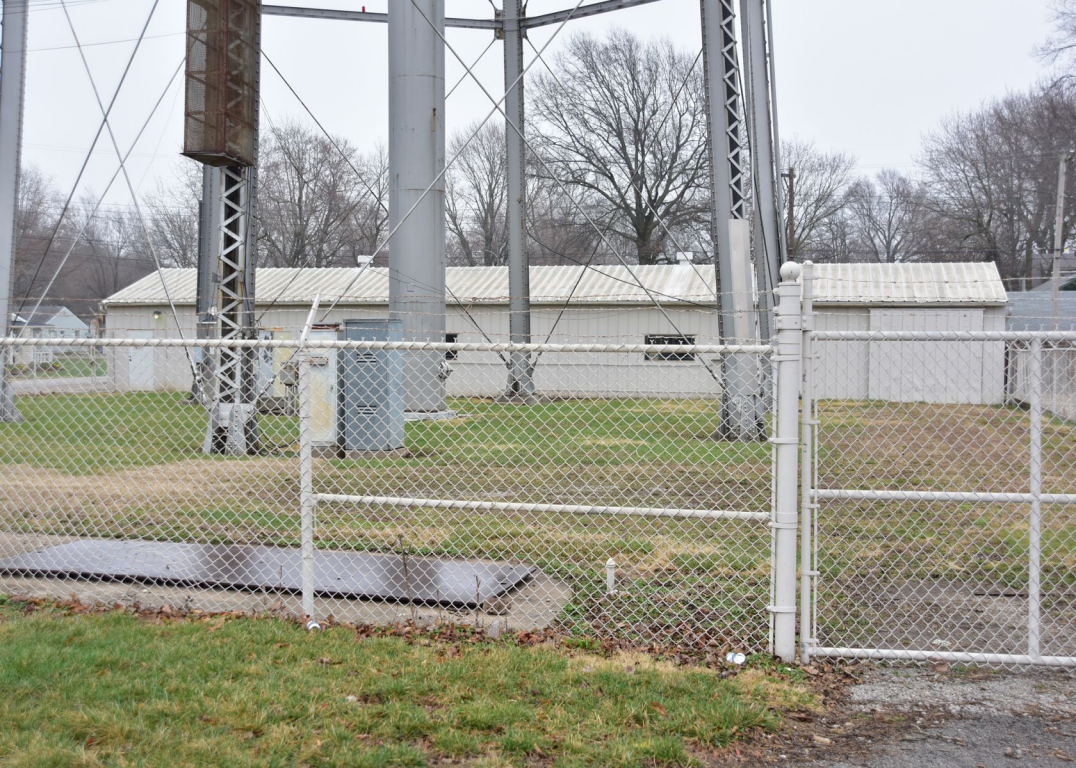
"This water tower structure stands approximately seventy-five feet high and consists of a cylindrical tank supported by a riveted steel support structure that forms a hexagonal footprint (Davis and Schwenk, 2003)."

The water tower located at 12819 7th Street does not appear significantly altered from its 2003 appearance.

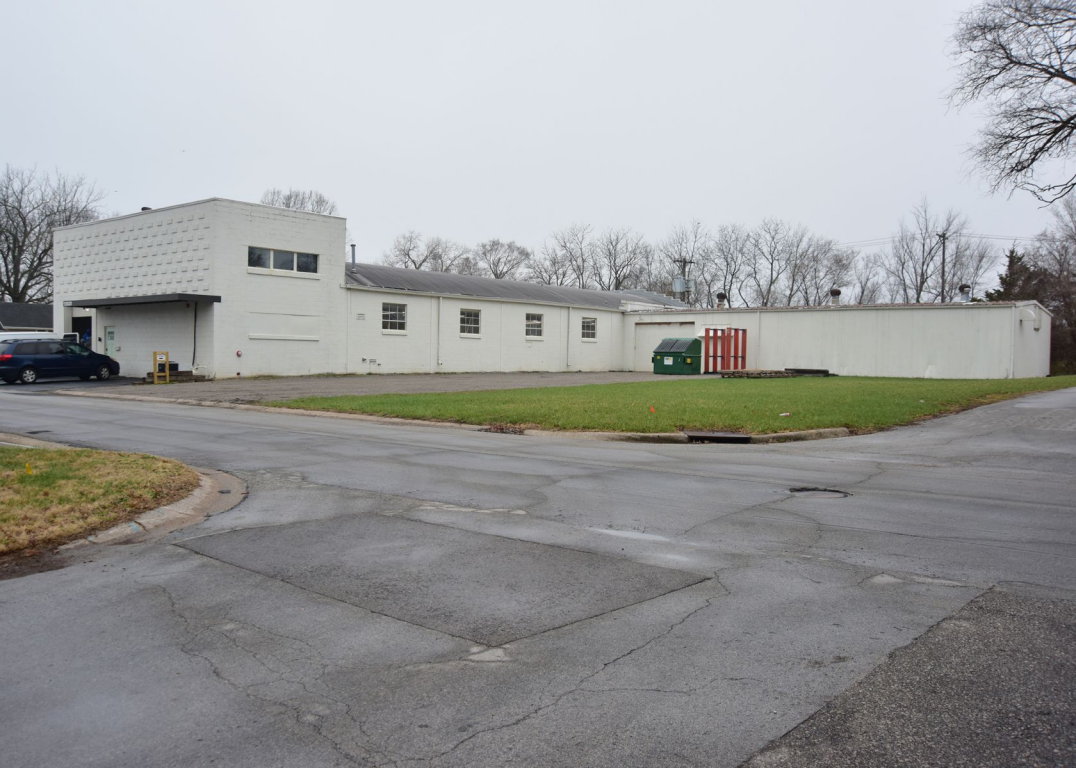
The top row of triple four-light sash windows at the secondary elevations have been replaced with triple one-light sash windows. The bottom row has been infilled.

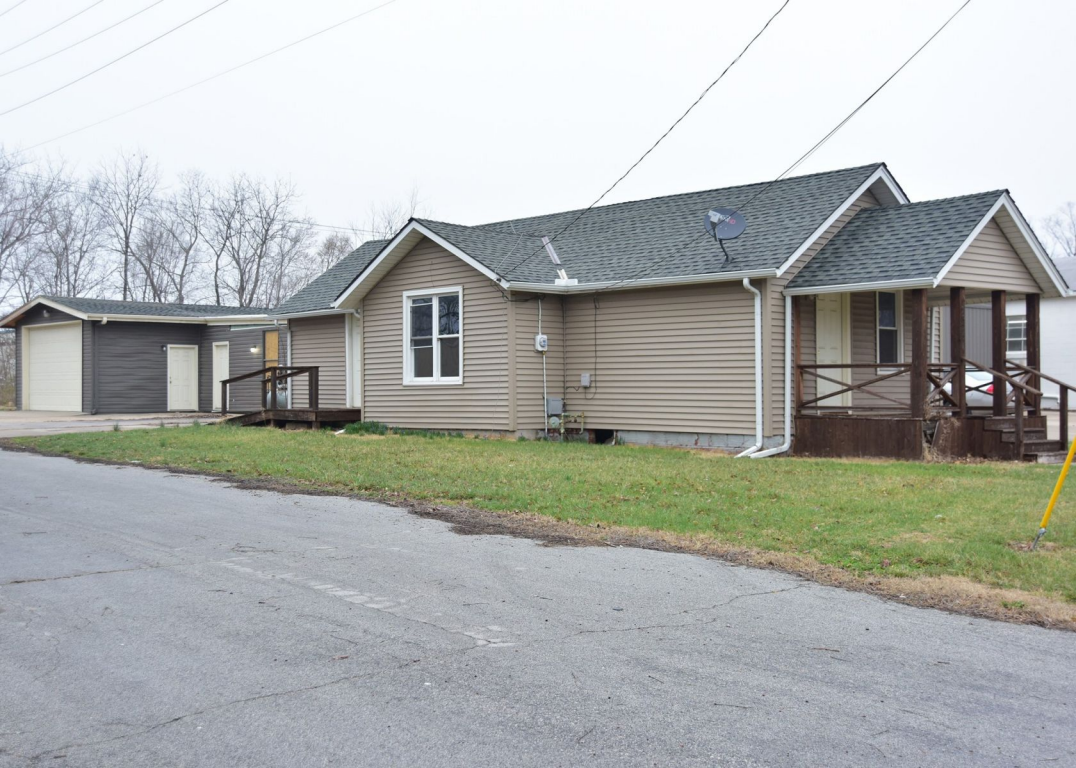
The non-historic wood doors are a post-2003 alteration. 12826 7th Street does not otherwise appear significantly altered since the 2003 survey. Other alteration dates are unknown, however they pre-date the 2003 survey.

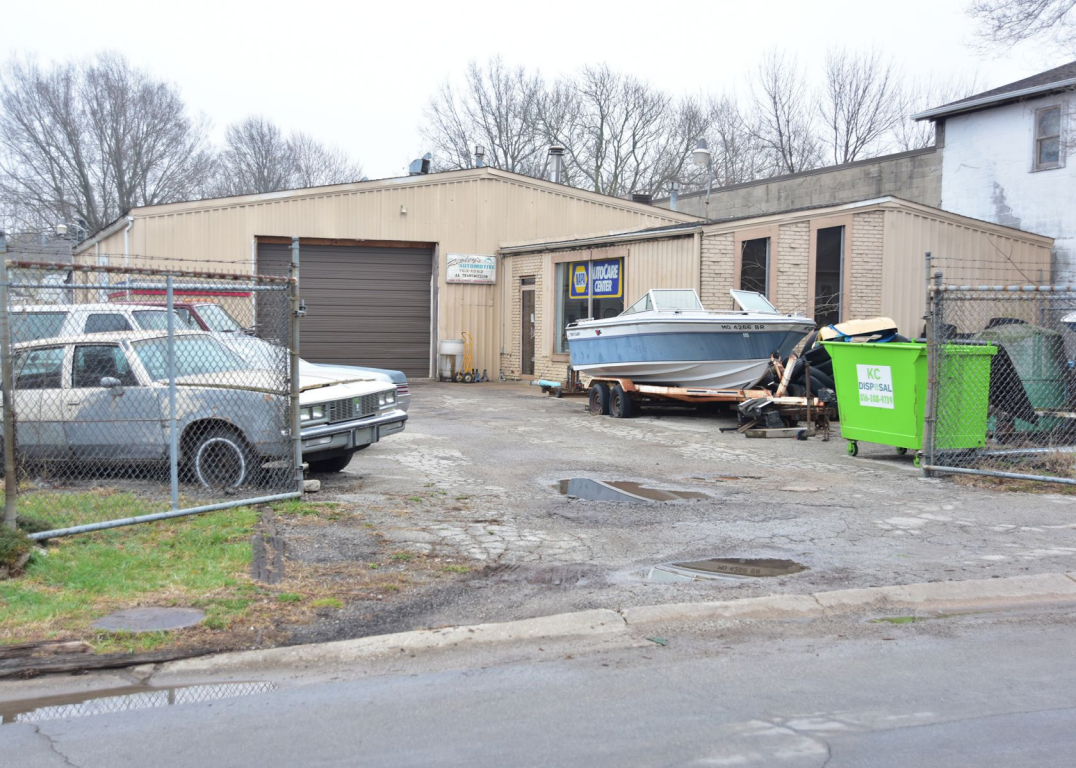
Asphalt has replaced the corrugated metal roof noted in the 2003 survey. The building otherwise does not appear altered from its 2003 appearance.

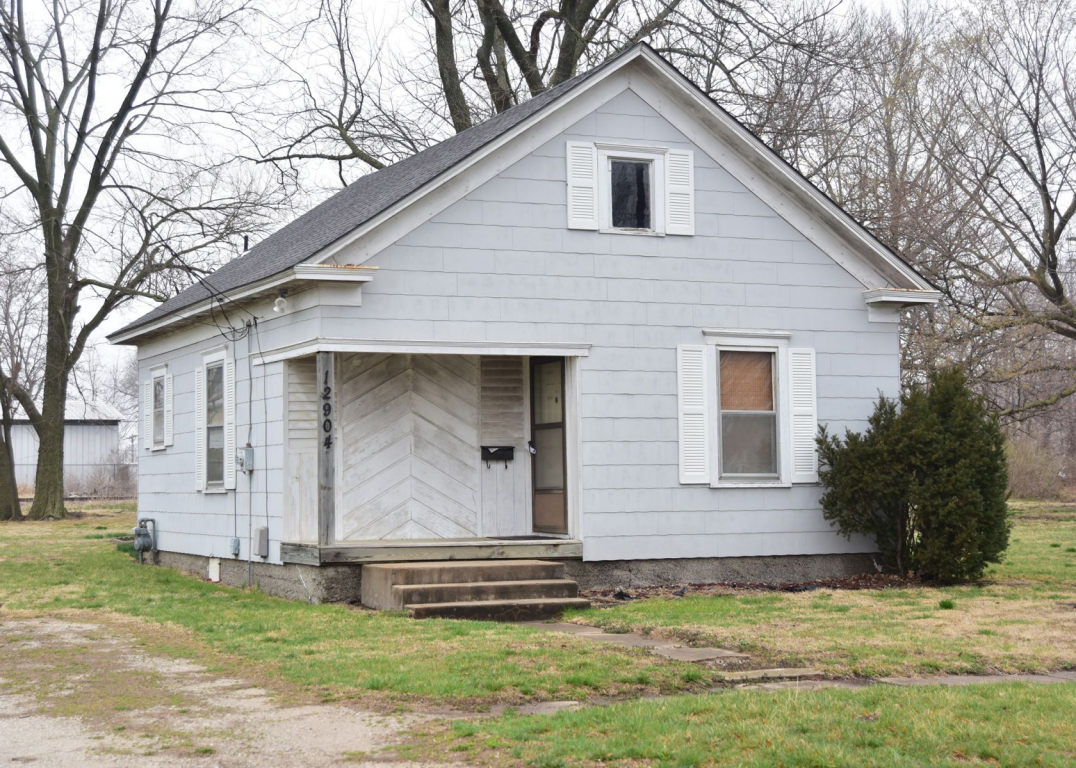
"This one-and-a-half-story, gable-front house has a rectangular footprint that is two bays wide and three bays deep. The front wall recesses at the south end bay, sheltering the perpendicular entrance. A single one-over-one light, double-hung sash window with flat board trim, crown molding, and shutters defines the other bay. Additional character-defining features include wide eaves with cornice returns and frieze bands, a small window opening with matching trim treatment in the front gable peak, and original molding trim surrounding the recessed porch bay (Davis and Schwenk, 2003)."

The dwelling features asbestos cladding and an asphalt roof. Non-historic wood cladding in chevron and linear clapboards has been applied to the recessed portion of the primary elevation, aluminum storm windows are located at all elevations visible from the right-of-way. 12904 7th Street does not appear significantly altered from its 2003 appearance. Alteration dates are unknown, however they pre-date the 2003 survey.

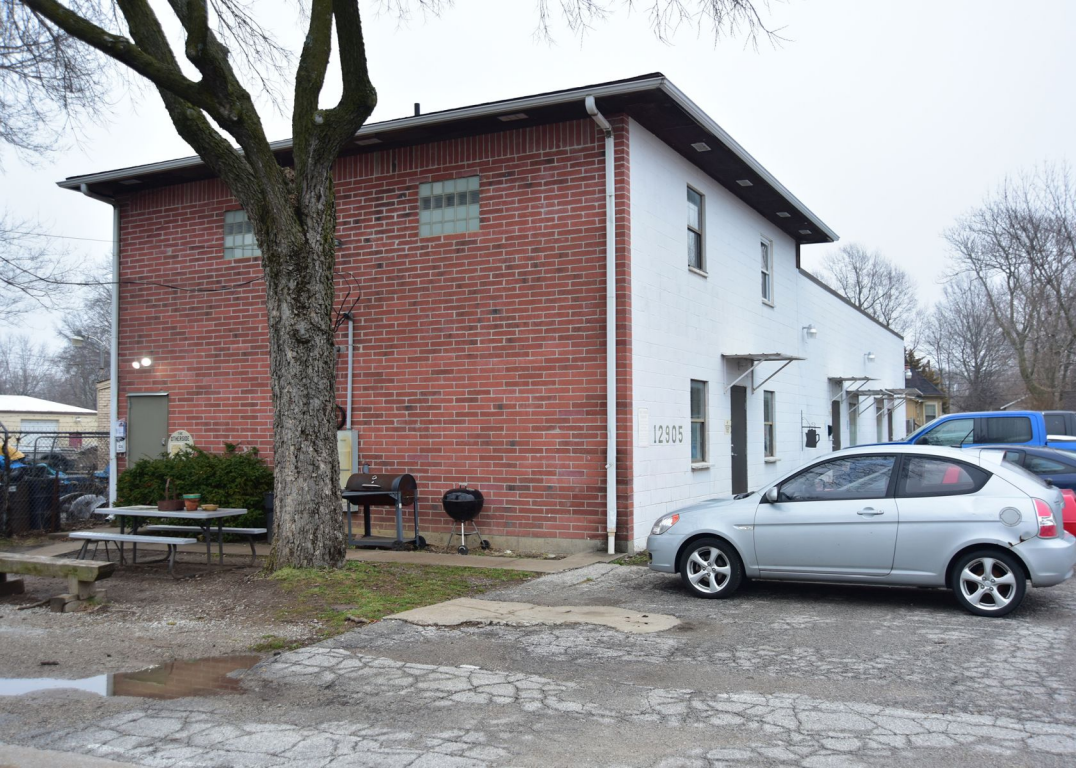
"This modern, two-story, concrete block commercial building has a rectangular footprint that is one bay wide and seven bays deep. Brick facing distinguishes the primary façade, which features a single entrance bay at the first story and two second-story window openings with glass block infill. Secondary entrances and one-over-one light, double-hung sash windows pierce the south (side) elevation. Additional character-defining features include a shallow pyramidal roof with very wide eaves (Davis and Schwenk, 2003)."

The glass block infill is composed of 20 blocks, arranged five-by-four, with the second row transparent while all others are opaque. 12905 7th Street does not appear significantly altered from its 2003 appearance.

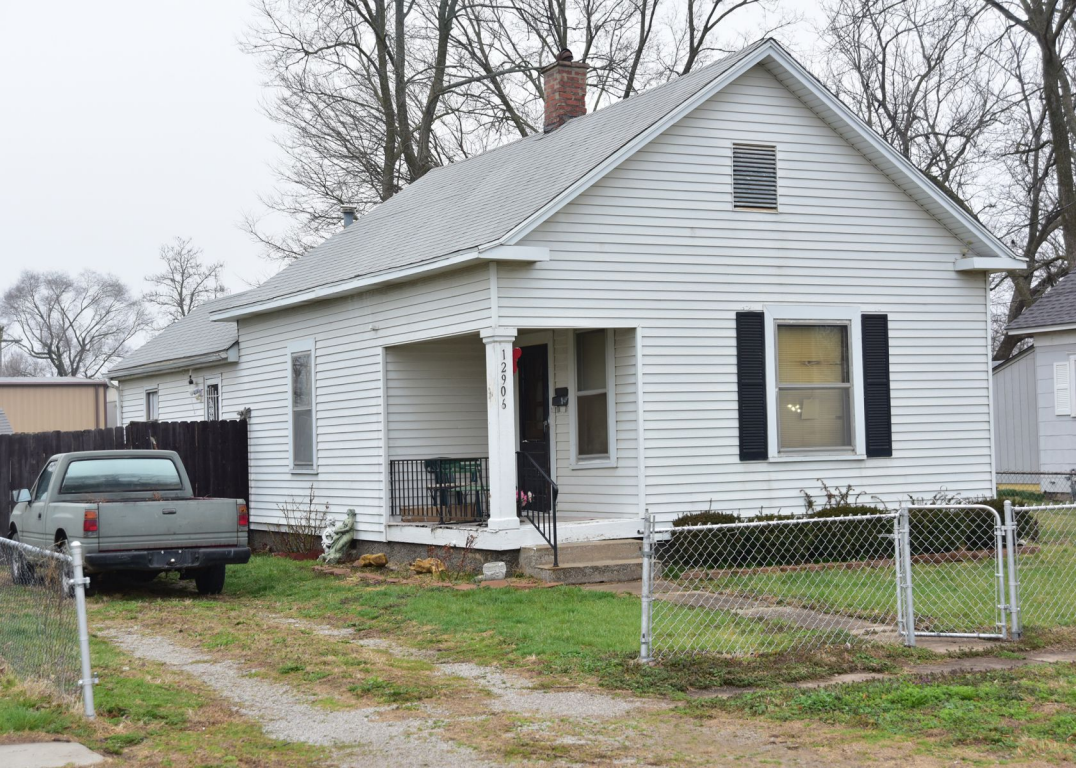
"This one-and-a-half-story, gable-front house has a rectangular footprint that is two bays wide and five bays deep. The front wall recesses at the south end bay, sheltering the perpendicular entrance. A single one-over-one light, double-hung sash window with flat board trim and shutters defines the other bay. Additional character-defining features include wide eaves with cornice returns, a small louvered window opening in the front gable peak, a small brick chimney at the center of the roof ridge, and the original square wood porch post featuring a modest capital (Davis and Schwenk, 2003)."

The dwelling features vinyl cladding and an asphalt roof. aluminum storm windows are present at all elevations visible from the right-of-way. 12906 7th Street does not appear significantly altered from its 2003 appearance. Dates of alteration are unknown, however the pre-date the 2003 survey.

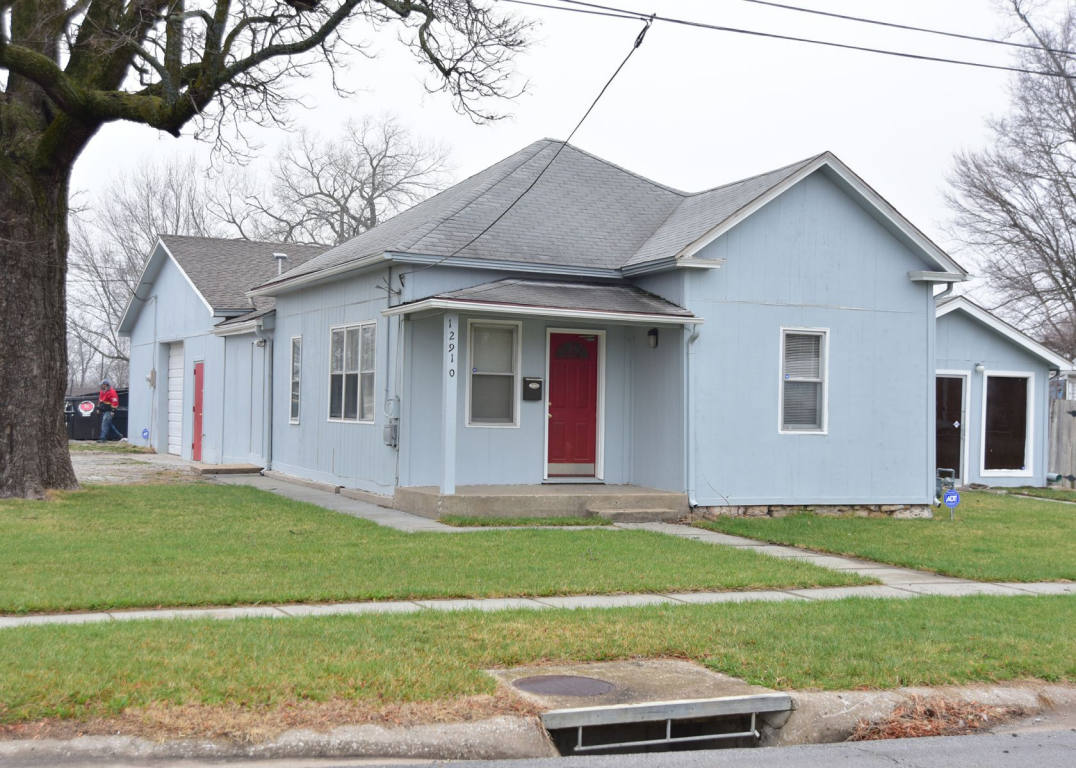
12910 7th Street does not appear significantly altered from its 2003 appearance. Although dates of alteration are unknown, they pre-date the 2003 survey.

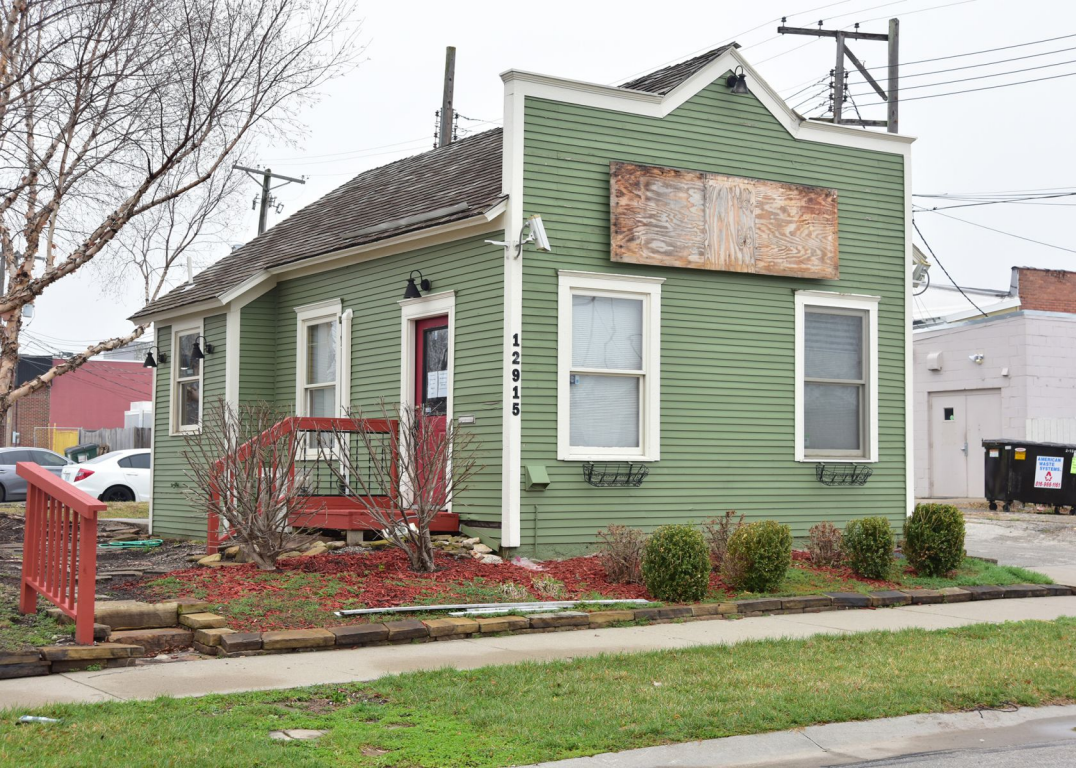
"This complex features four connected components, varying in size, shape, and era of construction. The primary block, constructed in 1912, is located at the southwest corner of the complex and features a false-front gabled roof. This building has a rectangular footprint that is two bays wide and three bays deep. Character-defining features include flat board trim around the entrance door (at the north end bay) and window openings; thin-profile clapboards with corner boards; and the exposed front gable peak above the false front wall. Along the perimeter of the lot, long one-story wood frame sheds with flat roofs connect the primary block to a two-story block of undetermined age at the northeast corner of the complex. Pressed wood siding covers the connecting sheds and the original masonry walls of this block. The one-story sheds also connect the primary block to a circa 1950 office block with a gable-front roof that is at the southeast corner of the complex. The office block has a rectangular footprint that is two bays wide and two bays deep and features wood clapboard siding; tight, boxed eaves; and a tripartite picture window. The complex displays two addresses: 19912 8th Street and 12915 7th Street (Davis and Schwenk, 2003)."

12915 7th Street has been significantly altered since the 2003 survey due to demolition of most of the complex.

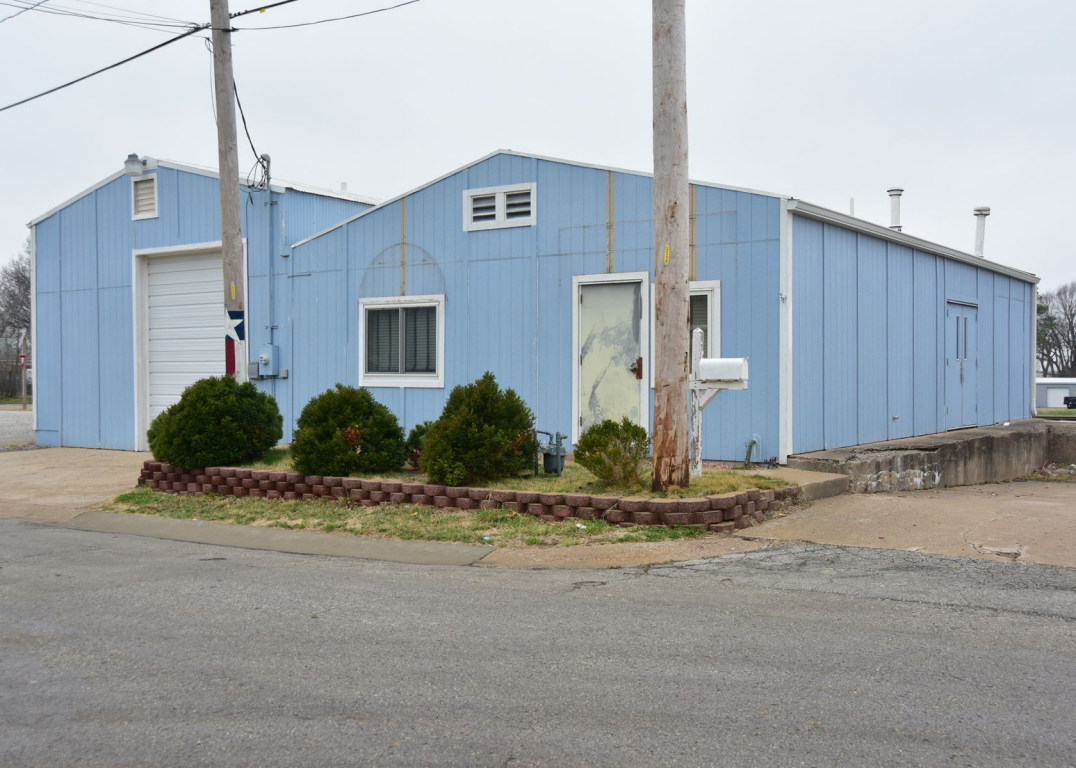
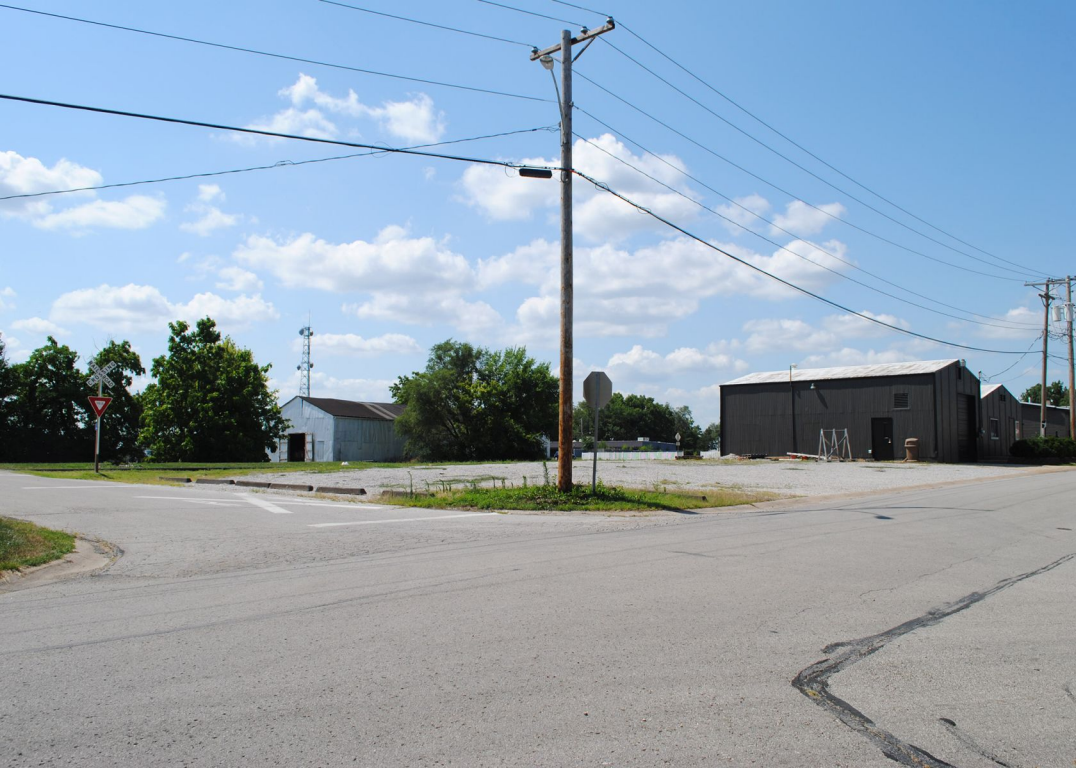
The vehicular bay opening has been reduced. A two-by-two metal window has replaced the picture window and a new one-light fixed metal window nearly abuts the door. Fabric awnings over the pedestrian entrance and windows of the east elevation were removed ca. 2013.

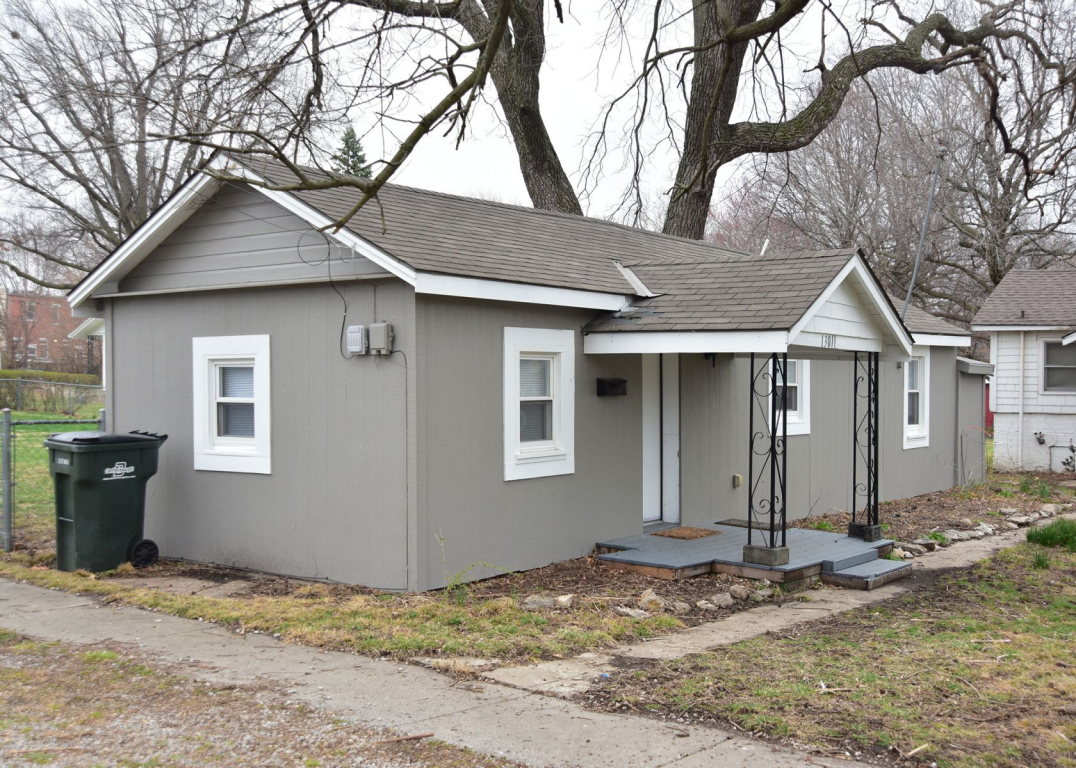
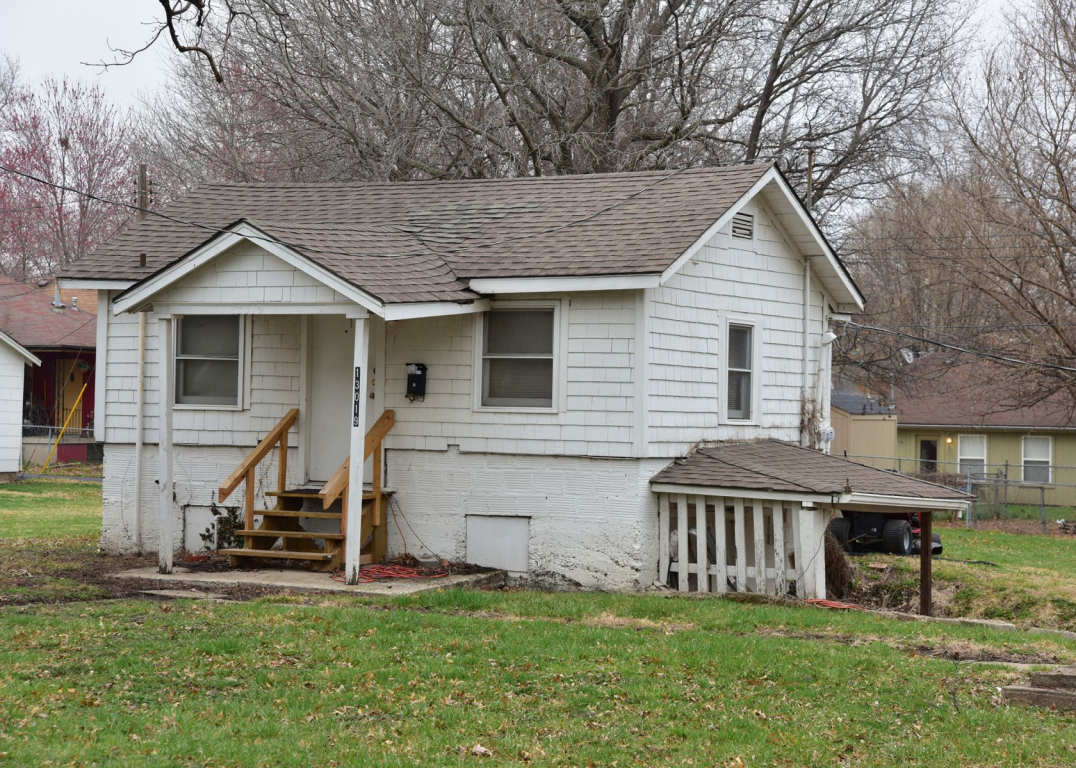
"This one-story, side-gabled house sits perpendicular to the street and has a rectangular footprint that is five asymmetrical bays wide and one bay deep. Decorative iron posts support the porch's projecting gable roof, which shelters the entrance at the second bay from the west end. Defining the other bays are single one-over-one light, double-hung sash windows with wide, flat board trim (Davis and Schwenk, 2003)."

A shed roof addition forms the fifth bay. The pressed board siding is not historic. 13011-19 does not appear significantly altered from its 2003 appearance. Dates of alteration are unknown, however pre-date the 2003 survey.

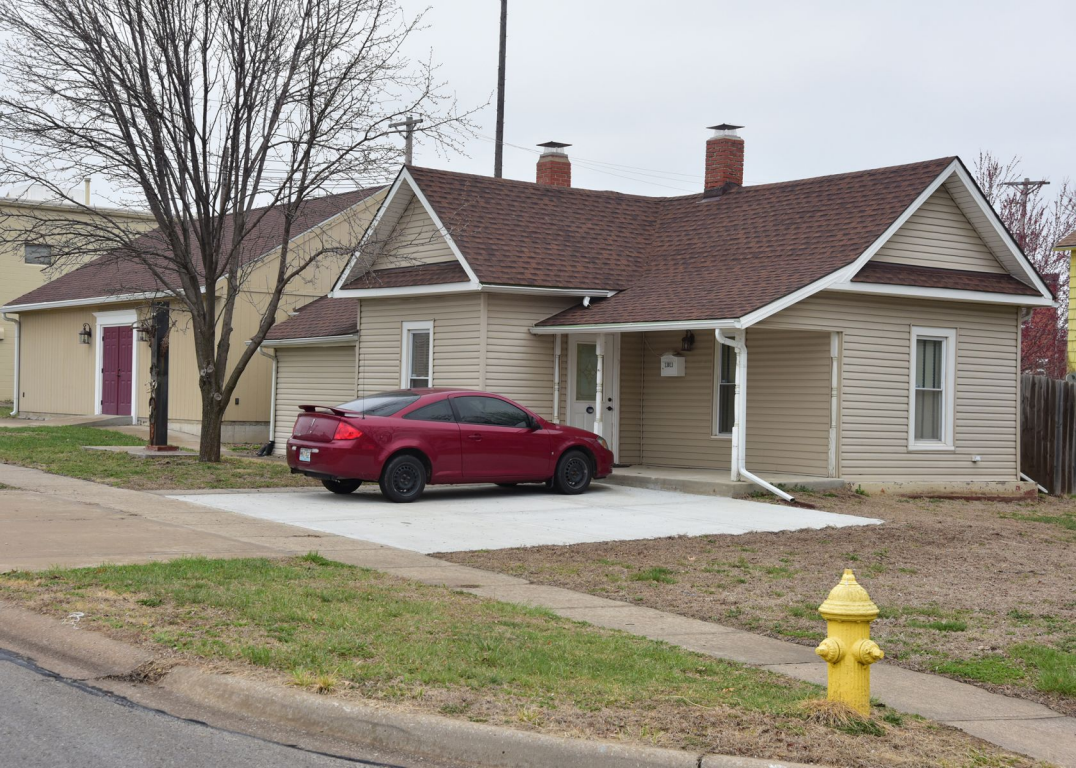
13013 7th Street has been significantly altered since the 2003 survey. The wood shingle cladding and wood sash windows have been replaced with vinyl. The crown molding of the windows and the scalloped vergeboard have been removed.
