MISSOURI DEPARTMENT OF NATURAL RESOURCES
STATE HISTORIC PRESERVATION OFFICE, P.O. Box 176, Jefferson City, MO 65102
ARCHITECTURAL/HISTORIC INVENTORY FORM

1. Survey number: JA-AS-088-001		2. Survey Name: Town of Grandview, Resurvey	
3. County: JACKSON		4. Address (Street No.): 13114 Street (name): 4th Street	
5. City: Grandview	Vicinity <input type="checkbox"/>	6. Lat / Long:	7. Township/Range/Section: T: R: S:
8. Historic name (if known):		9. Present/other name (if known):	
10. Ownership: <input checked="" type="checkbox"/> Private <input type="checkbox"/> Public		11a. Historic use (if known): Domestic-Single Dwelling	11b. Current use: Domestic-Single Dwelling

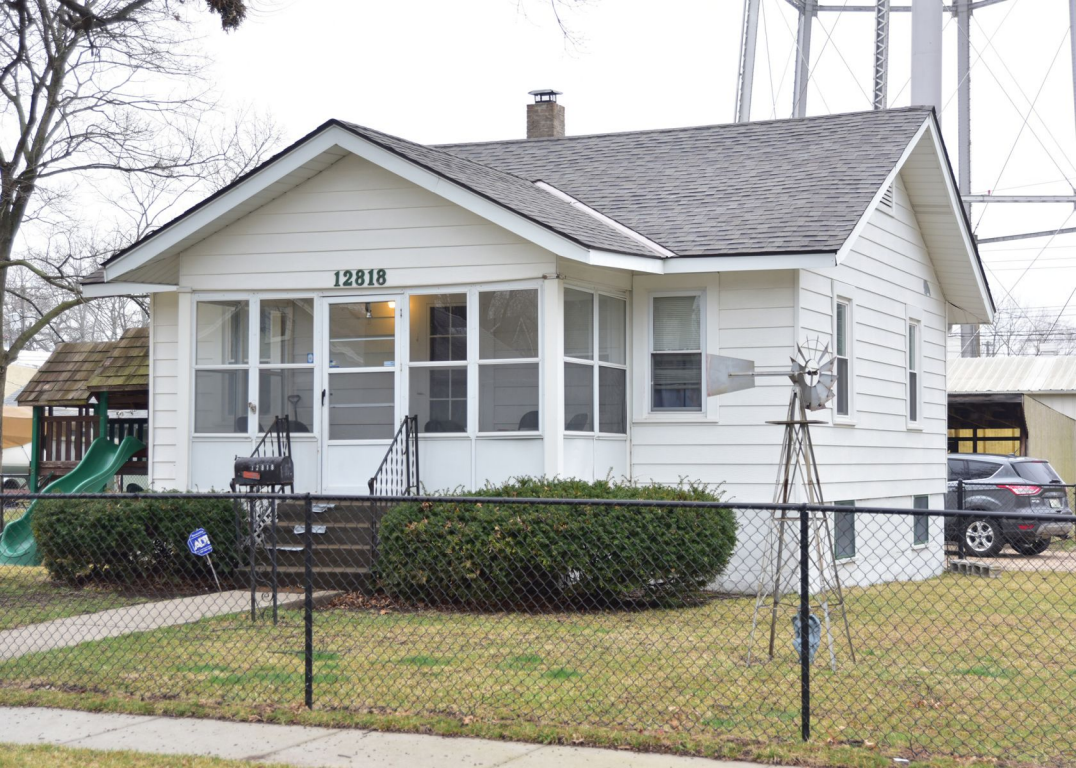
The dwelling features an asphalt roof and vinyl siding. Windows are vinyl replacements with stone windows present at all elevations visible from the right-of-way. 12818 8th Street does not appear significantly altered from its 2003 appearance. Dates of alteration are unknown, however pre-date the 2003 survey.

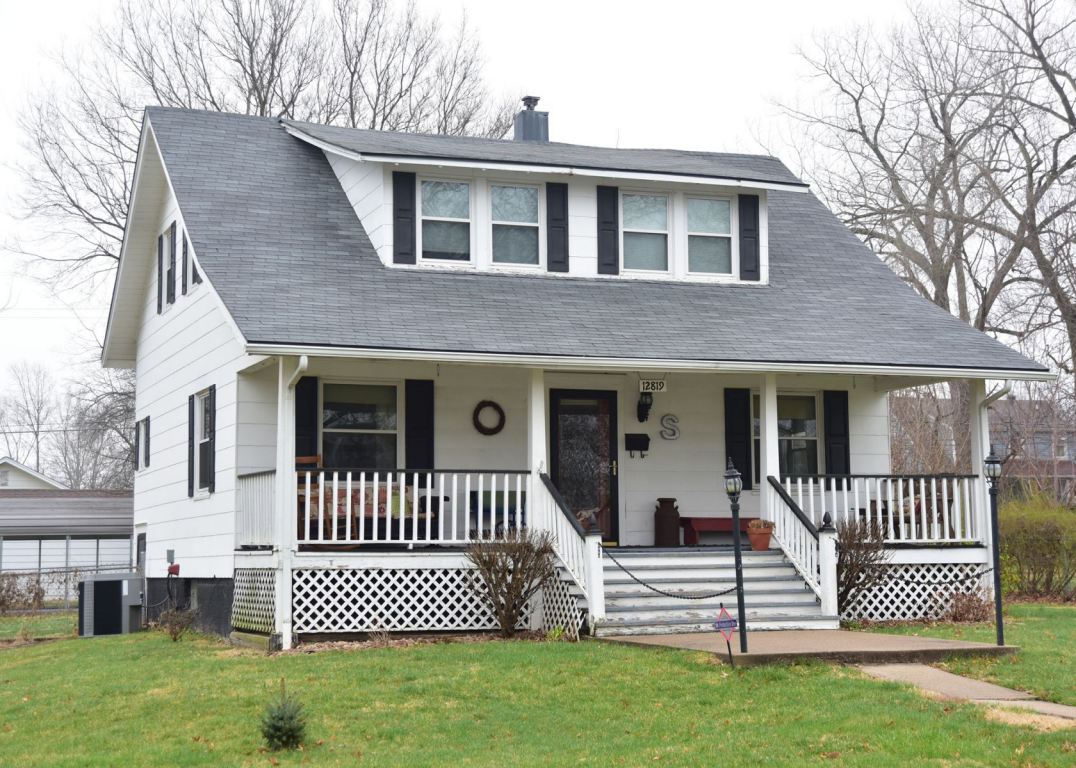
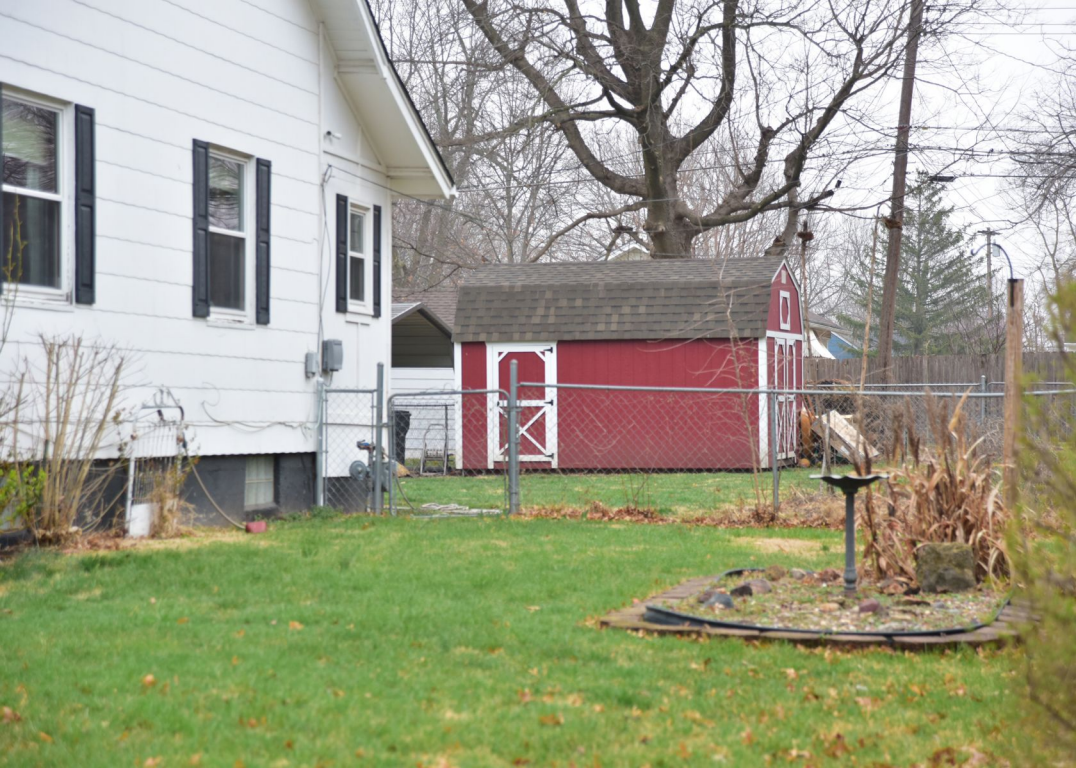
"This one-and-a-half-story, side-gabled bungalow has a rectangular footprint that is three bays wide and two bays deep. The front roof slope extends to form the full-width porch roof, which is supported by square wood columns and shelters the center bay entrance. Single one-over-one light, double-hung sash windows with shutters define the other bays. A large shed roof dormer projects from the front roof slope and contains two paired one-over-one light, double-hung sash windows with shutters. Additional character-defining features include the dwelling's wide eaves (Davis and Schwenk, 2003)."

The dwelling features asbestos siding and an asphalt roof. 12819 8th Street does not appear significantly altered from its 2003 appearance. Dates of alteration are unknown, however they pre-date the 2003 survey.

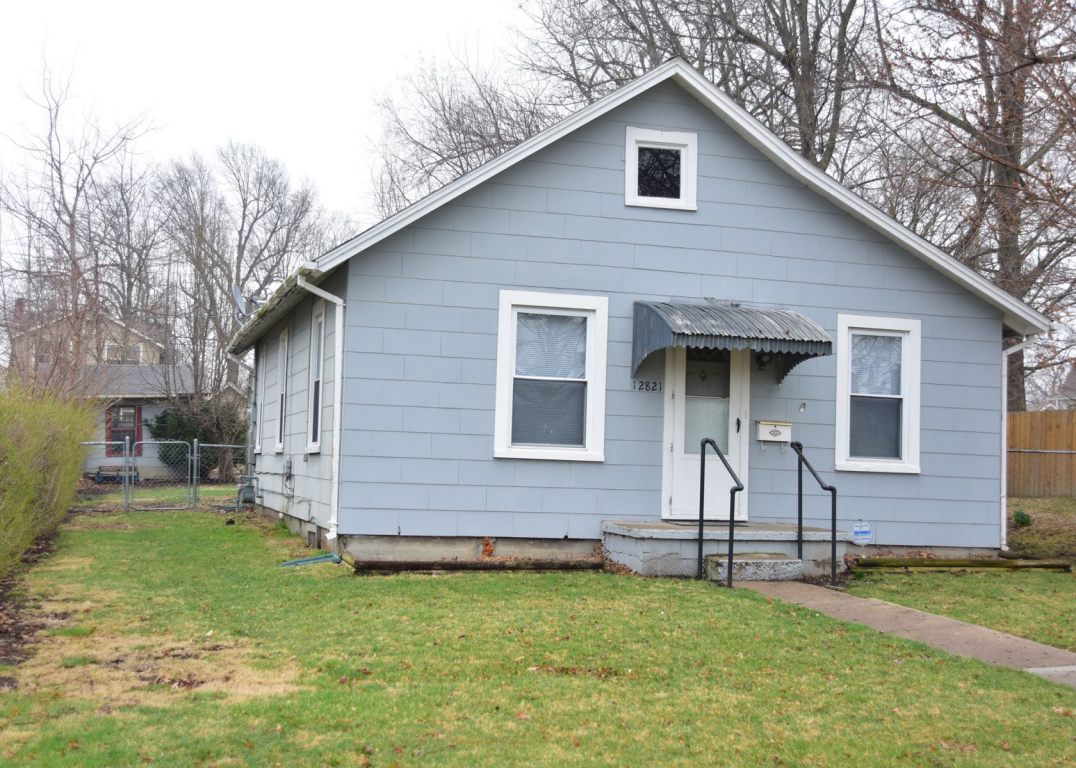
2821

12821 8th Street features an asphalt roof and concrete foundation. A metal awning is located over the primary entrance. The dwelling does not appear significantly altered from its 2003 appearance. Dates of alteration are unknown, however they pre-date the 2003 survey.

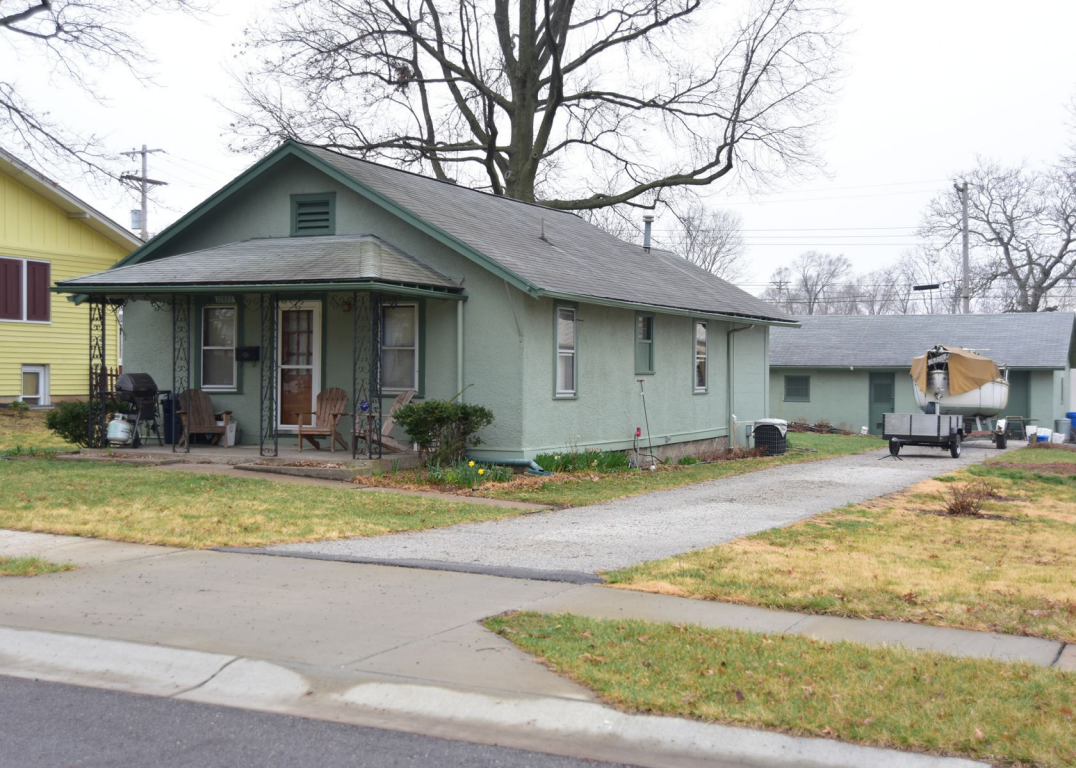
"This one-story, gable-front bungalow house has a rectangular footprint that is three bays wide and three bays deep. Stucco clads the exterior walls. Decorative iron posts support the three-quarter-width porch's hipped roof, which shelters the three façade bays, including the center bay entrance. Single one-over-one light, double-hung sash windows with flat board trim define the other bays. Additional character-defining features include the wide eaves with exposed rafter tails. The loss of original porch elements and the application of non-original stucco to the exterior walls compromise the integrity of this building (Davis and Schwenk, 2003)."

12822 8th Street does not appear significantly altered from its 2003 appearance. Dates of alteration are unknown, however they pre-date the 2003 survey.

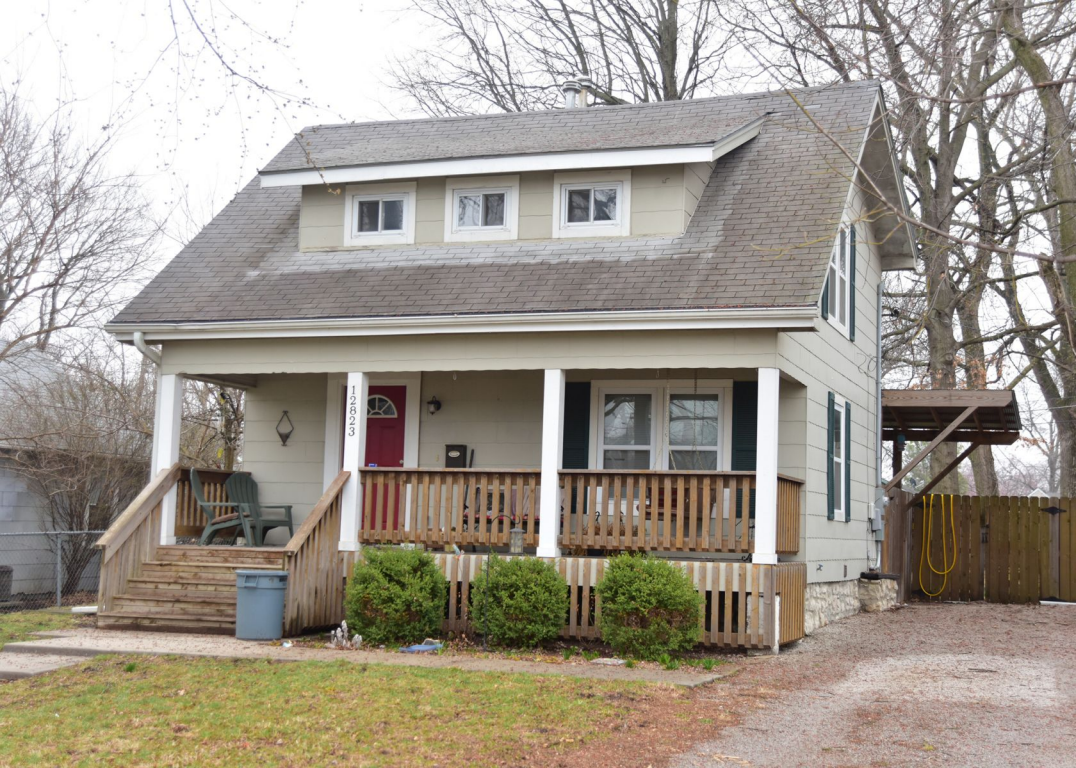
One-by one windows are located in the dormer and the porch elements have been altered, including the replacement of the balustrade and posts. Dates of the alterations noted by the 2003 survey are unknown, however they pre-date the 2003 survey.

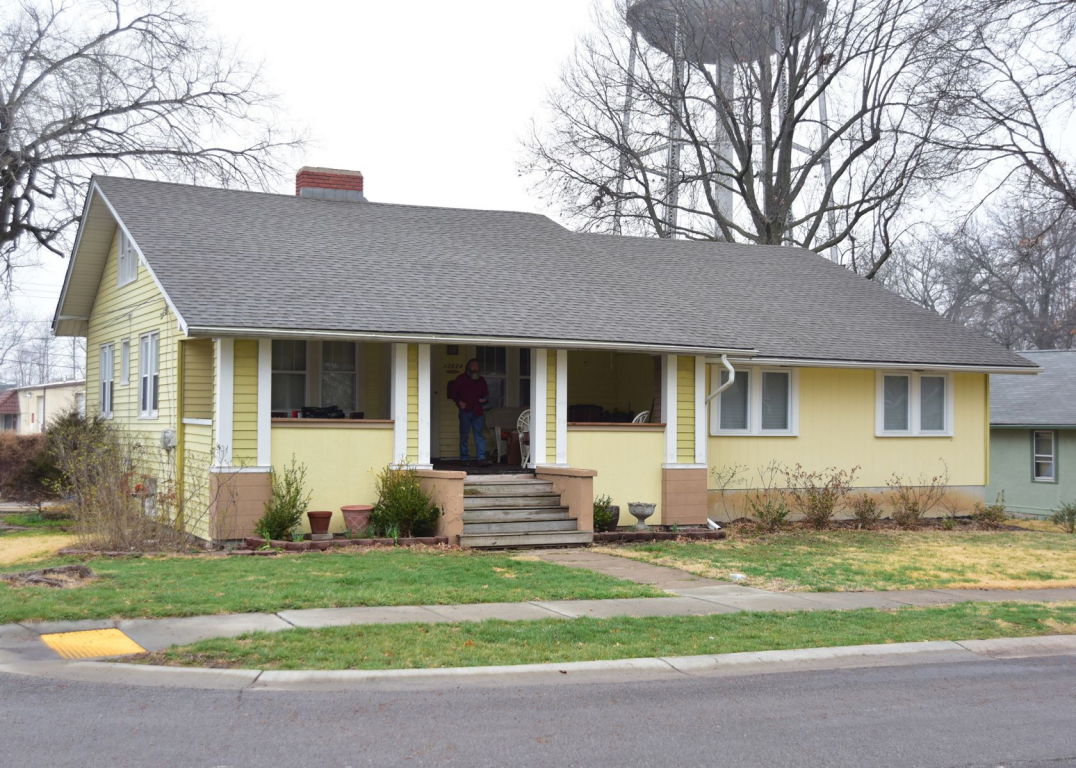
12824 8th Street has been significantly altered since the 2003 survey. A large, ca. 2006 addition is located at the north elevation. Windows have been replaced with vinyl sash.

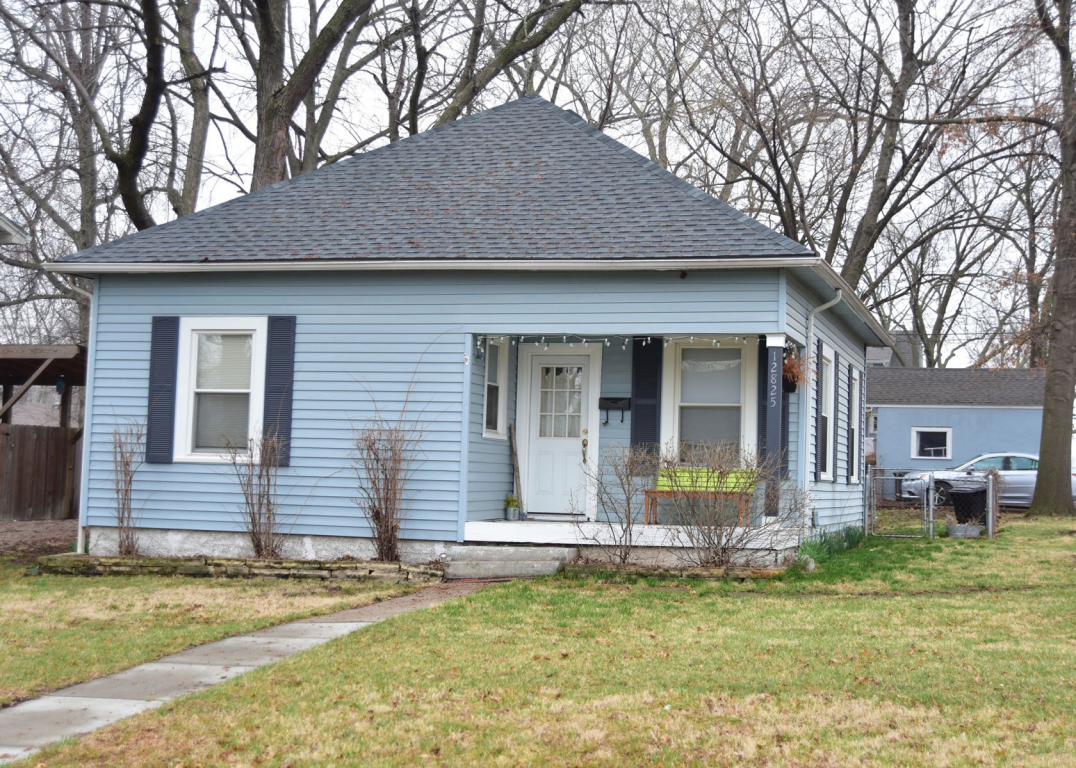
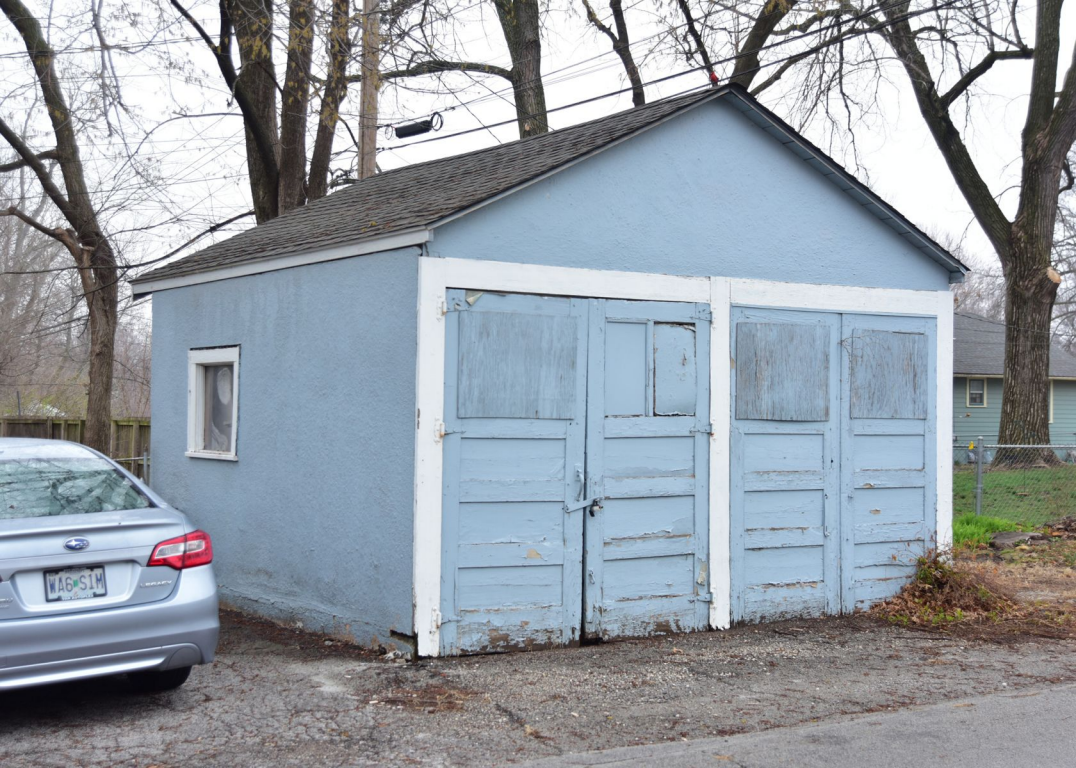
The foundation of 12825 8th Street has been parged, however the dwelling otherwise does not appear significantly altered since the 2003 survey. Dates of alteration are unknown, however they pre-date the 2003 survey.

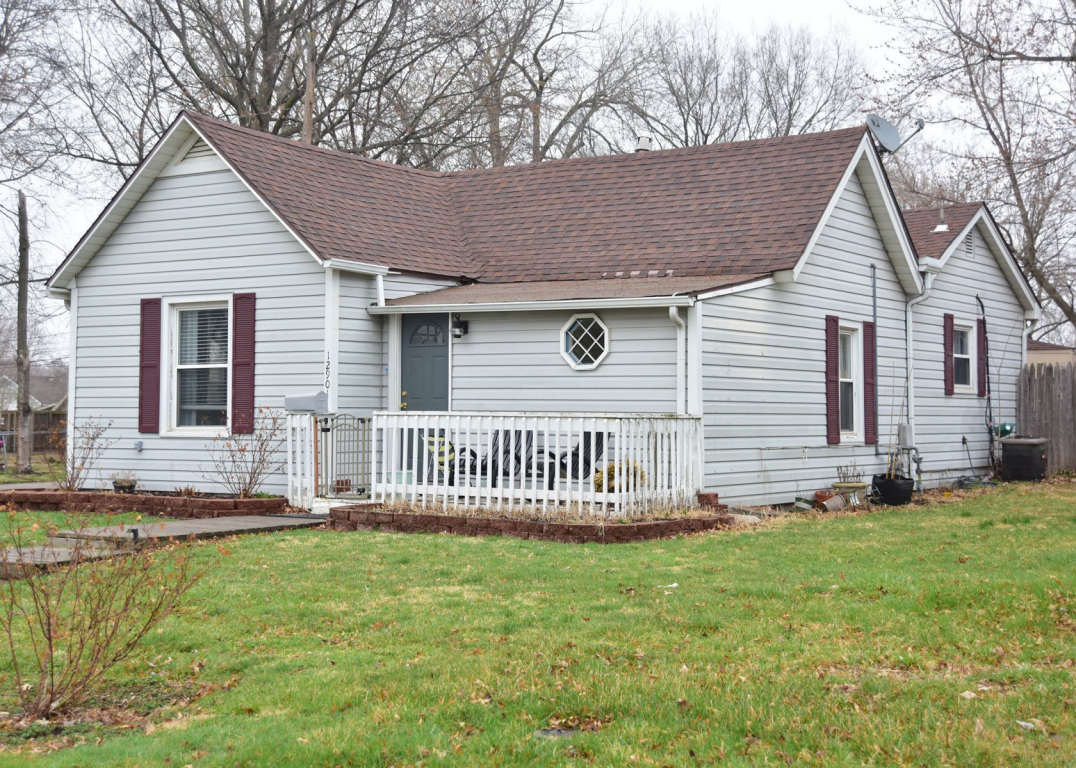
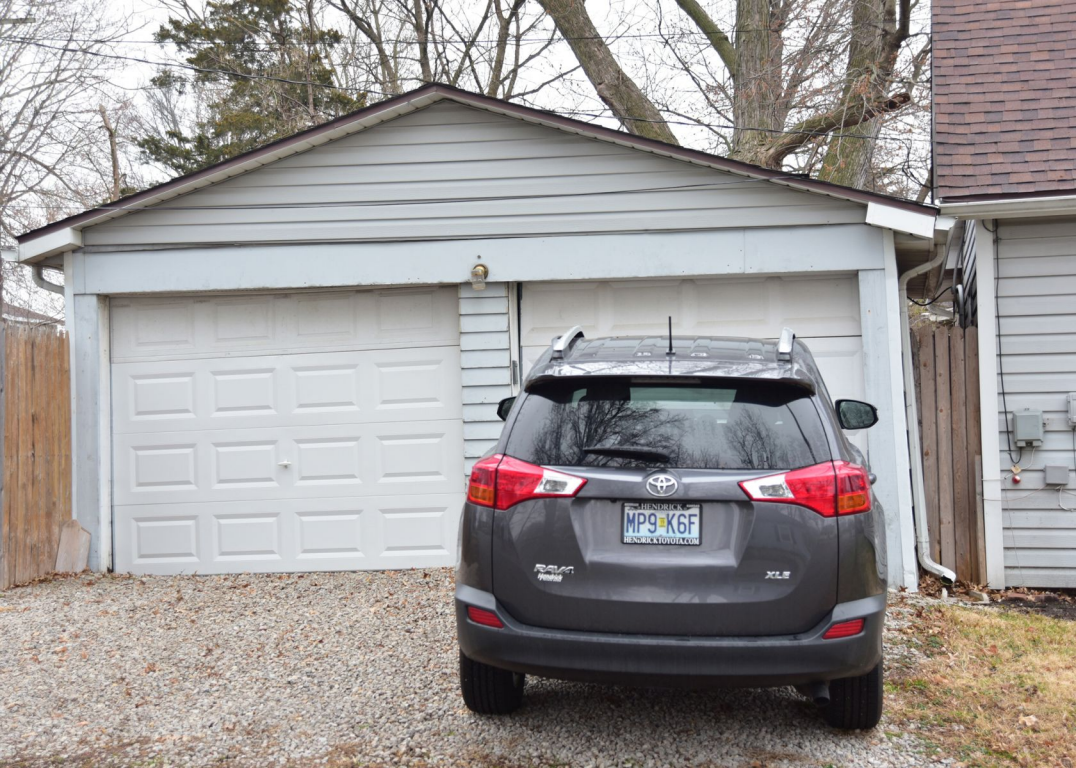
The awnings noted by the 2003 survey are no longer present. 12901 8th Street otherwise does not appear significantly altered from its 2003 appearance. The dwelling features vinyl windows and an asphalt roof.

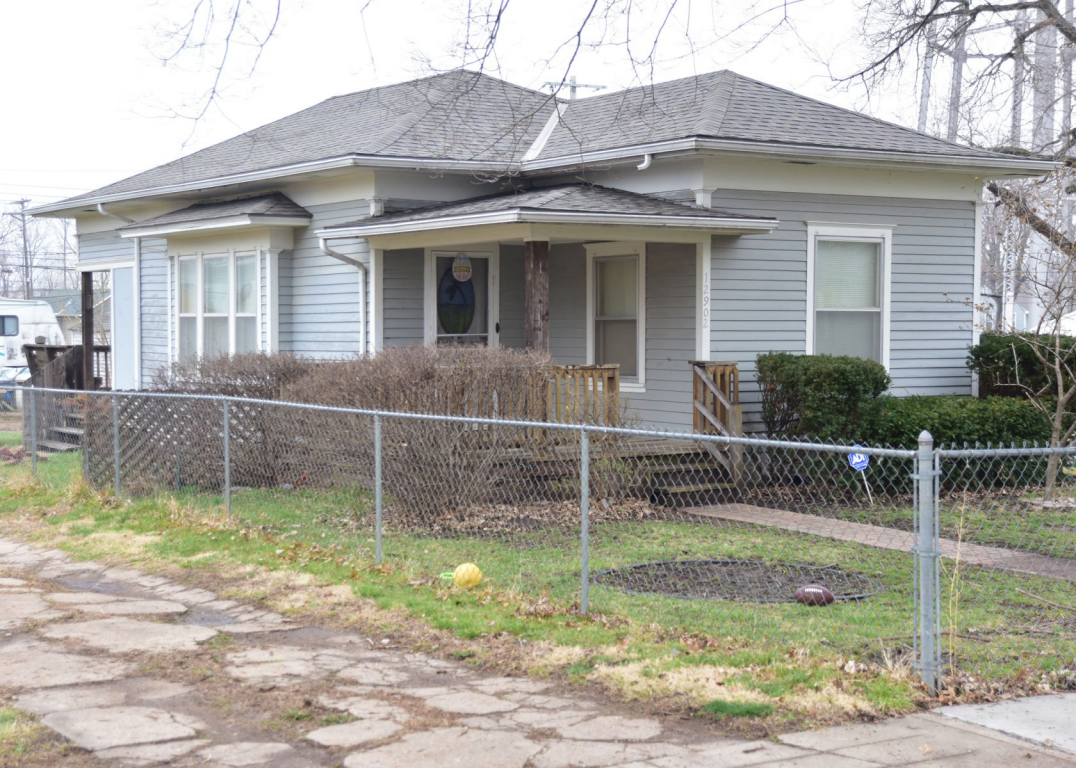
"This one-story house has a composite roof form and an irregular footprint that is three bays wide and three bays deep. The shallow hipped roof features two projecting wings that are slightly lower and have cross-hipped roofs. Non-original square wood posts support the porch's hipped roof, which shelters the entrance in the south end bay. Single one-over-one light, double-hung sash windows with shutters define the other bays. Additional character-defining features include the wide eaves and frieze band, the flat board window trim with modest crown molding, the wood clapboards with corner boards, and the square projecting bay that features a band of three windows and a hipped roof. The loss of original porch elements and the replacement of original windows compromises the integrity of this building (Davis and Schwenk, 2003)."

12902 8th Street does not appear significantly altered from its 2003 appearance. Dates of alteration are unknown, however they pre-date the 2003 survey.

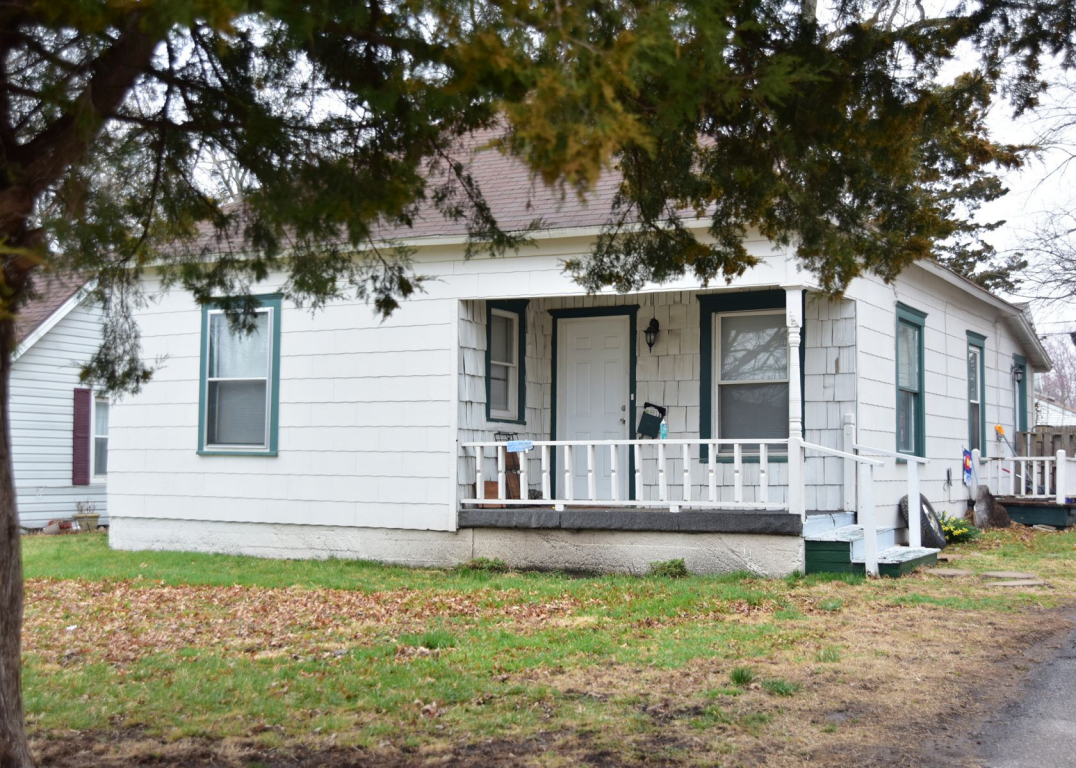
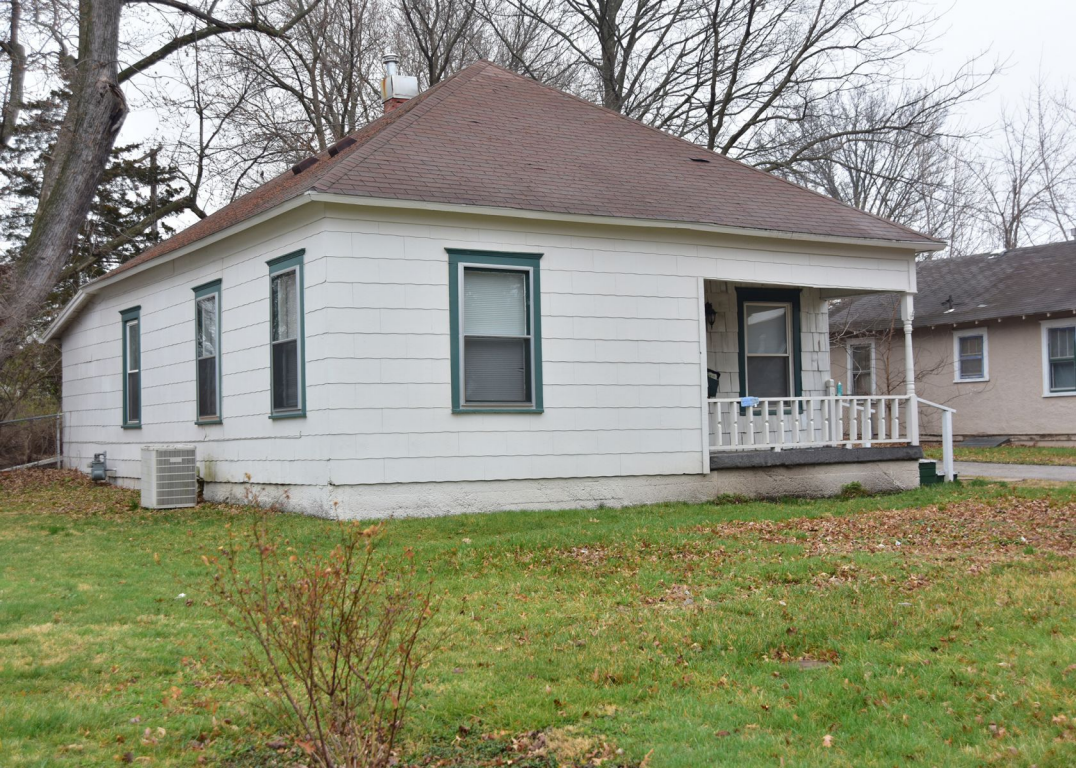
"This one-story Pyramidal Roof folk house has a rectangular footprint that is three bays wide and, with a rear one-bay shed addition, is four bays deep. The front wall recesses at the two south end bays to shelter the center bay entrance. Single one-over-one light, double-hung sash windows with flat board trim and modest crown molding define the other bays (Davis and Schwenk, 2003)."

Wood shingle clads the recessed portion of the front wall while asbestos clads all other walls. Windows are wood sash with aluminum storm windows at all elevations visible from the right-of-way. 12903 8th Street does not appear significantly altered from its 2003 appearance. Dates of alteration are unknown, however they pre-date the 2003 survey.

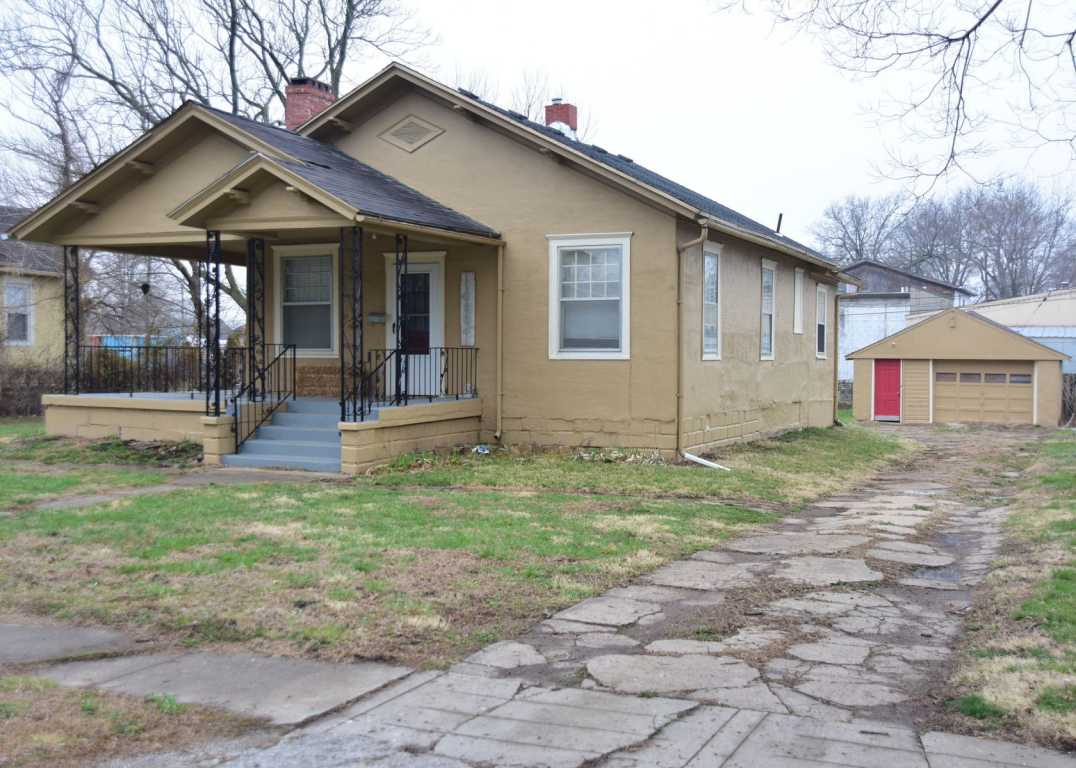
"This one-story bungaloid house features three nested front gables. This dwelling has an irregular footprint that is four bays wide and four bays deep. A gable spanning the width of three bays and aligned with the south roof slope projects to incorporate a wrap-around porch supported by decorative iron posts. A gable projects further at the second bay from the north end to distinguish the entrance. A secondary entrance occupies the south end bay. The original, single twelve-over-one light, double-hung wood sash windows with flat board trim and shutters define the other two façade bays. A one-story tower addition that features a conical roof extends from the rear of the south façade. Additional character-defining features include the wide eaves with modillions (horizontal brackets) and two brick chimneys (Davis and Schwenk, 2003)."

Shutters are no longer present. 12904 8th Street does not appear significantly altered from its 2003 appearance. Dates of alteration are unknown, however they pre-date the 2003 survey.

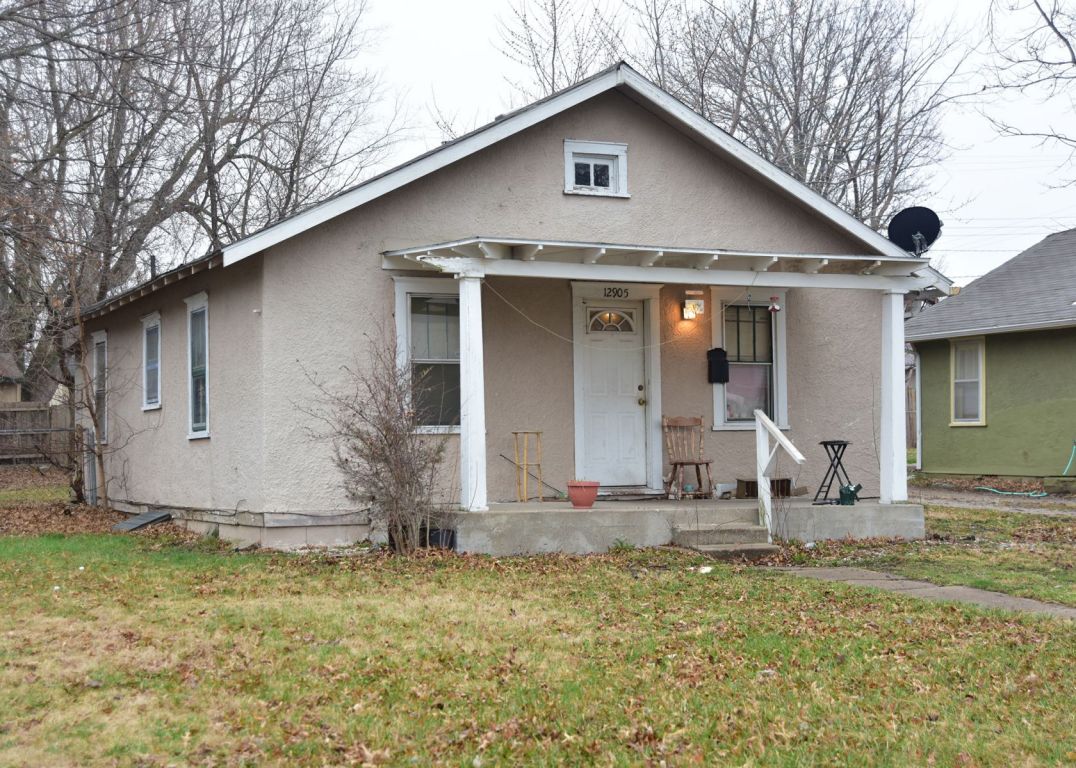
"A twin to its neighbor at 12907 8th Street, this one-story, gable-front bungaloid house has a rectangular footprint that is three bays wide and two bays deep. Square wood posts featuring modillions (horizontal brackets) support the three-quarter-width porch's flat roof, which shelters the façade bays, including the center bay entrance. The original three-over-one light, double-hung wood sash windows with flat board trim define the other bays. Additional character-defining features include the wide eaves with exposed rafter tails and the small window opening in the gable peak that contains the original two-light wood hopper window with flat board trim (Davis and Schwenk, 2003)."

12905 8th Street features an asphalt roof and stucco cladding. The dwelling does not appear significantly altered from its 2003 appearance.

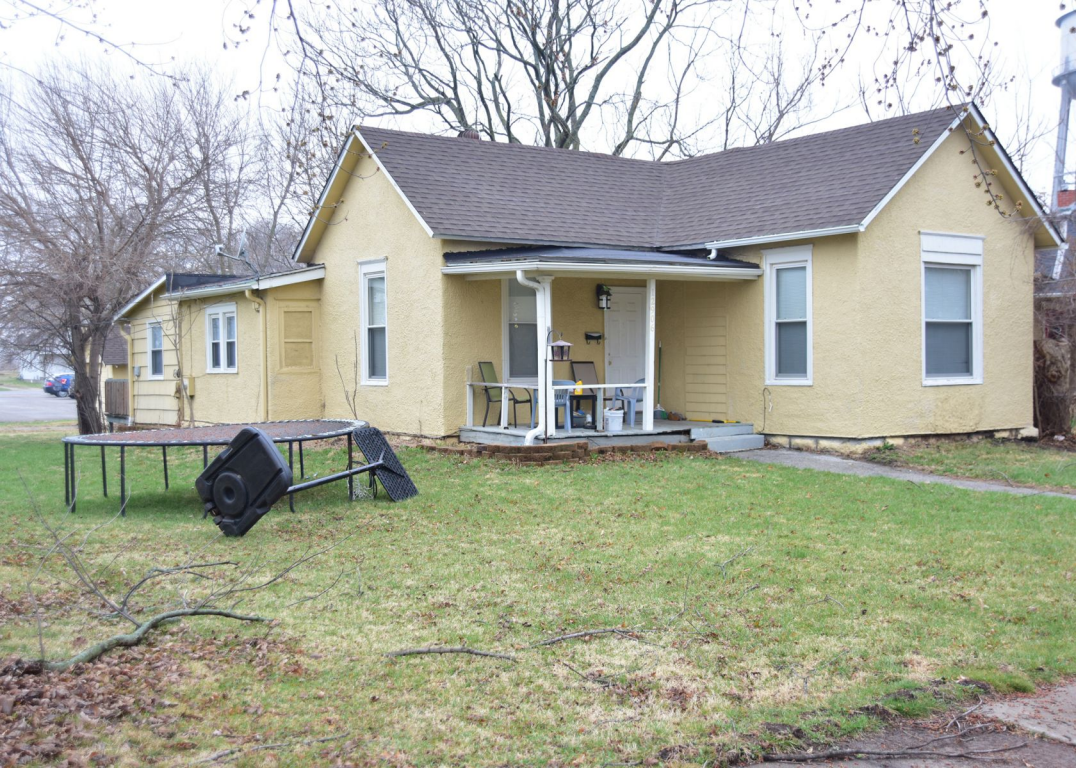
12906 8th Street does not appear significantly altered from its 2003 appearance. Dates of alteration are unknown, however pre-date the 2003 survey.

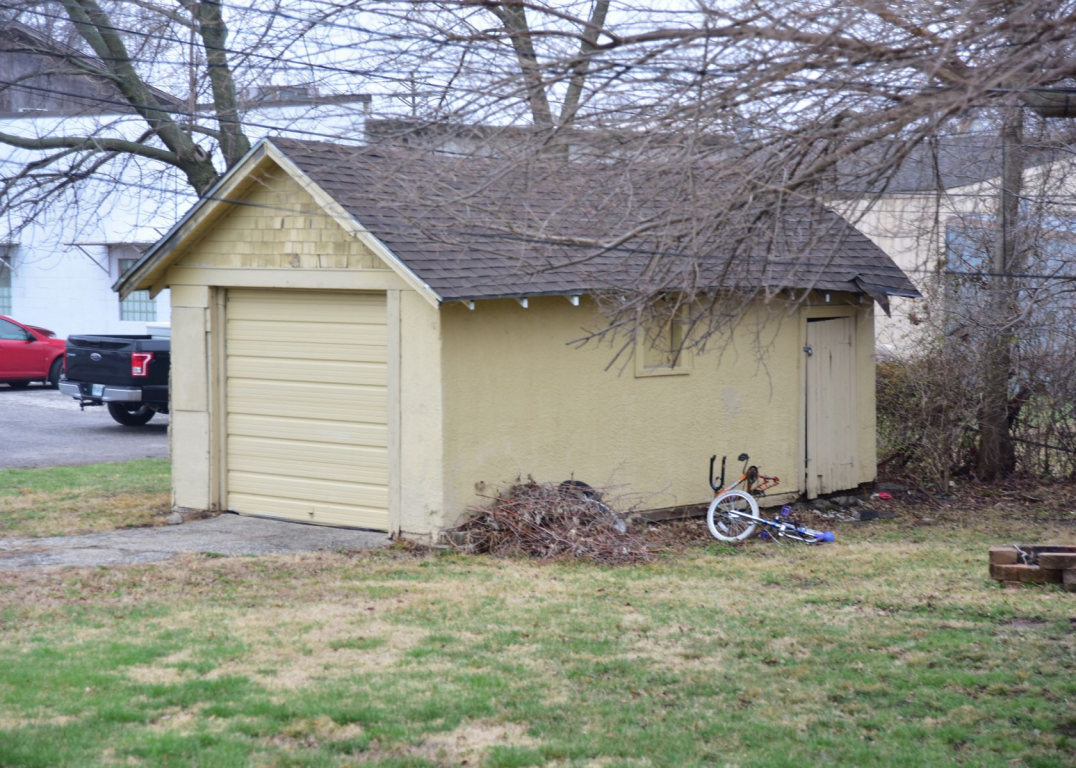
"This one-story, gable-front-and-wing folk house has two one-bay rear additions with shed roofs. This dwelling has a front-facing L-shaped footprint that is four bays wide and four bays deep. Square wood posts support the porch's shallow hipped roof, which shelters the two center bays, including the entrance in the second bay from the north end. Single two-over-one and one-over-one light, double-hung sash windows with flat board trim define the other bays. Additional character-defining features include the cast stone foundation (Davis and Schwenk, 2003)."

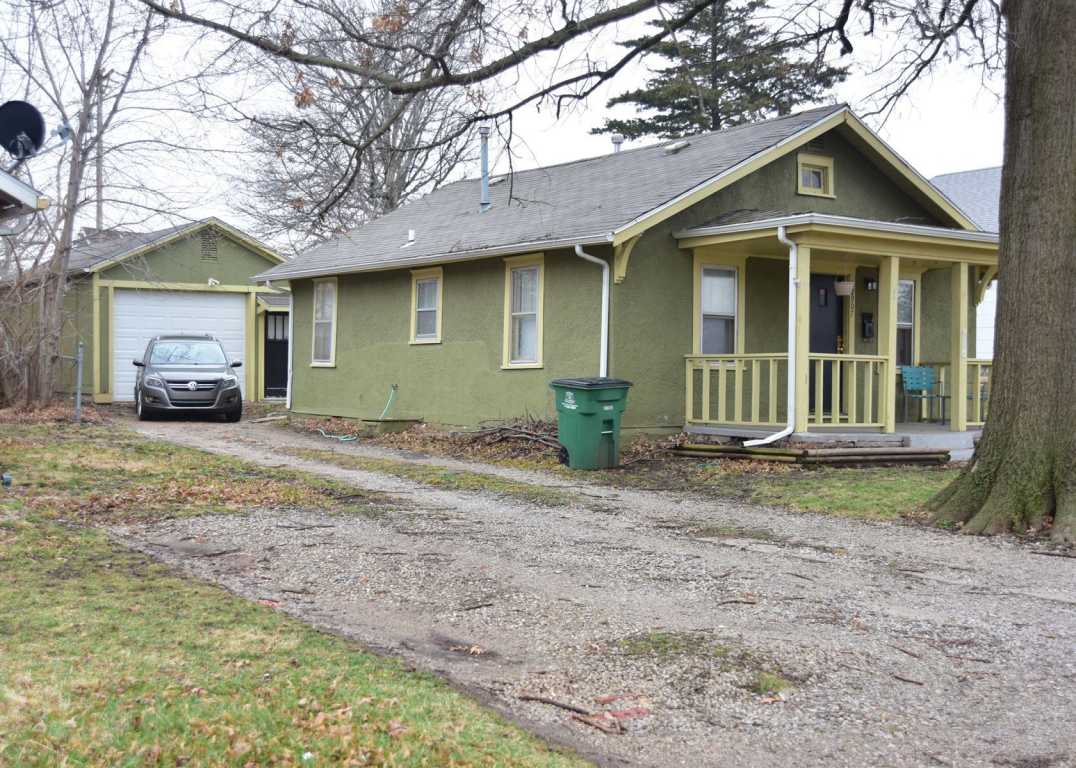
"A twin to its neighbor at 12905 8th Street, this one-story, gable-front bungaloid house has a rectangular footprint that is three bays wide and three bays deep. Square wood posts support the three-quarter-width porch's flat roof, which shelters the façade bays, including the center bay entrance. The original three-over-one light, double-hung wood sash windows with flat board trim define the other bays. Additional character-defining features include the wide eaves with exposed rafter tails and the small window opening in the gable peak that contains the original, two-light wood hopper window with flat board trim (Davis and Schwenk, 2003)."

12907 8th Street features an asphalt roof, stucco cladding, and matchstick balustrade. The dwelling does not appear significantly altered from its 2003 appearance.

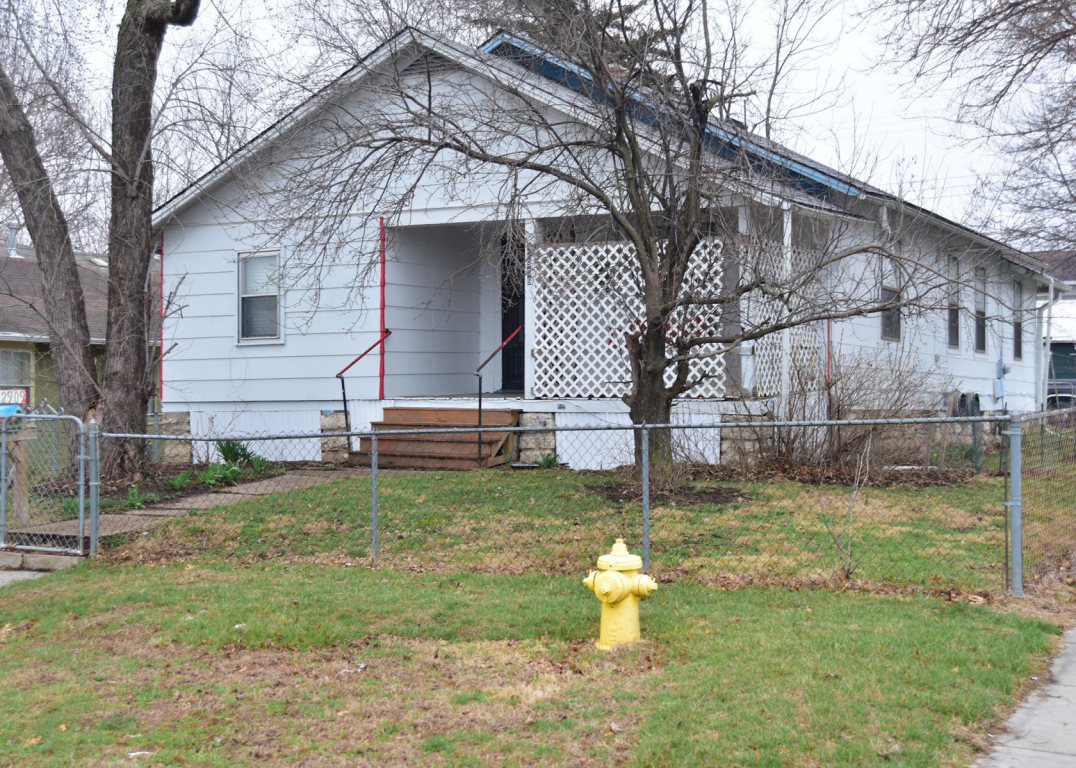
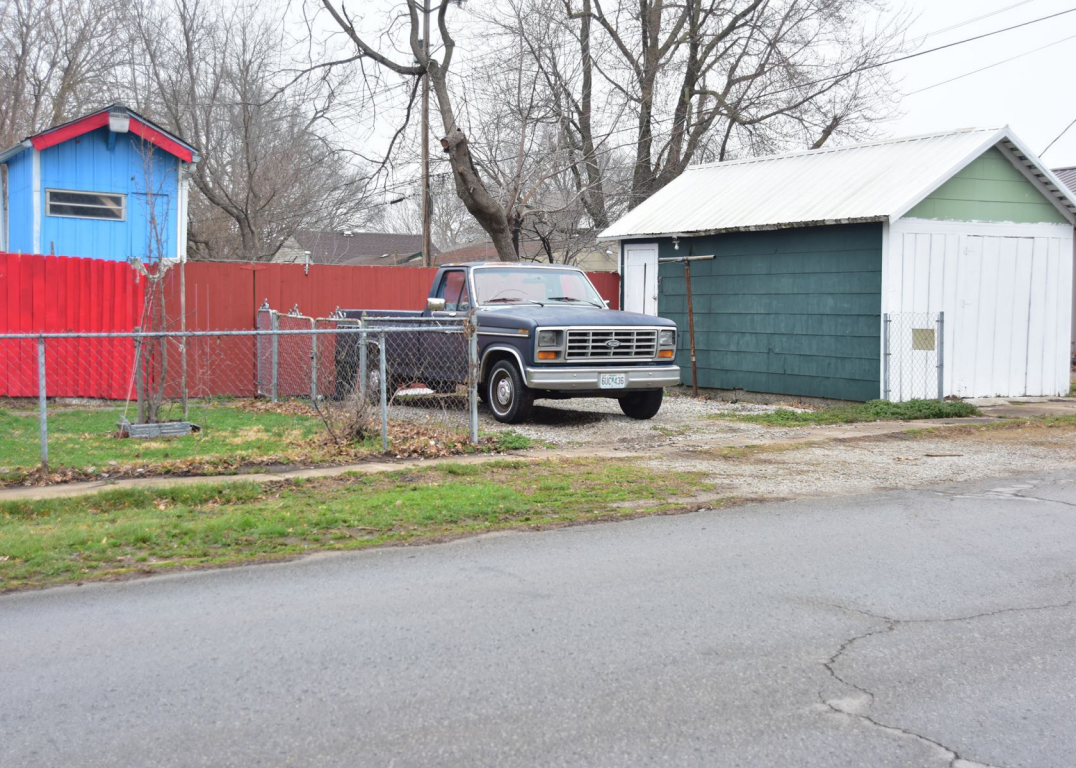
"This one-story, bungalow house has a rectangular footprint that is three bays wide and three bays deep. A nested, full-width front gable projects to form the porch roof, supported on square wood posts. The porch is enclosed at the south end bay that shelters the center bay entrance. Single one-over-one light, double-hung sash windows define the other bays. Additional character-defining features include the wide eaves, flat board window trim, and the rough-cut stone piers supporting the porch floor. The partial enclosure of the front porch, combined with the application of modern cladding materials and loss of porch elements, compromise the integrity of this building (Davis and Schwenk, 2003)."

12909 8th Street does not appear significantly altered from its 2003 appearance. Dates of alteration are unknown but pre-date the 2003 survey.

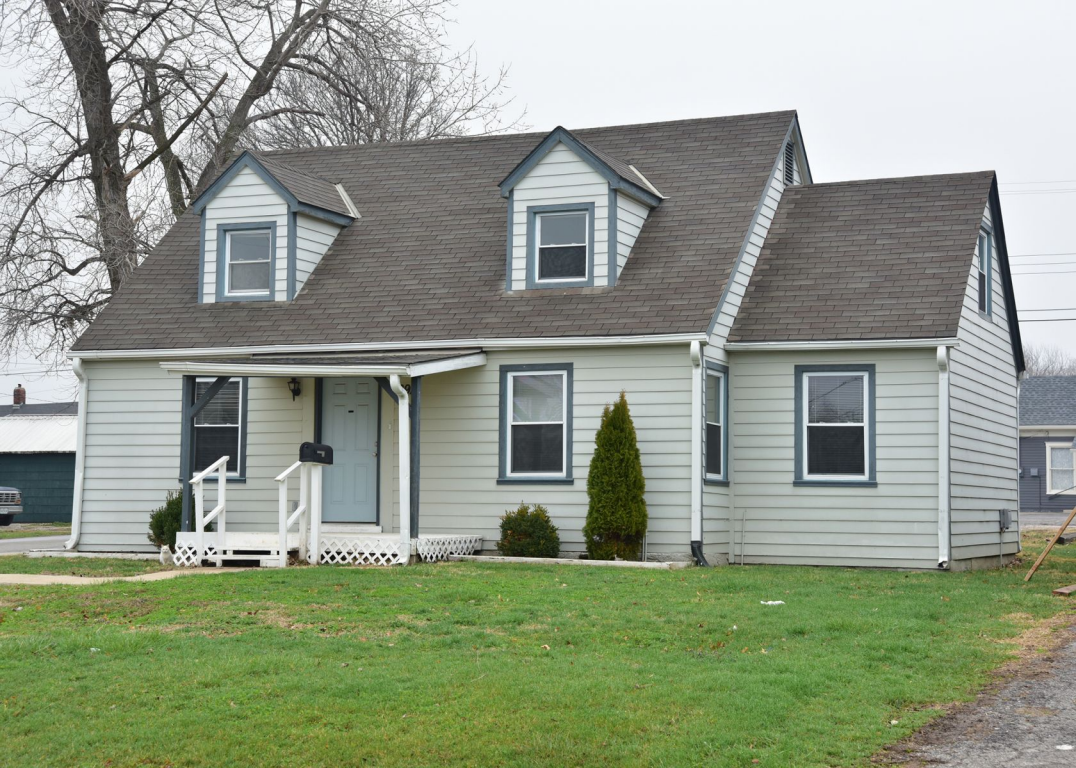
Windows have been replaced with one-over-one vinyl sash and the cladding has been replaced with vinyl siding since 2003. The date of the porch alteration is unknown, however pre-dates the 2003 survey.

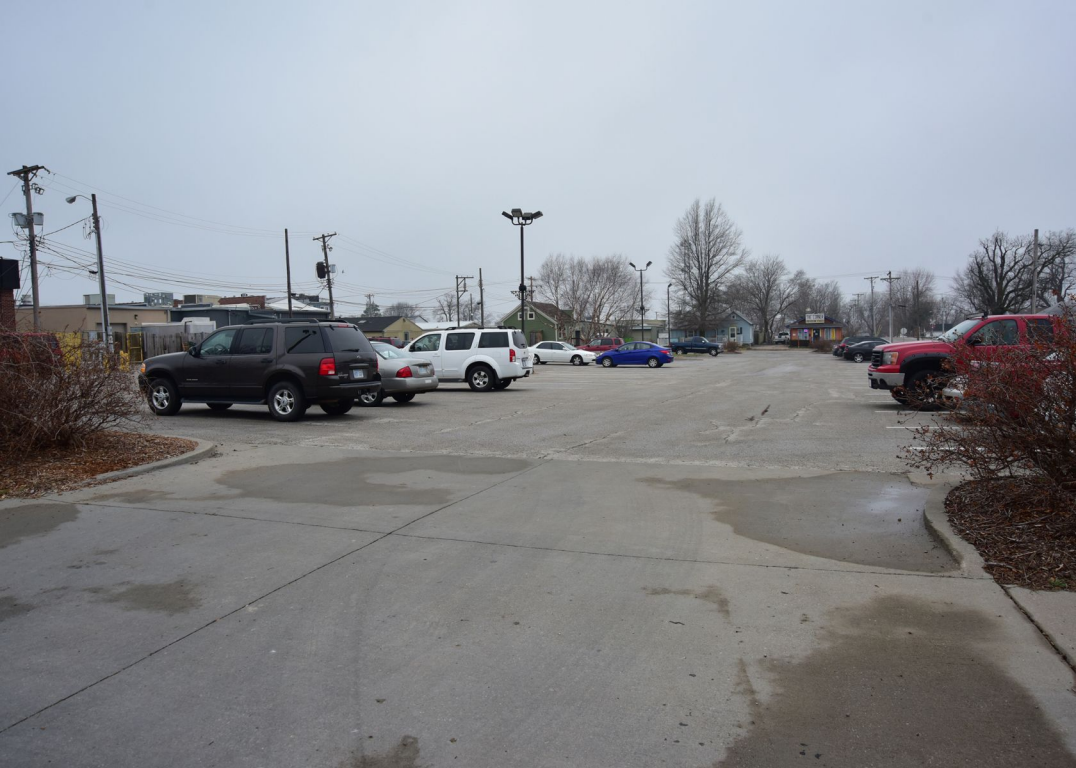
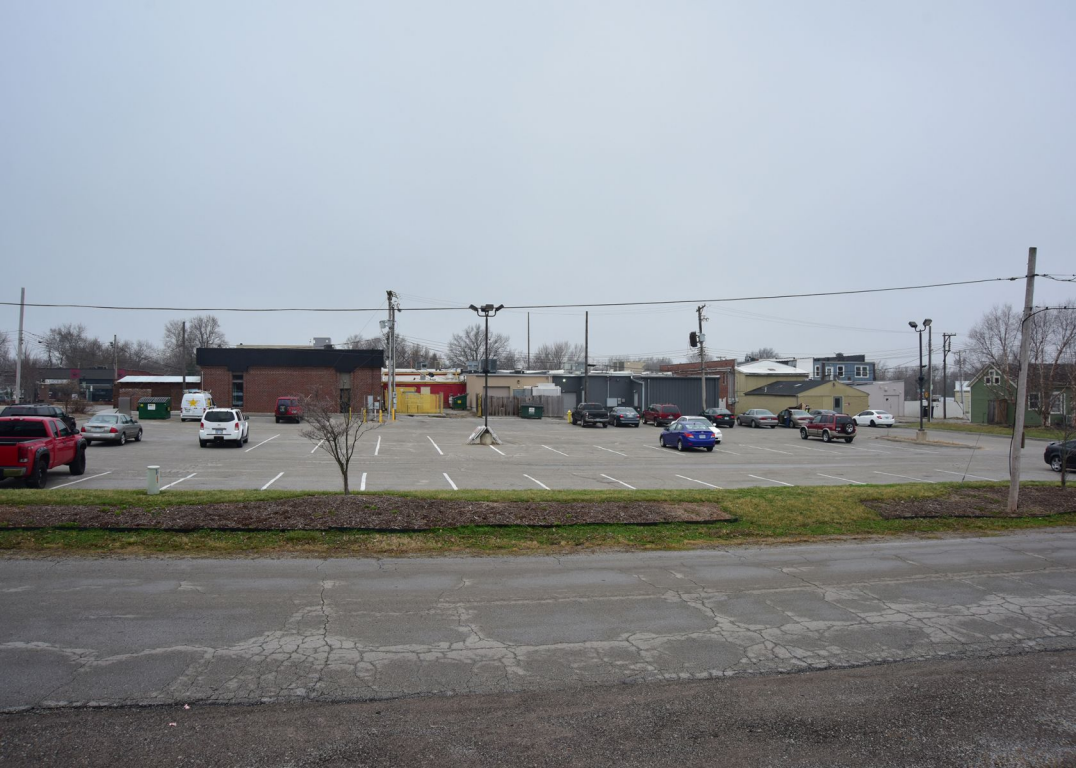
The complex was demolished ca. 2005 and replaced with a paved parking lot. Concrete islands and light posts are distantly placed within the lot.
