MISSOURI DEPARTMENT OF NATURAL RESOURCES
STATE HISTORIC PRESERVATION OFFICE, P.O. Box 176, Jefferson City, MO 65102
ARCHITECTURAL/HISTORIC INVENTORY FORM

1. Survey number: JA-AS-088-001		2. Survey Name: Town of Grandview, Resurvey	
3. County: JACKSON		4. Address (Street No.): 13114 Street (name): 4th Street	
5. City: Grandview	Vicinity <input type="checkbox"/>	6. Lat / Long:	7. Township/Range/Section: T: R: S:
8. Historic name (if known):		9. Present/other name (if known):	
10. Ownership: <input checked="" type="checkbox"/> Private <input type="checkbox"/> Public		11a. Historic use (if known): Domestic-Single Dwelling	11b. Current use: Domestic-Single Dwelling

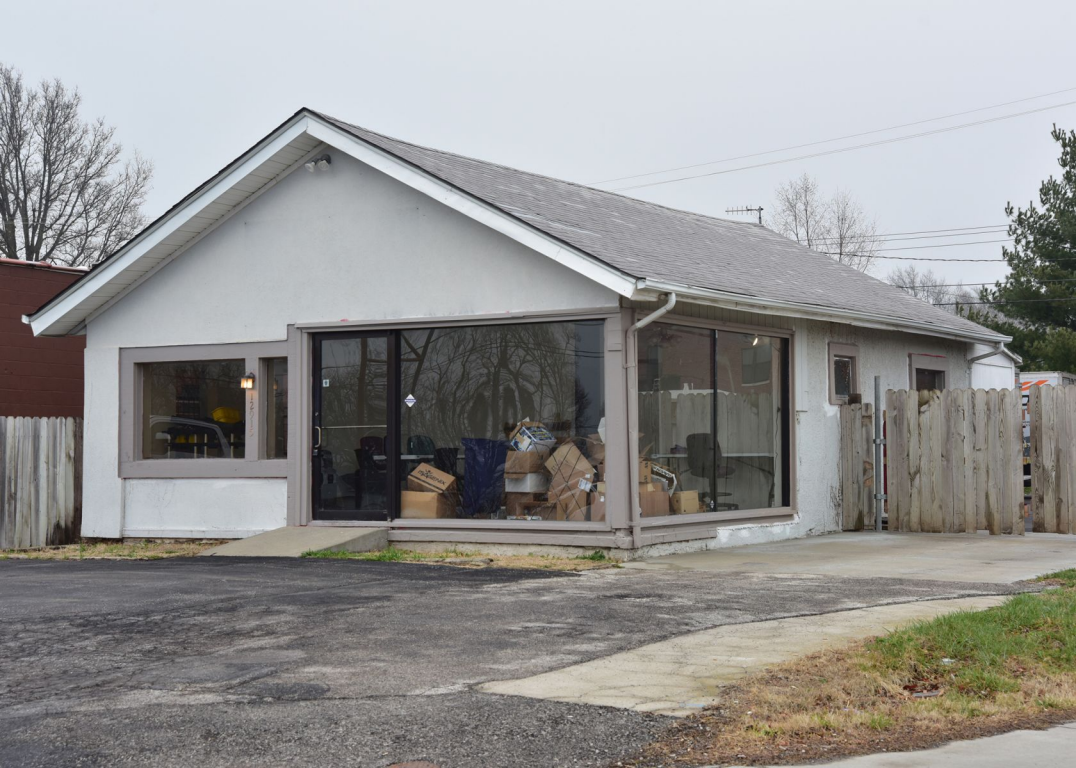
A large storefront window now wraps around the southwest corner. A metal door with glazing has replaced the previous wood door. Prior dates of alteration are unknown, however pre-date the 2003 survey.

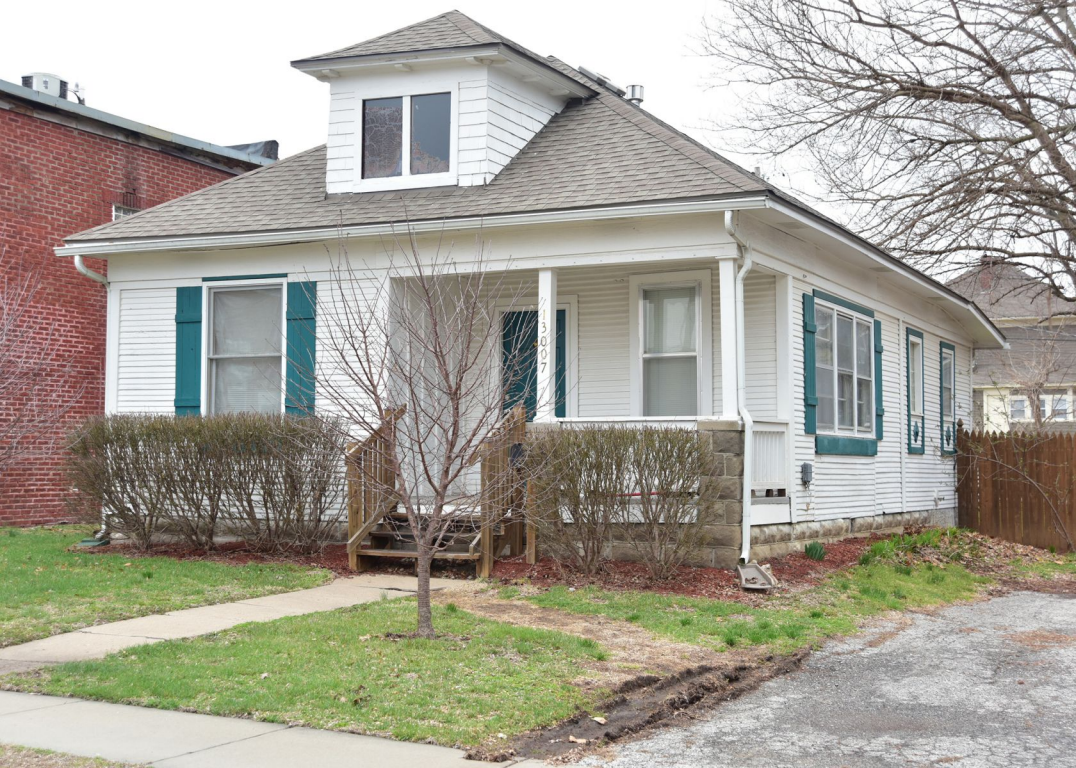
Windows are replacement and aluminum storm windows are present at all elevations visible from the right-of-way. Non-historic wood stairs provide access to the front porch. 13007 8th Street does not appear significantly altered from its 2003 appearance. Dates of alteration are unknown, however pre-date the 2003 survey.

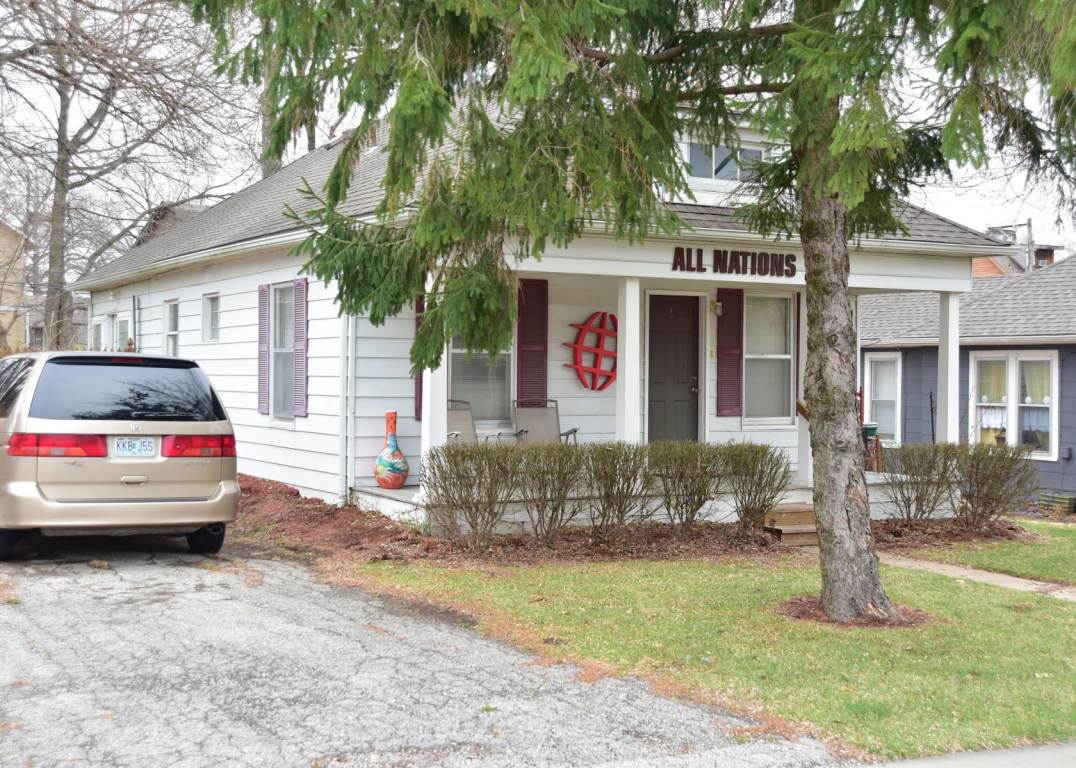
"This one-and-a-half-story Pyramidal Roof folk house has a rectangular footprint that is three bays wide and three bays deep. The front wall recesses to form a full-width porch that shelters the center bay entrance. Single one-over-one light, double-hung sash windows with shutters define the other façade bays. A shed dormer projects from the front roof slope and features the original, horizontal three-light hopper window. Additional character-defining features include the dwelling's wide eaves (Davis and Schwenk, 2003)."

13009 8th Street features an asphalt roof and wide profile vinyl cladding.

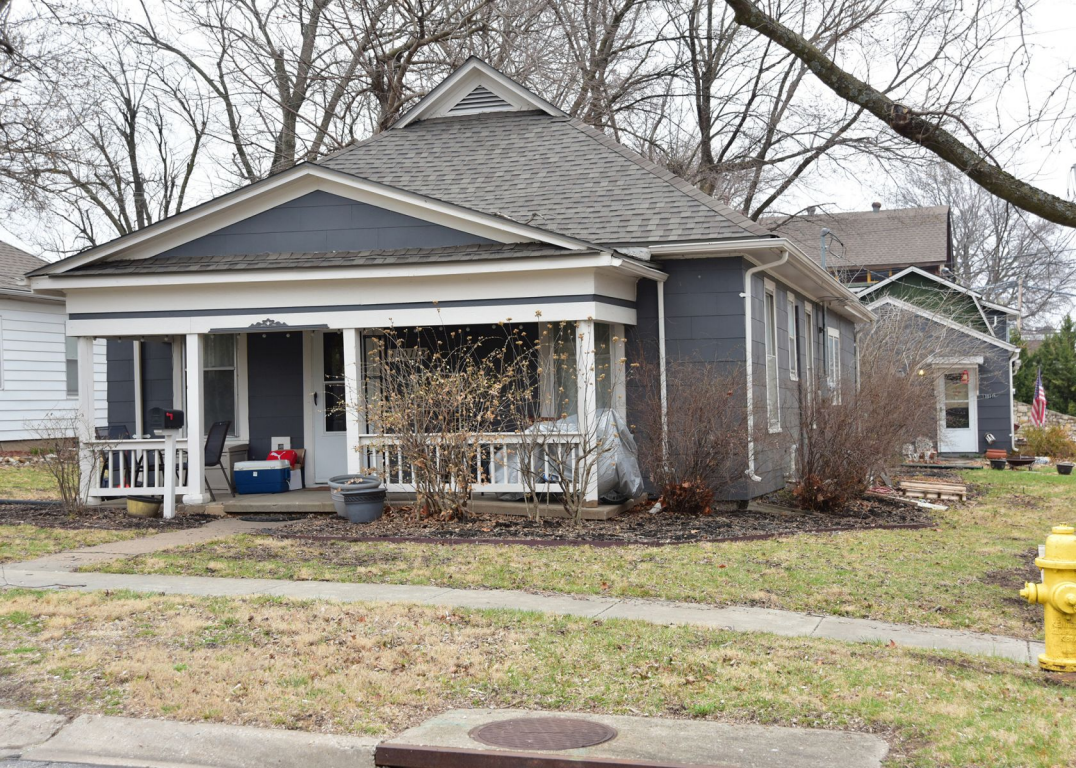
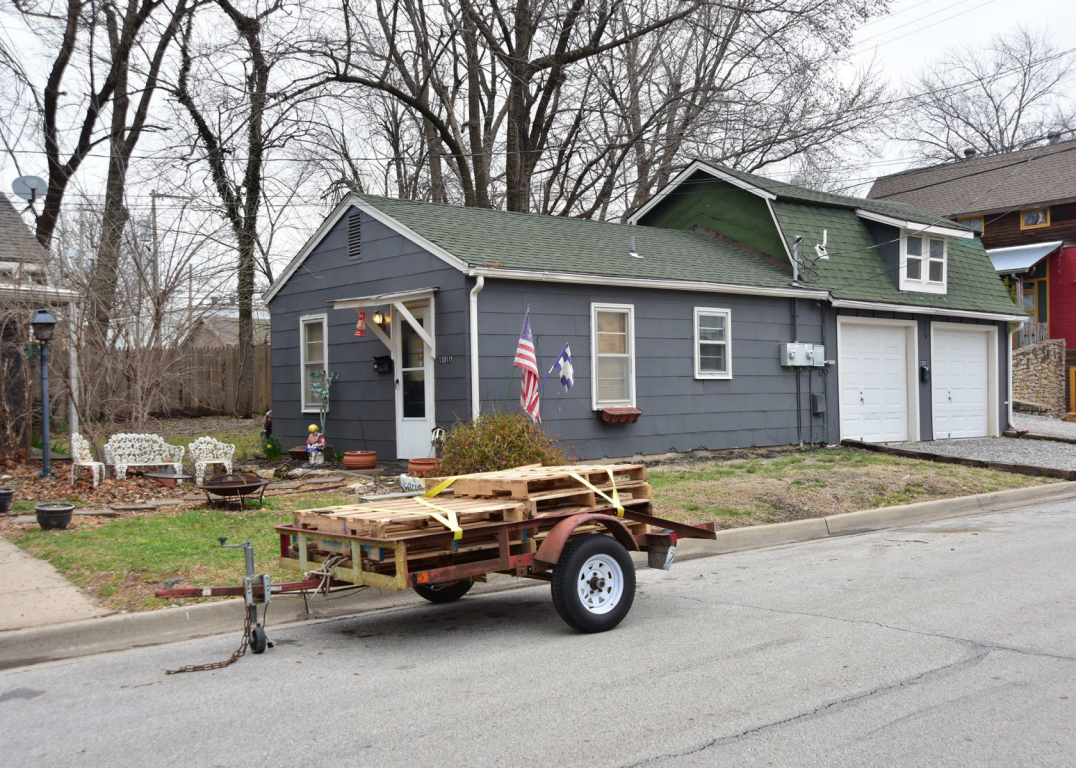
This one-story Pyramidal Roof folk house has a rectangular footprint that is three bays wide and four bays deep. Tuscan columns and square wood posts support the three-quarter-width porch's projecting gable-front roof, which shelters the center bay entrance. The original, single one-over-one light, double-hung wood sash windows with flat board trim define the other bays. Additional character-defining features include the small front gable vent at the roof peak, the pedimented gable-front porch and its matchstick balustrade, and the wide eaves (Davis and Schwenk, 2003)."

One Tuscan column remains. The dwelling features and asphalt roof and asbestos cladding. 13011A 8th Street does not appear significantly altered from its 2003 appearance. Dates of alteration are unknown, however pre-date the 2003 survey.

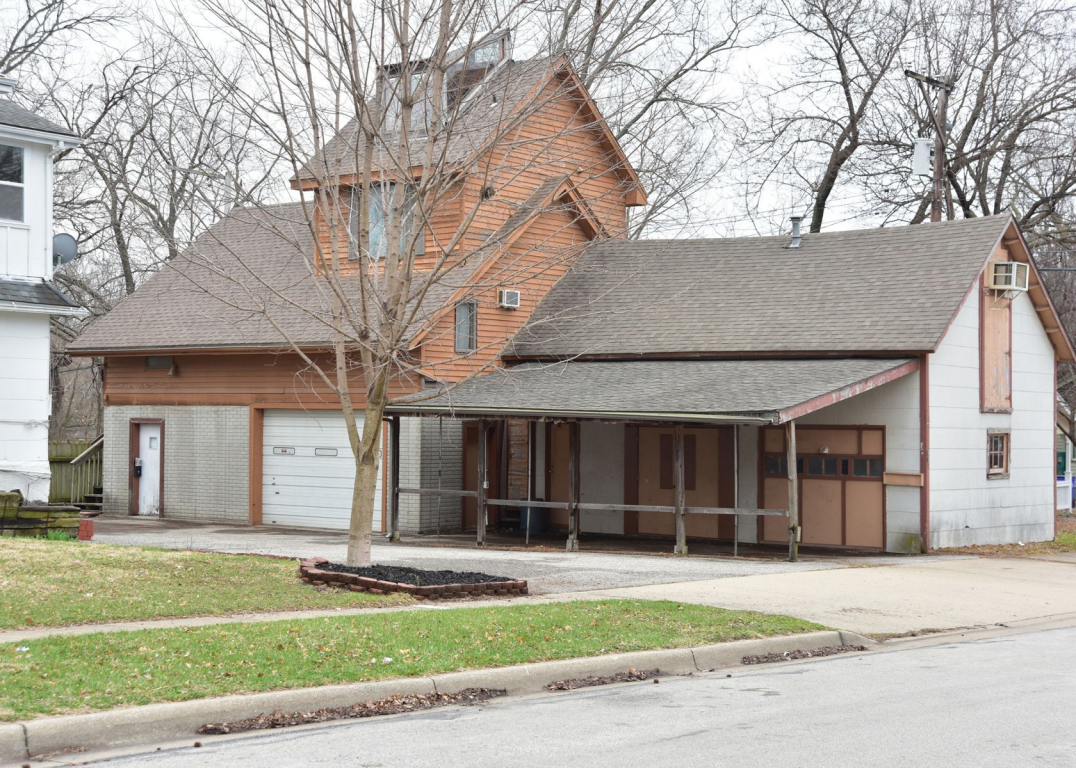
This resource does not appear significantly altered from its 2003 appearance. Dates of alteration are unknown, however pre-date the 2003 survey.

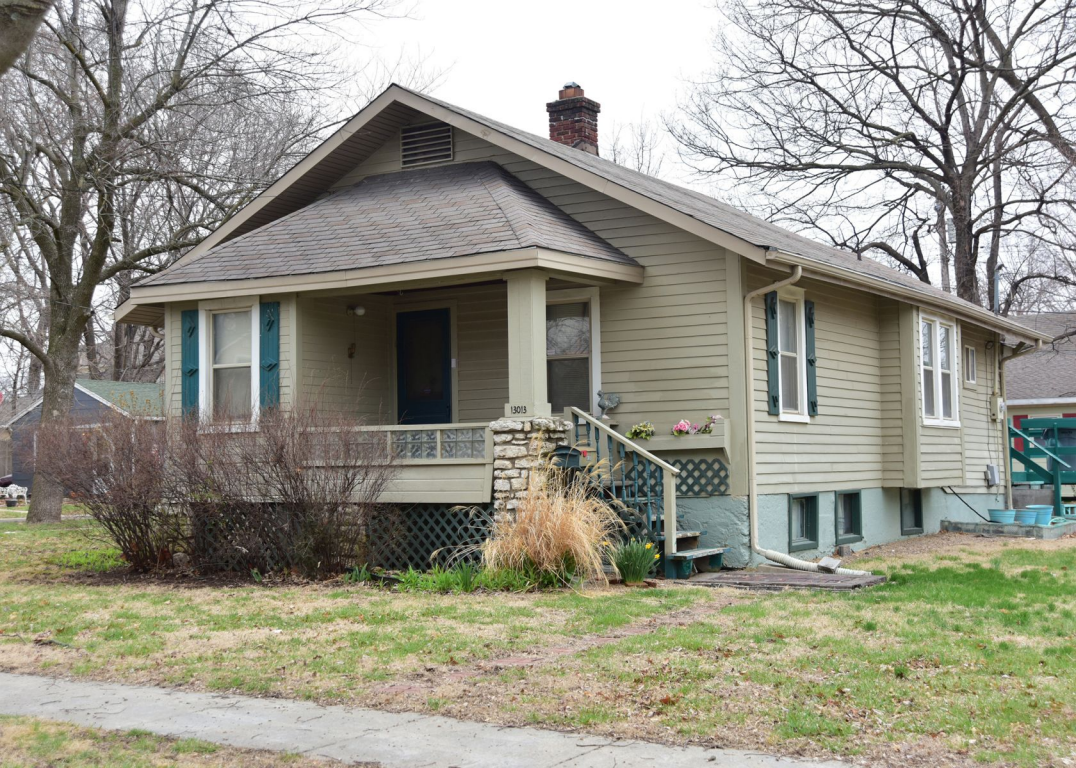
"This one-story, gable-front bungaloid house has a rectangular footprint that is three bays wide and three bays deep. Square wood posts resting on rough-cut limestone piers support the three-quarter-width porch's hipped roof, which shelters the center bay entrance and is enclosed (historic alteration) at the north end bay. The original, single three-over-one light, double-hung wood sash windows define the other bays. Additional character-defining features include the wide eaves, wood clapboard siding with corner boards, a brick ridge chimney, and a projecting square window bay at the south (side) elevation (Davis and Schwenk, 2003)."

Glass block lines the west edge of the porch and the porch stairs now have turned wood balusters. Dates of prior alteration are unknown, however pre-date the 2003 survey.

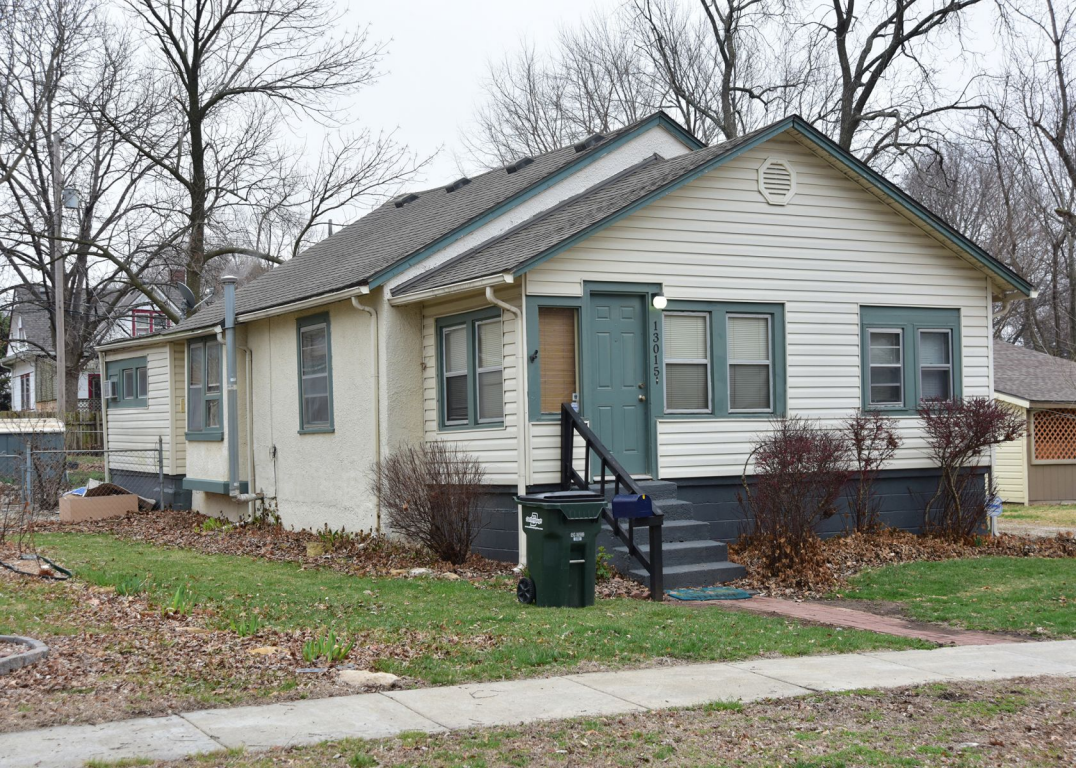
"This one-story, gable-front bungalow house has a rectangular footprint that is three bays wide and four bays deep. Vinyl clads the walls of the enclosed, three-quarter-width porch with a gable-front roof. Stucco clads the remaining exterior walls. Fenestration defines the bays and includes, from the north (left), an entrance door with a single side light and two non-original, paired, one-over-one light, double-hung sash windows. The enclosure of the front porch and the application of non-original stucco and vinyl wall materials compromise the integrity of this building (Davis and Schwenk, 2003)."

The dwelling features an asphalt roof. 13015 8th Street does not appear significantly altered from its 2003 appearance. Dates of alteration are unknown, however pre-date the 2003 survey.

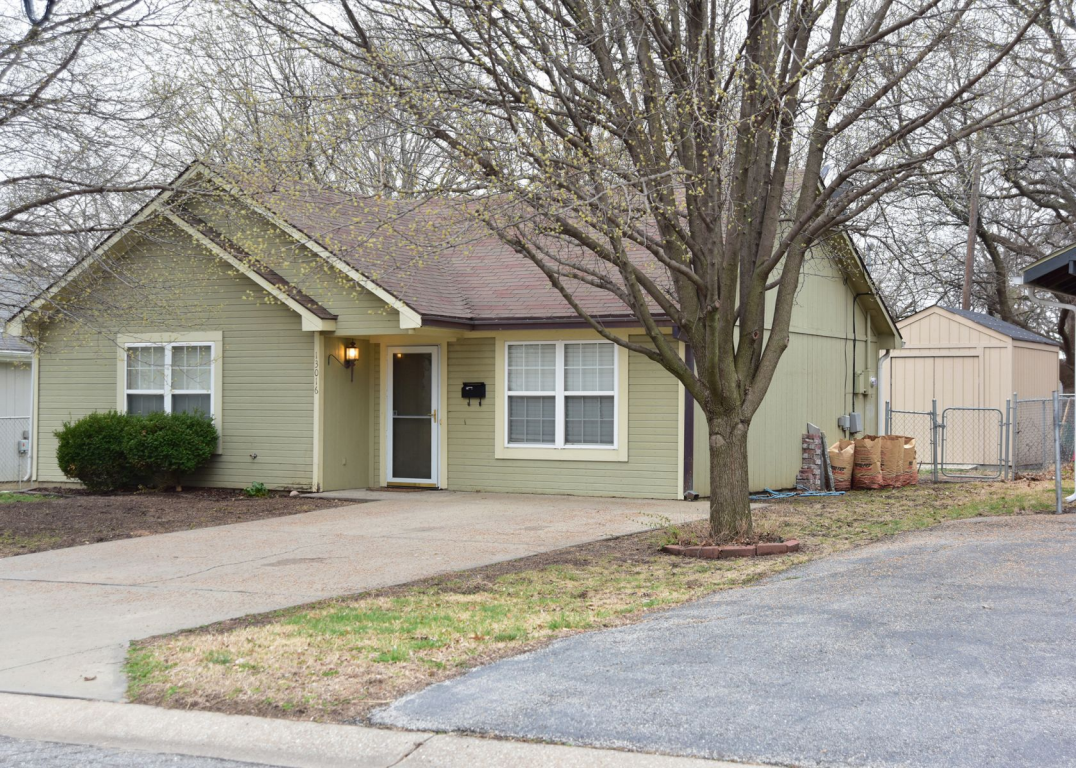
"This one-story house has an intersecting gable roof and a front-facing L-shaped footprint that is three bays wide and one bay deep. Fenestration defines the bays and includes a center bay entrance and paired double-hung sash windows with six-over-six light snap-in muntins. Additional character-defining features include the dwelling's wide, boxed eaves (Davis and Schwenk, 2003)."

13016 8th Street does not appear significantly altered from its appearance during the 2003 survey. The dwelling features an asphalt roof.

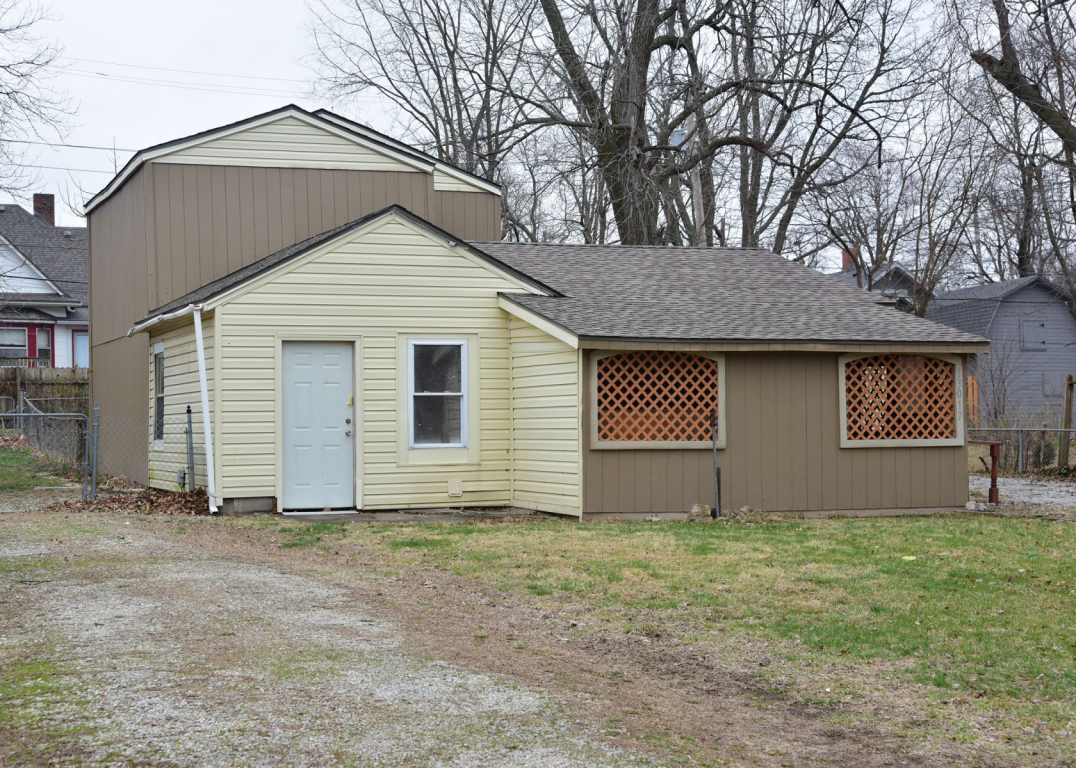
The mesh screen porch enclosure has been replaced with pressed wood with two segmental arch openings. Latticework covers the openings. Dates of prior alteration are unknown, however pre-date the 2003 survey.

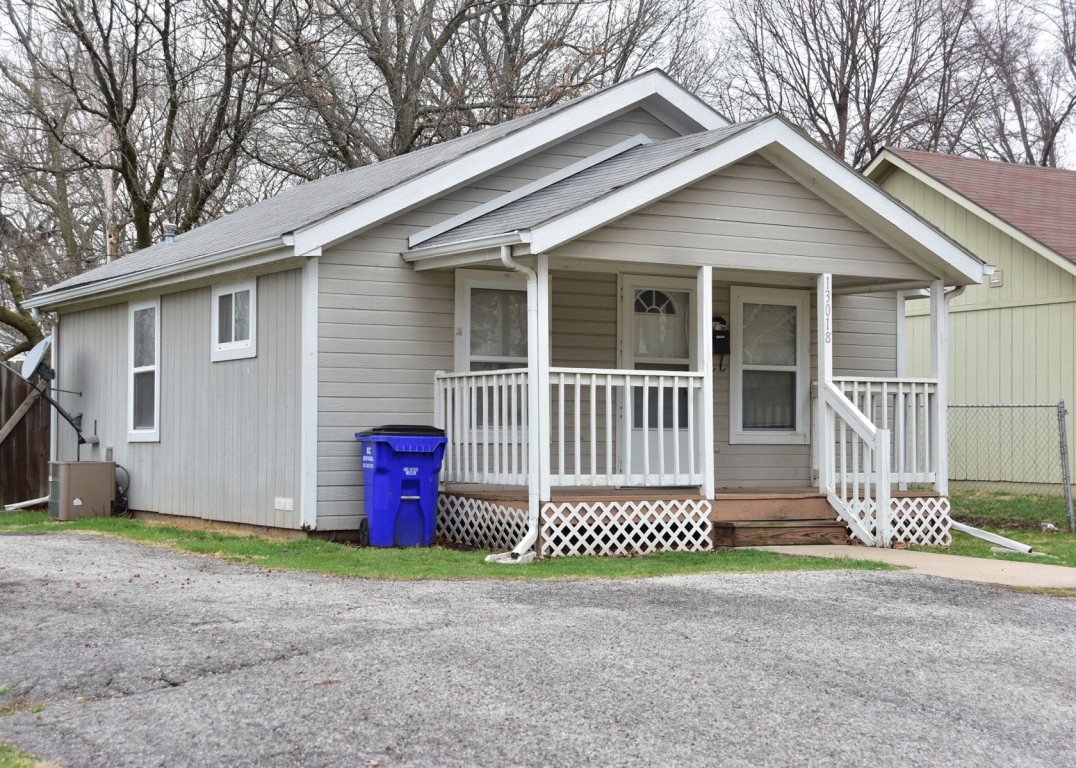
13018 8th Street features an asphalt roof and non-historic lattices at the base of the porch. The dwelling has new siding. The porch components have been replaced with squared wood posts and balustrade. Dates of prior alteration are unknown, however pre-date the 2003 survey.

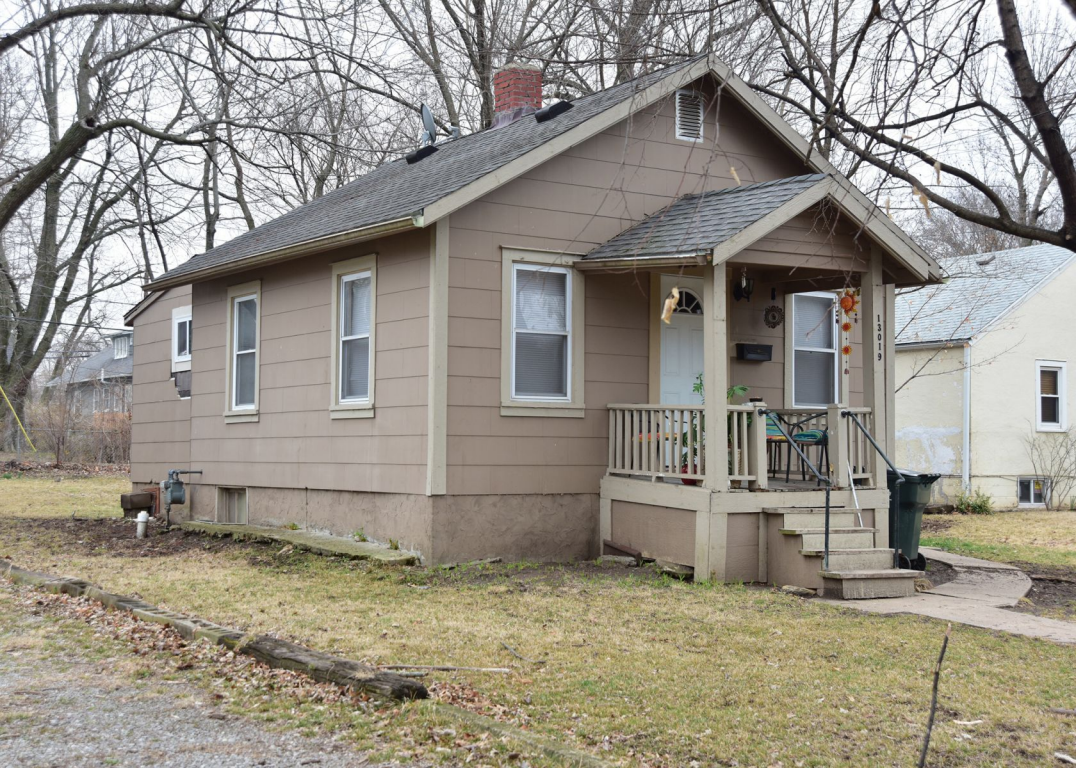
The dwelling features an asphalt roof, parged foundation, and aluminum storm windows at all elevations visible from the right-of-way. Wood sash windows have been replaced with vinyl. 13019 8th Street does not otherwise appear significantly altered from its 2003 appearance. Dates of the other alterations are unknown, however pre-date the 2003 survey.

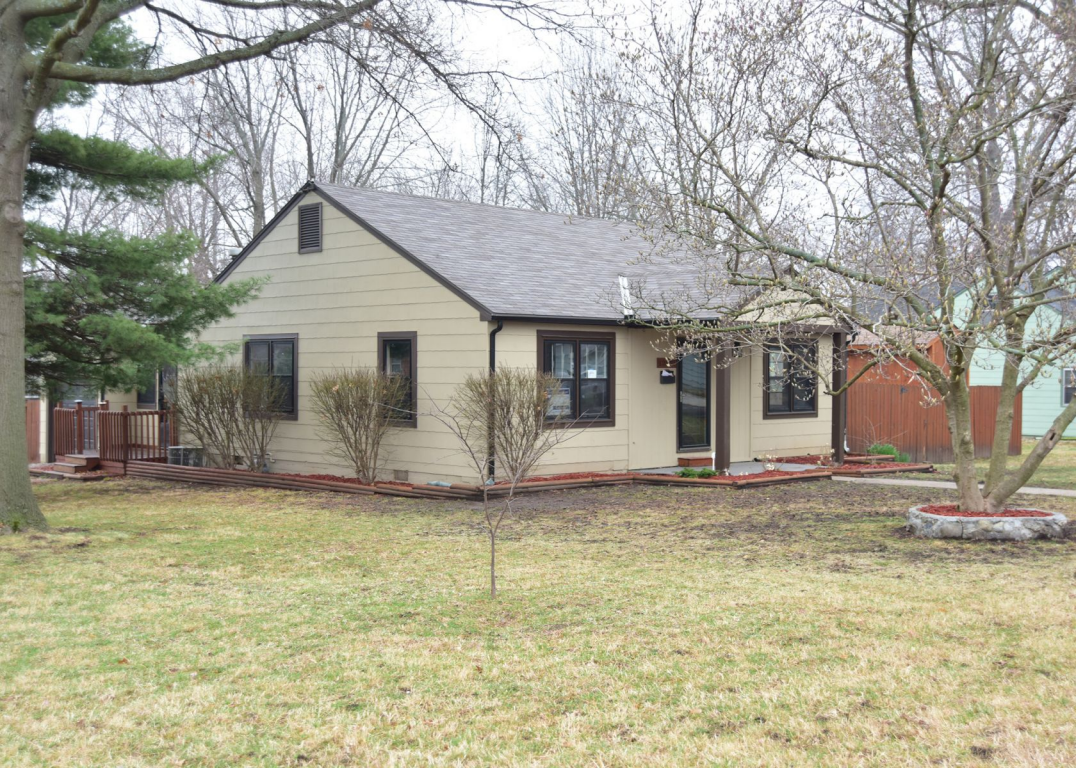
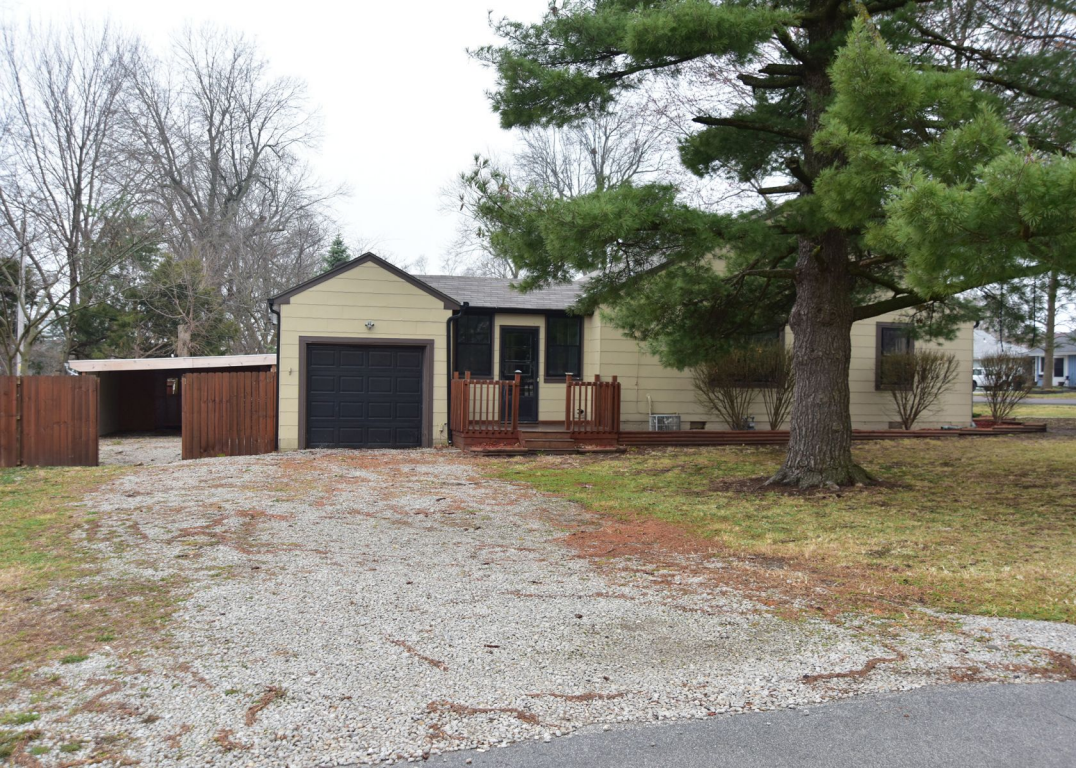
"This one-story, side-gabled house has a rear ell that connects to a gable-front, single-car garage. The dwelling has a rear-facing, L-shaped footprint that is three bays wide and six bays deep. Square wood posts support the projecting gable-front porch that shelters the center bay entrance. Forming the other bays are the original paired three-over-one light, double-hung wood sash windows with flat board trim. Additional character-defining features include the tight eaves with modest flat board molding and original asbestos shingle cladding (Davis and Schwenk, 2003)."

The dwelling features an asphalt roof and aluminum storm windows at all elevations visible from the right-of-way. 12901 10th Street does not appear significantly altered from its 2003 appearance.

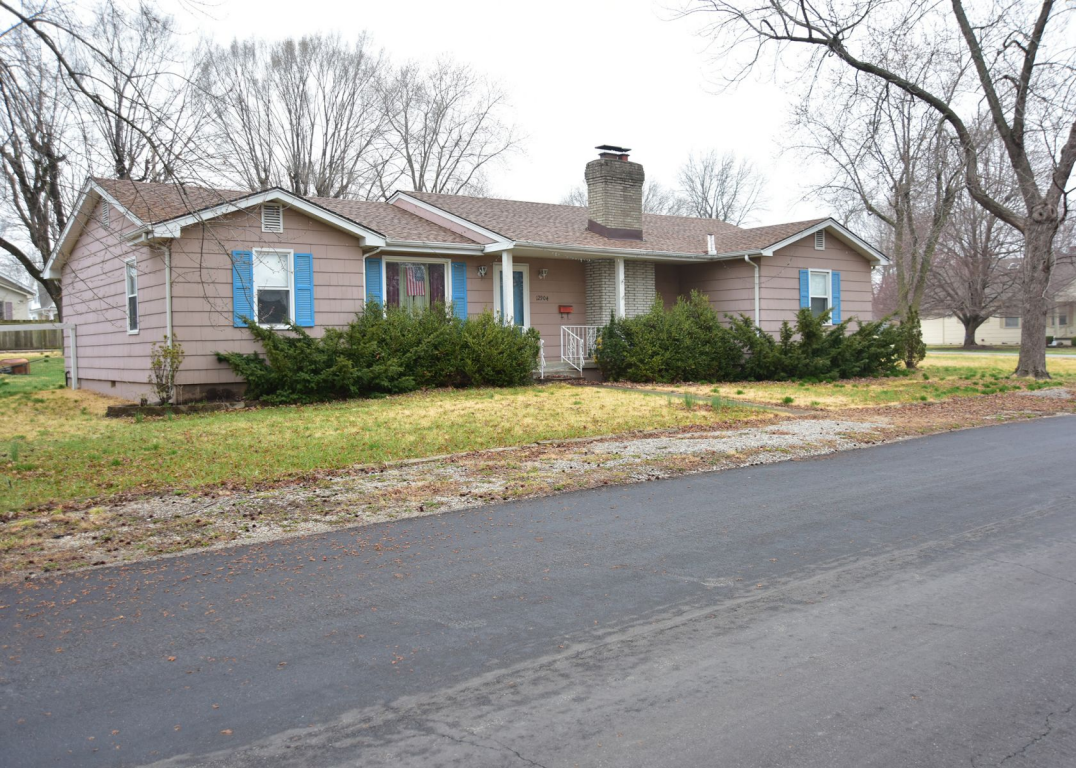
"This one-story, side-gabled Minimal Traditional style house has two lower, forward-projecting cross gables and a rear, intersecting, side-gabled, two-bay, two-car garage wing, thus forming an irregular footprint four asymmetrical bays wide and five bays deep. The front roof slope extends forward to shelter the entrance at the third bay from the south end. Forming the other bays are single one-over-one light, double-hung sash windows and a fixed-sash picture window, all flanked by shutters. Additional character-defining features include wide eaves and the broad exterior chimney adjacent to the primary entrance (Davis and Schwenk, 2003)."

12904 10th Street does not appear significantly altered from its appearance during the 2003 survey.

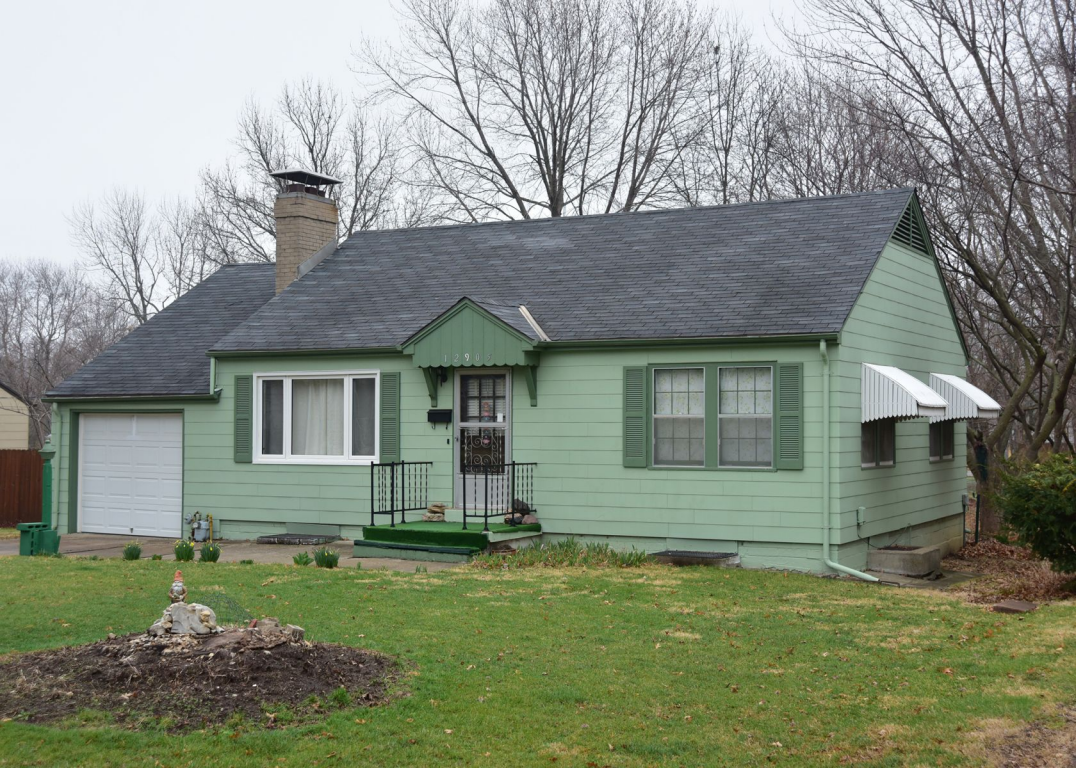
"This one-story, side-gabled house has a rectangular footprint that is four bays wide and two bays deep. At the second bay from the south end, knee brackets support a small cross gable roof that projects slightly to shelter the stoop entrance. At the north end bay, the roof height drops over the single-car garage. Forming the other bays are paired one-over-one light, double-hung sash windows and a tripartite picture window, all flanked by shutters. Additional character-defining features include the tight eaves, scalloped plank siding on the stoop porch gable, and the broad brick chimney located at the change in roof height junction (Davis and Schwenk, 2003)."

Snap-in muntins now divide the one-over-one windows into six-over-six. 12905 10th Street otherwise does not appear significantly altered from its 2003 appearance.

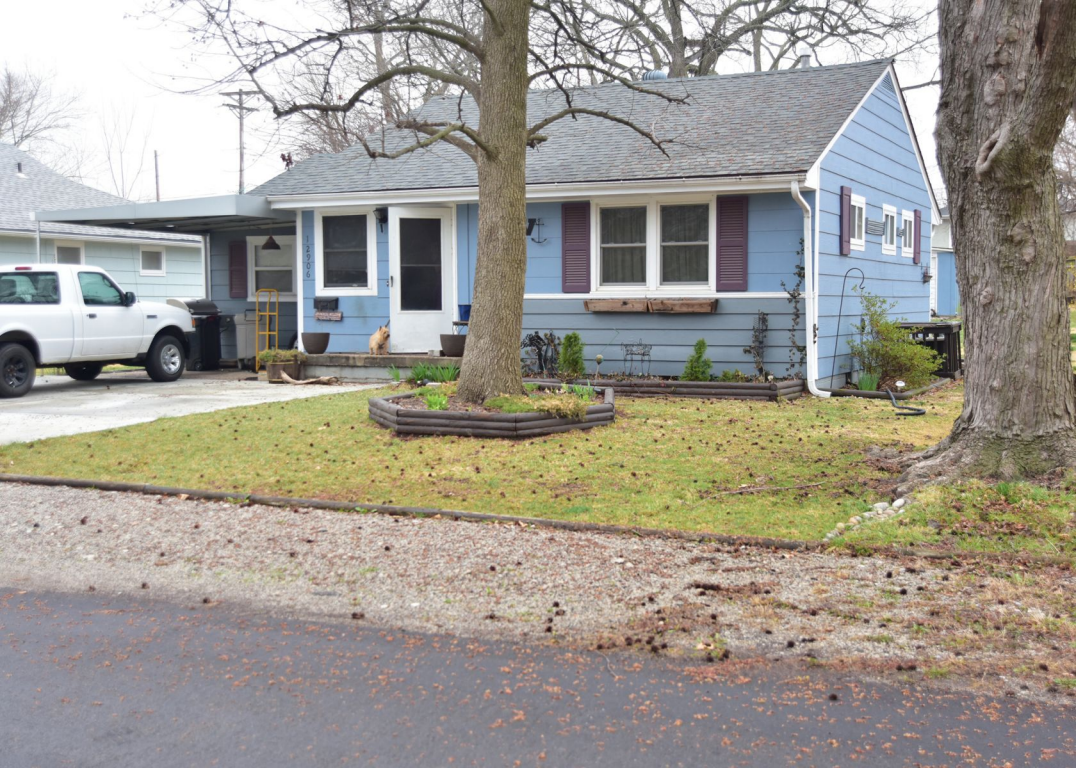
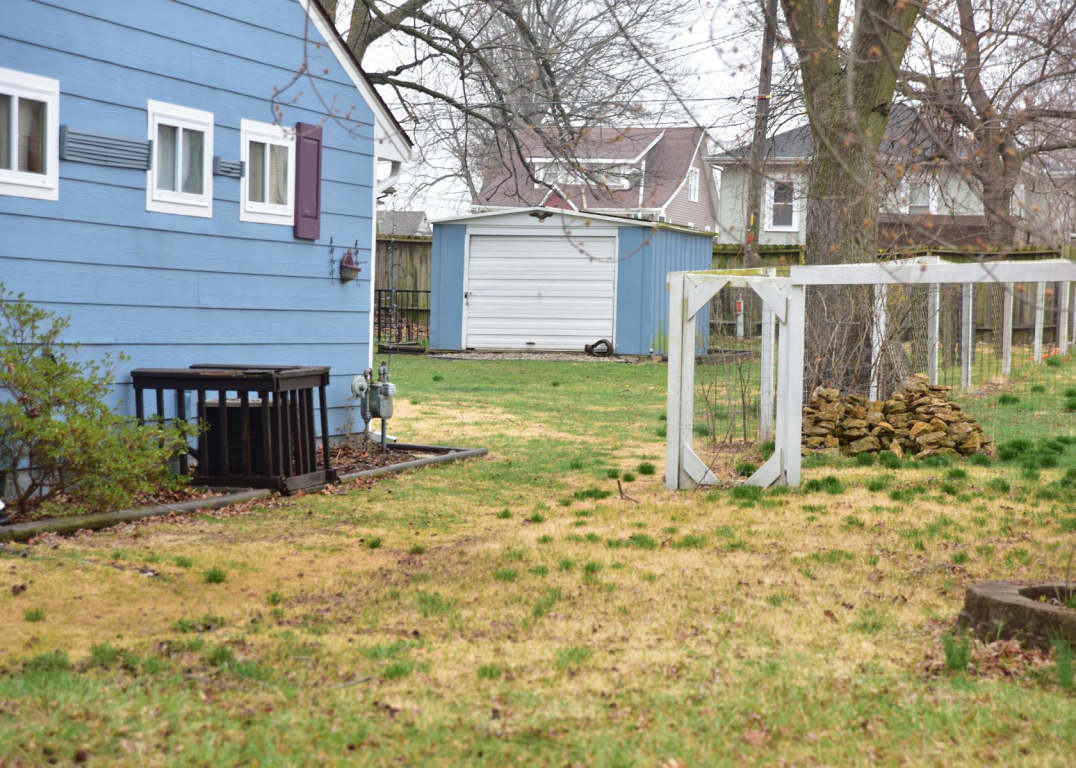
The six-over-six windows of 12906 10th Street have been replaced with one-over-one vinyl sash since the 2003 survey. Wide profile vinyl siding has replaced the original asbestos shingle cladding.

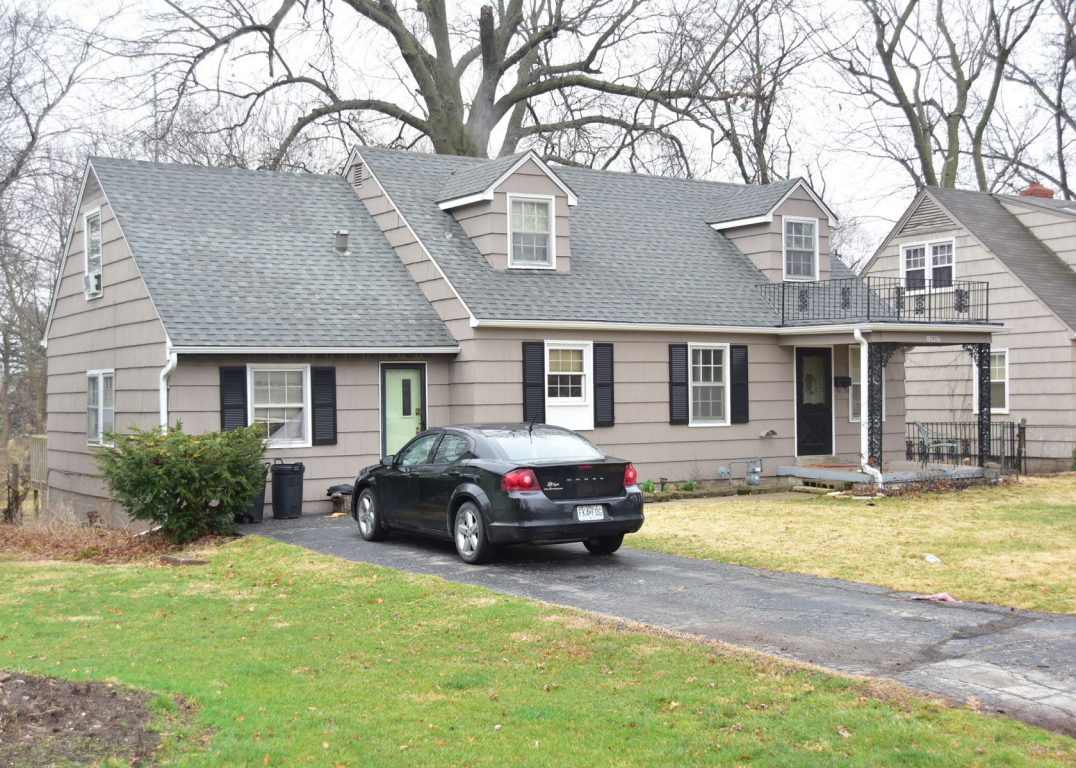
"This one-and-a-half-story, side-gabled Colonial Revival style house has a rectangular footprint that is six bays wide and three bays deep. Decorative iron posts support the flat porch roof that shelters the two south end bays, including the entrance at the second bay from the south end. The front wall and front roof slope step back at the two north end bays. There is a secondary entrance adjacent to this junction, where it appears that there was once a one-car garage in the front wall. The original six-over-six light, double-hung wood sash windows with shutters form the remaining bays. Two gabled dormers project from the front roof slope, each containing a single six-over-six light, double-hung sash window. Additional character-defining features include the tight eaves and the original asbestos shingle cladding (Davis and Schwenk, 2003)."

12907 10th Street does not appear significantly altered from its 2003 appearance. Dates of alteration are unknown, however pre-date the 2003 survey.

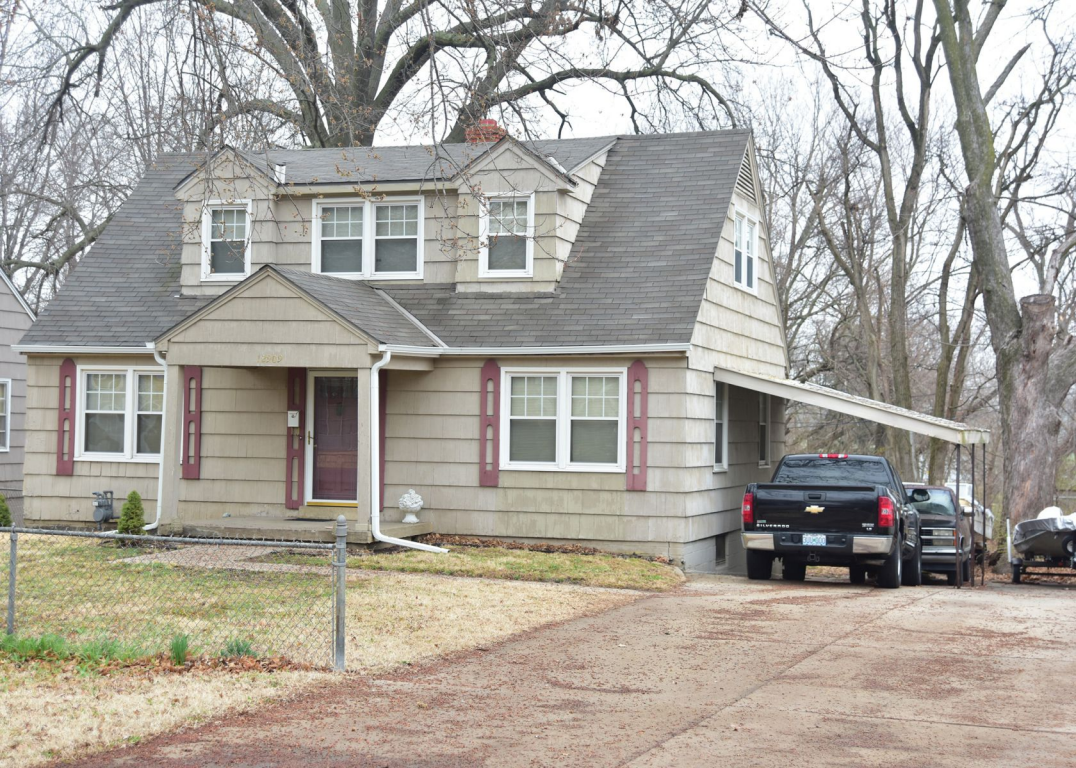
The original six-over-six wood sash windows have been replaced with six-over-one vinyl sash windows. A carport projects from the south elevation. The dwelling does not otherwise appear significantly altered from its 2003 appearance.

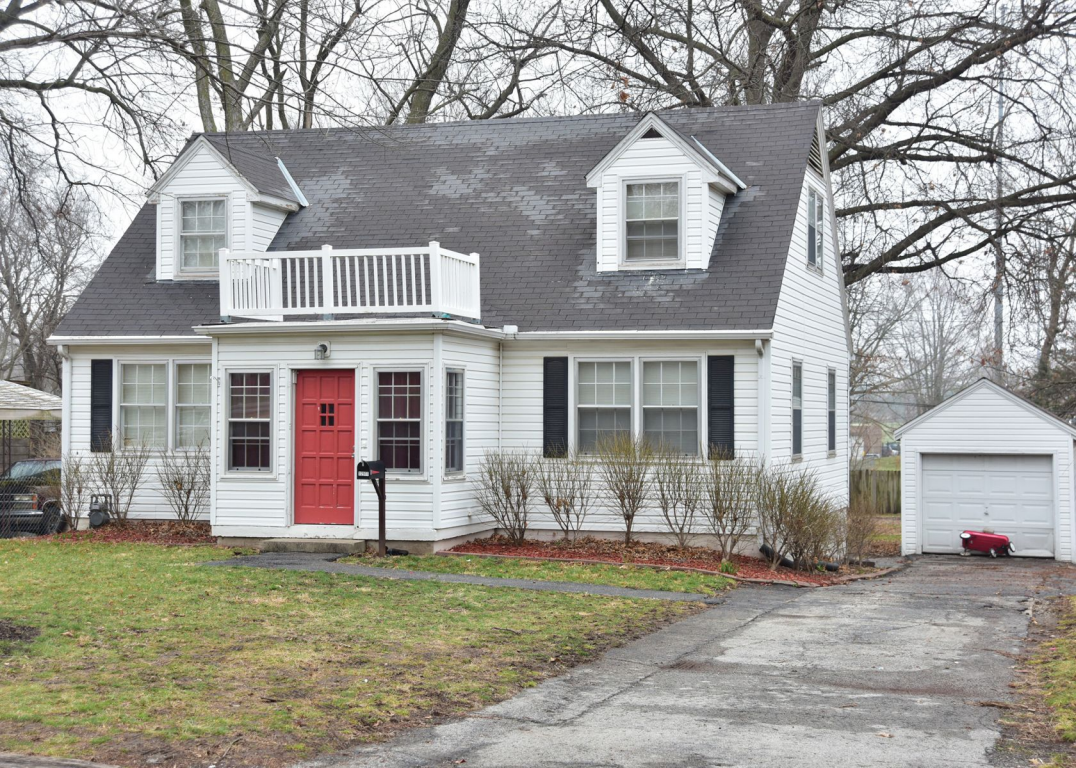
The asbestos cladding has been replaced with vinyl. 12911 10th Street otherwise does not appear significantly altered from its 2003 appearance. The date of the porch enclosure is unknown, however pre-dates the 2003 survey.

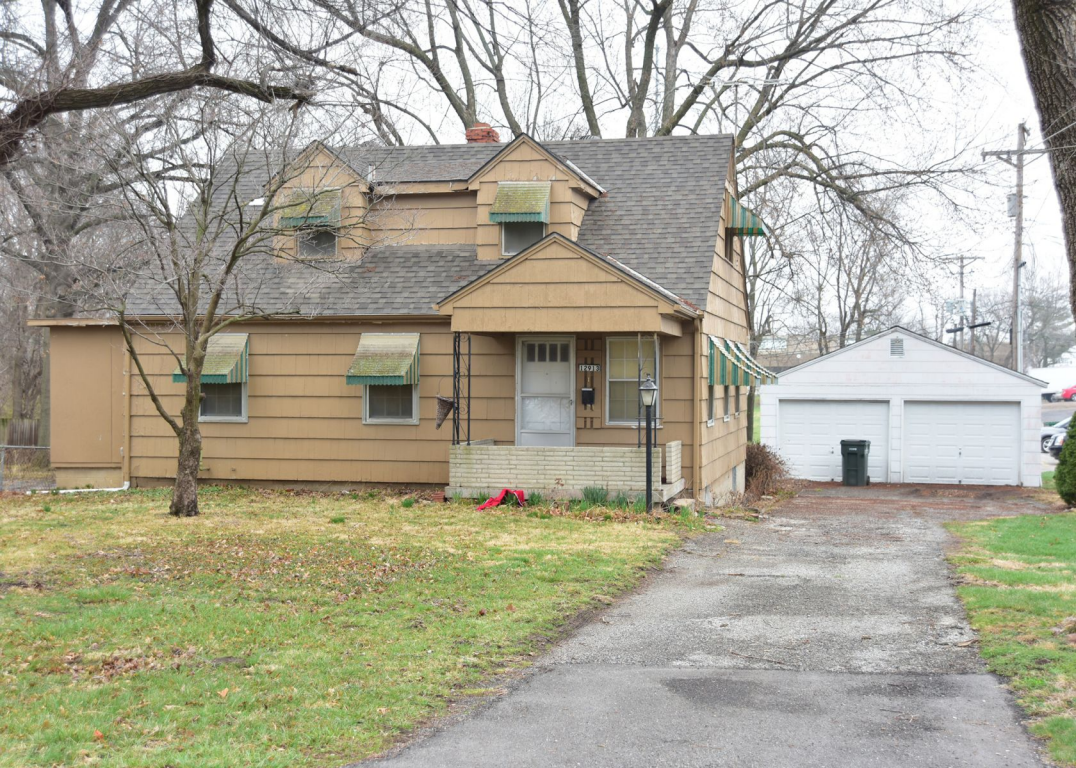
"This one-and-a-half-story, side-gabled Colonial Revival style house has a rectangular footprint that is four bays wide and two bays deep. Decorative iron posts support the projecting gable-front porch that shelters the entrance at the second bay from the south end. The original six-over-six light, double-hung wood sash windows form the primary façade's other bays. At the center of the front roof slope, a shed dormer connects the two gable-front dormers. Additional character-defining features include the tight eaves and the original asbestos shingle cladding (Davis and Schwenk, 2003)."

Aluminum storm windows are present at all elevations visible from the right-of-way. Metal awnings project over windows at the west and south elevations. 12913 10th Street does not appear significantly altered from its 2003 appearance.

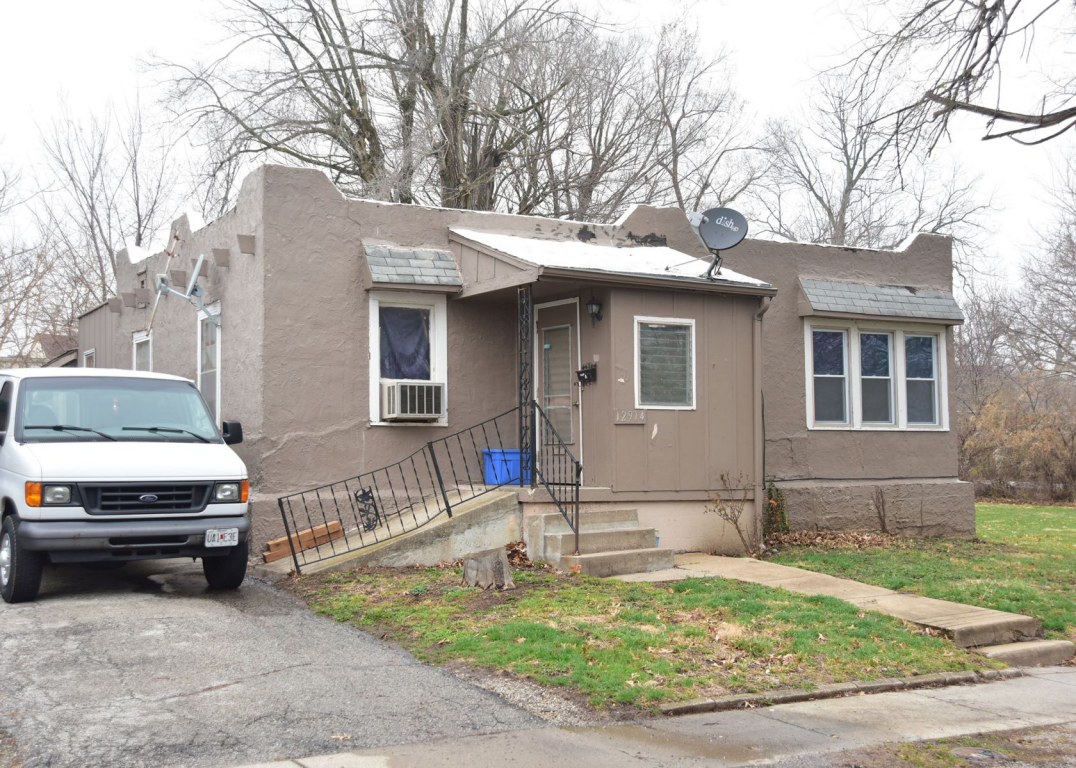
"This one-story Spanish Eclectic house with a flat roof has an irregular footprint that is four asymmetrical bays wide and four bays deep. Stucco covers the exterior and parapet walls, the latter of which features projecting faux vigas. Fenestration defines the bays on the primary façade, which includes an enclosed entrance porch with a shed roof at the second bay from the south end, and the original single and tripled six-over-six light, double-hung wood sash windows with flat board trim. Additional character-defining features include narrow pent roofs over the primary façade window bays, raised parapet wall sections, and the projecting foundation wall profile covered in parging (Davis and Schwenk, 2003)."

The six-over-six windows are now one-over-one. The dwelling otherwise does not appear significantly altered since the 2003 survey.
