MISSOURI DEPARTMENT OF NATURAL RESOURCES
STATE HISTORIC PRESERVATION OFFICE, P.O. Box 176, Jefferson City, MO 65102
ARCHITECTURAL/HISTORIC INVENTORY FORM

1. Survey number: JA-AS-088-001		2. Survey Name: Town of Grandview, Resurvey	
3. County: JACKSON		4. Address (Street No.): 13114 Street (name): 4th Street	
5. City: Grandview	Vicinity <input type="checkbox"/>	6. Lat / Long:	7. Township/Range/Section: T: R: S:
8. Historic name (if known):		9. Present/other name (if known):	
10. Ownership: <input checked="" type="checkbox"/> Private <input type="checkbox"/> Public		11a. Historic use (if known): Domestic-Single Dwelling	11b. Current use: Domestic-Single Dwelling

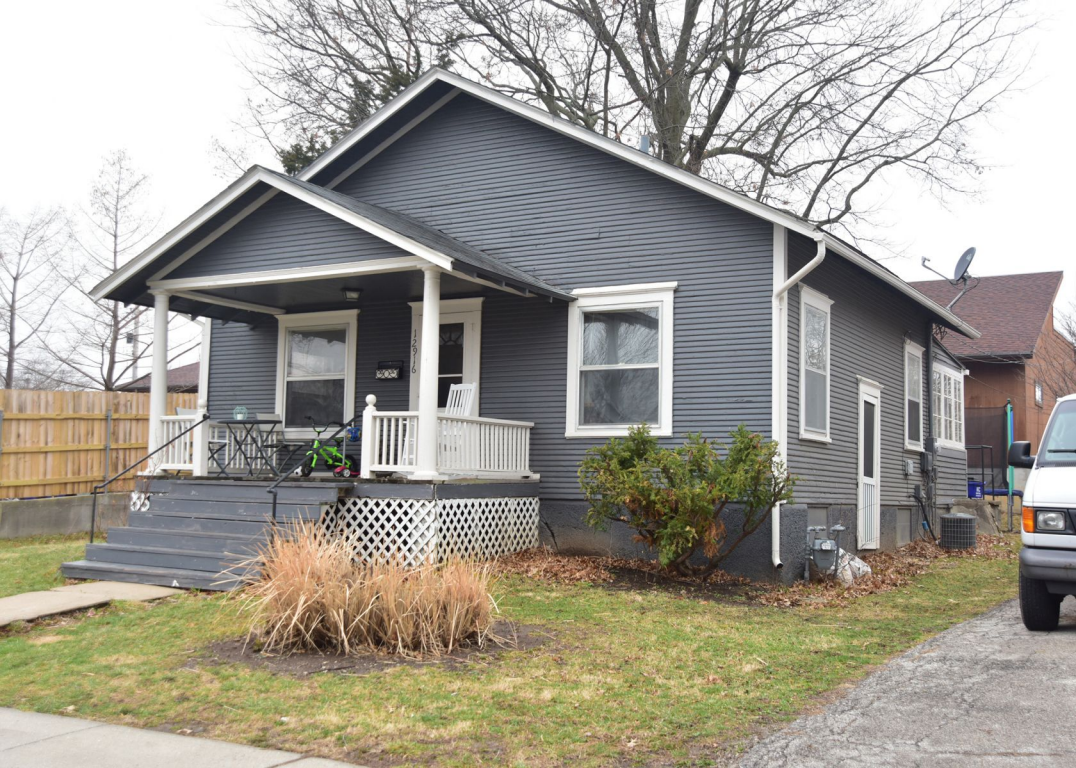
"This one-story, gable-front bungalow has a rectangular footprint that is three bays wide and three bays deep. A projecting gable-front porch shelters the two south end bays, including the center bay entrance. Single one-over-one light, double-hung sash windows with flat board trim form the other bays. Additional character-defining features include wide eaves with exposed rafter tails, the original Tuscan column porch posts, matchstick balustrade, and thin profile wood clapboards (Davis and Schwenk, 2003)."

A small shed roof addition is present at the rear of the dwelling. 12916 10th Street does not appear significantly altered from its 2003 appearance. The date of the addition is unknown, however it pre-dates the 2003 survey.

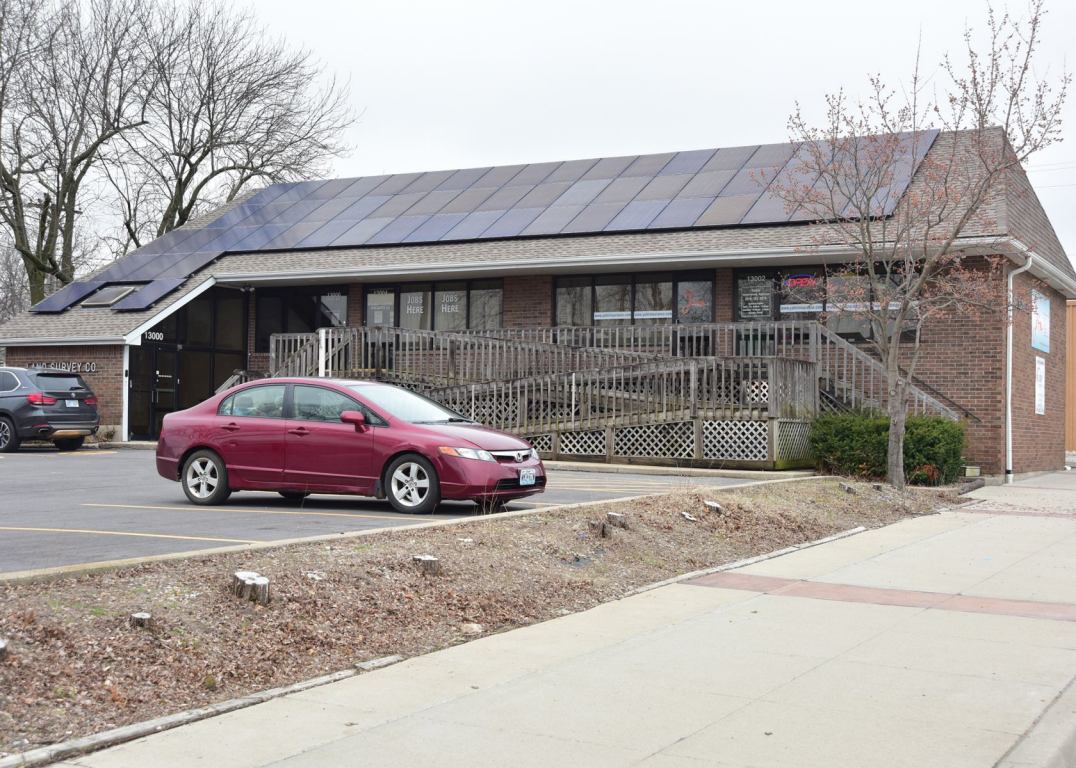
"This one-story, side-gabled modern professional building has an L-shaped plan that is four bays wide. The front roof slope dominates the façade, featuring wide front eaves and projecting forward with the front wall at the south end. Each bay contains three- and four-part, aluminum-framed storefront display window systems that include glass entrance doors. The building displays the address 13002 (Davis and Schwenk, 2003)."

A large accessibility ramp dominates the primary elevation. Aerial imagery indicates the installation of solar panels at the front and rear slopes of the roof occurred ca. 2014. The building displays addresses 13000-13004. It otherwise does not appear significantly altered from its 2003 appearance.

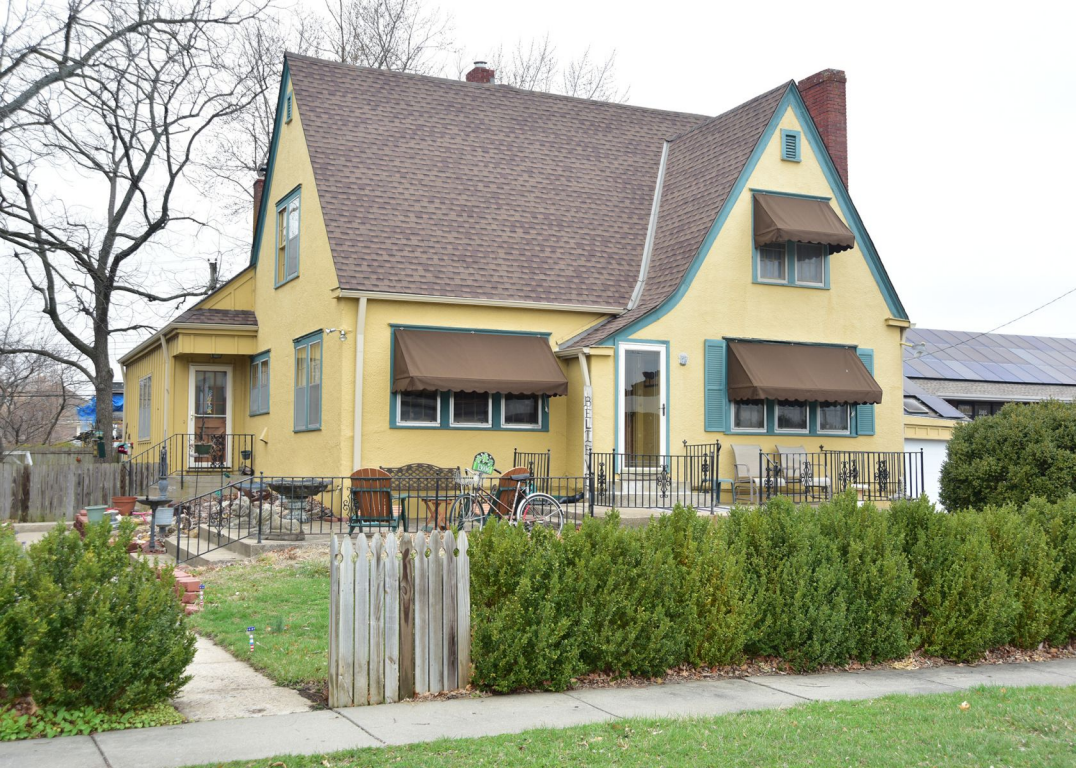
"This one-and-a-half-story, side-gabled Tudor Revival style house has an irregular footprint that is four bays wide and three bays deep. The main block has a classic steeply pitched, asymmetrical, projecting cross gable roof. The modern wing addition at the rear has a gable roof. The fenestration defines the bays and includes the stoop entrance at the second bay from the south end; the original triple six-over-six light, double-hung wood sash windows with flat board trim, and a five-part display window system at the rear wing. Additional character-defining features include the stucco treatment on the exterior walls and the broad exterior brick chimney at the north elevation (Davis and Schwenk, 2003)."

13006 10th Street does not appear significantly altered from its 2003 appearance. The date of construction for the addition is unknown, however it pre-dates the 2003 survey.

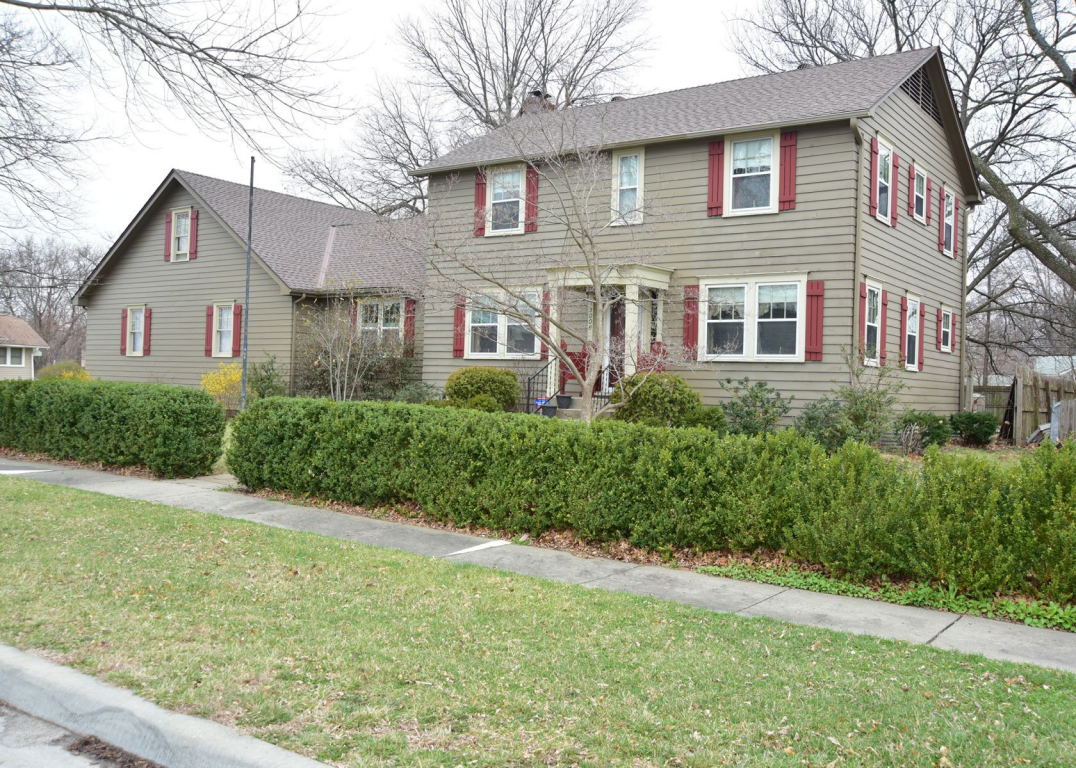
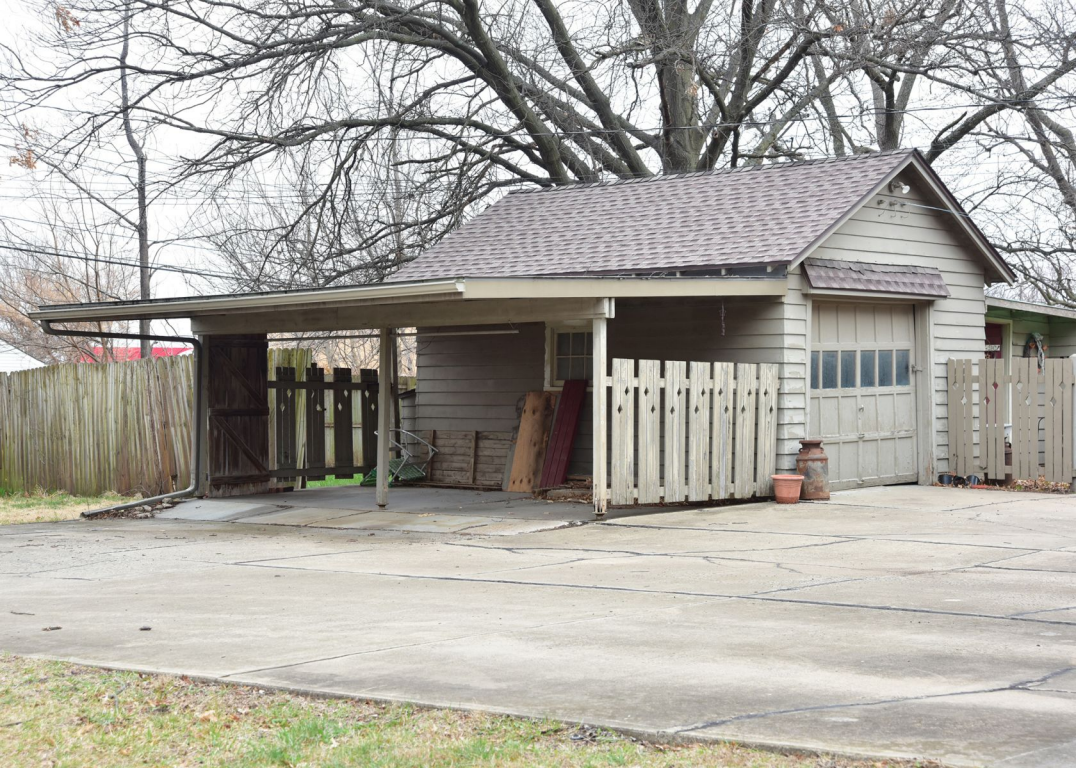
"This two-story, side-gabled Colonial Revival style house consists of a classic Georgian main block and a large gable-front garage addition with connecting wing at the south end. The house has an irregular footprint that is six asymmetrical bays wide. At the second bay from the north end, square wood posts support a flat porch roof that accentuates the entrance, which is flanked by sidelights. Forming the remaining bays are single and paired six-over-one light, double-hung wood sash windows with shutters. Additional character-defining features include the wide wood clapboards (Davis and Schwenk, 2003)."

13008 10th Street does not appear significantly altered from its 2003 appearance.

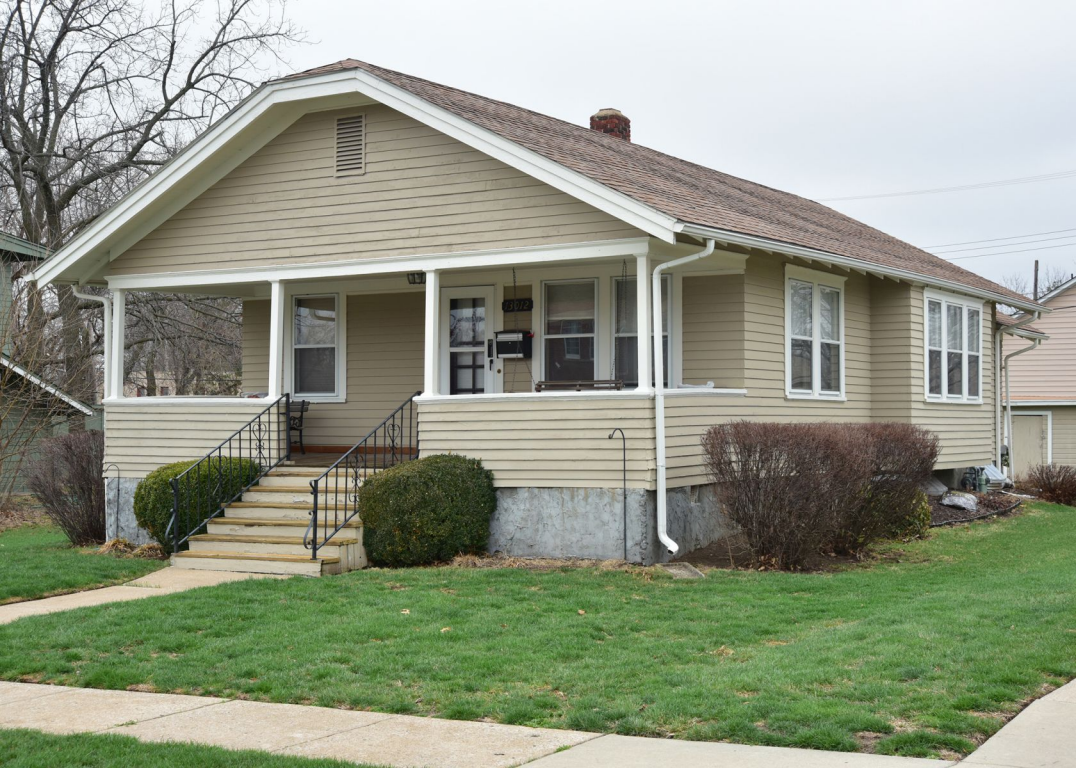
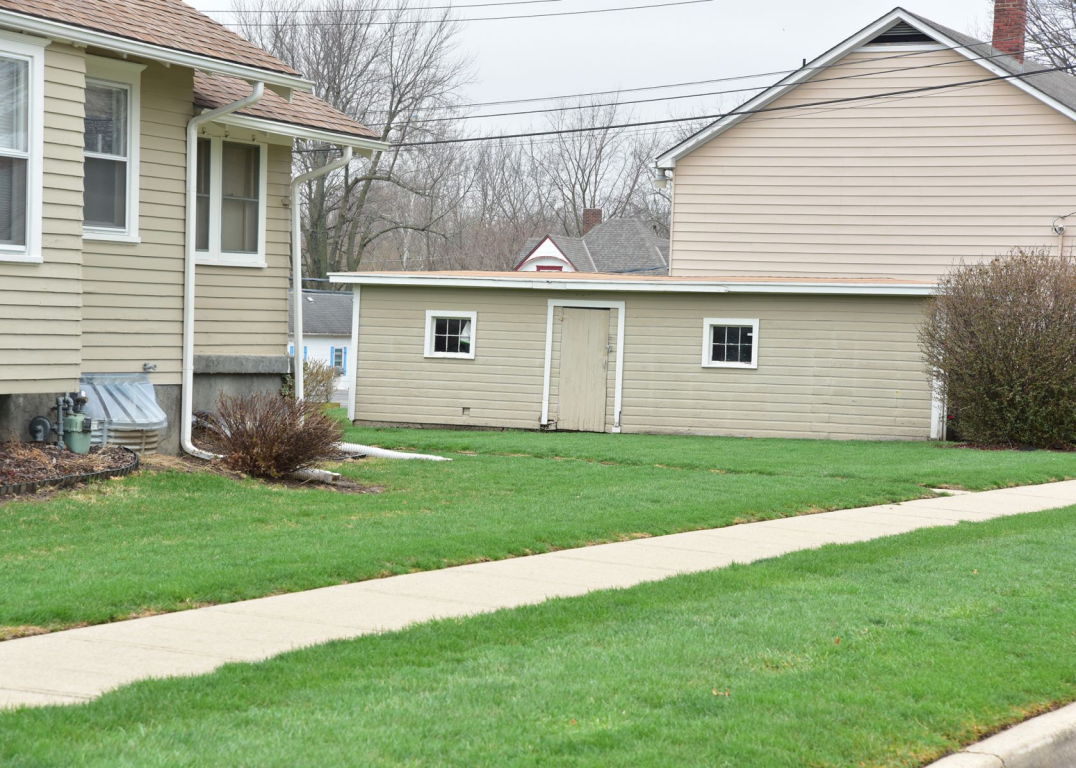
"This one-story Craftsman style bungalow forms a rectangular footprint that is three bays wide and three bays deep. The main roof features a clipped front gable and projects forward to form the full-width porch roof, which is supported by the original square posts that rest on a solid porch balustrade. Fenestration defines the bays, which includes the center bay entrance and the single and paired one-over-one light, double-hung sash windows with flat board trim. Additional character-defining features include the wood clapboard exterior wall cladding, which also wraps the porch balustrade; the wide eaves with exposed rafter tails; and the square bay window at the north elevation (Davis and Schwenk, 2003)."

13012 10th Street does not appear significantly altered from its 2003 appearance.

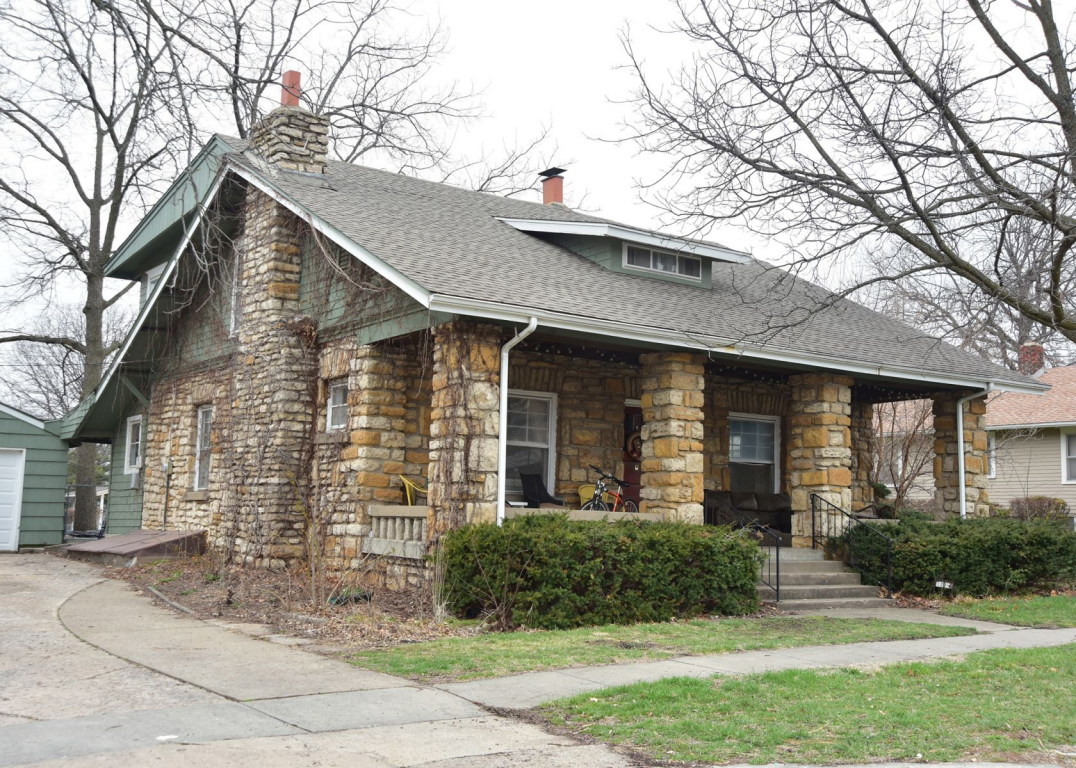
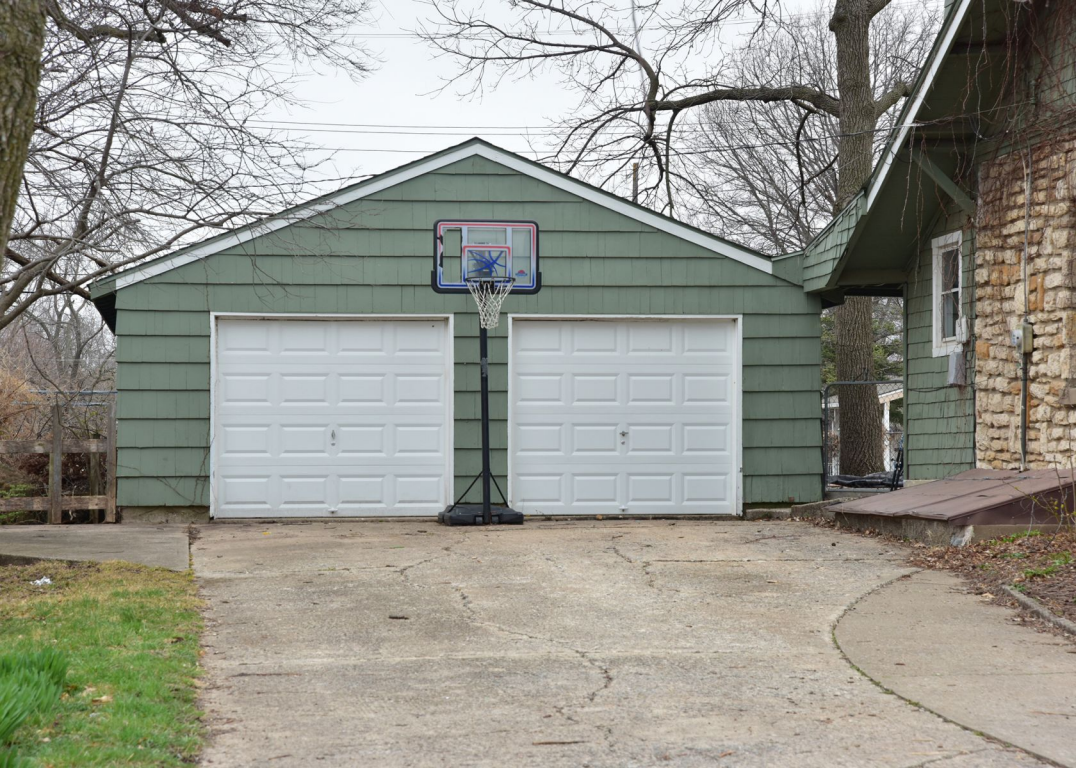
"This one-and-a-half-story, side-gabled Craftsman bungalow has a rectangular footprint that is three bays wide and four bays deep. Rough-cut, irregular coursed stone is the dominant feature of this dwelling. The front roof slope extends forward to form the full-width porch roof that is supported by heavy square stone columns. Fenestration defines the bays and includes the center bay entrance and single nine-over-one light, double-hung wood sash windows with ashlar stone sills and rough-cut soldier-lain stone lintels. A very shallow shed dormer pierces the front roof slope and contains a horizontal three-light hopper sash. Additional character-defining features include very wide eaves with knee brackets; stone balusters and an ashlar rail surrounding the porch floor; wood shingle cladding the side gable peaks; and a large exterior stone chimney at the south elevation (Davis and Schwenk, 2003)."

13014 10th Street does not appear significantly altered from its 2003 appearance.

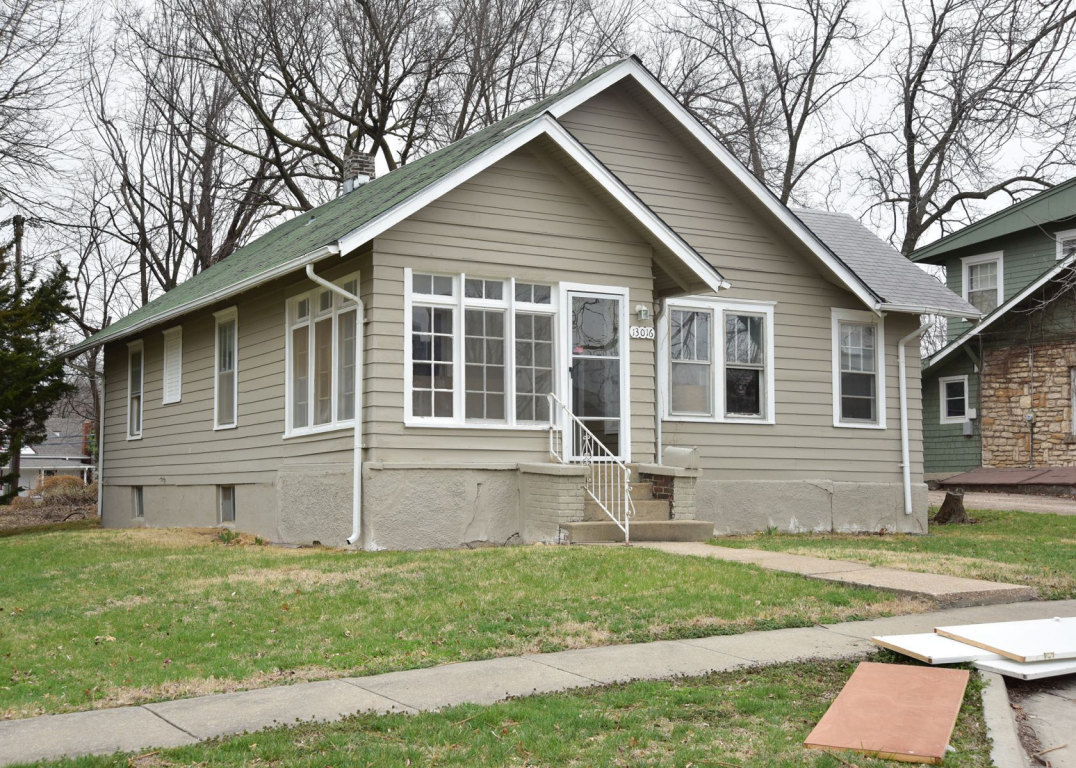
13016 10th Street does not appear significantly altered from its 2003 appearance.

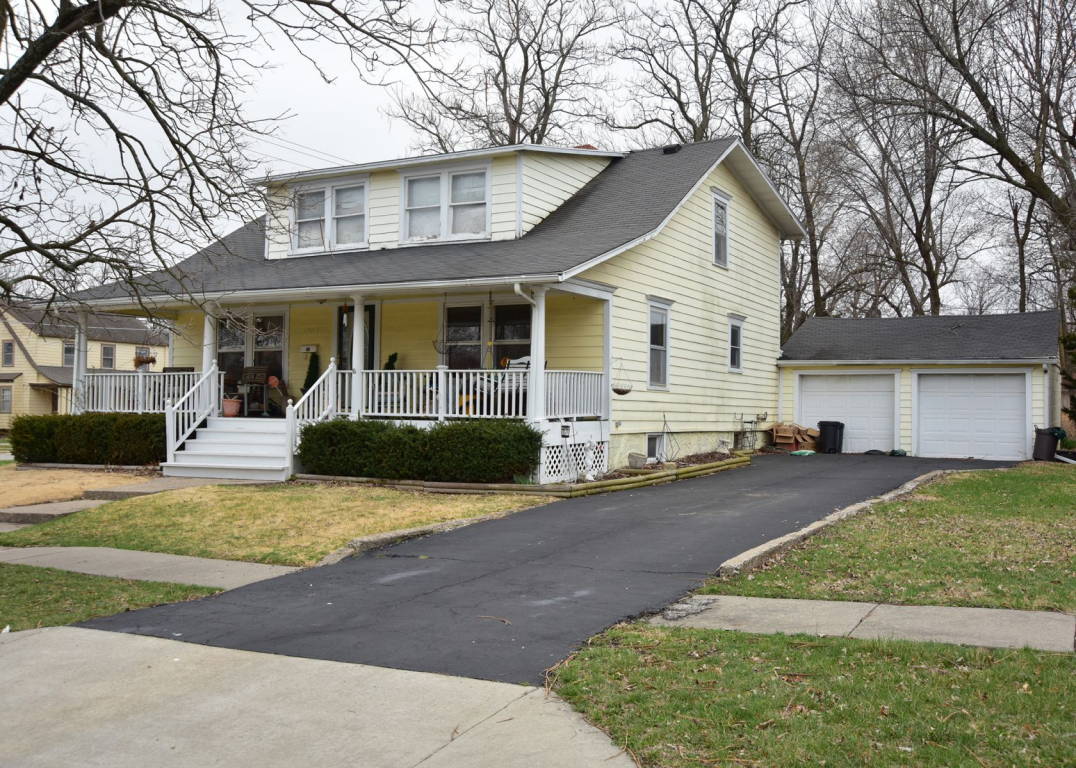
13018 10th Street now has Masonite siding that closely mimics the wood clapboard cladding noted by the 2003 survey. The exact date of alteration is unknown, however the 2005 National Register listing notes Masonite siding for this dwelling by that time.

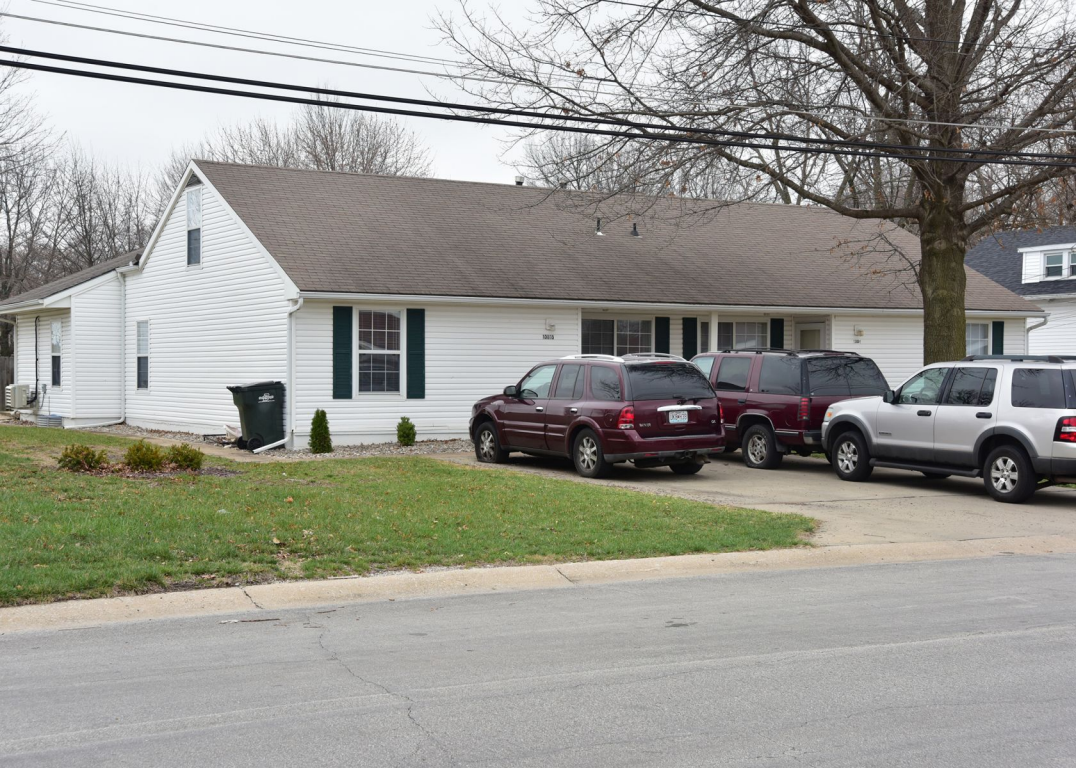
13005-07 12th Street has been significantly altered since the 2003 survey. The dwelling now features vinyl cladding and vinyl six-over-six replacement windows. A ca. 1969 rear addition pre-dates the 2003 survey.

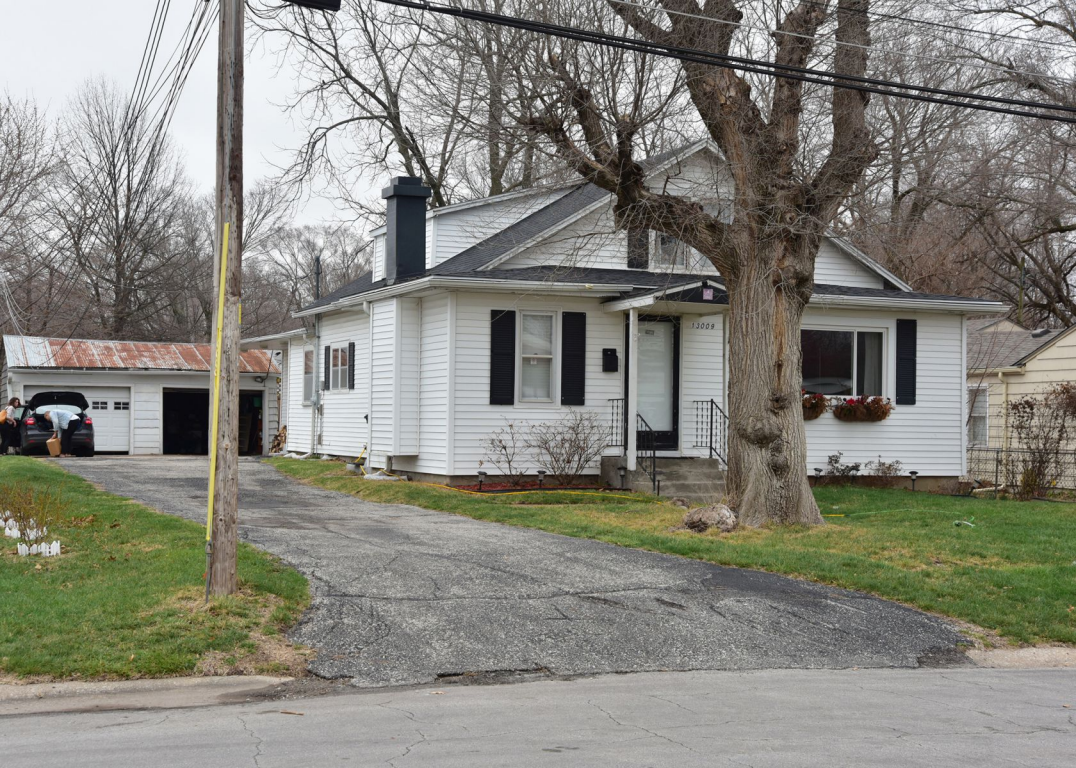
"This one-and-a-half-story, gable-front house has a rectangular footprint that is three bays wide and two bays deep. A pent roof shelters the full width of the façade. Turned posts support the non-original, projecting gable-front porch roof over the center bay entrance. Single and paired one-over-one light, double-hung sash windows form the other bays. Two single shed dormers project from each roof slope. Wide-profile, pressed wood siding clads the exterior walls as well as the lower half of the exterior brick chimney on the north elevation. The loss of original porch elements, original windows, and the application of modern wall cladding compromises the integrity of this building (Davis and Schwenk, 2003)."

The southern bay is defined by a tripartite picture window. The dwelling has been reclad with vinyl and turned wood posts at the west corners of the porch have been removed.

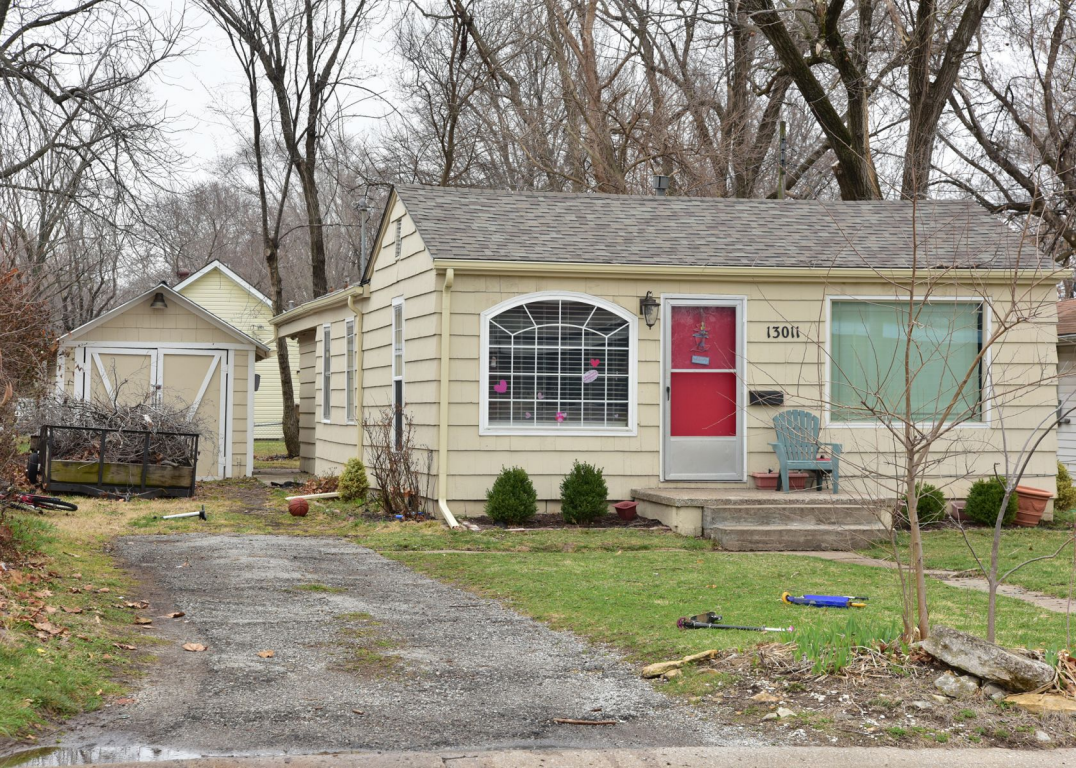
"This one-story, side-gabled house has a rectangular footprint that is three asymmetrical bays wide and has a rear shed addition that is three bays deep. Fenestration defines the bays and includes the stoop entrance in the center bay and paired one-over-one light, double-hung sash windows. Additional character-defining features include wood shingle cladding the exterior walls and the tight eaves (Davis and Schwenk, 2003)."

The windows are six-over-one replacements with snap-in muntins. The fenestration of the primary elevation has been significantly altered since the 2003 survey. The south bay is now defined by a large fixed sash window while the north bay is defined by a twenty-eight-light segmental arch picture window.

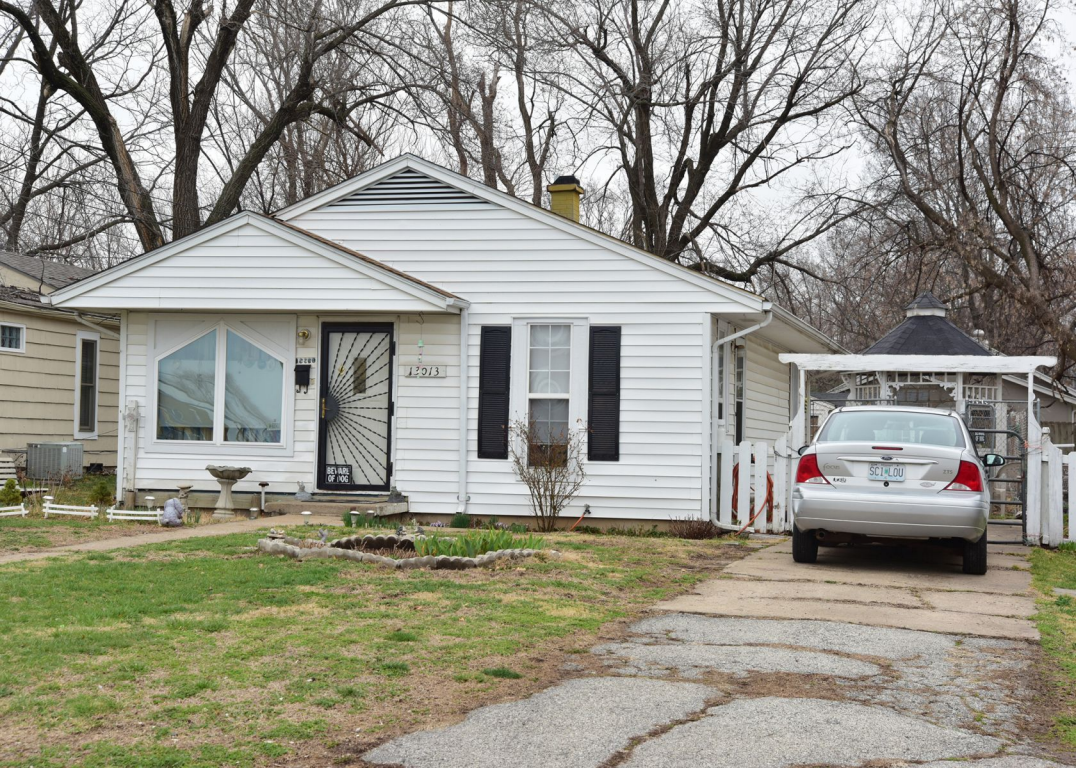
"This one-story, gable-front house has a rectangular footprint that is three asymmetrical bays wide and three bays deep. A two-bay gable projects over the north end bays which include the center bay stoop entrance. Single and paired one-over-one light, double-hung sash windows form the other bays. Additional character-defining features include tight façade eaves and wide, side elevation eaves. The application of vinyl siding compromises the integrity of this building (Davis and Schwenk, 2003)."

13013 12th Street has been altered since the 2003 survey. The south bay of the primary elevation is now defined by a six-over-six vinyl sash window with snap-in muntins. The north bay is defined by a two-part pentagonal picture window. The date of construction for the front gabled rear addition and the date of alteration for the application of vinyl cladding are unknown, however they pre-date the 2003 survey

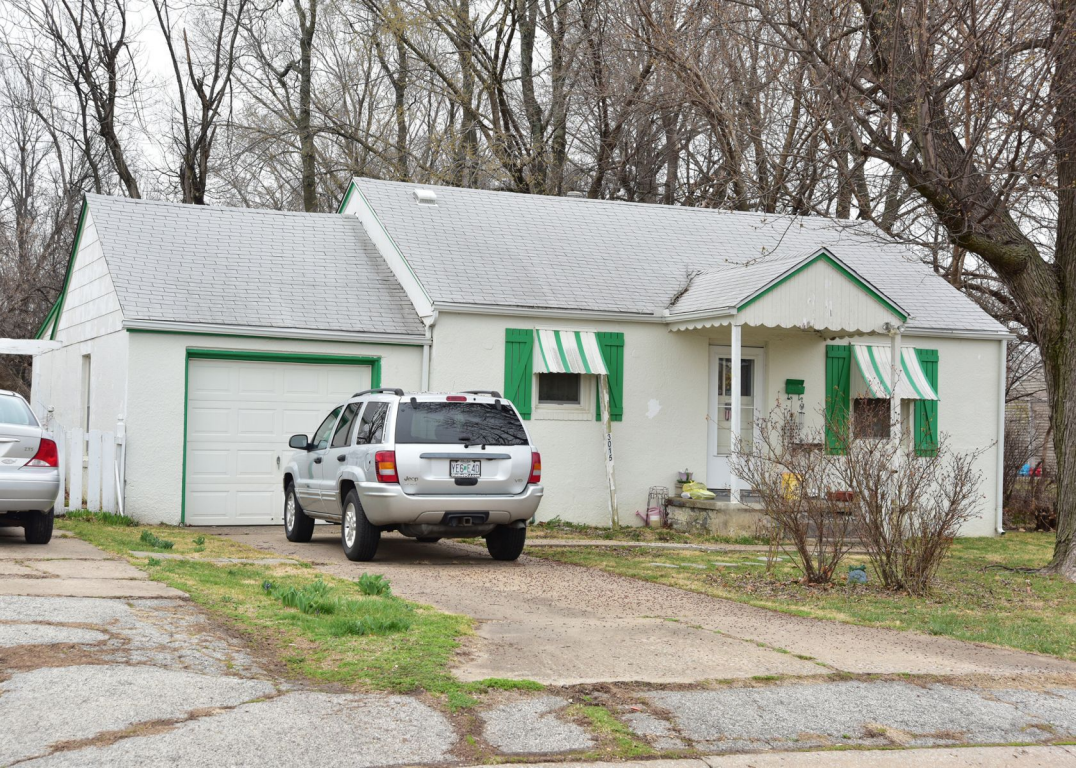
"This one-story Massed Plan, side-gable house forms a rectangular footprint four asymmetrical bays wide (including a one-bay rear shed addition) and three bays deep. Stucco clads the exterior walls. A projecting gable-front porch roof supported by square wood posts shelters the entrance at the second bay from the south end. The front wall and roof slope step back at the north end bay, which contains a single-car garage bay. Single, one-over-one light, double-hung sash windows form the other bays. Additional character-defining features include tight eaves, scalloped plank siding on the porch gable, and a three-pane, half-light entrance door, which appears to be original (Davis and Schwenk, 2003)."

A shed roof addition is present at the rear of the dwelling. 13015 12th Street does not appear significantly altered from its 2003 appearance. Dates of alteration are unknown, however pre-date the 2003 survey.

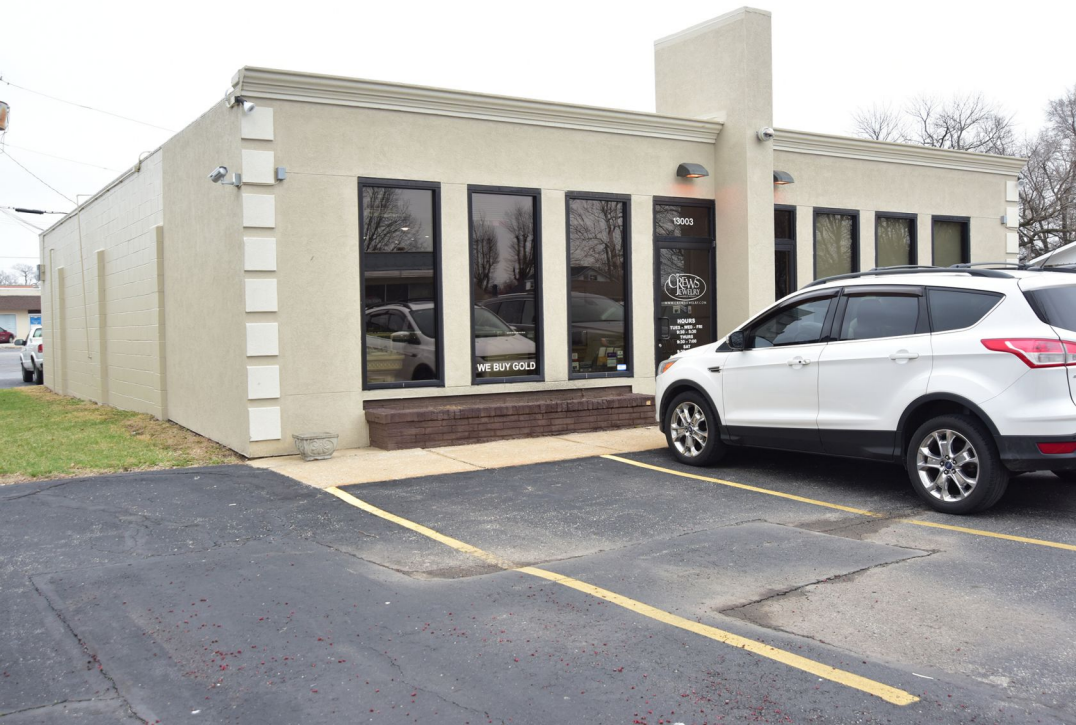
"This one-part commercial block building features blonde brick facing applied to a concrete block structure and has a rectangular footprint that is four symmetrical bays wide and three symmetrical bays deep. A vertical brick wall rises perpendicular to the façade through a visor porch roof dividing the facade between the two storefronts. Aluminum-framed glass doors occupy the two center bays flanking the dividing wall. Two-part, aluminum-framed display windows form the other bays. Additional character-defining features include the original low bulkheads with header brick sills and the original brick planters directly in front of the bulkheads. Multi-light, steel casement sash windows form the bays on the secondary elevations (Davis and Schwenk, 2003)."

13003 A-B 13th Street has been significantly altered since the 2003 survey. Stucco has replaced the brick facing and has been applied to the brick wall dividing the primary elevations. Quoins are located at the primary elevation. The two-part display windows have been replaced by narrow one-part display windows, dividing the primary elevation into eight symmetrical bays. The multi-light casement windows of the other elevations have been replaced with one-light fixed aluminum sash. The porch visor roof is no longer extant.

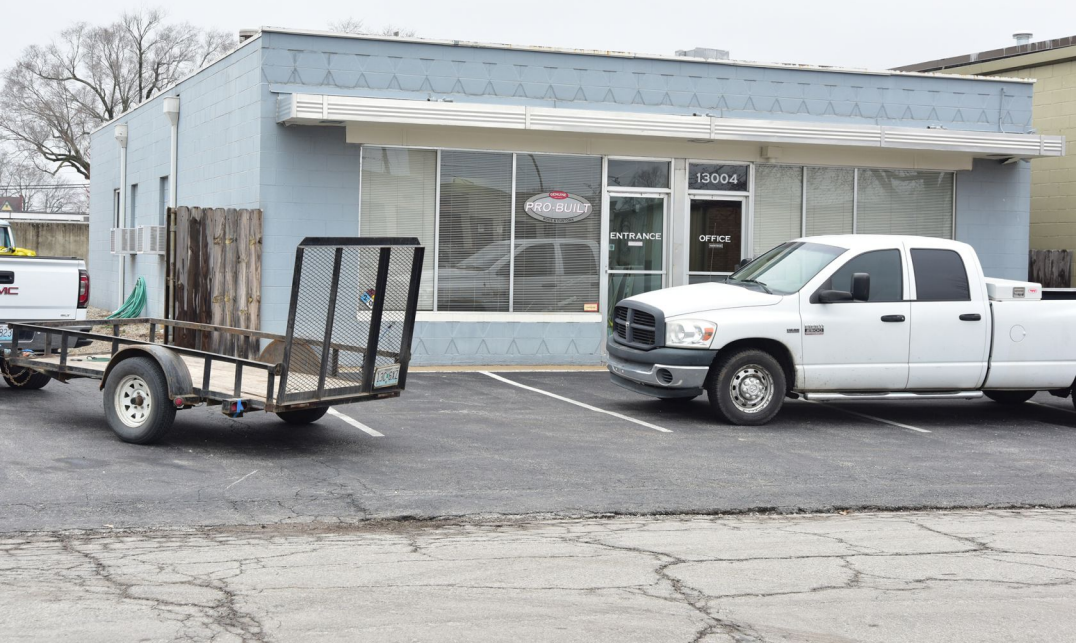
"This one-part commercial block building has a rectangular footprint that is four bays wide and three bays deep. Concrete blocks cast with a decorative hexagonal pattern distinguish the façade, which features a visor porch that shelters the two glass door entrances in the center bays of the storefront window system. Three-part, aluminum-framed display windows occupy the two outer bays. Multi-light, steel casement sash windows form the bays on the secondary elevations (Davis and Schwenk, 2003)."

The multi-light steel casement sash windows have been replaced with one-light fixed sash windows. 13004 13th Street does not otherwise appear significantly altered from its 2003 appearance.

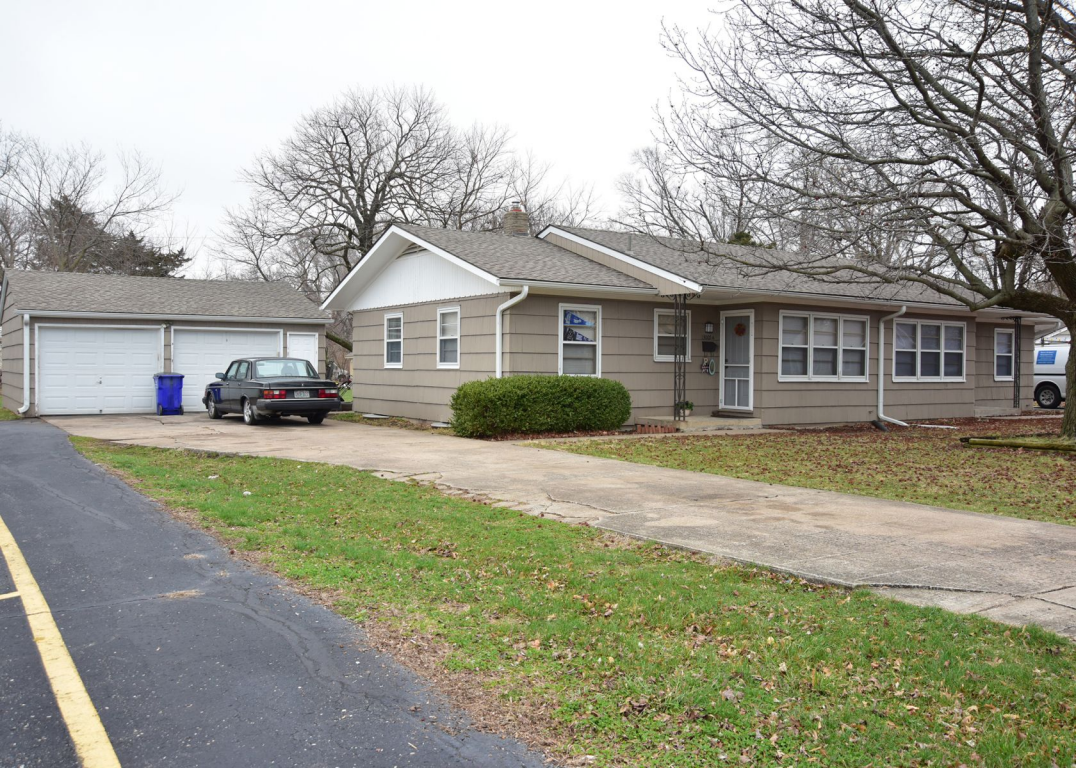
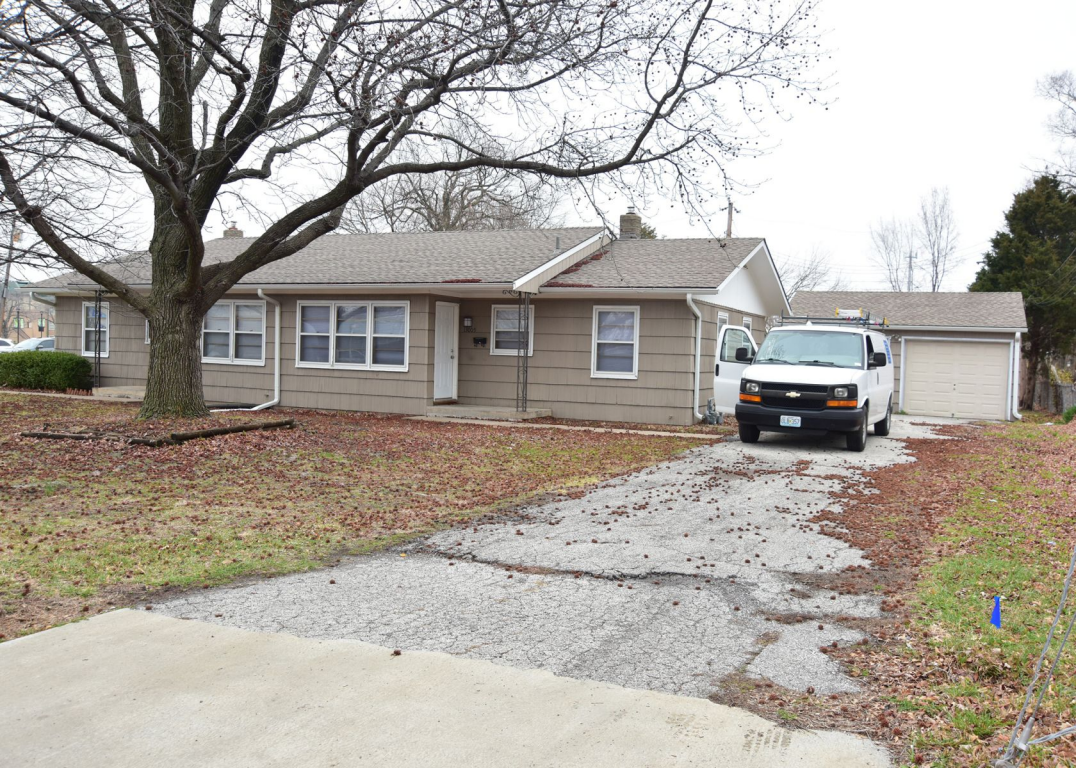
"This one-story, side-gabled Ranch style duplex has a rectangular footprint that is six symmetrical bays wide and two bays deep. Asbestos shingles clad the exterior walls. Defining the bays are single and triple one-over-one light, double-hung sash windows. The front wall steps forward at the two center bays and the front roof slope extends forward across the four central bays to form recessed single-bay entrance porches supported by ornamental iron posts with entrance doors leading perpendicularly into each residential unit. Additional character-defining features include very wide eaves and scalloped wood plank siding in the end gables (Davis and Schwenk, 2003)."

Windows are wood sash, Vinyl sash storm windows are present at all elevations visible from the right-of-way. 13005 A-B 13th Street does not appear significantly altered from its 2003 appearance.

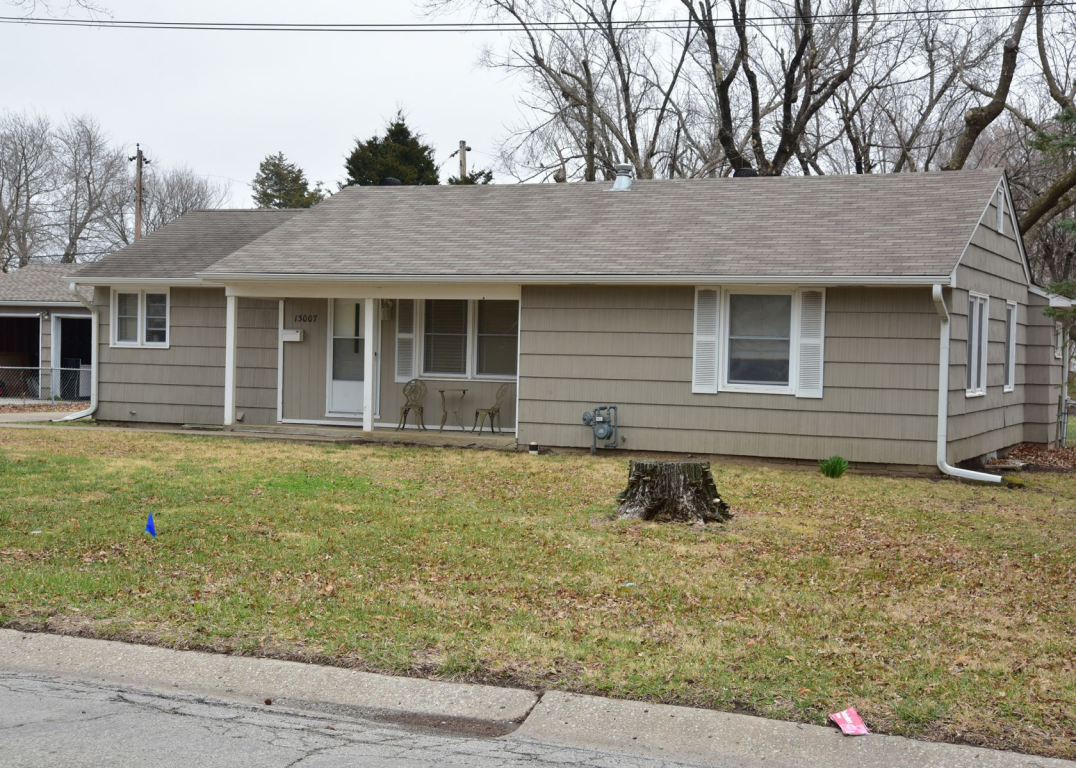
"This one-story, side-gabled Ranch style house has a rectangular footprint that is four asymmetrical bays wide and two bays deep. The front roof slope extends forward across the three south end bays and the front wall projects forward at the south end bay, thus forming a two-bay, recessed porch that shelters the entrance in the third bay from the south end. Single and paired one-over-one light, double-hung sash windows flanked by shutters form the remaining bays. Additional character-defining features include wide eaves and the asbestos cladding (Davis and Schwenk, 2003)."

13007 13th Street does not appear significantly altered from its 2003 appearance. The date of window replacement is unknown, however pre-dates the 2003 survey.

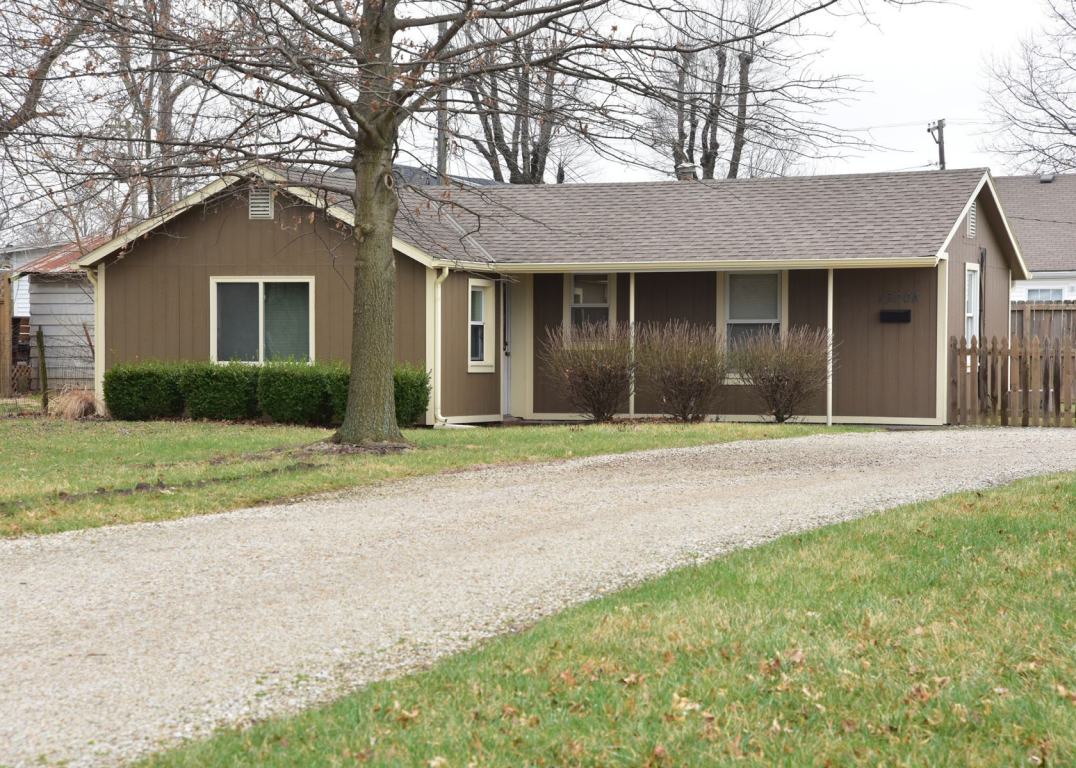
"This one-story Ranch style house has an intersecting gable roof and an L-shaped footprint that is three bays wide. A board-and-batten treatment covers the exterior walls. The front slope of the side-gabled wing projects to shelter the entrance in the north side of the gable-front section. Single one-over-one light, double-hung vinyl sash windows and a tripartite fixed-sash window form the other bays. The non-original wall cladding and roof materials, combined with the loss of original porch elements and replacement windows, compromises the integrity of this building (Davis and Schwenk, 2003)."

The tripartite fixed-sash window has been replaced with a two-part casement window and the cladding is now pressed wood. Dates of prior alteration are unknown, however pre-date the 2003 survey.

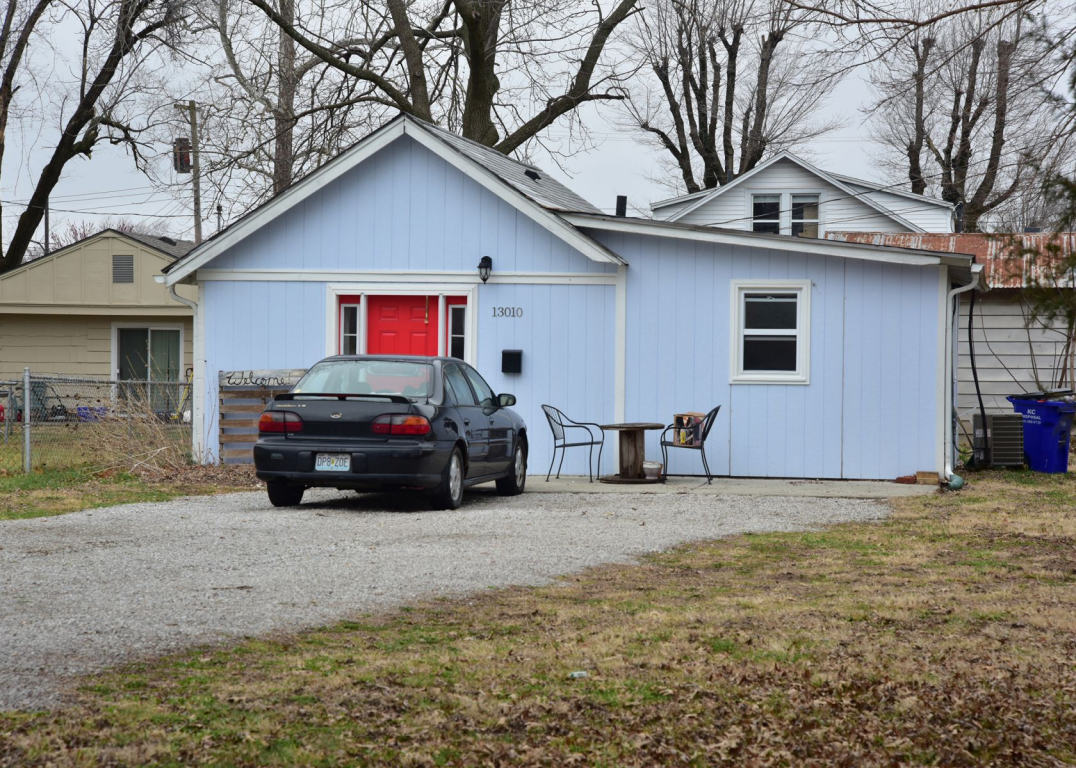
"This one-story, single-car garage with a gable-front roof has thin-profile wood clapboards, exposed rafter tails. A three-bay side addition with a shed roof obscures the primary façade (Davis and Schwenk, 2003)."

13010 13th Street has been significantly altered from its 2003 appearance. The three-bay addition at the primary elevation was removed in 2011. A one-bay addition with shed roof is located at the north elevation. Pressed wood vertical cladding is applied to the north and east elevations. The north bay of the primary elevation is defined by a single, one-over-one window with vinyl sash. The south bay is defined by a non-historic pedestrian entrance with sidelights.
