MISSOURI DEPARTMENT OF NATURAL RESOURCES
STATE HISTORIC PRESERVATION OFFICE, P.O. Box 176, Jefferson City, MO 65102
ARCHITECTURAL/HISTORIC INVENTORY FORM

1. Survey number: JA-AS-088-001		2. Survey Name: Town of Grandview, Resurvey	
3. County: JACKSON		4. Address (Street No.): 13114 Street (name): 4th Street	
5. City: Grandview	Vicinity <input type="checkbox"/>	6. Lat / Long:	7. Township/Range/Section: T: R: S:
8. Historic name (if known):		9. Present/other name (if known):	
10. Ownership: <input checked="" type="checkbox"/> Private <input type="checkbox"/> Public		11a. Historic use (if known): Domestic-Single Dwelling	11b. Current use: Domestic-Single Dwelling

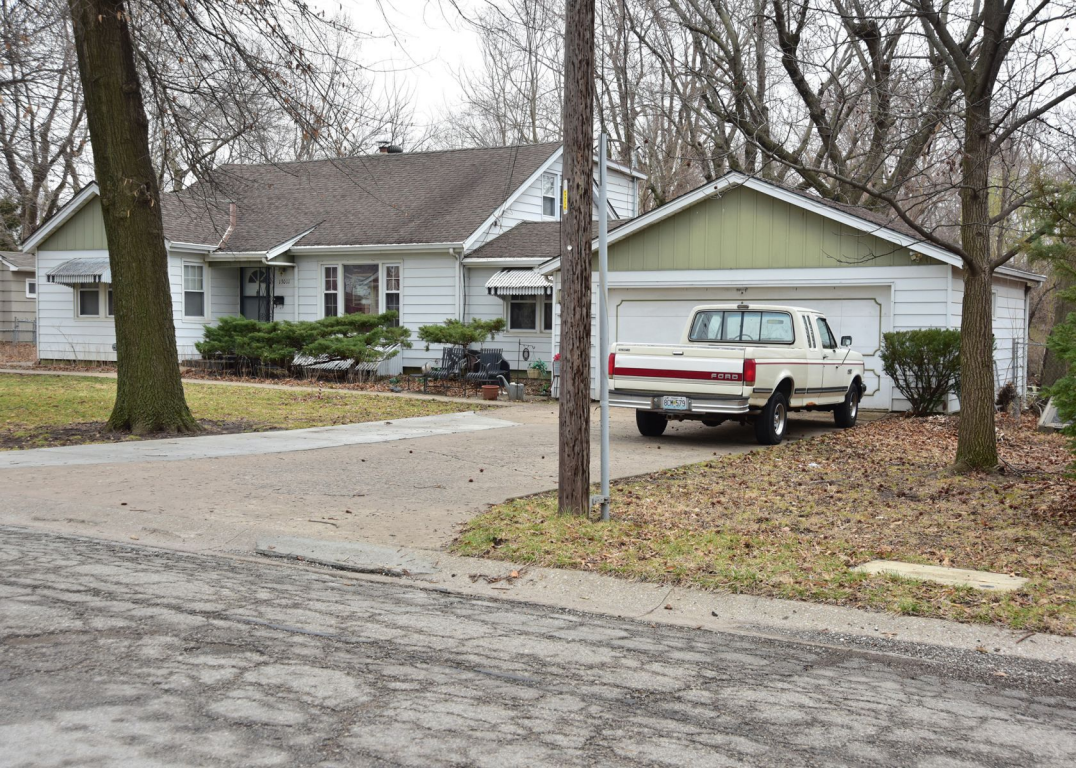
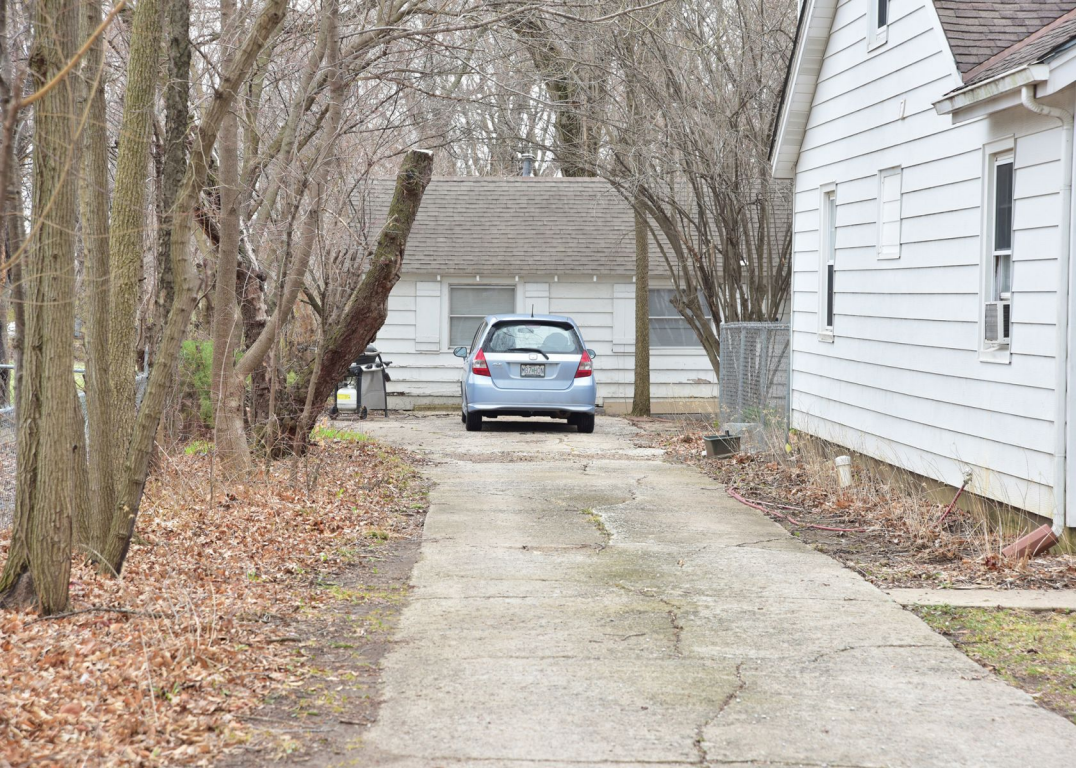
"This one-story, side-gabled Minimal Traditional style house has an irregular footprint that is five bays wide and three bays deep. A single-bay wing with a side-gabled roof connects the three-bay-wide main block to a single-bay, two-car garage with a gable-front roof at the south end. Decorative iron posts support the flat porch roof that shelters the entrance, which is in the second bay from the north end, at the junction of the projecting gable at the north end bay. Forming the other bays are paired one-over-one light, double-hung sash windows and a tripartite picture window, each of which is sheltered by a metal awning. Additional character-defining features include the board-and-batten wall treatment in the front gables (Davis and Schwenk, 2003)

Windows are six-over-one vinyl sash with snap-in muntins. The metal awning over the picture window has been removed. 13011 13th Street does not otherwise appear significantly altered from its 2003 appearance. Dates of all other alterations are unknown, however they pre-date the 2003 survey.

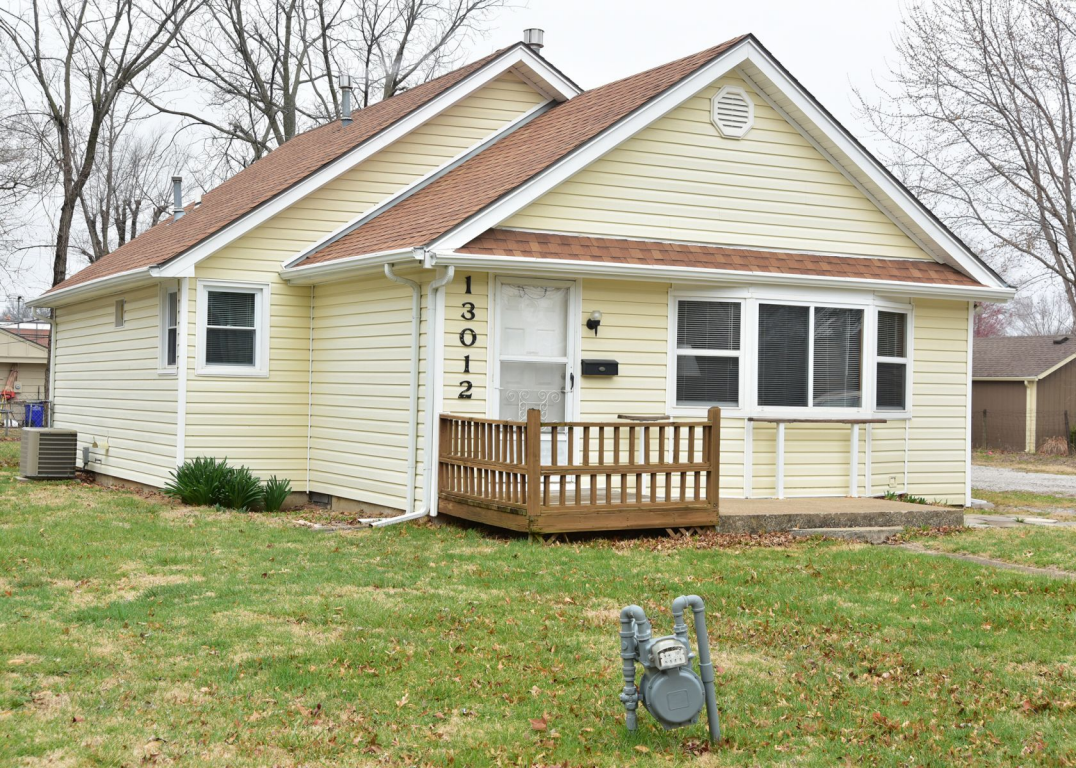
1
3
0
1
2

"This one-story, gable-front bungalow house has a rectangular footprint that is three asymmetrical bays wide and four bays deep. The original gable-front porch is now enclosed and features a stoop entrance in the center bay and a tripartite bay window in the north end bay. Single one-over-one light, double-hung sash windows fill the tripartite bay window and form the remaining bay of the primary façade as well. The enclosure of the character-defining front porch and the application of modern wall cladding materials compromises the integrity of this building (Davis and Schwenk, 2003)."

13012 13th Street has been reclad with narrow profile vinyl cladding. Dates of prior alteration are unknown, however pre-date the 2003 survey.

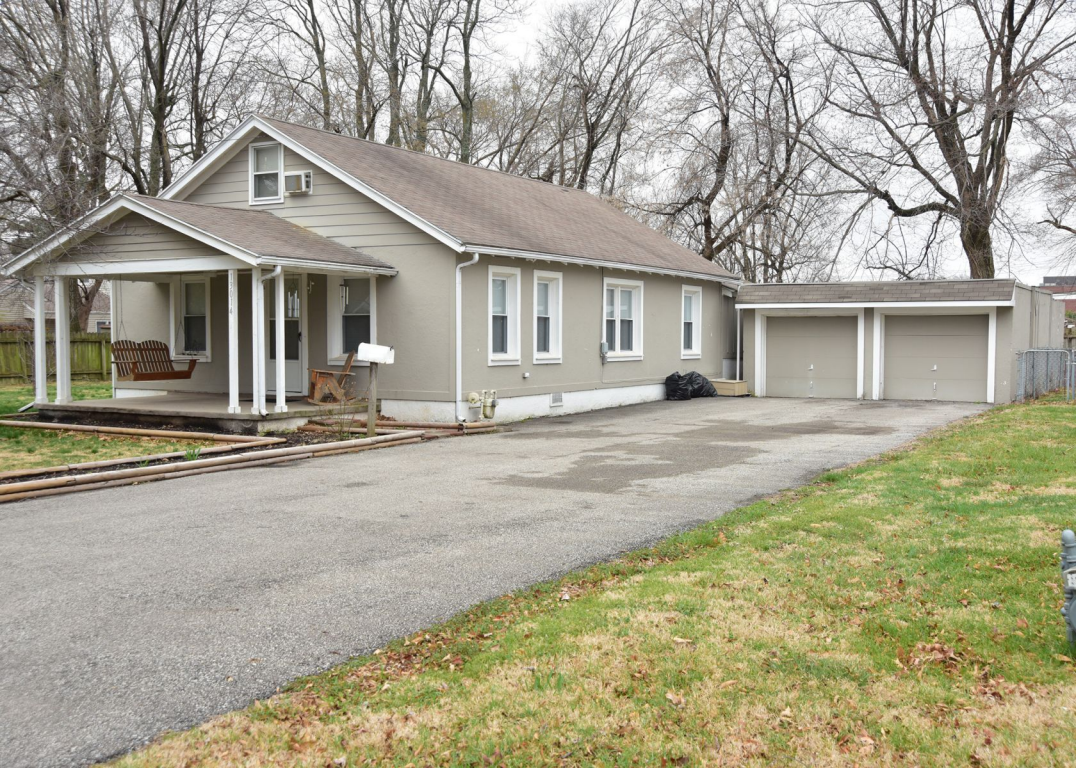
"This one-and-a-half-story, gable-front house has a rectangular footprint that is three bays wide and four bays deep. Stucco covers the exterior walls and parging covers the exposed foundation walls. The three-quarter-width porch has non-original square wood posts supporting the gable-front roof that shelters the center bay entrance. The porch is missing its original balustrade. The original three-over-one light, double-hung wood sash windows with flat board trim form the remaining bays of each elevation. Additional character-defining features include exposed rafter tails and clapboards in the gable peak (Davis and Schwenk, 2003)."

The windows are now one-over-one vinyl sash. 13014 13th Street otherwise does not appear significantly altered from its 2003 appearance. Dates of all other alterations are unknown, however pre-date the 2003 survey.

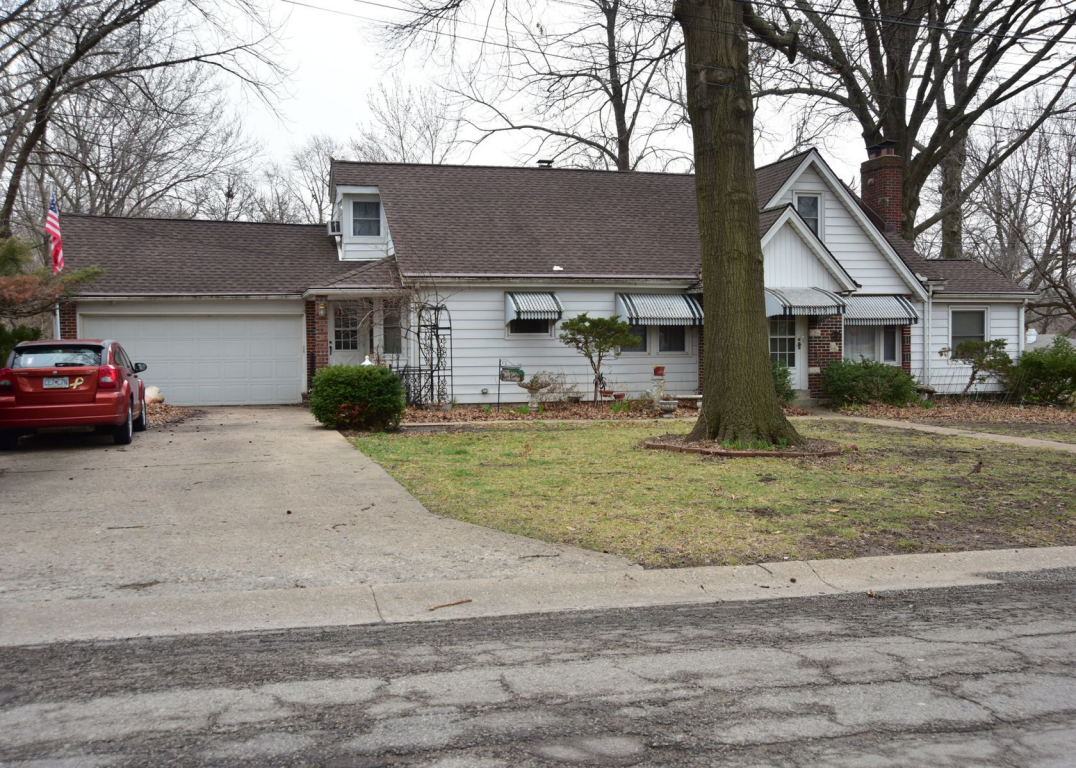
"This one-and-a-half-story Minimal Traditional style house has an intersecting gable roof and an irregular footprint that is six asymmetrical bays wide and four bays deep. Two nested front gables dominate the primary façade. Brick and rough-cut stone clad the wall below the front gables, the smaller of which distinguishes the entrance at the third bay from the south end. Forming the remaining bays are single one-over-one light, double-hung sash windows and a tripartite picture window. A single-bay, two-car garage occupies the north end bay, which steps back from the main façade wall. Additional character-defining features include a brick chimney punctuated with rough-cut stones and the rough-cut stone foundation (Davis and Schwenk, 2003)."

13015 13th Street does not appear significantly altered from its 2003 appearance. Dates of alteration are unknown, however they pre-date the 2003 survey.

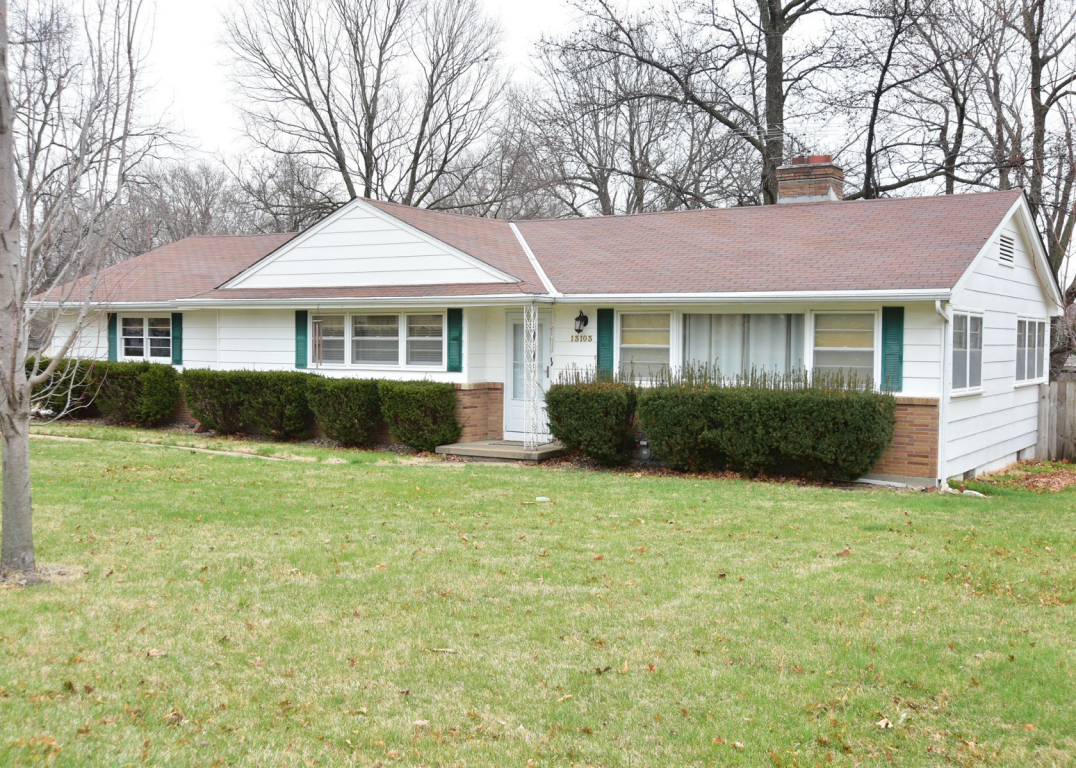
"This one-story, side-gabled Ranch style house has an intersecting gable roof and a rectangular plan that is four asymmetrical bays wide and two bays deep. The front gable distinguishes a projection in the front wall and the recessed entrance at the second bay from the south end. Forming the remaining bays are paired and triple one-over-one light, double-hung windows and a tripartite fixed-sash picture window, all of which are flanked by shutters. Additional character-defining features include brick cladding on the lower half of the primary façade, wide-profile wood clapboards cladding the remaining exterior walls, a broad brick chimney rising through the rear roof slope, and the wide eaves (Davis and Schwenk, 2003)."

13103 13th Street does not appear significantly altered from its 2003 appearance.

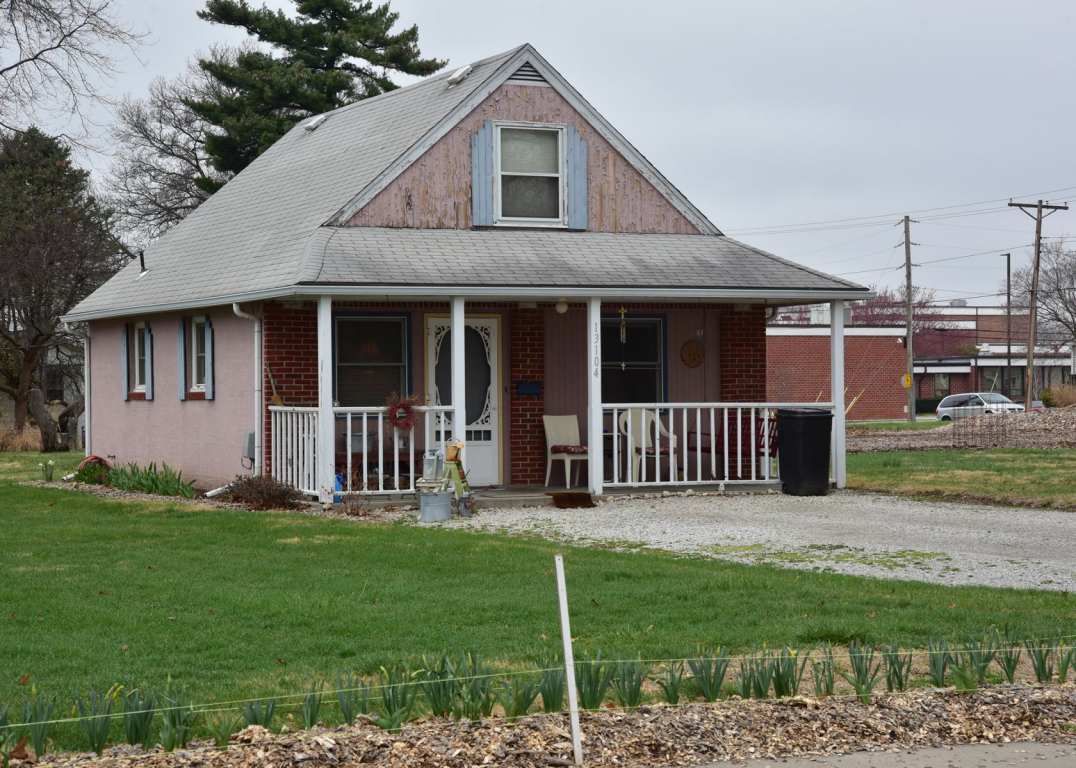
"This one-story, gable-front house has a rectangular footprint that is three bays wide and two bays deep. Three brick pilasters visually divide the front façade. Stucco covers the exterior walls and wood paneling covers the front gable peak. Non-original square posts support the full-width porch's hipped roof that shelters the center bay entrance. The porch is missing its original balustrade. Single one-over-one light, double-hung sash windows form the remaining bays. Additional character-defining features include the dwelling's tight eaves. The non-original wall cladding, loss of original porch elements, and replacement windows compromise the integrity of this building (Davis and Schwenk, 2003)."

13104 13th Street does not appear significantly altered from its 2003 appearance. Dates of alteration are unknown, however they pre-date the 2003 survey.

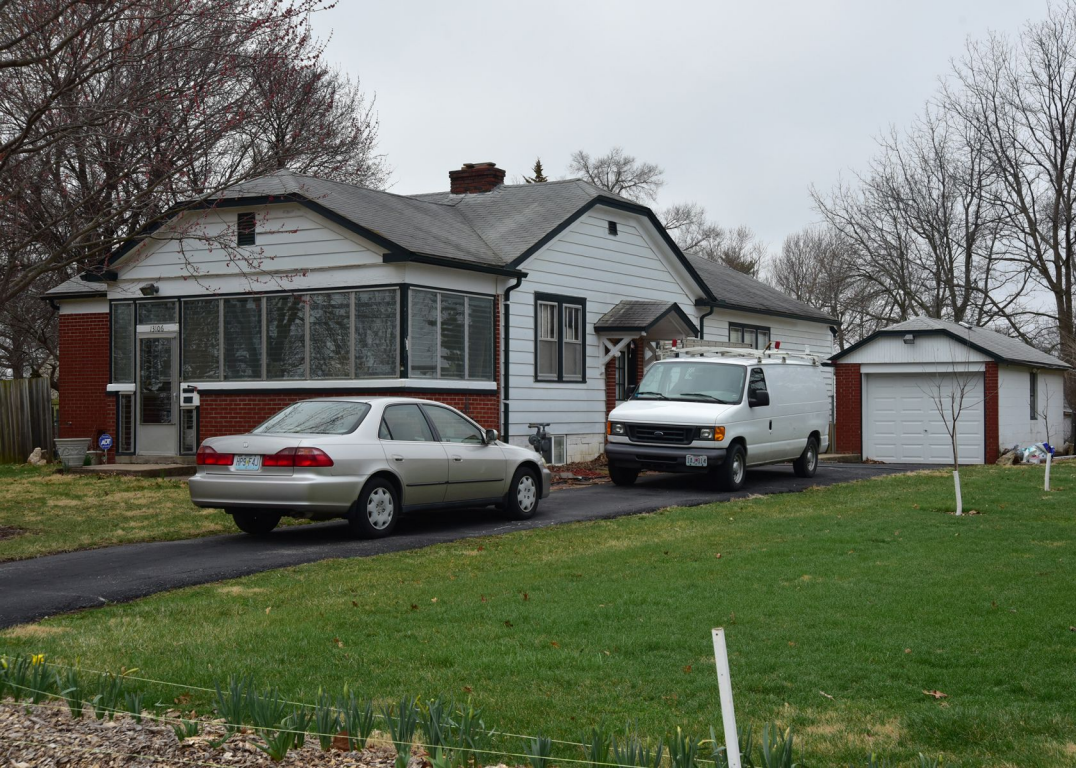
"This one-story bungalow has an intersecting clipped-gable roof and an irregular footprint that is two asymmetrical bays wide and three bays deep. The front clipped gable projects to form the porch roof. The porch is enclosed with an aluminum-framed louvered glass window and entrance door system. Forming the remaining bays on each elevation are the original single and paired three-over-one light, double-hung wood sash windows with flat board trim. On the north elevation, knee brackets support the stoop's gable roof above a second entrance (Davis and Schwenk, 2003)."

13106 13th Street does not appear significantly altered from its 2003 appearance. Dates of alteration are unknown, however pre-date the 2003 survey.
