1. Survey No. JO-AS-007-0001			2. Survey name: GROVER & BROAD STREETS ARCHITECTURAL/HISTORICAL SURVEY						
3. County: JOHNSON		4. Ad 400	ddress (Street No.)	Street (name) BROAD

5.City: Vicinity: 6 WARRENSBURG			eographical Reference .76041 / -93.73371	ce:	7. Town T: 46	nship/Range/Section: R: 26 S:24			
8.Historic name (if known):				9. Present/other	name (if	name (if known):

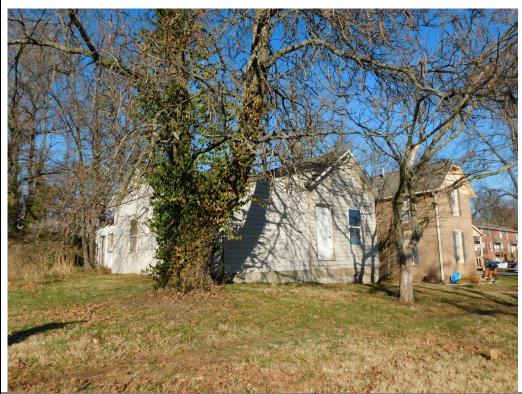
Photographer: Date: Description:
KRISTIN DYER 11/17/2020 LOOKING NORTHEAST

41. (cont.) Description of primary resource. Expand box as necessary, or add continuation pages.
This one-story house features a stone foundation and non-historic wood exterior walls. The façade features wood lap siding, and it is
two bays wide with wood door in the first bay and a one-over-one hung window in the second bay. The remaining elevations has

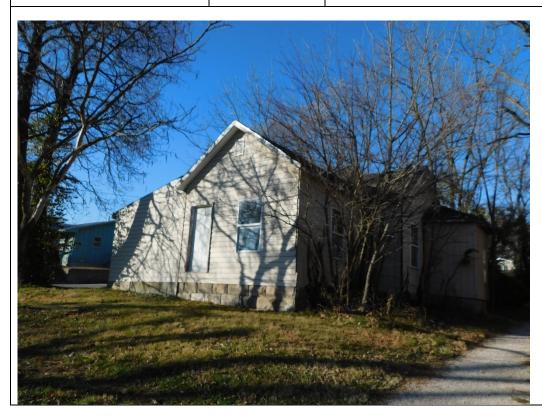
Date: 11/17/2020 Description: LOOKING NORTHWEST

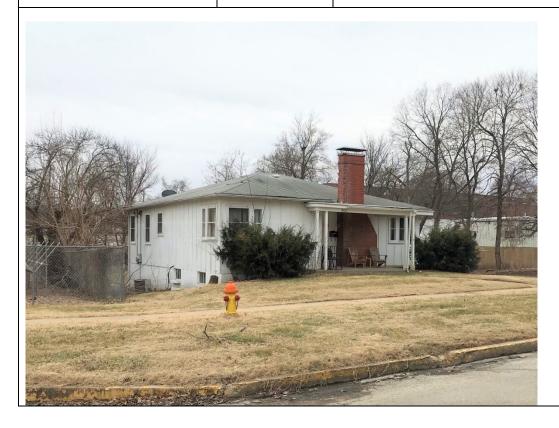
Description: LOOKING SOUTHWEST

partial-width porch with a flat roof, paired boxed columns, and concrete foundation.

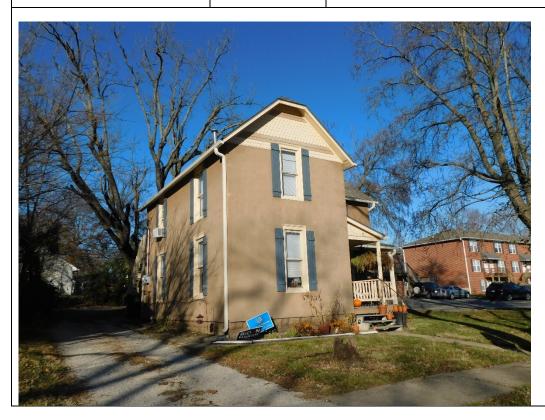
Date: 11/17/2020 Description: LOOKING NORTHEAST

original one-over-one hung windows.

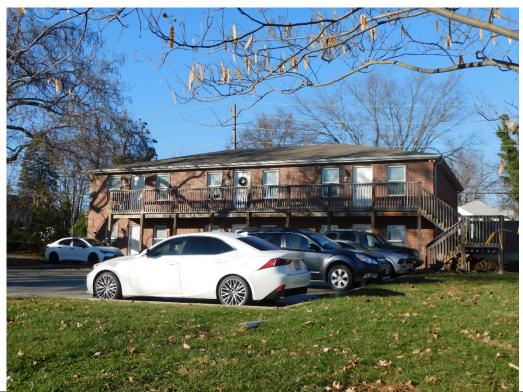
Photographer: Date: Description:
KRISTIN DYER 11/17/2020 LOOKING NORTHWEST

41. (cont.) Description of primary resource. Expand box as necessary, or add continuation pages.
This two-story multifamily apartment building features a concrete foundation, brick exterior walls, and a hipped gable roof. The building has a rectangular footprint, and the façade is nine bays wide. The second story bays mirror the first story bays. Every three bays are grouped together with a window, door, and window. The windows are one-over-one hung vinyl windows. Access to the second story is located by wood stairs on the east side that leads to a partial-width wood deck. There is an asphalt parking lot located in the front.

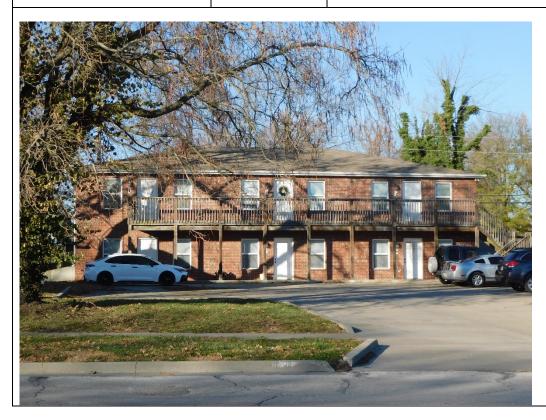
Date: 11/17/2020 Description: LOOKING NORTH

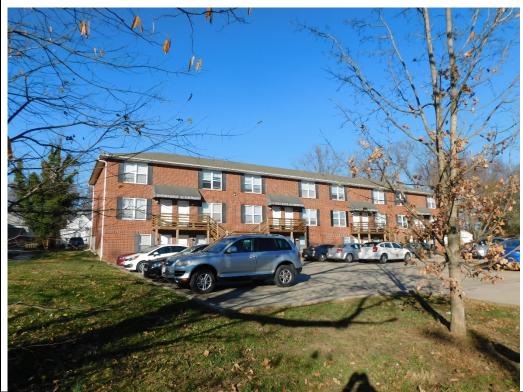
Photographer: Date: Description:
KRISTIN DYER 11/17/2020 LOOKING NORTHEAST

This three-story multifamily apartment building features a concrete foundation, brick exterior walls, and a hipped gable roof. The building has a rectangular footprint, and the façade is 15-bays wide as defined by the first story. The first and second story bays are grouped in fours with window, door, door, window except the second-story has paired windows and a cloth awning over the doors. The third story features paired windows with no doors. There are vinyl shutters on the second and third story windows. Access to the second story is by a shared wood stairs and land between the first and second set of bays and the third and fourth set of bays which lead to a separate wood balcony. The building is not eligible since it does not meet the 50-year threshold for eligibility.

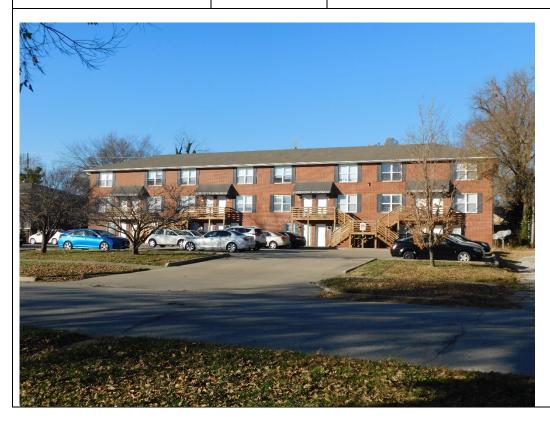
Date: 11/17/2020 Description: LOOKING NORTH

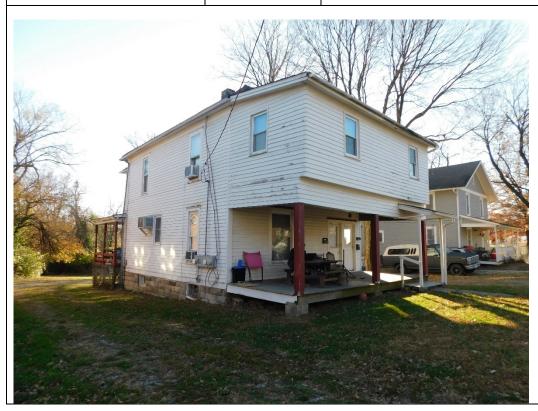
Photographer: KRISTIN DYER Date: 11/17/2020 Description: LOOKING SOUTHWEST

a full-width recessed one-story porch with a post-1945 enclosed addition on the second story. The enclosed second story has a one-over-one window in sech bay with one on each side. There is an attached shed roof over the step leading to the porch. The side elevations feature one-over-one wood windows on either side. There is a one-story addition located in the rear with a concrete foundation, wood lap siding, and a hipped roof. This building is considered non-contributing due to the addition of the second-story

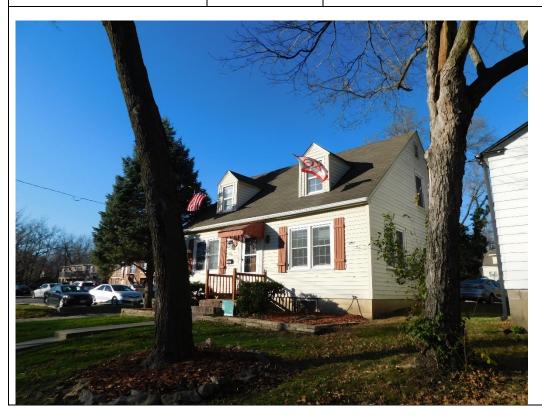
Date: 11/17/2020 Description: LOOKING NORTHWEST

40. (cont.) Description of environment and outbuildings. Expand box as necessary, or add continuation pages.
This contributing one-story garage features concrete block foundation, wood siding, and a front gable roof. There is a single metal paneled garage door.

41. (cont.) Description of primary resource. Expand box as necessary, or add continuation pages.
This one-and-a-half story Cape Cod Colonial Revival house features a concrete block foundation, vinyl exterior walls, and a side gable roof. The façade is three bays side with a centered wood entry flanked on either side by paired six-over-six wood hung windows with non-historic shutters. The entry has an aluminum awning with a concrete and brick stoop. The roof has asphalt

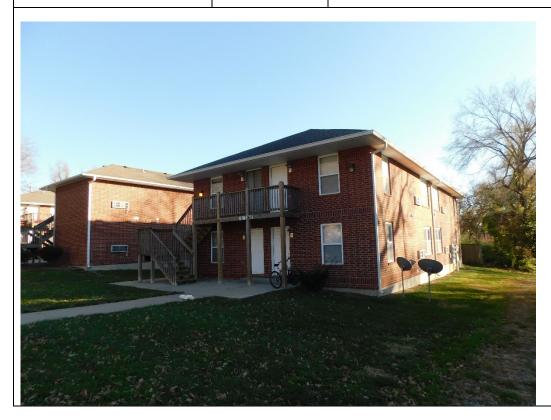
Description: LOOKING SOUTHEAST

This two-story multifamily apartment building features a concrete foundation, brick exterior walls, and a hipped roof with a wide eave overhang. The building has a rectangular footprint with the short-end facing Broad Street. The façade is four bays wide, and the second story mirrors the first story. Every two bays are grouped together with a window, door, door, and window. The windows are one-over-one hung vinyl windows. There is a soldier brick course slightly above the foundation line and between the first and second stories. Access to the second story is by wood stairs and landing located to the east of the building that leads to a partial width wood deck. The front façade of the building is mirrored on the rear. The side elevations feature matching siding, and paired or single matching windows. There is a parking lot located in the rear of the lot.

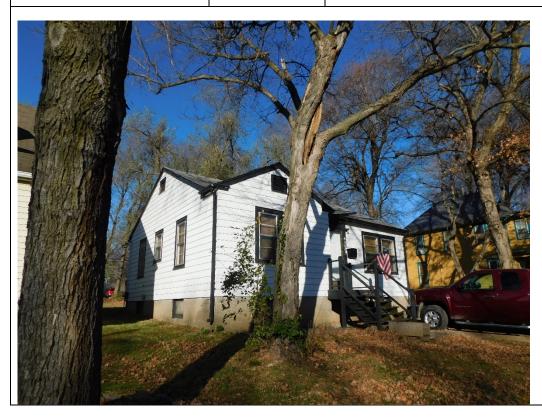
Date: 11/17/2020 Description: LOOKING NORTHEAST

41. (cont.) Description of primary resource. Expand box as necessary, or add continuation pages.
This one-story minimal traditional house features a concrete foundation, weatherboard siding, and cross gable roof with no eave overhang. The first bay features a slightly projecting cross gable with paired horizontal two-over-two aluminum windows. The second bay features the entry door, and the final bay features paired horizontal two-over-two aluminum windows. There is a wood deck and stairs in front of the entry. The side elevations feature weatherboard siding and paired or single horizontal two-over-two aluminum windows. The basement windows are one-light awning windows.

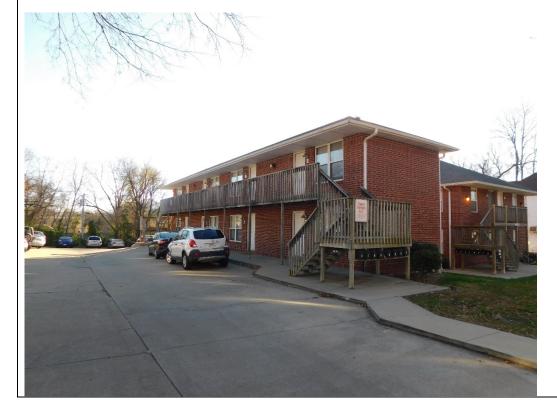
Photographer: Date: Description: LOOKING SOUTHWEST

This two-story multifamily apartment building features a concrete foundation, brick exterior walls, and a hipped roof with a moderate eave overhang. The building has a rectangular footprint with the short-end facing Broad Street. The façade faces to the east towards 422 Broad Street. The building is eight bays wide, and every two bays are grouped together with paired windows, door or vice-versa. The windows are one-over-one hung vinyl windows. There is a soldier brick course lightly above the foundation line and between the first and second stories. Access to the second story is by wood stairs and landing found on either end of the faced that leads to a full-width balcony. The rear elevation features matching brick exterior and the protrusion of the heat and air units. The building is not eligible since it does not meet the 50-year threshold.

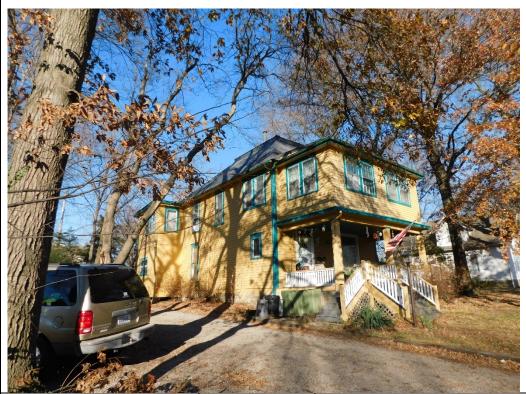
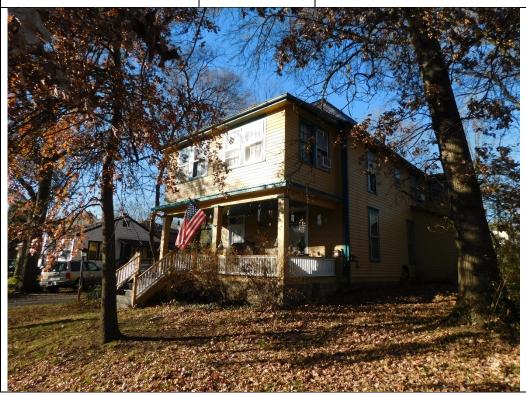
Description: LOOKING NORTHWEST

41. (cont.) Description of primary resource. Expand box as necessary, or add continuation pages.
This two-story foursquare house features a stone foundation, wood lap siding, and hipped gable roof. The façade is three bays with a entry door in the first bays and a one-over-one wood windows in the other bays. The building features a full-width recessed one-story porch with an enclosed addition on the second story. The porch features wood boxed columns railing and concrete block foundation. There is a post-1945 second-story addition above the porch that features a shed roof, wood lap siding, and paired eight-over-eight wood hung windows. The side elevations feature paired and single one-over-one hung windows, and there is two-story post-1945 addition on the rear, barely visible from the street. This building is considered non-contributing do the second-story addition above the porch that detracts from the historic integrity.

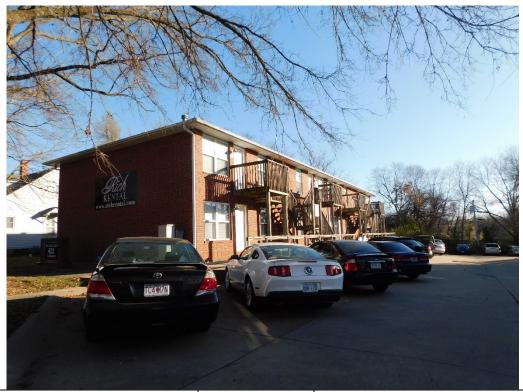
Photographer: Date: Description:
KRISTIN DYER 11/17/2020 LOOKING SOUTHEAST

This two-story multifamily apartment building features a concrete foundation, brick exterior walls, and a hipped roof with a moderate eave overhang. The building has a rectangular footprint with the short-end facing Broad Street. The façade faces to the west towards 420 Broad Street. The building is 12 bays wide, and every three bays are grouped together with paired windows, door, window. The windows are one-over-one hung vinyl windows. There is a soldier brick course lightly above the foundation line and between the first and second stories. Access to the second story is by wood stairs and landing shared between the first and second grouped bays and between the third and four grouped bays. Each grouped bay has its own partial-width balcony. The rear elevation features one-over-one hung windows on the first story, and one-over-one hung windows and doors on the second story that lead to wood balconies. The building is not eligible since it does not meet the 50-year threshold.

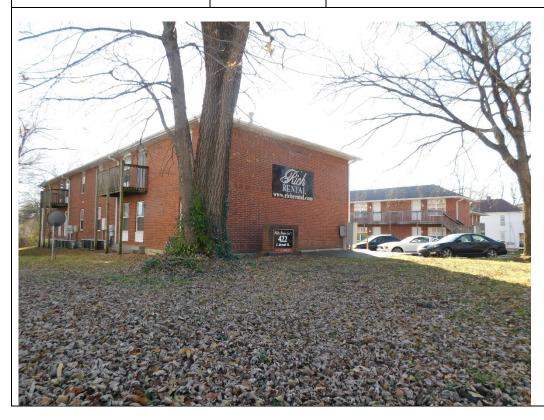
Date: 11/17/2020 Description: LOOKING SOUTHWEST

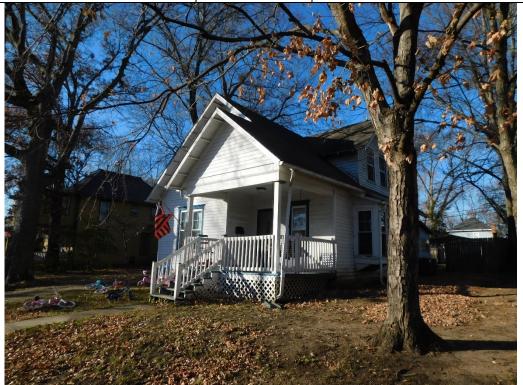
Photographer: Date: Description:
KRISTIN DYER 11/17/2020 LOOKING NORTHWEST

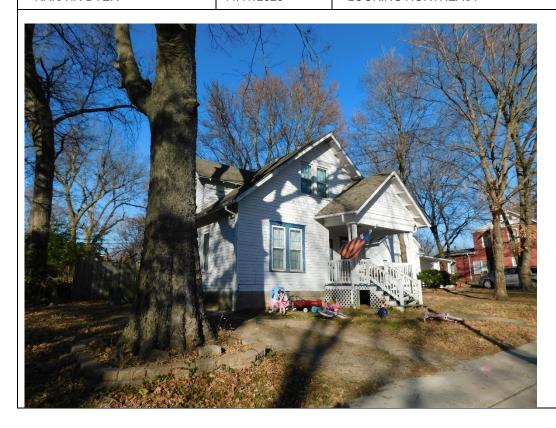
Photographer: KRISTIN DYER Date: 11/17/2020 Description: LOOKING NORTHEAST

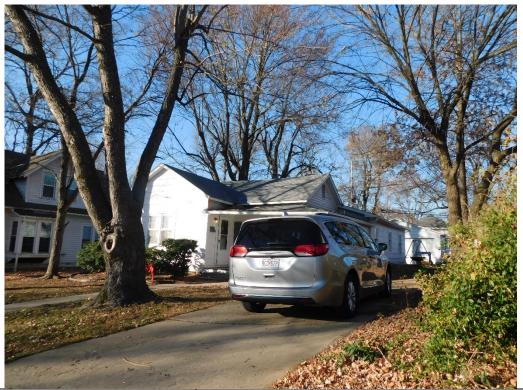
Photographer: Date: Description: LOOKING NORTHWEST

This one-story front-gable-and-wing house features a stone foundation, aluminum siding, and a cross gable roof. The façade is two bays wide with the projecting cross gable in the first bay with paired one-over-one double-hung wood windows. The second bay has paired one-over-one double-hung wood windows, and the entry door is located on the side elevation of the projecting cross gable. A partial-width porch is located in the intersection of the cross gables. It features a shed roof, box columns, and wood decking. Previously a partial-wraparound porch with the side enclosed after 1945. The house's roof features a cross gable with asphalt

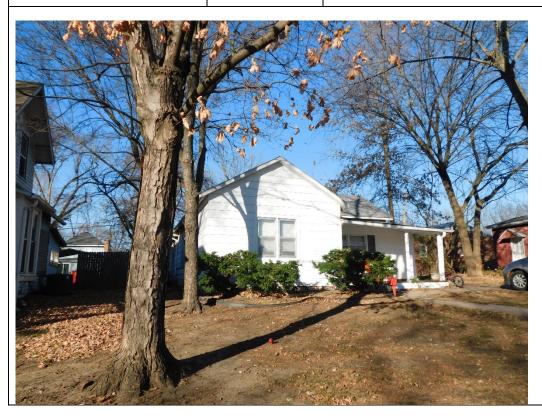
Date: 11/17/2020 Description: LOOKING NORTHEAST

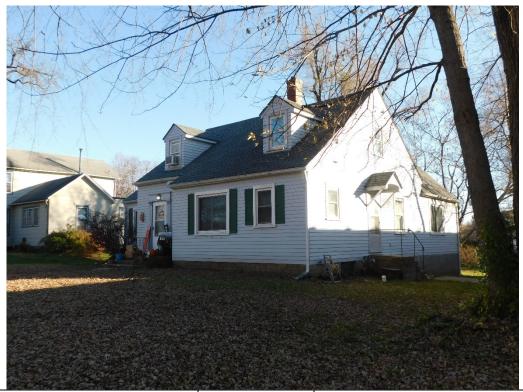
Photographer: Date: Description:
KRISTIN DYER 11/17/2020 LOOKING SOUTHEAST

This one-and-a-half story Colonial Revival features a rusticated concrete block foundation and vinyl exterior walls. The façade is four bays wide. The first and third bays have two-light wood windows, and the first bay is recessed in recessed from the building line as well as height. The entry located in the second bay has a concrete stoop with metal railings, and it is slightly recessed. The final bay features a one-over-one double-hung wood window. The roof features a side gable roof with two gable dormers. The gable dormers have vinyl siding and a one-over-one vinyl window. There is a off-centered chimney located on the front slope.

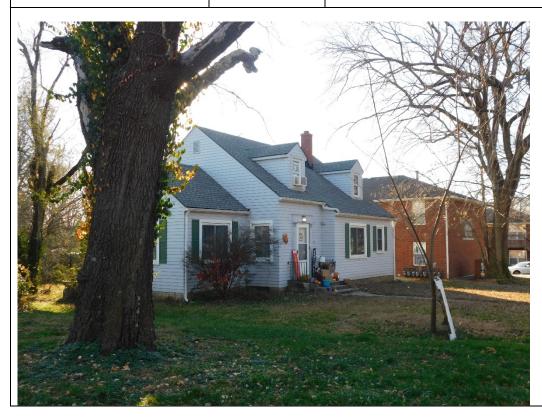
Date: 11/17/2020 Description: LOOKING SOUTHWEST

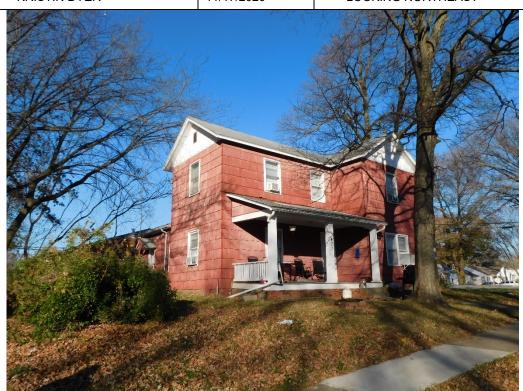
Photographer: Date: Description: LOOKING NORTHEAST

41. (cont.) Description of primary resource. Expand box as necessary, or add continuation pages.
This two-story front-gable-and-wing house features a stone foundation and shingle exterior walls. The façade is three bays wide with a double-hung wood window and a entry door in the first two bays, and paired double-hung wood windows is the last bay. The last bay features the projecting cross gable. The second-story feature one-over-one double-hung wood windows in each bay. The gable-

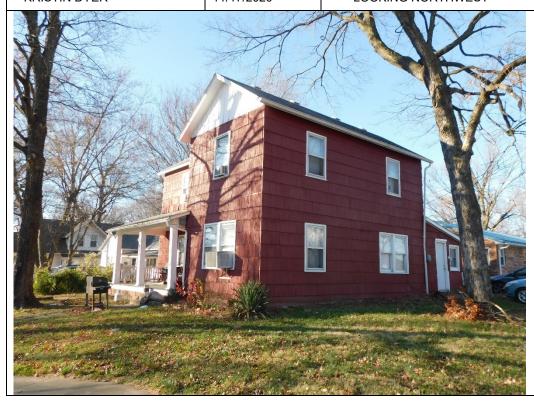
Date: 11/17/2020 Description: LOOKING NORTHWEST

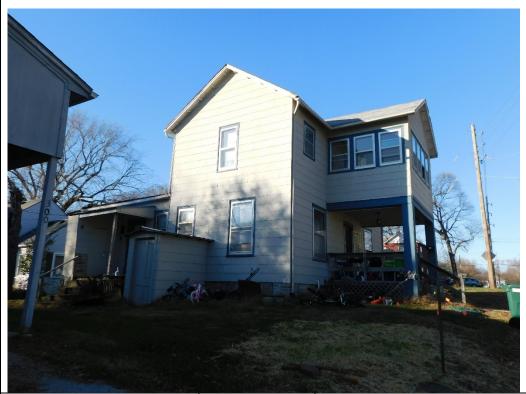
LOOKING NORTHWEST

41. (cont.) Description of primary resource. Expand box as necessary, or add continuation pages.
This two-story front-gable-and-wing features a stone foundation and asbestos exterior walls. The façade is three bays wide with a central entry flanked on either side by a single one-over-one wood window. The building features a partial-width recessed porch
under a projecting second-story cross gable. The cross gable features asbestos siding and ribboned one-over-one bung wood

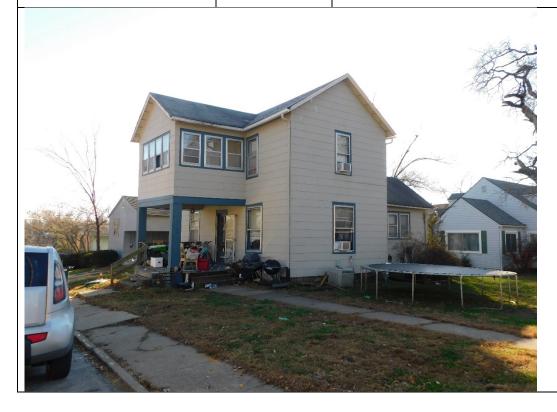
Description: LOOKING SOUTHWEST

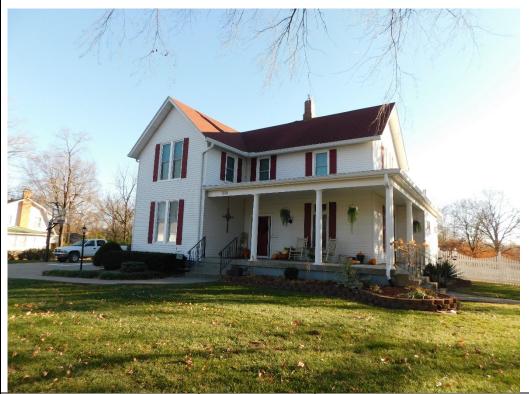
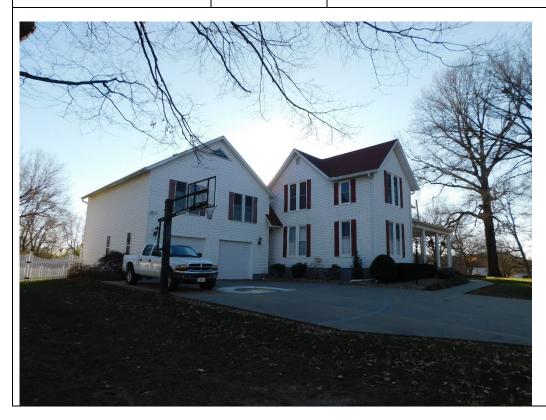
Description: LOOKING SOUTHWEST

This two-story front-gable-and-wing house features a concrete foundation and vinyl exterior wall. The façade is three bays wide. The first bay features the projecting cross gable with paired one-over-one double-hung wood windows. The second and third bay are under the partial-width wraparound porch with a slab door in the second bay, and a one-over-one double-hung wood window and one-light transom in the final bay. The porch features classical columns and a concrete foundation. All other elevations feature vinyl siding with paired or single one-over-one double-hung wood windows. The roof features a cross gable with shingles and an off-centered brick chimney on straddling the ridge. There is a 1997 two-story garage addition located to the east connected by a hyphen. The garage features a concrete foundation, vinyl siding and a front gable roof. There are two metal paneled garage doors on the first-story and paired one-over-one hung wood windows in the second story. The house and garage windows have non-historic shutters.

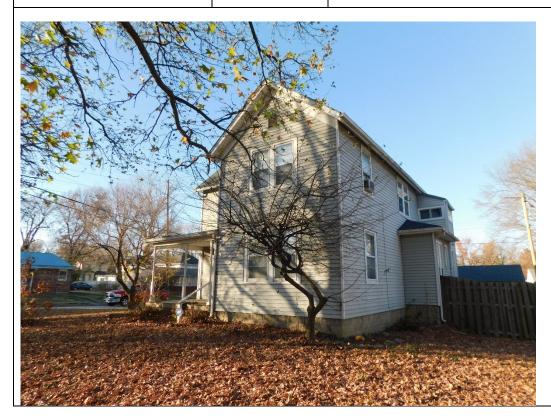
Date: 11/17/2020 Description: LOOKING NORTHWEST

40. (cont.) Description of environment and outbuildings. Expand box as necessary, or add continuation pages.
This contributing c. 1920, one-story garage is located along the alley facing Zoll Street. The garage is one bay wide and features a concrete foundation, vinyl siding, and a front gable roof. A metal paneled garage door fills the bay.

41. (cont.) Description of primary resource. Expand box as necessary, or add continuation pages.
This two-story front-gable-and-wind house features a stone foundation, and vinyl exterior walls. The façade is two bays wide with the projecting cross gable in the second bay with paired one-over-one double-hung wood windows. The first bay has a one-over-one

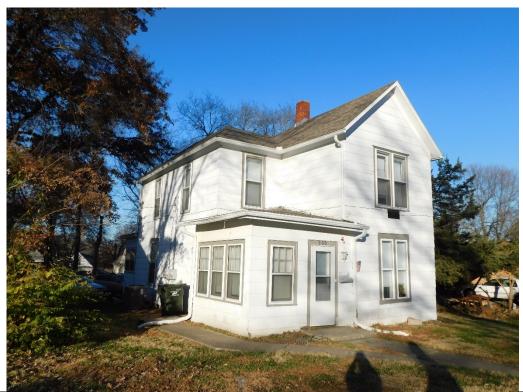
Photographer: Date: Description:
KRISTIN DYER 11/17/2020 LOOKING NORTHEAST

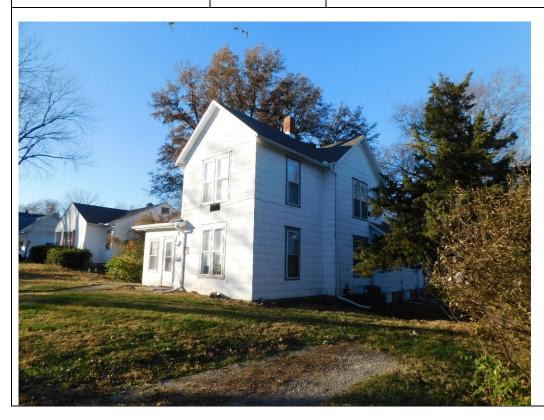
Description: LOOKING NORTHWEST

41. (cont.) Description of primary resource. Expand box as necessary, or add continuation pages.
This two-story front-gable-and-wing features an irregular plan, stone foundation, and asbestos siding. The façade is three bays. The
first two bays are located in an enclosed porch within a cross of the gable and wing. There is a historic six-over-one double-hung

wood in the first bay and an entry door in the second bay with matching windows down the west elevation. The third bay features the gable-end, and it is filled with replacement one-over-one vinyl hung paired windows. The second story features original one-over-one double-hung wood windows. The side elevations feature original one-over-one double-hung wood windows. The roof features

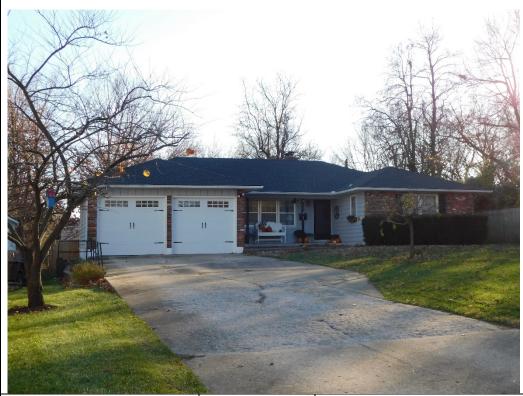
Photographer: Date: Description:
KRISTIN DYER 11/17/2020 LOOKING SOUTHWEST

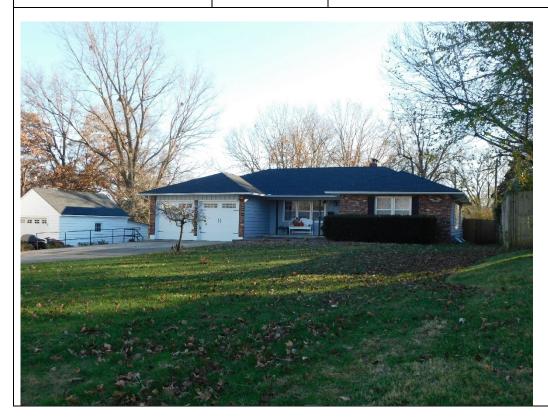
Date: 11/17/2020 Description: LOOKING SOUTH

41. (cont.) Description of primary resource. Expand box as necessary, or add continuation pages.
This one-story ranch features a pavilion plan with a concrete foundation and brick exteriors walls. The façade is five bays with the
third and fourth bay recessed within the pavilion with wood paneled walls. The first two bays are filled with carriage style garage
doors with two eight-light transoms. The third bay features a group of three six-over-six original wood windows. The fourth bay has a slab door, and the final bay has paired six-over-six original wood windows. There is a one-story recessed shallow porch with wood
columns and concrete foundation. The side elevations feature matching original windows with wood lap siding. The roof has asphalt
shingle hinned gable roof with cross hinned gables on either end

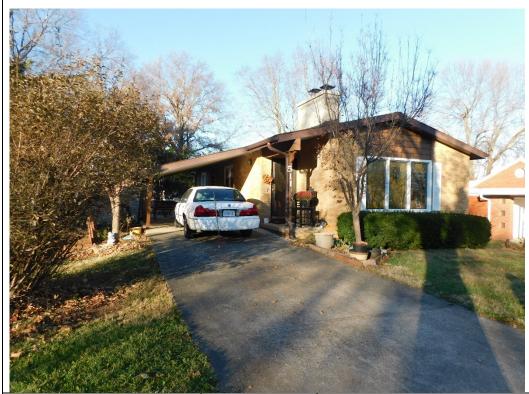
Photographer: Date: Description: LOOKING NORTHEAST

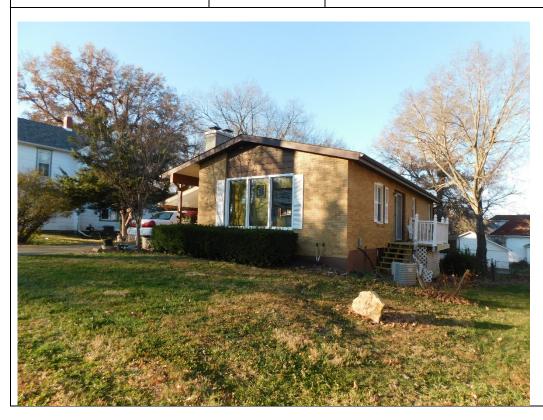
Description: LOOKING NORTHWEST

41. (cont.) Description of primary resource. Expand box as necessary, or add continuation pages.
This one-story contemporary house features a T-plan with a concrete foundation, buff brick and wood exterior walls, and a low-pitch front gable roof. The façade is two bays with a recessed one-bay porch with an entry door in the first bay and grouped non-original vinyl casement windows with wood shingles above and below the windows. The west elevation features an attached lean-to carport extending from the roof with wood columns. There are paired replacement one-over-one hung vinyl windows. The east elevation features replacement one-over-one hung vinyl windows and a sliding glass door onto an open deck.

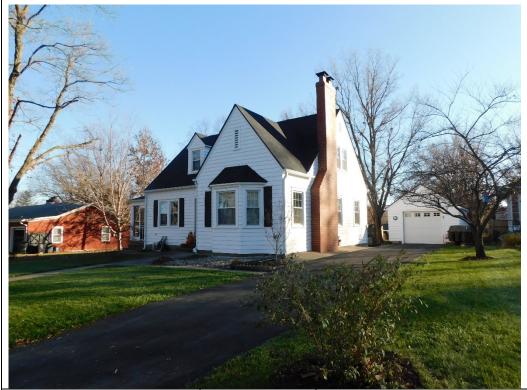
Photographer: Date: Description: LOOKING SOUTHEAST

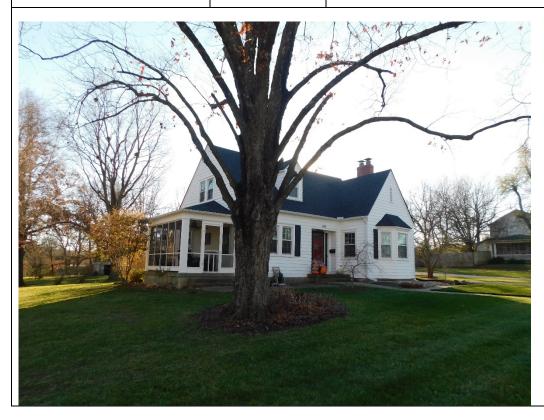
Date: 11/17/2020 Description: LOOKING SOUTHEAST

41. (cont.) Description of primary resource. Expand box as necessary, or add continuation pages.
This one-and-a-half story Tudor Revival features an irregular plan with a concrete foundation, vinyl exterior walls, and a cross gable roof. The façade is four bays wide with a one-story screen porch in the first bays that extends partially down the east elevation. It features a hipped roof, wood box columns, and a concrete foundation. The second bay is filled with paired replacement six-over-six hung vinyl windows with faux shutters. The third bay is filled with a wood door with four-light wood sidelights. The final bay is located in the projecting gable. It features a half-hexagonal bay with three replacement six-over-six vinyl hung windows with faux shutters and hipped roof. The side elevations feature vinyl exterior walls with replacement six-over-six vinyl hung windows. The half-story

features paired replacement six-over-six vinyl hung windows. There is an exterior brick chimney on the west elevation, and there is a

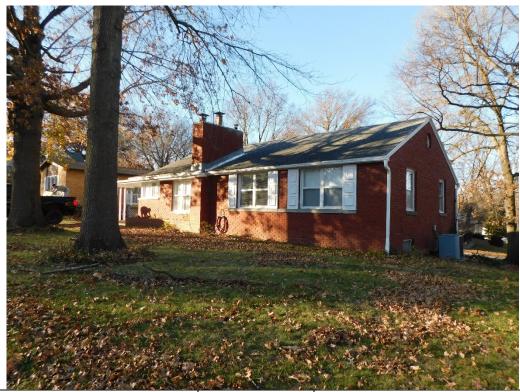
Photographer: Date: Description:
KRISTIN DYER 11/17/2020 LOOKING NORTHWEST

41. (cont.) Description of primary resource. Expand box as necessary, or add continuation pages.
This one-story ranch features a rectangular plan, brick exteriors wall, and a side gable roof. The façade is five bays wide with a recessed attached garage in the first bay with a flat roof that extends flushed with the main building with group wood posts. The second bay features grouped replacement vinyl casement windows that turn the corner leading to the entry door on the side elevation. The third bay features grouped replacement one-over-one vinyl hung windows, and the remaining two bays feature paired replacement one-over-one vinyl hung windows with geometric faux wood shutters. There is an off-centered rectangular brick chimney that partially extend from the façade. The chimney run perpendicular to the building. The east elevation features two

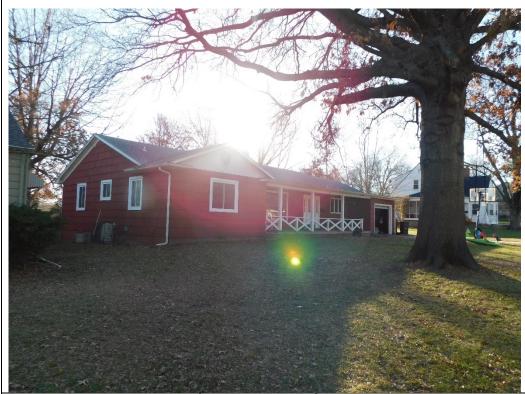
Photographer: Date: Description: LOOKING SOUTHWEST

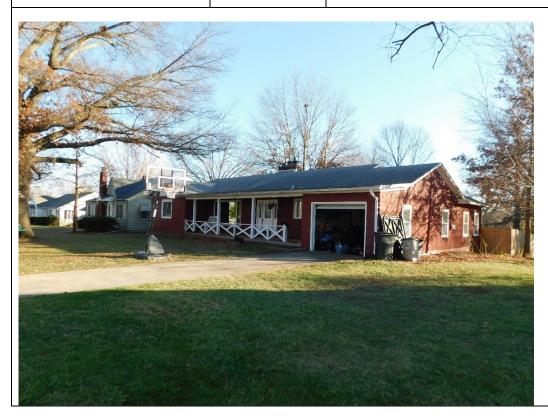
Date: 11/17/2020 Description: LOOKING SOUTHEAST

41. (cont.) Description of primary resource. Expand box as necessary, or add continuation pages.
This one-story ranch features a rectangular plan, wood shingle exterior walls, and a cross gable roof. The façade is five bays with the first bay featuring the gable-end of the cross gable with a replacement sliding vinyl window. The second, third, and fourth bay are

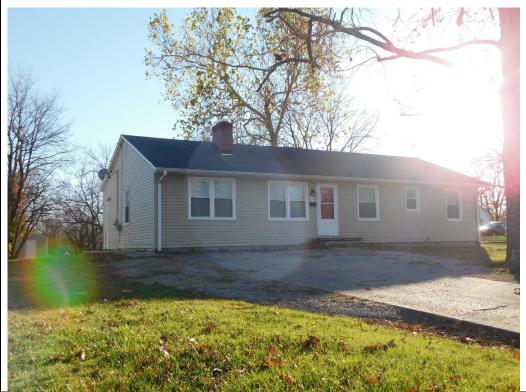
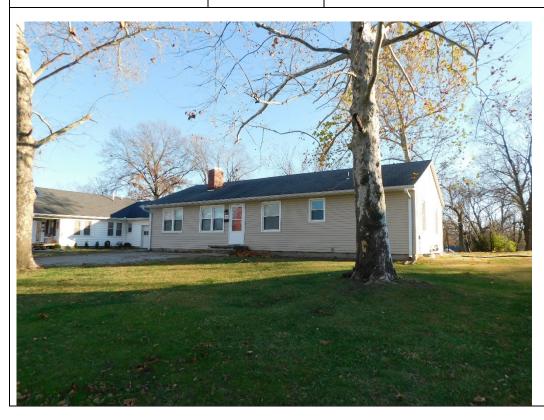
41. (cont.) Description of primary resource. Expand box as necessary, or add continuation pages.
This one-story ranch features a concrete foundation, vinyl exterior walls, and a side gable roof. The façade is six bays with paired replacement one-over-one hung vinyl windows in the first and second bay. A solid entry door fills the third bay, and replacement one-over-one hung vinyl windows fill the remaining bays. There is an off-centered chimney along the front slope. The east elevation features a replacement one-over-one hung vinyl window and a solid entry door, and the west elevation features two replacement one-over-one hung vinyl windows. This building is not eligible due to alterations to the siding and fenestration.

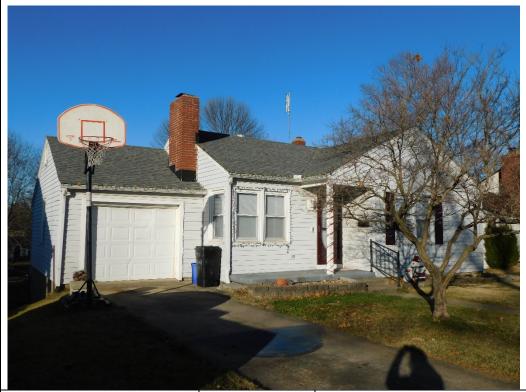
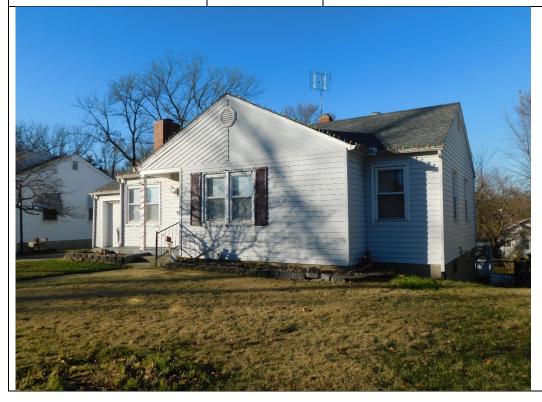
41. (cont.) Description of primary resource. Expand box as necessary, or add continuation pages.
This one-story split minimal traditional house features a concrete foundation, vinyl exterior walls, and a cross gable roof. The façade is five bays with a metal paneled garage in the first bay, paired replacement one-over-one vinyl hung windows in the second and

fourth bays, a wood door in the third bay, and a paired replacement one-over-one vinyl hung in the final bay. There is a one bay recessed porch with a wood column in front of the entry with a concrete landing that extends in front of the second and third (entry) bays. The garage is slightly recessed from the main house, and there is an exterior brick chimney located between the garage wall and the house wall. A second chimney is located on the rear slope. On the west elevation, there is a paired replacement one-over-one vinyl hung windows. This house matches

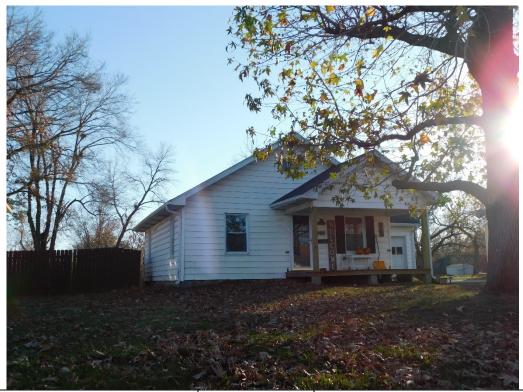
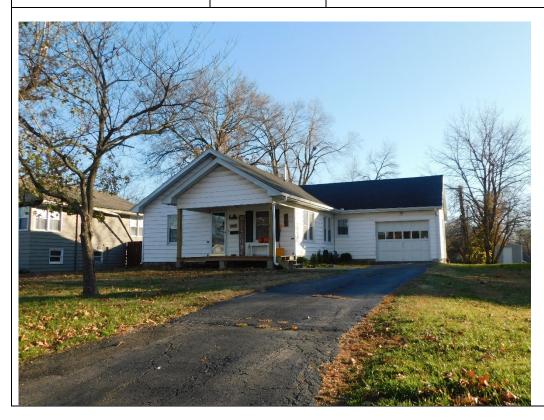
This one-story Bungalow/Craftsman features a stone foundation, vinyl exterior walls, and a cross gable roof. The building is three bays with a center entry door flanked on either side by a replacement one-over-one hung vinyl window. There is a partial-width porch over the second and third bays with a front gable roof, vinyl siding in the gable-end, wood box columns, and wood decking. The east elevation features two replacement one-over-one hung vinyl windows. The west elevation features paired replacement one-over-one hung vinyl windows. There is a one-story attached garage in the rear L facing Broad Street. It features replacement one-over-one hung vinyl windows and a wood paneled garage door with six-light windows. This building is not eligible due to alterations to the siding and fenestration.

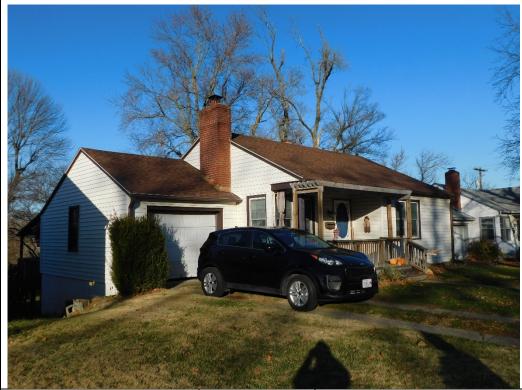
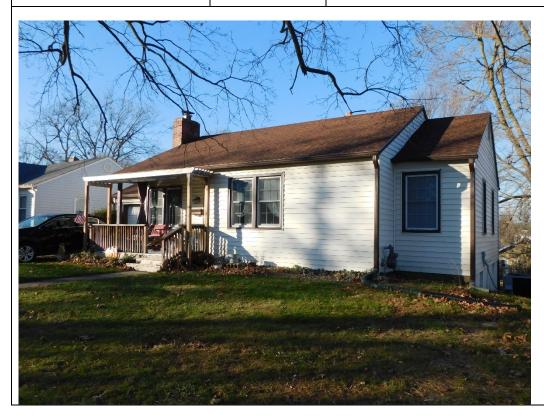
41. (cont.) Description of primary resource. Expand box as necessary, or add continuation pages.
This one-story split minimal traditional features a concrete foundation, vinyl exterior walls, and a side gable roof. The façade is five bays with a metal paneled garage in the first bay, paired replacement six-over-six vinyl hung windows in the second and fourth bays, a wood door in the third bay, and a replacement six-over-six vinyl hung in the final bay. There is a two bay recessed porch in front of the second and third (entry) bays, and it features wood columns, wood railing, and a partial wood pergola. The garage is slightly

recessed from the main house, and there is an exterior brick chimney located between the garage wall and the house wall. On the west elevation, there is a replacement six-over-six vinyl hung window. The east elevation features two replacement six-over-six vinyl
