1. Survey number: CO-AS-008-001		2. Survey Name: West Main Street Survey	
3. County: Cole		4. Address (Street No.): 100	Street (name): East Circle Drive
5. City: Jefferson City	Vicinity <input type="checkbox"/>	6. Lat / Long:	7. Township/Range/Section: T: R: S:
8. Historic name (if known):		9. Present/other name (if known):	
10. Ownership: <input checked="" type="checkbox"/> Private <input type="checkbox"/> Public		11a. Historic use (if known): Domestic-Single Dwelling	11b. Current use: Domestic-Single Dwelling

MISSOURI DEPARTMENT OF NATURAL RESOURCES
STATE HISTORIC PRESERVATION OFFICE, P.O. Box 178, Jefferson City, MO 65102
ARCHITECTURAL/HISTORIC INVENTORY FORM

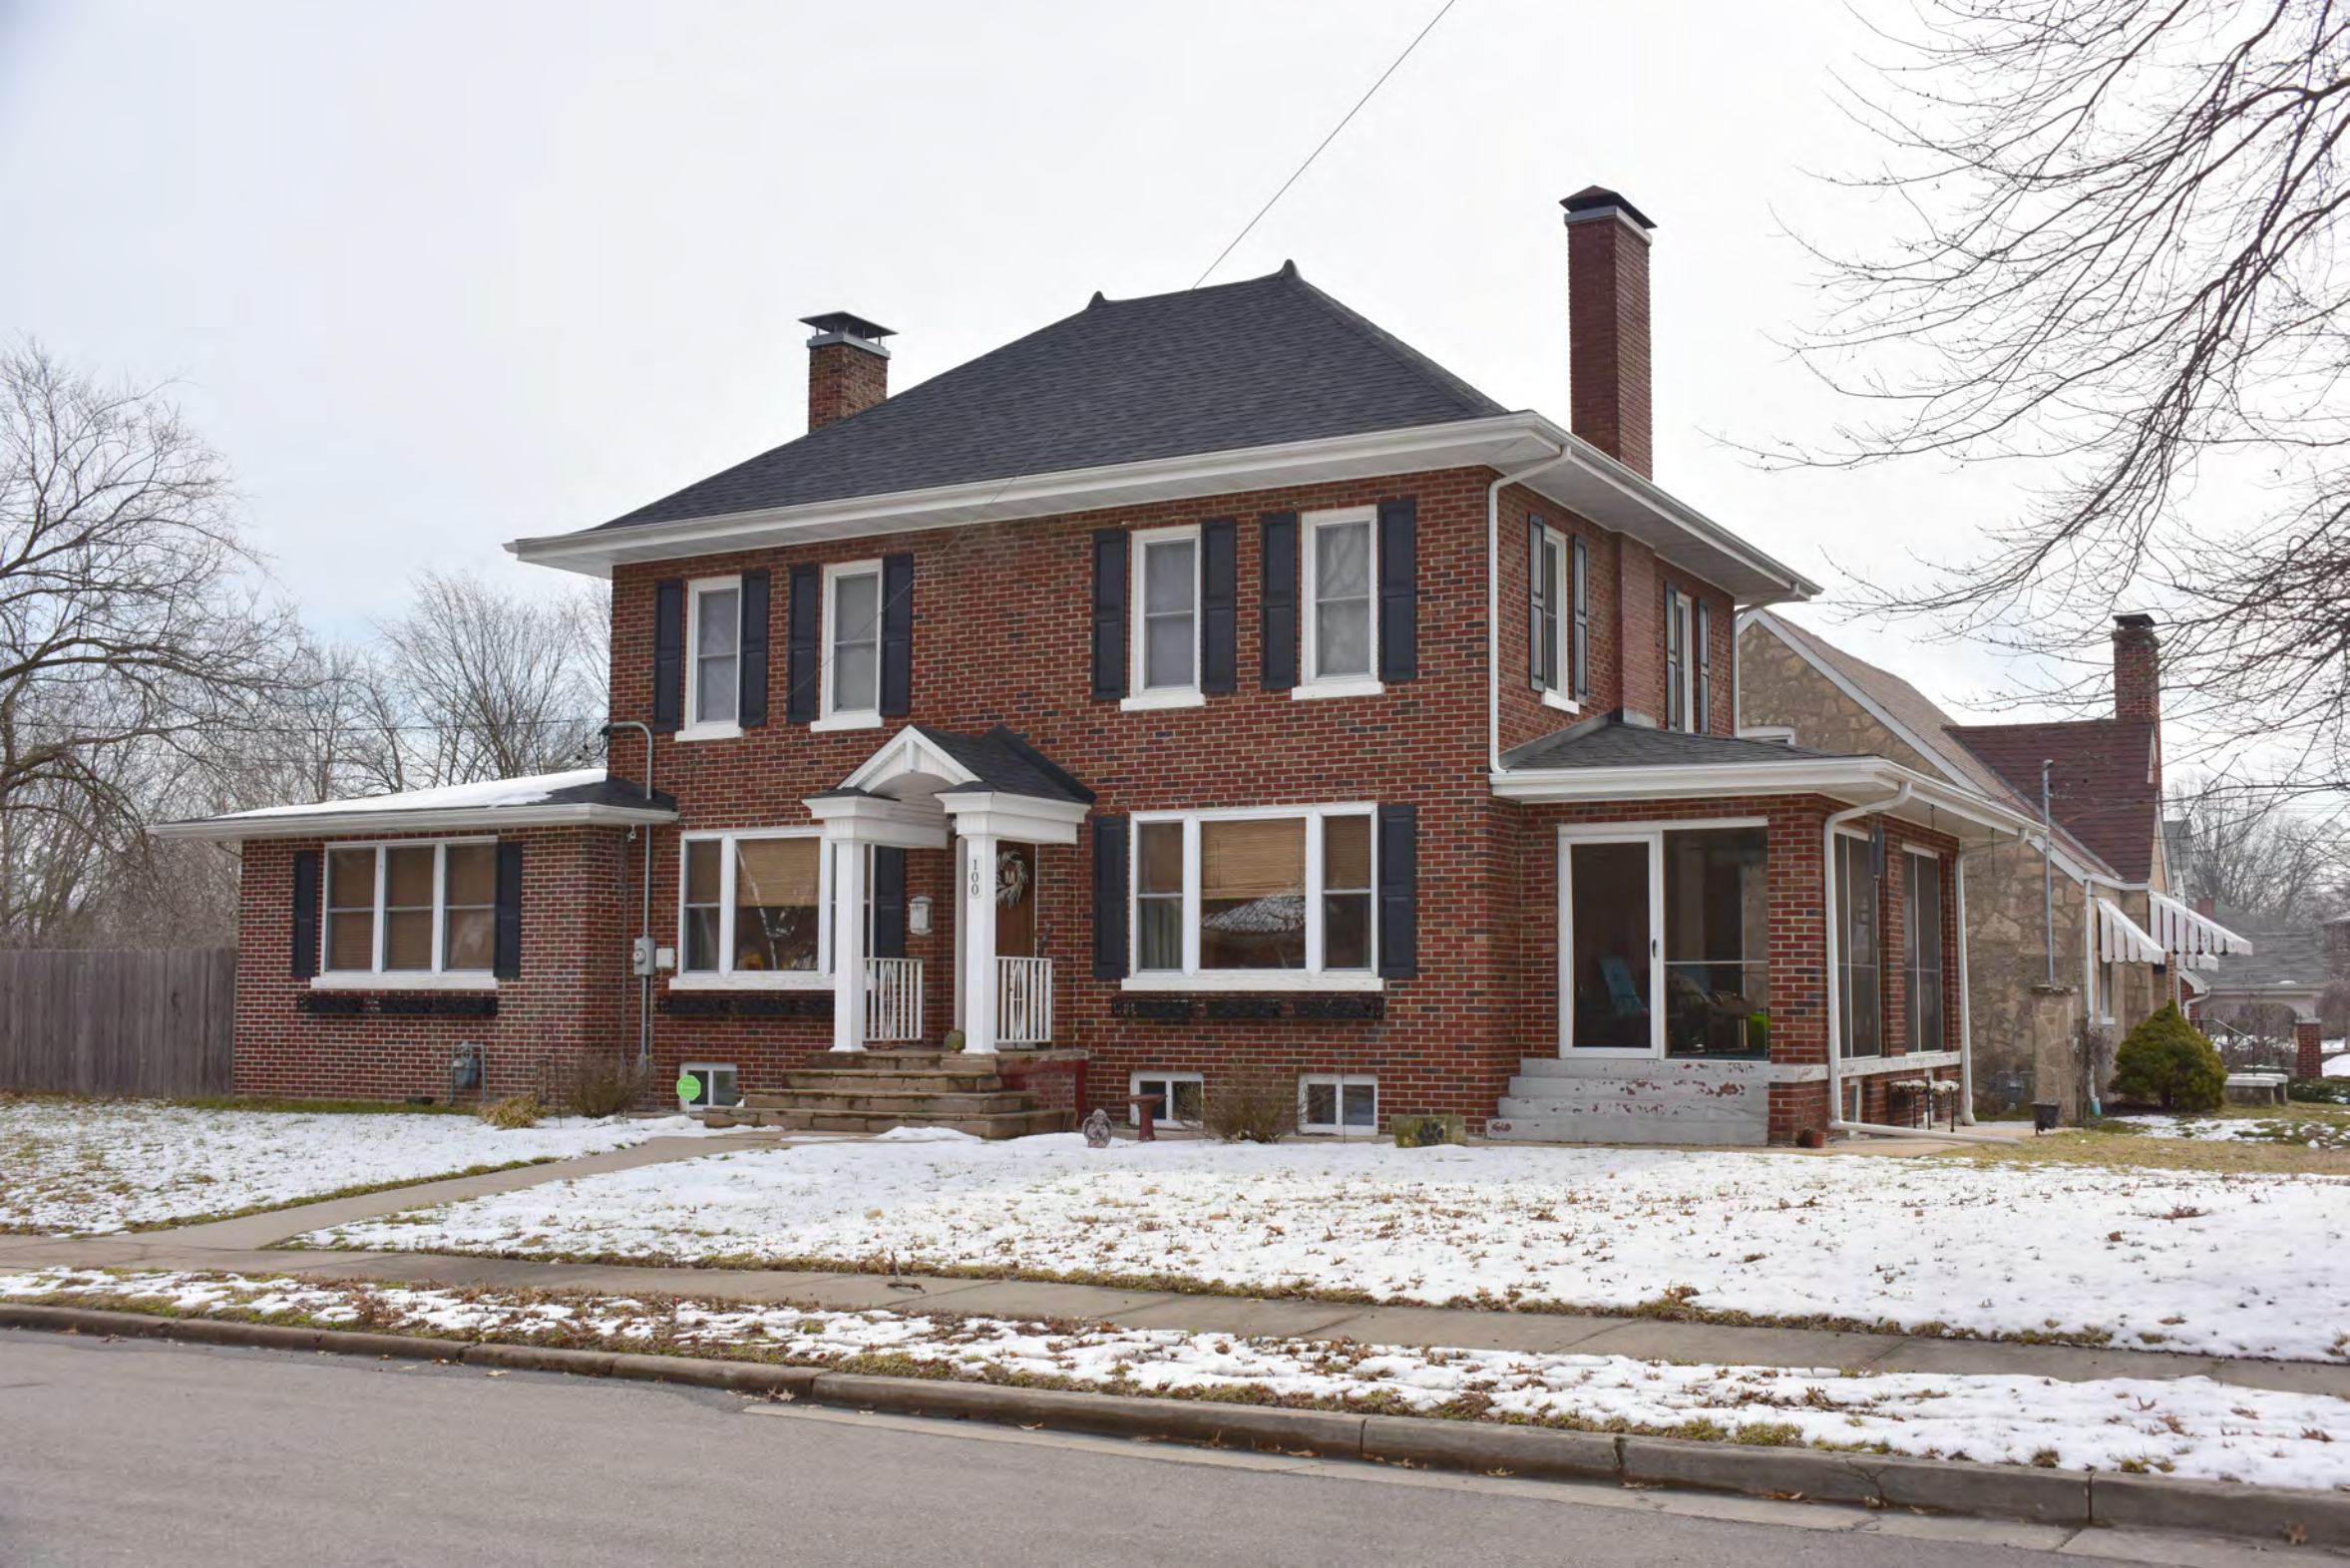
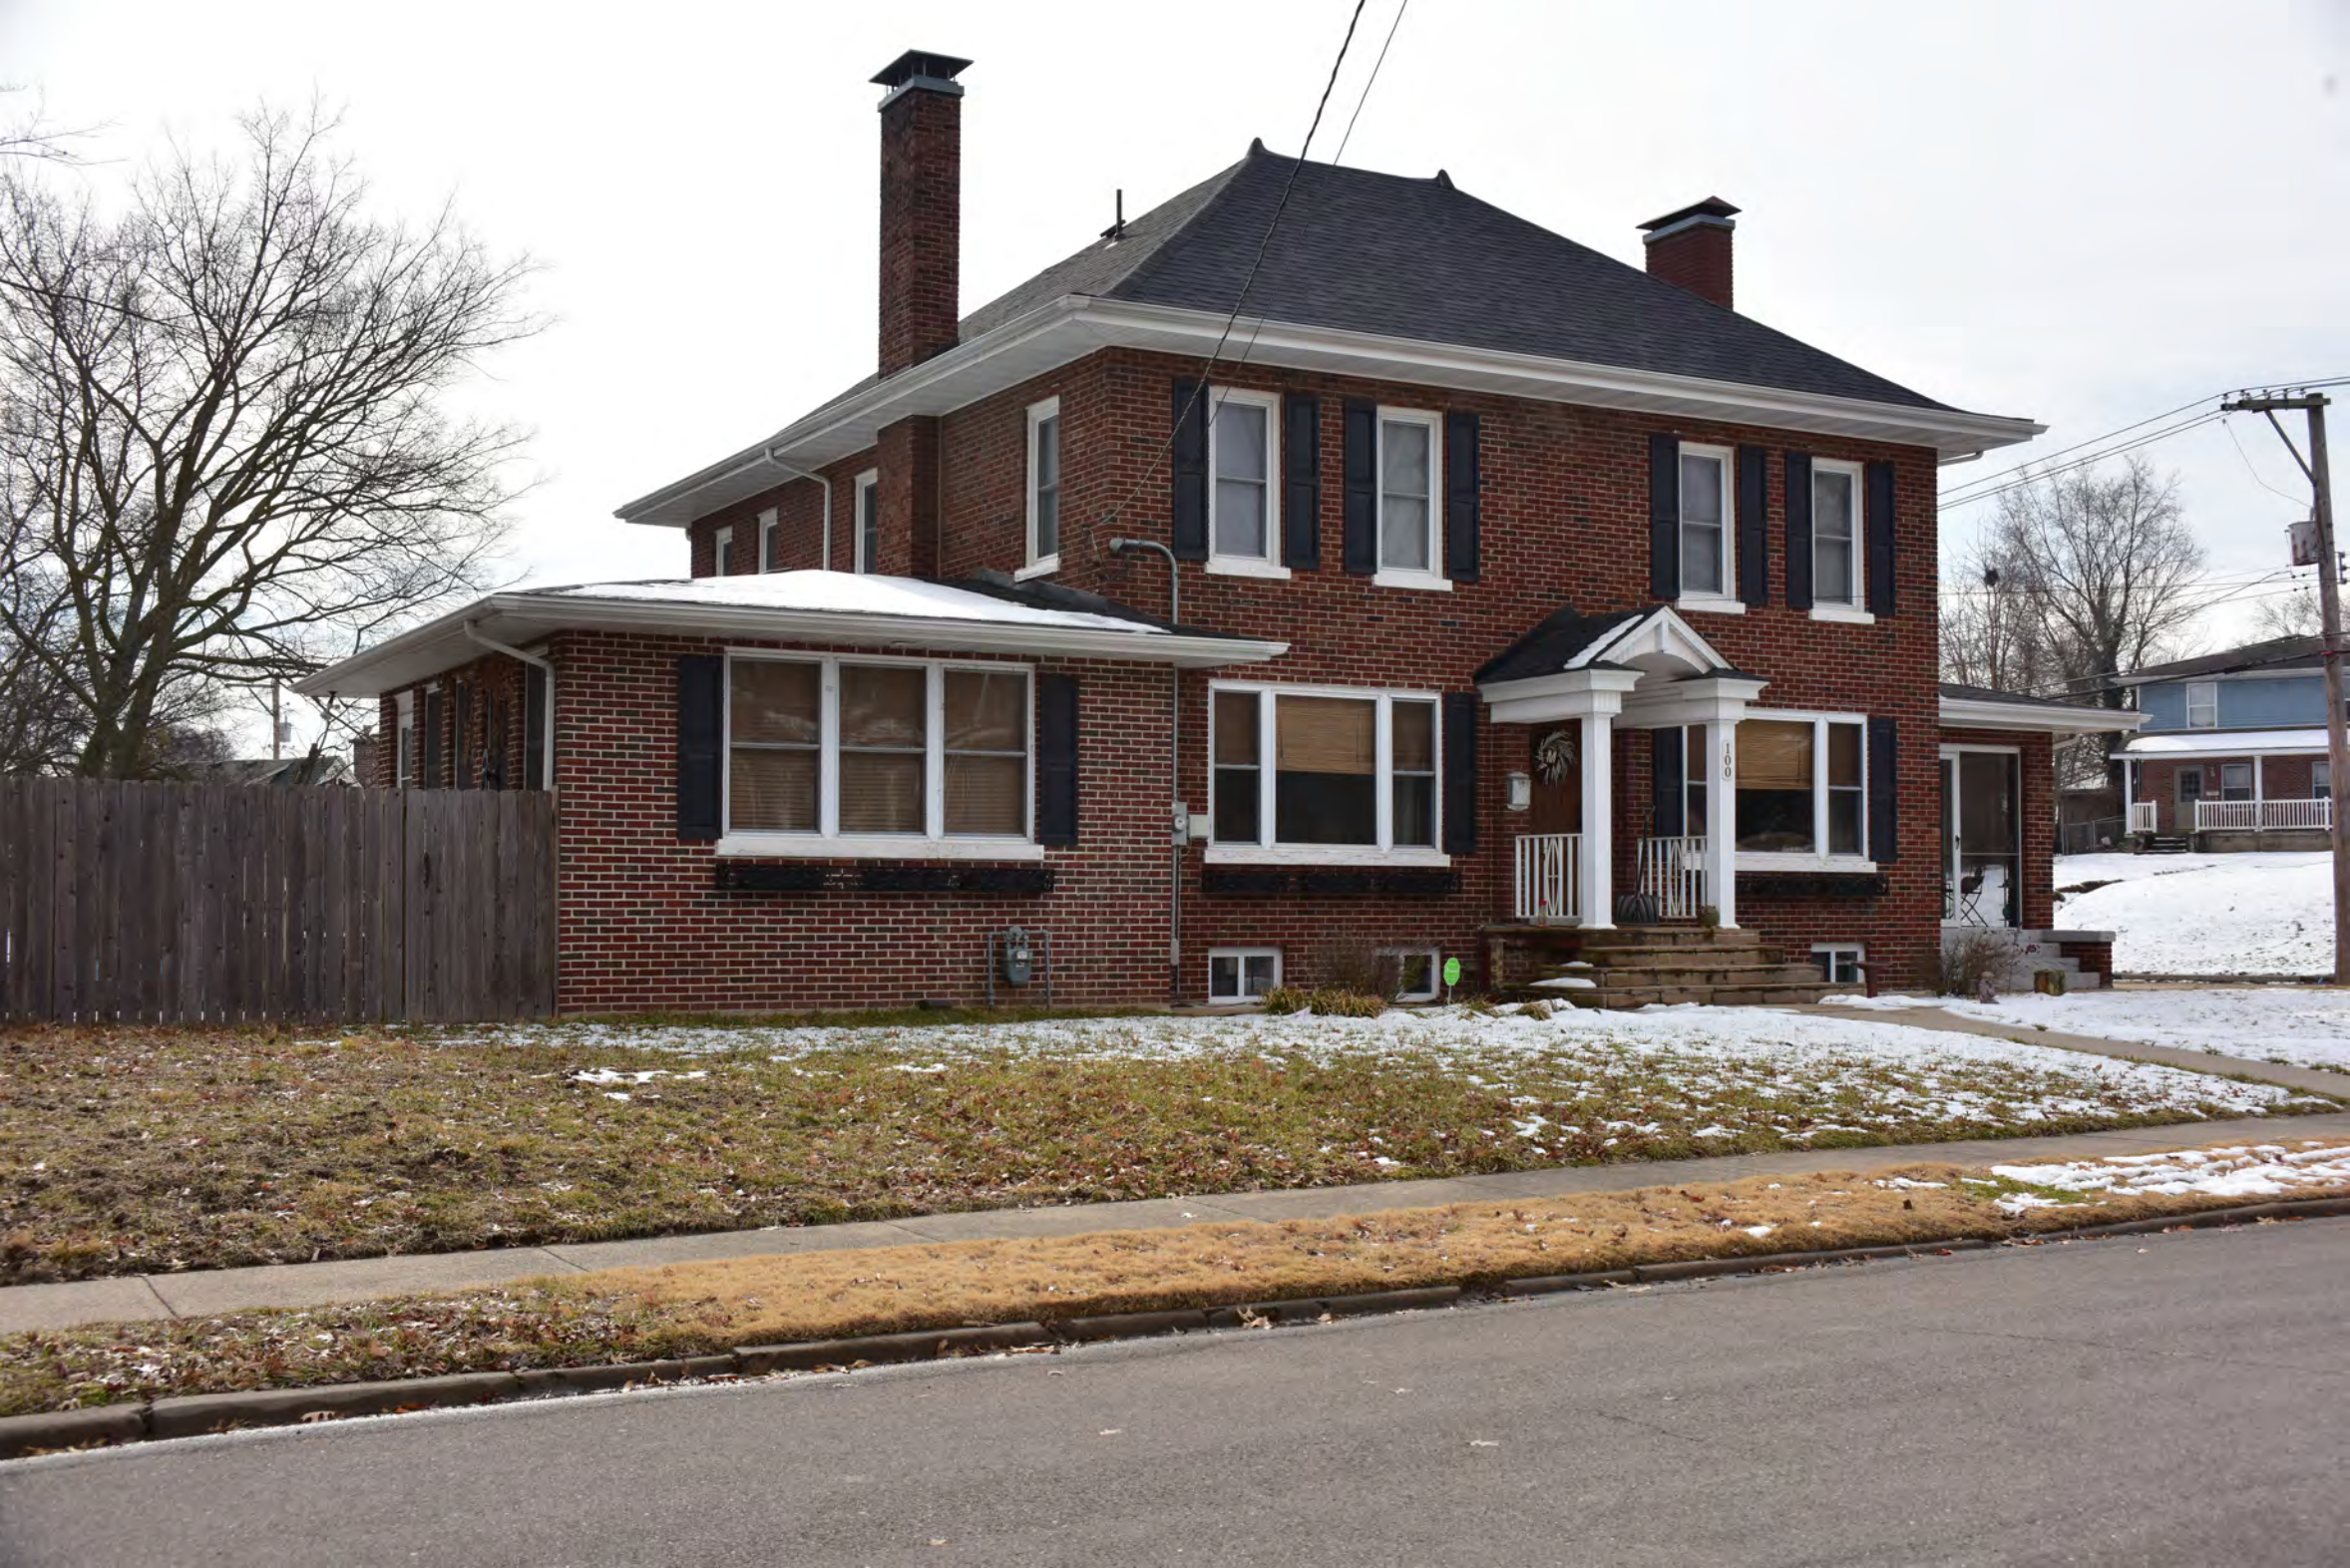
100 East Circle Drive is a two-story brick Colonial Revival dwelling with a hipped asphalt roof and T-shaped plan. A two-story hipped roof ell projects from the rear and contains a single-car garage at the basement level. The dwelling is five bays wide and four bays deep. A one-story brick addition with an asphalt hipped roof projects from the north elevation and contains the first bay. A bank of three non-historic 1/1 windows defines the bay. Tripartite windows define bays two and four. Vinyl 1/1 windows flank a center fixed pane. The dwelling's primary entrance fills the center bay. A one-story screened porch with hipped roof defines the south bay. Brick columns on a brick foundation support the shallow hipped roof of the porch. Non-historic windows fill the narrow second-story bays. All visible windows have stone sills and false shutters. Brick chimneys pierce the roofline at both the south and north elevations. The chimneys are positioned between the main block and the addition and screened porch at their respective elevations. A brick stoop with concrete steps projects from the primary entrance. A portico with broken pediment shelters the stoop. A two-story hipped roof ell projects from the rear.

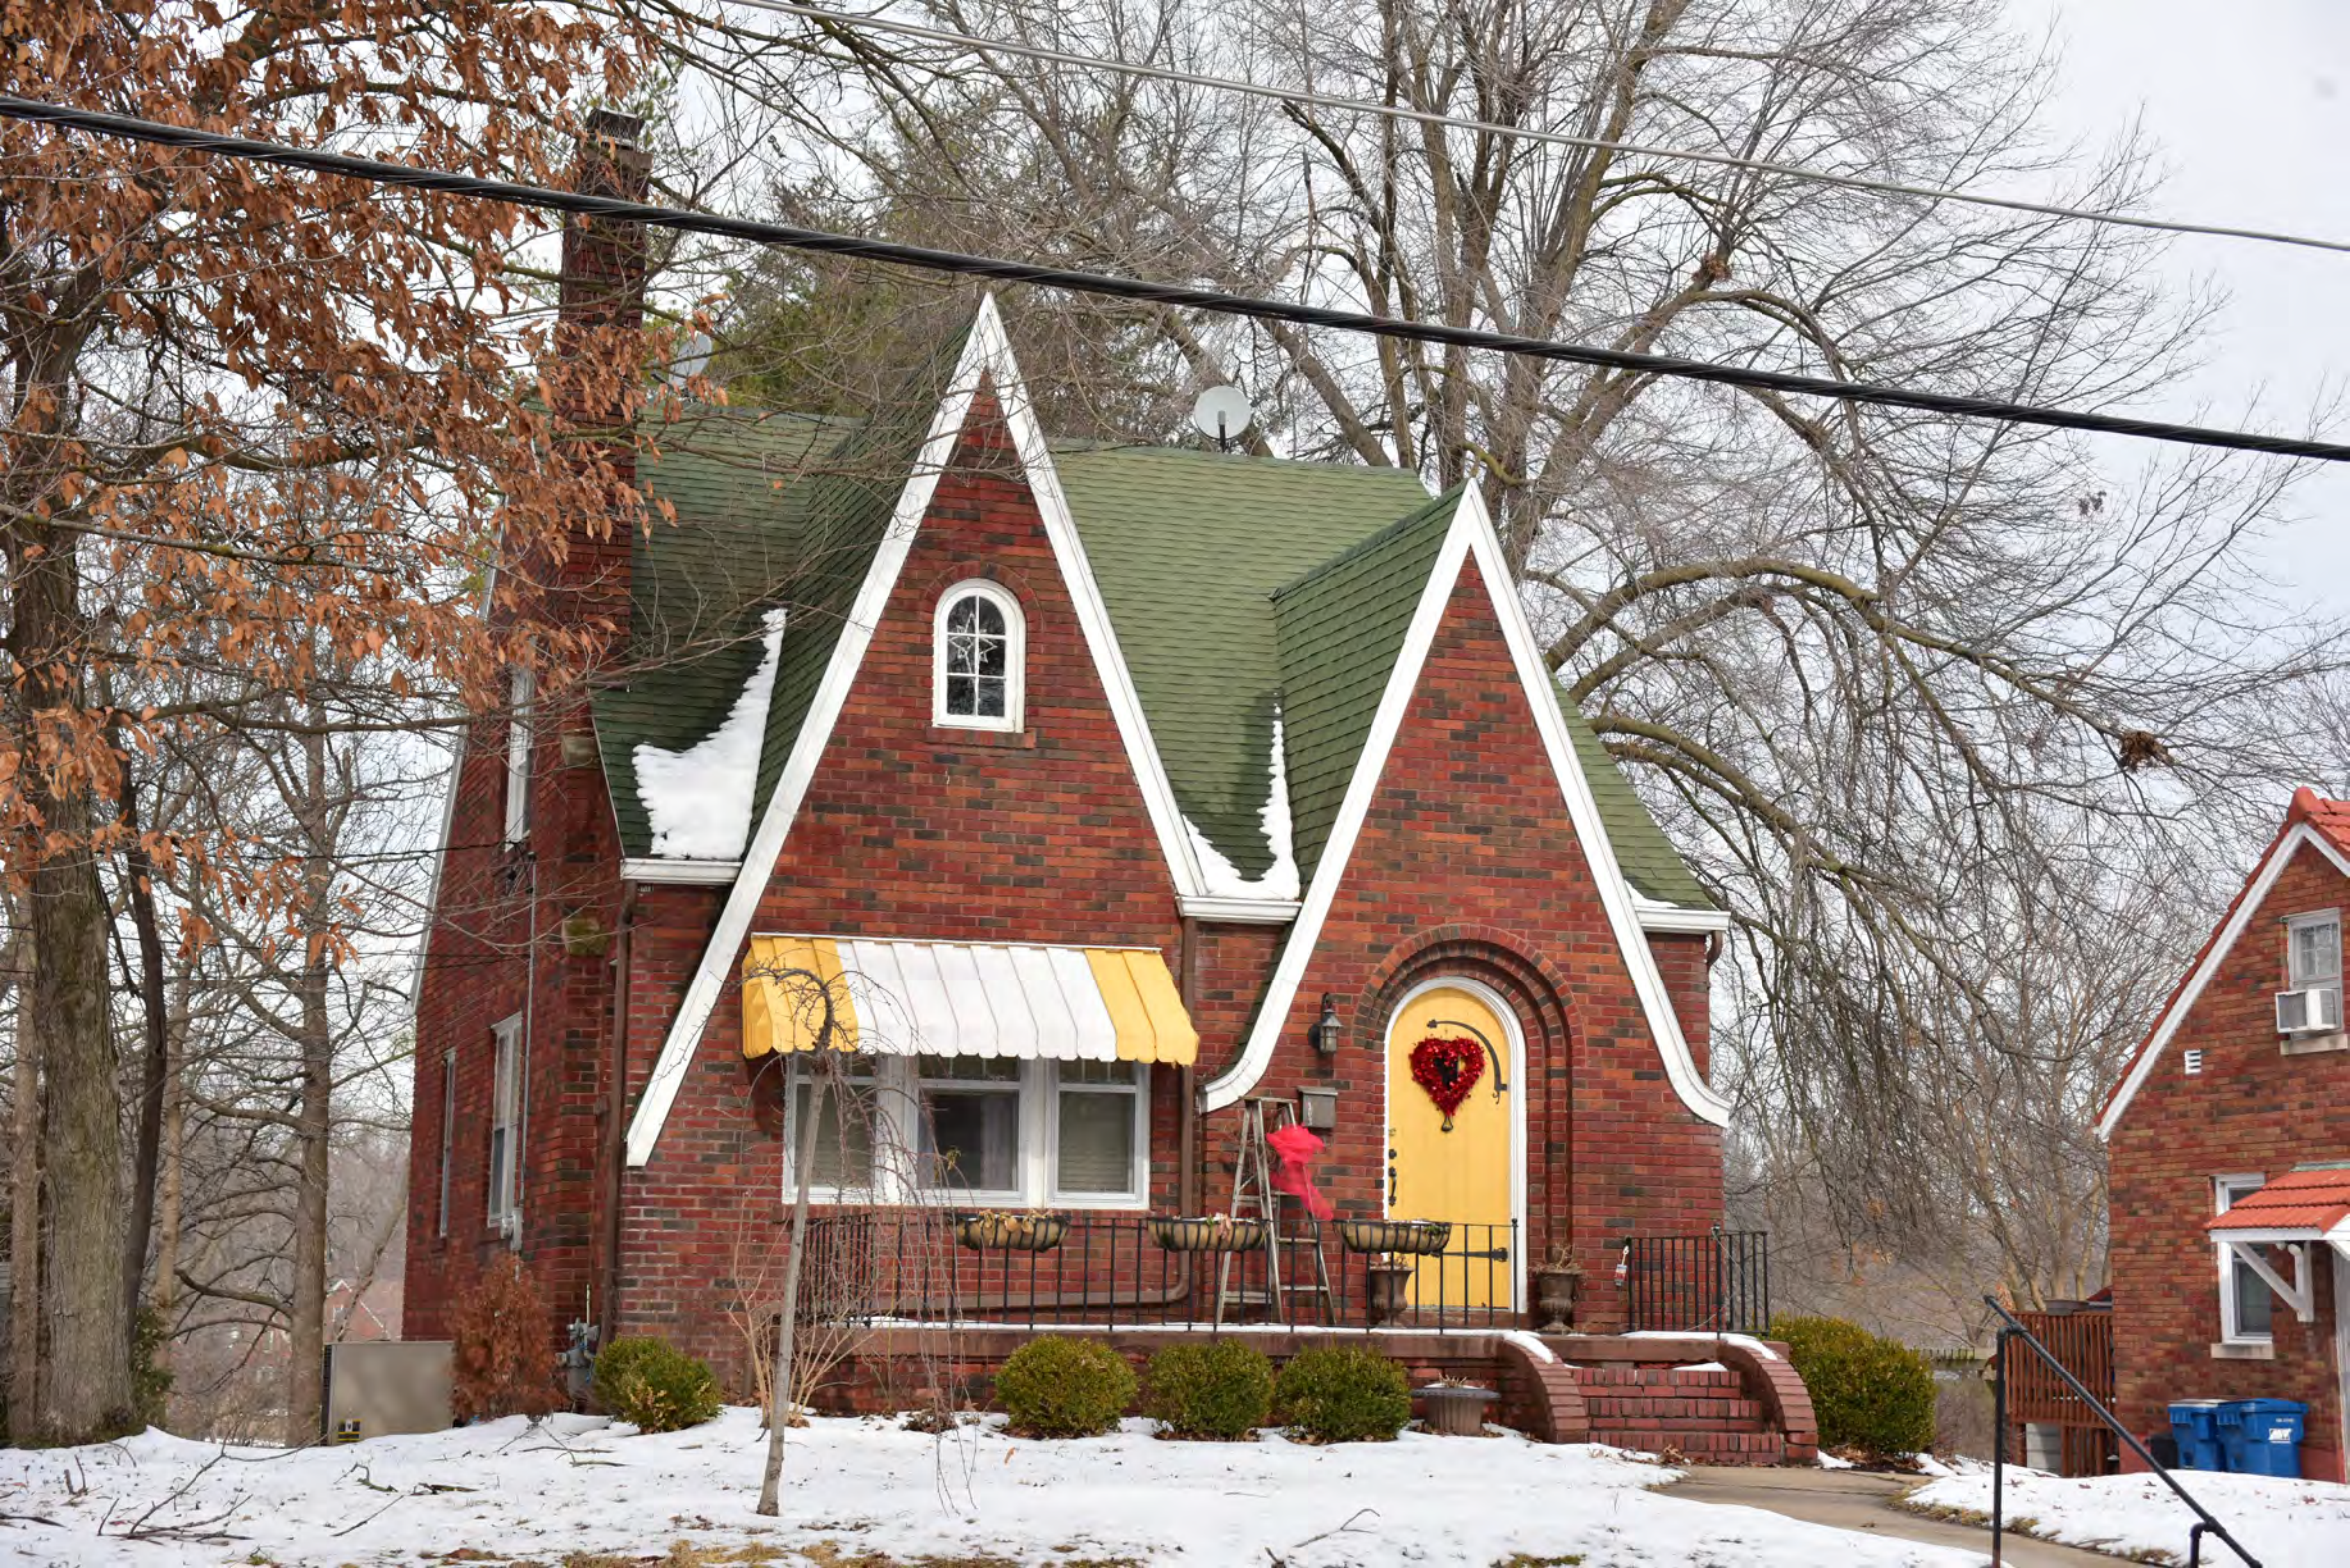
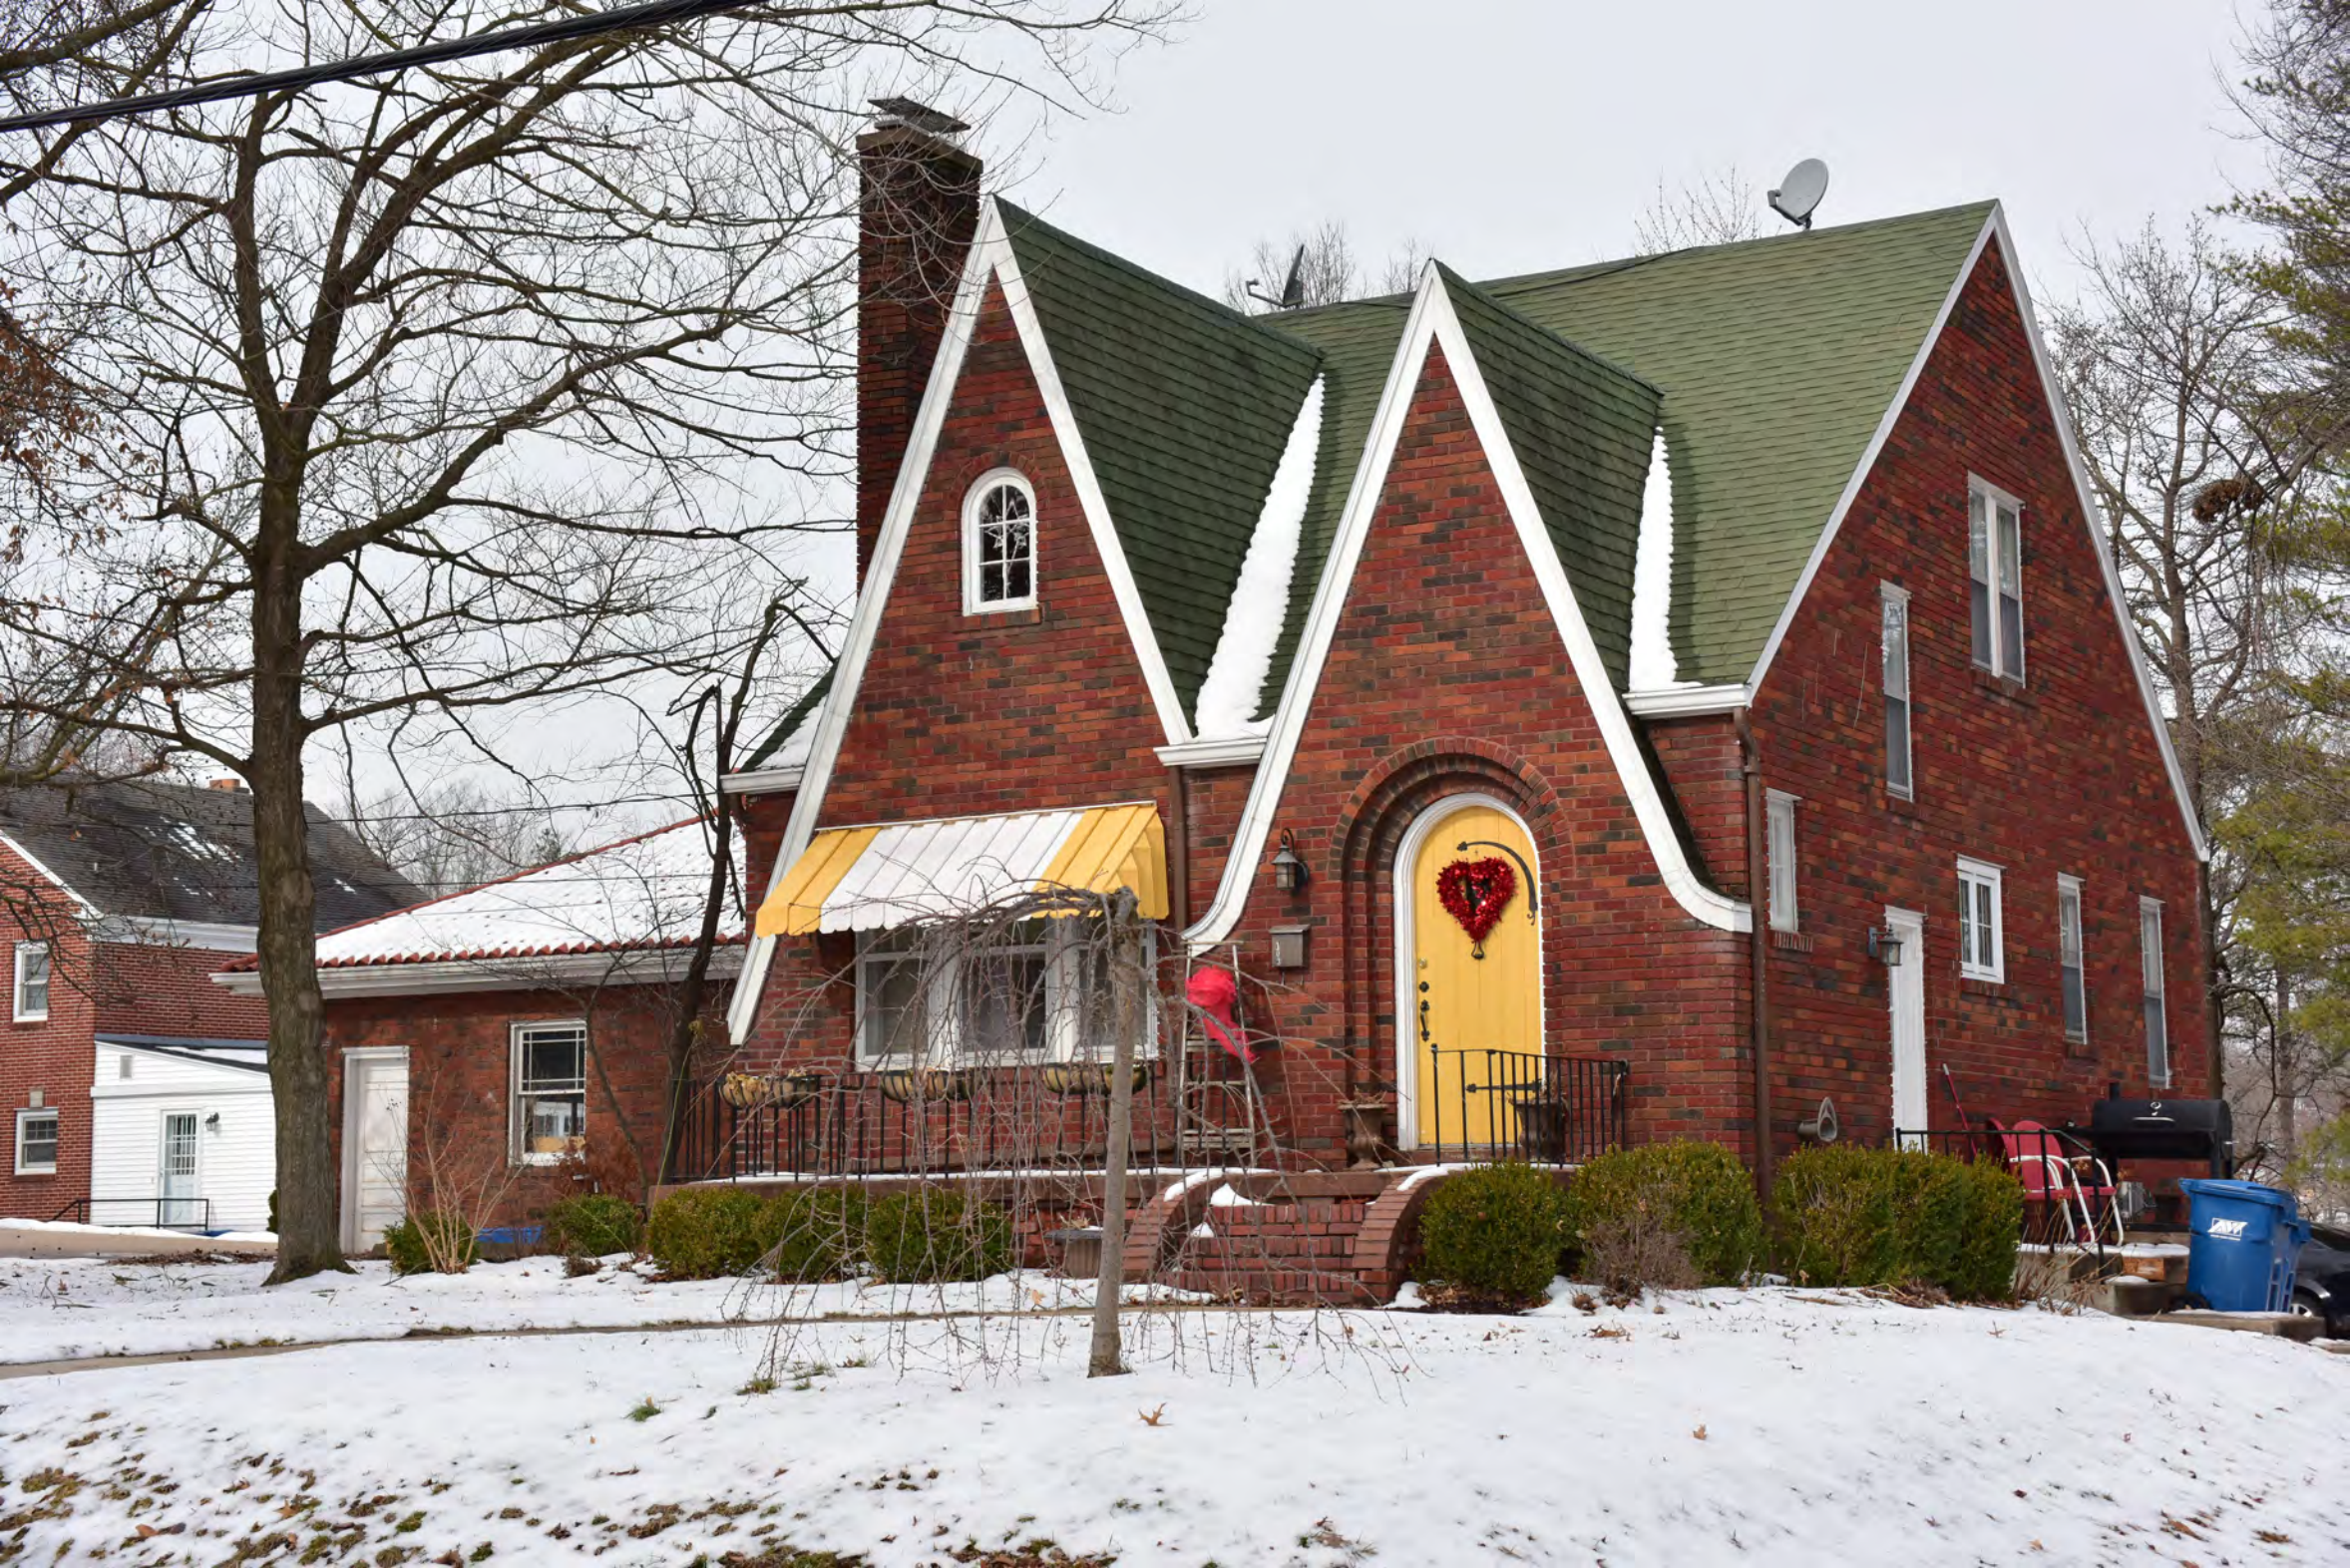
103 East Circle Drive is a one-and-one-half story brick restrained Tudor Revival dwelling with a rectangular plan and asphalt side-gable roof with two cross gables at the primary elevation. The cross gables are narrow with steep slopes. A brick exterior chimney is located at the dwelling's southeast corner. The dwelling is two bays wide and four asymmetrical bays deep. A bank of three historic 3/1 wood windows defines the primary elevation's south bay while the primary entrance defines the north bay. A non-historic metal canopy shelters the window bay. A historic wood door with single-light glazing fills the rounded arch entrance bay. A historic six-light rounded arch wood window occupies the south cross gable apex. A secondary entrance defines the first bay at the north elevation. Historic 6/1 wood windows fill most secondary elevation window bays. All window bays have brick sills. An open platform porch with a brick foundation and concrete floor spans the primary elevation. Low, curved brick walls flank brick steps at the north end. A concrete stoop projects from the secondary elevation. Historic metal railings line the porch and stoop. An integrated historic single-car garage is located at basement level and is accessed at the rear.
