1. Survey number: CO-AS-008-001		2. Survey Name: West Main Street Survey	
3. County: Cole		4. Address (Street No.): 100	Street (name): East Circle Drive
5. City: Jefferson City	Vicinity <input type="checkbox"/>	6. Lat / Long:	7. Township/Range/Section: T: R: S:
8. Historic name (if known):		9. Present/other name (if known):	
10. Ownership: <input checked="" type="checkbox"/> Private <input type="checkbox"/> Public		11a. Historic use (if known): Domestic-Single Dwelling	11b. Current use: Domestic-Single Dwelling

MISSOURI DEPARTMENT OF NATURAL RESOURCES
STATE HISTORIC PRESERVATION OFFICE, P.O. Box 178, Jefferson City, MO 65102
ARCHITECTURAL/HISTORIC INVENTORY FORM

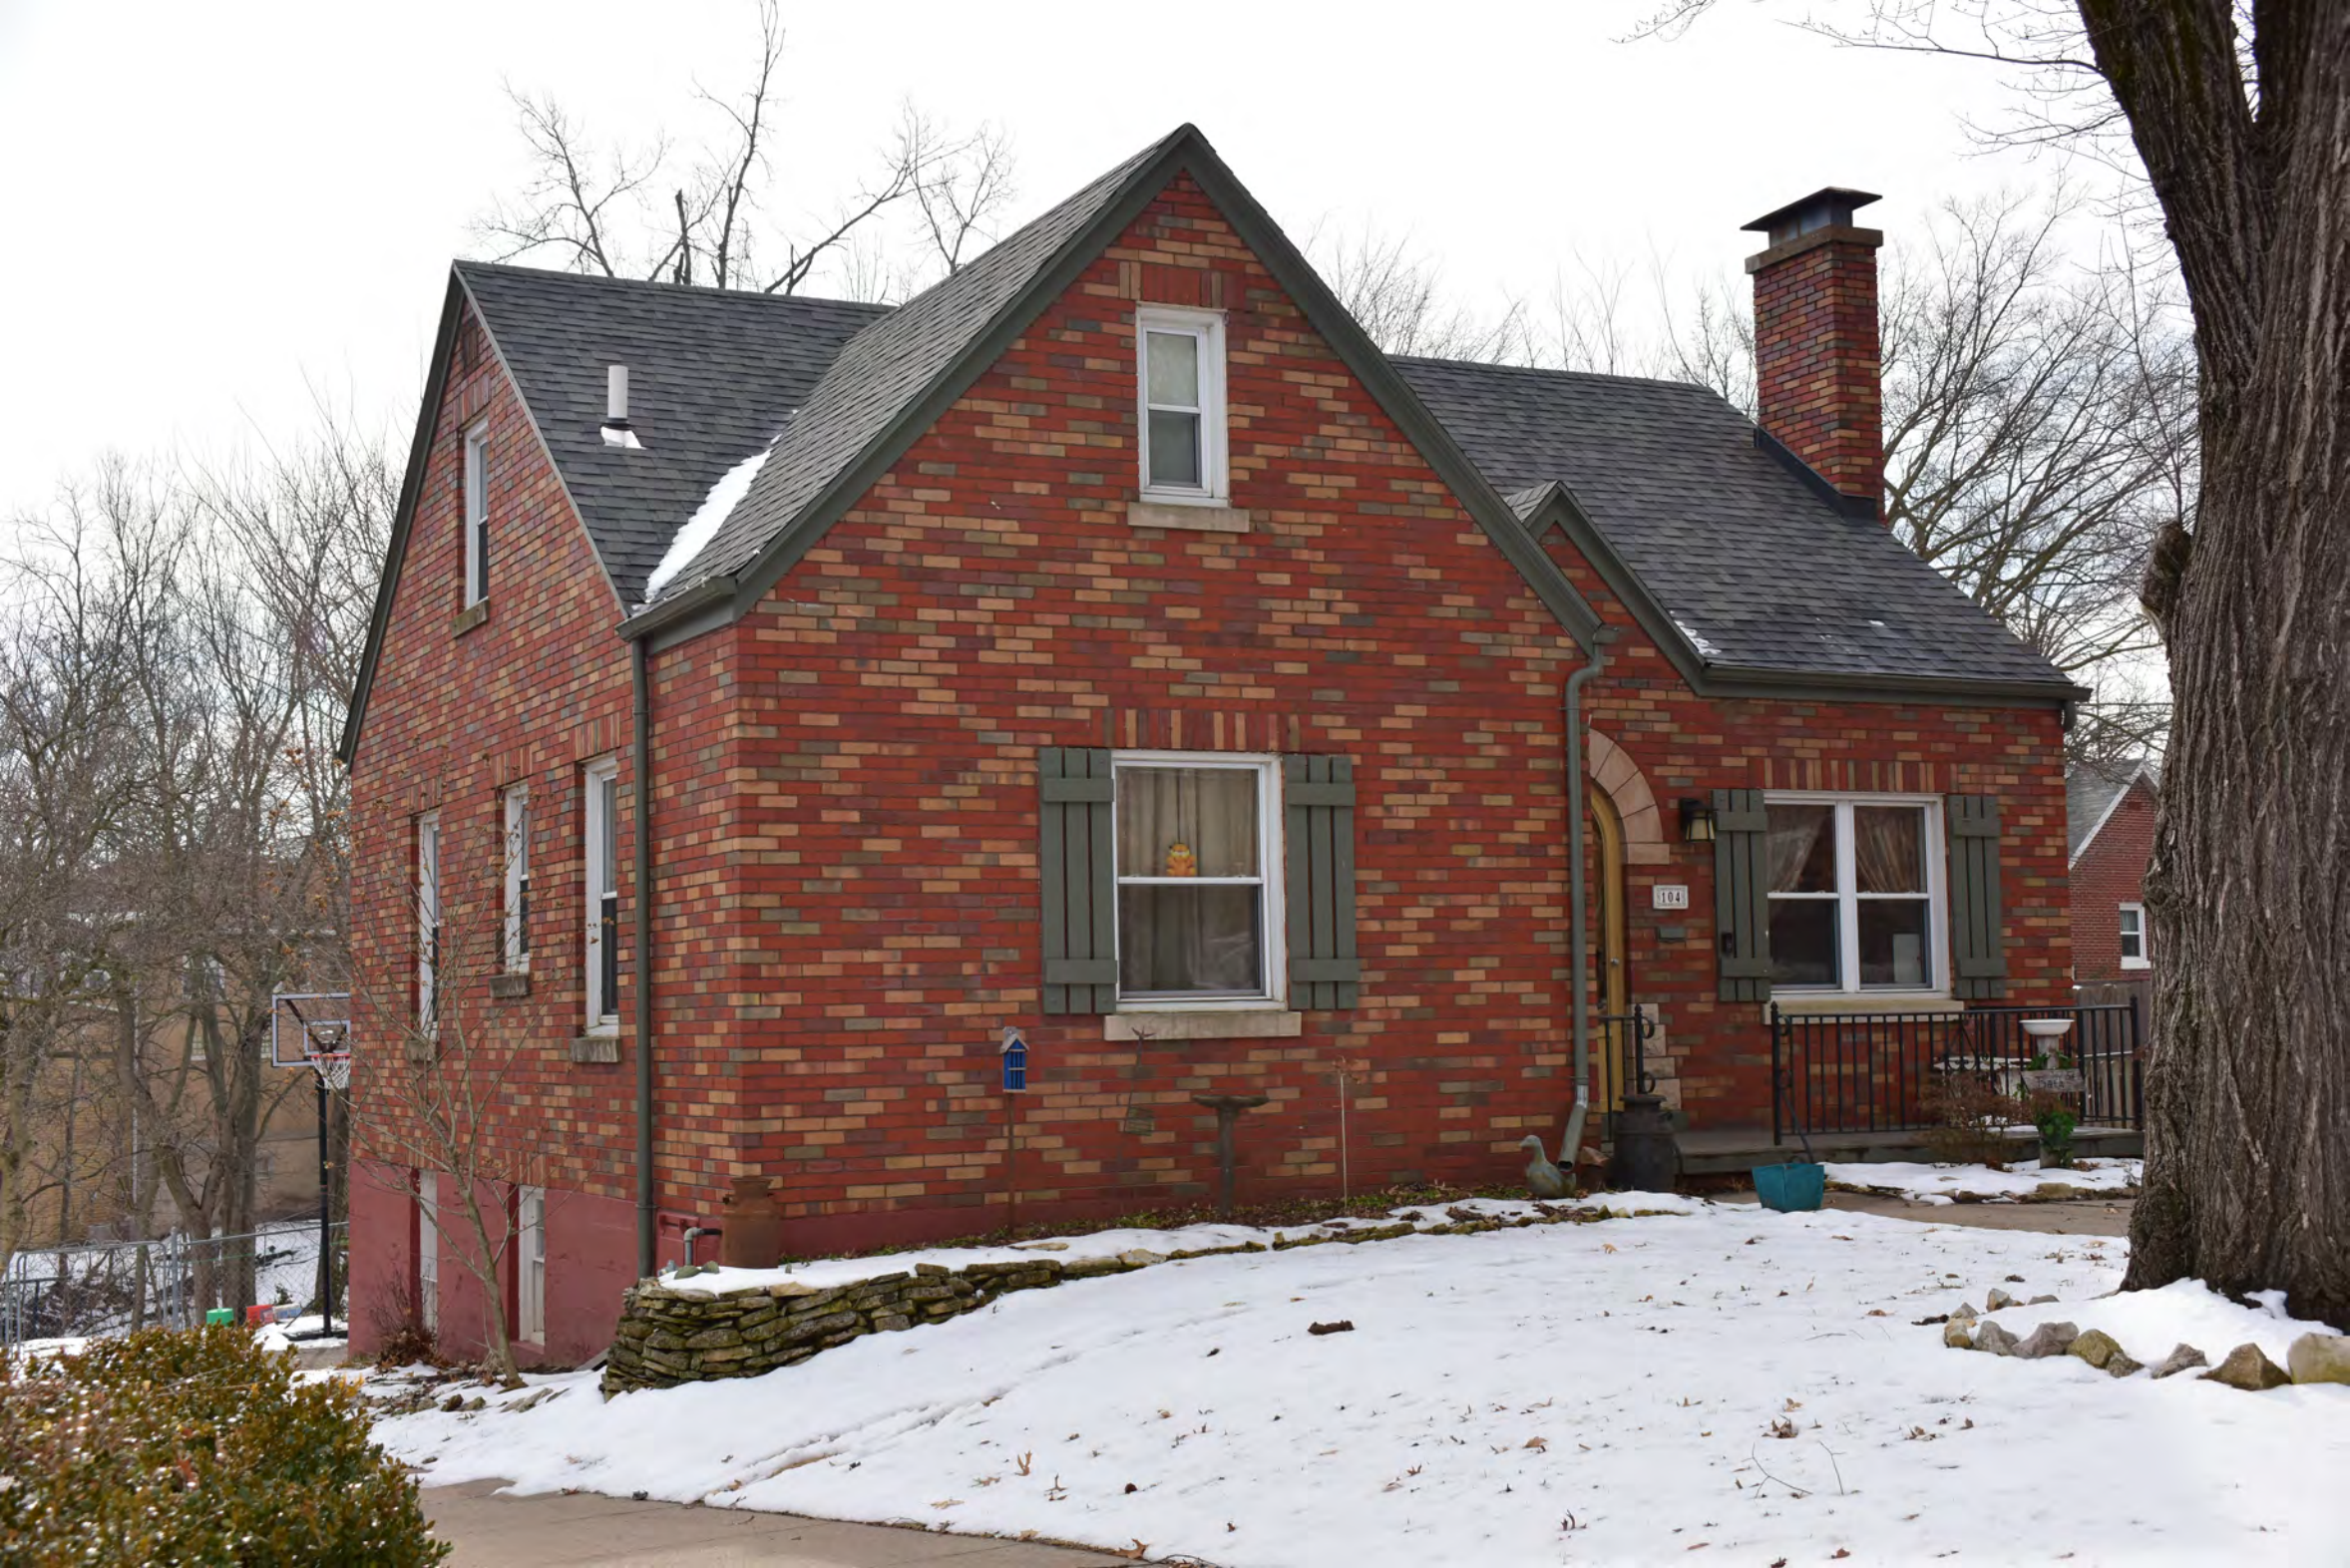
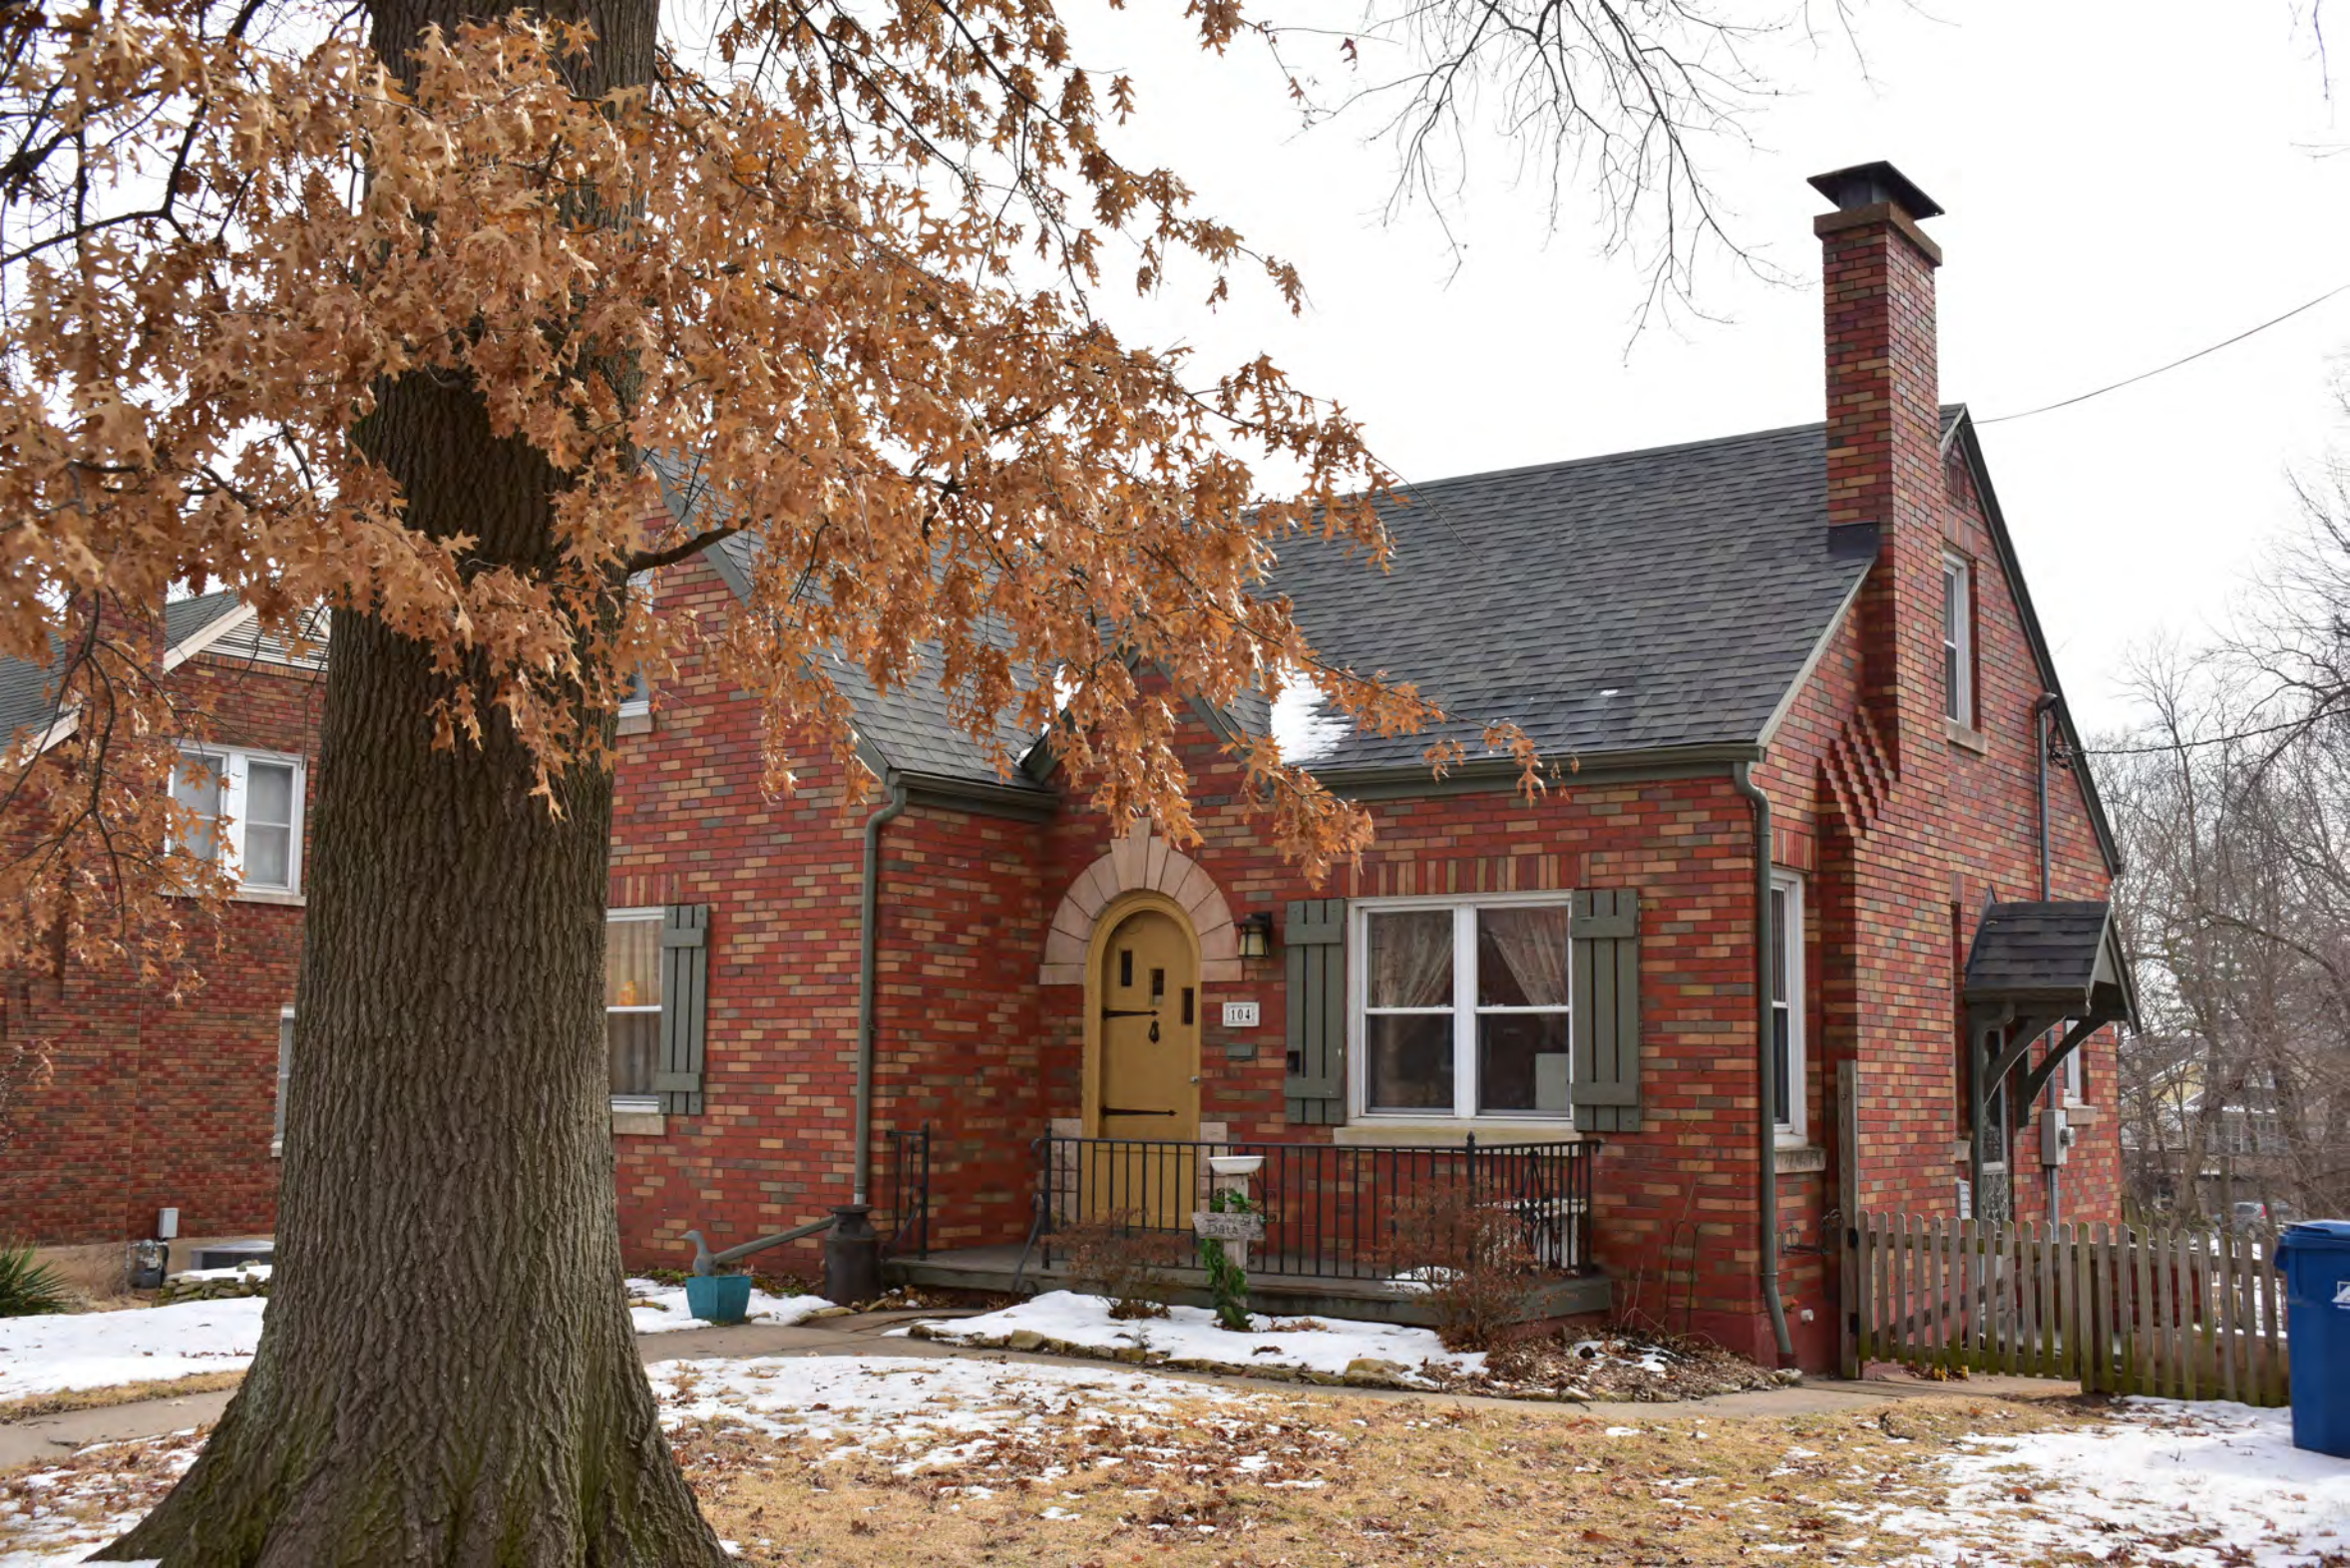
104 East Circle Drive is a one-and-one-half story single-family dwelling with an L-shaped plan. It has multi-color brick cladding, a concrete foundation, and an asphalt side-gable roof. A gable-front ell projects from the north end of the primary elevation. The dwelling is three bays wide and three bays deep. A non-historic 1/1 vinyl window fills the north bay while a pair of matching windows defines the south bay. A small 1/1 non-historic window fills the historic opening in the gable-end of the ell. All windows have stone sills. A rounded arch entrance with a historic wood door defines the center bay. Decorative stonework with a keystone tops the opening while matching stonework frames the bottom-third. A small center wall gable is positioned above the entrance. A concrete platform with metal railing projects below the south two bays. A secondary entrance with concrete stoop is centered on the south elevation. A wood gable shelters the entrance. An exterior chimney with decorative brickwork is positioned east of the entrance. An integrated historic single-car garage is located at basement level and is accessed at the rear.

Alterations to 104 East Circle Drive include the replacement of historic windows with vinyl windows. While the windows are replacements, they fill historic openings and the historic fenestration pattern remains unchanged. 104 East Circle Drive otherwise retains good integrity. This resource would be contributing to the potential Walinko Place Historic District, significant in the areas of Architecture and Community Planning and Development in association with the expansion of Jefferson City and increased suburban development during the twentieth century as well as its associations with Walinko Place, a notable suburban development during the Depression and War Years.

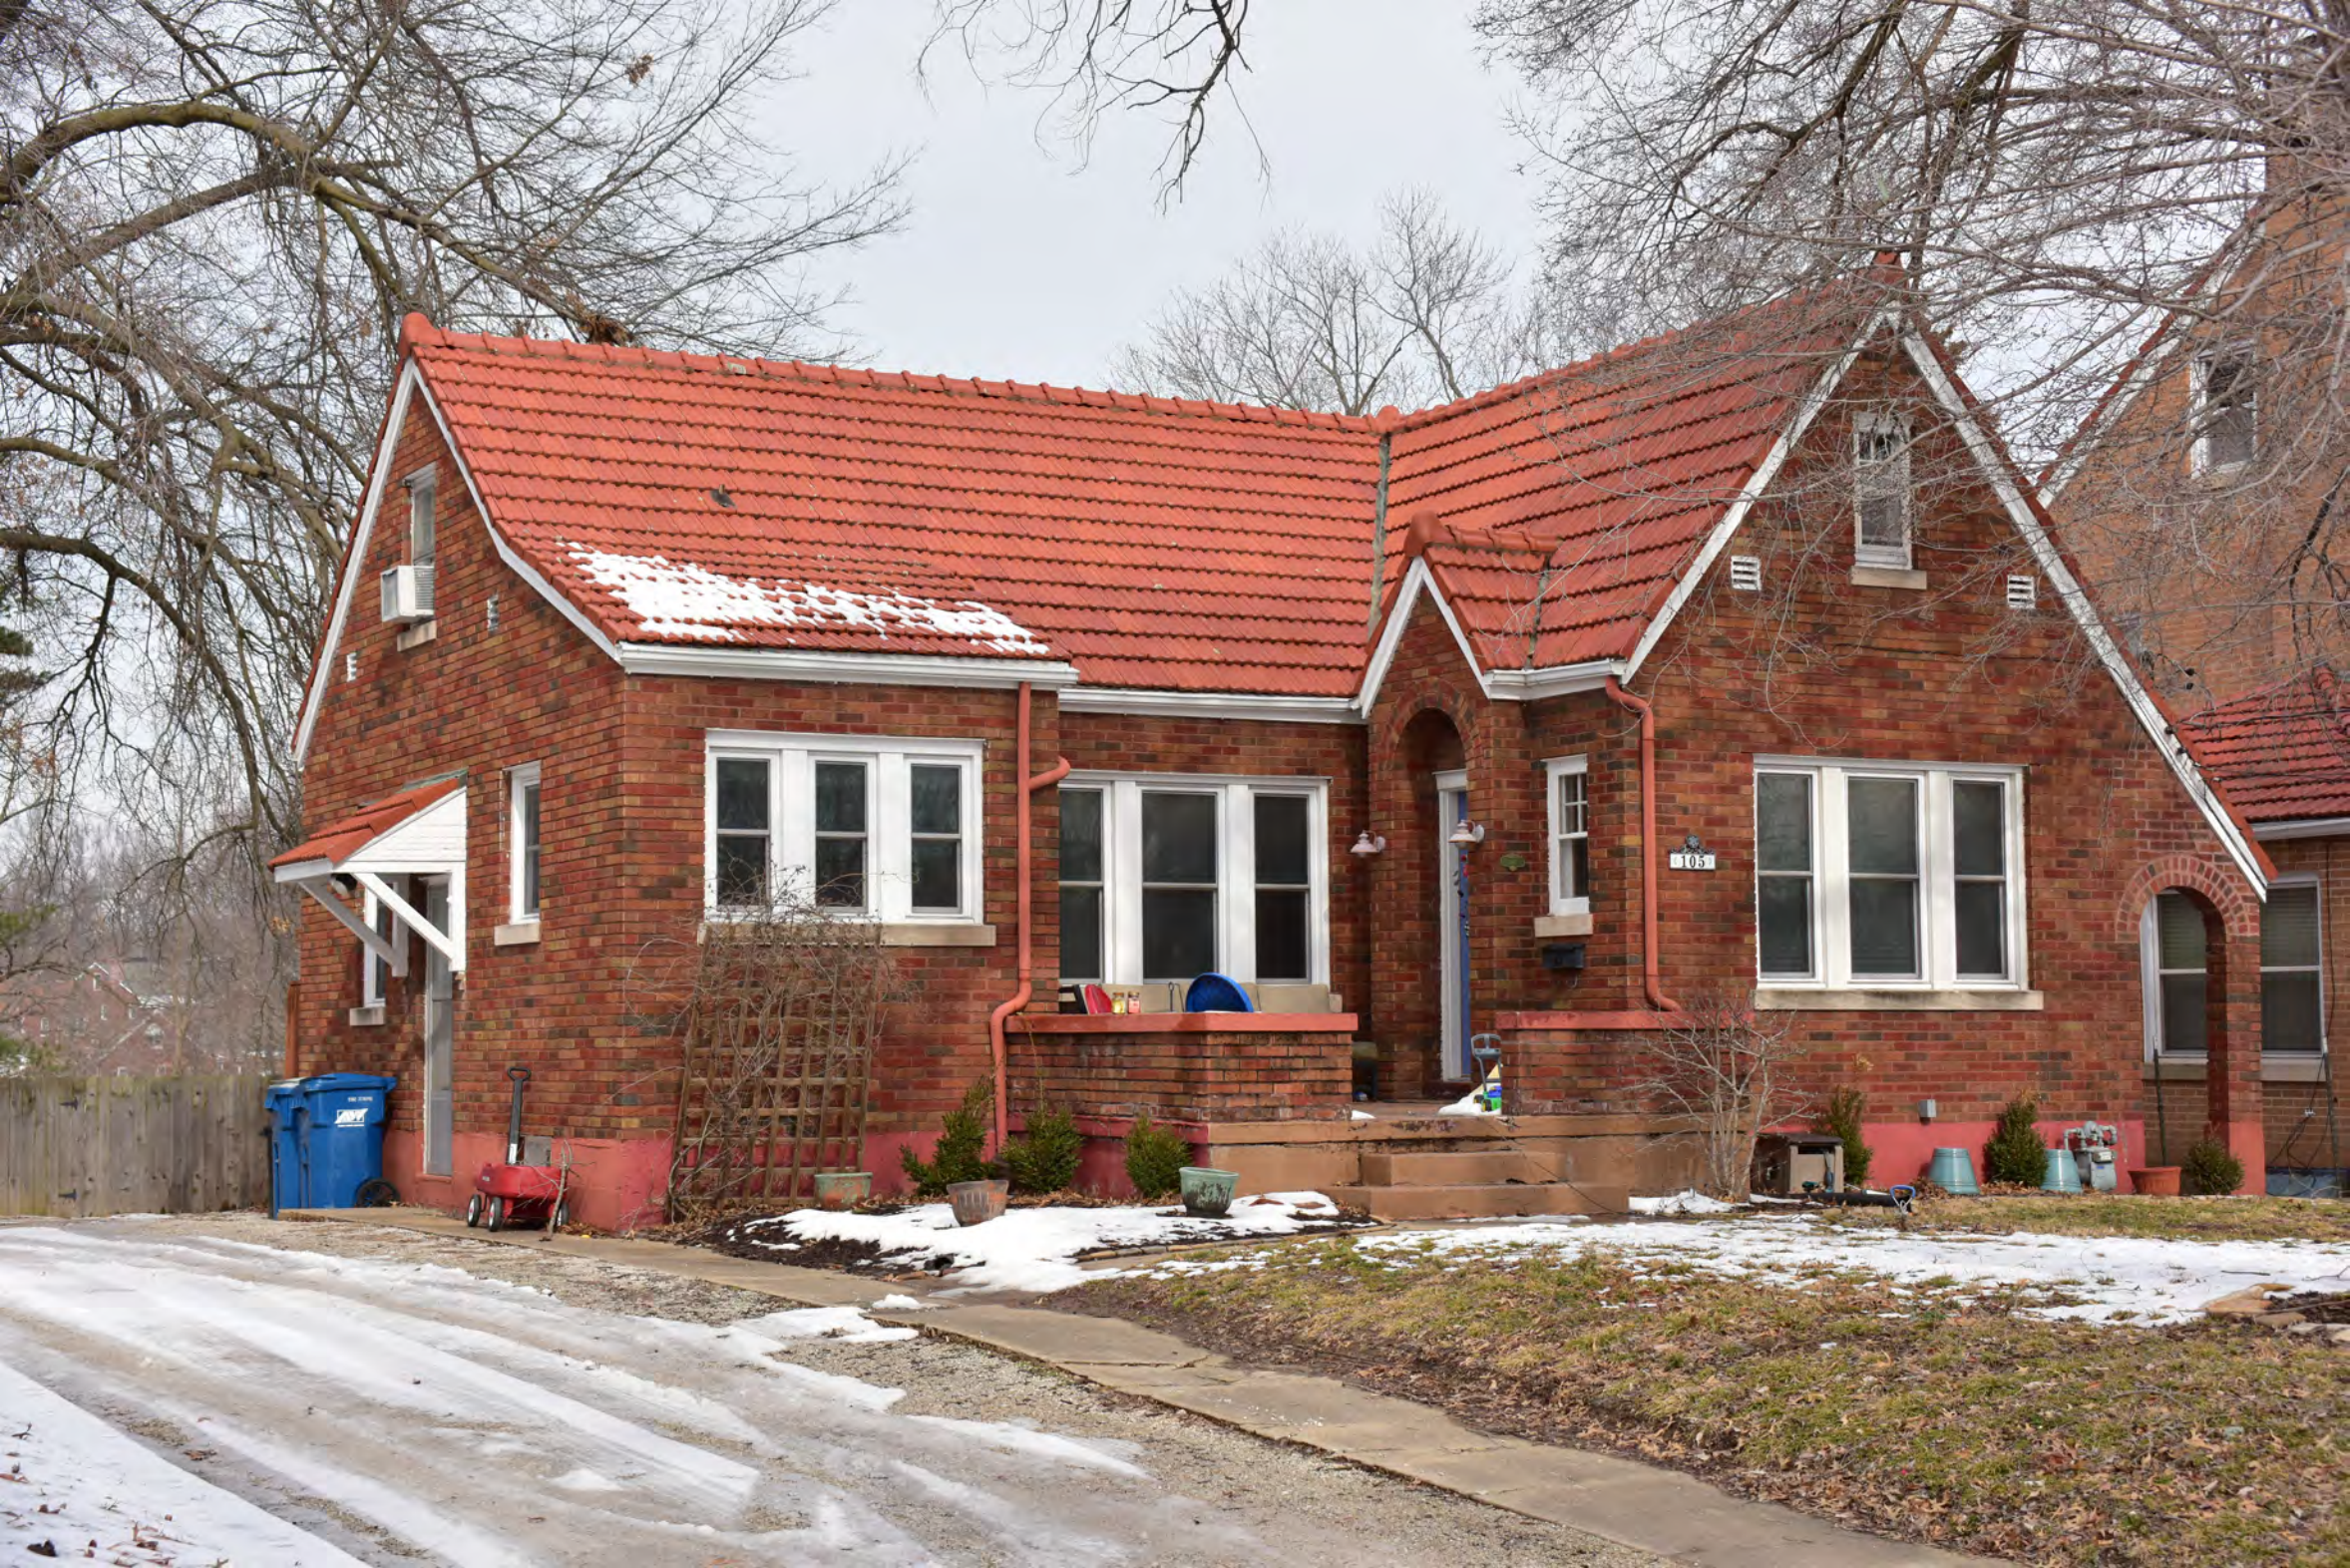
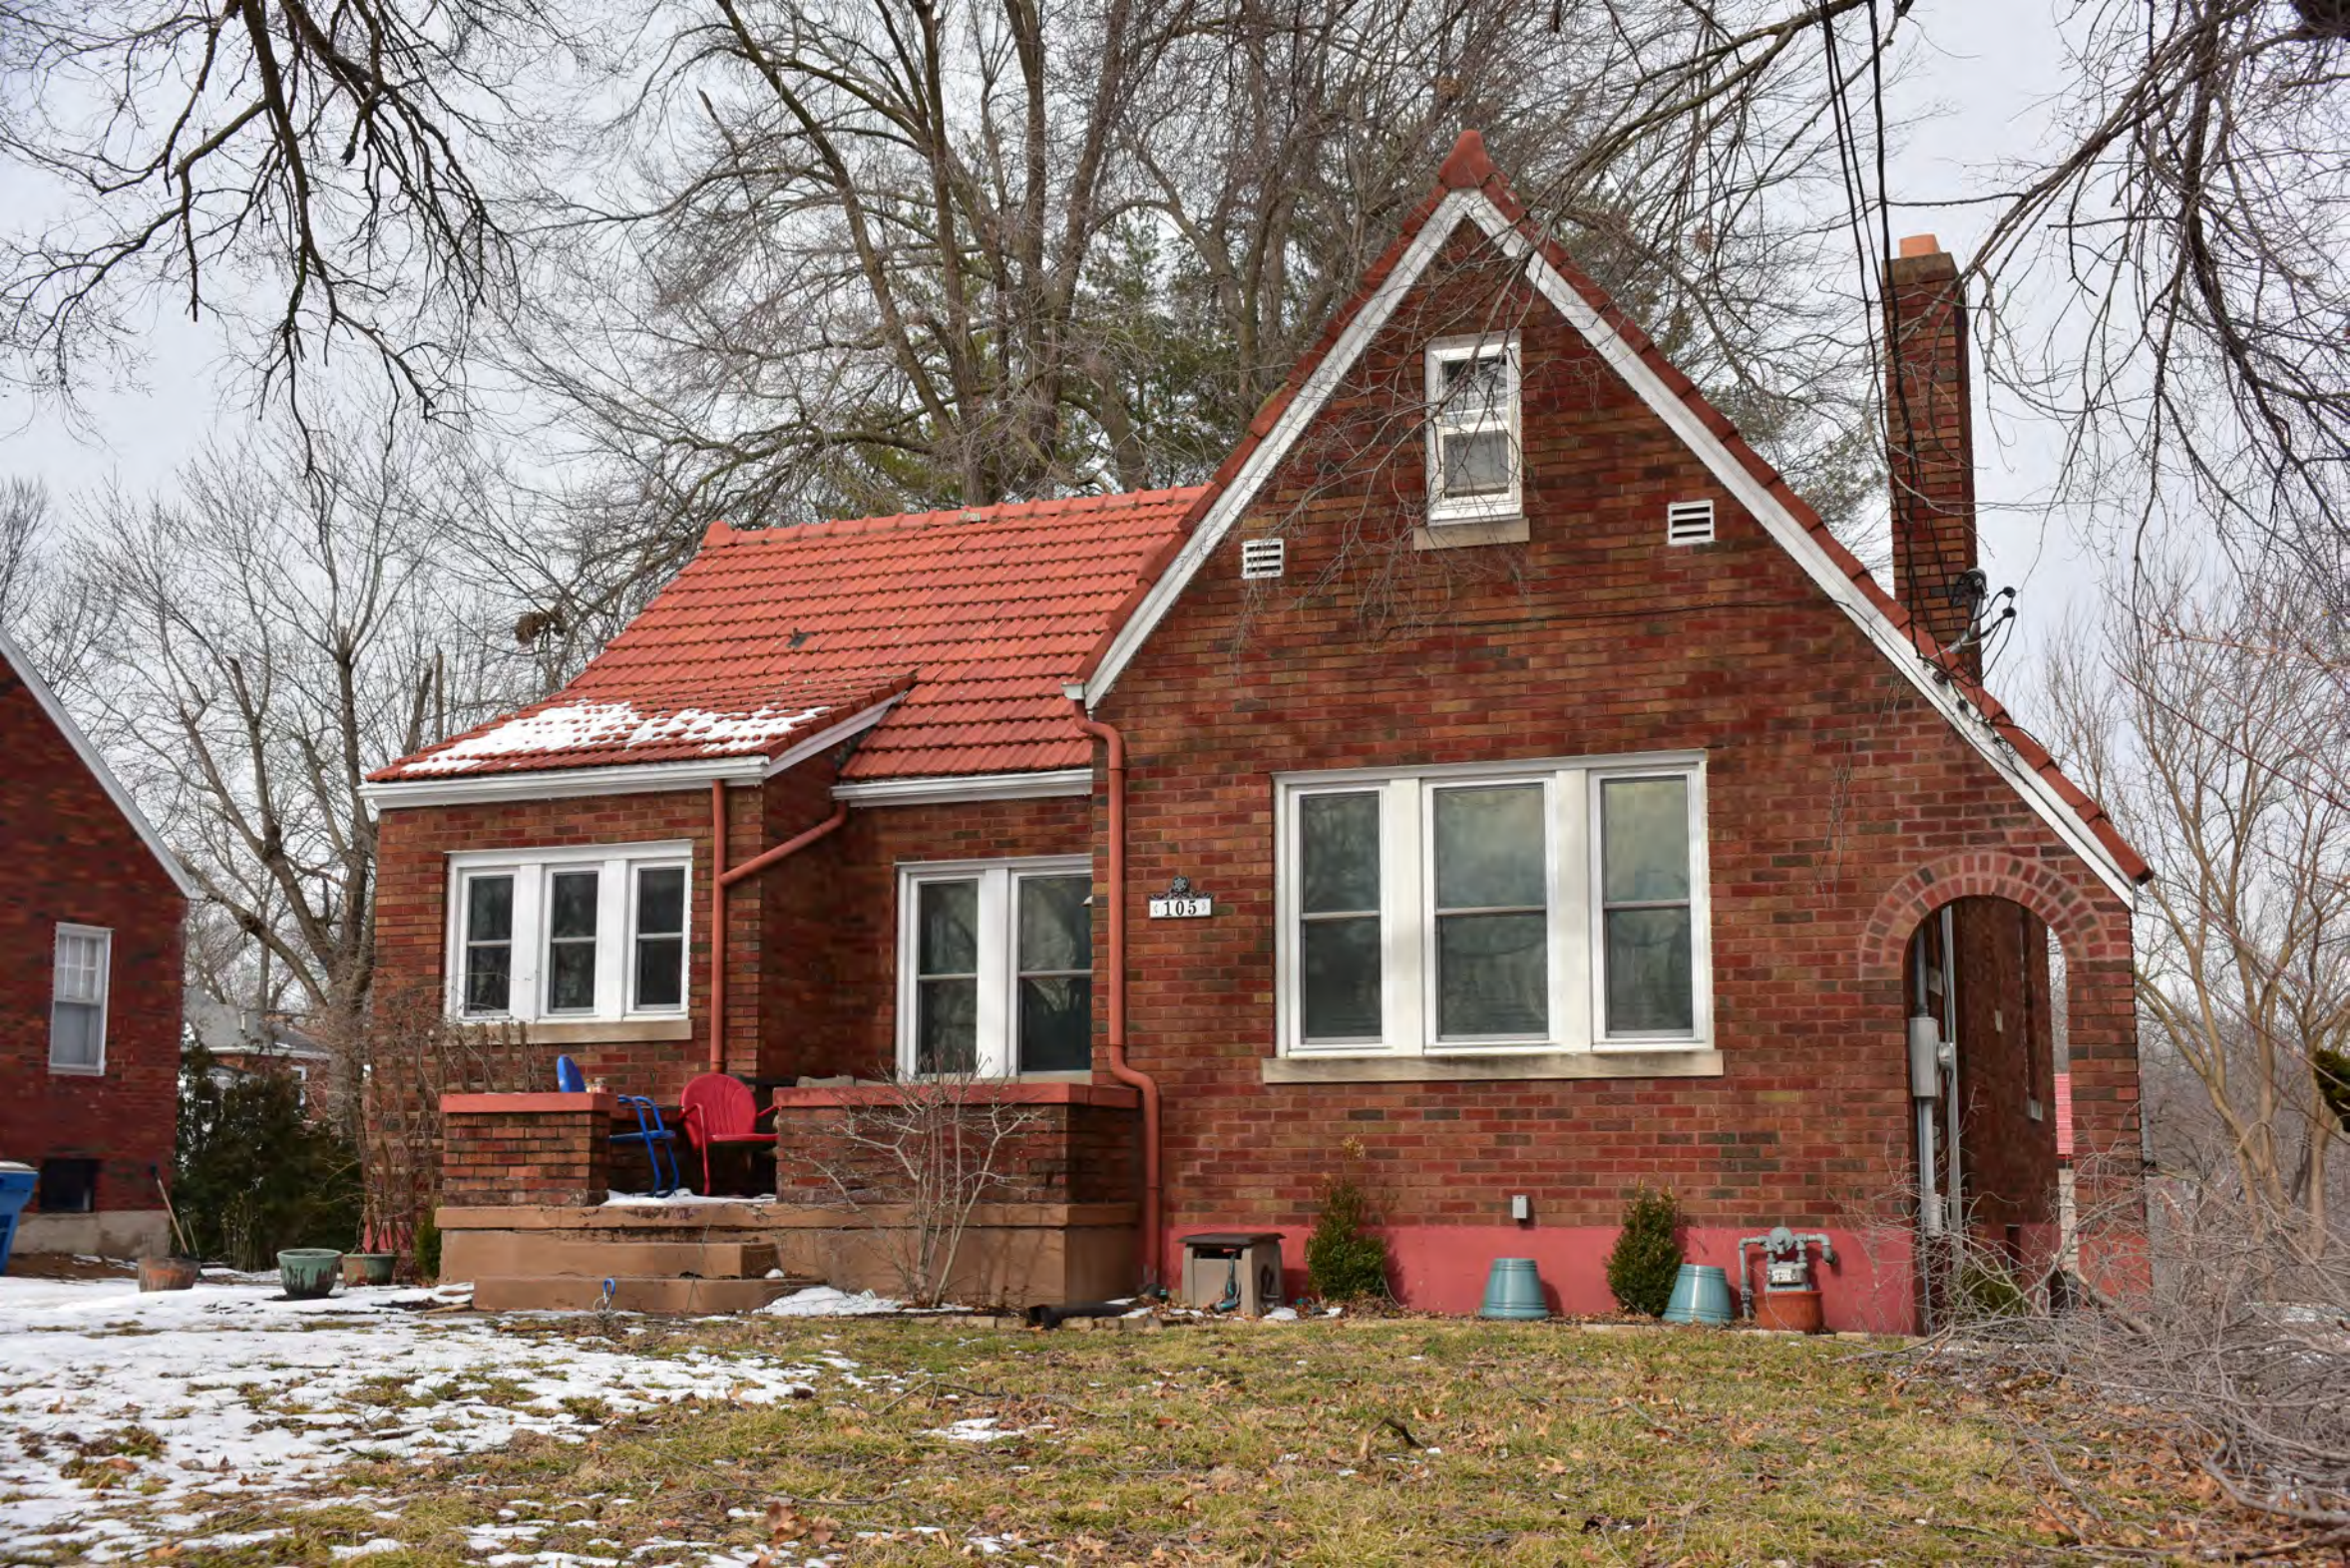
105 East Circle Drive is a one-and-one-half-story single-family dwelling with a U-shaped plan. It is three bays wide and three bays deep. The brick dwelling has a concrete foundation and terra cotta tile roof. A narrow shed-roof ell projects from the south end of the primary elevation while a gable-front ell with a brick wingwall projects from the north. The wingwall contains a rounded arch. A concrete platform porch with brick knee walls extends from the center of the elevation. Three-ganged 1/1 vinyl windows occupy each of the primary elevation bays. A historic 4/1 wood window is centered in the gabled-ell end. The primary entrance is located on the south elevation of the gabled-ell and contains a historic wood door. A small center gable and brick archway shelter the entrance. A small historic 4/1 wood window is positioned west of the entrance. A secondary entrance is centered on the south elevation. A shed roof with wood knee brackets shelters the entrance. A brick side-slope chimney is centered on the north elevation and pierces the eave. An integrated historic single-car garage is located at basement level and is accessed at the rear.

Alterations to 105 East Circle Drive include the replacement of some historic windows with vinyl windows. While the windows are replacements, they fill historic openings and the historic fenestration pattern remains unchanged. 105 East Circle Drive retains good integrity. This resource would be contributing to the potential Walinko Place Historic District, significant in the areas of Architecture and Community Planning and Development in association with the expansion of Jefferson City and increased suburban development during the twentieth century as well as its associations with Walinko Place, a notable suburban development during the Depression and War Years.

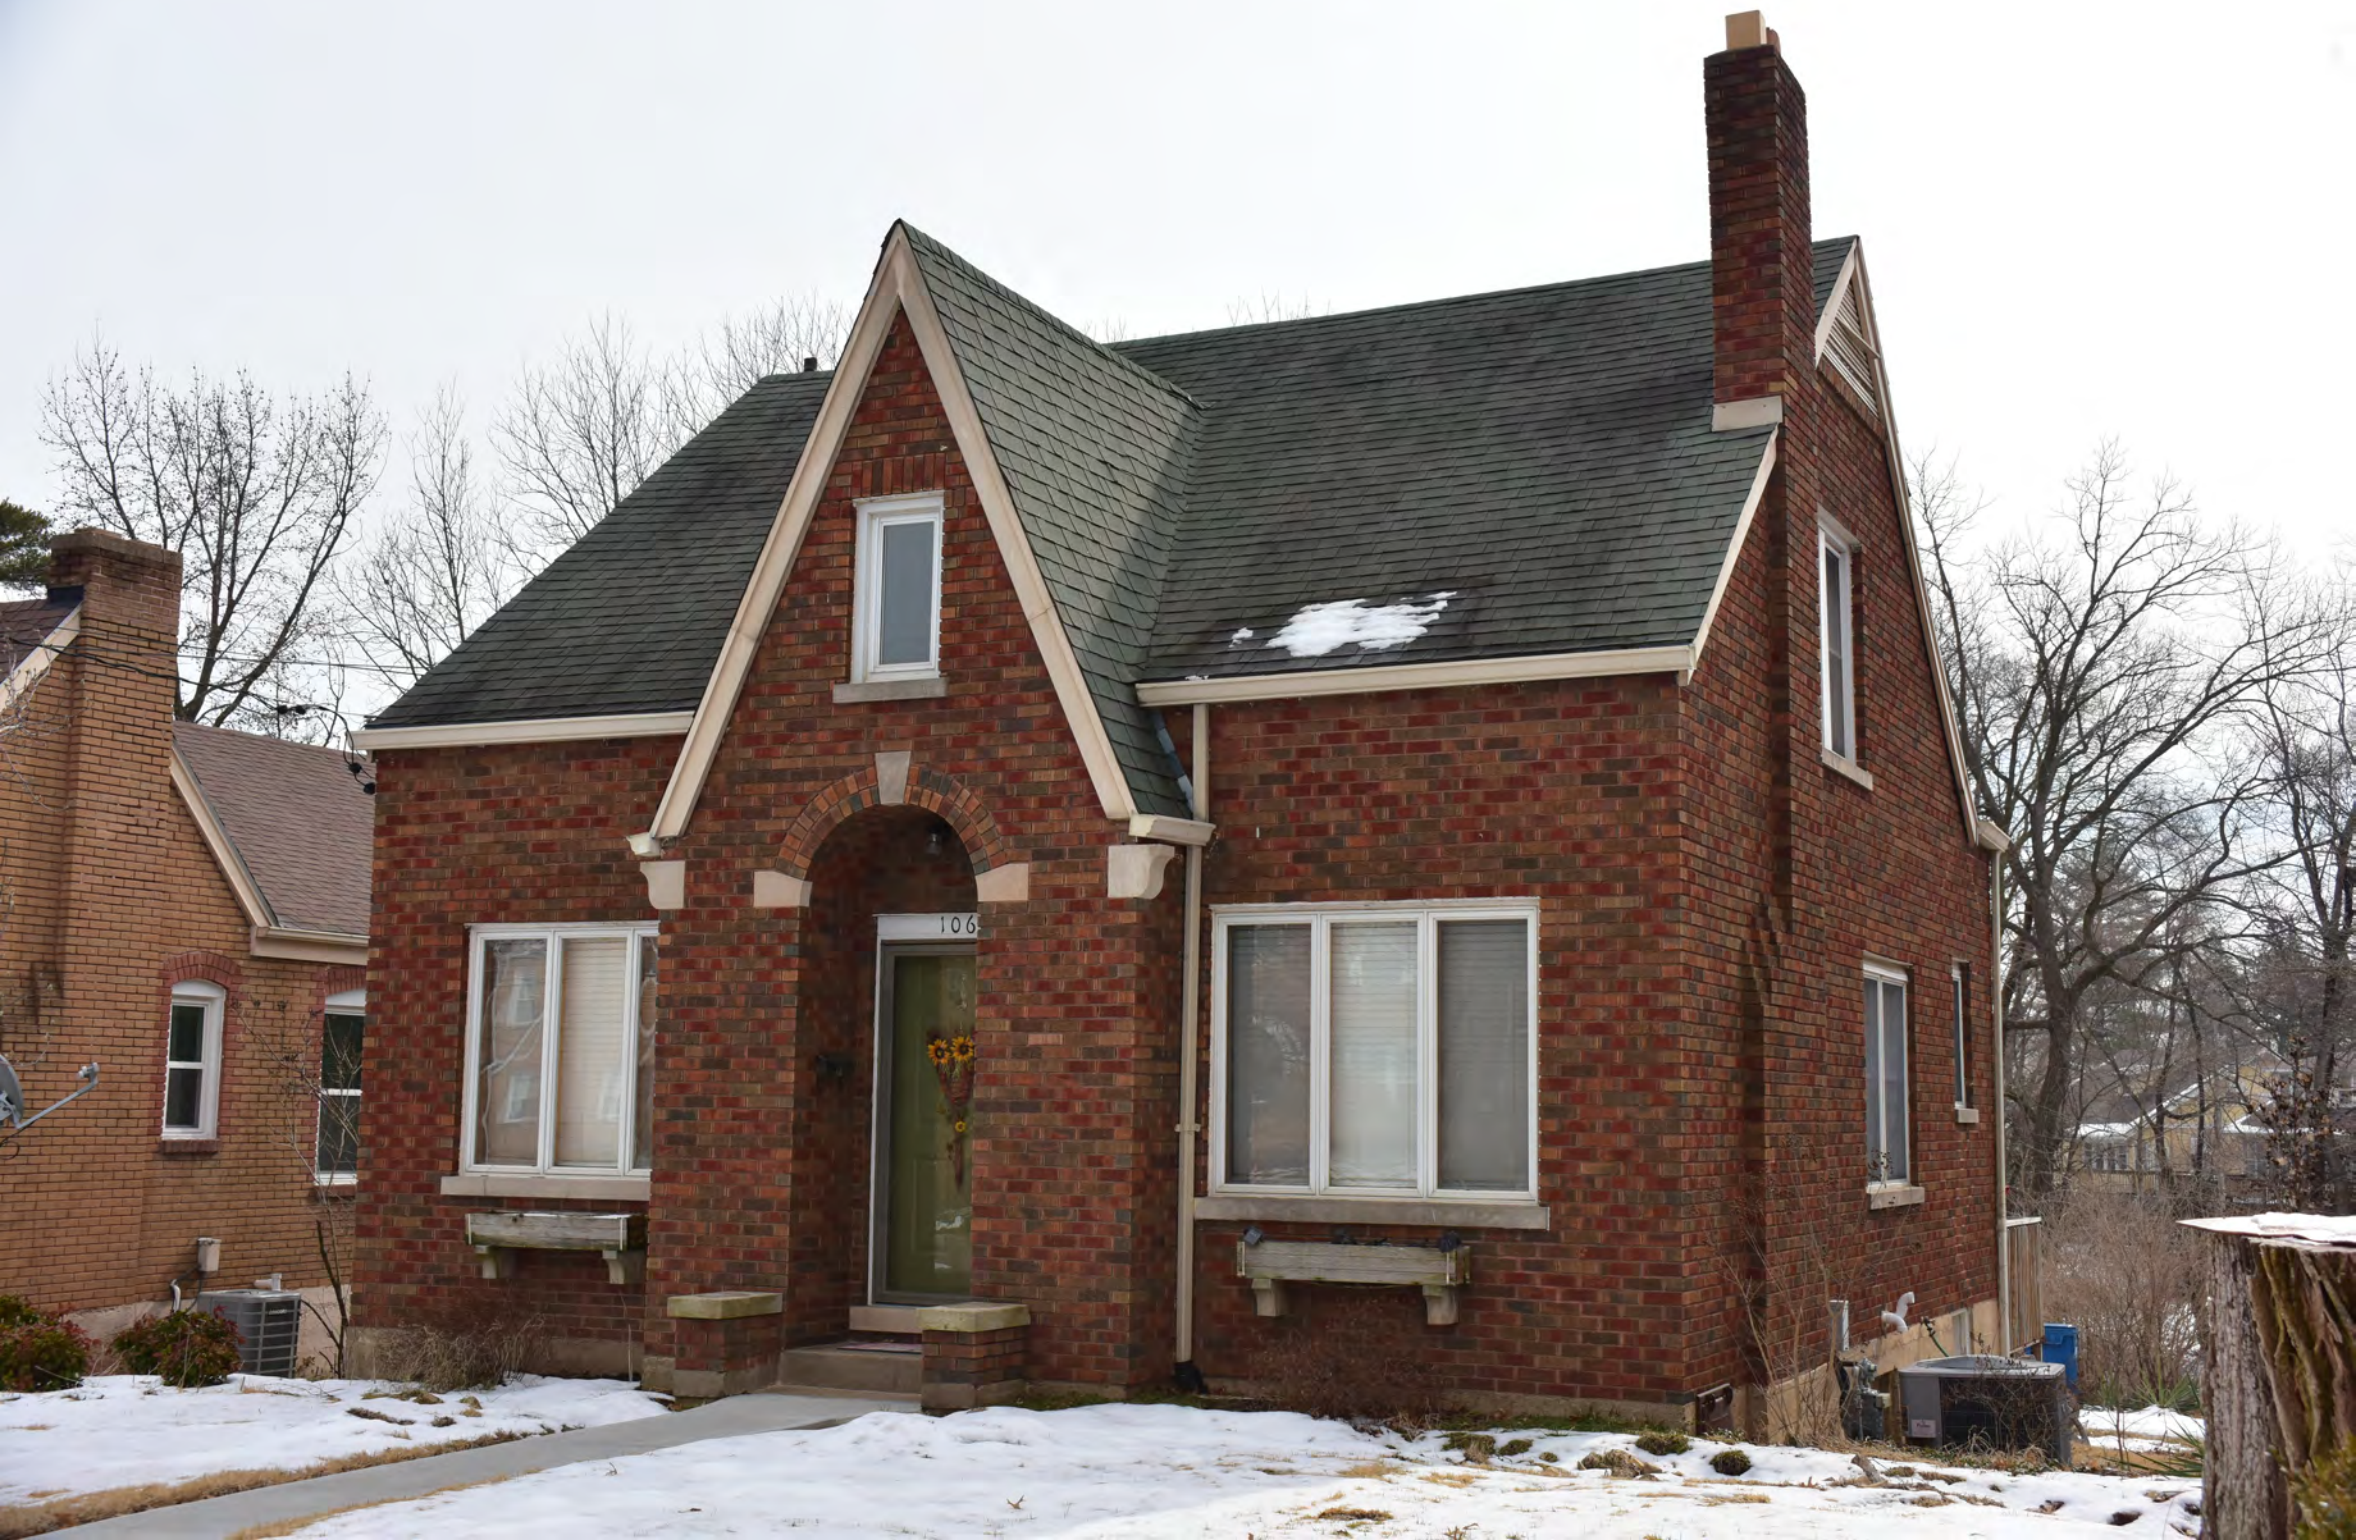
106 East Circle Drive is a one-and-one-half story Minimal Traditional dwelling. It has a concrete foundation, brick cladding, and an asphalt cross-gable roof with narrow eaves. A brick exterior chimney projects slightly from the north elevation and pierces the eave. The dwelling is three bays wide and three bays deep. Tripartite single-pane casement windows with storm windows define the north and south bays of the primary elevation while the entrance defines the center bay. The primary elevation cross-gable projects from a shallow porch with a rounded brick arch which shelters the concrete stoop. The round arched opening has exaggerated concrete voussoirs at the keystone and spring points. Low, concrete-capped knee walls flank the arch. A one-light window is centered in the cross-gable. Secondary elevation windows are historic 1/1 wood sash. All windows have storm windows and stone sills. Historic stone window box brackets are centered under the primary elevation picture windows. An integrated historic single-car garage is located at basement level and is accessed at the rear. A non-historic wood deck projects from the rear elevation.

Alterations to 106 East Circle Drive include the replacement of historic windows with vinyl windows at the primary elevation and a non-historic wood deck at the rear elevation. While the windows are replacements, they fill historic openings and the historic fenestration pattern remains unchanged and historic windows remain at all secondary elevations visible from the right of way. The deck is minimally visible from the right of way and does not obscure the historic form. 106 East Circle Drive retains good integrity. This resource would be contributing to the potential Walinko Place Historic District, significant in the areas of Architecture and Community Planning and Development in association with the expansion of Jefferson City and increased suburban development during the twentieth century as well as its associations with Walinko Place, a notable suburban development during the Depression and War Years.
