1. Survey number: CO-AS-008-001		2. Survey Name: West Main Street Survey	
3. County: Cole		4. Address (Street No.): 100	Street (name): East Circle Drive
5. City: Jefferson City	Vicinity <input type="checkbox"/>	6. Lat / Long:	7. Township/Range/Section: T: R: S:
8. Historic name (if known):		9. Present/other name (if known):	
10. Ownership: <input checked="" type="checkbox"/> Private <input type="checkbox"/> Public		11a. Historic use (if known): Domestic-Single Dwelling	11b. Current use: Domestic-Single Dwelling

MISSOURI DEPARTMENT OF NATURAL RESOURCES
STATE HISTORIC PRESERVATION OFFICE, P.O. Box 178, Jefferson City, MO 65102
ARCHITECTURAL/HISTORIC INVENTORY FORM

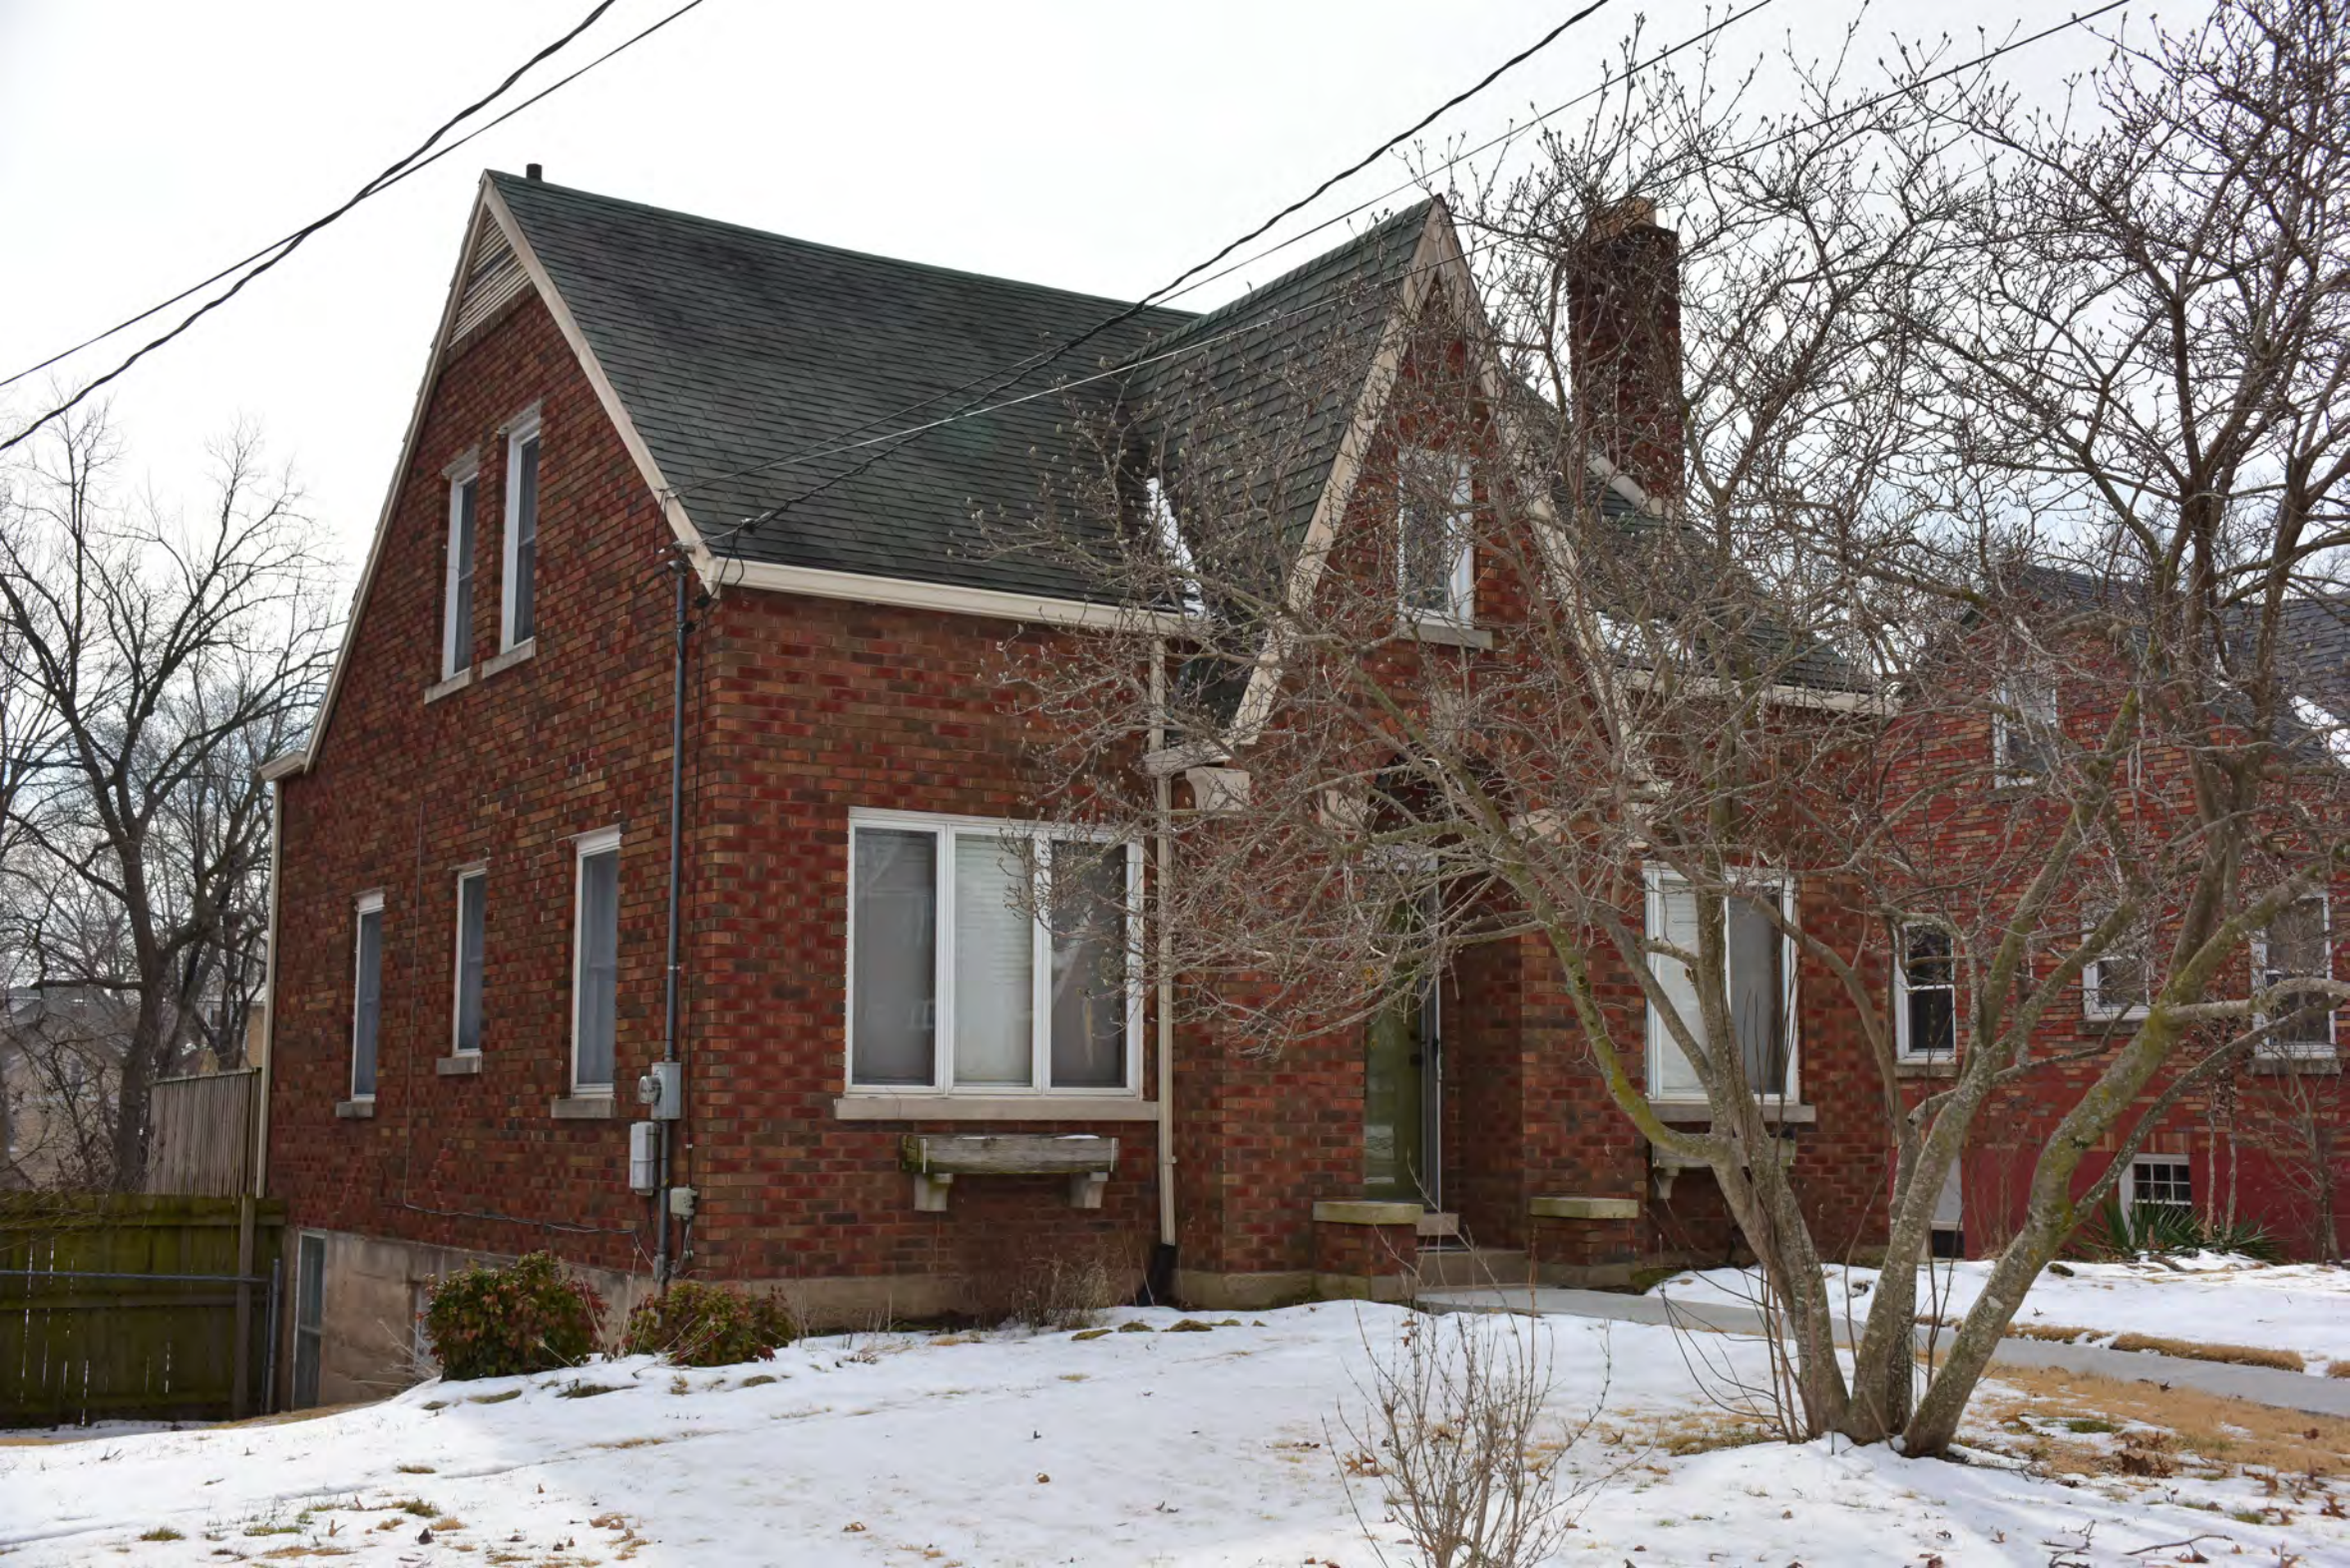
106 East Circle Drive is a one-and-one-half story Minimal Traditional dwelling. It has a concrete foundation, brick cladding, and an asphalt cross-gable roof with narrow eaves. A brick exterior chimney projects slightly from the north elevation and pierces the eave. The dwelling is three bays wide and three bays deep. Tripartite single-pane casement windows with storm windows define the north and south bays of the primary elevation while the entrance defines the center bay. The primary elevation cross-gable projects from a shallow porch with a rounded brick arch which shelters the concrete stoop. The round arched opening has exaggerated concrete voussoirs at the keystone and spring points. Low, concrete-capped knee walls flank the arch. A one-light window is centered in the cross-gable. Secondary elevation windows are historic 1/1 wood sash. All windows have storm windows and stone sills. Historic stone window box brackets are centered under the primary elevation picture windows. An integrated historic single-car garage is located at basement level and is accessed at the rear. A non-historic wood deck projects from the rear elevation.

Alterations to 106 East Circle Drive include the replacement of historic windows with vinyl windows at the primary elevation and a non-historic wood deck at the rear elevation. While the windows are replacements, they fill historic openings and the historic fenestration pattern remains unchanged and historic windows remain at all secondary elevations visible from the right of way. The deck is minimally visible from the right of way and does not obscure the historic form. 106 East Circle Drive retains good integrity. This resource would be contributing to the potential Walinko Place Historic District, significant in the areas of Architecture and Community Planning and Development in association with the expansion of Jefferson City and increased suburban development during the twentieth century as well as its associations with Walinko Place, a notable suburban development during the Depression and War Years.

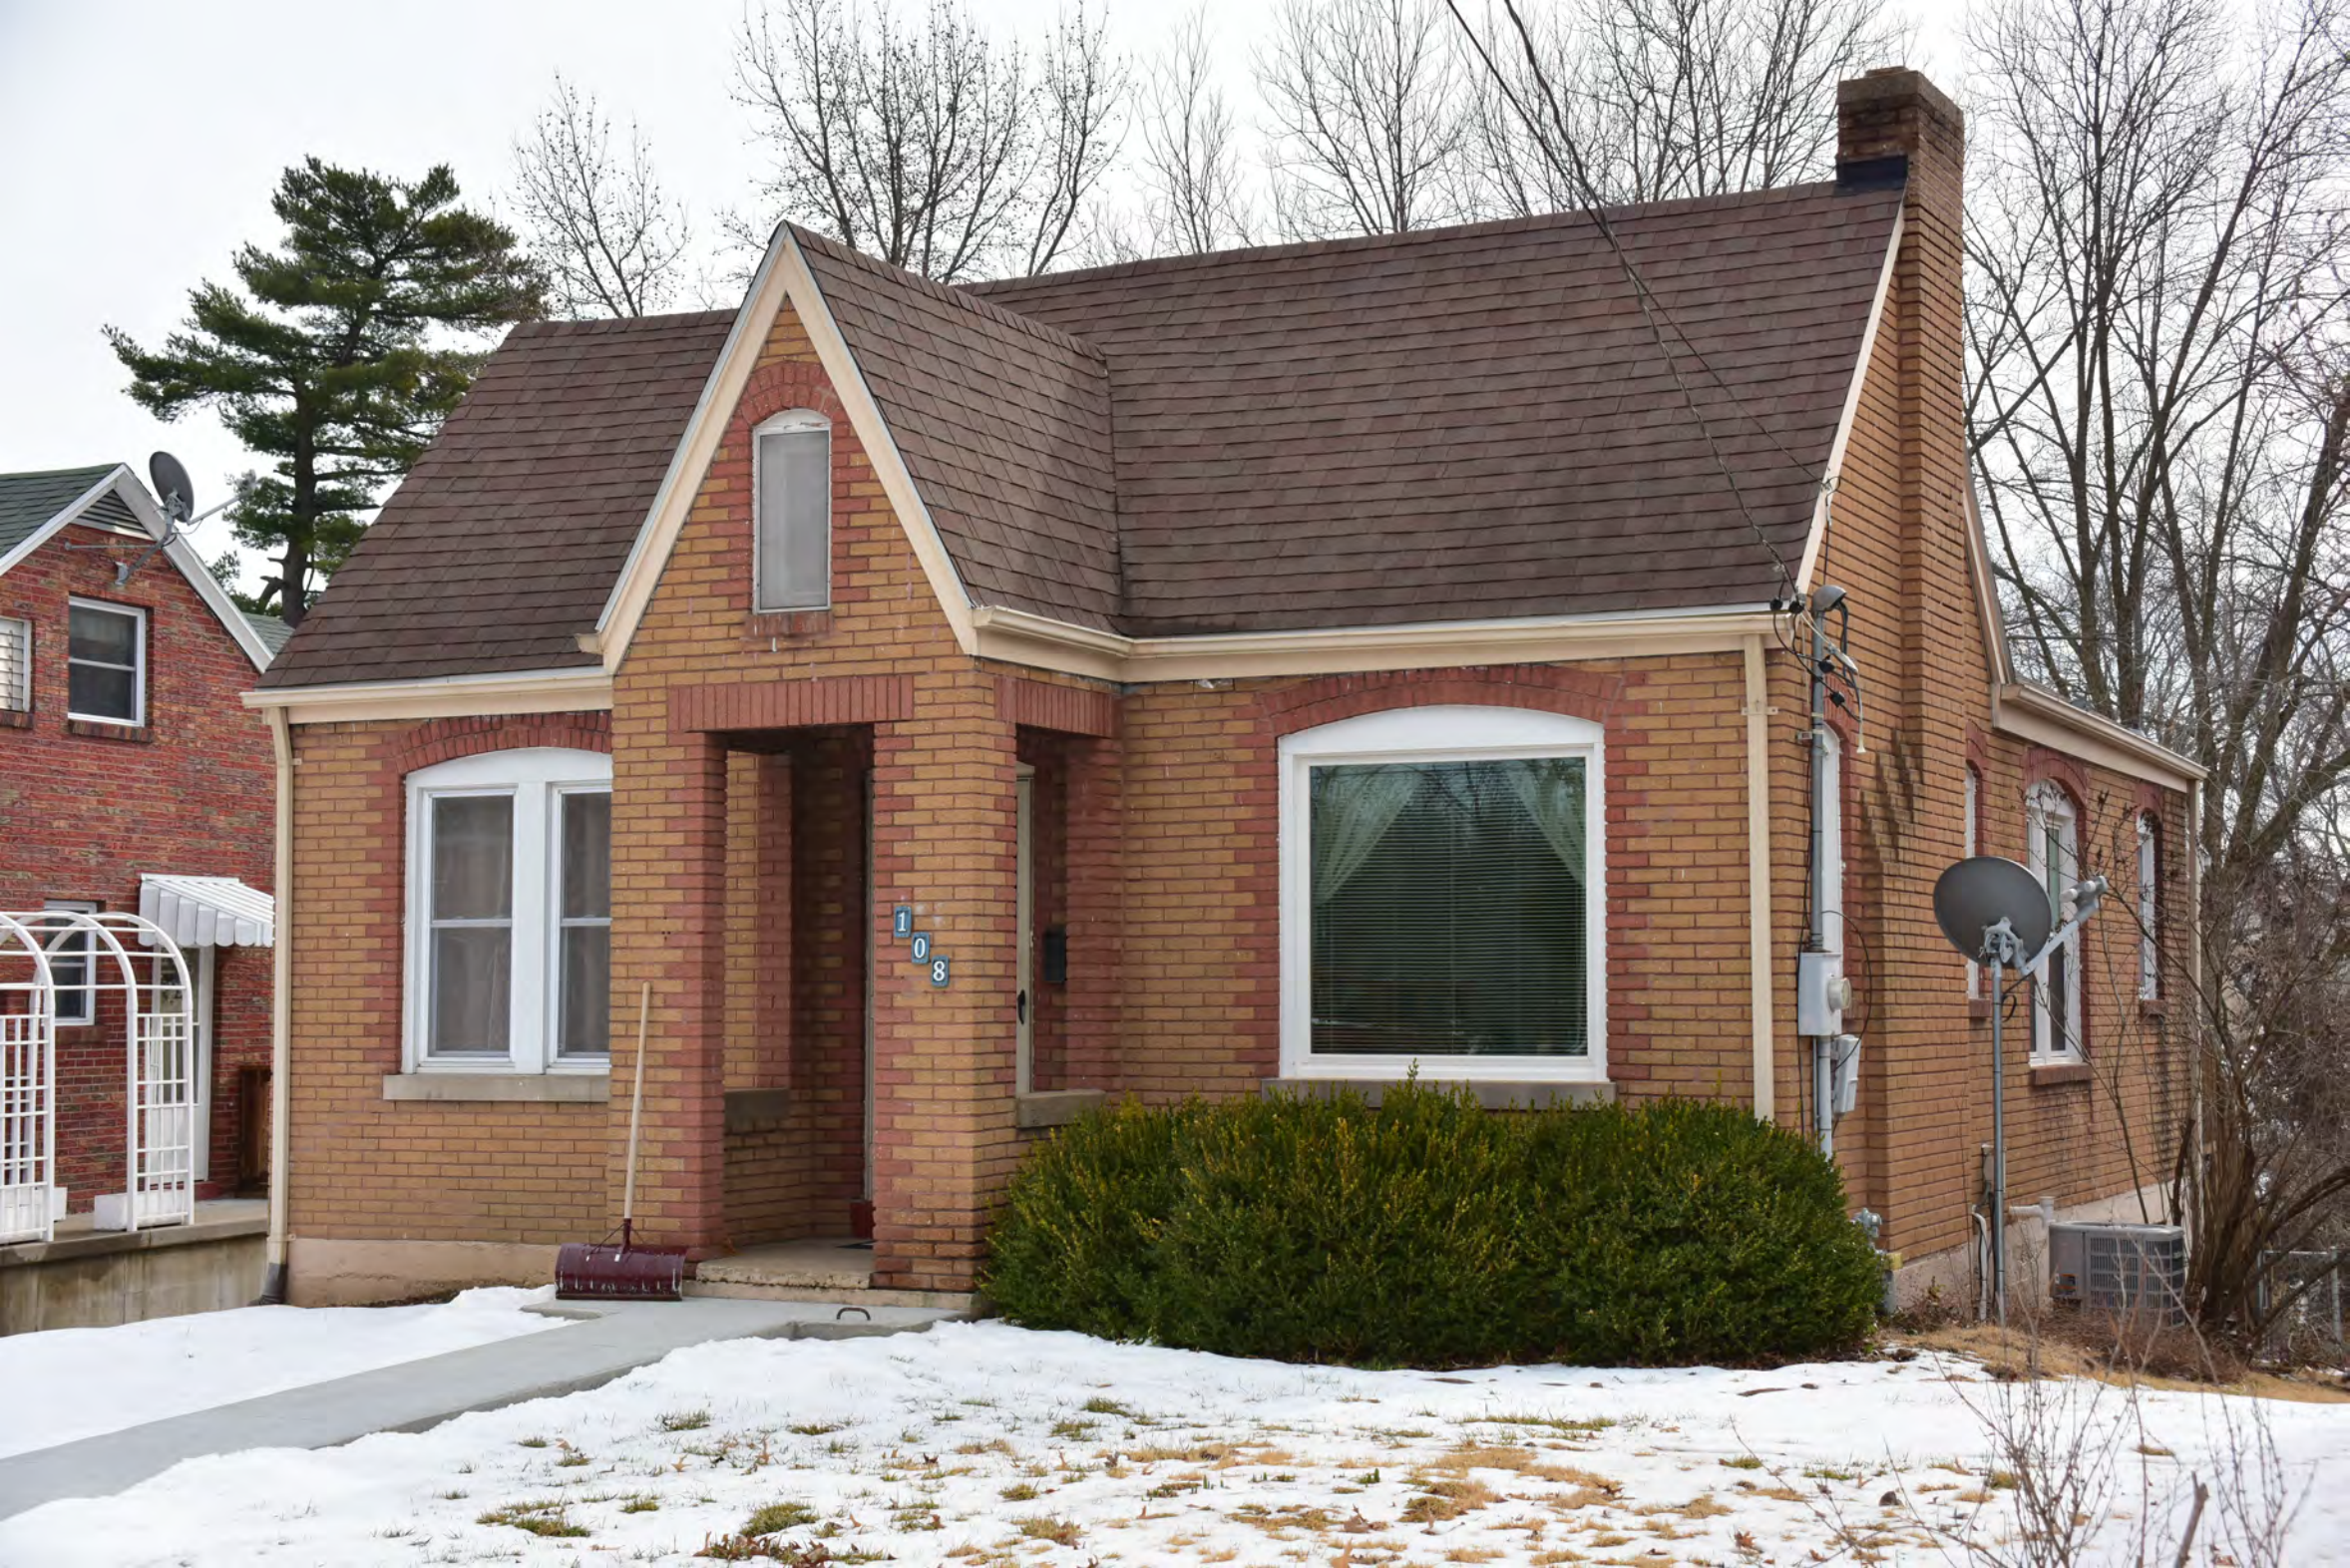
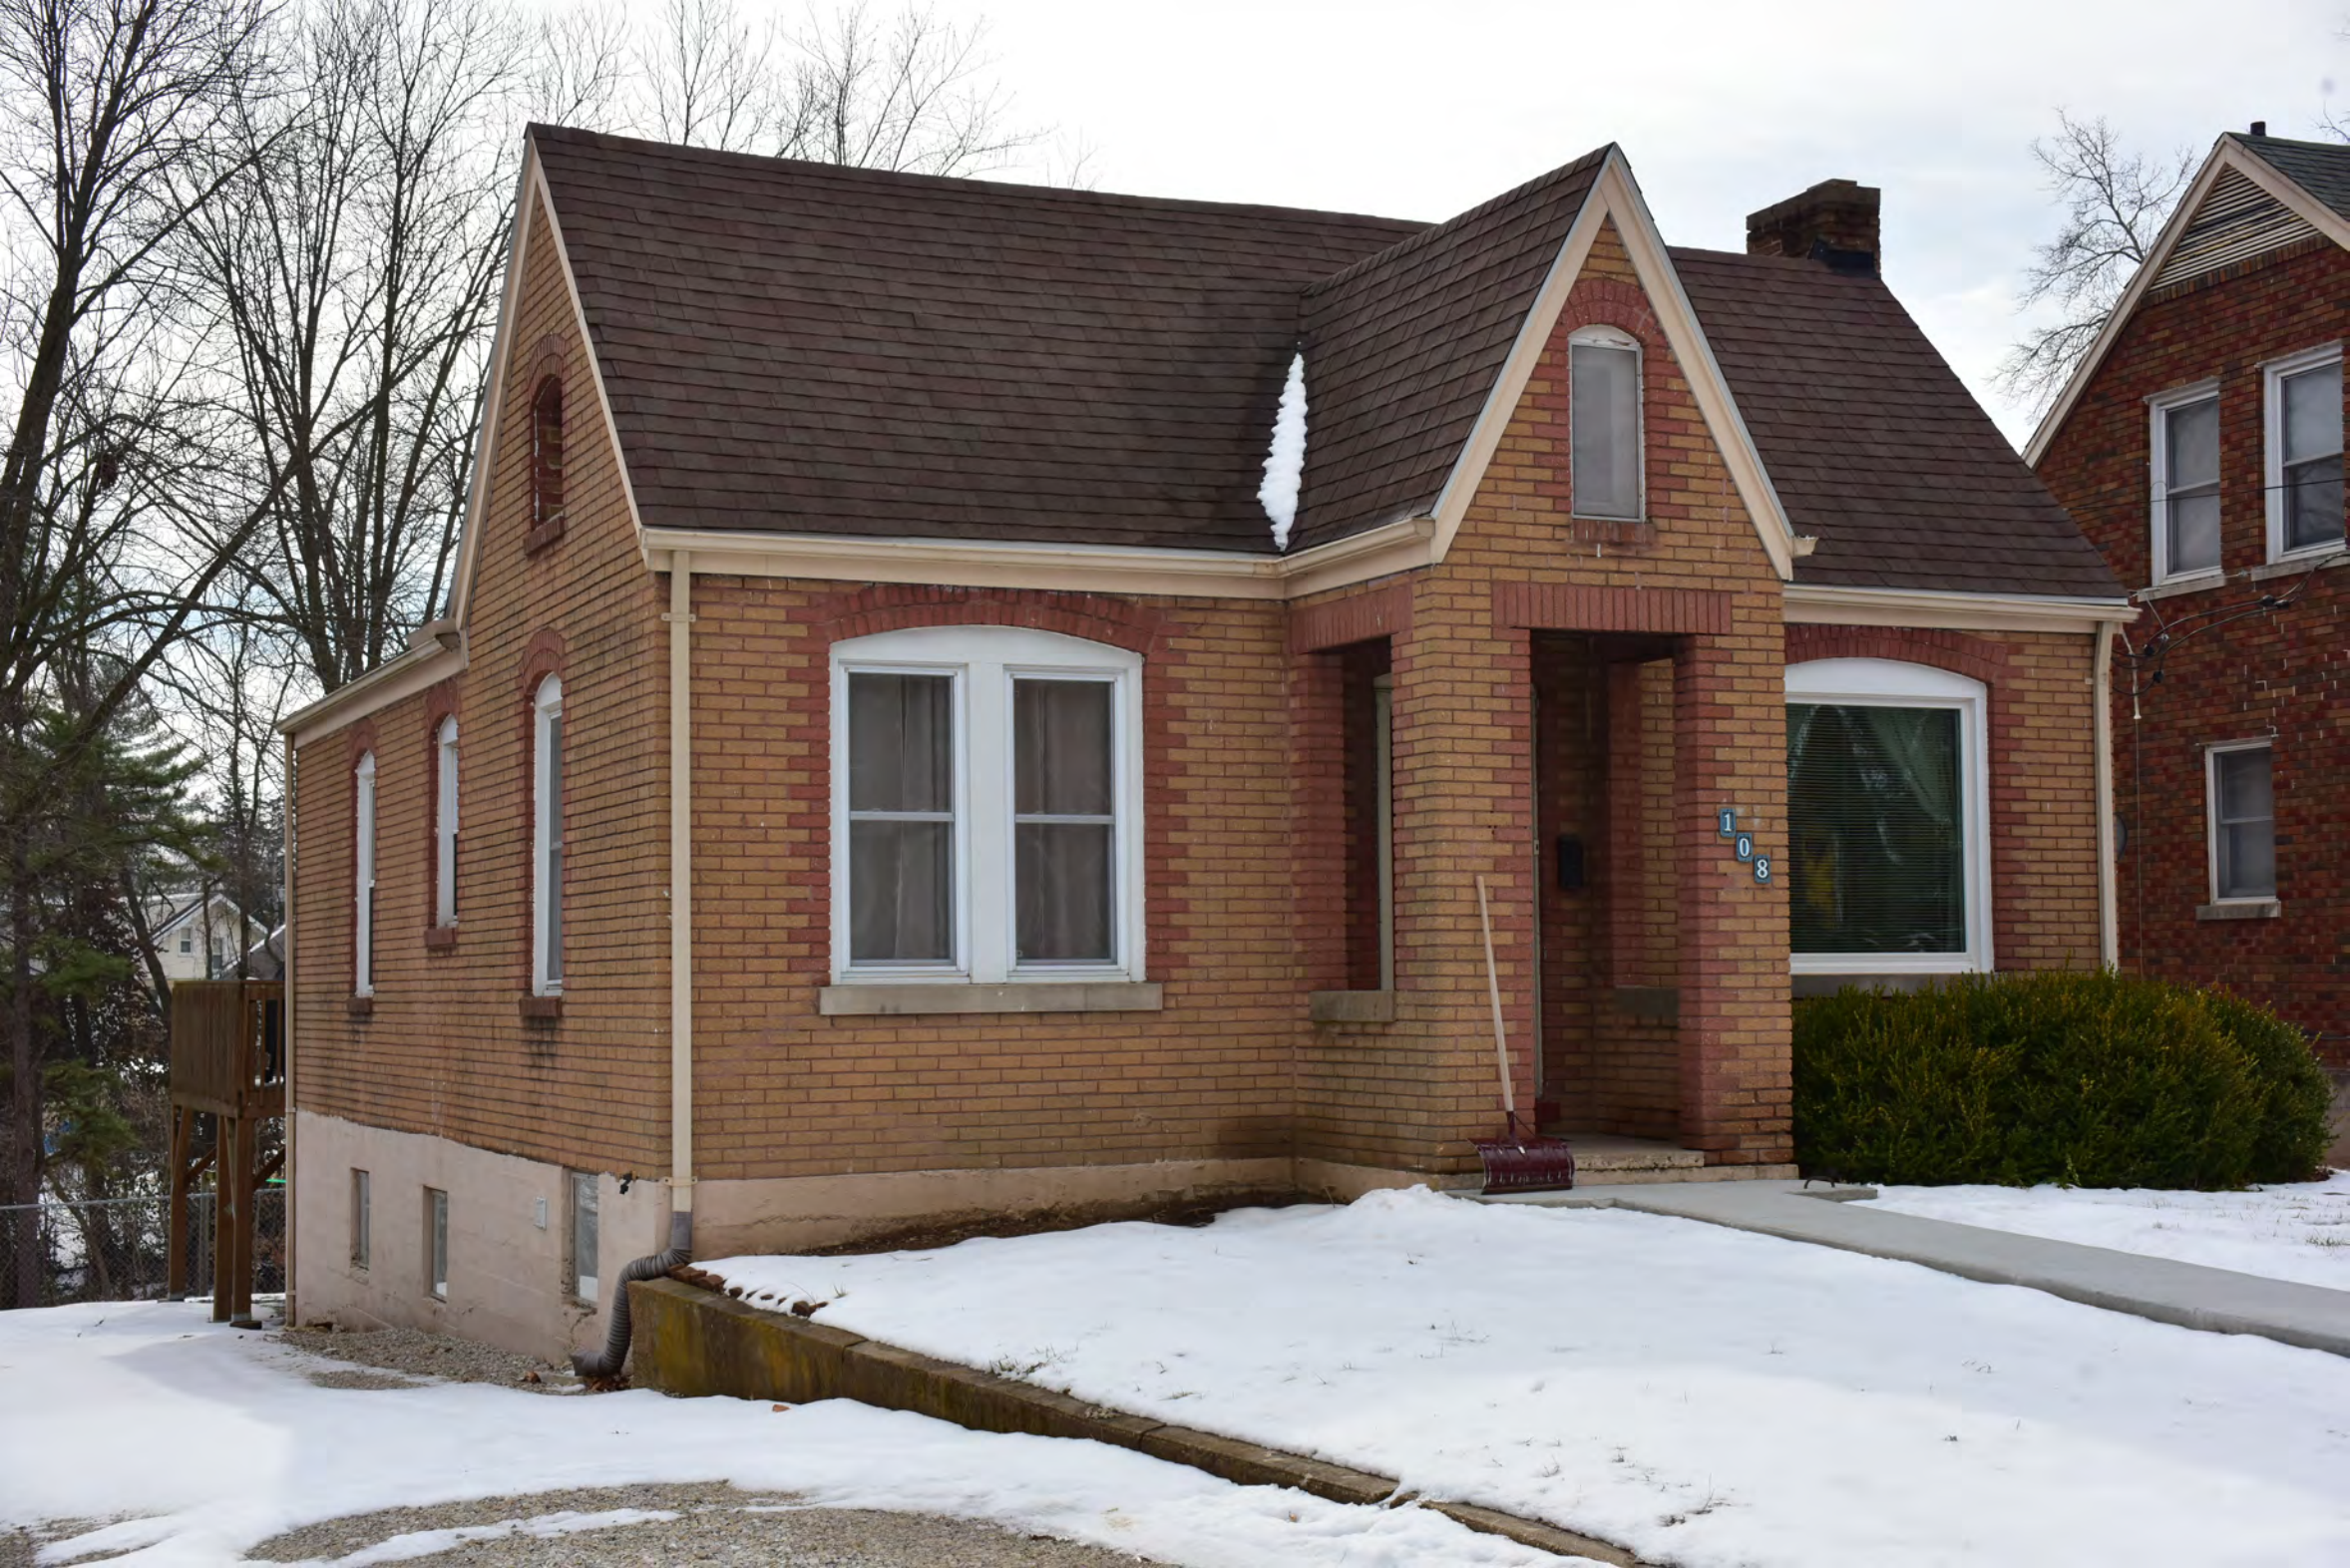
108 East Circle Drive is a one story Minimal Traditional dwelling. It has a concrete foundation, yellow brick cladding, and an asphalt intersecting-gable roof with narrow eaves. A side-gable fronts East Circle Drive while a perpendicular gable extends to the west. A brick exterior chimney projects slightly from the south elevation and pierces the eave. The dwelling is three bays wide. A center gable projects to form a narrow open porch with brick columns and defines the center bay. Low, concrete-capped brick knee walls line the north and south sides of the porch. The porch shelters the primary entrance which features a historic three-light wood door and restrained Colonial pediment. A pair of non-historic 1/1 vinyl windows fills the north bay while a non-historic one-light vinyl picture window fills the south bay. Both window bays have segmental arch openings and concrete sills. A historic one-light window with segmental arch opening and brick sill is located in the center gable. The secondary elevation windows are 1/1 replacements with segmental arch openings and brick sills. Red brick accents each window and door opening on all elevations, excluding those at basement level. An integrated historic single-car garage is located at basement level and is accessed at the rear. A c. 2007 enclosed sunporch addition projects from the rear of the dwelling

Alterations to 108 East Circle Drive include the replacement of historic windows and a rear addition. Although the windows are replacements, they fill historic openings and the addition is not visible from the public right of way nor does it obscure the original form or design. This resource retains good integrity would be contributing to the potential Walinko Place Historic District, significant in the areas of Architecture and Community Planning and Development in association with the expansion of Jefferson City and increased suburban development during the twentieth century as well as its associations with Walinko Place, a notable suburban development during the Depression and War Years.

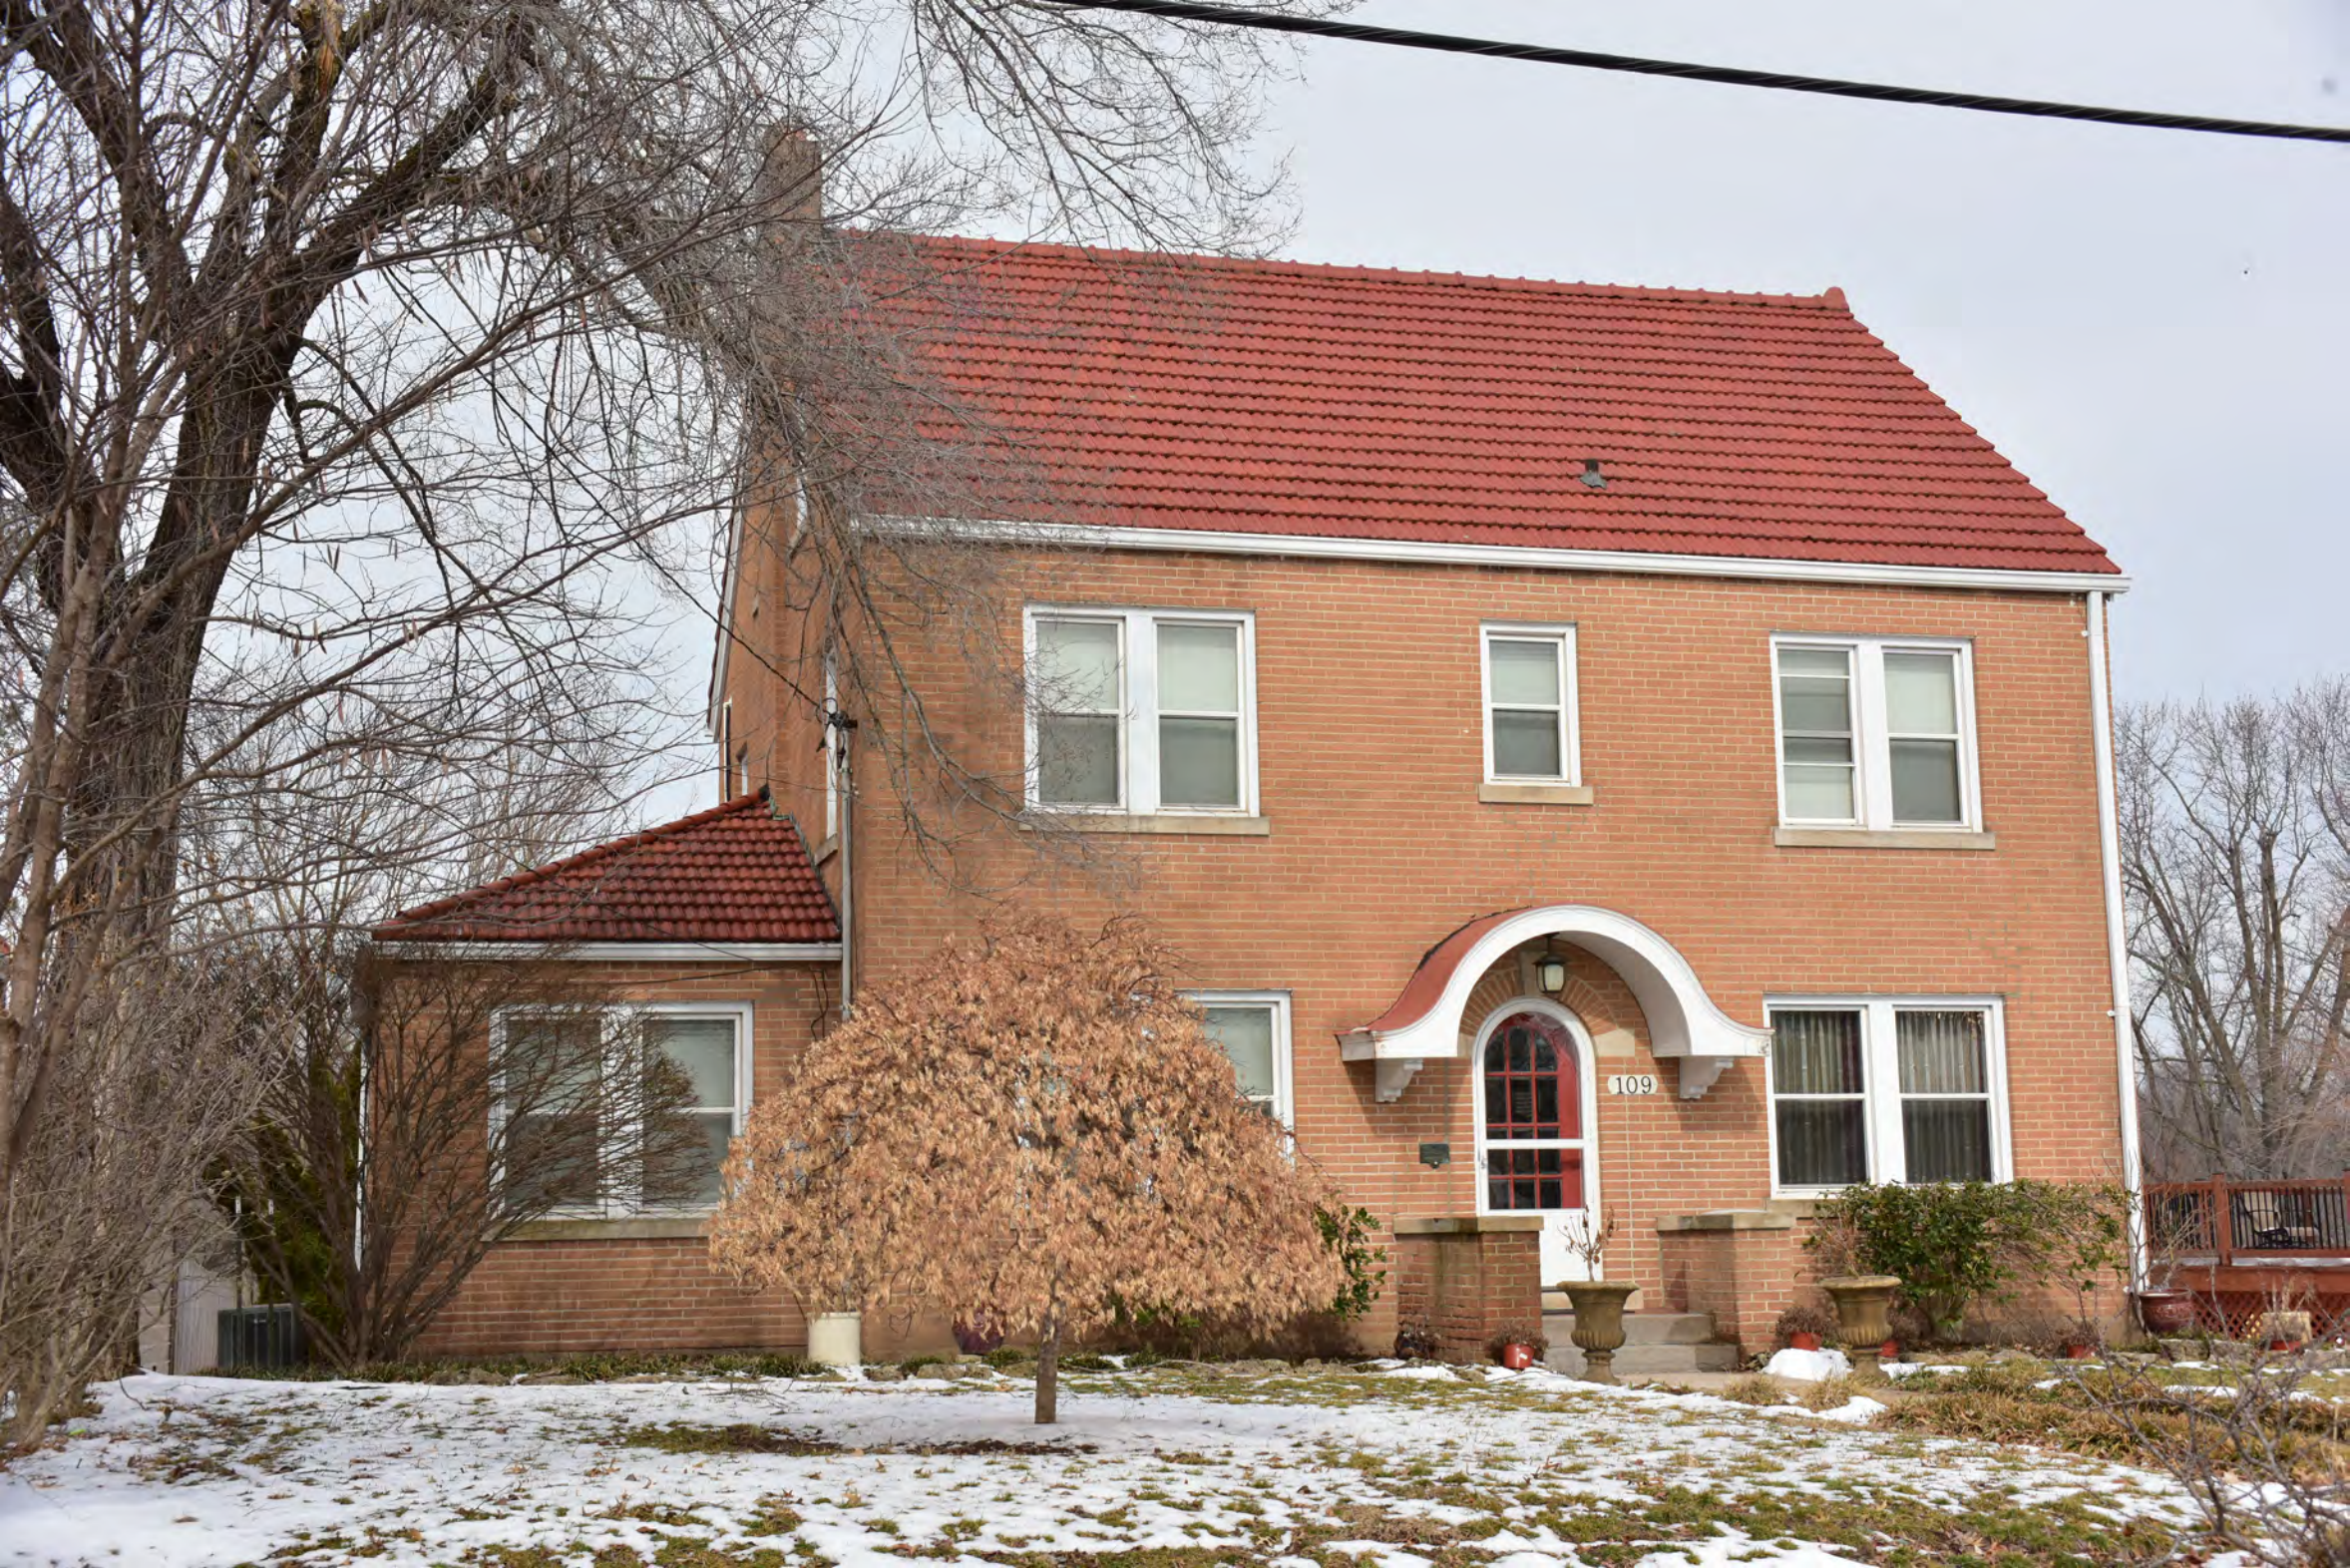
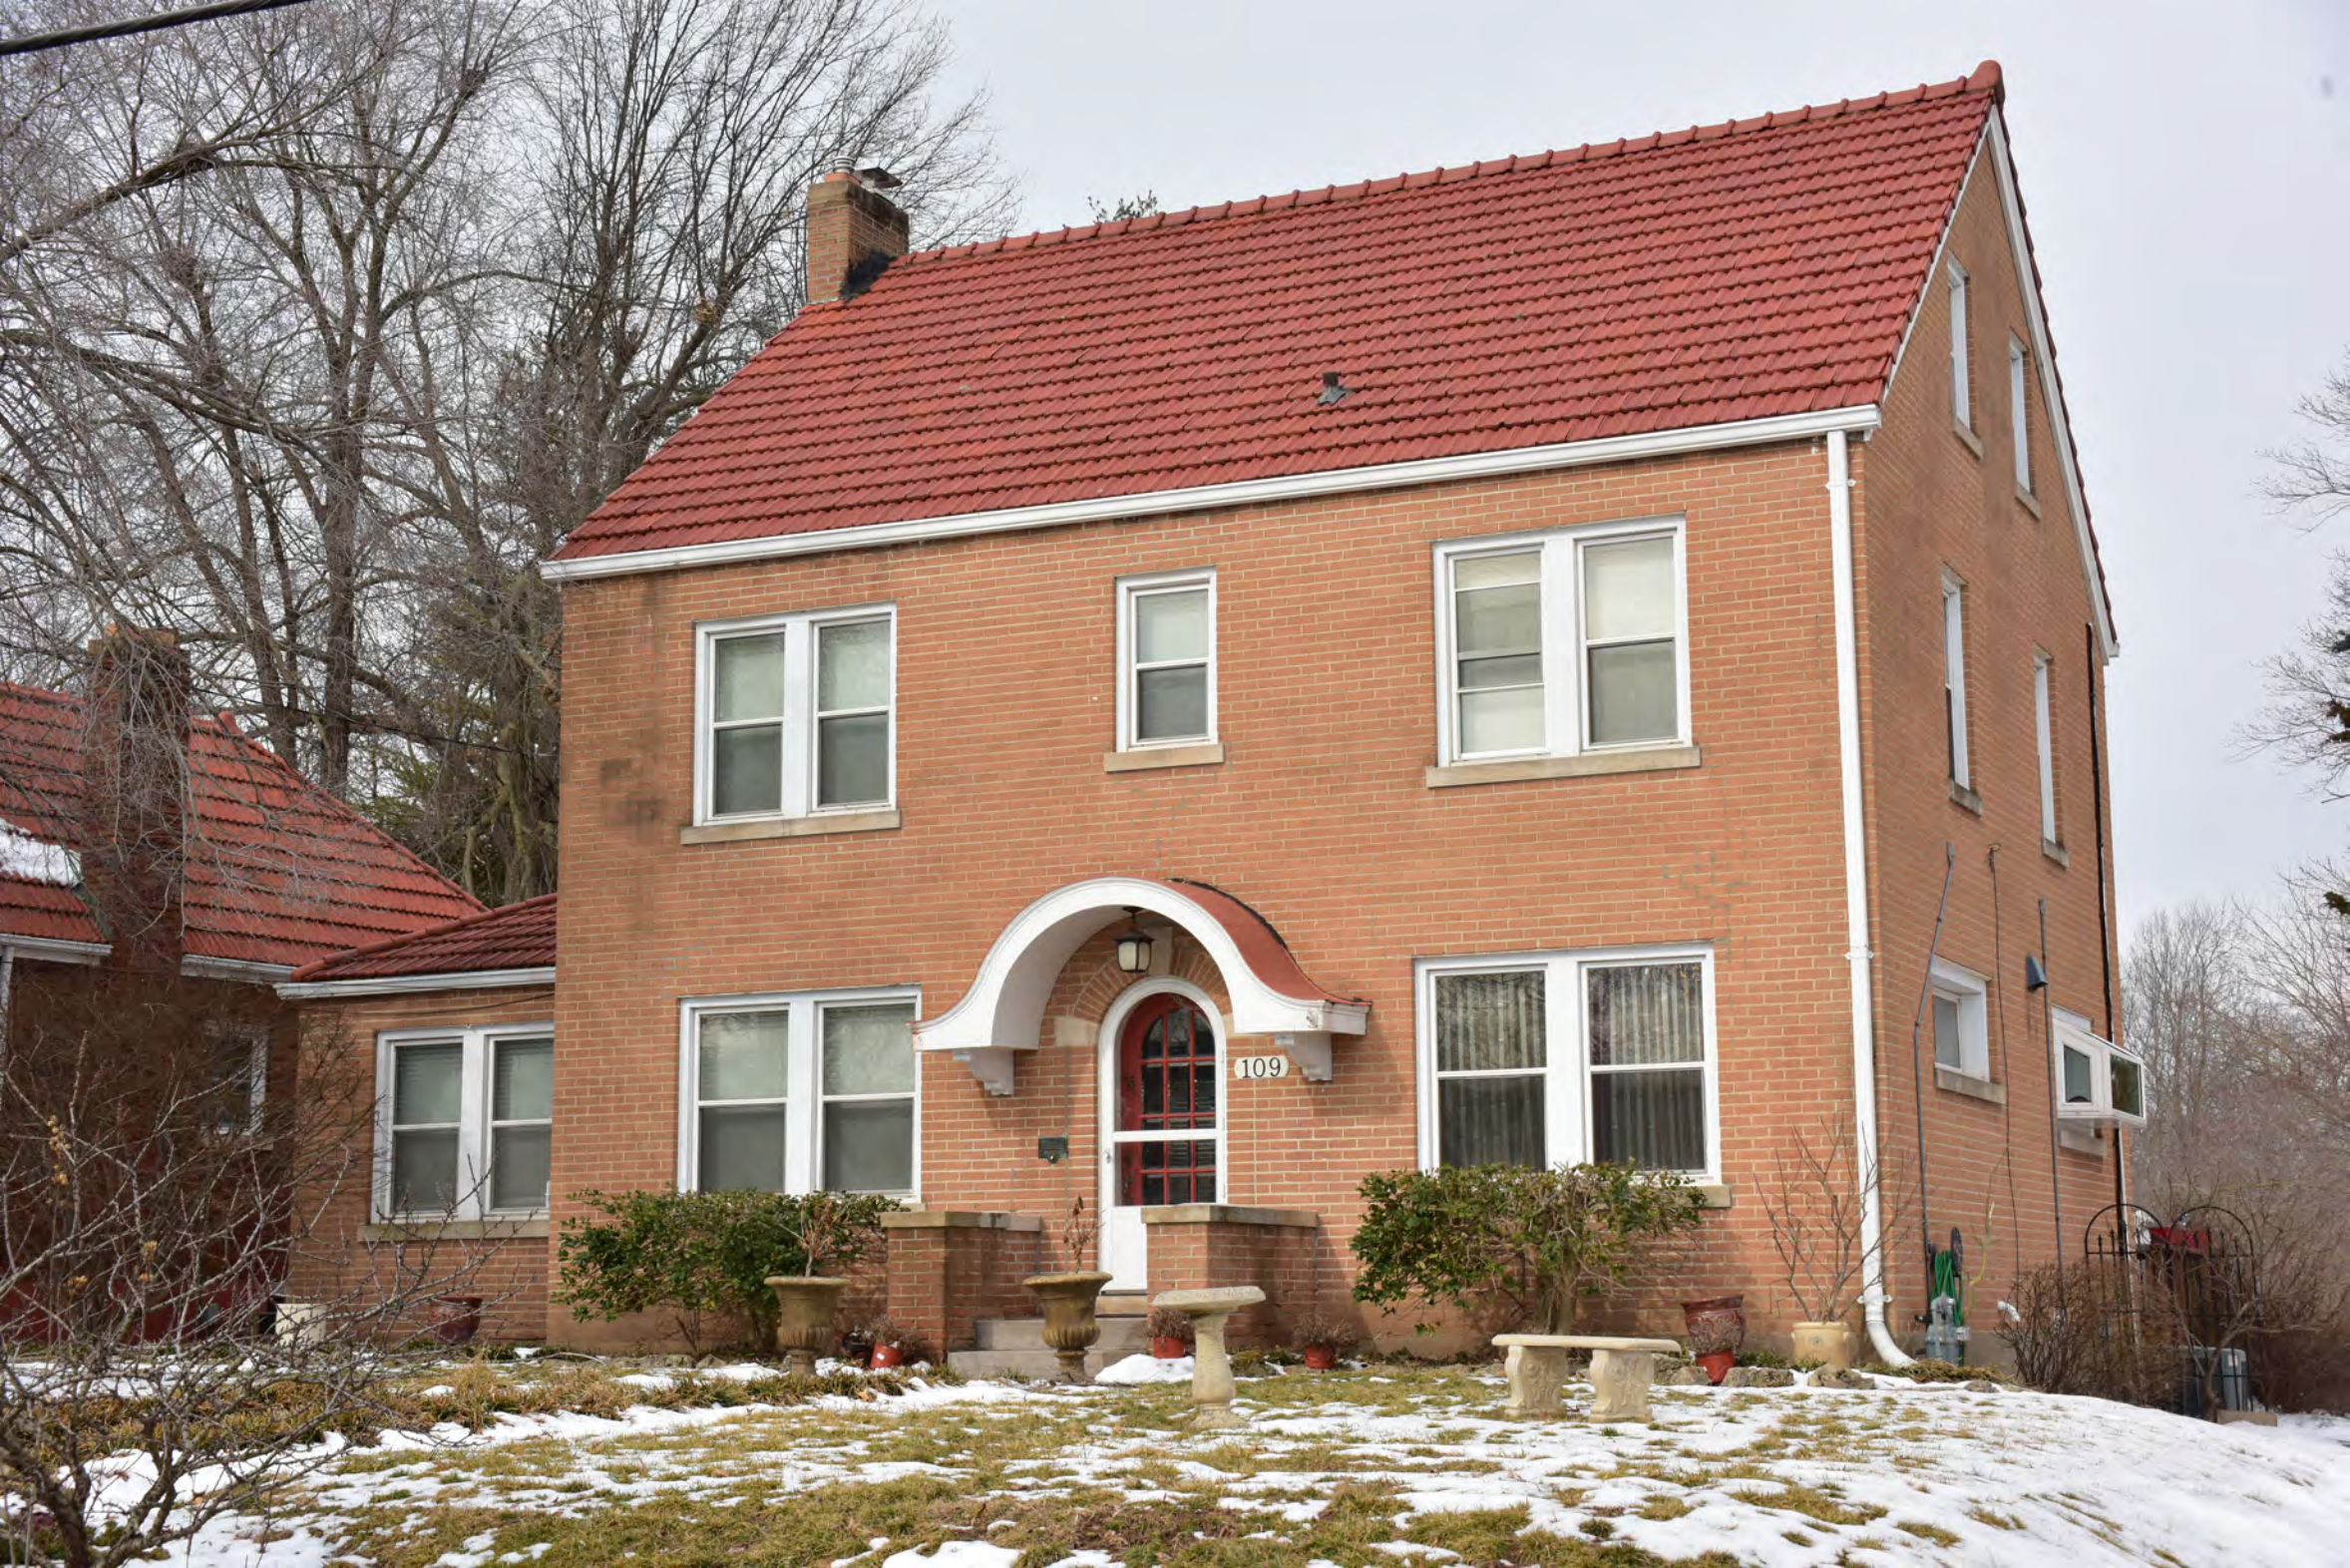
109 East Circle Drive is a two-and-one-half story Minimal Traditional dwelling with restrained Colonial Revival influences. It has a concrete foundation, brick cladding, and a tile side-gable roof. A brick exterior chimney projects slightly from the south elevation and pierces the gable apex. The dwelling is four bays wide at the first story. A one-story hipped-roof ell contains the southern bay. Pairs of 1/1 non-historic vinyl windows define Bays 1, 2, and 4 while the entrance defines Bay 3. The entrance bay contains a historic arched multi-light wood door. Stone accents in a keystone-motif top the arched opening. A curved hood with flared ends and knee brackets shelters the concrete stoop. Concrete-capped knee walls flank the stoop. Pairs of 1/1 non-historic vinyl windows occupy the north and south second-story bays while a small 1/1 vinyl window defines the center bay. The secondary elevation windows are 1/1 replacements. All windows visible from the right of way have stone sills. An integrated historic single-car garage is located at basement level and is accessed at the rear. A non-historic wood deck projects from the rear.

Alterations to 109 East Circle Drive include the replacement of historic windows and a non-historic rear deck. Although the windows are replacements, they fill historic openings and the deck is not visible from the public right of way nor does it obscure the original form or design. This resource retains good integrity would be contributing to the potential Walinko Place Historic District, significant in the areas of Architecture and Community Planning and Development in association with the expansion of Jefferson City and increased suburban development during the twentieth century as well as its associations with Walinko Place, a notable suburban development during the Depression and War Years.
