1. Survey number: CO-AS-008-001		2. Survey Name: West Main Street Survey	
3. County: Cole		4. Address (Street No.): 100	Street (name): East Circle Drive
5. City: Jefferson City	Vicinity <input type="checkbox"/>	6. Lat / Long:	7. Township/Range/Section: T: R: S:
8. Historic name (if known):		9. Present/other name (if known):	
10. Ownership: <input checked="" type="checkbox"/> Private <input type="checkbox"/> Public		11a. Historic use (if known): Domestic-Single Dwelling	11b. Current use: Domestic-Single Dwelling

MISSOURI DEPARTMENT OF NATURAL RESOURCES
STATE HISTORIC PRESERVATION OFFICE, P.O. Box 178, Jefferson City, MO 65102
ARCHITECTURAL/HISTORIC INVENTORY FORM

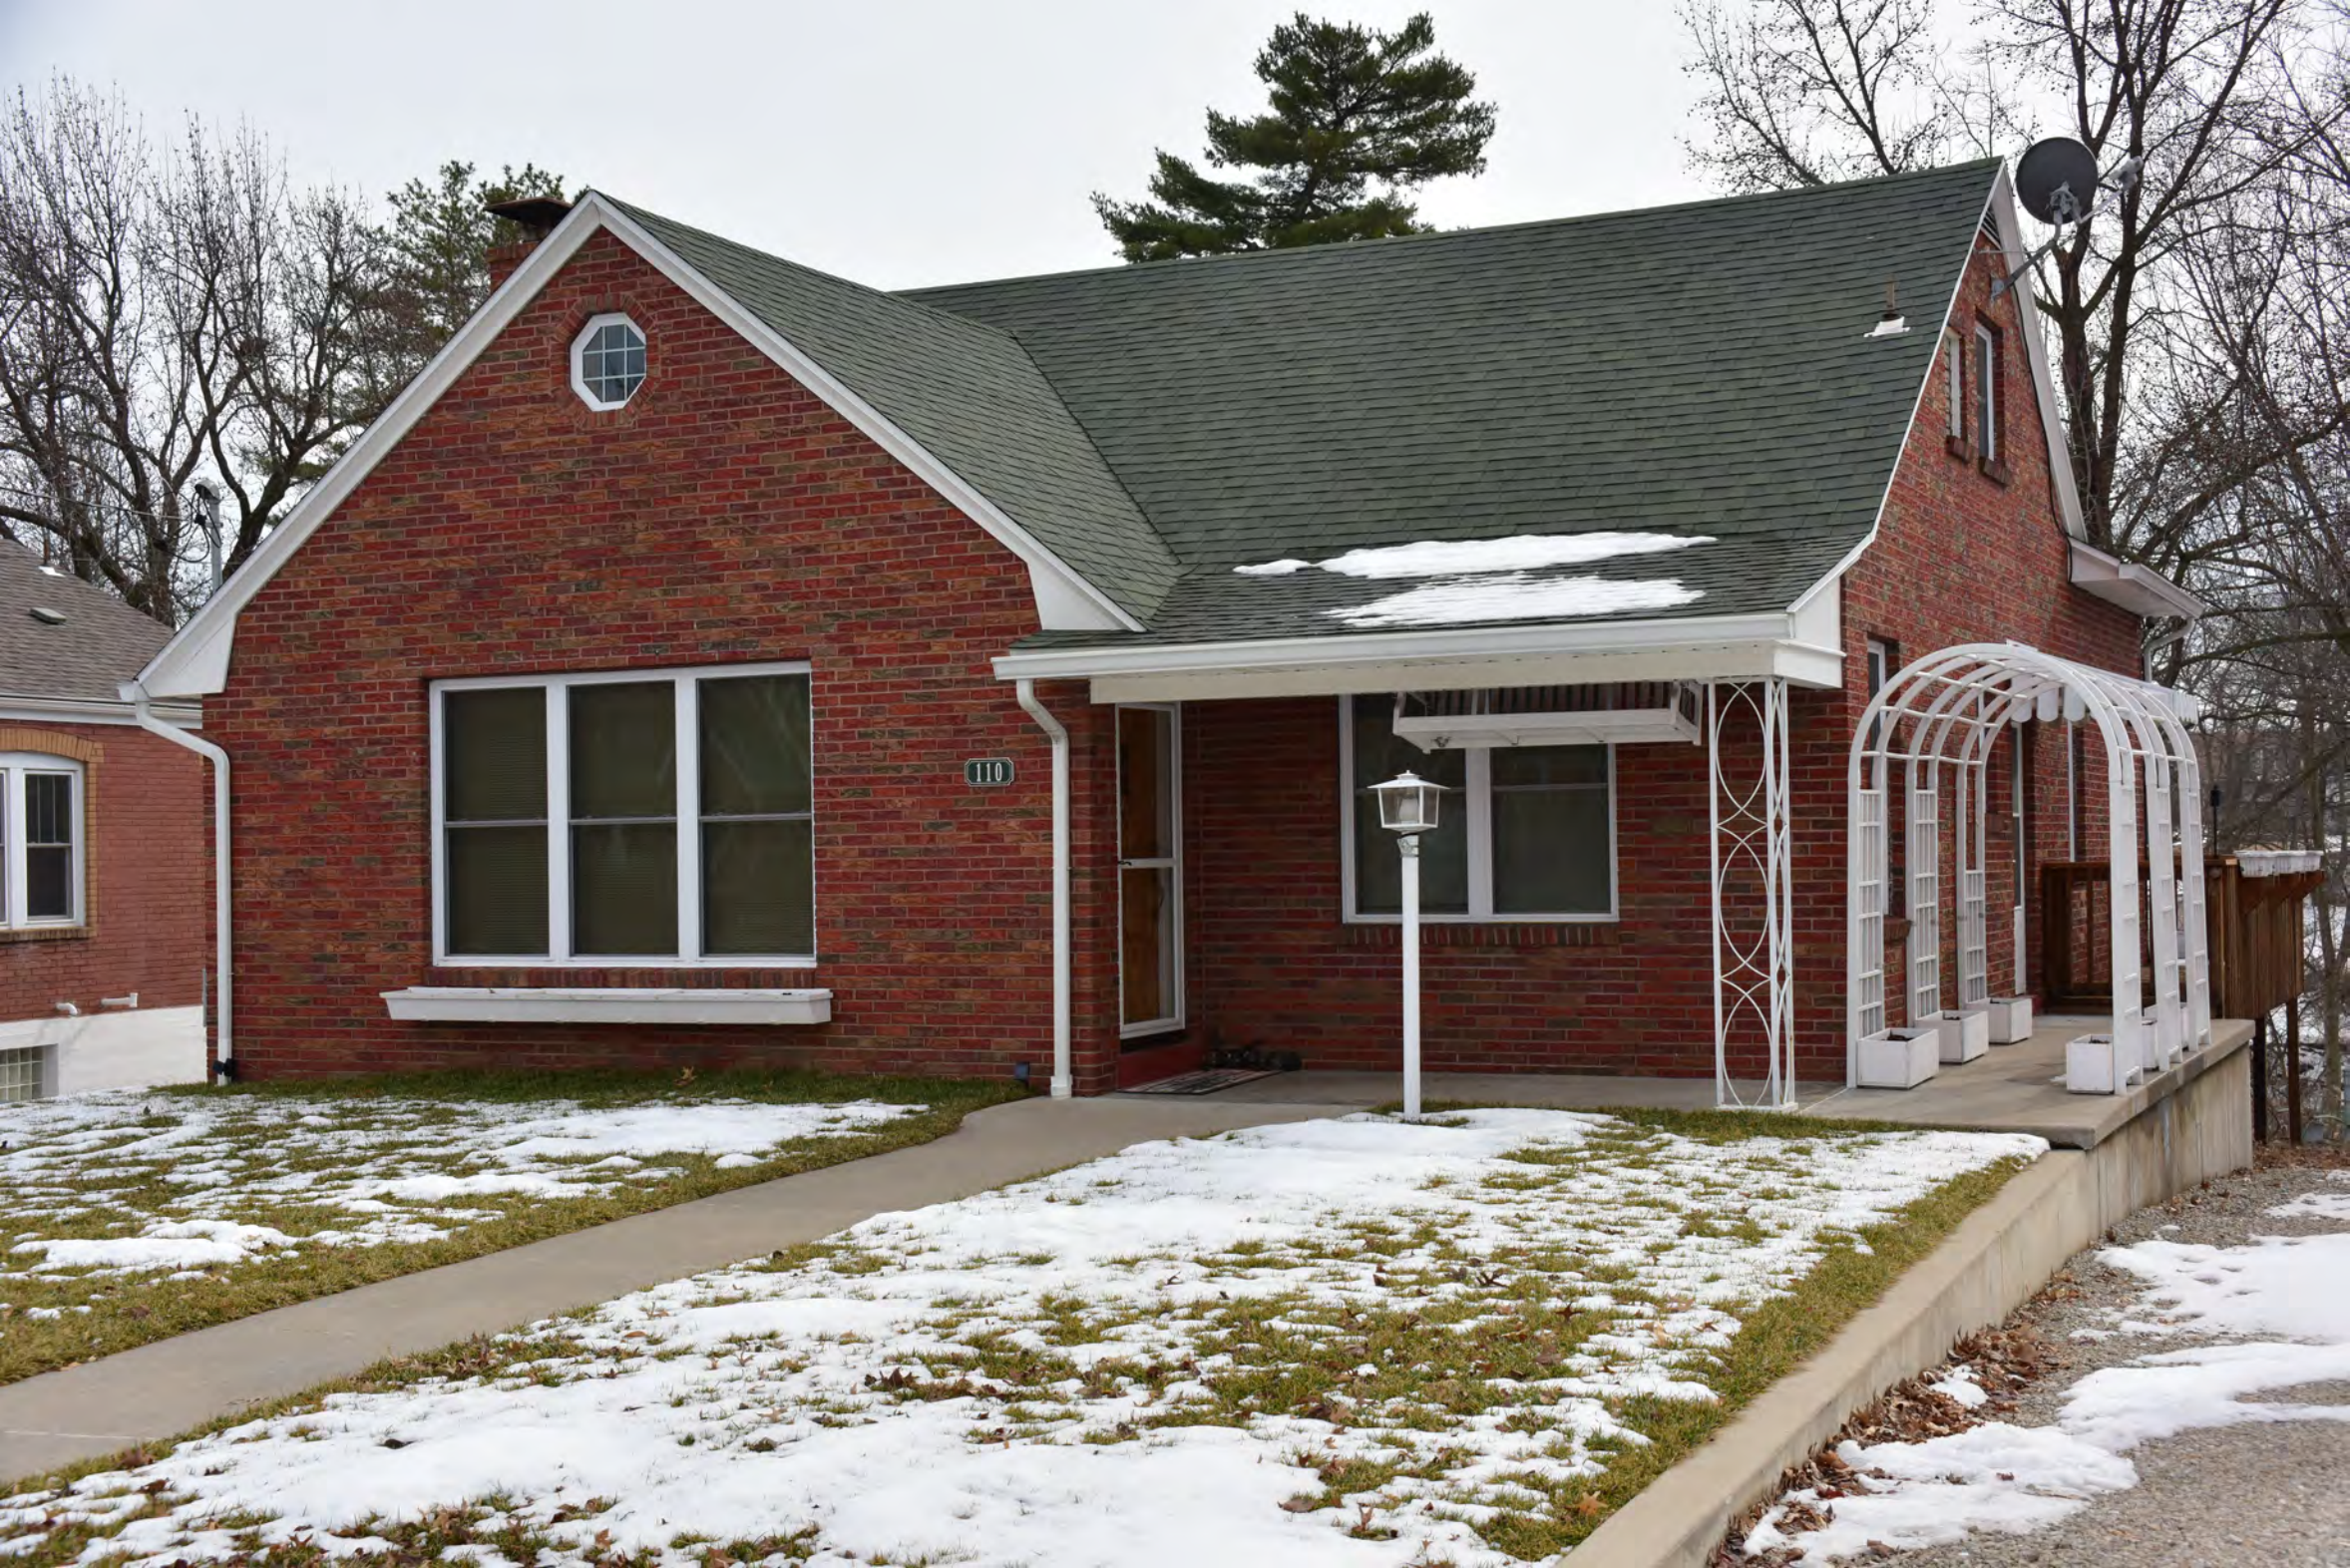
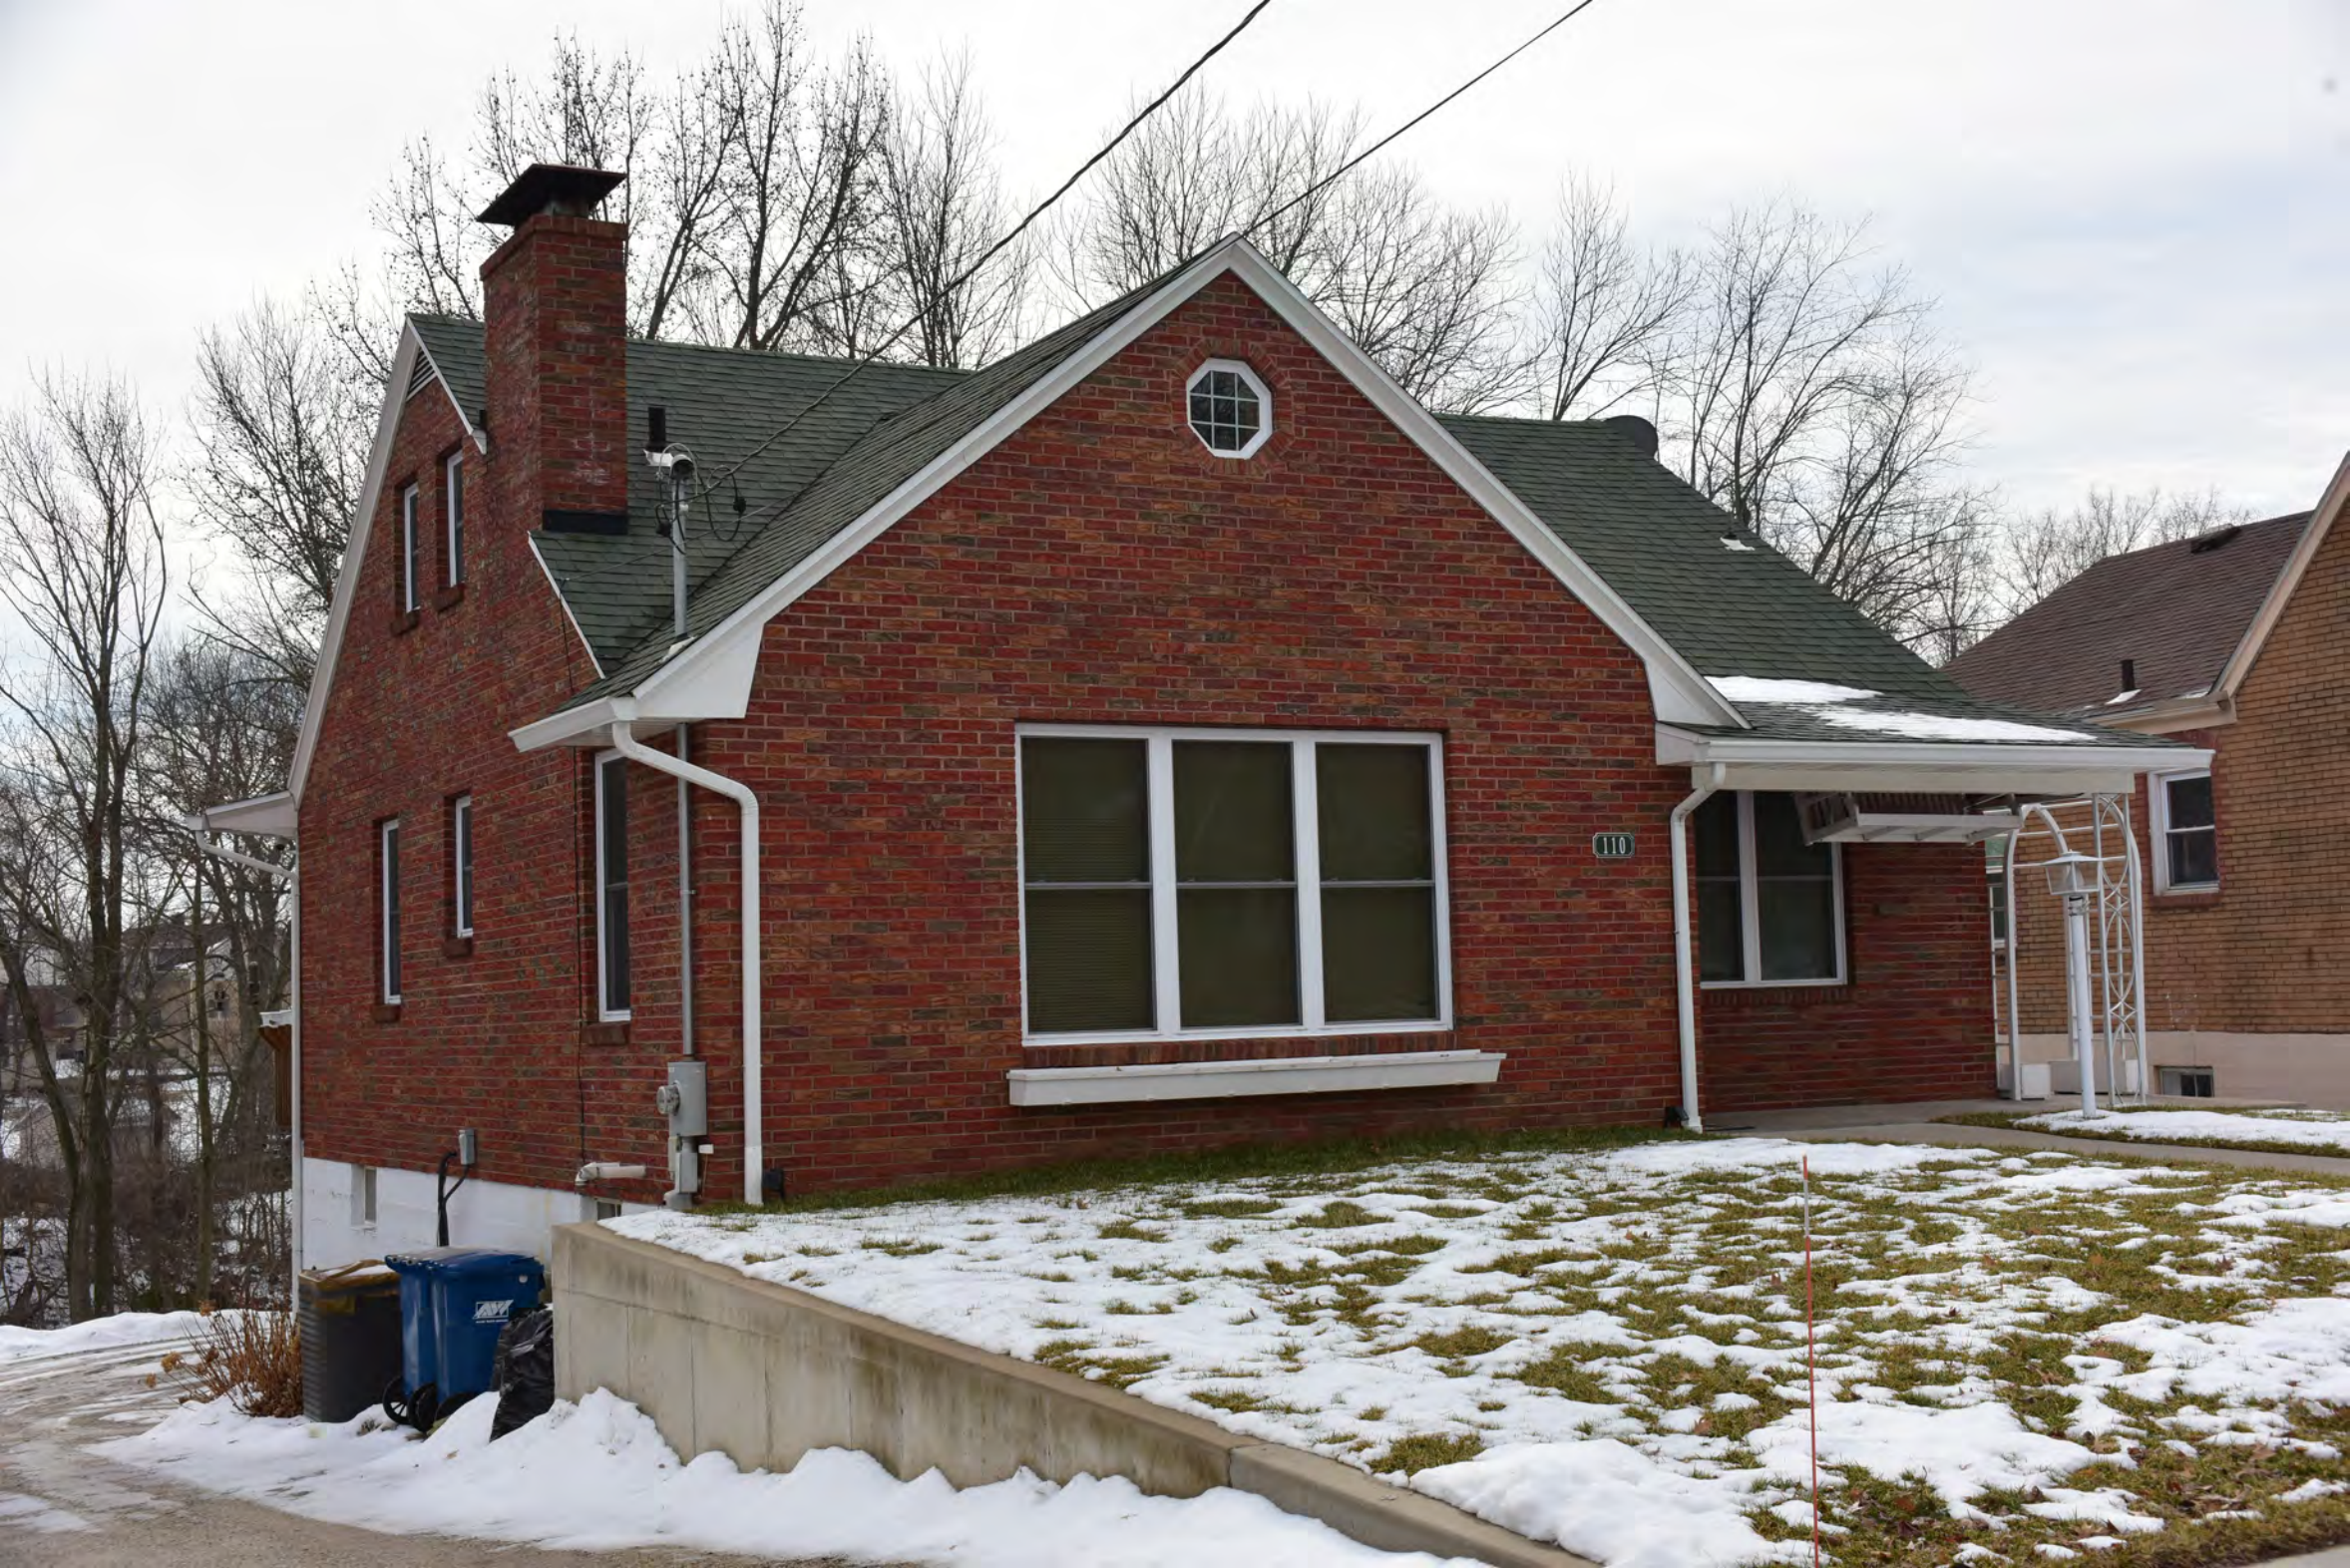
110 East Circle Drive is a one-and-one-half story Minimal Traditional dwelling. It has a concrete foundation, brick cladding, and an asphalt gabled-ell roof. A brick side chimney projects pierces the roof at the north elevation. The dwelling is two bays wide at the first story. A gable-roof ell contains the northern bay. Three ganged 1/1 non-historic vinyl windows define the bay. A non-historic nine-light octagonal vinyl window is centered in the gable apex above the bay. Two-ganged 1/1 non-historic vinyl windows define the south bay. The primary entrance is in the south wall of the gabled ell. An open partial-width porch with a shed roof and decorative metal support post shelters the entrance and south bay. The concrete porch floor wraps around the first-half of the south elevation to form a patio. A non-historic wood deck abuts the concrete patio and continues along the rear elevation. An integrated historic single-car garage is located at basement level and is accessed at the rear.

Alterations to 110 East Circle Drive include the replacement of historic windows and a non-historic rear deck. Although the windows are replacements, they fill historic openings and the deck is minimally visible from the public right of way nor does it obscure the original form or design. This resource retains good integrity would be contributing to the potential Walinko Place Historic District, significant in the areas of Architecture and Community Planning and Development in association with the expansion of Jefferson City and increased suburban development during the twentieth century as well as its associations with Walinko Place, a notable suburban development during the Depression and War Years.

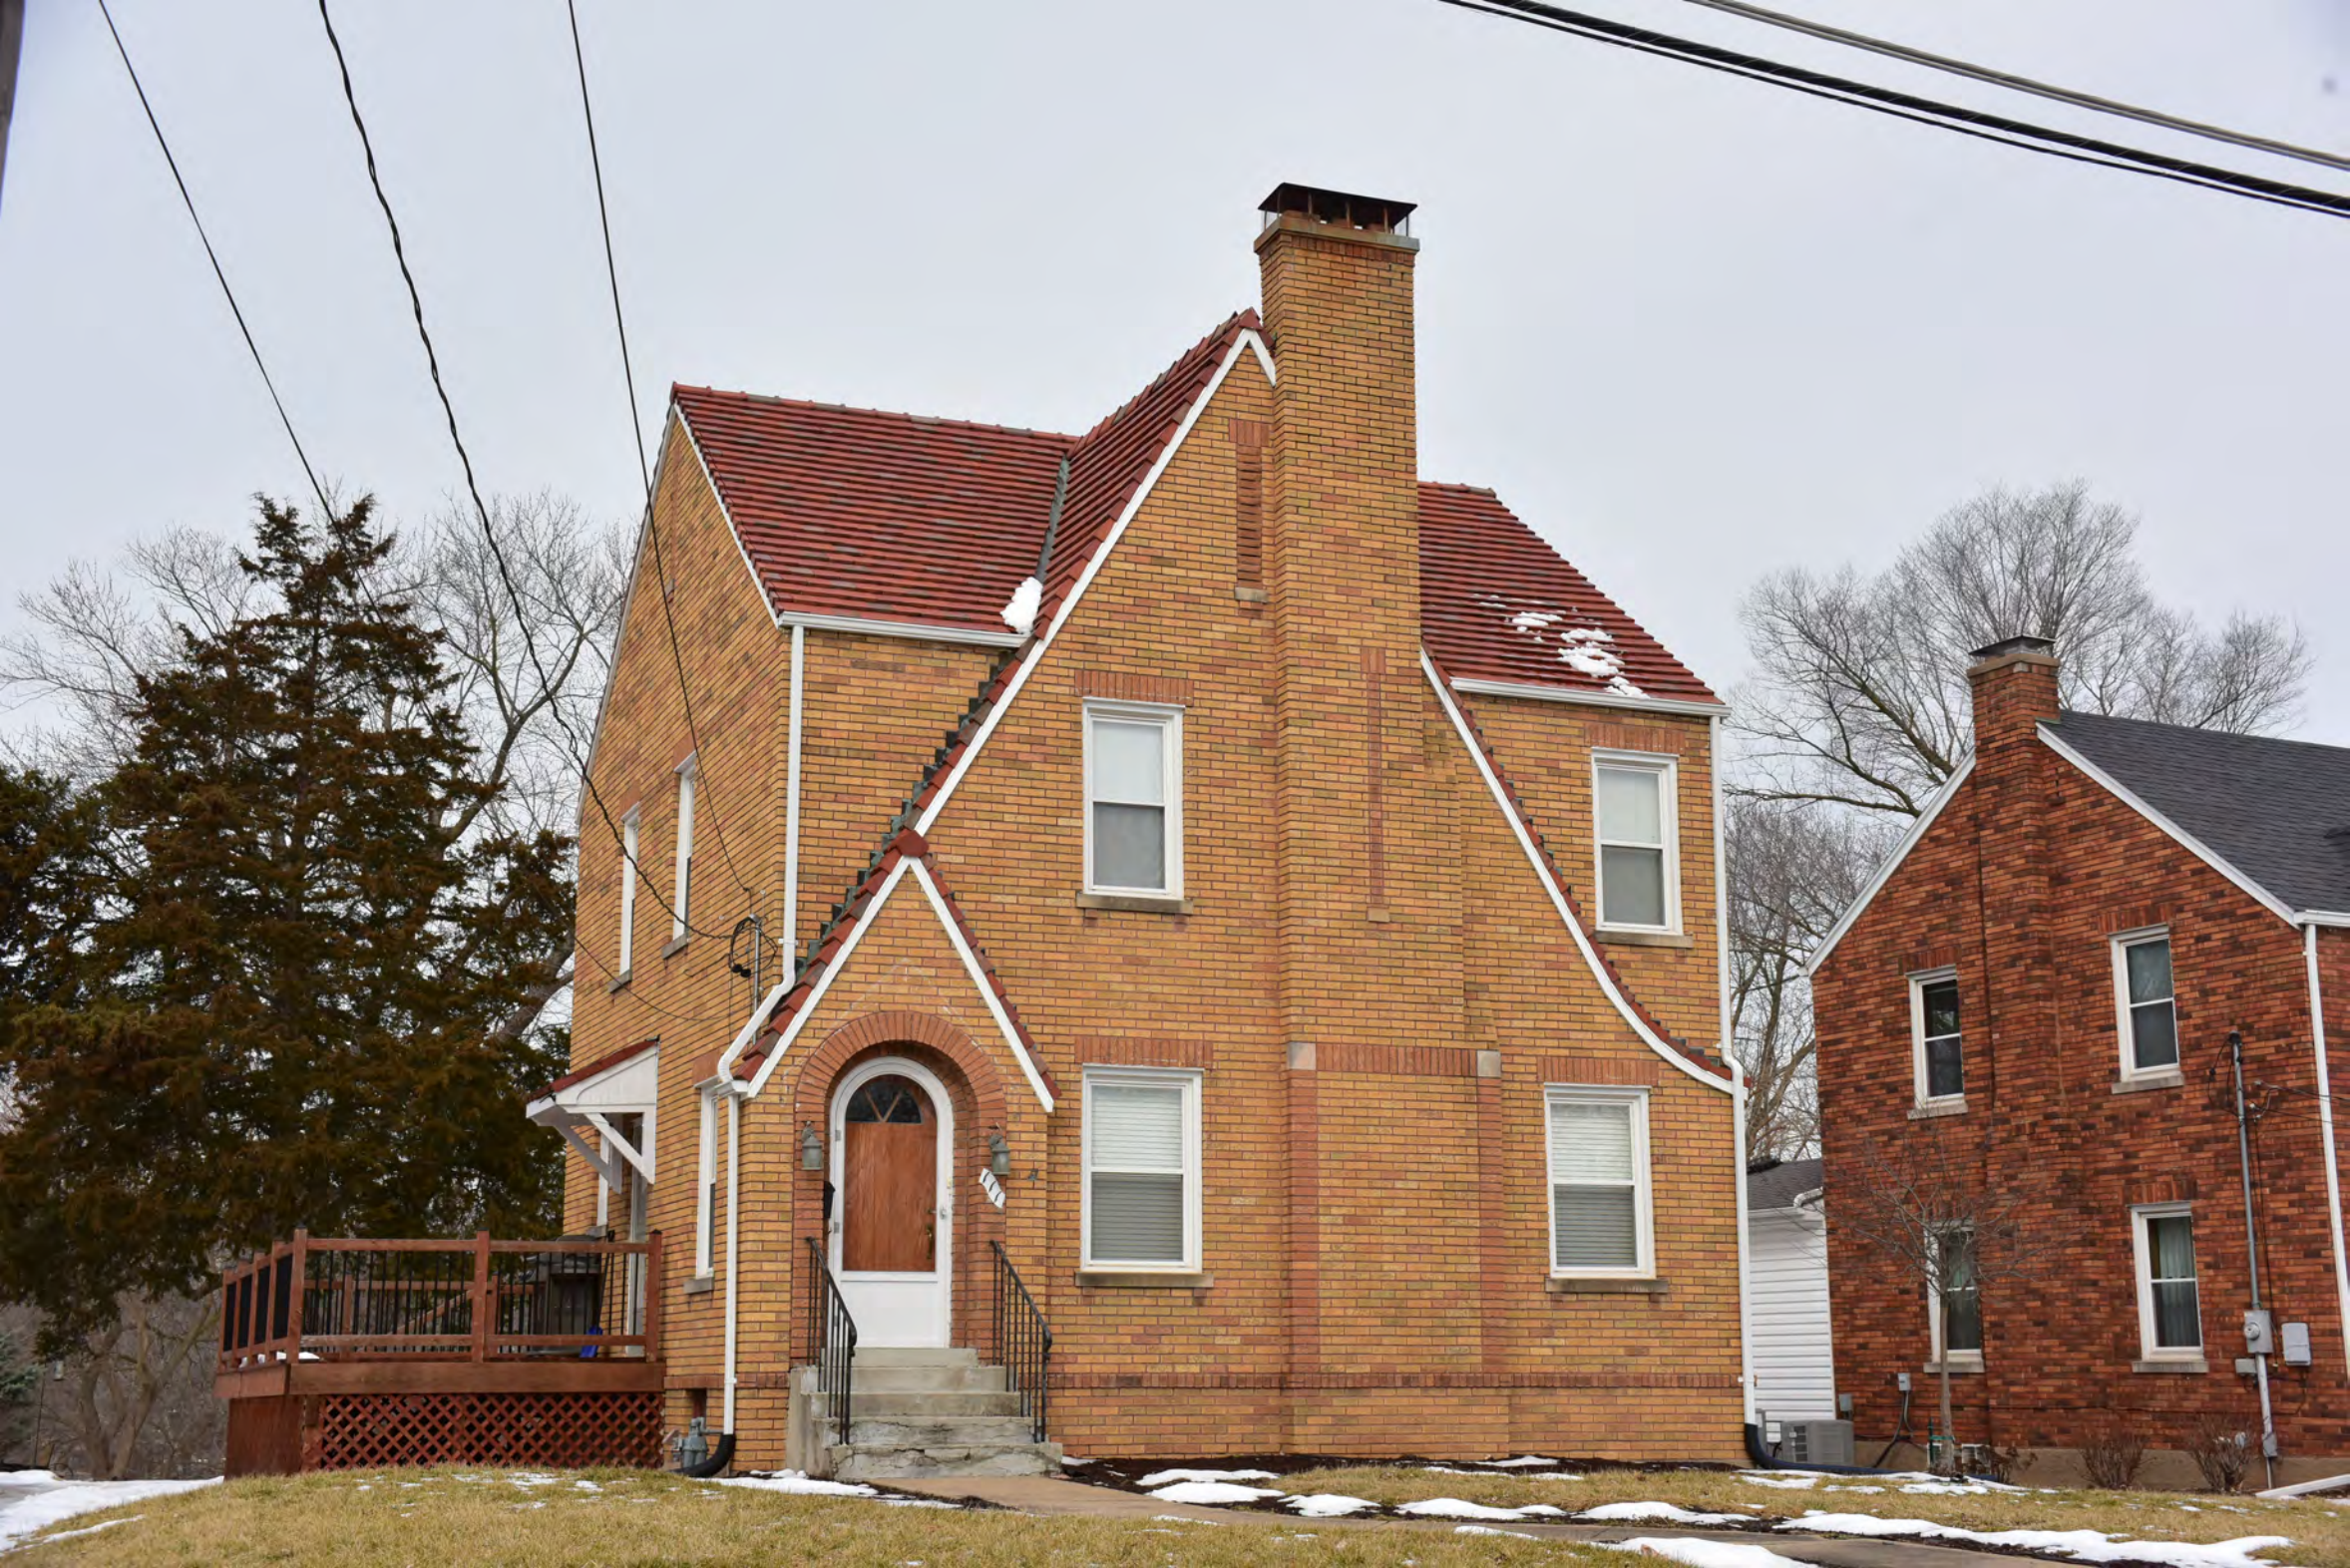
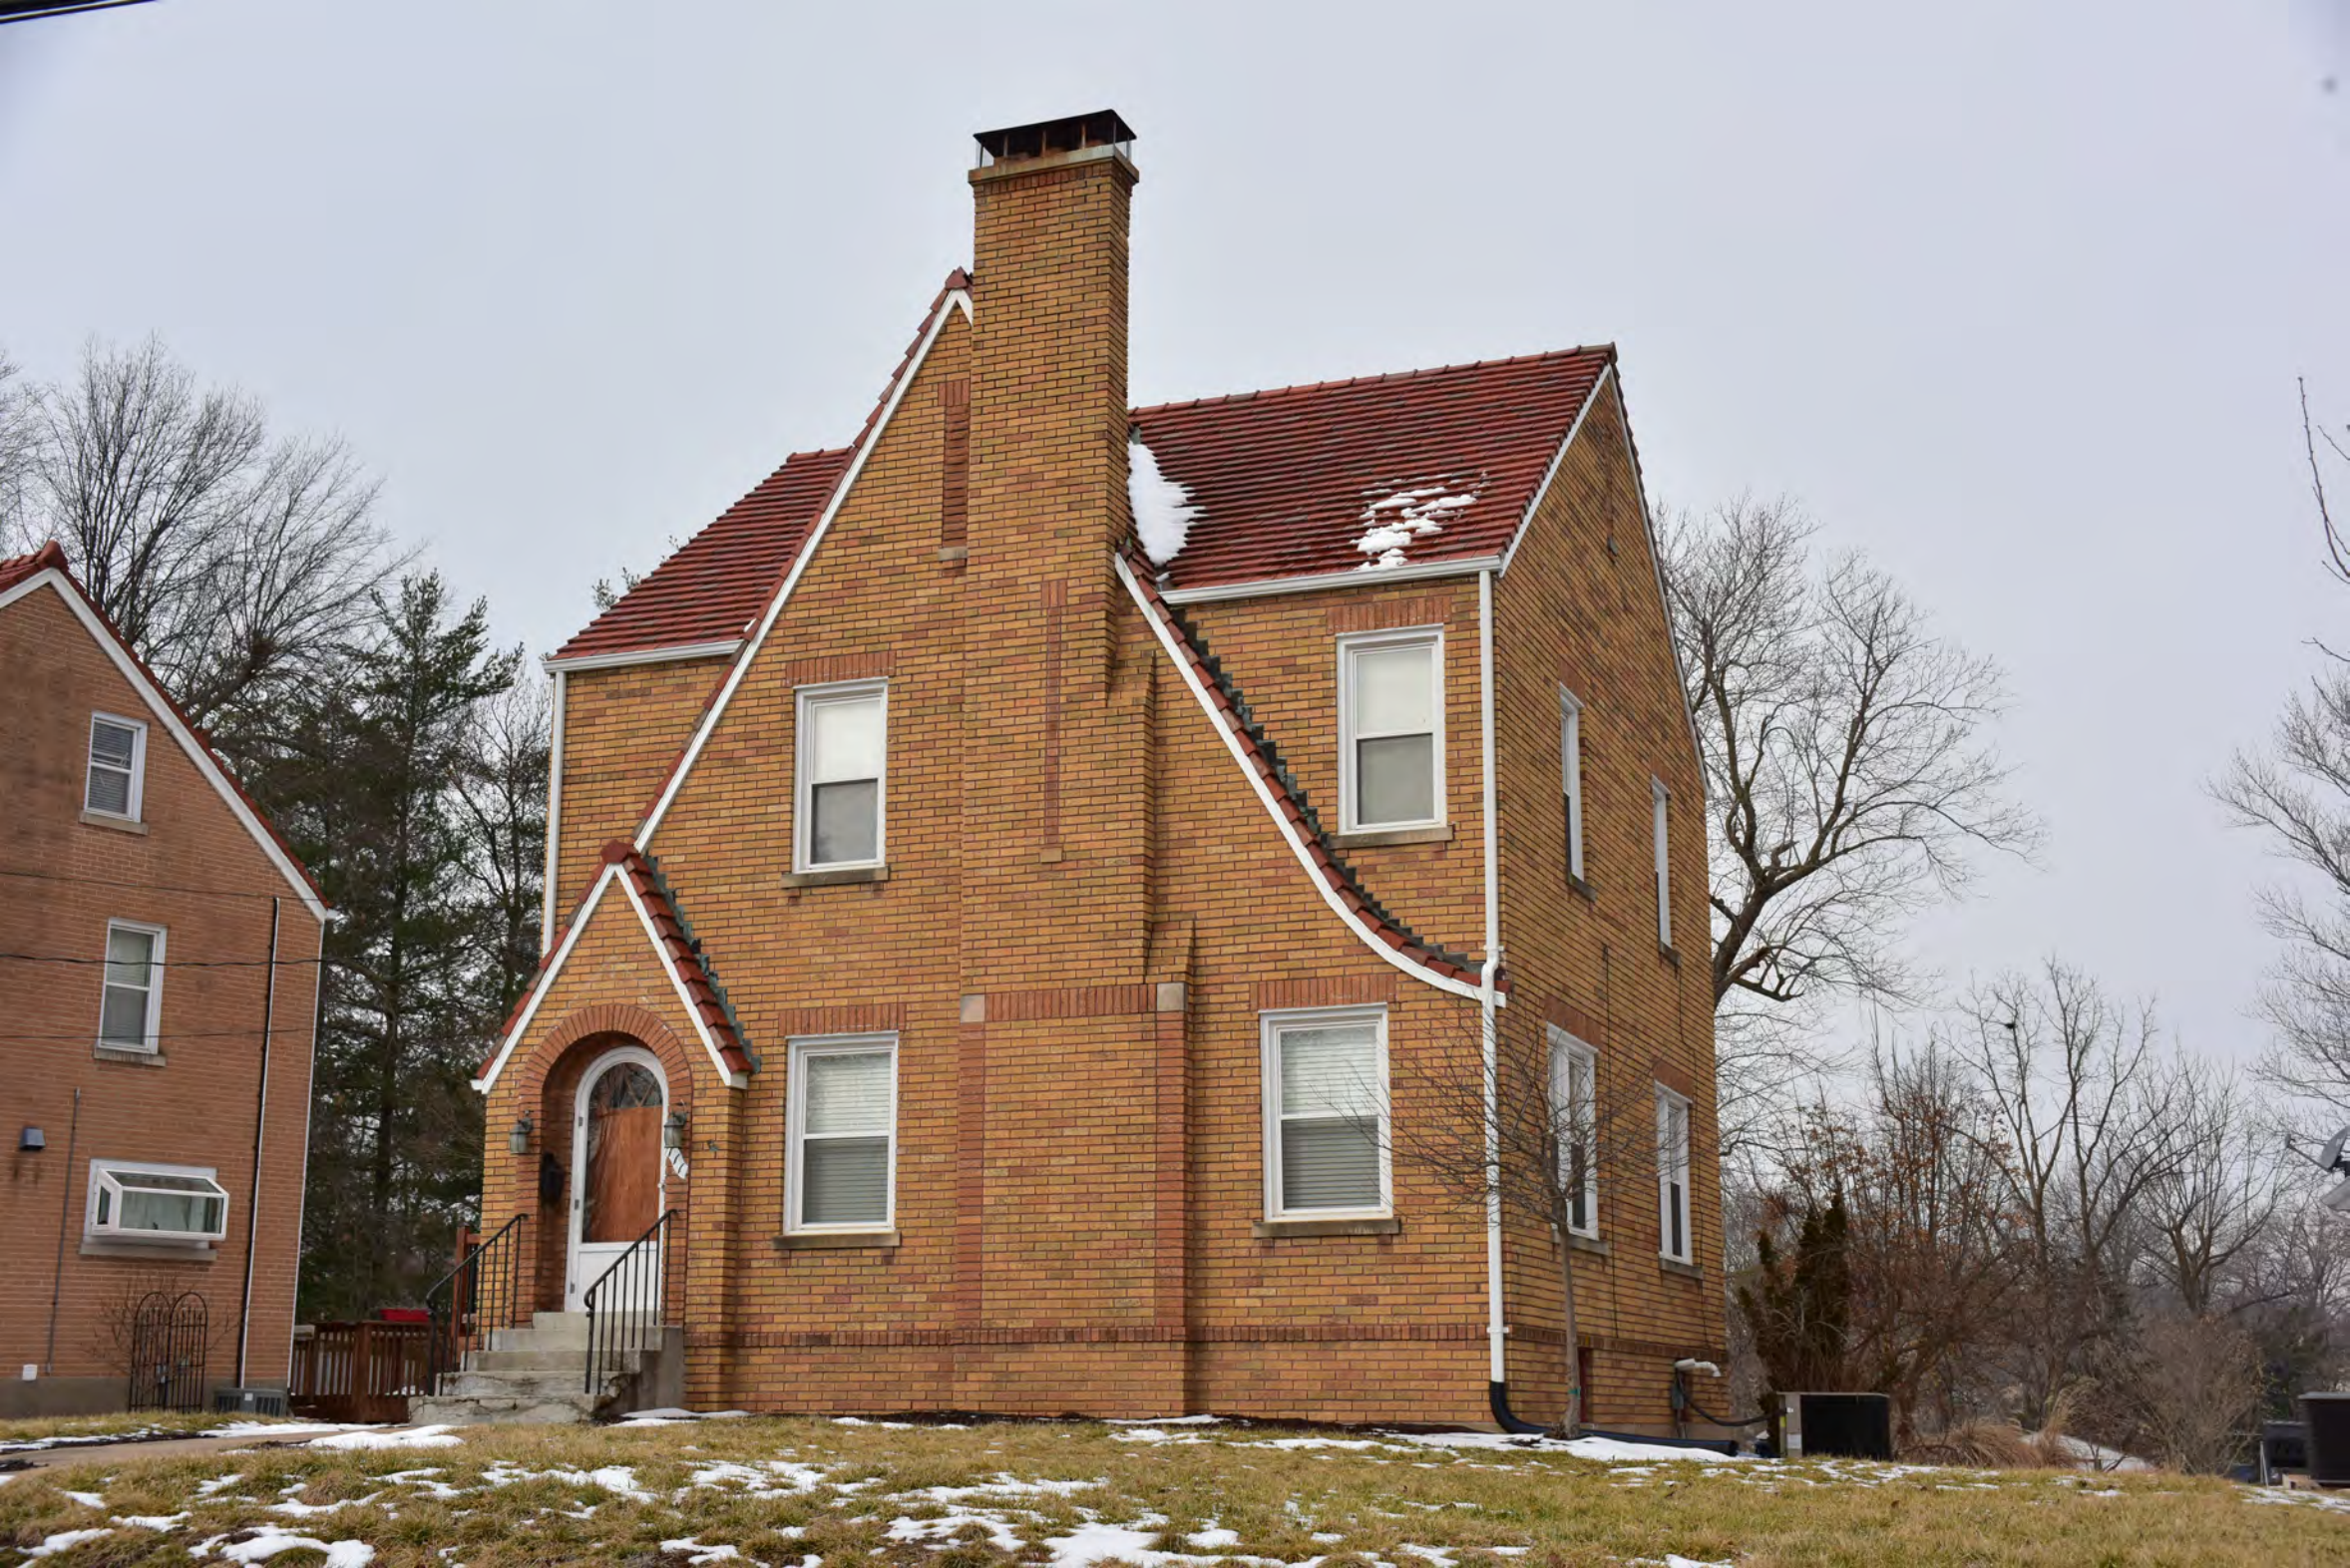
111 East Circle Drive is a two-and-one-half story Minimal Traditional dwelling with restrained Tudor Revival influences. It has a concrete foundation, yellow brick cladding with red brick accents, and a tile center-gabled roof. The center gable roofline extends to the first-story. A small nested gable is positioned in the south corner of the primary elevation. Tile tops the center gable and nested gable. The dwelling is four bays wide at the first story. The nested gable defines the first bay and contains the primary entrance. The entrance is slightly recessed within a rounded arch opening. A concrete stoop with metal railings projects from the entrance. An exterior chimney defines the third bay and pierces the center gable. Non-historic 1/1 vinyl windows define the remaining two bays. The windows have stone sills and red soldier brick lintels. Matching windows are located directly above at the second-story. A secondary entrance is centered on the south elevation and opens to a non-historic wood deck, which wraps around to the rear. A shed roof with knee brackets shelters entrance. An integrated historic single-car garage is located at basement level and is accessed at the rear.

Alterations to 111 East Circle Drive include the replacement of historic windows and a non-historic deck at the south elevation. Although the windows are replacements, they fill historic openings. The deck does not obscure the original form or design. This resource retains good integrity and would be contributing to the potential Walinko Place Historic District, significant in the areas of Architecture and Community Planning and Development in association with the expansion of Jefferson City and increased suburban development during the twentieth century as well as its associations with Walinko Place, a notable suburban development during the Depression and War Years.

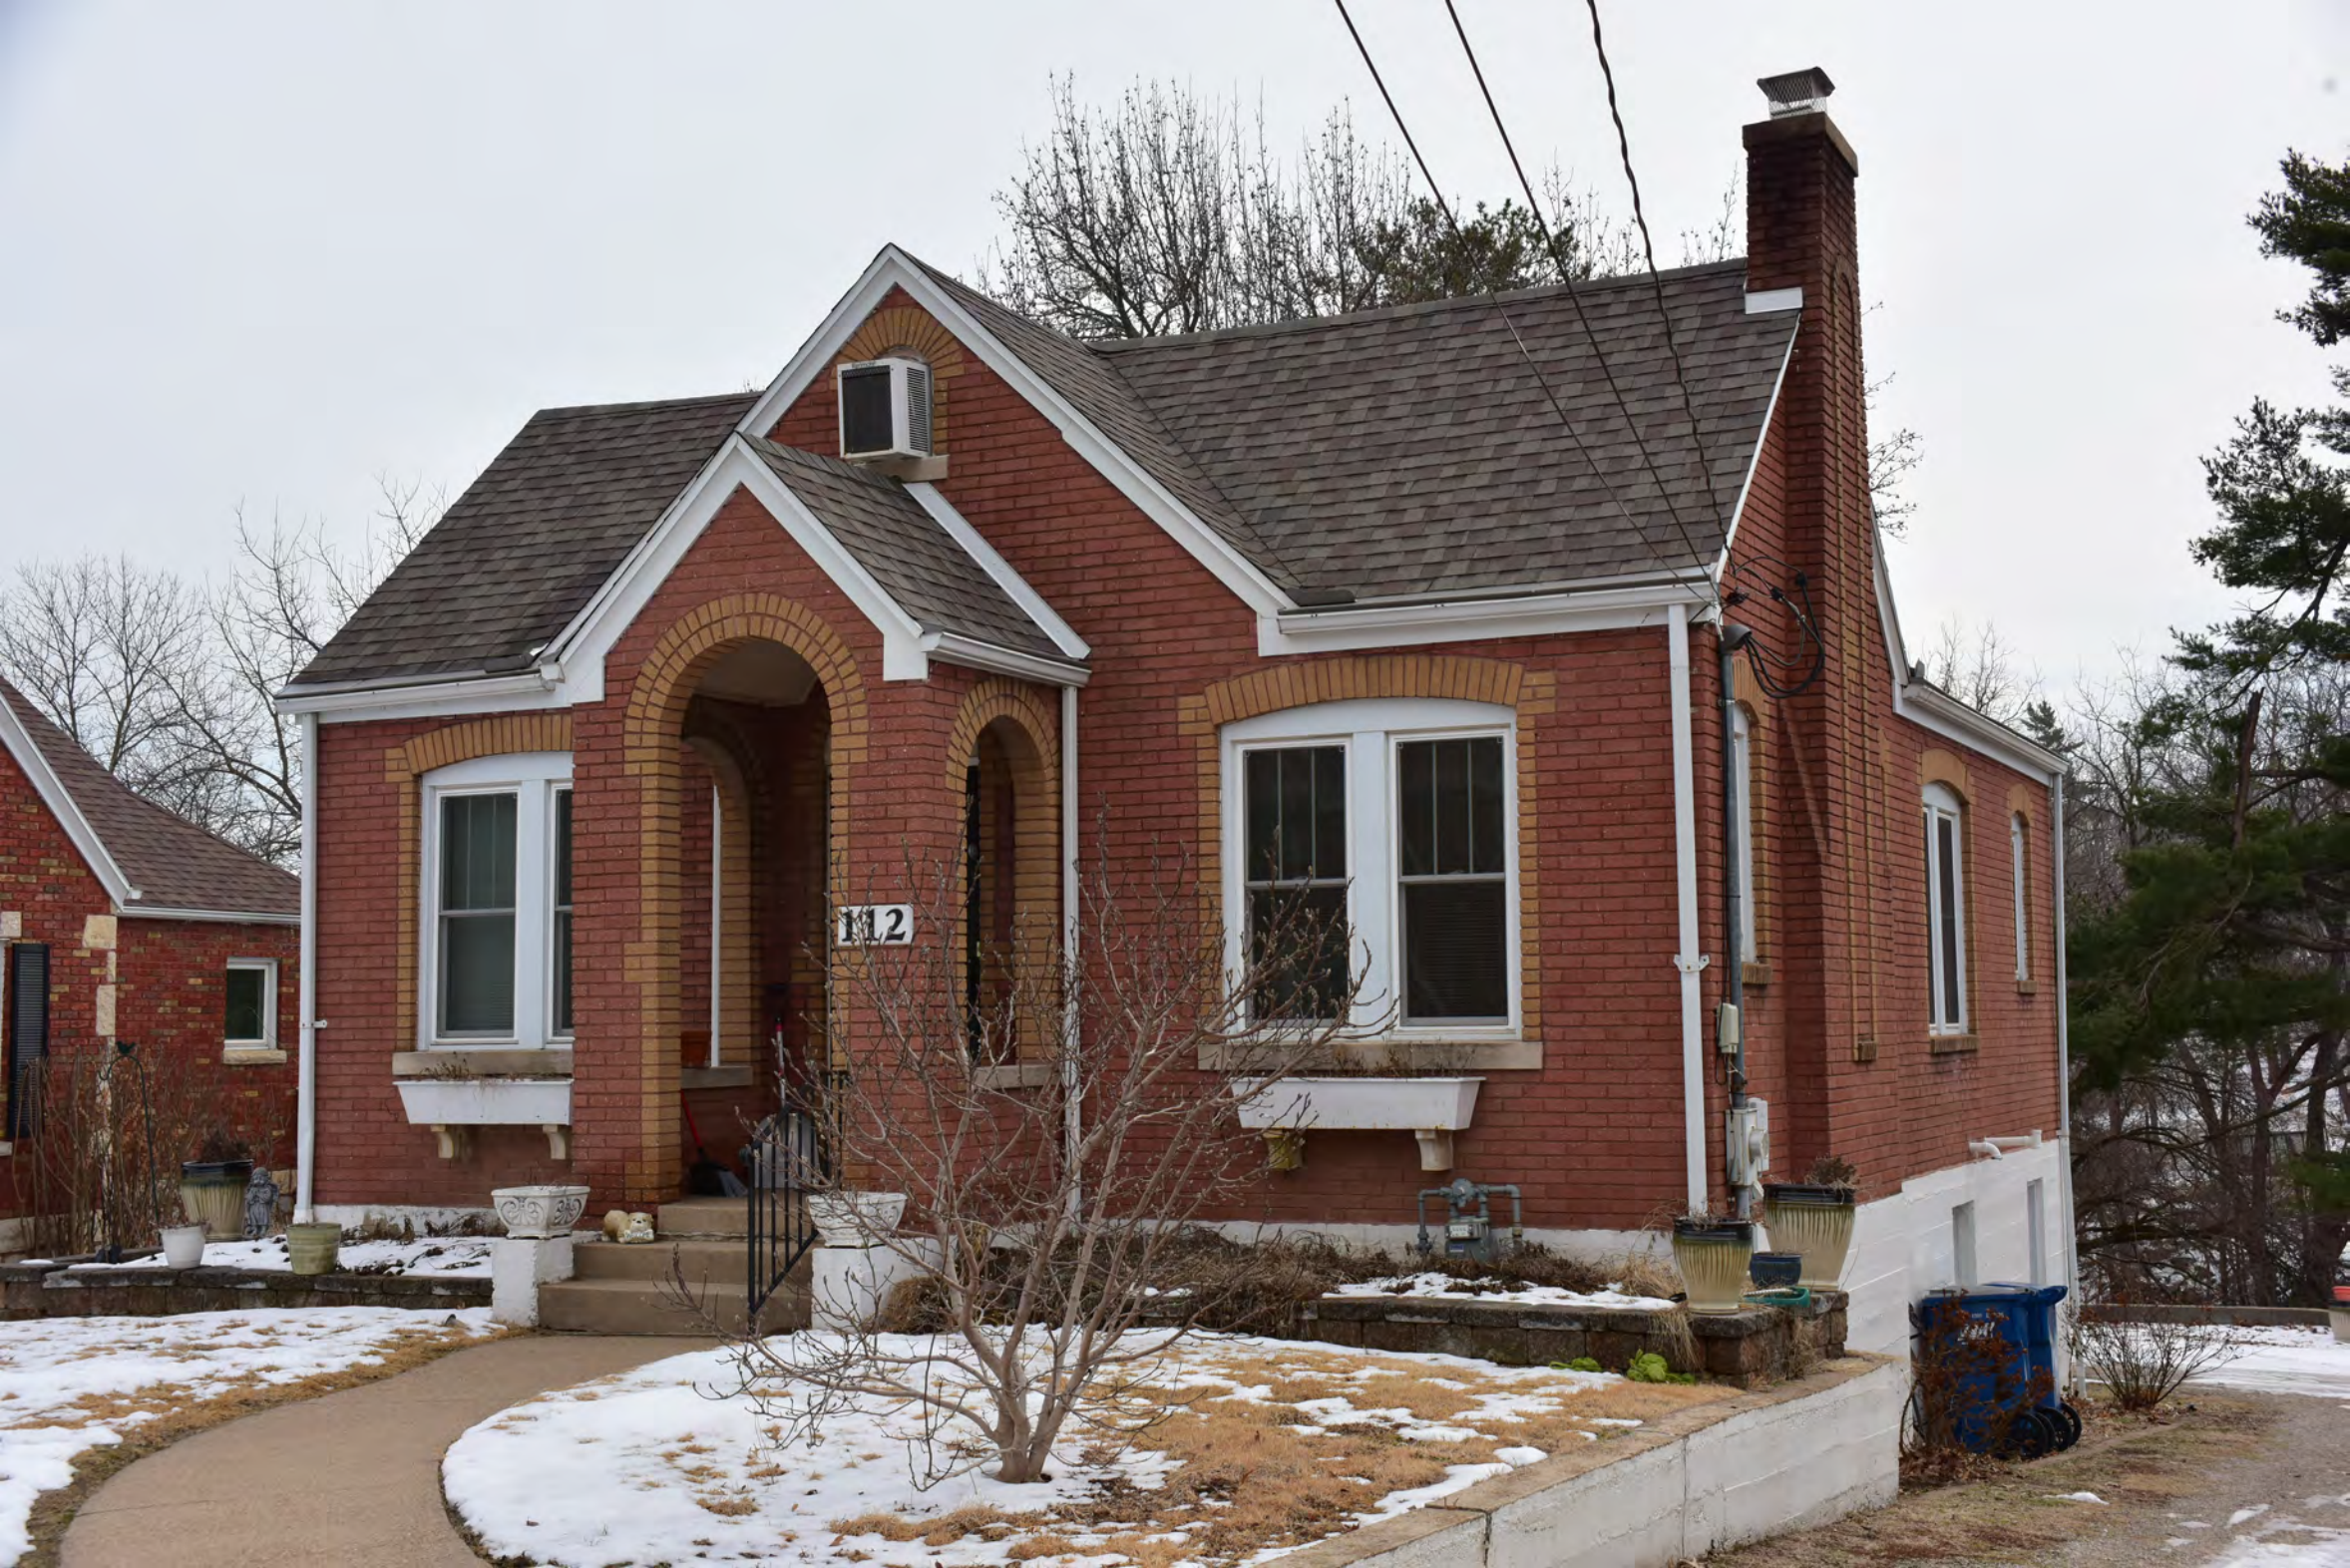
112 East Circle Drive is a one story Minimal Traditional dwelling. It has a concrete foundation, yellow brick cladding, and an asphalt intersecting-gable roof with narrow eaves. A center-gable roof fronts East Circle Drive while a perpendicular gable extends to the west. A brick exterior chimney projects slightly from the south elevation and pierces the eave. Yellow brick accents the chimney in a rounded arch with centered sunburst motif. The dwelling is three bays wide. A narrow, front-gable open porch with brick columns and defines the center bay. Low, concrete-capped brick knee walls line the north and south sides of the porch. Rounded arch openings are located above the walls and a full-length rounded arch opening provides access to the concrete stoop. The porch shelters the primary entrance. Pairs of non-historic 3/1 vinyl windows fill the north and south bays. Both window bays have segmental arch openings and stone sills. Historic stone window box brackets are positioned under the window bays. A small window with segmental arch opening and stone sill is located in the center gable. An AC unit fills the window opening. Yellow brick accents each window and door opening on all elevations, excluding those at basement level. An integrated historic single-car garage is located at basement level and is accessed at the rear.

Alterations to 112 East Circle Drive include the replacement of historic windows. Although the windows are replacements, they fill historic openings and the historic fenestration pattern remains intact. 112 East Circle Drive retains good integrity. This resource would be contributing to the potential Walinko Place Historic District, significant in the areas of Architecture and Community Planning and Development in association with the expansion of Jefferson City and increased suburban development during the twentieth century as well as its associations with Walinko Place, a notable suburban development during the Depression and War Years.
