1. Survey number: CO-AS-008-001		2. Survey Name: West Main Street Survey	
3. County: Cole		4. Address (Street No.): 100	Street (name): East Circle Drive
5. City: Jefferson City	Vicinity <input type="checkbox"/>	6. Lat / Long:	7. Township/Range/Section: T: R: S:
8. Historic name (if known):		9. Present/other name (if known):	
10. Ownership: <input checked="" type="checkbox"/> Private <input type="checkbox"/> Public		11a. Historic use (if known): Domestic-Single Dwelling	11b. Current use: Domestic-Single Dwelling

MISSOURI DEPARTMENT OF NATURAL RESOURCES
STATE HISTORIC PRESERVATION OFFICE, P.O. Box 178, Jefferson City, MO 65102
ARCHITECTURAL/HISTORIC INVENTORY FORM

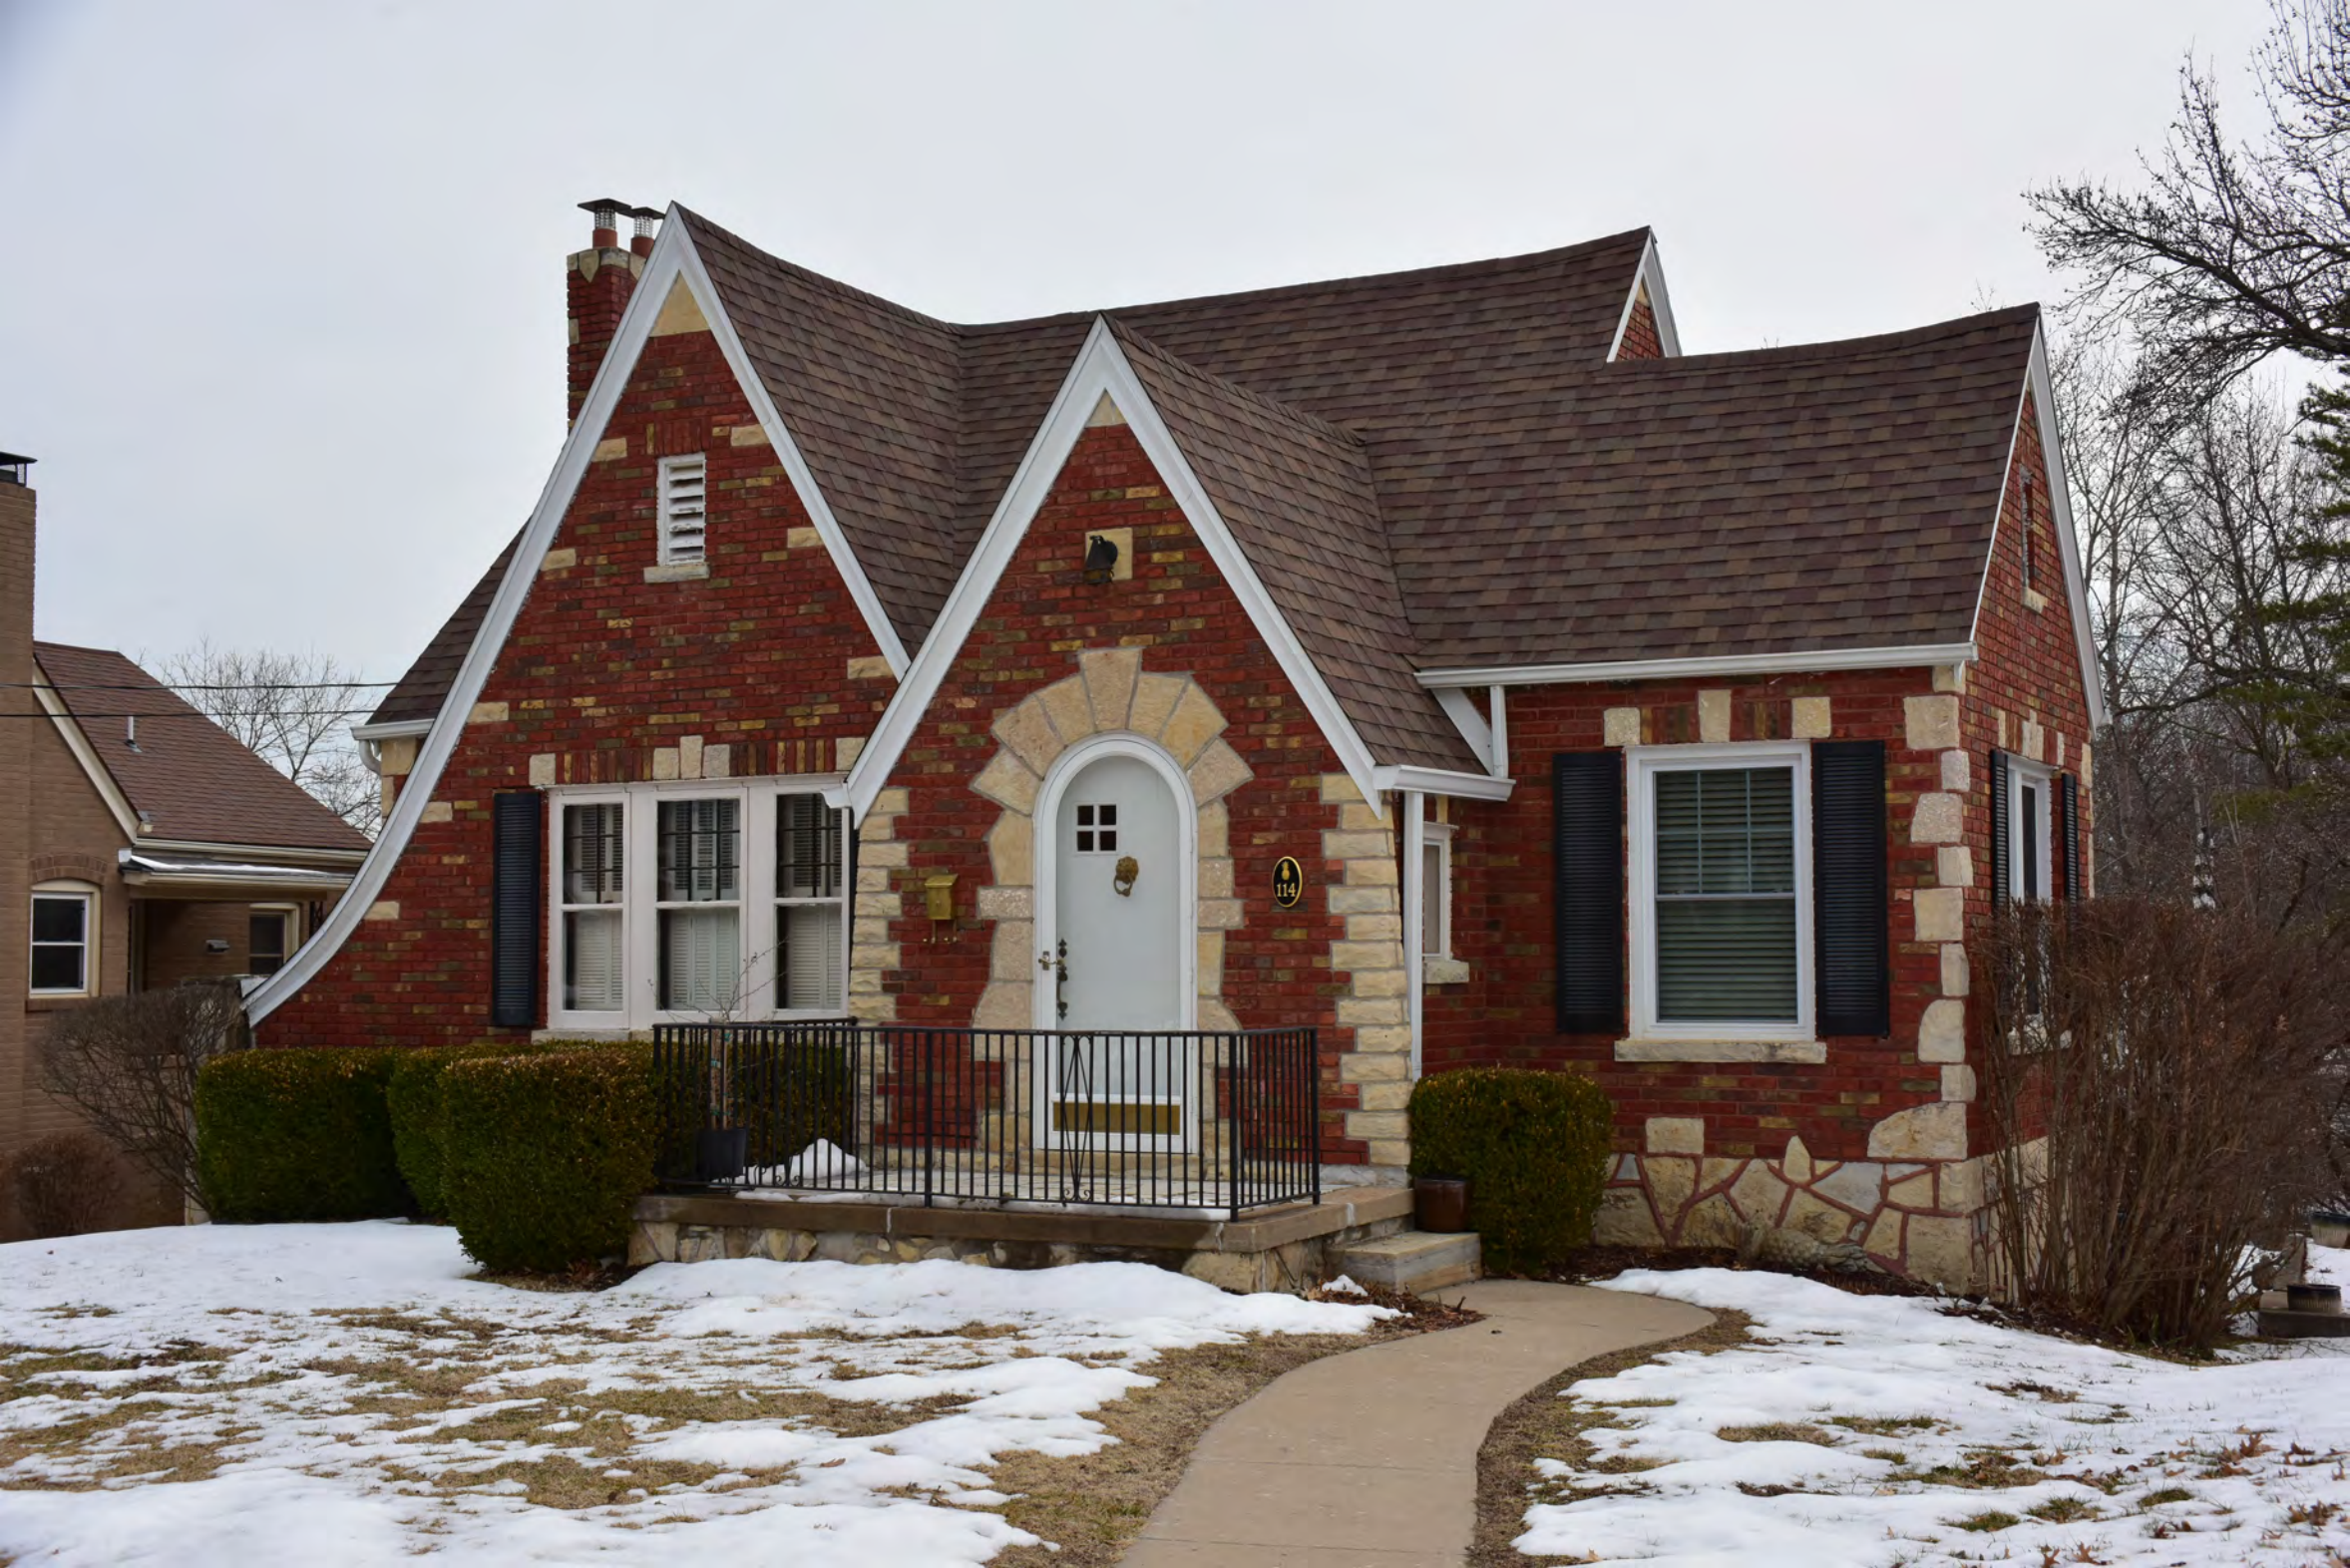
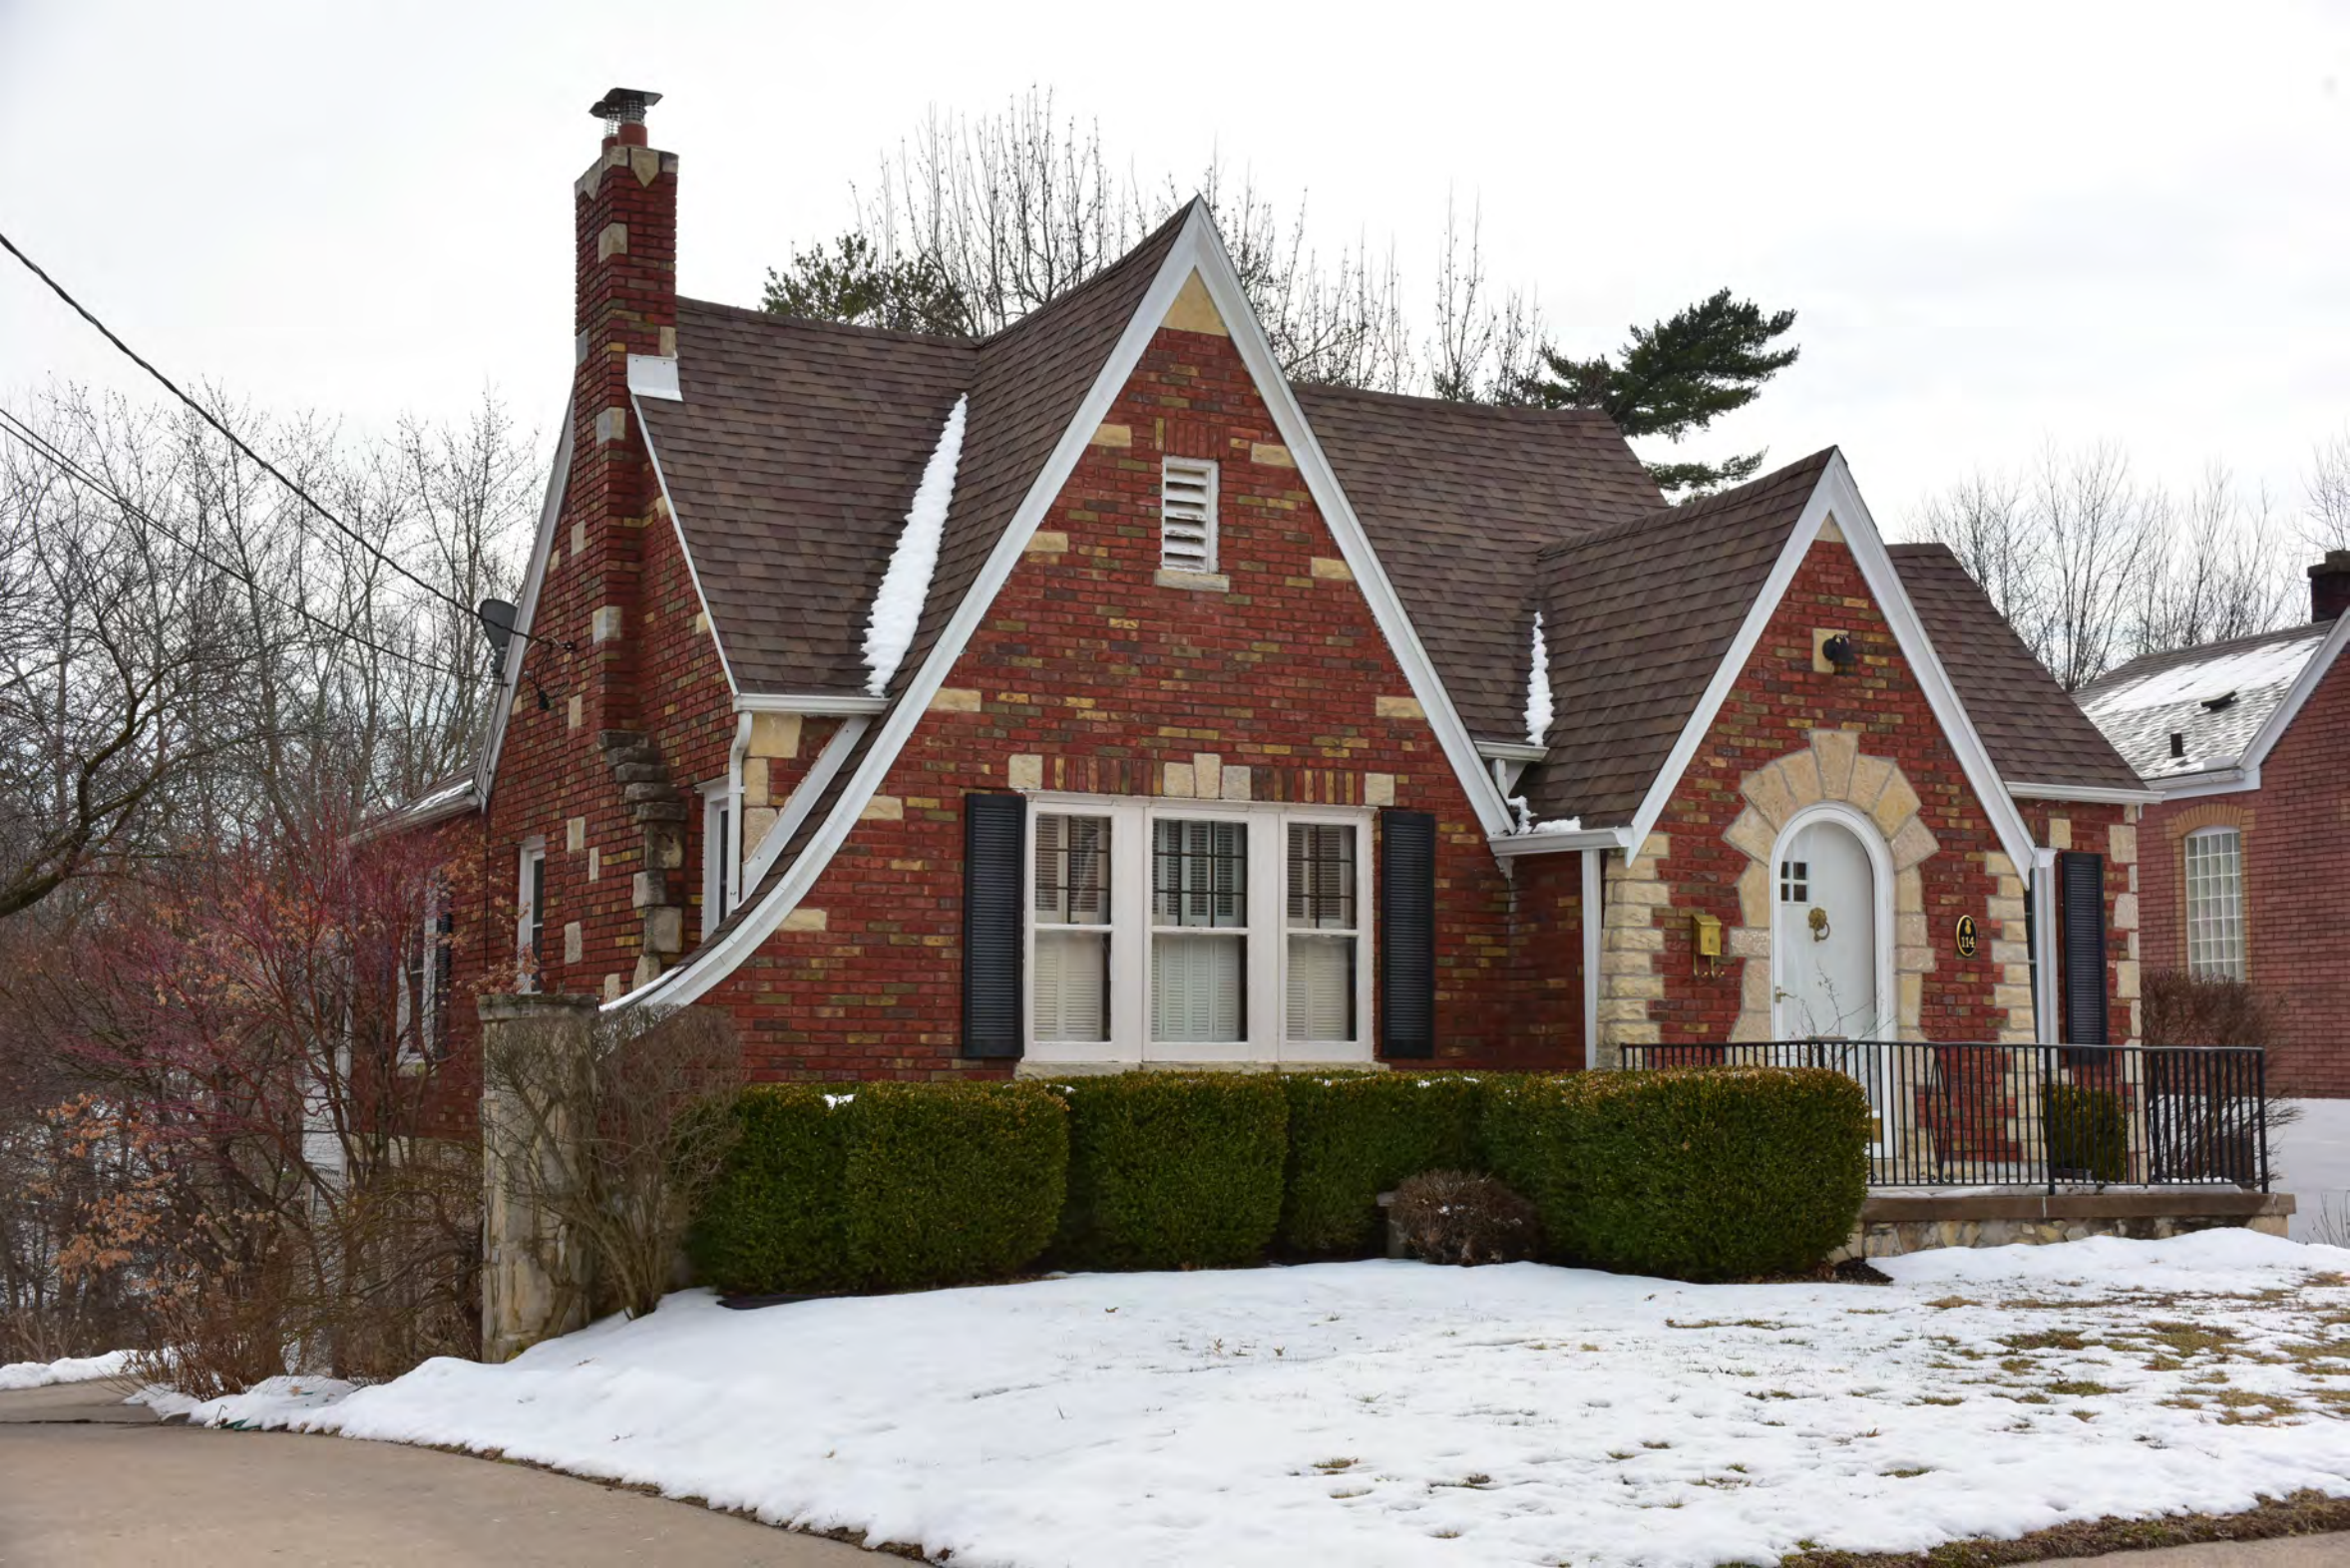
114 East Circle Drive is a one-and-one-half story Tudor Revival dwelling. It has a split-stone foundation, brick cladding with stone accents, and an asphalt intersecting-gable roof. A side-gable with two low cross gables fronts East Circle Drive while a perpendicular gable extends to the rear. The north cross-gable flares to the north, forming a narrow wingwall connected to a stone pier. The center cross-gable projects, forming an enclosed vestibule. A shed-roof enclosed sunporch spans the rear of the dwelling. A side-gable ell projects from the south elevation. A brick exterior chimney with stone accents pierces the gable at the north elevation. The dwelling is three bays wide. The north cross-gable defines the first bay and contains three ganged historic wood windows. Narrow 6/1 windows flank the central 9/1 window. Historic 1/1 wood storm windows protect each window. The entrance to the centered vestibule includes a rounded arch opening with stone accents and a historic wood door with small four-light window. A small one-light window is located in the south wall of the vestibule. A non-historic 6/1 vinyl windows defines the remaining primary elevation bay. The windows have stone sills and red soldier brick lintels with stone keystone motif accents. A platform porch with a split-stone foundation, concrete floor, and metal balustrade spans the width of the vestibule. An integrated historic single-car garage is located at basement level and is accessed at the rear.

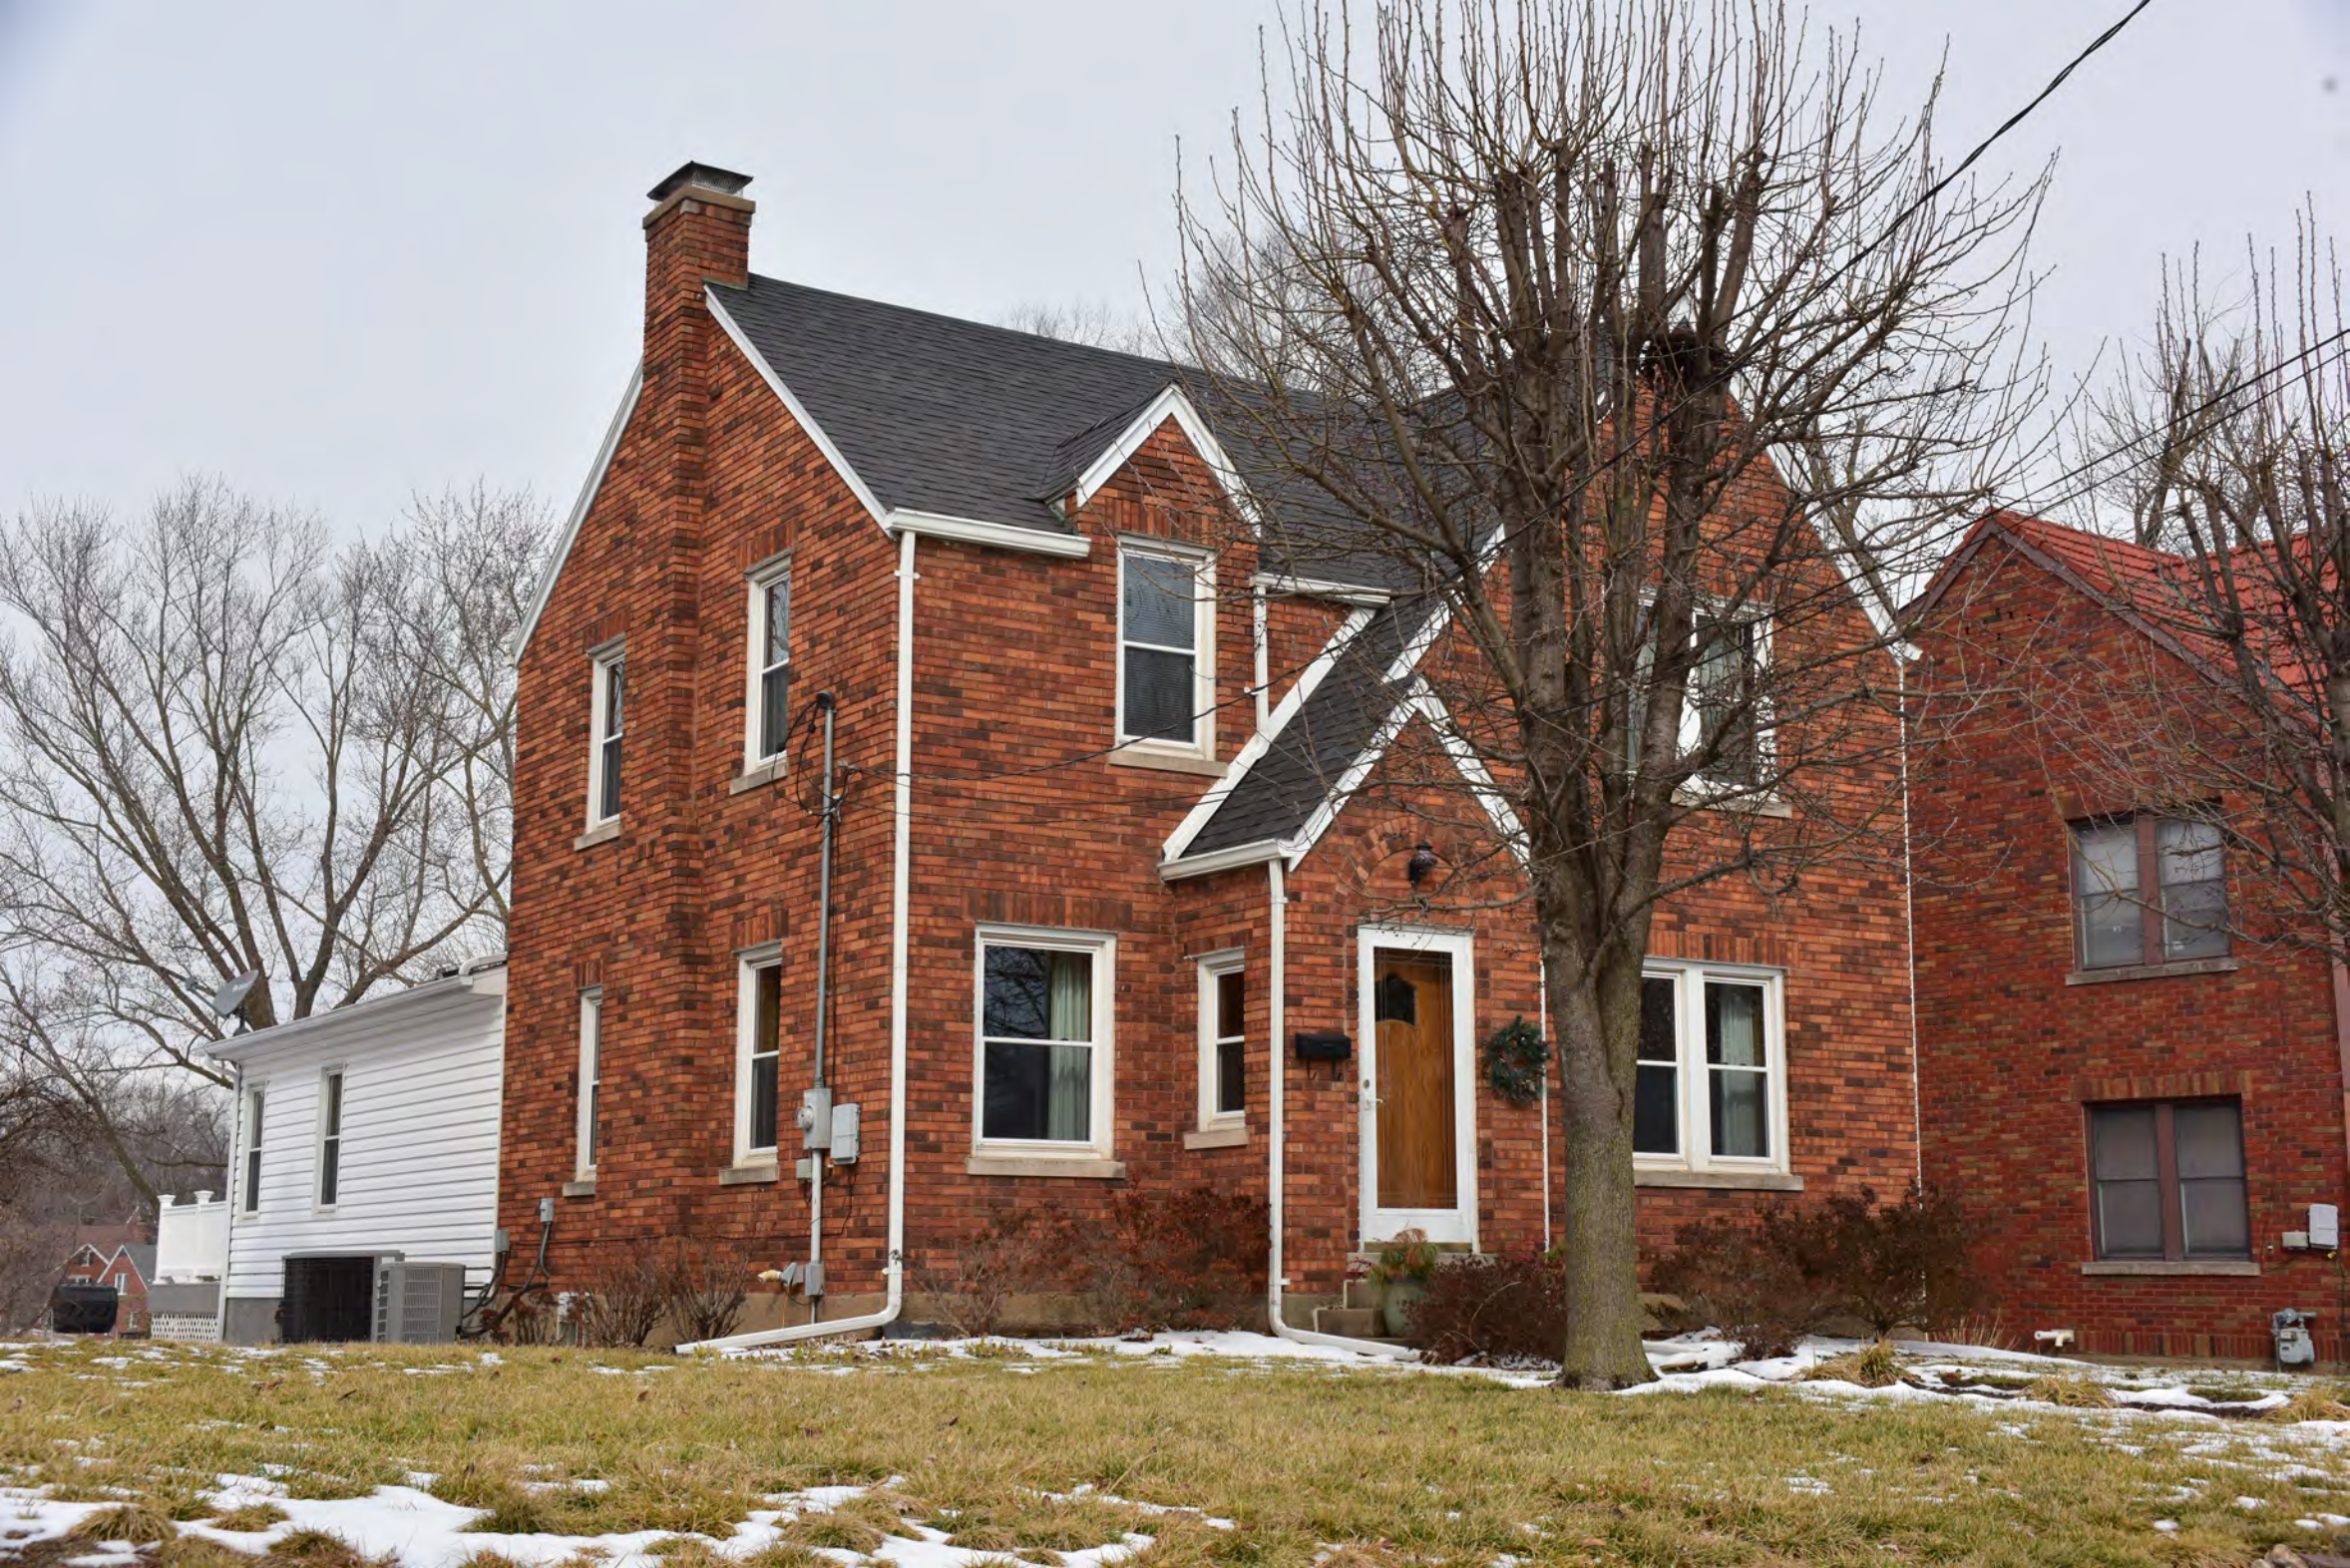
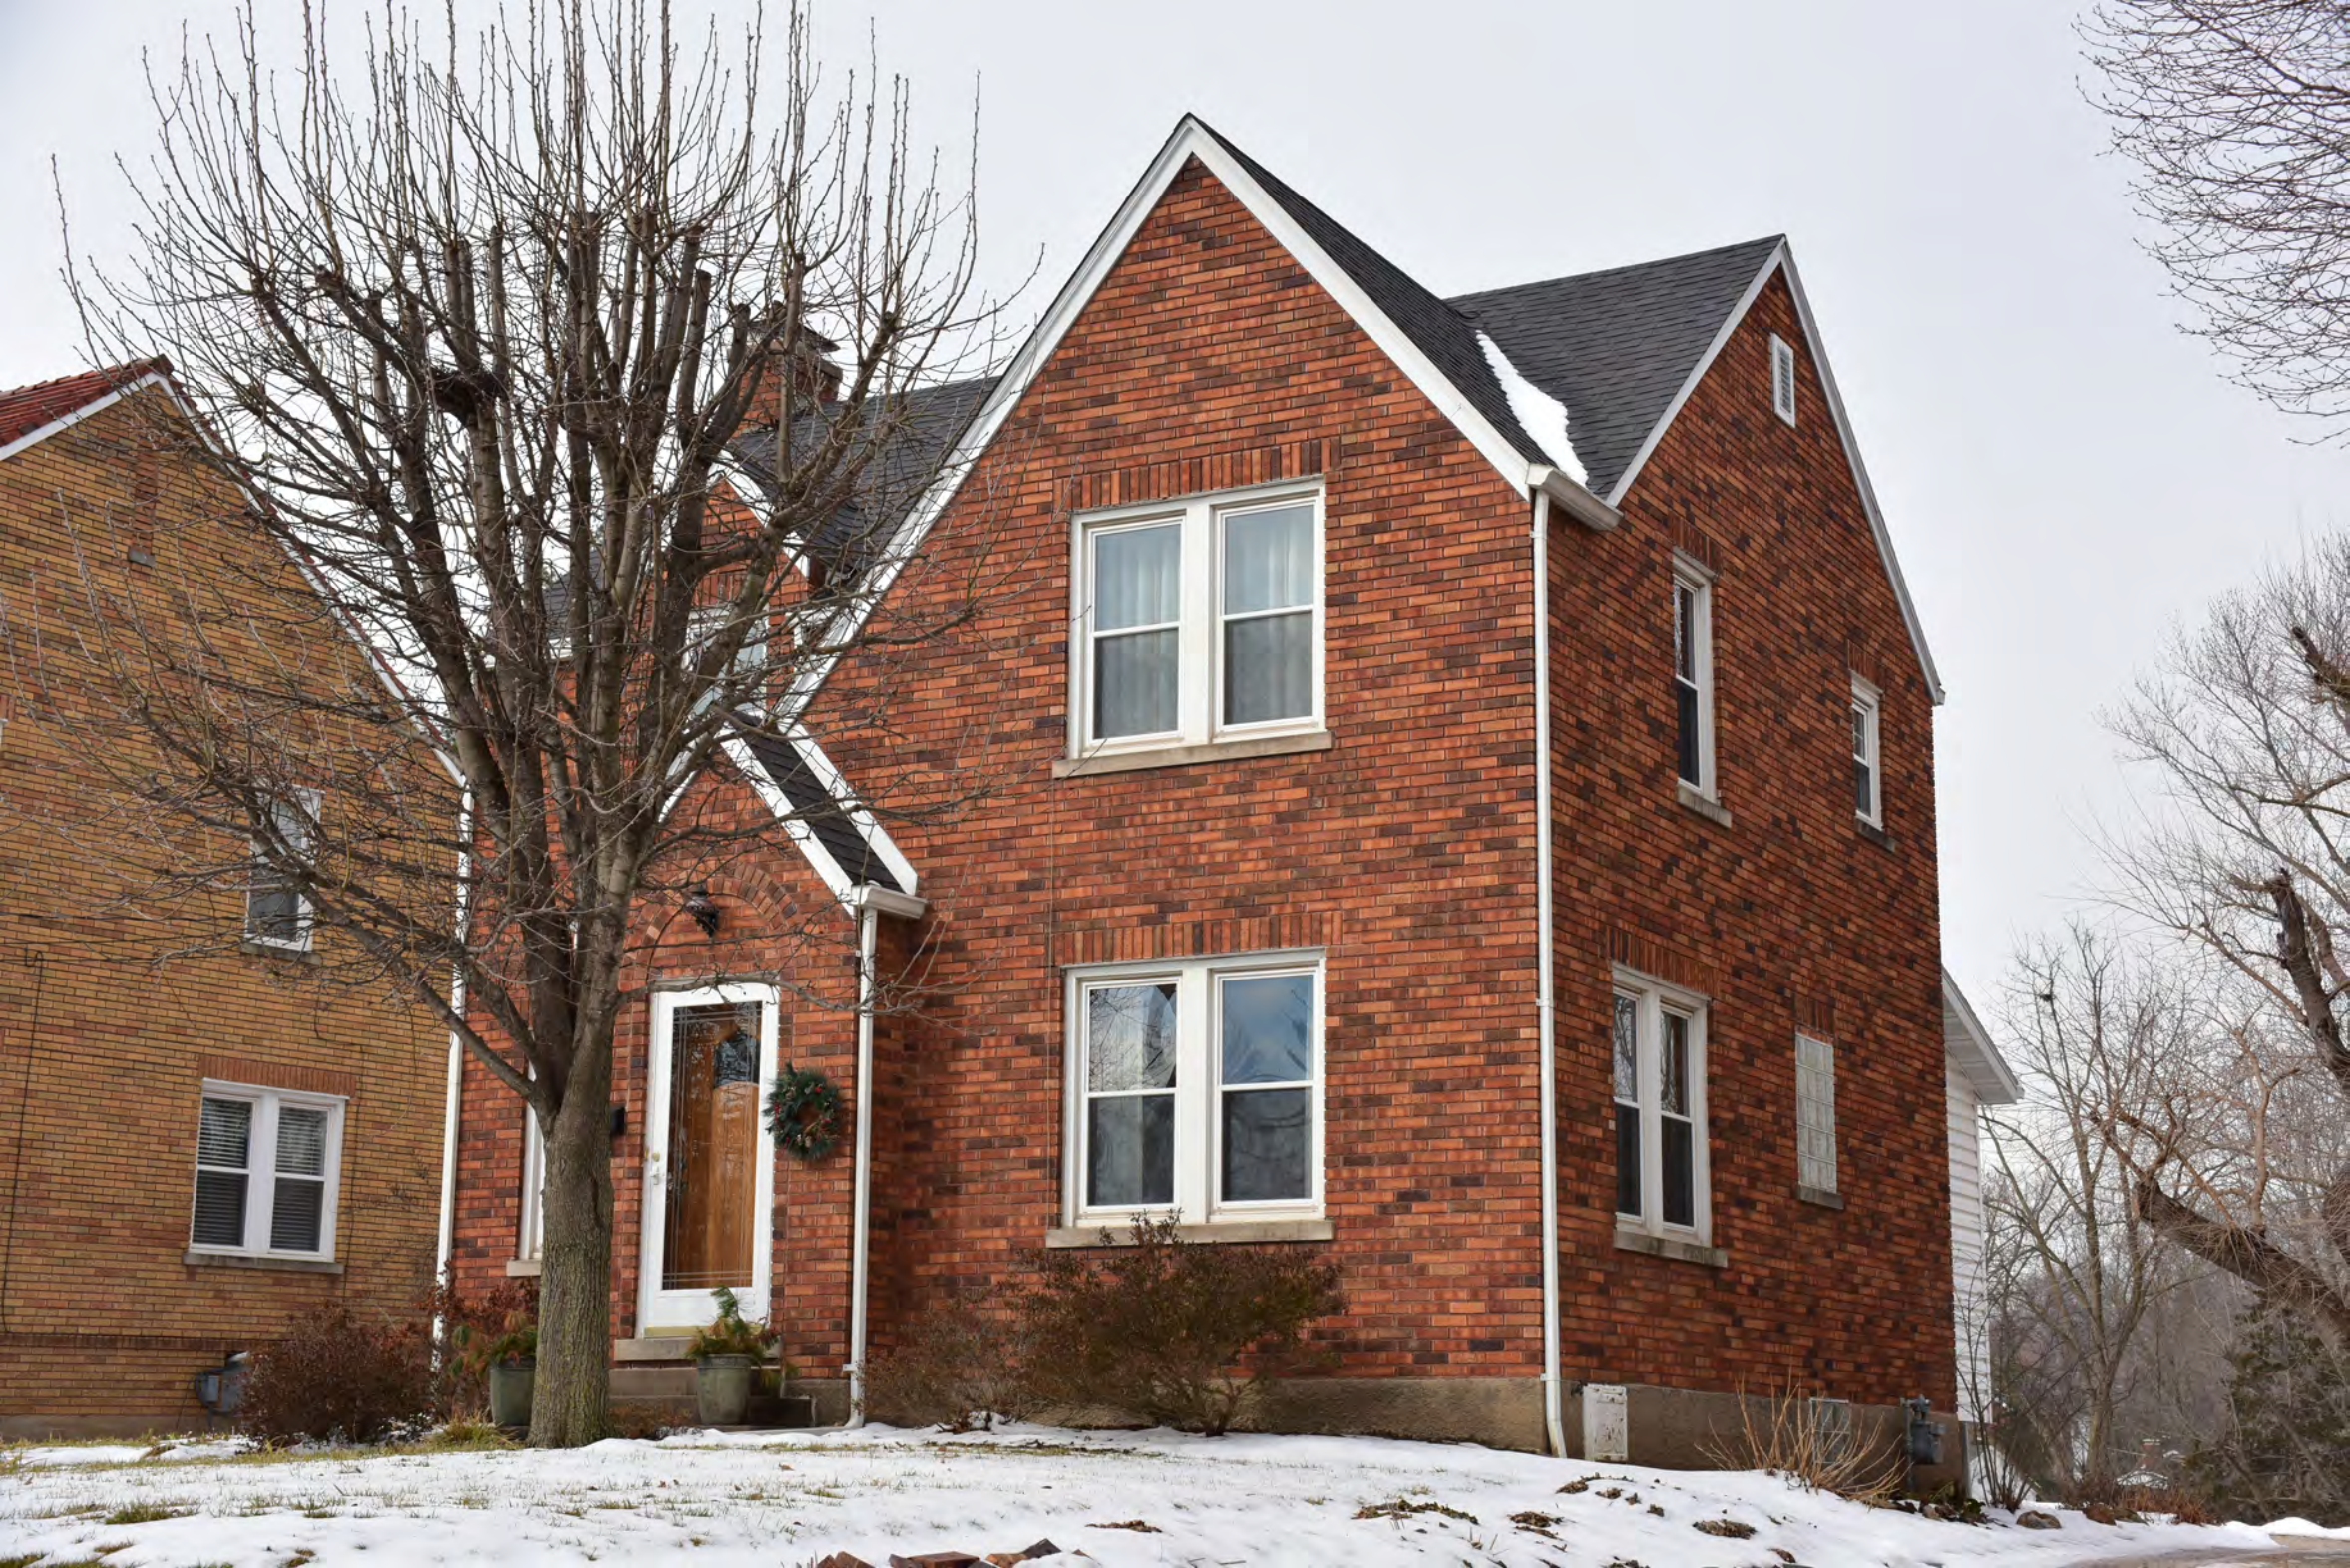
115 East Circle Drive is a two-and-one-half story Minimal Traditional dwelling. It has a concrete foundation, red brick cladding, and an asphalt side-gable roof with a shallow gabled-ell at the north half and small gabled wall dormer at the south half. A one-story vinyl-clad addition with an L-shaped plan and deck extends from the rear elevation. A brick exterior chimney is centered on the south elevation and pierces the gable apex. The dwelling is three bays wide at the first story. A 1/1 vinyl window defines the first bay. Two-ganged 1/1 vinyl windows define the north bay and are in the ell. A narrow front-gable vestibule defines the center bay. The entrance contains a historic wood door with pentagonal single-light glazing. A low-relief brick arch accents the doorway and a small 1/1 window is centered on the south wall of the vestibule. A narrow concrete stoop projects from the entrance. Single and paired non-historic 1/1 vinyl windows define the two second-story primary elevation bays. Windows define the secondary elevation bays and are primarily 1/1 vinyl. All visible windows have stone sills and soldier brick lintels. An integrated historic single-car garage is located at basement level and is accessed at the rear.
