1. Survey number: CO-AS-008-001		2. Survey Name: West Main Street Survey	
3. County: Cole		4. Address (Street No.): 100	Street (name): East Circle Drive
5. City: Jefferson City	Vicinity <input type="checkbox"/>	6. Lat / Long:	7. Township/Range/Section: T: R: S:
8. Historic name (if known):		9. Present/other name (if known):	
10. Ownership: <input checked="" type="checkbox"/> Private <input type="checkbox"/> Public		11a. Historic use (if known): Domestic-Single Dwelling	11b. Current use: Domestic-Single Dwelling

MISSOURI DEPARTMENT OF NATURAL RESOURCES
STATE HISTORIC PRESERVATION OFFICE, P.O. Box 178, Jefferson City, MO 65102
ARCHITECTURAL/HISTORIC INVENTORY FORM

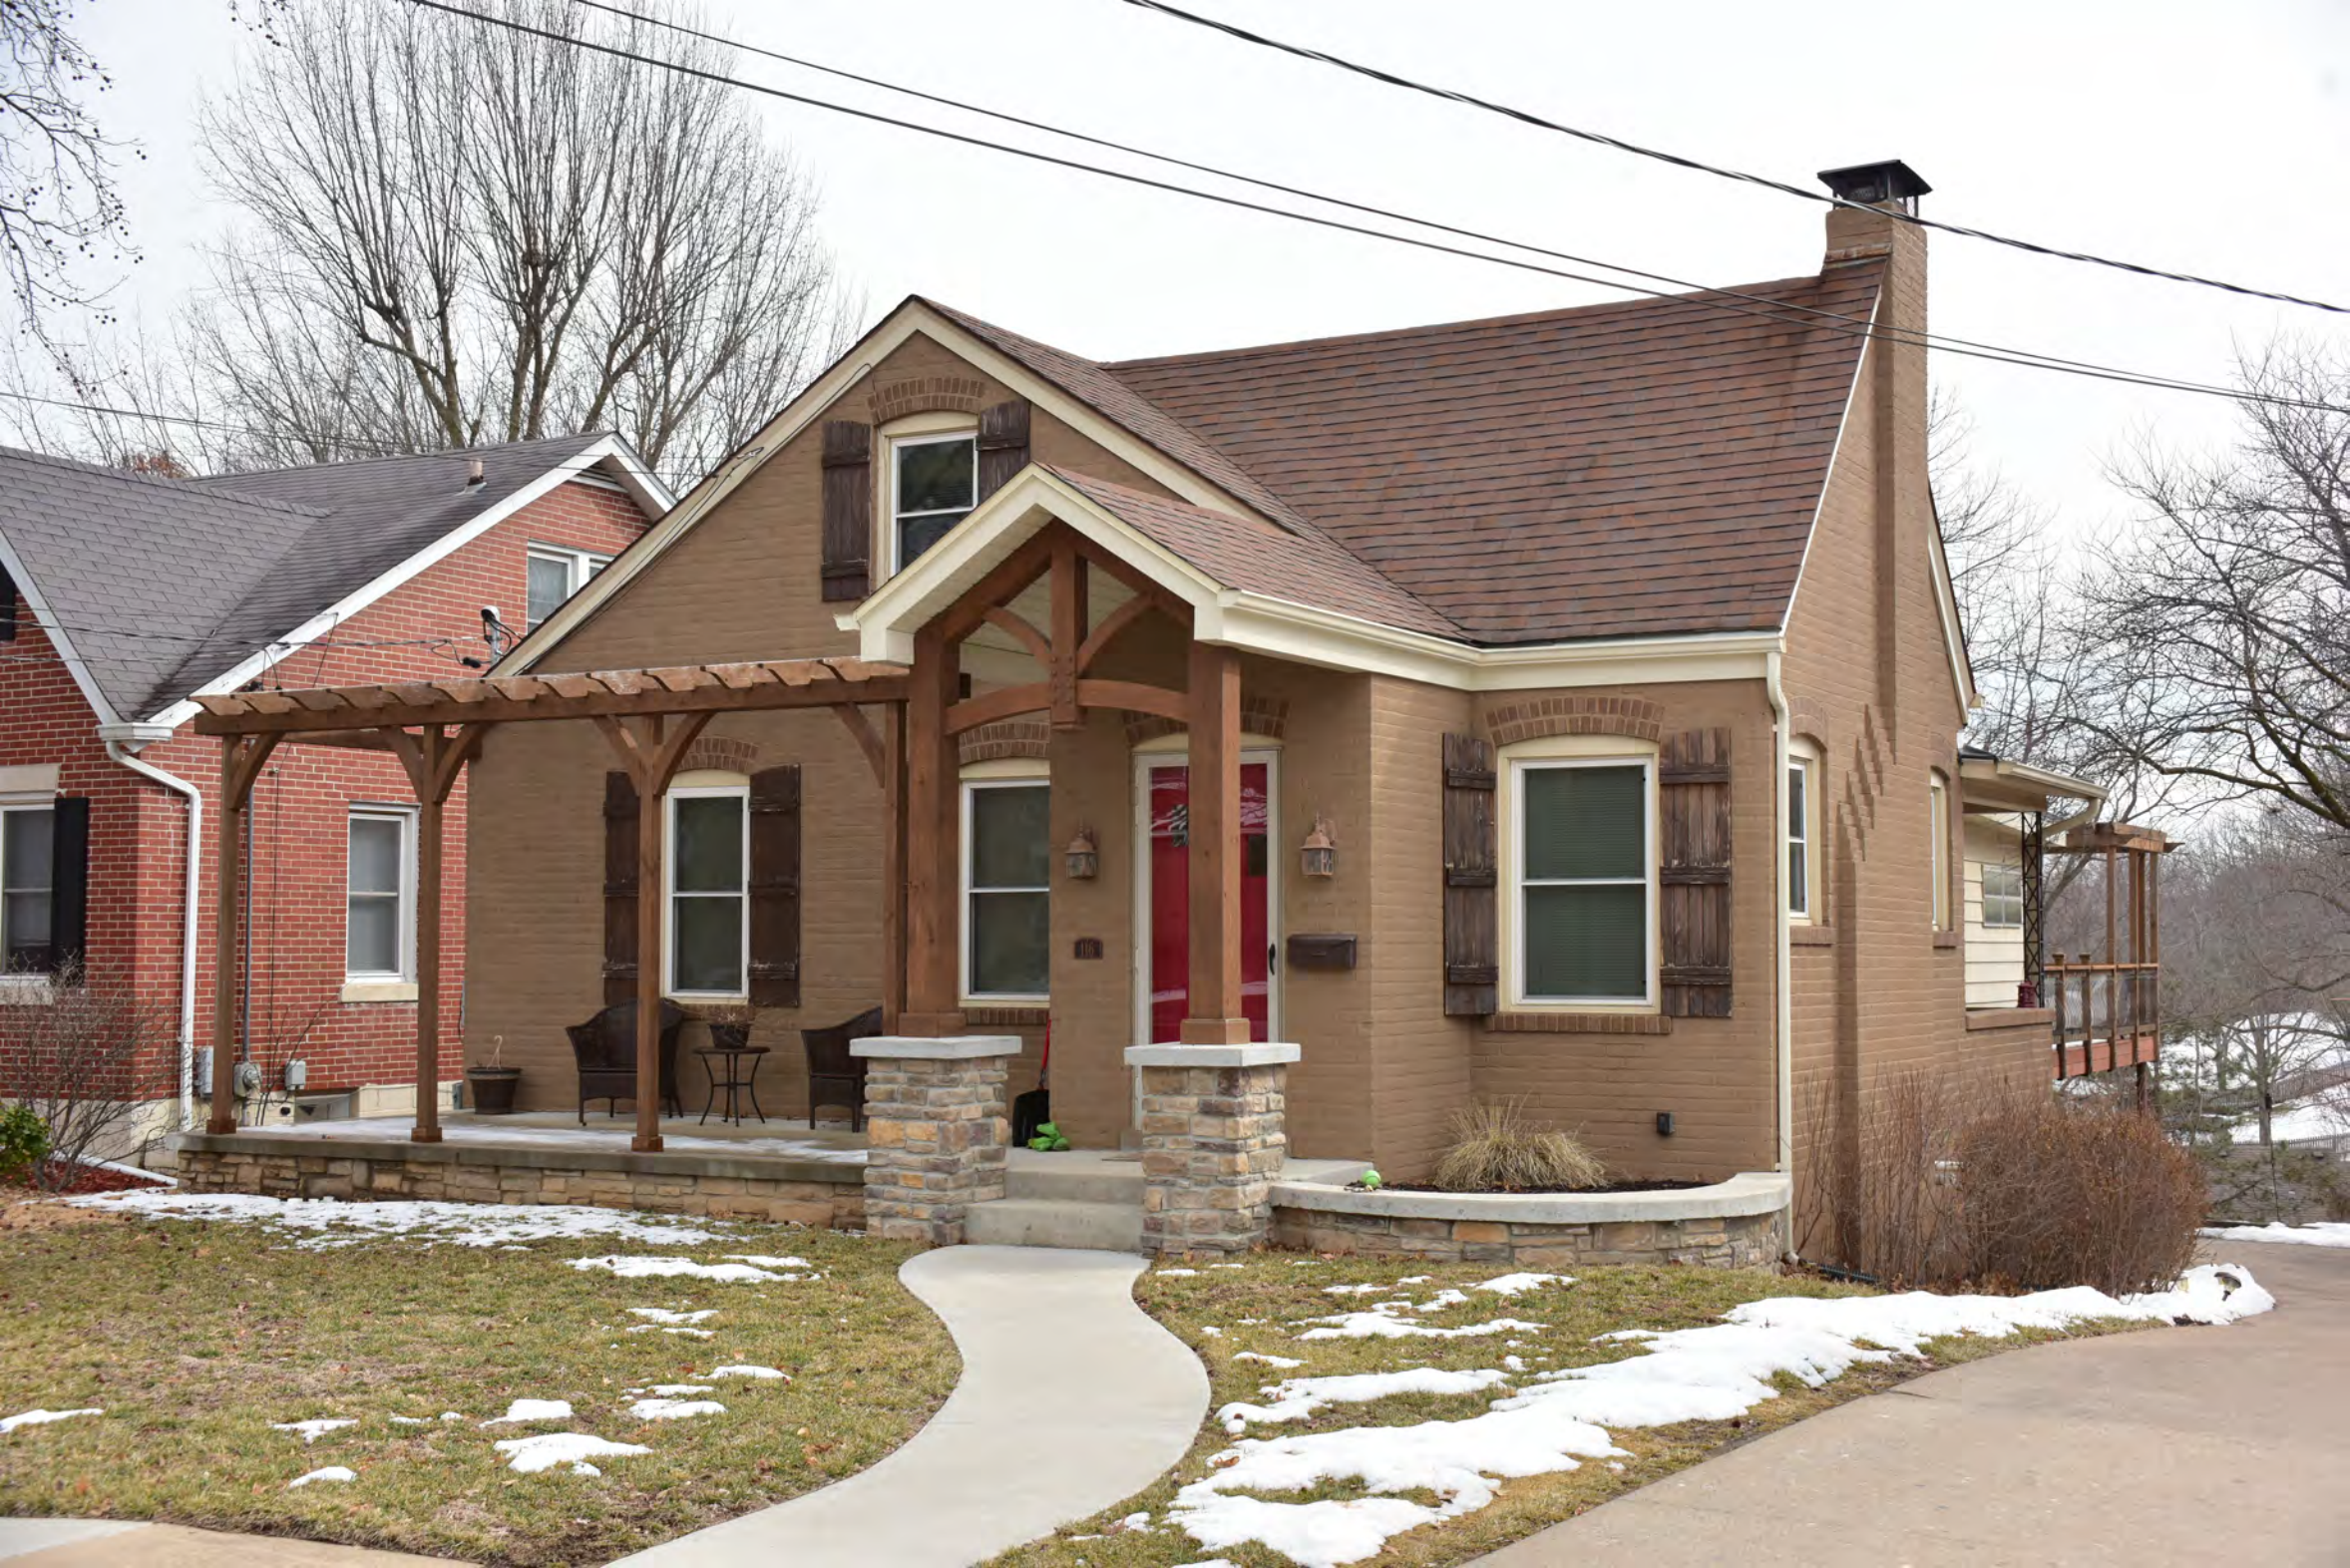
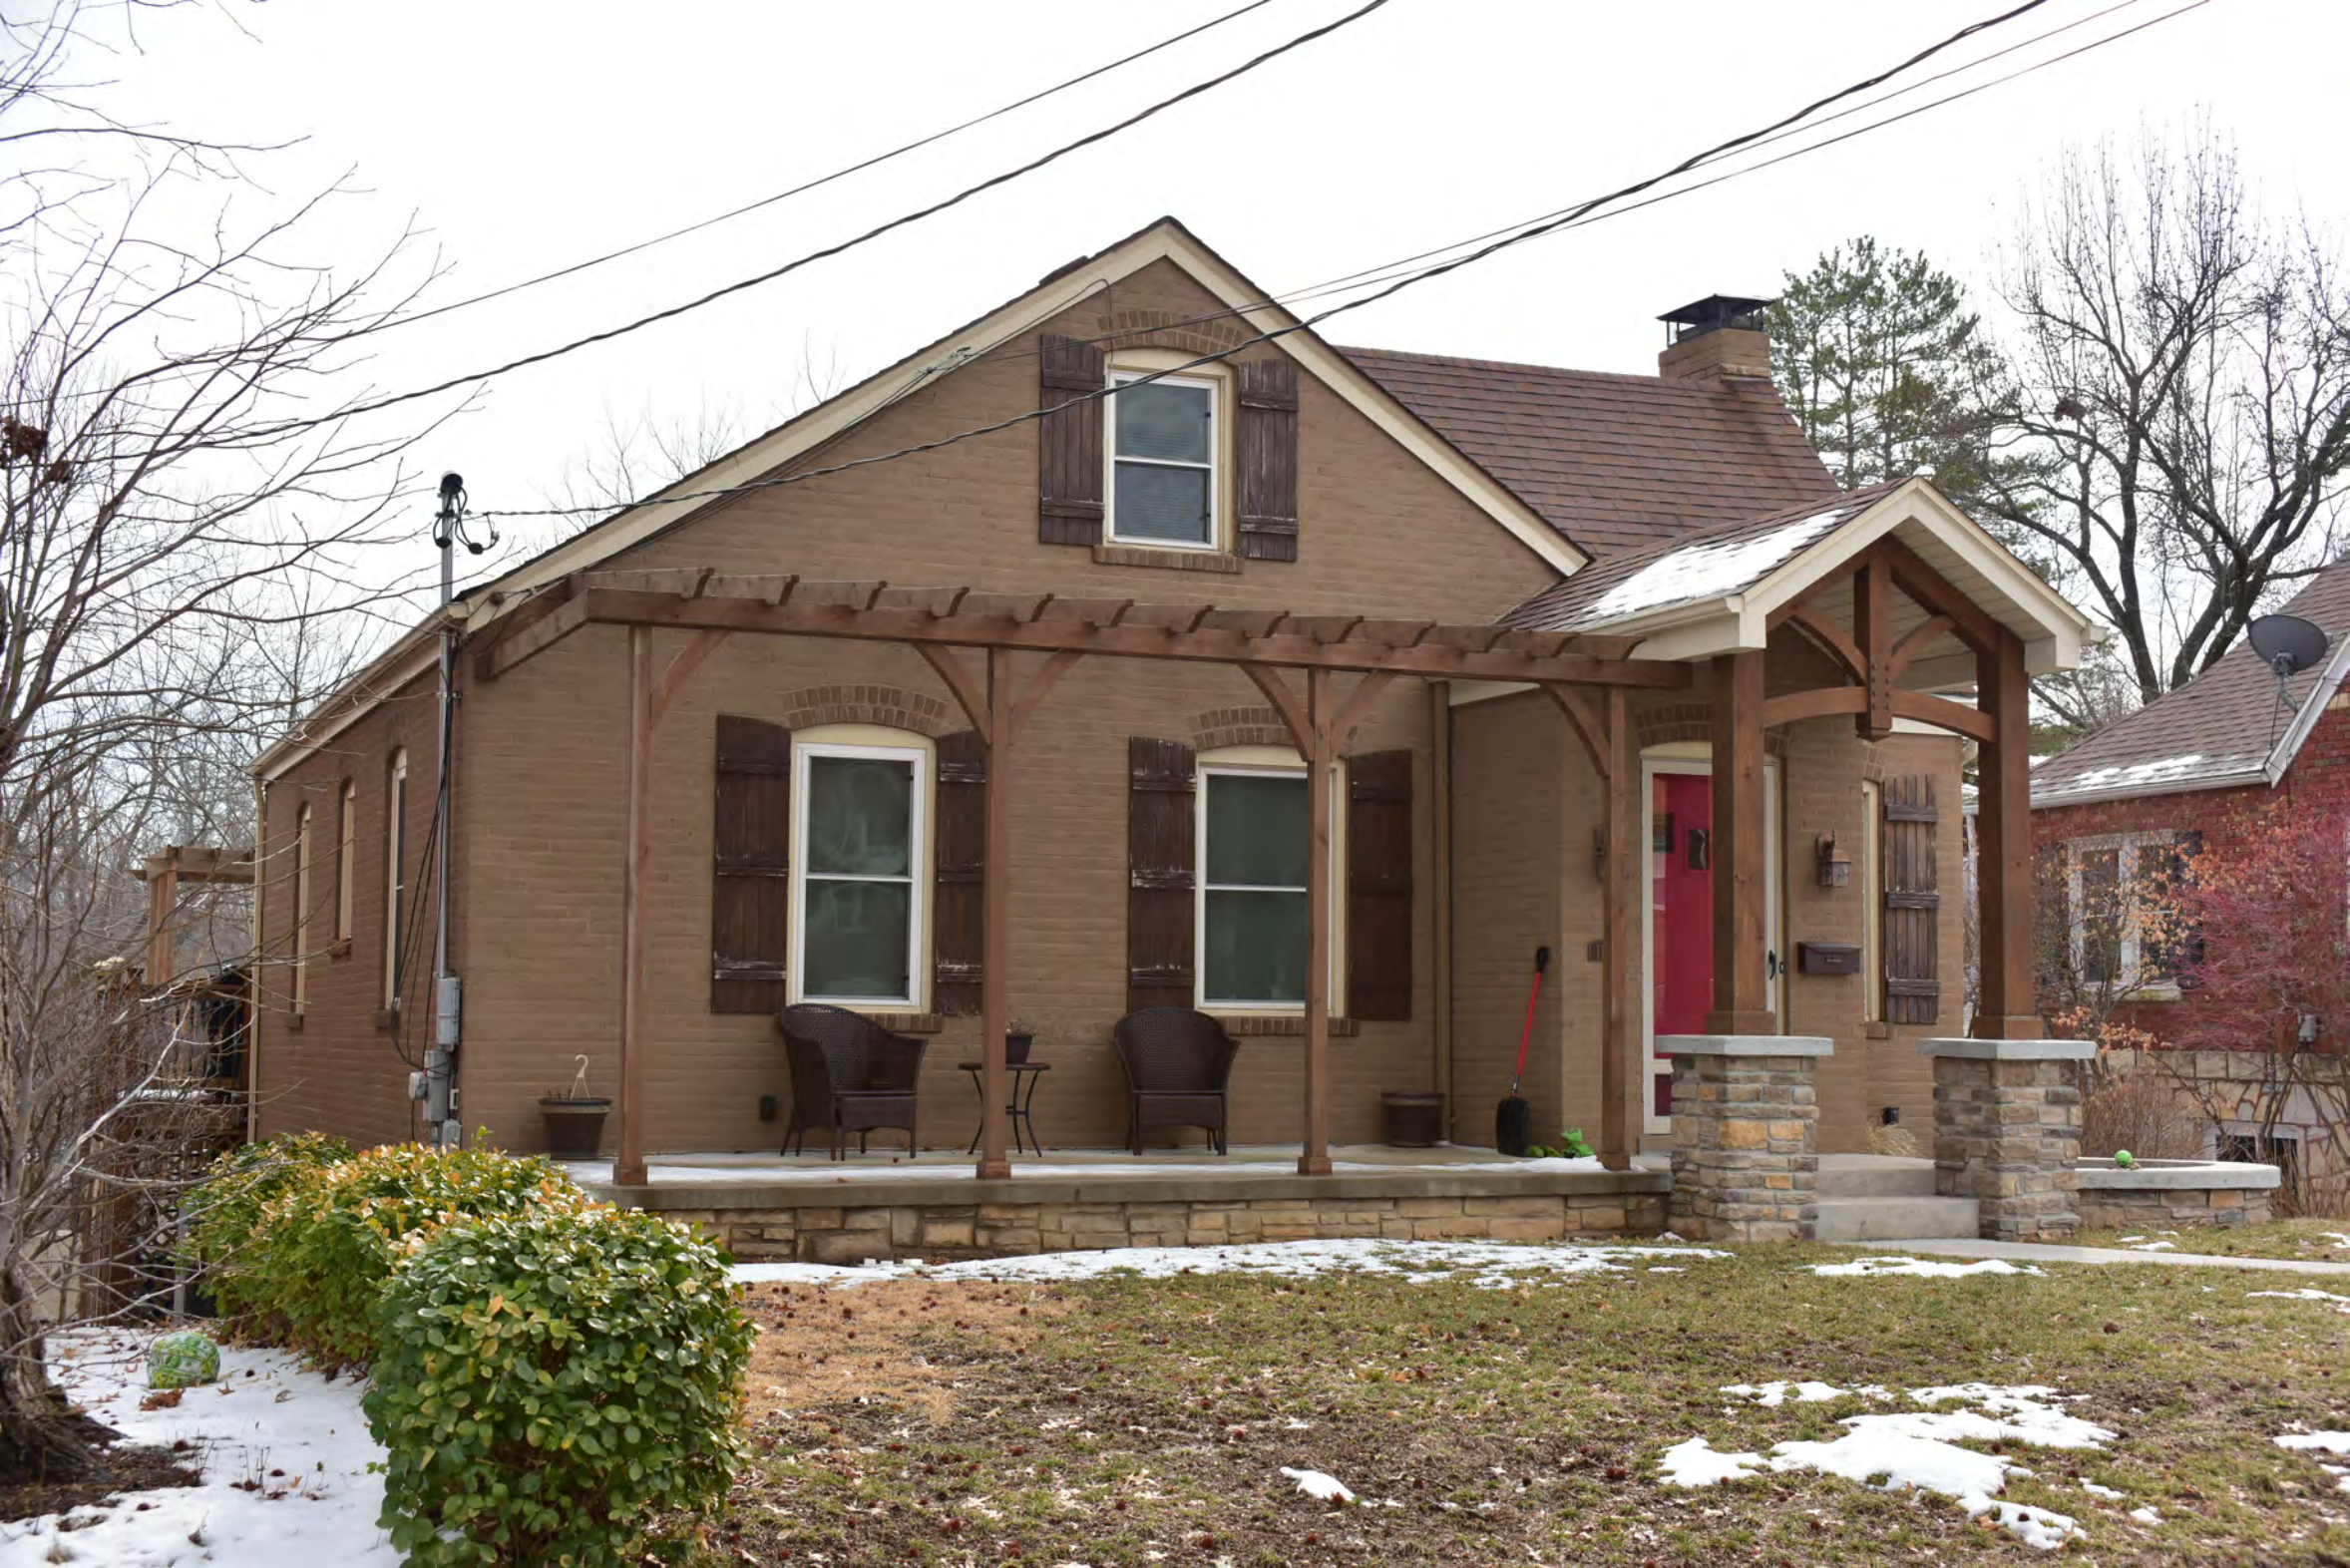
116 East Circle Drive is a one-and-one-half story single-family dwelling with brick cladding, a concrete foundation, and an asphalt gabled-ell roof. The primary roof mass is front-gabled while a side-gabled ell projects from the south elevation. A one-story hardboard-clad addition with non-historic wood deck extends from the rear. A shed-roof open porch with decorative metal support post occupies juncture between the ell and addition. The dwelling is four bays wide. Non-historic 1/1 vinyl windows define Bays 1, 2, and 4. All windows have header brick sills, arched lintels, and non-historic wood shutters. A narrow brick enclosed vestibule defines Bay 3. A non-historic gable roof shelters the entrance. Non-historic squared wood columns on stone piers support the roof and decorative wood beams fill the gable end. A non-historic concrete patio with a stone-faced foundation extends below Bays 1 and 2. A non-historic wood pergola shelters the bays. An integrated historic single-car garage is located at basement level and is accessed at the rear.

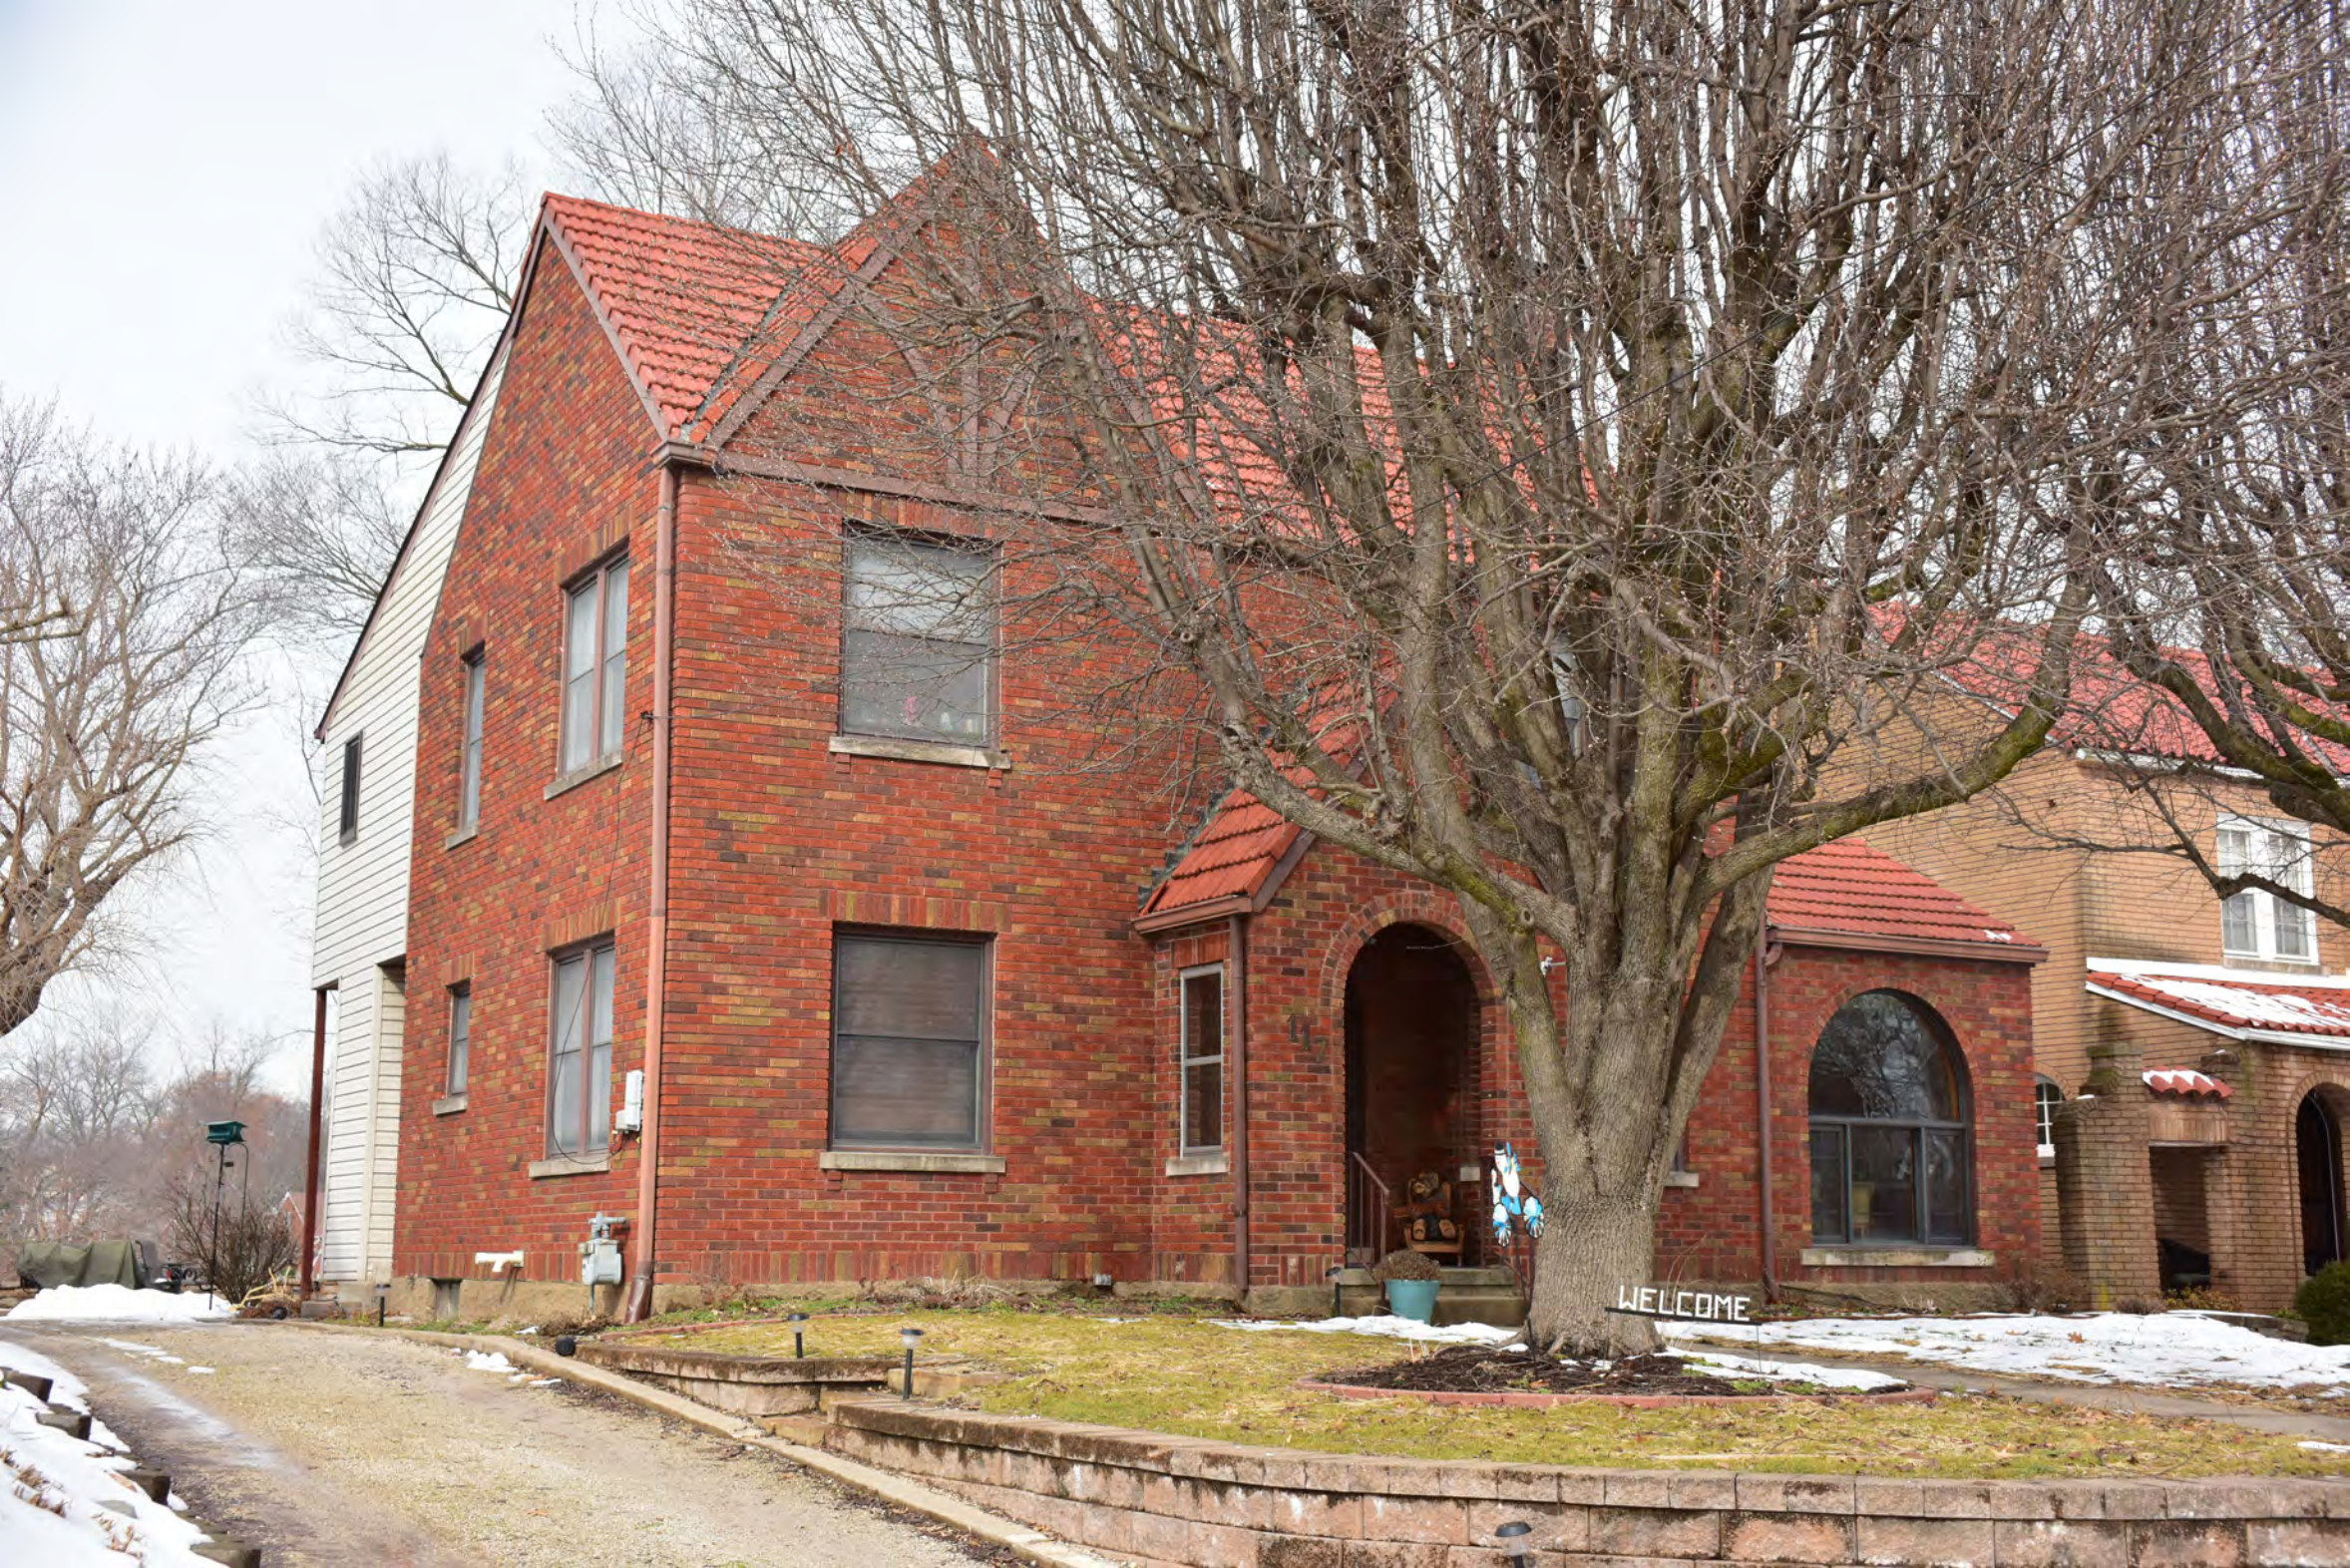
117 East Circle Drive is a two-and-one-half story Minimal Traditional dwelling with restrained Tudor Revival influences. It has a concrete foundation, multi-color brick cladding, and a tile side-gable roof with a gabled wall dormer at the south end. Half-timbering ornaments the dormer gable end. A one-story enclosed sunporch with a side-gable tile roof extends from the north elevation. A brick chimney is centered on the north elevation and pierces the gable apex. The dwelling is four bays wide at the first story. A front-gable brick vestibule with a tile roof and arched entrance shelters primary entrance, which features a historic arched wood door, and defines Bay 2. The sunroom contains the north bay. A large historic tripartite window with multi-light glazing and a large upper sash with decorative glazing fills the bay. The upper sash appears non-historic however the lower sash is historic. The window has a stone sill. Single and paired 1/1 metal windows define the remaining two bays. They have stone sills and soldier brick lintels. Header bricks form brackets below the sills at each end. Matching windows are located directly above at the second story. Single and paired 1/1 windows defines the north and south elevation bays. A series of one- and two-story vinyl-clad additions spans the rear elevation.

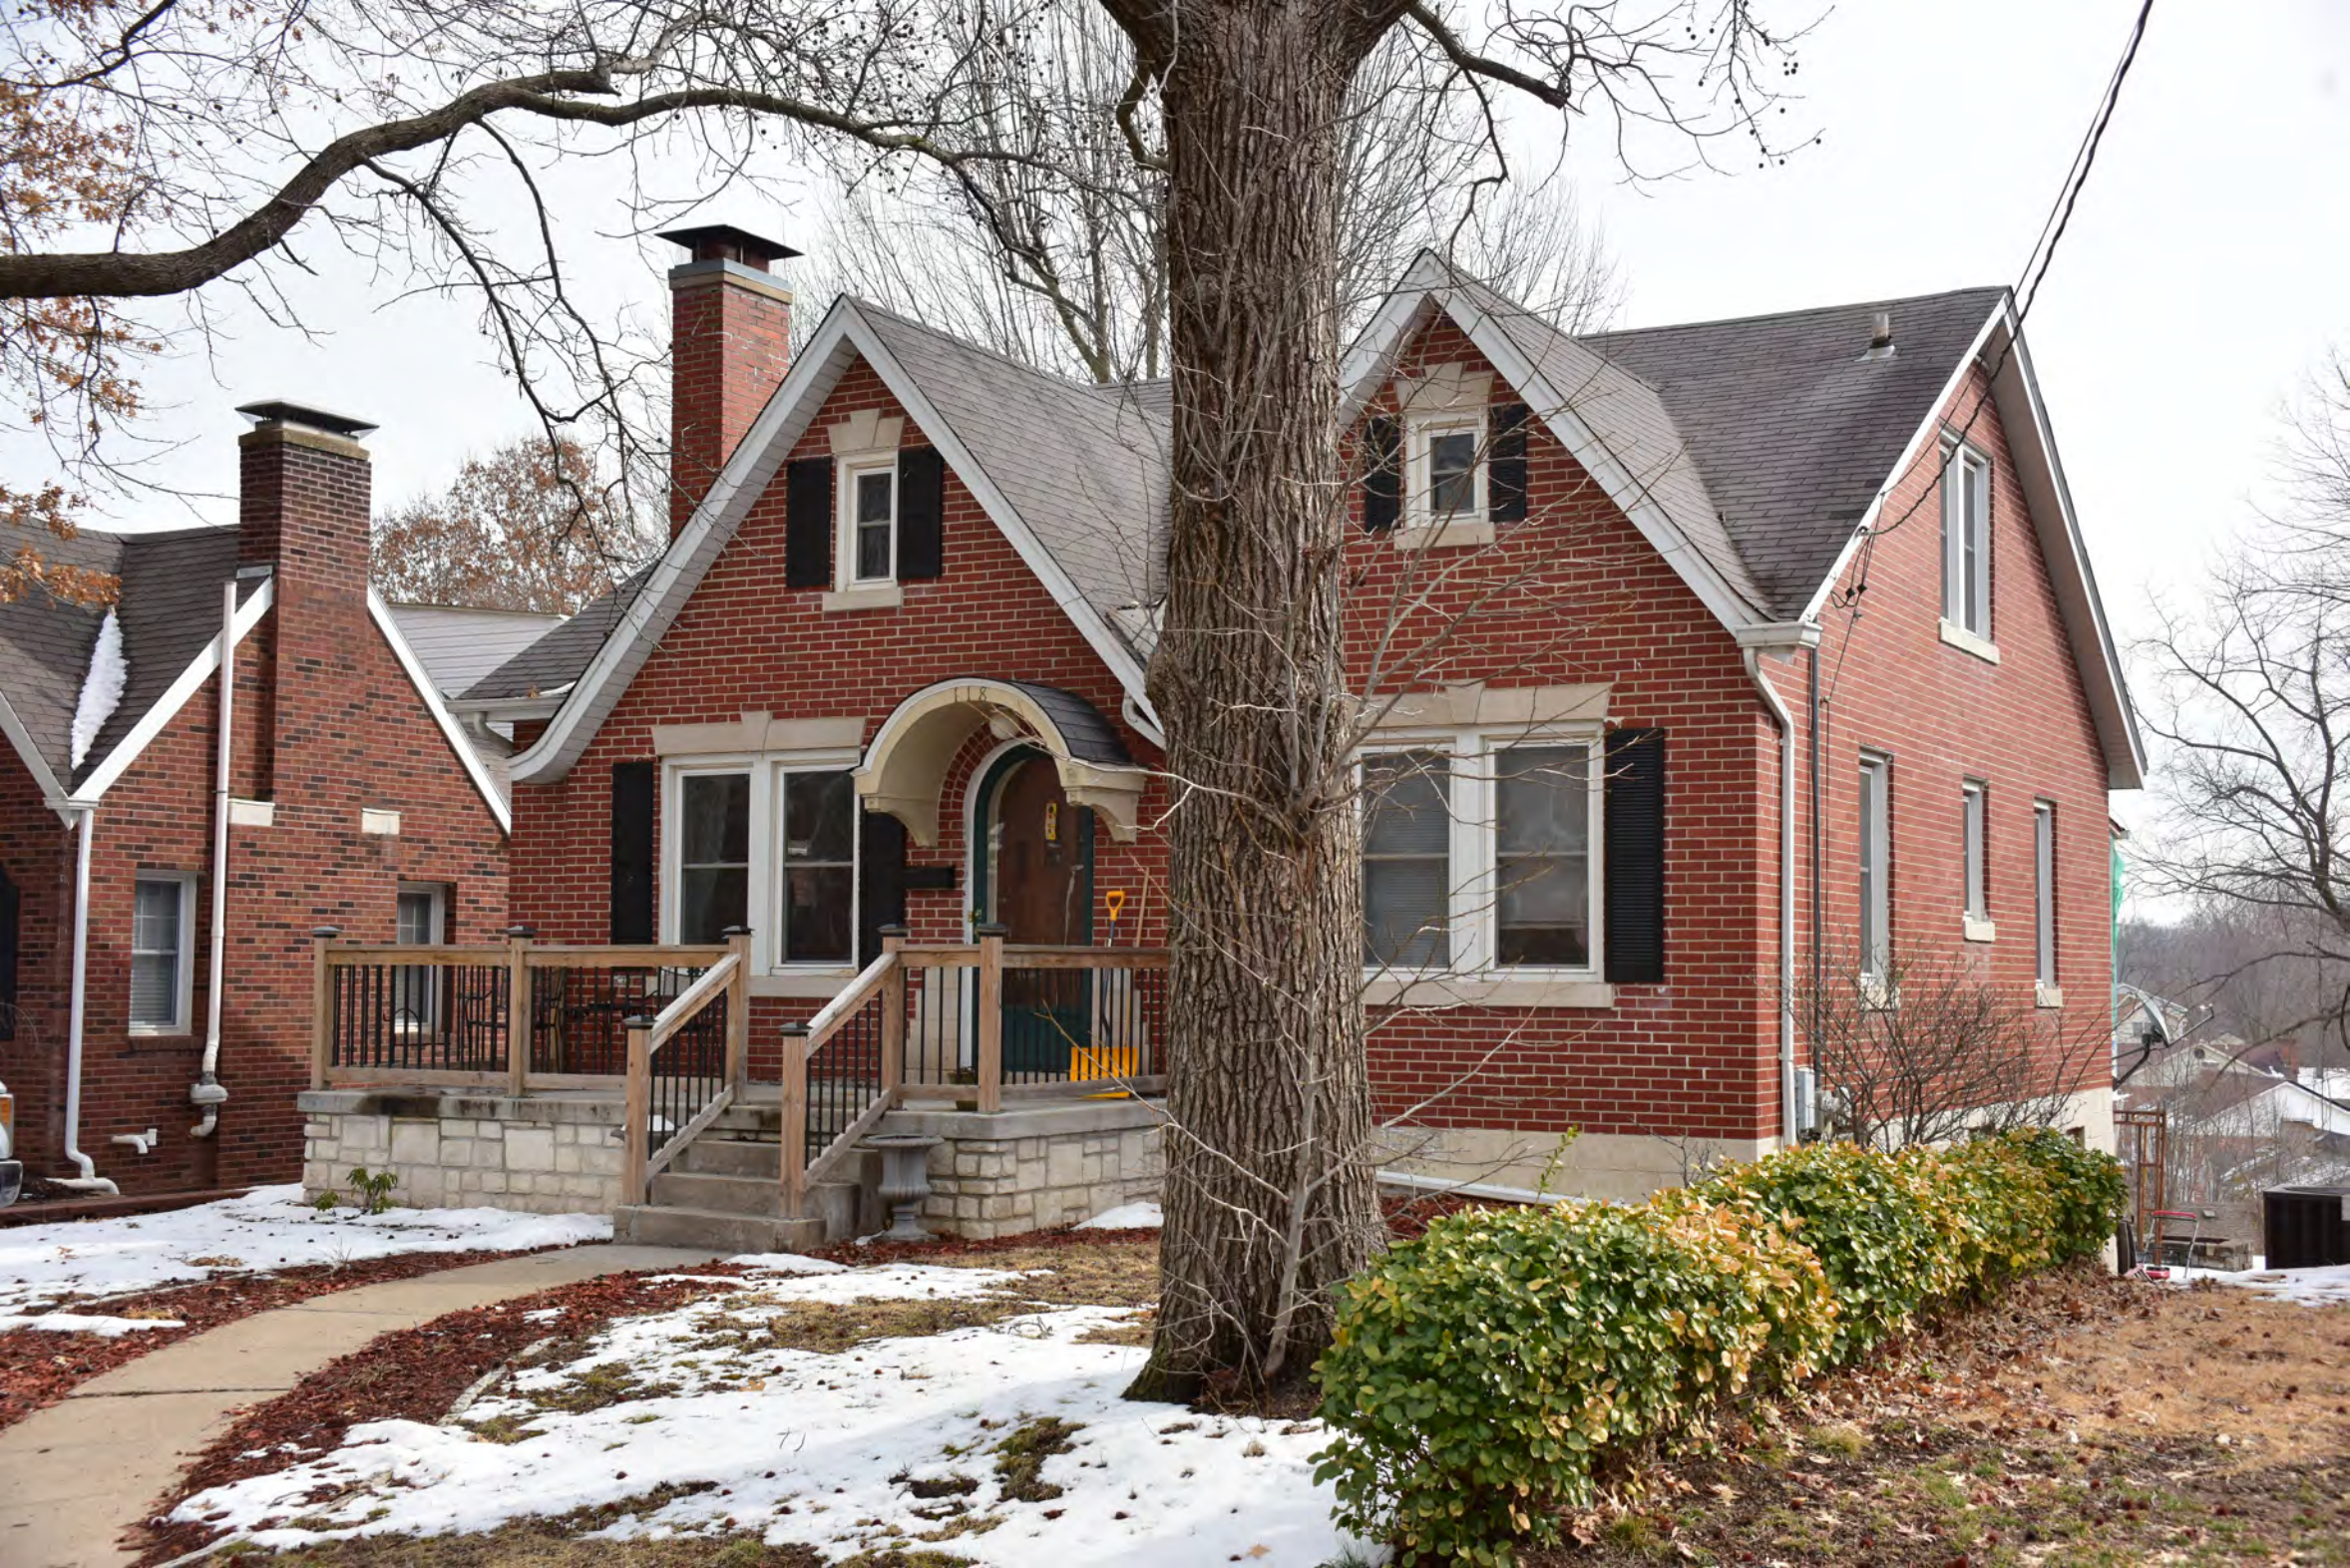
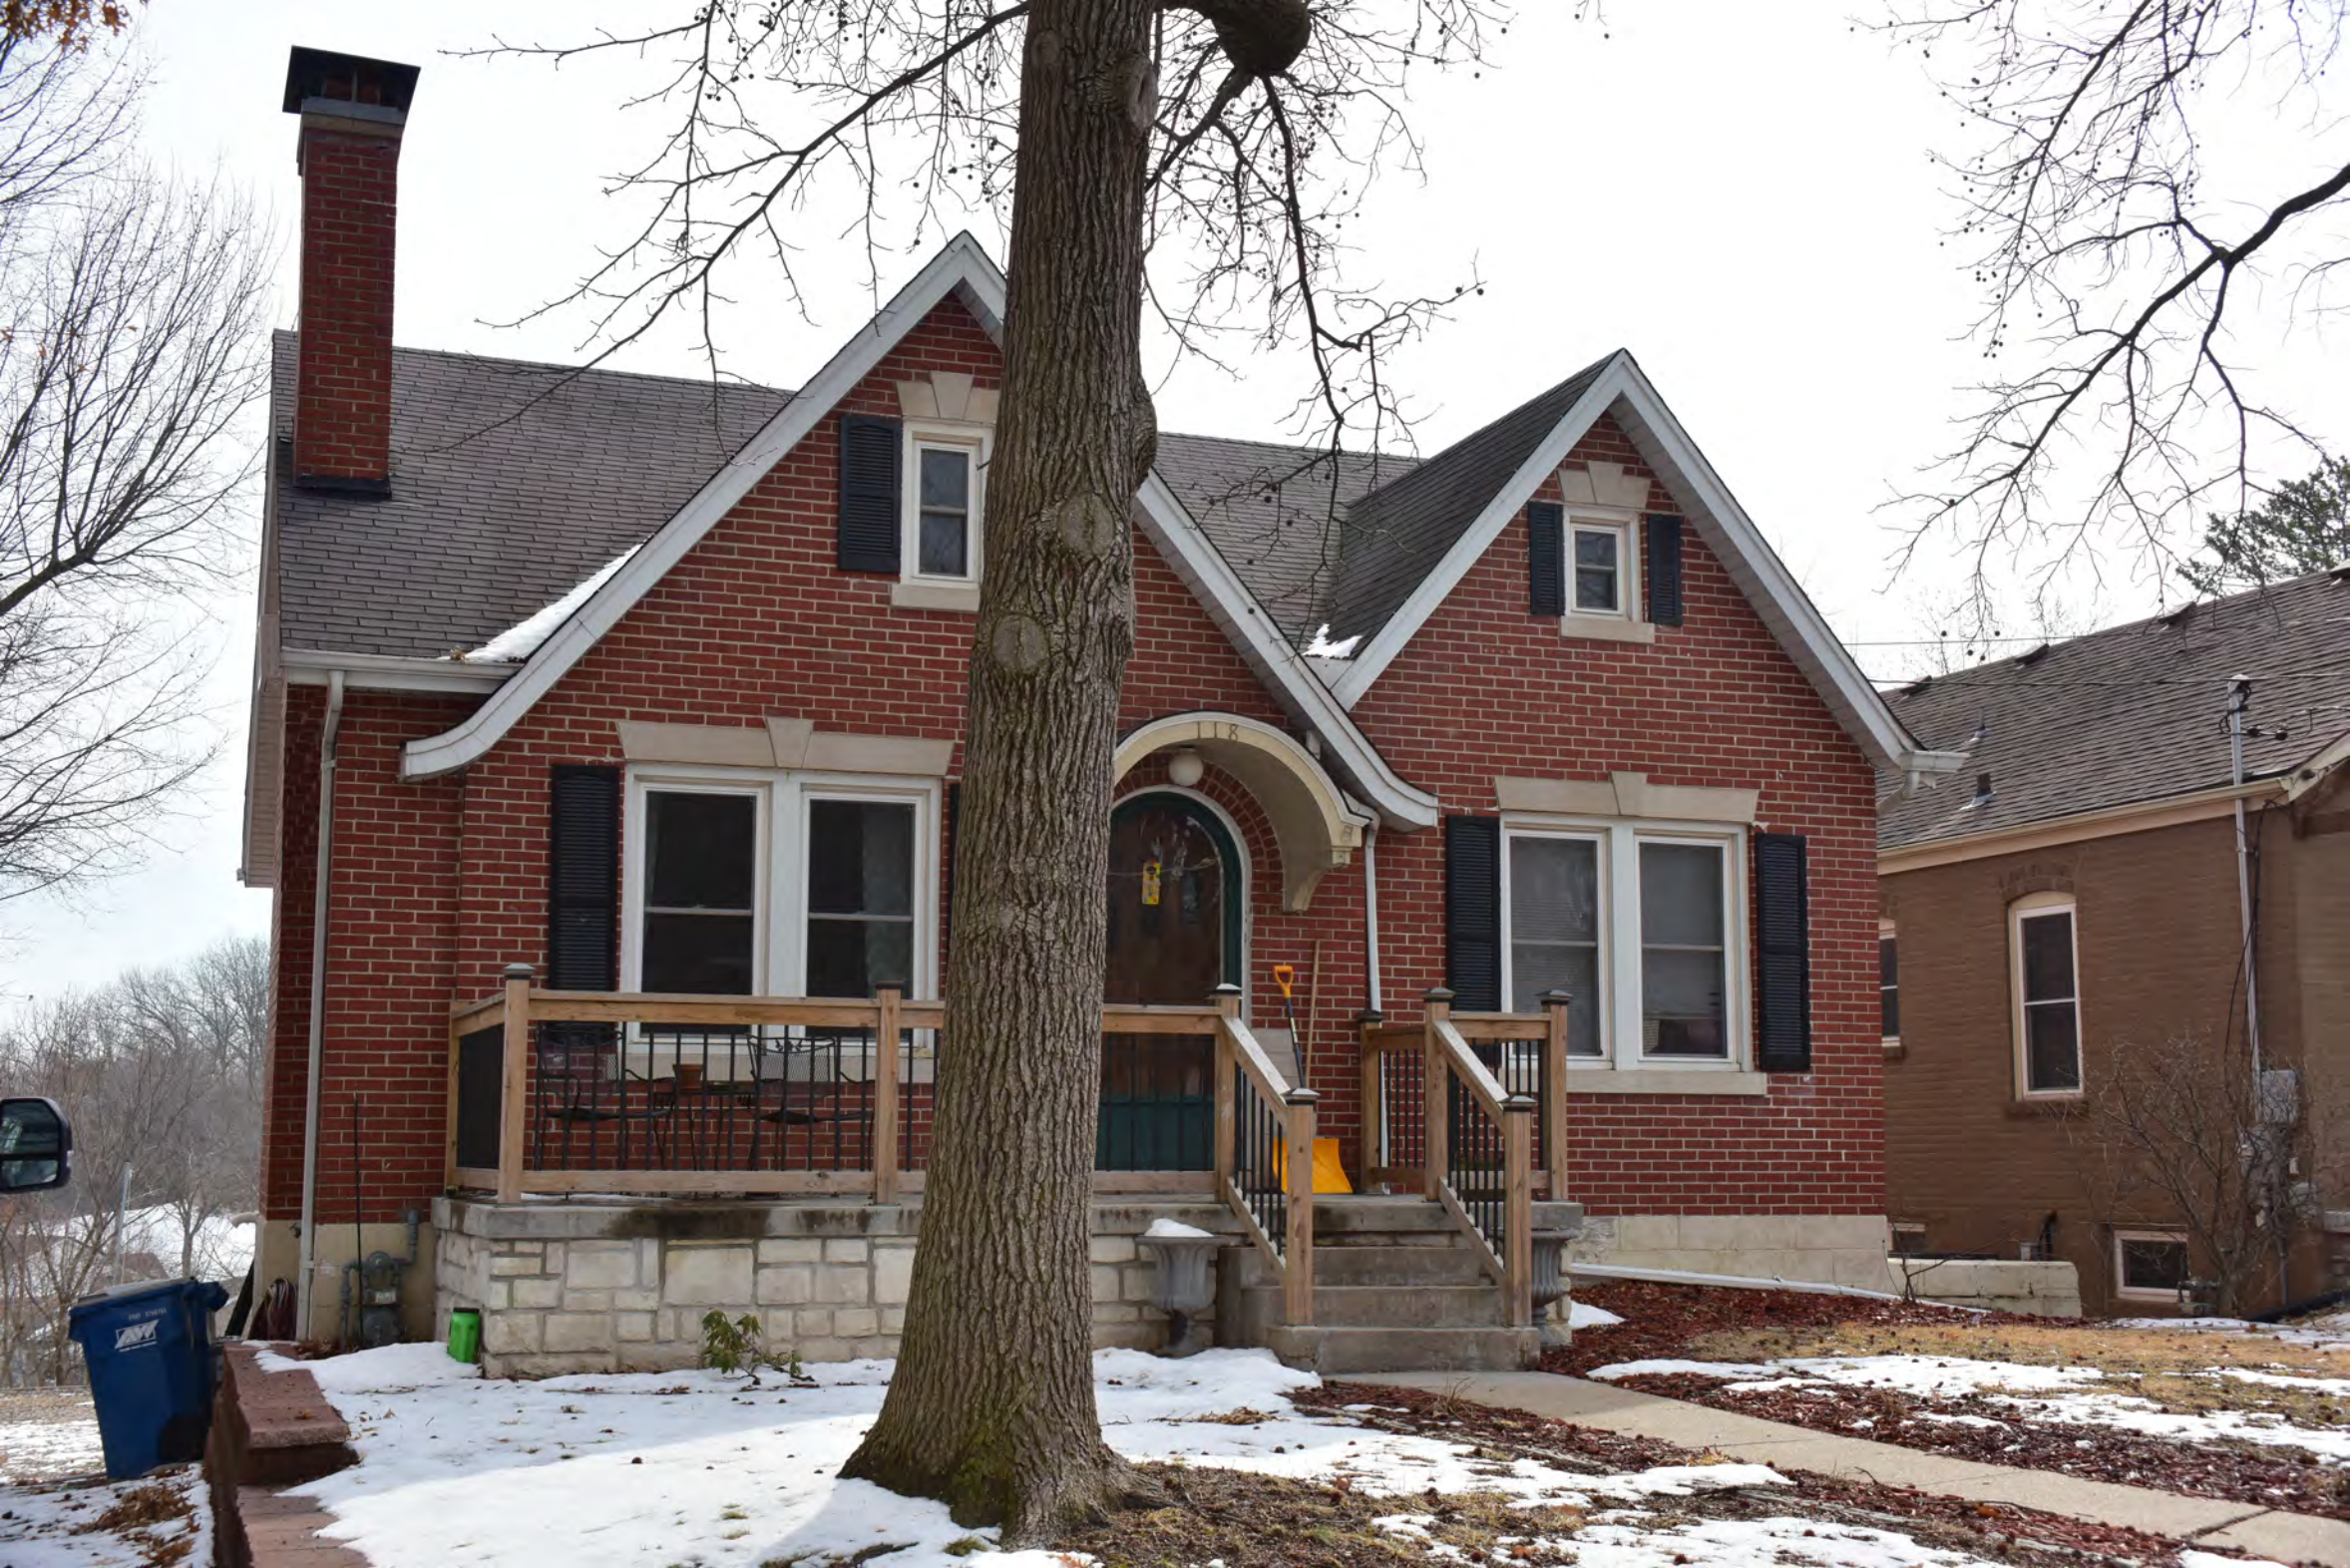
118 East Circle Drive is a one-and-one-half story Minimal Traditional dwelling with retrained Colonial Revival influences. It has brick cladding, a concrete foundation, and an asphalt side-gabled roof with two low cross-gables at the primary elevation. A brick chimney pierces the roofline at the north elevation. The dwelling is three bays wide. Paired 1/1 historic windows with storm windows define the north and south bays while the primary entrance defines the center bay. The windows have continuous stone sills and continuous stone lintels with keystones. The entrance is arched and contains a historic wood door with three-light glazing. A curved hood with knee brackets shelters the entrance. A non-historic partial-width platform porch projects below the first and second bays. It has a stone-face foundation, concrete floor, and wood and synthetic balustrade. A sunporch extends from the rear. An integrated historic single-car garage is located at basement level and is accessed at the rear.
