1. Survey number: CO-AS-008-001		2. Survey Name: West Main Street Survey	
3. County: Cole		4. Address (Street No.): 100	Street (name): East Circle Drive
5. City: Jefferson City	Vicinity <input type="checkbox"/>	6. Lat / Long:	7. Township/Range/Section: T: R: S:
8. Historic name (if known):		9. Present/other name (if known):	
10. Ownership: <input checked="" type="checkbox"/> Private <input type="checkbox"/> Public		11a. Historic use (if known): Domestic-Single Dwelling	11b. Current use: Domestic-Single Dwelling

MISSOURI DEPARTMENT OF NATURAL RESOURCES
STATE HISTORIC PRESERVATION OFFICE, P.O. Box 178, Jefferson City, MO 65102
ARCHITECTURAL/HISTORIC INVENTORY FORM

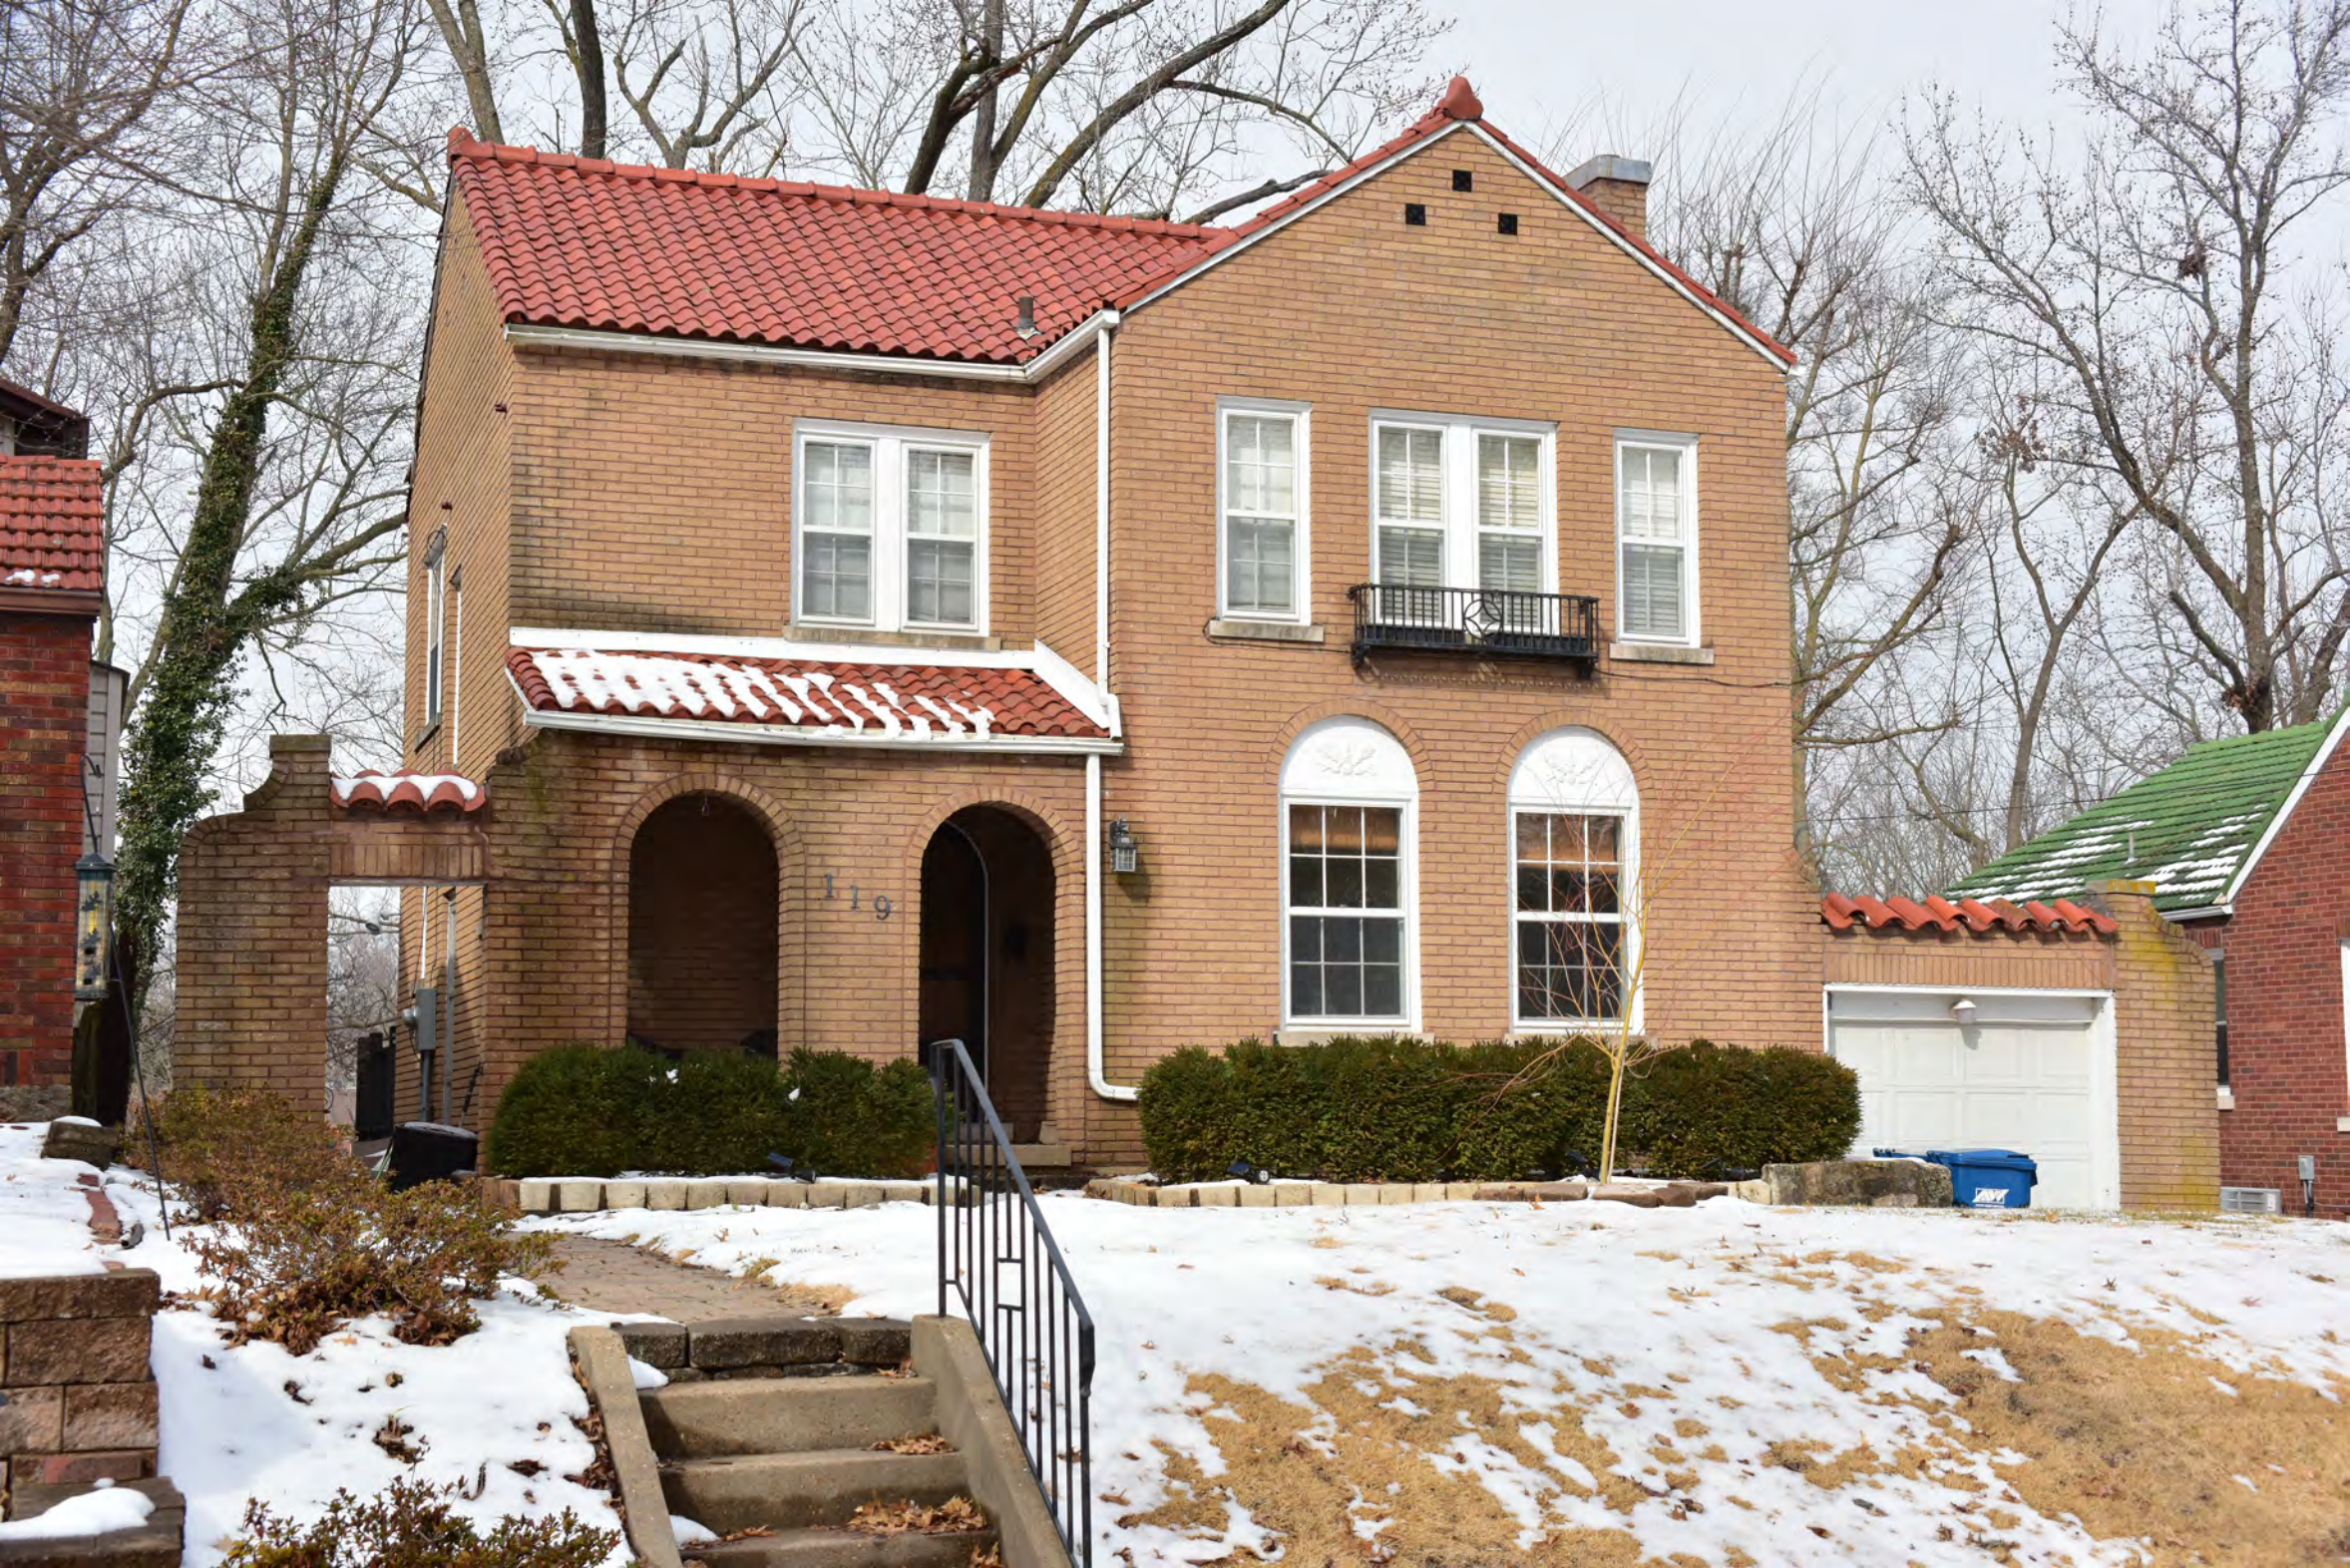
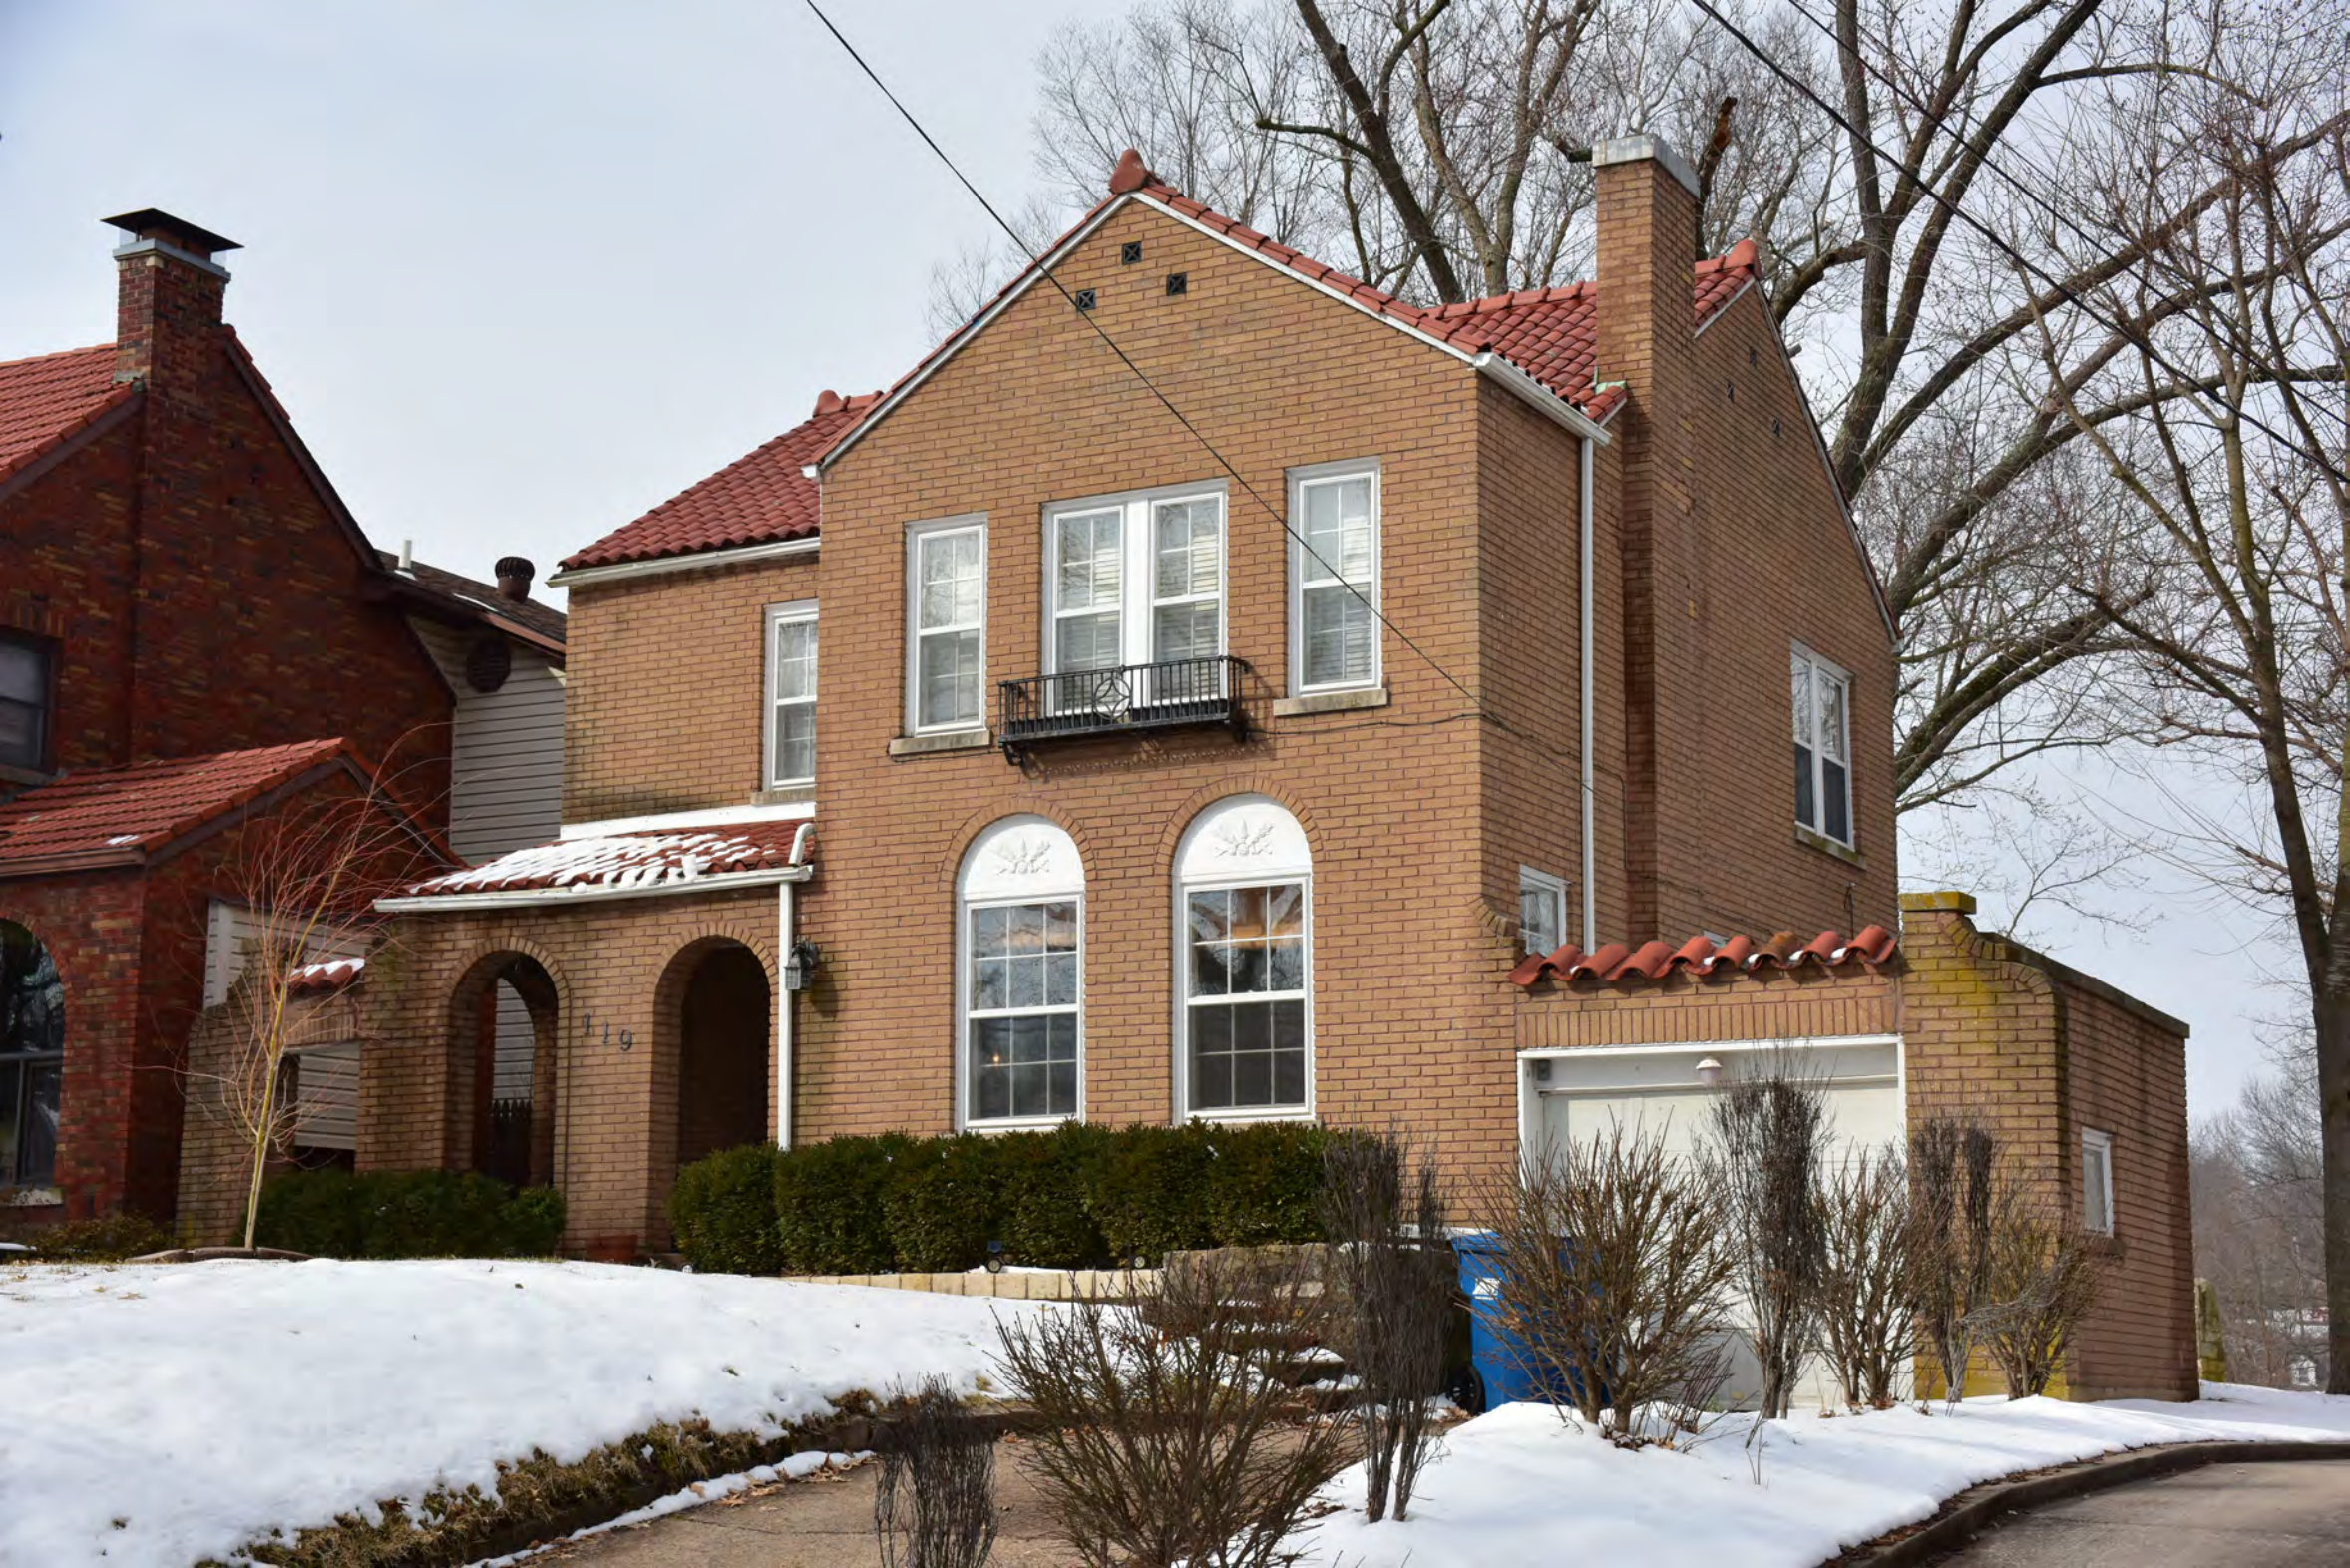
119 East Circle Drive is a two-and-one-half story Minimal Traditional dwelling with restrained Spanish/Mission Revival influences. It has a concrete foundation, yellow brick cladding, and a tile gabled-ell roof. A brick exterior chimney on the north elevation pierces the narrow eave. The dwelling is three bays wide at the first story. The first bay recedes and contains the entrance. The entrance features a historic arched wood door. A partial-width open porch with a tile shed roof shelters the entrance. A brick arcade with two rounded arches supports the roof. A Moorish-inspired wing wall with square doorway extends from the arcade. The north-two bays are in the gabled-ell. Each bay contains a historic 6/6 wood window. Embossed arched panels top each window. The second-story is four bays wide. A pair of 4/4 historic wood windows define the first and third bays. Narrow 4/4 historic wood window define the second and fourth bays. A historic metal false balcony spans the width of the third bay. Three metal inlays with a cross motif are centered in the gable end, above the third bay. The secondary elevation fenestration is irregular and includes a mixture of single and paired historic 4/4 wood windows. All windows have stone sills. A historic one-story single-car attached garage extends from the north elevation. A non-historic overhead door fills the vehicular bay and a Moorish-inspired wingwall abuts the bay.

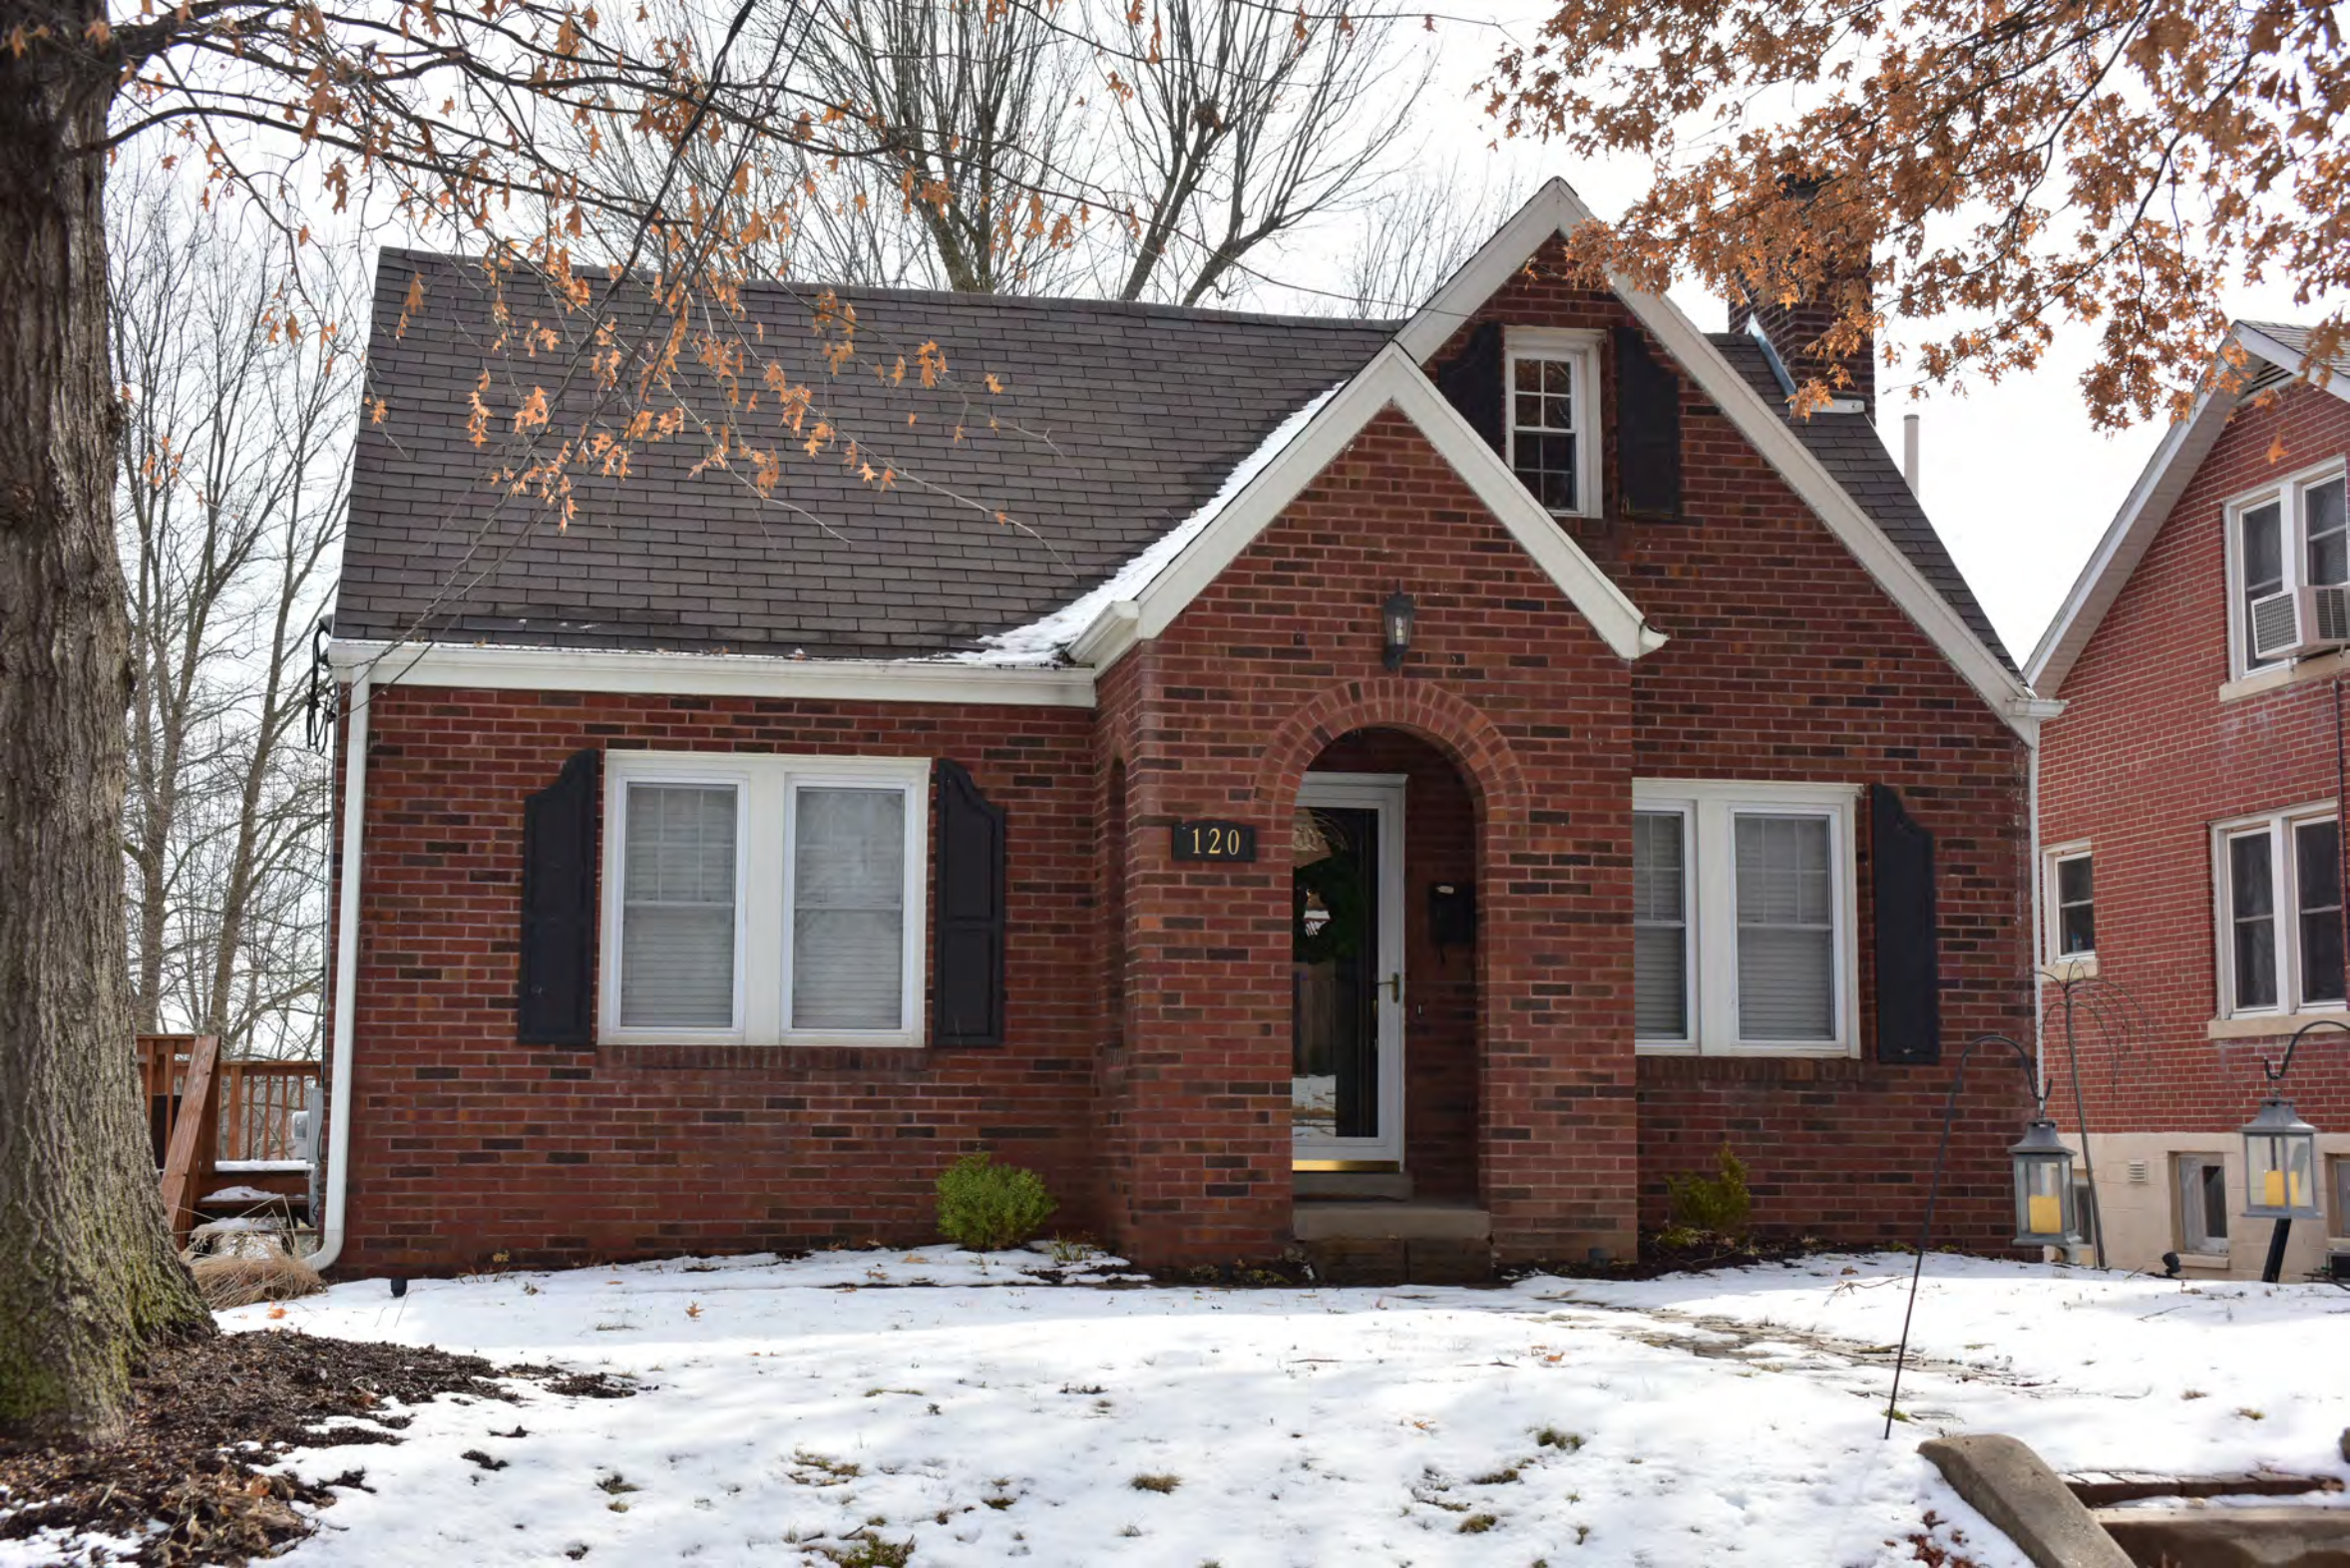
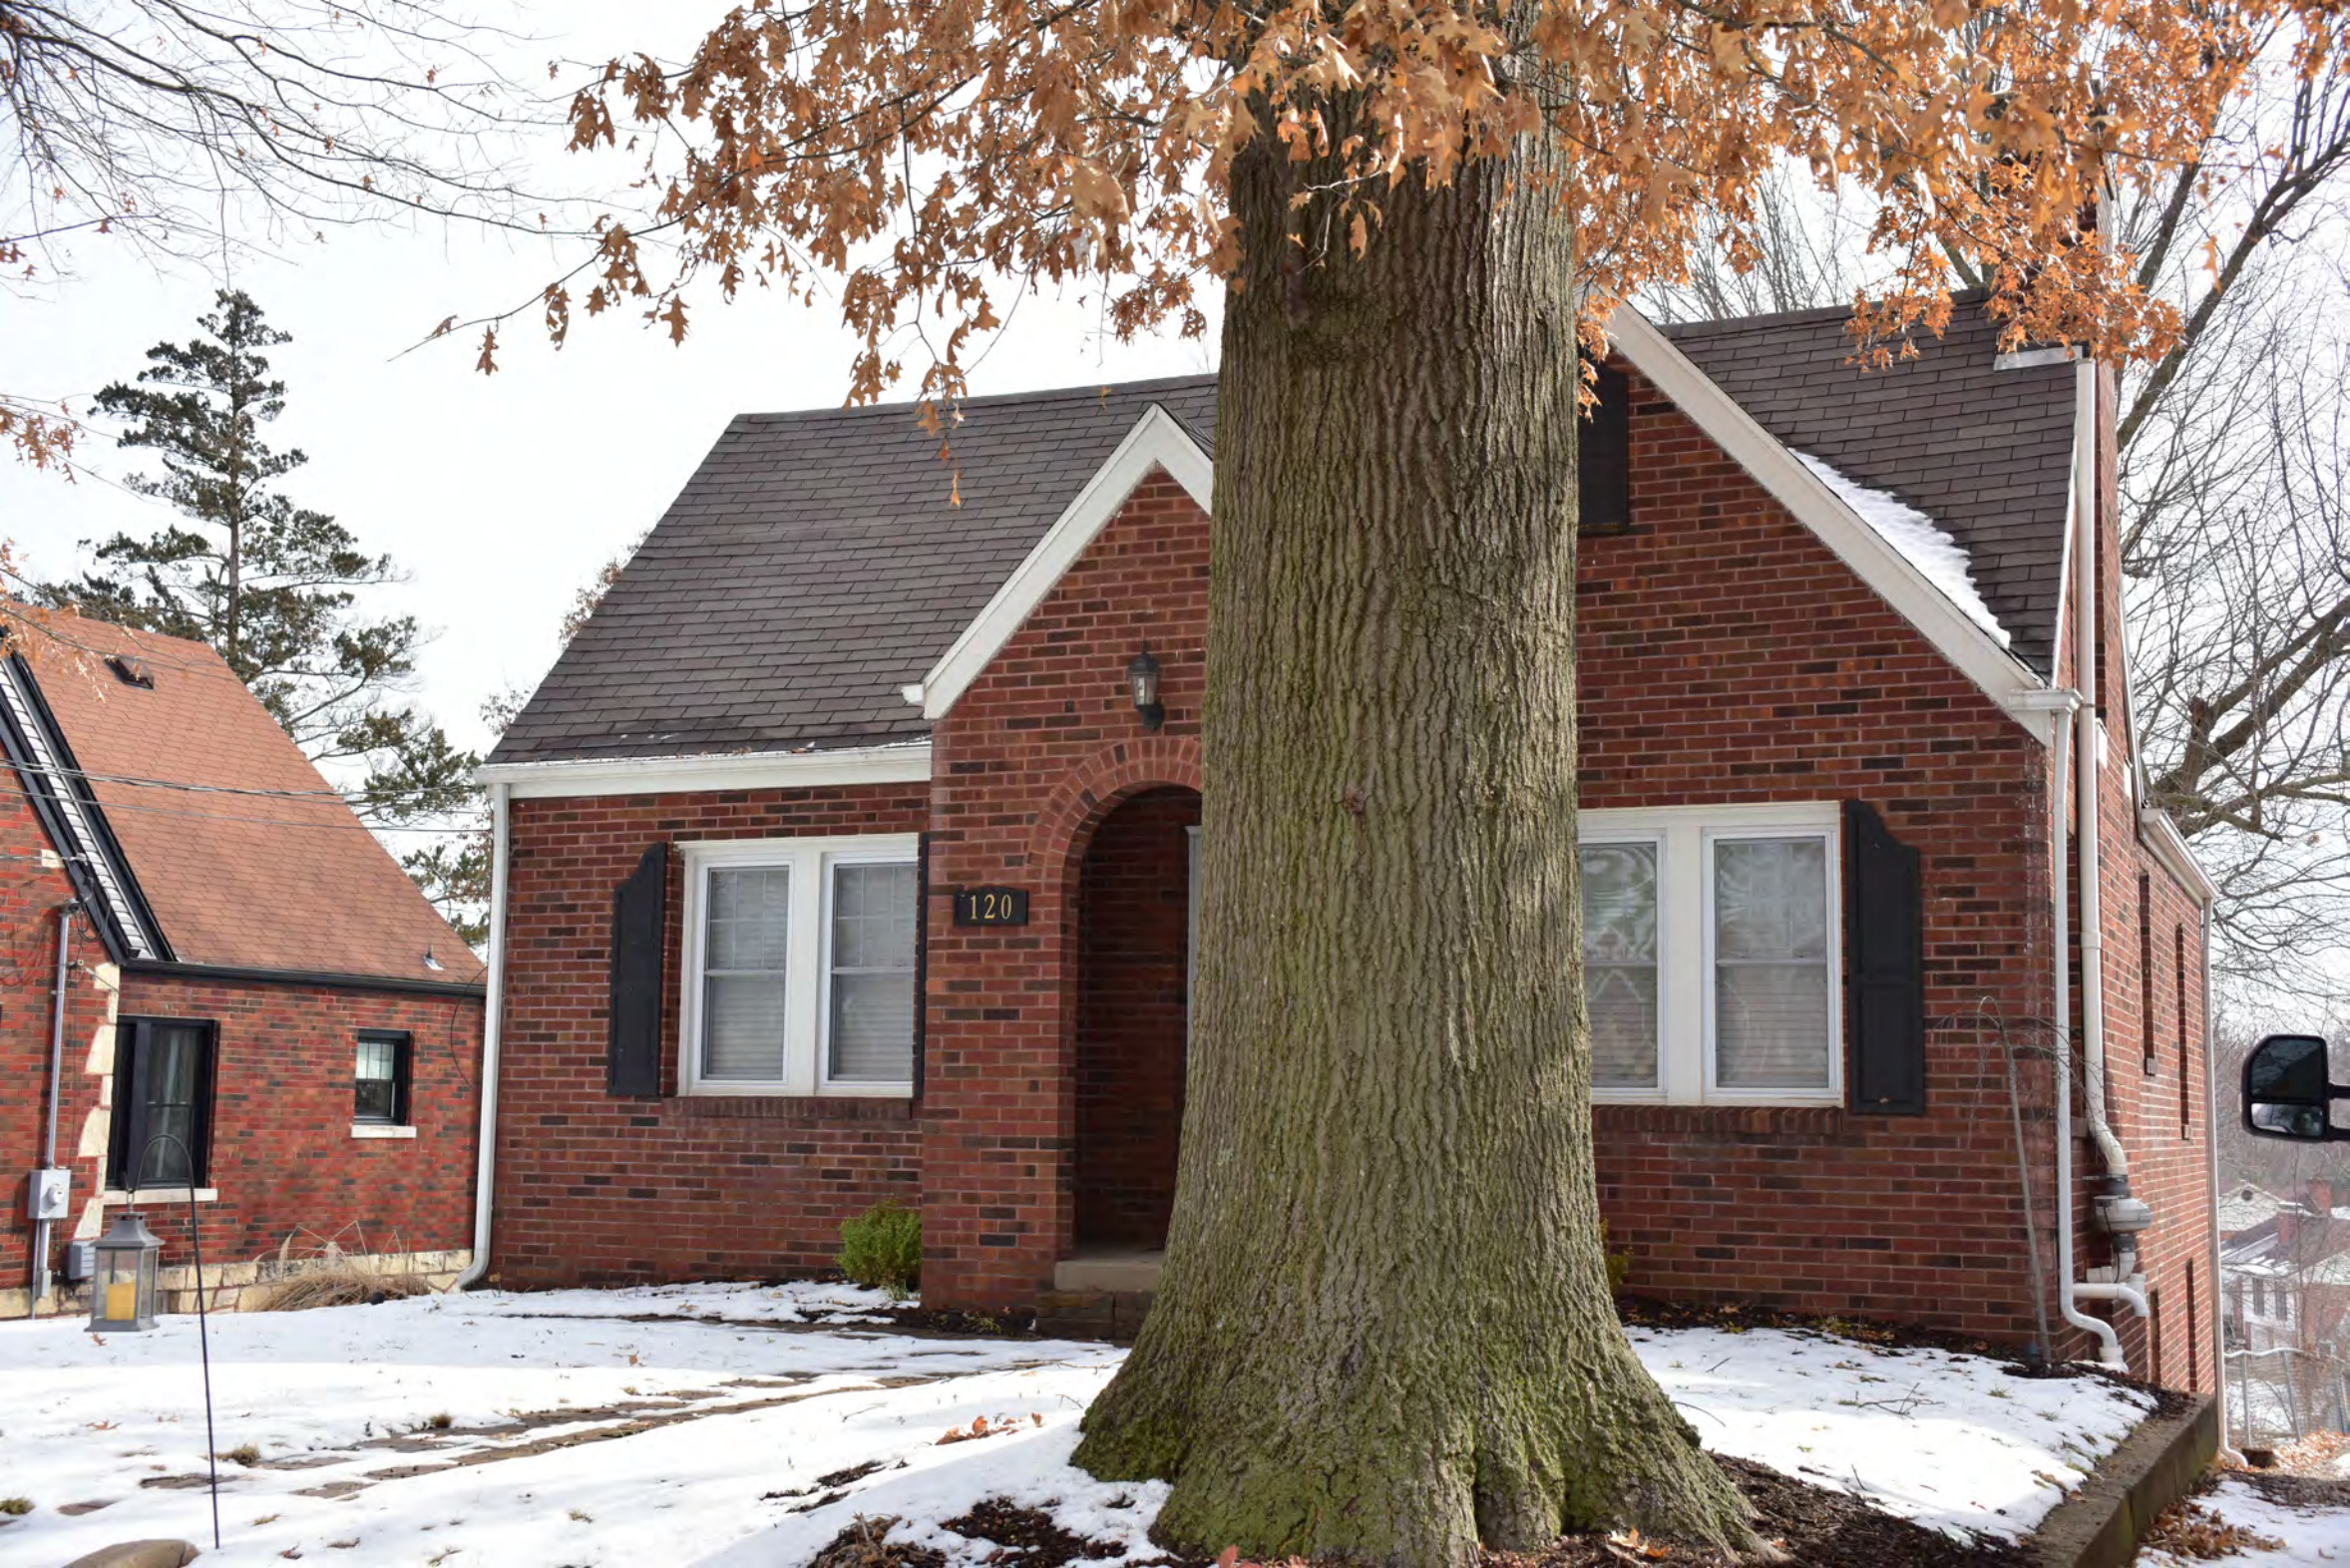
120 East Circle Drive is a one-and-one-half story single-family Minimal Traditional dwelling with brick cladding, a concrete foundation, and an asphalt intersecting gable roof. A side-gable roof with a front-gable wall dormer fronts the lot while a perpendicular gable extends to the rear. The dwelling is three bays wide. The primary entrance defines the center bay. It contains a non-historic door. Paired non-historic 6/1 vinyl windows define the remaining bays. A small 4/4 historic wood window is centered in the wall dormer gable. All windows have header brick sills, narrow crown molding, and false shutters. A gabled open vestibule shelters the entrance. The entrance is arched, and arched openings pierce the north and south walls. Concrete steps provide access to the entrance. A brick chimney pierces the gable at the south elevation. A non-historic wood deck projects from the rear half of the north elevation and wraps around to the rear, where it abuts a shed-roof sunroom. An integrated historic garage is located at the basement level and is accessed at the rear.
