1. Survey number: CO-AS-008-001		2. Survey Name: West Main Street Survey	
3. County: Cole		4. Address (Street No.): 100	Street (name): East Circle Drive
5. City: Jefferson City	Vicinity <input type="checkbox"/>	6. Lat / Long:	7. Township/Range/Section: T: R: S:
8. Historic name (if known):		9. Present/other name (if known):	
10. Ownership: <input checked="" type="checkbox"/> Private <input type="checkbox"/> Public		11a. Historic use (if known): Domestic-Single Dwelling	11b. Current use: Domestic-Single Dwelling

MISSOURI DEPARTMENT OF NATURAL RESOURCES
STATE HISTORIC PRESERVATION OFFICE, P.O. Box 178, Jefferson City, MO 65102
ARCHITECTURAL/HISTORIC INVENTORY FORM

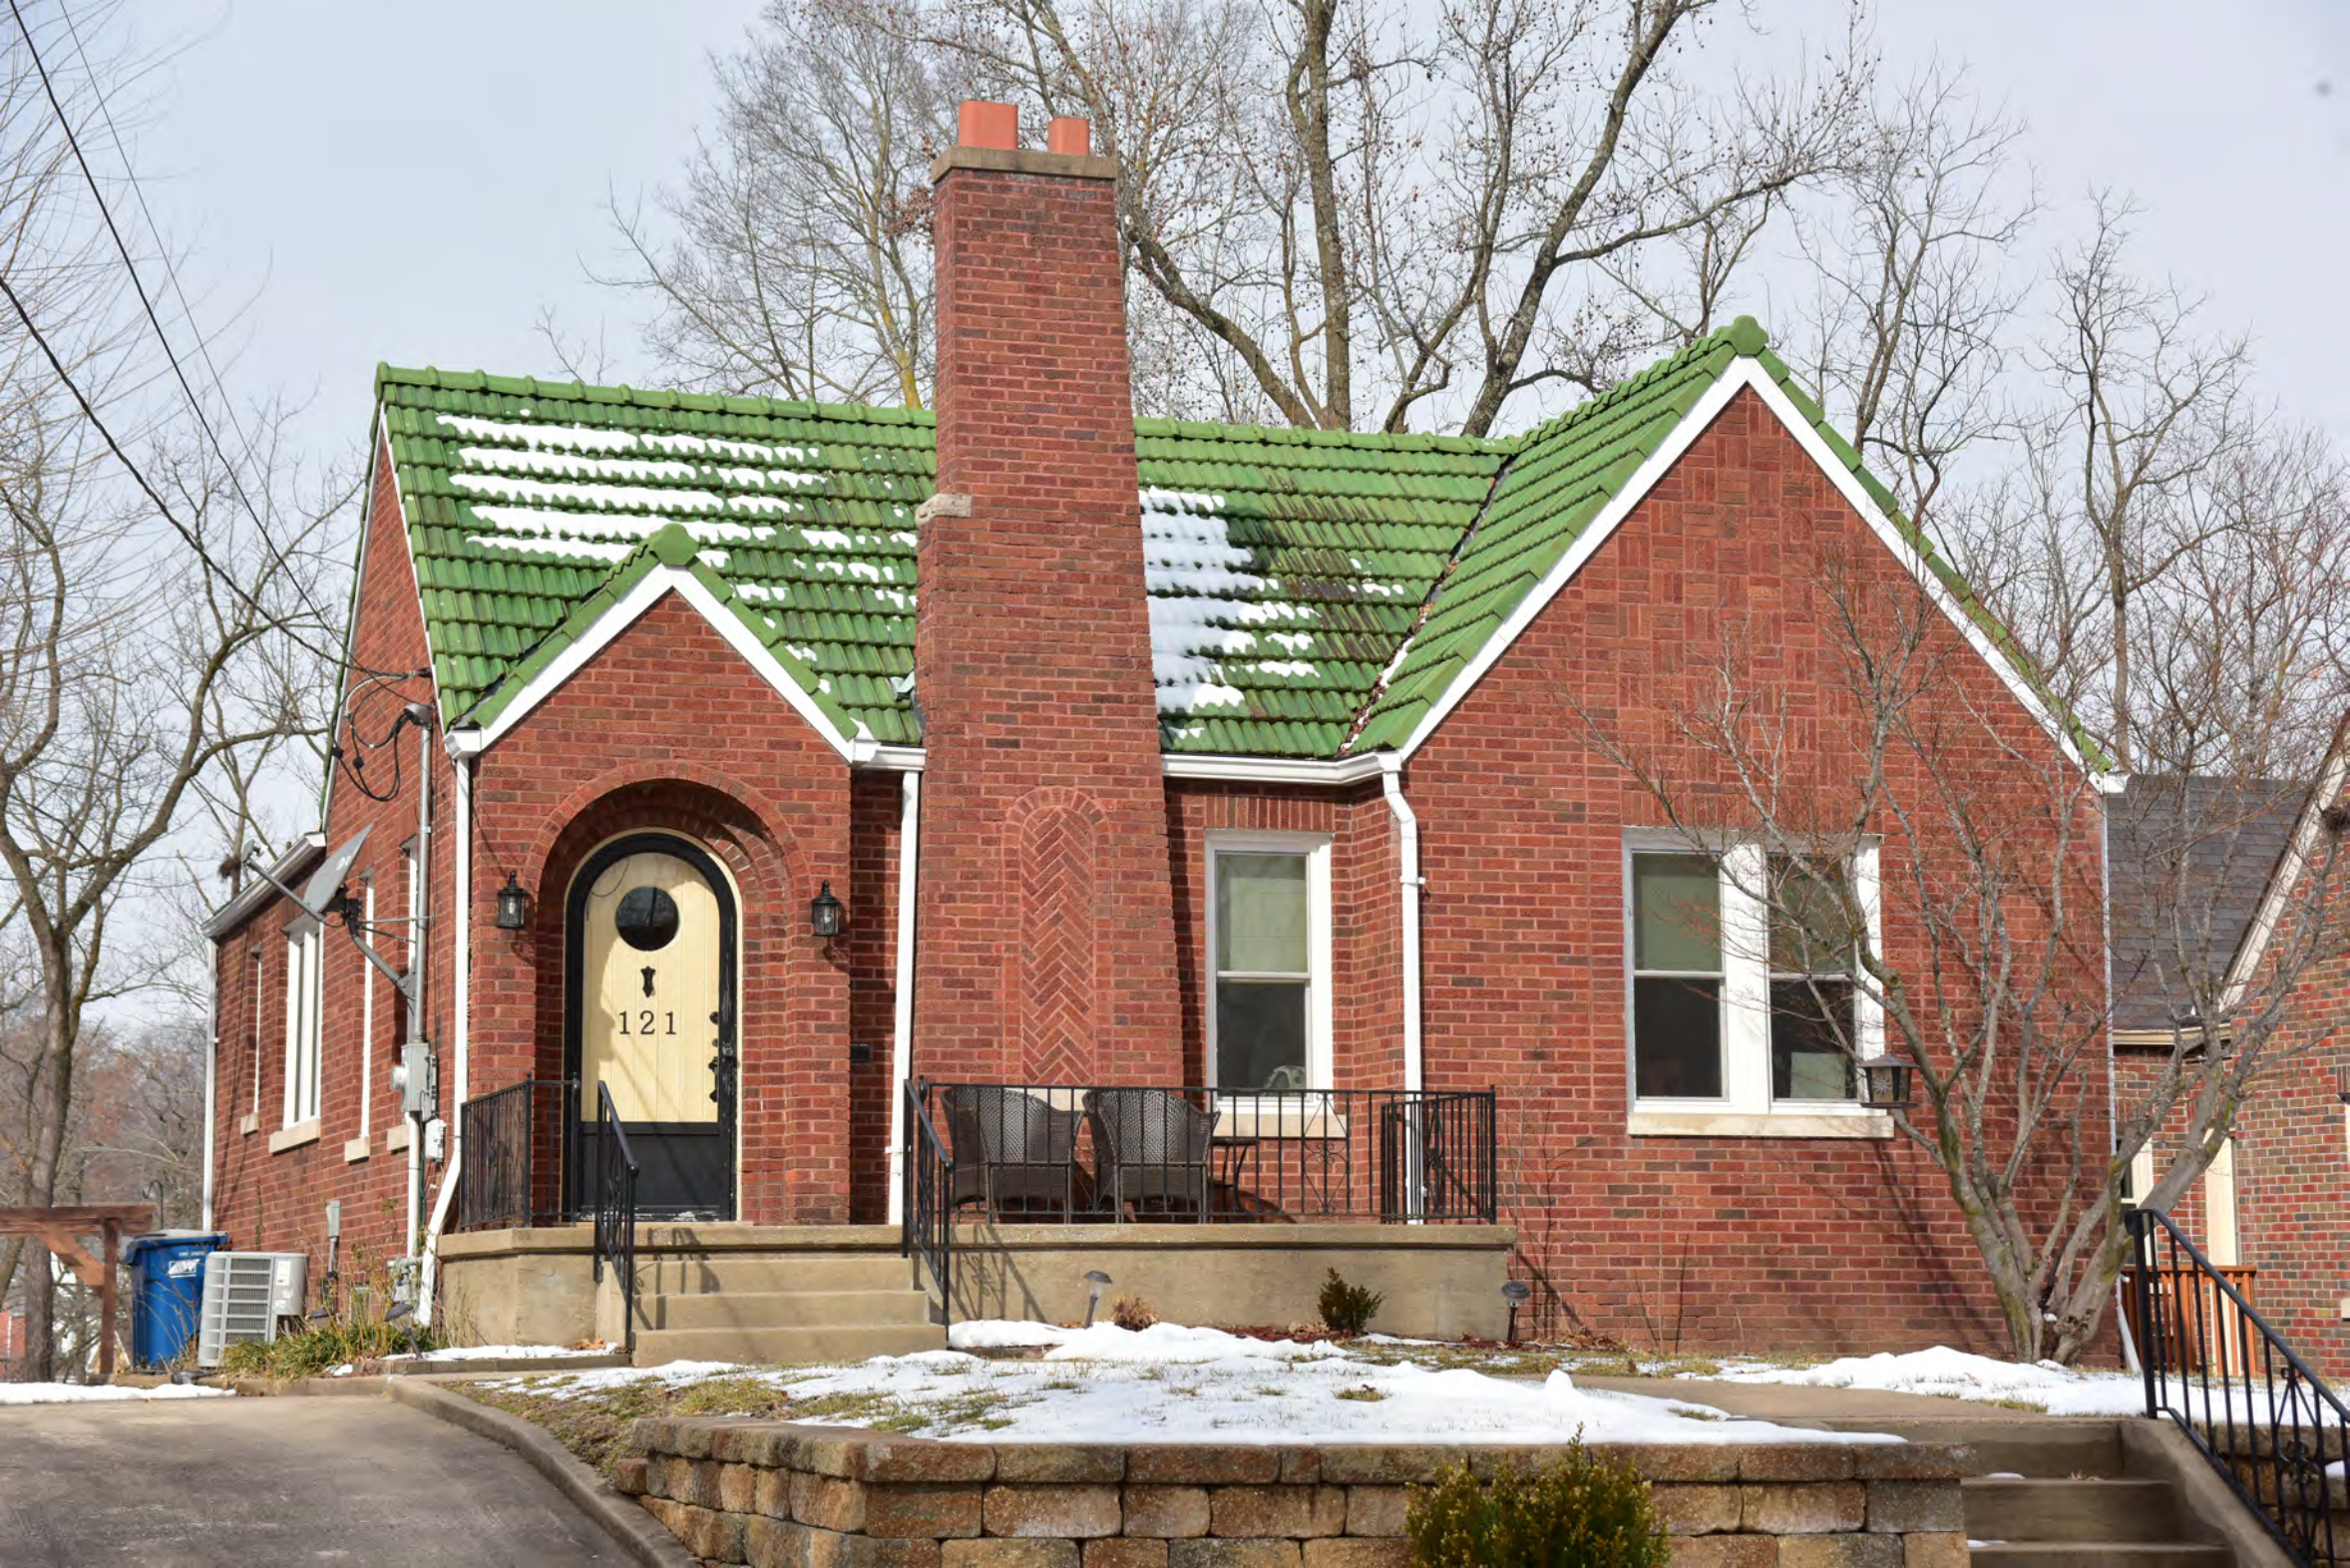
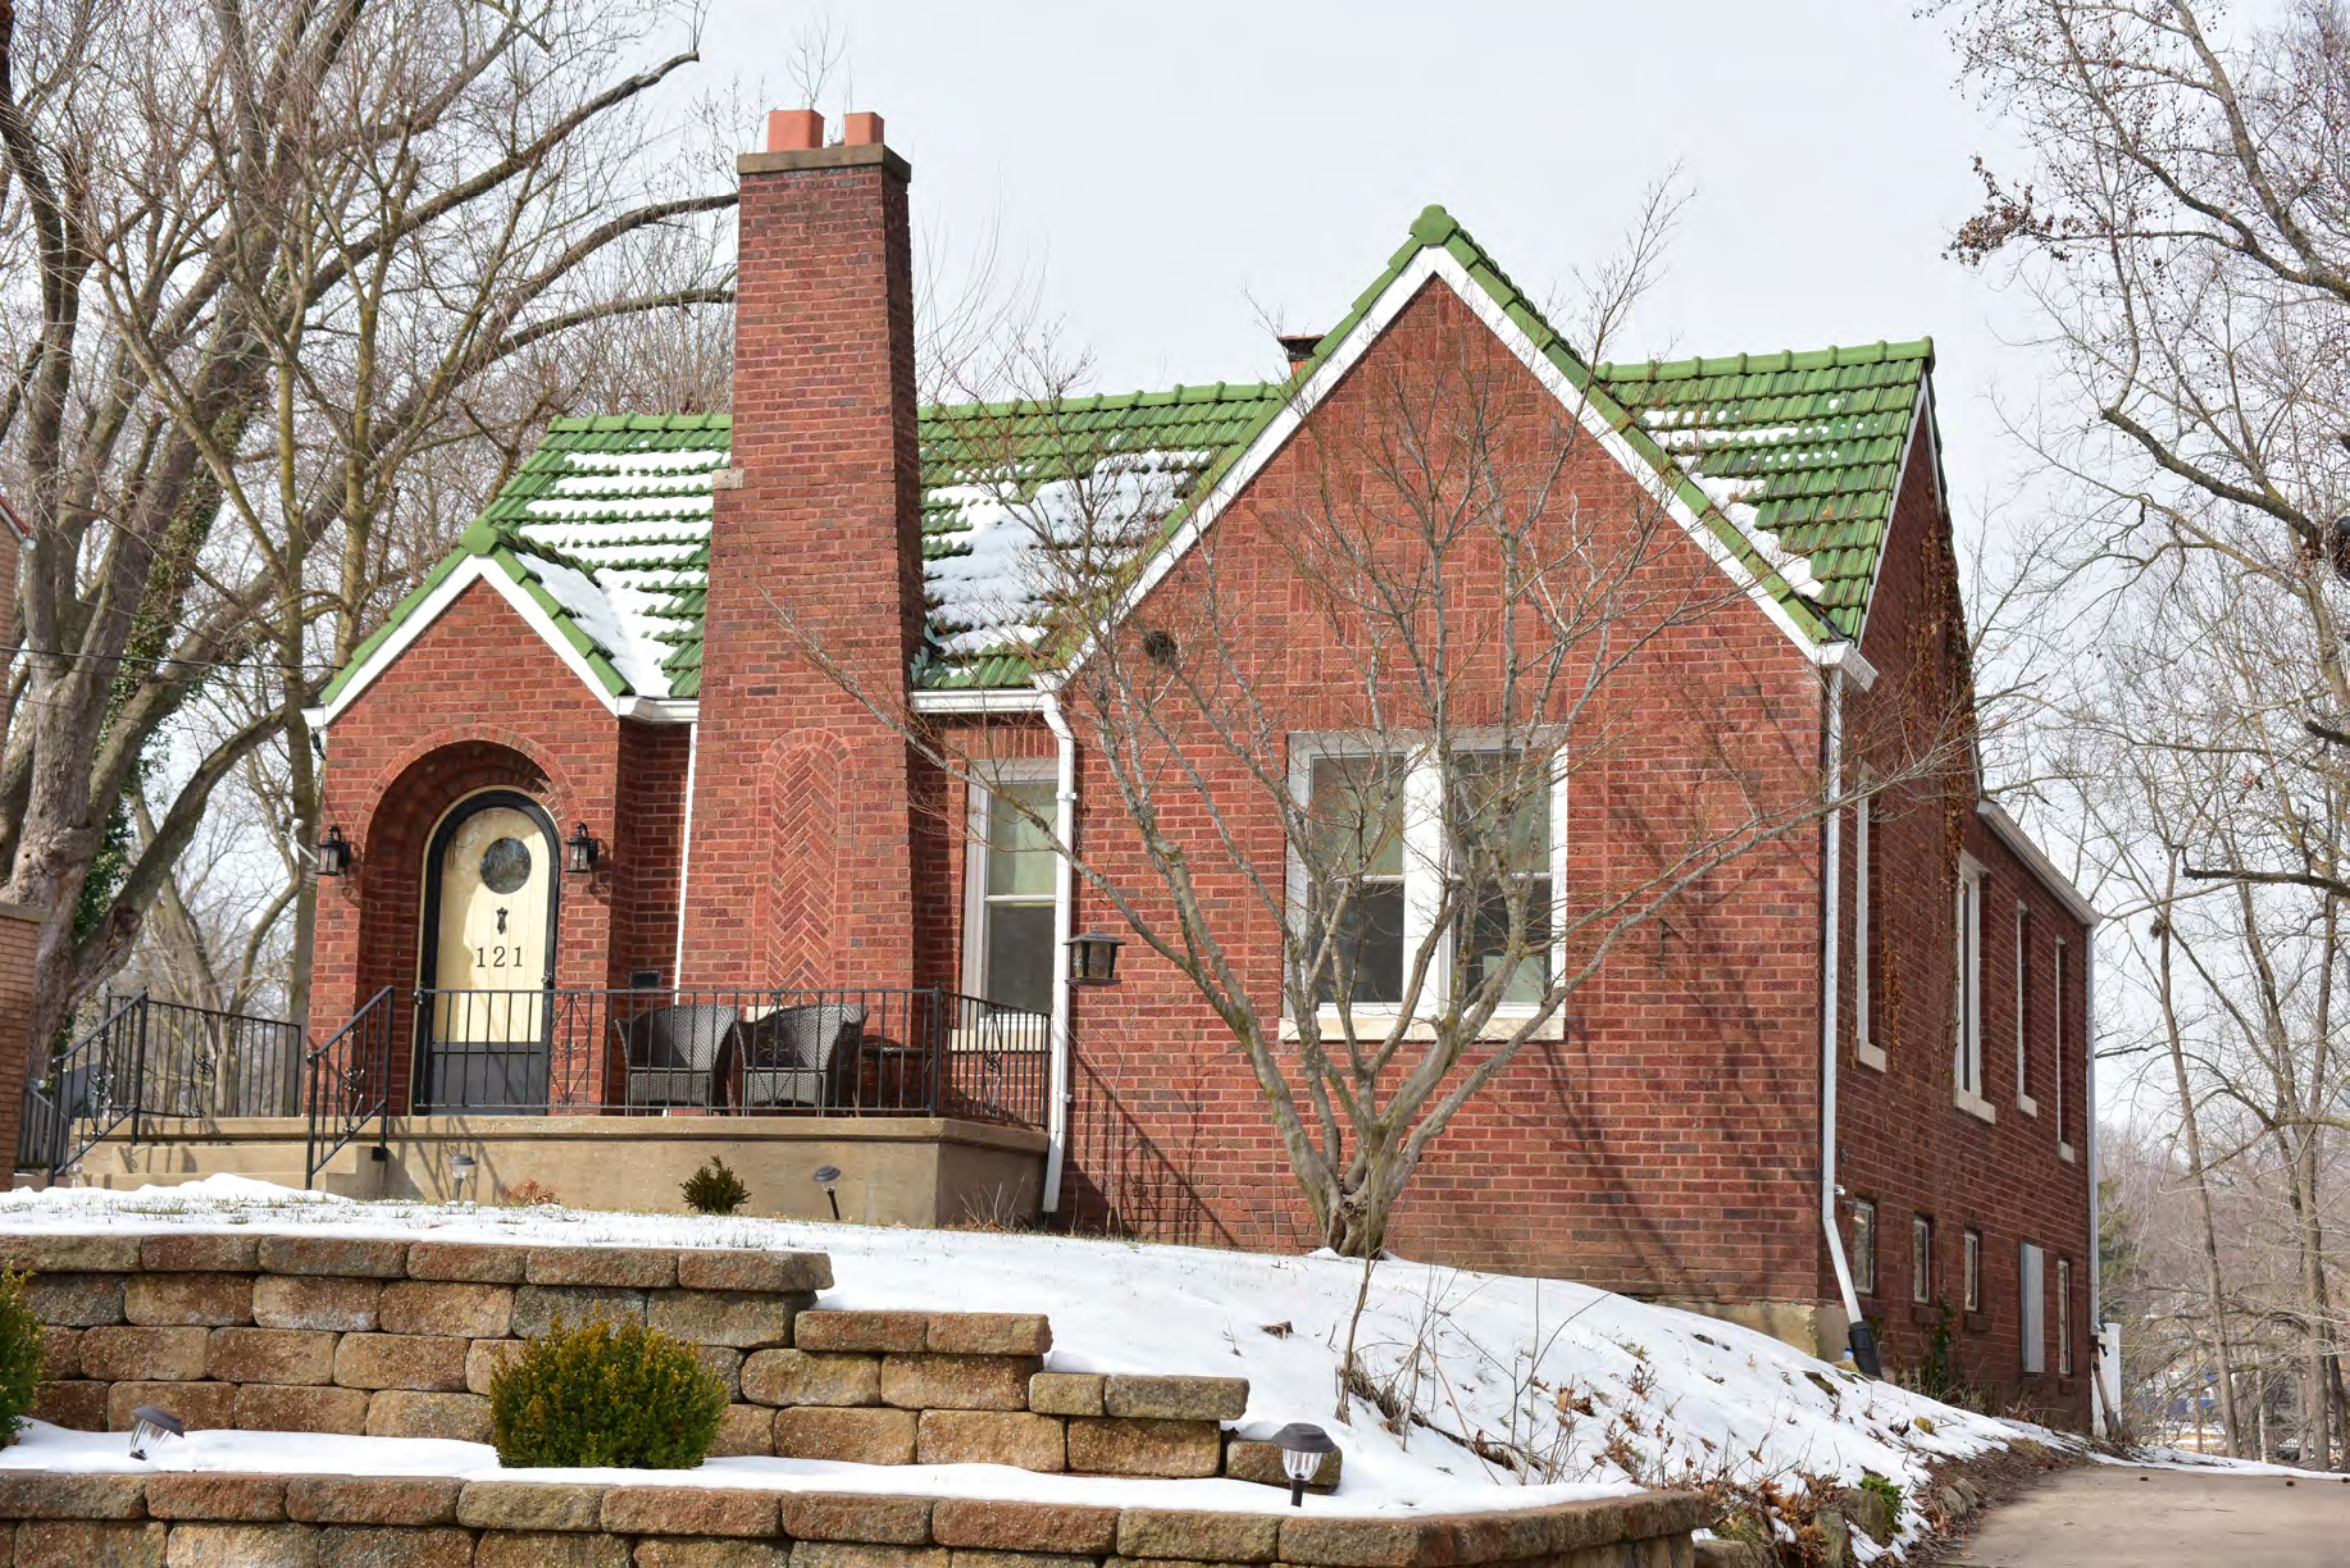
121 East Circle Drive is a one-and-one-half story single-family Minimal Traditional dwelling with restrained Tudor Revival influences. It has brick cladding, a concrete foundation, and a green clay tile intersecting gable roof. A side-gable roof with a front-gable ell fronts the lot while a perpendicular gable extends to the rear. The dwelling is four bays wide. The primary entrance defines the south bay. It contains a historic wood door with round single-light glazing. A shallow front-gable brick porch shelters the entrance. It has a green clay tile roof, and an arched opening with stepped brickwork. A brick exterior chimney defines the second bay. The chimney is tapered and features decorative brick work at the base. Single and paired 1/1 vinyl windows define the third and fourth bays respectively. The windows have stone sills and soldier brick lintels. The fourth bay is in the gabled-ell. Decorative brickwork in a basket weave motif tops the bay and extends to the gable apex. A partial-width concrete platform porch extends below the south three bays. Concrete steps access the porch and a metal railing lines the perimeter. An integrated historic garage is located at the basement level and is accessed at the rear.

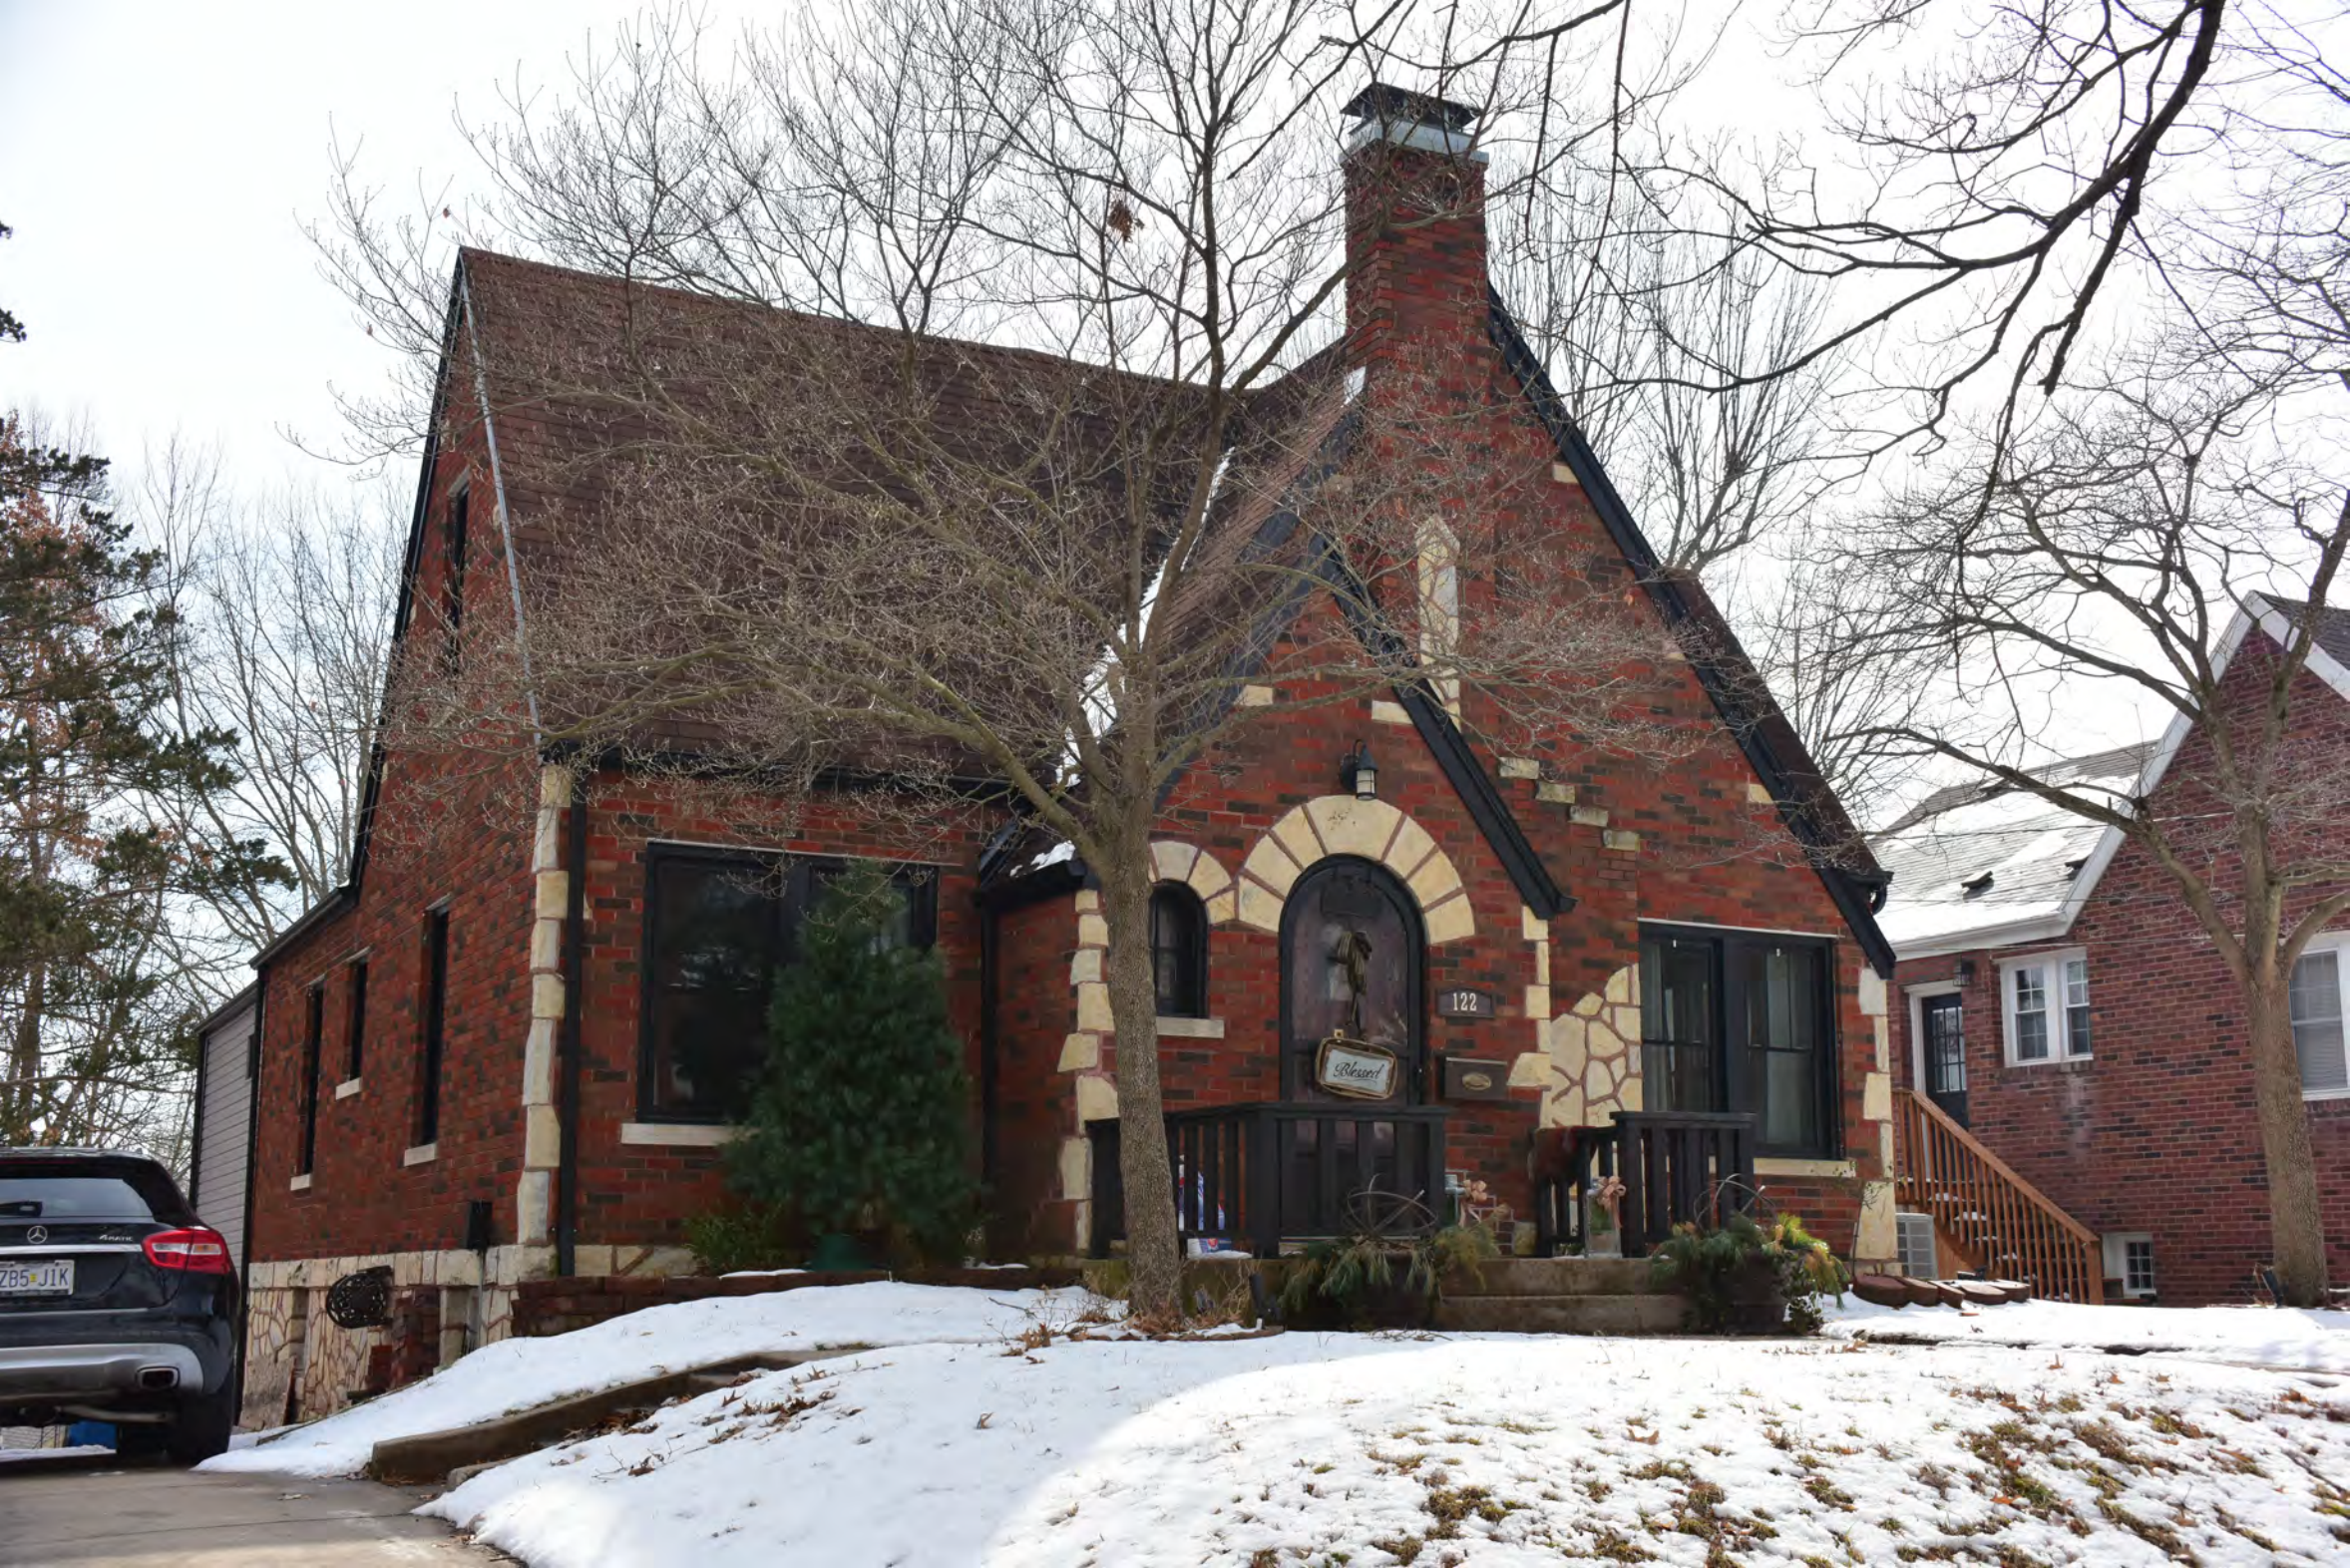
122 East Circle Drive is a one-and-one-half story single-family Tudor Revival dwelling. It has multi-color brick cladding with stone accents, a split stone foundation, and an asphalt intersecting gable roof. A side-gable roof with a nested front-gables fronts the lot while a perpendicular gable extends to the rear. The dwelling is four bays wide. Paired 3/1 historic windows with stone sills define the first and fourth bays. A brick vestibule defines the second bay. It is located within the lower nested gable and contains the primary entrance. The entrance is arched and contains a historic wood door with glazing. A historic rounded arch four-light wood window is located immediately south of the entrance. Stone accents top the entrance and window. A brick exterior chimney with stone accents defines the third bay and pierces the upper-gable. A partial-width concrete platform porch with wood balustrade extends from the vestibule. A one-story vinyl-clad sunporch projects from the rear elevation. A non-historic wood deck abuts the sunporch. An integrated historic garage is located at the basement level and is accessed at the rear.

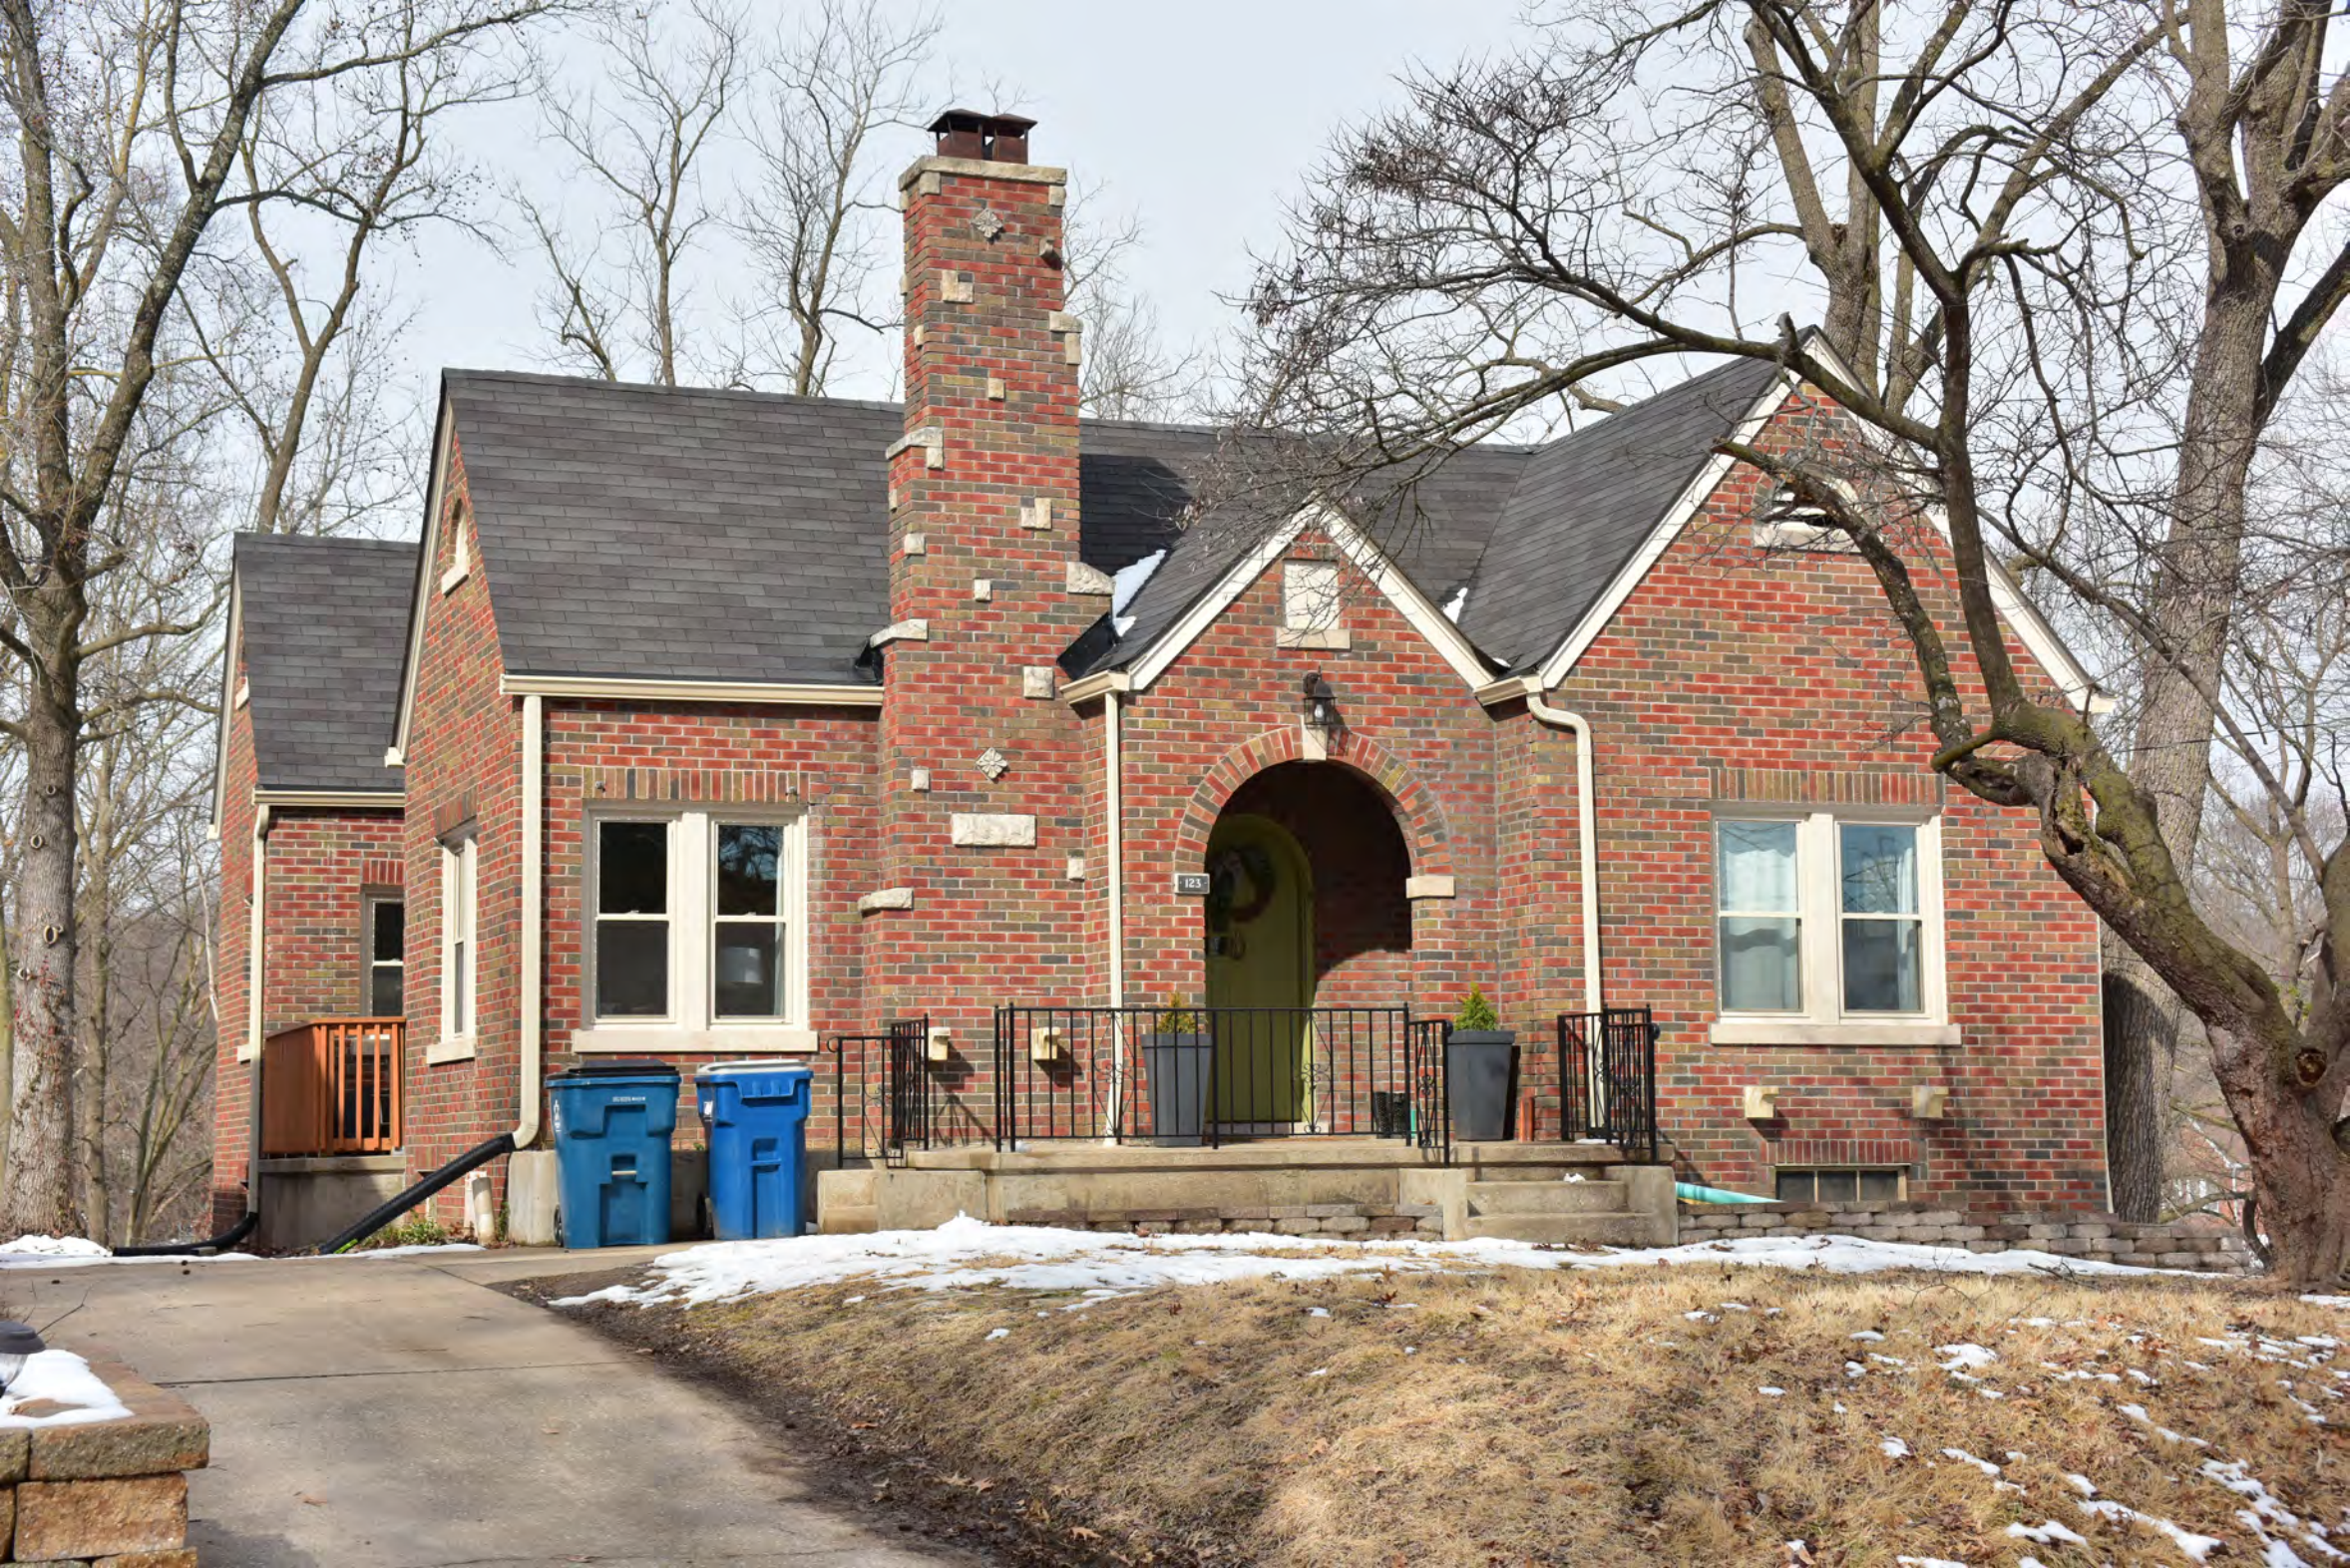
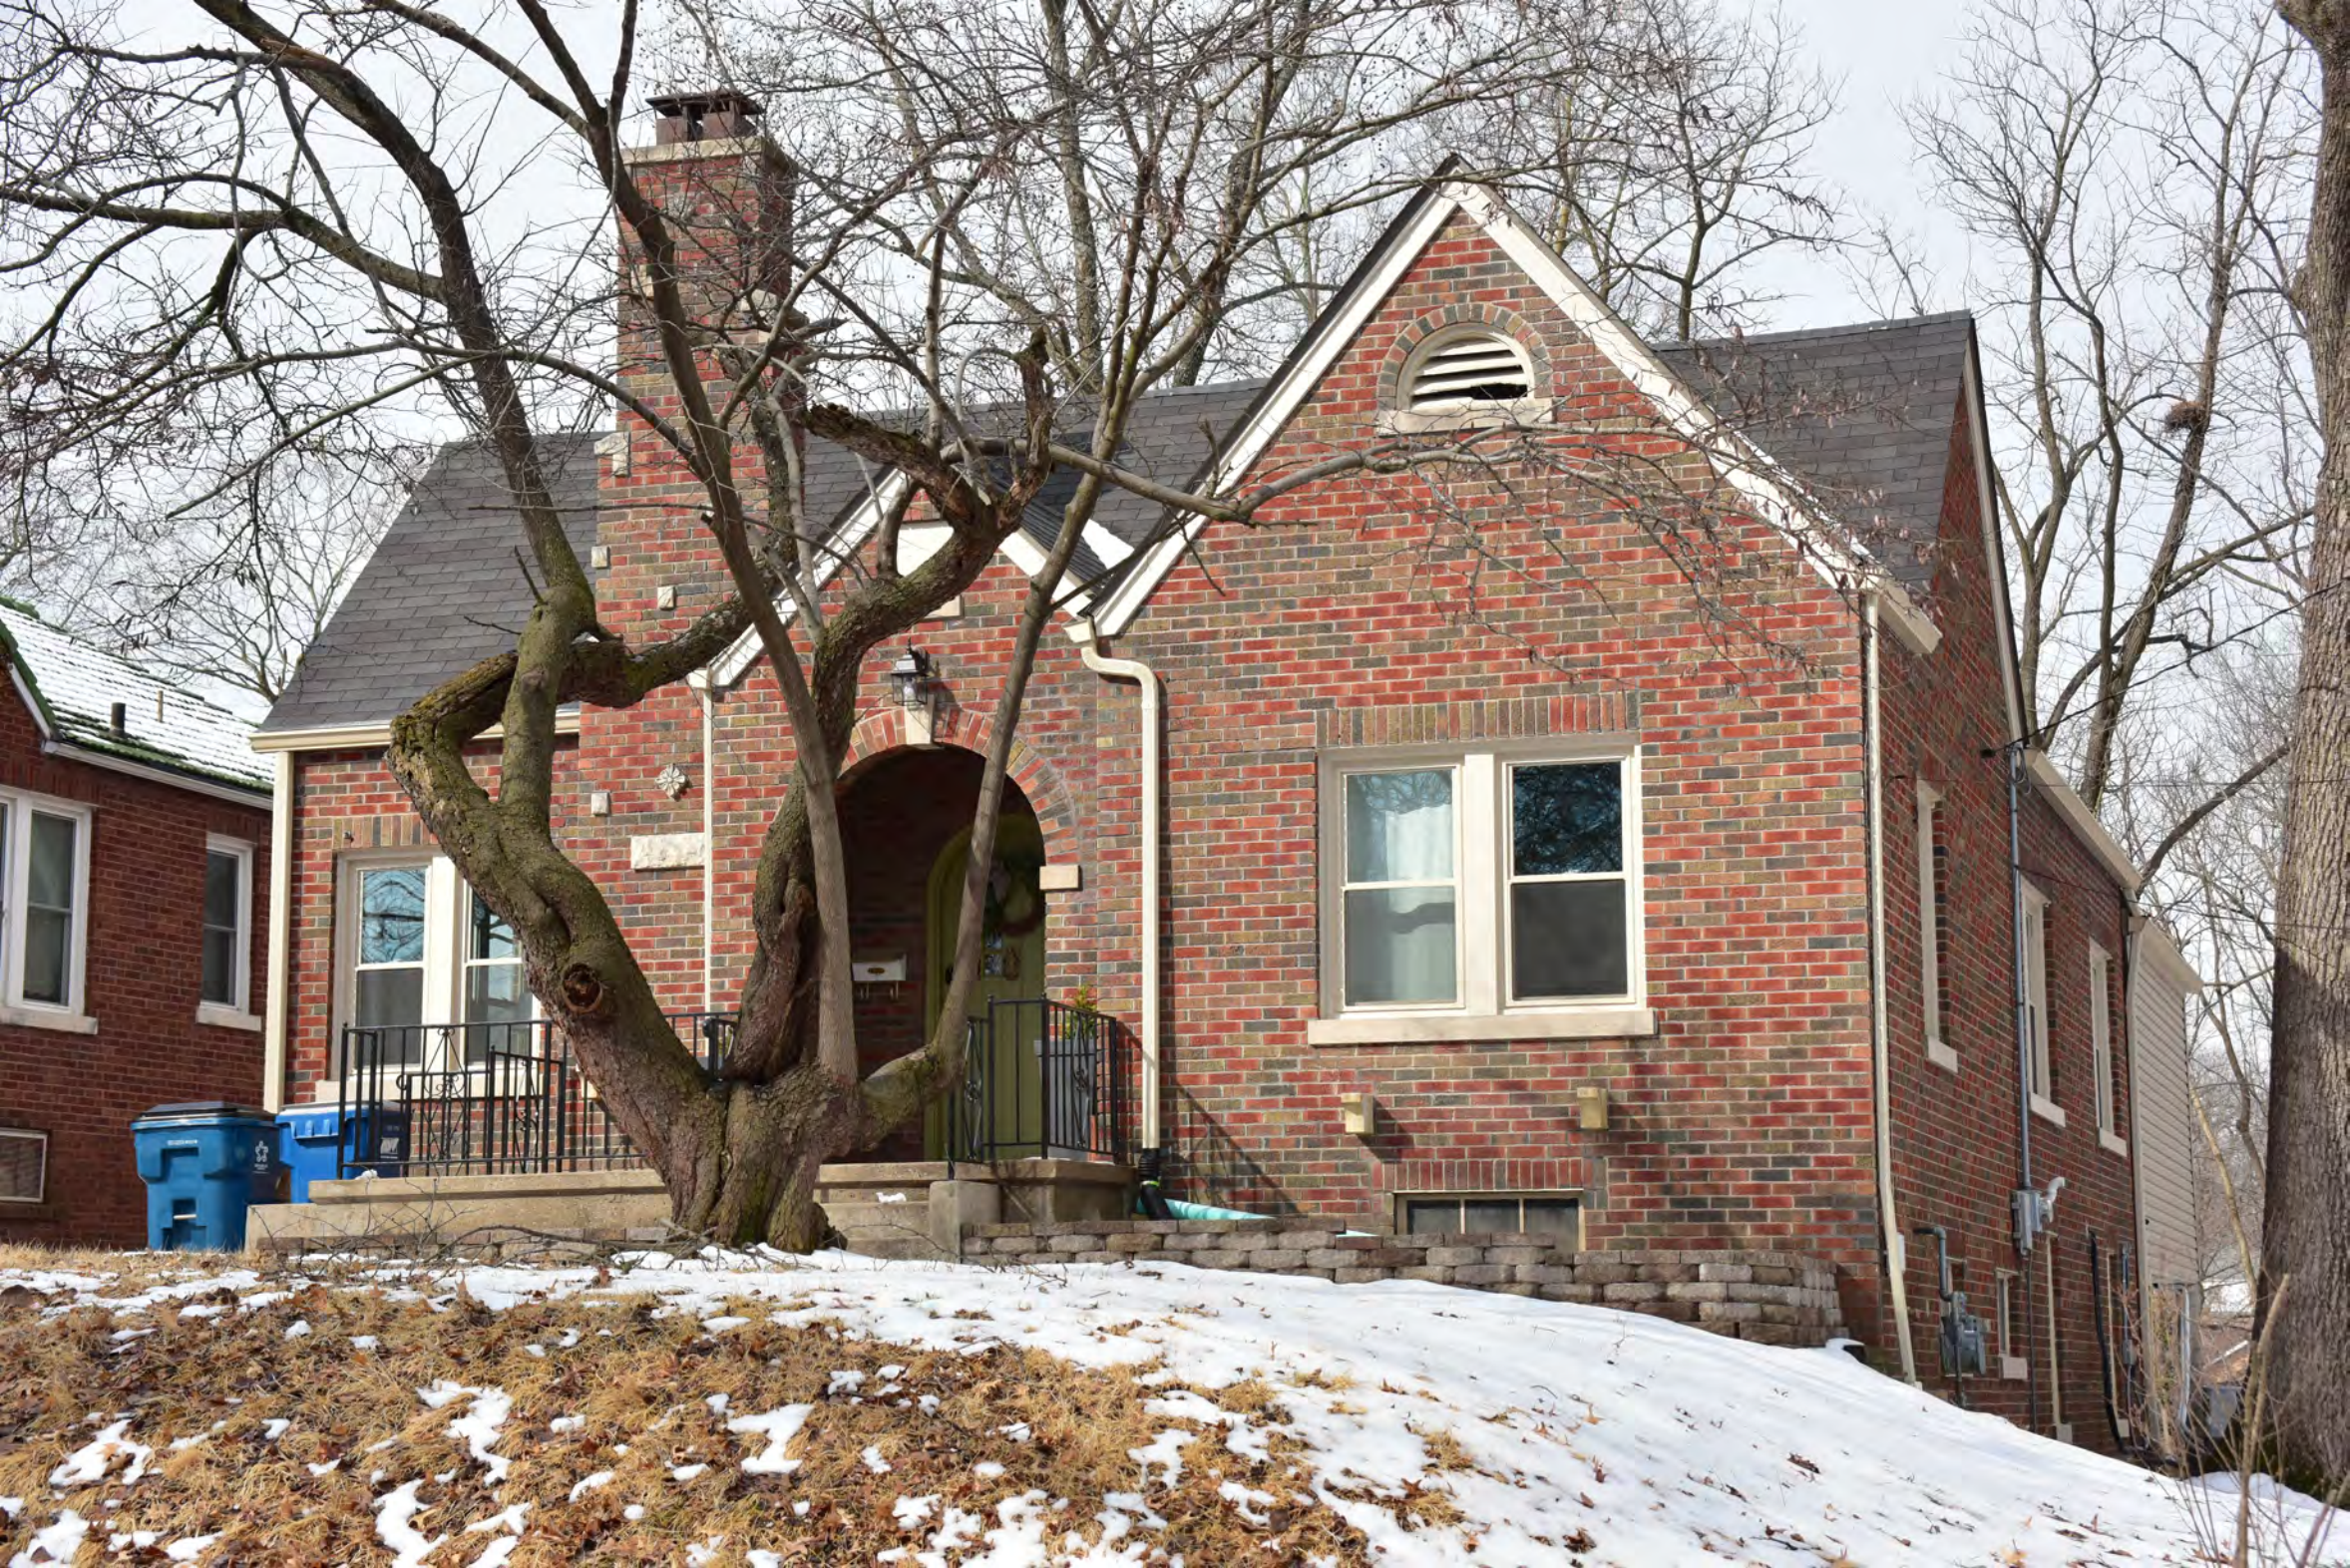
123 East Circle Drive is a one-and-one-half story single-family Minimal Traditional dwelling. It has multi-color brick cladding with stone accents, a concrete foundation, and a complex asphalt intersecting gable roof. A side-gable roof with Low cross-gables fronts the lot while a perpendicular gable extends to the rear. Two cross-gables extend from the south elevation. The dwelling is four bays wide. Paired 1/1 vinyl windows with stone sills define the first and fourth bays. A brick exterior chimney with stone and floral motif tile accents defines the second bay. A small cross gable defines the third bay and contains the entrance. The entrance recedes, forming a narrow open porch. The porch entrance is arched with stone accents in a keystone motif. The primary entrance is arched and contains a historic wood door. A large cross-gable contains the fourth bay. A partial-width concrete platform porch with metal railing extends below the second and third bays. A one-story vinyl-clad addition projects from the rear elevation. An integrated historic garage is located at the basement level and is accessed at the rear.
