1. Survey number: CO-AS-008-001		2. Survey Name: West Main Street Survey	
3. County: Cole		4. Address (Street No.): 100	Street (name): East Circle Drive
5. City: Jefferson City	Vicinity <input type="checkbox"/>	6. Lat / Long:	7. Township/Range/Section: T: R: S:
8. Historic name (if known):		9. Present/other name (if known):	
10. Ownership: <input checked="" type="checkbox"/> Private <input type="checkbox"/> Public		11a. Historic use (if known): Domestic-Single Dwelling	11b. Current use: Domestic-Single Dwelling

MISSOURI DEPARTMENT OF NATURAL RESOURCES
STATE HISTORIC PRESERVATION OFFICE, P.O. Box 178, Jefferson City, MO 65102
ARCHITECTURAL/HISTORIC INVENTORY FORM

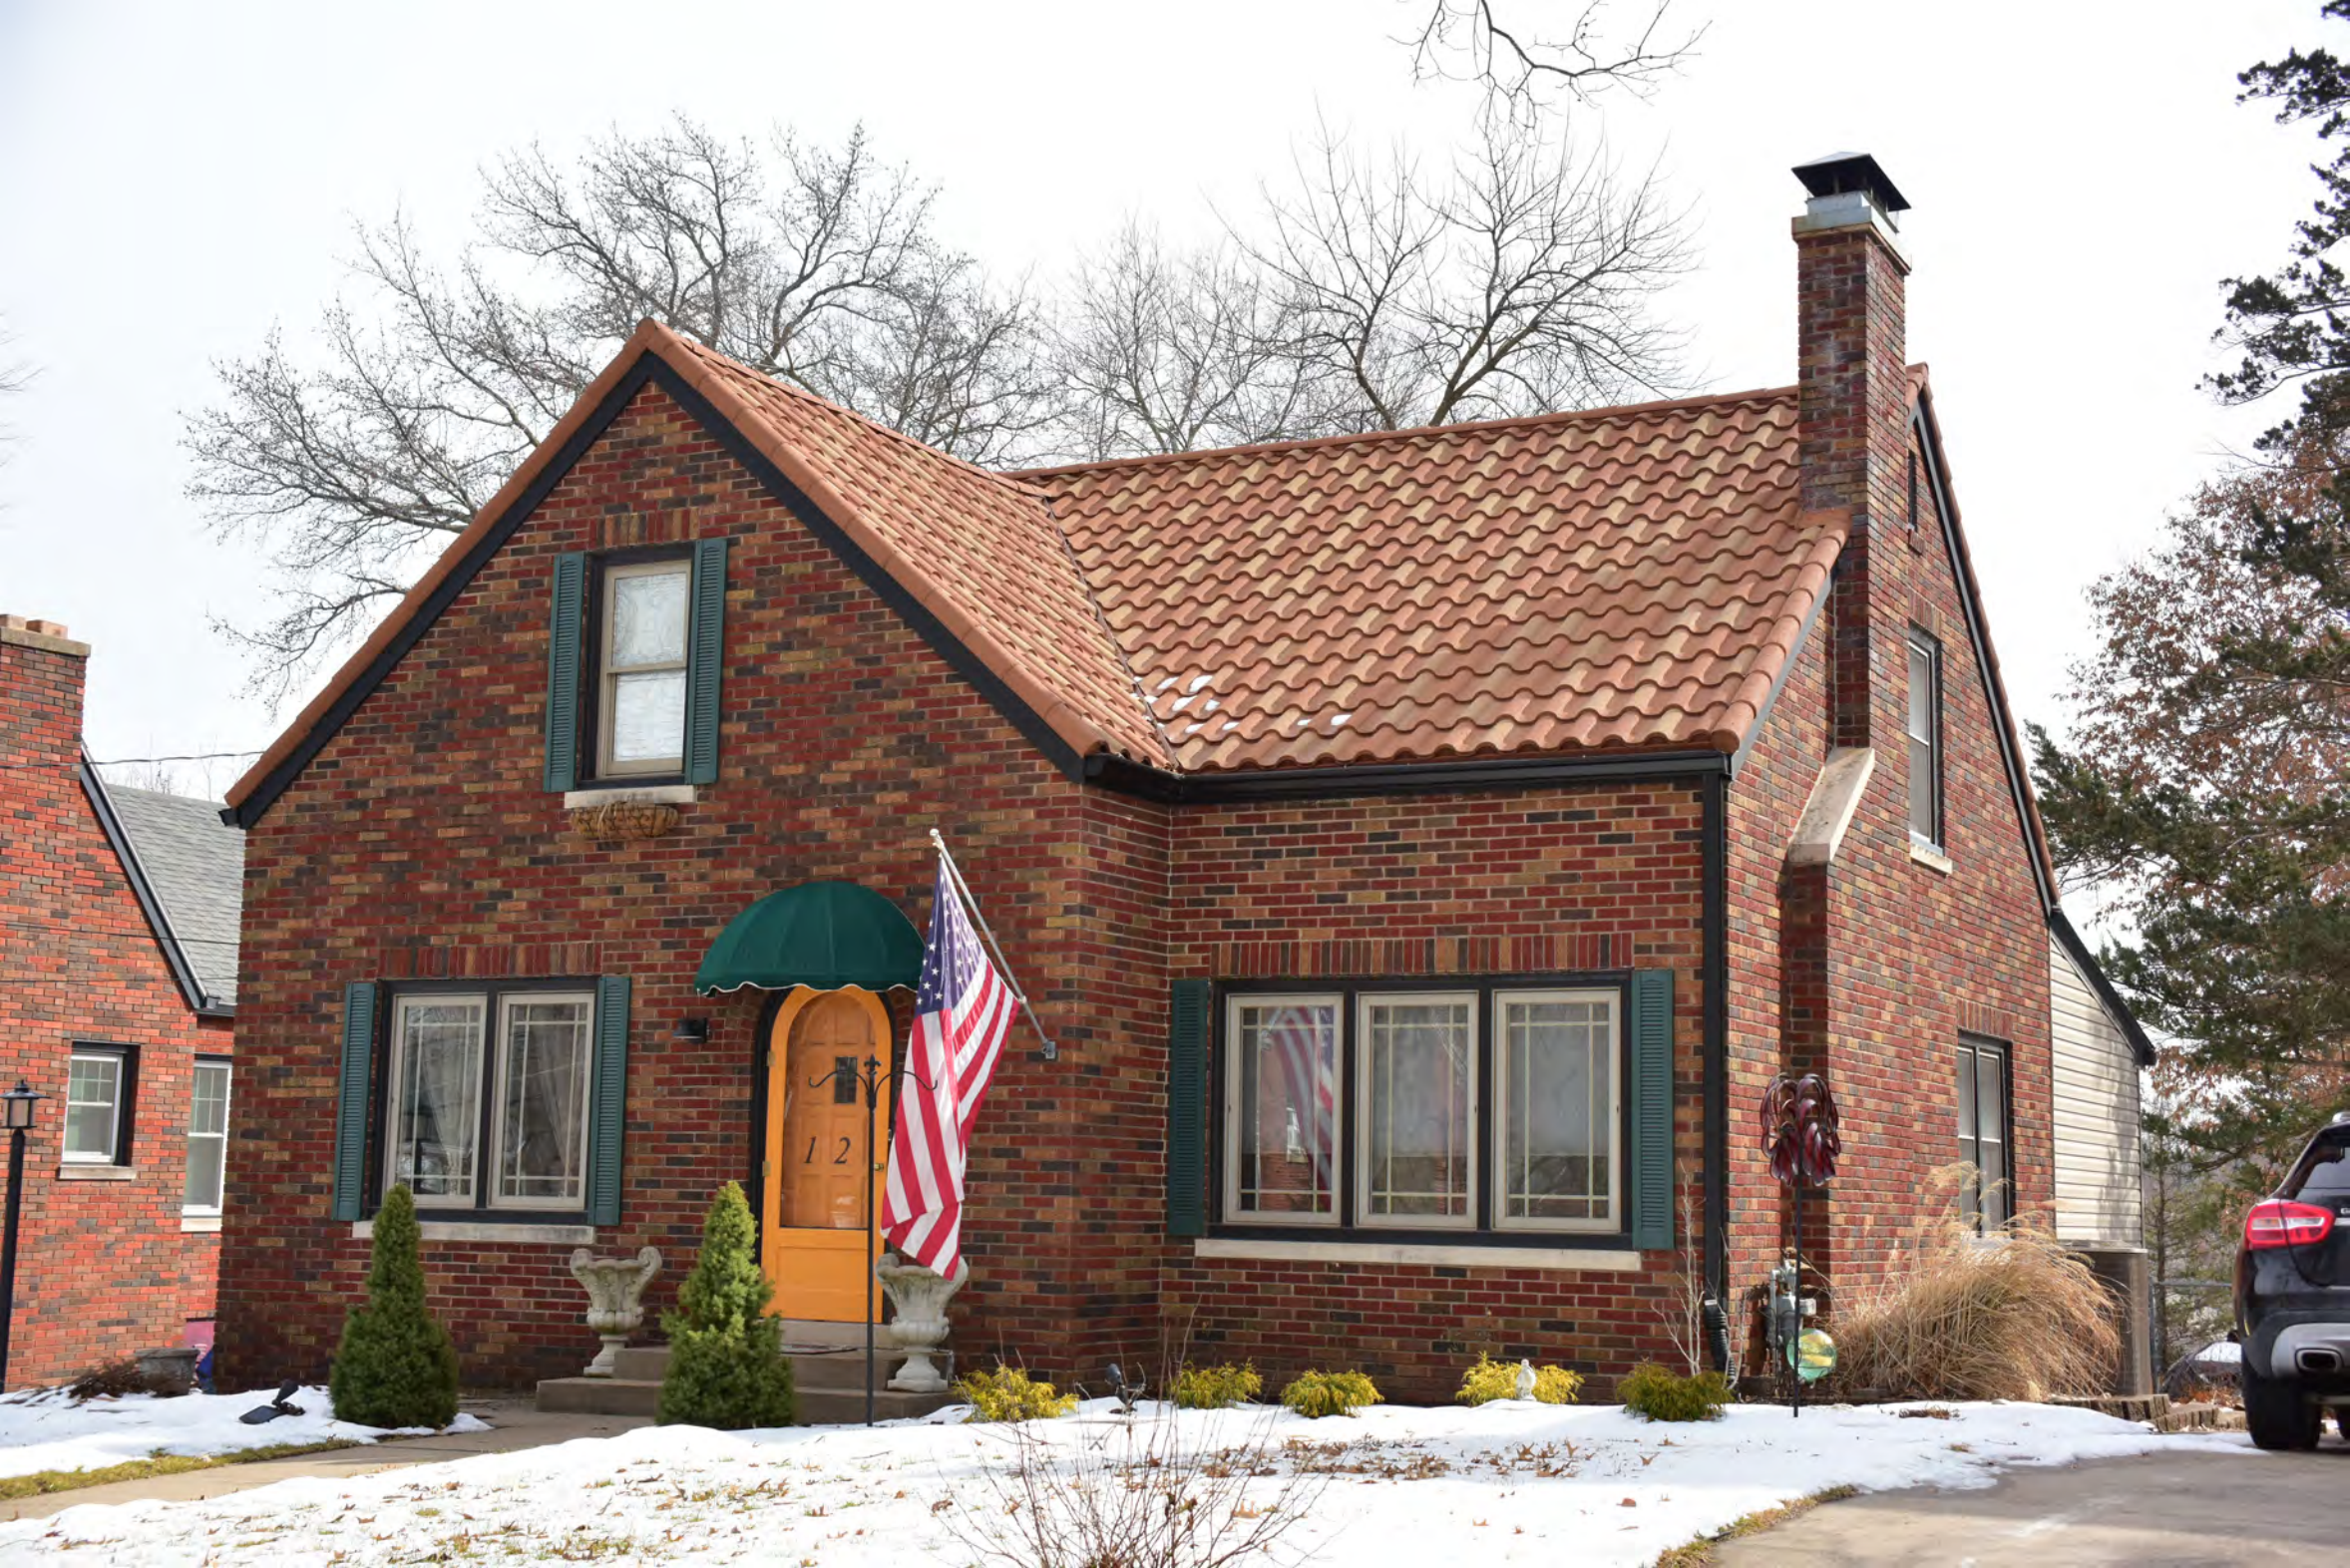
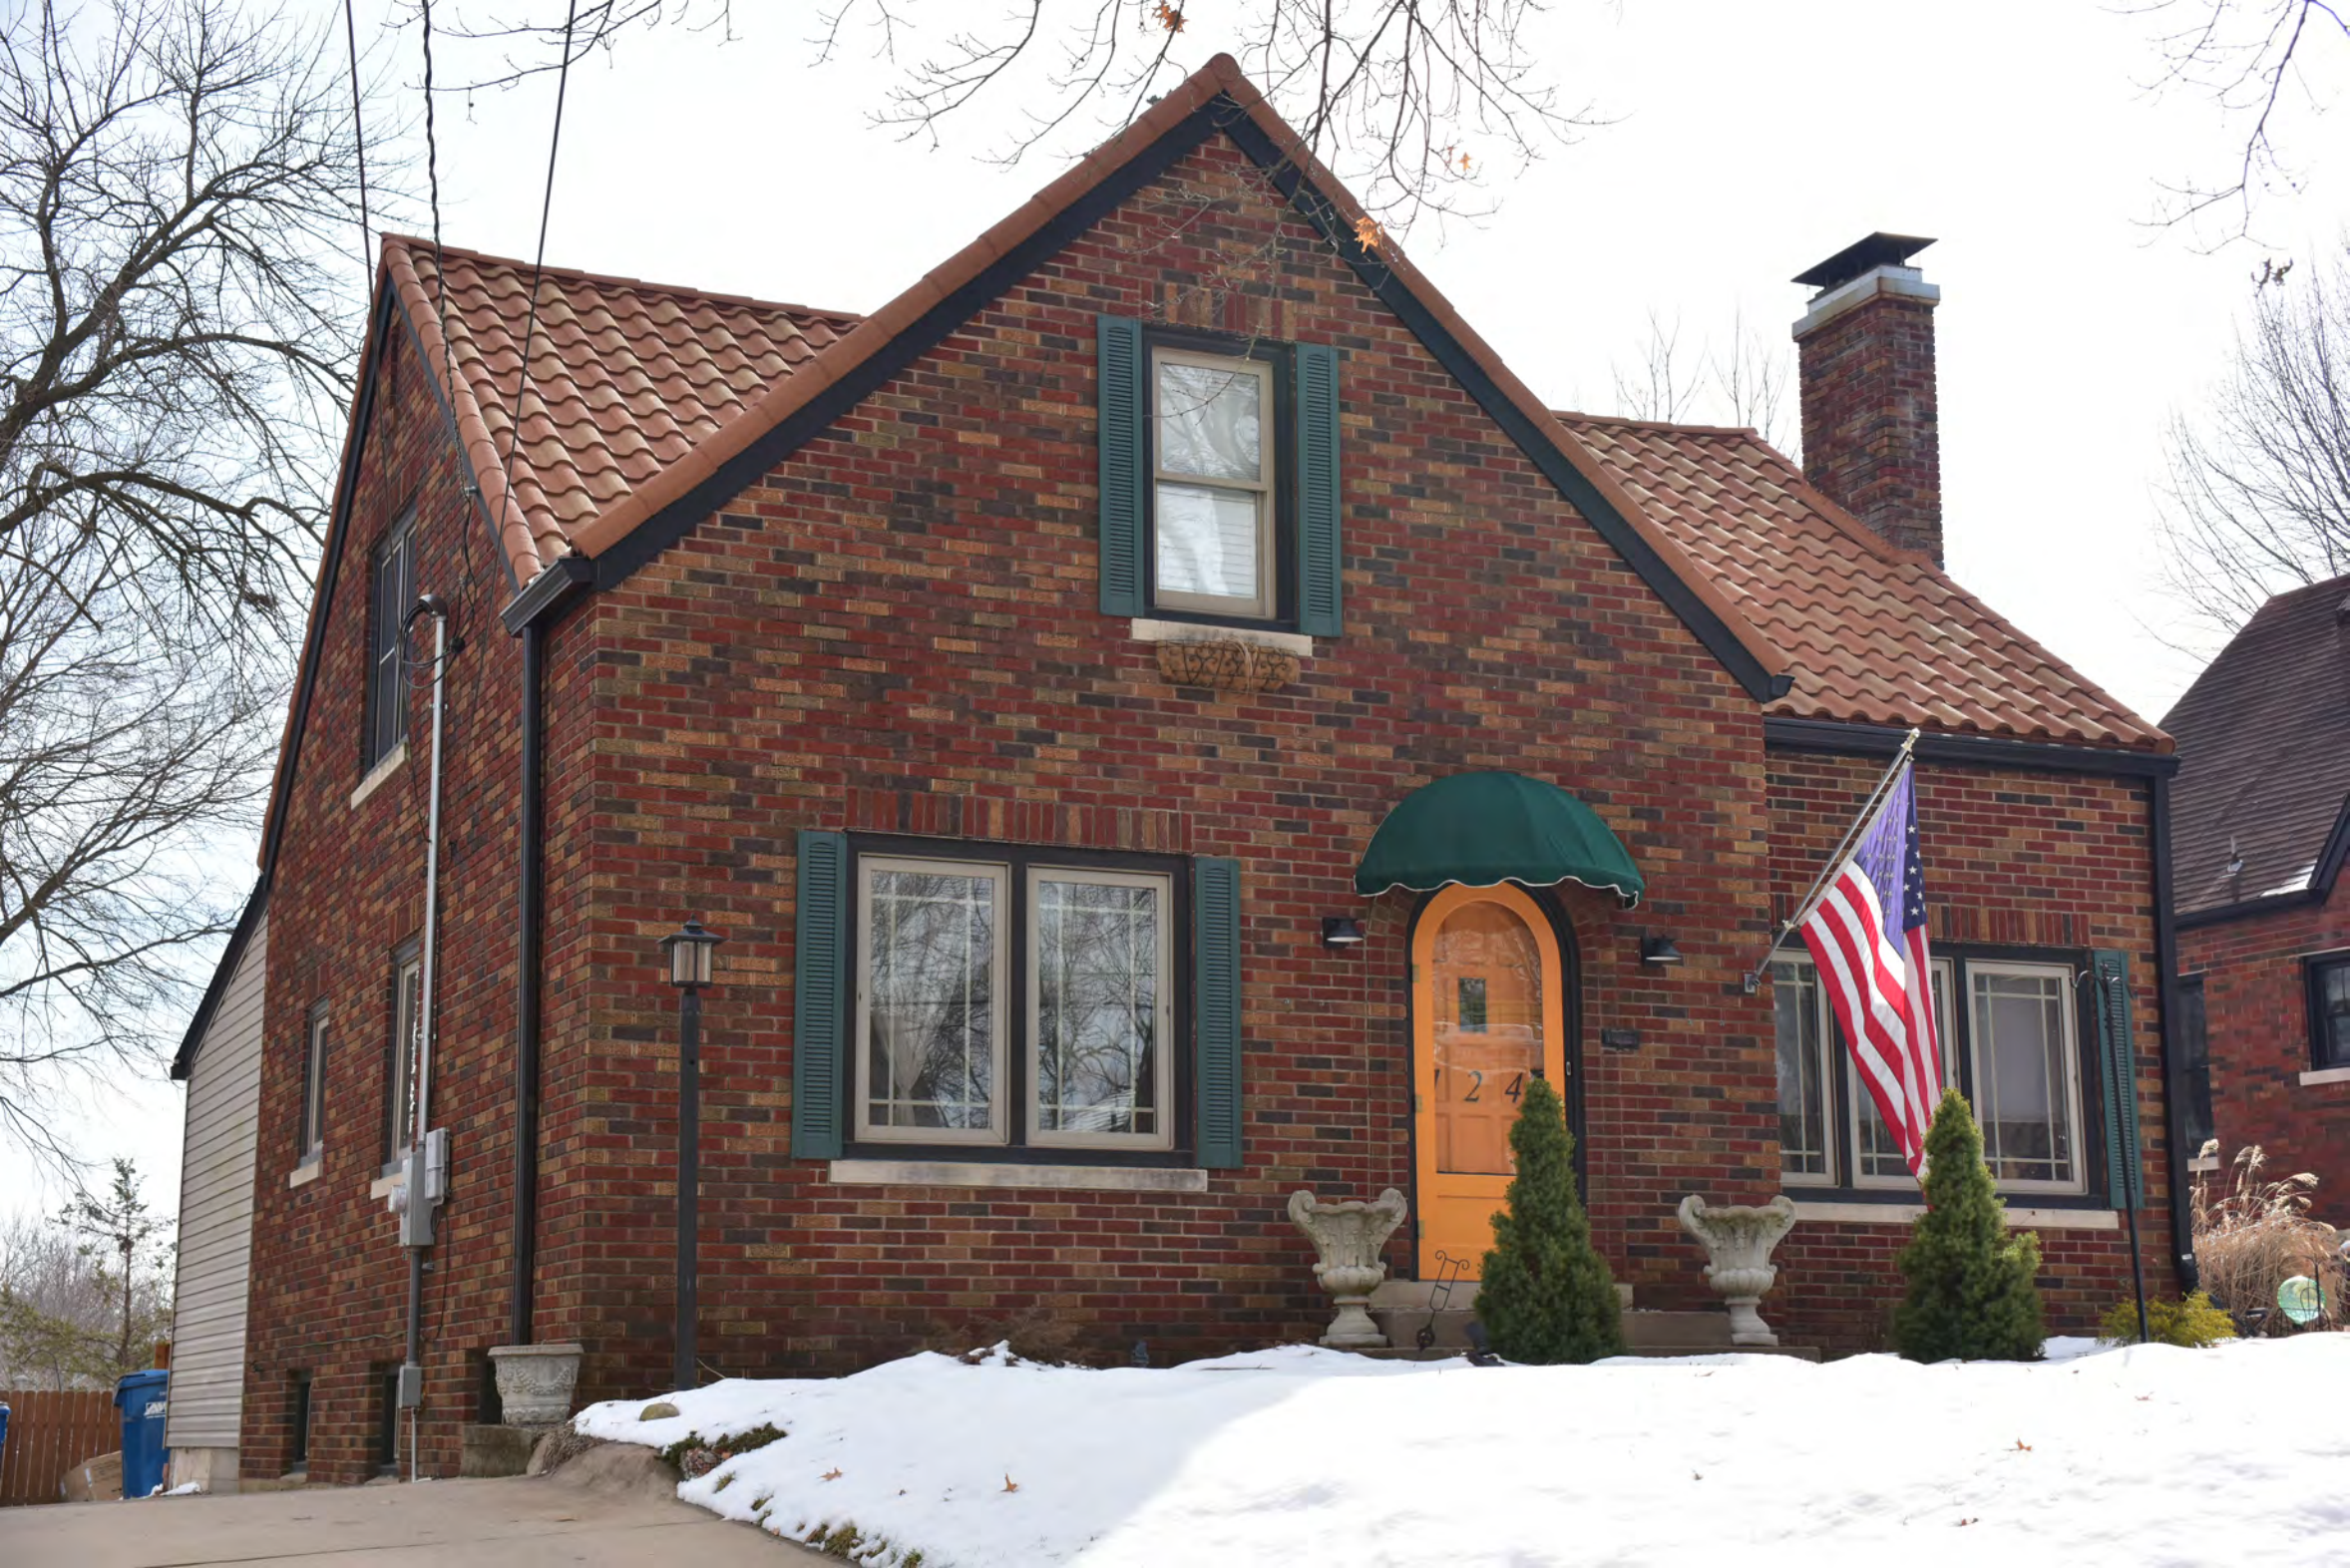
124 East Circle Drive is a one-and-one-half story Minimal Traditional dwelling. It has multi-color brick cladding, a concrete foundation, and a composite tile gabled-ell roof. The dwelling is three bays wide. The first and second bays are in the ell. A pair of non-historic vinyl windows with geometric muntins fills the first bay while a trio of matching windows defines the third bay. A small 1/1 non-historic window occupies the gable-end of the ell. All windows have stone sills and soldier brick lintels. A rounded arch entrance with historic wood door defines the center bay. A concrete stoop projects from the entrance. A non-historic fabric awning shelters the stoop. A brick exterior chimney pierces the gable at the south elevation. An integrated historic single-car garage is located at basement level and is accessed at the rear. A shed-roof vinyl-clad addition projects from the rear elevation above the garage.

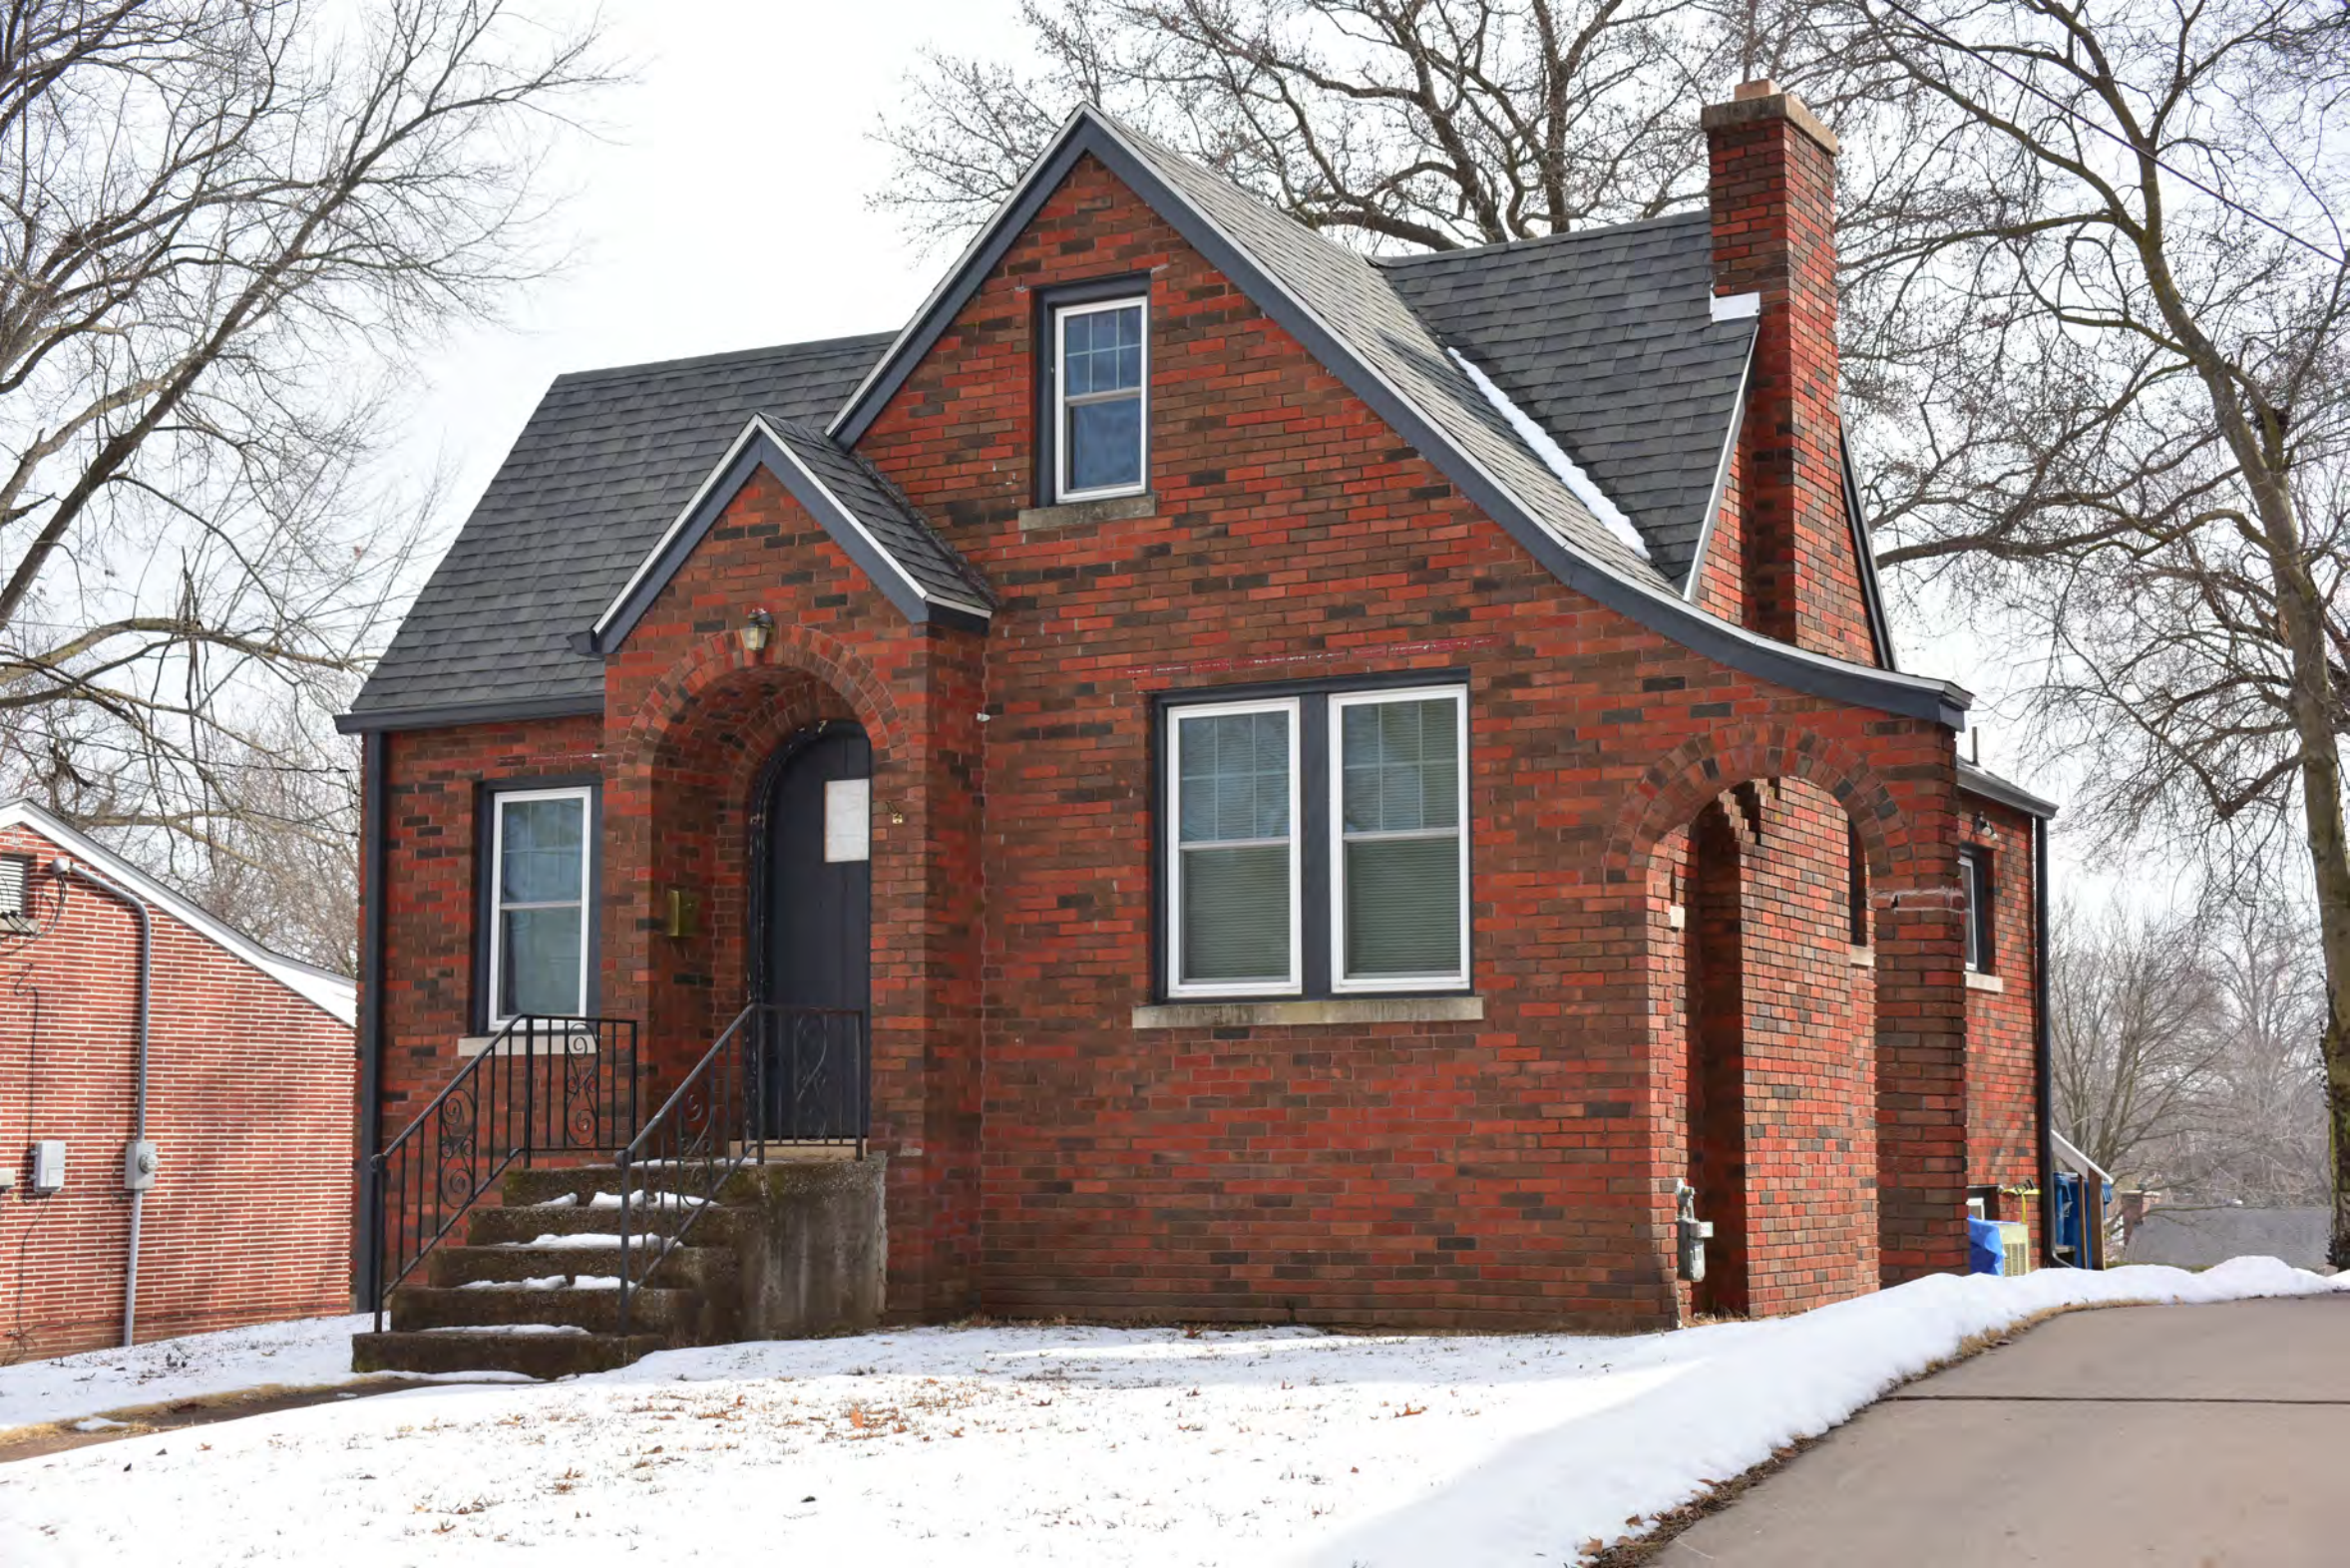
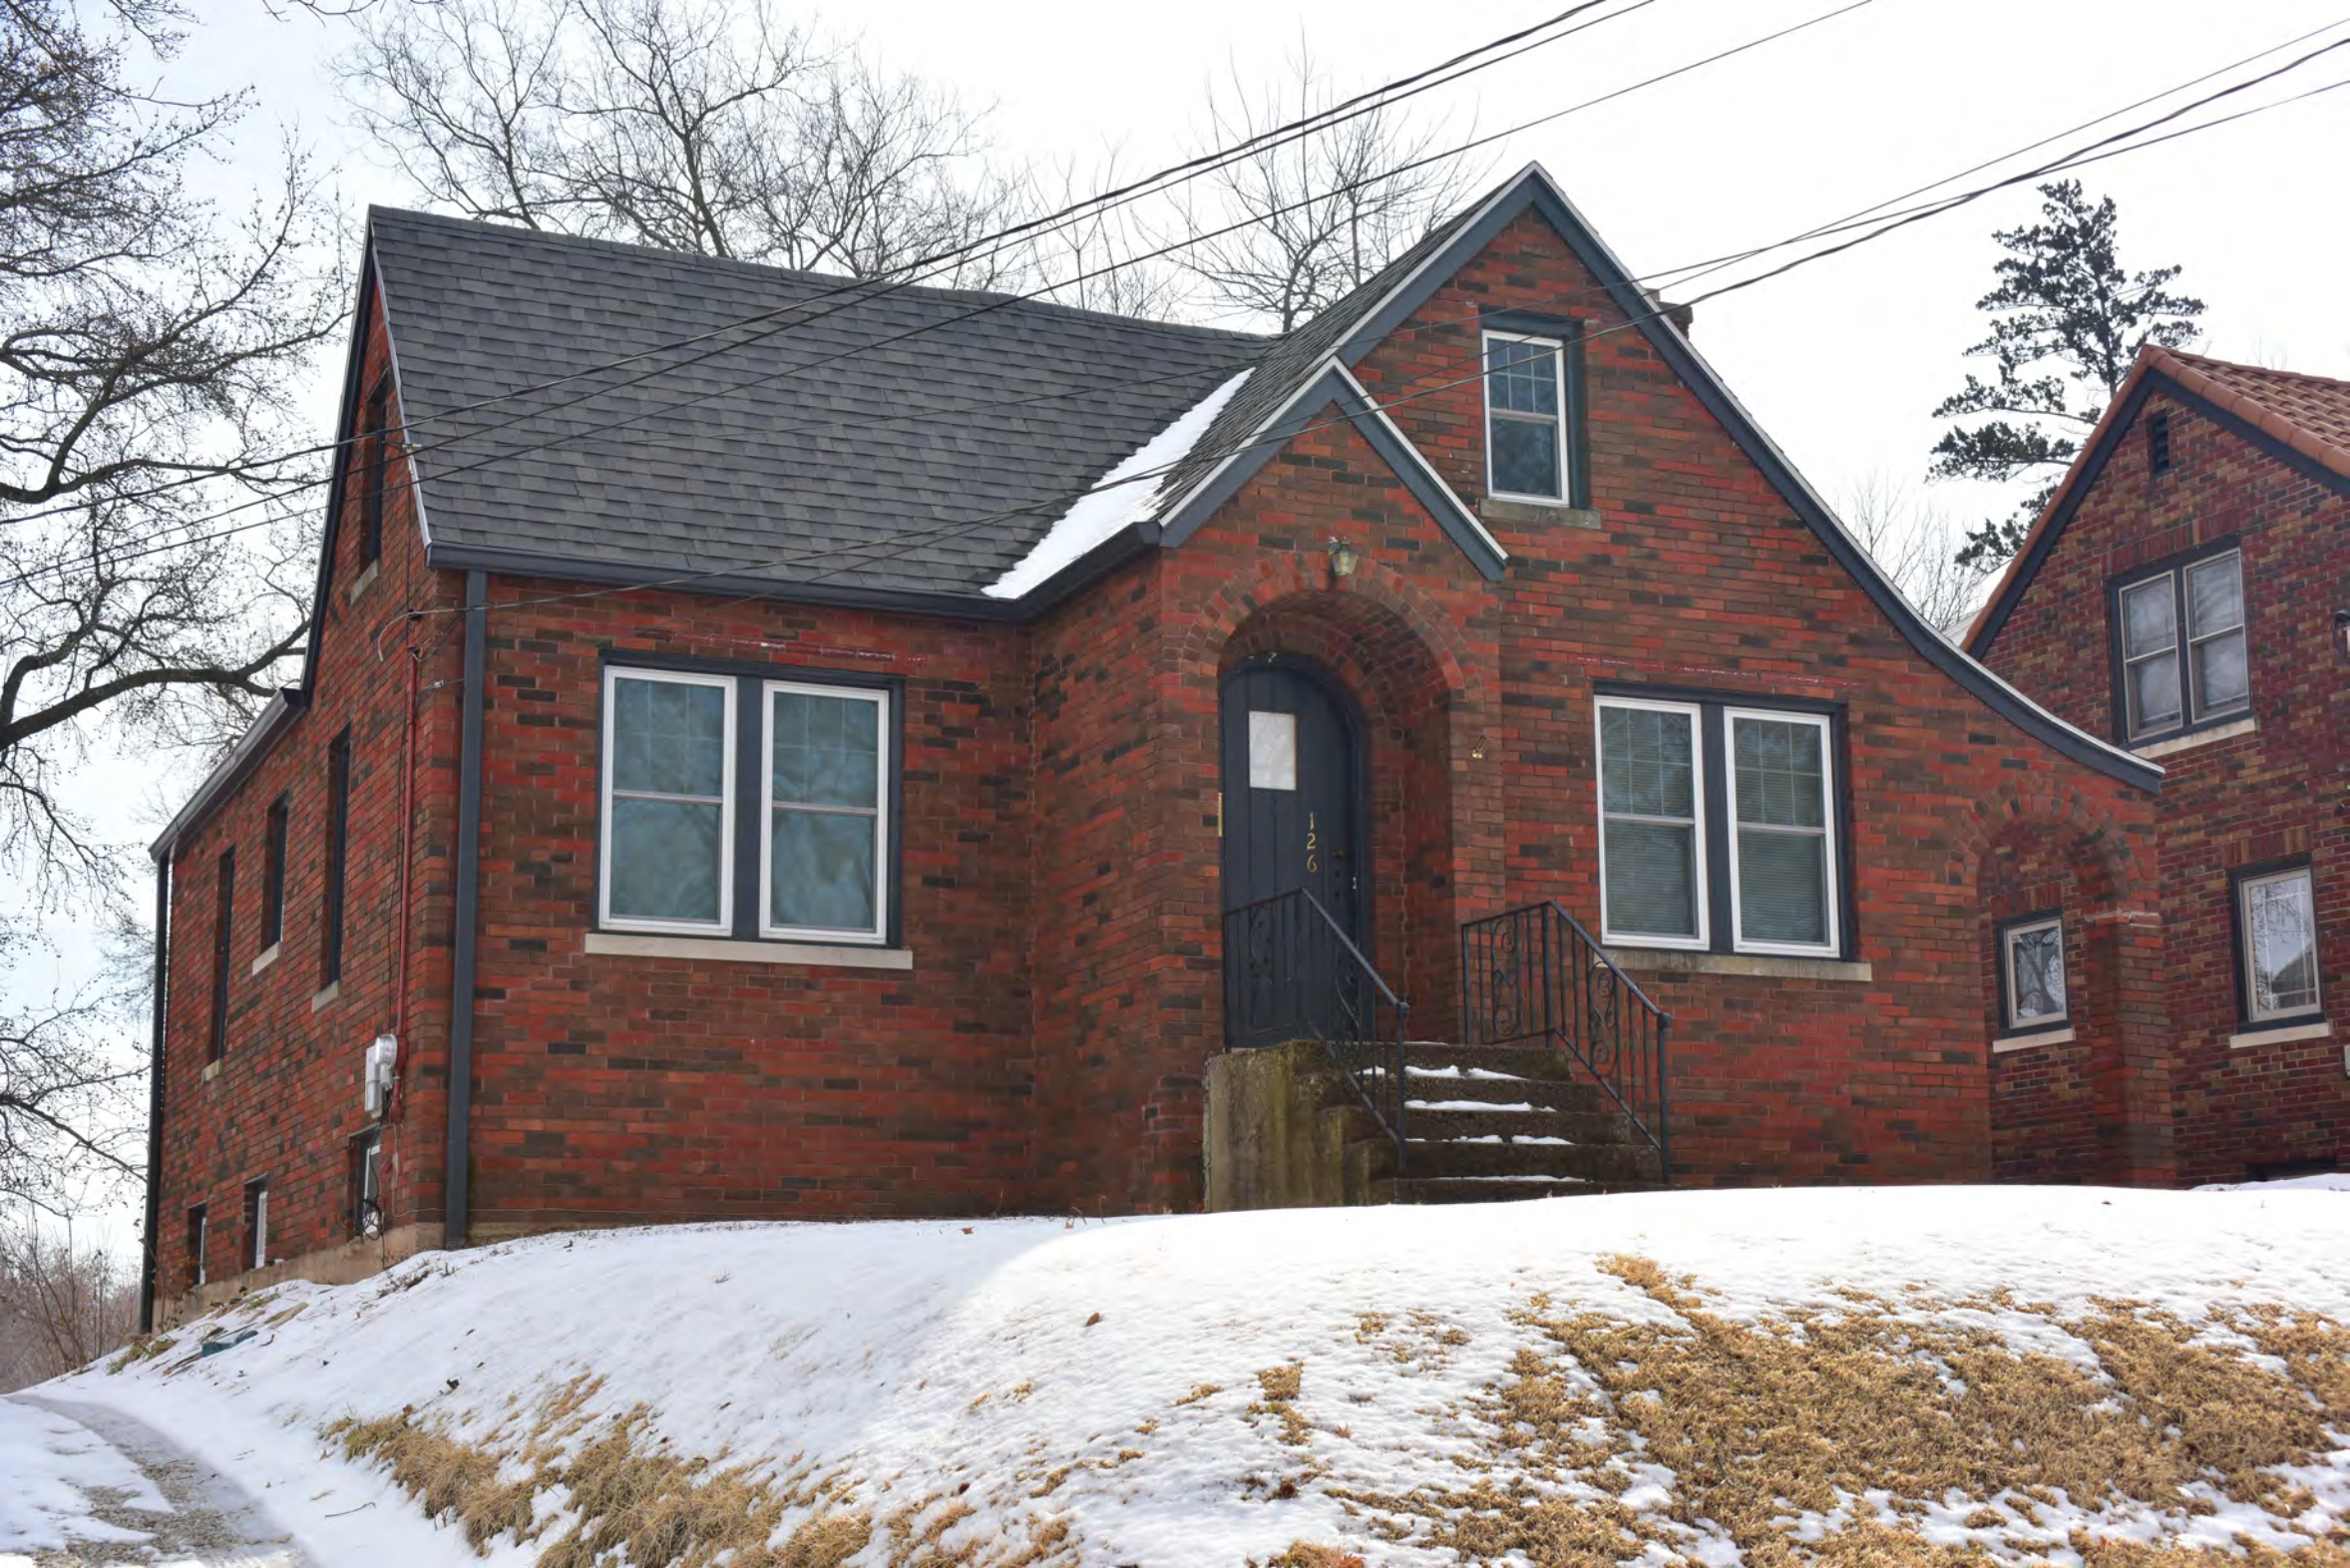
126 East Circle Drive is a one-and-one-half story Minimal Traditional dwelling. The brick dwelling has a concrete foundation and complex asphalt roof. A side-gable fronts the street while a perpendicular gable extends at the rear. A gable-front ell with brick wingwall projects from the primary elevation. The wingwall contains a rounded arch. The primary elevation is three bays wide. Paired 6/1 vinyl windows with continuous stone sills define the outer bays while the entrance defines the center bay. The entrance is recessed slightly and contains a historic arched wood door with single-light glazing. A gable shelters the entrance. A concrete stoop with metal railings provides access. A brick exterior chimney pierces the gable at the south elevation. An integrated historic single-car garage is located at basement level and is accessed at the rear. Aerial imagery indicates the presence of a deck at the rear however it is not visible from the right of way.

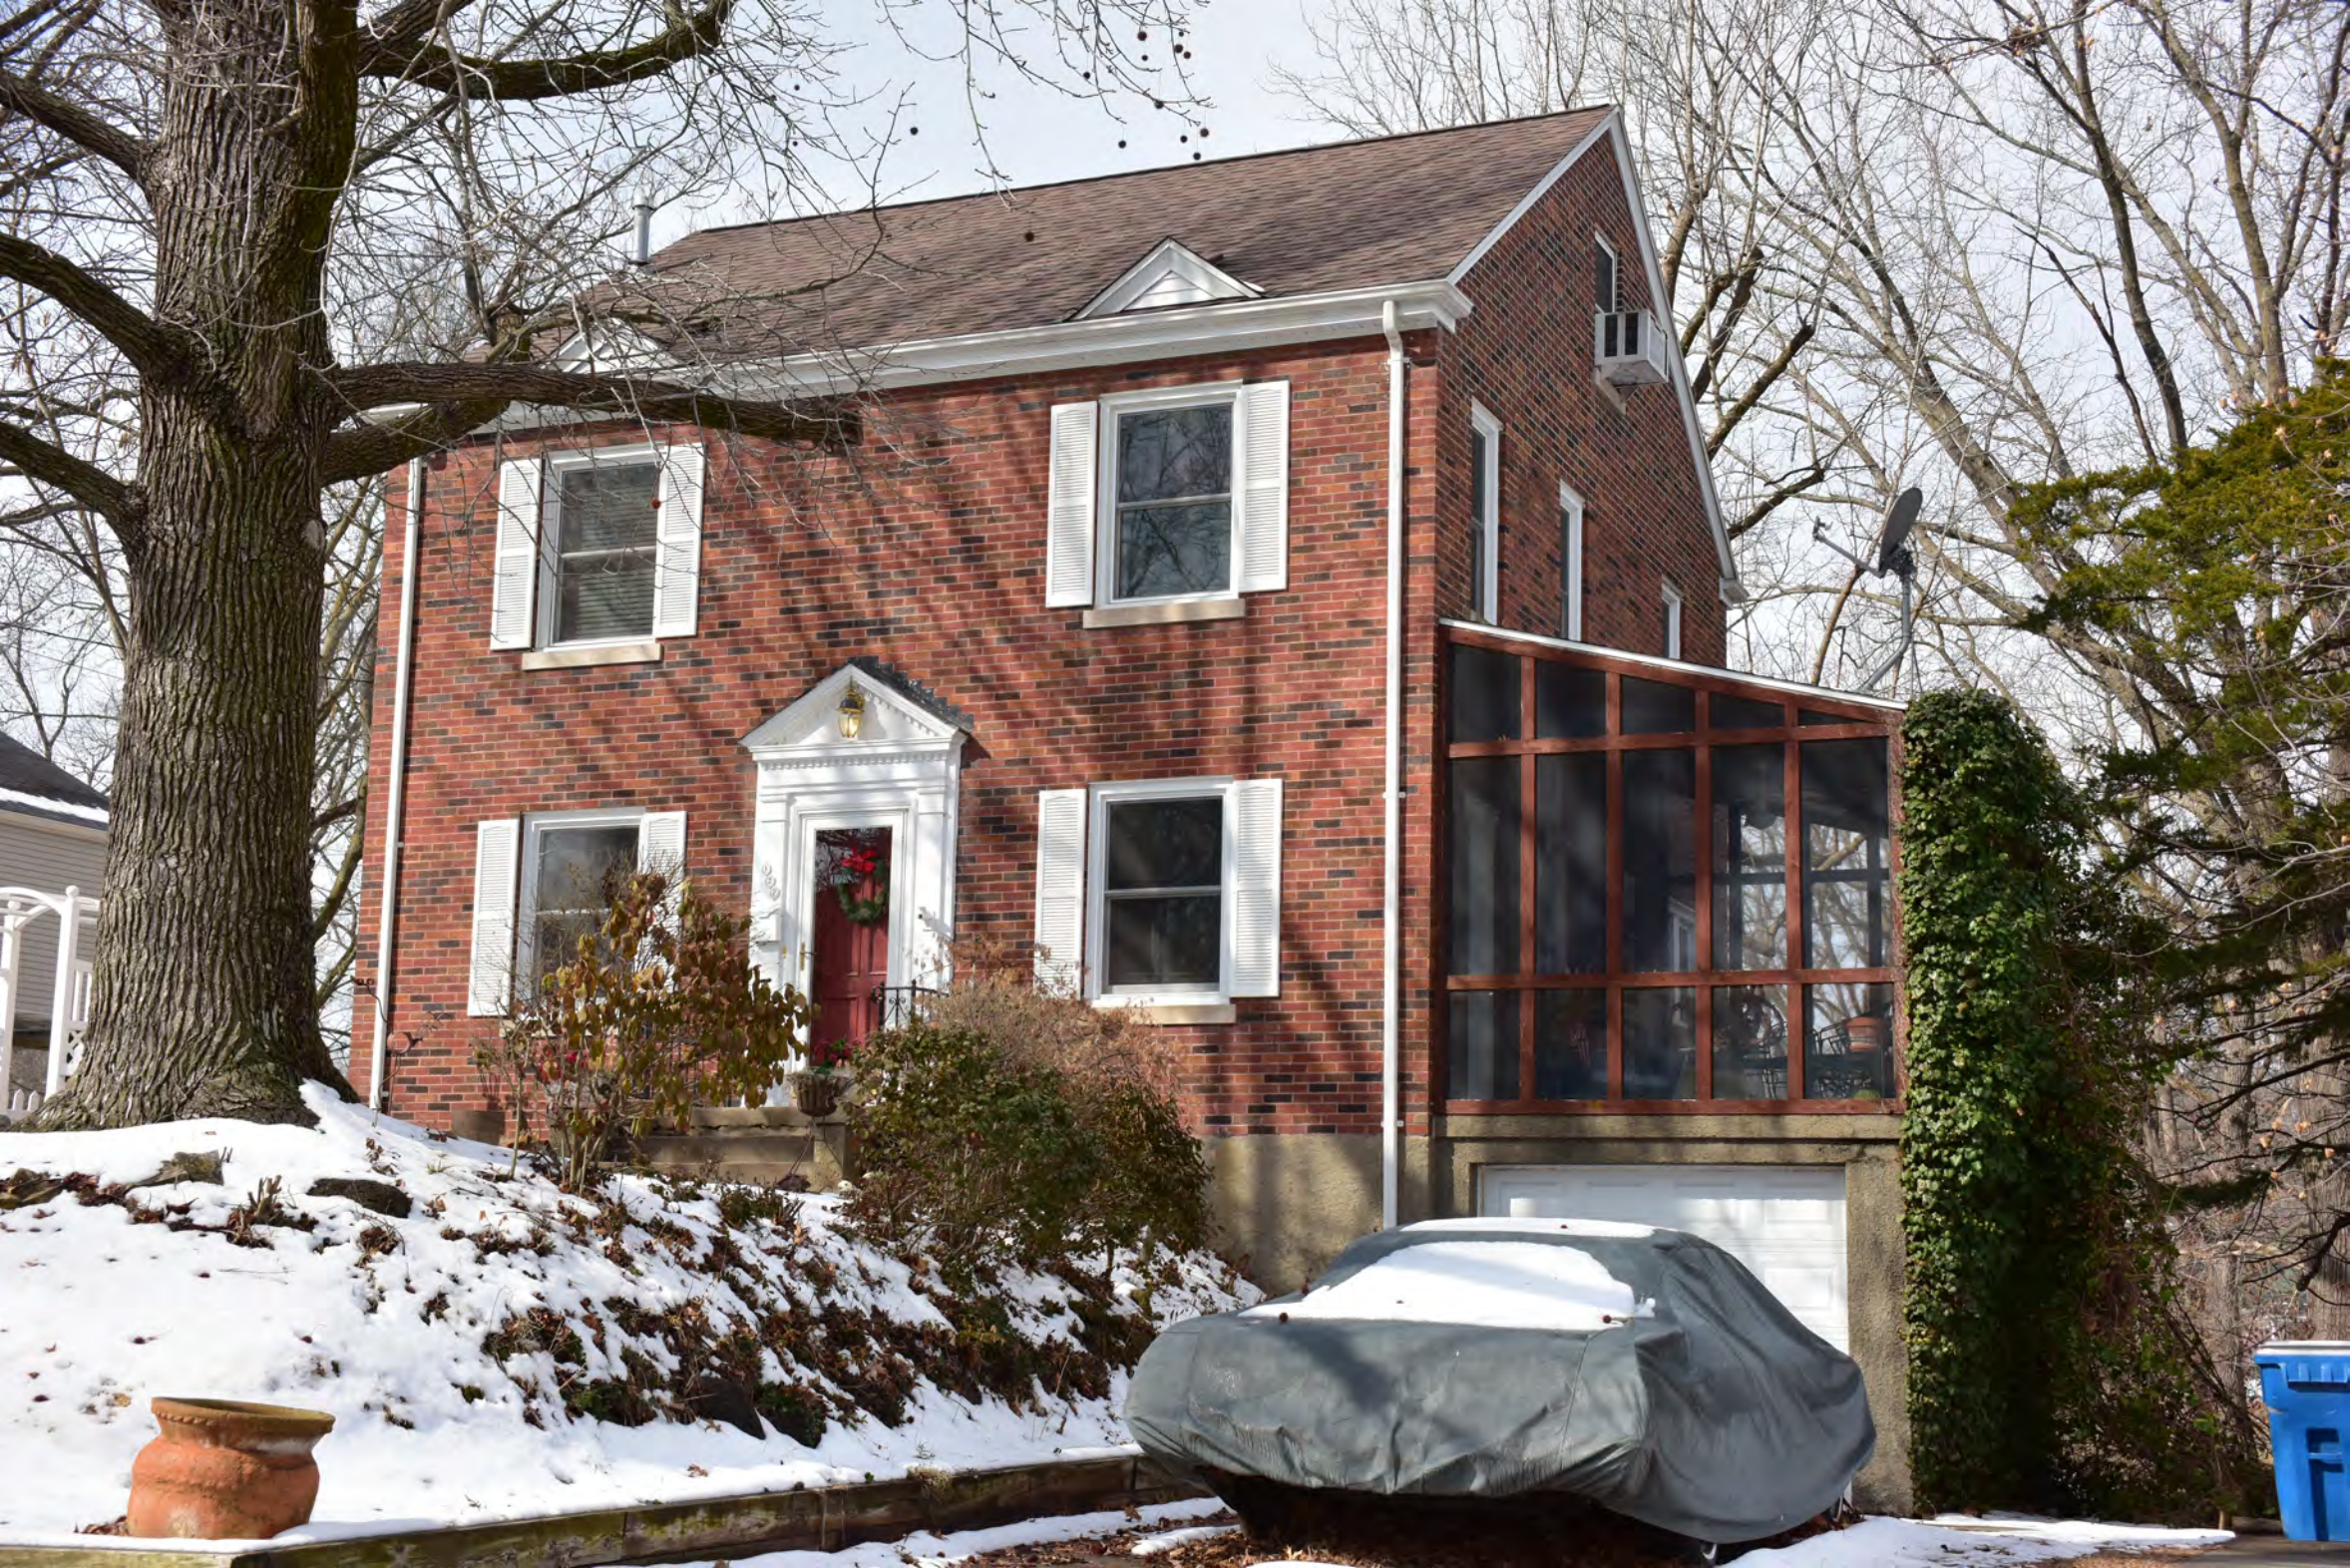
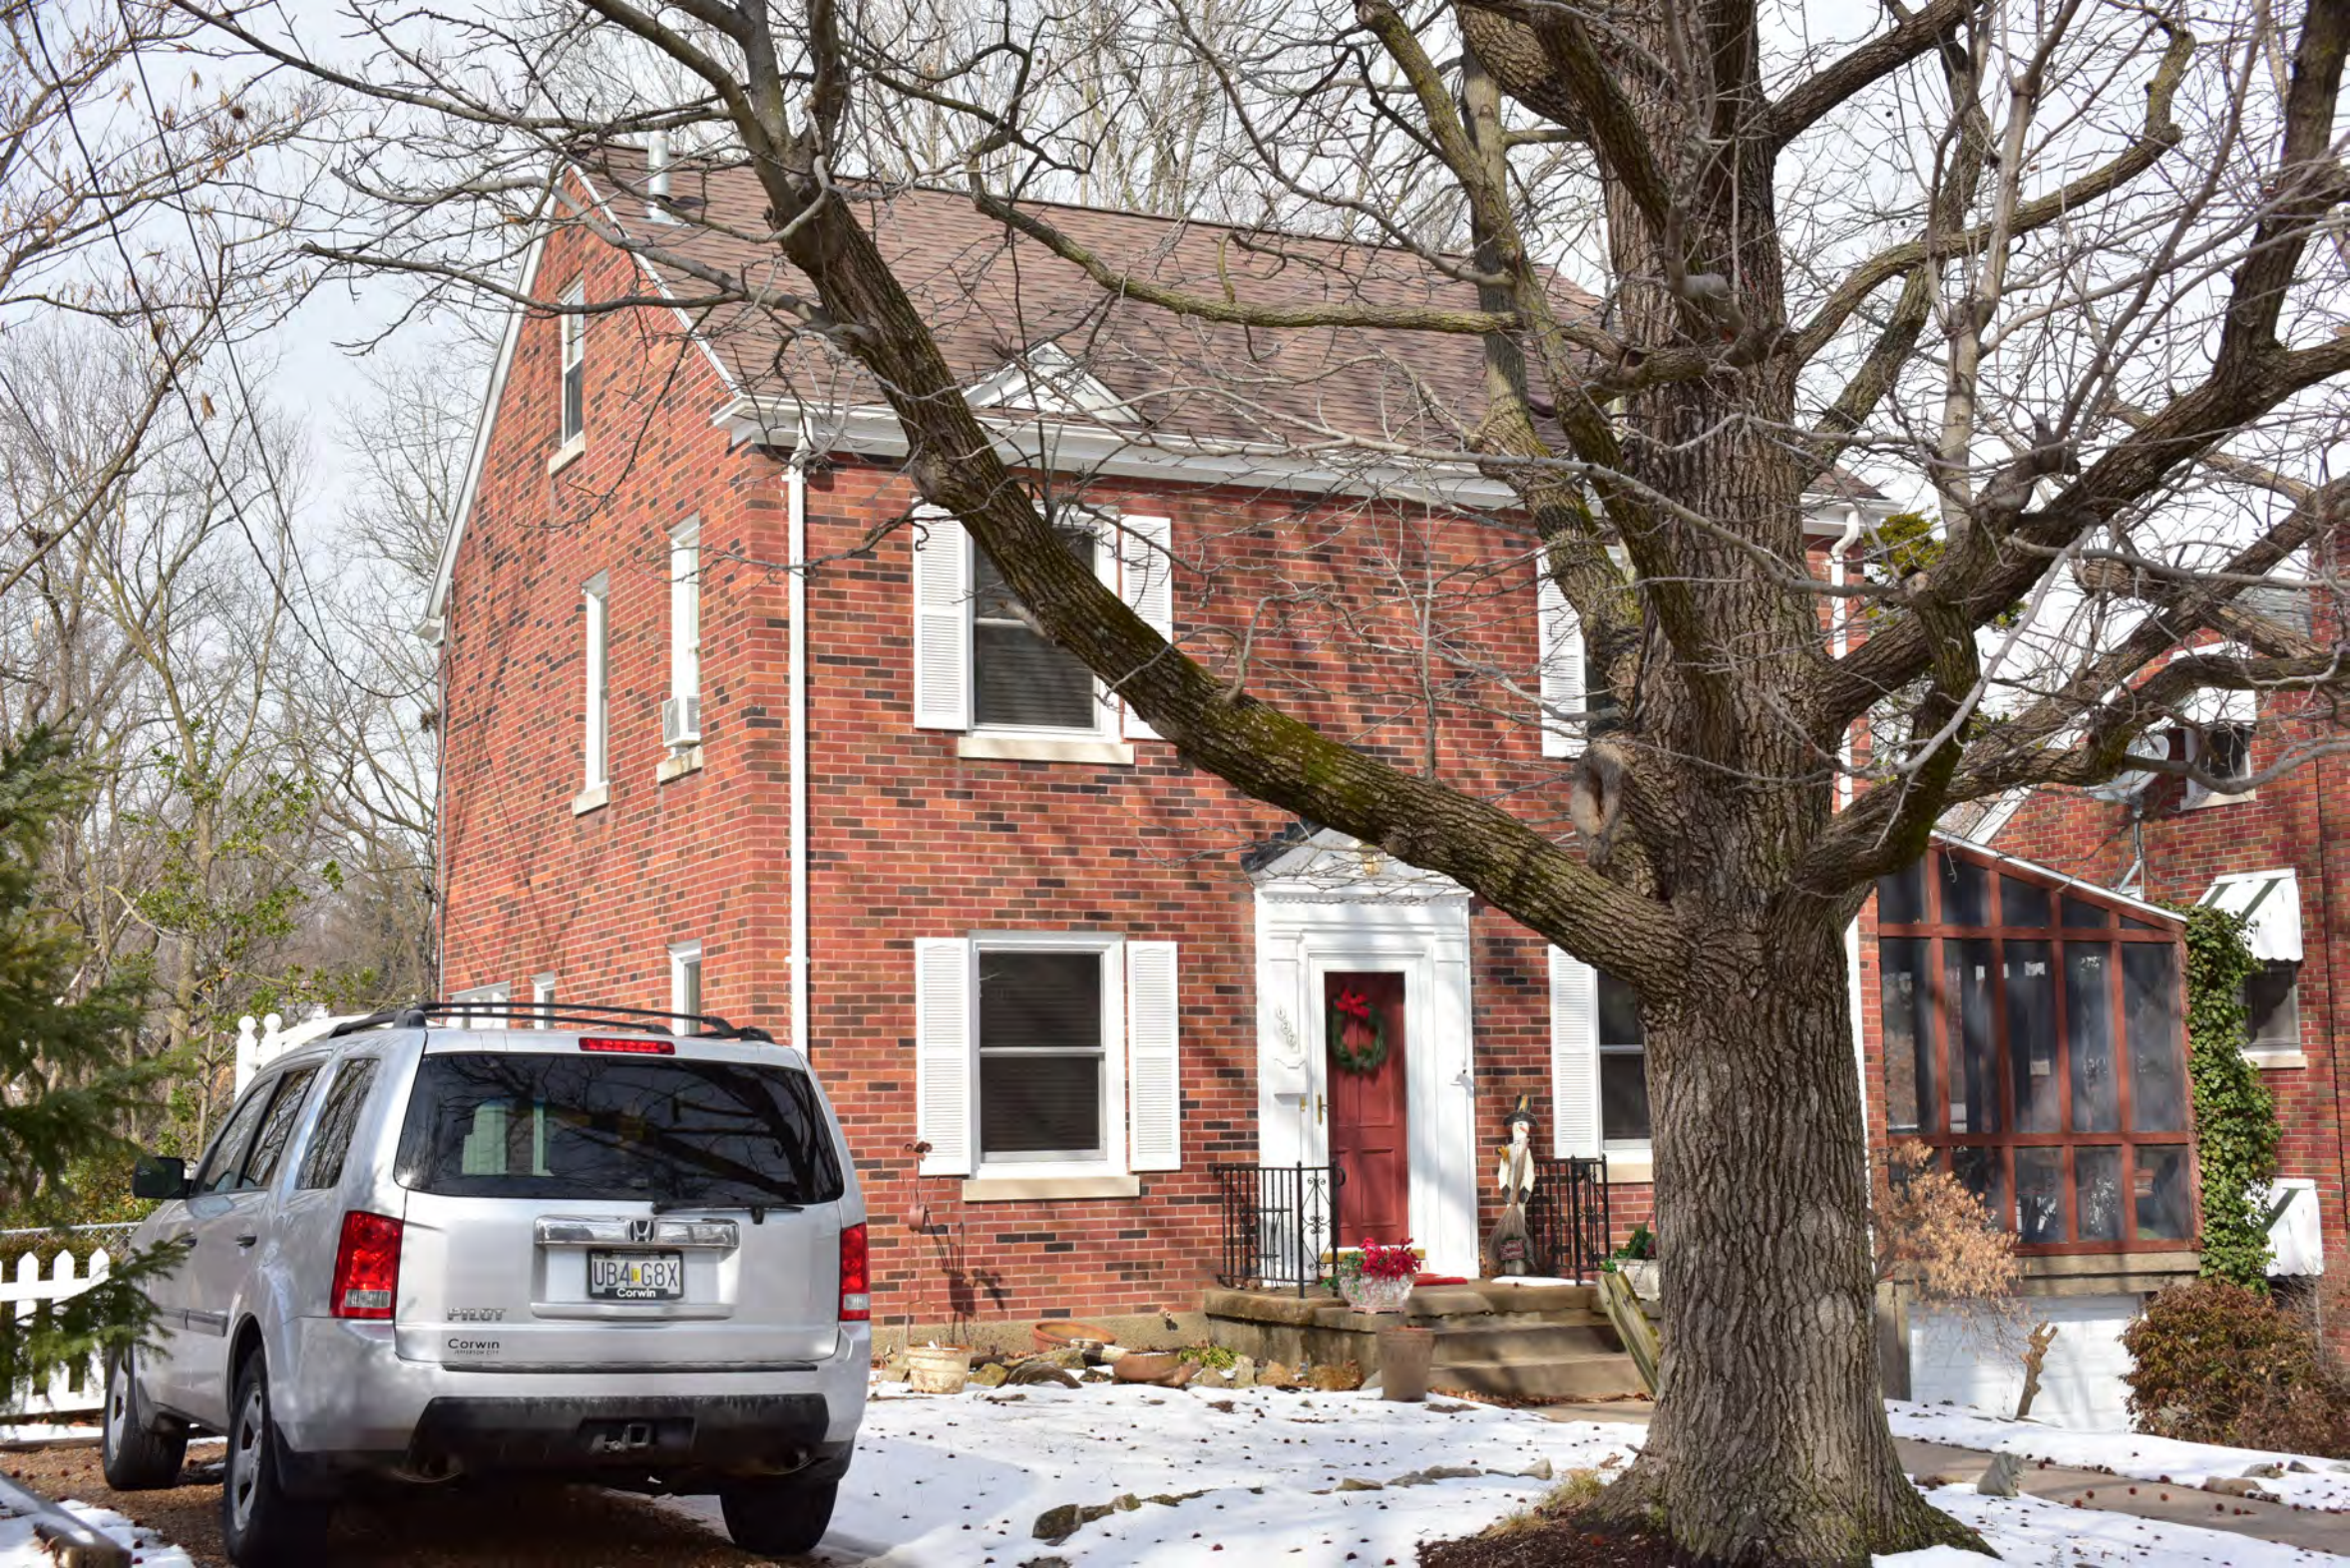
127 East Circle Drive is a two-and-one-half story Colonial Revival dwelling with brick cladding, a parged concrete foundation, and side-gable asphalt roof. It is three bays wide at the first story. Historic 1/1 wood windows with stone sills, storm windows, and false shutters define the north and south bays while the primary entrance defines the center bay. The entrance features a classical surround with pilasters and dentilled pediment. A concrete stoop with metal railing projects from the entrance bay. Historic 1/1 wood windows with stone sills, storm windows, and false shutters define both second-story primary elevation bays. Small gable dormers are positioned above the second-story windows. Wood clapboard fills the dormer ends. A historic one-story attached garage extends from the north elevation at basement level. A non-historic overhead door fills the vehicular bay. A non-historic shed-roof screened porch with wood frame tops the garage. A historic secondary entrance accesses the screened porch.
