1. Survey number: CO-AS-008-001		2. Survey Name: West Main Street Survey	
3. County: Cole		4. Address (Street No.): 100	Street (name): East Circle Drive
5. City: Jefferson City	Vicinity <input type="checkbox"/>	6. Lat / Long:	7. Township/Range/Section: T: R: S:
8. Historic name (if known):		9. Present/other name (if known):	
10. Ownership: <input checked="" type="checkbox"/> Private <input type="checkbox"/> Public		11a. Historic use (if known): Domestic-Single Dwelling	11b. Current use: Domestic-Single Dwelling

MISSOURI DEPARTMENT OF NATURAL RESOURCES
STATE HISTORIC PRESERVATION OFFICE, P.O. Box 178, Jefferson City, MO 65102
ARCHITECTURAL/HISTORIC INVENTORY FORM

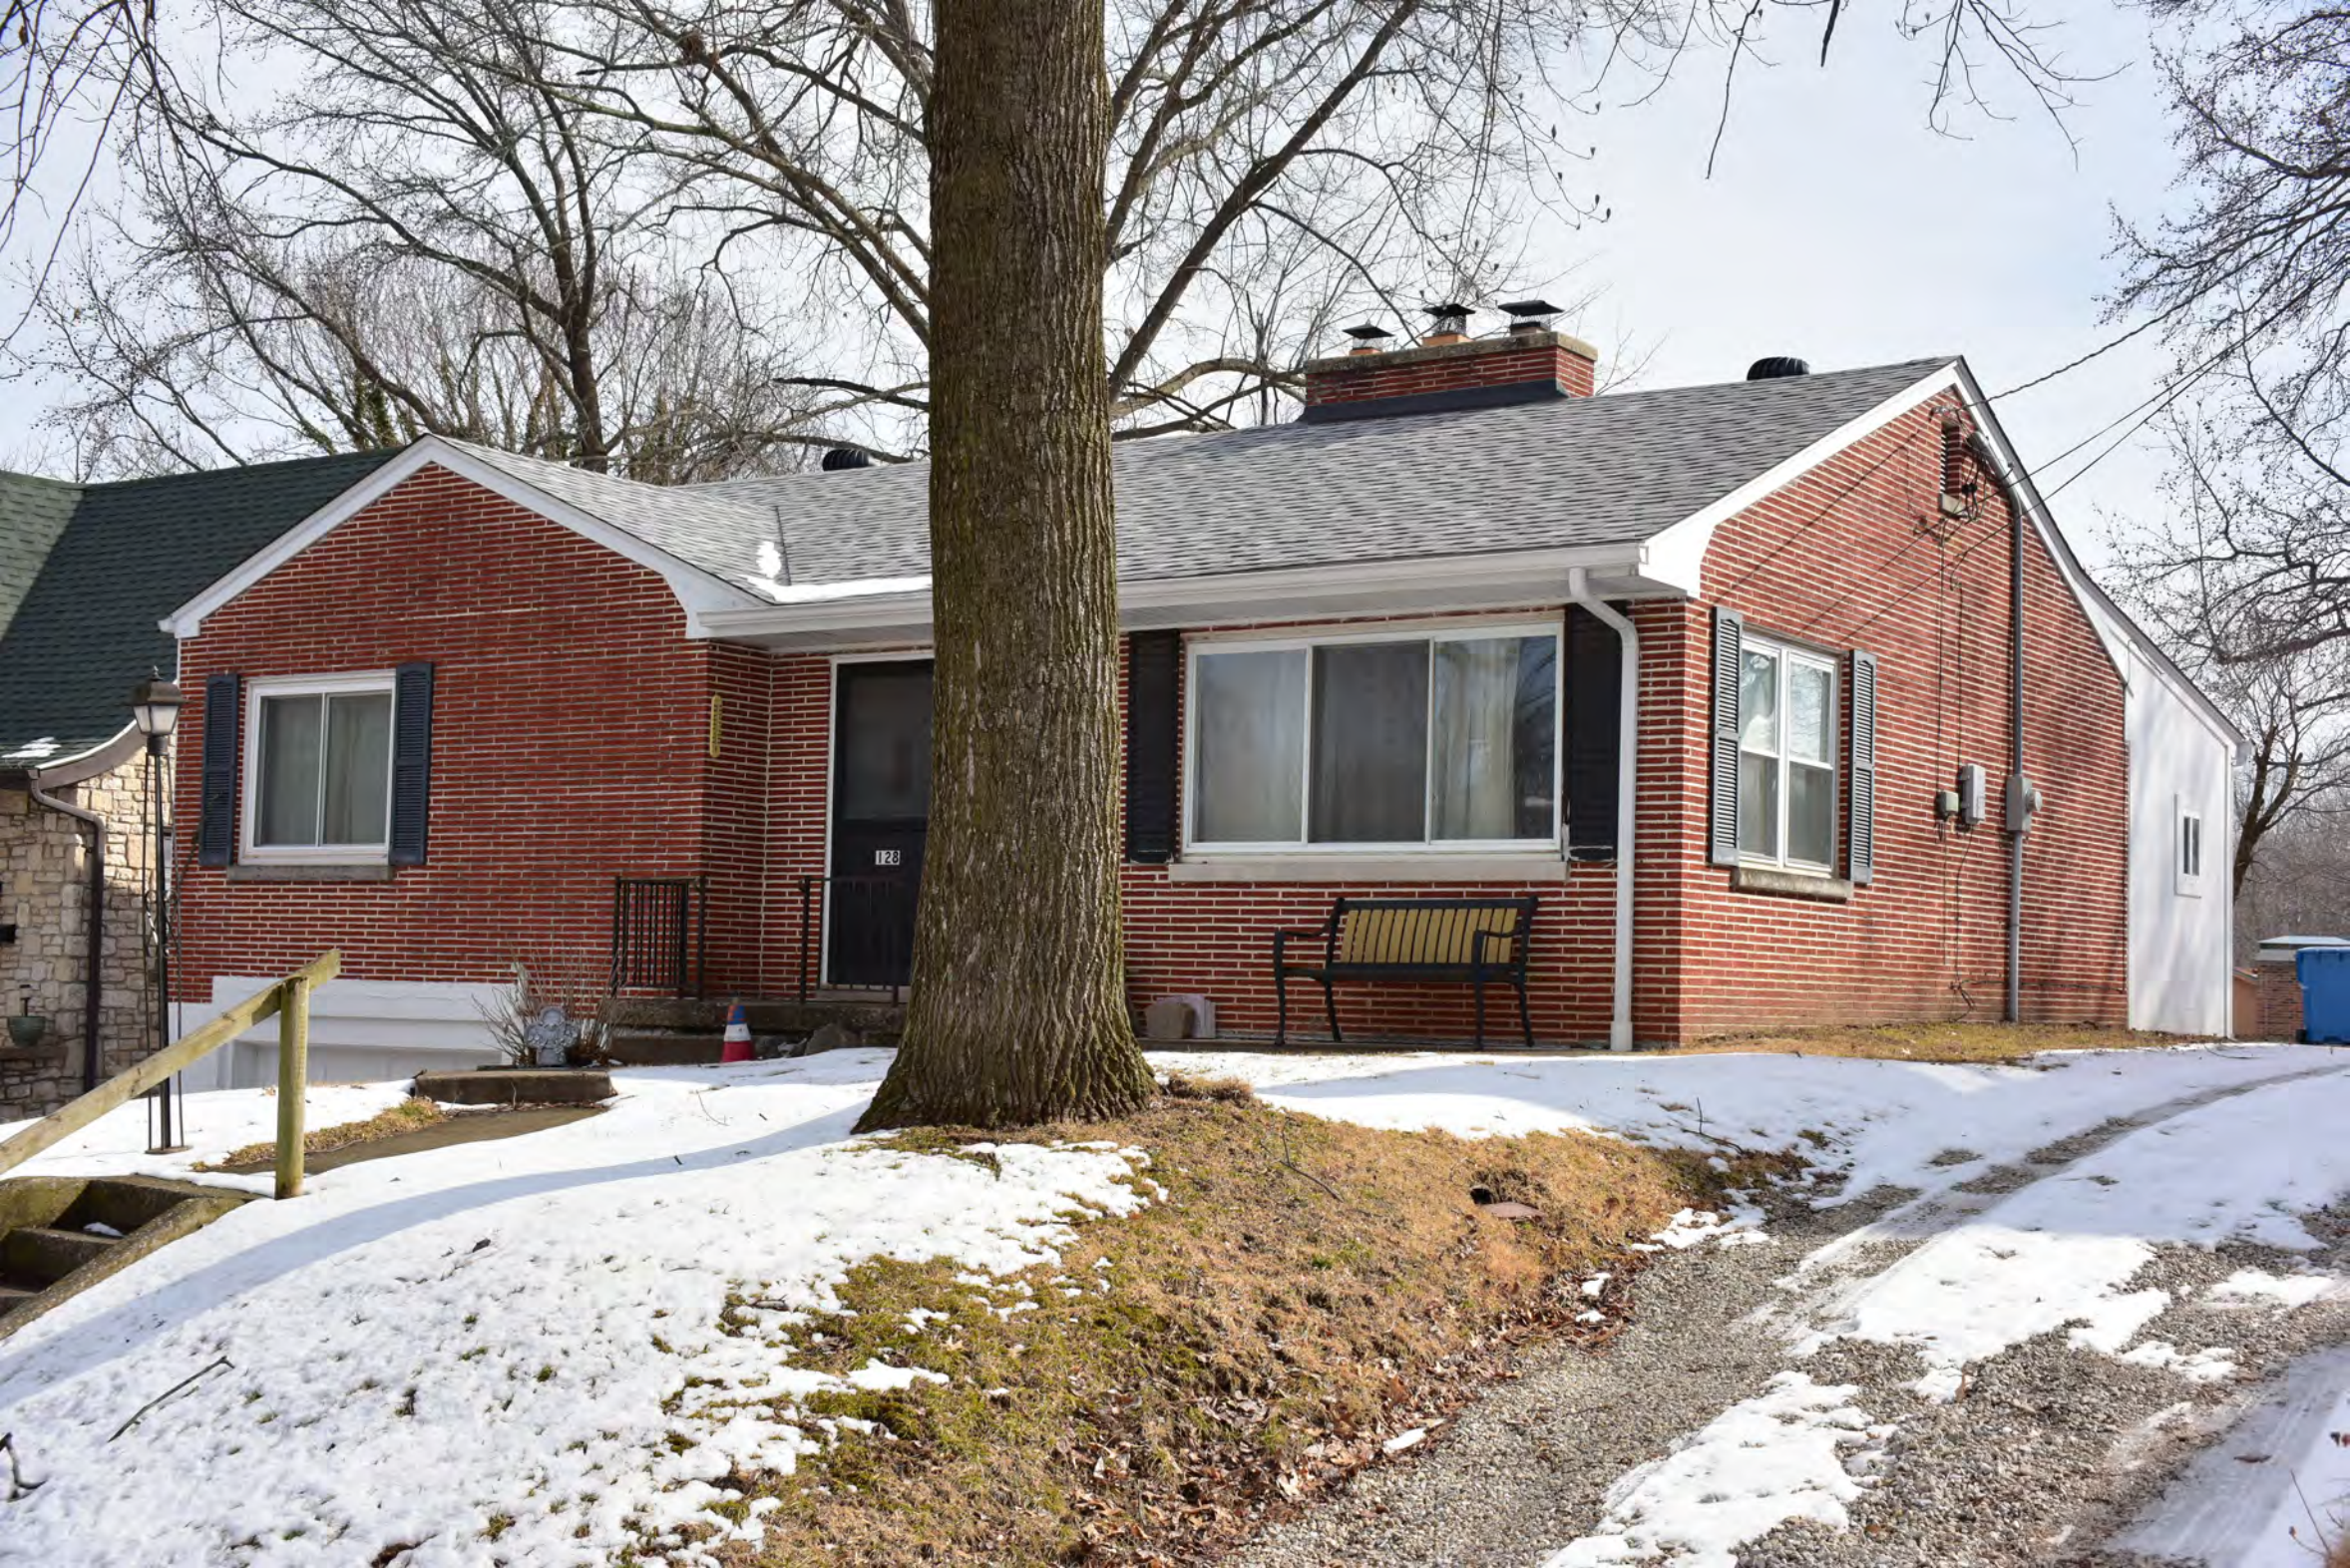
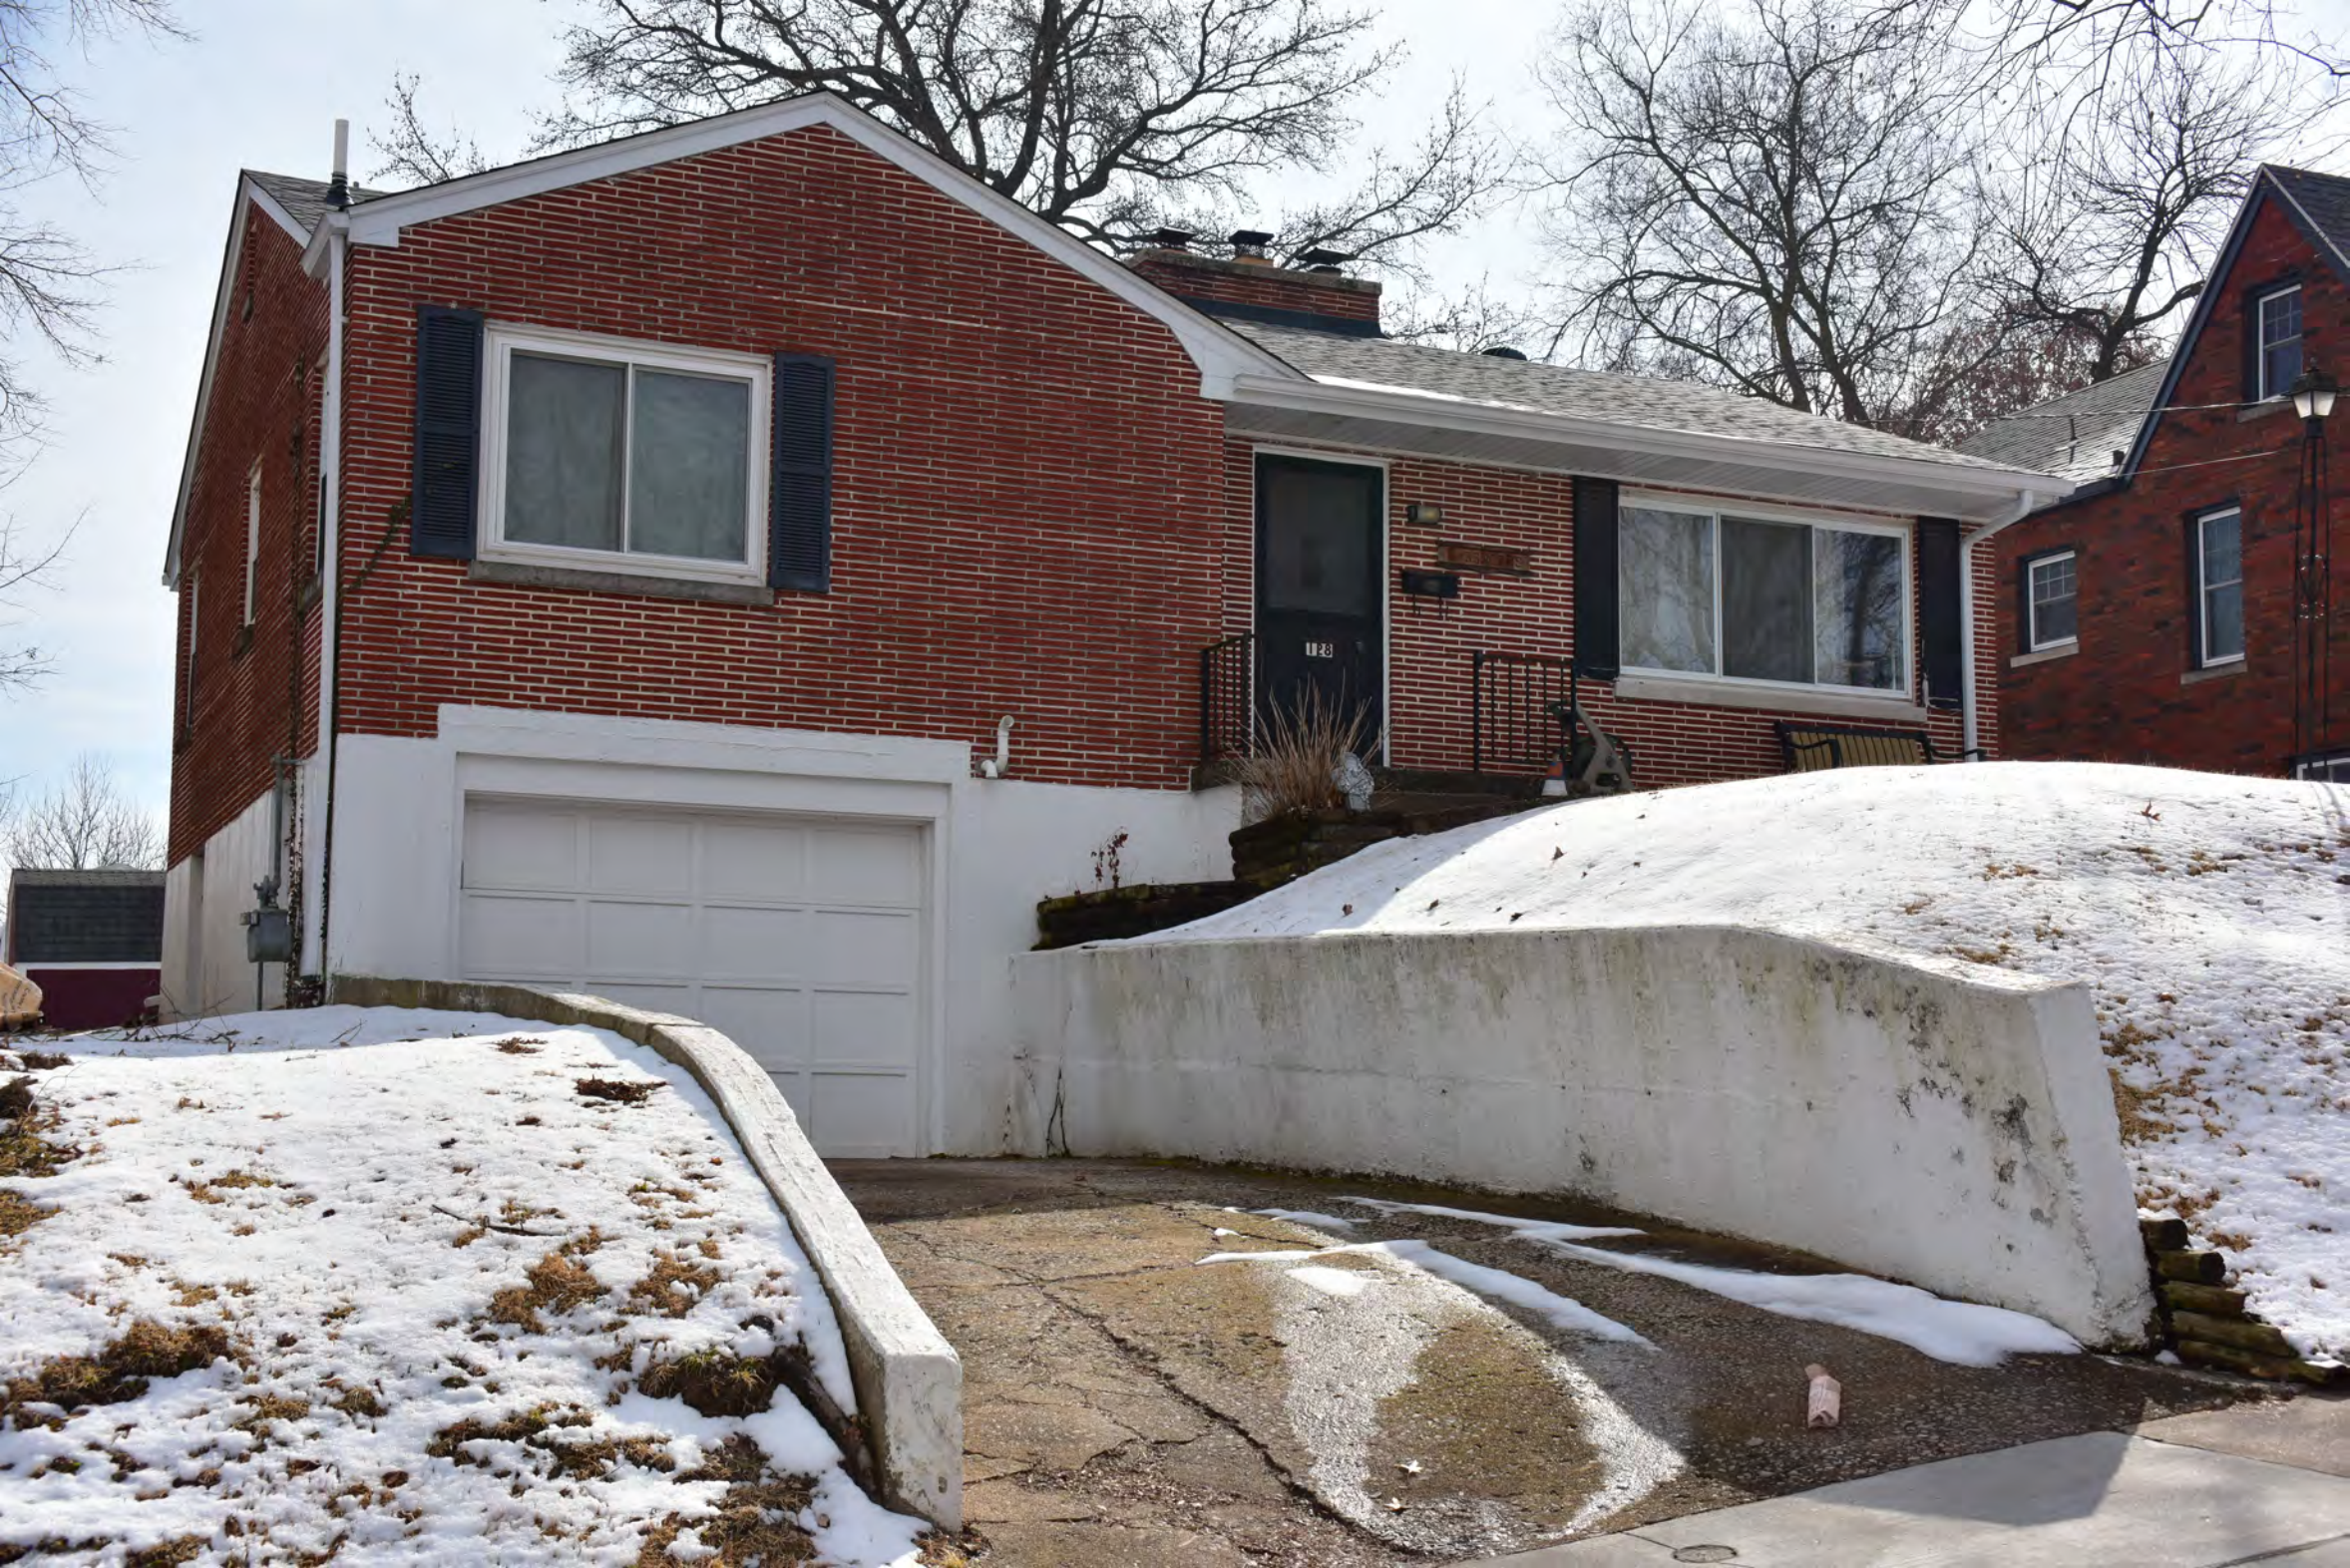
128 East Circle Drive is a one-story Ranch dwelling with a raised basement. It has narrow brick cladding, a concrete foundation, and side-gable asphalt roof with a gabled wall dormer at the north end of the primary elevation. It is three bays wide. A vinyl 1-by-1 sliding window defines the first bay. It is off-set north of center under the gable dormer. A vinyl tripartite picture window defines the third bay. Both windows have concrete sills and false shutters. The entrance defines the center bay and includes a historic wood door with glazing and a metal storm door. A concrete stoop with metal railing projects from the entrance bay. A rectangular straddle-ridge chimney pierces the roof. A one-car integrated garage is located below the first bay at basement level. A non-historic overhead door fills the vehicular bay. A shed-roof hardboard-clad enclosed porch is located at the southeast corner of the dwelling.

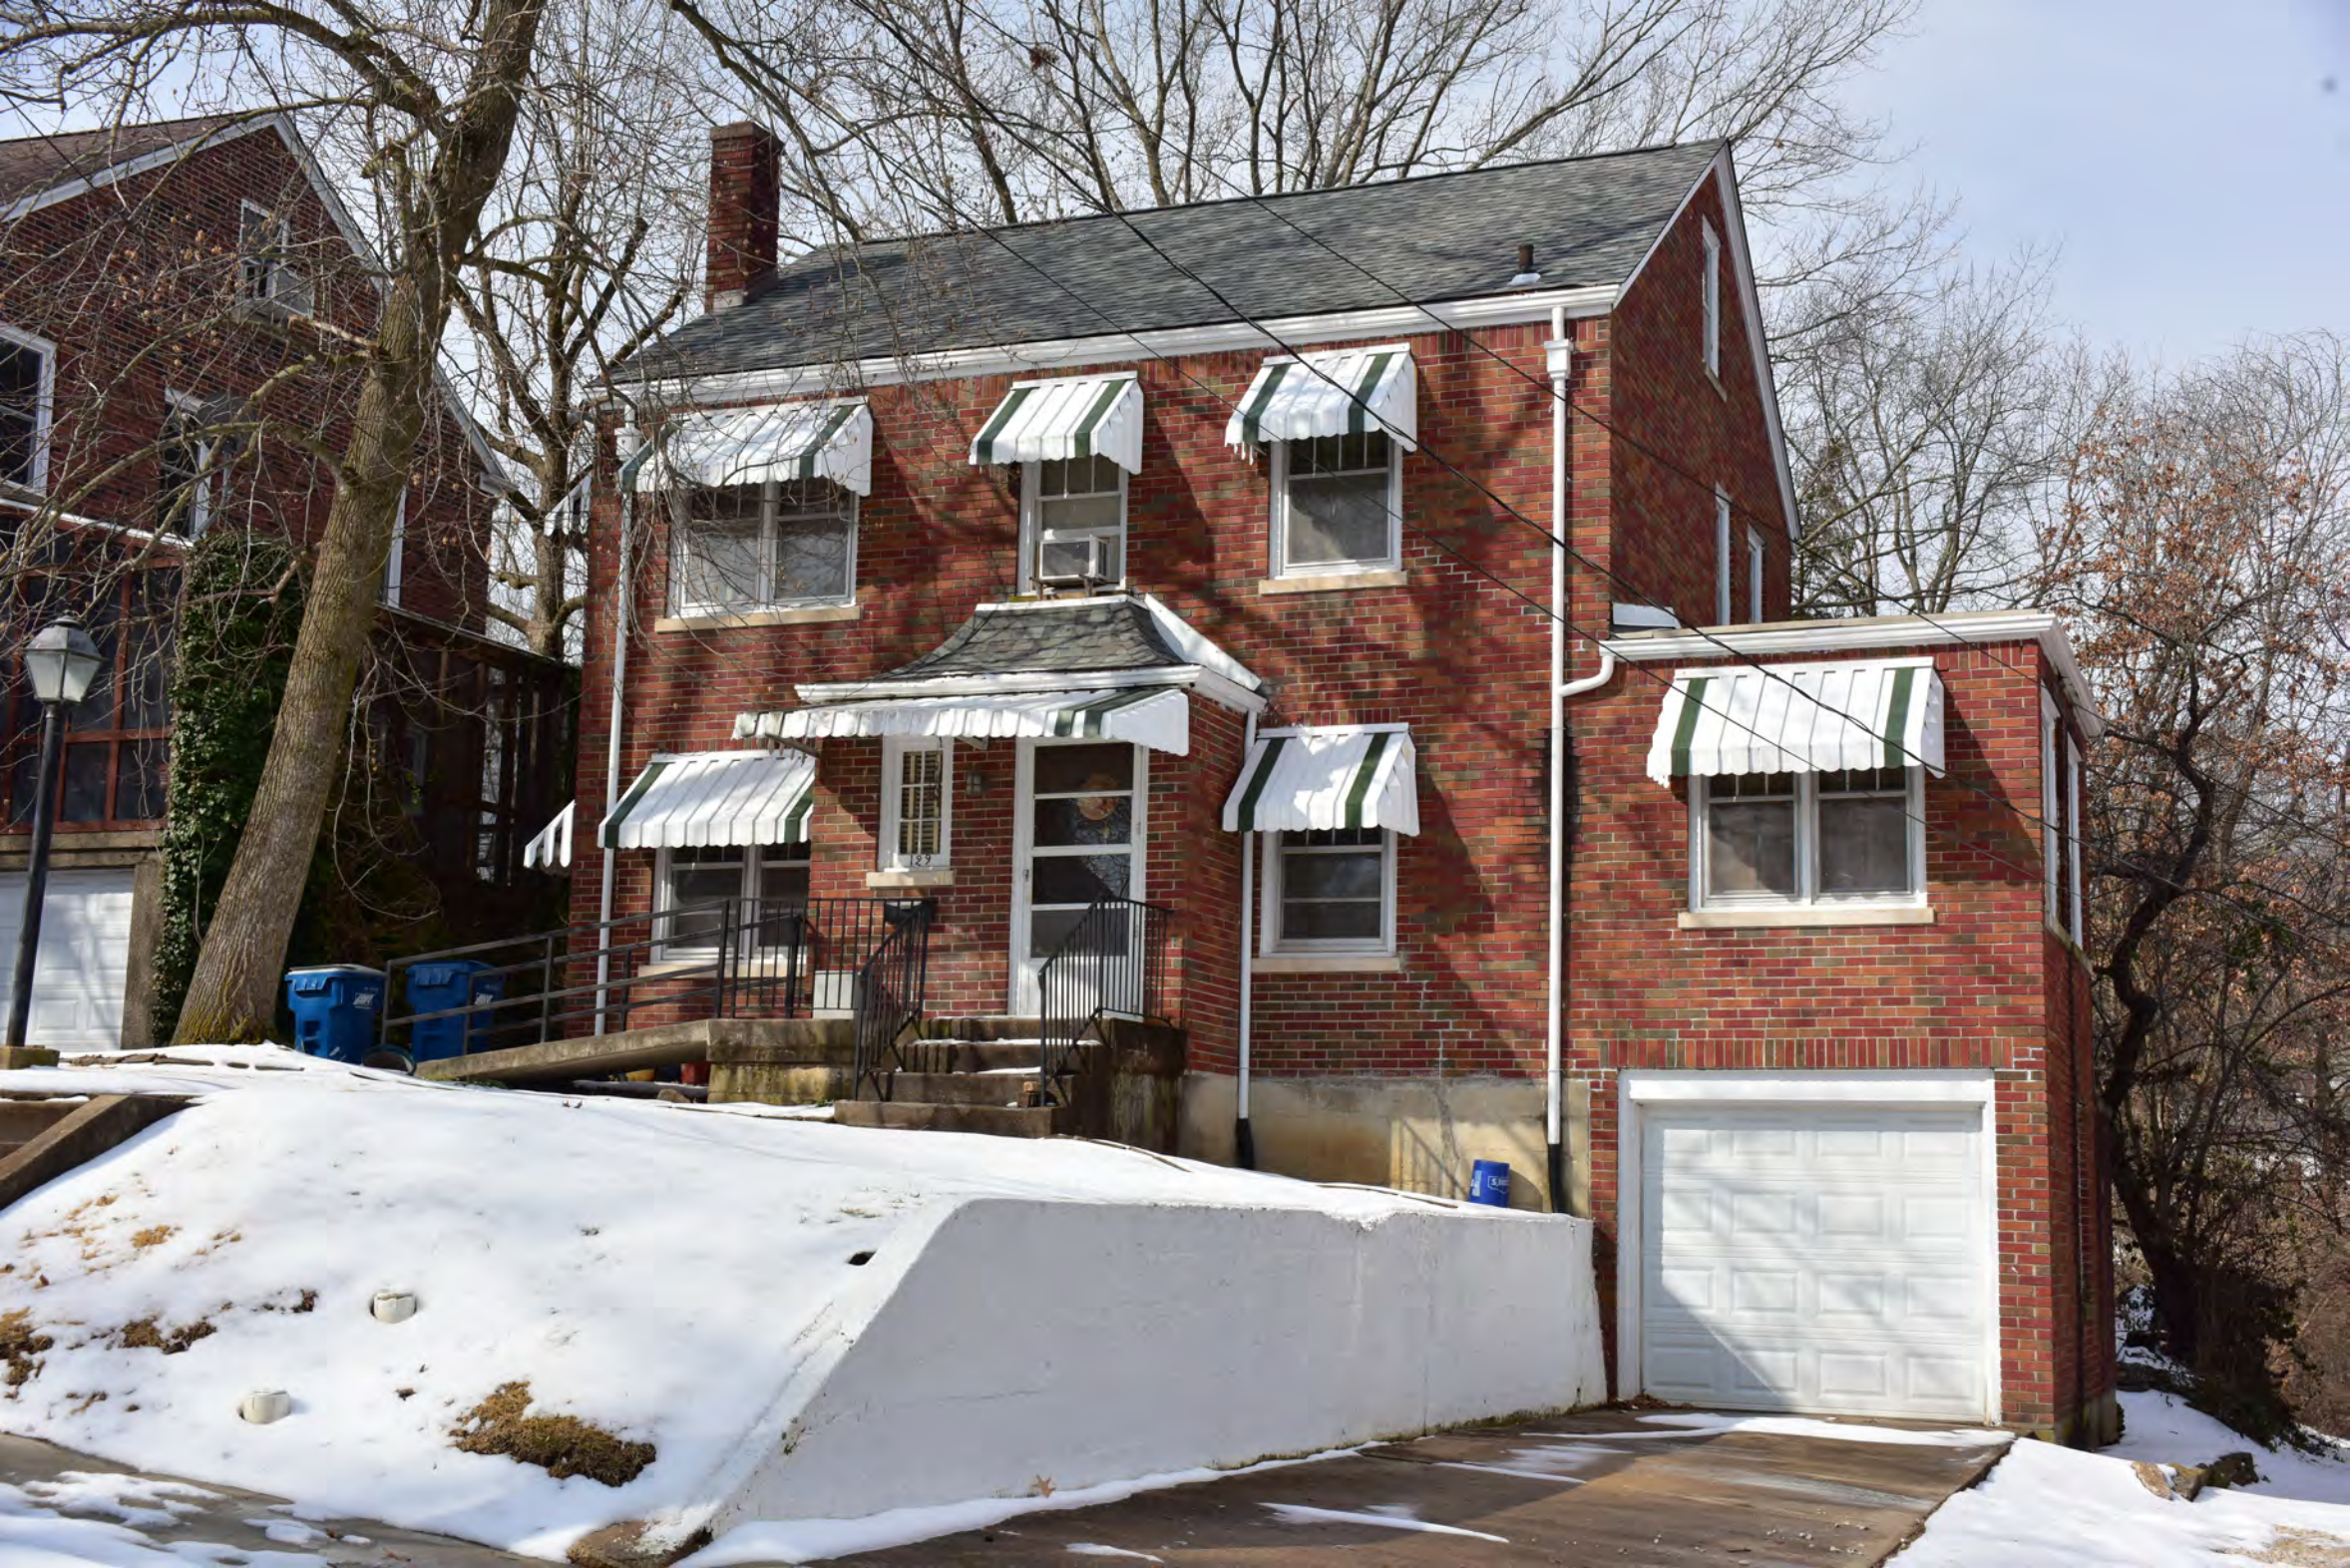
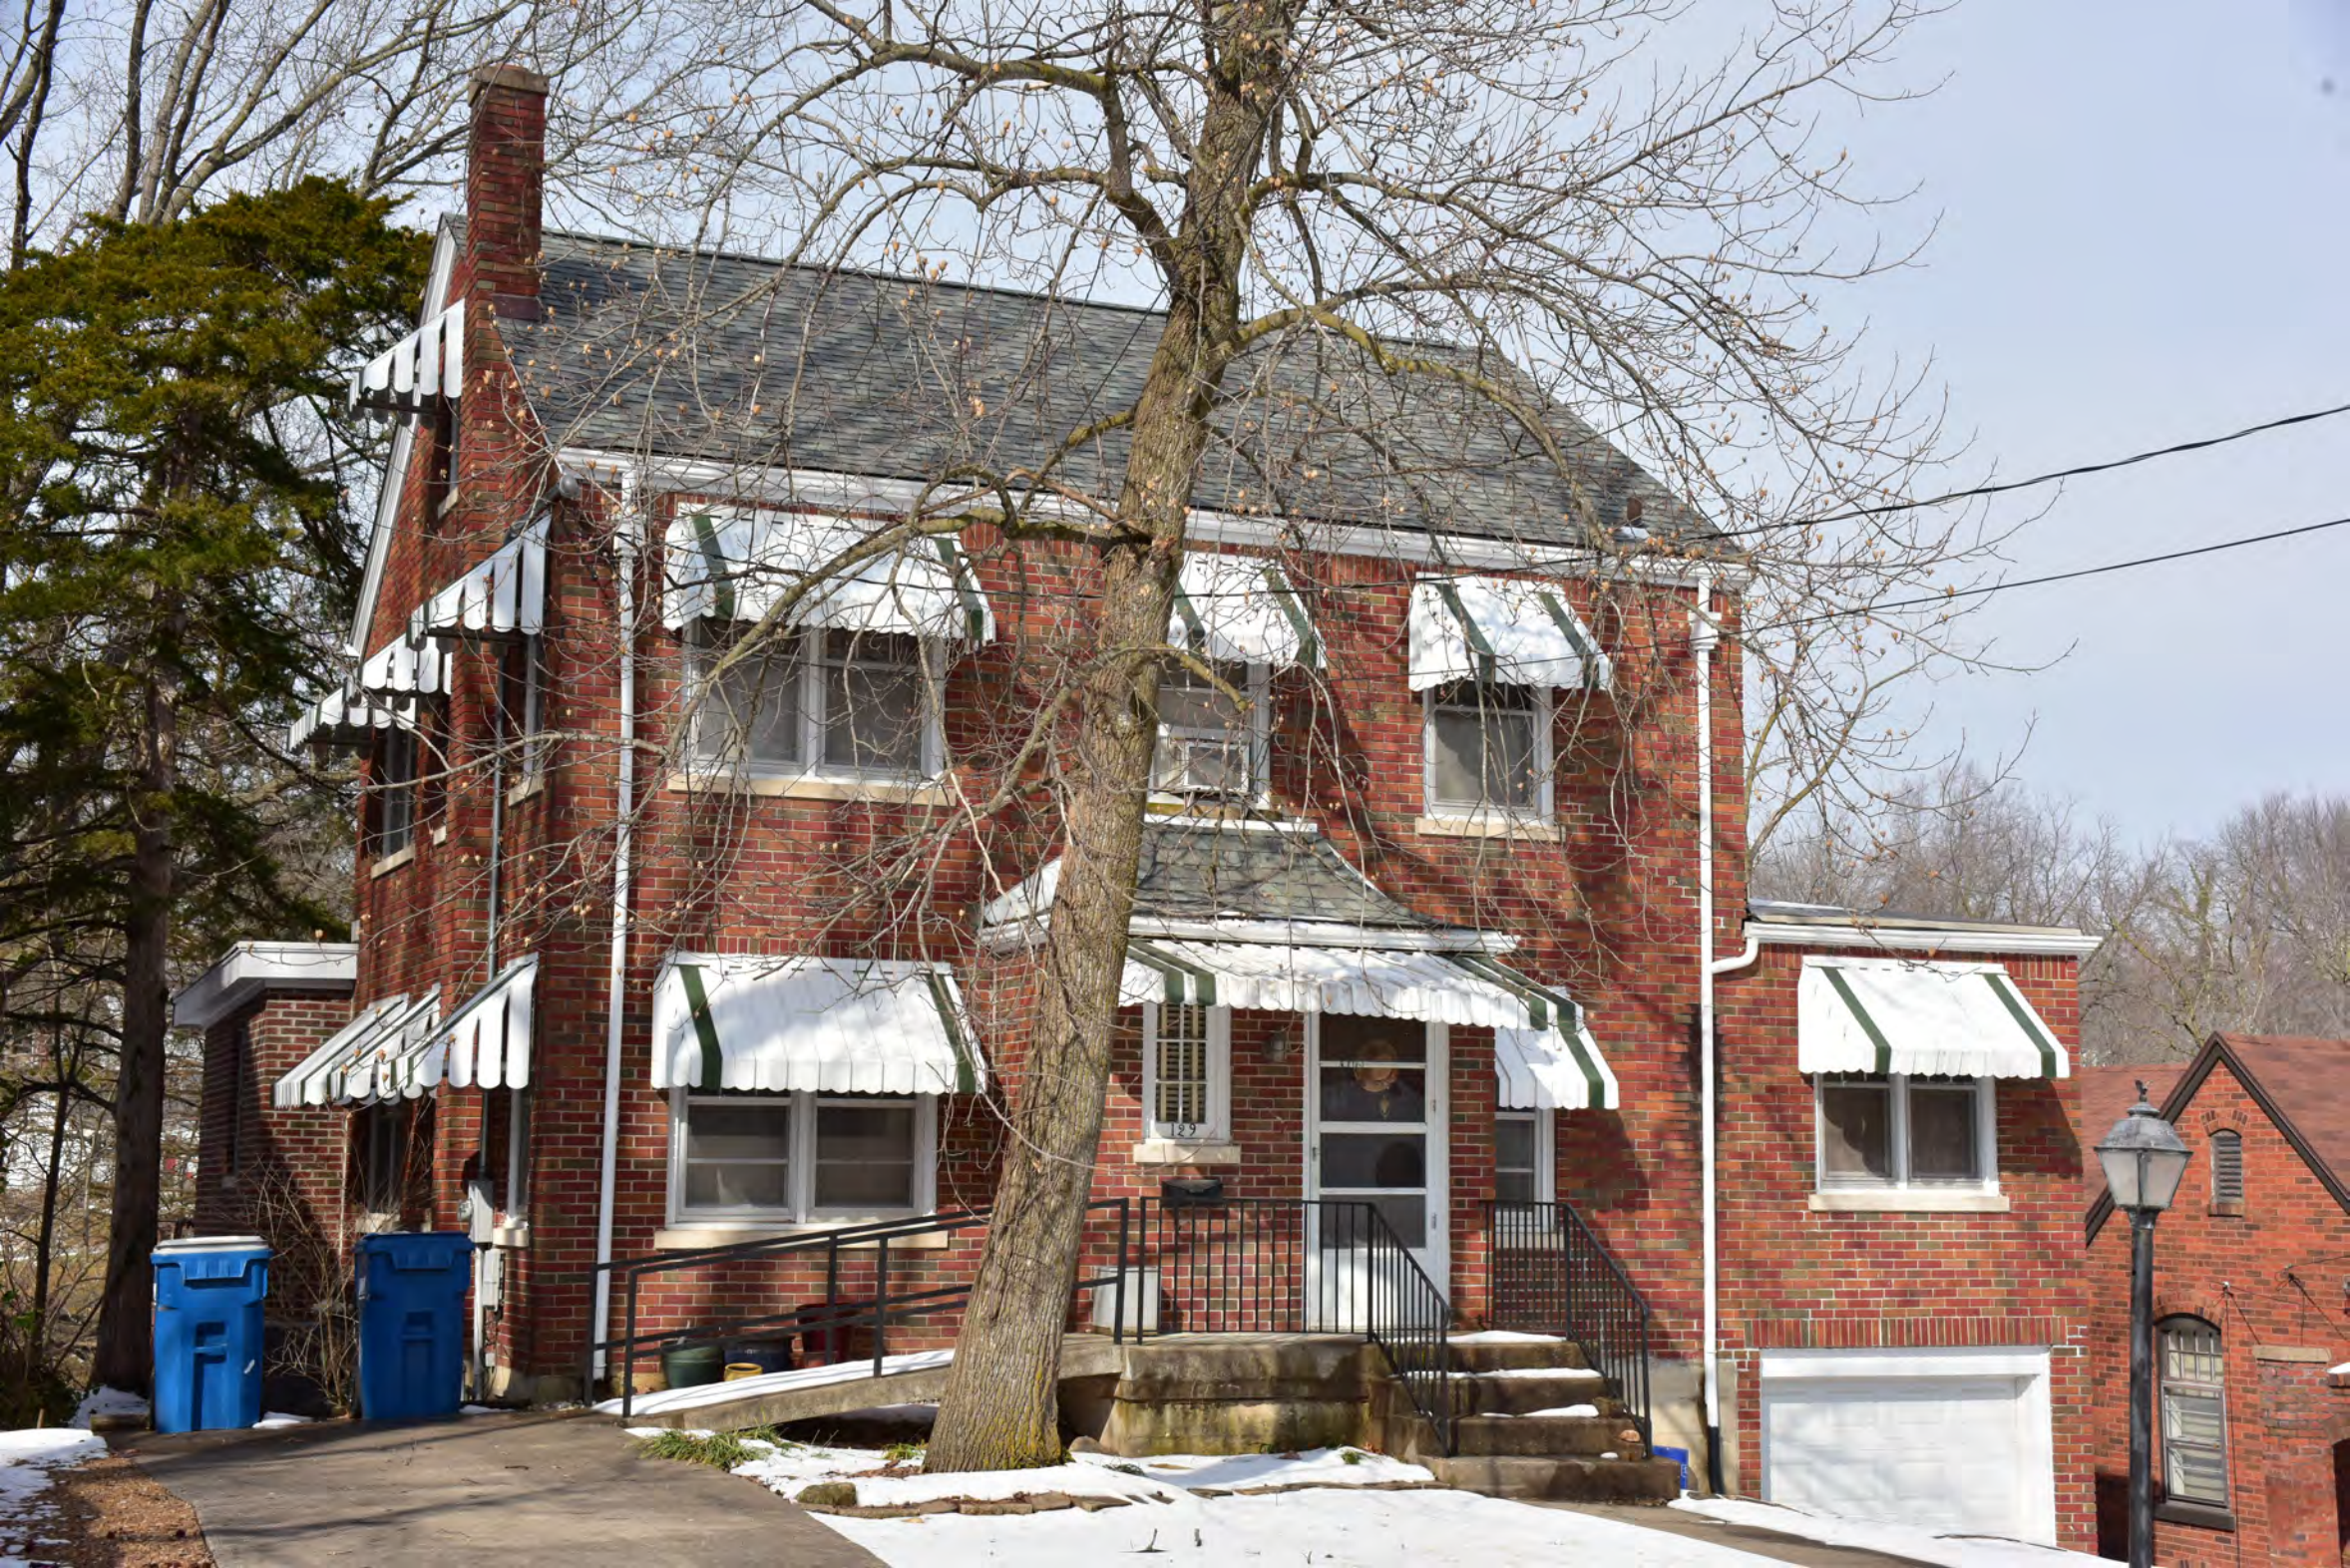
129 East Circle Drive is a two-and-one-half story Minimal Traditional dwelling with restrained Colonial Revival influences. It has a concrete foundation, multi-color brick cladding, and an asphalt side-gable roof. A brick exterior chimney is located on south elevation and pierces the gable eave. The dwelling is four bays wide at the first story. Paired 3/1 historic wood windows with a continuous stone sill define the first bay while a single 4/1 wood window with a stone sill defines the north bay. A hipped-roof brick vestibule defines the center bay and contains the primary entrance and a small window. The entrance contains a historic wood door with glazing. A six-light historic wood window is positioned immediately south of the entrance. A concrete stoop with a concrete ramp and metal railings projects from the vestibule. A one-story ell with a flat roof contains the fourth bay. Paired 3/1 historic wood windows with a continuous stone sill defines the bay. The ell contains a historic integrated single-car garage at the basement level. A non-historic overhead door fills the garage bay. Non-historic metal awnings shelter all windows and the entrance at the primary elevation. All secondary elevation windows visible from the right of way are historic wood with a variety of pane arrangements and stone sills. A post-1967 one-story brick-clad addition is present at the rear.

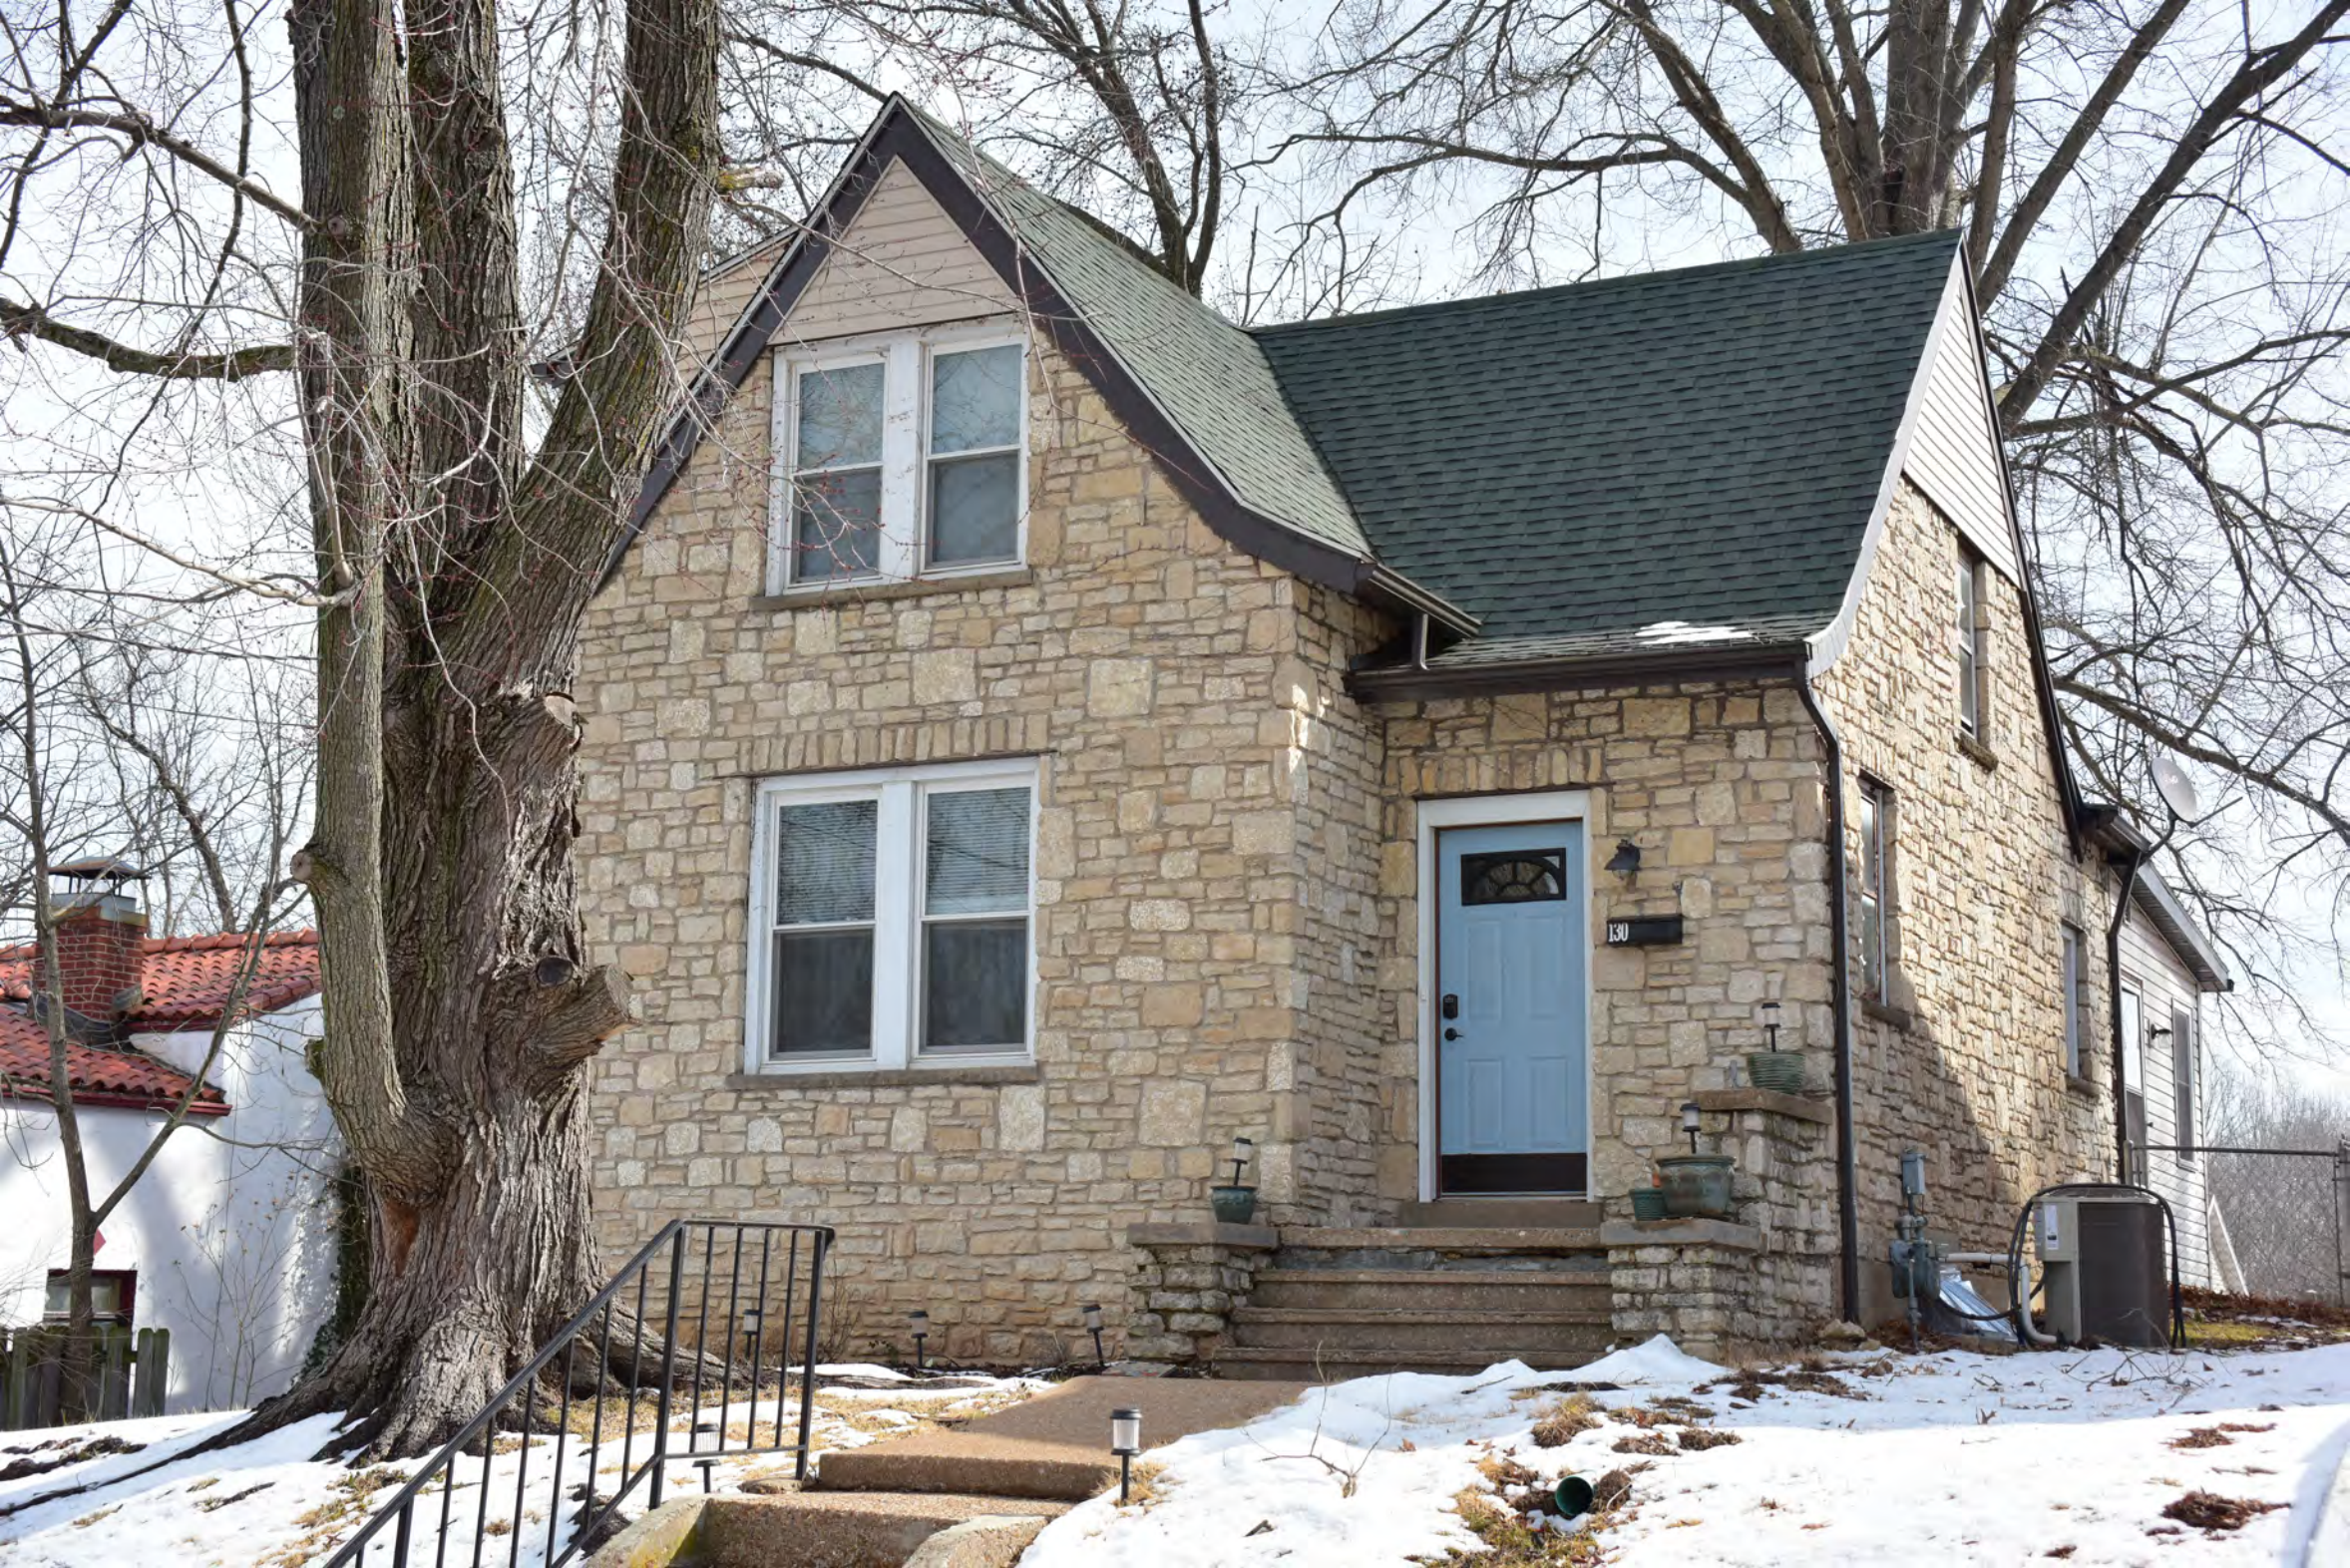
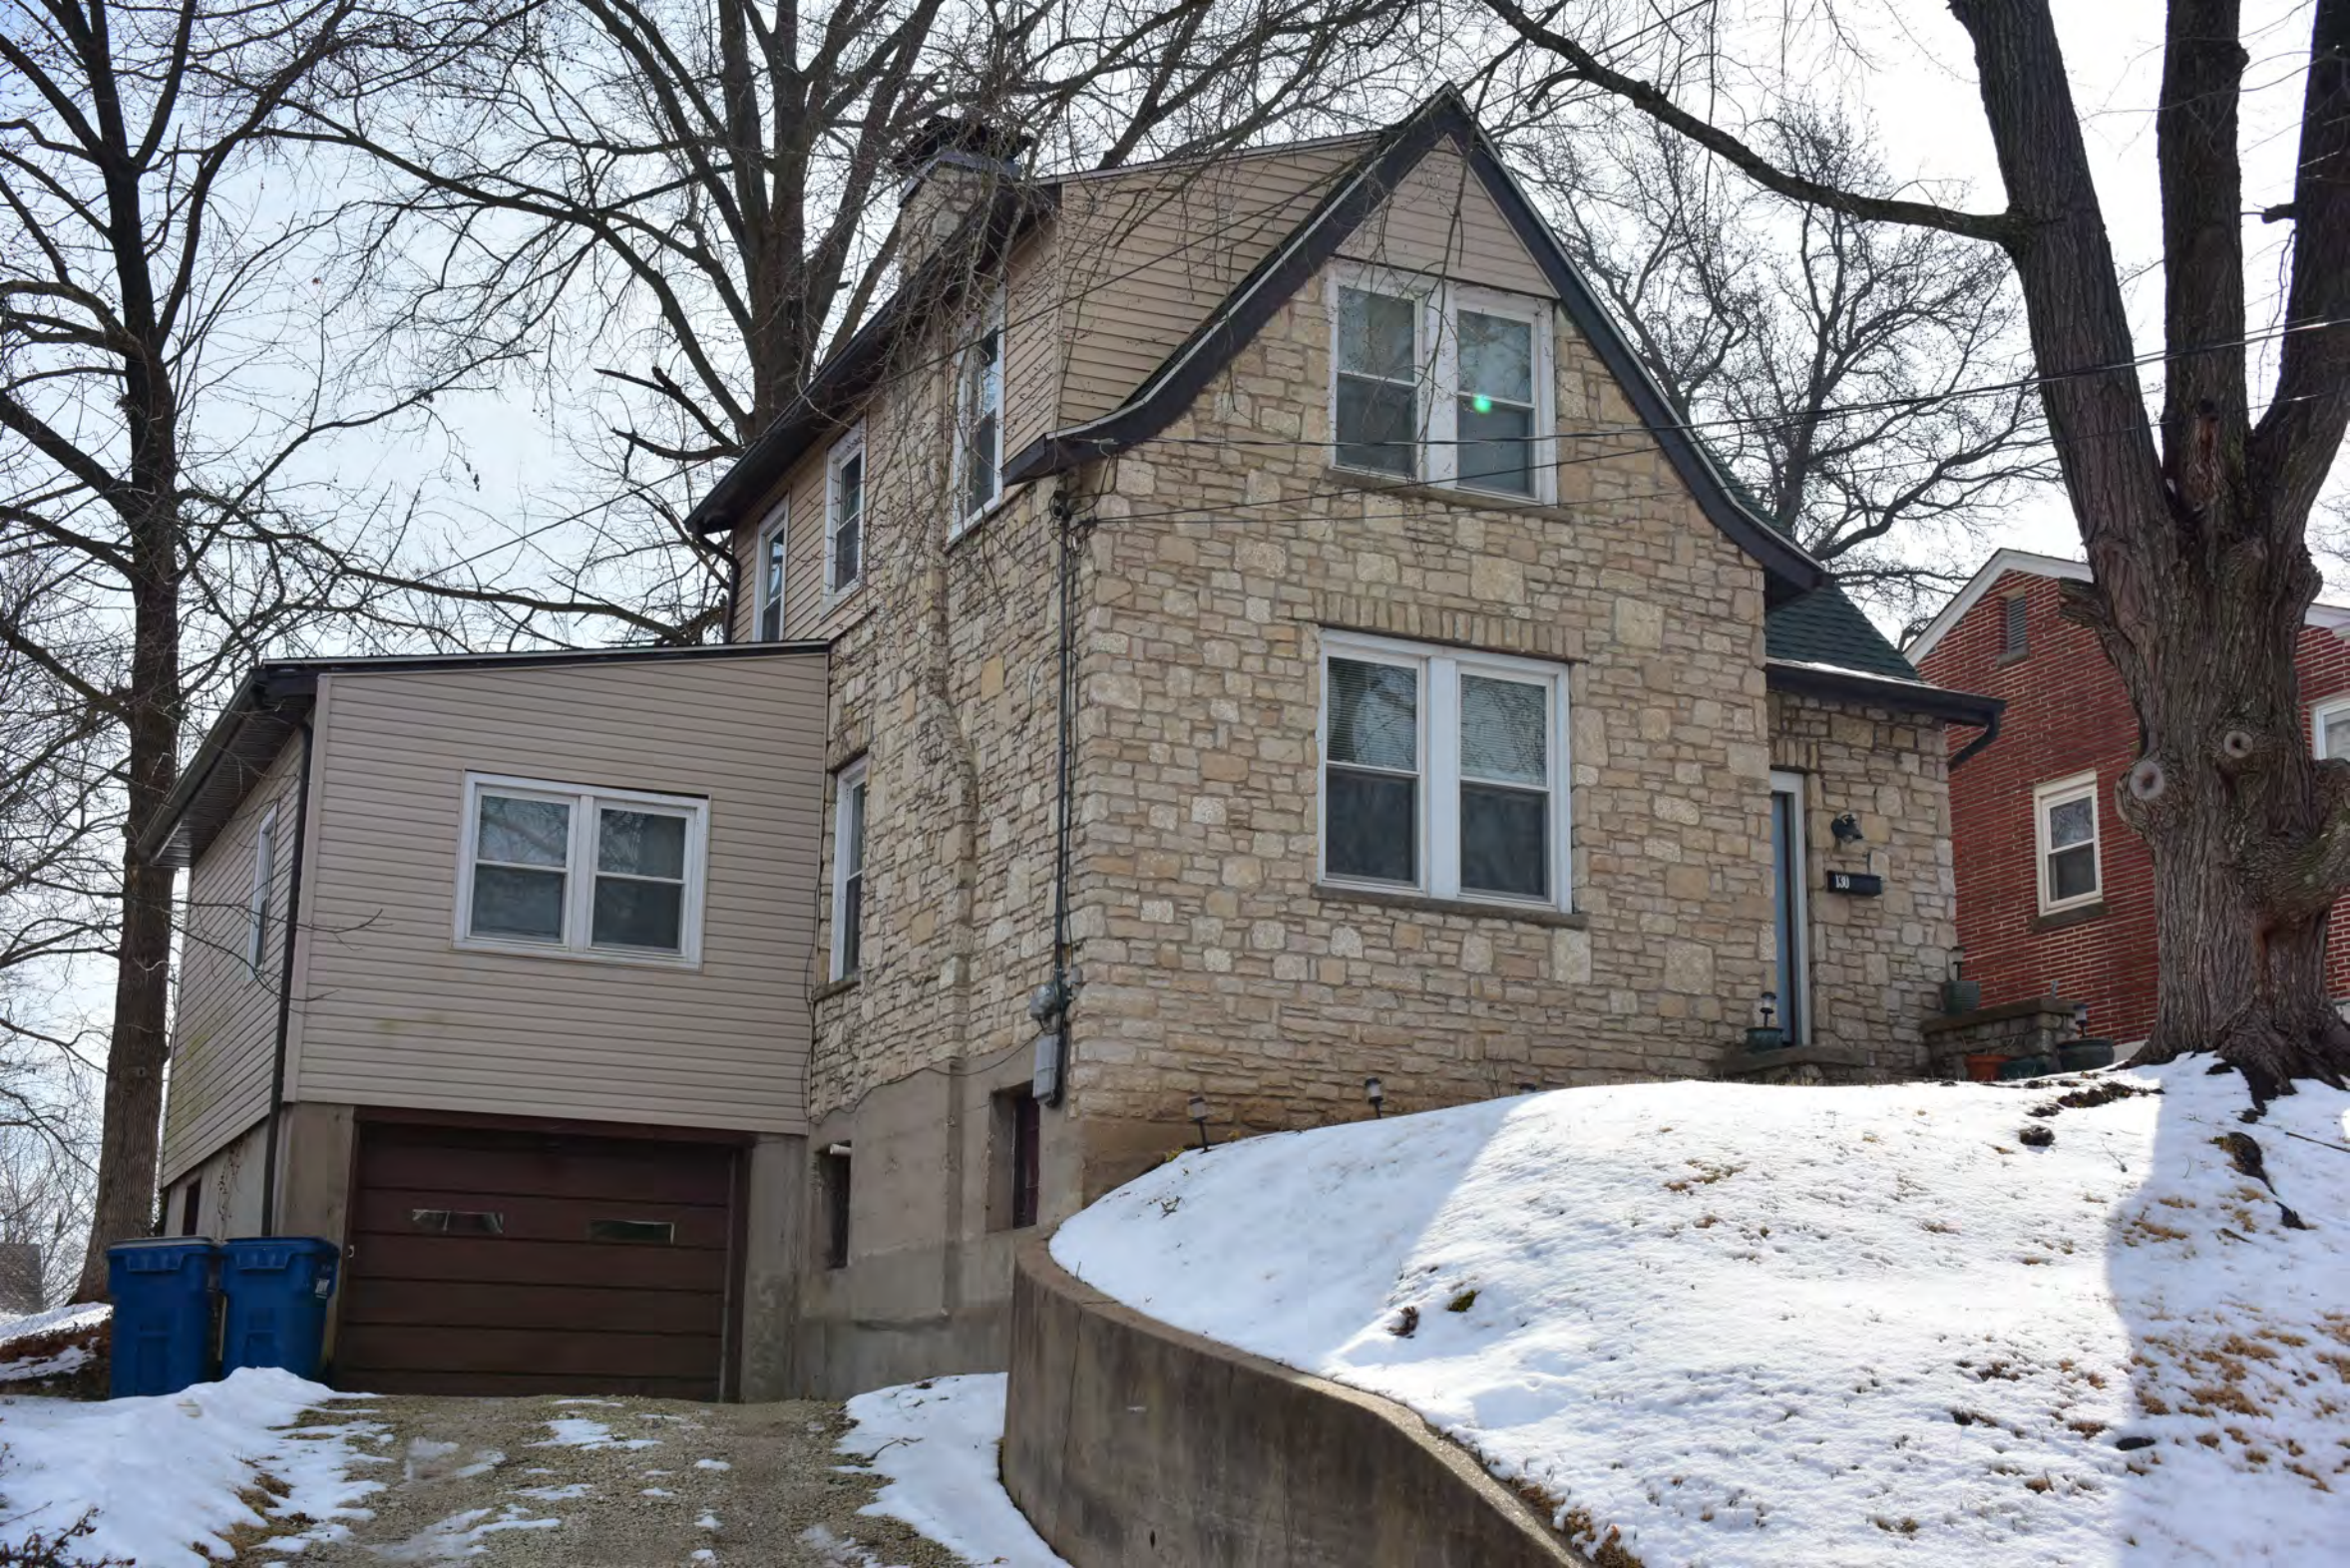
130 East Circle Drive is a one-and-one-half-story Minimal Traditional dwelling with a concrete foundation, stone cladding, and an asphalt gabled-ell roof. The ell is located on the south elevation. Metal siding clads all gable apexes. A post-1967 hardboard-clad shed dormer spans the north slope of the primary gable. The dwelling is two bays wide. Paired non-historic 1/1 vinyl windows define the first bay. The second bay is located in the gabled ell and contains a non-historic door. A concrete stoop lined with stone piers projects from the entrance. Paired non-historic 1/1 vinyl windows are centered in the primary elevation gable. A c. 1965 single-car garage projects from the north elevation. A metal-clad shed-roof addition tops the garage. A metal-clad shed-roof addition extends from the rear elevation.
